Technical Report

October 1971

BLAST RESPONSE OF FIVE NFSS BUILDINGS

STANFORD RESEARCH INSTITUTE
Menlo Park, California 94025 · U.S.A.

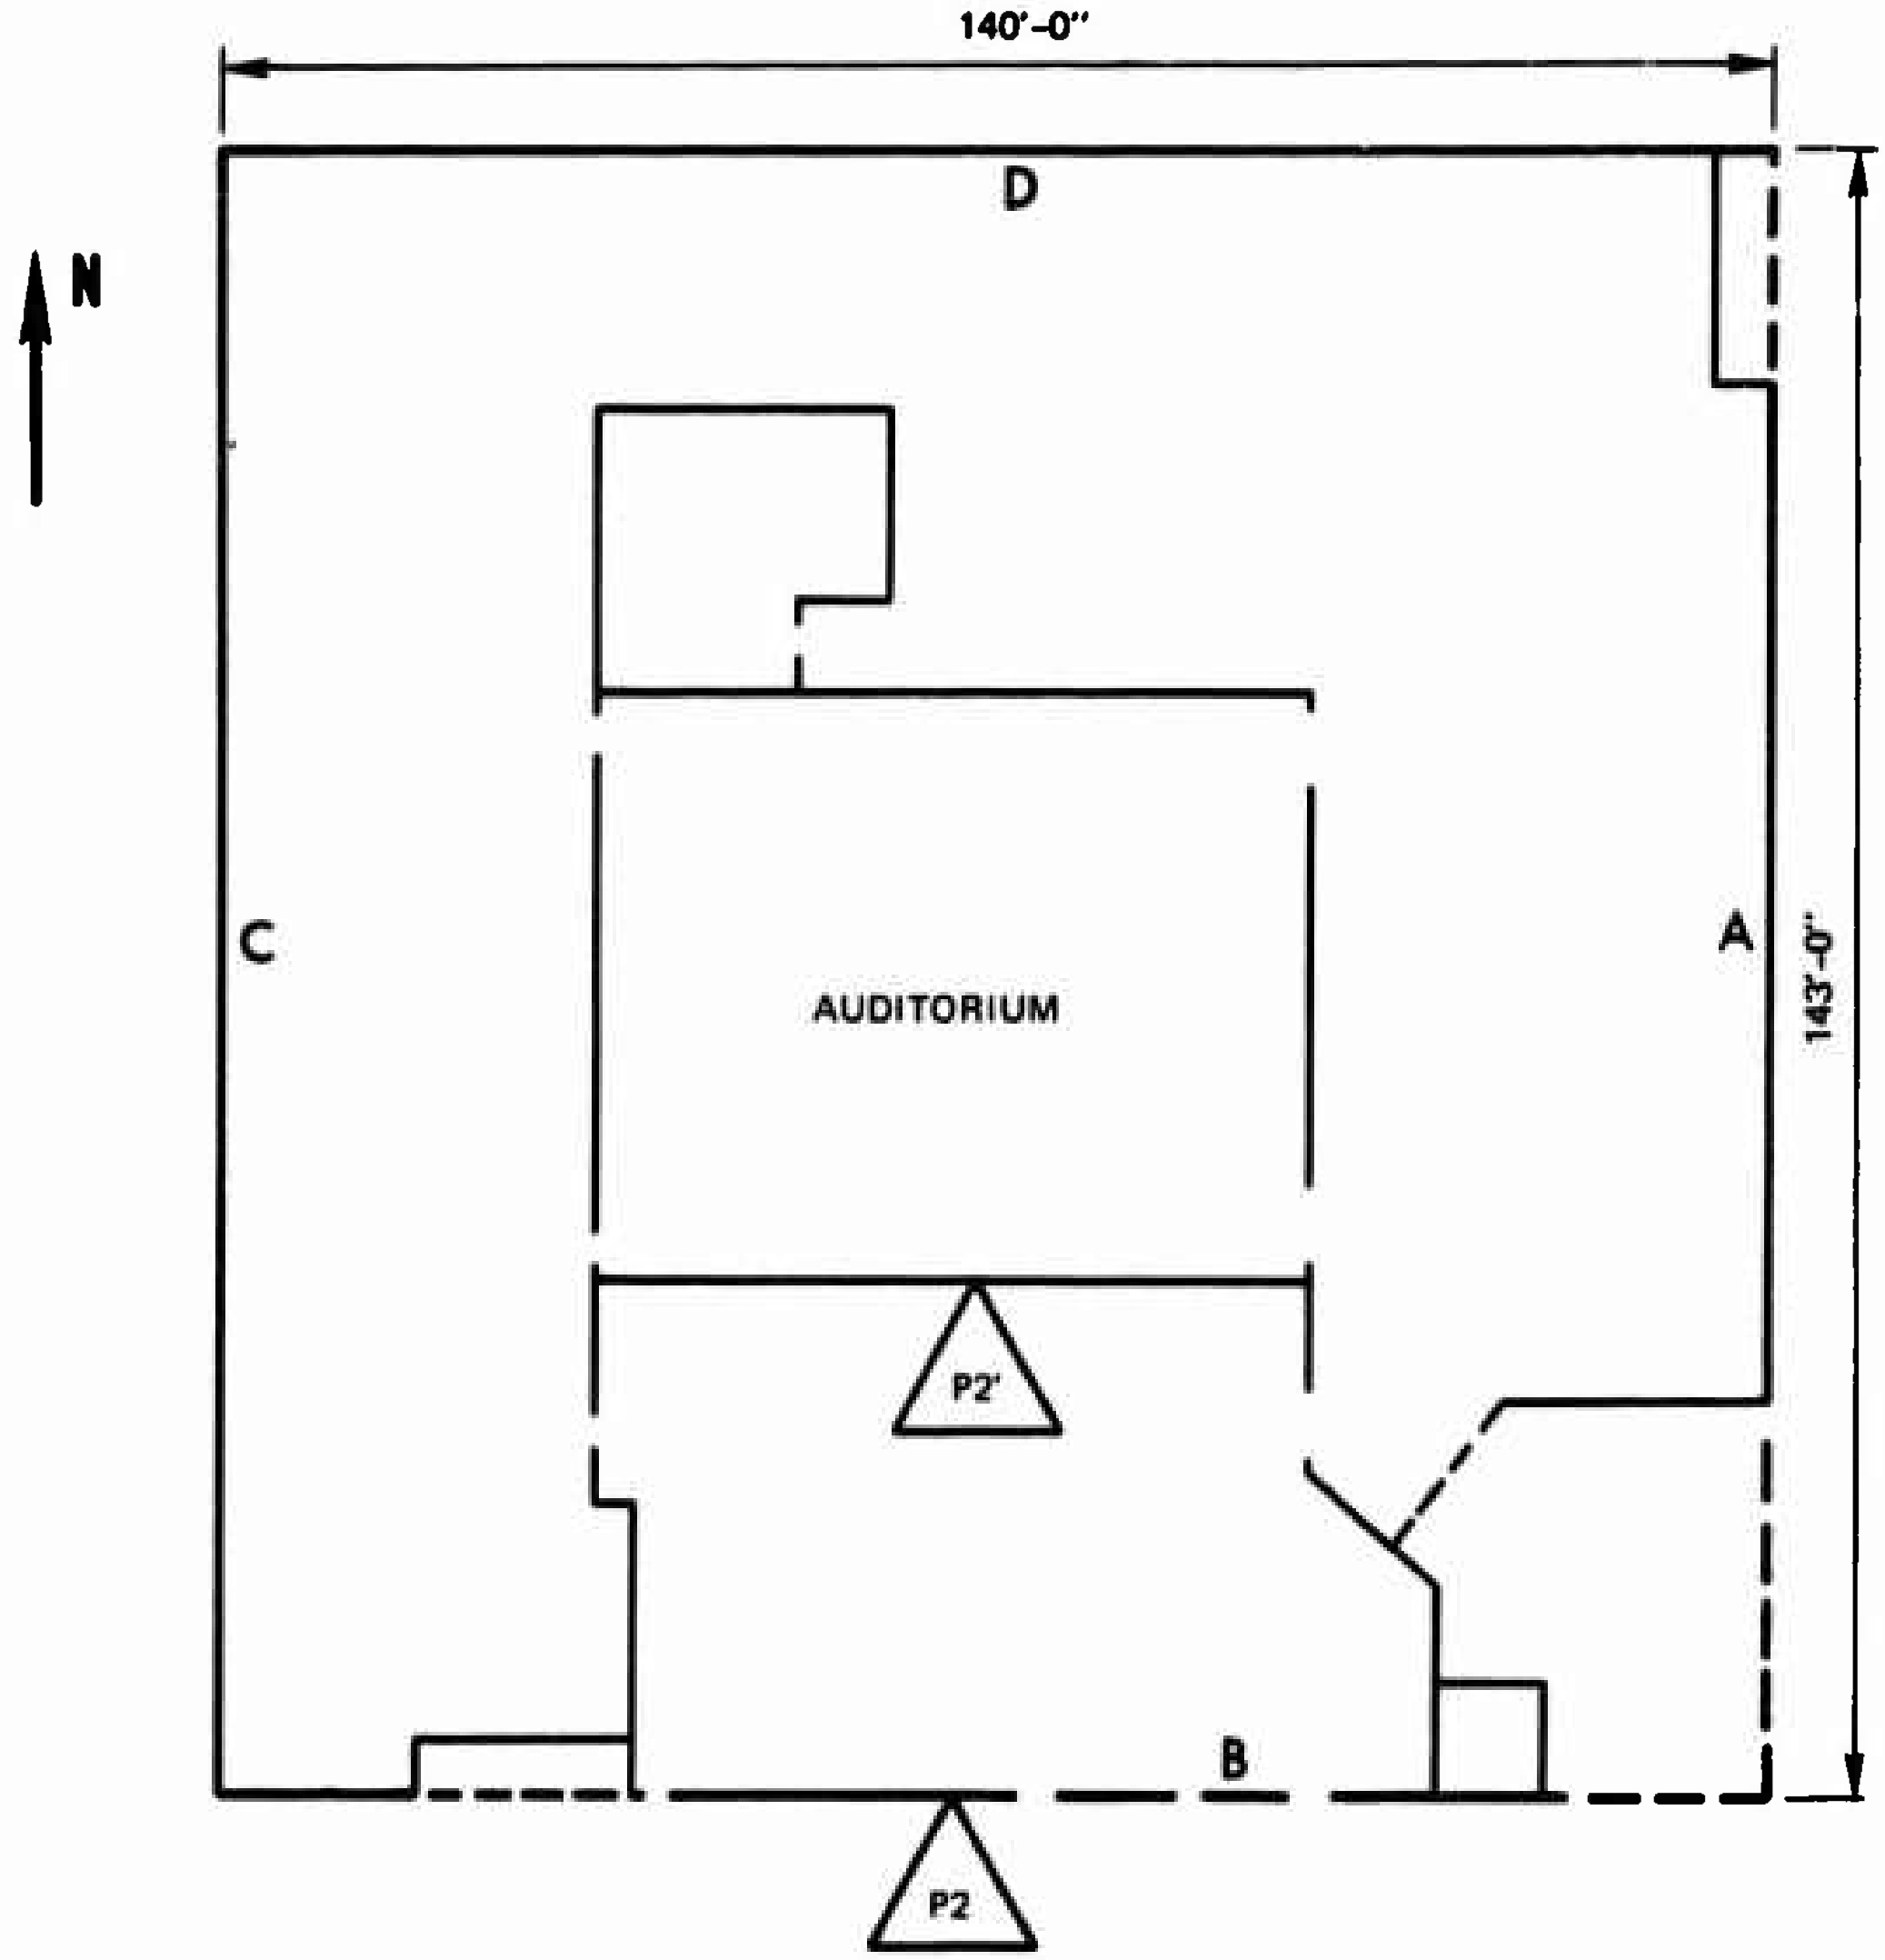
FIGURE 3 PLAN VIEW OF INTERIOR WALLS ON SECOND STORY
GREENSBORO PUBLIC LIBRARY

For the interior wall surrounding the auditorium (Cases IIF2′ and IIP2′), the analysis using the building plan data resulted in a prediction for the mean collapse overpressure that was about 30 percent greater than that made with the survey data. Since the wall properties were similar for both cases, as noted in Table 3, it is evident that the difference resulted from the variation in the area of openings and room volume, which would affect the pressure-time history on the walls.

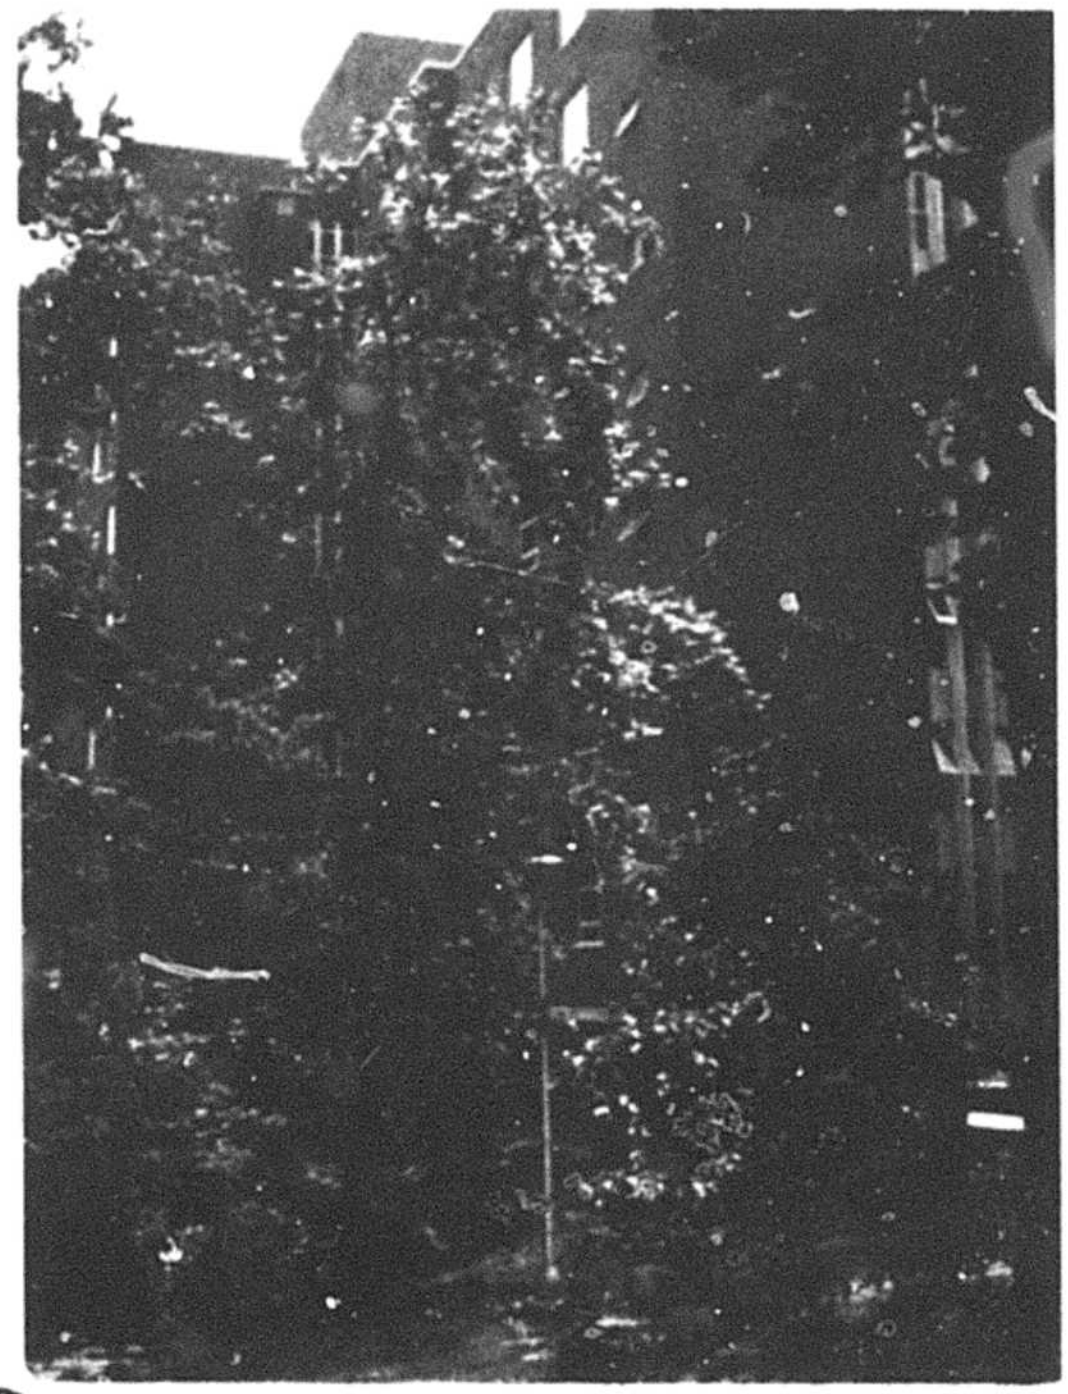
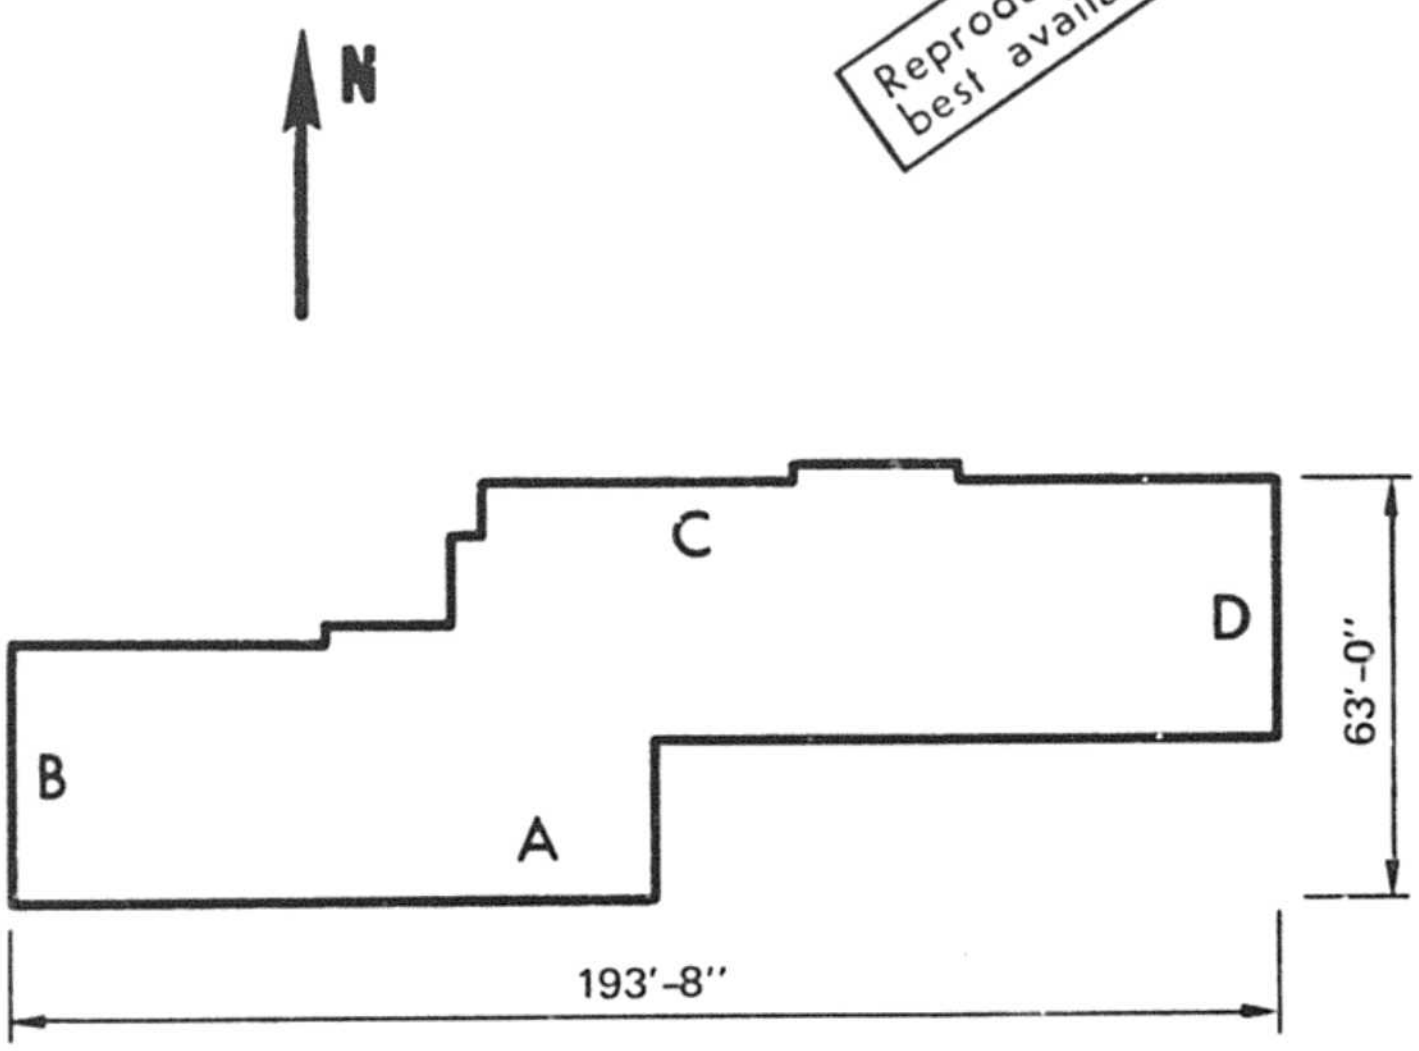
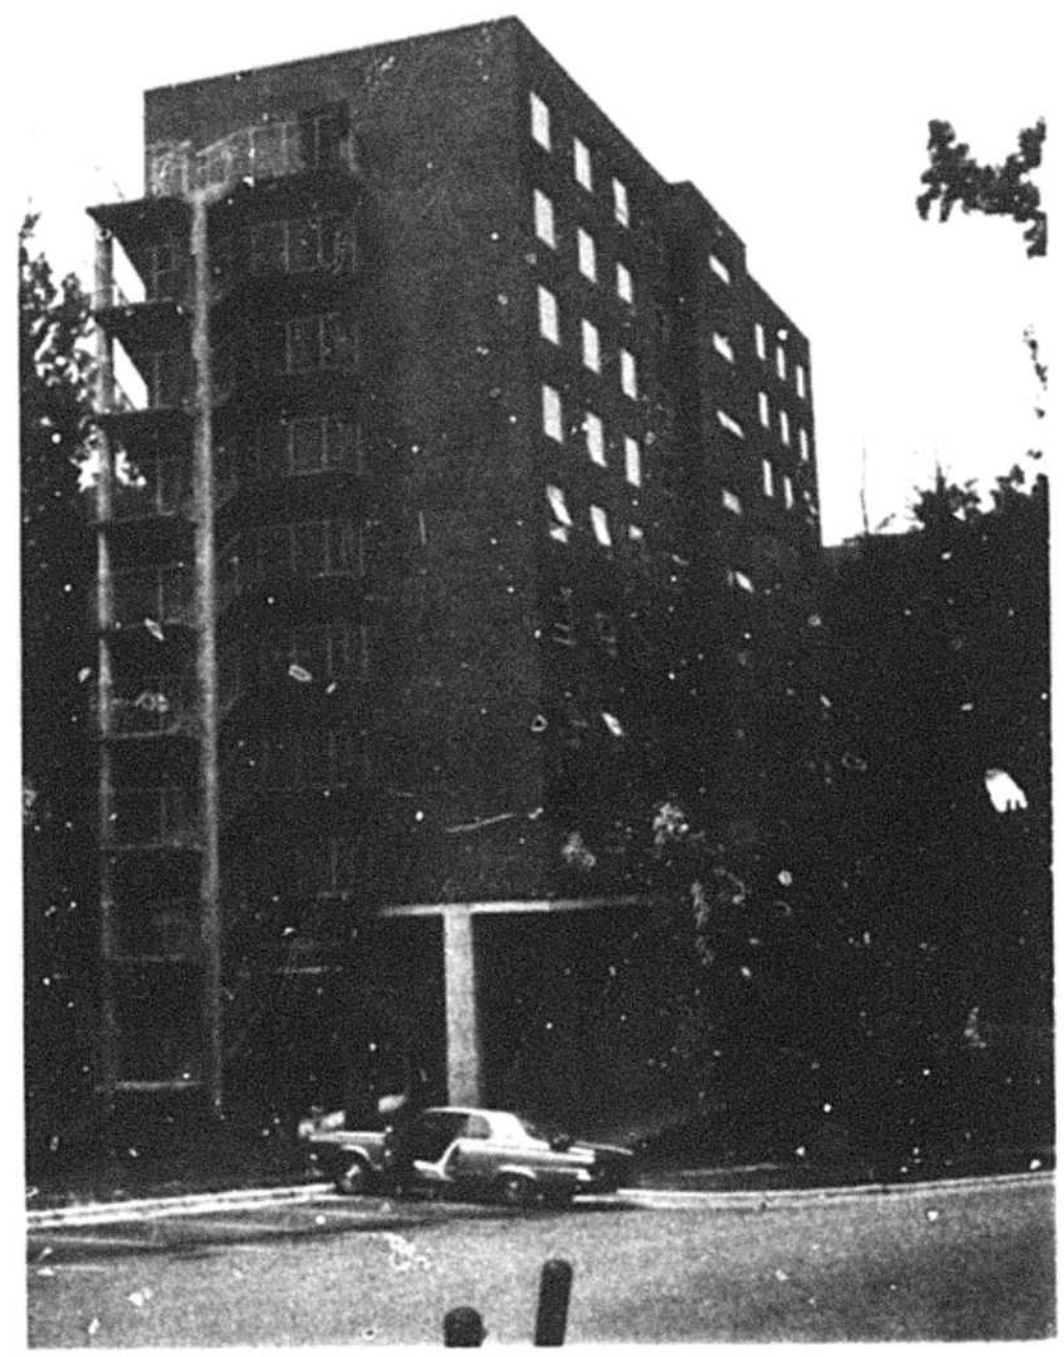
FIGURE 4 PHOTOGRAPHS AND PLOT PLAN OF LAURA CONE DORMITORY described as 6-in. thick and inset in the frame; there was a limited amount of 8-in. concrete block on the basement and first story levels. The brick veneer was 4-in. thick with a 1-in. cavity on all sides of the building.

Field Survey Data. During the on-site survey the exterior walls of the Dormitory were classified as nonreinforced concrete block panel walls with brick masonry veneer. The concrete block on the upper floors was

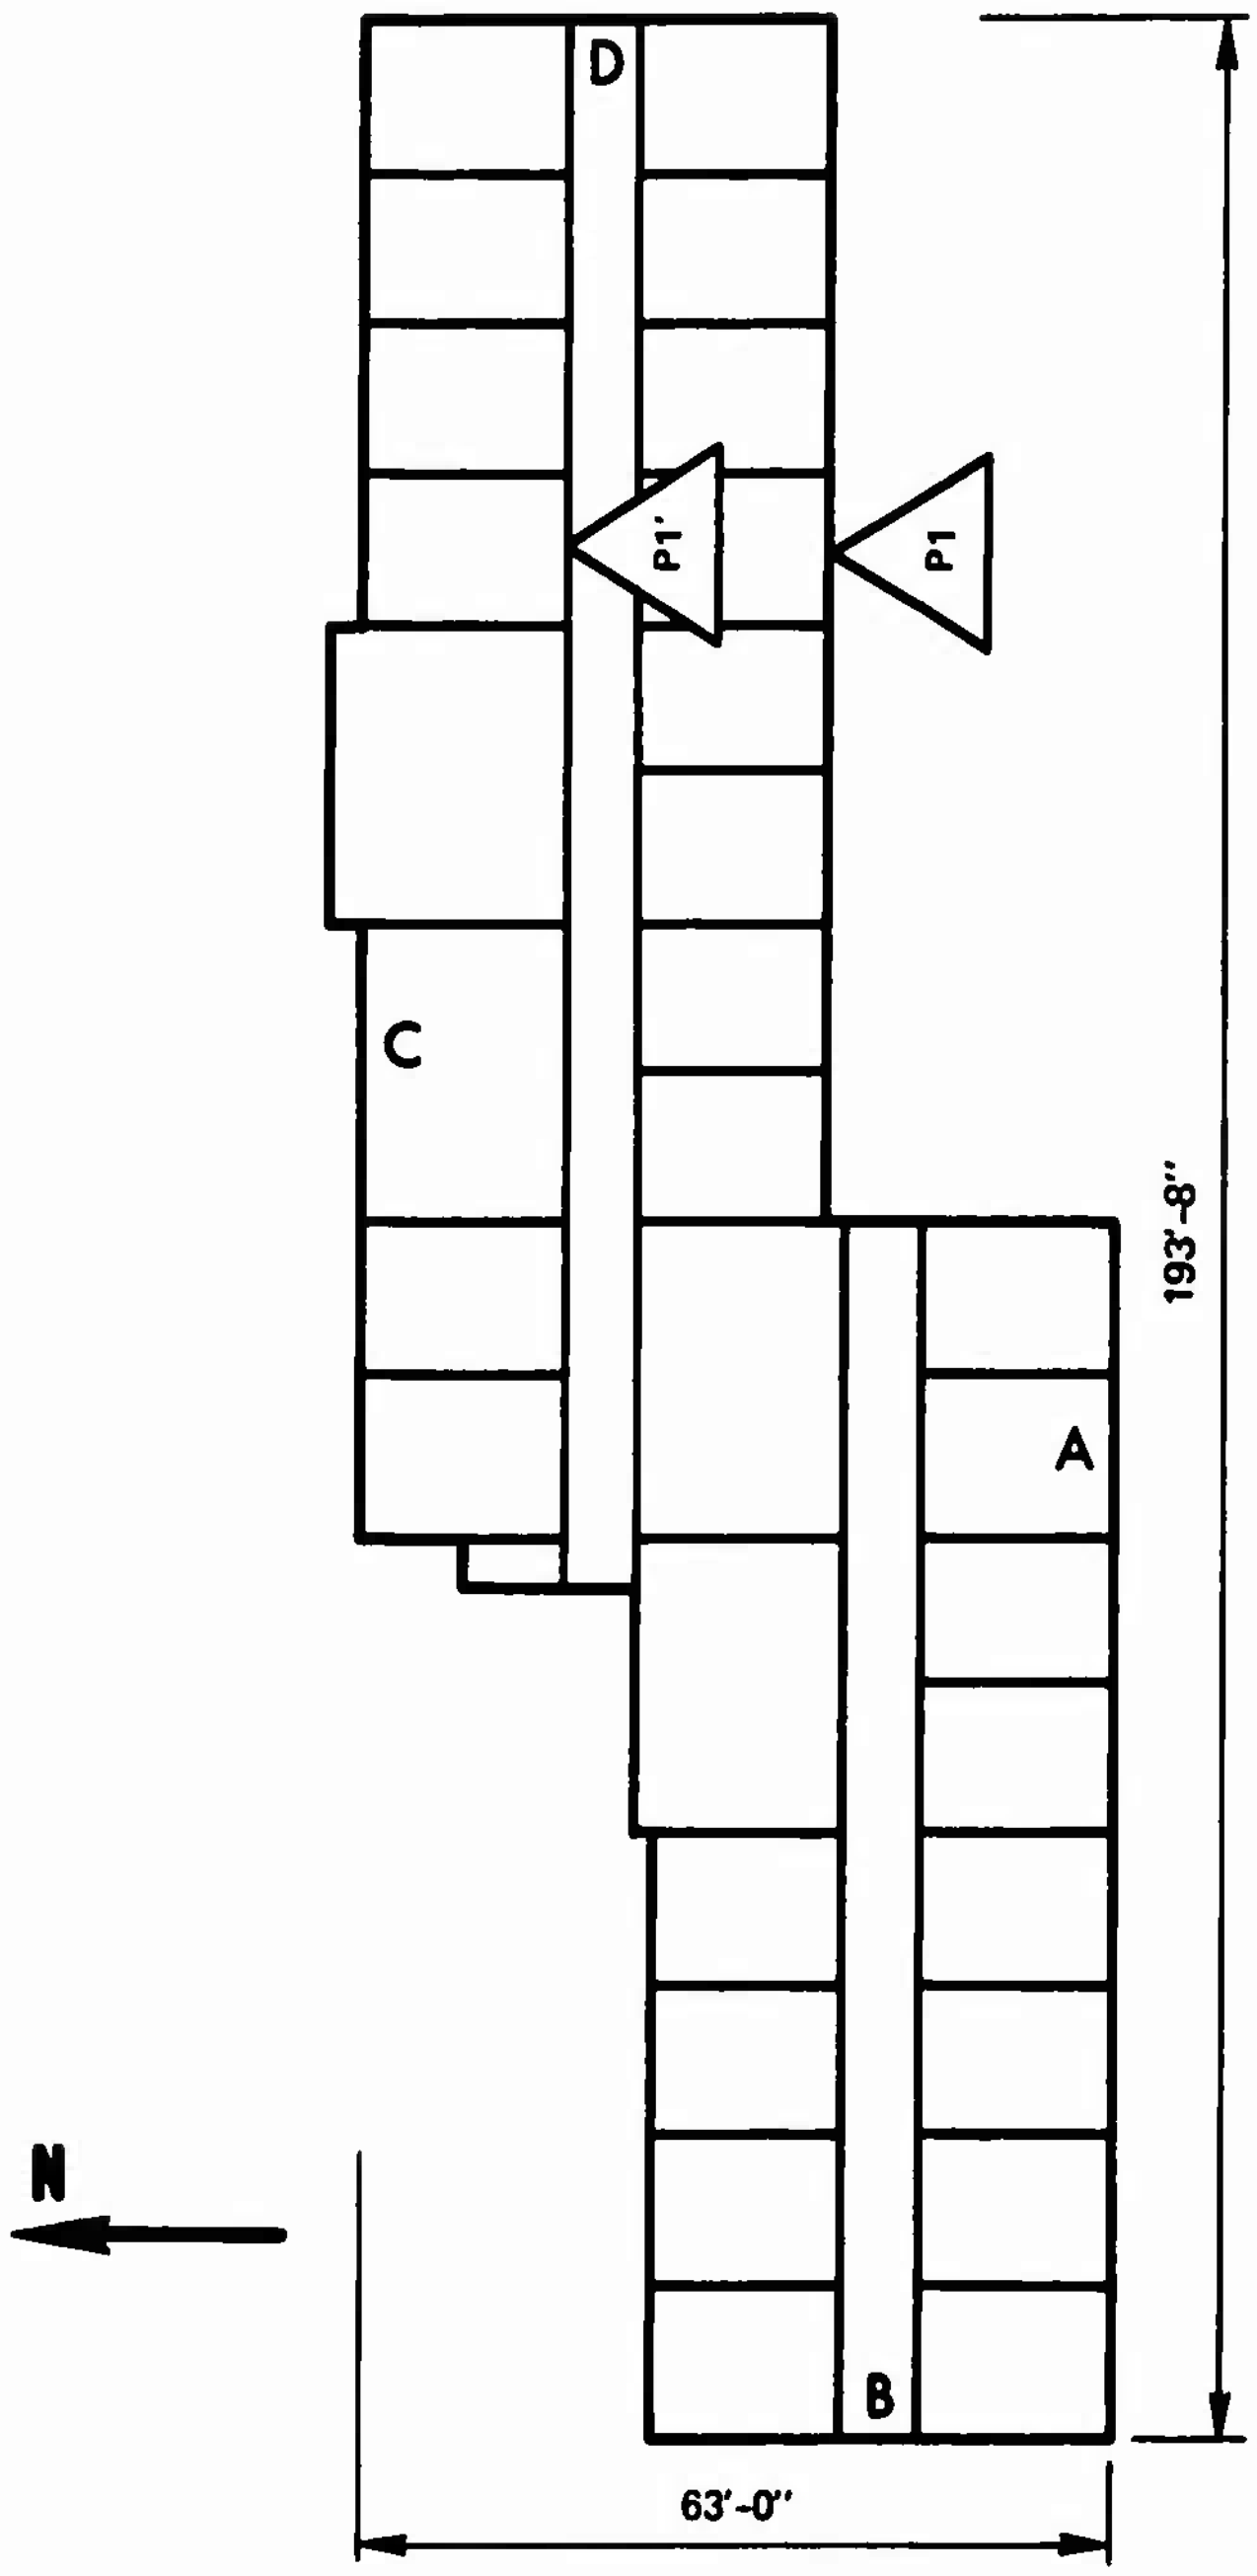
FIGURE 5 PLAN VIEW OF INTERIOR WALLS ON UPPER STORIES
LAURA CONE DORMITORY

The interior wall analyzed for a blast wave striking side A is indicated on Figure 5. The dimensions and wall properties used in the analysis are given in Table 4.

The predicted collapse overpressure for the interior corridor walls using the survey data can be seen to be four times that obtained using the plan data. This resulted solely from the different support conditions used. For the survey data analysis it was assumed that the interior partitions could arch between floor beams, but the plans showed that the top of the corridor wall was not in direct contact with the floor beams and the wall would therefore develop its resistance through bending.

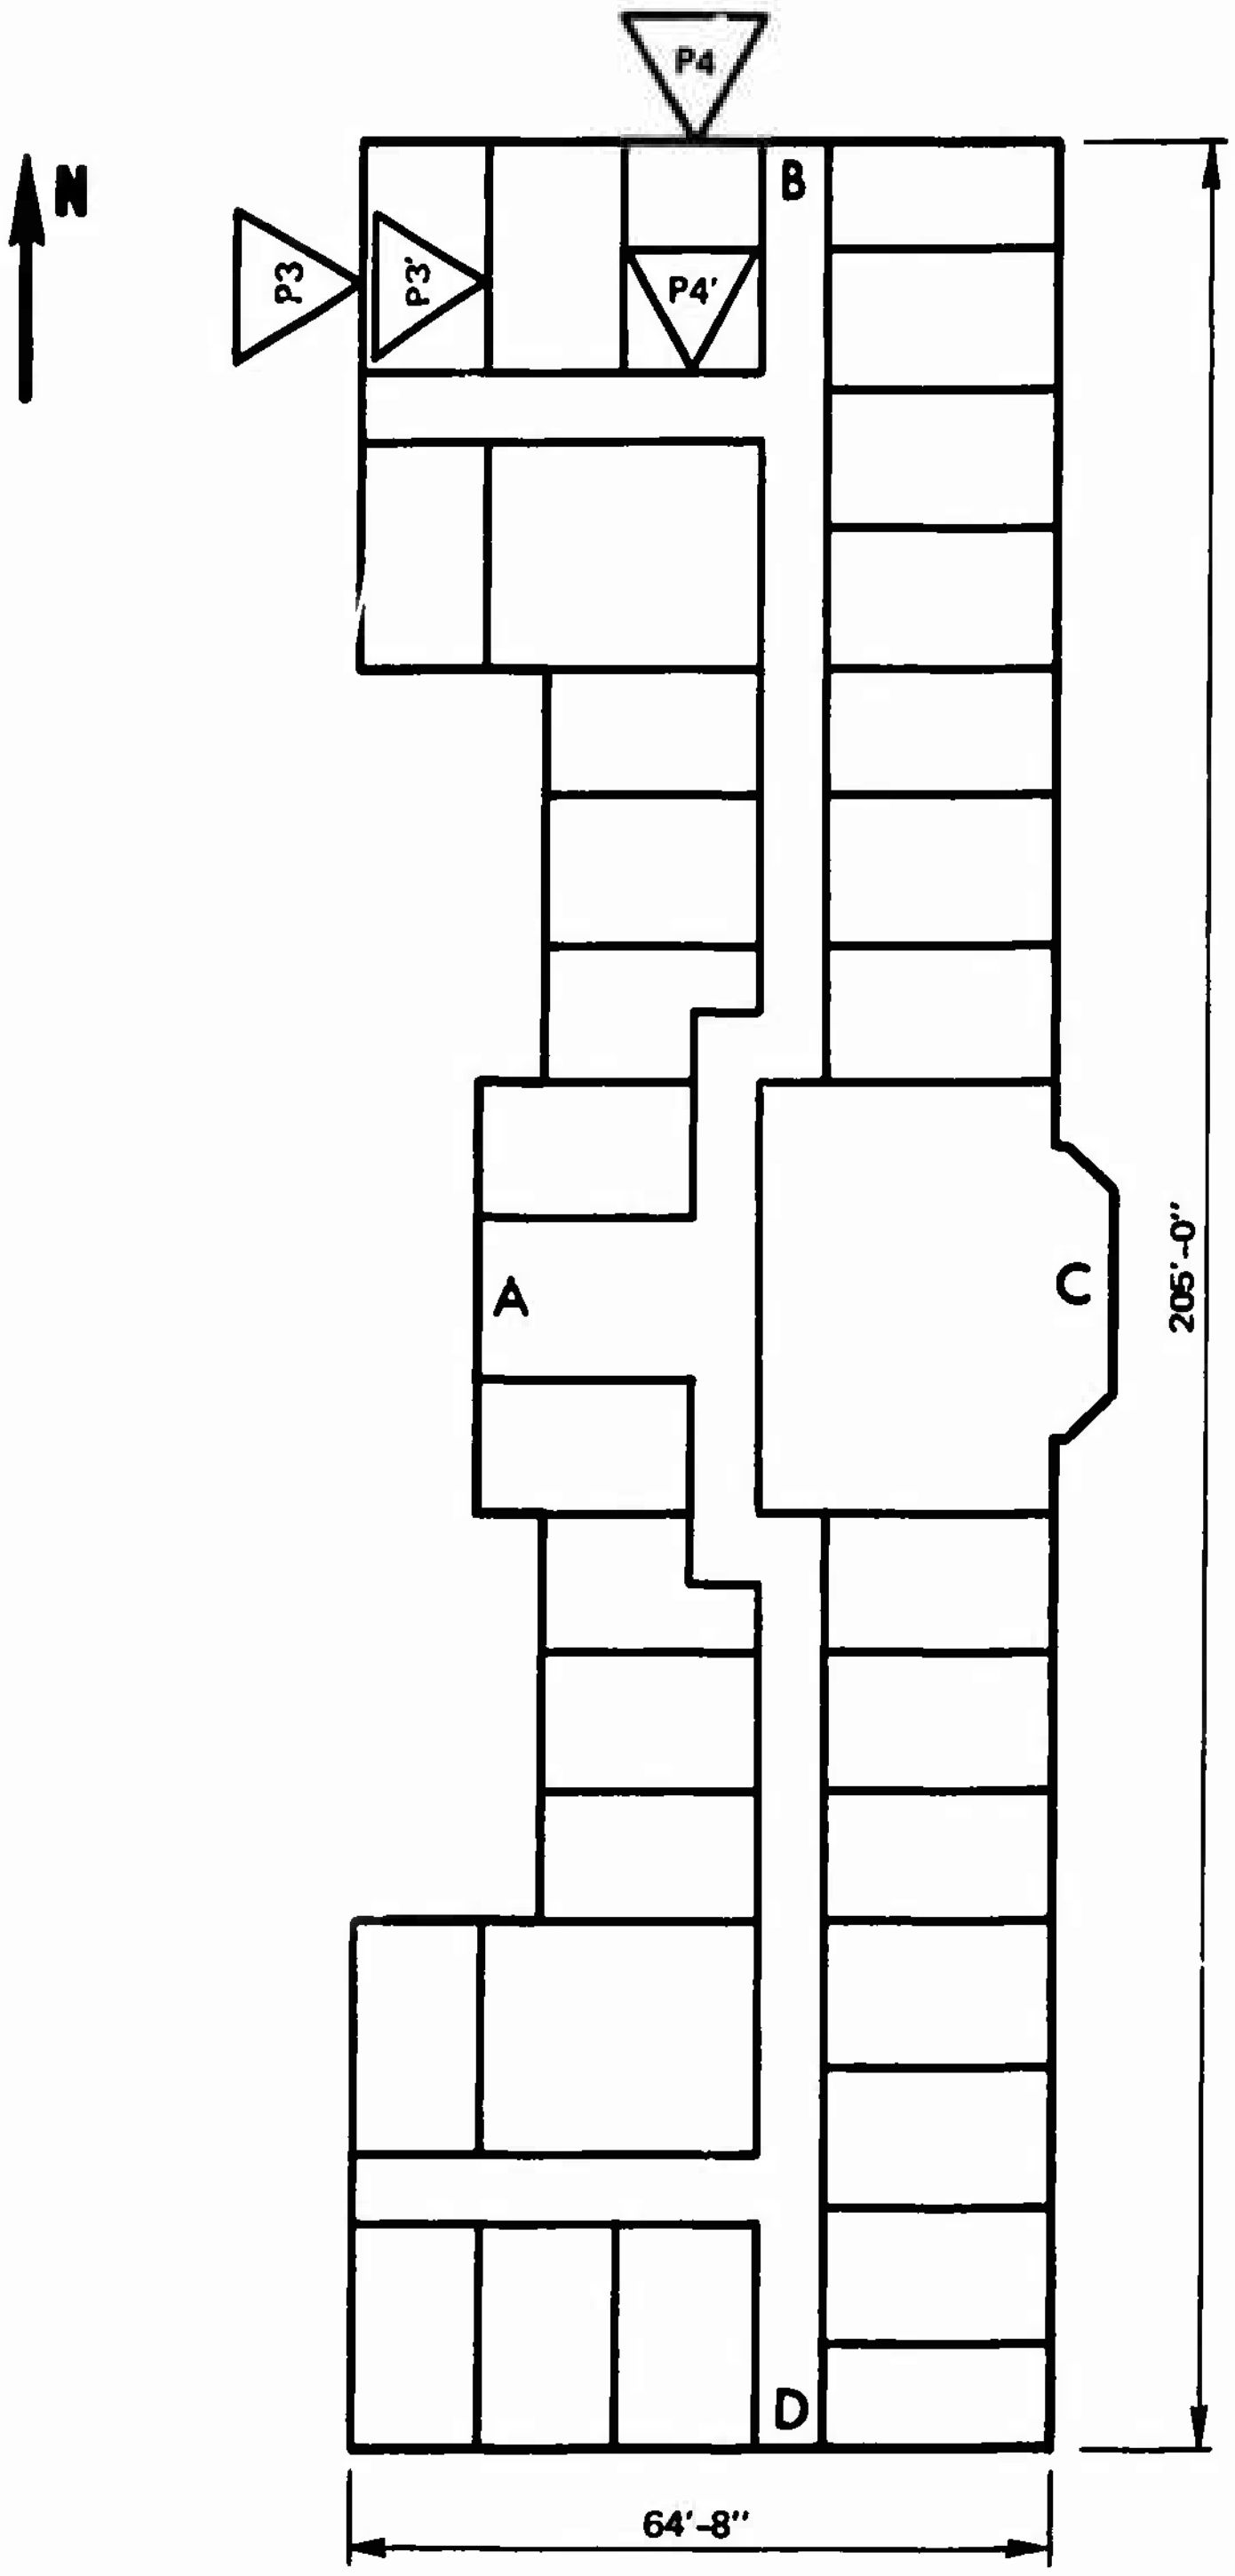
FIGURE 8 PLAN VIEW OF INTERIOR WALLS ON SECOND STORY
WILLA B. PLAYER HALL

As mentioned previously for the survey data, the interior partitions along the corridors were analyzed for each story level but a separate analysis was not performed for the partitions between adjacent rooms because both walls had been described as of similar construction. For the interior corridor partitions, the predicted collapse overpressure for the plan data analysis was 4.6 psi for all three stories (Case IVP4′); this value ranges from 2.4 to 9.2 times those obtained with the survey data (Cases IVF2′, 4′, and 6′). The primary reason for this difference results from the support conditions assumed for the two analyses. That is, for the survey data analysis it was assumed that the corridor walls were of the load-bearing wall type--this accounts for the variation of values with story height--but for the plan data the walls were assumed to arch between floor beams.

For the interior partitions between rooms, the predicted collapse overpressure for the plan data analysis was only 0.2 psi (Case IVP3′), which is 0.1 to 0.4 of the values obtained with the survey information (Cases IVF2′, 4′, and 6′). This difference was also a result of the difference in assumed support conditions for the two analyses; i.e., the plans showed that the partition between rooms developed their resistance in bending only, without the effect of the vertical in-plane forces that were included for the load-bearing wall in the survey data case.
