DAMAGE PROFILES IN SILICON AND THEIR IMPACT ON DEVICE RELIABILITY

International Business Machines Corporation

TECHNICAL REPORT No. 1
January 1973

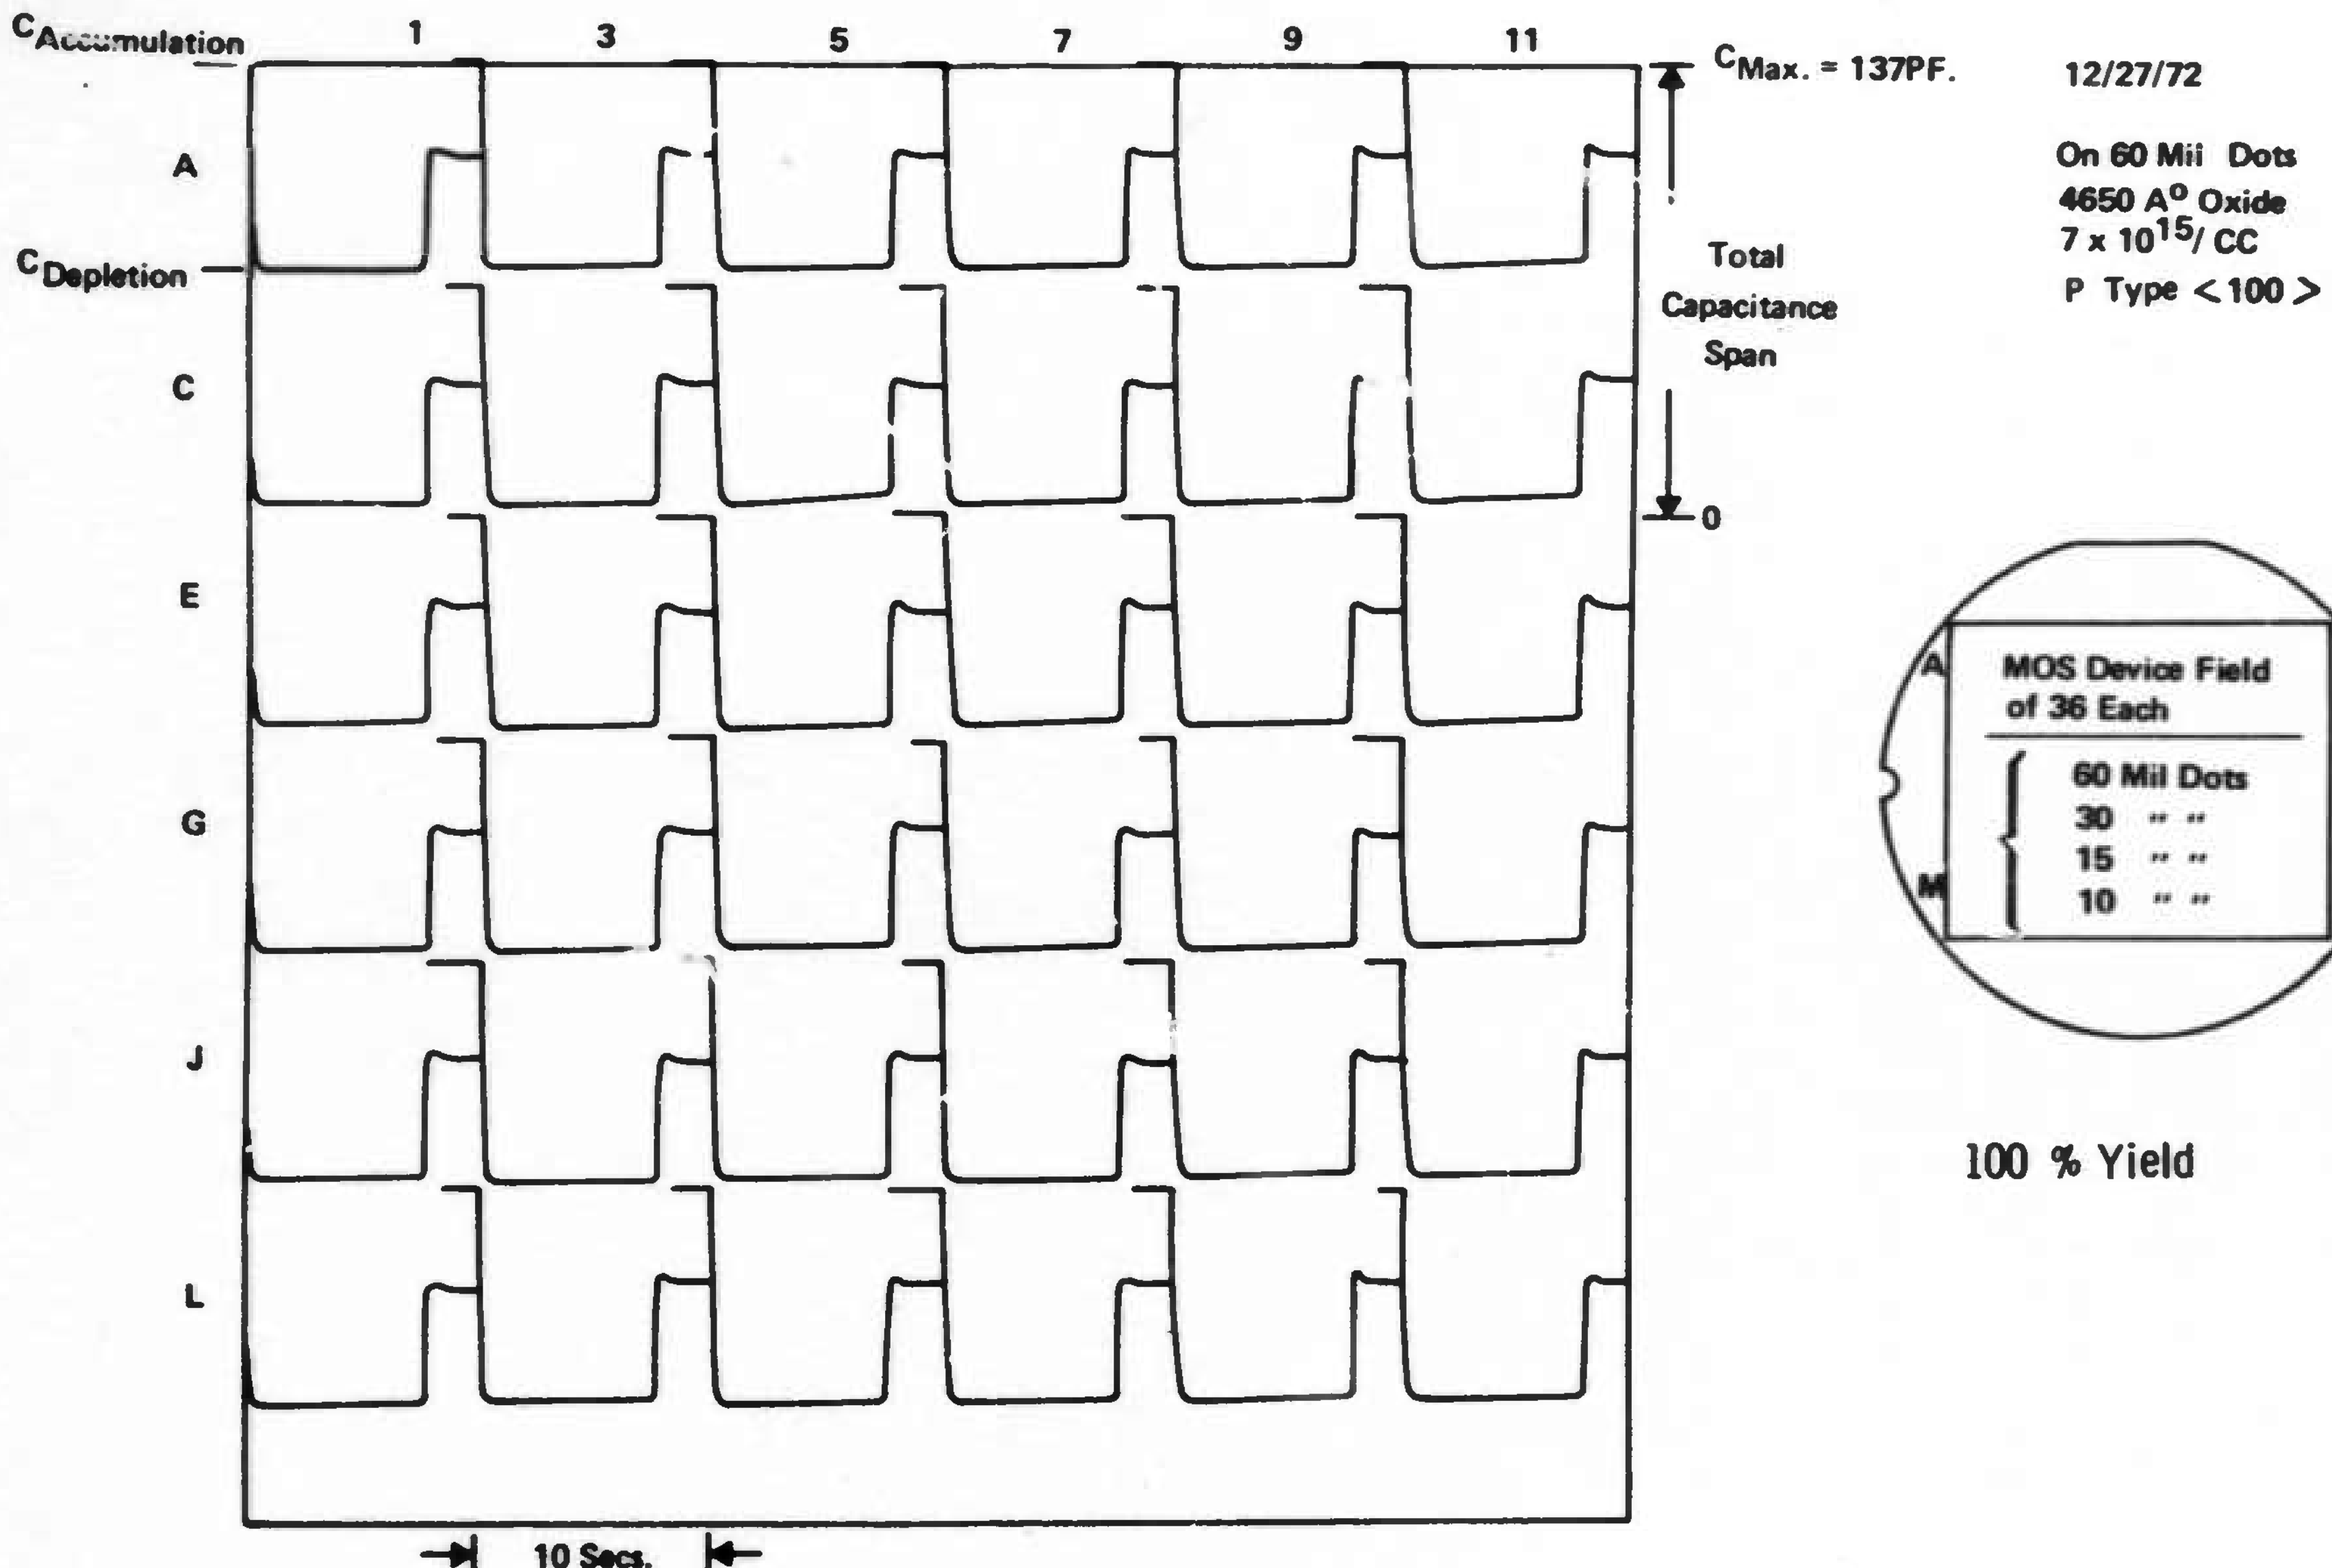
Fig. 1a. Storage time map of silicon wafer with 36 MOS capacitors. All devices good.

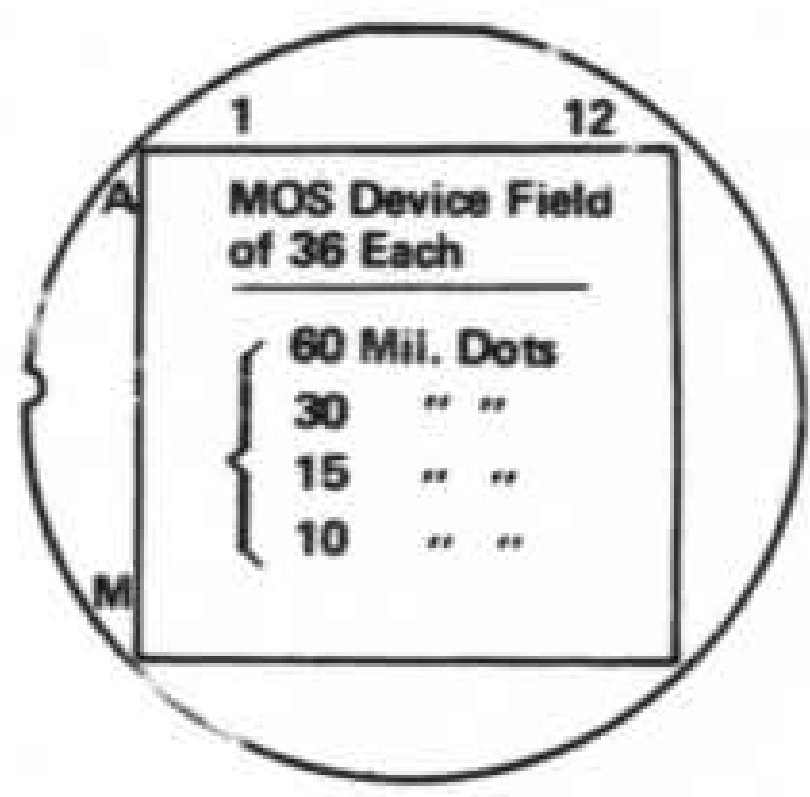
Fig. 1b. Storage time map of silicon wafer with 36 MOS capacitors. All devices bad.

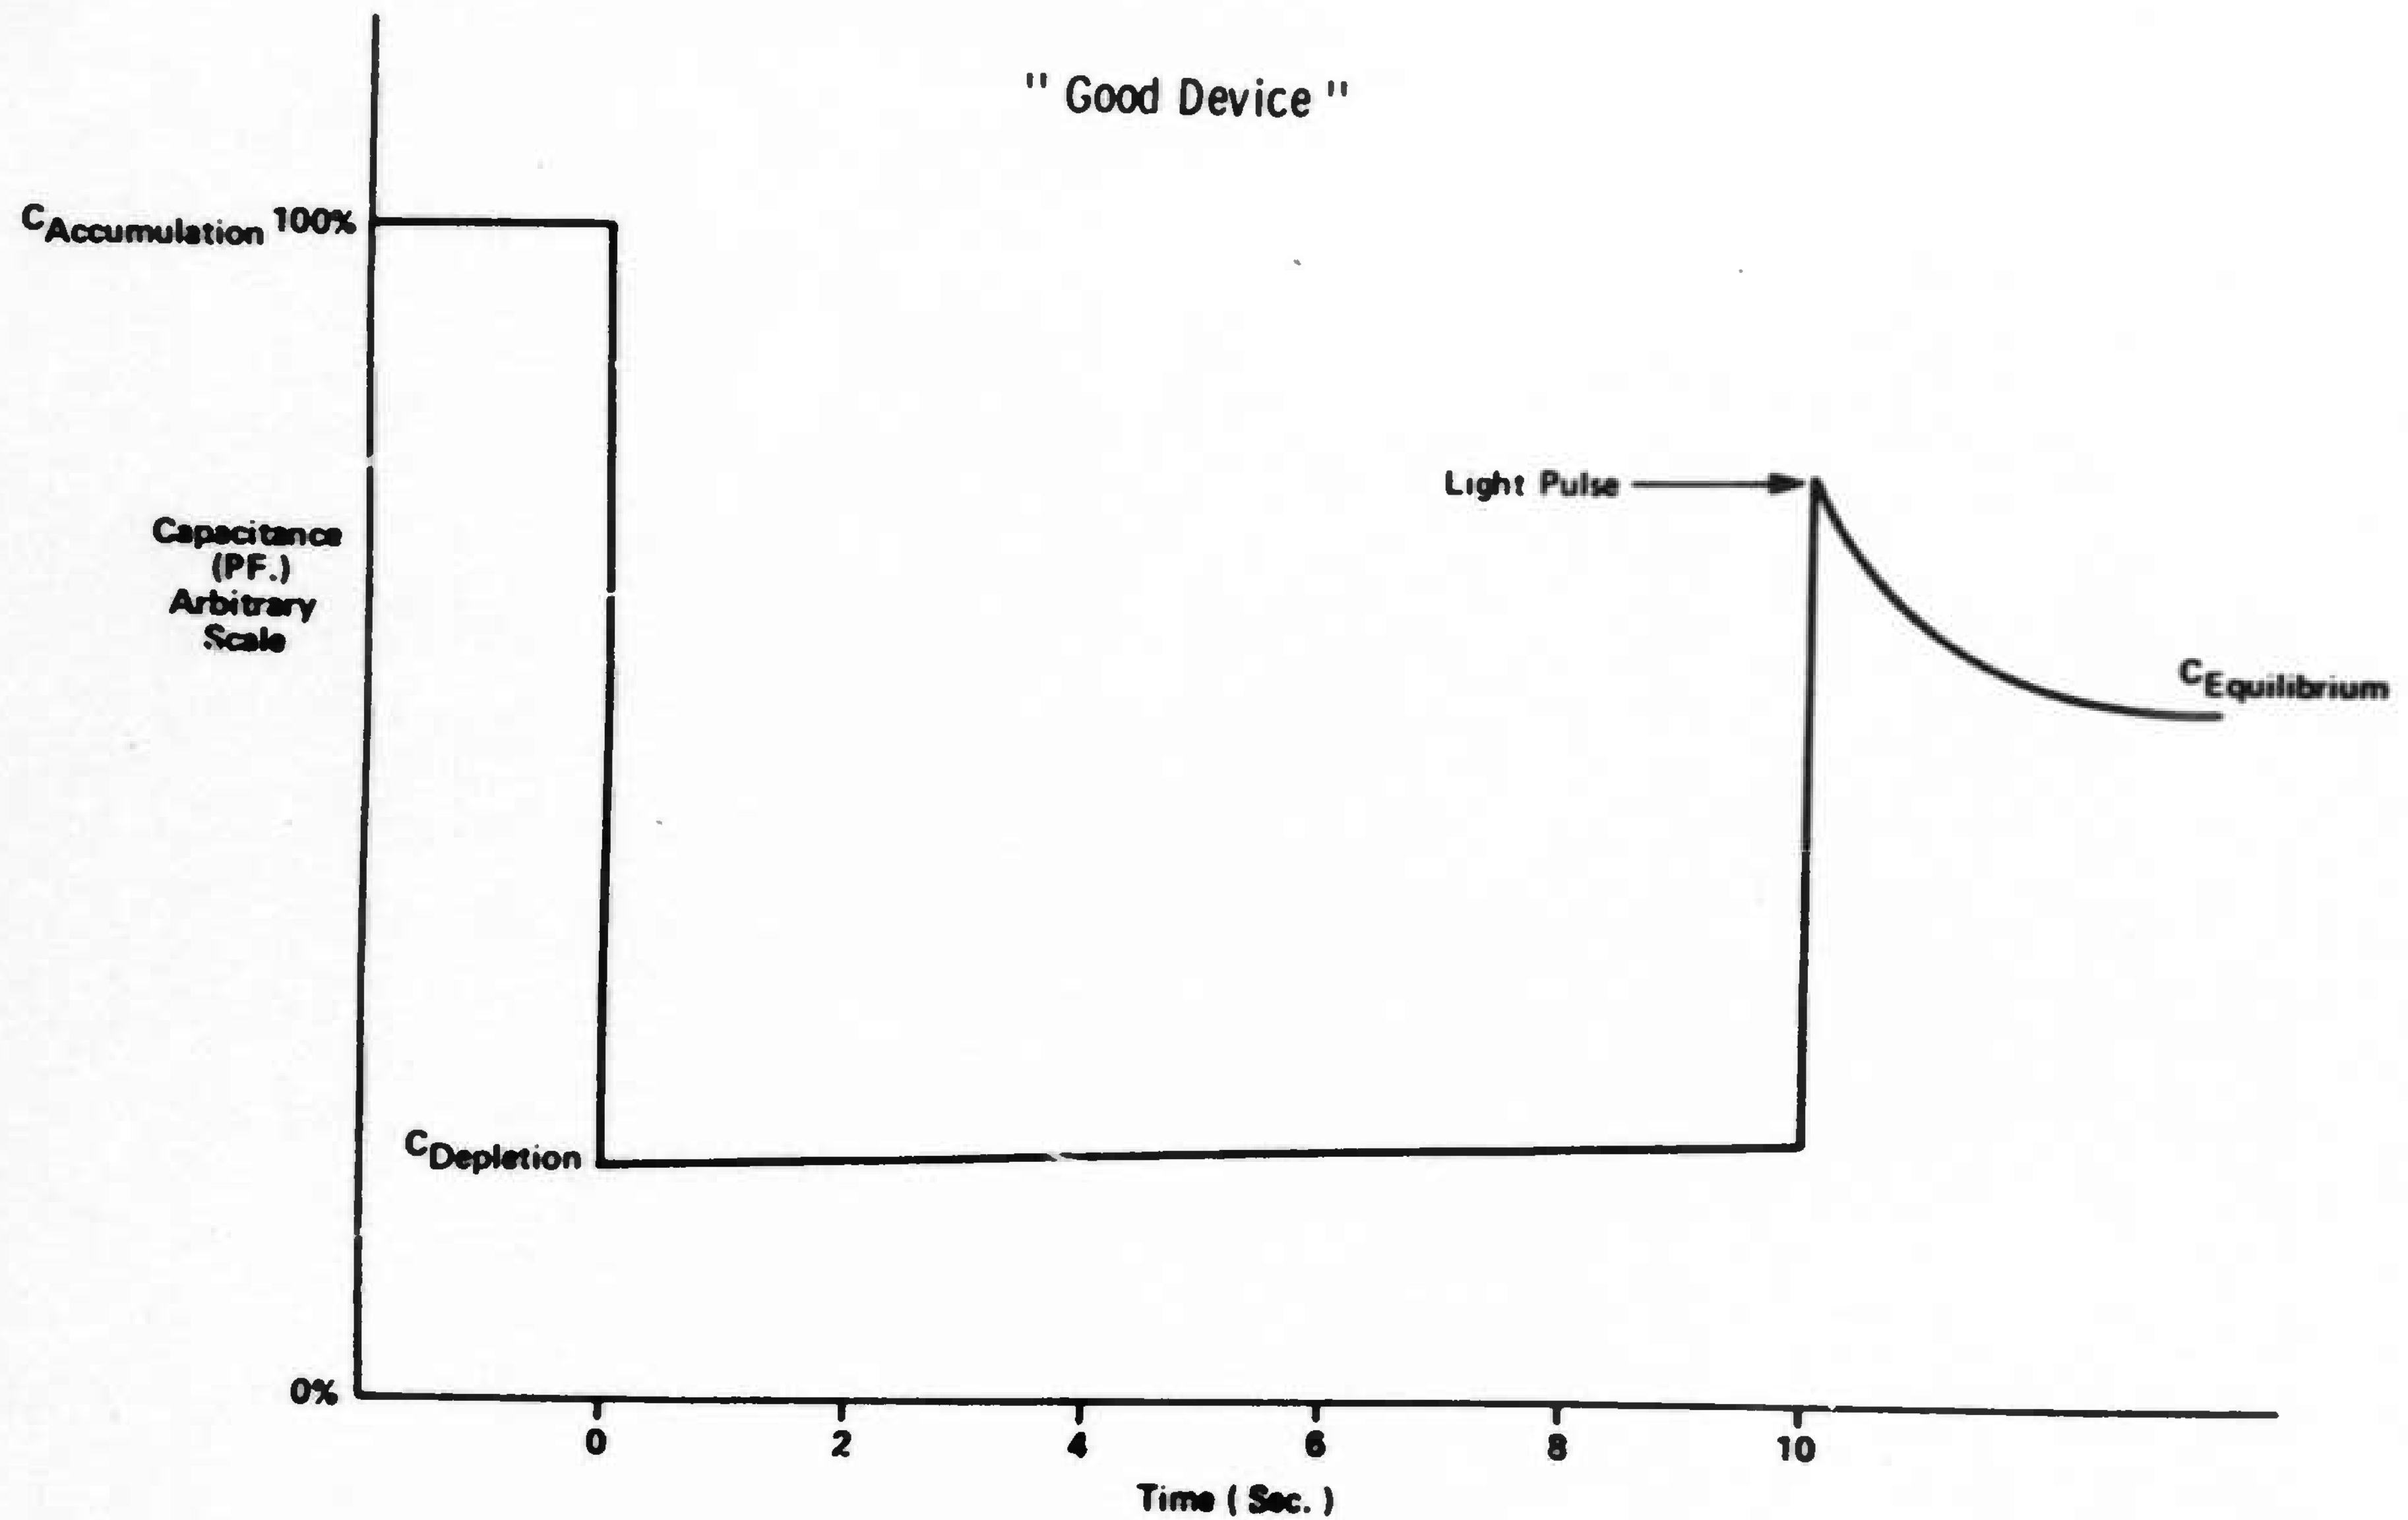
Fig. 1c. Single C-t curve of good device.

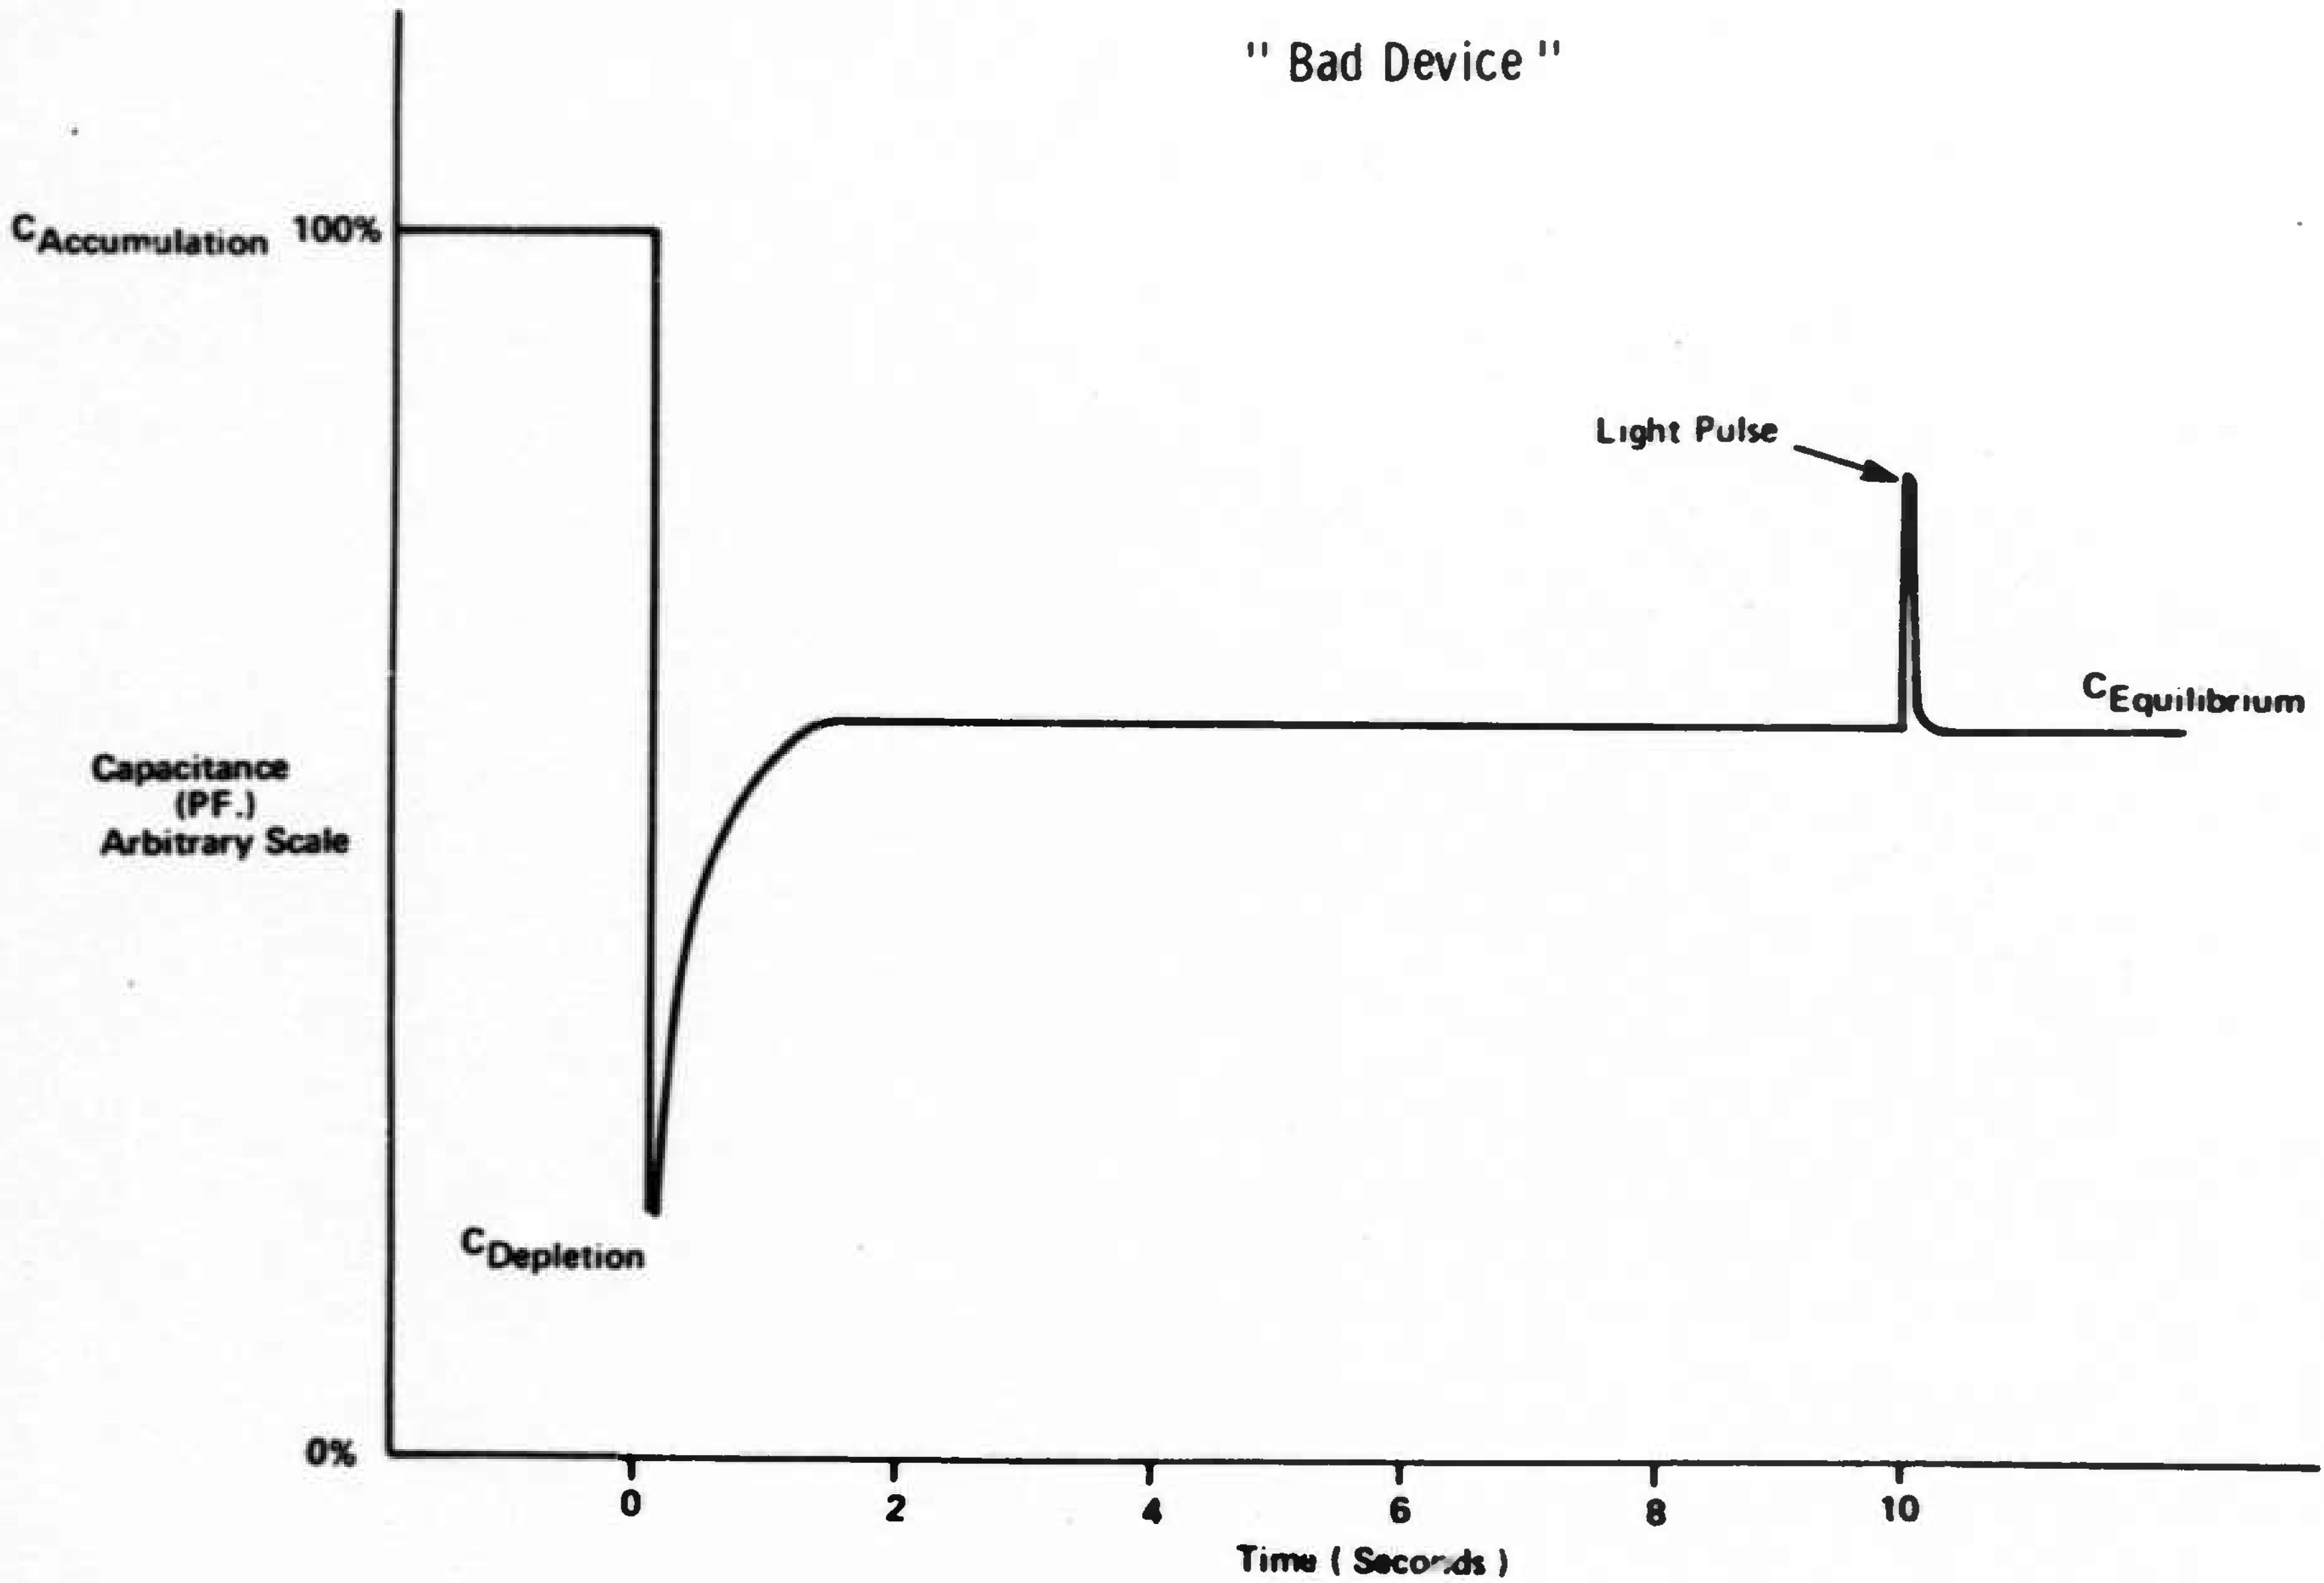
The following is a survey of defects found in devices that yield a C-t response curve as shown in Fig.1d. The average density of defects found in such devices is approximately 10^4 defects/cm^2.

Fig. 1d. Single C-t curve of bad device.

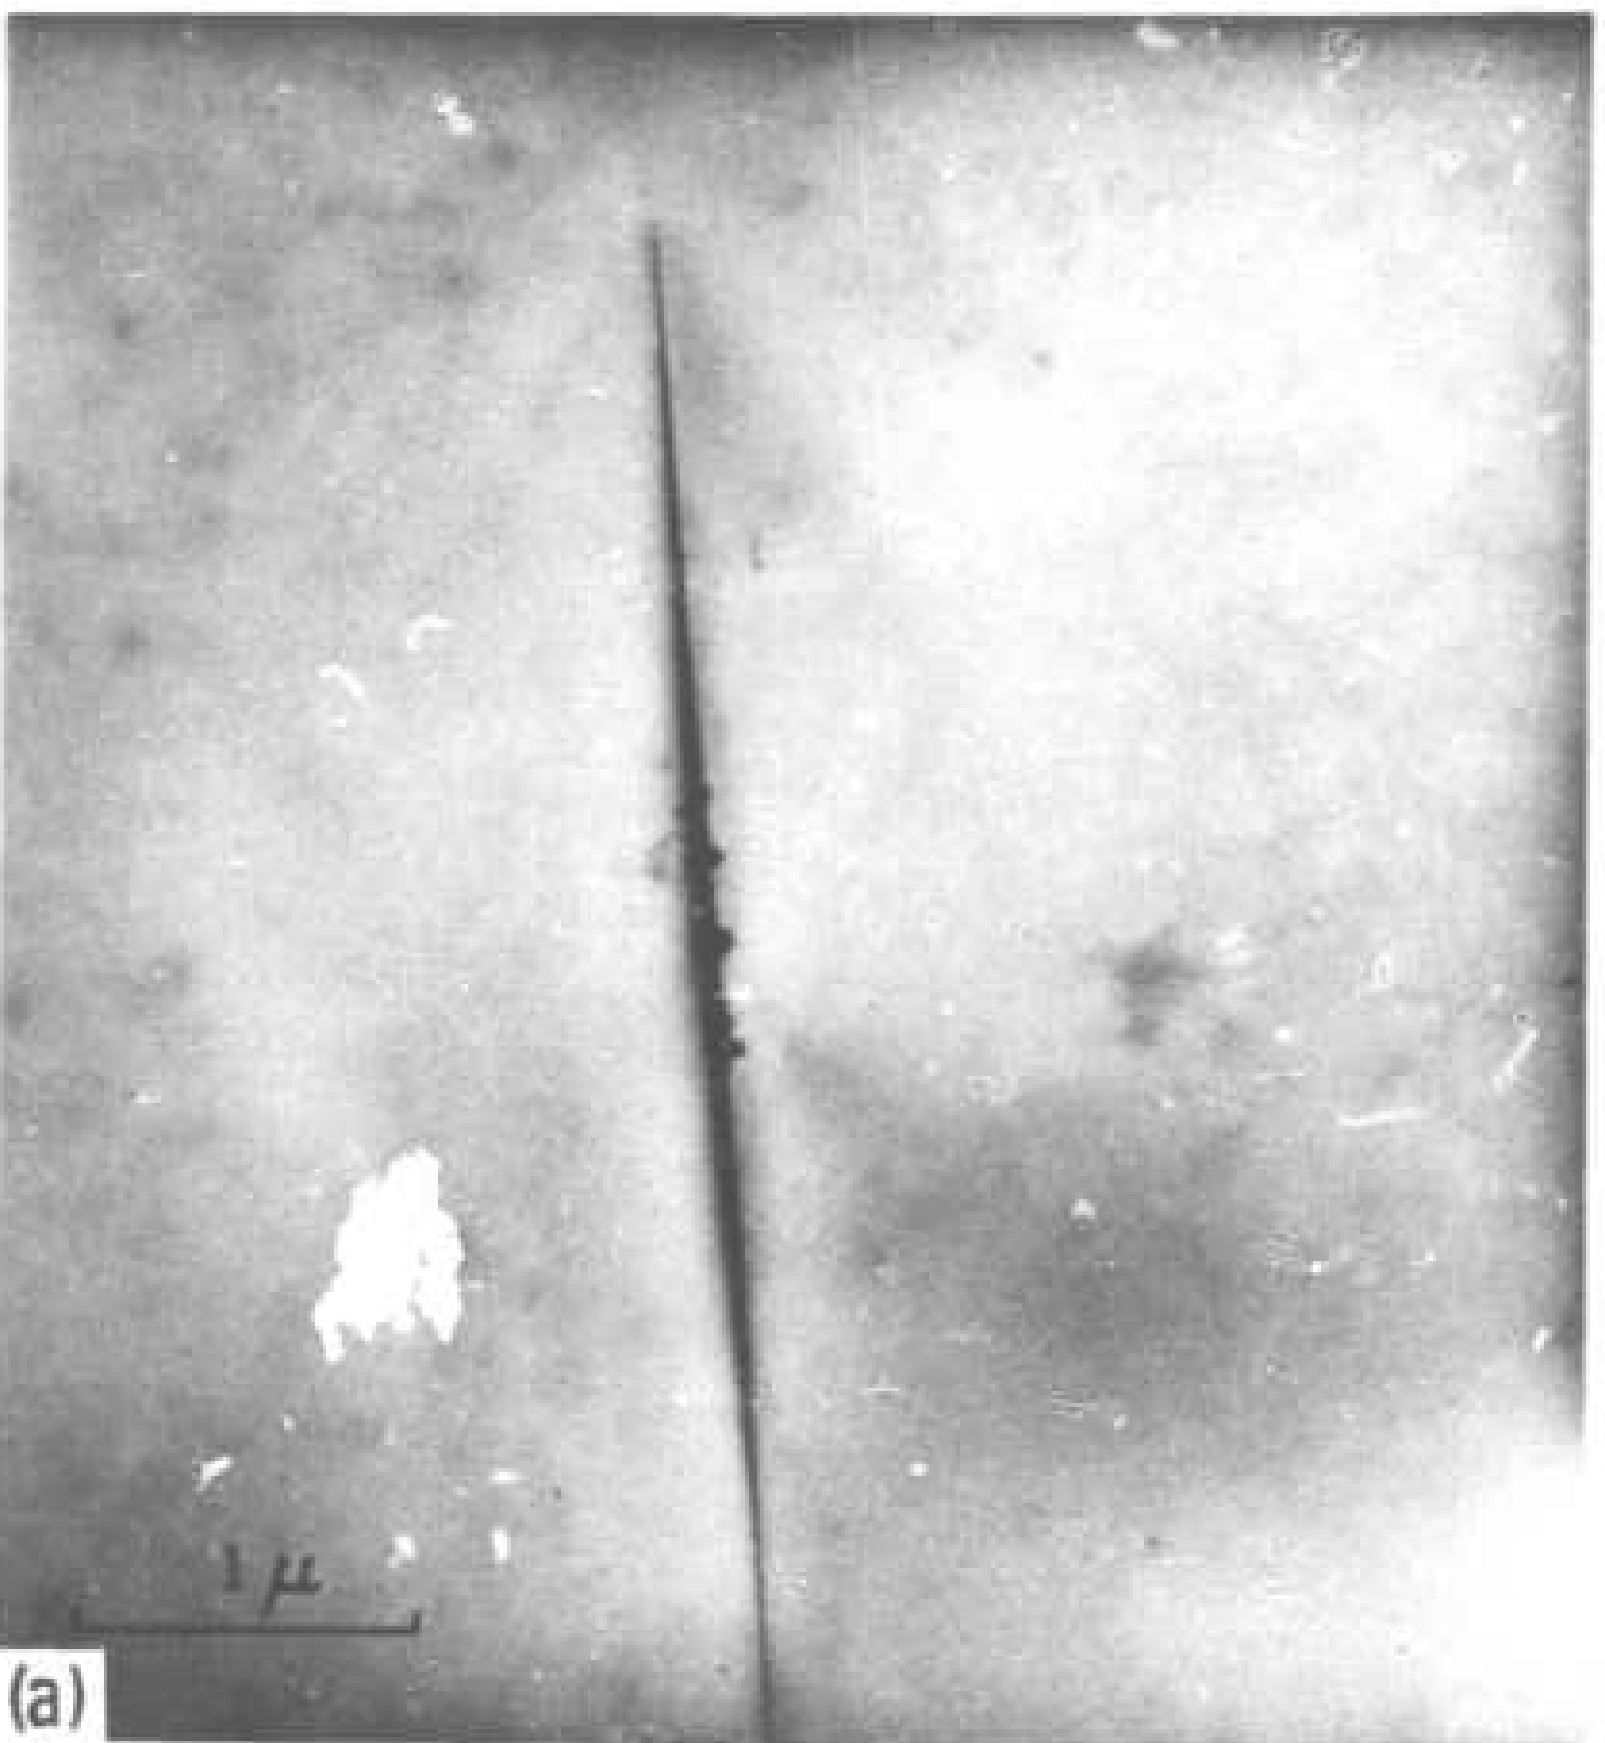
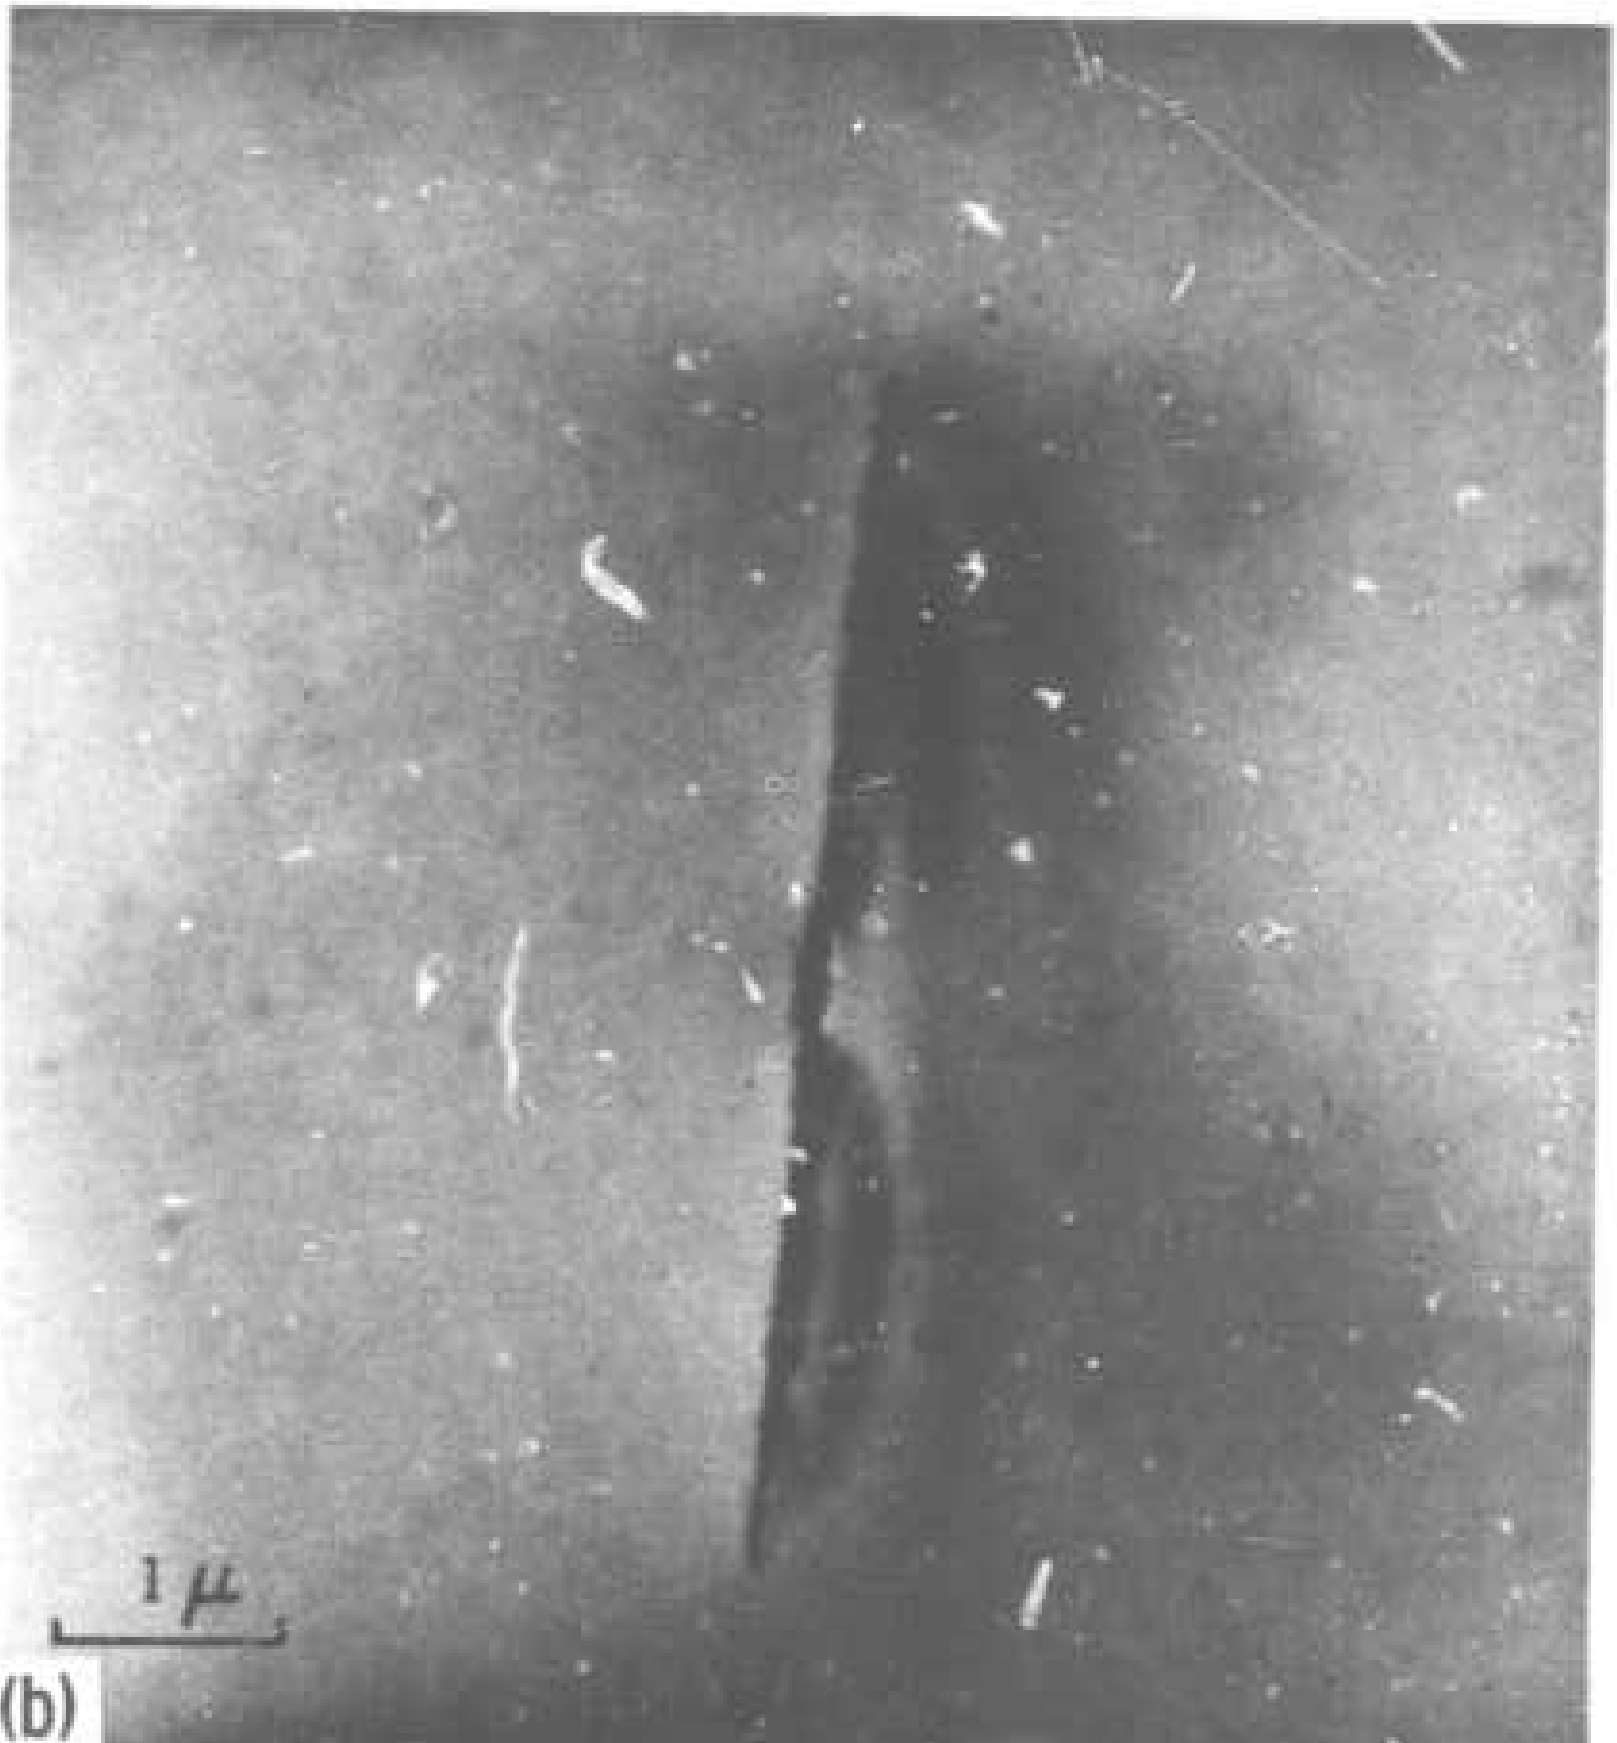
microns down to only 0.1μm. A simple line defect of approximately 10μm in length is shown in Fig. 2a. Note the shape of the line: very thin ends, thicker in the center and sometimes additional dot contrast in the center. The dot contrast could indicate contamination. The TEM of Fig. 2a was recorded using multi-beam diffraction (kinematical diffraction), therefore, stress effects caused by the defects in the lattice are not displayed. A two beam (dynamical case) recording of a similar defect is shown in Fig. 2b. Most striking are the stress contours (white on the left side and black on the right side of the defect). During tilting extinction contours are generated primarily at the ends of the line defect and sweep across the micrograph during tilting. The extinction contours never cross the defect line. This indicates a clear physical separation of the crystal along and parallel to the defect line. The black/white beat contrast along the ends of the line indicates that the black contrast lines slopes down from the ends towards the middle of the line.

Fig. 2. TEM micrographs of 8μm-long split in lattice. (a) Multibeam recording. (b) Two-beam recording revealing stress effects in lattice.
