DAMAGE PROFILES IN SILICON AND THEIR IMPACT ON DEVICE RELIABILITY

International Business Machines Corporation

TECHNICAL REPORT No. 1
January 1973

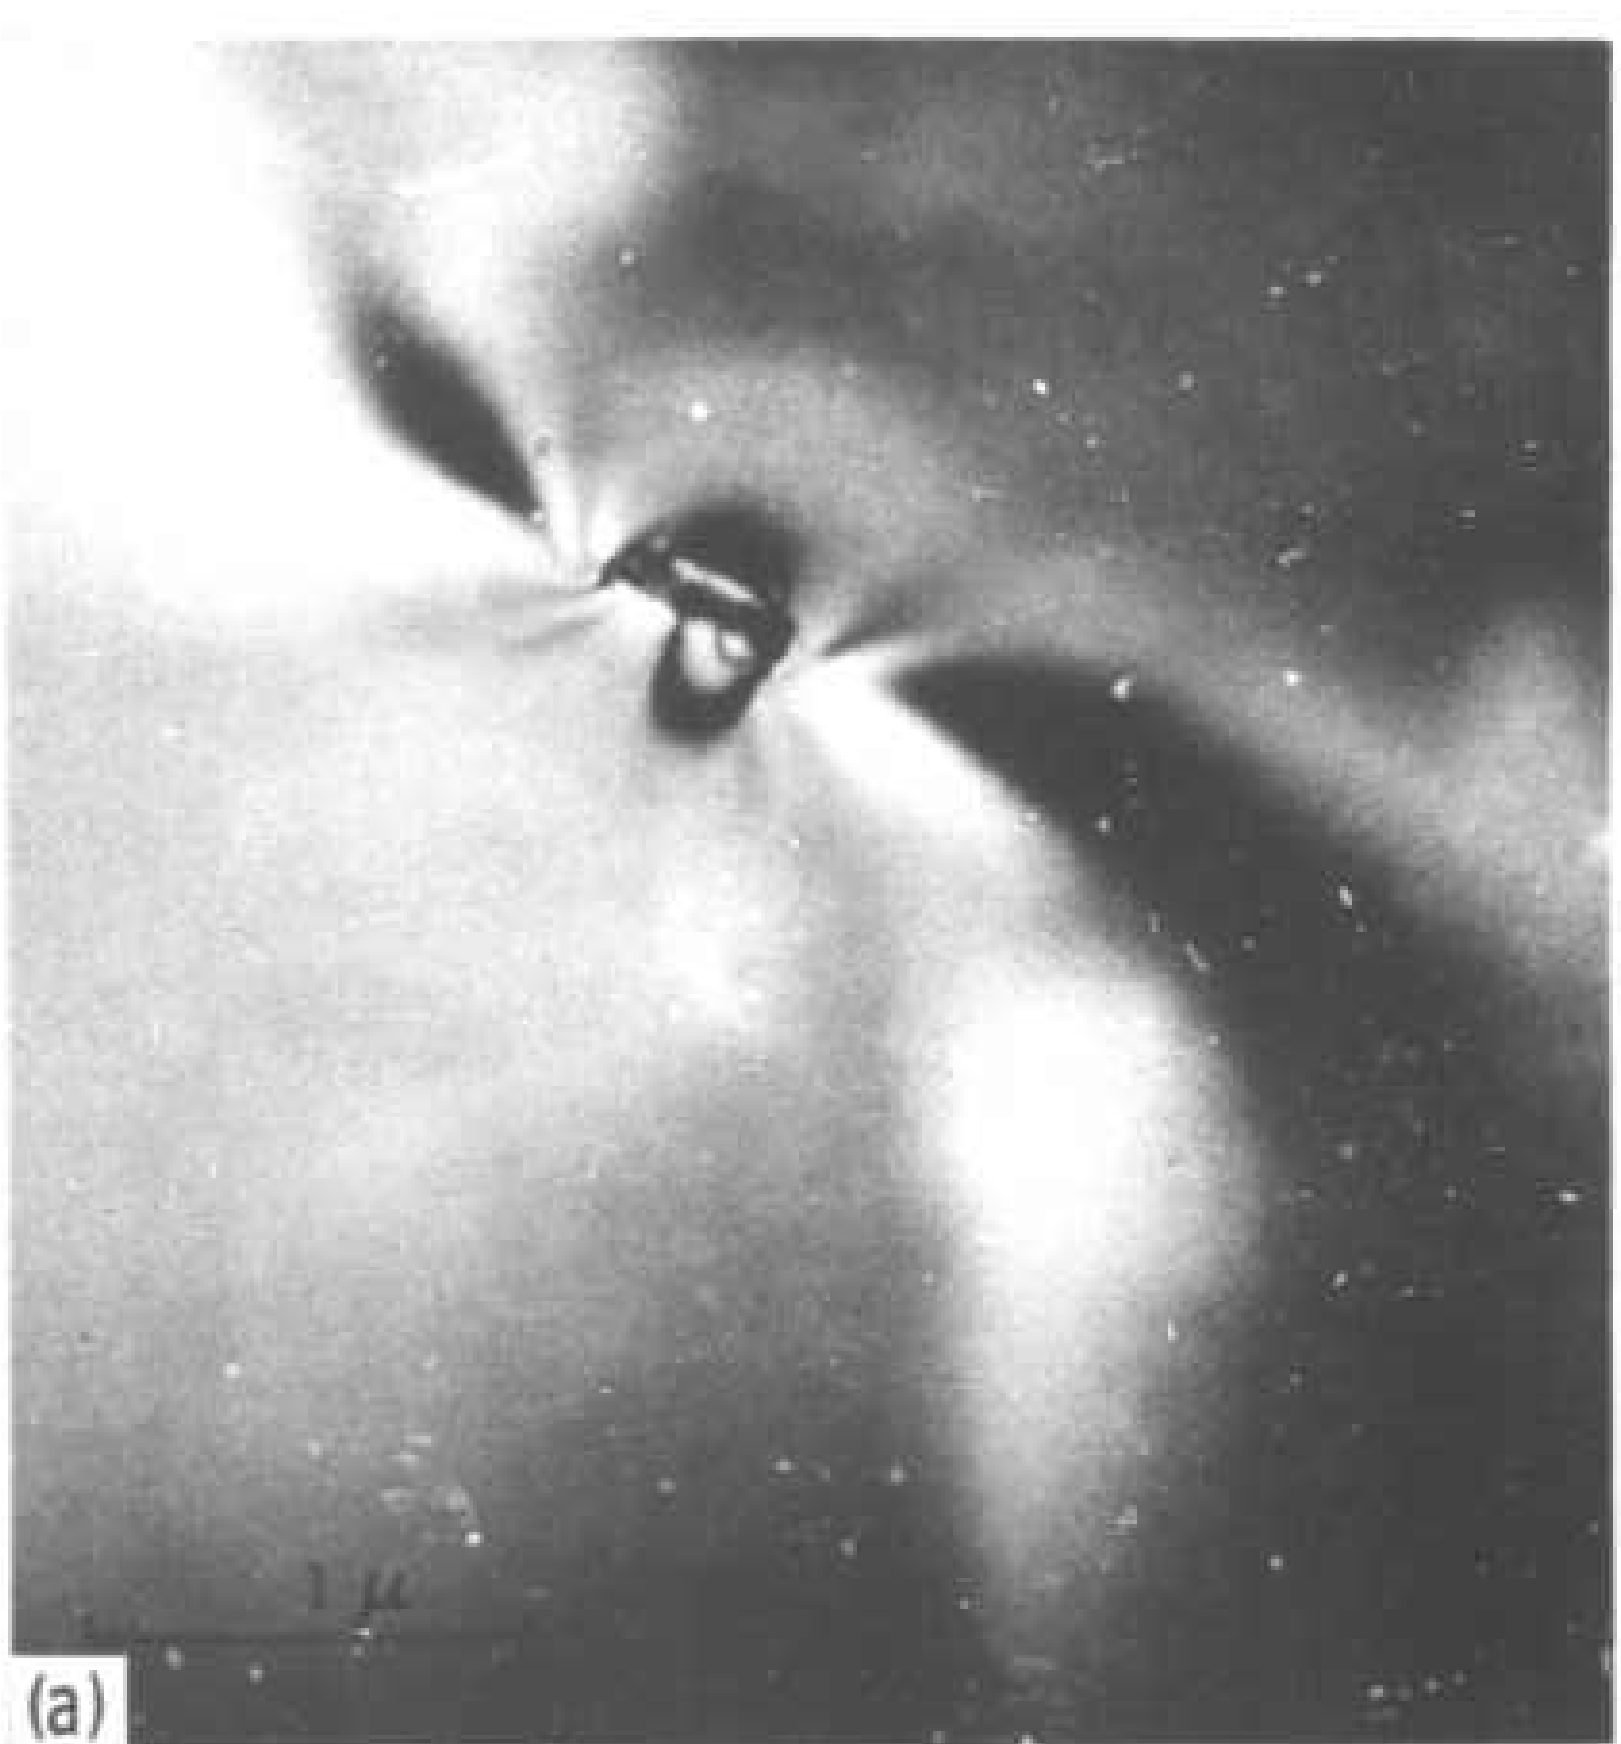
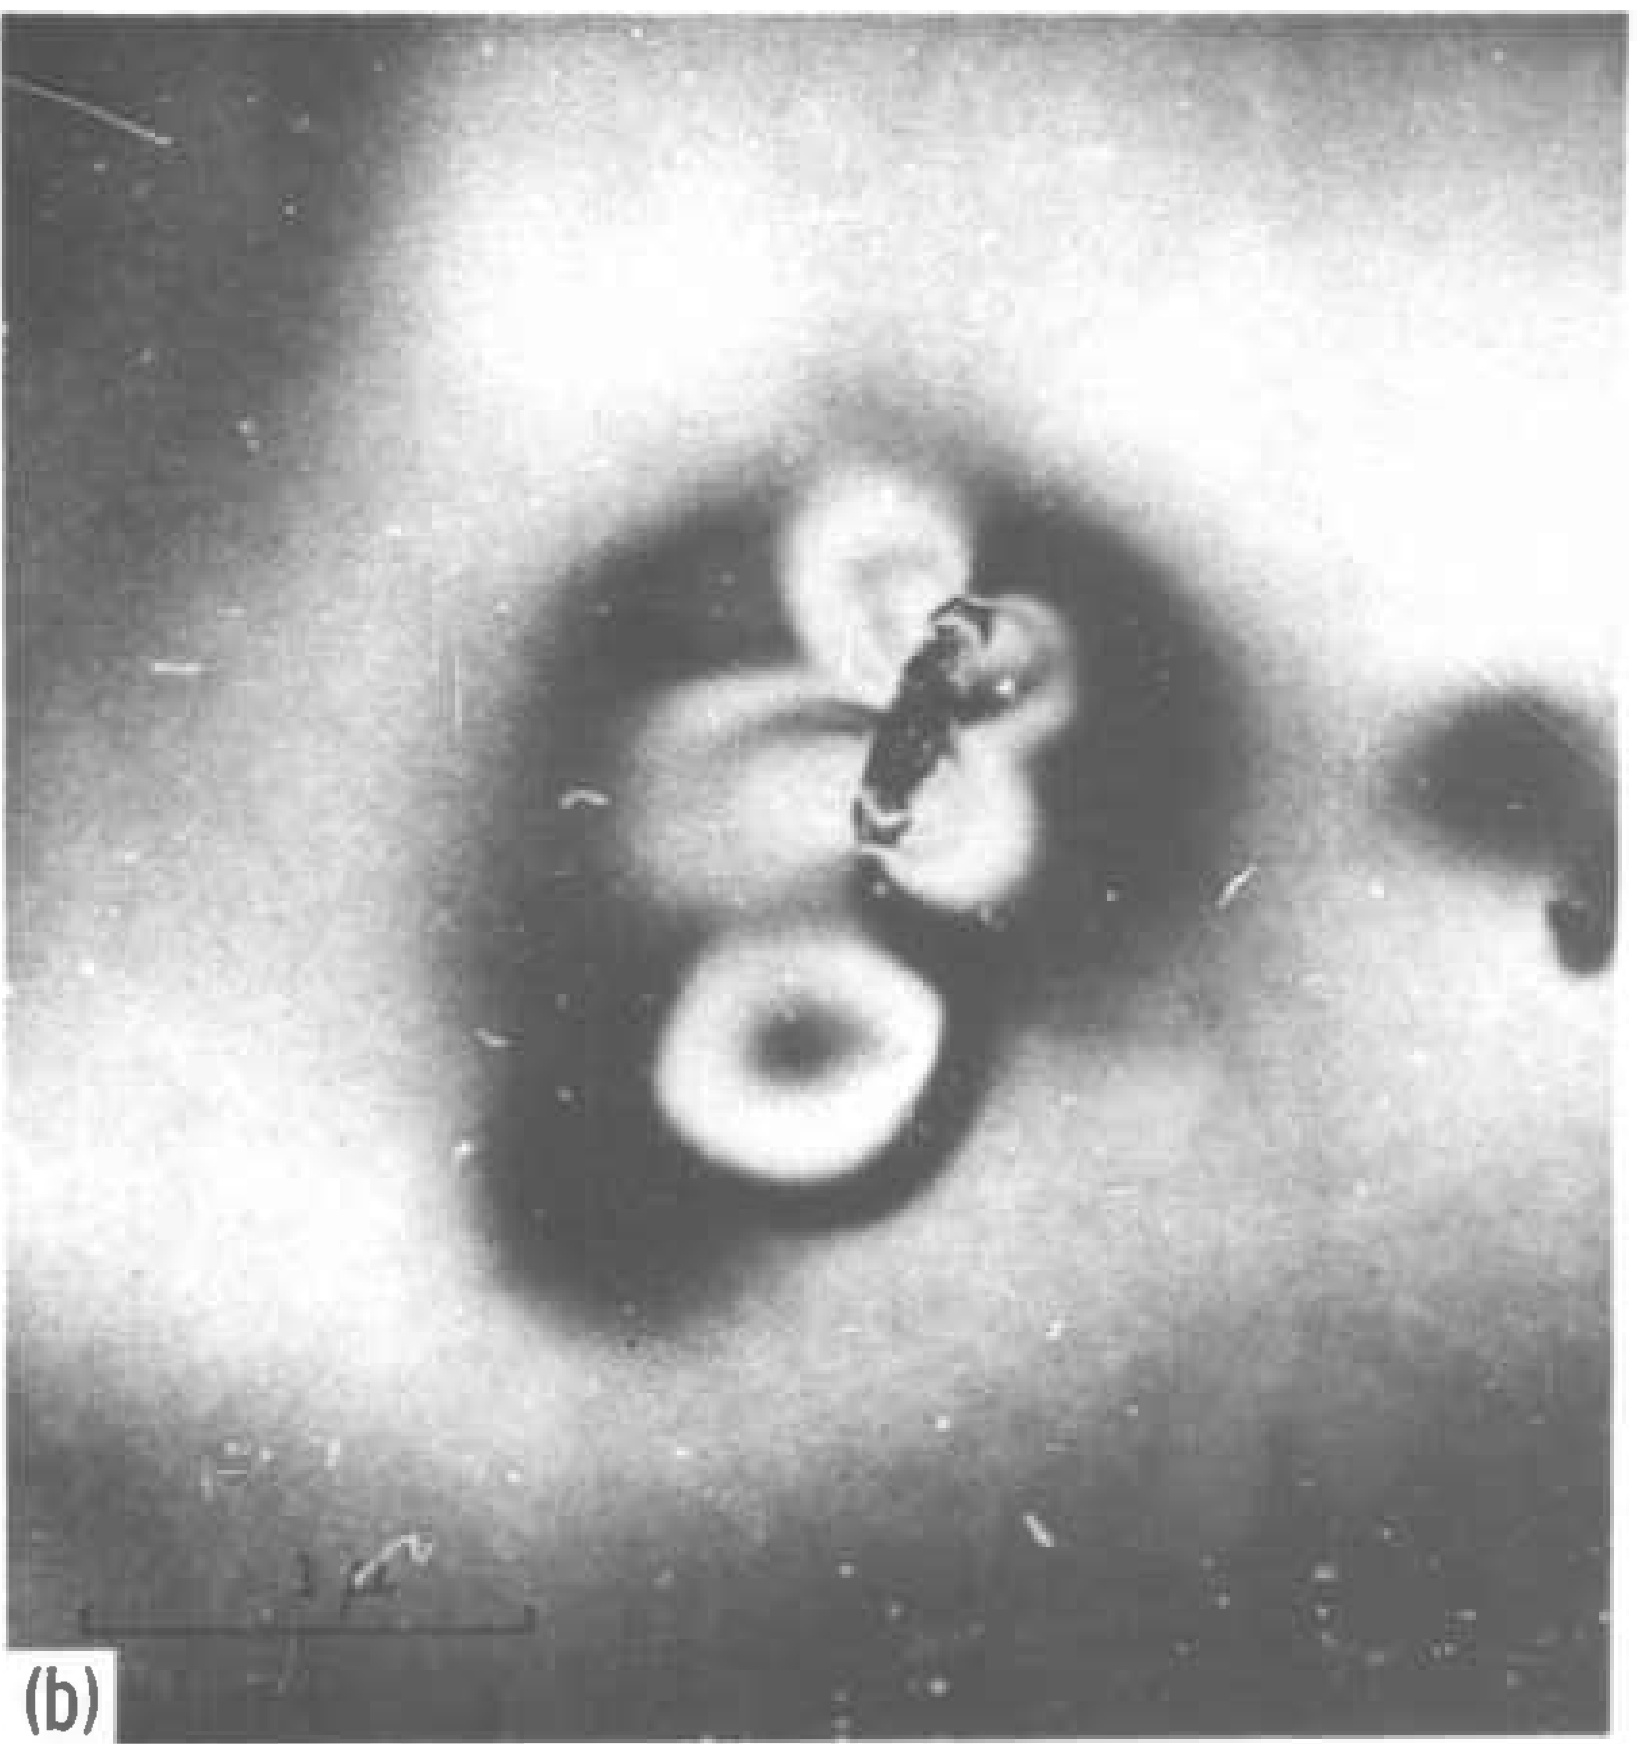
Small linear defects are displayed in the micrographs of Fig. 3. Noteworthy are the strong stress contours displayed by such small defects. The length of the defects is approximately 0.3μm. Both defects show strong Moire contrast indicative of a clear lattice separation along the short defect line.

Fig. 3. TEM micrographs of 0.3μm-long microsplit. (a) Note strong stress contours emerging from the ends. (b) Associated four-fold stress contours.

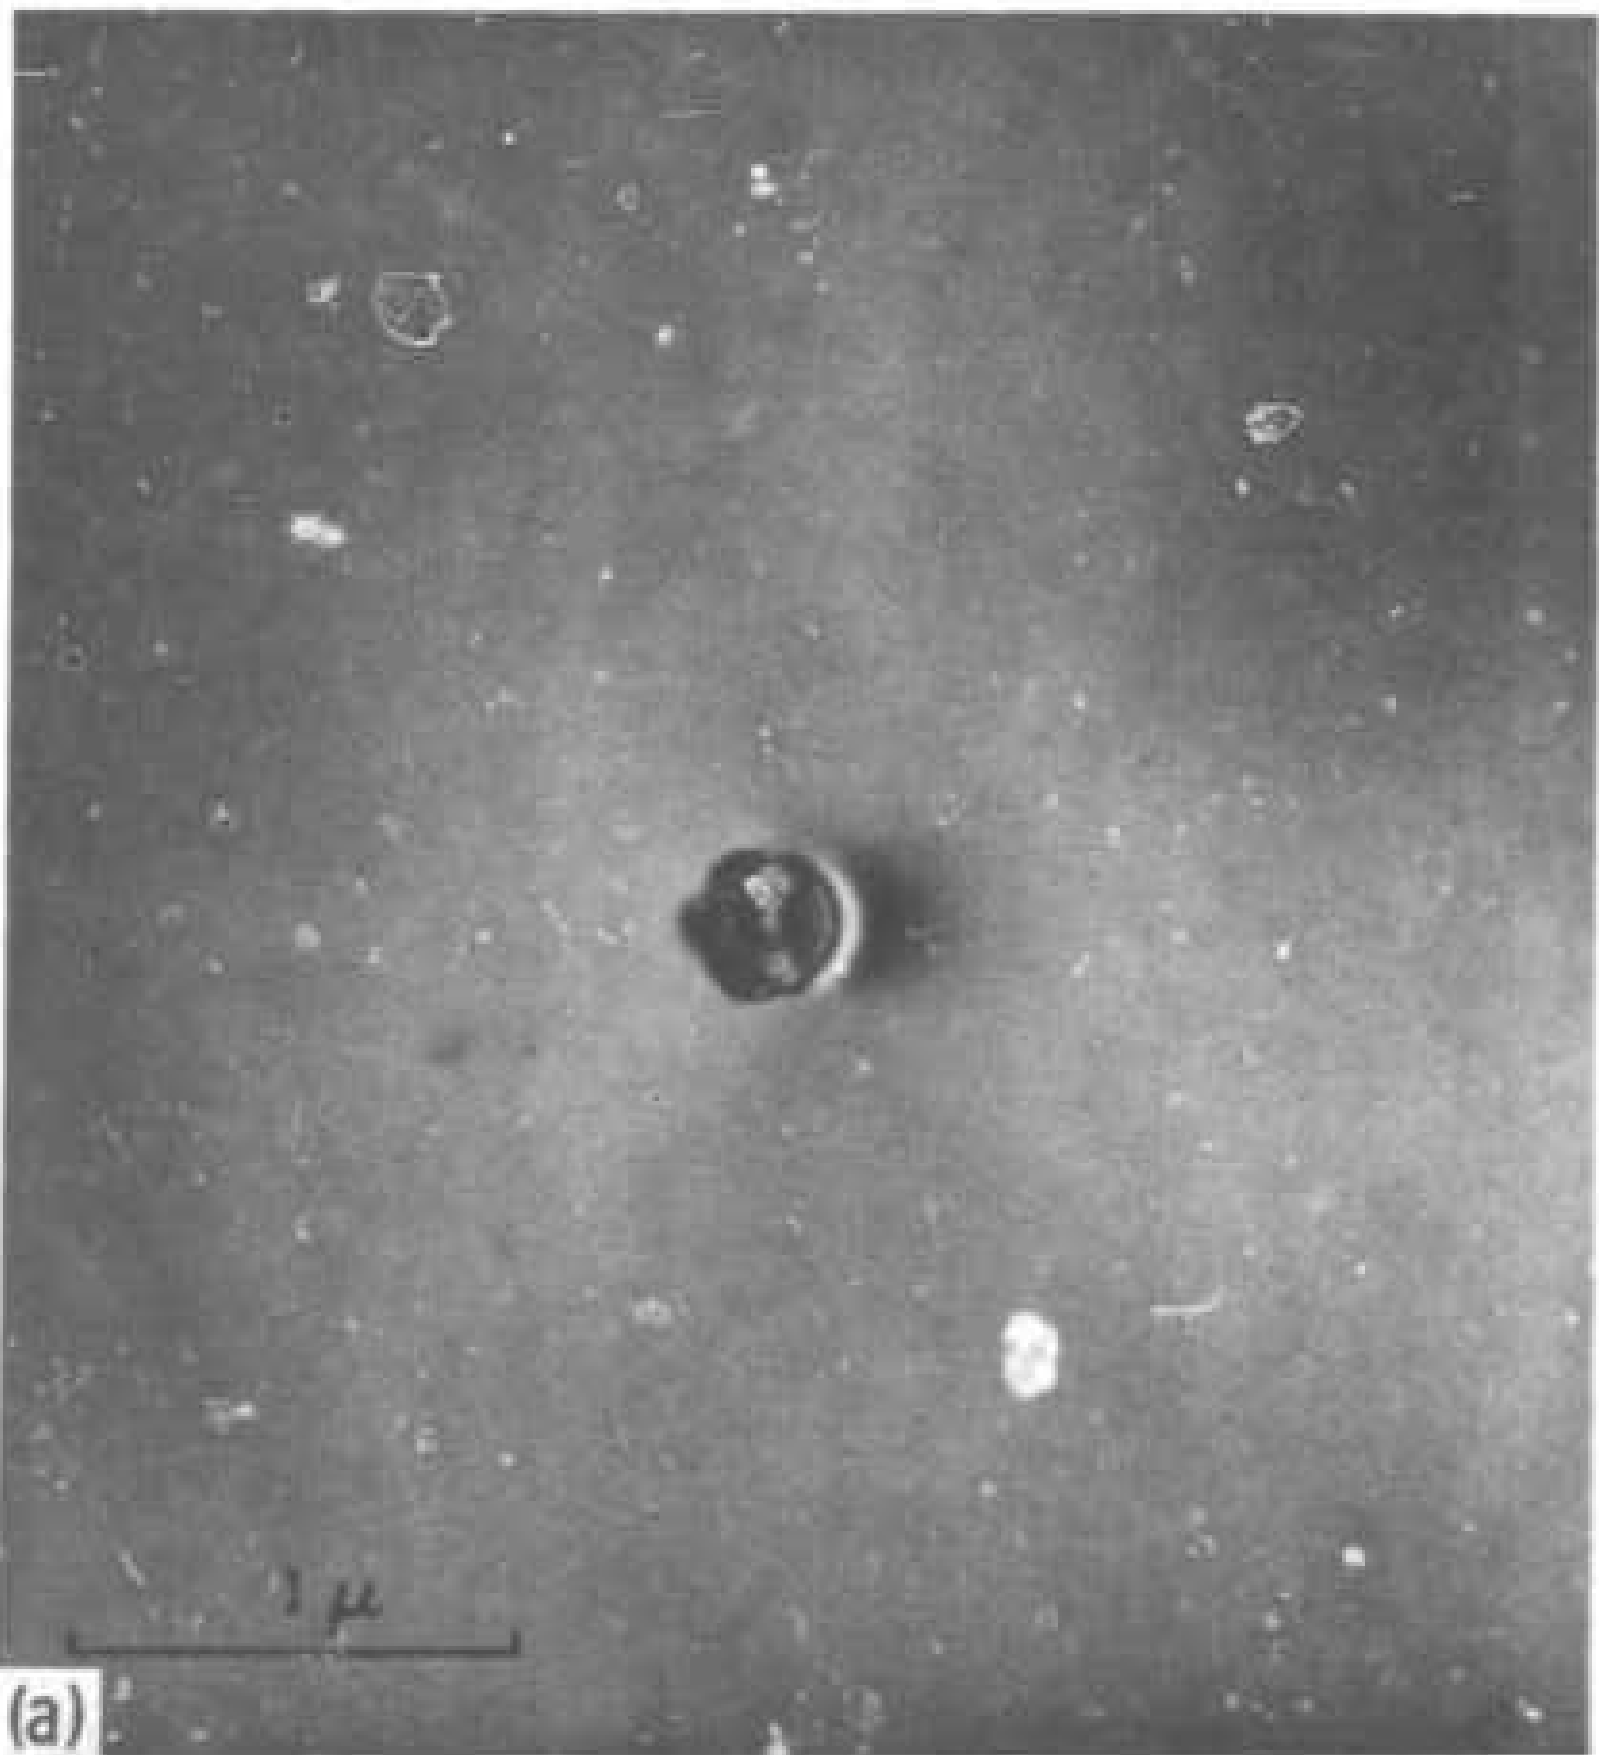
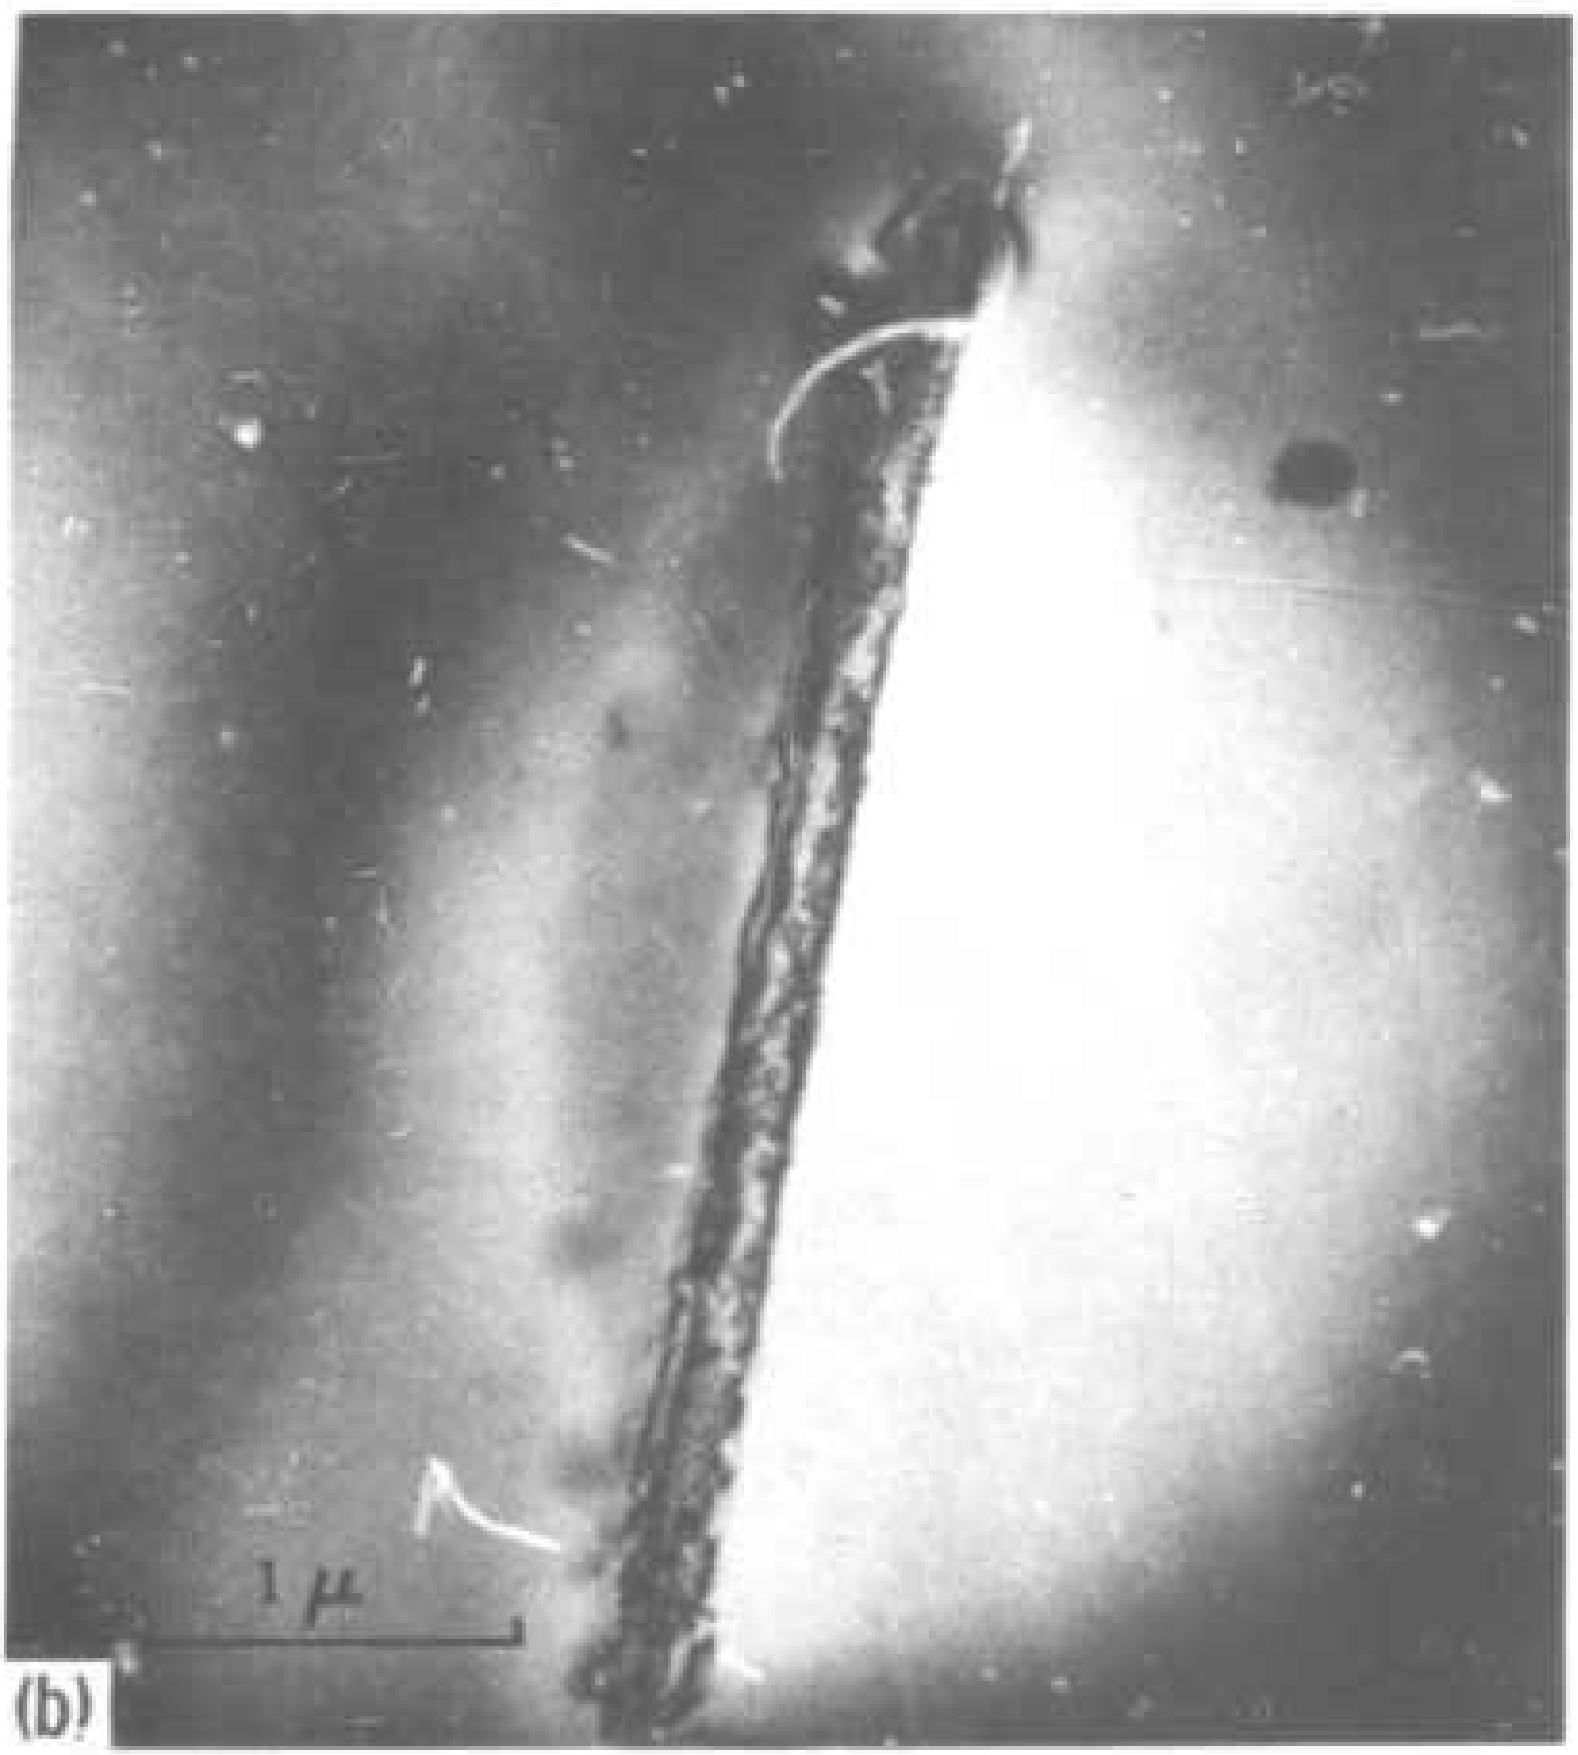
A set of line defects, each line approximately 1μm long, is shown in Fig. 4. The defects are oriented along <110> directions and penetrate each other at 90 degrees. Both line defects show Moire contrast and are surrounded by a highly stressed lattice. A short (0.2μm) and a long (8μm) defect are contrasted in Figs. 5a, b. Again both defects are visible due to Moire contrast. The long defect shows well developed rotation Moire contrast at the ends. Again, stress concentrations are confined to the ends of the fault.

Fig. 5. TEM micrographs. (a) 0.1μm microsplit. (b) 10μm-long split. Note Moire patterns, well developed at the ends.

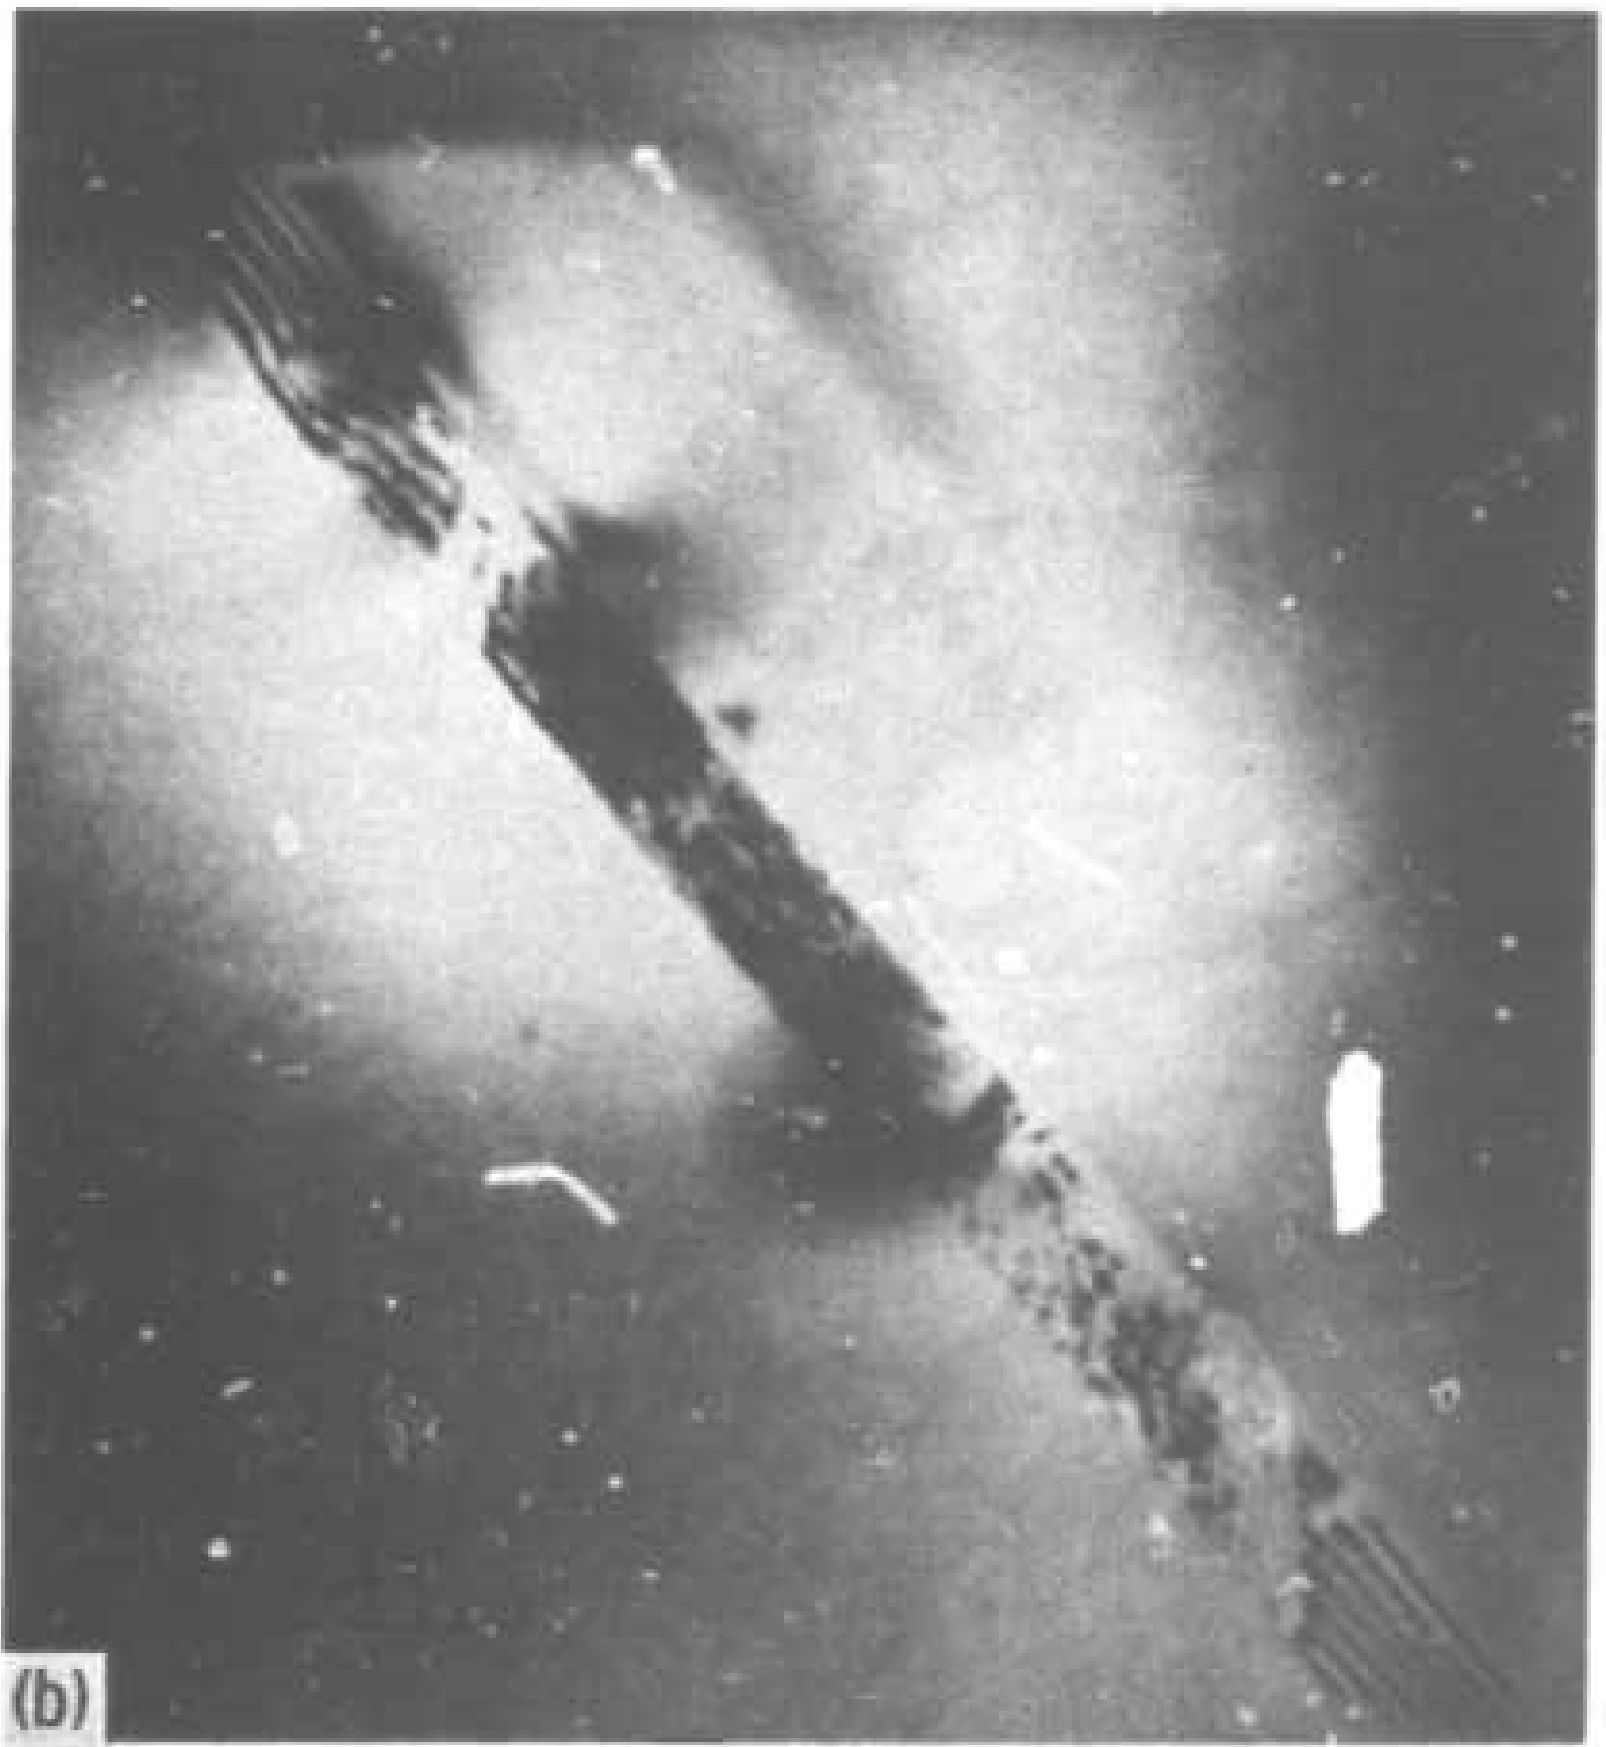
An interesting series of micrographs is displayed in Figs. 6a, b. Evidently, the shear stresses displayed in the preceding micrographs at the fault ends are large enough in this case to generate stacking faults. Figure 6a shows the birth of a stacking fault due to stress relief at one end of the linear defect while Fig. 6b shows well developed stacking faults at both ends of the defect.

Fig. 6. TEM micrographs of microsplit. (a) Birth of stacking fault at one end. (b) Stacking faults at both ends.

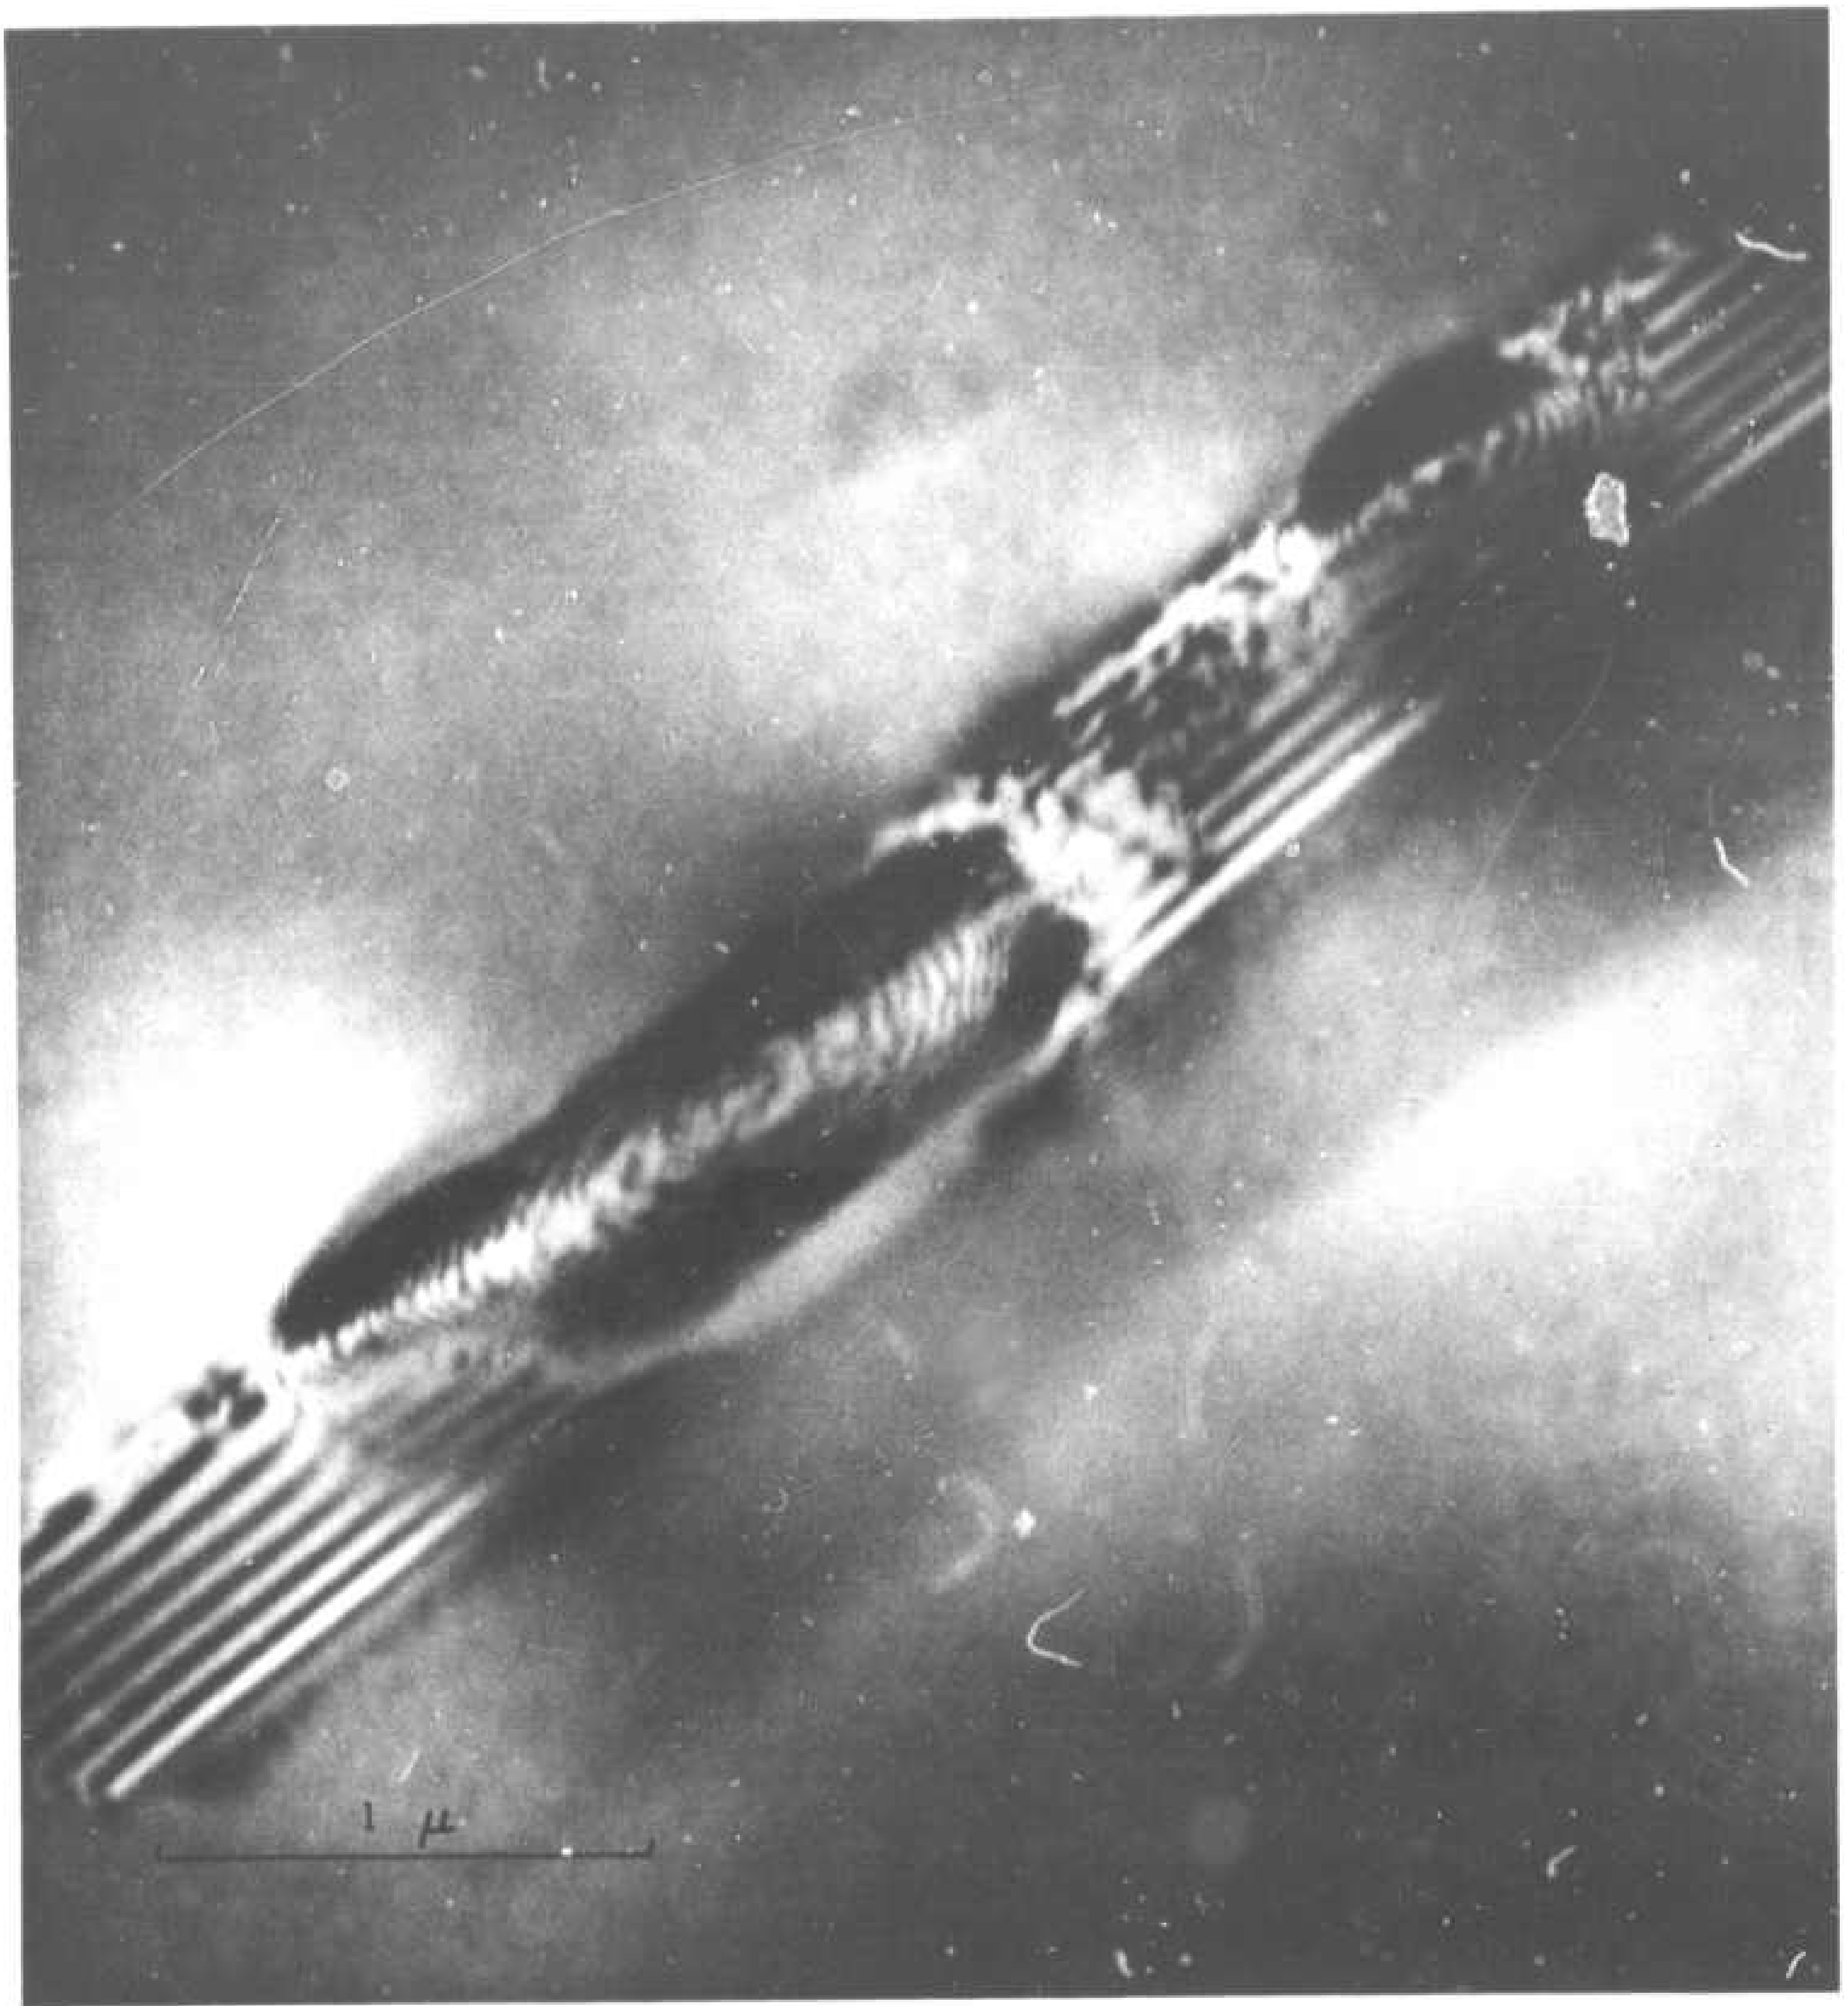
A beautiful example of stress relief through stacking fault generation is shown in Fig. 7. One can see two linear defects producing excellent Moire patterns and complete stress relief through fully developed stacking faults.

Fig. 7. TEM micrograph of microsplit showing excellent Moire patterns and fully developed stacking faults.
