DAMAGE PROFILES IN SILICON AND THEIR IMPACT ON DEVICE RELIABILITY

International Business Machines Corporation

TECHNICAL REPORT No. 1
January 1973

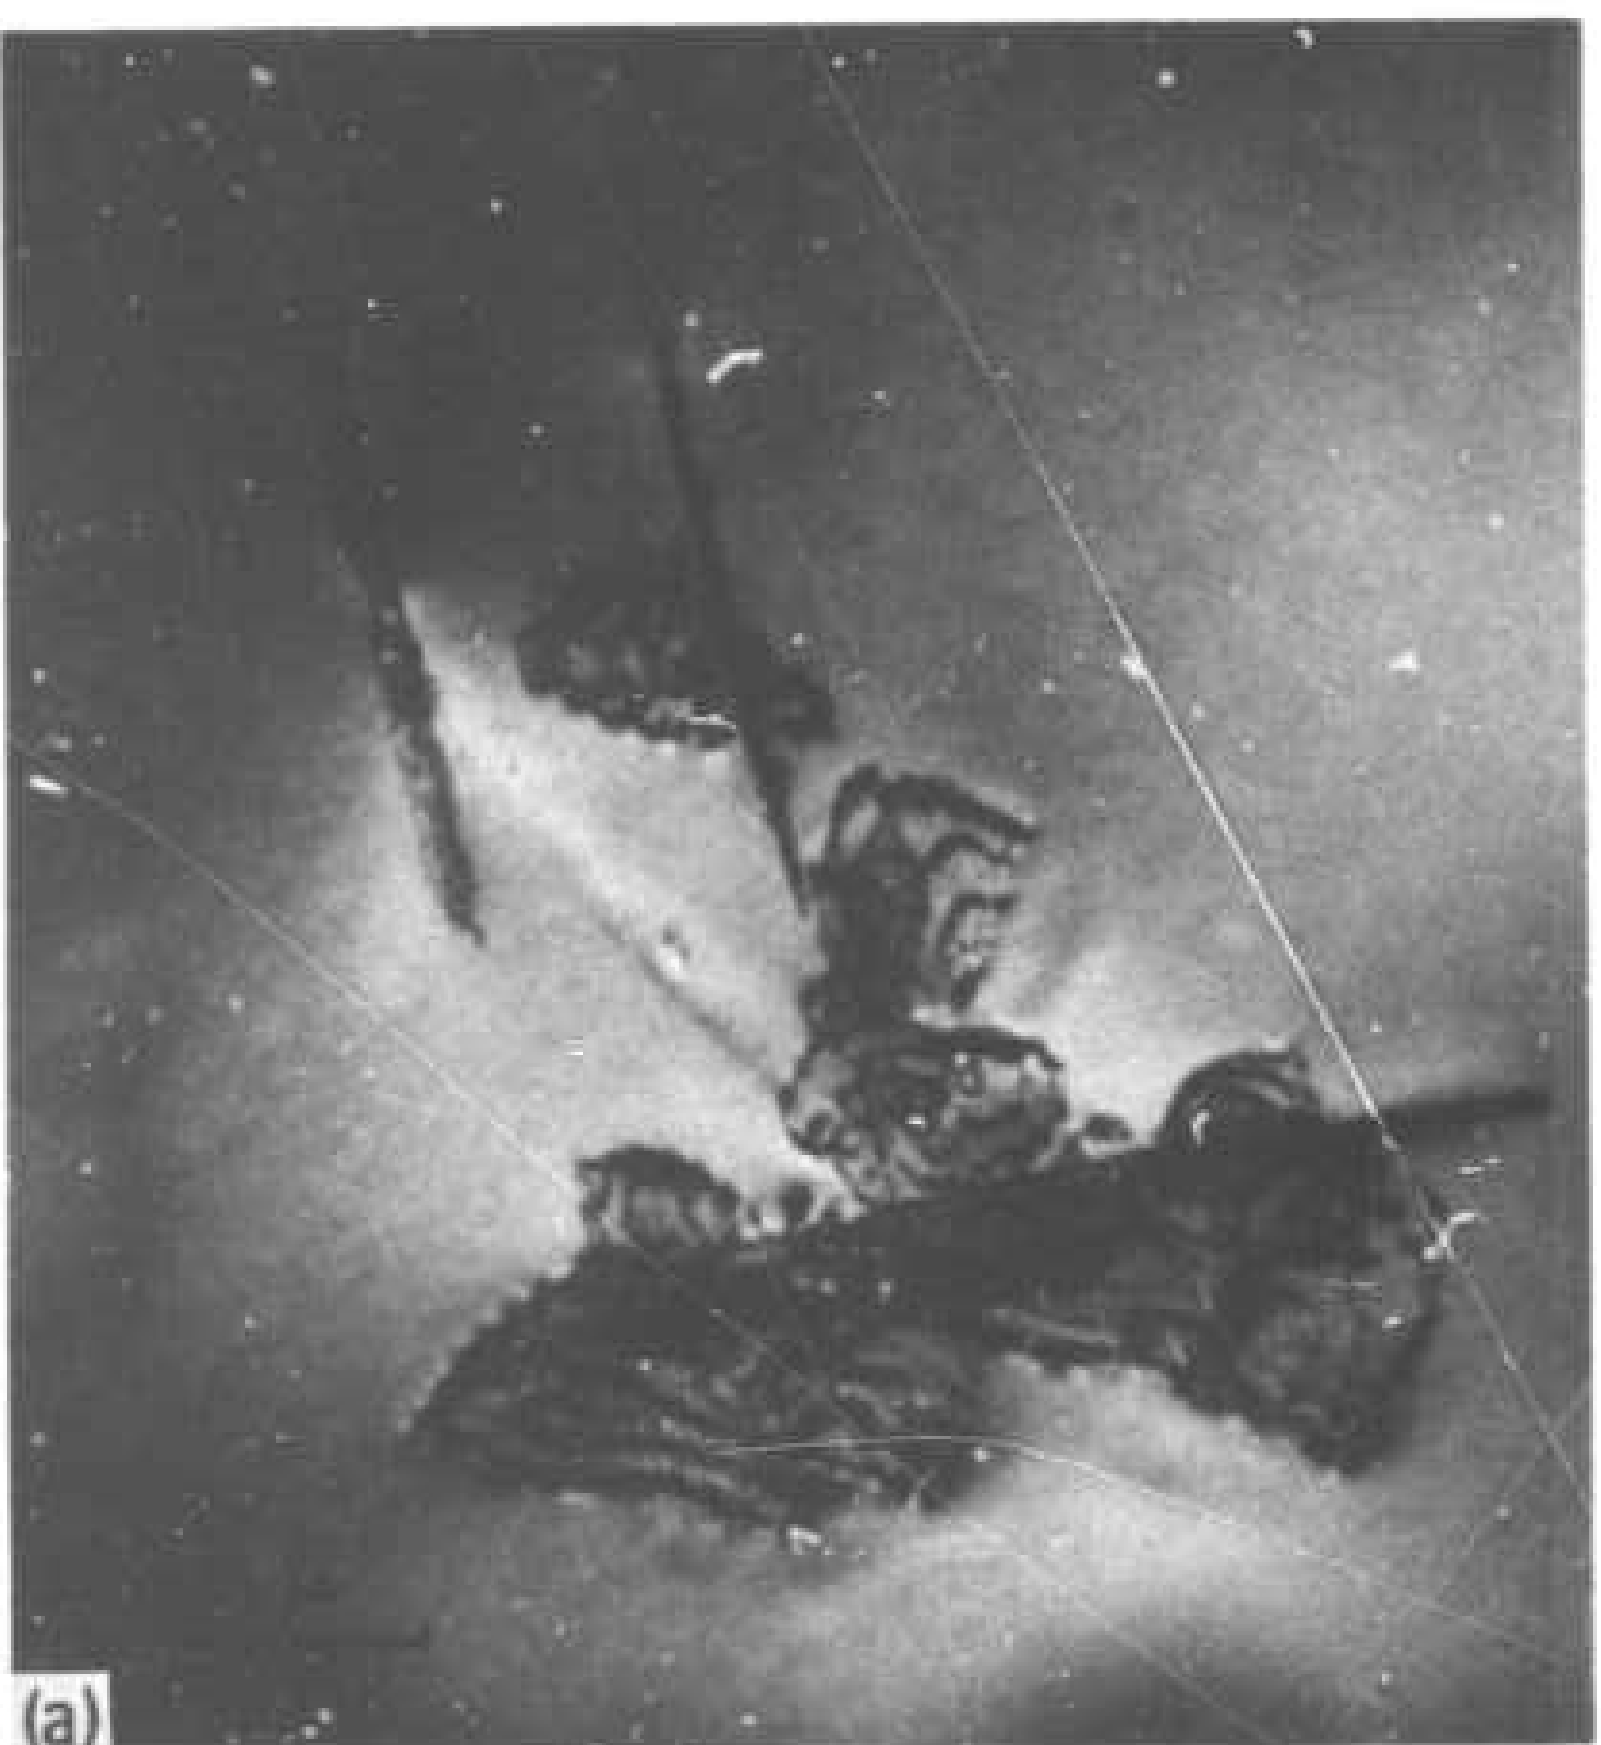
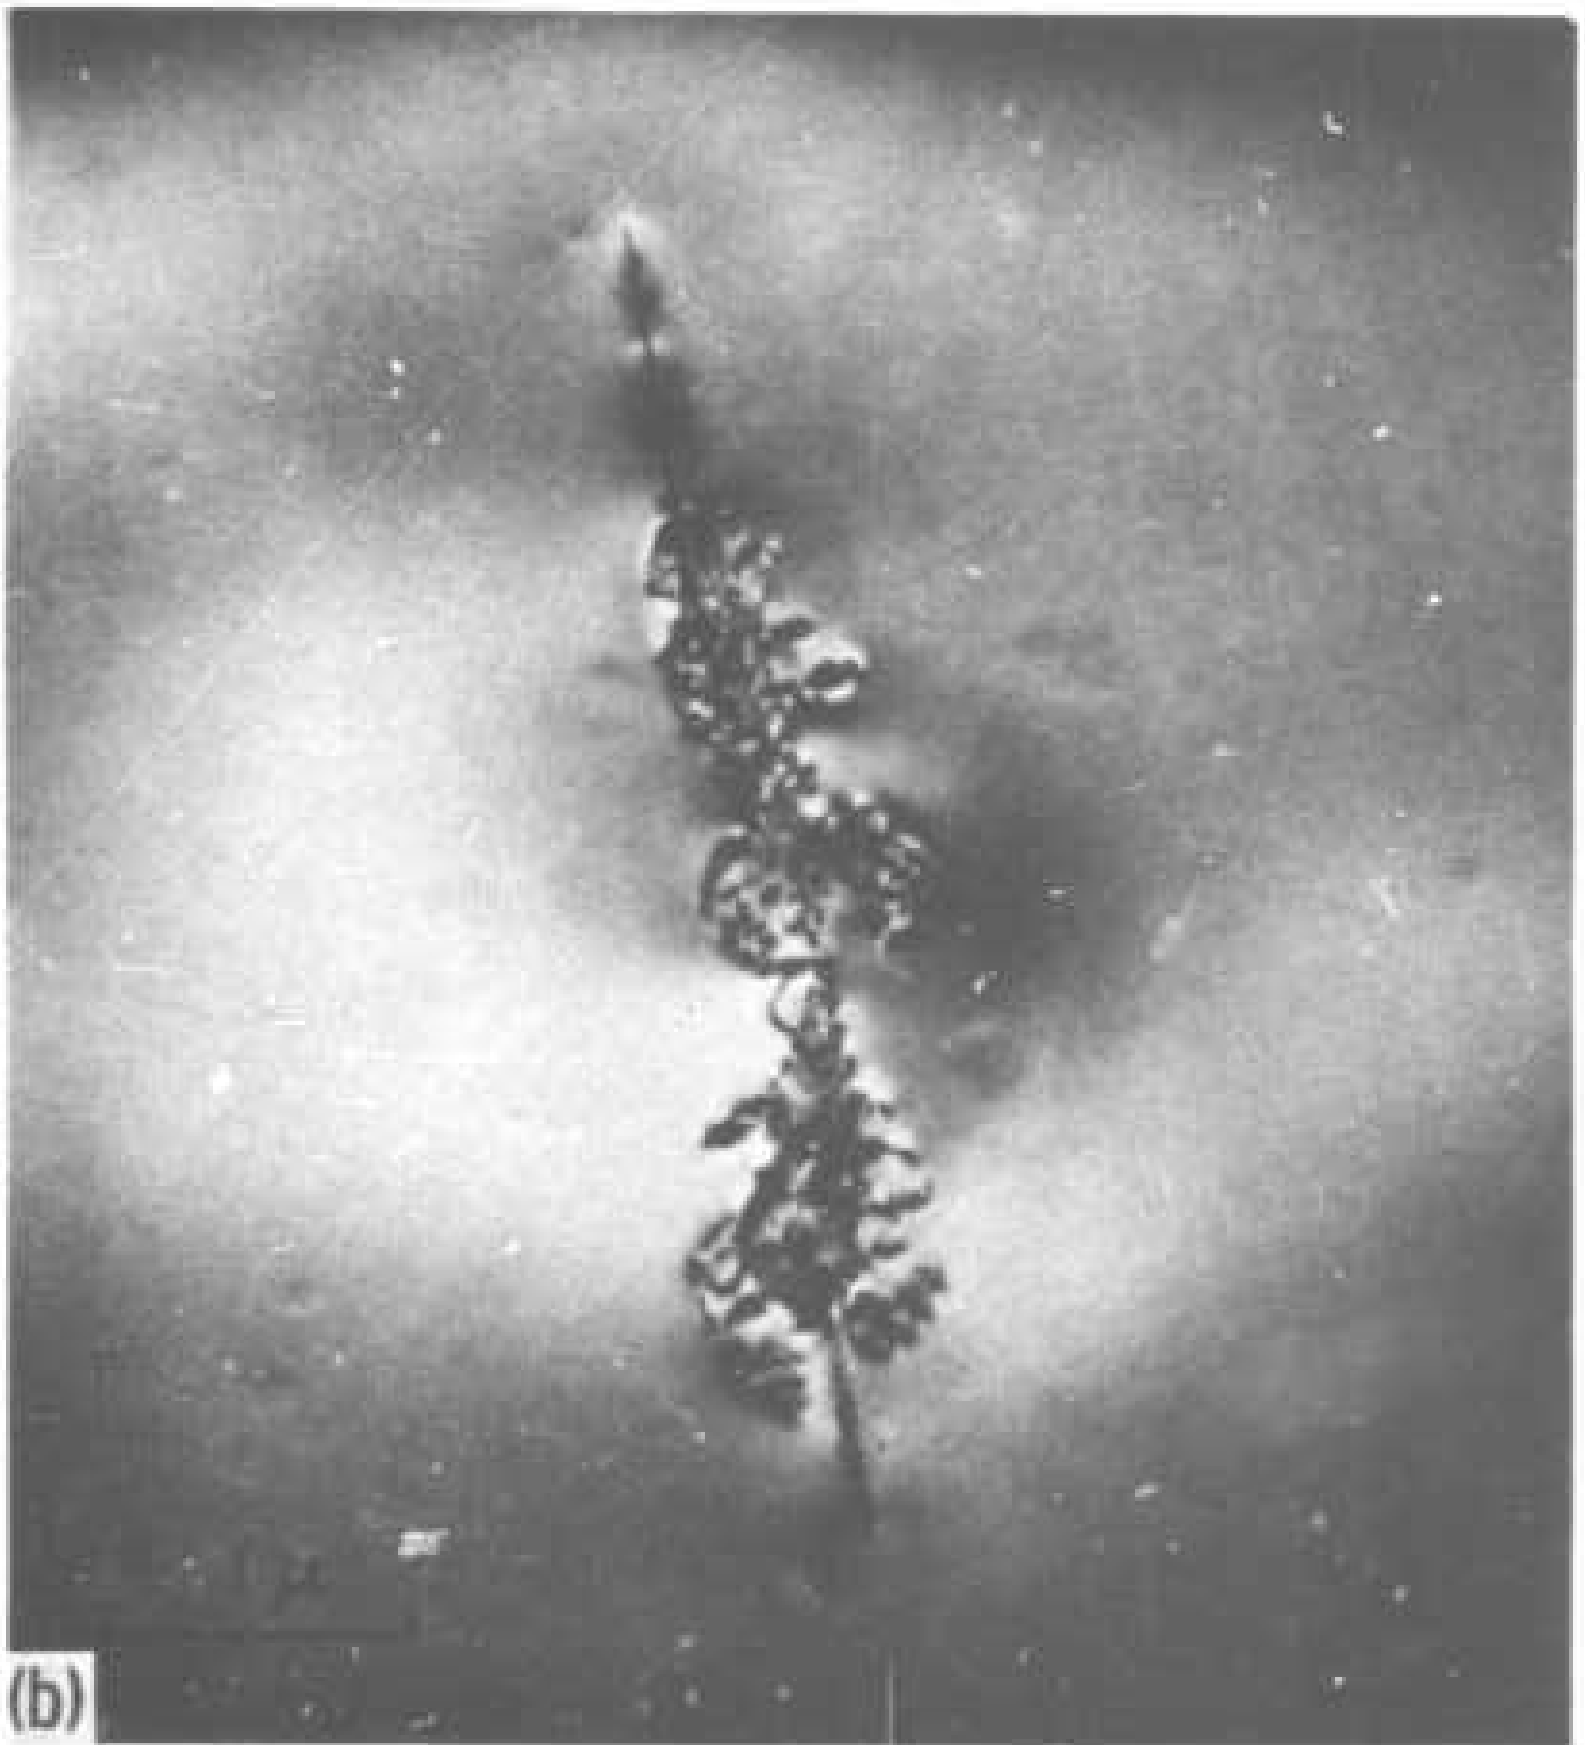
examples are shown in Figs. 8a, b. Both micrographs show groups of linear faults interacting and producing complicated defect patterns.

Fig. 8. TEM micrographs of group of splits. (a) Single splits in perpendicular orientation. (b) Single splits in parallel orientation.

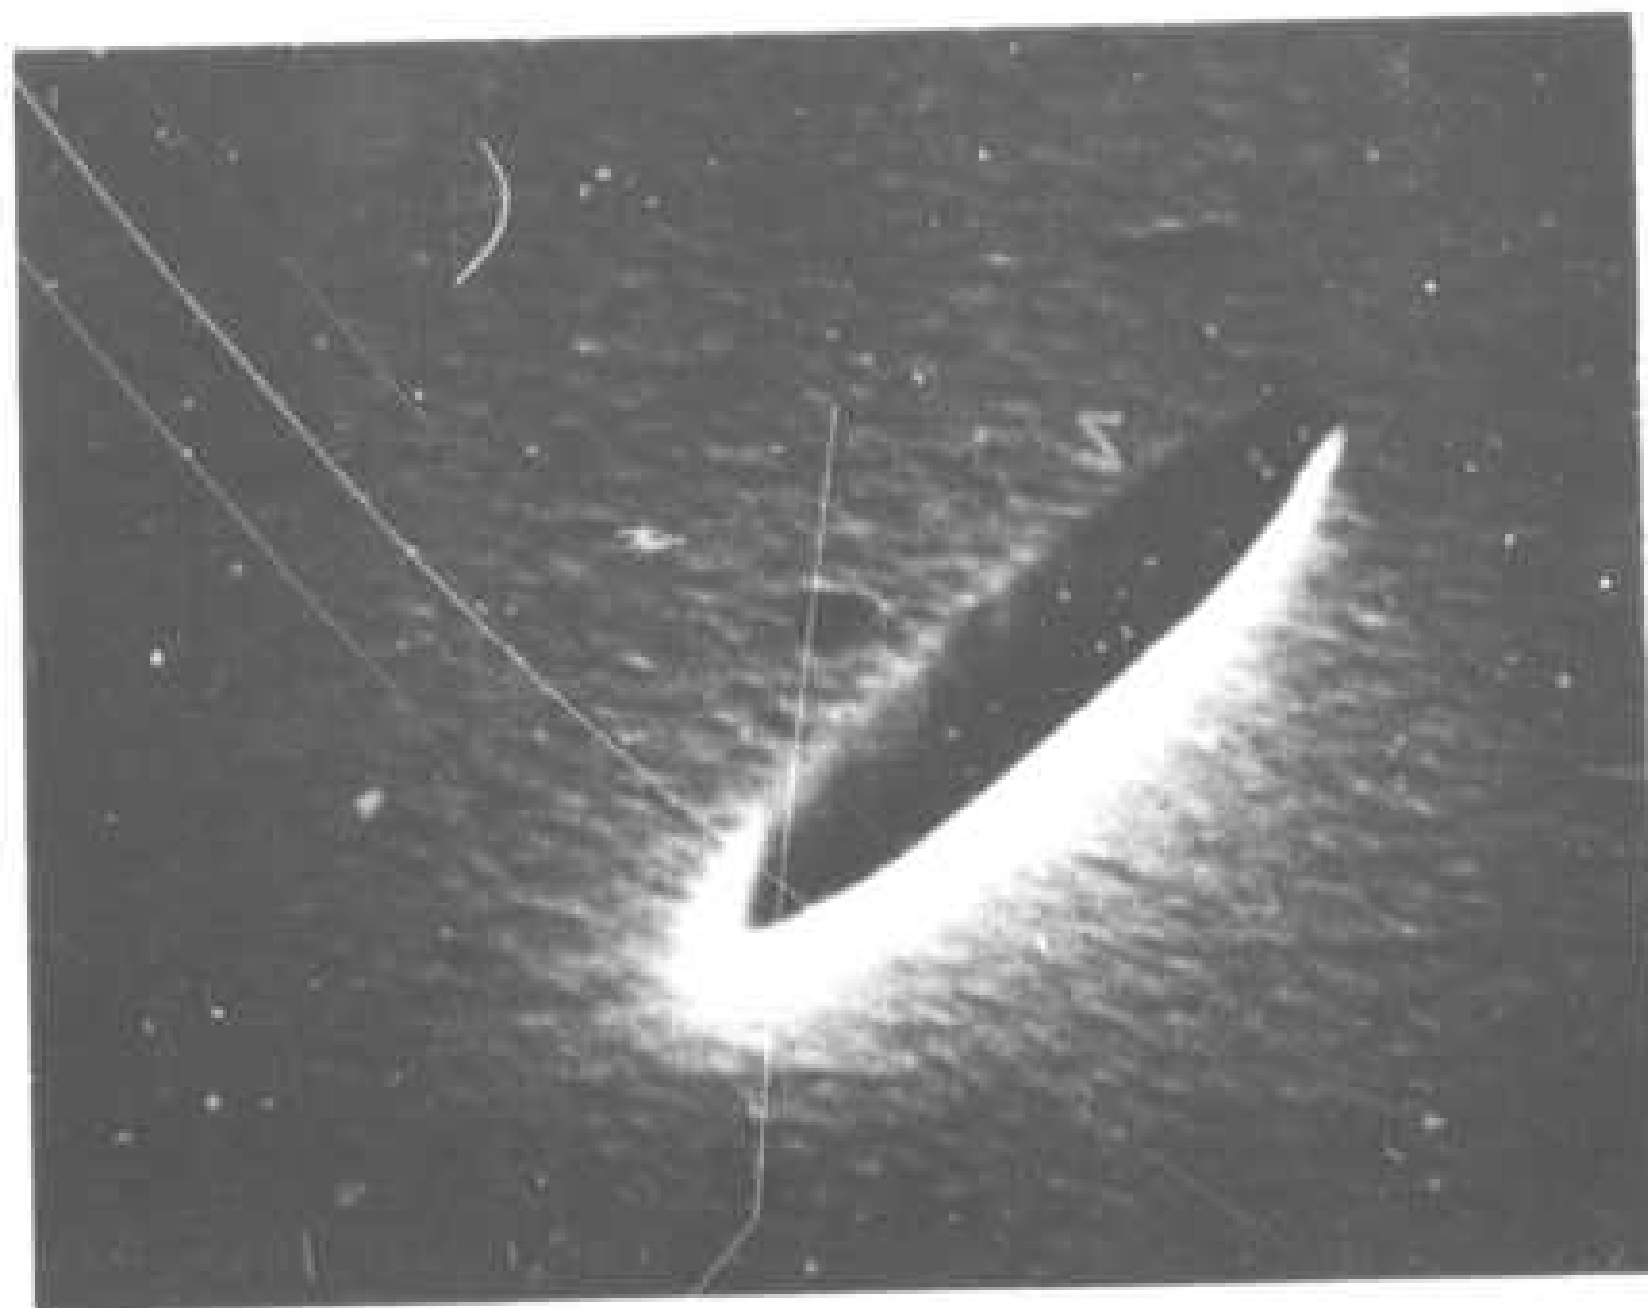
micrographs. A cross-sectional view of two microsplits after etching is shown in the SEM photomicrograph of Fig. 10b. The cross-sections show that such faults penetrate to different depths and are not confined to cleavage planes. This observation supports partial split experiments made on germanium.[9]

Fig. 10. SEM micrographs of split. (a) From etch figures corresponding to Fig. 9. (b) Cross section of two different splits.
