CAMOUFLAGE DISPENSER, HELICOPTER MOUNTED

AAI Corporation

Army Land Warfare Laboratory

December 1972

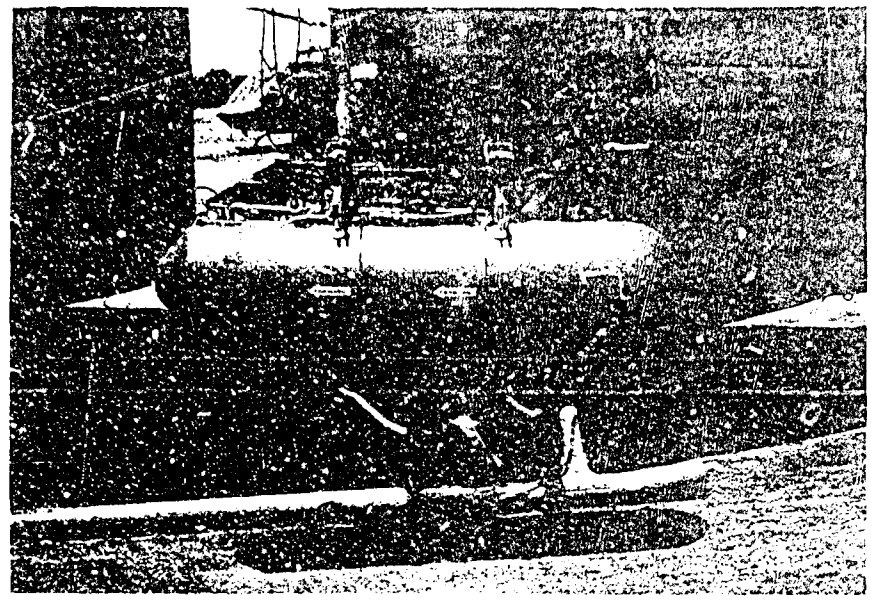
Figure 1

73E01-1A DISPENSERS - PORT AND STARBOARD MOUNTING

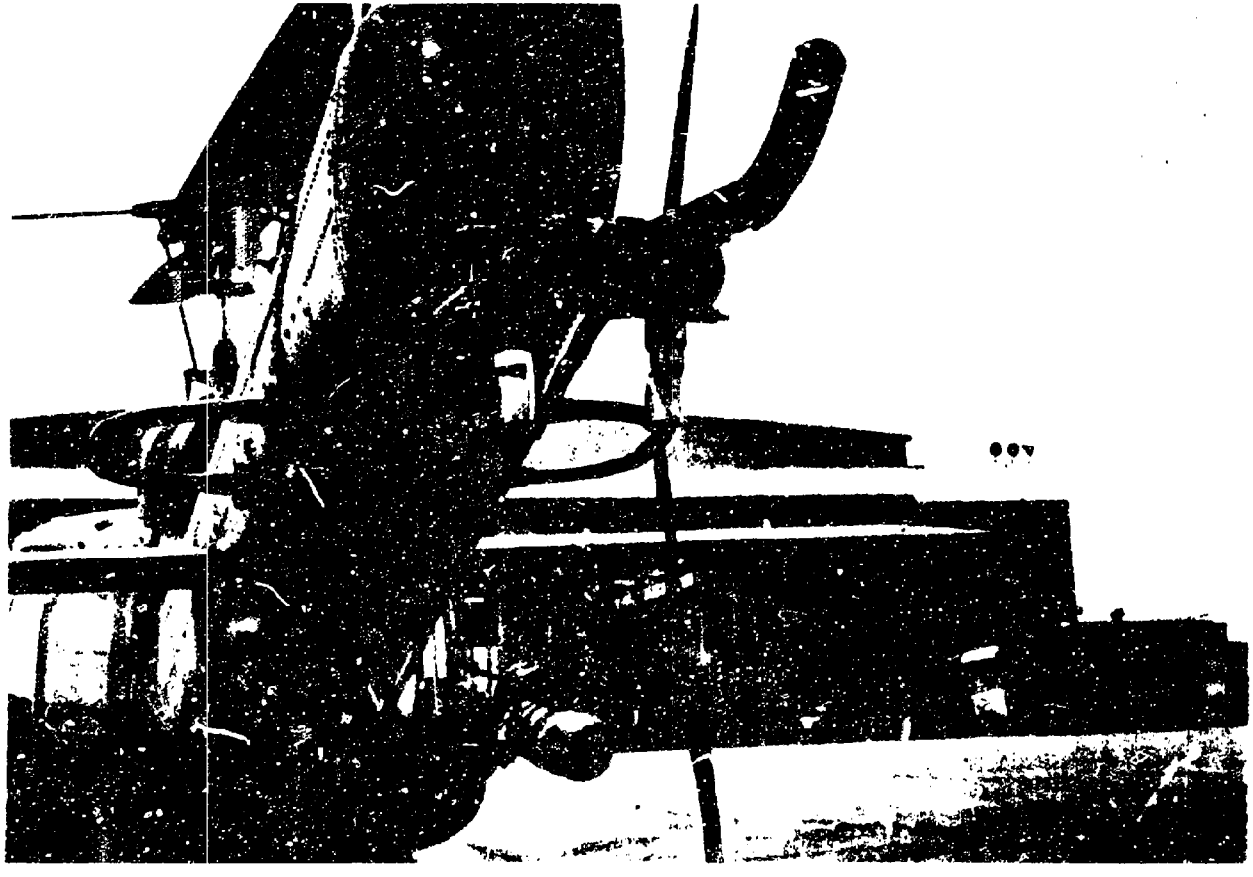
Figure 3

49° ANGLE SPRAY NOZZLE-MOUNTED

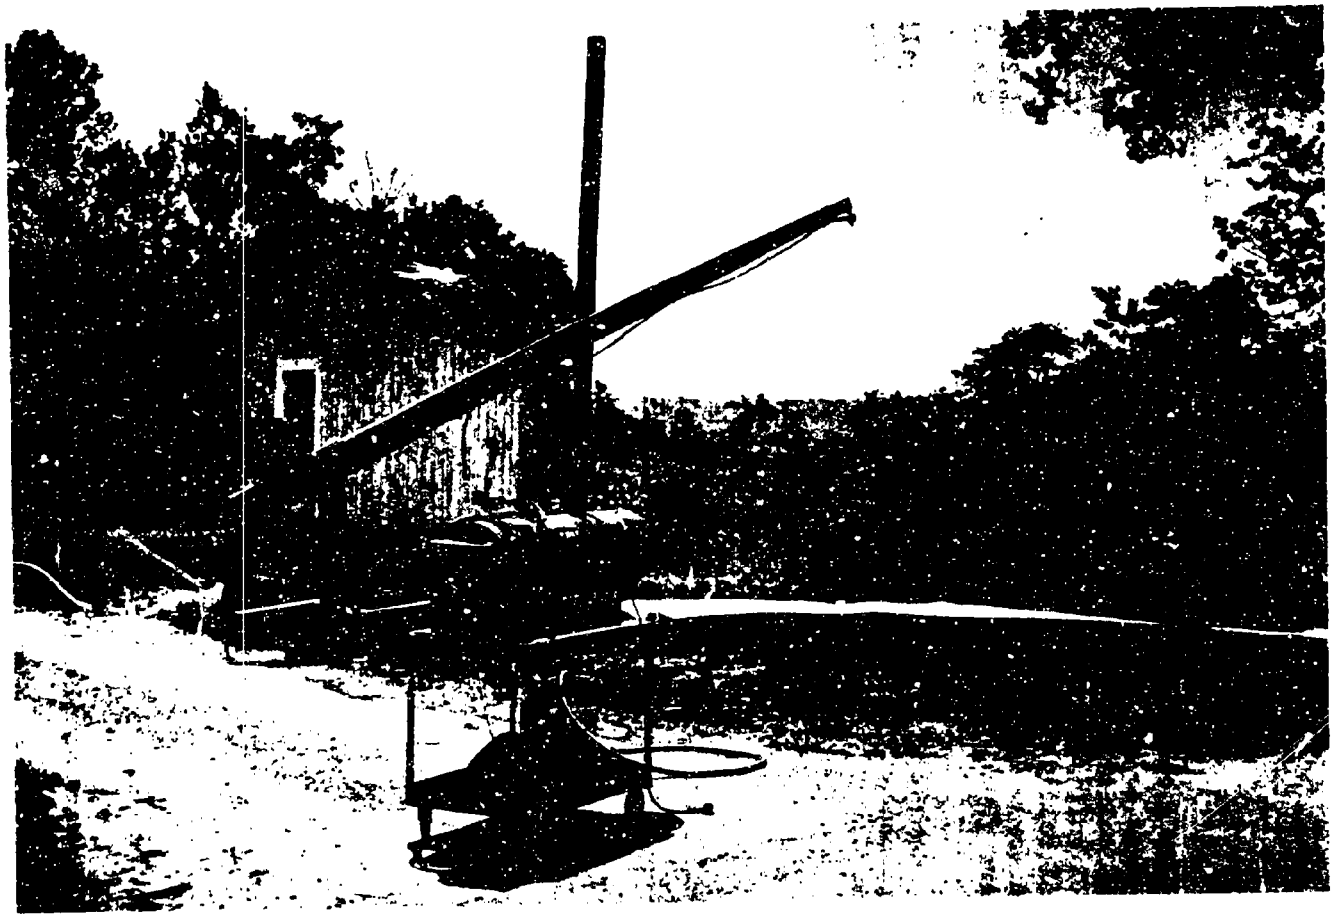
Figure 5

TEST STAND

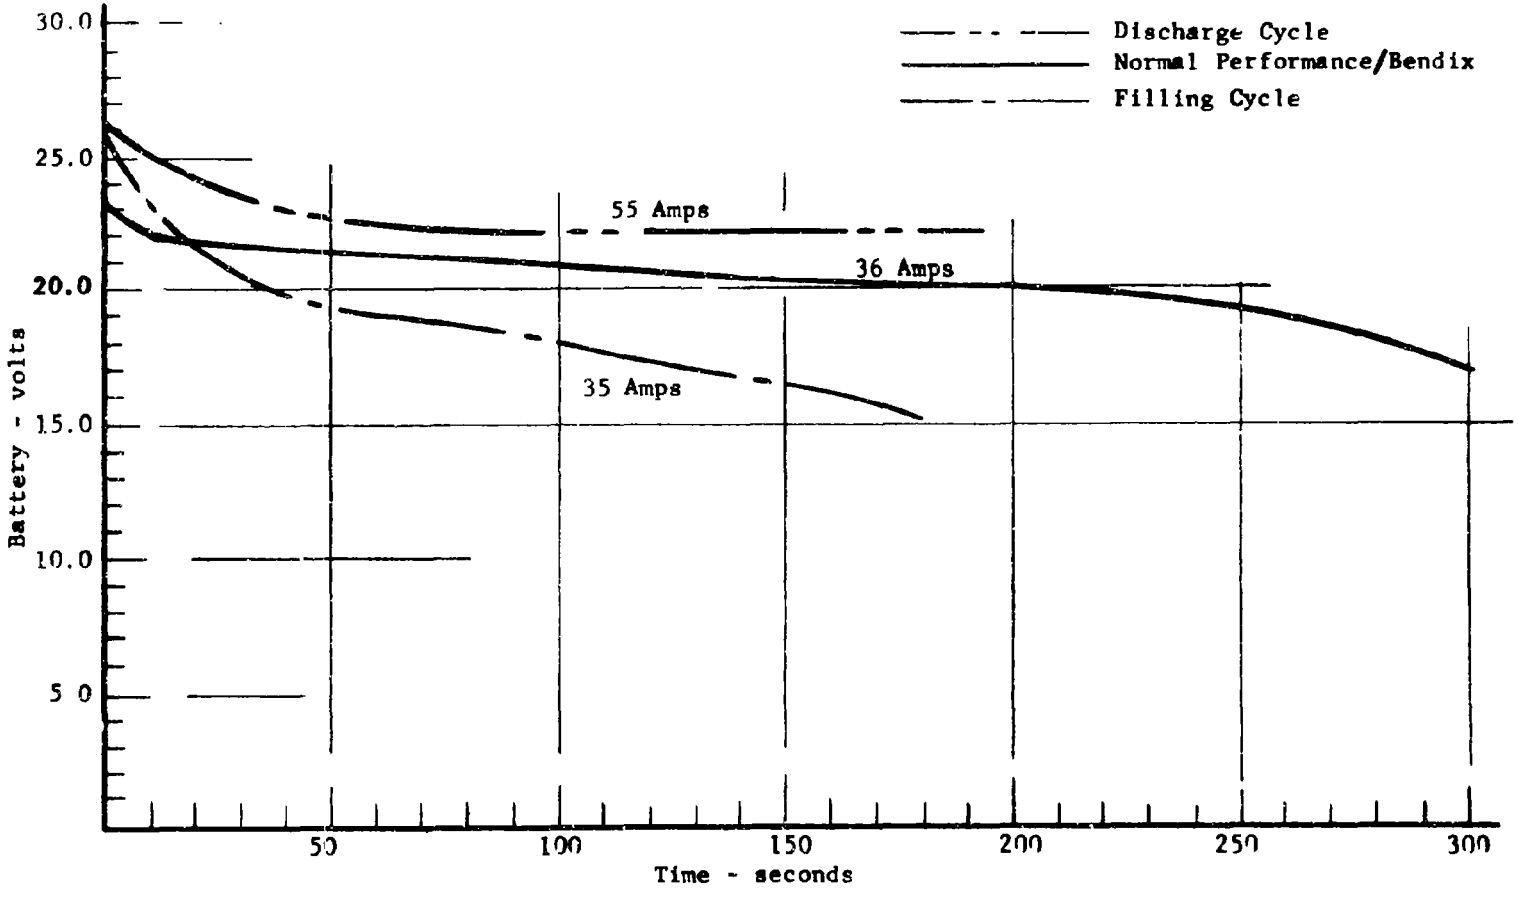
8.2.3 Figure 20 charts the electrical performance of the tested units.

Figure 20. Electrical Performance Chart.

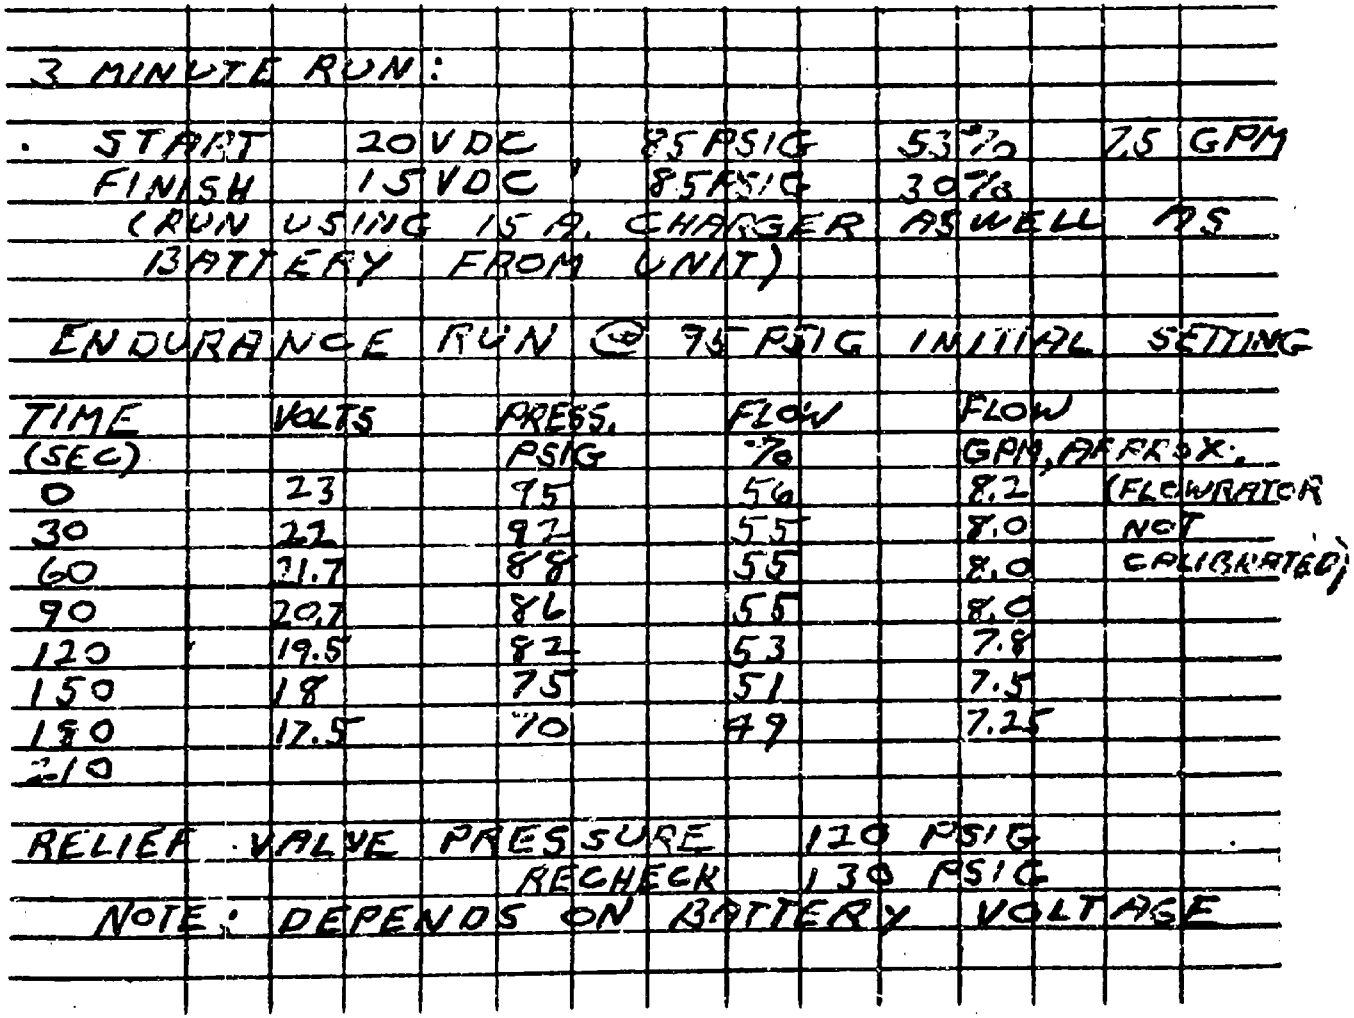
START	20 VDC	85 PSIG	53%	7.5 GPM
FINISH	15 VDC	85 PSIG	30%

Figure 21. Unit No. 9 - Bendix - Endurance Run.

The nickel-cadmium storage battery from the dispenser was re-charged and was used to operate the pump for this test, but it proved inadequate for the job. The battery apparently was in need of deep-cycle reconditioning service to equalize the state of charge of the individual cells. The tests were completed with a 15-ampere power supply connected across the battery terminals.

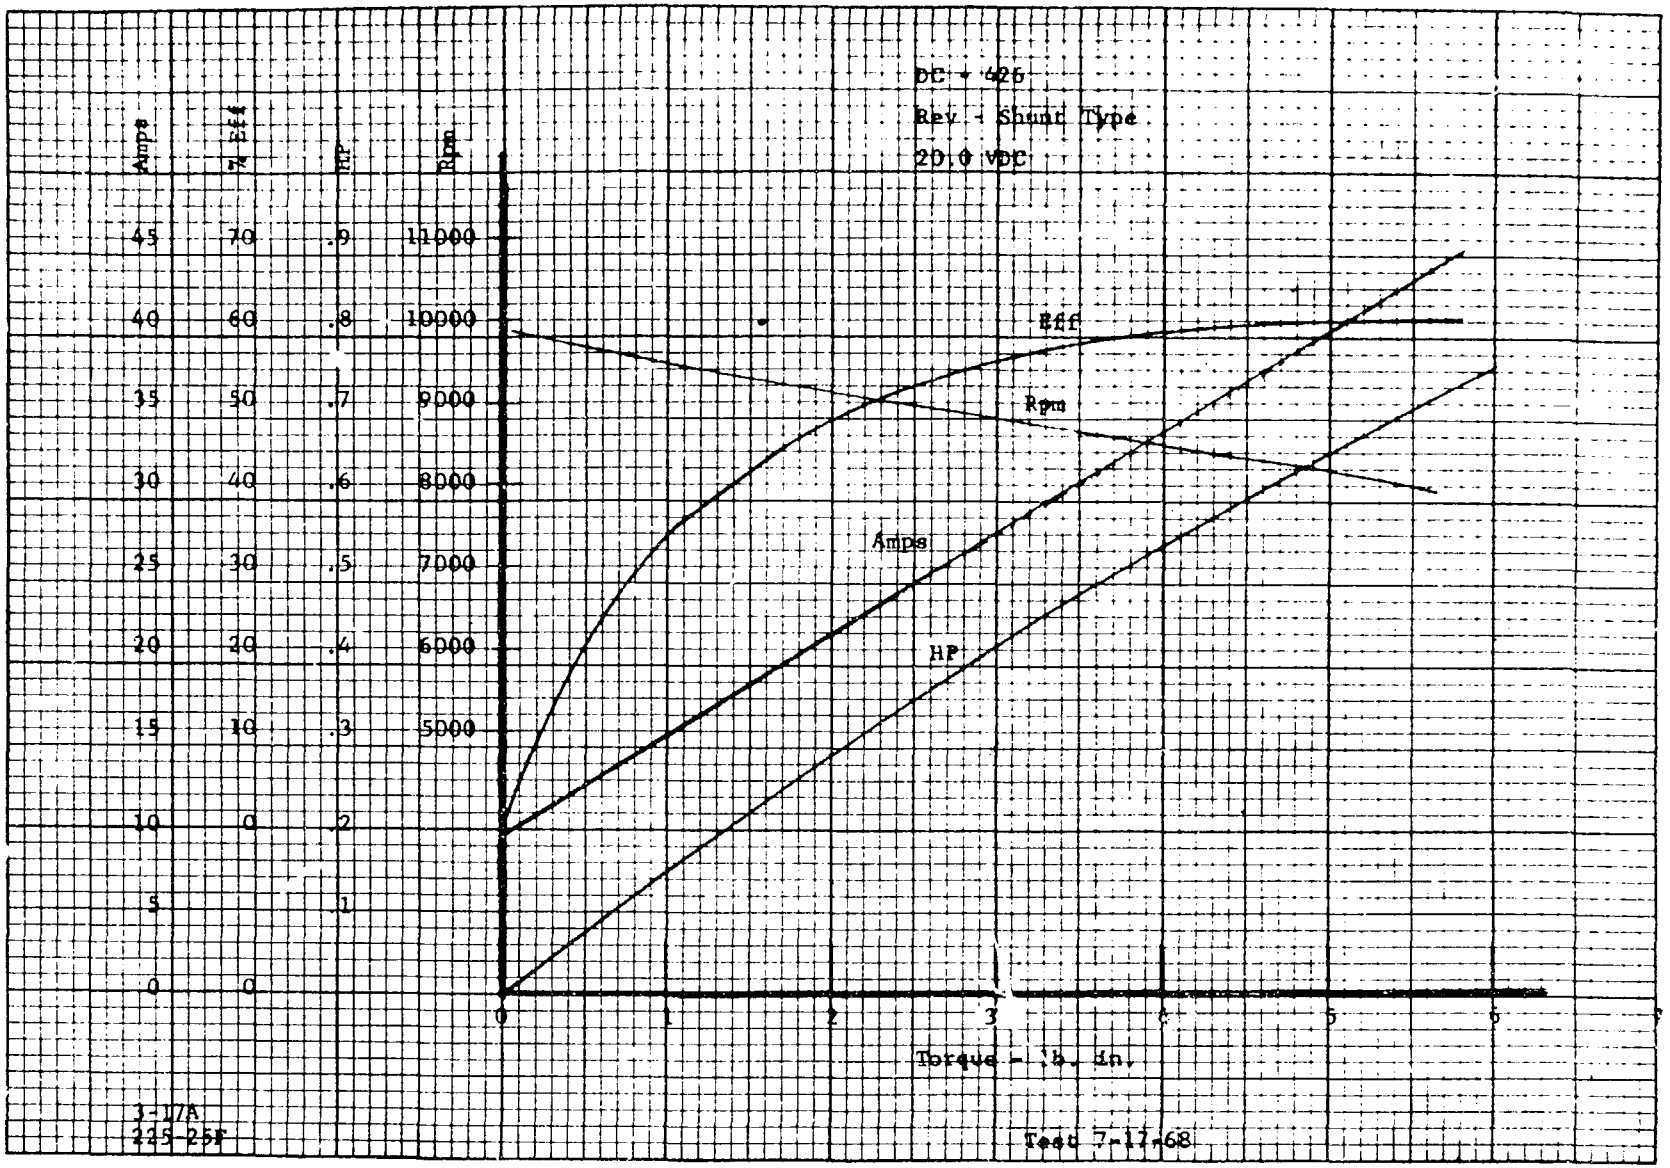
Figure 22. Original Pump Motor Performance Data.

9.3.2 Figure 22 was provided by the Bendix Corporation and represents their data, obtained in testing the 73E01-1A pump motor during the dispenser design study.

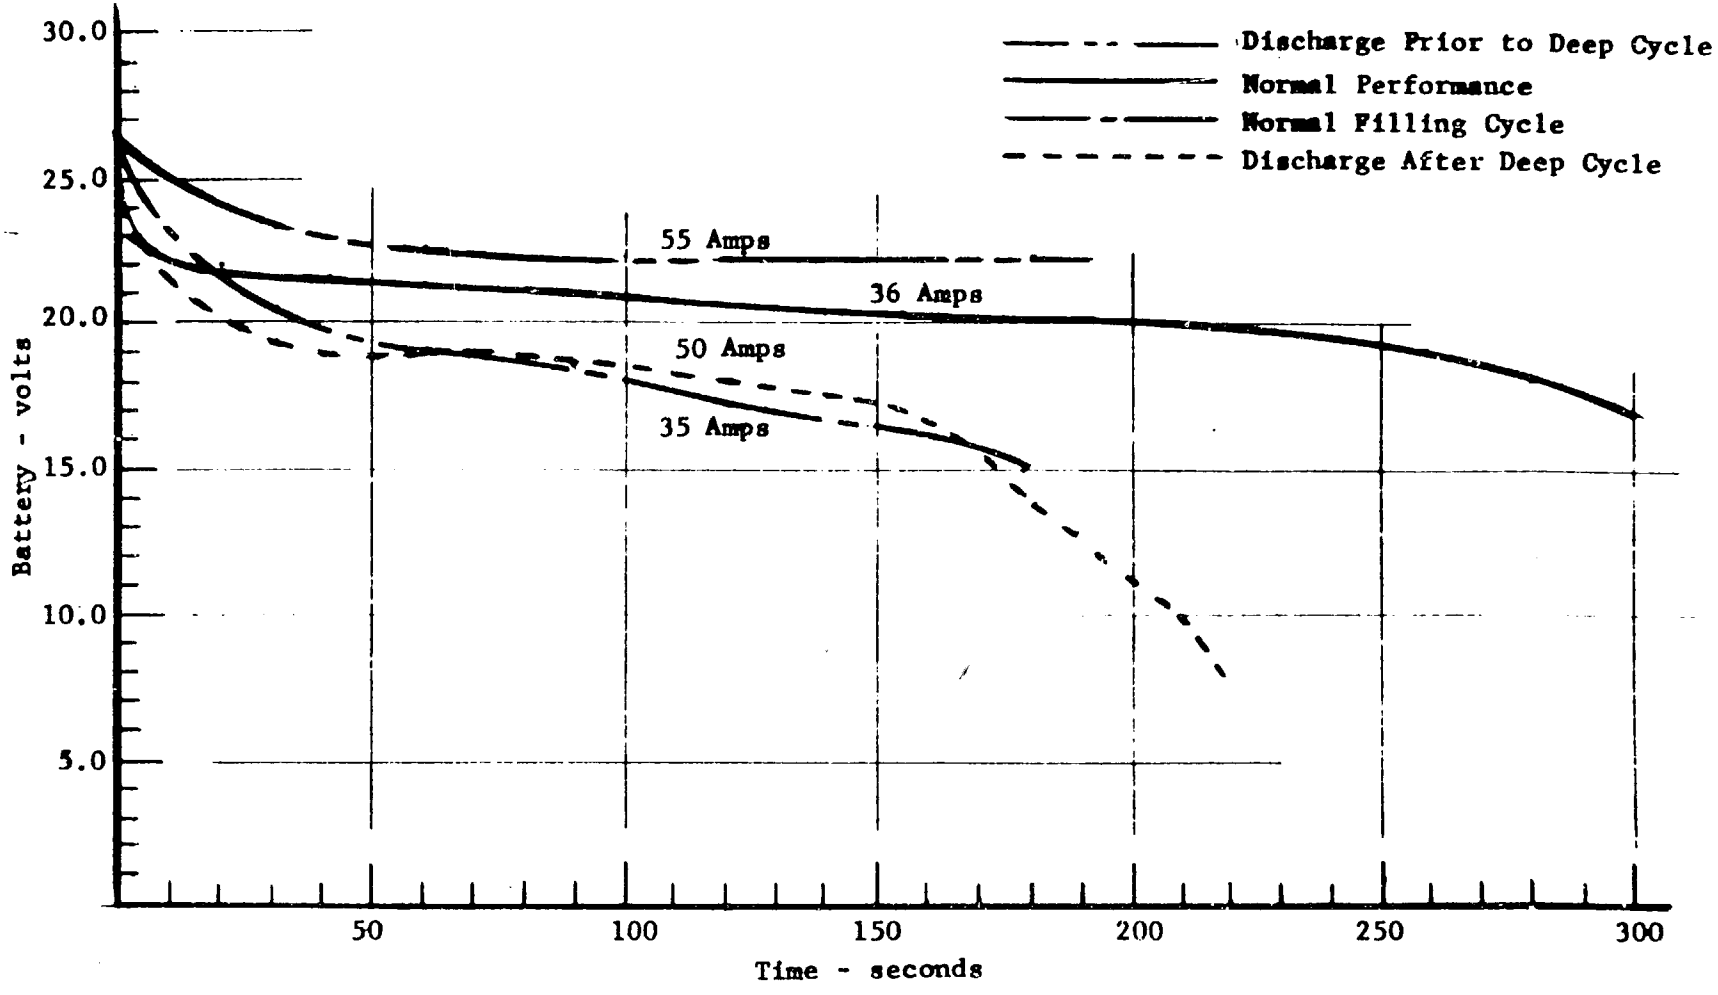
10.0.7 Expelling tests with dispenser No. 19 after deep-cycling showed a more rapid drop in voltage while operating. A comparison performance chart is shown in Figure 23. Additional information can be found in Sections 8 and 9. Figure 24 shows the front view of the 73E01-1A battery with individual cells.

Figure 23. Battery Discharge Performance.

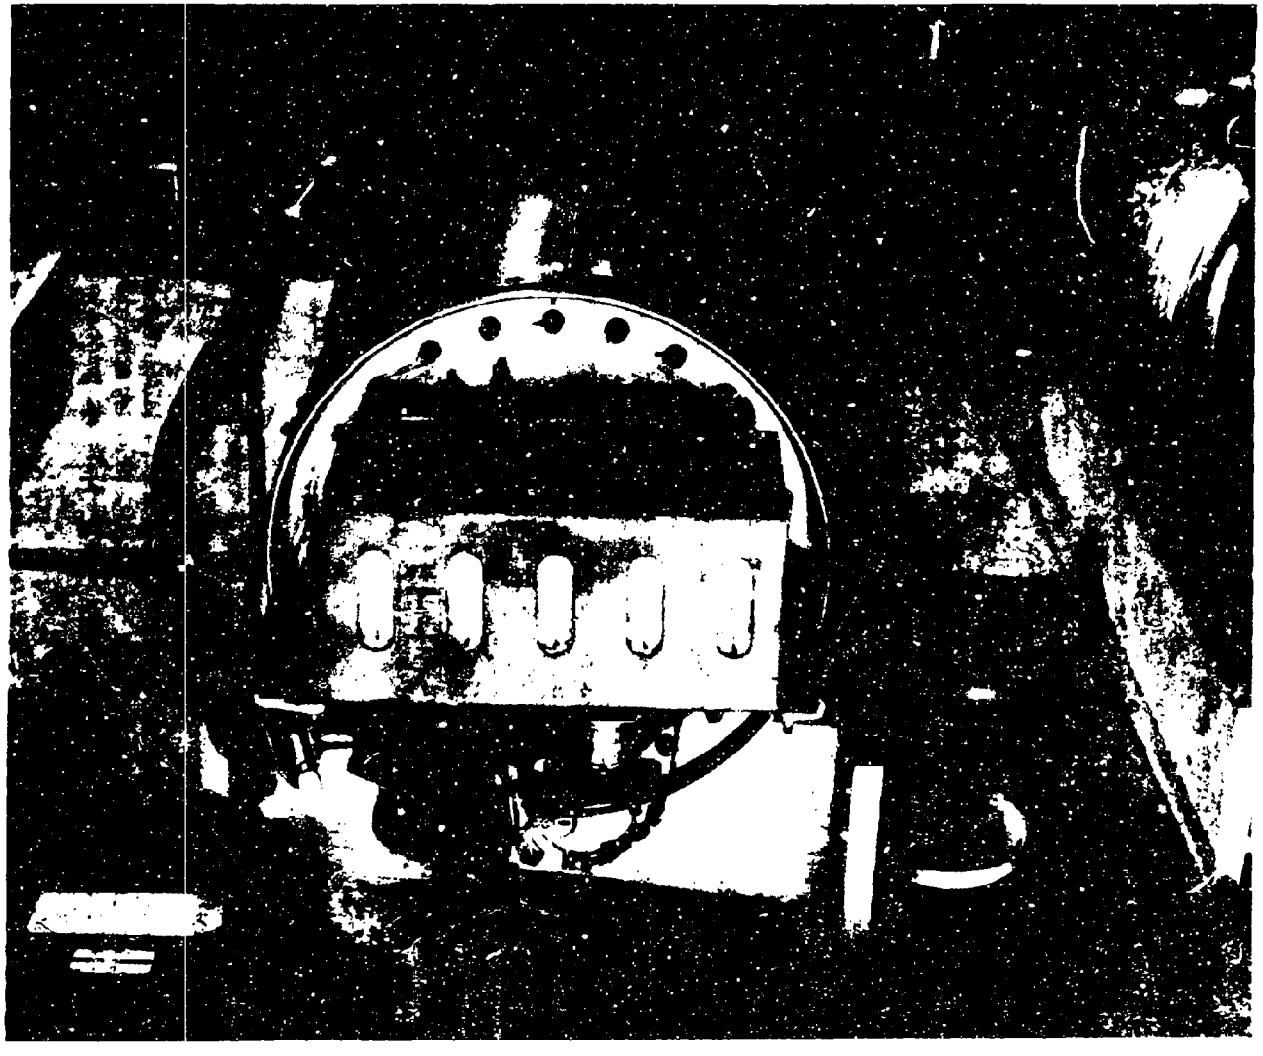
Figure 24

FRONT VIEW OF 73E01-1A BATTERY
SHOWING 19 INDIVIDUAL CELLS

The state of charge of the battery was poor, apparently due to cell imbalance. This was probably caused by extended storage in a hot environment (Viet Nam). The battery can likely be restored to full capacity by deep-cycle charging.
