RESIDUAL SAW DAMAGE IN SILICON WAFERS AND ITS INFLUENCE ON MOS CAPACITANCE RELAXATION

INTERNATIONAL BUSINESS MACHINES CORP.

JULY 1973

9a. ORIGINATOR'S REPORT NUMBER(S)
TR 22.1692

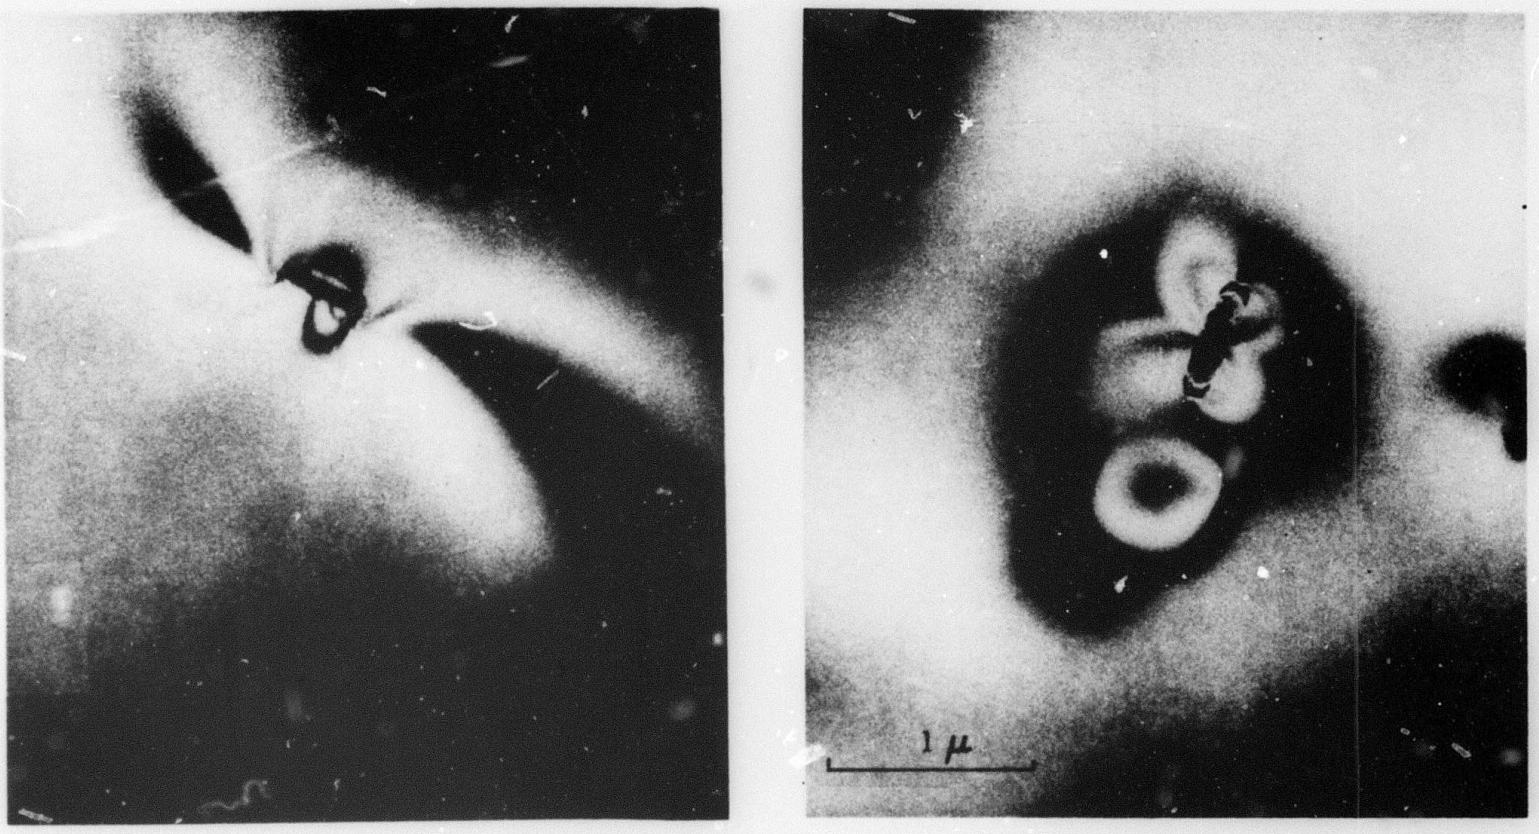
studies were made on numerous good and bad devices. Microsplits were found in bad devices only. Considerable differences in microsplit size for different wafers were also noted. Examples are shown in Figs. 6. After processing and testing of approximately 300 different silicon wafers several general observations were made which can be summarized as follows:

Fig. 6a. Example of microsplit configuration as found in "bad" devices.

Fig. 6b. Examples of microsplit configurations as found in "bad" devices.

Fig. 6c. Examples of microsplit configurations as found in "bad" devices.

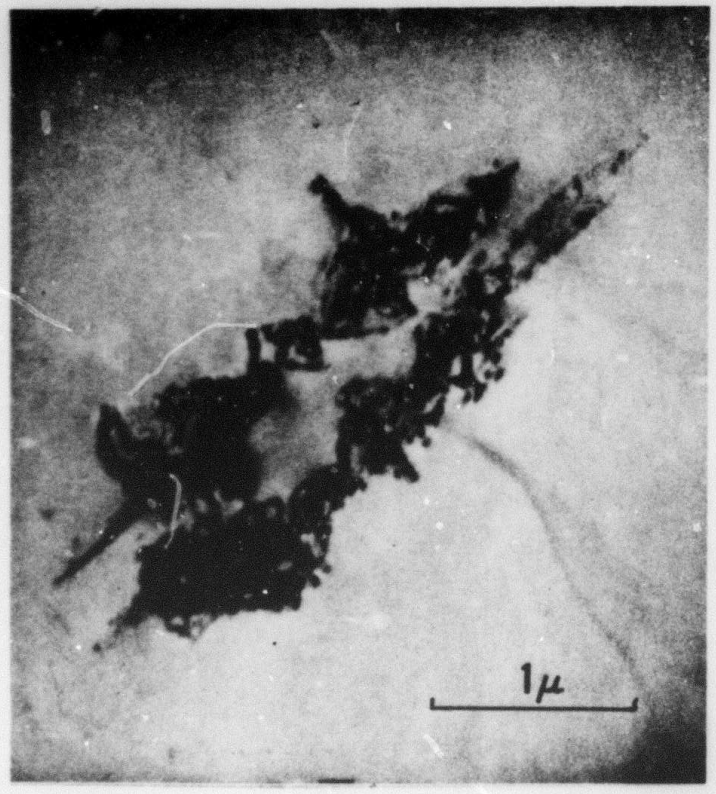
Transmission electron microscopy of bad devices after fast and slow copper polishing reveals interesting differences in the defect size. Representative examples are shown in Figs. 10 a,b. The microsplits are considerably larger in the fast polished wafer. This indicates clearly that the slow polish is much more effective in damage removal than a fast polishing action. This is also confirmed through the good agreement of Syton and copper (slow) polishing results. If both techniques have approximately the same stock removal rate of 1 mil/hour they seem to give identical results.

Fig. 8a. Examples of microsplits as seen in the TEM. Typical for fast polishing.

Fig. 8b. Examples of microsplits as seen in the TEM. Typical for slow polishing.
