DESIGN AND FATIGUE TESTING OF INTEGRAL ARMORED SERVO ACTUATOR MODIFIED TRUNNION

United Aircraft Corporation

October 1974

REPORT DOCUMENTATION PAGE		READ INSTRUCTIONS BEFORE COMPLETING FORM
1. REPORT NUMBER USAAMRDL-TR-74-80	2. GOVT ACCESSION NO.	3. RECIPIENT'S CATALOG NUMBER

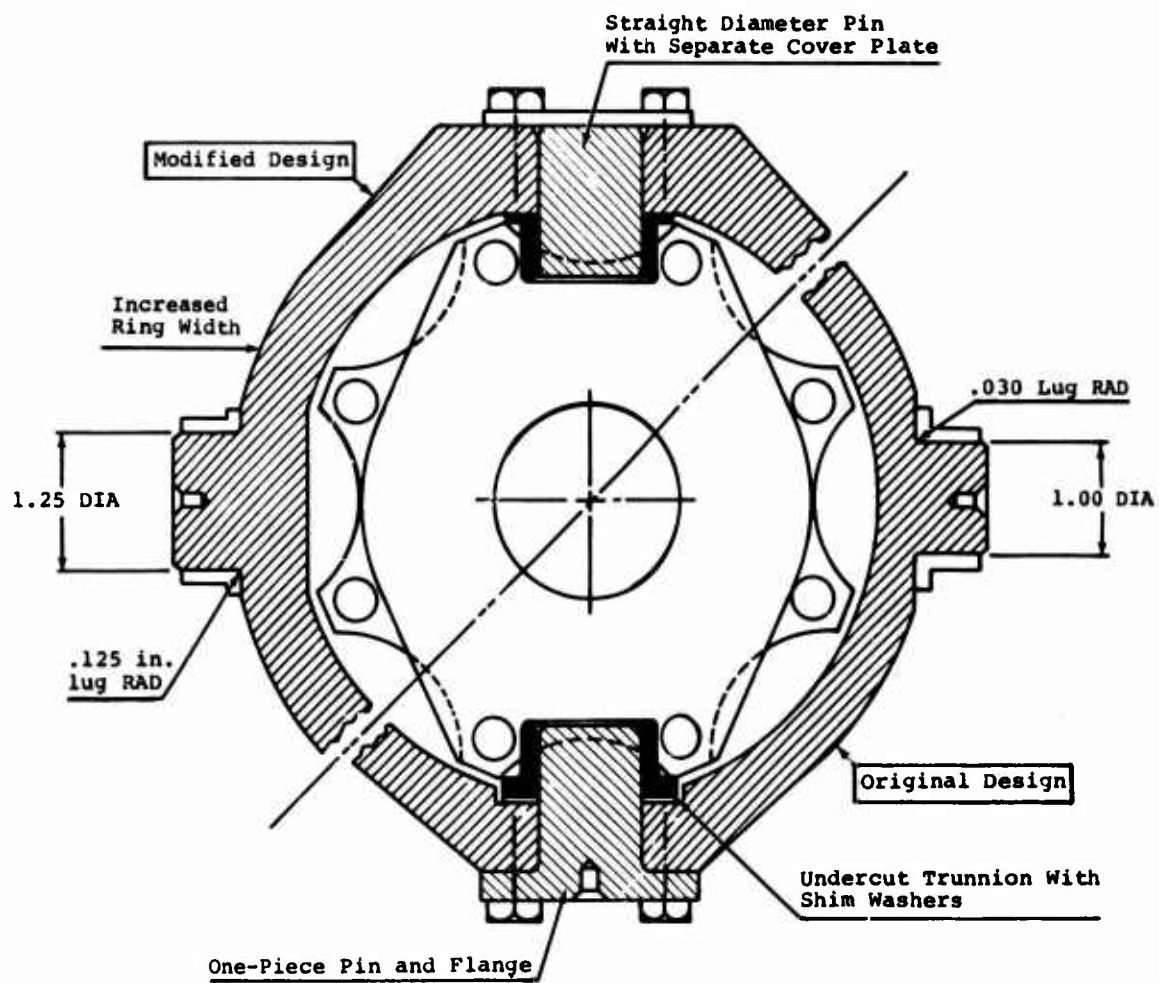
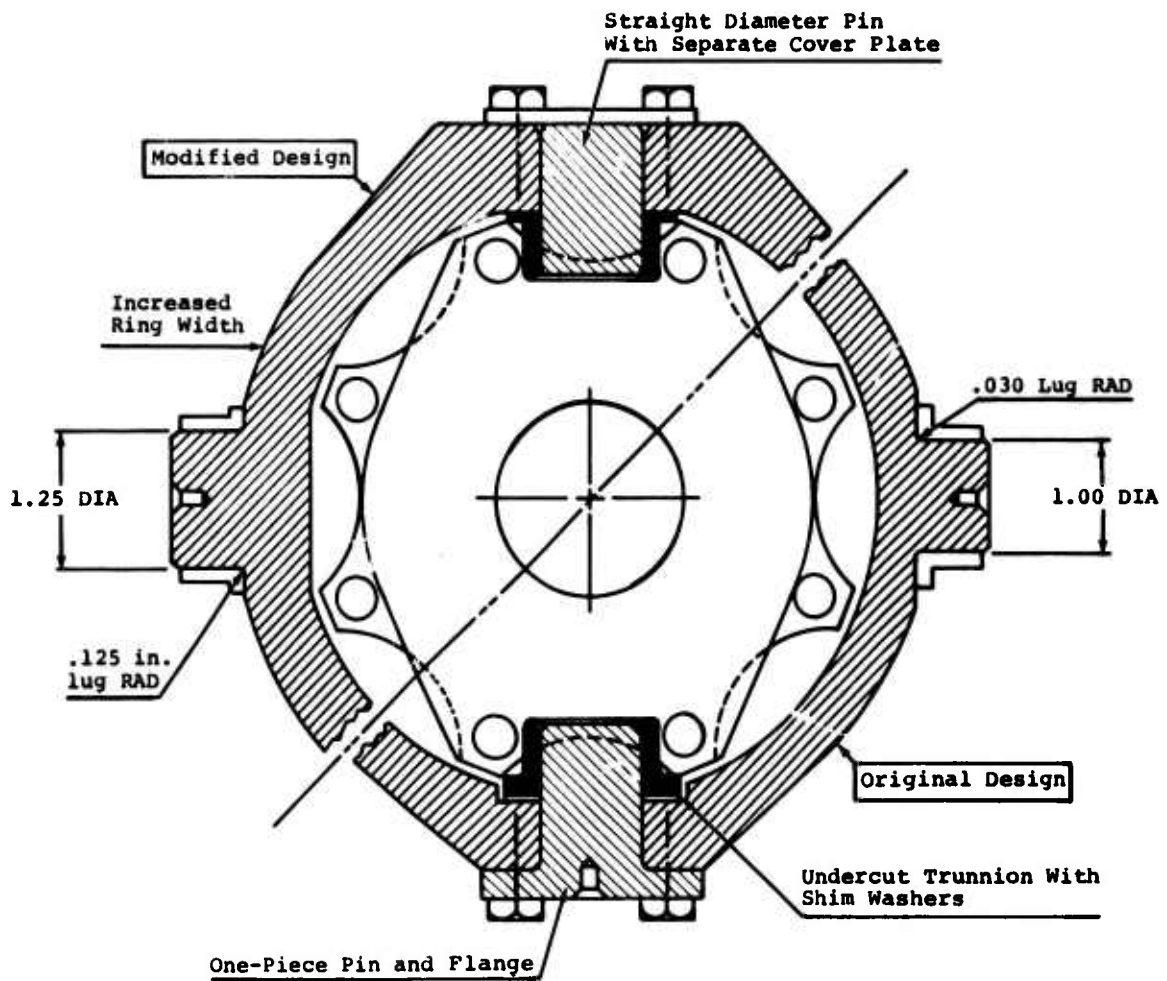
Figure 1.   DPSA Servo Trunnion - Modified Versus
Original Design.

Failures encountered in the original trunnion included frac-
tures both of the pin and of the lug. The pin design included
a relatively thin integral flange which was bolted to the
trunnion ring to maintain the pin in position. Under heavy
loading, the flange tended to prevent deflection of the pin,
thereby reacting part of the imposed bending moment. Fractures
occurred at the change of section where the flange joined the
straight section of the pin. In the modified design, the pin
was fabricated as a straight diameter with a separate cover
plate to retain the pin in place.

The fracture of the trunnion lug was at the change of section
where the lug joined the trunnion ring. Analysis of the
fracture concluded that poor machine finish and questionable
shot-peening quality in the lug/ring radius were contributing
factors. To strengthen the lug, the new trunnion employs a
larger lug diameter with a considerably more generous radius.
In addition, care was taken during fabrication to provide the
proper finish and shot-peening to the radius.

In addition to the specific changes related above, a general
attempt was made to utilize the full space envelope available
to provide stiffening of the ring structure. Also, by more
carefully contouring the I.D. of the ring to the servo
housing O.D., a closer tolerance fit was maintained, resulting
in a minimum unsupported area of the pin as it traverses

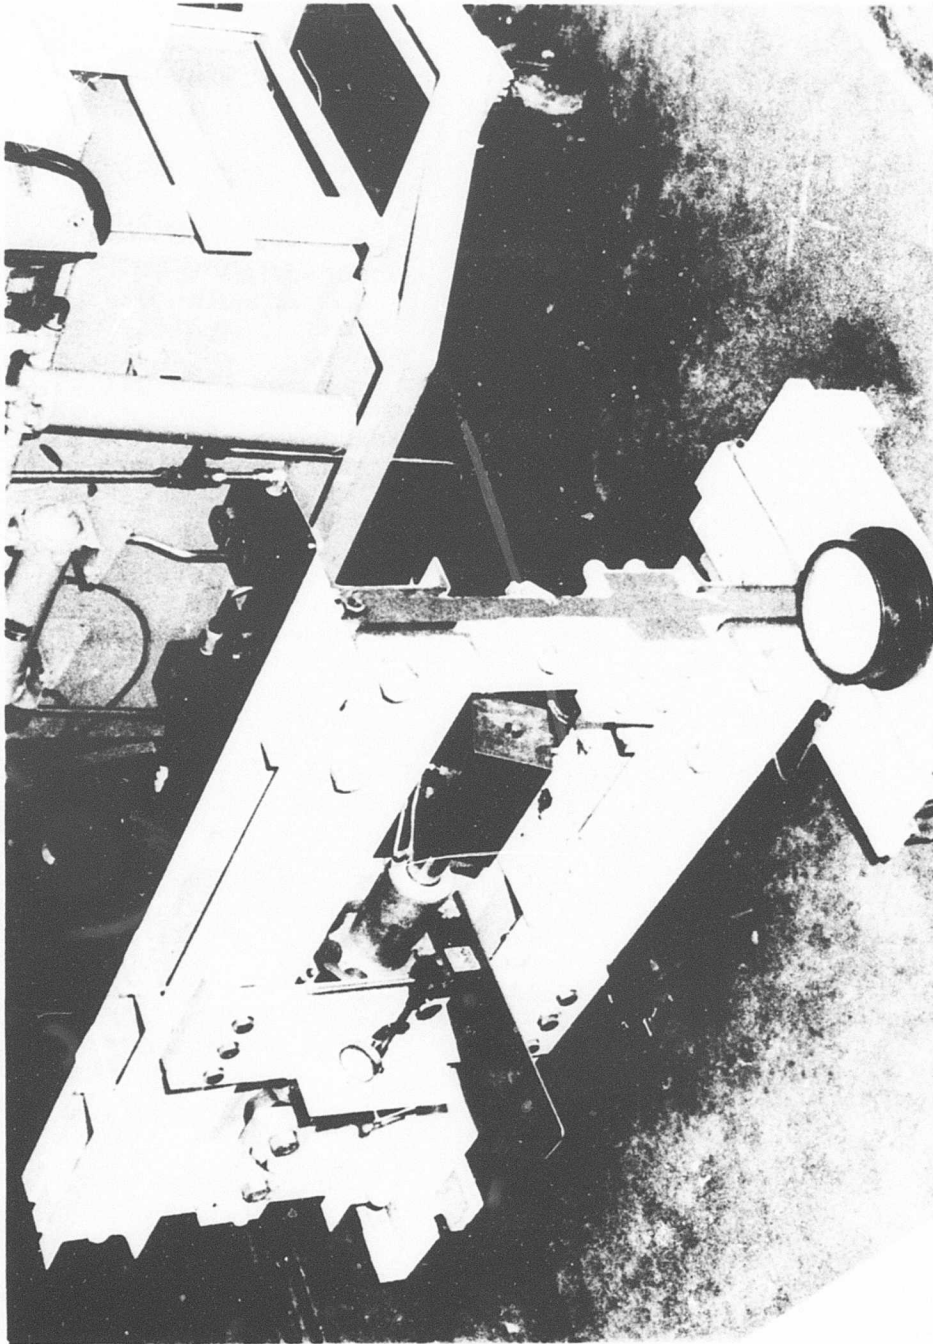
Figure 3. Modified Trunnion Deflection Test Setup.

The trunnion deflection versus load test setup is shown in Figure 3, with detailed photographs, Figure 4 and Figure 5, showing a close-up of the trunnion installation and the deflection measurement system. The trunnion spring rate was found to be 1,692,000 lb/in. in the retracting direction and 1,450,000 lb/in. in the extending direction. A complete listing of trunnion deflection versus load is contained in Table I, and a plot is given in Figure 6.

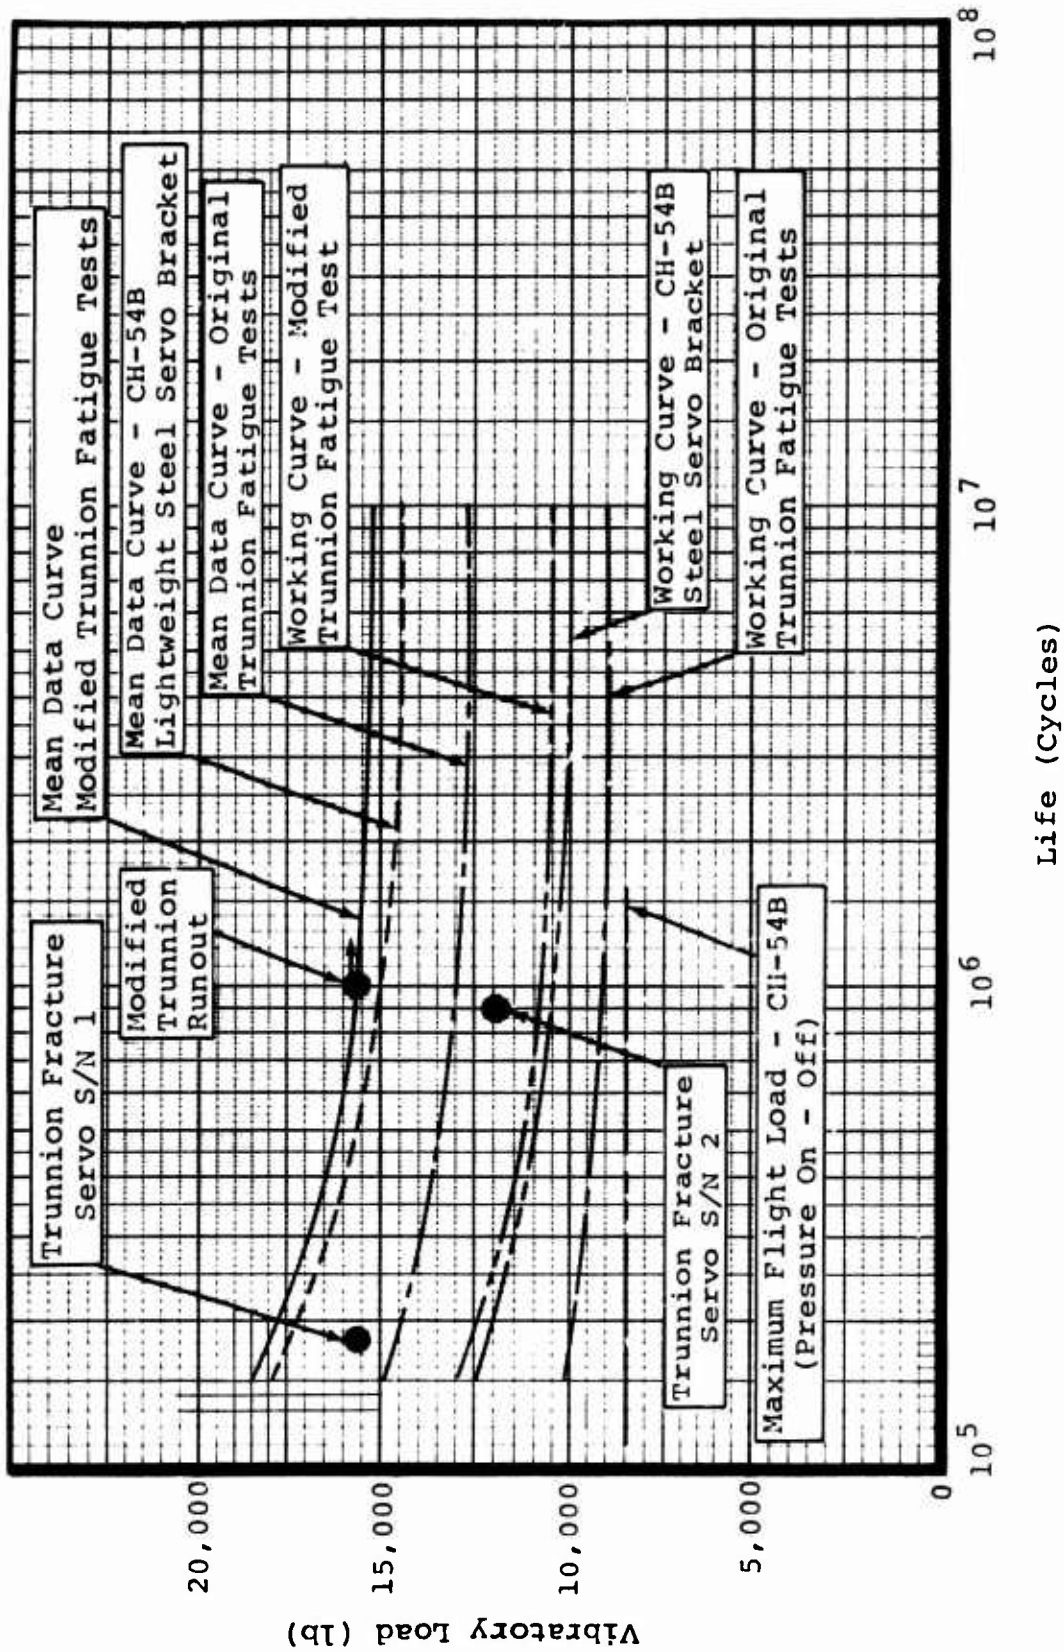
Figure 10. Modified Trunnion Mean and Working S/N Curves.

The S/N curves for the modified armored servo trunnion, original trunnion, and CH-54B production mounting assembly are shown in Figure 10. The fatigue strength of the modified trunnion exceeded that of the production mounting assembly based on a single test data point.

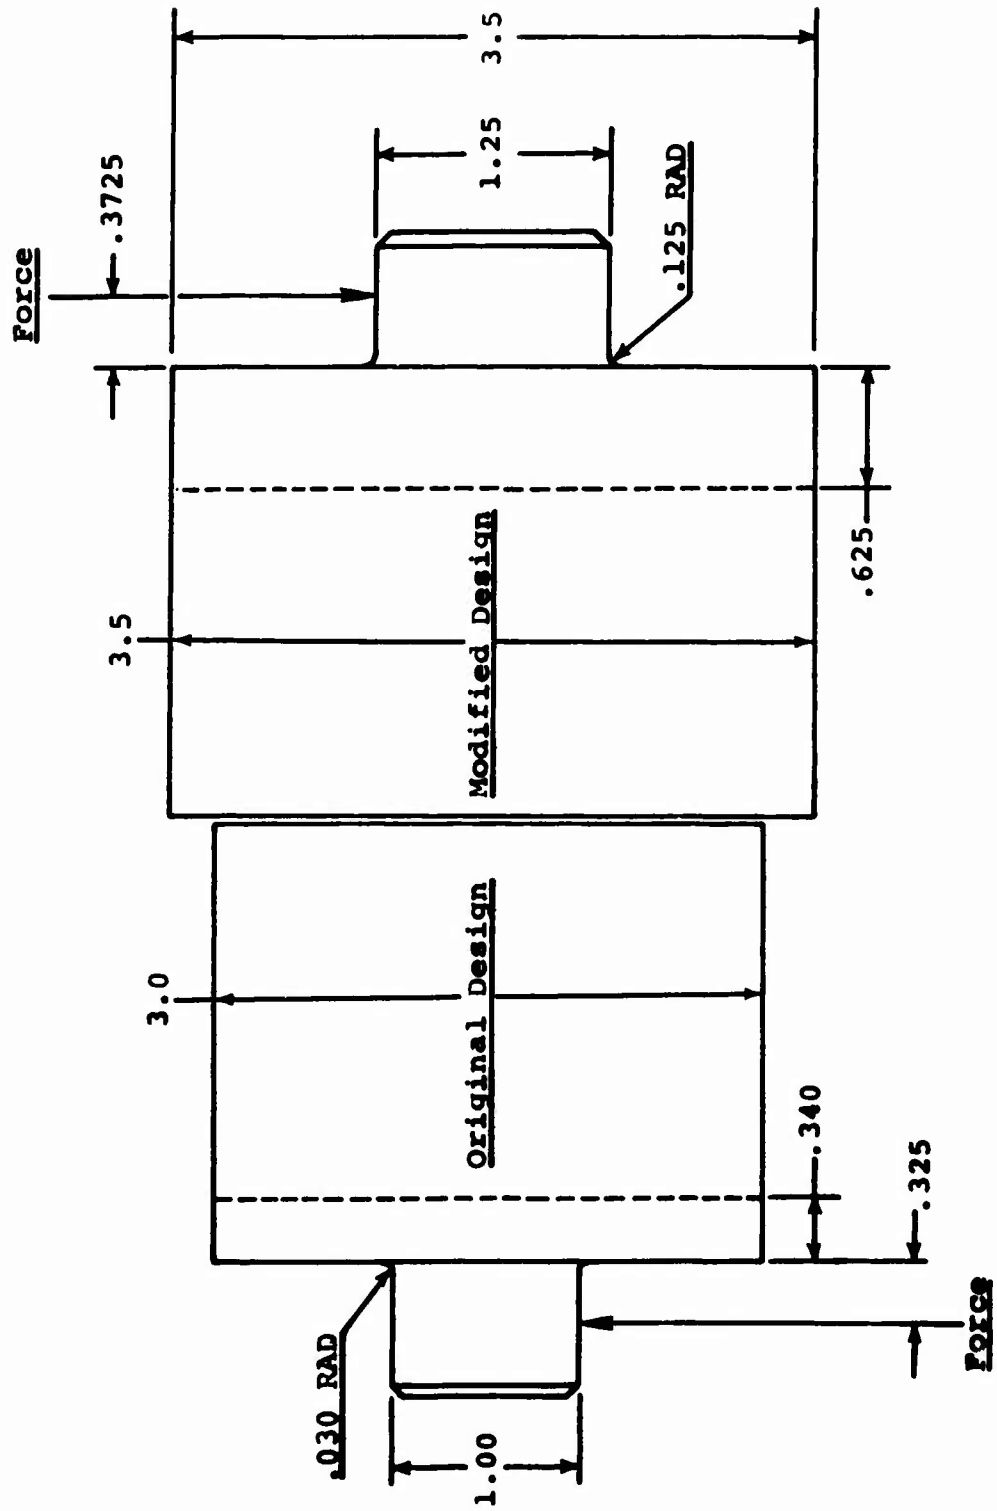
Figure 11. Lug Design Geometry - Original Versus Modified.

Fatigue testing of the trunnion reported under Contract
DAAJ02-72-C-0071 showed that the critical portion of the
structure was the support lug. (See Figure 11.) The structural
strength of the lug was shown to be lower than that of the
equivalent CH-54B production part. The critical load of the
spectrum is imposed by the "OFF-ON-OFF" cycles of the 3000 -
psi hydraulic system.

The analysis indicated that the increases in lug diameter
and reduction of stress concentrations should result in the
structure meeting an infinite life criterion.

Parameter	Original Trunnion	Modified Trunnion
Fillet radius, r'	$.030$ in.	$.125$ in.
Diameter of lug, d	$.9995$ in.	1.24975 in.
Approximate diameter of base, D	2.0 in.	1.85 in.
r/d	$.030015$	$.10002$
D/d	2.001	1.4803
K_t	2.56	1.67

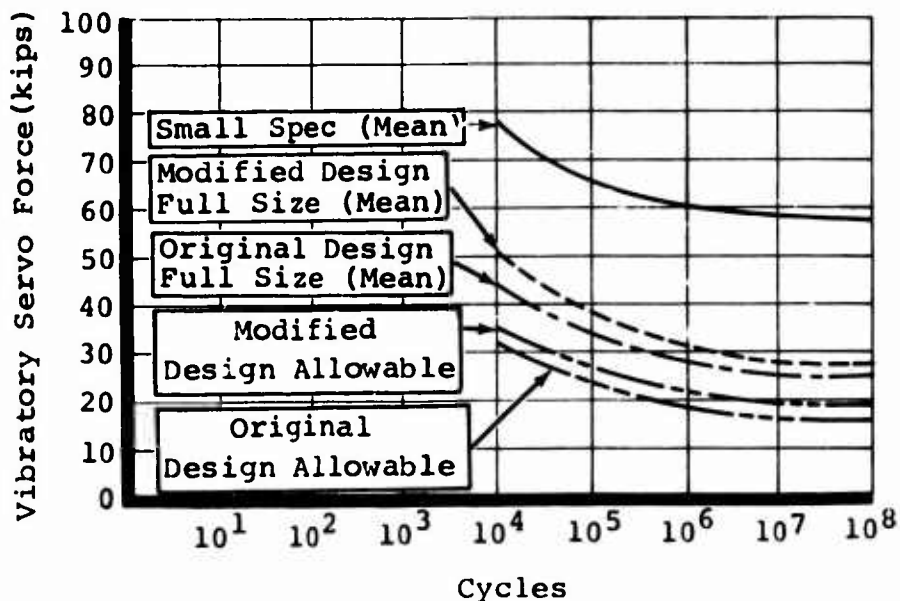
Figure 12. Theoretical Vibratory Stress Versus Life, Integrally Armored Servo Trunnion.

Figure 12 was obtained from figures (3.2.01 and 3.1.02) of SER 50586[1] using the calculations shown in Table IV and Table V. The lower four curves of Figure 12 were plotted in Figure 13 with the ordinate changed from stress to the corresponding vibratory force in the servo. Values of the curve points are given in Table VI. In addition, the two test points for the old design were plotted in Figure 13. In Figure 14, the curves from Figure 13 have been adjusted by the ratio necessary to cause the mean curve of the old design to pass through the test points. Values of curve points are given in Table VII.

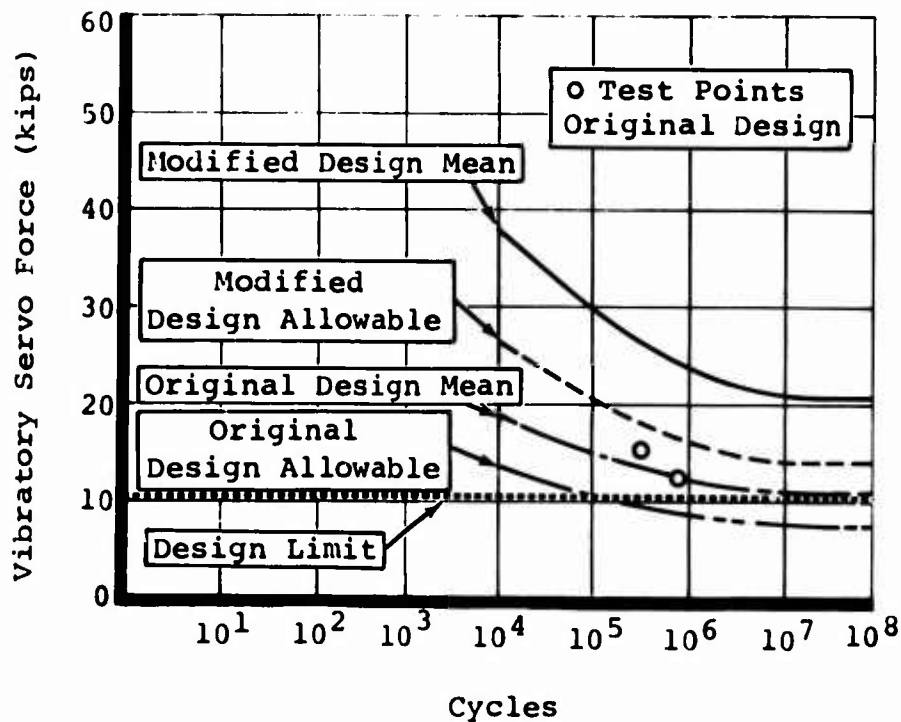
Figure 14.   Vibratory Load Versus Life, Integrally Armored Servo Trunnion Corrected for Empirical Data.

The design limit vibratory load is also plotted on Figure 14. It can be seen from Figure 14 that the original design would have a finite life under limit load, whereas the modified design is unlimited.
