AFRPL-TR-75-62

STORABILITY INVESTIGATIONS OF WATER LONG-TERM STORAGE EVALUATION SECOND ANNUAL REPORT

AEROJET LIQUID ROCKET COMPANY

DECEMBER 1975

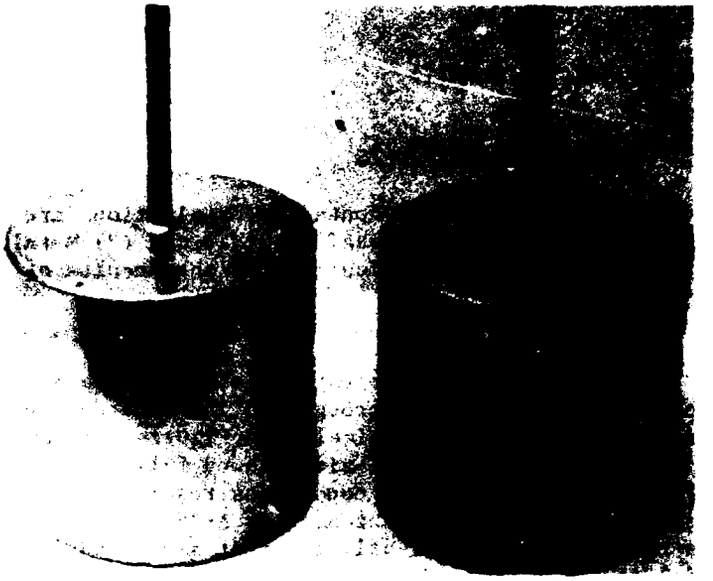
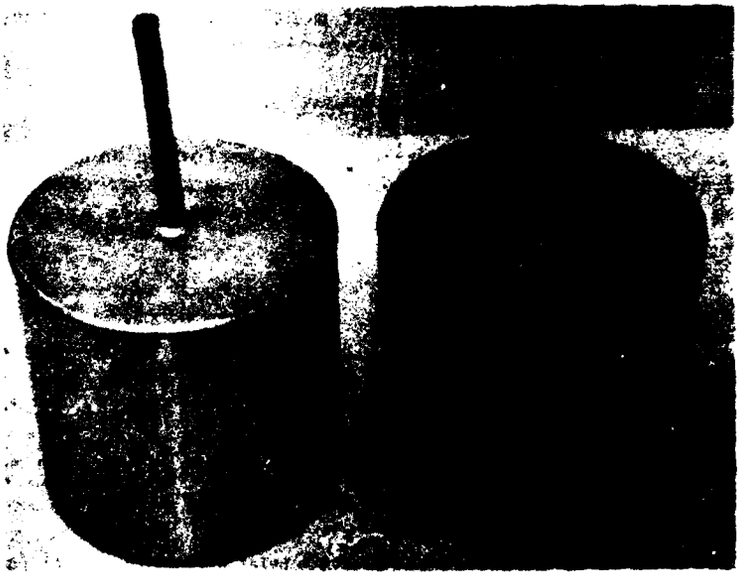
Figure 1. 304 Stainless Steel Containers, Magnification 1/3X

No discrepancies were found in the 304 stainless steel containers. One of the containers, No. 2, had a darker appearance than the remaining containers. This condition is attributable to inadequate hydrogen gas coverage in the tank during annealing after welding. The weld contaminants reported in the examination of the six and twelve month exposure tanks were not found in this examination.

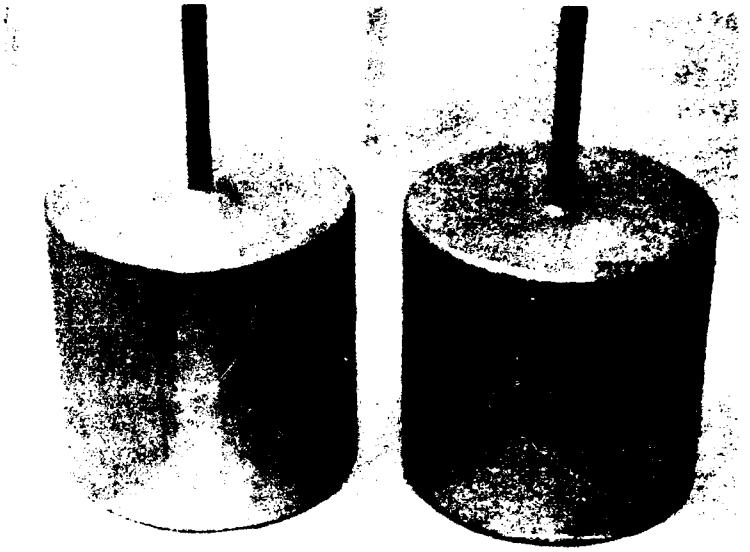
The external appearance of the containers is documented photographically in Figures 1 through 5. The internal appearance of the containers is documented photographically in Figures 6 through 15. Examination of these surfaces without visual aids showed full penetration for the full length of all weldments. Other conditions resulting from fabrication and cleaning procedures were: (1) etching of A-286 containers during pickling; (2) isolated dark areas, a tightly adherent smut, and isolated shiny deposits of material in one of the 17-4PH stainless steel containers; (3) a tightly adherent smut in the Inconel 718 containers; and (4) isolated areas of residual titanium oxide, localized circular areas of attack, and a general mottled appearance including fingerprint contamination in the 6Al-4V titanium containers.

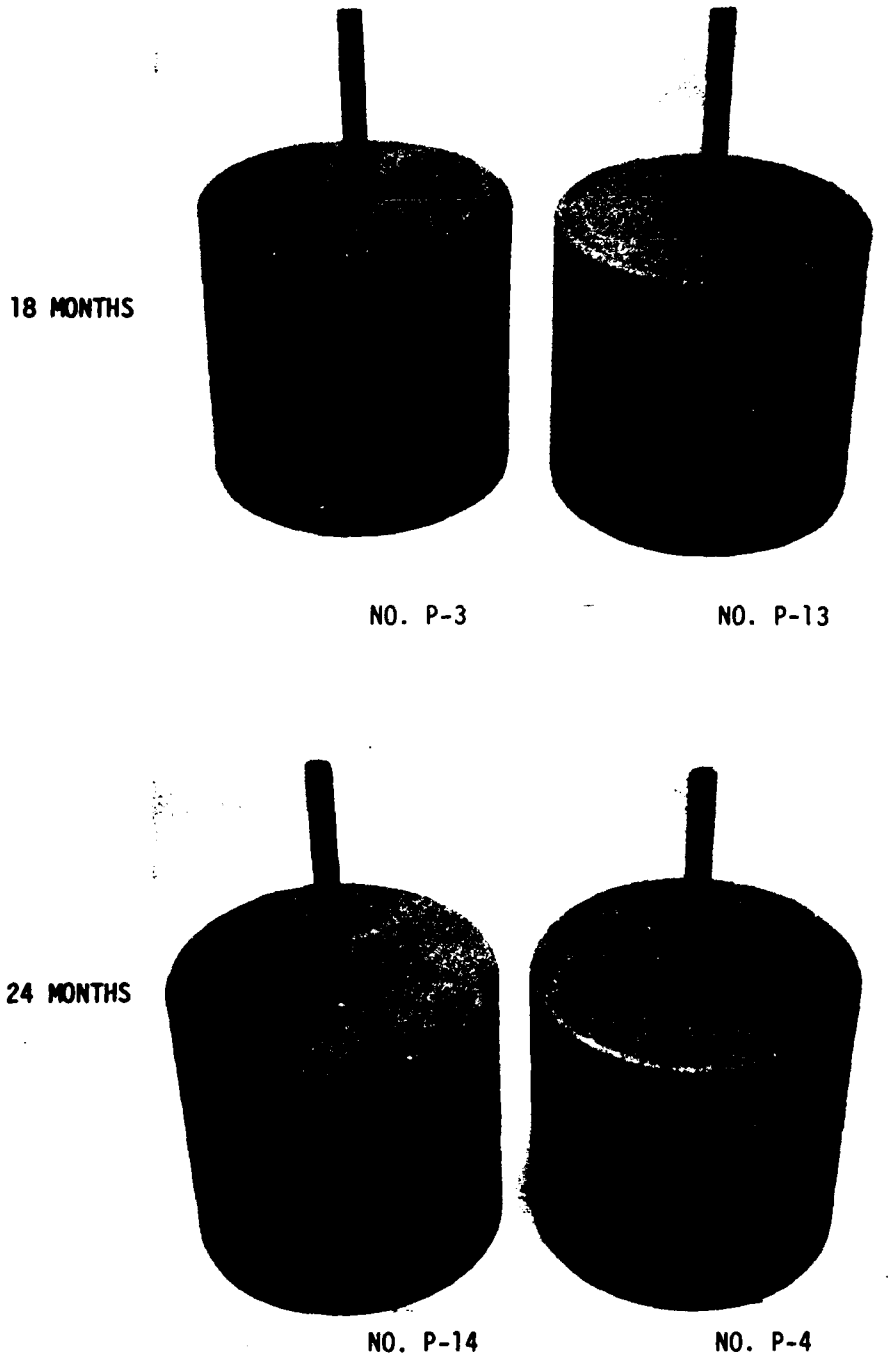
Figure 3. 17-4PH H-1025 Stainless Steel Containers, Magnification 1/3X

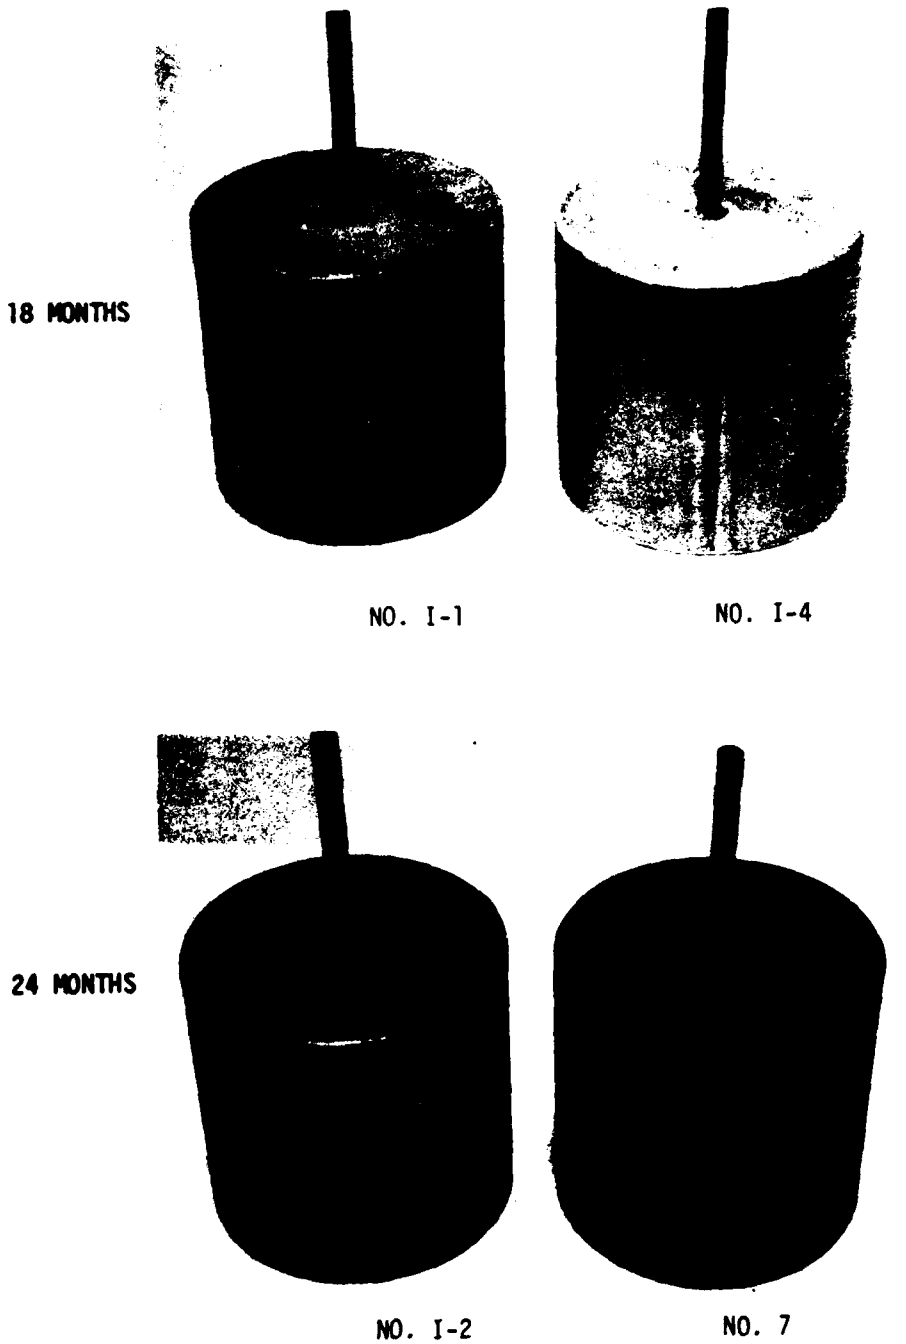
Figure 4. Inconel 718 Containers, Magnification 1/3X

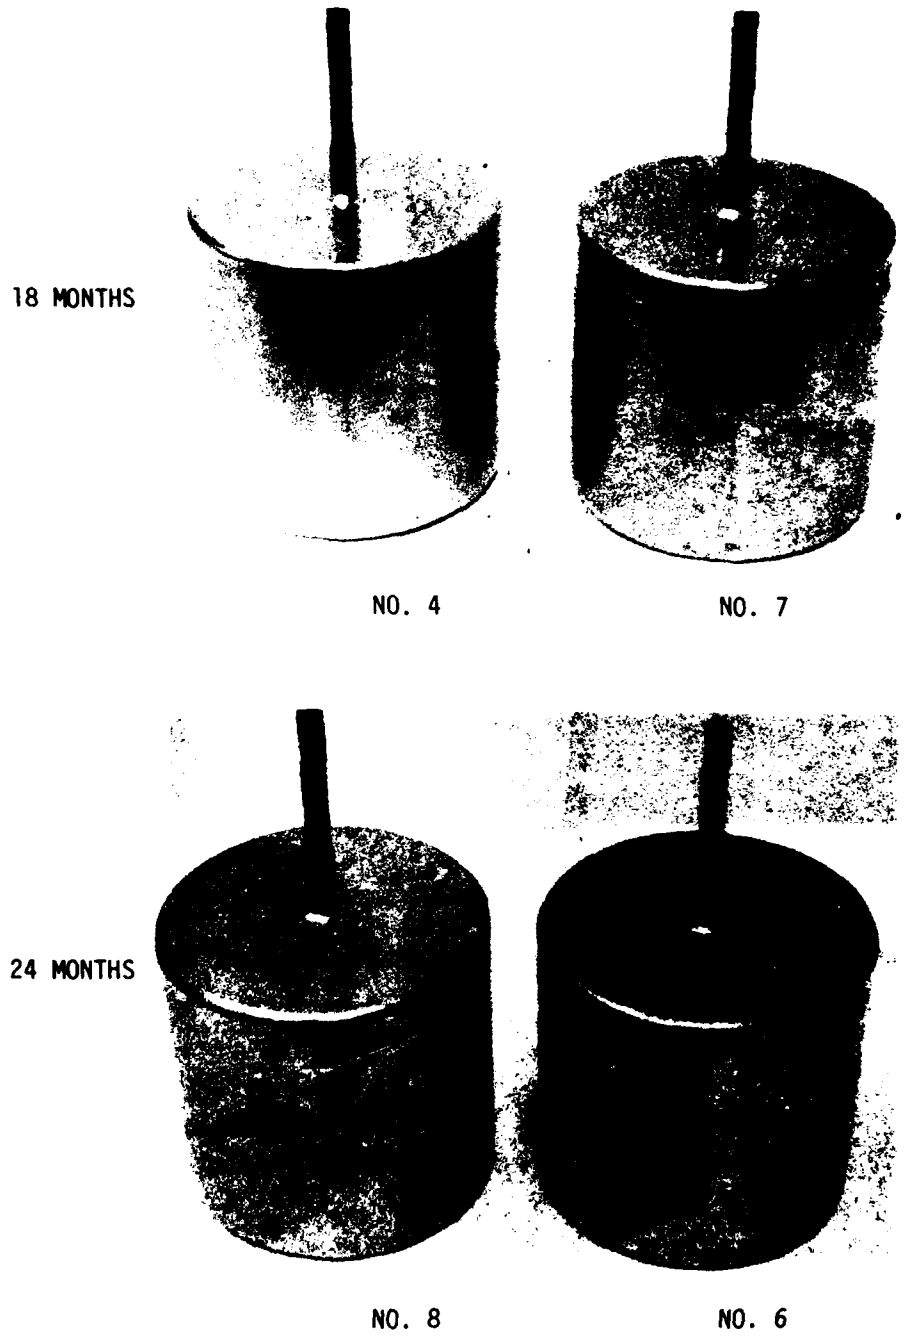
Figure 5. 6Al-4V Titanium Containers, Magnification 1/3X

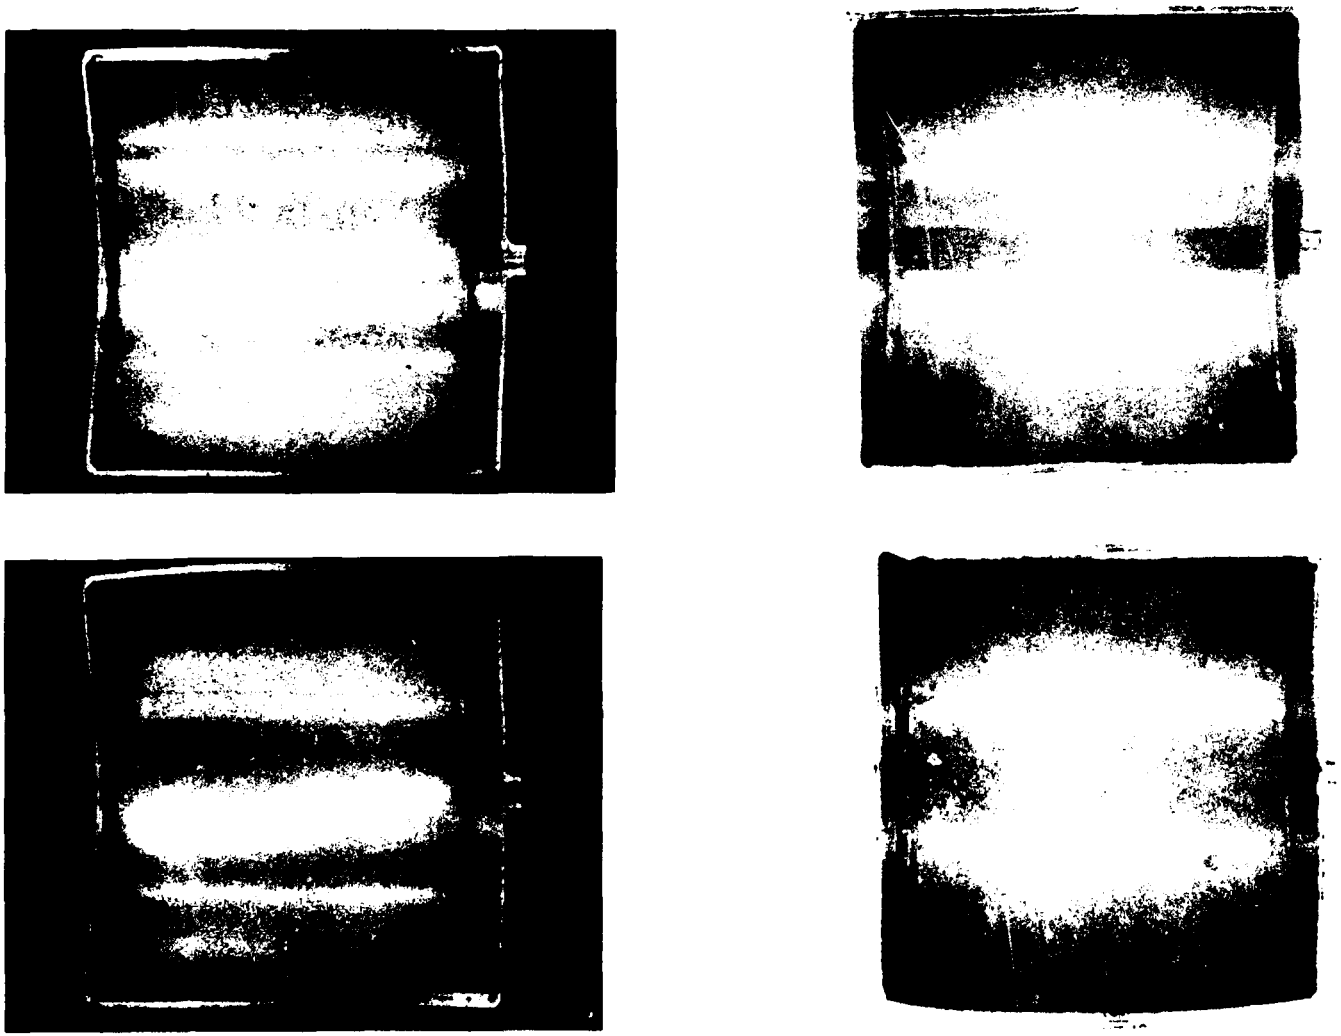
Figure 6. Interior of 304 Stainless Steel Containers after Exposure in Oxygen Free Water, Magnification 3/5X

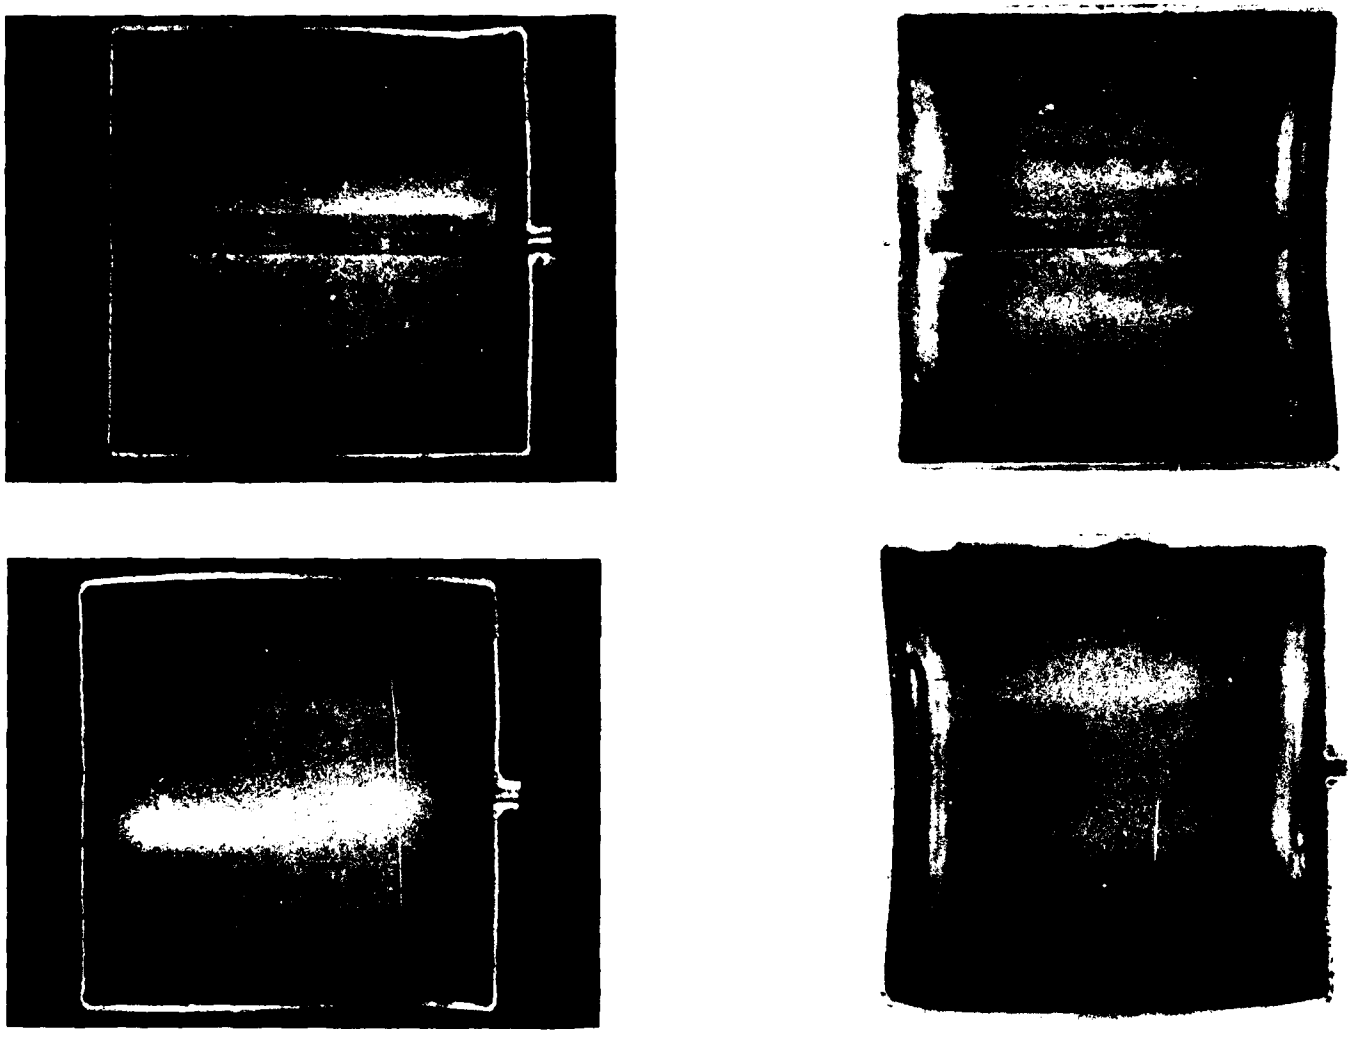
NO. 1 18 MONTHS NO. 7 24 MONTHS

Figure 7. Interior of 304 Stainless Steel Containers after Exposure in Oxygen Saturated Water, Magnification 3/5X

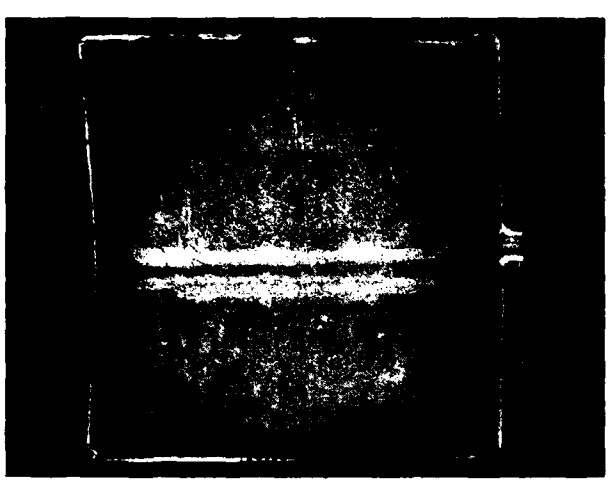
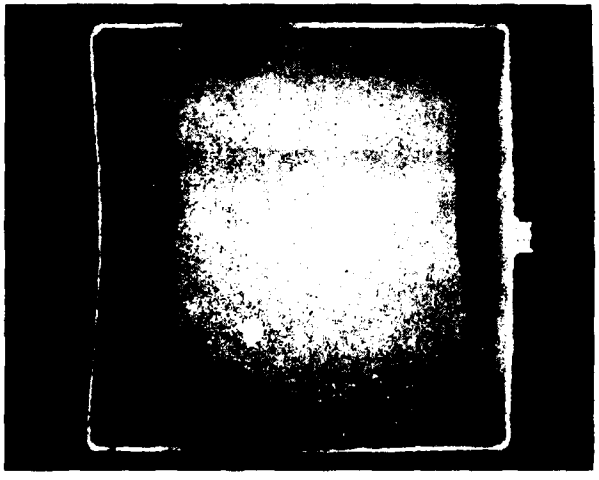
Figure 8. Interior of A-286 Containers after Exposure in Oxygen Free Water, Magnification 3/5X

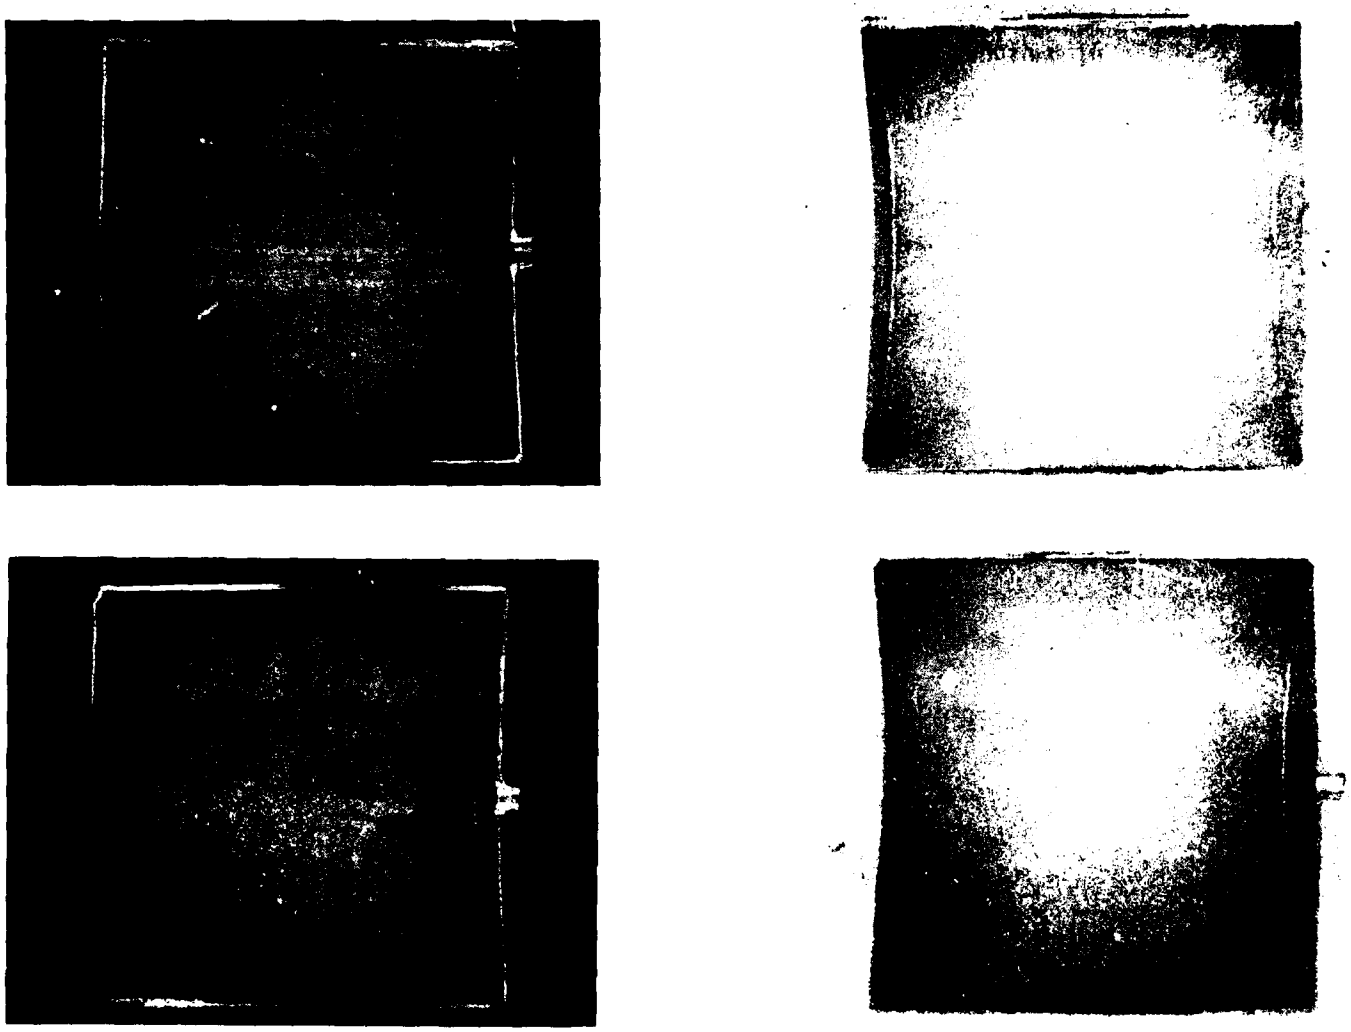
NO. A-2 18 MONTHS NO. 4 24 MONTHS

Figure 9. Interior of A-286 Containers after Exposure in Oxygen Saturated Water, Magnification 3/5X

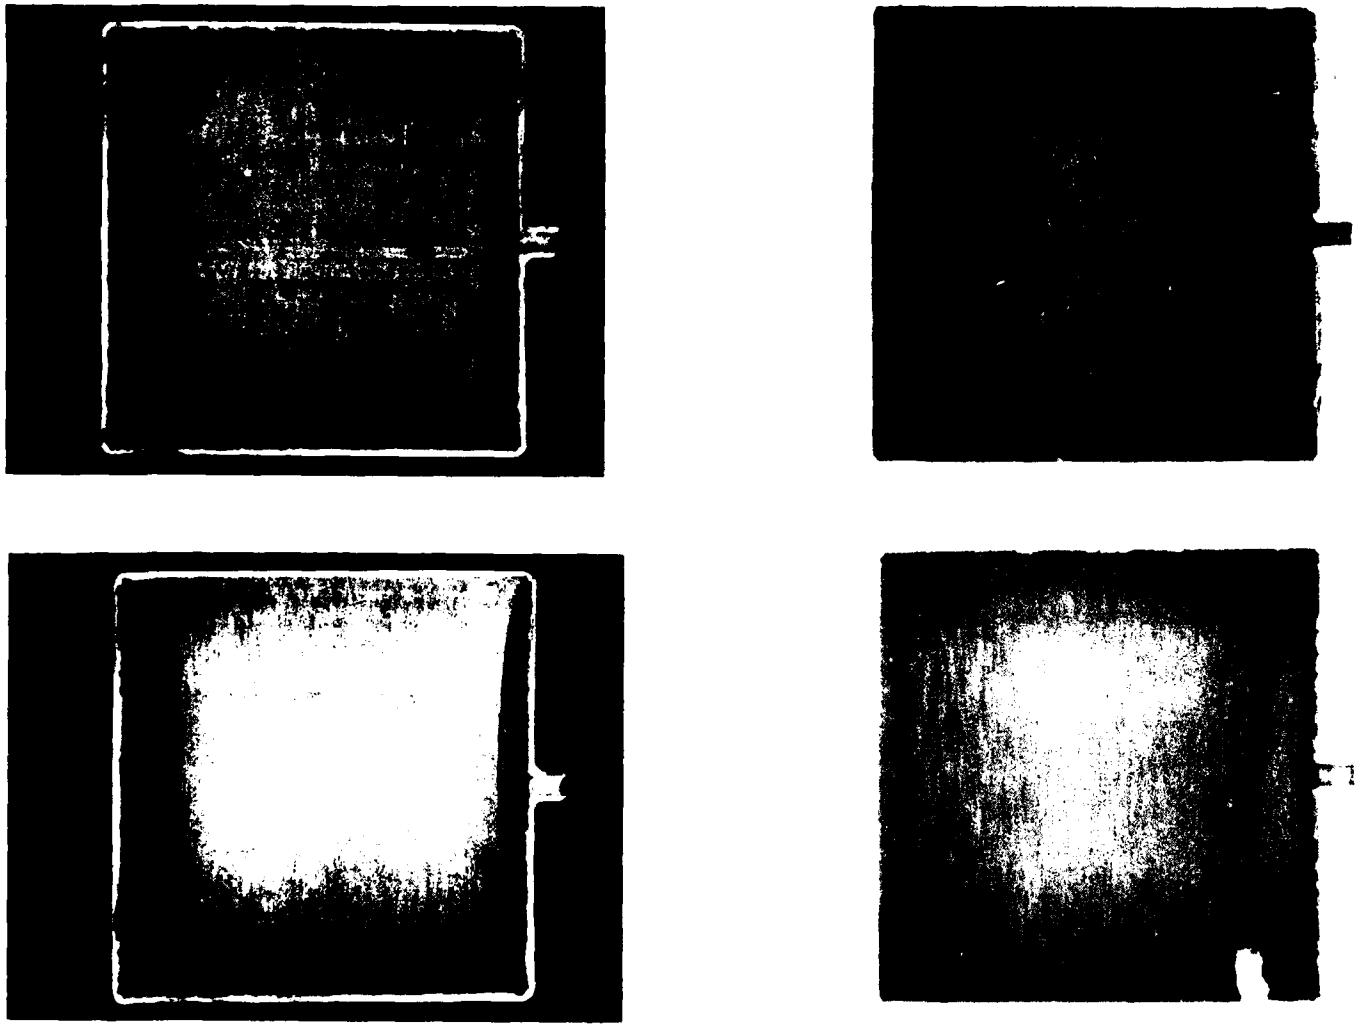
Figure 12. Interior of Inconel 718 Containers after Exposure in Oxygen Free Water, Magnification 3/5X

As with the six and twelve month storage containers, examination of the interior surfaces at moderate magnification revealed a dark, porous area at the edge of all closure weldments. It could not be definitely established whether the condition is selective attack during pickling, alone, or in combination with entrapment of oxides due to inadequate back-up gas coverage during welding. The condition is not attributable to water storage. Three of the four tanks contained weld cracks. Representative photomacrographs and photomicrographs are shown in Figures 21 through 23. The network devolute pattern of the crack illustrated in Figure 21 is either shrink porosity or areas where entrapped oxides from welding were removed by pickling. Metallographic examination of the weld crack shown in Figure 23 indicated that the defect was not a crack but a discontinuity formed by the removal of entrapped oxides by pickling. Porosity similar to that shown in Figure 21 was also found.

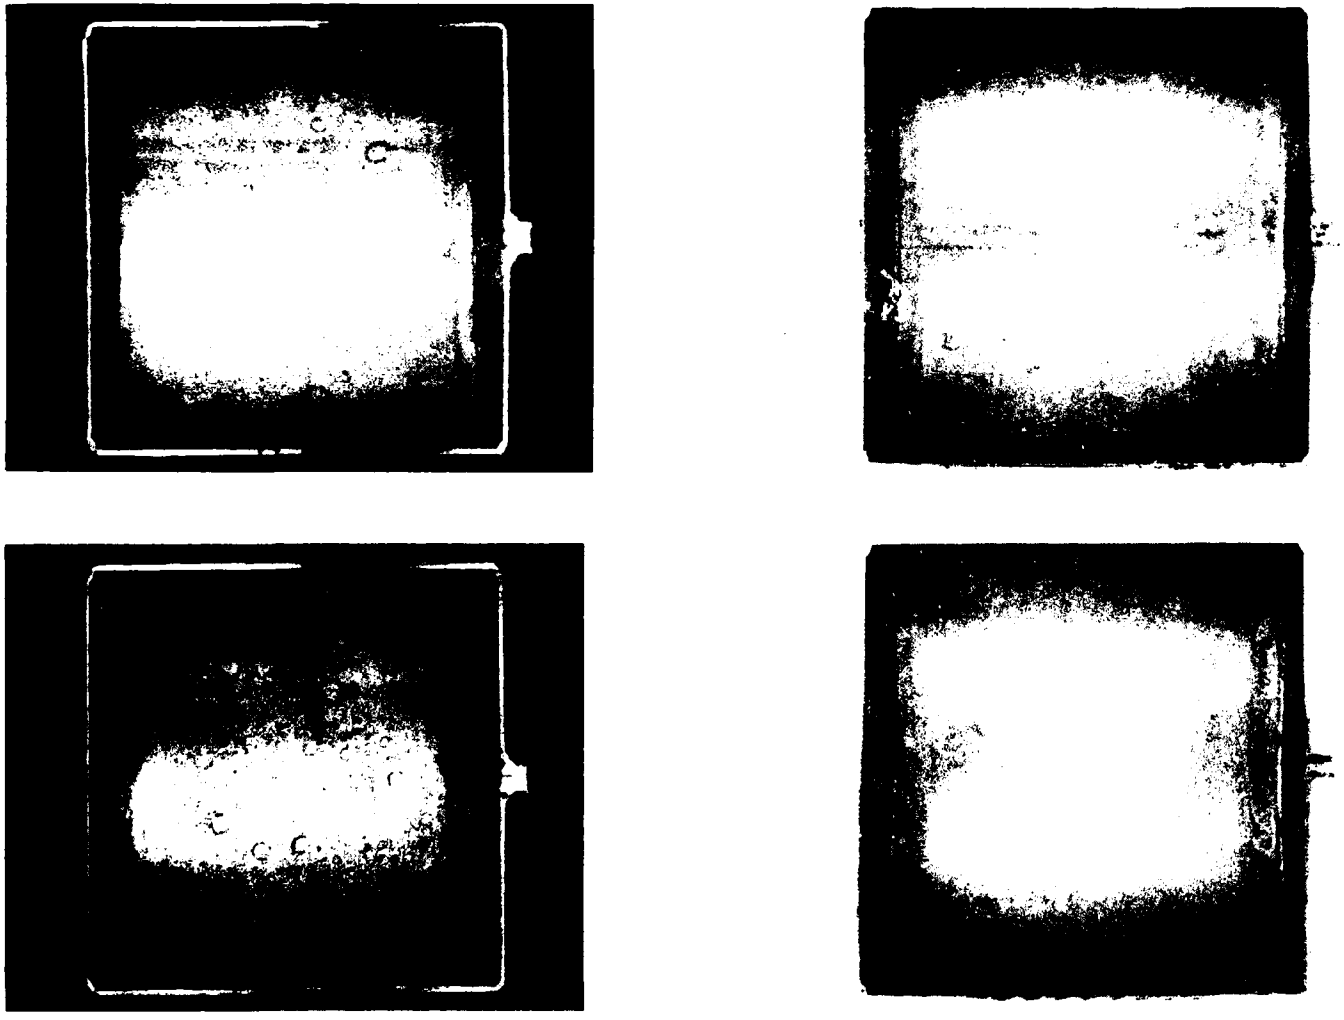
Figure 14. Interior of 6Al-4V Titanium Alloy Containers after Exposure to Oxygen Free Water, Magnification 3/5X

All containers exhibited small isolated areas of titanium oxide from the heat treatment (aging) that were not removed during pickling. Examination of mottled areas at small magnifications revealed that these areas are primarily stain. Portions of these stained surfaces contained crater-like areas outlined by knifelike corrosion. Metallographic examination of sections taken through these areas revealed no detectable depth to the corrosion effects associated with the stained areas. Areas where stains appeared in the form of fingerprints, Figure 24, were given closer scrutiny to detect possible hot-salt stress corrosion effects, since the containers were aged in the contaminated condition. No defects attributable to water storage were found.

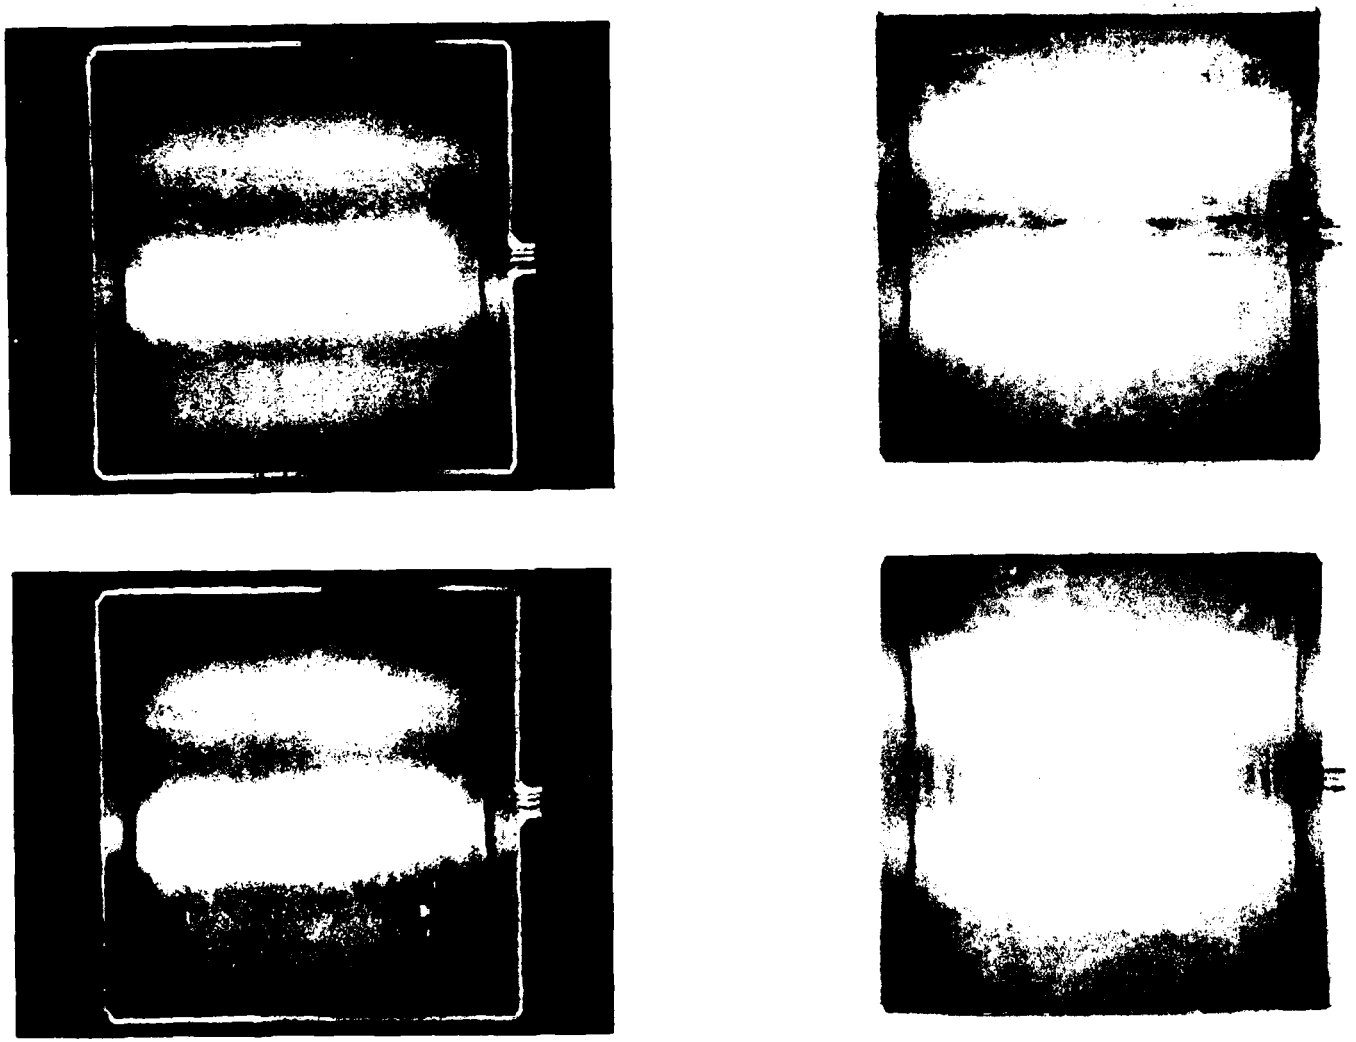
Figure 15. Interior of 6Al-4V Titanium Alloy Containers after Exposure in Oxygen Saturated Water, Magnification 3/5X

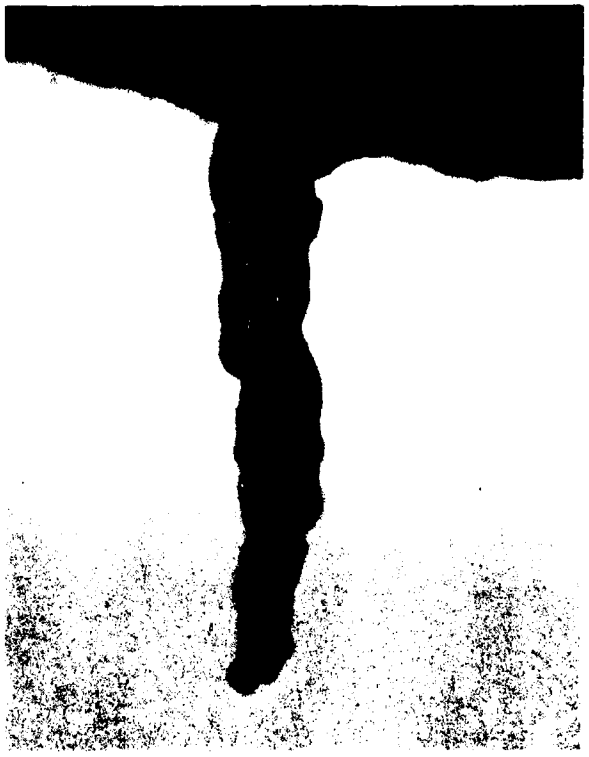
Figure 19. Weld Crack in 17-4PH Stainless Steel No. P-4 Container

The presence of contaminants in the titanium alloy containers prior to heat treatment and the weld cracks found in the A-286, Inconel 718, and 17-4PH stainless steel containers are attributable to inadequate process control on the part of the container supplier. In spite of the presence of the contaminants, the water quality was not significantly impaired.

c. Dye penetrant inspect welds then trim tubes to required length. No cracks allowed.

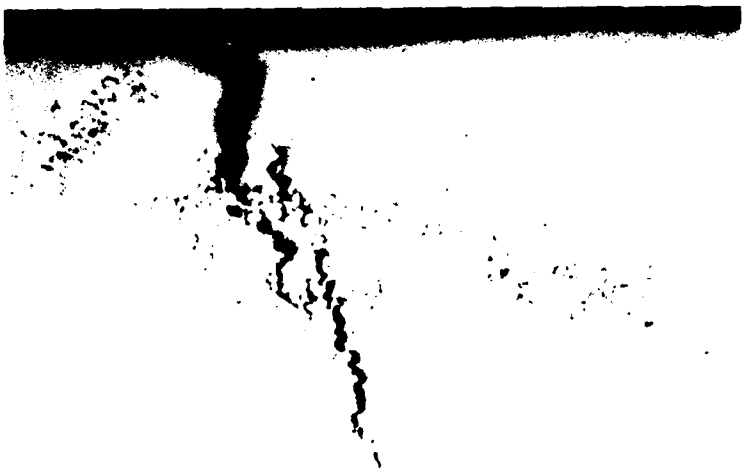
Figure 21. Weld Crack in Inconel 718 No. I-4 Container
