AD-A051 650 CHRYSLER CORP CENTER LINE MI WARREN DEFENSE DIV F/G 17/5
CONTRACTOR PROTOTYPE QUALIFICATION TEST (PQT-C) M60A1(PI) TANK --ETC(U)
DEC 77 R PAVER DAAK30-76-C-0005

(9) Final Report,
For
(6) Contractor Prototype
Qualification Test (PQT-C)
M60A1(PI) Tank Thermal Sight (TTS)
AN/VSG-2 .

Prepared For
Army Materiel Readiness Command
Project Manager - M60 Tank Development
By
Warren Defense Division
Chrysler Corporation

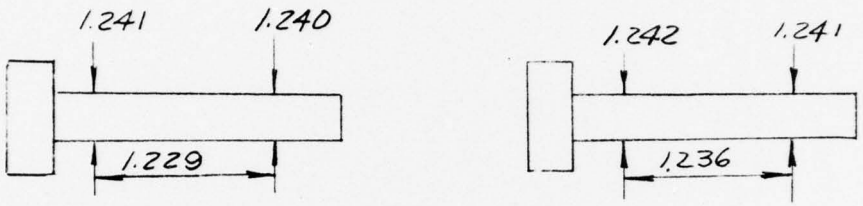
During preparation of three TTS tanks for the Ft. Knox PQT-C tests, three modified shock assembly mounting pins were installed in the upper bearing, attaching the shock to the hull mount on right side of tank. The threaded pins were torqued to 175 ft-lbs. After completion of 1500 endurance miles during PQT-C tests, torque on the bolts varied from 75 to 150 ft-lbs. Each pin was easily removed compared to the standard pins, with no physical damage evident, except some rust. Very little wear was noticeable. No problems were encountered during reinstallation of the pins, which were torqued to 175 ft-lbs. The upper shock pins from PQ-2 tank measured as follows:

The modified pins remained in the TTS tanks at Ft. Knox for evaluation during additional field tests.
