FINAL REPORT

DEVELOPMENT OF BASIC PROCESSING TECHNOLOGY

BEARING QUALITY SILICON NITRIDE BALLS

DECEMBER 1977

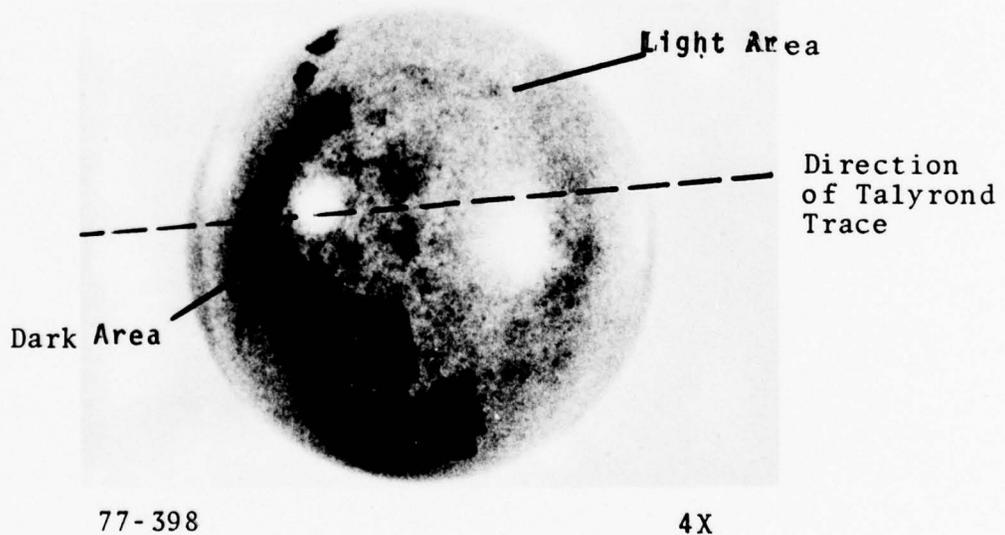
The GTE Sylvania rough spheres were produced by cold isostatic pressing followed by sintering. The geometric quality of these rough spheres was also very good. A large proportion of these balls had a mottled appearance consisting of light and dark grey areas (Figure 2). During the course of finishing it was found that the light area machined significantly faster than the dark area preventing the balls from rounding to <0.62 μm. Talyrond trace on a lapped ball (Figure 3) shows the surface unevenness.

Figure 2.   Macrophotograph Showing Light and Dark Grey Areas
            on a Mottled GTE Sylvania Cold Pressed and Sintered
            Silicon Nitride Ball Which Has Poor Fatigue and
            Wear Life.

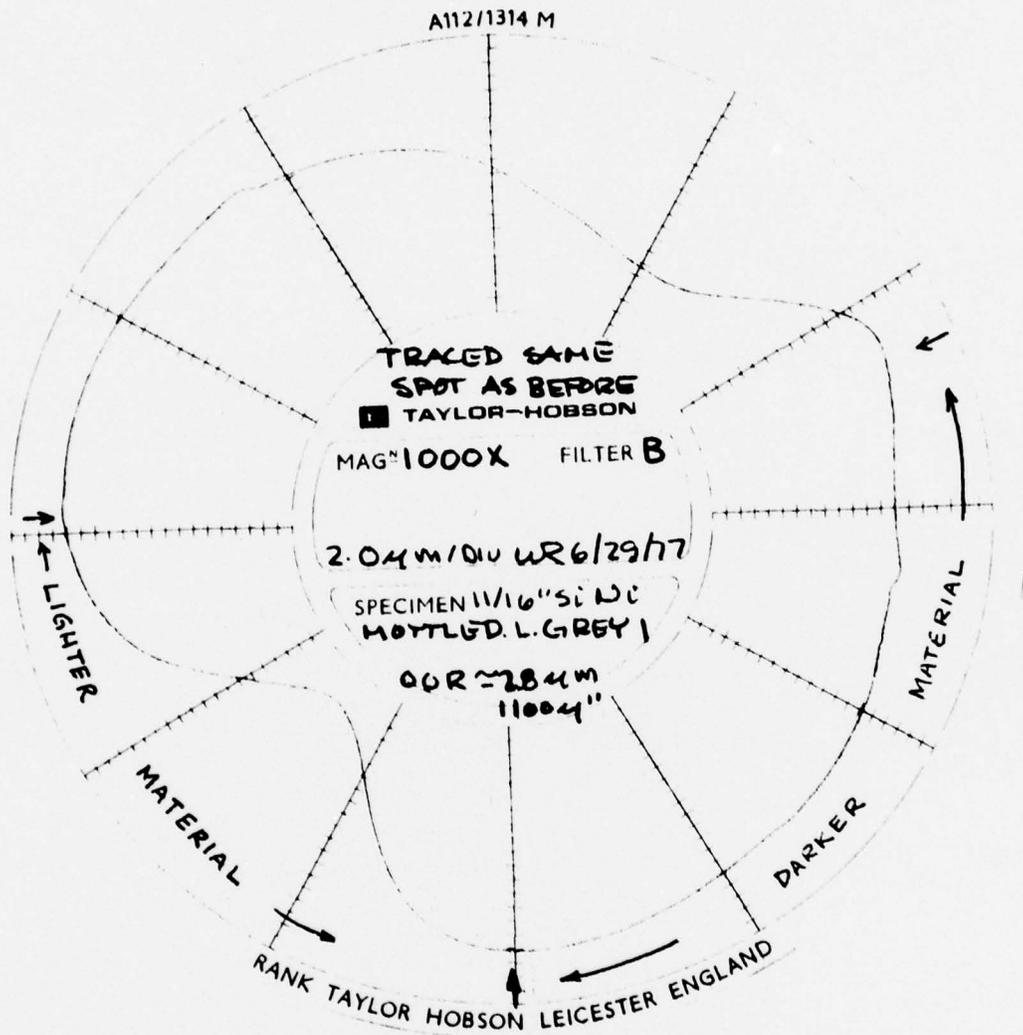
Figure 3.   Talyrond Trace on the Mottled GTE Sylvania Ball
            in Figure 2

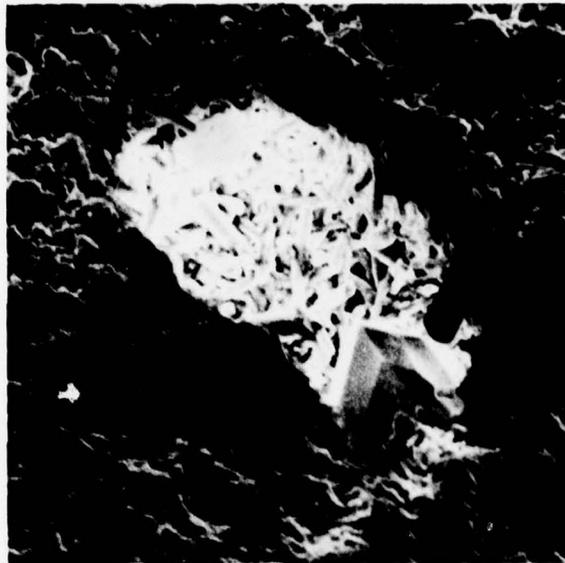
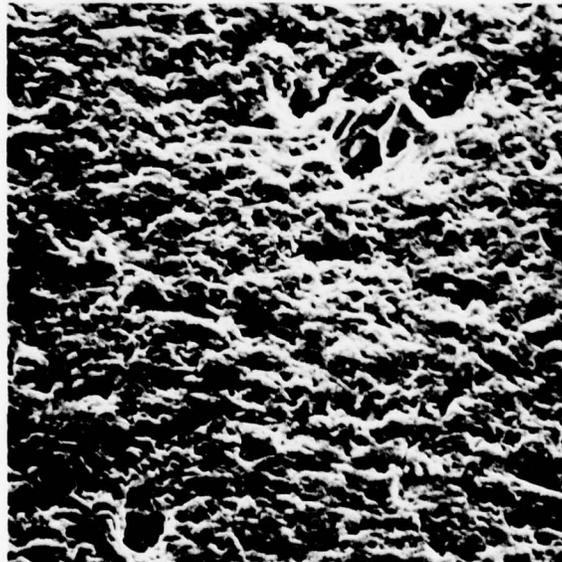
Figure 4.   Scanning Electron Micrographs Showing Difference in the Degree of Sintering Between Light and Dark Regions on a GTE Sylvania Ball Surface.

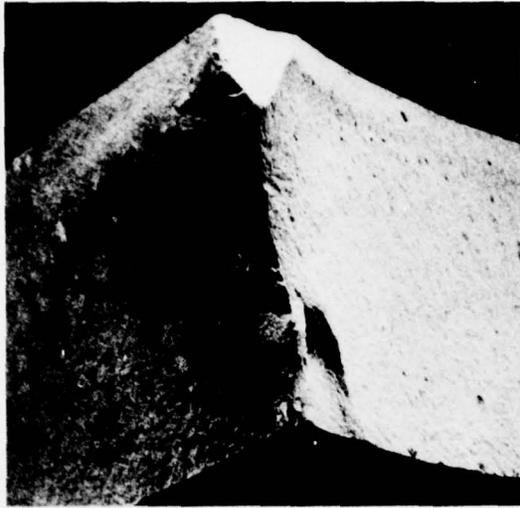
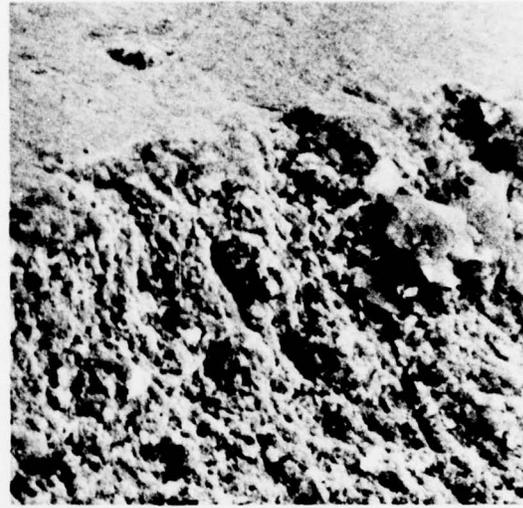
Fractographs made with a SEM are shown in Figures
10-12. Porosity is clearly responsible for fracture initia-
tion in the GTE Sylvania sample. A high magnification view
of the pore surface does not reveal unsintered silicon
nitride grains, probably since they may have been dislodged
in the fracture process. In the Ceradyne material a cluster
of second phase particles (free Si) was responsible for
fracture initiation. A high magnification view of the frac-
ture surface shows presence of a large volume fraction
of the second phase particles. Fracture initiation in
the Norton material appears to have occurred at surface
scratches. The degree of material cleanliness and absence
of porosity explain the high strength value obtained for
the Norton's NORALIDE NC132 grade silicon nitride.

Figure 10.   Fractograph of a Fractured GTE Sylvania Disc
              (0.43 GPa) Showing Fracture Initiation at a
              Pore.   Second Phase Inclusions (A) are visible
              at the Higher Magnification

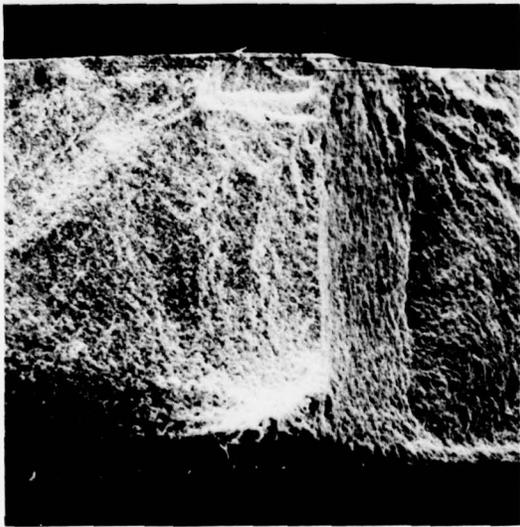
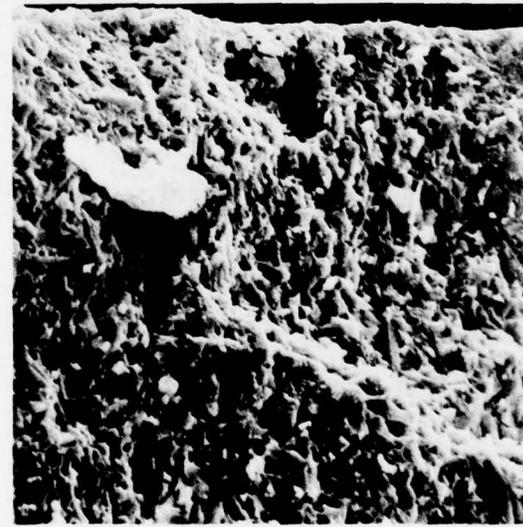
Figure 11.   Fractograph of a Fractured Ceralloy 147Y Disc
              (0.56 GPa) Showing Fracture Initiation at a
              Second Phase Inclusion (B).

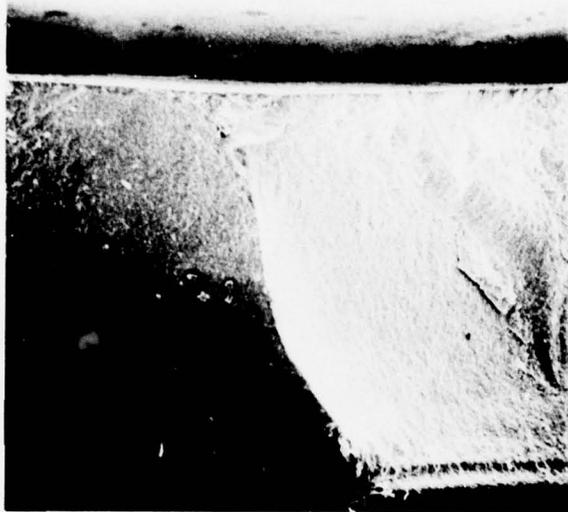
Figure 12.   Fractograph of a Fractured NC132 Disc (0.99 GPa)
              Indicating Fracture Initiation at Residual
              Surface Scratches.

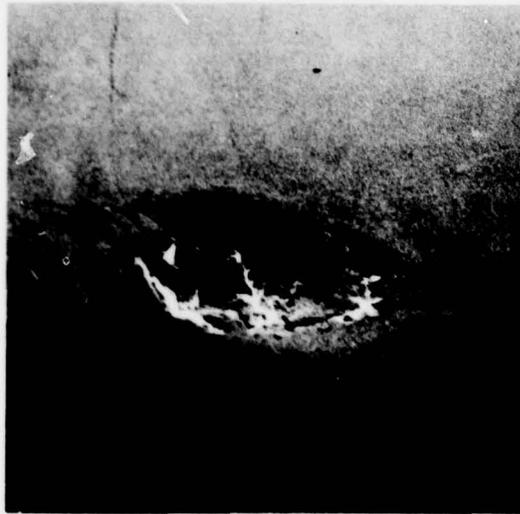
Examination of spalled NC132 balls revealed two types of spall initiation. All but one spall were normal fatigue spalls of the type shown in Figure 24. It is seen in Figure 24 that the Hertz cracks predominate at the edge of the track and move towards the center of the track as they progress. On the odd spall (Figure 25) the Hertz cracks had formed at the center of the track and ran perpendicular to the track. The spall is seen to be bounded on one side by a Hertz crack. Such Hertz cracks, running perpendicular to the track, are formed by repeated contact with a spall edge on the support balls. In most cases a spalled support ball does not cause the test ball to fail due to the indexing of the spalled region out of the contact band. None of the spalls occurred in the equatorial band region indicating absence of strength degradation in that region.

Figure 24.   Normal Fatigue Spall on an NC132 Ball.

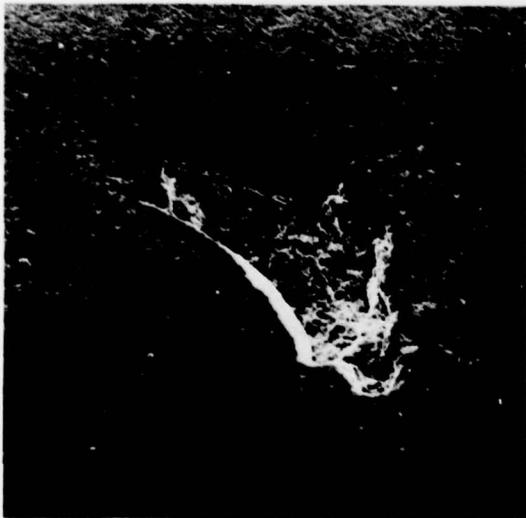
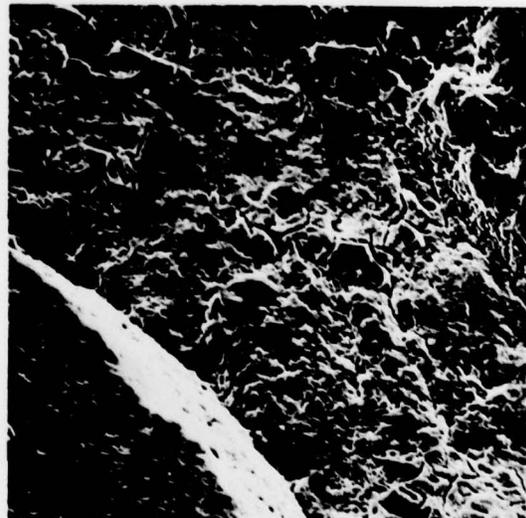
Figure 25.   Fatigue Spall Caused Due to Repeated Contact
with Spalls on Support Balls.

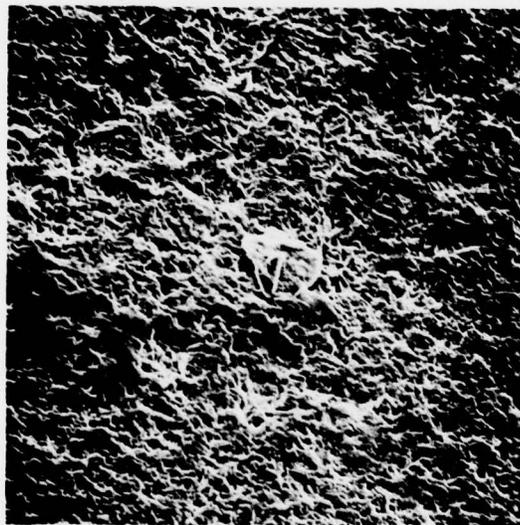
The glazed material would then peel off suddenly and the process
repeated itself. It was also obvious during the testing of
Ceralloy 147Y balls that the wear would often start as pitting
or microspalling at the light colored (grey) areas which were
randomly distributed over the surface of the ball.

Examination of the rolling track on a Ceralloy 147Y ball shows microspalls and wear debris particles generated that cause oil discoloration during testing (Figure 26).

Figure 26.   Microspalls and Wear Debris Found on a Fatigue
             Tested Ceralloy 147Y Ball.
