CONTRACTOR REPORT ARLCD-CR-78033

USING GRAPHITE FILAMENT COMPOSITION AS A DIE MATERIAL

R. J. STYNE

OCTOBER 1978

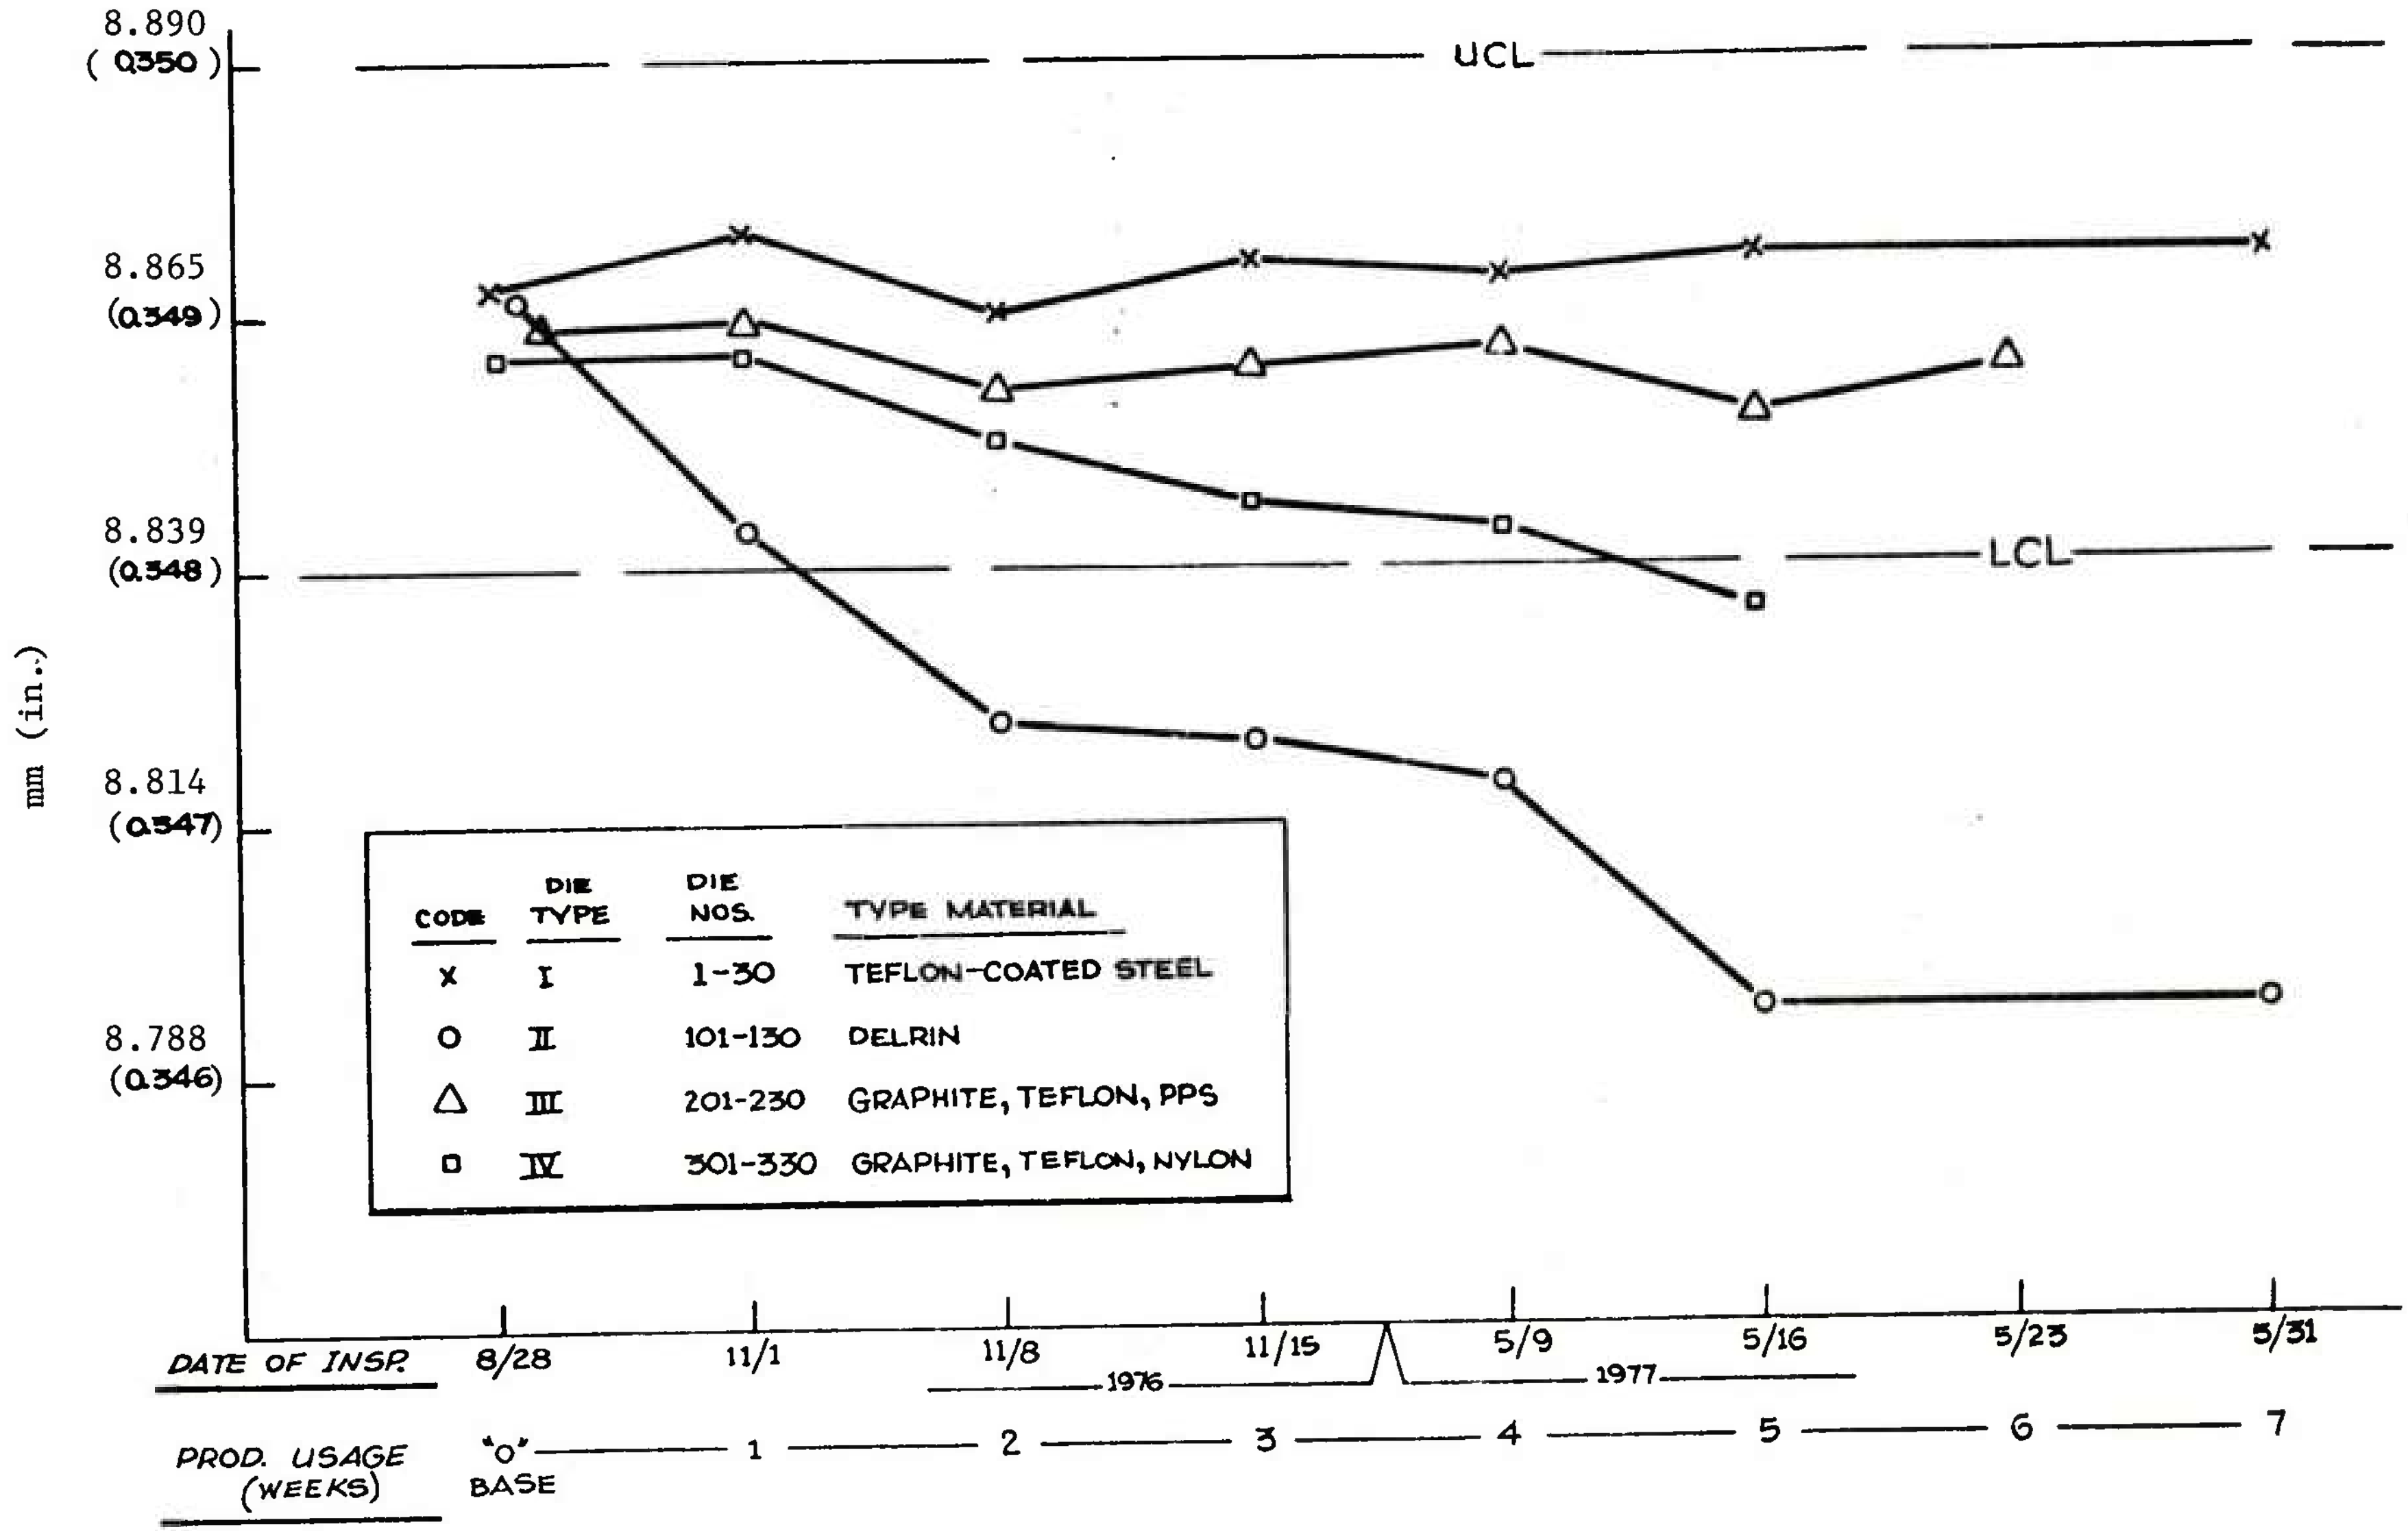
Figure 8. Comparative plot of die agate ID measurements versus time.

A review of the data in Table 6 (plotted on Figure 8) shows that the Teflon-coated steel die agates underwent the least change of any of the die agate types evaluated and, in fact, did provide a significant degree of dimensional stability. Thus, Teflon-coated steel is an excellent candidate for a standard die agate.

Figure 8 contains a plot of the die agate ID measurements of representative Delrin die agates. It shows that the die agate ID measurements approached the established quality control lower limits of 8.839 mm (0.348 in) after the first week of use and were beyond the lower limit on each subsequent inspection throughout the evaluation.

Table 7 presents a summary of the agate ID data obtained for the selected samples of Delrin-type agates and compares the original agate ID measurements for the middle of the agate barrel to that obtained throughout the evaluation period. These data show a gradual reduction in the agate ID over the entire period of evaluation with averaged measurements changing from an original agate ID measurement of 8.867 mm (0.3491 in) to a final ID measurement of 8.793 mm (0.3462 in). A statistical analysis performed on these data showed the change in ID to be highly significant. A review of the data in Table 7 (plotted in Figure 8) also shows that the Delrin agates changed in more ID dimensions than any of the four agate types used in this evaluation.

A review of the physical measurement data presented in Tables 8 and 9 and highlighted in Figure 8 shows that over the period of this evaluation the graphite/Teflon/PPS agates did not undergo dimensional changes. The graphite/Teflon/nylon agates did change and behaved in a similar manner but to a lesser extent that the Delrin agates previously discussed. Therefore, from a dimensional standpoint, only the graphite/Teflon/PPS agate is deemed to be satisfactory. The graphite/Teflon/PPS agates were found to have dimensional stability similar to the Teflon-coated steel.

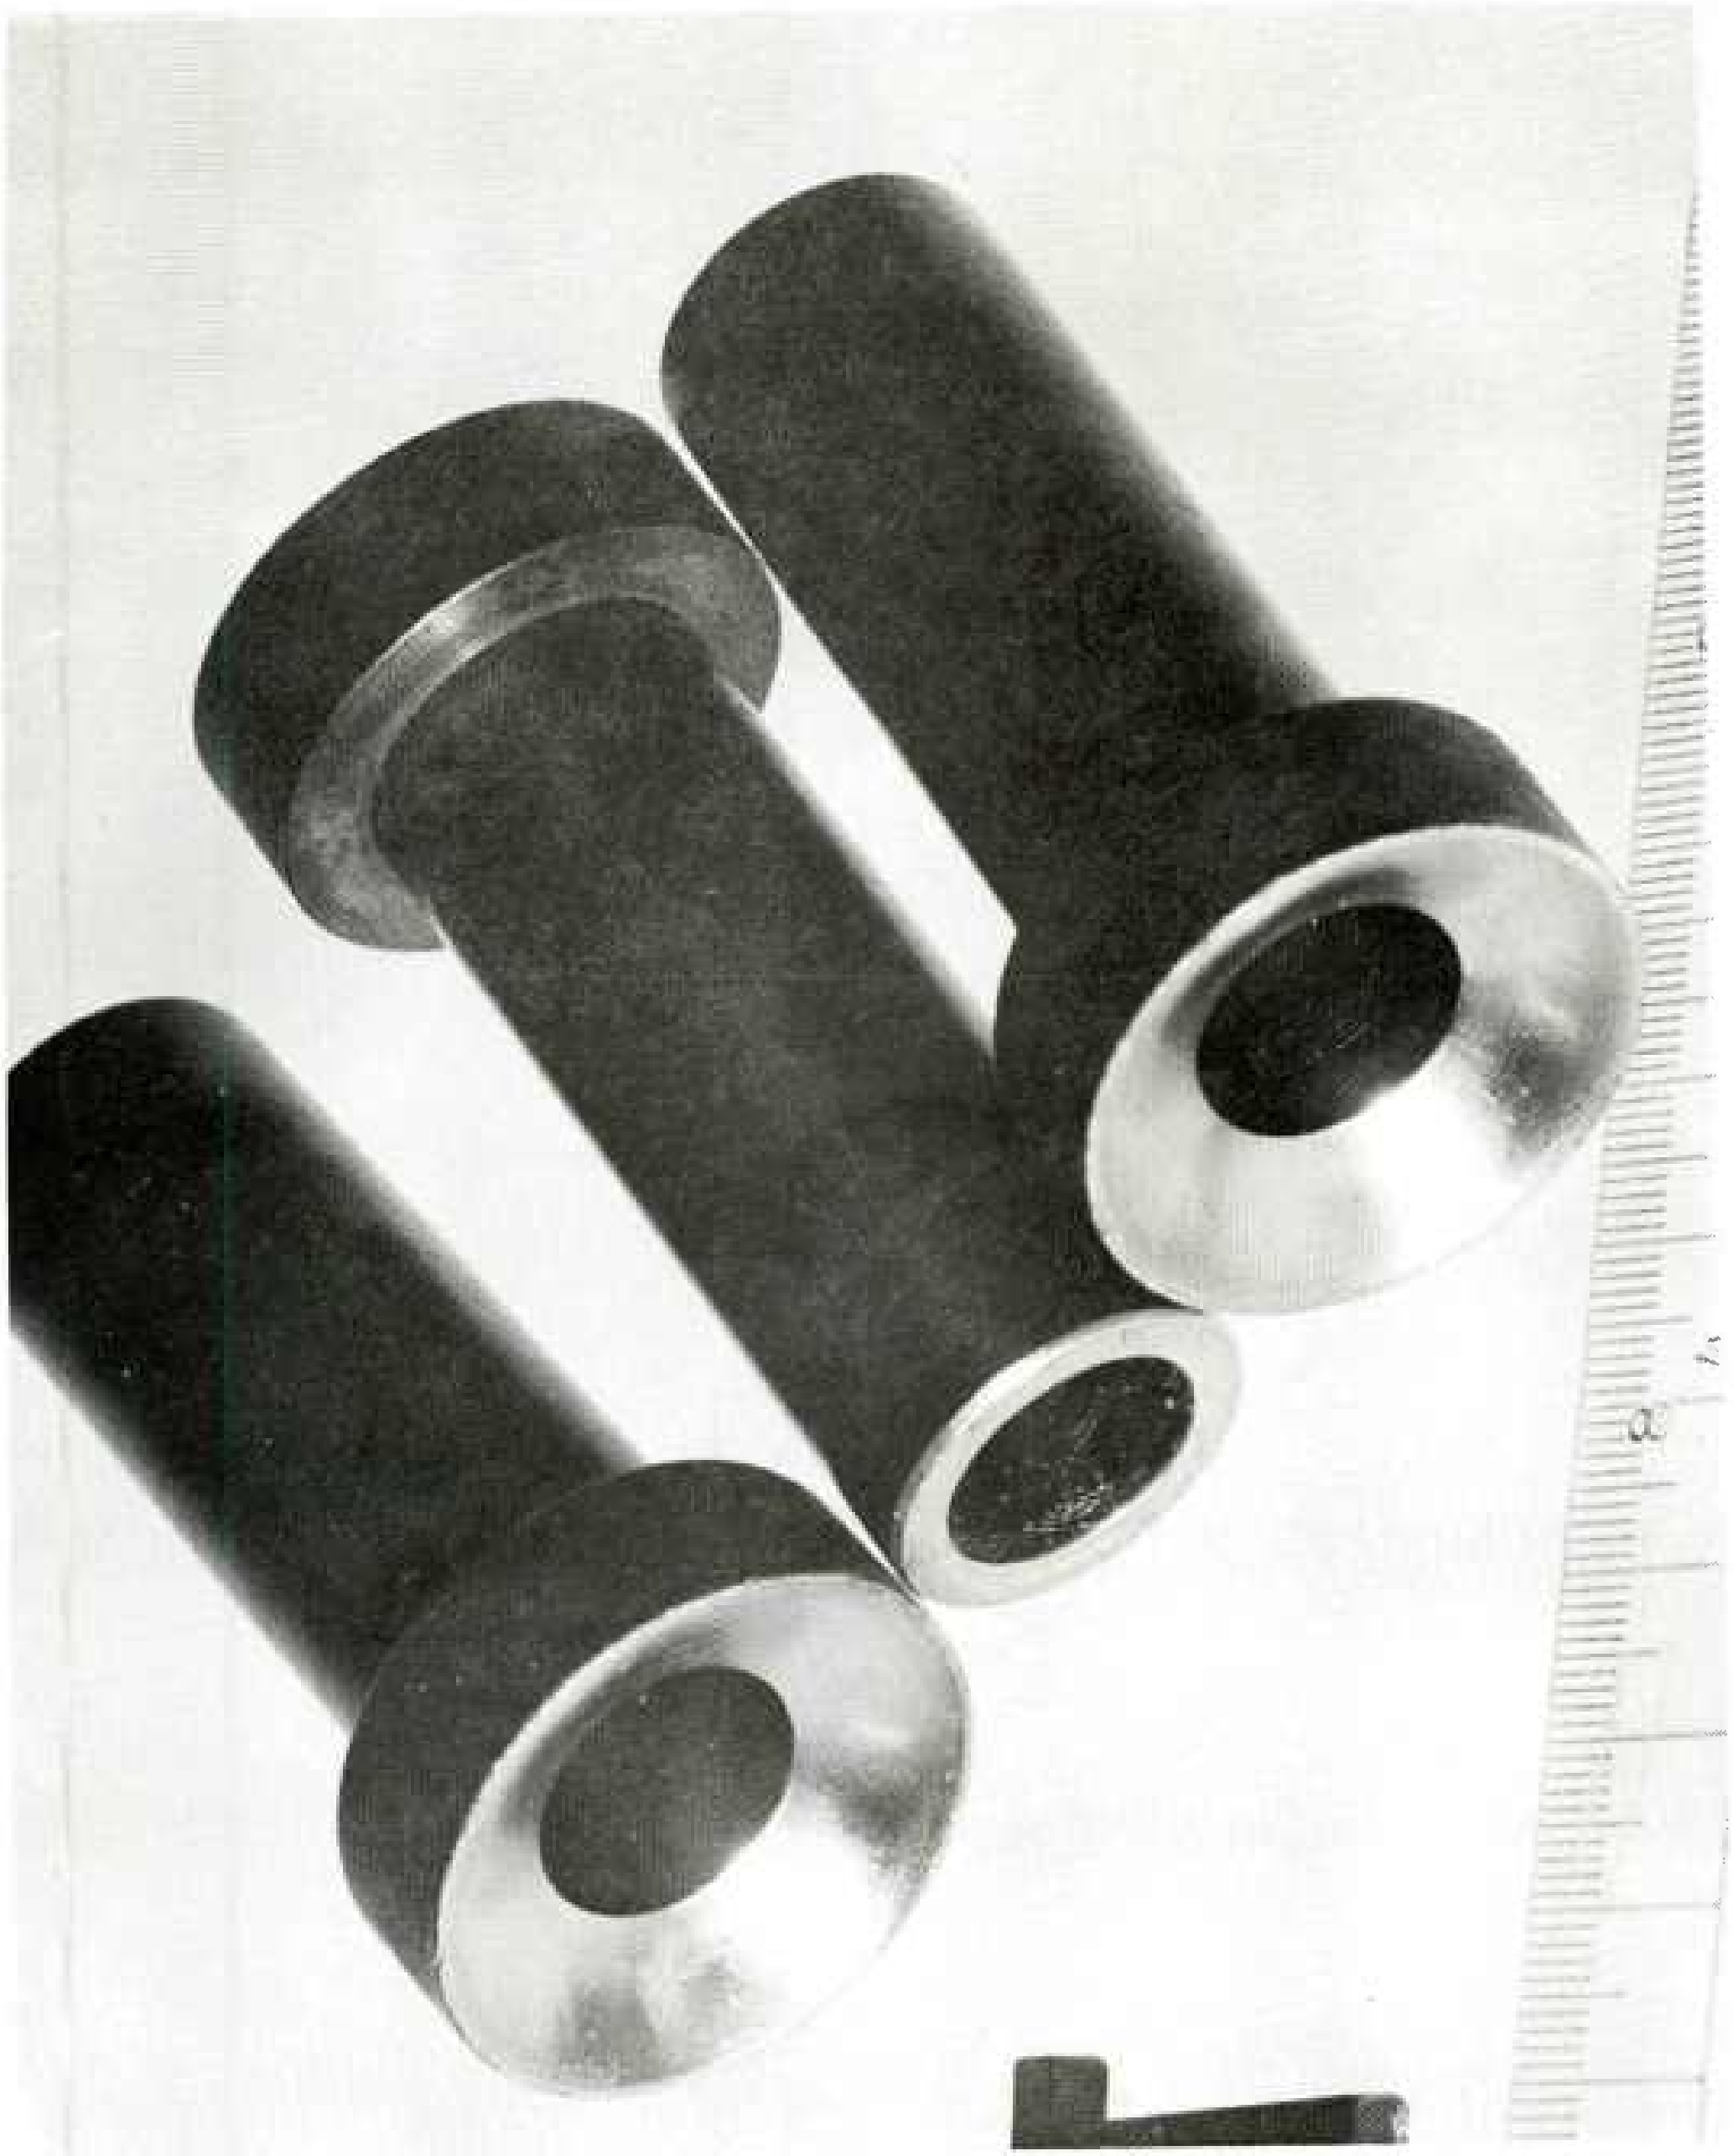
A careful inspection of representative samples of agates after one week of use showed some irregularity in the continuity of the coated surface near the center area of the agate ID. This was observed as a result of the measurement technique in which a dial indicator gage was moved up and down the inside of the barrel ID, and an irregular surface was indicated. This discontinuity was thought to be caused either by a slight breakdown of the Teflon coating or by wear. The original inspection prior to use did not indicate this condition. It was concluded that a slight breakdown of the Teflon coating in the center of the agate barrel ID allowed the Teflon to flow down the barrel to the exit surface. This condition was further substantiated by an inspection after three weeks of use. At that time, a slight buildup of material [approximately 0.025 mm (0.001 in)] was observed on the extreme outer edge of the agate exit ID. The center area of the agate ID surface was also observed to be rough when compared to the rest of the barrel ID.

Although physical measurements of the agate ID exit area at the end of the evaluation failed to show any significant buildup or change, visual inspection of the center of the agates still indicated various conditions of coating discontinuity when viewed from either end. It was not possible during this study to accurately determine whether the coating was breaking down and flowing, but the change in coating appearance was an indication of coating change during usage. This condition needs further substantiation. Thus, if this type of material is used for die agates, a more extensive evaluation should be attempted. The inspection results of the Teflon-coated agates obtained after seven weeks of usage are presented in Table 11 with typical photographic examples (Figure 9). Figure 10 is an enlarged view of the agate inside surface at the exit end; it shows that irregular coating scratches were observed in practically all of the agates. A microscopic examination led to the conclusion that these scratches were not caused by the normal breakdown of the coating due to usage but were caused by some type of mechanical action involved with propellant manufacturing or the agate cleaning process.

Figure 9. Typical Teflon-coated steel die agates following seven weeks of production use.

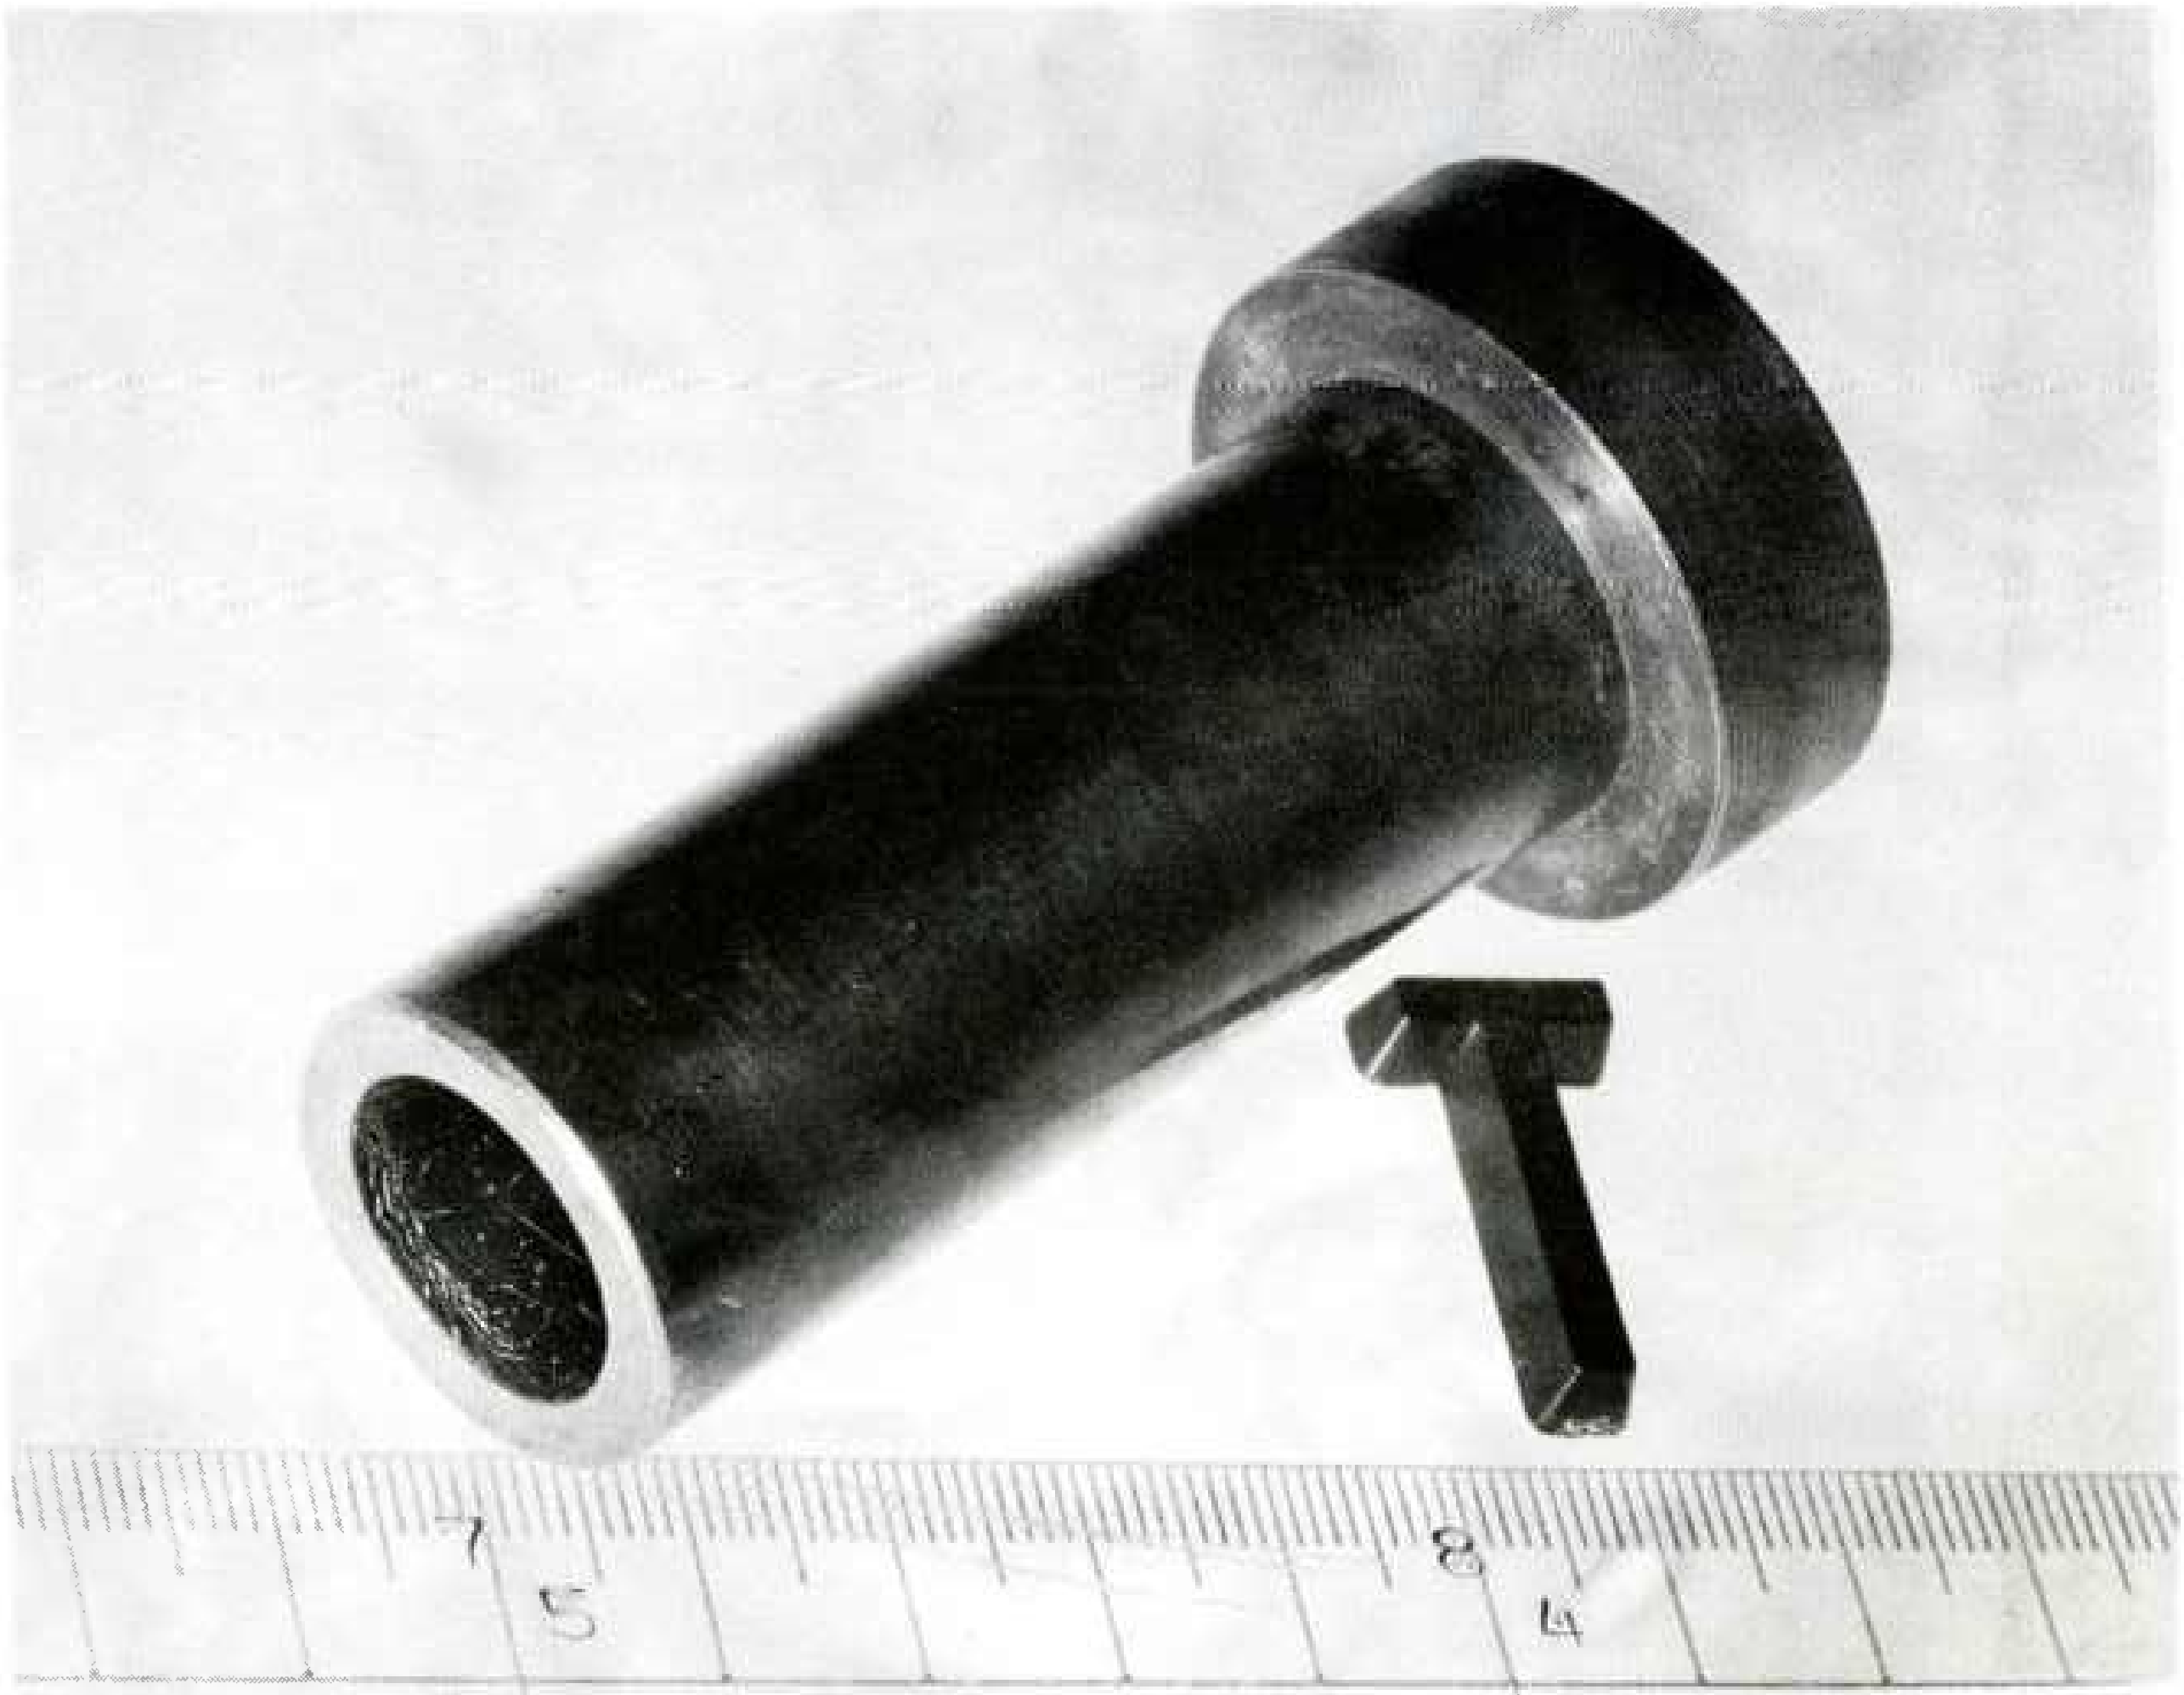
Figure 10. Typical example of damaged Teflon coating in agate exit ID surface.

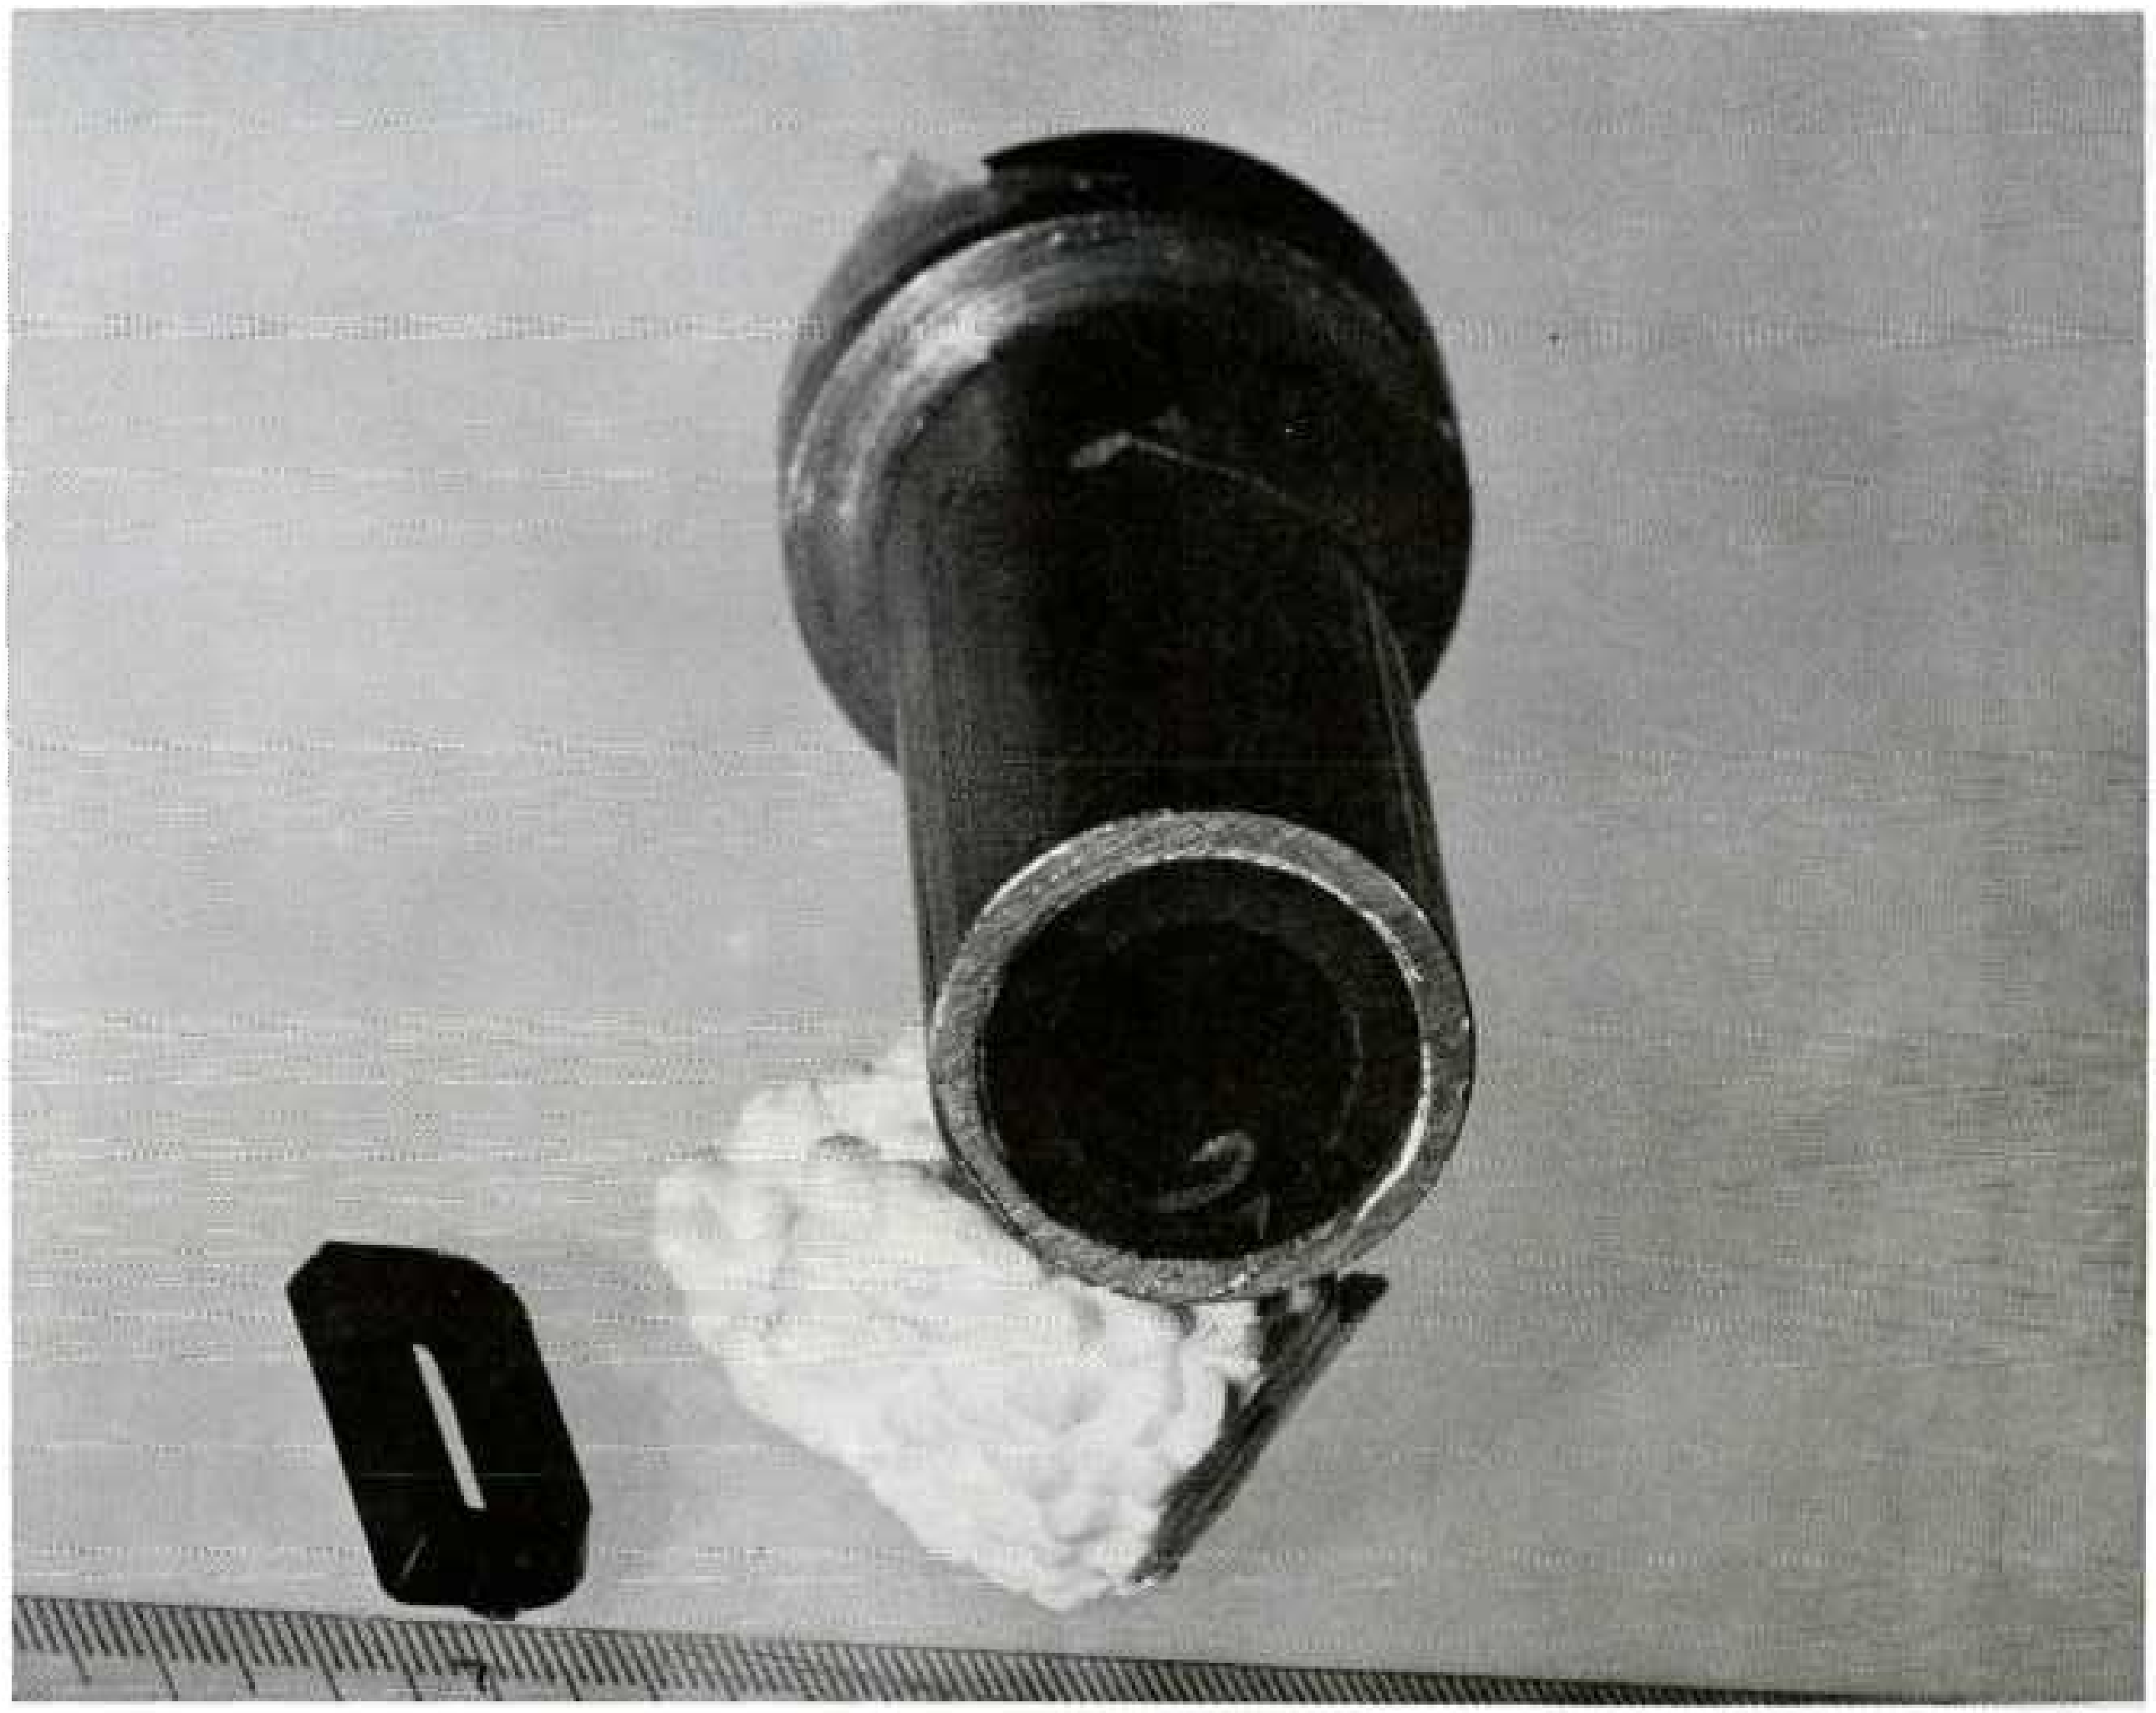
Agate No. 125 was removed from production during the fourth week of use because it was producing a propellant strand with an irregular, raised surface. An examination of this agate following disassembly of the die holder immediately upon removal from the press showed that the exit ID surface of the Delrin agate material had been sliced as though it had been cut with a knife (Figure 11). Concurrently, the Propellant Department's die cleaning foreman reported several Delrin agates from other presses that

Figure 11. Delrin agate showing damage after four weeks use.

had been cut or damaged in the same manner. It was theorized by the Propellant Department's supervisory personnel that the cuts may have been caused by a brass corkscrew or a knife used by production operators attempting to remove propellant from plugged die agates. Agates Nos. 110, 128, and 129 were observed during inspection at the completion of five weeks evaluation to contain bad chips or cuts on the agate exit ID surface likely caused in the same way as agate No. 125. Agate No. 128 was also visibly out of round at the exit end. Of these agates, Nos. 128 and 129 were considered to be damaged sufficiently to cause them to be removed drom production. Figure 12 is a photograph of Delrin agate No. 129 and is representative of the agates showing damage to the exit web surface due to some type of tool damage. Note the evidence of the faint circular cut ring in the Delrin web surface which is presumed to be caused by the die removal tool. This appears to be the same cut rings that have caused significant damage to the graphite agates which will be discussed later.

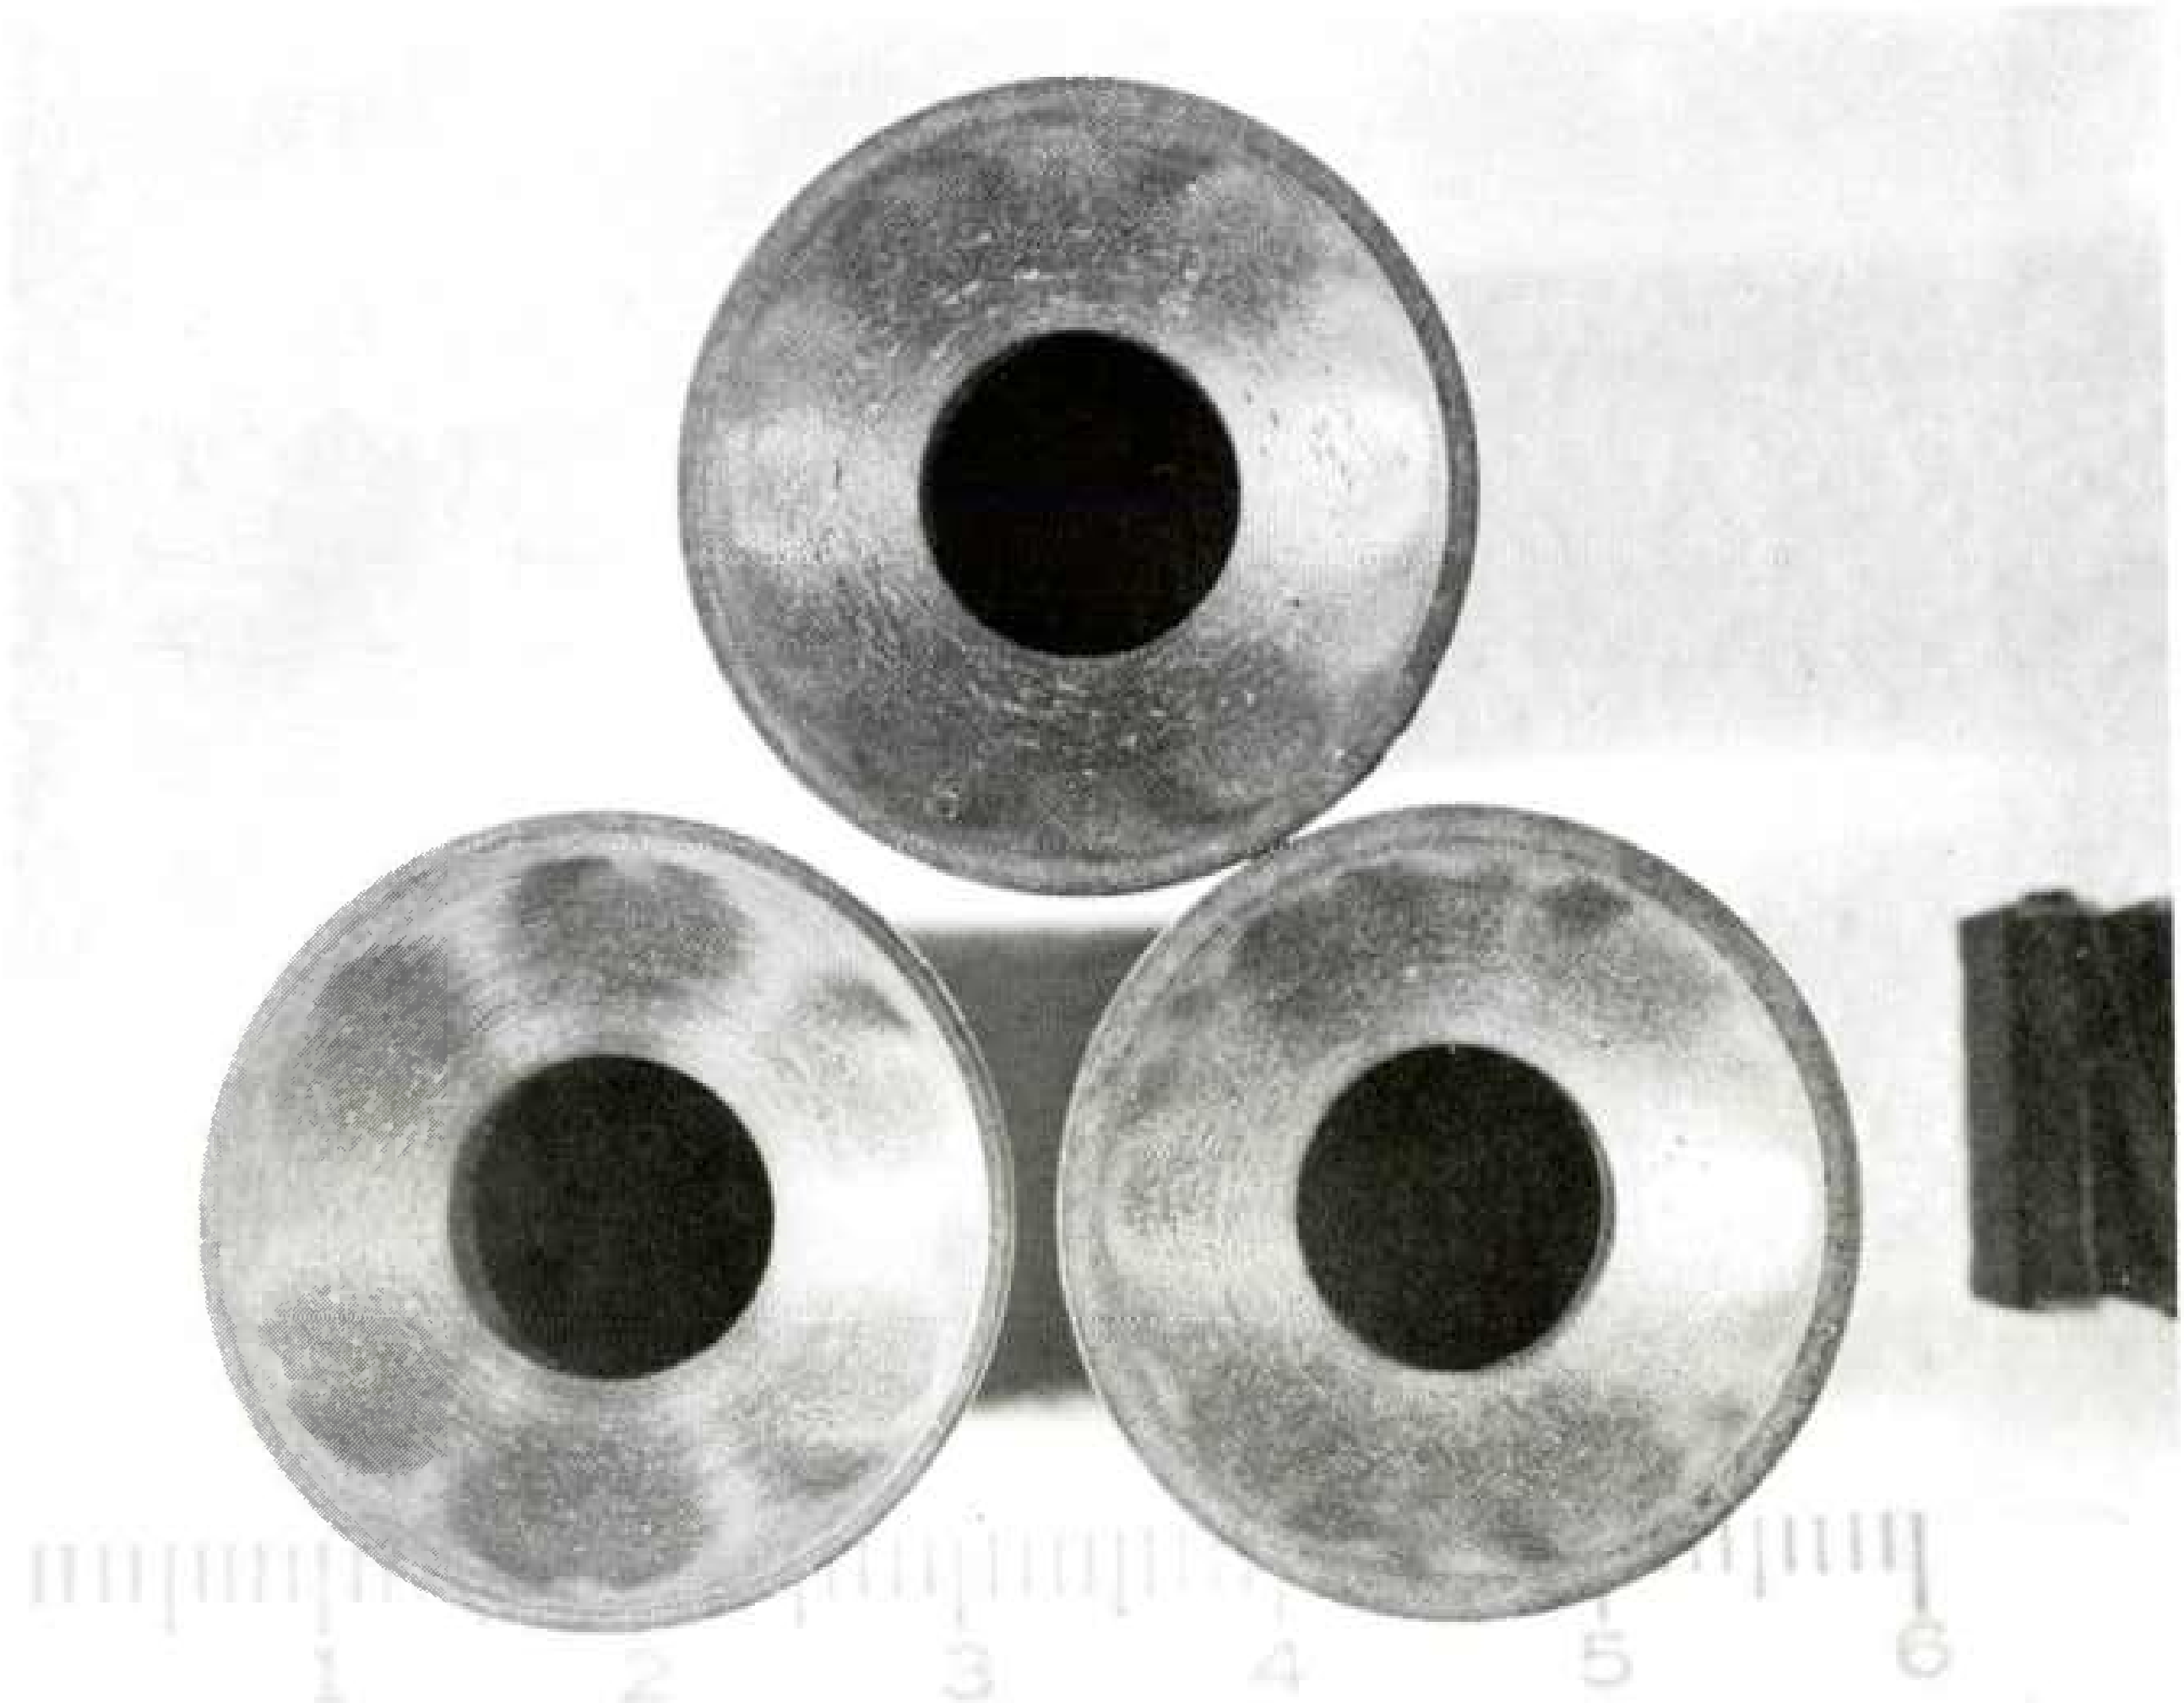
Figure 13. Graphite/Teflon/nylon agates (bottom) showing irregular wear on the agate approach angle surface. Top single agate shows pits and porosity in the approach angle surface.
