CONTRACTOR REPORT ARLCD-CR-78033

USING GRAPHITE FILAMENT COMPOSITION AS A DIE MATERIAL

R. J. STYNE

OCTOBER 1978

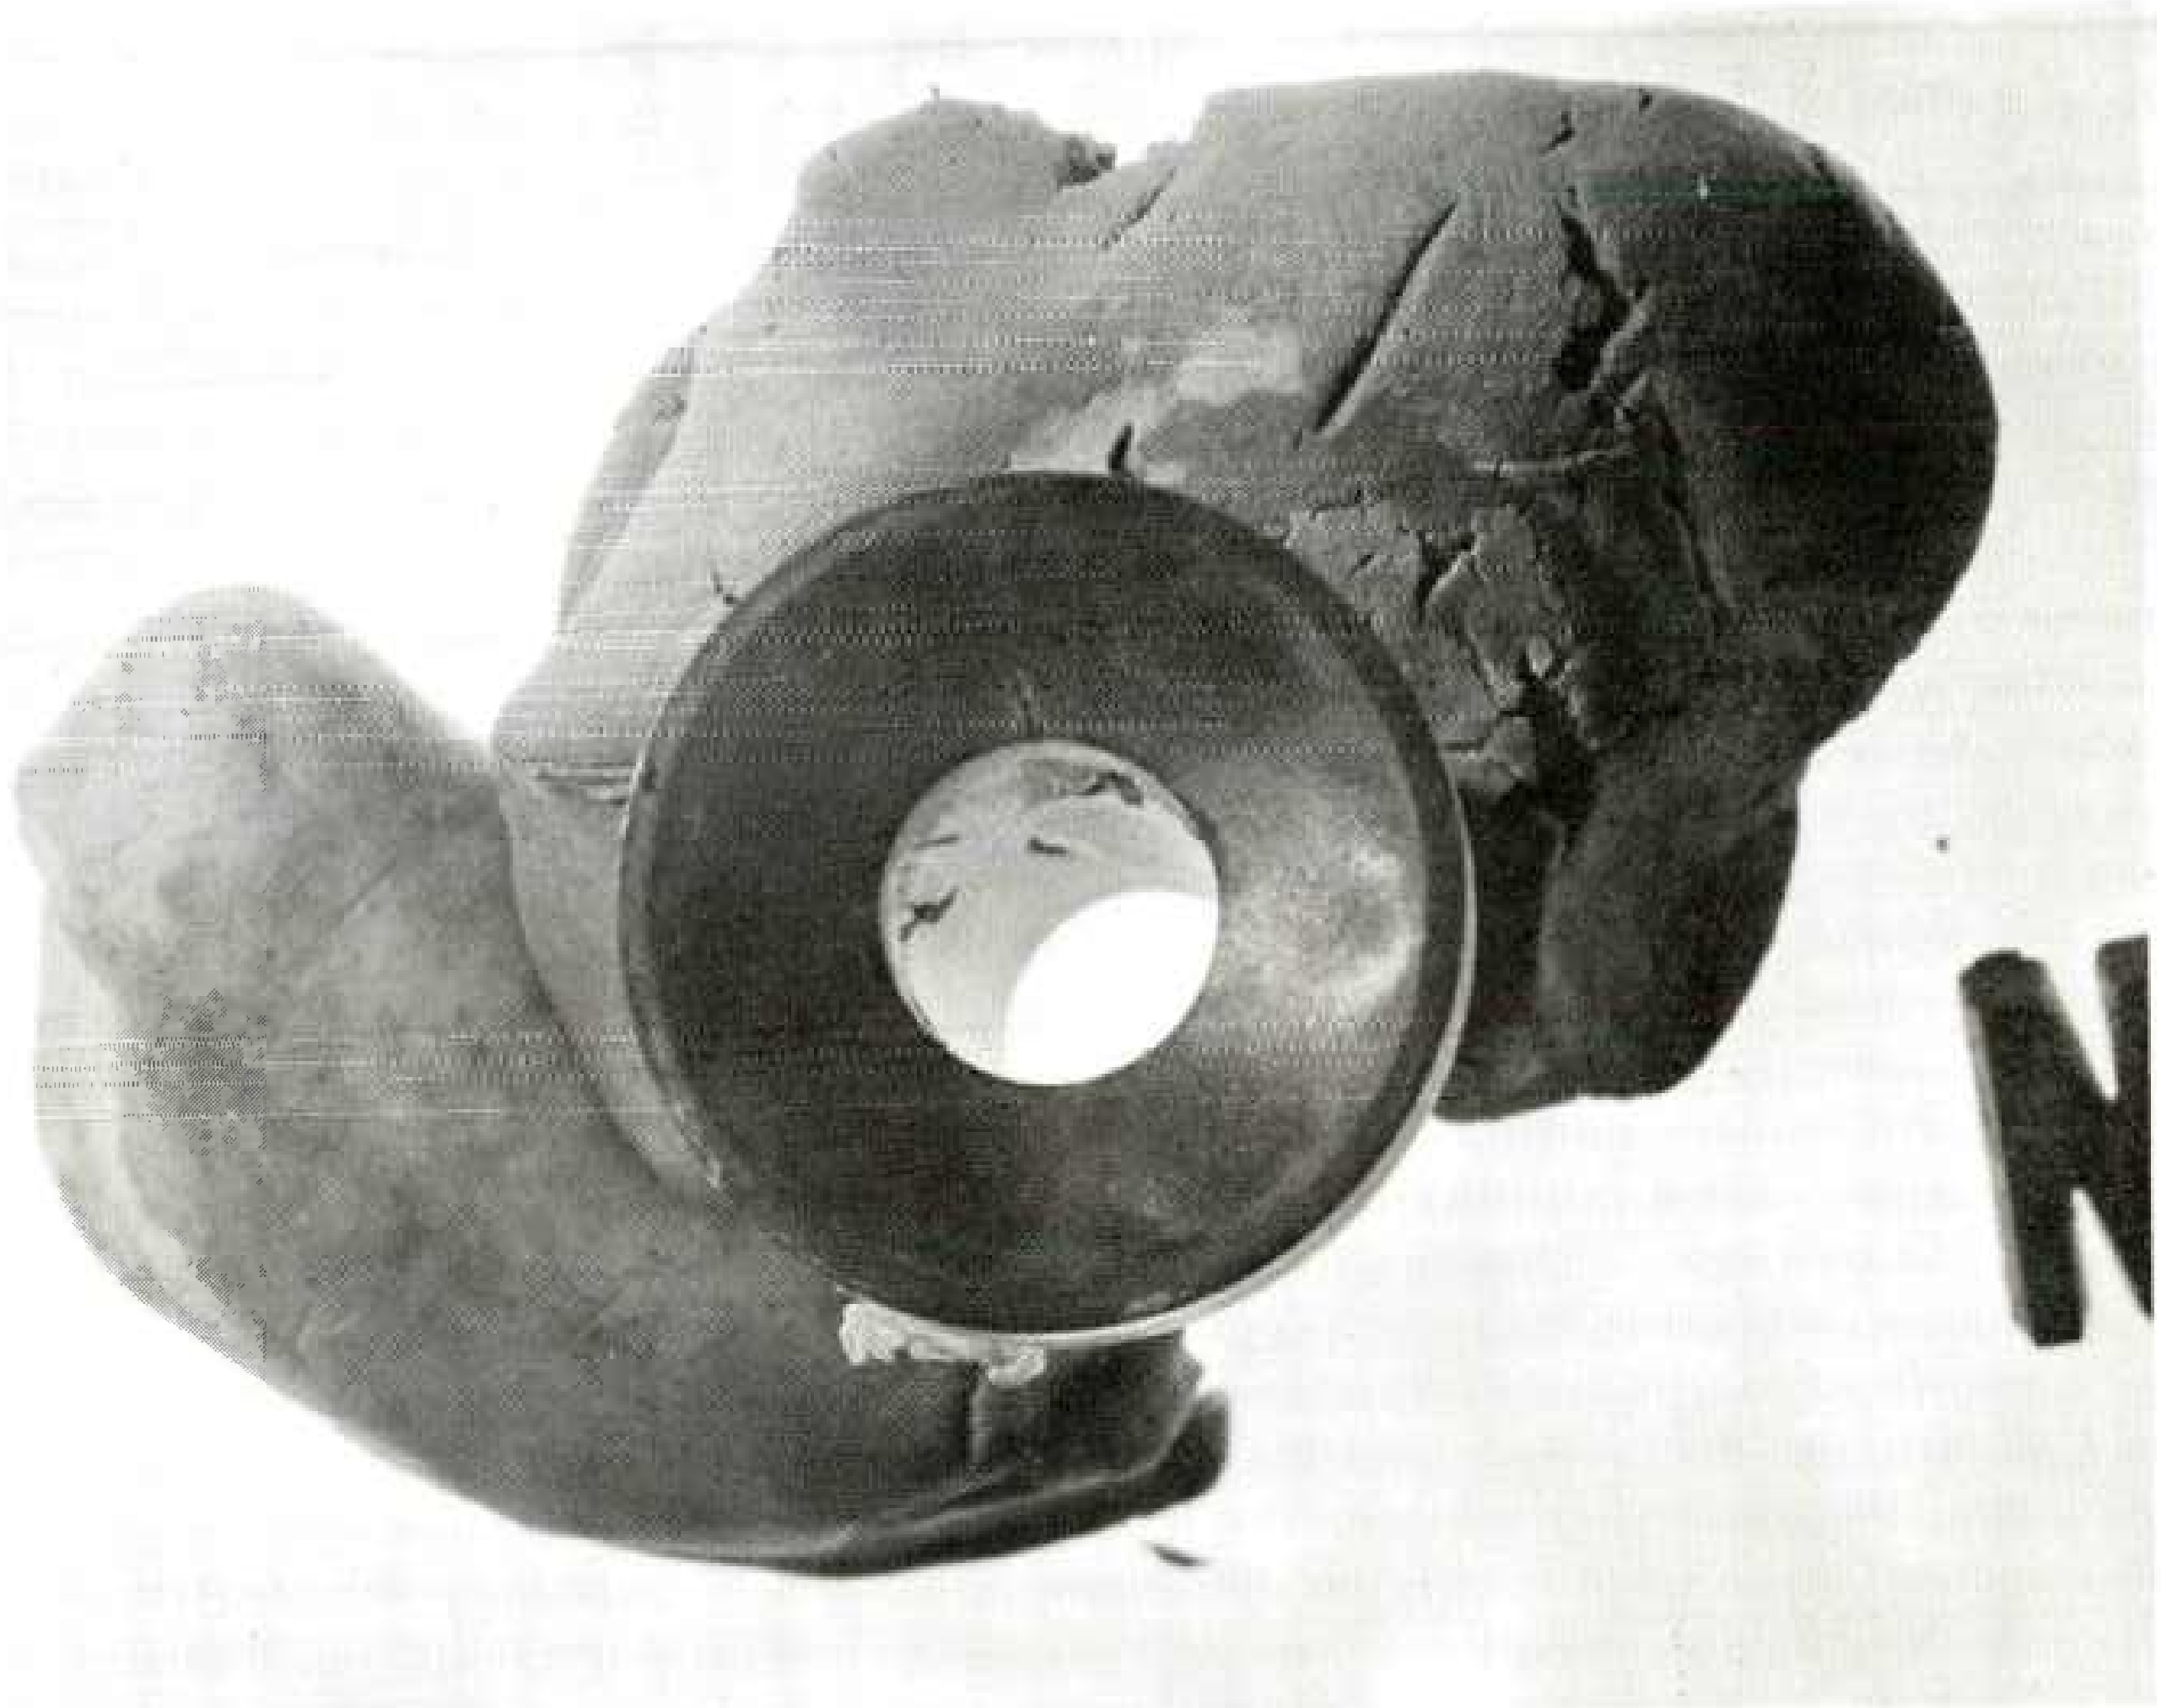
d. No. 310 - Five deep gouge marks were observed in the agate barrel ID. Several of these marks resembled open-edged frayed fissure lines or voids (Figure 14). This agate was removed from the evaluation at this point.

Figure 14. Graphite/Teflon/nylon agate displaying pits, voids, and fissures in the agate ID surface.

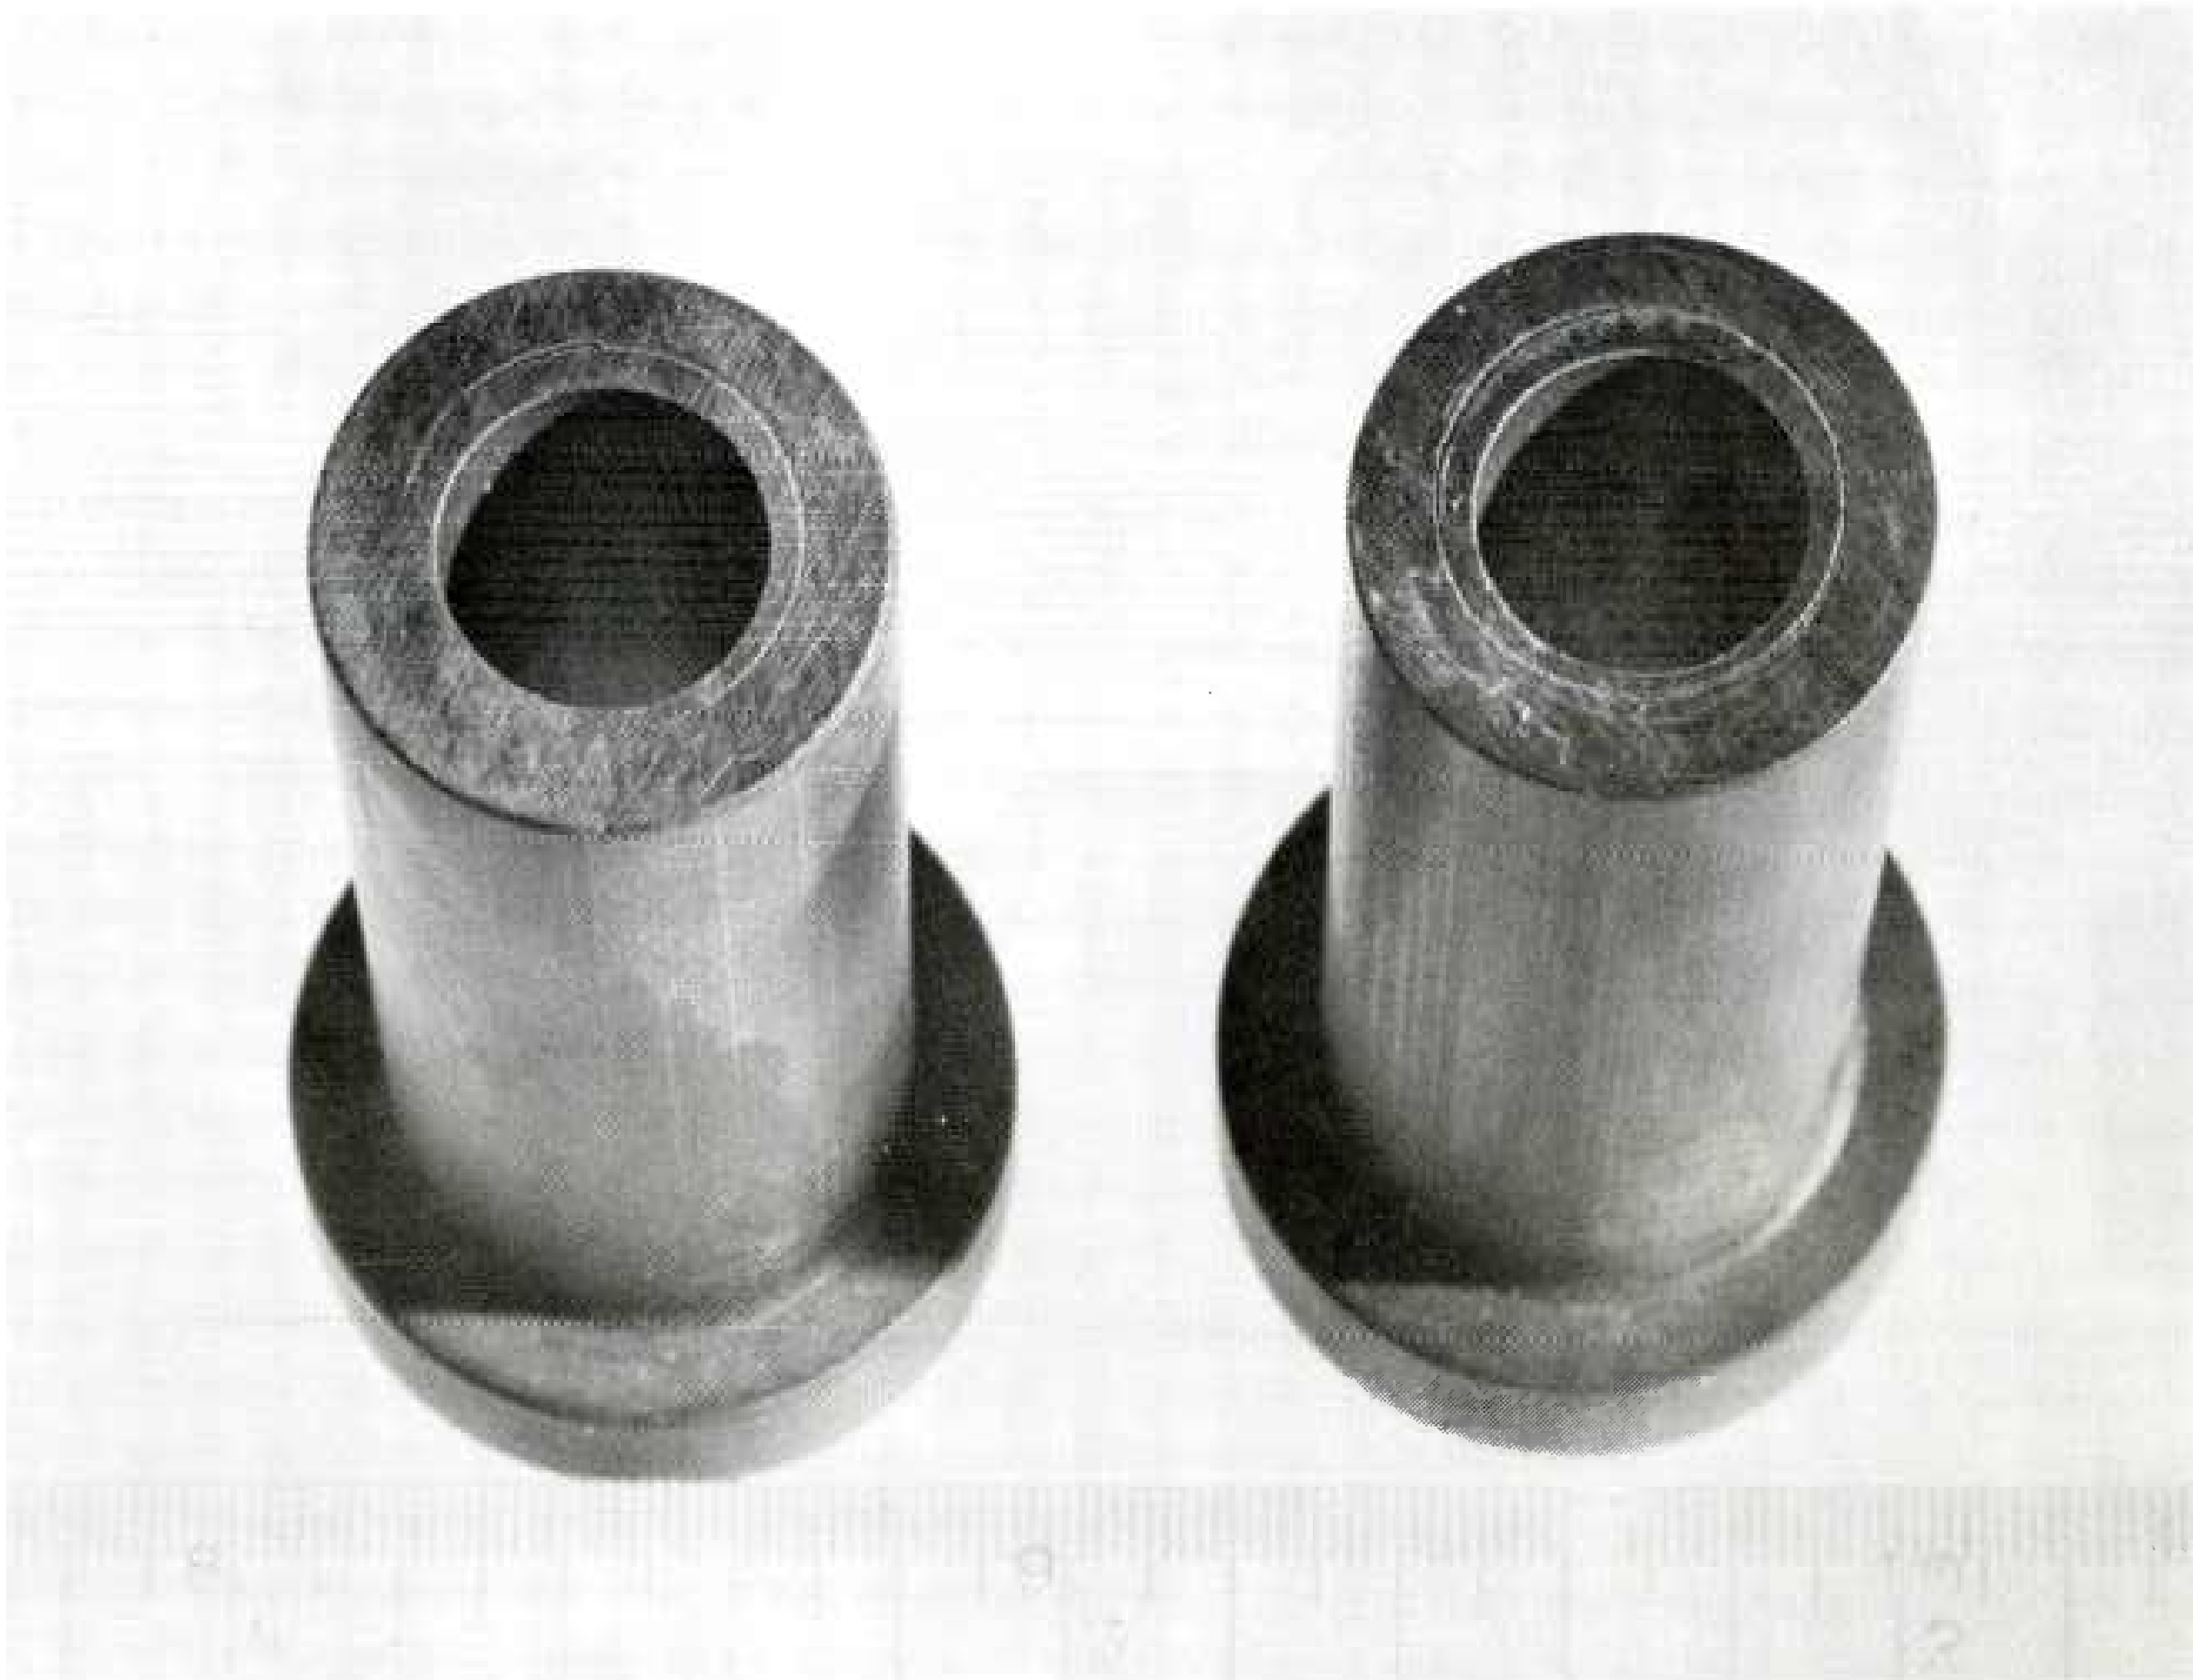
Figure 15. Typical graphite/Teflon/nylon agates displaying angular cuts (rings) in the exit web surface caused by the die agate removal tool.

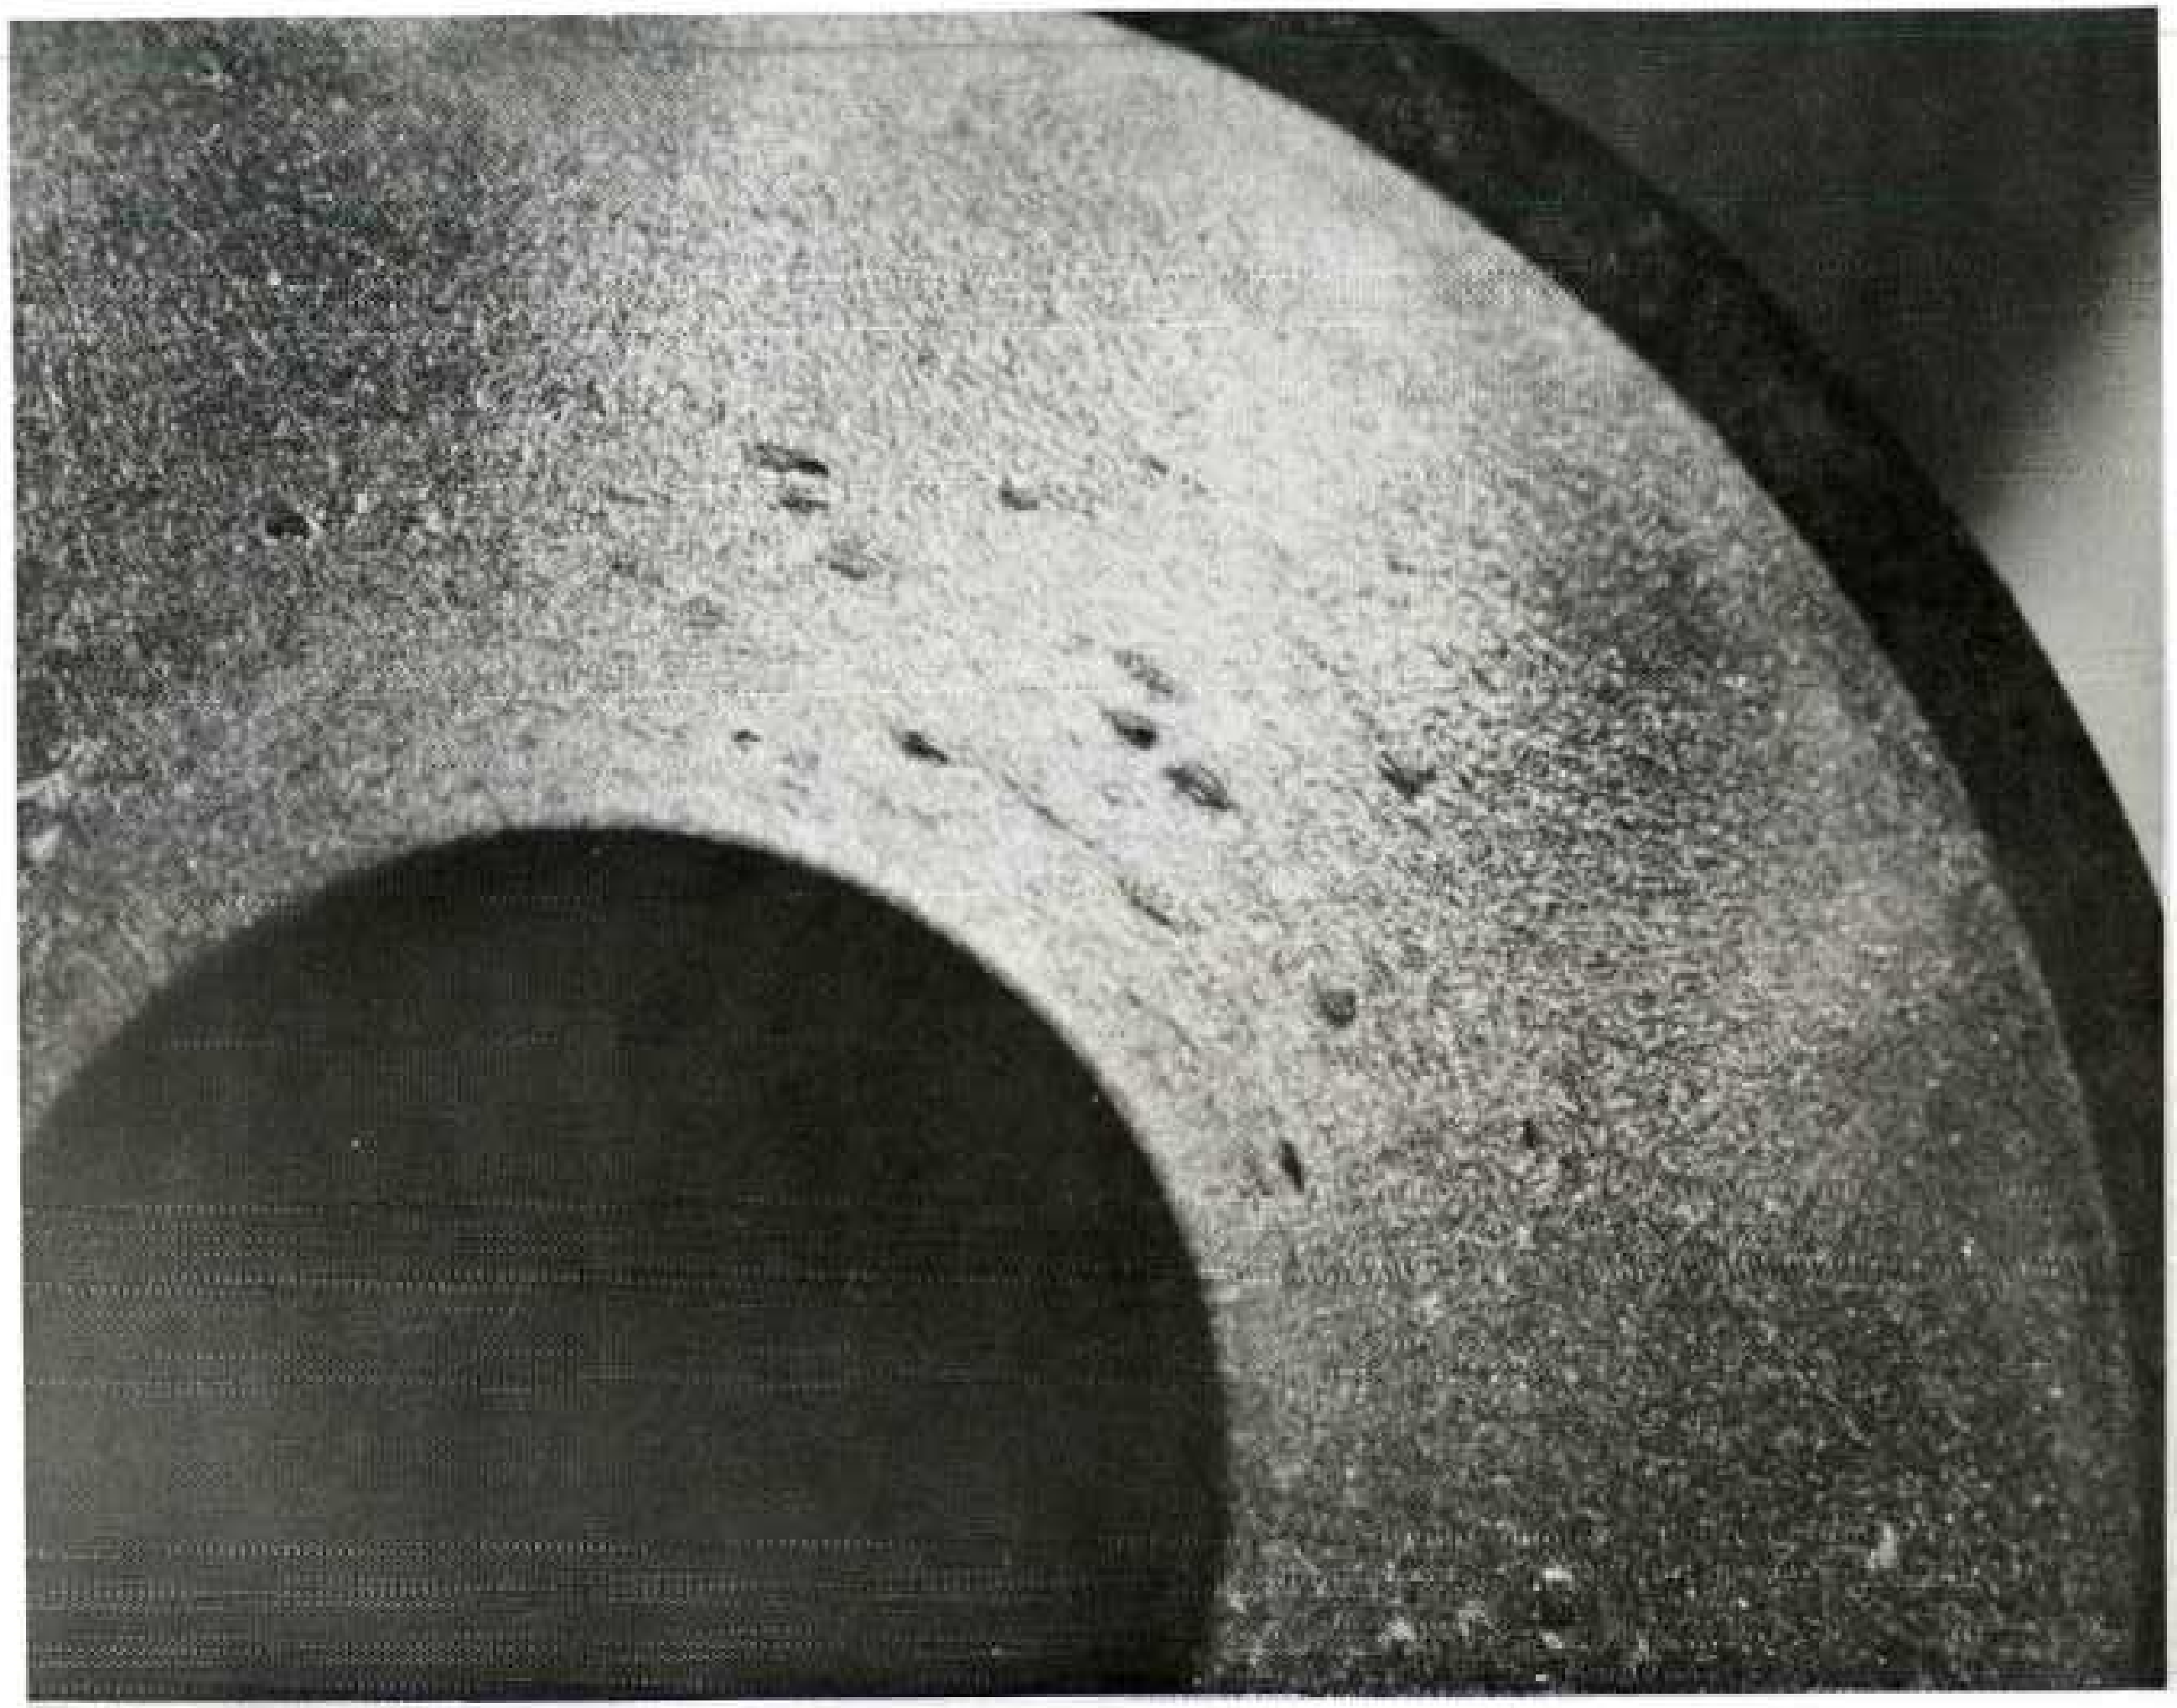
Figure 16. Typical example of the graphite/Teflon/nylon agates displaying porosity in the approach angle surface. (This is an enlarged view of the top agate shown in Figure 13.)

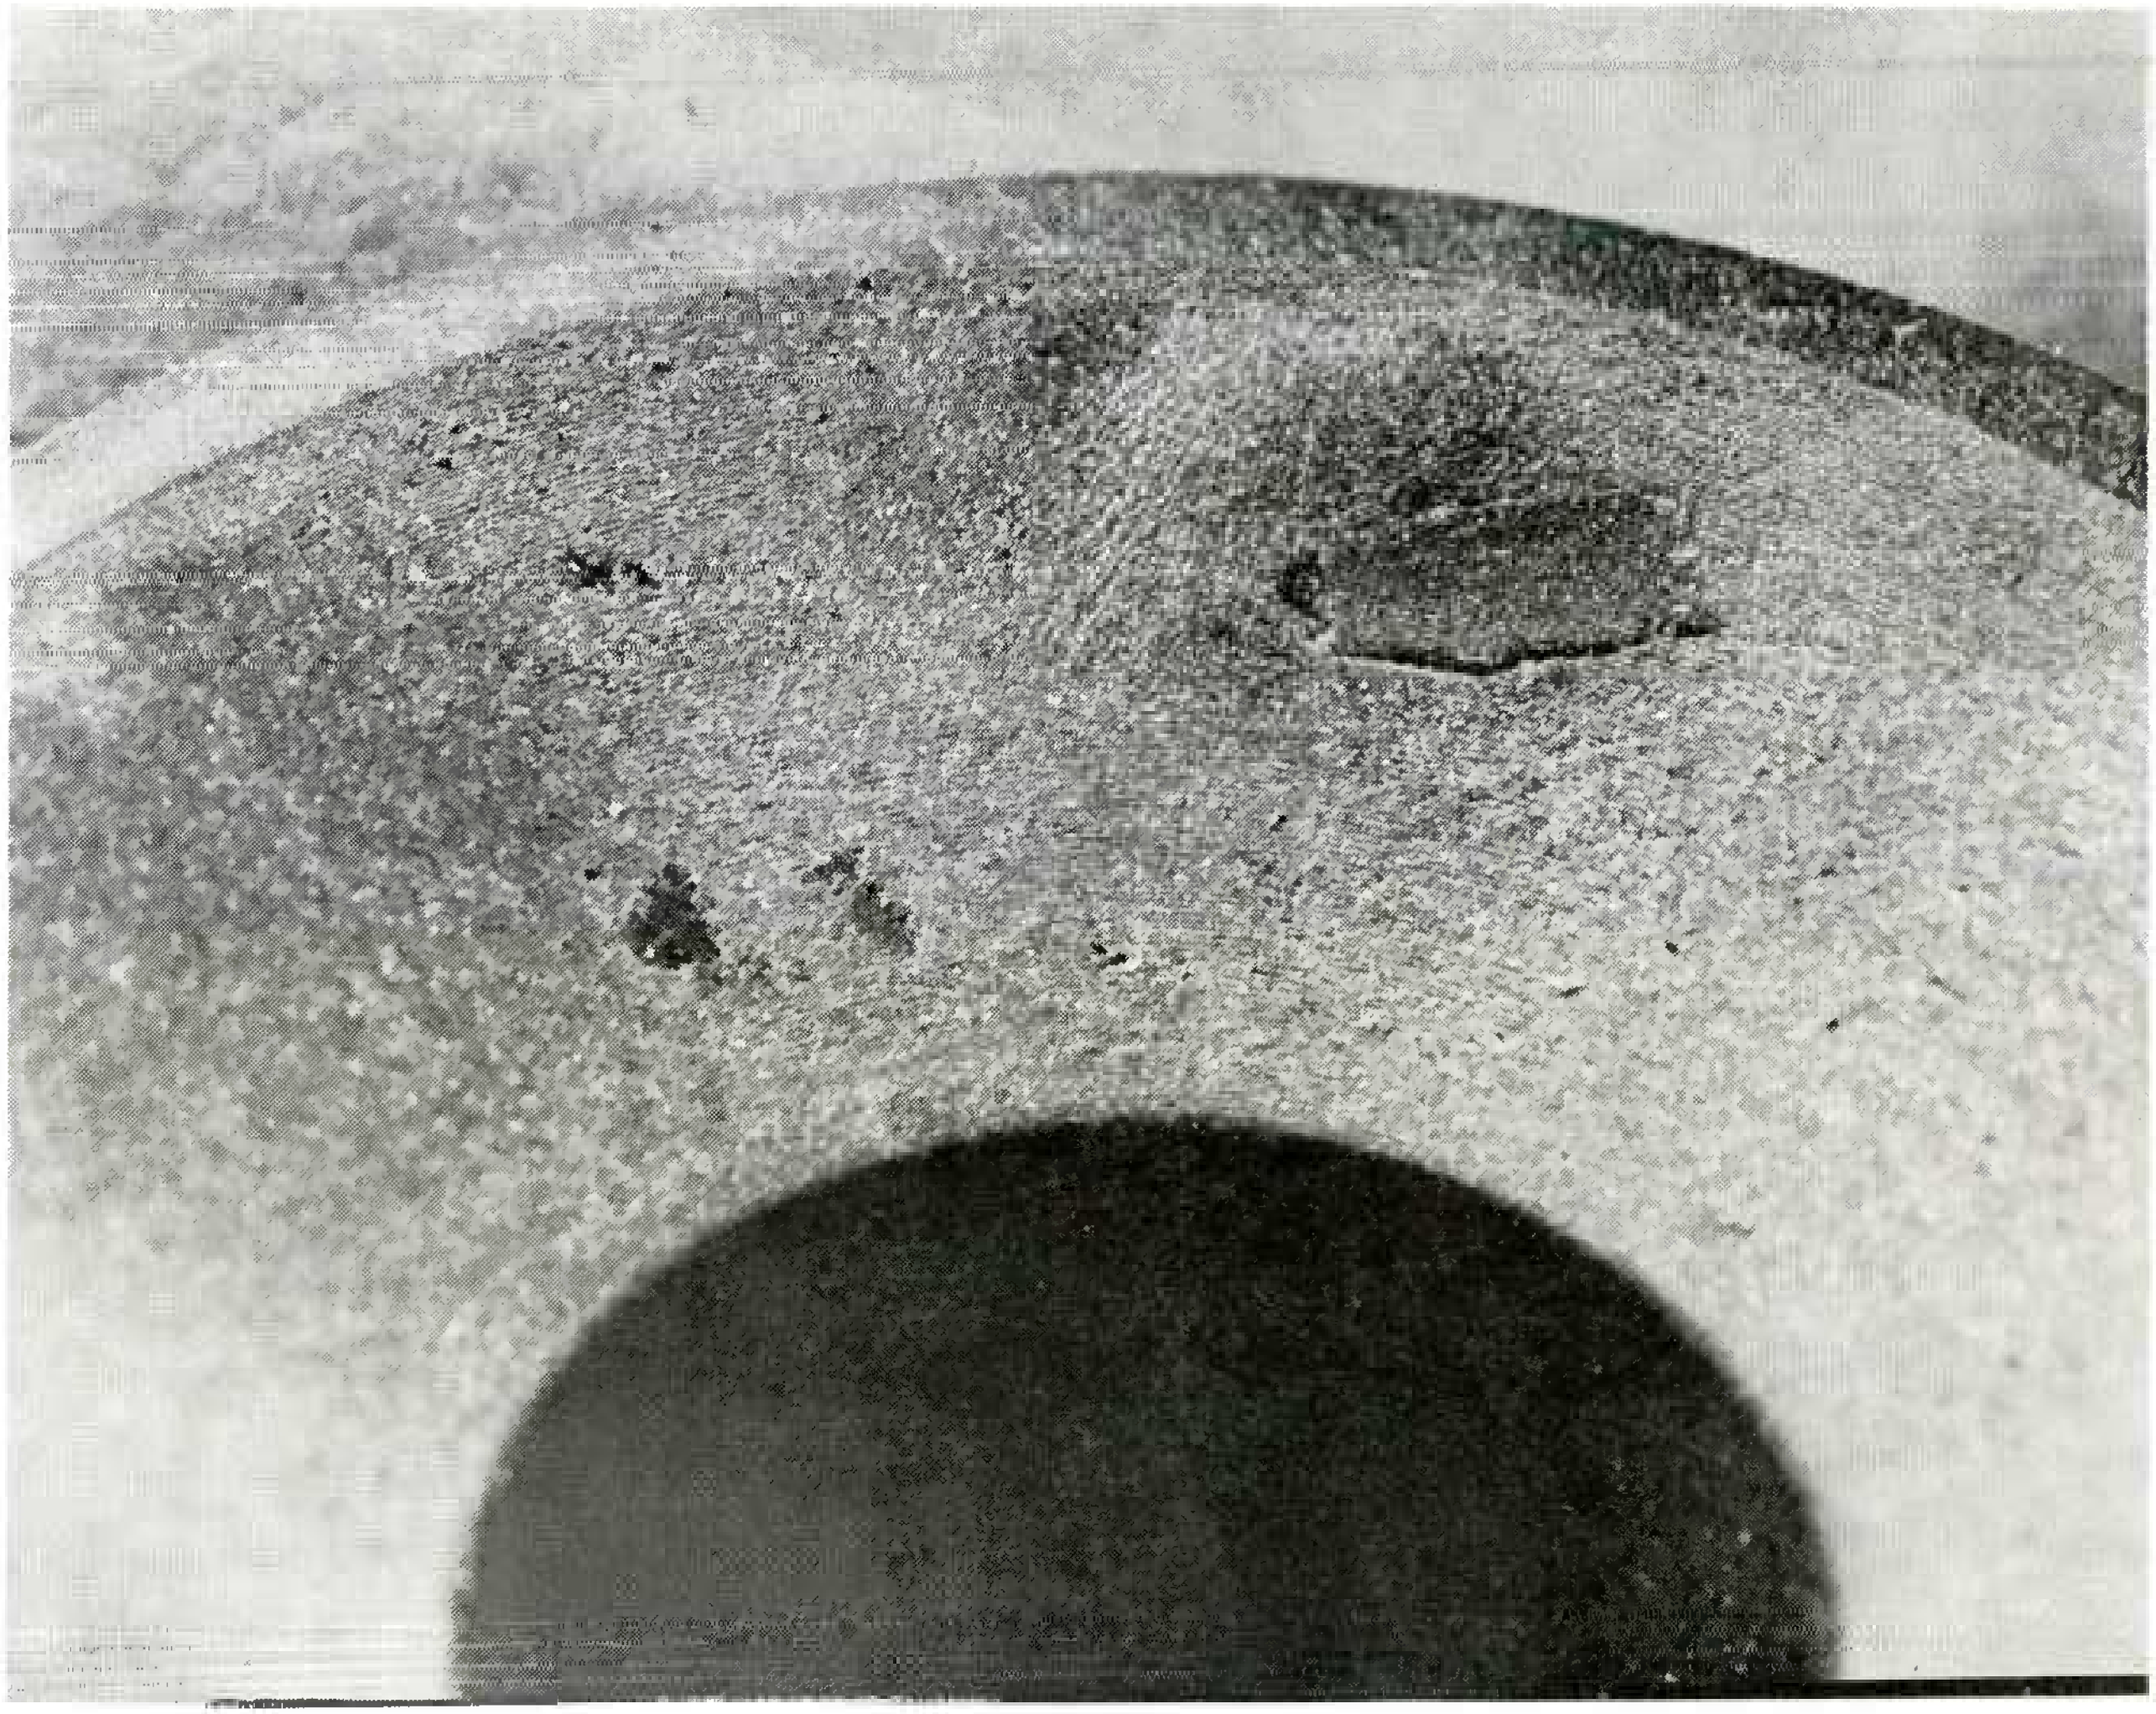
(Figure 13). Figure 17 is an enlargement of the agate approach angle surface of No. 311 showing pits, voids, and evidence of delamination or poor material consolidation. Figure 18 shows several agates which have chips or dents in approach angle or exit surfaces that are presumed to occur during the die agate assembly, disassembly, or cleaning operations. A complete summary of the data obtained from this final inspection is included in Table 13. A review of these data led to the conclusion that this material has poor wear resistance and may even be chemically affected by cleaning solvents or propellant constituents, thus making it an unsatisfactory candidate for a die agate material.

Figure 17. Typical graphite/Teflon/nylon agate showing both pits and voids in the approach angle and a large area resembling delamination of the molded composite material.

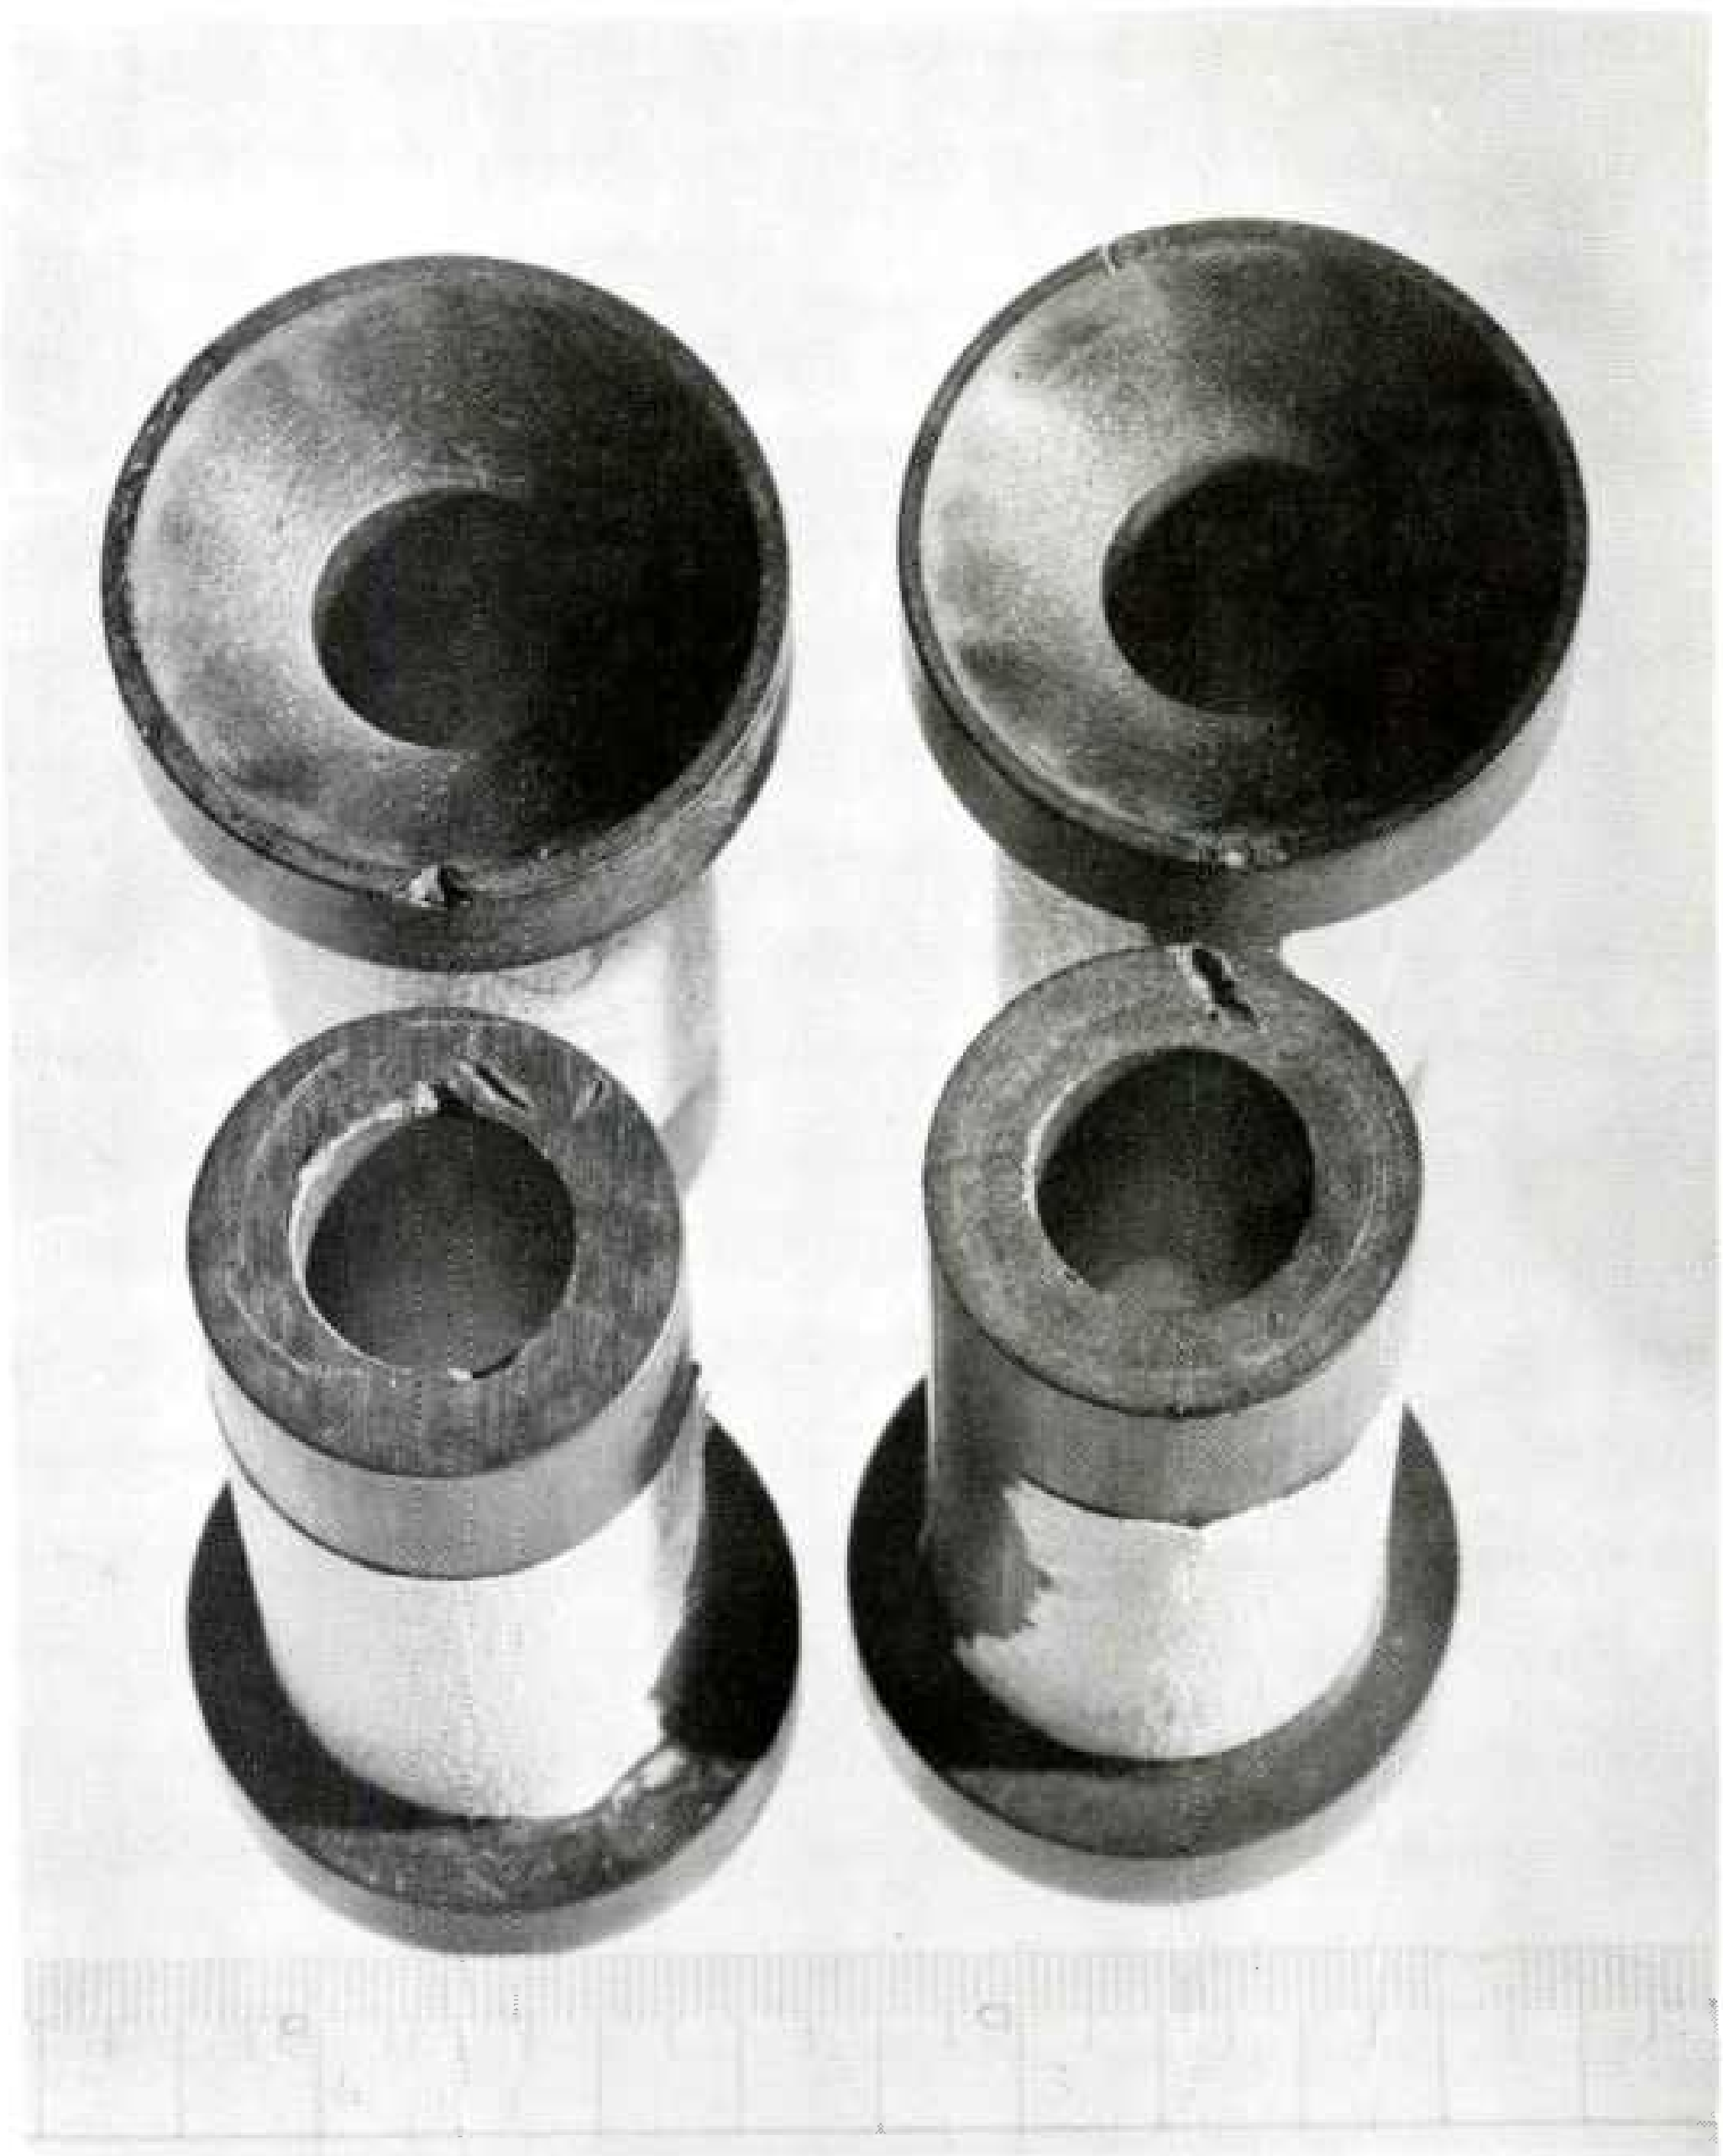
Figure 18. Typical graphite/Teflon/nylon agates with chips and dents in the approach angle and exit surfaces caused by production operations.

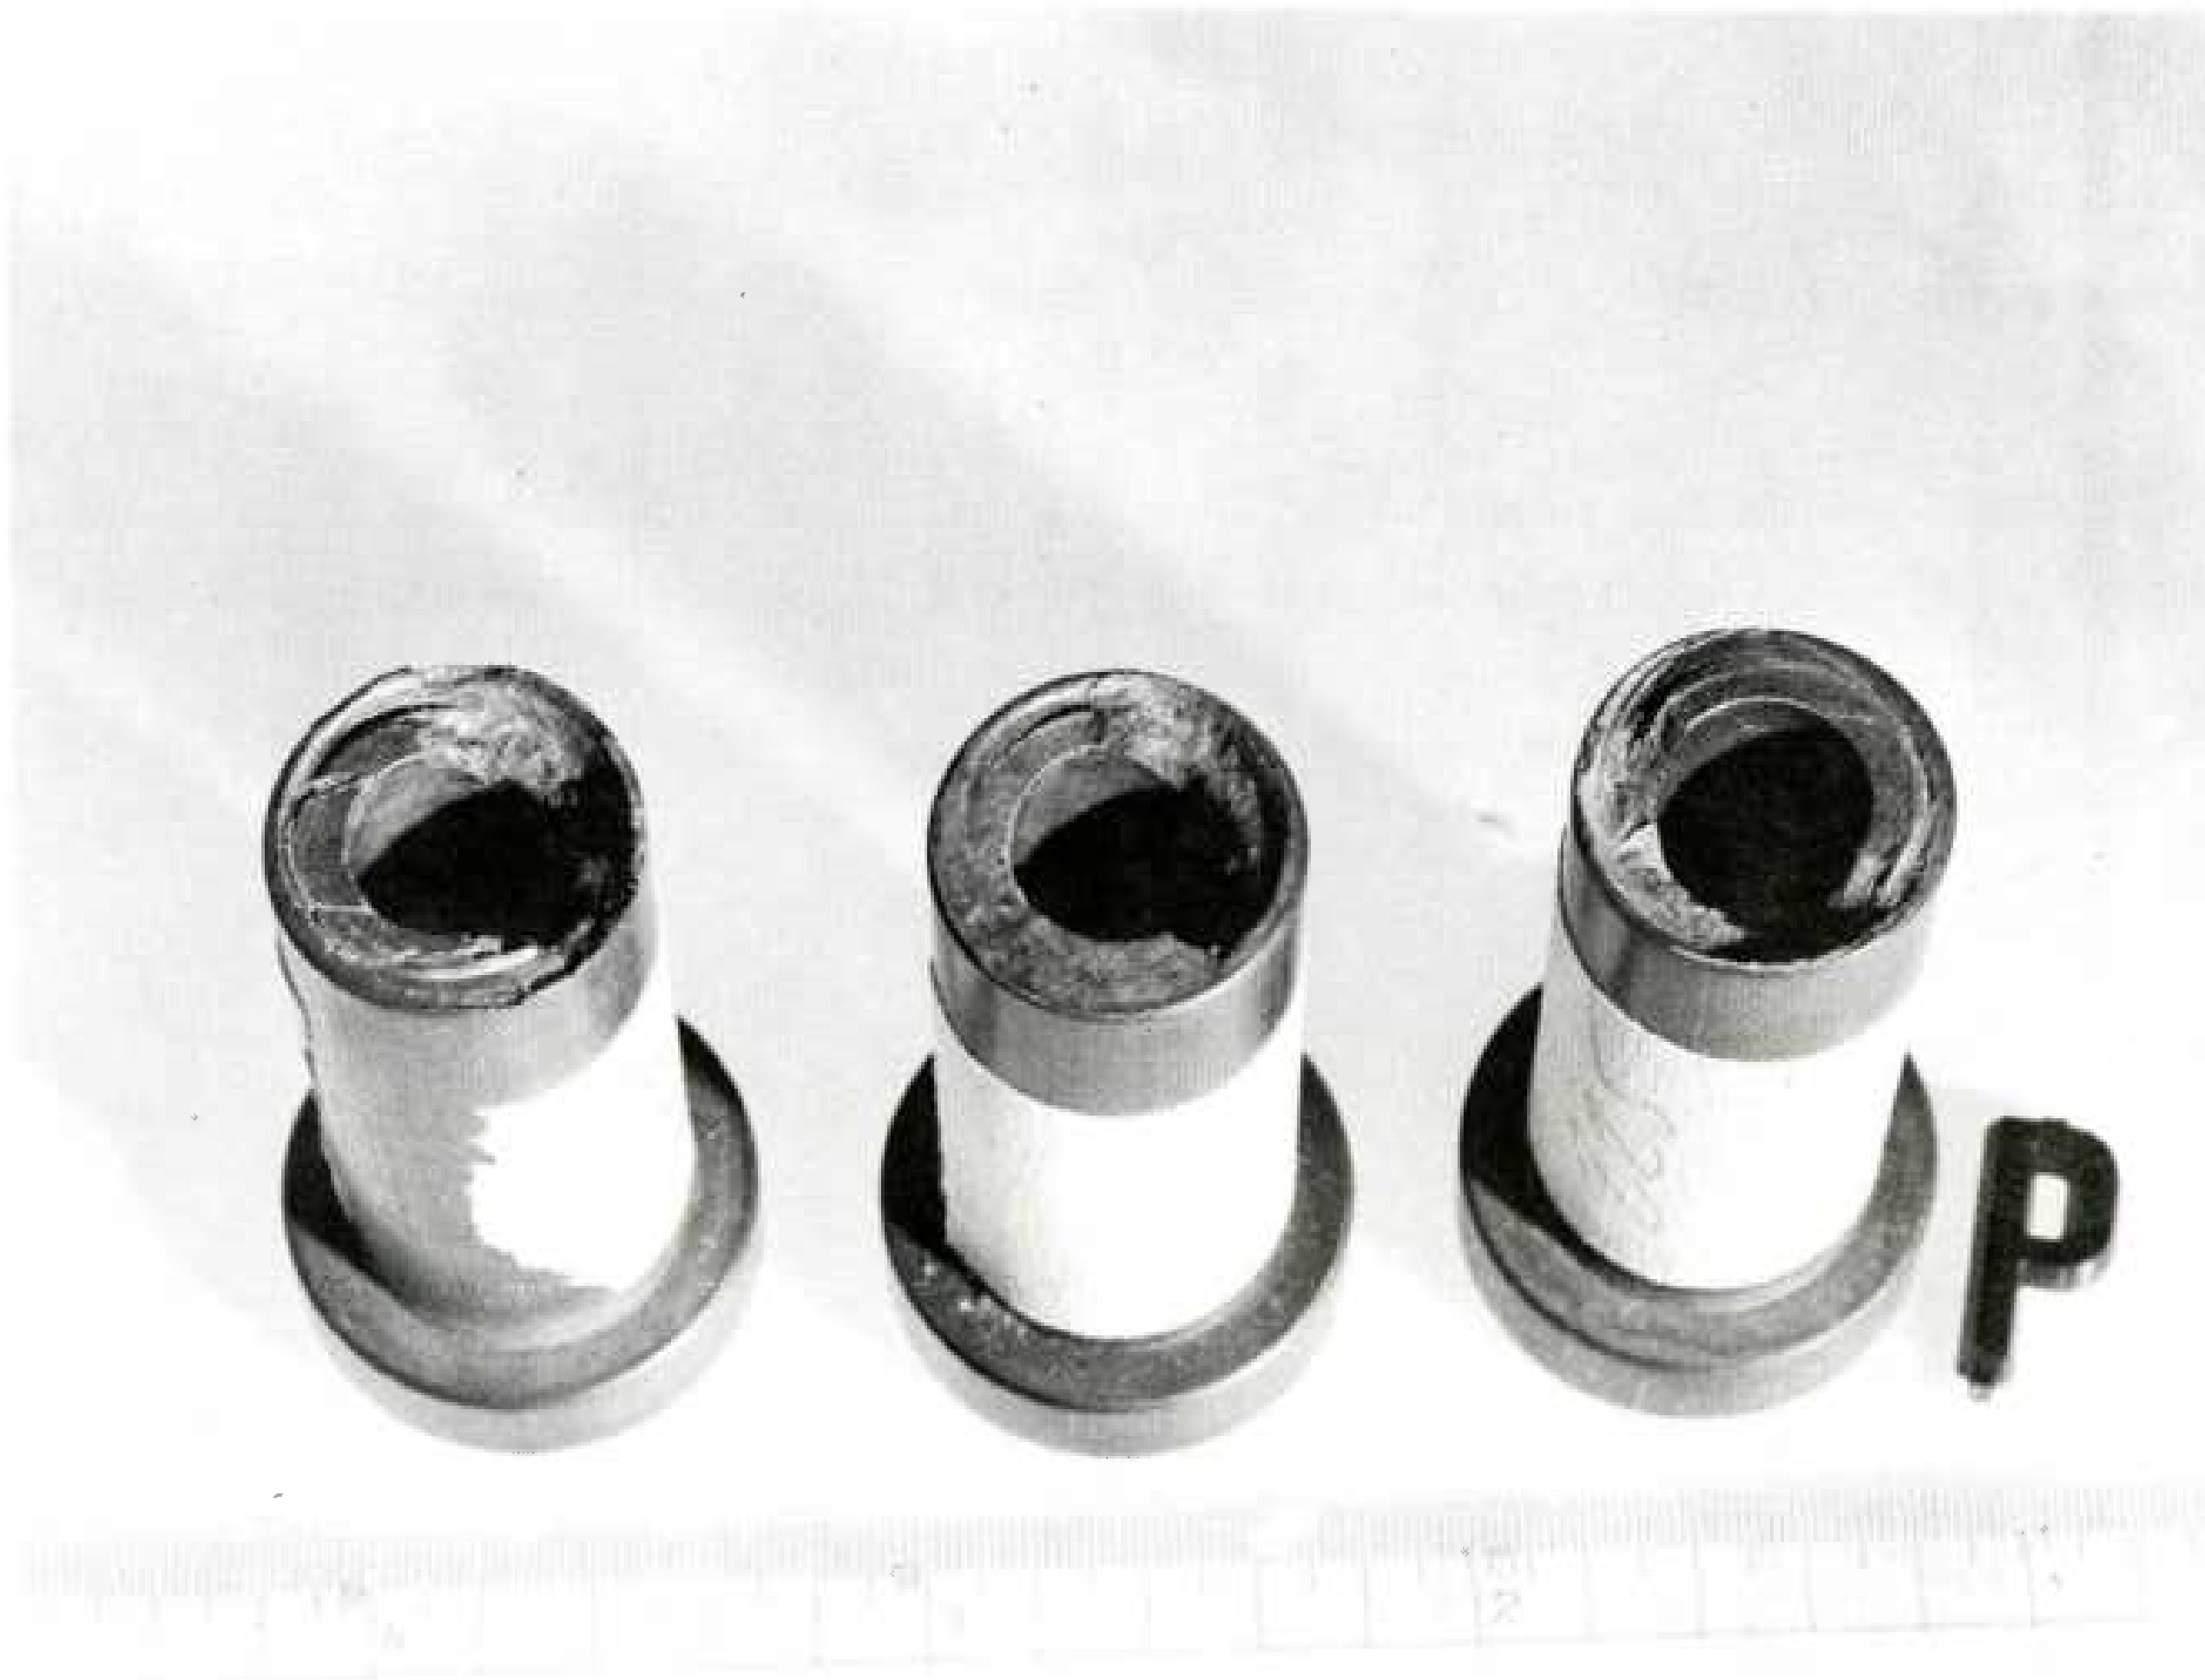
a. Eight agates contained small chips or gouged places in the flat exit surface (web) of the agate. It was assumed that the damage was caused by the production die agate disassembly operation or by cuts in the agate ID exit area. The latter was presumed to be caused by the strand removal tool utilized to remove plugged strands from the agates while the die agates were still in the 305 mm (12 in) press. These agates involved were Nos. 203, 204, 205, 207, 211, 221, 222, and 225.

Figure 19. Examples of graphite/Teflon/PPS agates showing damage to exit web surfaces.
