CONTRACTOR REPORT ARLCD-CR-78033

USING GRAPHITE FILAMENT COMPOSITION AS A DIE MATERIAL

R. J. STYNE

OCTOBER 1978

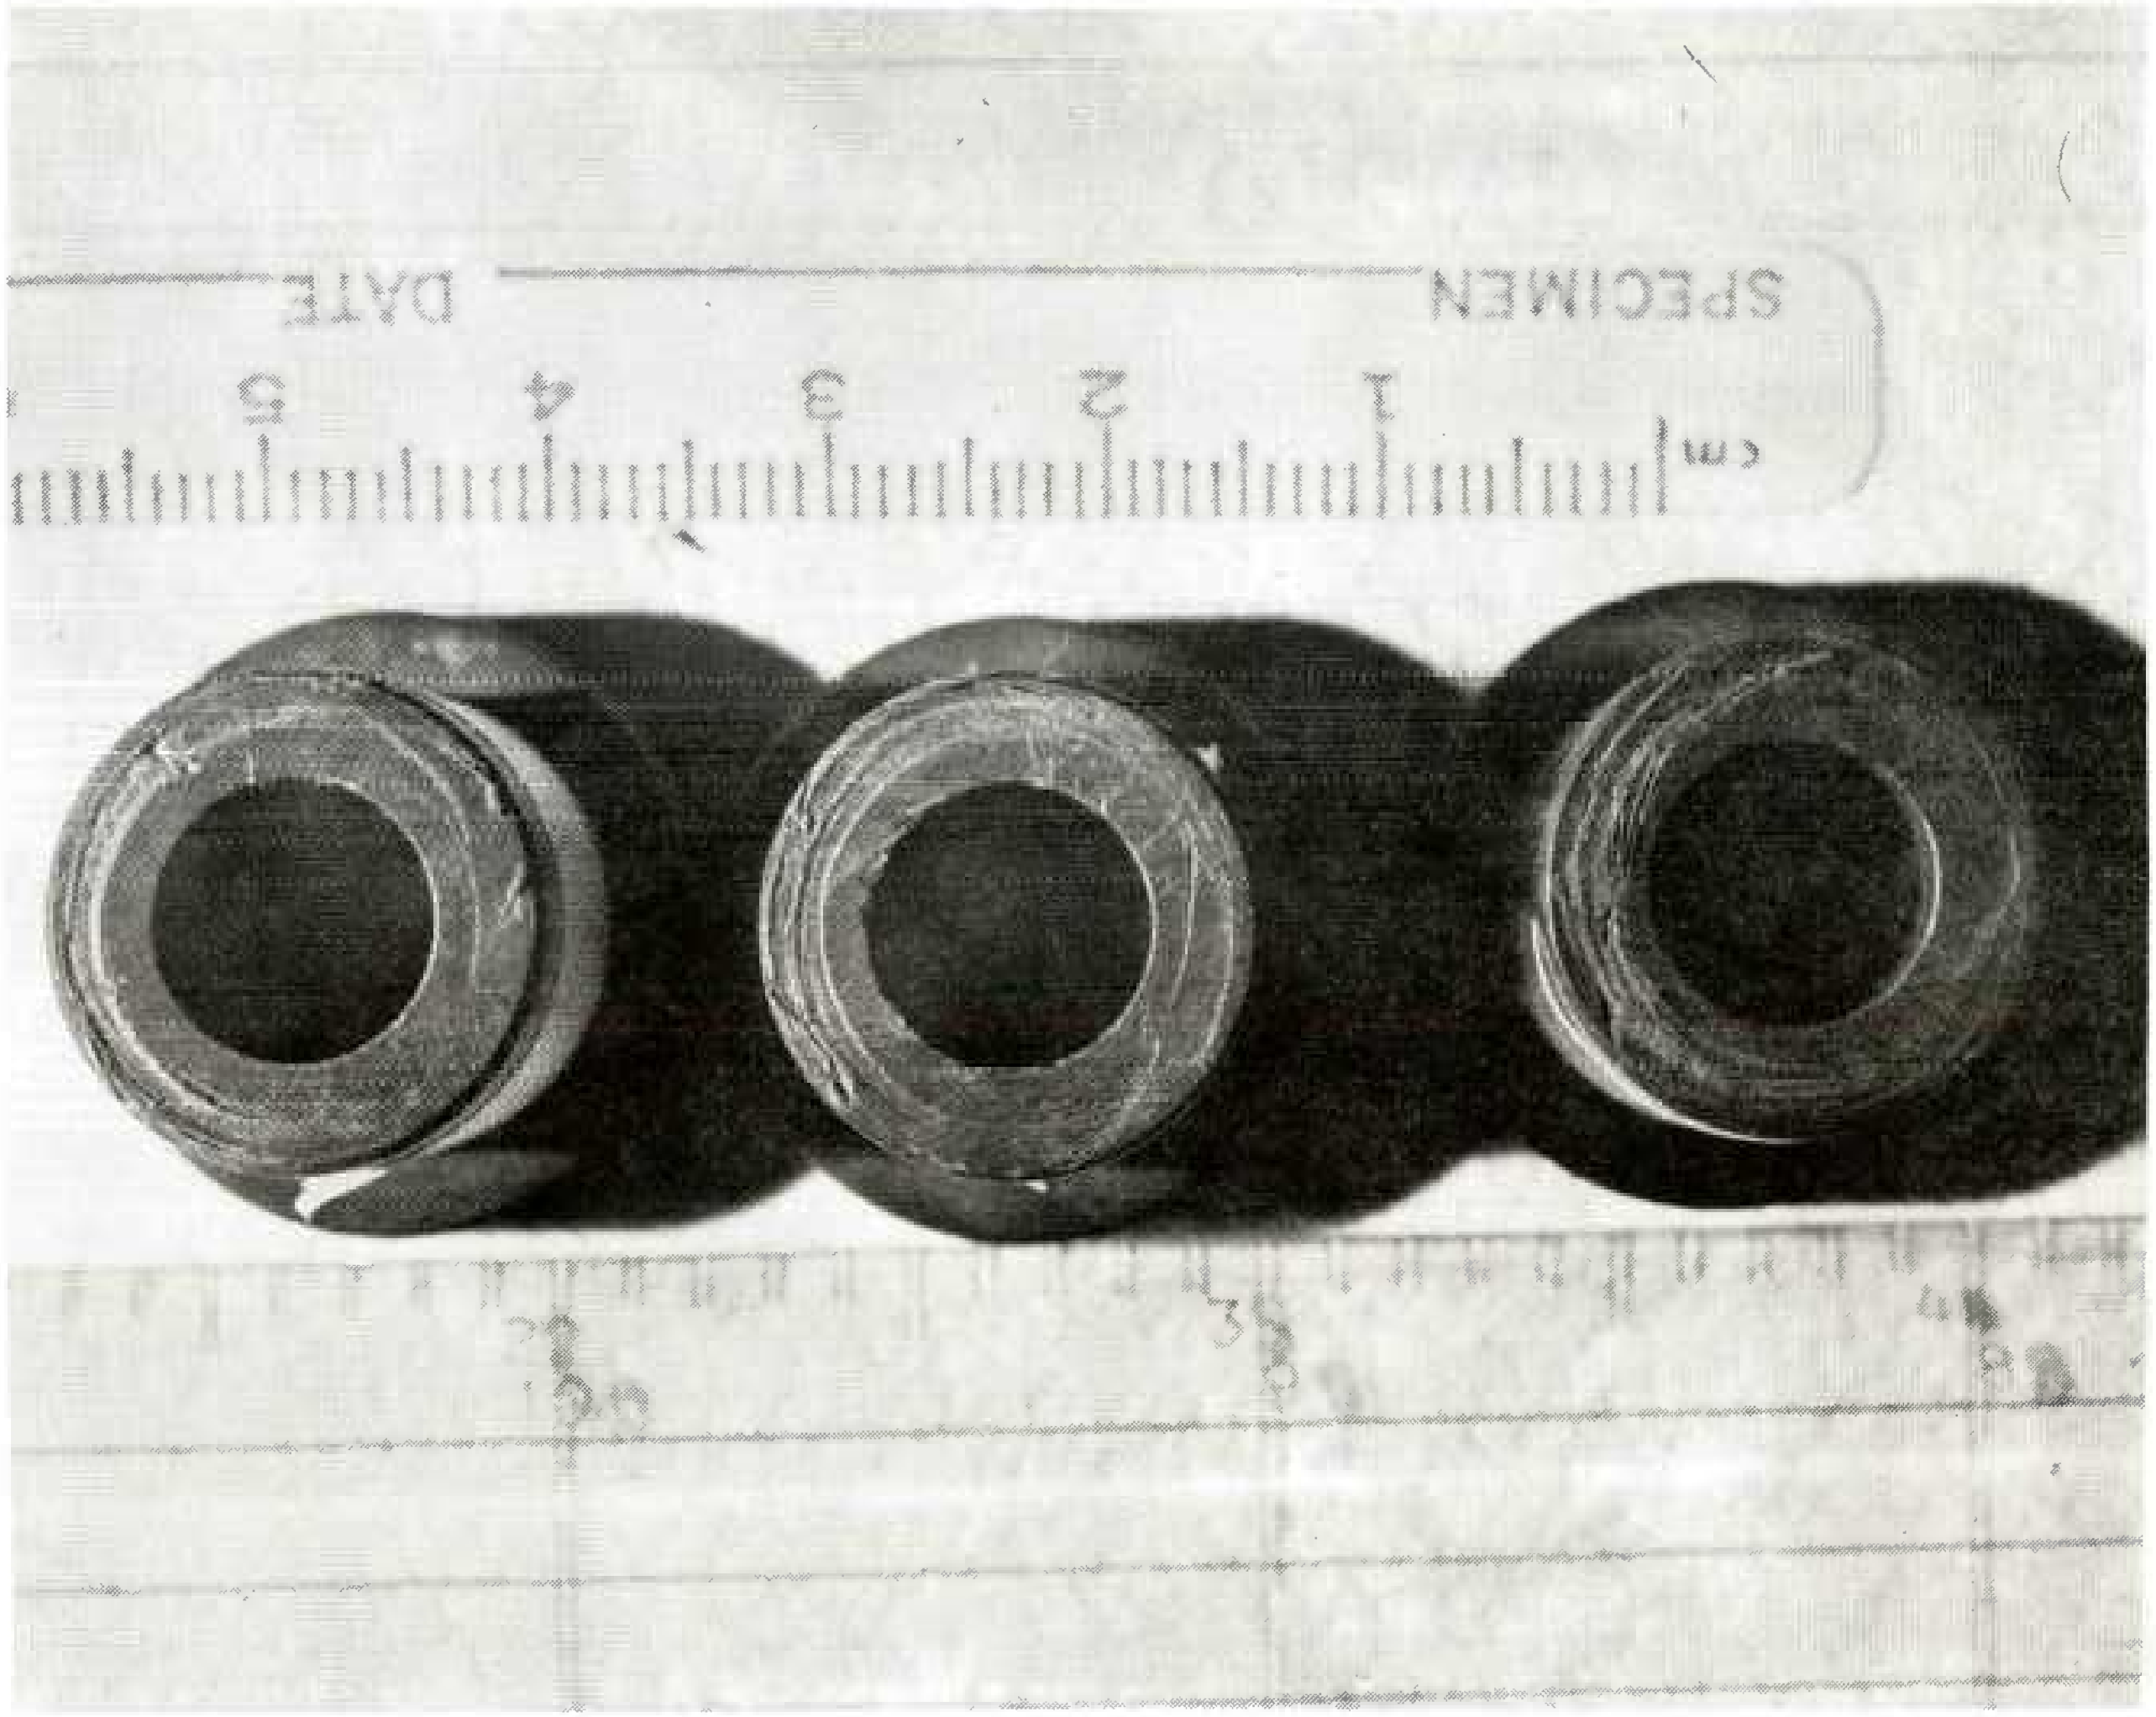
Figure 20. Examples of graphite/Teflon/PPS agates showing angular rings caused by the die removal tool and related to web damage depicted in Figure 19.

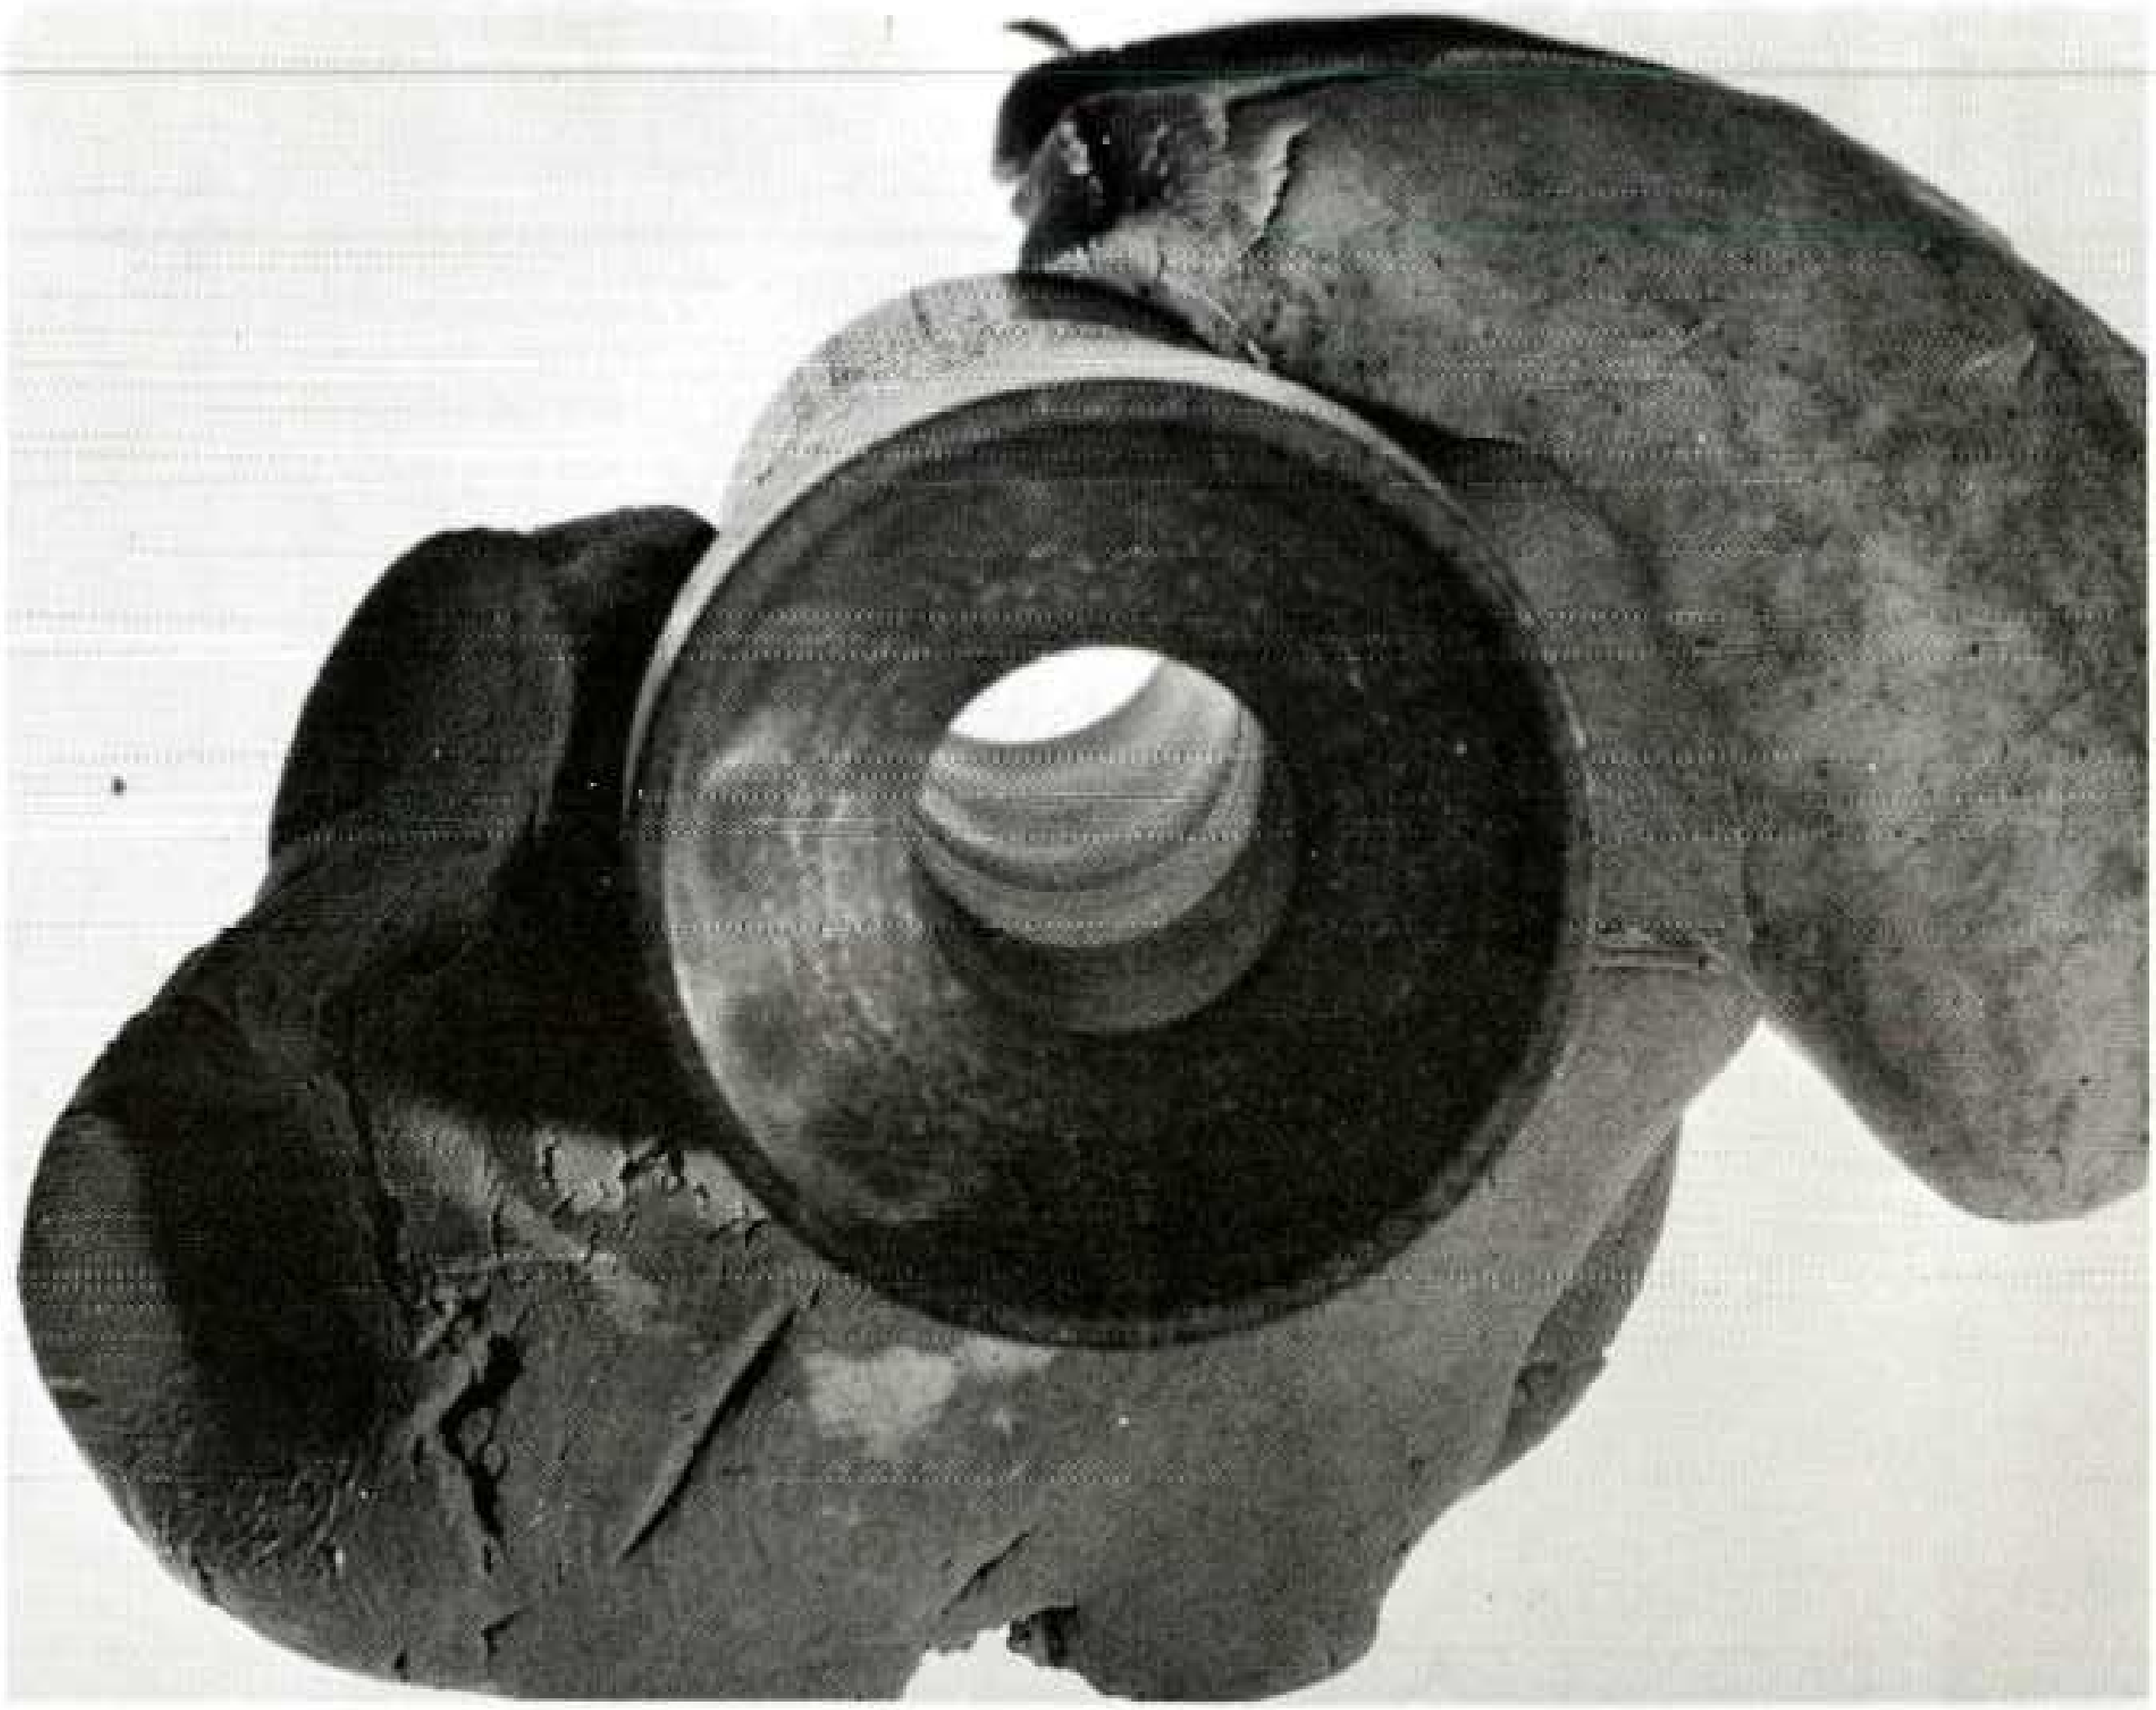
Figure 22. Example of graphite/Teflon/PPS agate showing angular rings indicating irregular agate ID wear.

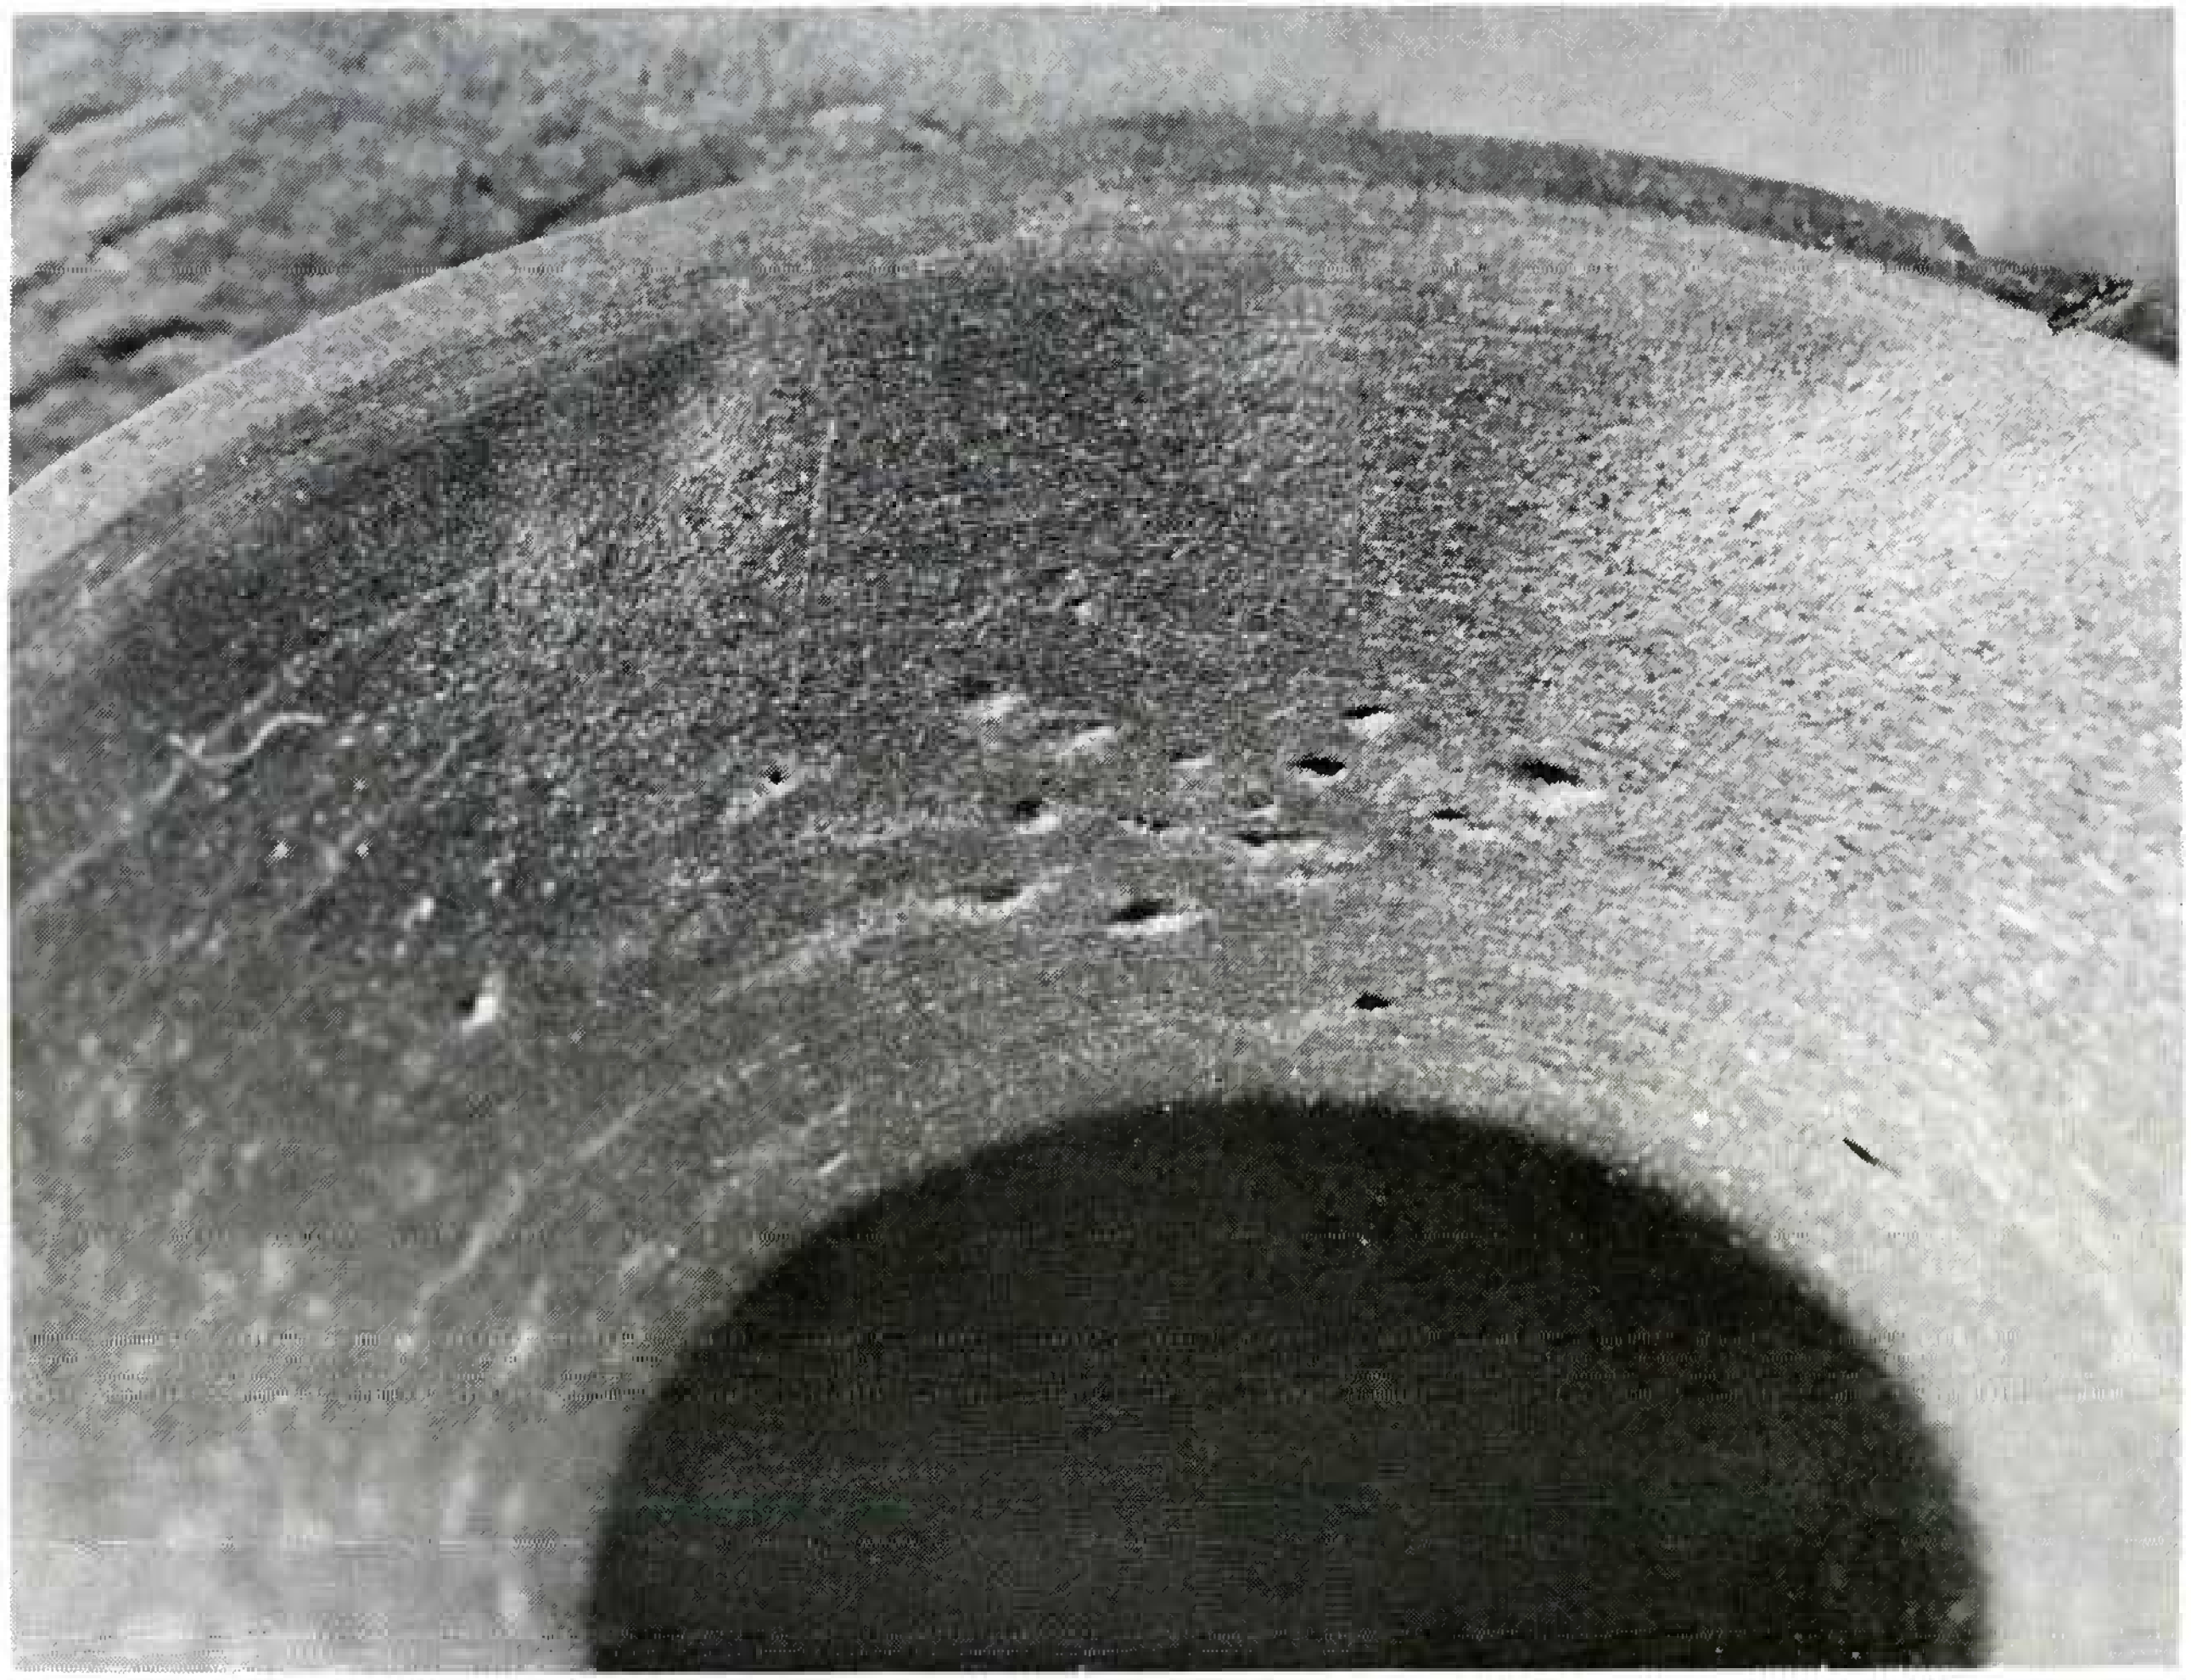
Figure 23. An enlargement of the approach angle surface of a graphite/Teflon/PPS agate which shows pitting that occurred in several agates.

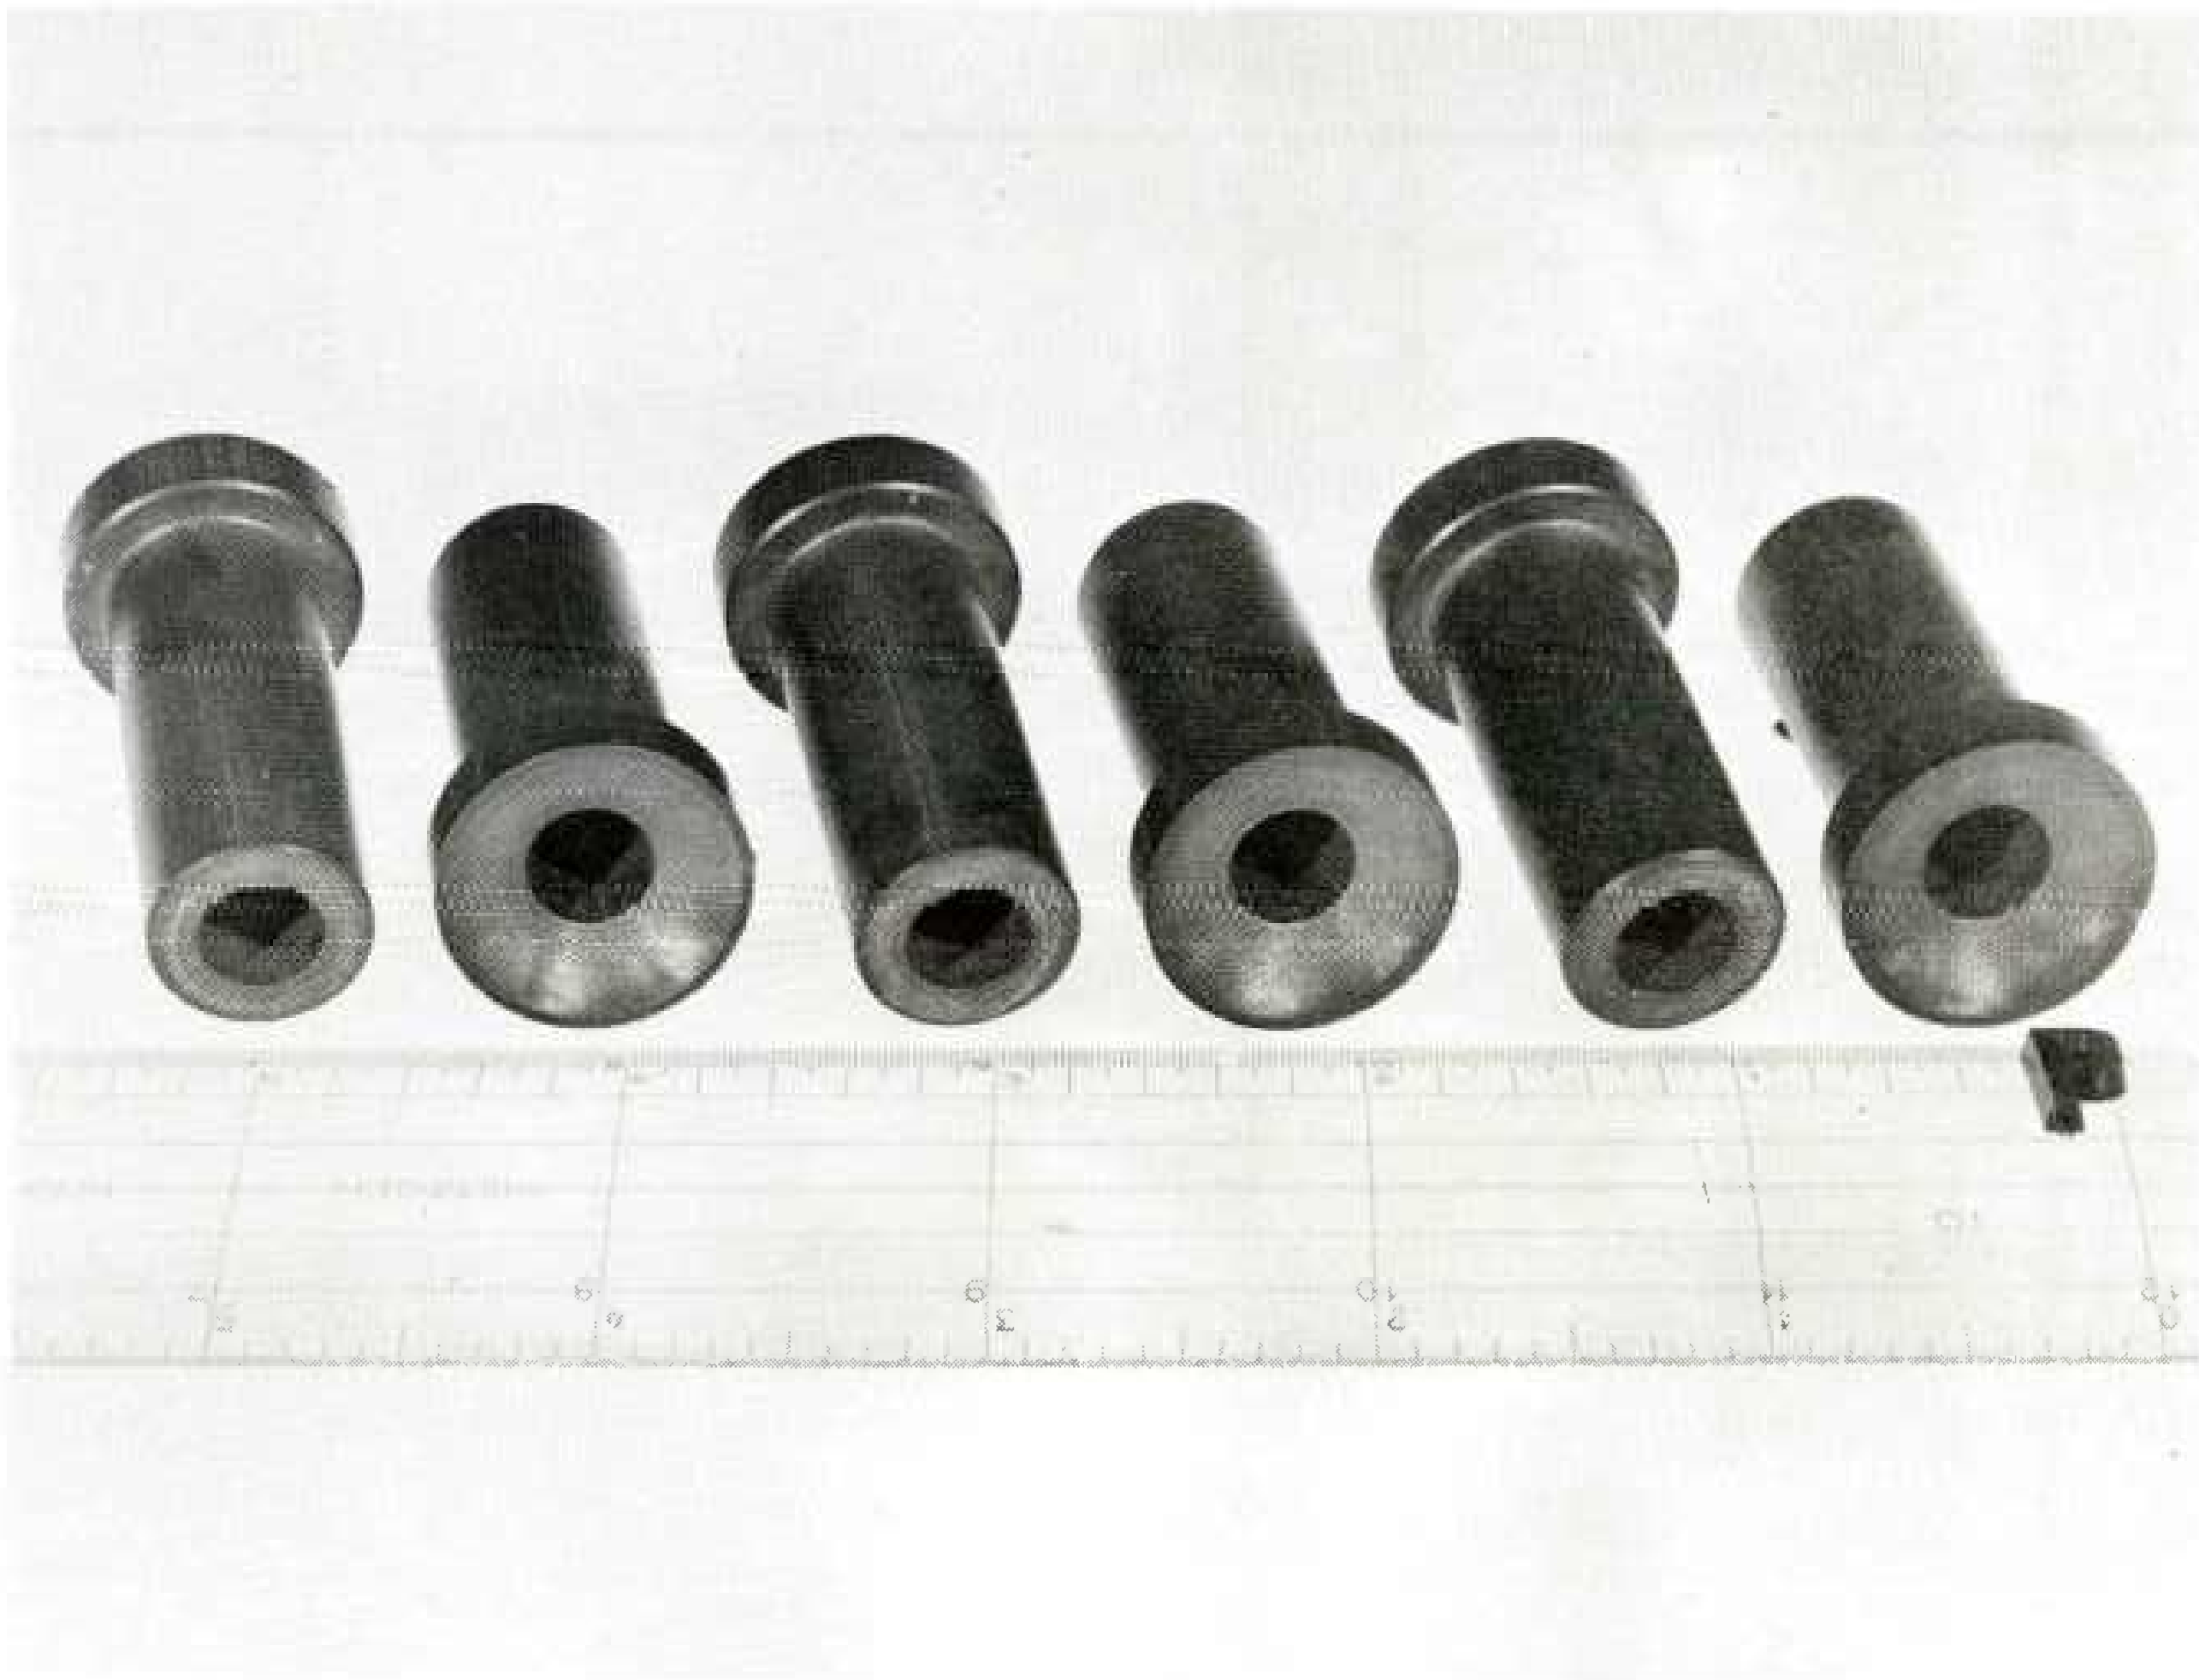
Figure 24 shows typical examples of graphite/Teflon/PPS agates judged to be free of significant defect after six weeks of production usage. They may be visually compared for a comparison of serviceability to the agates shown in Figure 6.

Figure 24. Examples of graphite/Teflon/PPS agates at the completion of the six week evaluation period.
