AFFDL-TR-79-3014

A-10 STATIC STRUCTURAL TEST PROGRAM

February 1979

Final Technical Report

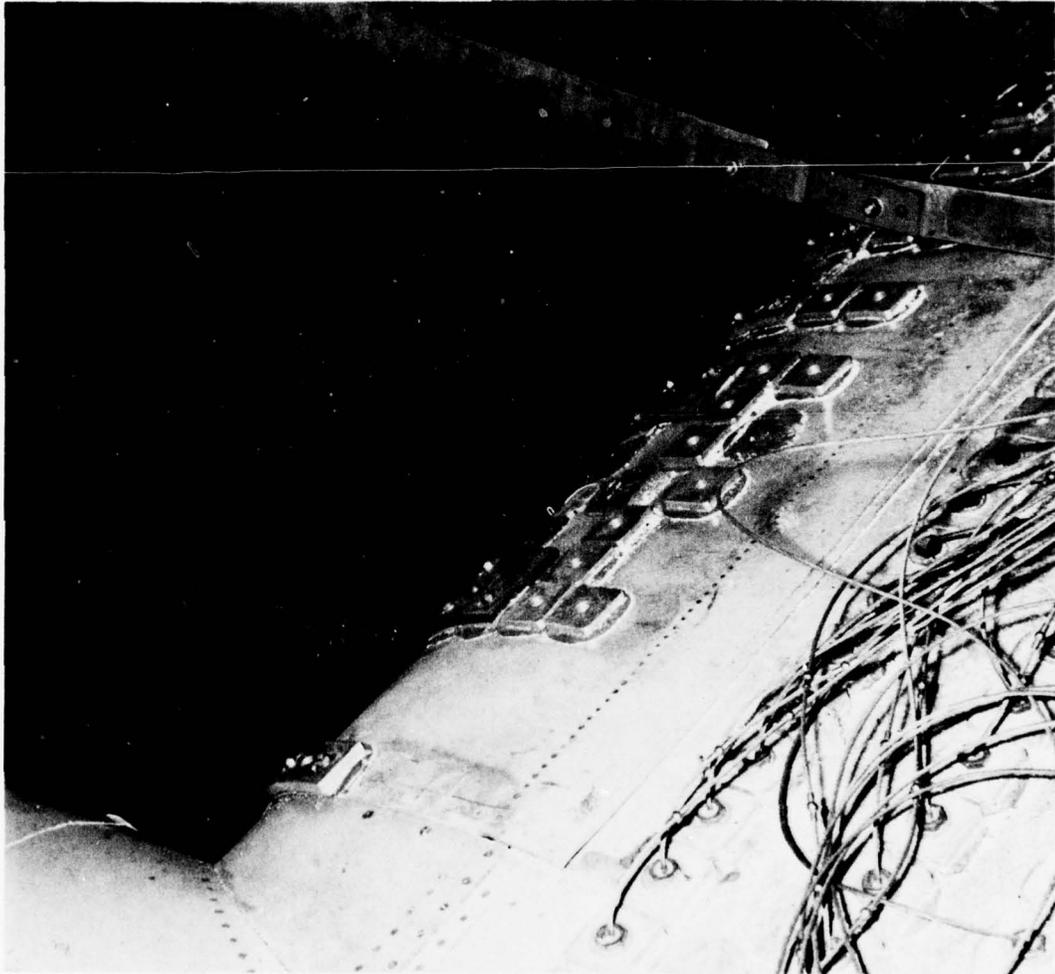
There was a failure in the test hardware at approximately 95% DUL. This condition was repeated as a failing load test (Item 87). The structure supported 127% DUL. At this load, the upper inboard cover of the wing failed between BL0 and LBL23. Damage to the structure after the failing load test is shown in Figures 8 through 18.

Figure 9: Damage After Failing Load Test-
Left Side Leading Edge Slat;
Outboard End

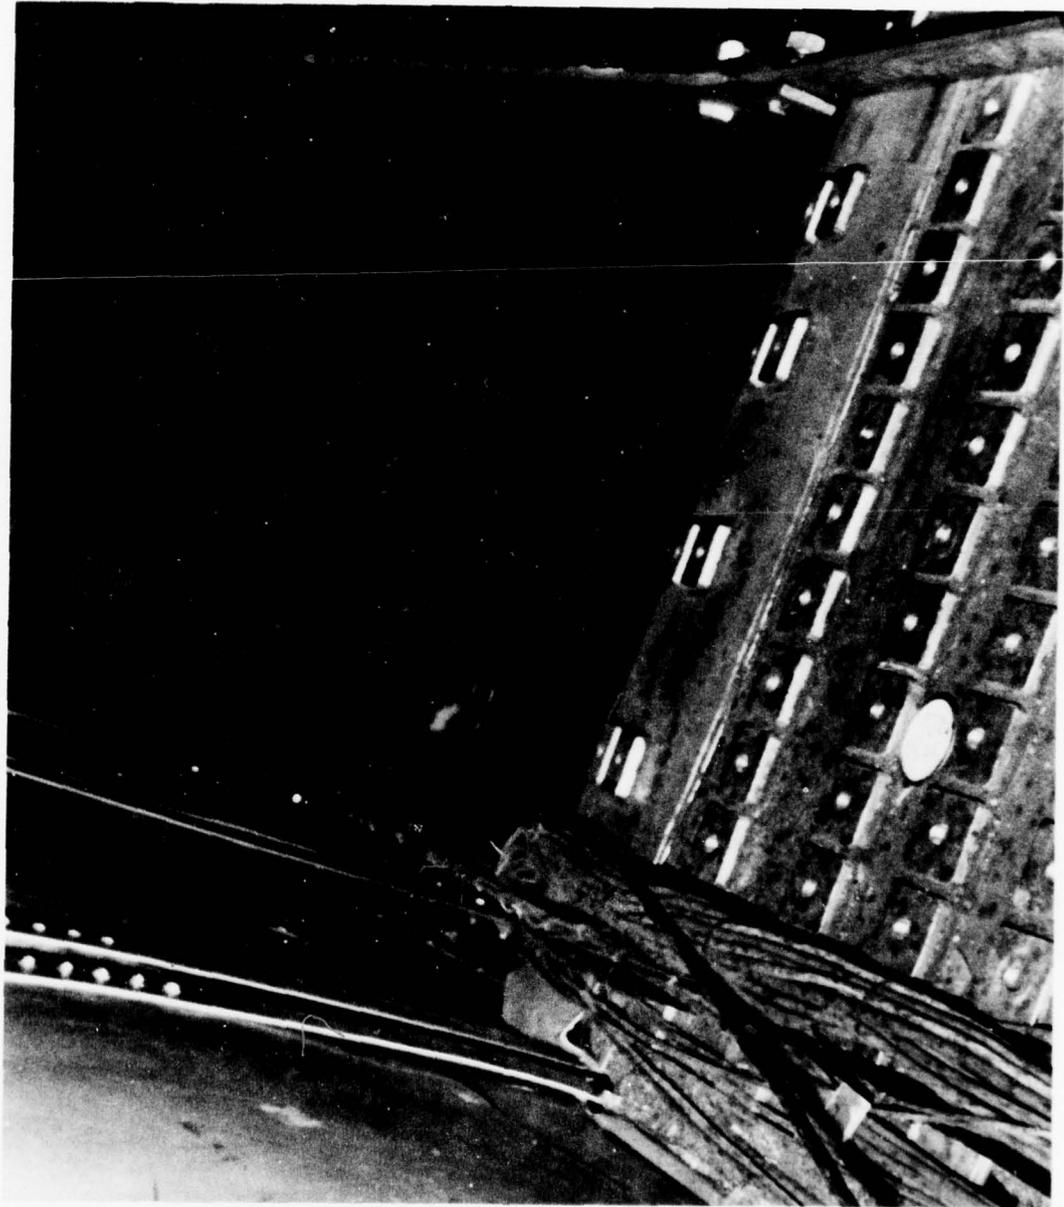
Figure 10:   Damage After Failing Load Test-
Right Side Leading Edge Slat;
Inboard End

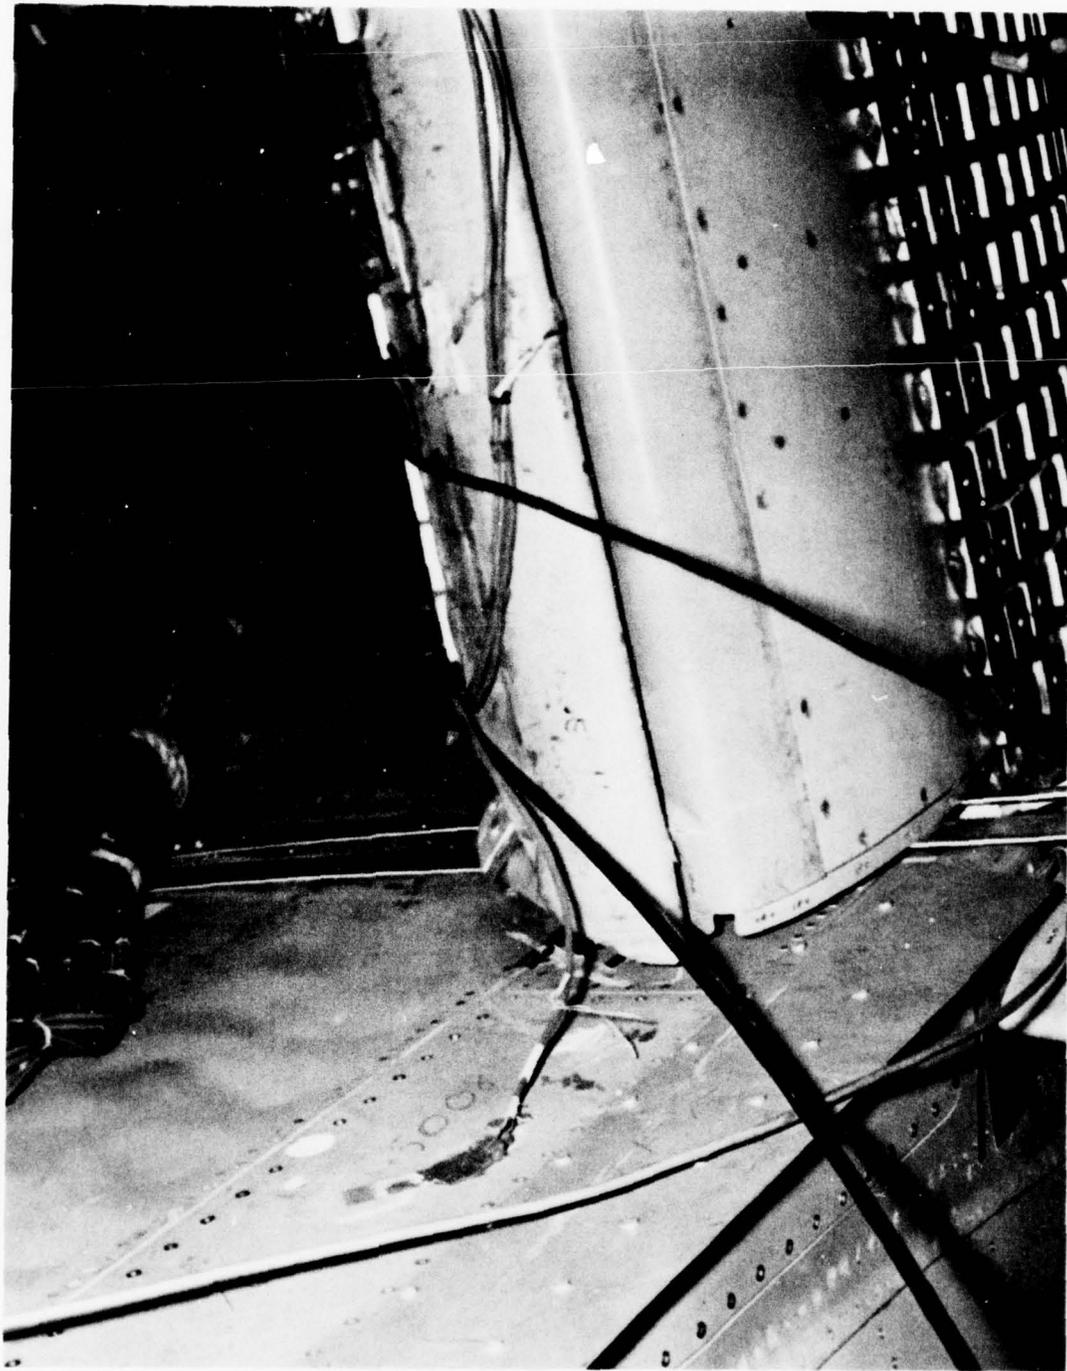
Figure 11: Damage After Failing Load Test–
Left Side Leading Edge Slat;
Inboard End

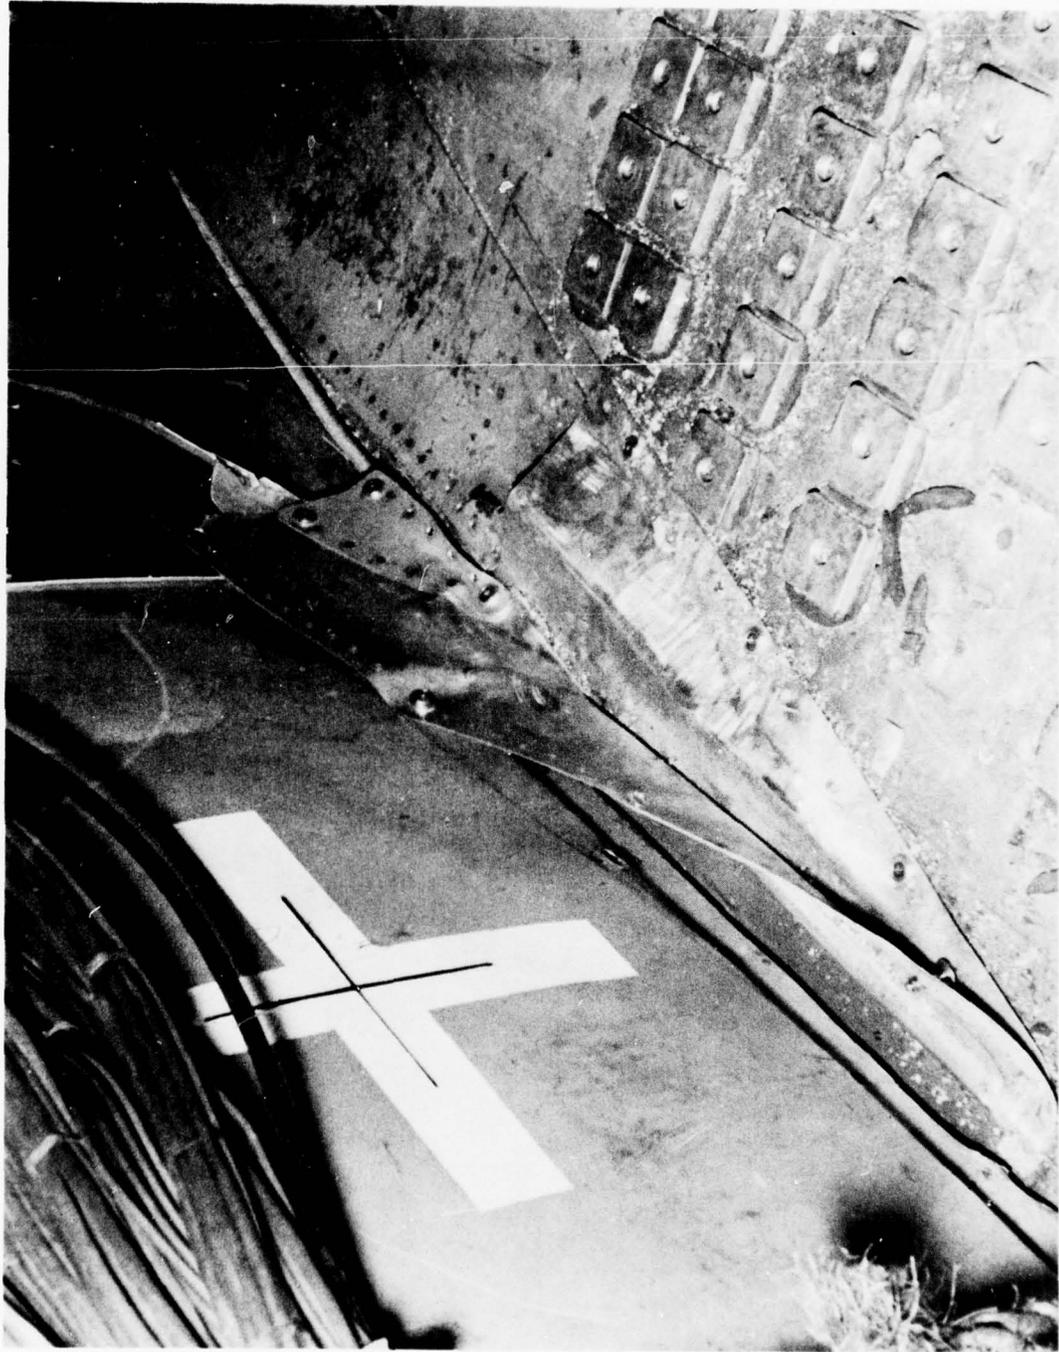
Figure 13: Damage After Failing Load Test-Wing-Fuselage Fairing; Left Side

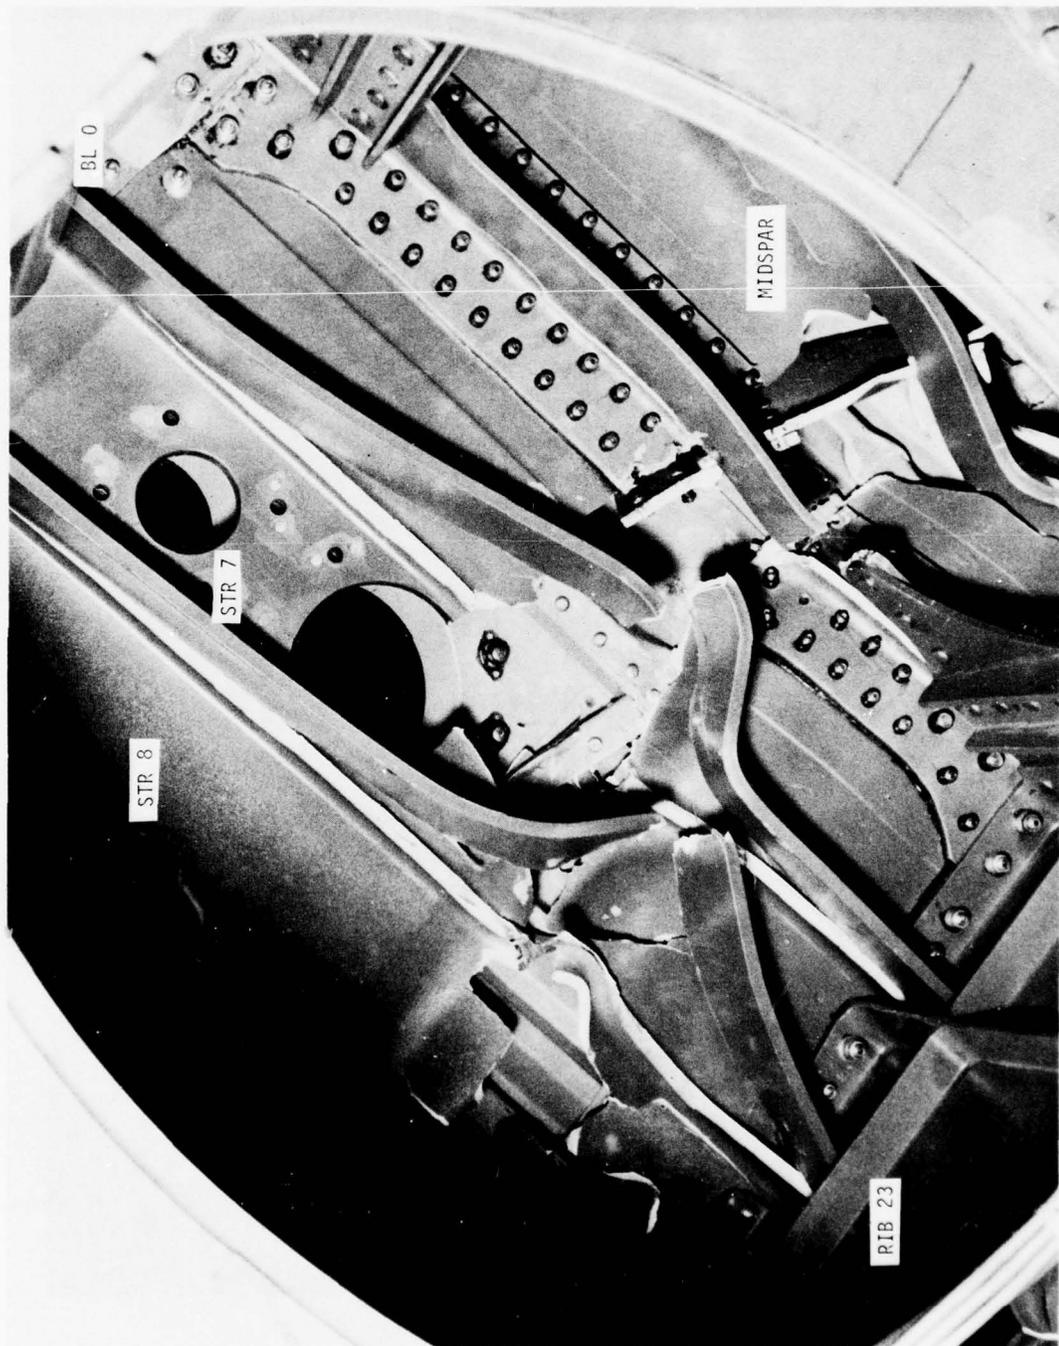
Figure 14. Inside of Wing Upper Cover Between BL 0 and LBL 23

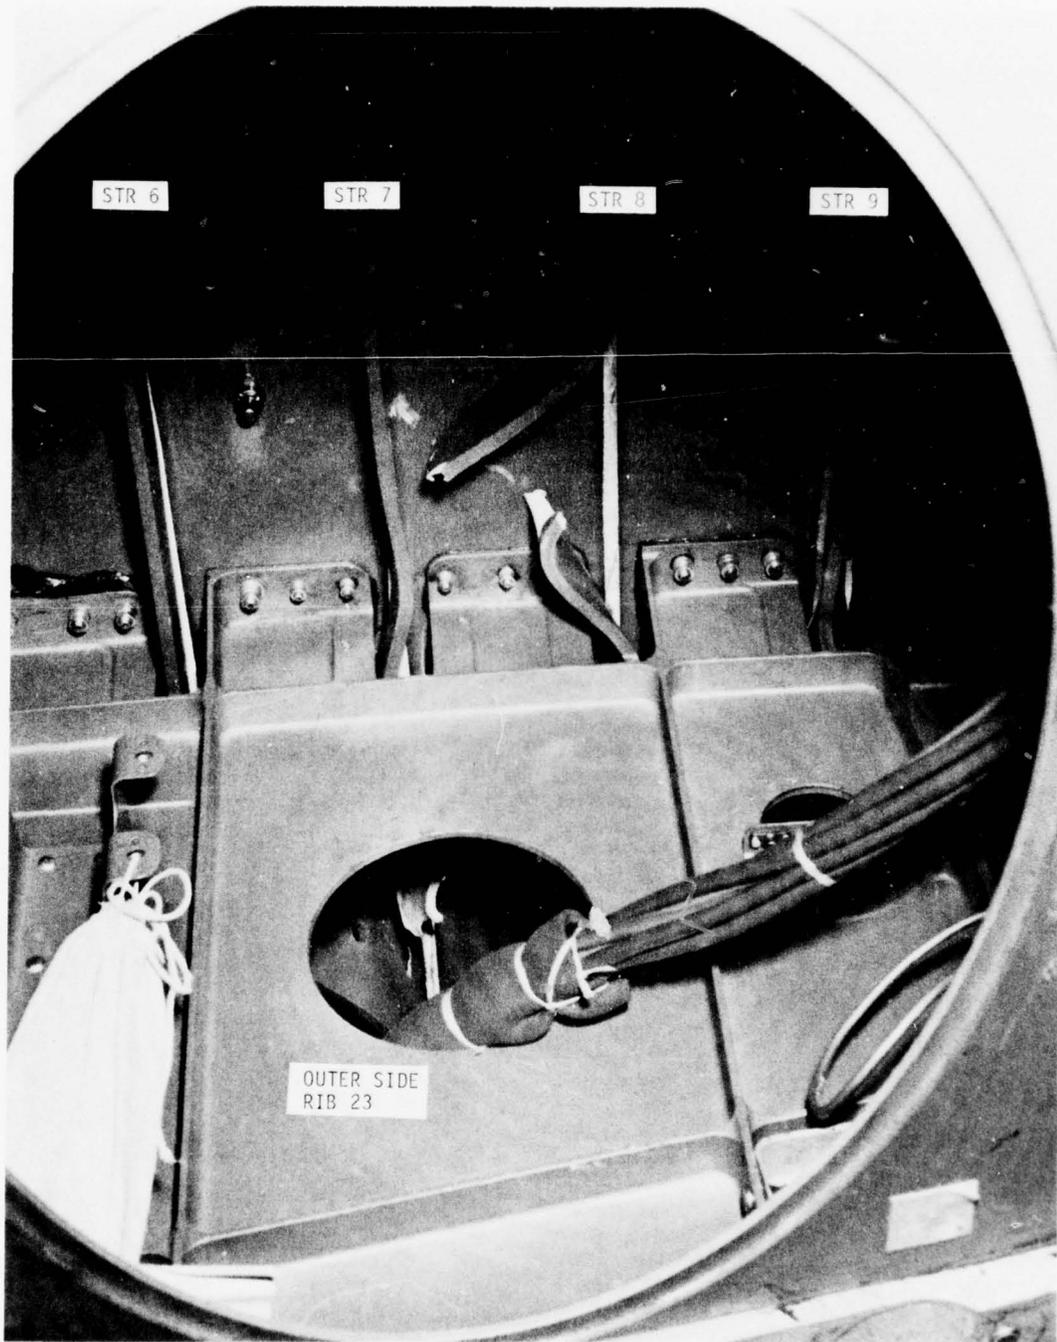
Figure 15. Inside of Wing Upper Cover Between LBL 23 and LBL 34

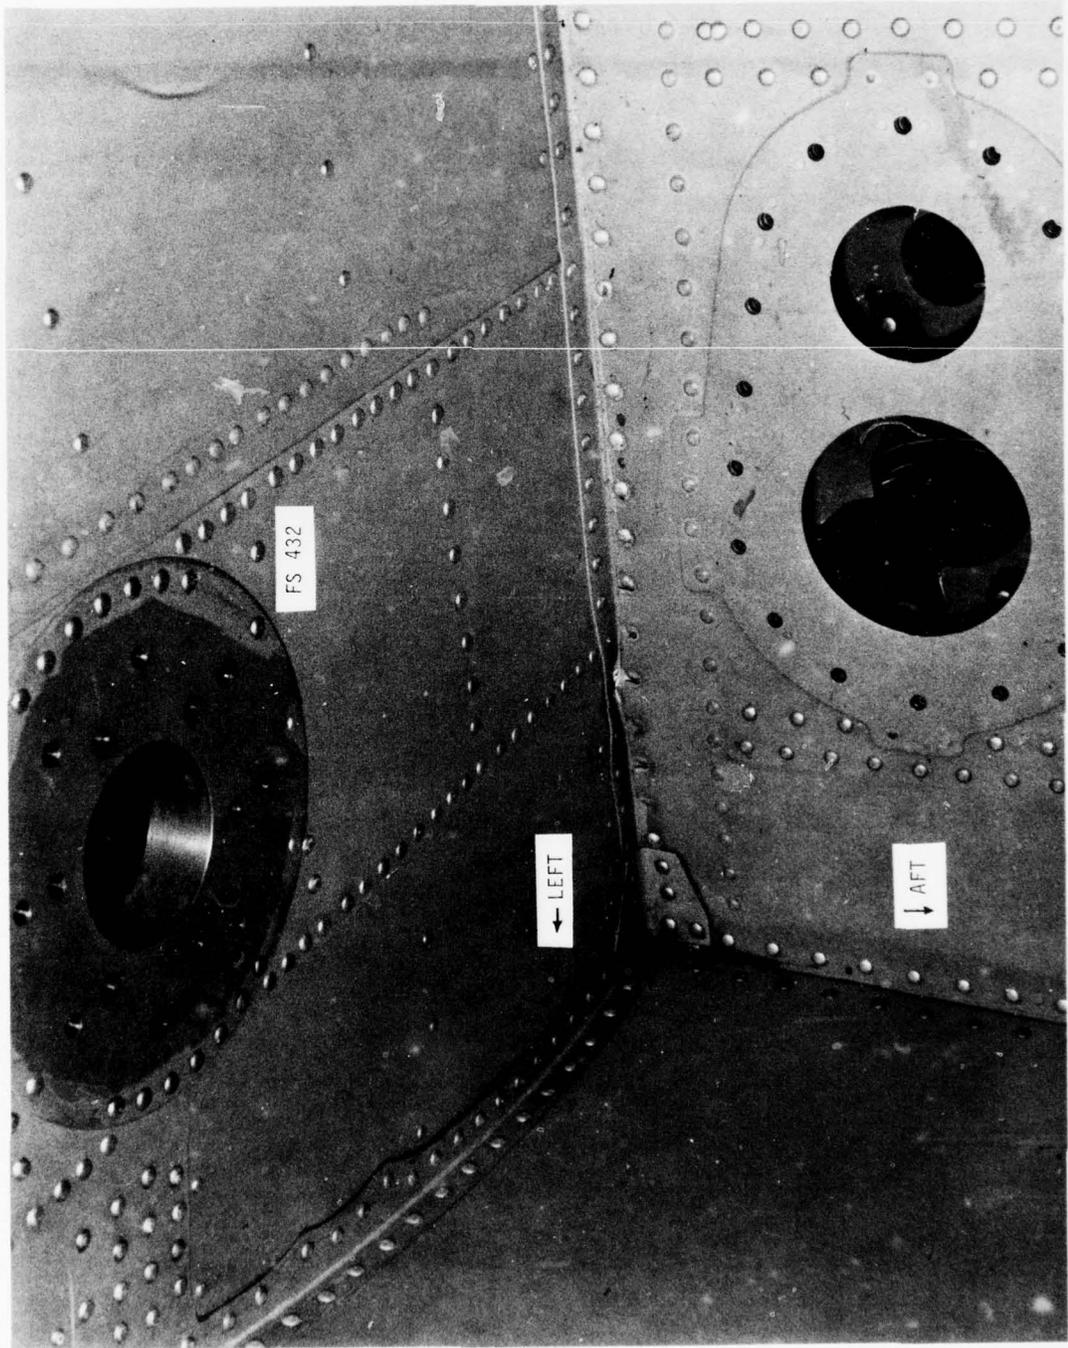
Figure 16. Inside of Fuselage Fuel Cell

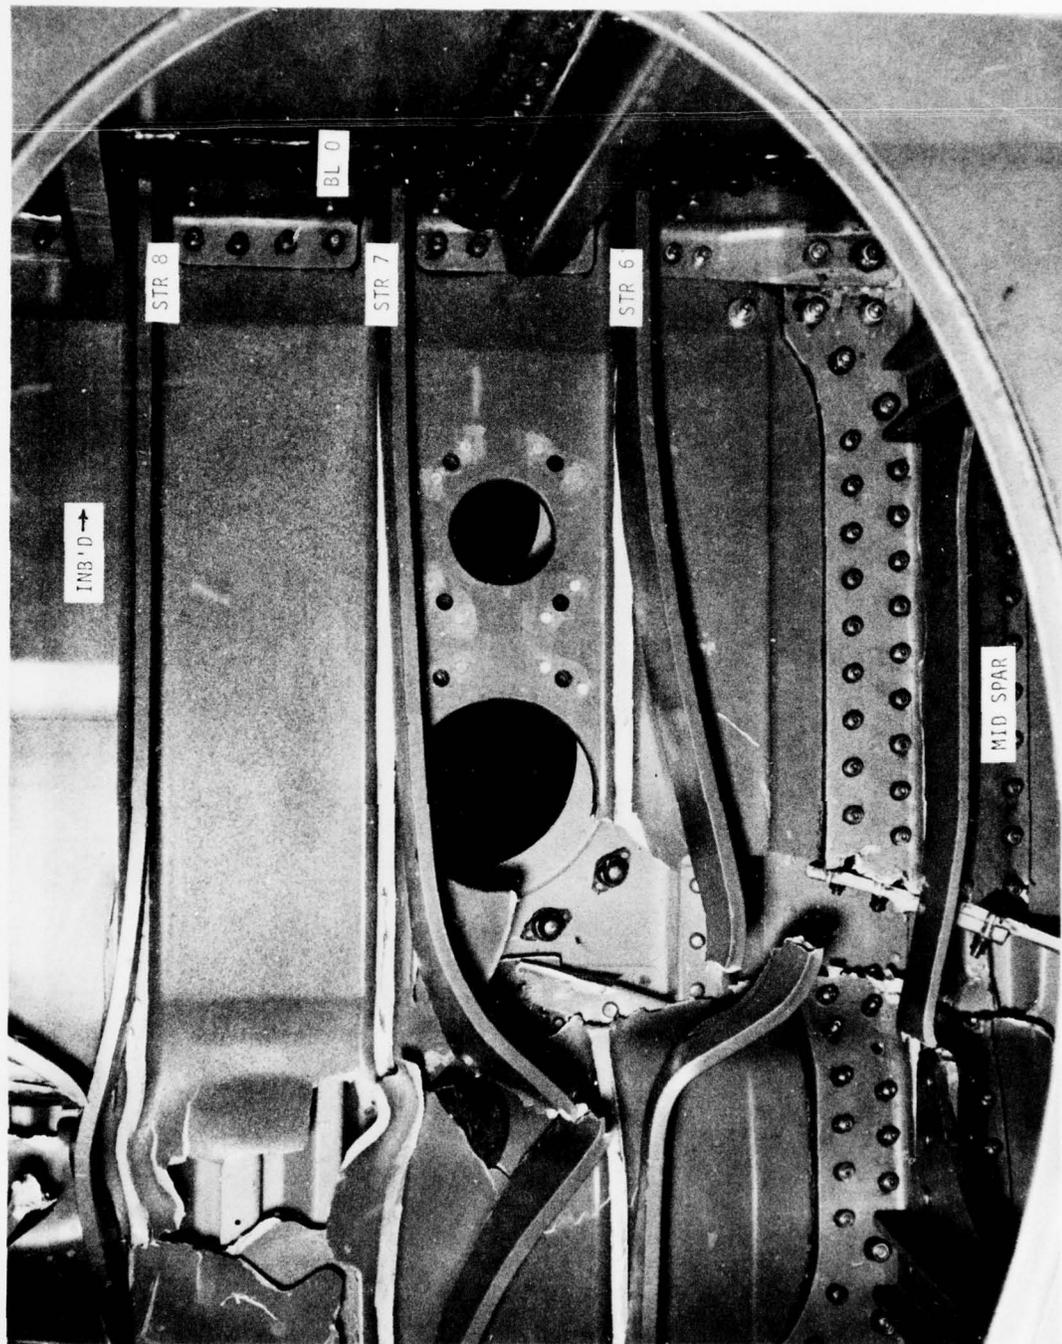
Figure 17. Inside of Wing Upper Cover Between BL 0 and LBL 23

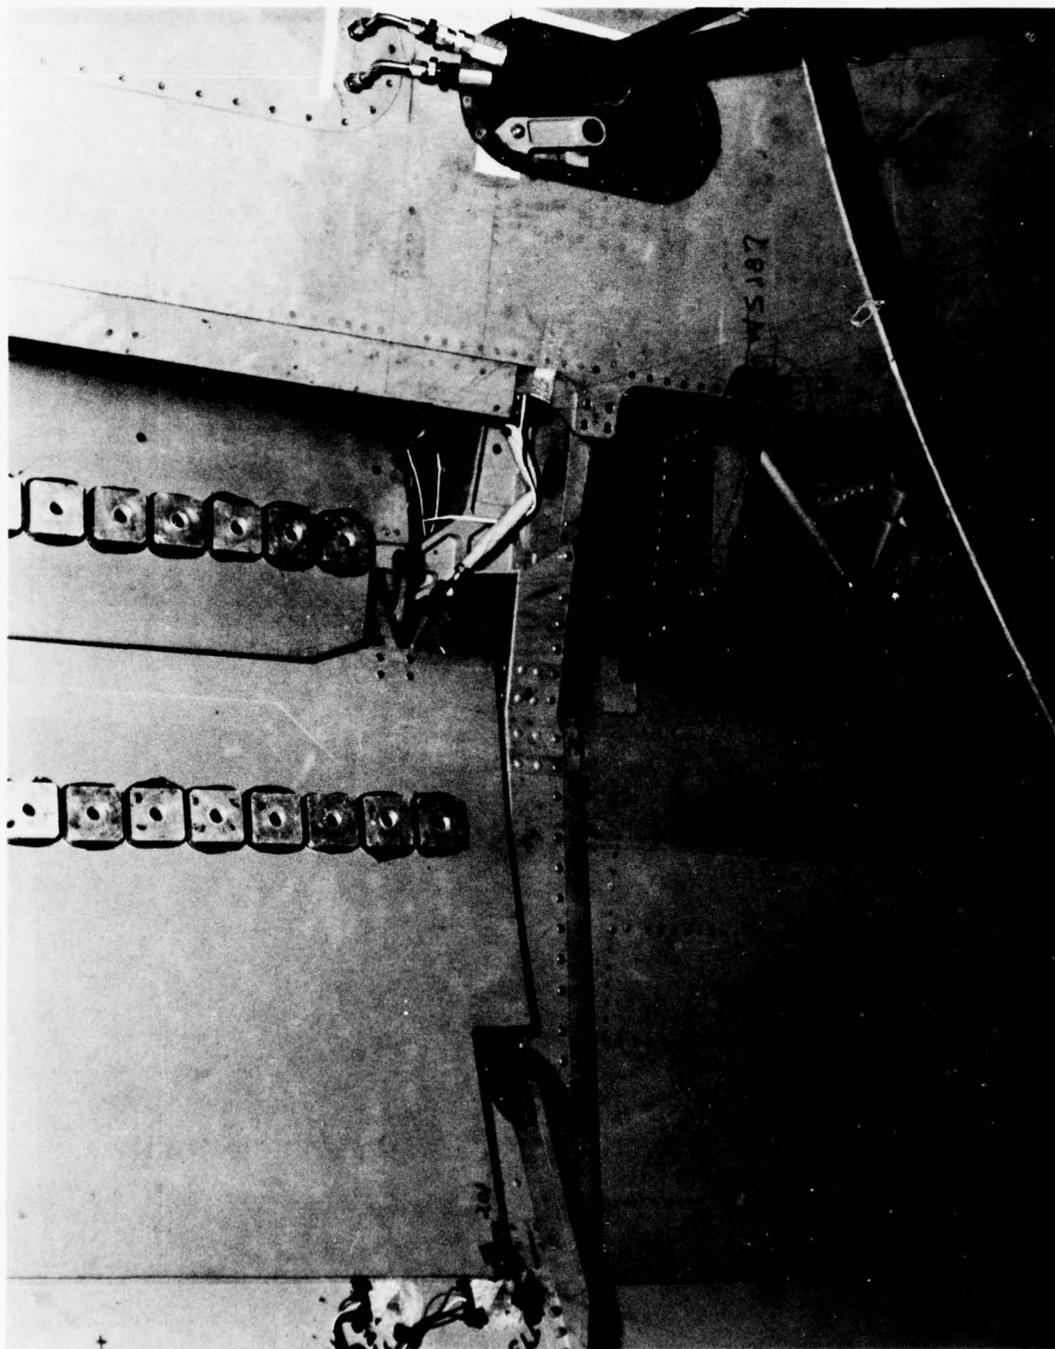
At 80% DUL, the Trim Tab Drive Pushrod (P/N 160C622007) buckled (Fig. 20). The critical design condition for which the geared tab was tested was the powered mode at 450 KEAS with the aileron 21° TED and a 0% speed brake setting, tab at 45° and tab hinge moment of - 6940 inch-pounds ultimate. However, based on flight test data, the maximum tab hinge moment is - 3720 inch-pounds. This occurs in the powered mode at 450 KEAS with the aileron at 28° TEU and a 40% speed brake setting. Based on the above facts, FRC concluded that the aileron tab components did pass the required static ultimate test and no further testing would be required. The A-10 SPO concurred with this opinion.

Figure 20. Failed Trim Tab Drive Pushrod - Part No. 160C622007

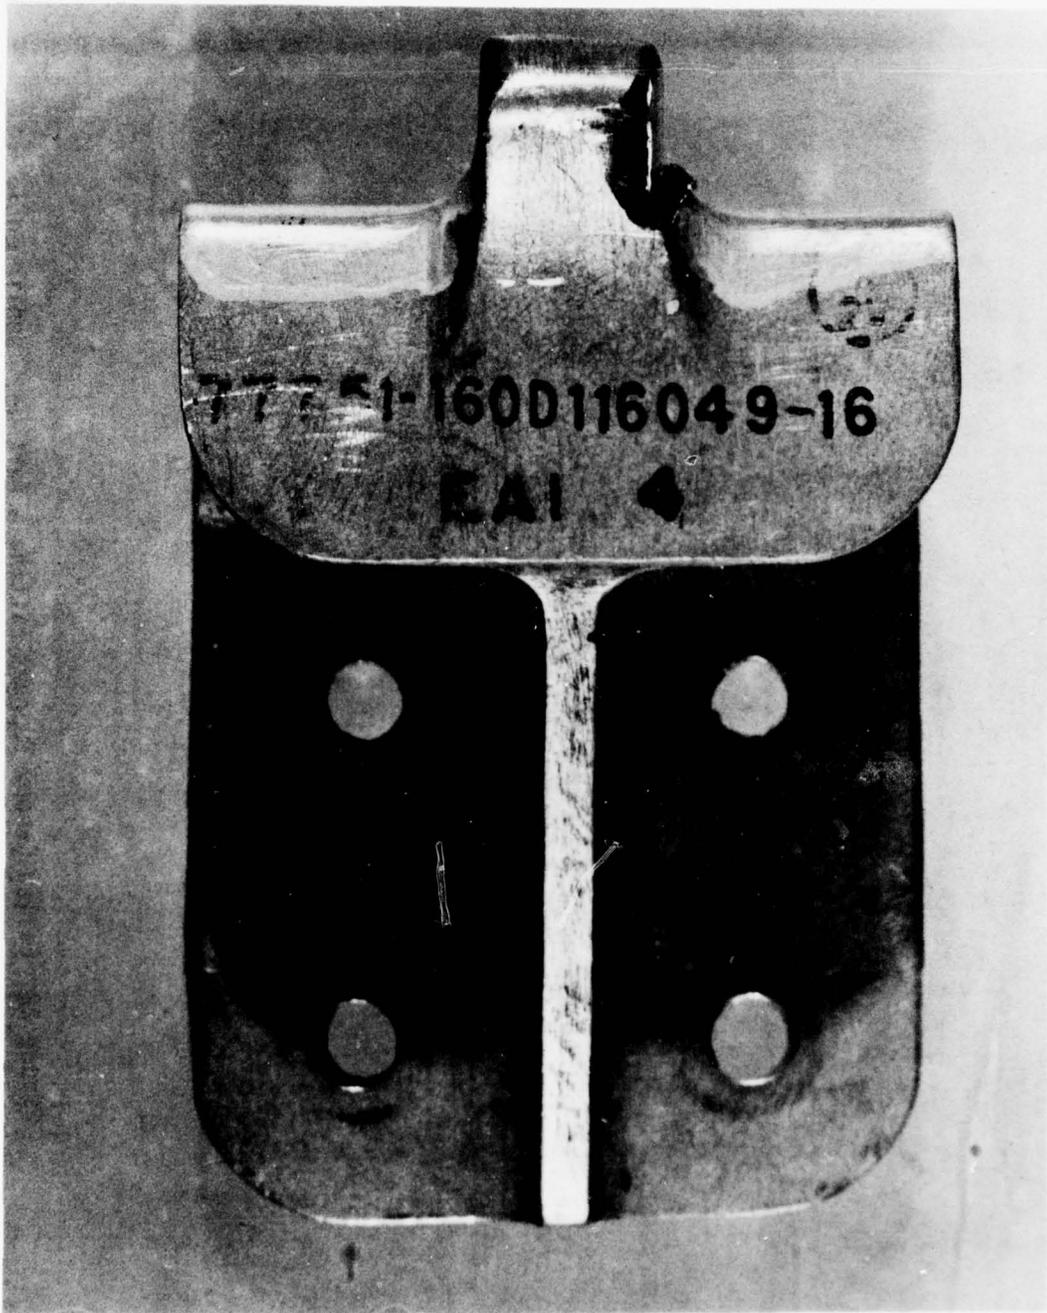
While approaching limit pressure (4.9 psig) for the Cockpit Pressuri-
zation Test, a noise was heard and the cockpit pressure dropped. It was
found that the right hand canopy support fittings had become disengaged
due to the aft movement of the canopy as the pressure was increased. The
fittings attached to the cockpit side rails (P/N 160D116049) are aluminum,
the fittings on the canopy (P/N 160D117244) are steel. The failure
occurred when the canopy had moved aft to a point where the canopy fitting
sheared off a portion of the side rail fitting (Fig. 21). It was also
found that the right hand side rail fitting had been installed 3/16" aft
of center. The left hand fitting was 1/8" aft of center. The side rail
fitting was re-designed by FRC with a wider flange (.625 inch). The re-
designed parts were installed and the test re-run. At a cockpit pressure
of 5.35 psig (72.9% DUL) the same type of failure occurred (Fig. 22).

Figure 21. Failed Canopy Support Fitting – Part No. 160D116049-16

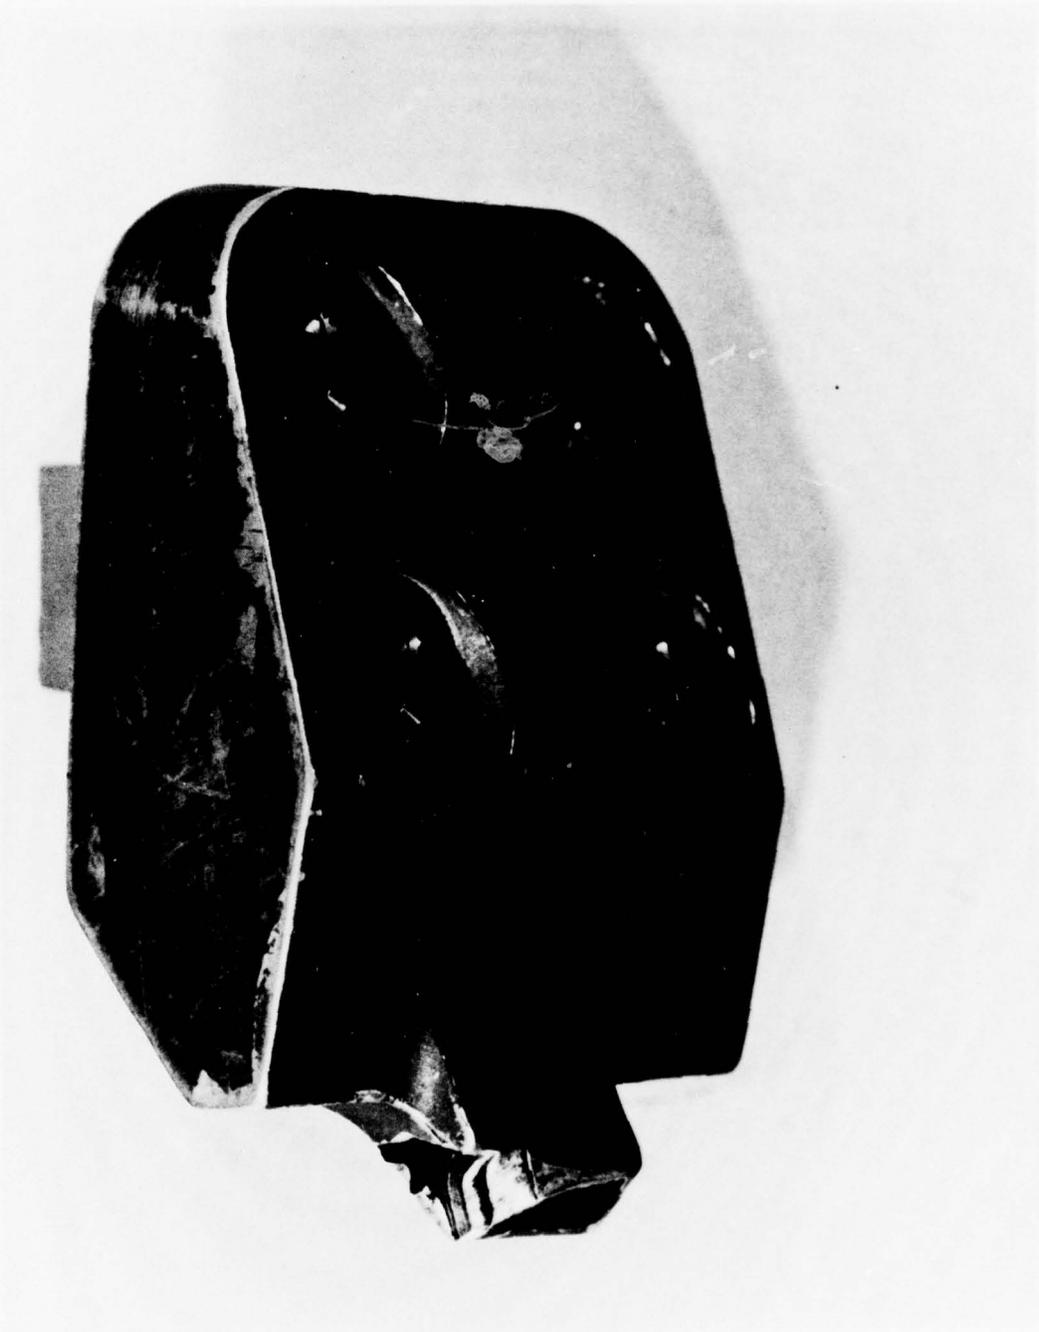
Figure 22. Failed Canopy Support Fitting - Part No. 160D116049-12

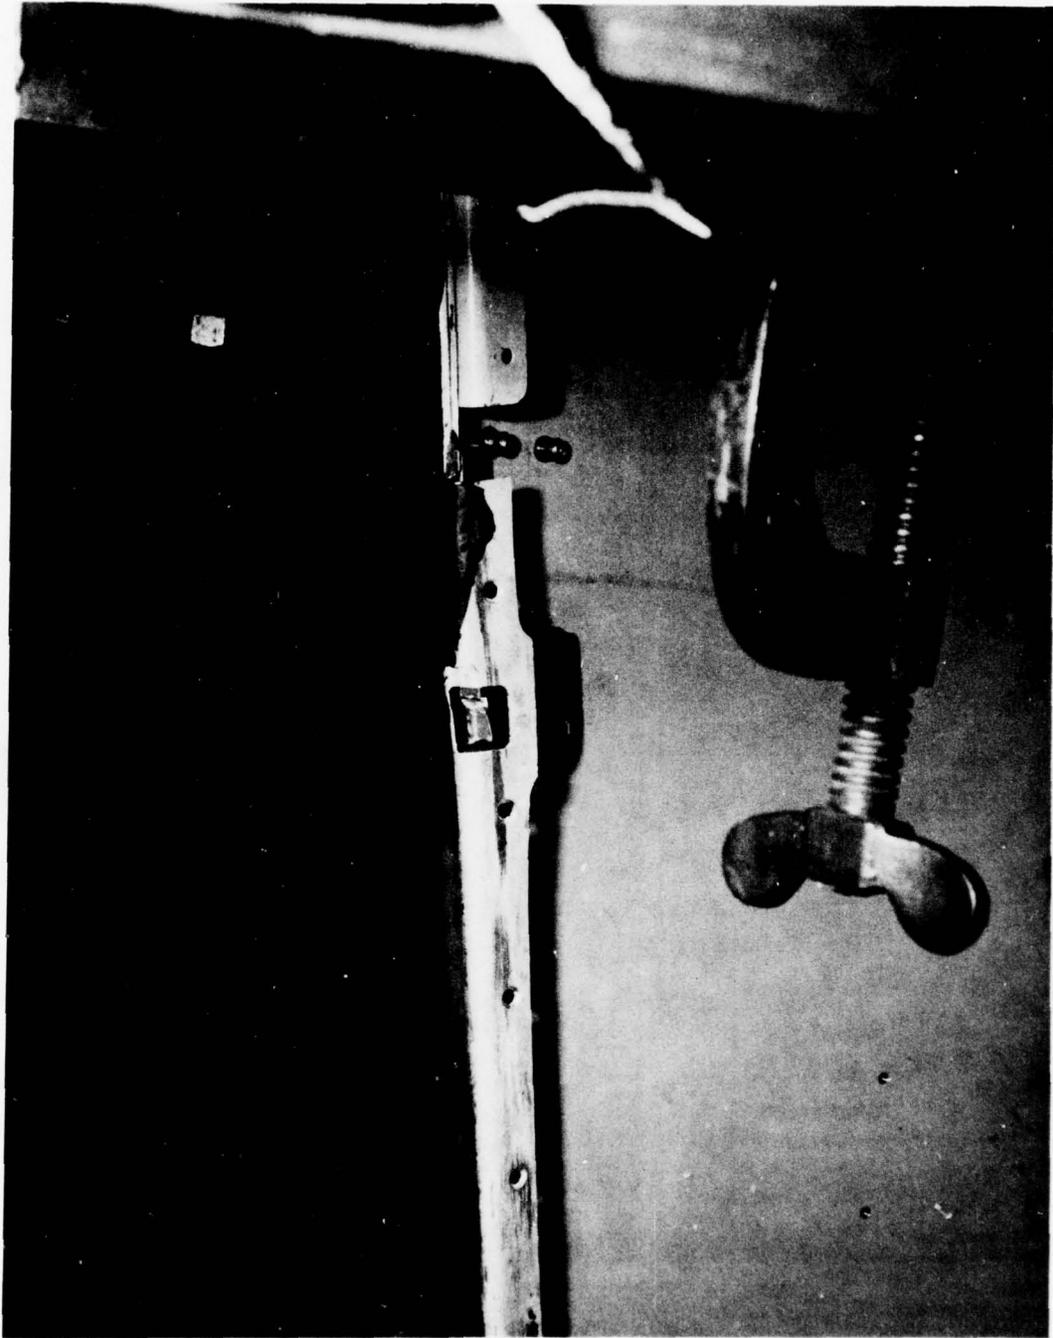
There were secondary failures of the canopy and of the right hand cockpit
side rails (Fig 23 thru 26).

Figure 23. Canopy Support Fitting Installation - P/N 160D116049-12

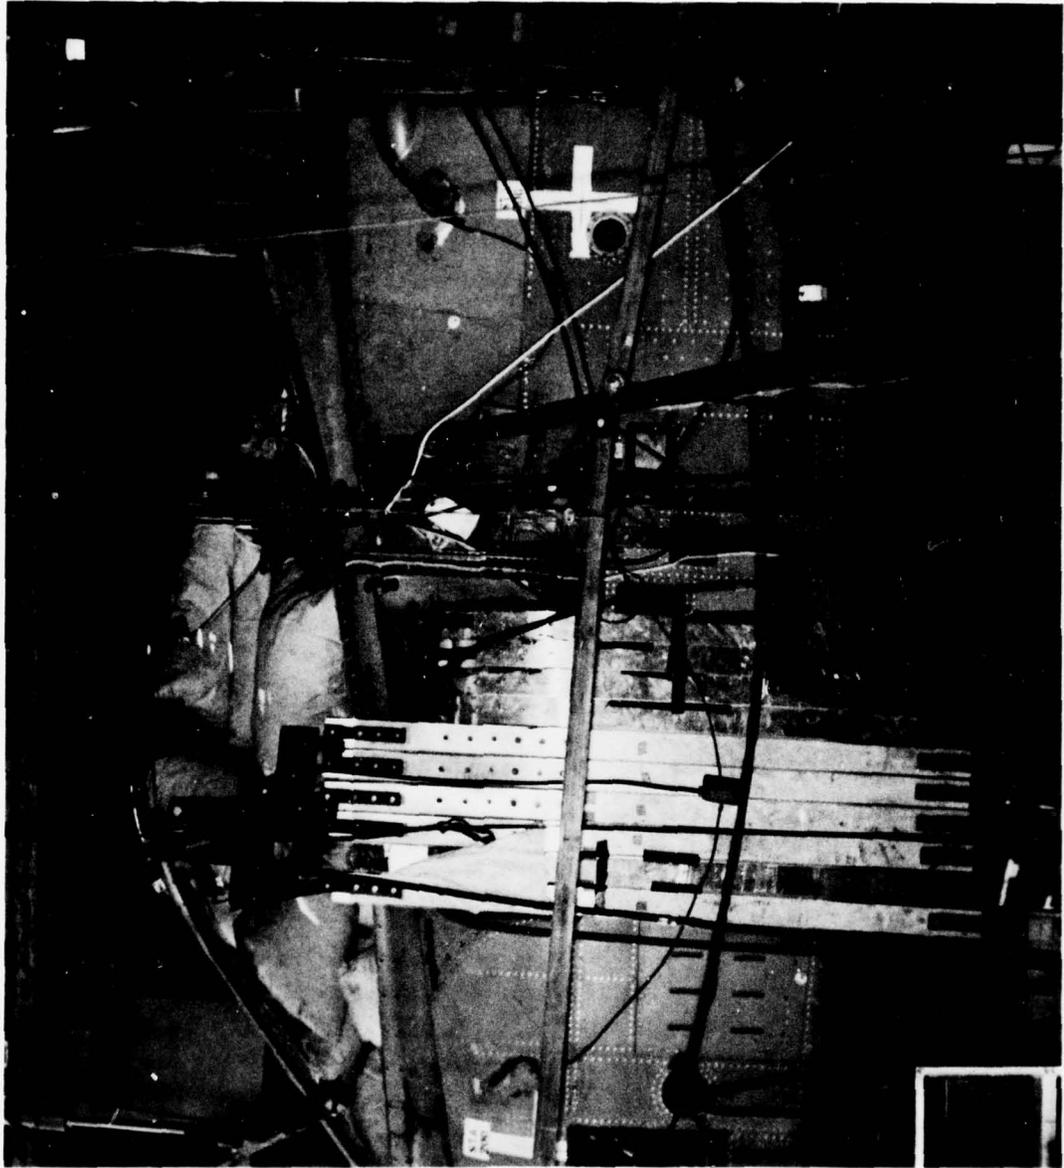
Figure 25. Failed Canopy

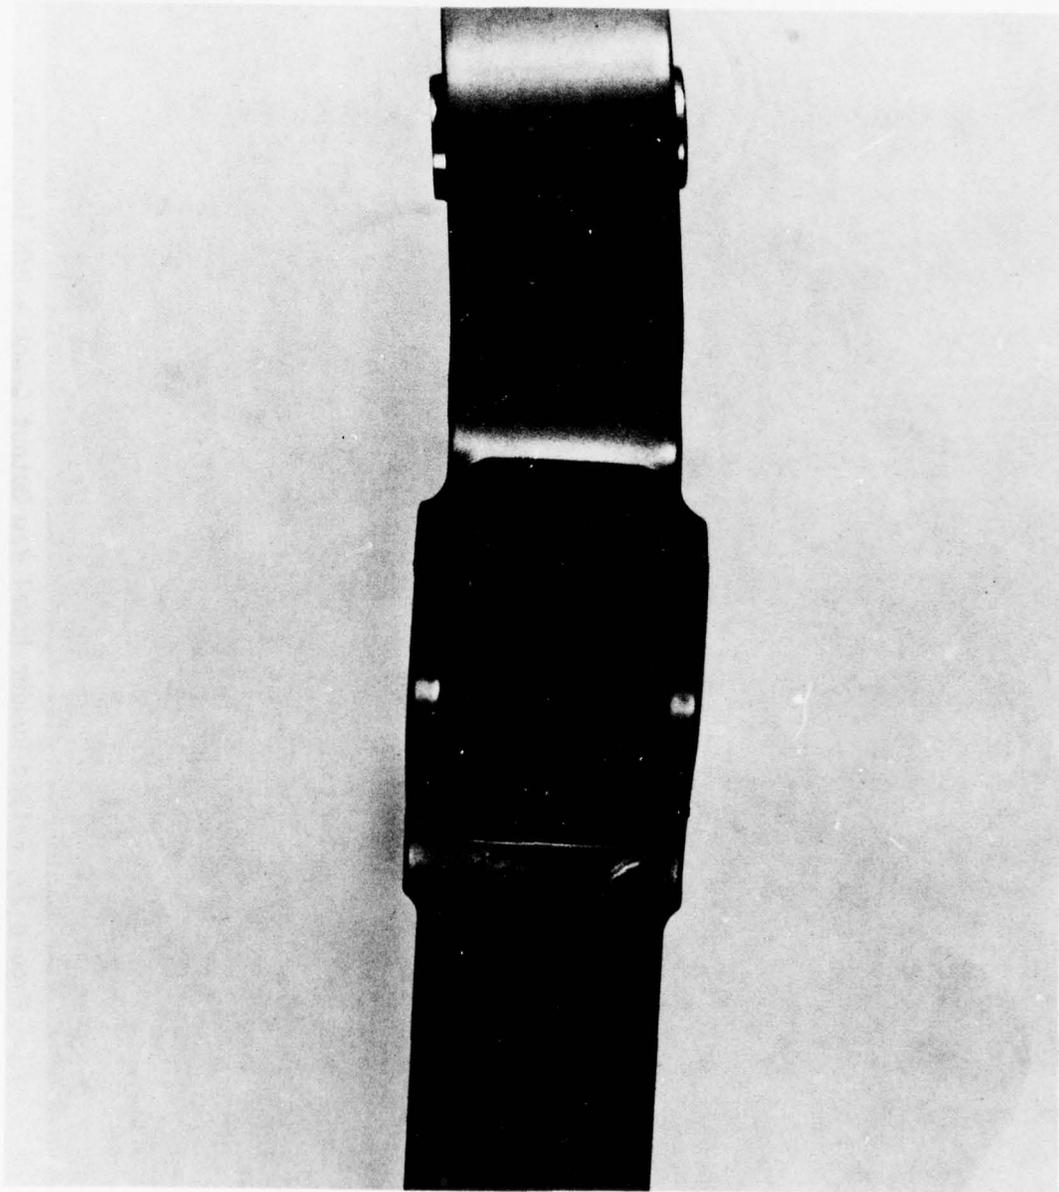
The Yaw Control Subsystem, Manual Reversion Mode Test (C-15h) was started with the bellcrank 1/4" from the stop. The bellcrank was against the stop at approixmately 63% DUL. The test was re-started with the bellcrank 1/2" from the stop. While loading from 90% to 95% DUL, the load started to drop. The test was stopped to review the data and inspect the system, no damage was found. The test was re-started. At 60% DUL, the observer in the cockpit reported that the bellcrank appeared to be rolling. The system was inspected and there being no apparent damage, testing was continued. While loading to 90% DUL the applied load started to drop. The test was stopped and inspection of the system showed that the Rudder Pedal Output Yaw Crank (P/N 160D123150) was bent (Fig. 27 and 28). The crank from the left side of the system was removed and installed in place of the damaged crank. The test was repeated and the system supported 100% DUL.

Figure 27. Failed Rudder Pedal Yaw Output Crank - P/N 160D123150

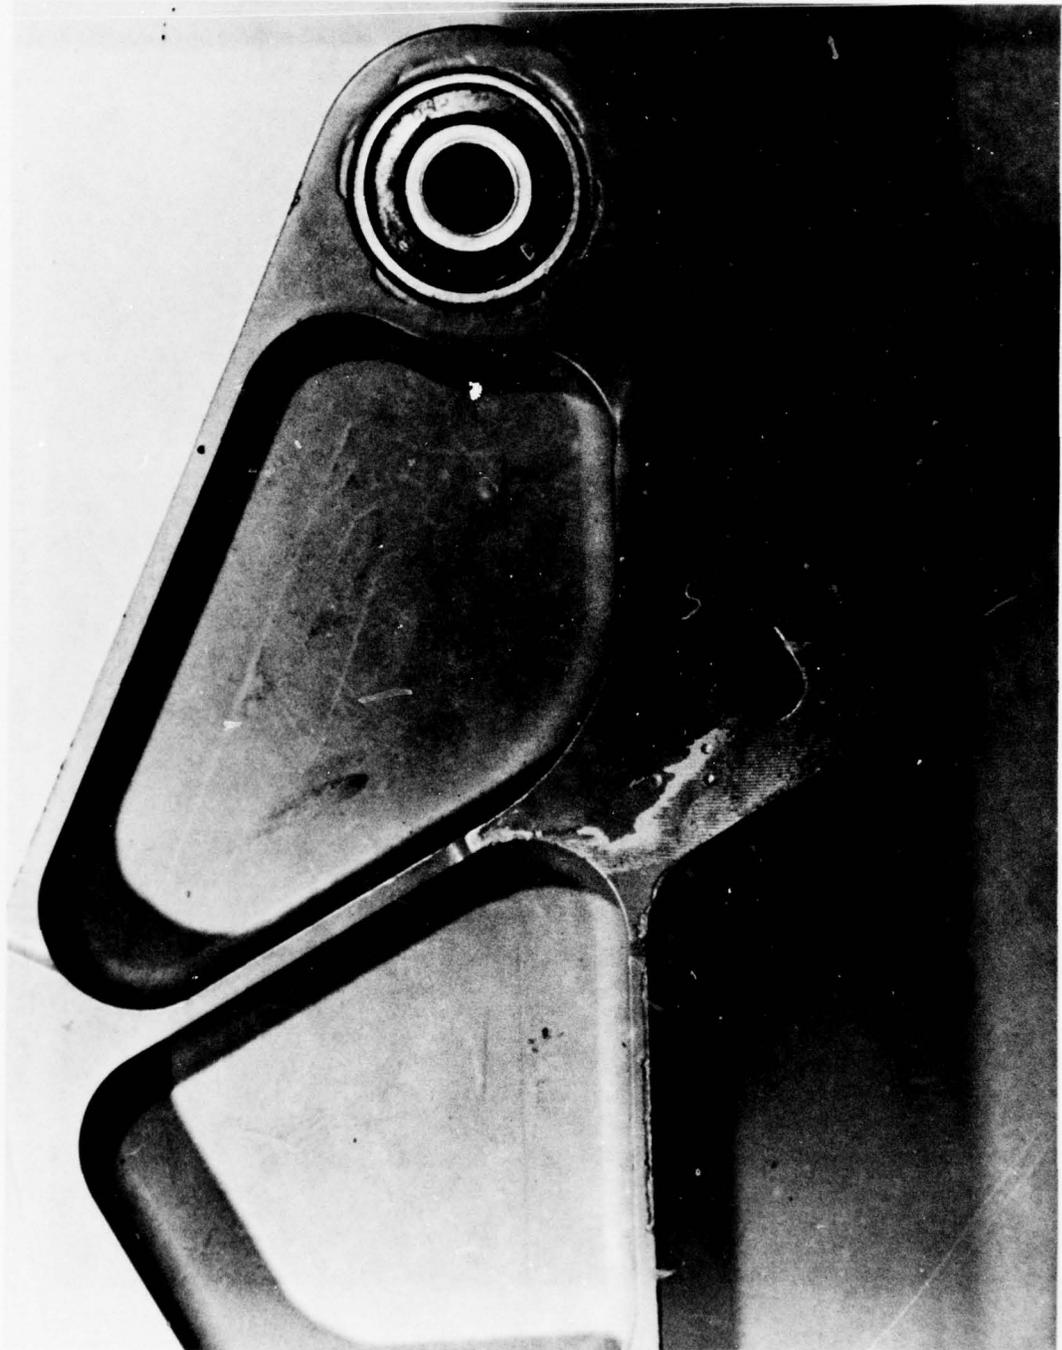
Figure 28. Failed Rudder Pedal Yaw Output Crank - P/N 160D123150

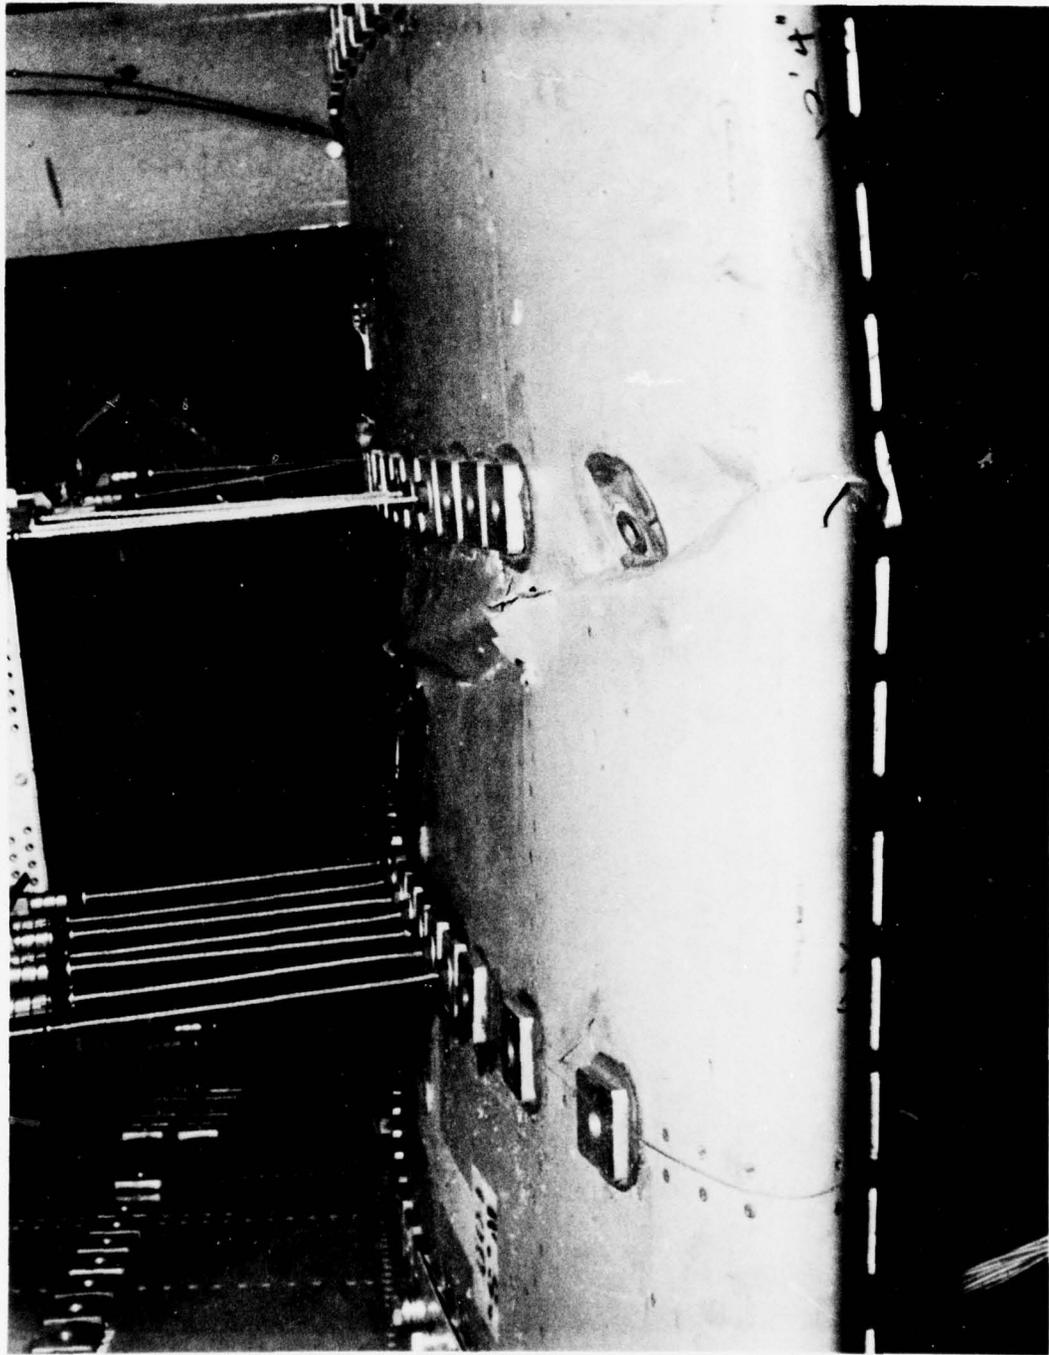
The Empennage Failing Load Test (Condition RPM-BDW-750-05 / 5.86g) was run to demonstrate the growth potential of the empennage. During the first run (Item 88), there was a failure in the left engine vertical load fitting at 133% DUL. In an attempt to induce a failure in the vertical tail, FRC revised the empennage loads for the second run (Item 89). However, the Right Hand Horizontal Tail failed at 158% DUL. This figure is based on the original empennage loading condition. Damage to the structure is shown in Figures 29 through 31.

Figure 29. Right-Hand Horizontal Tail Upper Cover After
Failing Load Test
