AFFDL-TR-79-3014

A-10 STATIC STRUCTURAL TEST PROGRAM

February 1979

Final Technical Report

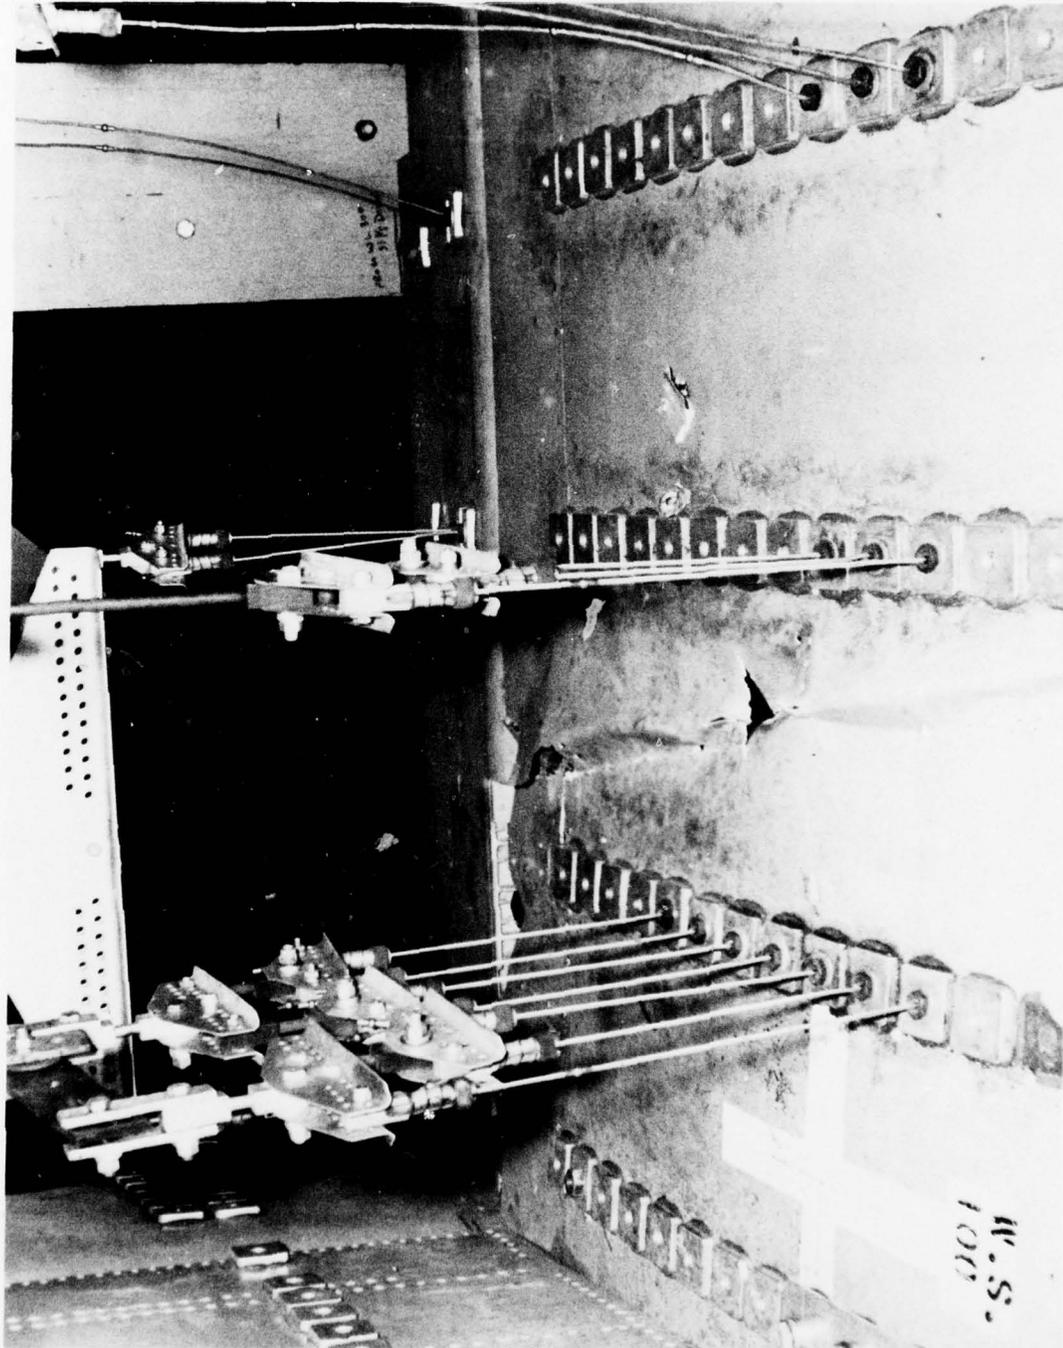
The Empennage Failing Load Test (Condition RPM-BDW-750-05 / 5.86g) was run to demonstrate the growth potential of the empennage. During the first run (Item 88), there was a failure in the left engine vertical load fitting at 133% DUL. In an attempt to induce a failure in the vertical tail, FRC revised the empennage loads for the second run (Item 89). However, the Right Hand Horizontal Tail failed at 158% DUL. This figure is based on the original empennage loading condition. Damage to the structure is shown in Figures 29 through 31.

Figure 30. Right-Hand Horizontal Tail Upper Cover After Failing Load Test

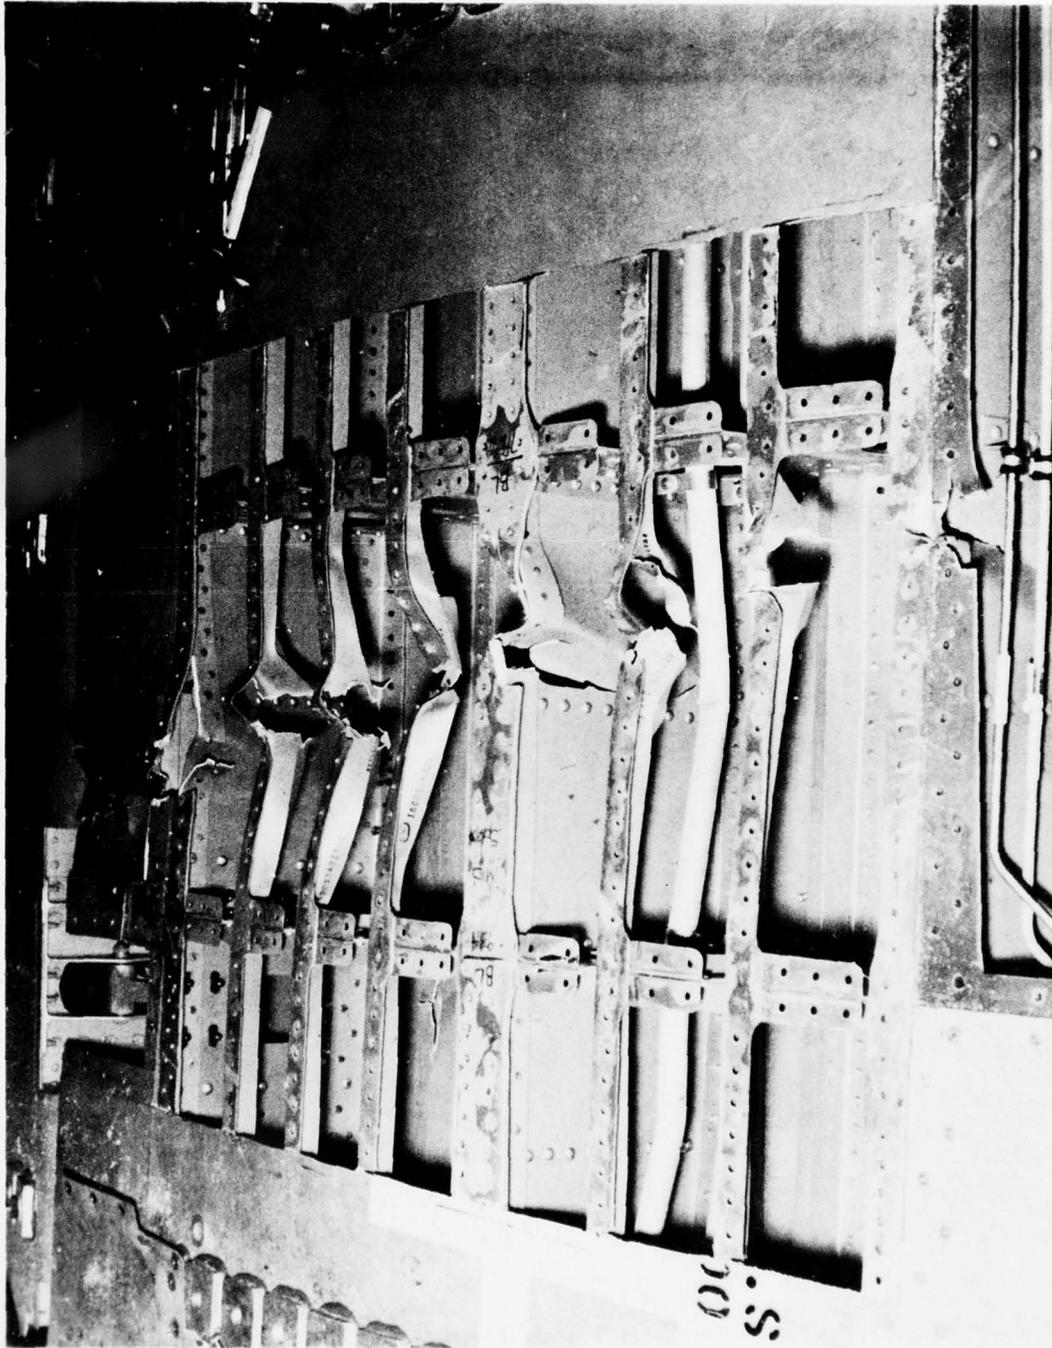
Figure 31. Right-Hand Horizontal Tail Spar and Stringer Damage After Failing Load Test

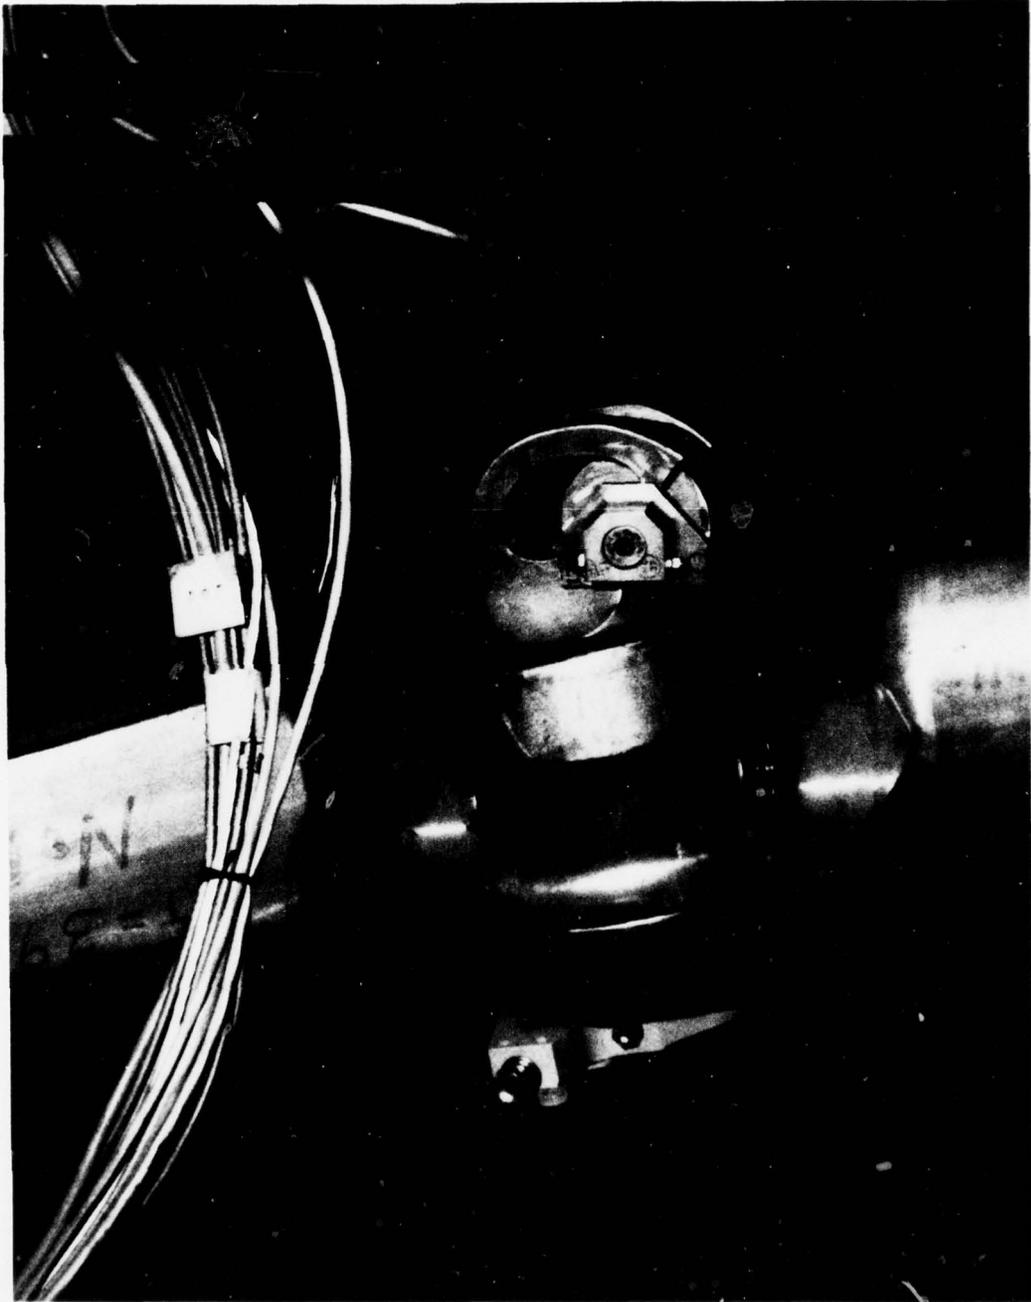
The Main Landing Gear Support Structure Failing Load Test (Two Point Brake Roll Condition) was run to 113% DUL. At this load, the drag strut pickup lugs on the socket pin failed (P/N 19062). The failure and damaged parts are shown in Figures 32 through 36.

Figure 32. Left Main Landing Gear After Failing Load Test

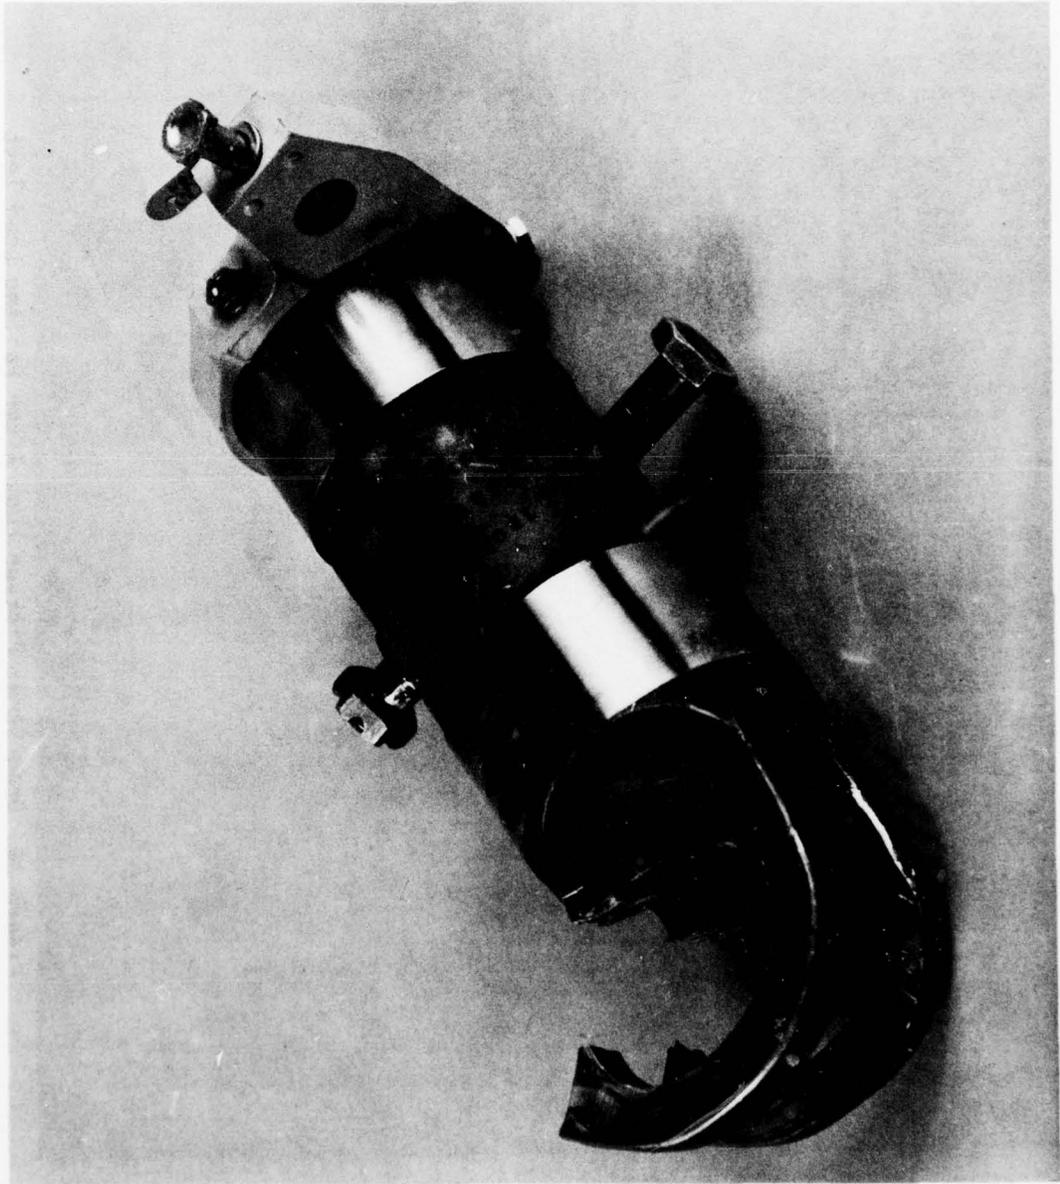
Figure 33. Socket Pin (Part No. 19062) After Failing Load Test

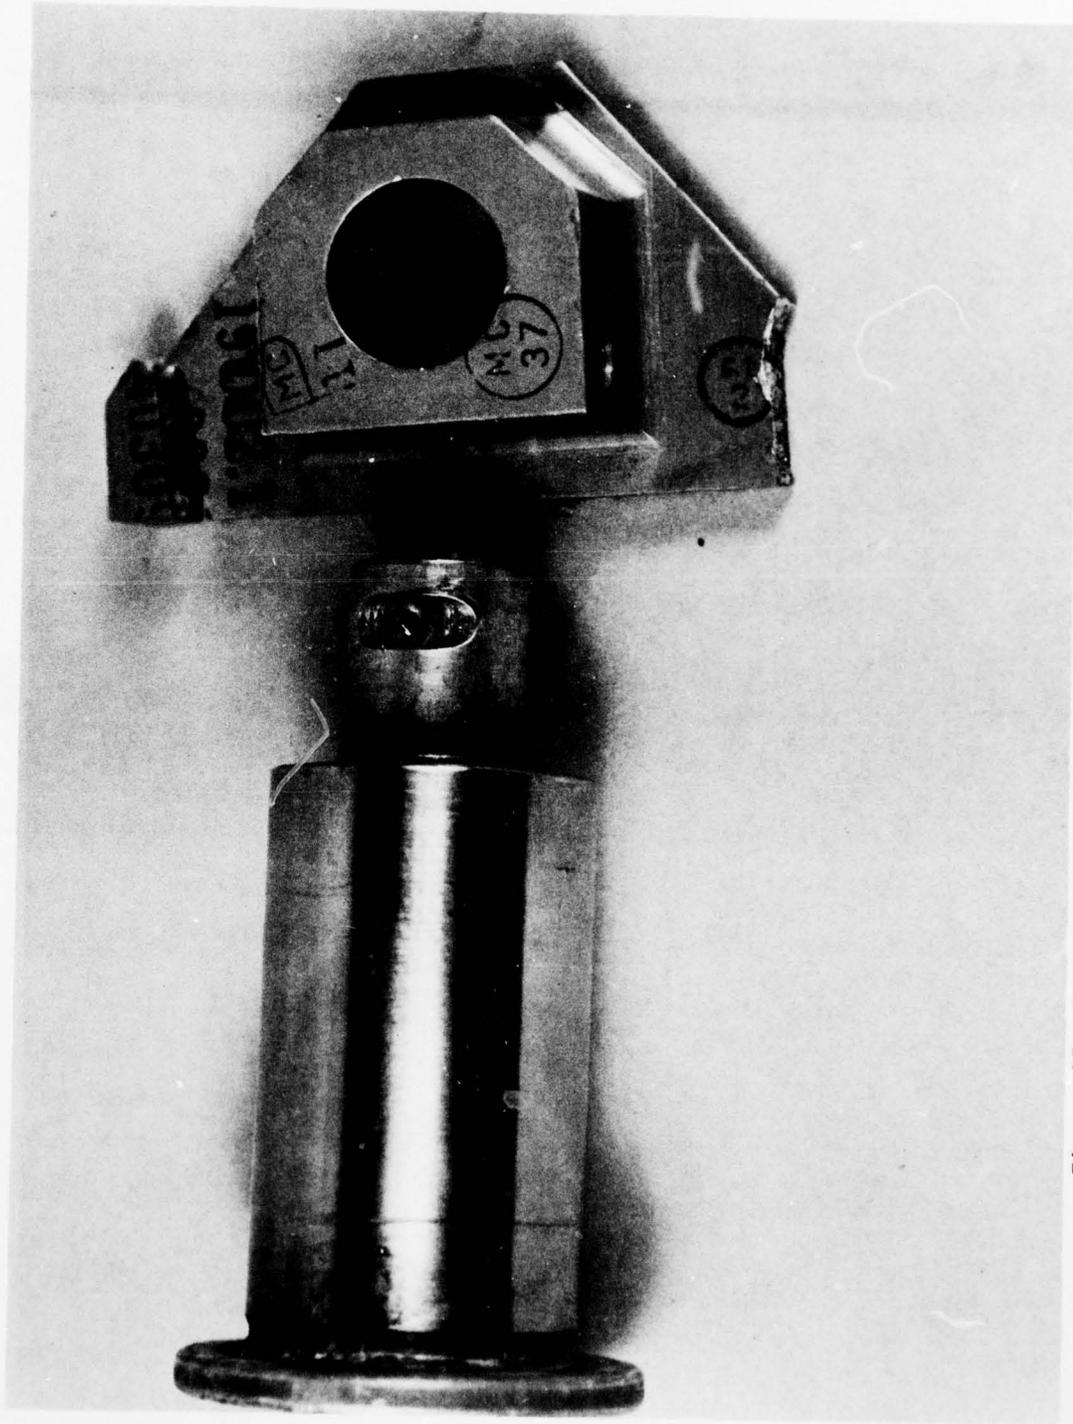
Figure 35. Drag Strut Pin (Part No. 19001) After Failing Load Test

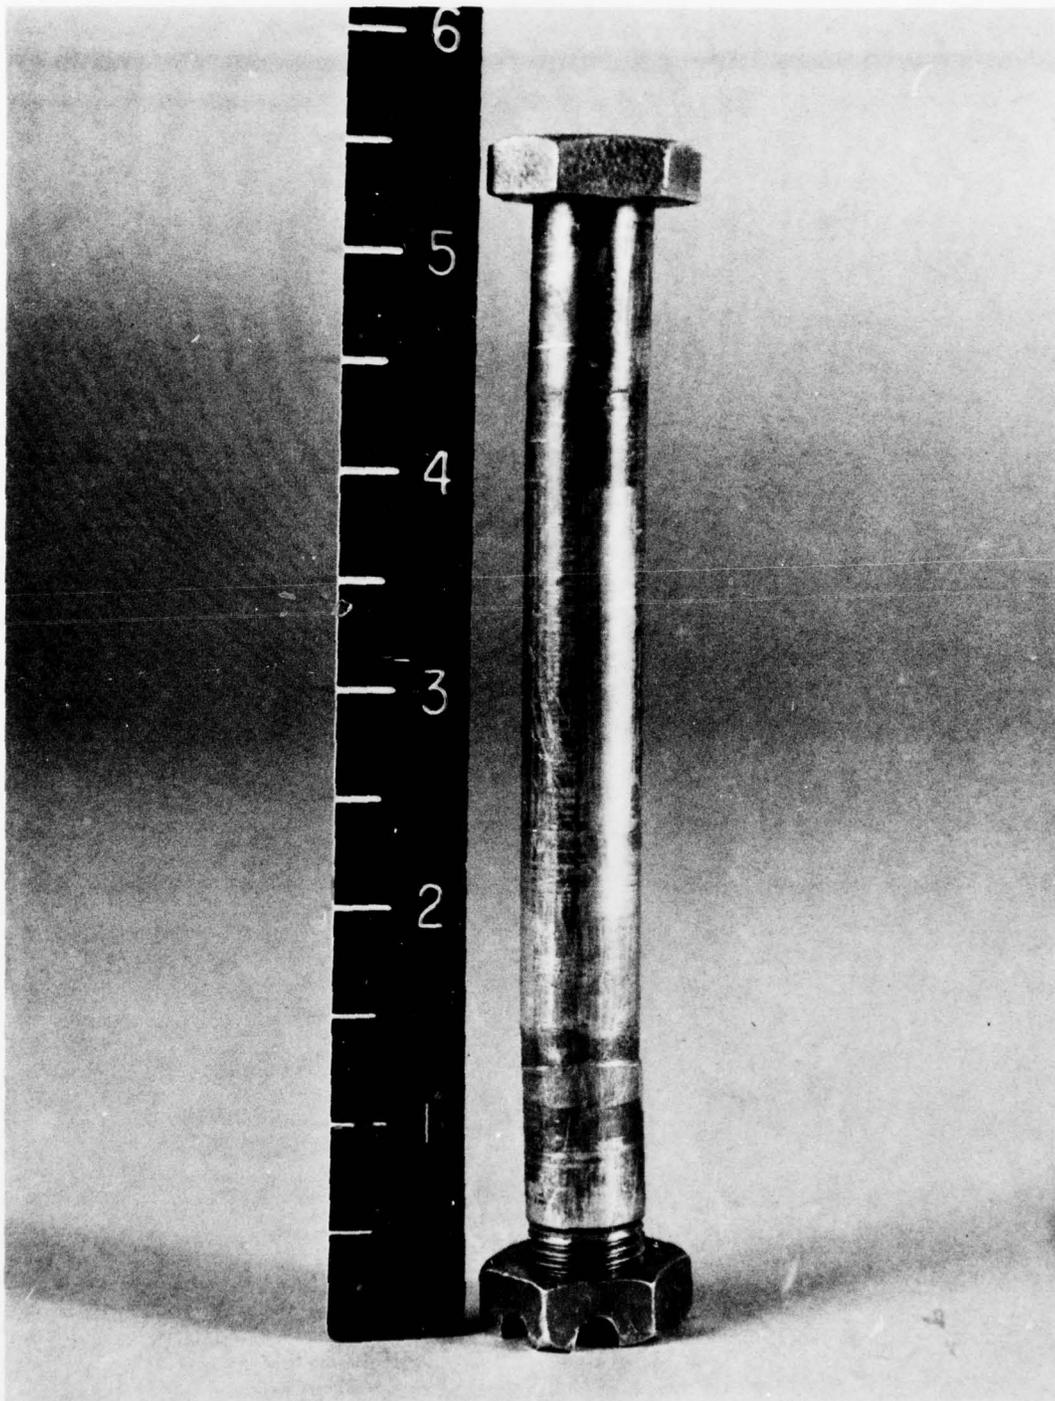
Figure 36. NAS 464P9-74 Bolt After Failing Load Test

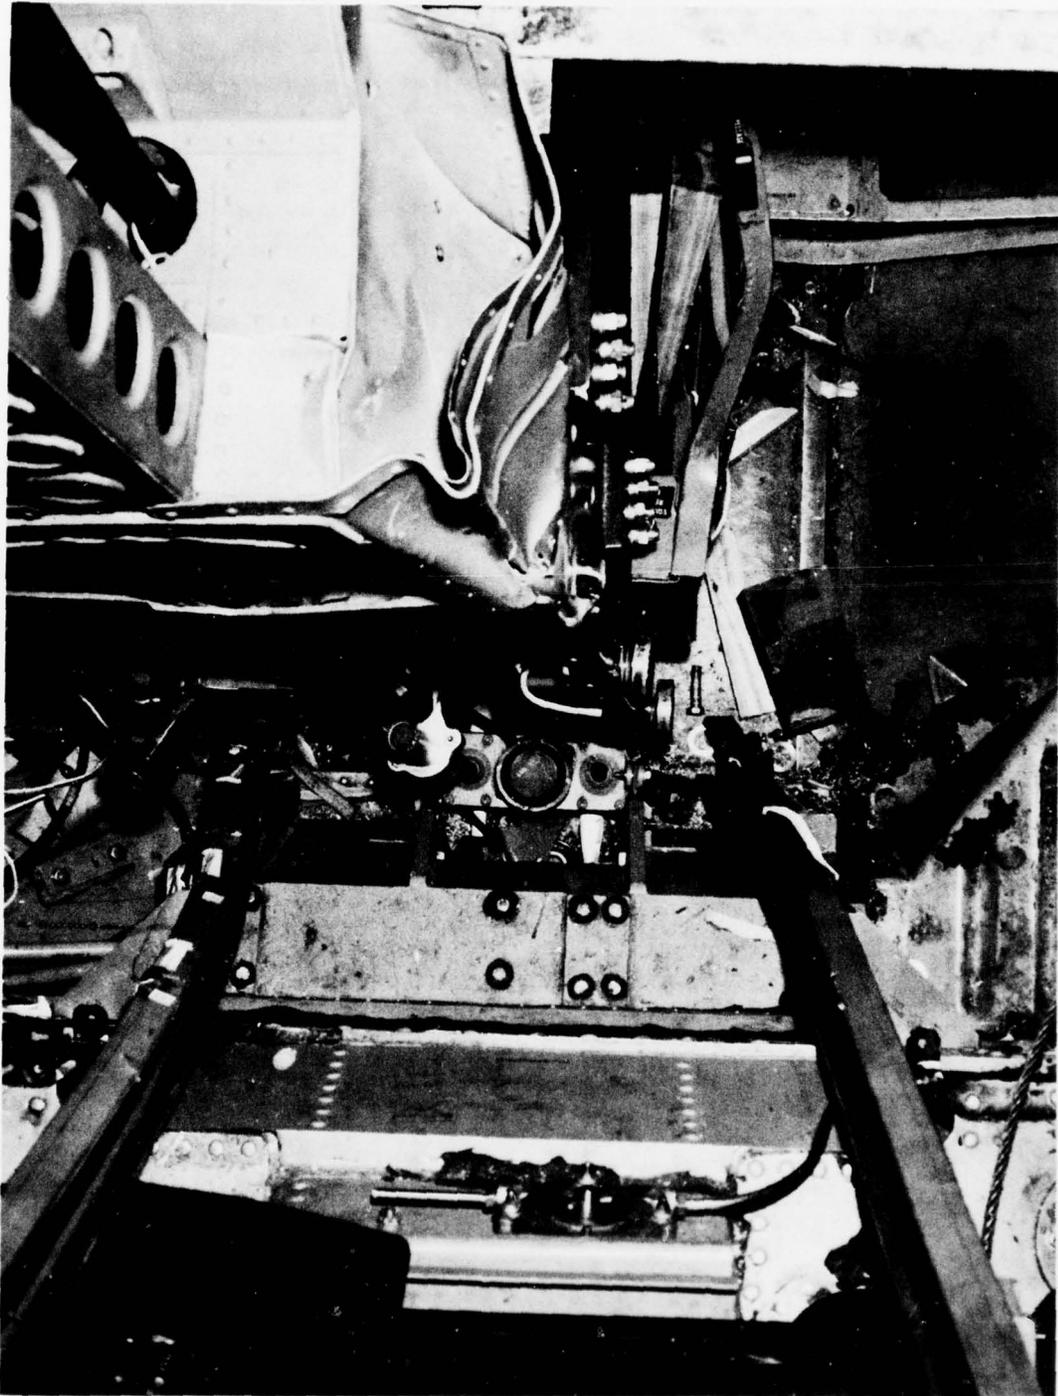
The ACES II HTES Seat Support Structure Test was run to 93% DUL. At this load, the seat rails (P/N 160D188065-1 & -2) and the rail attachment lugs on the seat support casting (P/N 160D116027) failed. The A-10 SPO has determined that this load level is adequate for acceptance of the seat support structure. Therefore, a re-design and re-test of the structure is not necessary. The failure and damaged parts are shown in Figures 37 through 39.

Figure 37. ACES II HTES Seat Support Structure After Failure

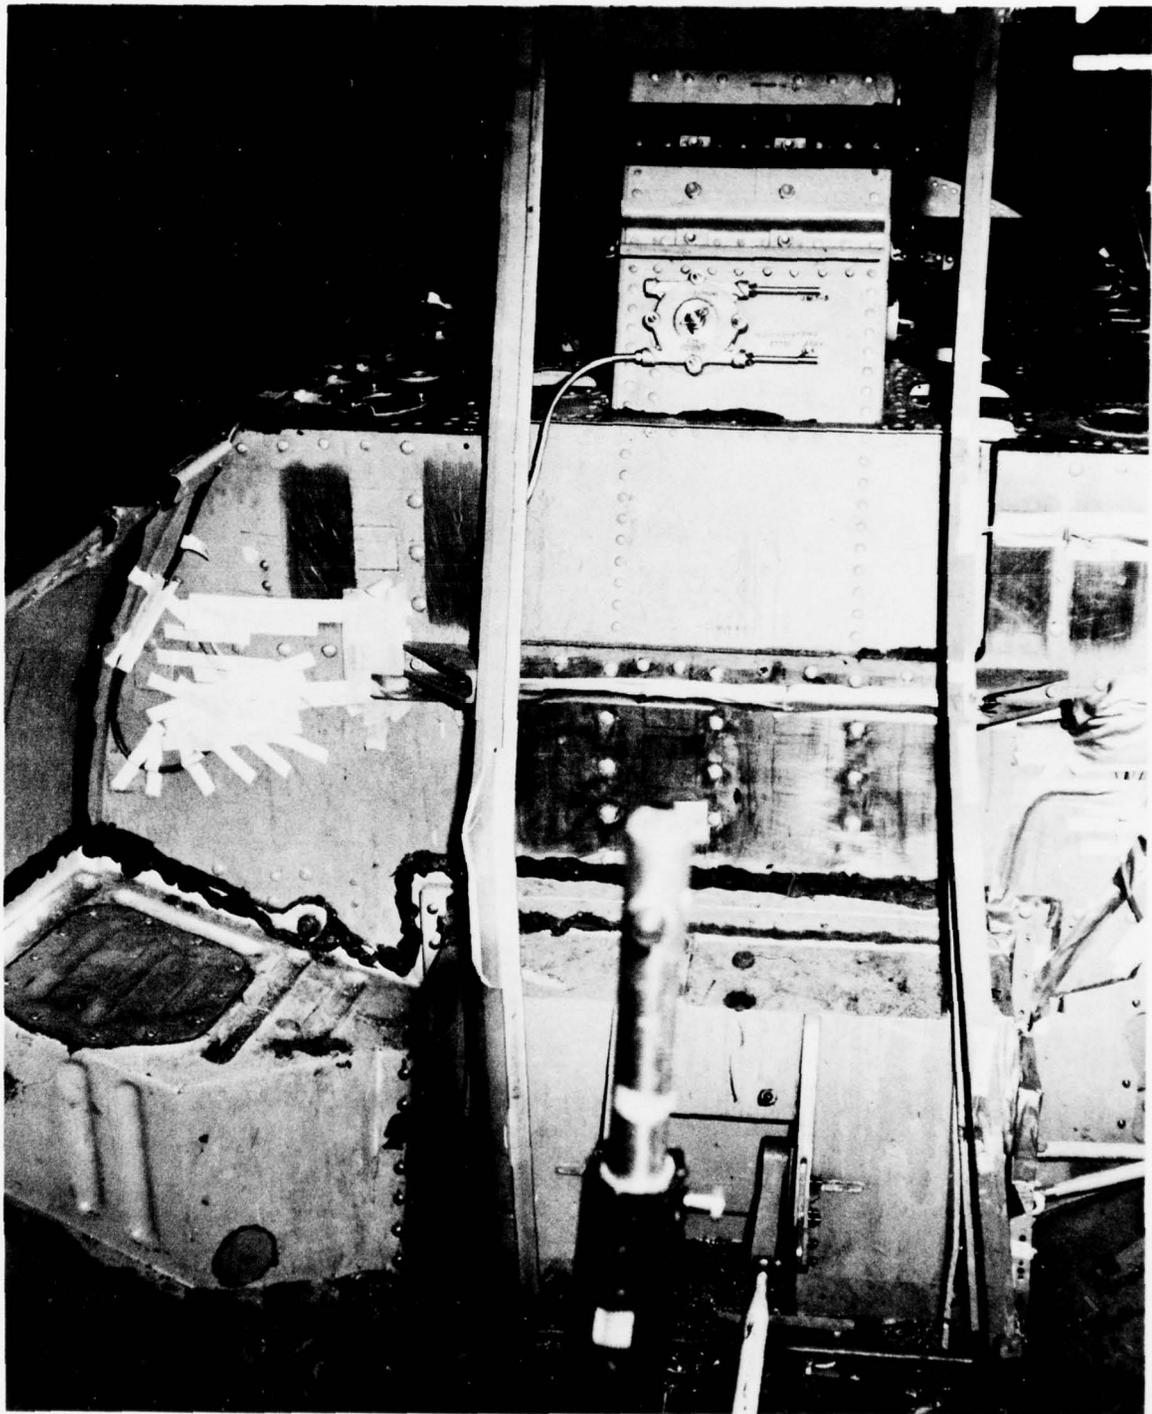
Figure 38. Seat Rails (Part No. 160D188065) After Failure

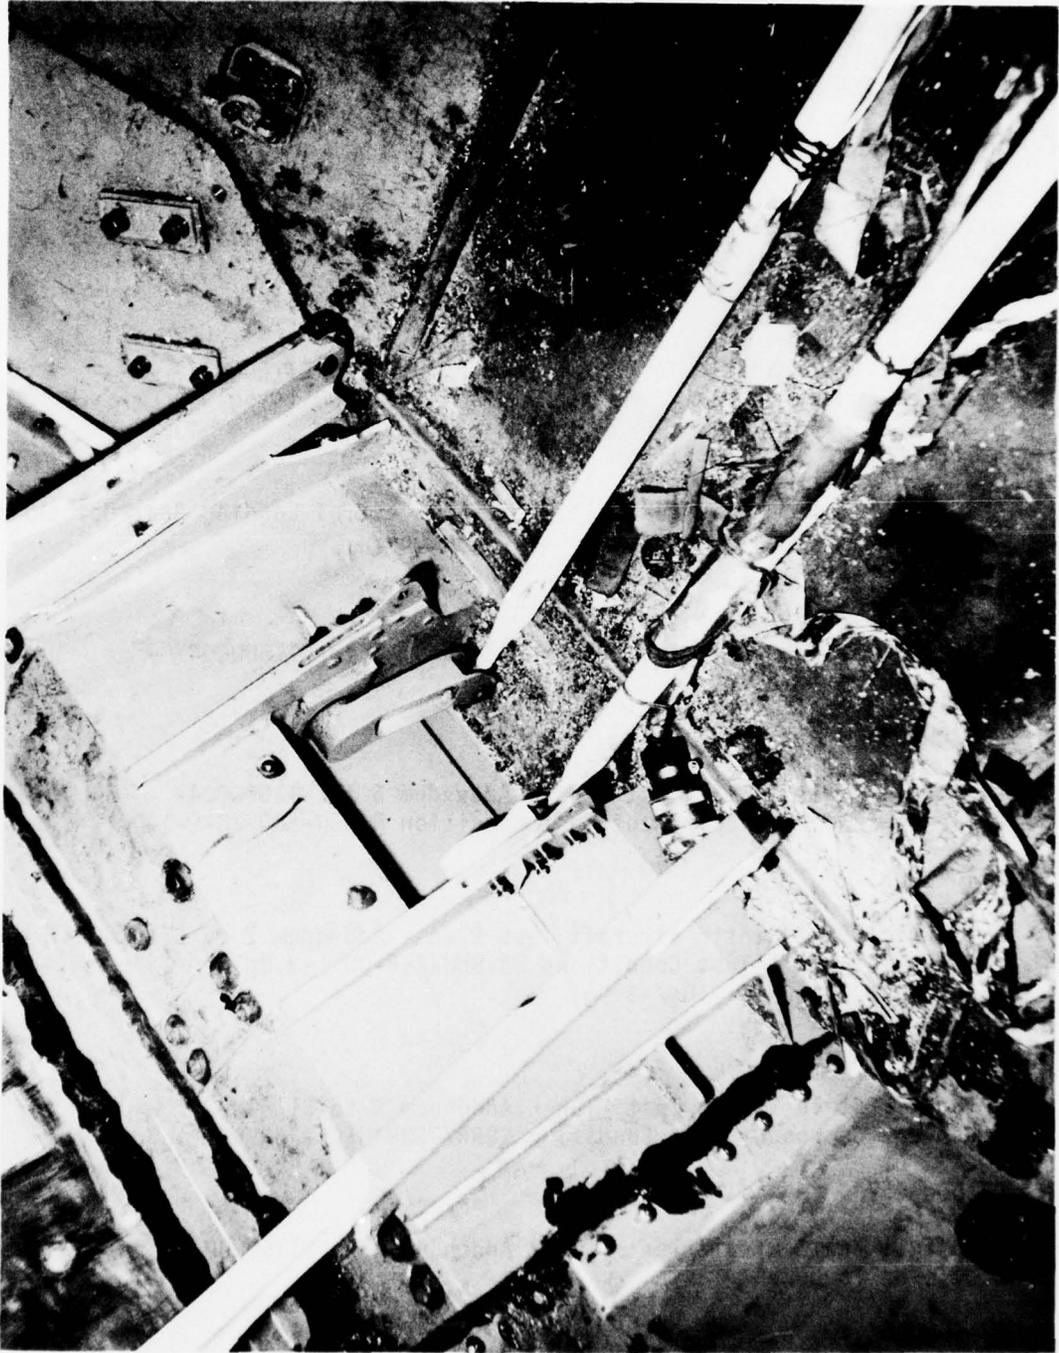
Figure 39. Support Casting (Part No. 160D116027) After Failure
