REPORT DOCUMENTATION PAGE	READ INSTRUCTIONS BEFORE COMPLETING FORM
1. REPORT NUMBER	2. GOVT ACCESSION NO. AD-A091 134 / 3. RECIPIENT'S CATALOG NUMBER
4. TITLE (and Subtitle) Phase I Inspection Report Findley Lake Dam Lake Erie Basin, Chautauqua County, New York Inventory No. 752	5. TYPE OF REPORT & PERIOD COVERED Phase I Inspection Report National Dam Safety Program 6. PERFORMING ORG. REPORT NUMBER

(6) PHASE I INSPECTION REPORT
NATIONAL DAM SAFETY PROGRAM
FINDLEY LAKE DAM (Inventory No. NY
[redacted] N.Y. 752)
LAKE ERIE BASIN
CHAUTAUQUA COUNTY, NEW YORK
Phase I Inspection Report

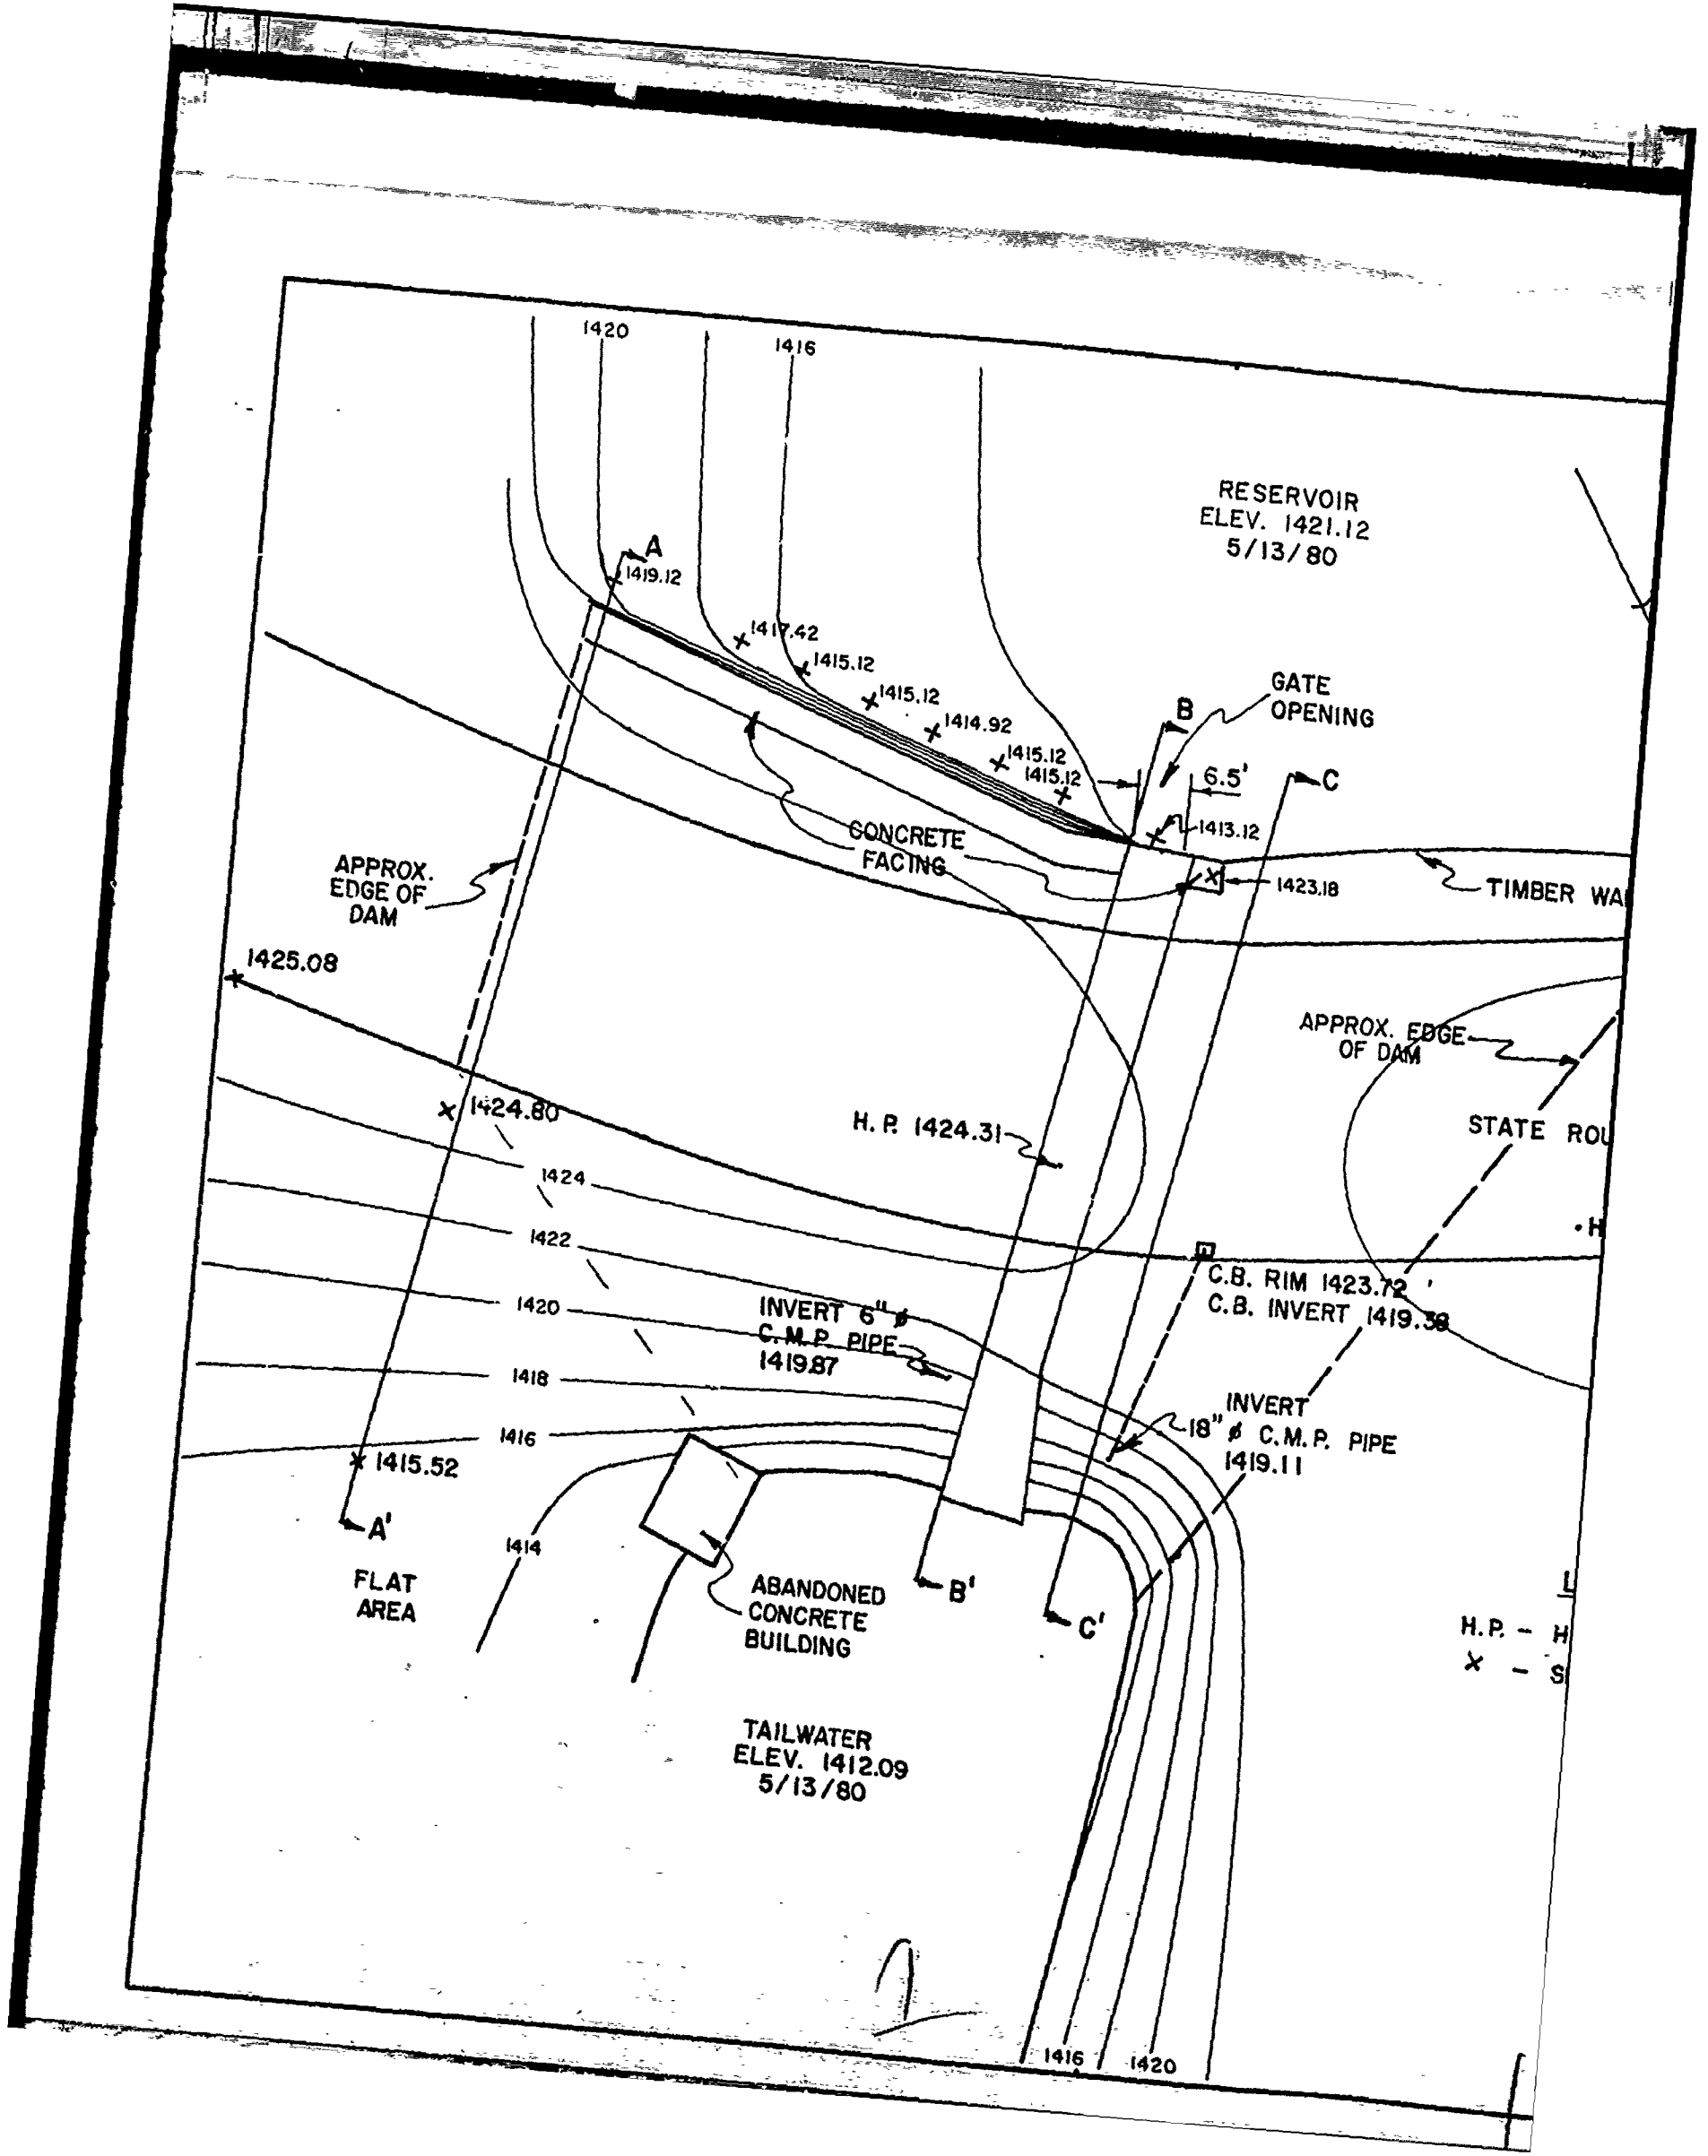
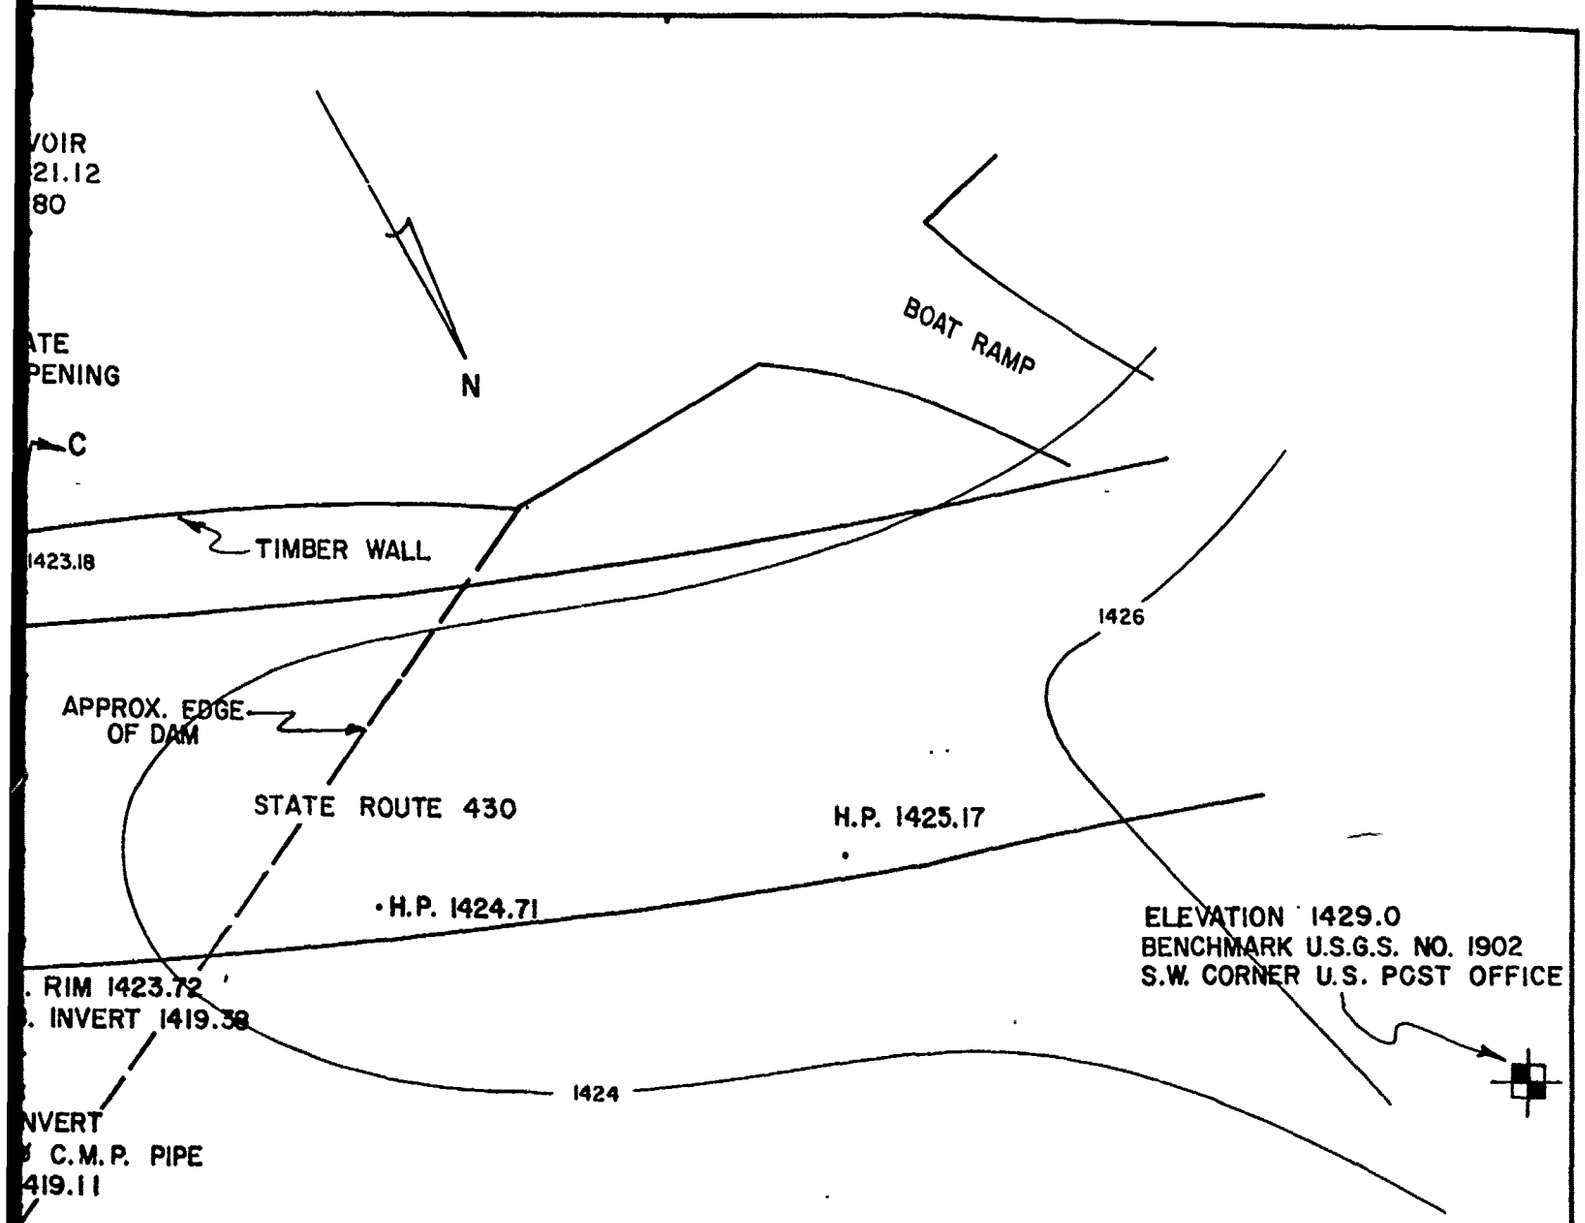
THOMSEN ASSOCIATES		
PLAN OF DAMSITE		
FINDLEY LAKE DAM N.Y. # 752 FINDLEY LAKE, NEW YORK		
DR.BY: C.E.T.	SCALE: 1" = 20'	PROJ. NO. E-80-1
CK'D.BY:	DATE: JUNE 1980	DRWG.NO. 1

The crest of the dam is covered with an asphaltic concrete roadway having a width of 30 feet. Evidence of embankment or spillway movement was detected on either side of the principal spillway box conduit. This was in the form of transverse cracks paralleling the spillway that were observed in the asphaltic pavement. Also, the concrete facing on the upstream slope was badly deteriorated east of the spillway intake gate. The timber facing west of the spillway gate has moved laterally toward the reservoir a maximum distance of about 2 feet near the center of this section. A depression has developed in the embankment as a result of this timber wall movement. It appeared as though there has been some "loss of ground" associated with this depression.

Erosion has occurred along the downstream slope west of the principal spillway outlet. This section has been lined with riprap to minimize future erosion. The cause of this slope erosion appears to be from surface water runoff discharged through an 18 inch C.M.P. which extends from a catch basin along the north side of the roadway.

Another 6 inch C.M.P. outlets east of the spillway outlet structure on the downstream slope. The origin of this pipe could not be determined. No discharge was observed from either pipe on the dates of the visual inspection.

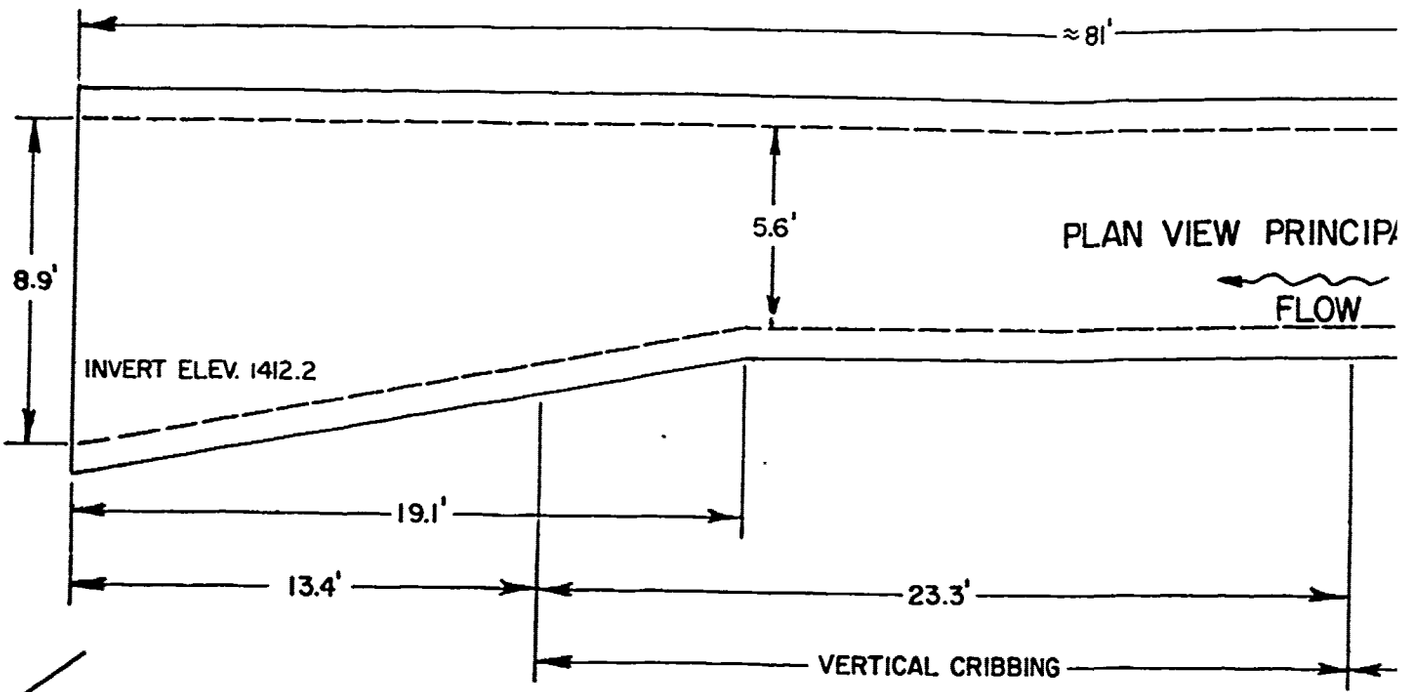
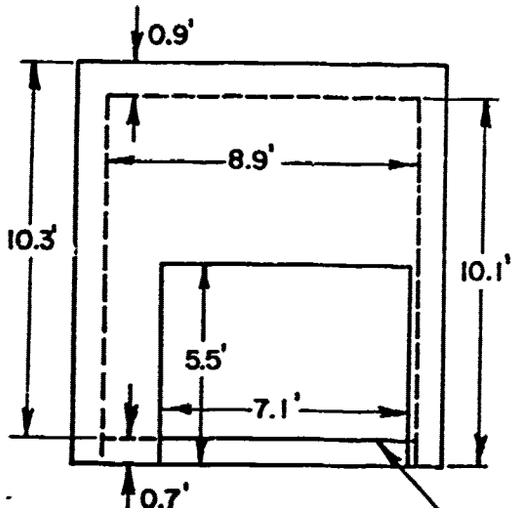
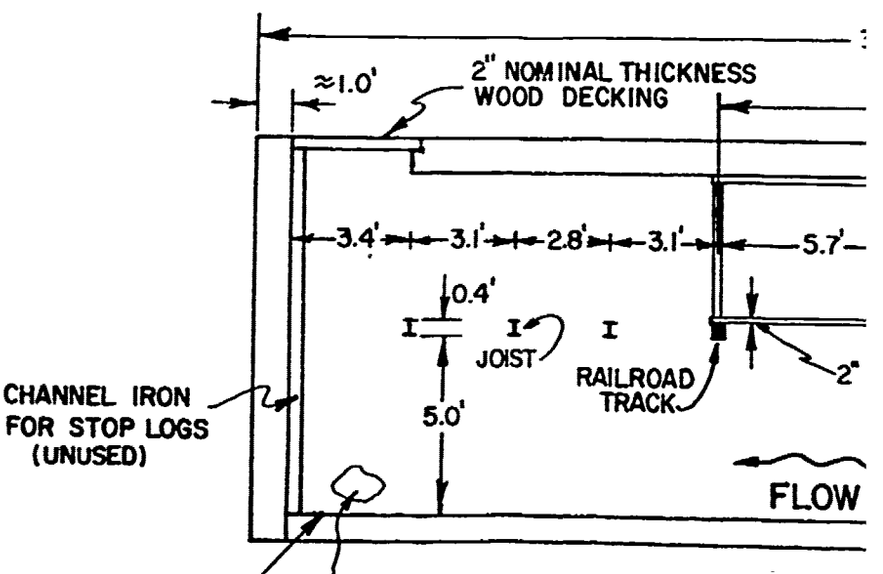
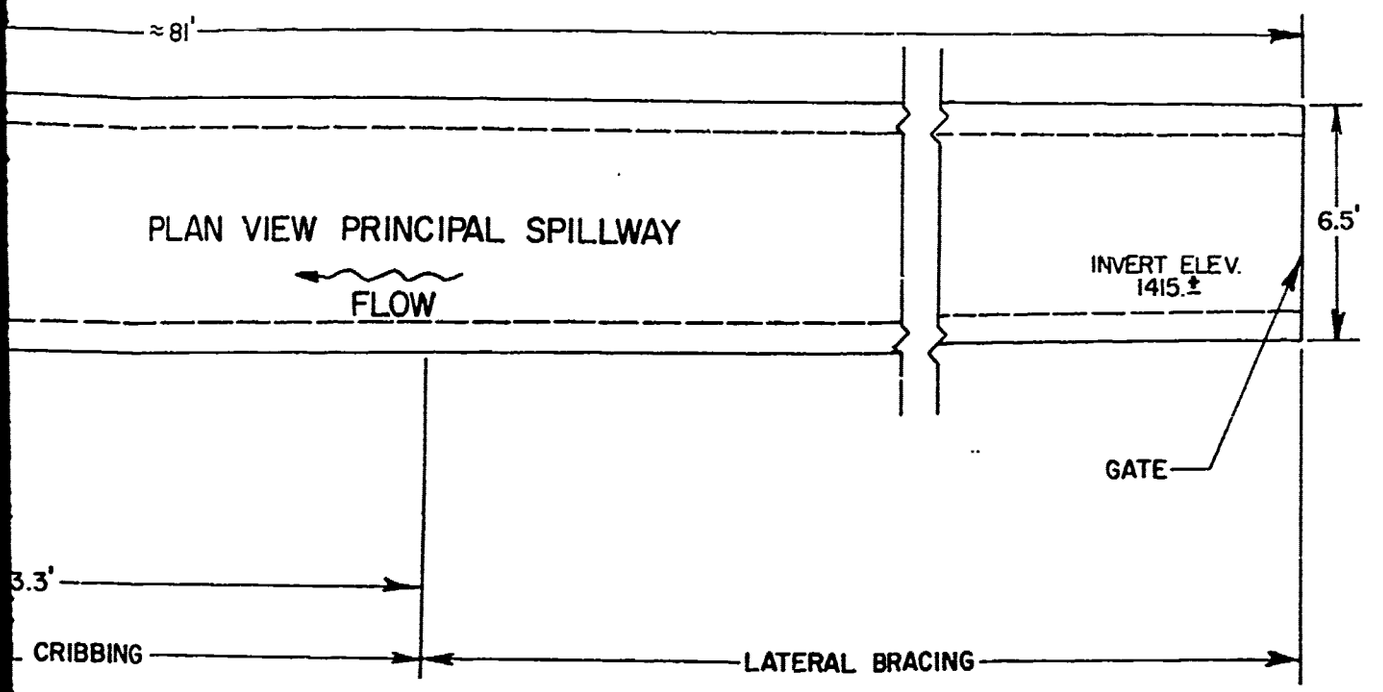
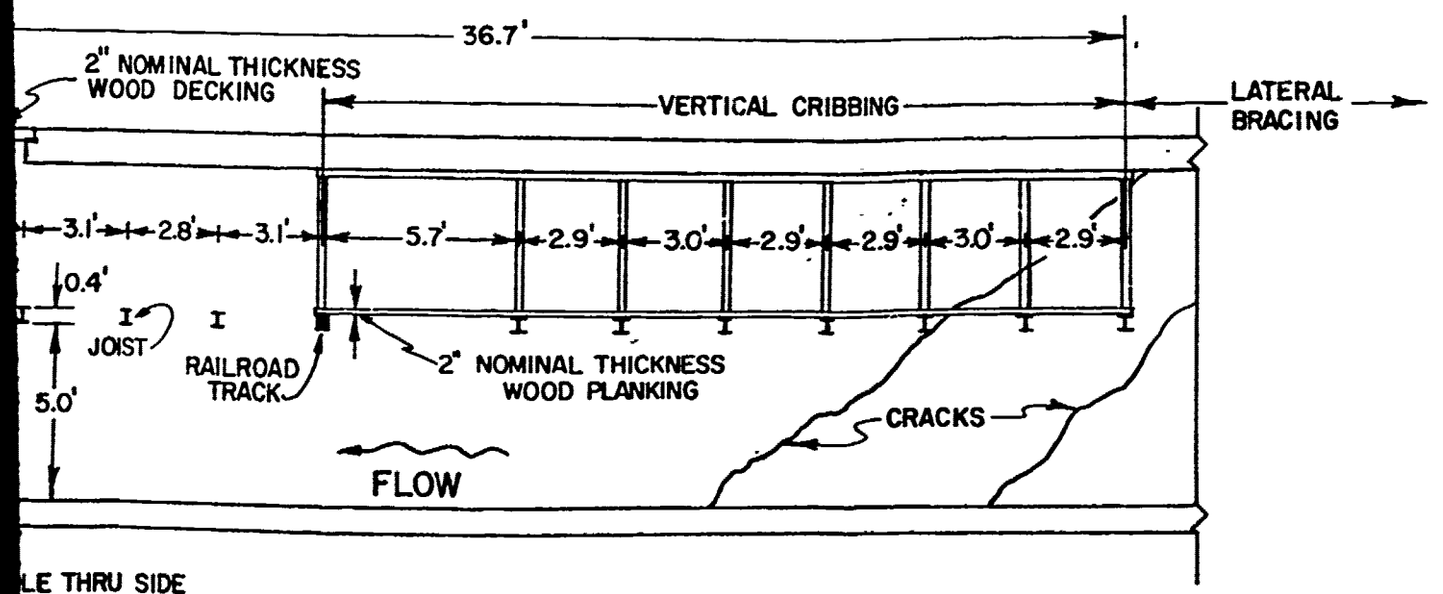
VIEW OF EAST SIDE
PRINCIPAL SPILLWAY

The box conduit is provided with internal lateral bracing (or struts) through steel members which, at the time of the visual inspection, were so badly rusted that the entire webs of these members were missing. In addition, temporary wood vertical cribbing and laterial support had been provided. These are depicted on Drawing No. 5 in Appendix E.

The concrete within 2 feet of the base of the spillway is badly deteriorated. In one location near the exit orfice and along the east wall, a hole has developed through the concrete which is about 8-10 inches in diameter. Numerous structural cracks were also observed in the sidewalls. Details of the internal bracing and the limits of the vertical cribbing and wood bracing, as well as the geometry of the principal spillway, are shown in the Drawings contained in Appendix E.

5) Repair or replace the existing outlet structure
