Technical Memorandum 21-80

AN INVESTIGATION OF THE FIVE POINT RESTRAINT SYSTEM FOR AVIATORS

October 1980

U. S. ARMY HUMAN ENGINEERING LABORATORY

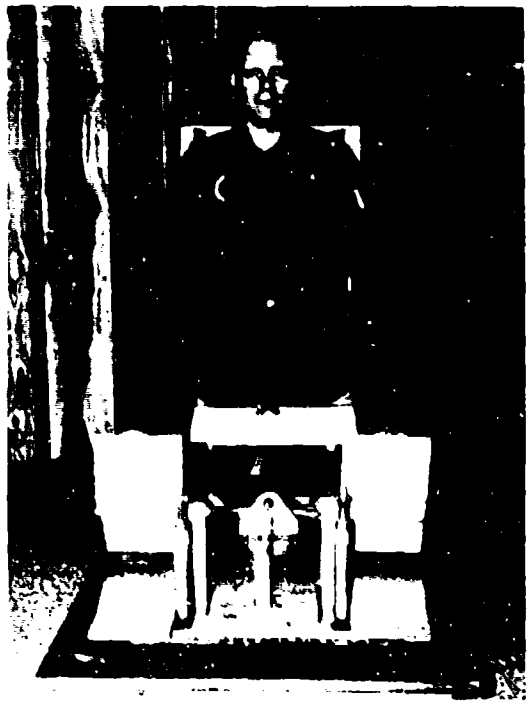
Figure 1. Five point restraint system.

a. Full body view of restraint system.

b. Close-up of restraint system anchoring point.

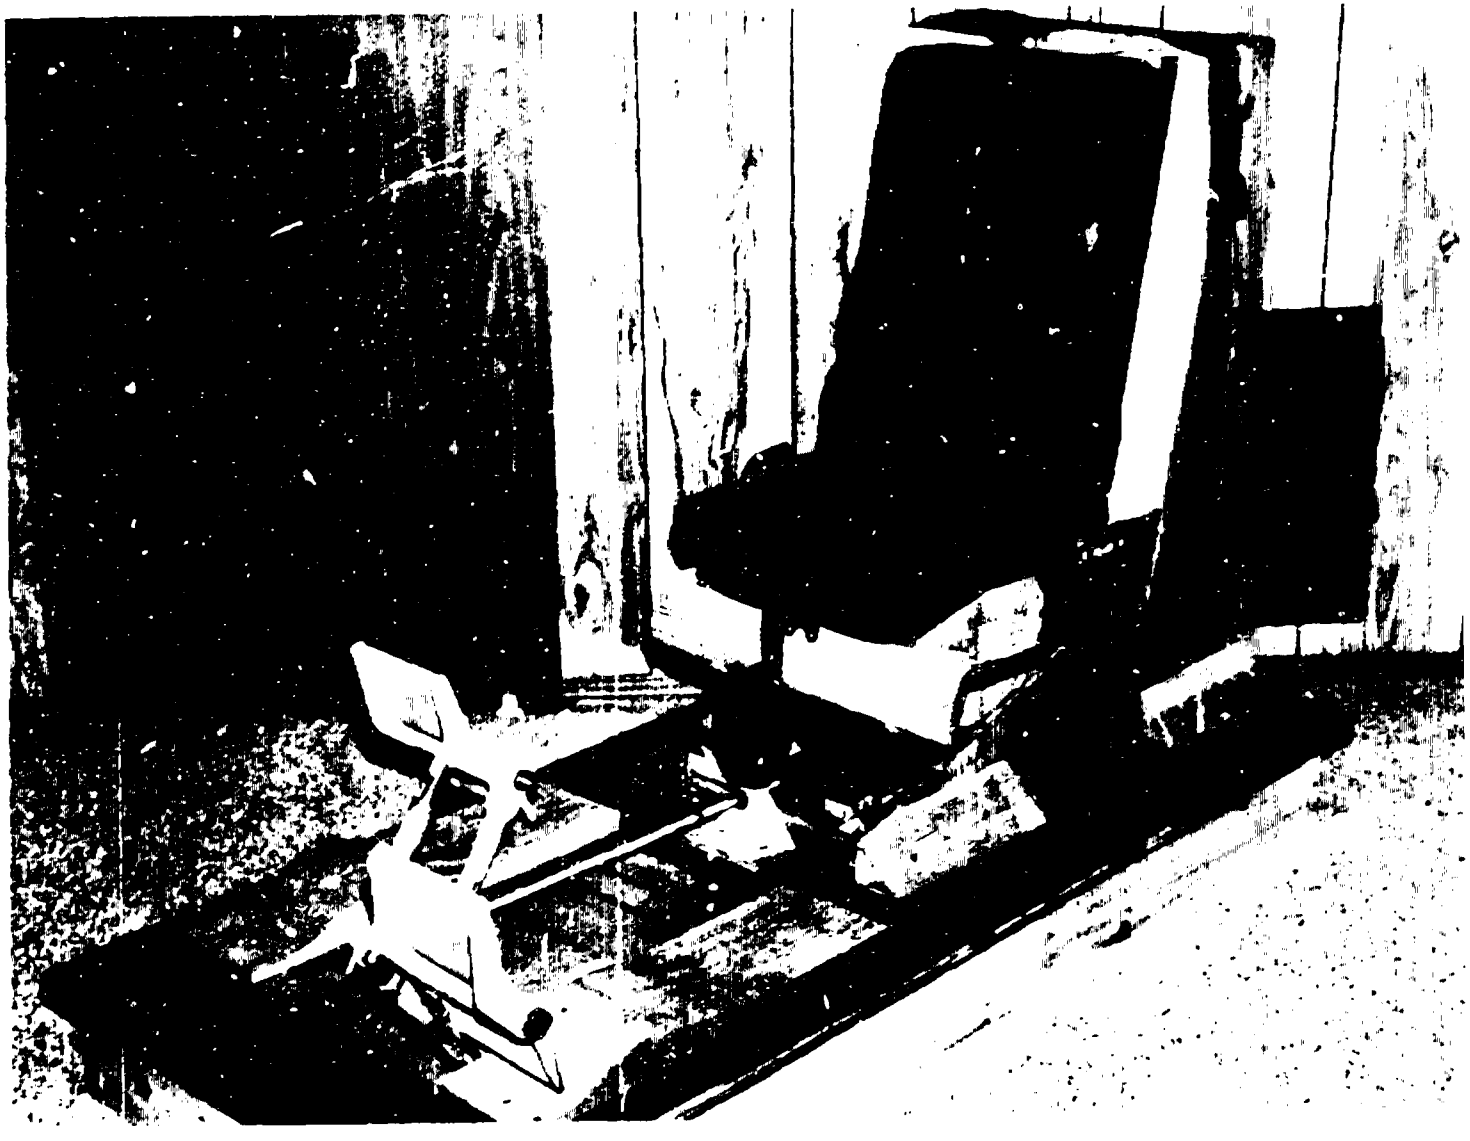
Figures 4 and 5 show the lumbar support can be adjusted in height with hook and file fasteners.

Figure 4. Seat assembly.

Figure 5. Cushion probes.
