ESTABLISHMENT OF ENGINEERING DESIGN DATA FOR
HYBRID STEEL/CERAMIC BALL BEARINGS

Phase II

Final Report on Contract Number N00019-79-C-0418

SKF TECHNOLOGY SERVICES

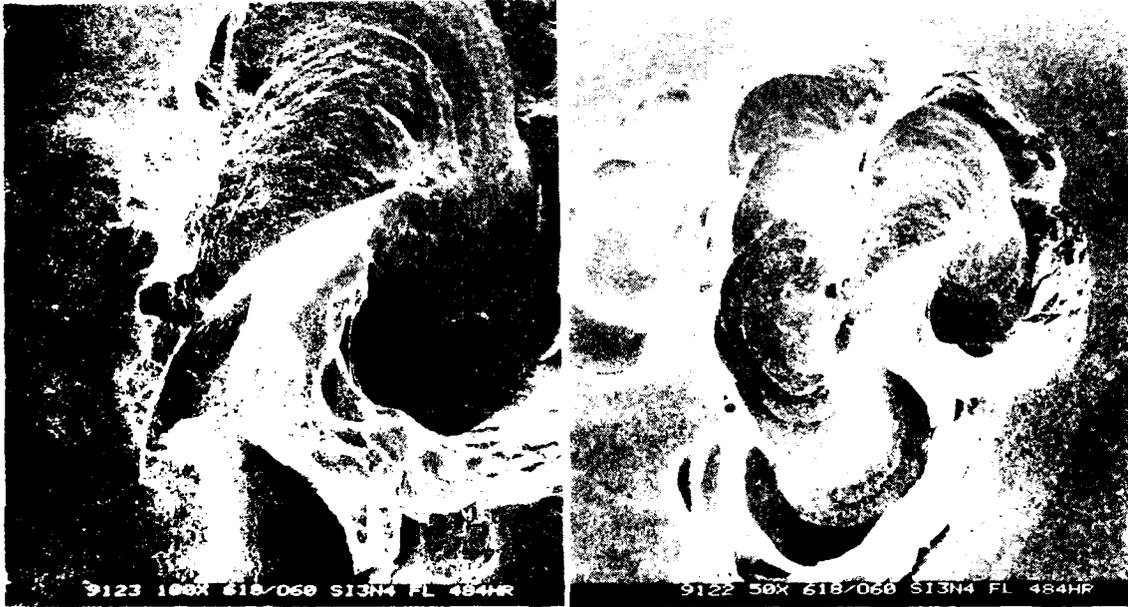
Figure ... Photomicrographs of Ball Fracture Origin and Outer
Ball ... all Run Under Low Load
... ...: 484 Hours

Figure 16 shows the spall origin in a silicon nitride ball and an M50 outer ring spall, both from bearing 060. This bearing failed after 484 hours of operation at the low load. The silicon nitride spall origin is similar to these noted in the high load tests as illustrated with the comparison of Figures 13 and 16. Again no inclusions were dete ted at the fracture origin.

The outer race spall shown in Figure 16 is not typical of the failures seen previously on steel components from hybrid bearings. In all previous cases, the failure of the steel part occurred in conjunction with a ceramic component failure which was thought to cause the ring failure. The steel races in those instances showed plastic deformation, general areas of denting, and deep narrow spalls oriented across the groove. While the current spall was also found in a bearing with a ball failure, the appearance of the spall was more typical of that seen in an all steel bearing. It is therefore possible that the ring spall preceeded the ball failure in this specific bearing.
