A.C. SCHNEIDER LAKE DAM
GASCONADE COUNTY, MISSOURI
MO. 31563

PHASE I INSPECTION REPORT
NATIONAL DAM SAFETY PROGRAM

PREPARED BY: U. S. ARMY ENGINEER DISTRICT, ST. LOUIS

SEPTEMBER, 1980

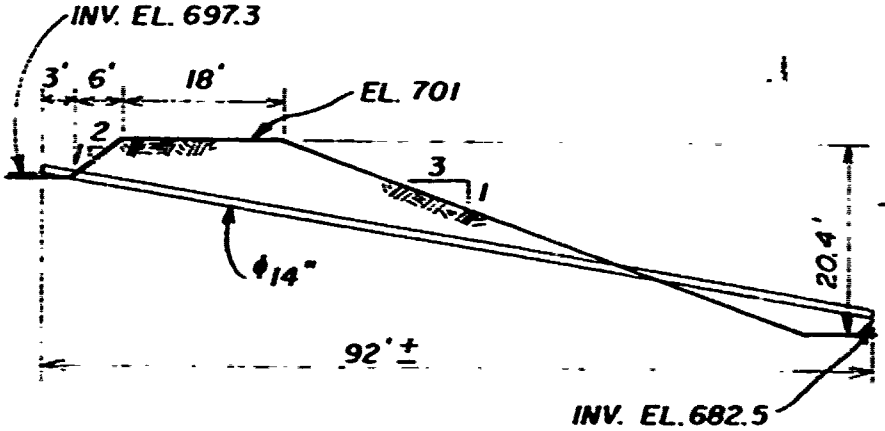
SECTION I-I
PRINCIPAL SPILLWAY

The principal spillway conduit probably has no protective coating along its entire length which would prevent rust and corrosion from taking place. Also, under a full conduit, velocities could be high and set up severe vibrations in the latter 29 feet of unsupported spillway conduit. There are trees, grass and brush growing immediately adjacent to the spillway opening, plus a small pile of brush seemingly floating in front of the inlet, approximately 10 feet away (Photo 5).

5. The principal spillway outlet pipe should in some way be supported or braced in order to relieve the present cantilevered condition to the extent that it is unaffected by vibratory stresses when flowing under head.
