# INSTALLATION RESTORATION PROGRAM
# PHASE I: RECORDS SEARCH
# WILLIAMS AFB, ARIZONA

February 1984

ENGINEERING-SCIENCE
57 Execuitve Park South, N.E.
Suite 590
Atlanta, Georgia 30329
#36372

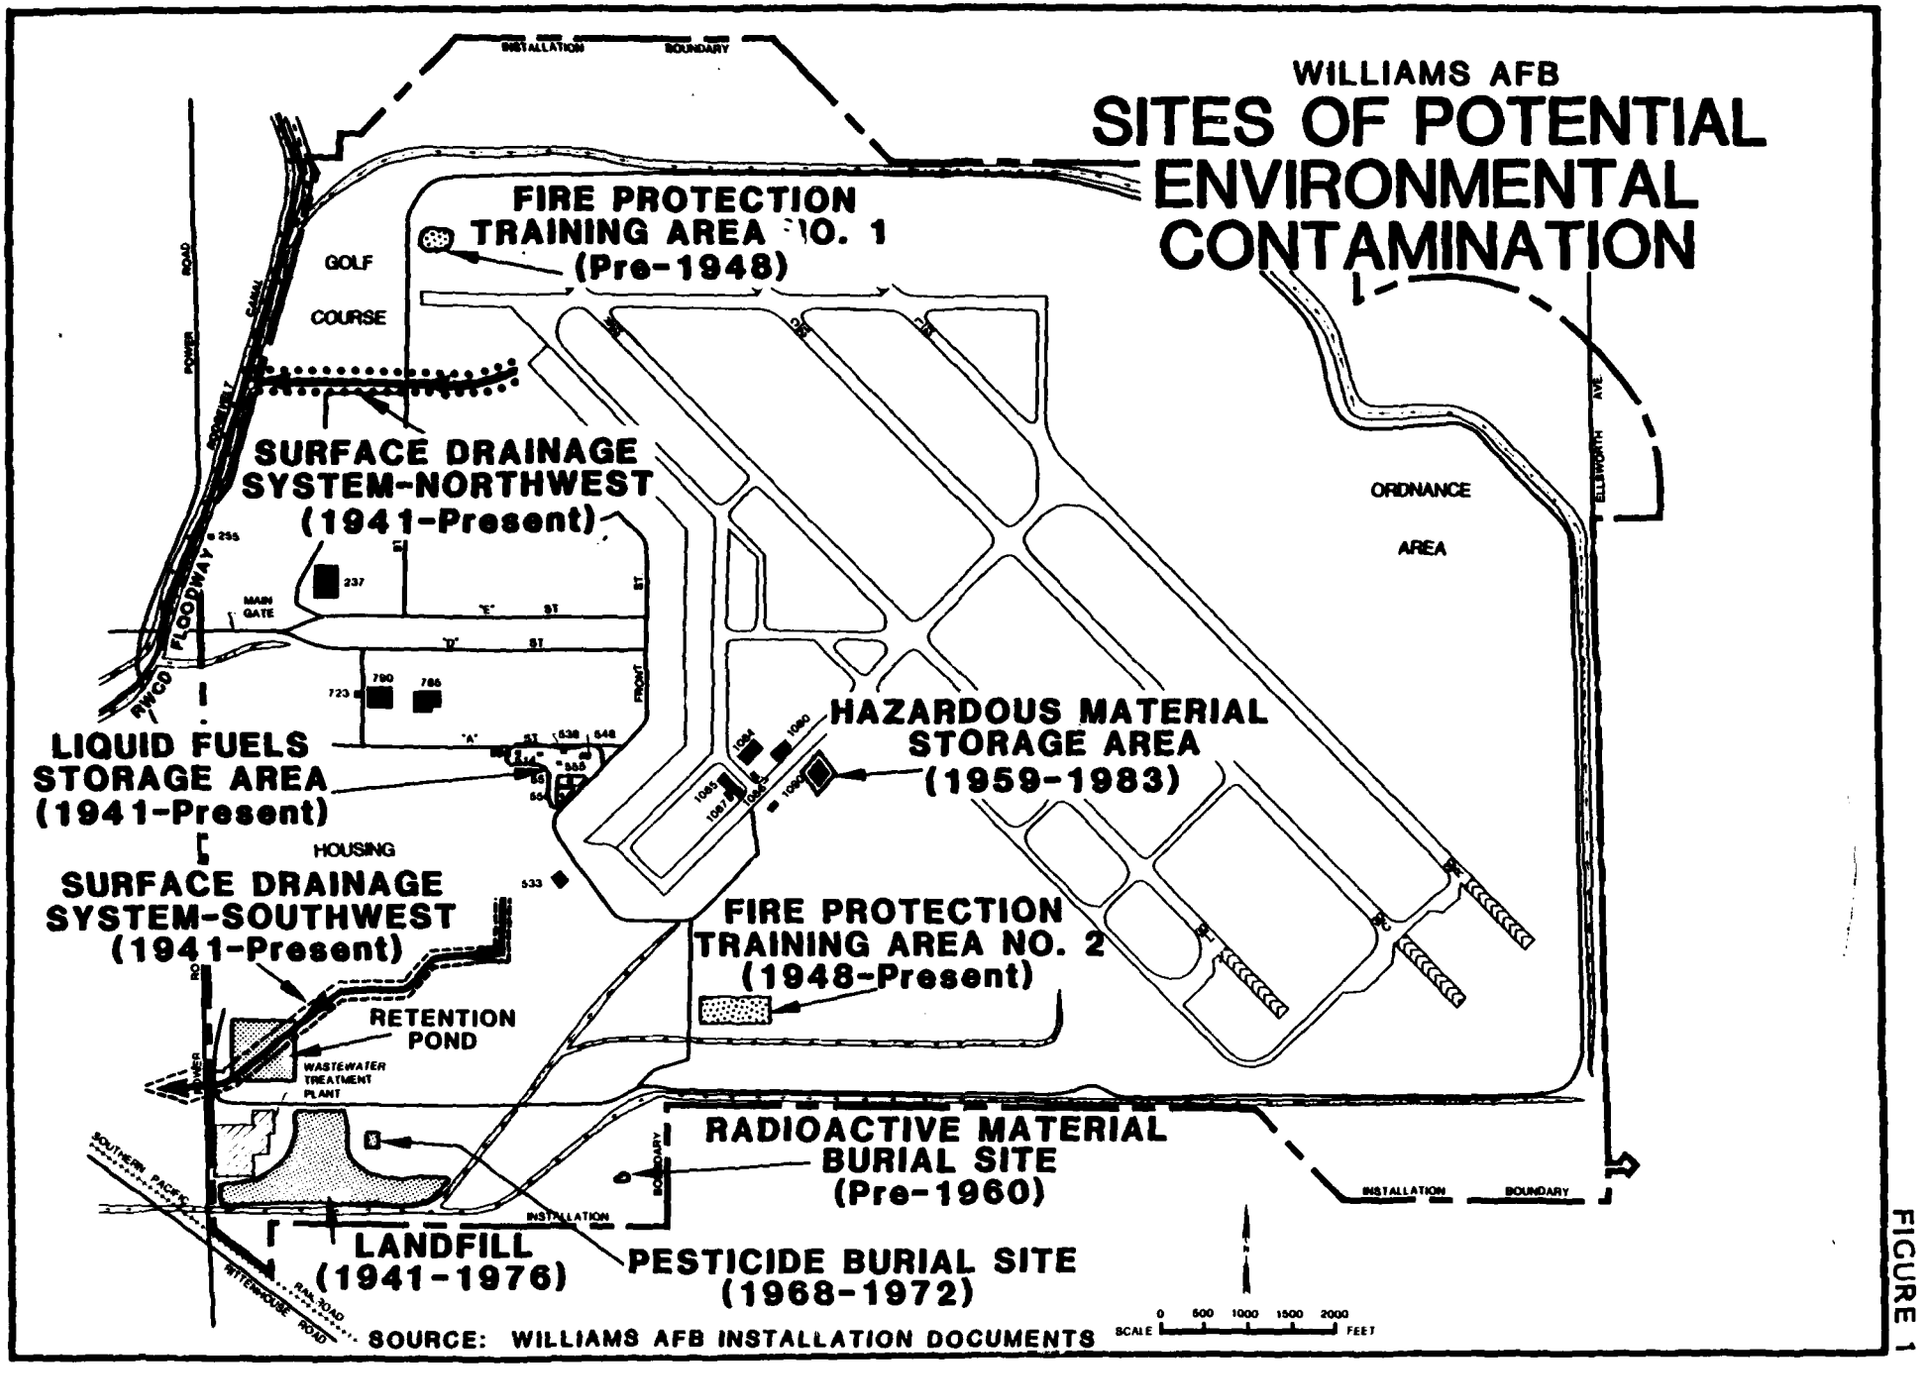
FIGURE 1

The areas found to have sufficient potential to create environmental contamination are as follows:

- o Fire Protection Training Area No. 2
- o Liquid Fuels Storage Area
- o Surface Drainage System - Southwest
- o Landfill
- o Pesticide Burial Site
- o Surface Drainage System - Northwest

Recommended guidelines for future land use restrictions at the disposal sites are presented in Section 6. A program for proceeding with Phase II of the IRP at Williams AFB is also presented in Section 6. The recommended actions include a one-time soil boring, sampling and analysis program to determine if contamination exists. This would be expanded to define the extent and type of contamination if the initial step reveals site contamination. The Phase II recommendations are summarized in Table 2.

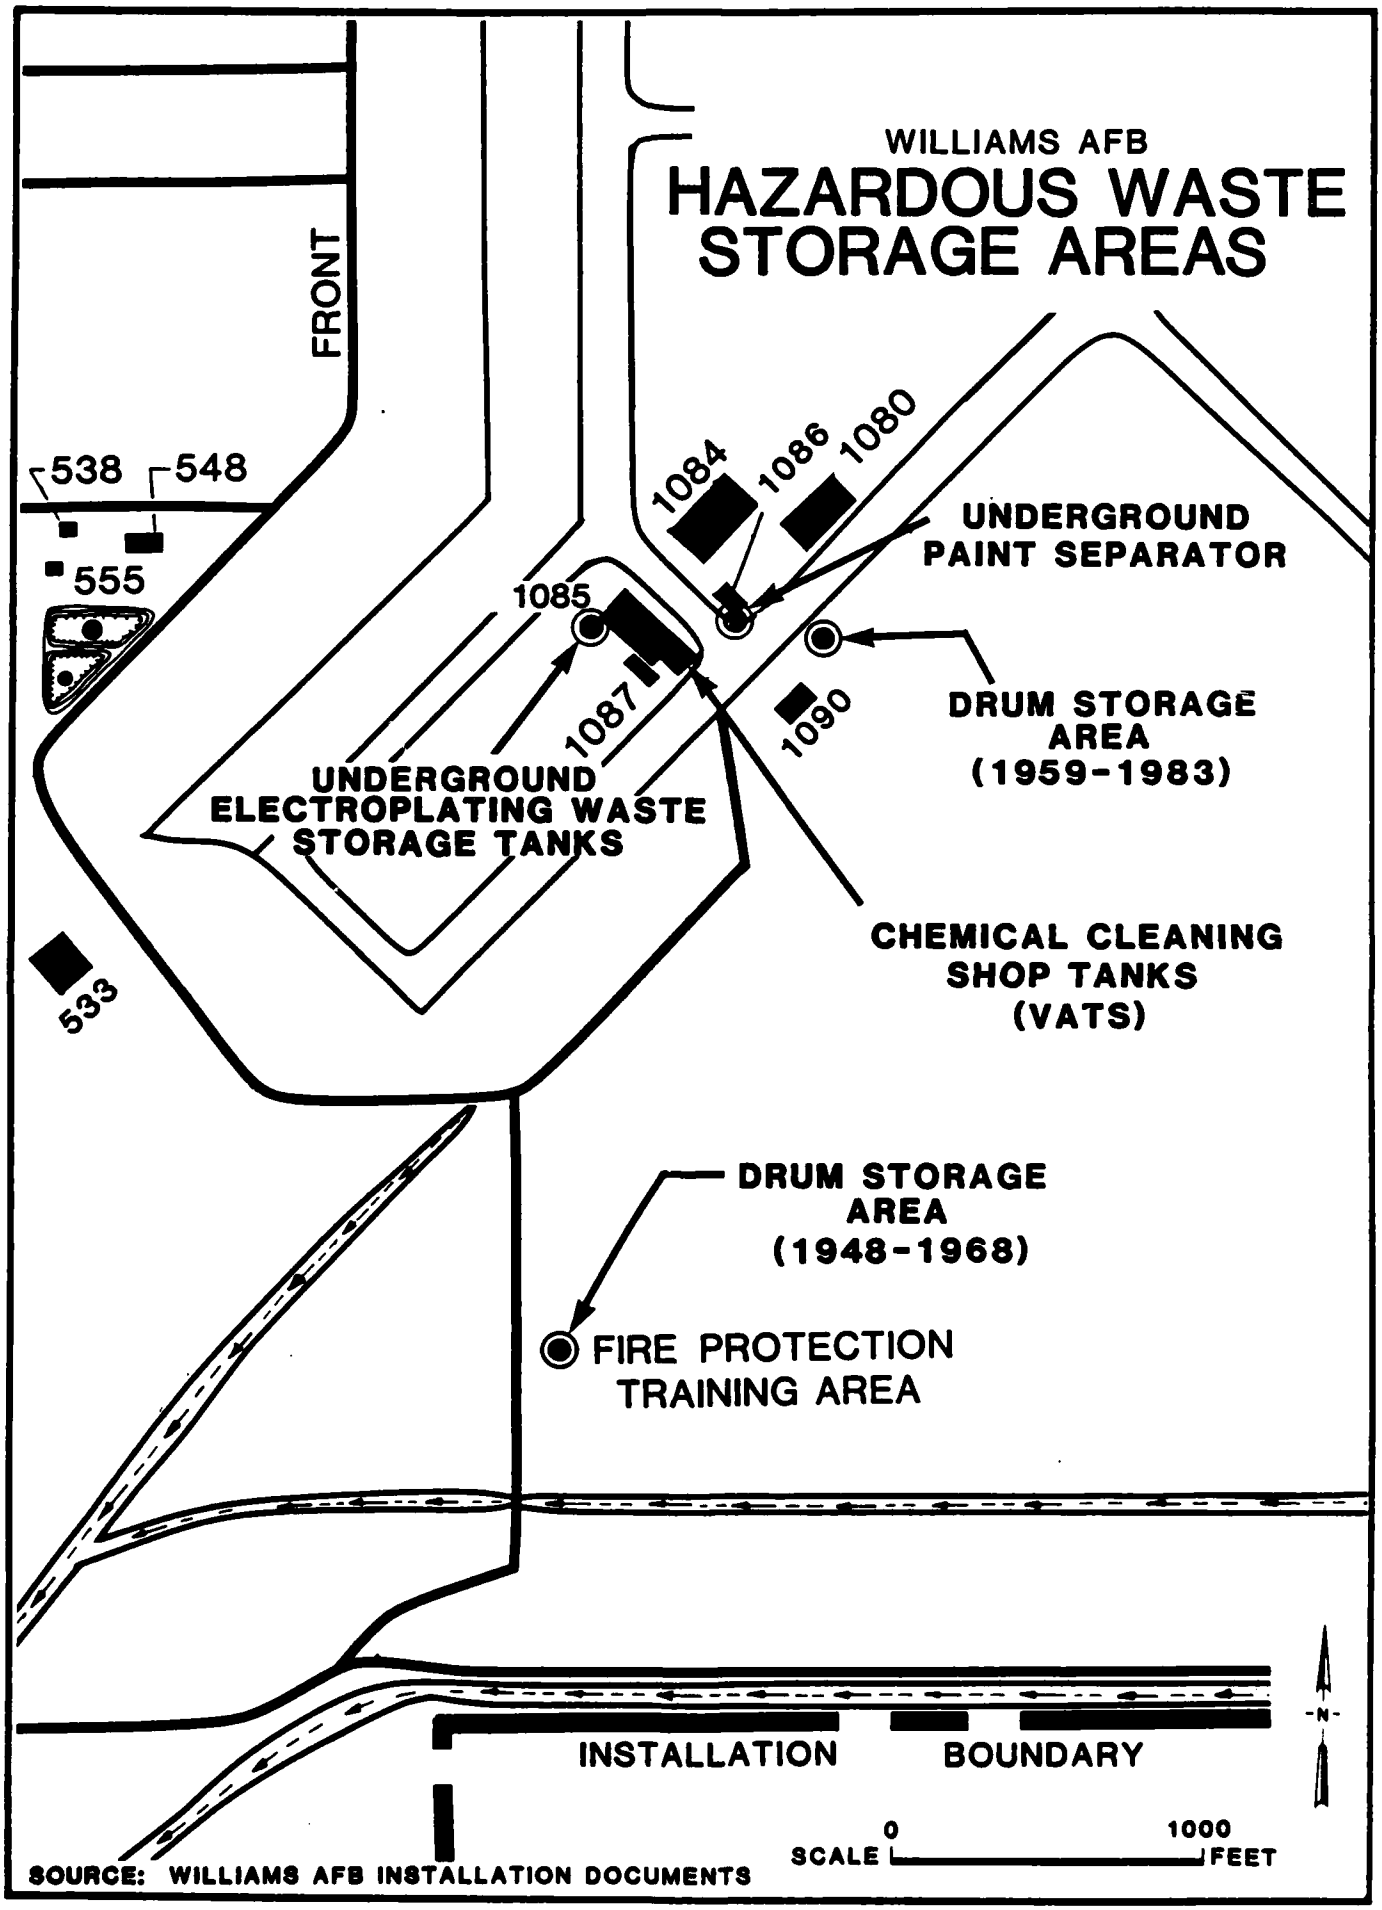
The base has three hazardous waste accumulation points: 1) underground tanks near the electroplating shop in Building 1085, 2) an underground paint separator next to the corrosion control shop, and 3) the process tanks in the chemical cleaning shop in Building 1085. The locations of these facilities are shown in Figure 4.1. One of the tanks near the electroplating shop receives wastes from cadmium plating operations. The other tank receives chromium plating wastes. The paint separator receives wastes from paint stripping operations that are performed in Buildings 25 and 1086. It also receives waste emulsifier from the NDI/SOAP Laboratories and small quantities of compatible hazardous wastes from the weather, maintenance and electric shops. The contents of the electroplating tanks and paint separator tank are removed from the tanks every 60 days, by a contract carrier that is licensed by the U.S. EPA, and taken to an approved treatment, storage or disposal (TSD) facility. The chemical cleaning tanks in Building 1085 are pumped when the process solutions are spent by the same contract carrier.

There are presently no drum storage areas for hazardous wastes at Williams AFB. There are no records of the existence of drummed storage areas on the base, however interviews with base personnel revealed that waste oils, solvents, JP-4 and other combustible materials were stored near Fire Protection Training Area No. 2 near the south side of the

base. These wastes were taken in drums to the area by shop personnel. The maximum number of full drums in storage at FPTA No. 2 was estimated at approximately 50 by present and past base employees.

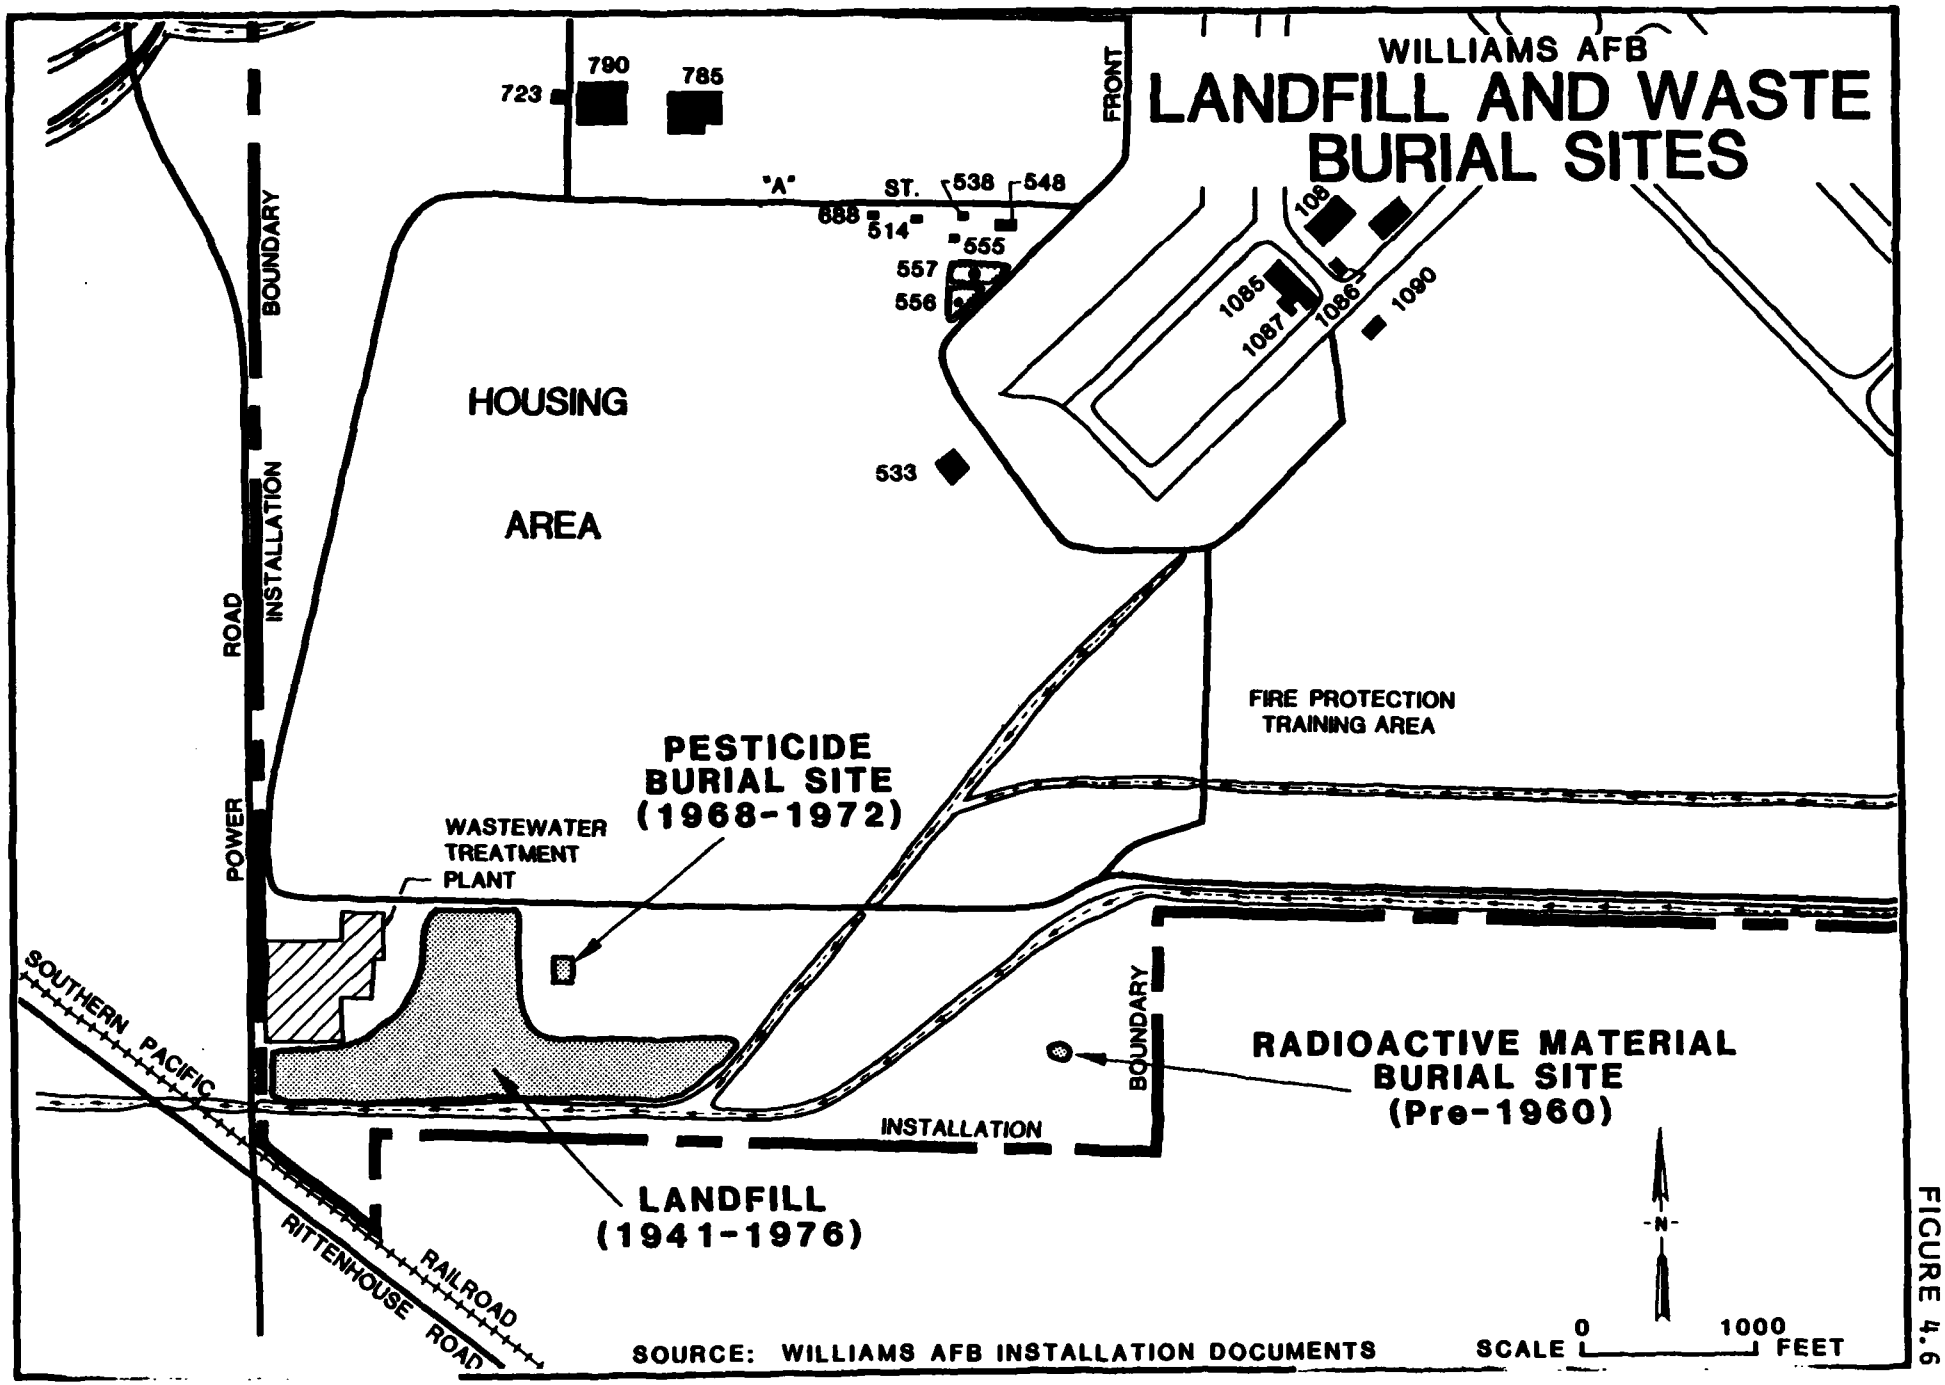
FIGURE 4.6

The area of the landfill site is approximately 34 acres. Filling first started in the southwest corner of the site (Figure 4.6). It then progressed to the area east of the wastewater treatment plant, followed by filling in the southeast corner of the site. During the 1940's and 1950's material deposited at the landfill was routinely burned.

The landfill site is adjacent to the major drainage channel (normally dry) which runs along the southern installation boundary. Drainage from the site reaches this channel during runoff events. Some vegetation has re-established on the site since closure. The top surface of the landfill is irregular from differential trench settlement
