INSTALLATION RESTORATION PROGRAM

PHASE I — RECORDS SEARCH

5073rd Air Base Group
Shemya AFB, Alaska

September 1984

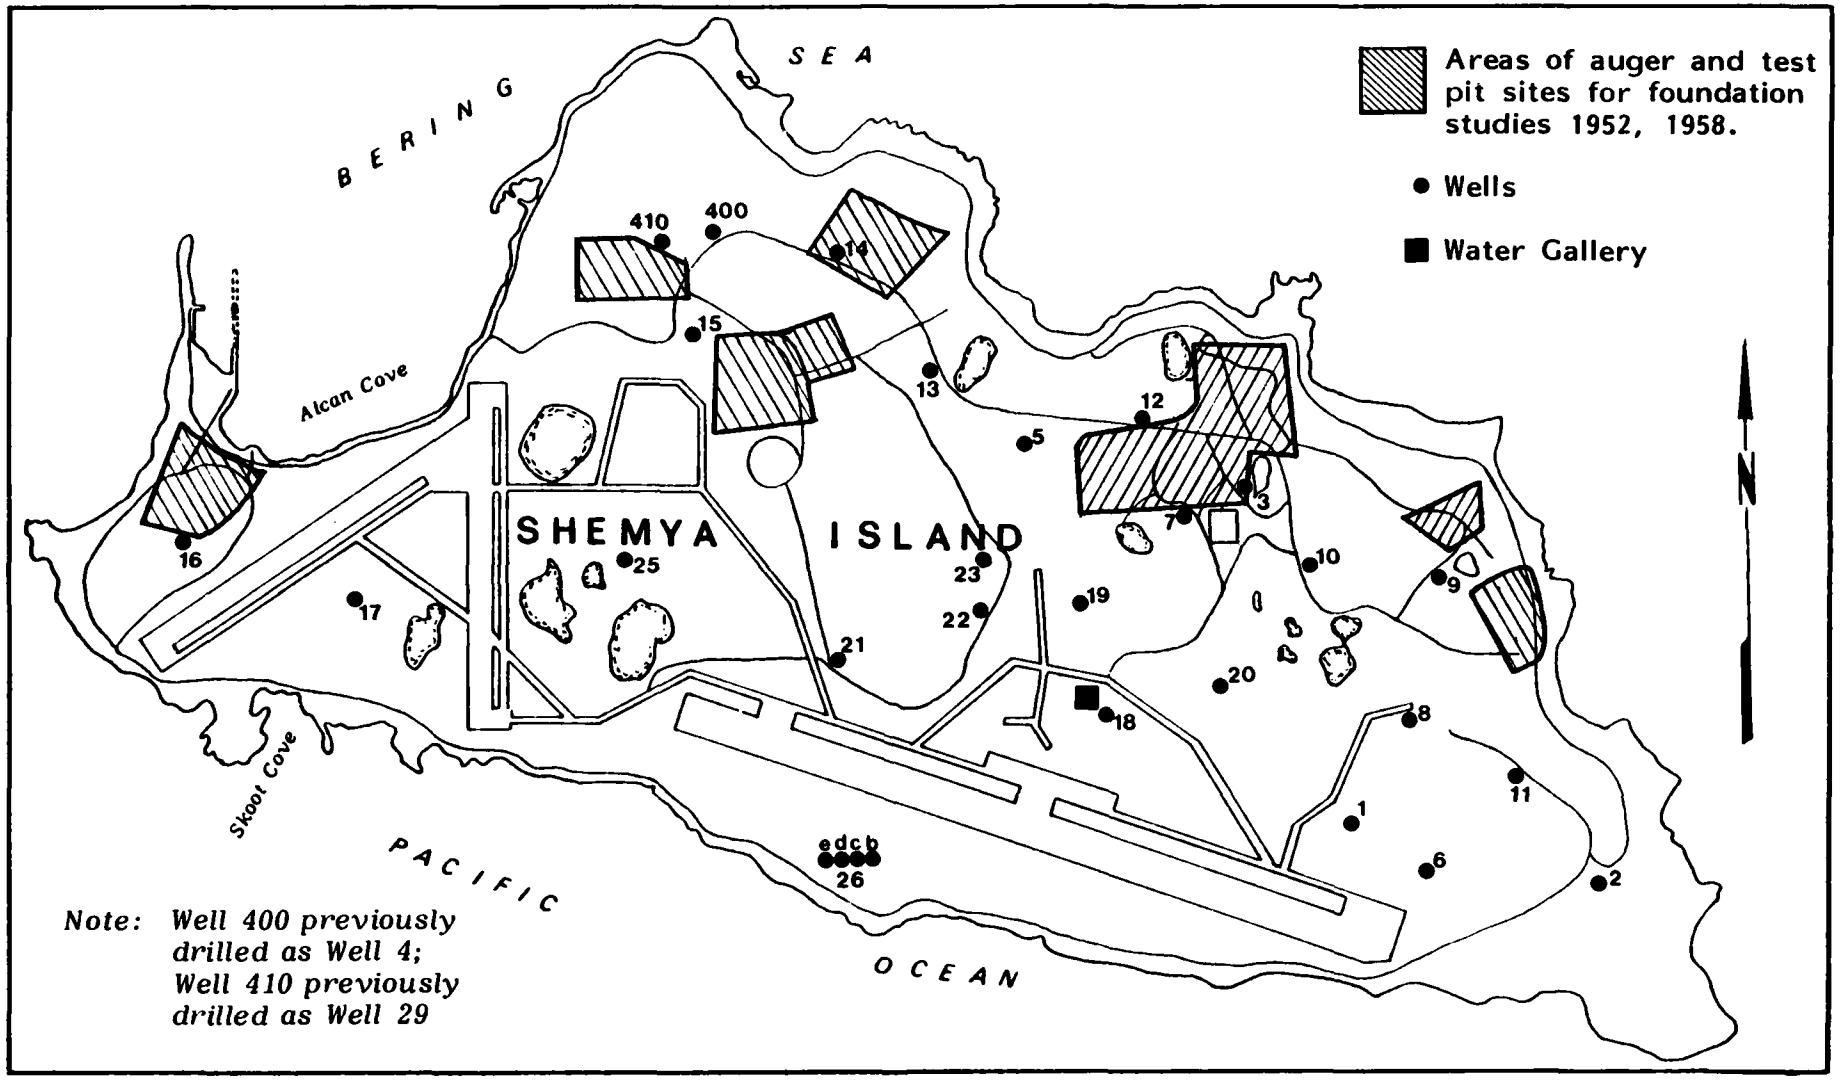
In 1943, 30 wells were drilled to replace contaminated surface water supplies then in use. Well yields were reported to be generally limited to 25 gpm. Figure 3.9 identifies the location of these wells. While on Shemya Island, the JRB field team came across Well 2 (southeast corner of the island). It was uncapped and standing water was observed in the casing. In addition, Figure 3.9 shows the location of auger holes and test pits that were excavated for foundation studies (U.S. Army 1952, 1958). Only when needed are Wells 400 (formerly Well 4) and 410 (formerly Well 29) used to supplement the gallery water supply. The combined yield of these two wells is 110 gpm. Well 400 delivers 80 gpm with 10 feet of drawdown (a specific capacity of 8.0 gpm/ft of drawdown). Well 410 delivers 30 gpm with 56 feet of drawdown (a specific capacity of 0.53 gpm/ft of drawdown). The specific capacity is a measure of a well's relative efficiency. It is the yield of a well expressed as gallons per minute (gpm) pumped, divided by feet of drawdown at a given time. Evidently these wells tap a very productive portion of the deep (bedrock) aquifer. However, Well 400 appears to be very efficient in comparison to Well 410 based upon specific capacities of each well. The distance between the wells is 710 feet. No pumping interference between the wells has been observed (U.S. Army, 1958). Table 3.2 presents a summary of available static water level elevations in Wells 400 and 410 over a 16 year period. The apparent lowering of the shallow groundwater table suggests that some mining of stored groundwater supplies has occurred.

LOCATION OF WELLS AND FOUNDATION STUDIES
SHEMYA ISLAND, 1952-1958

The Air Force is encouraged to locate and at least cap all abandoned wells (see Figure 3.9). Each well cap should be fitted with a 1/2-inch threaded sounding port for easy access to measure water levels. Each cap should be removable to allow the collection of water samples for future water quality control programs. The wells should be sounded for total depth and static water levels. Any wells to be sampled for water quality testing should be

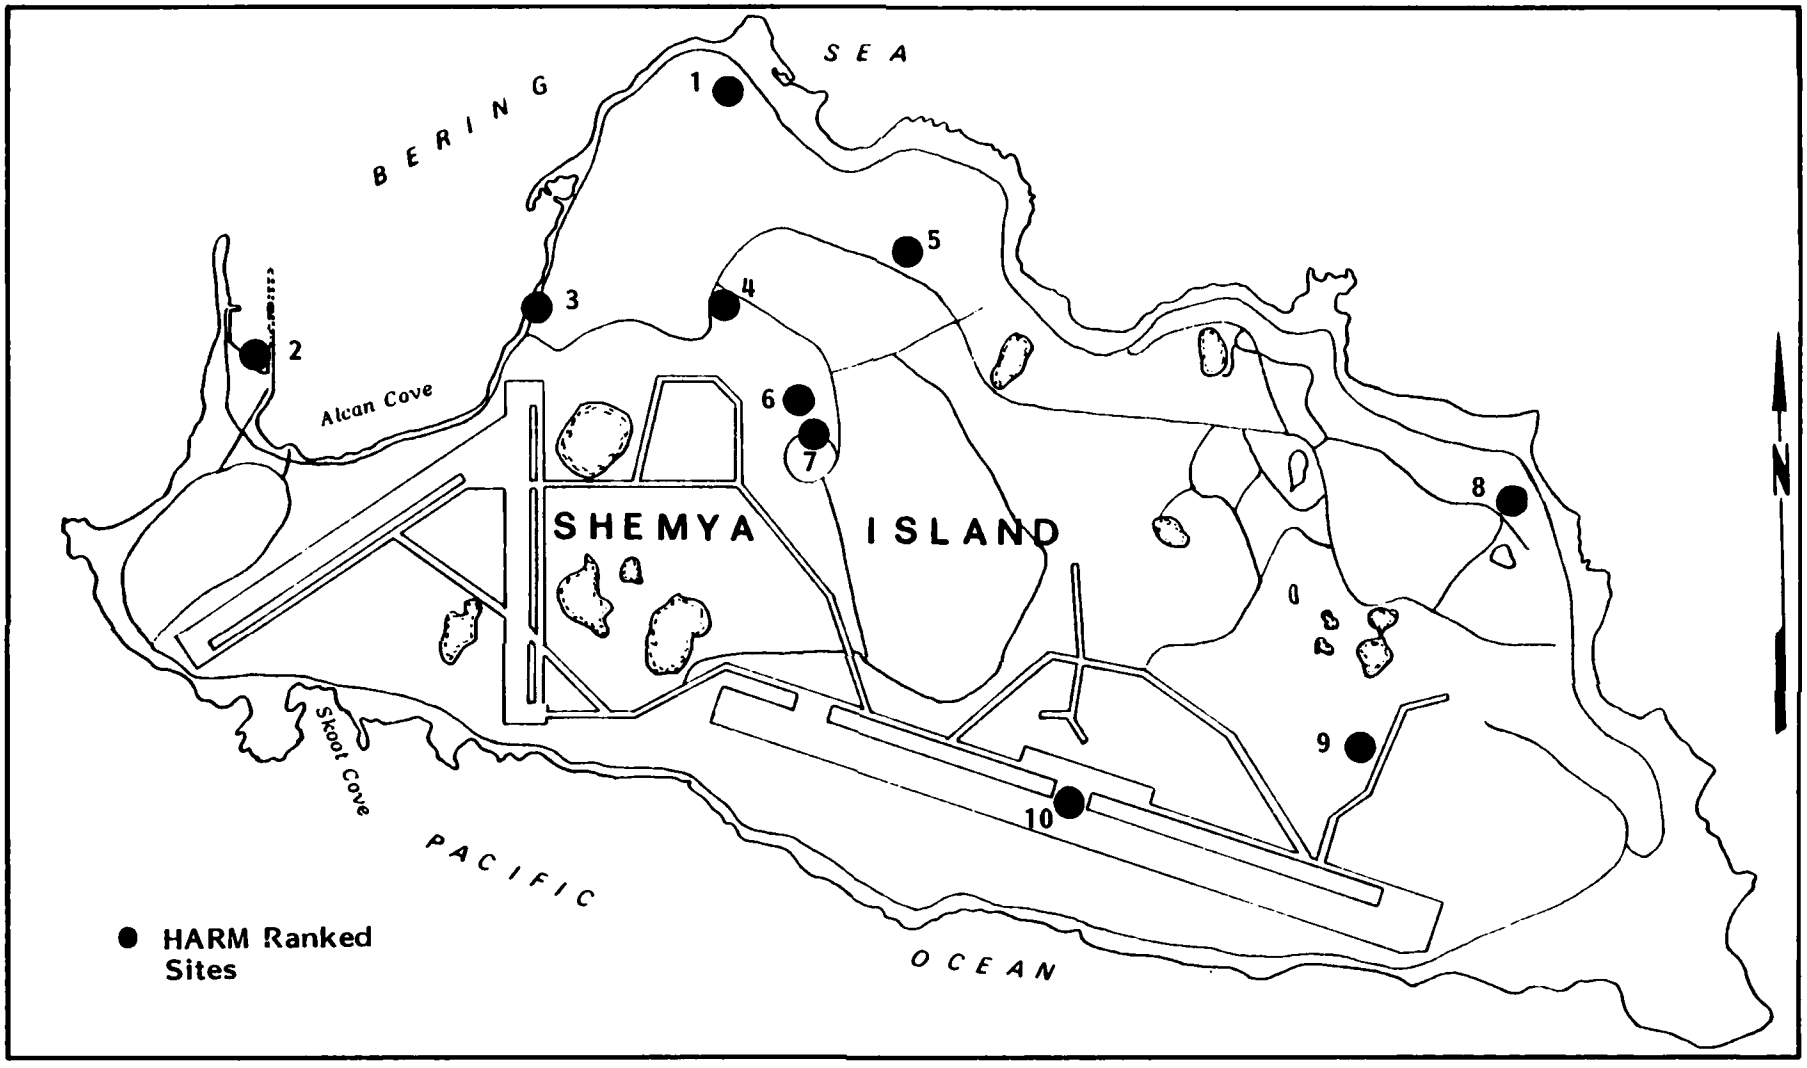
Several sites have been documented relating to the operation and management of the POL system and POL spills. Locations of these sites are presented on Figure 4.1 and brief site descriptions of six of the fuel or POL spills follow. Sites PS-1, 7, 8 and 9 involve industrial chemicals or reagents and are described in Section 4.2.3 of this report.

POL AND SPILL SITES, SHEMYA AFB
Sites PS-1 through PS-10

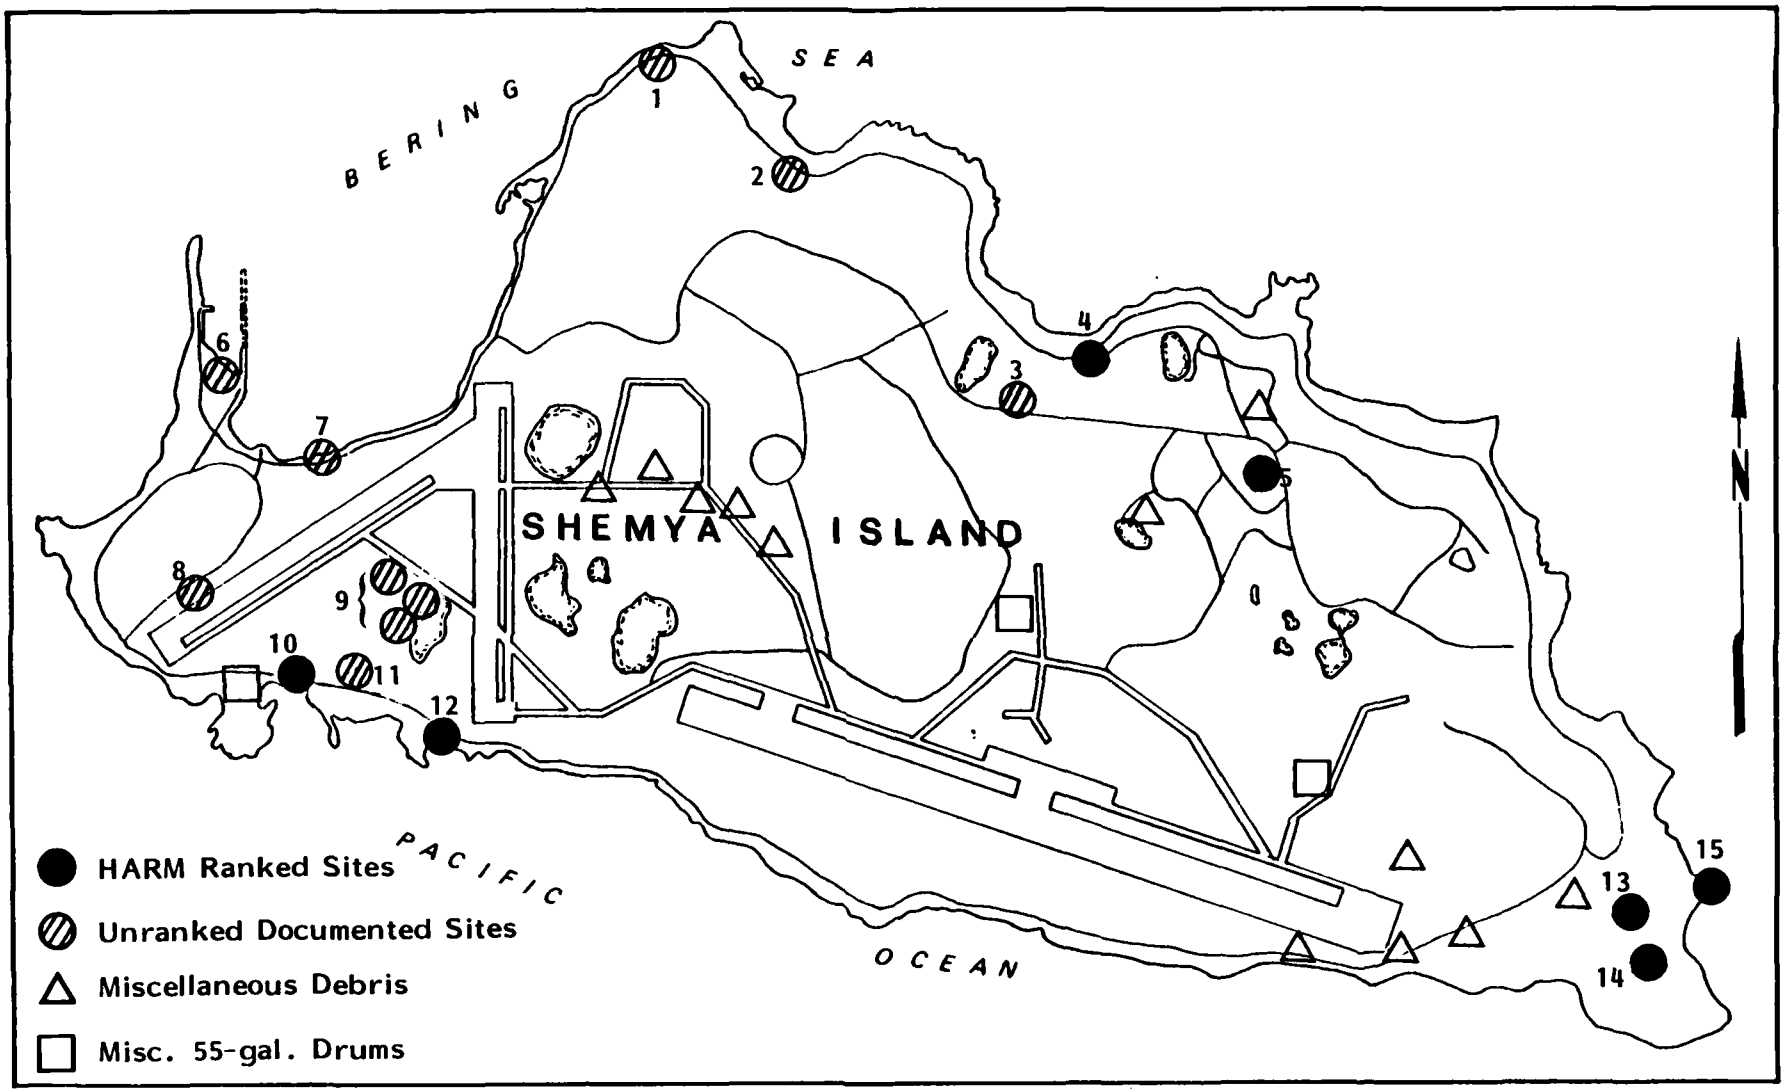
Several solid waste sites were observed and documented. However, due to the ubiquity of this problem on Shemya only the major solid waste disposal sites have been listed in this investigation. Locations of these solid waste sites are presented on Figure 4.2 and brief site descriptions follow:

It is estimated that well over a thousand barrels are disposed at this site located on the north shore of Shemya Island near the intersection of North Beach and Grace Roads. It is unknown how long these barrels have been at this location, but it is estimated that they are of the World War II era. Most of the barrels are crushed and in varying degrees of deterioration. This site is less than 50 feet from the ocean. Efforts have been made by the Air Force to remove these barrels. Because it is unknown what was in these drums, and that they are subject to storm tides, a potential for contamination exists. Therefore, HARM scoring is required.

SOLID WASTE SITES, SHEMYA AFB
Sites SW-1 through SW-15

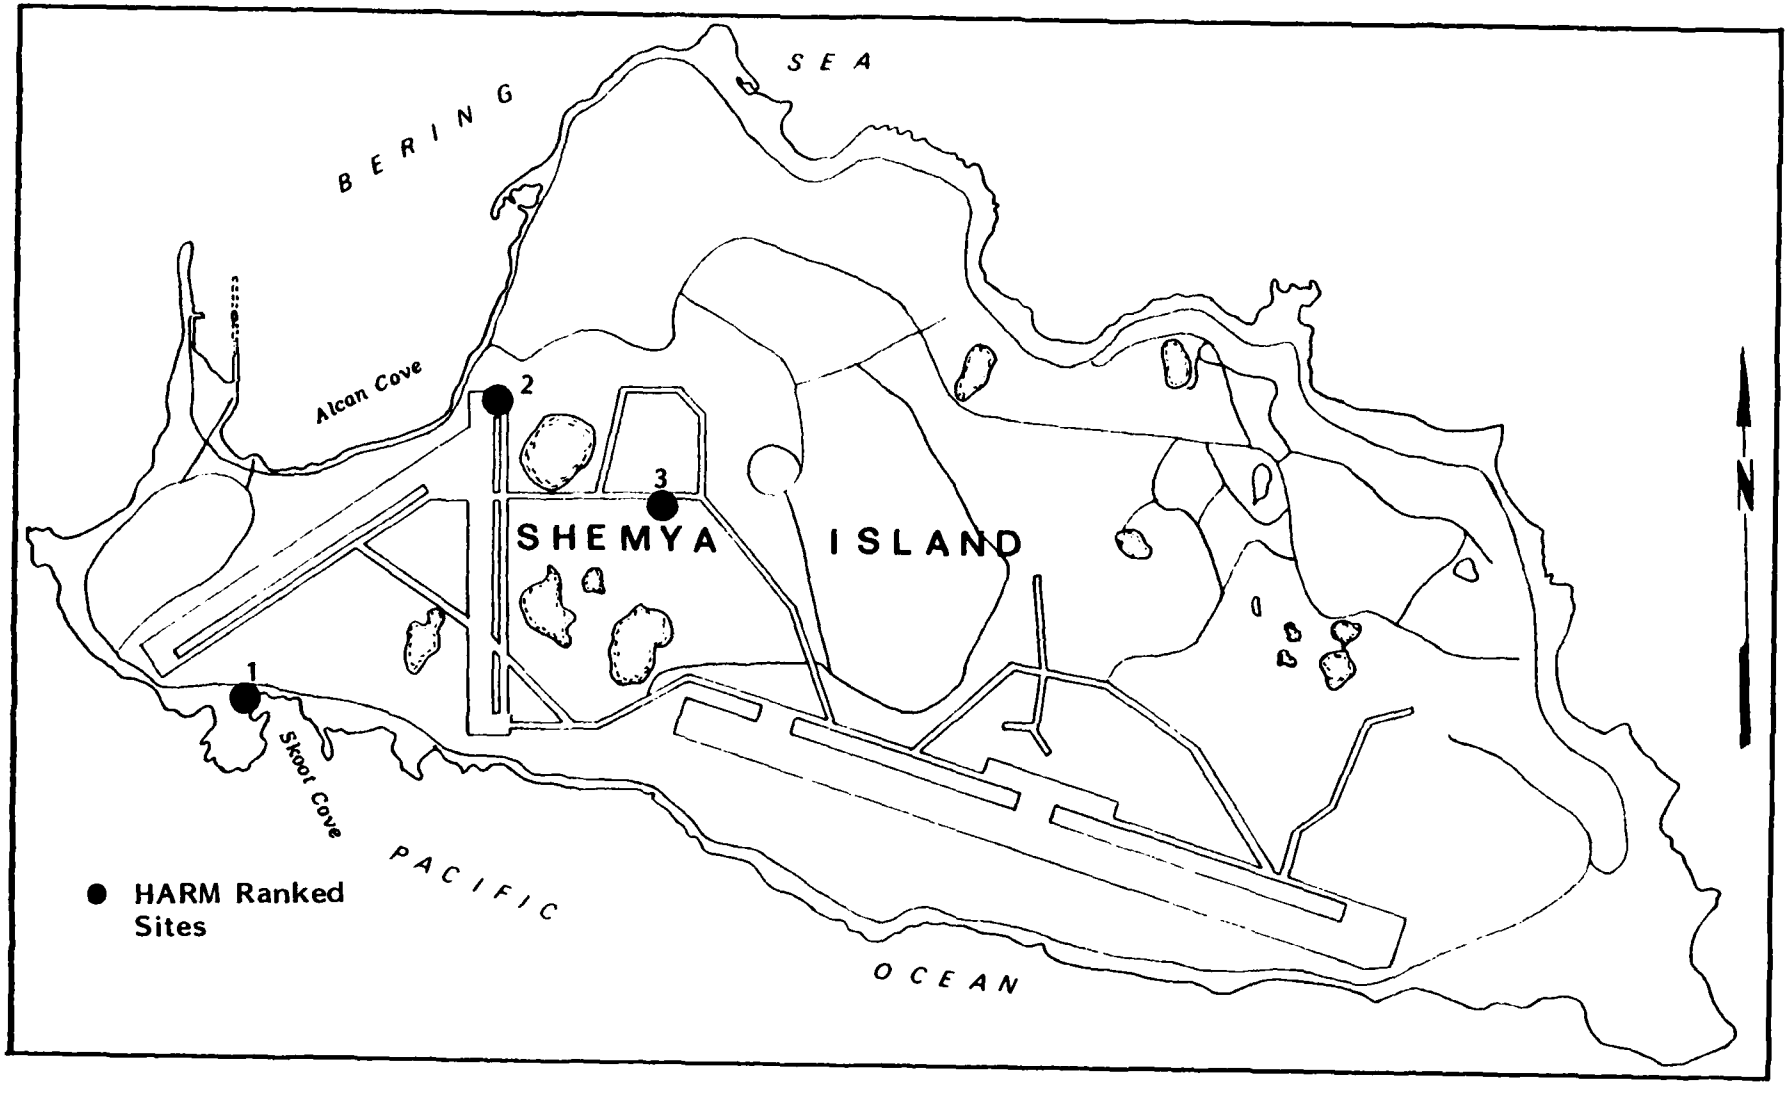
Three locations serve as fire department training exercise areas. These burn areas are located on Figure 4.3 and a brief description of each follows.

The "Lightning Strike" is an area on the north end of Skoot Cove where the fire department practices fire fighting training. Debris is piled on the beach against the hillside then ignited using JP-4 (see Photo H, Appendix H). The Air Force has used this site since the early 1970's to dispose of waste oil from the power plant. Prior to the 1970's waste POL was either applied to road surfaces or discharged to the ocean either directly or through the sewerage system. Waste oil is transported to the site in an 875 gallon bowser. The

FIRE TRAINING SITES, SHEMYA AFB
Sites FT-1 through FT-3

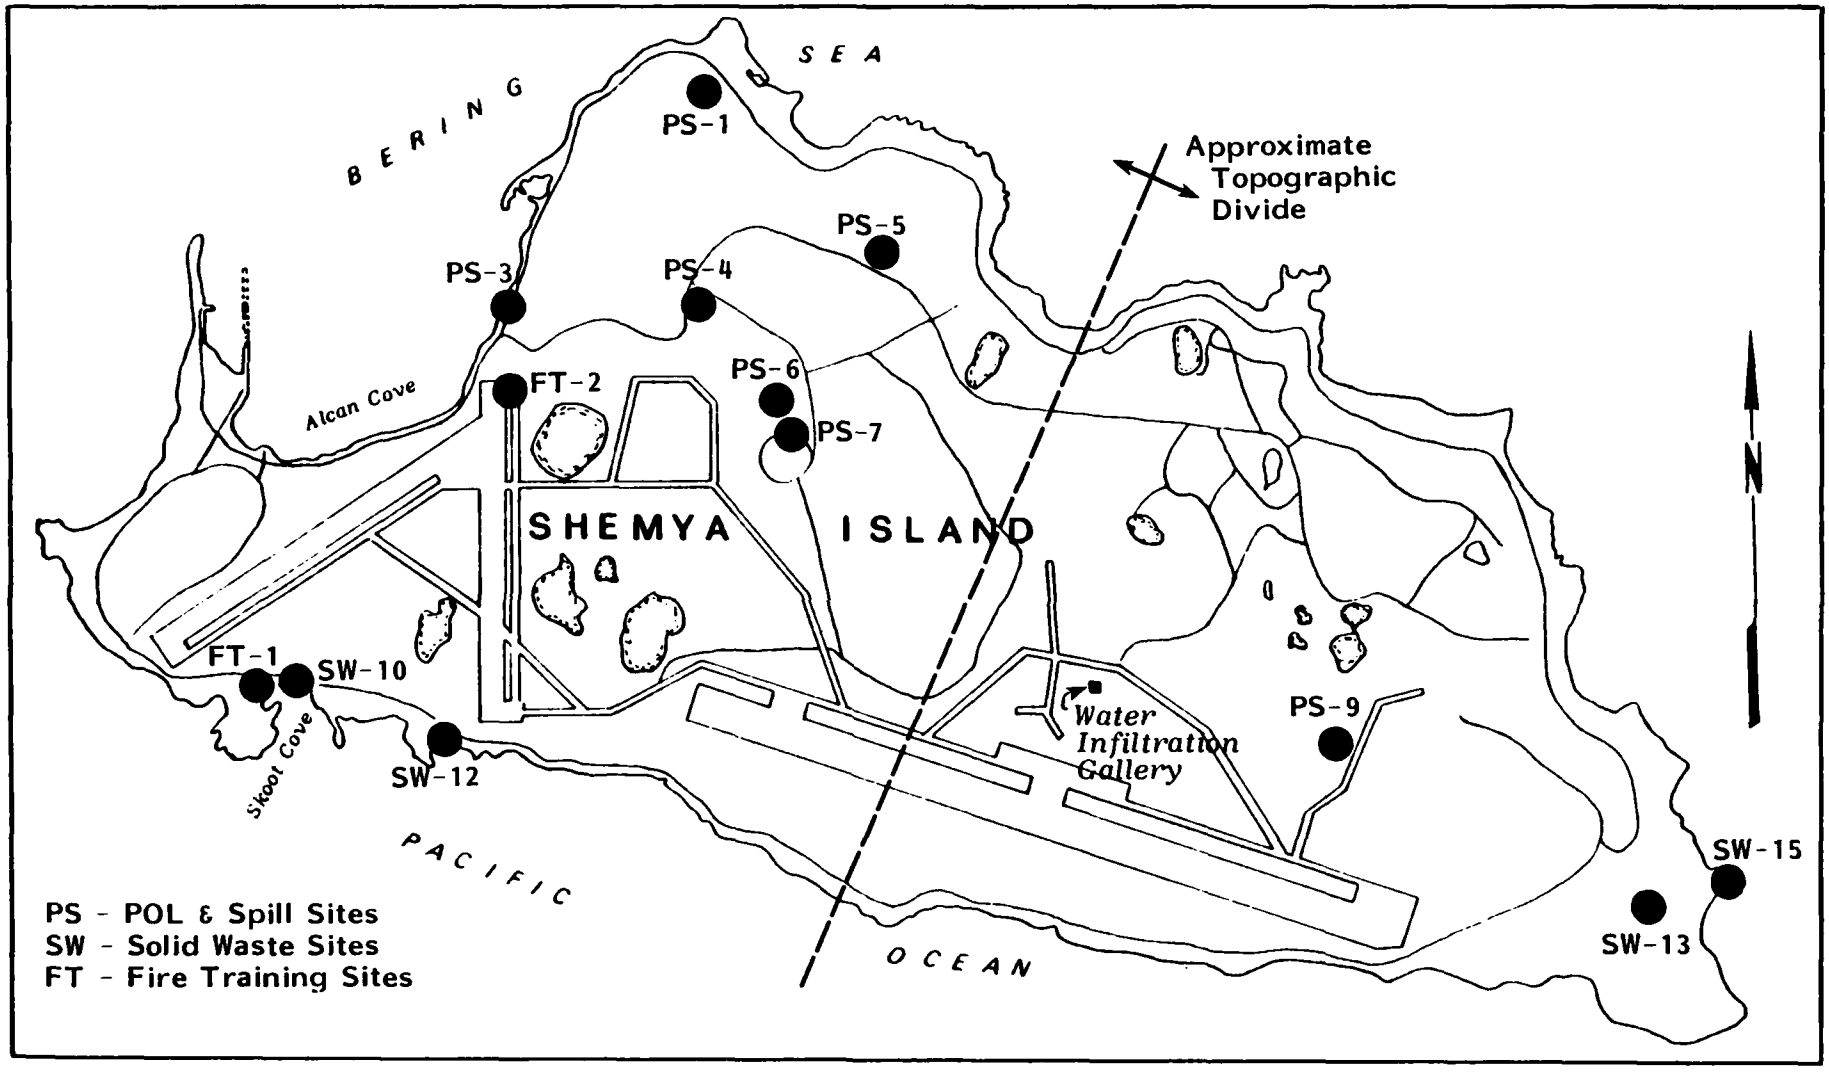
Thirteen of the Shemya AFB sites had HARM ratings which exceeded a score of 50. Follow-on actions are recommended for each of these sites. Figure 5.1 identifies the location of these 13 sites, while a discussion of each with the highest ranked site first, is presented below. For those sites which received a HARM score below 50 and for which there is a low potential for contaminant mobilization or migration, the reader is urged to review Section 4.2 for a site description.

LOCATION OF WASTE DISPOSAL SITES RECOMMENDED FOR FOLLOW-ON ACTION
SHEMYA AFB

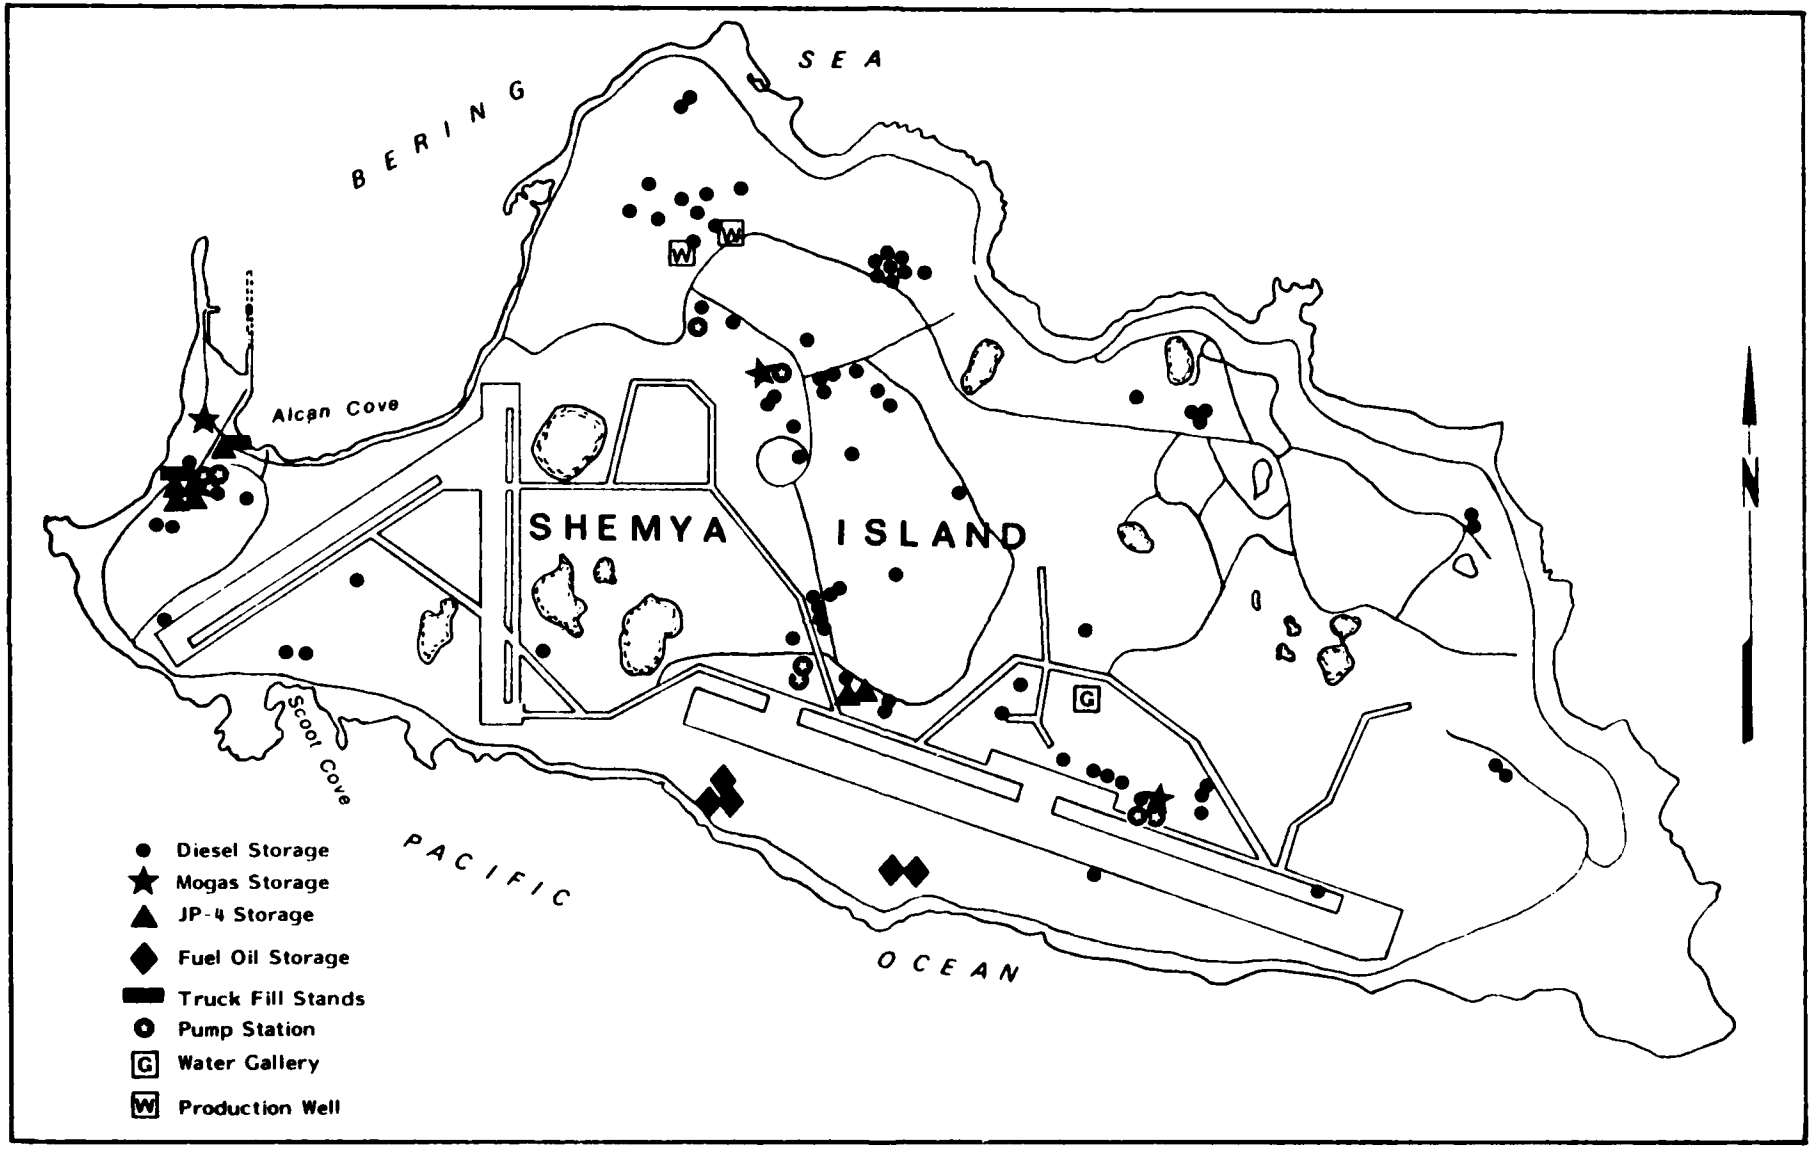
EXISTING POL STORAGE AND TRANSFER FACILITIES AND
THEIR RELATIONSHIP TO LOCATION OF BASE WATER SUPPLIES
(from Shemya AFB Utility Drawings)

- All liquid fuels storage facilities and the distribution system should be tested and replaced if necessary. Alaskan Air Command recommends a major rehabilitation of the total fuels system be initiated before 1990.

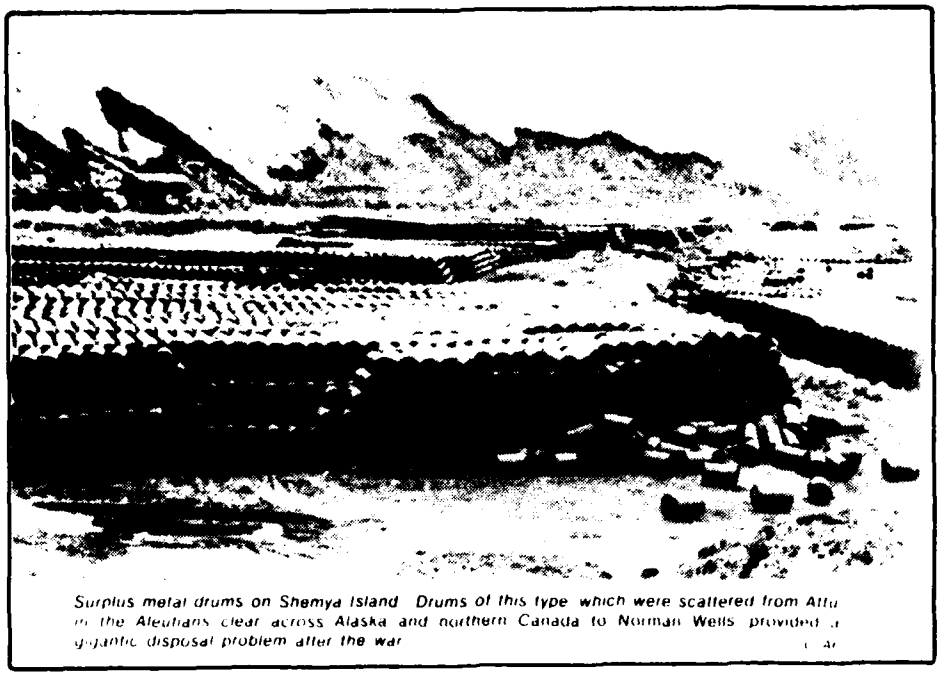
A

Surplus metal drums on Shemya Island. Drums of this type which were scattered from Attu in the Aleutians clear across Alaska and northern Canada to Norman Wells provided a gigantic disposal problem after the war.

Petroleum Storage During World War II
in Alcan Cove, Shemya AFB

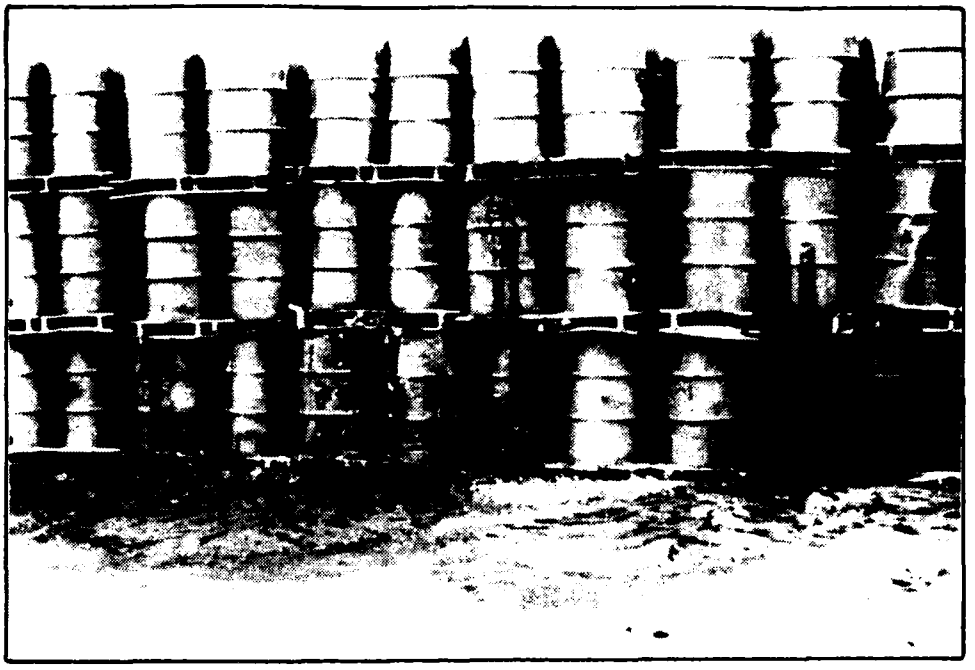
Site PS-9, Roofing Tar Drum Storage
HARM Ranking: No. 8
