DOT/FAA/CT-84/10

Seat Experiments for the Full-Scale Transport Aircraft Controlled Impact Demonstration

March 1985
Final Report

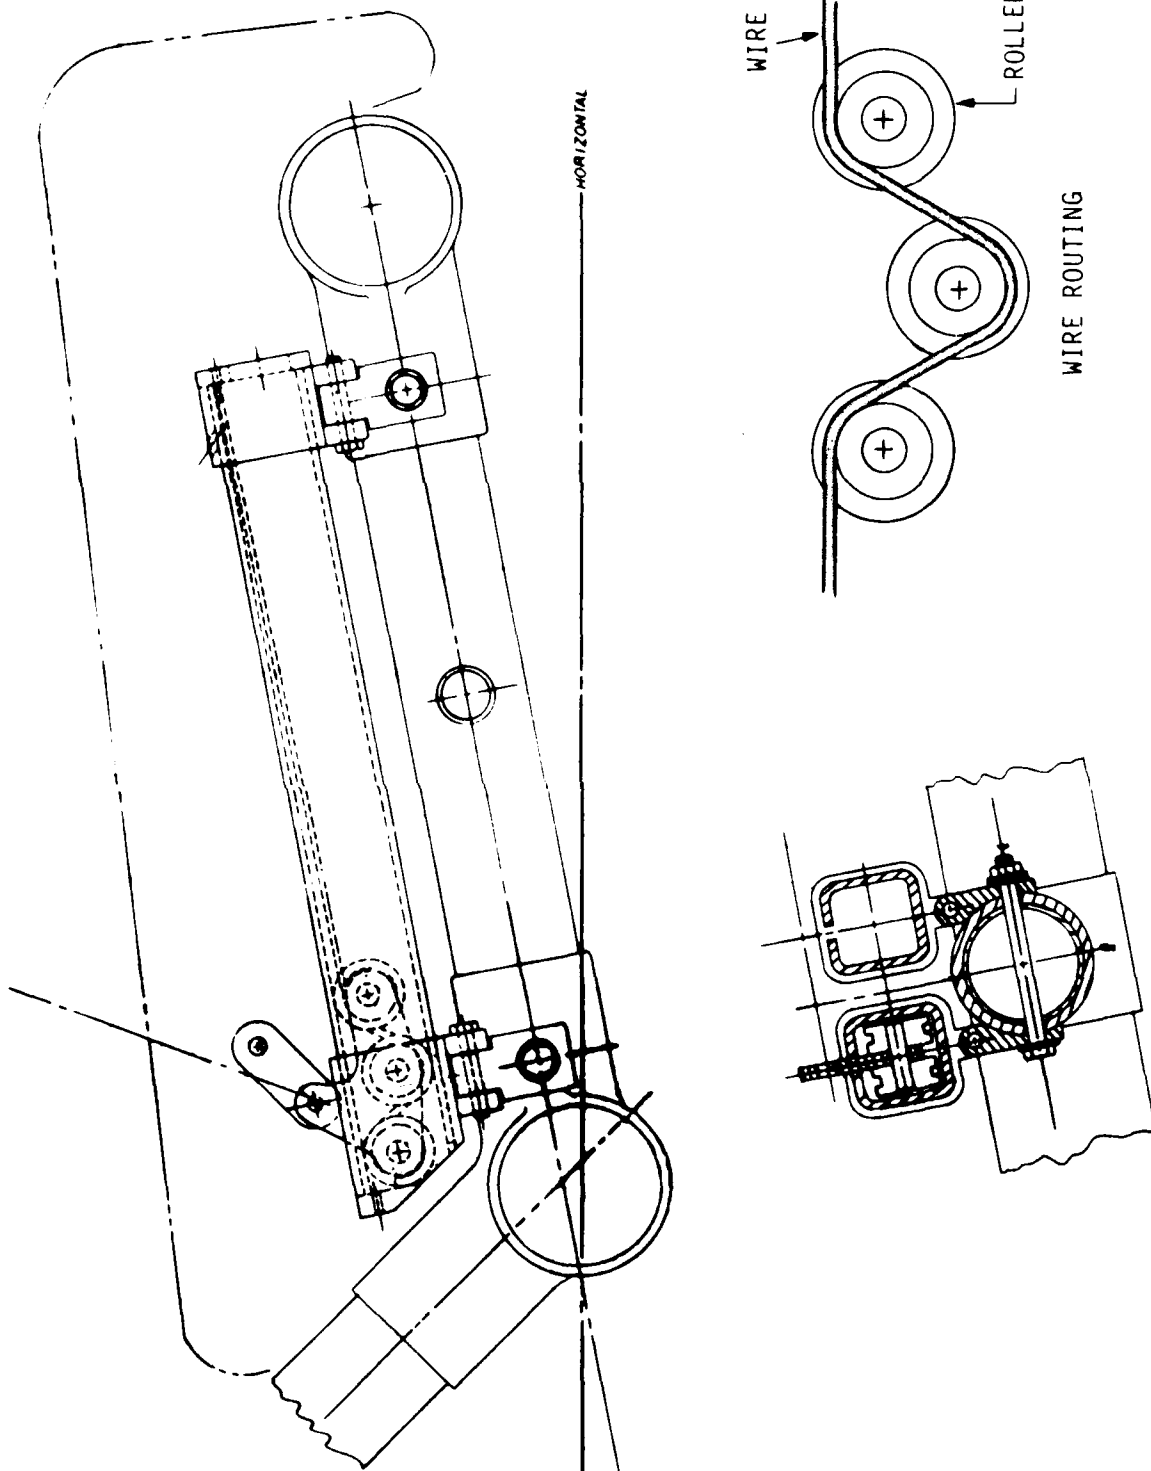
ENERGY ABSORBERS. The energy absorbers on the Weber MOD I feature a wire-bending mechanism consisting of a housing, trolley, and two wires. The housing is a square tube which contains and constrains the trolley as it is pulled forward by the lap belt through a slot which runs the length of the housing. The trolley limits the forward component of the lap belt load by deforming two pieces of music wire through three sets of double rollers. The number of rollers, their diameter and spacing, and the wire diameter and material, determine the force required to pull the trolley. Component testing to determine the specifics of these parameters for the seat modification is described in Appendix H. Figure 60 shows the components in the lap belt energy absorber. A unique feature of the design is that the same rollers serve to limit the friction caused by the large upward load component.

Figure 60. Weber MOD I seat lap belt energy absorber.

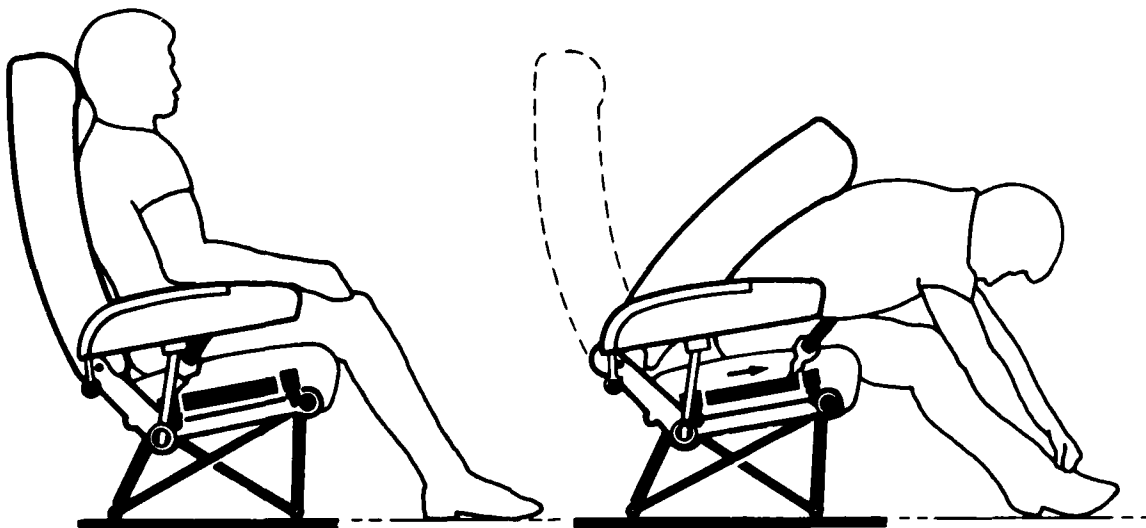
MODIFICATION CONCEPT. Four modification concepts were originally considered
for the Weber seat, including the energy-absorbing restraint system shown in
figure 55. Based on preliminary studies (reference 38), the energy-absorbing
restraint system was selected as the preferred configuration. A rear-leg energy-
absorbing concept was the runner-up, and was the subject of a second modifica-
tion.

Figure 55. Weber MOD I seat before and after stroking.

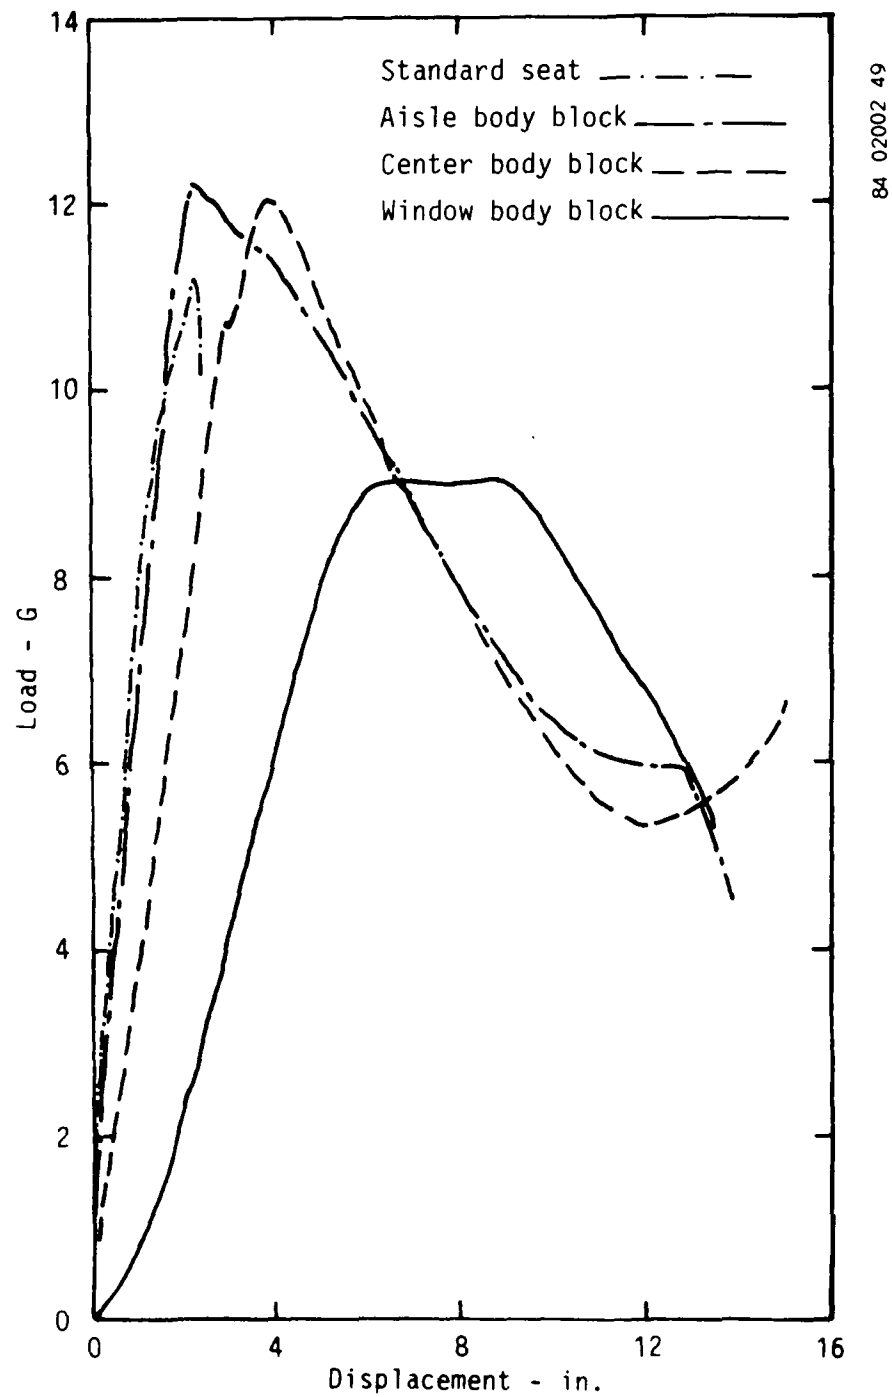
Figure 64. Load versus forward displacement of standard seat and body blocks of Weber MOD I seat.

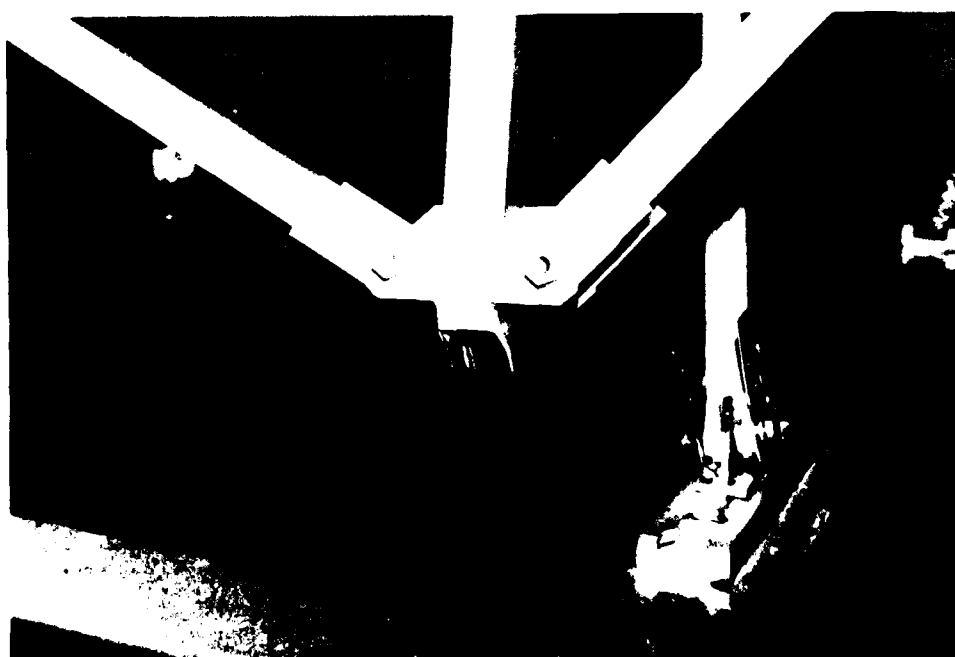
Figure 66.   Failure point on Weber MOD I seat (Lateral Test).

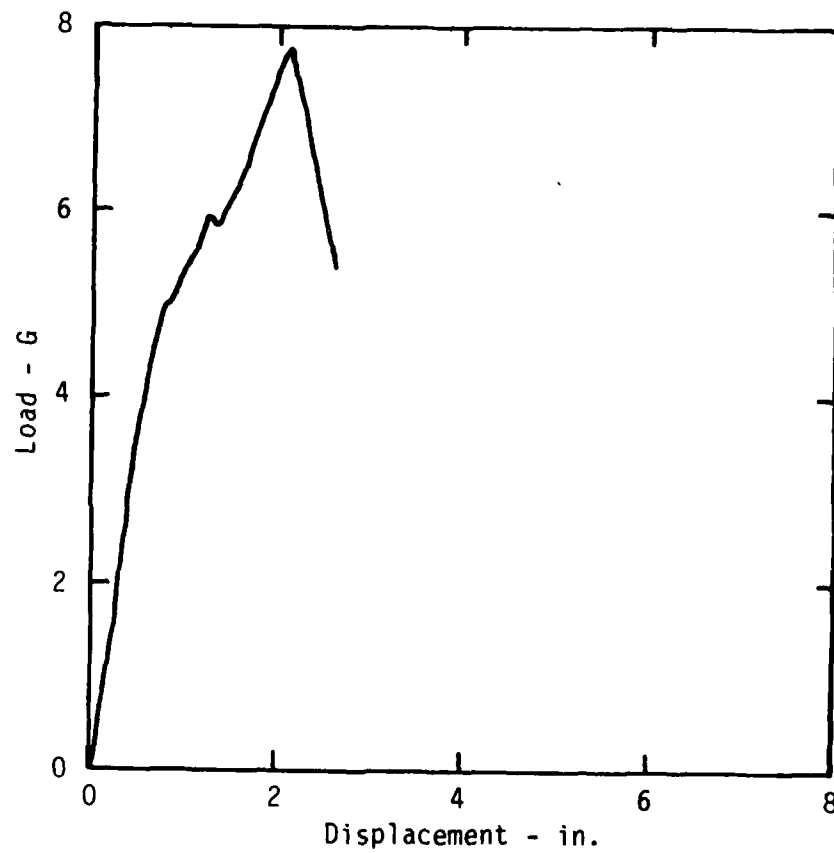
RESULTS OF LATERAL STATIC TEST. A lateral load was applied to the body blocks (figure 65) until the seat failed. This occurred at 7.8 G, when the front window-side leg pulled through the bolt attaching it to the track fitting. Figure 66 shows this failure, and figure 67 is the loading curve during the test. Further details of the seat's performance are in reference 40.

Figure 67.   Load versus lateral displacement of Weber MOD I seat.

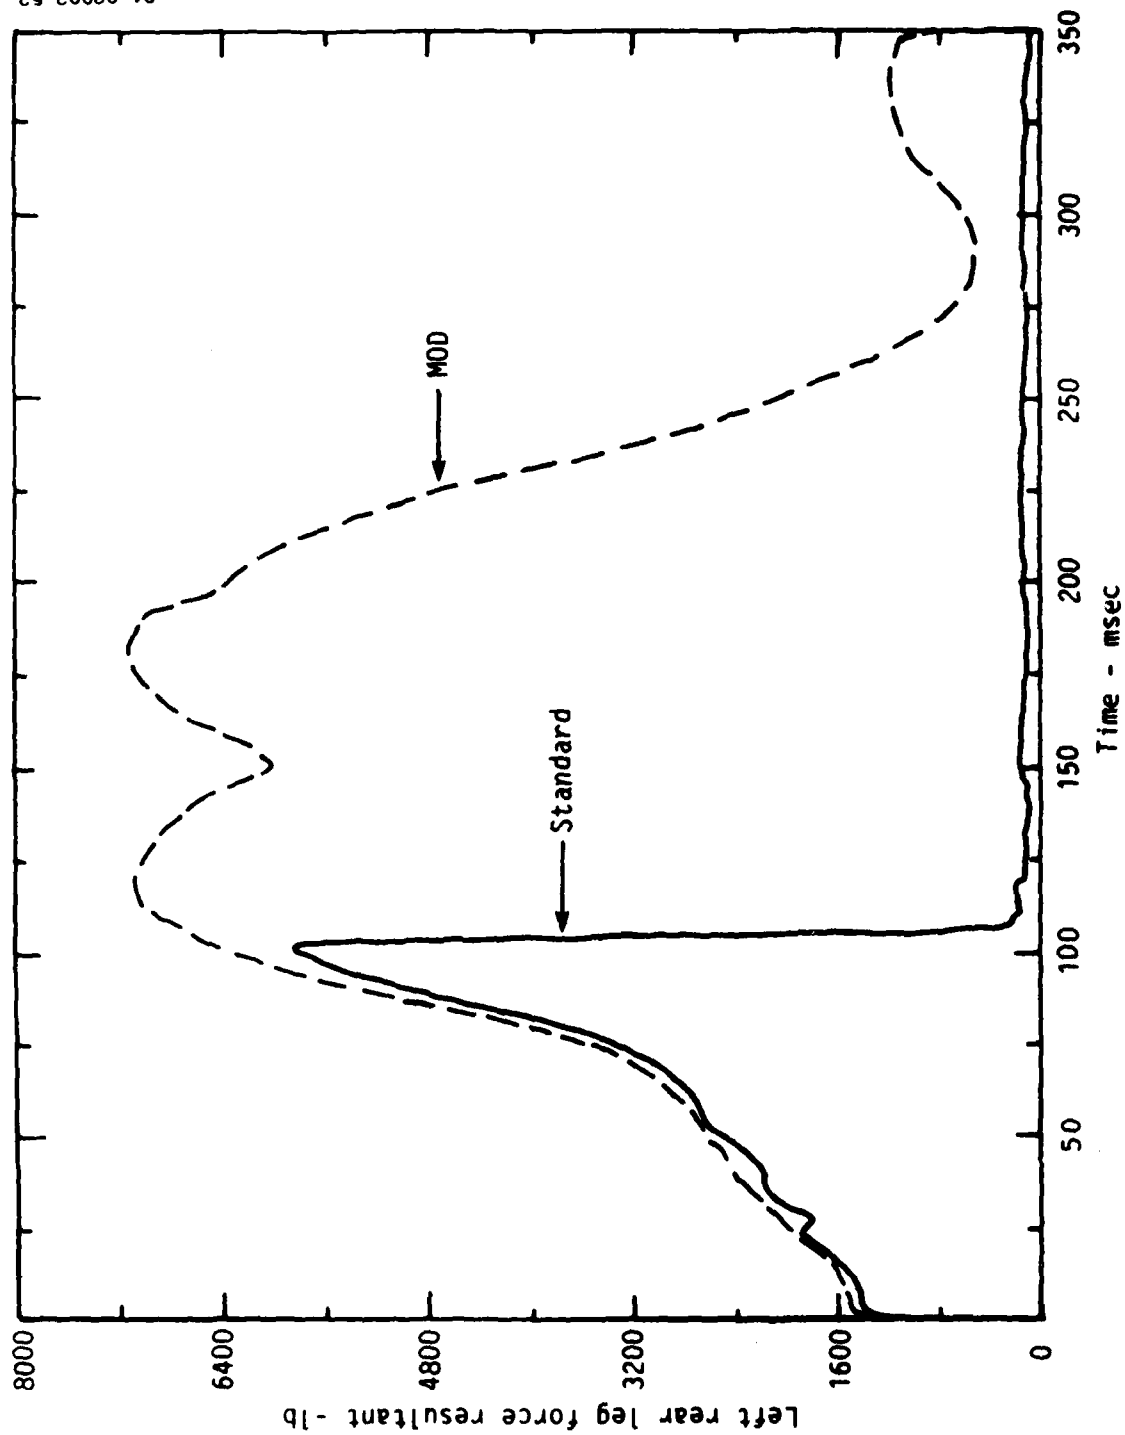
The reactions of the window-side legs of the Weber standard and MOD I seats from the dynamic pulse are both illustrated in figure 71. The curves are similar until the standard seat fails at 5900 lb. The load on the modified seat leg goes up to 7000 lb until the energy absorbers start stroking and attenuate the load for 60 msec.

Figure 71. Rear window-side leg force resultants of standard and Weber MOD I seats.

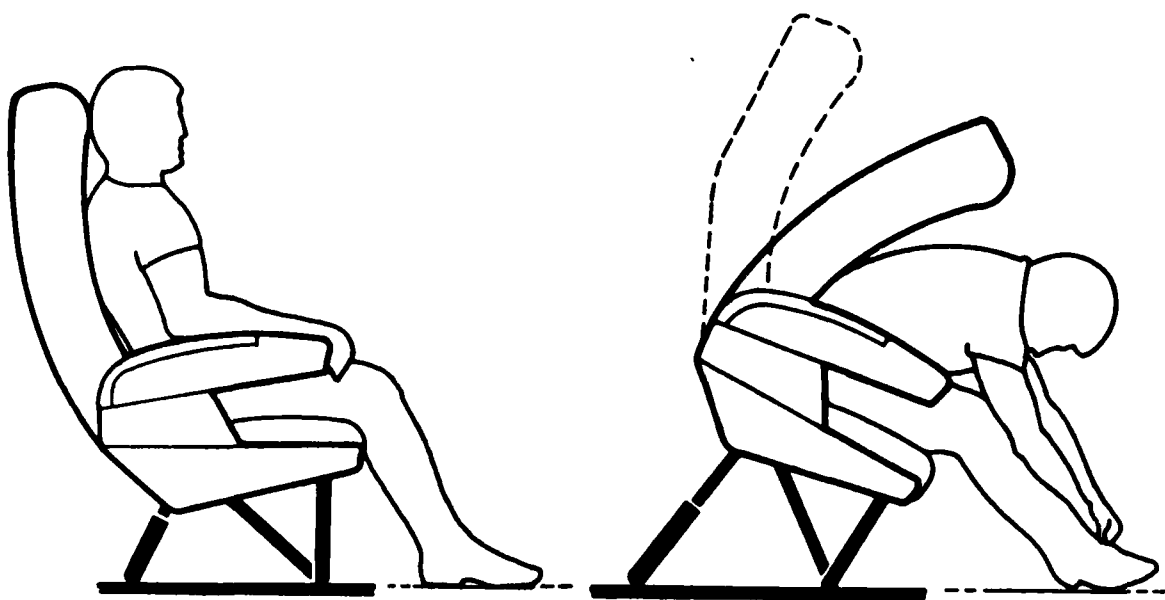
MODIFICATION CONCEPT. As discussed earlier, the second concept for modifica-
tion of the Weber seat was a rear-leg, energy-absorbing seat. This concept,
as shown in figure 72, uses tensile energy absorbers to replace the standard
seat rear legs, and allows the seat to pivot forward about the track fitting
attachments on the front legs.

Figure 72. Weber MOD II seat before and after stroking.

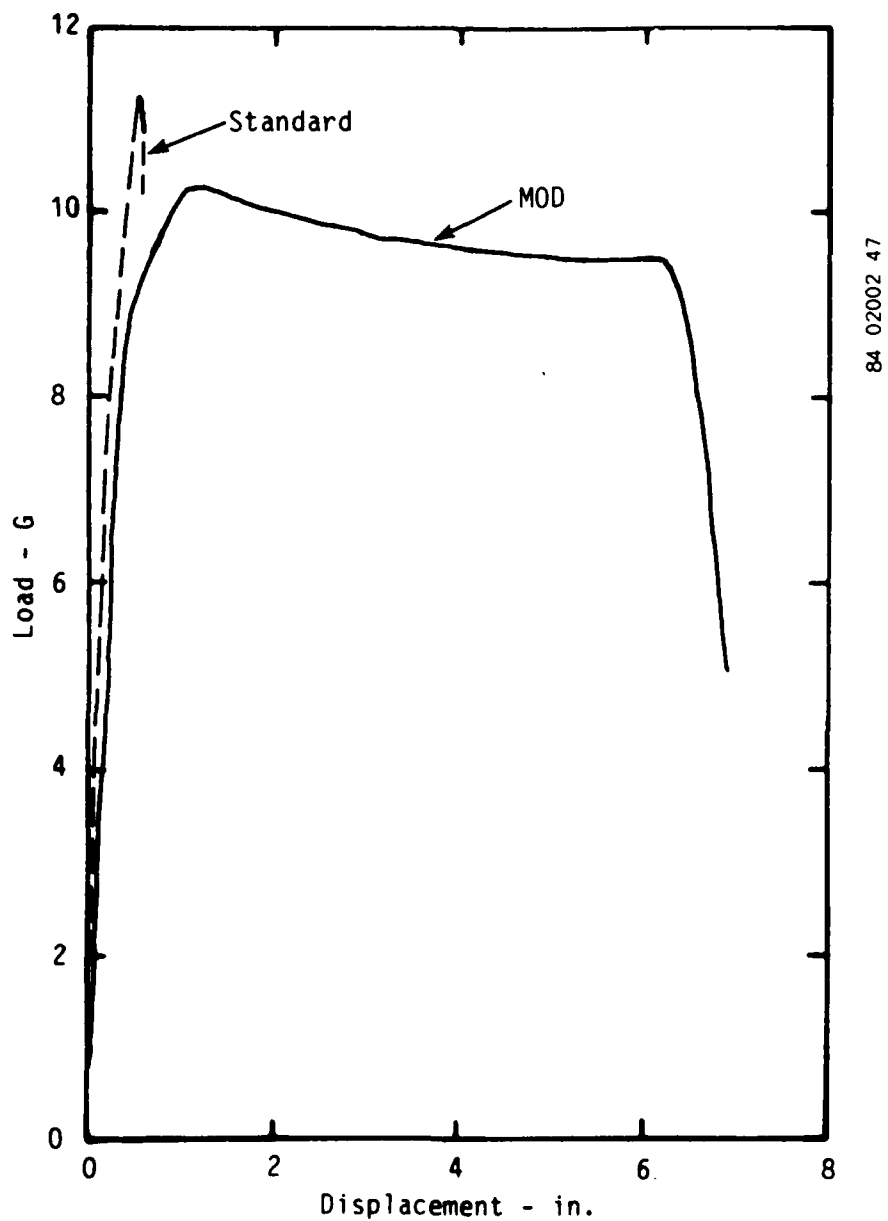
The significant difference between the standard and modified seats is demonstrated by the load/displacement curves in figure 80. Further curves, and a detailed performance description of the seat, are in reference 41.

Figure 80. Load versus forward displacement of
standard and Weber MOD II seats.

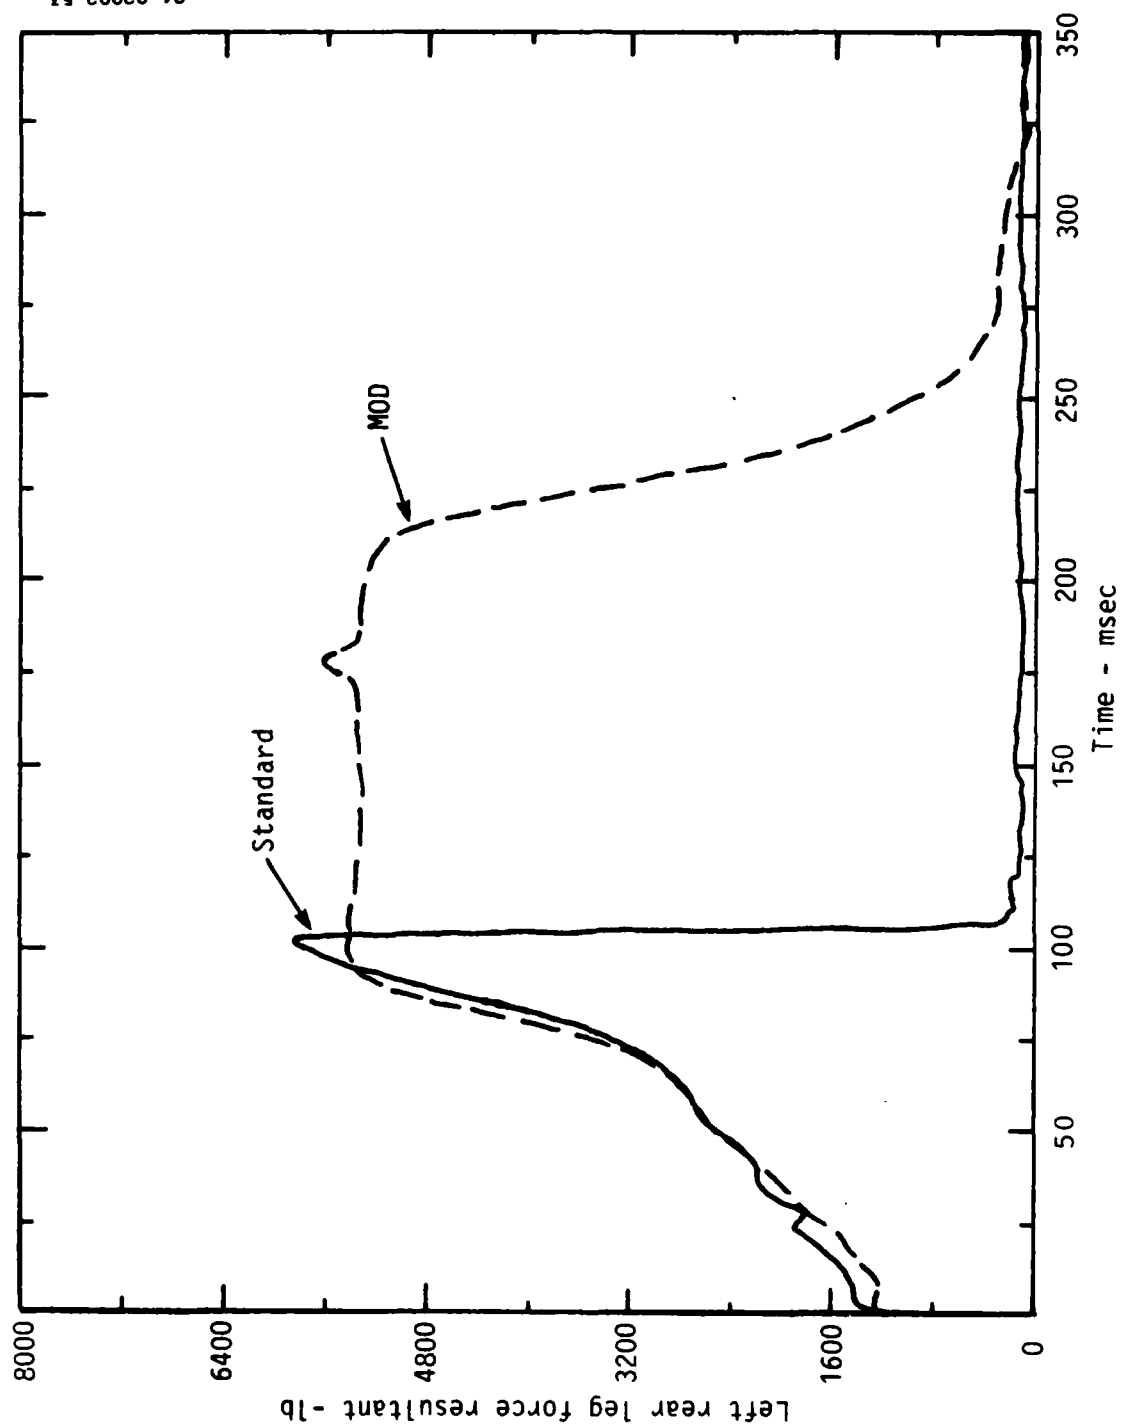
Figure 86. Rear window-side leg force resultants of standard and Weber MOD II seats.

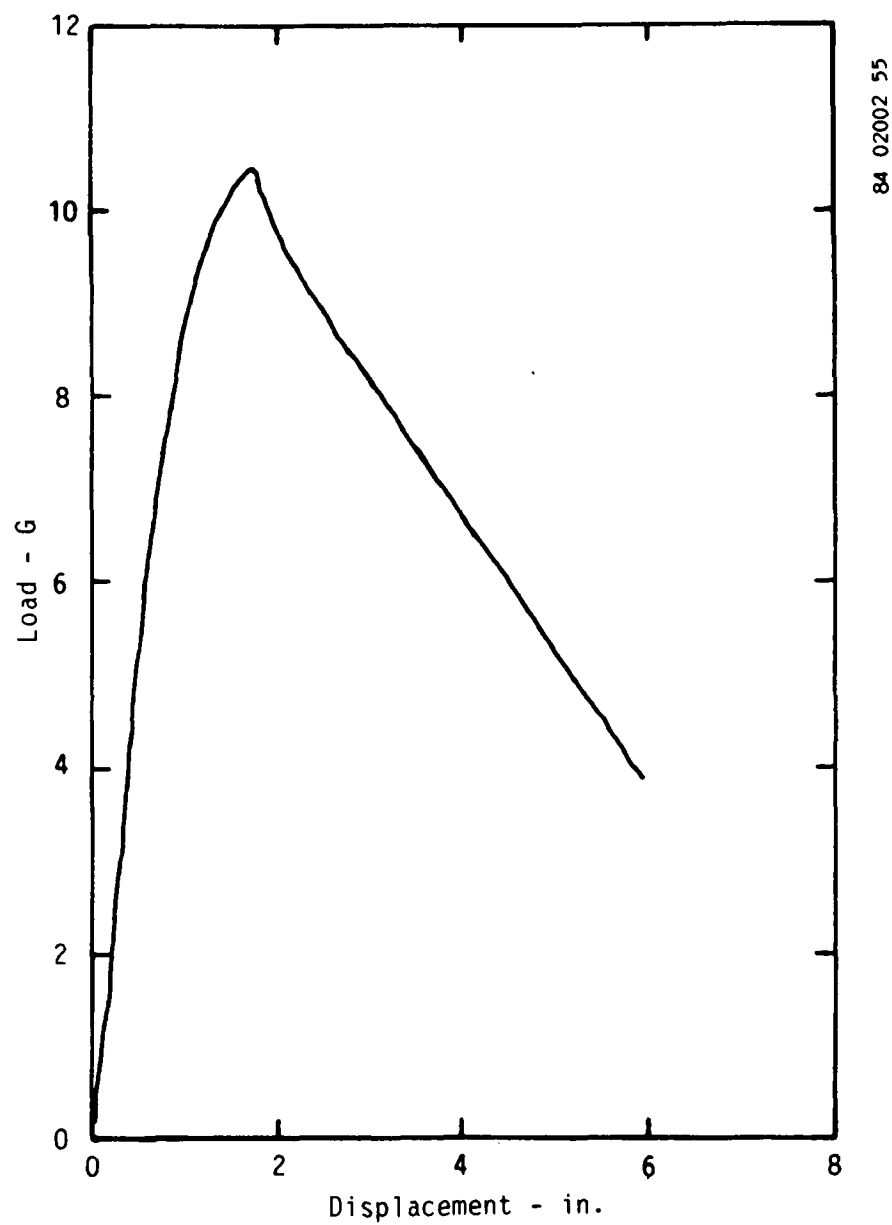
Figure 83. Load versus lateral displacement of Weber MOD II seat.

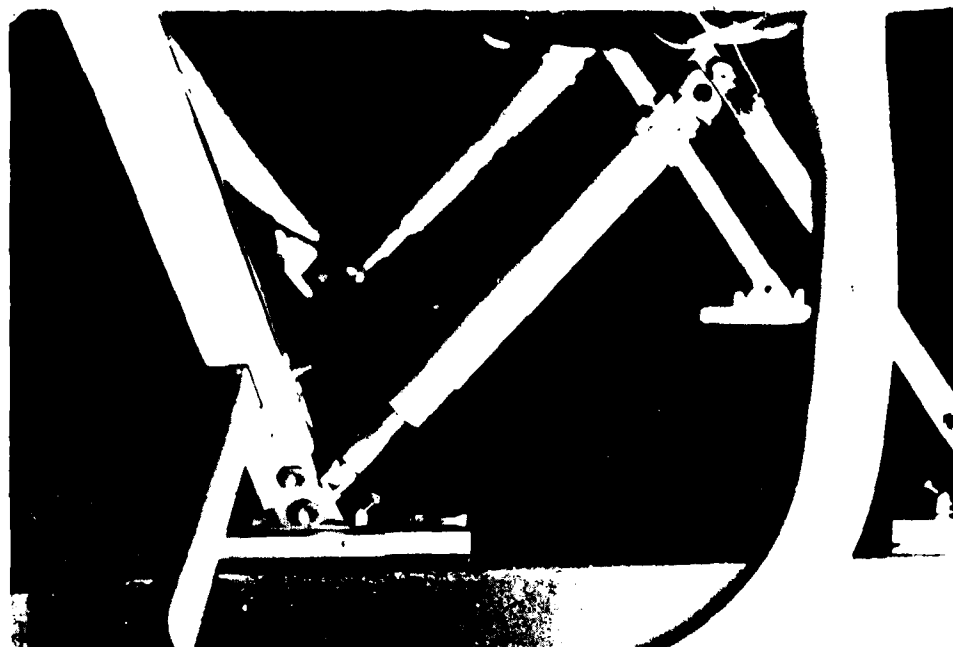
RESULTS OF FORWARD STATIC TEST. The modified seat was tested in the forward direction. At 7.6 G the seat began stroking forward and exhibited little rotation about the yaw axis (figure 105). The applied load was increased until, at 10.1 G, the fitting on the rear window-side leg failed at the weld and the test was stopped. Figure 106 shows the fitting, and figure 107 shows a similar failure occurring to the fitting on the aisle-side leg. Figure 108 shows a posttest view of the stroked window-side energy absorber and the pitching forward of the front leg caused by the failed fitting. Figure 109 is a view of the stroked aisle-side energy absorber.

Figure 109. Posttest aisle-side energy absorber on
UOP MOD I seat (Forward Static Test).

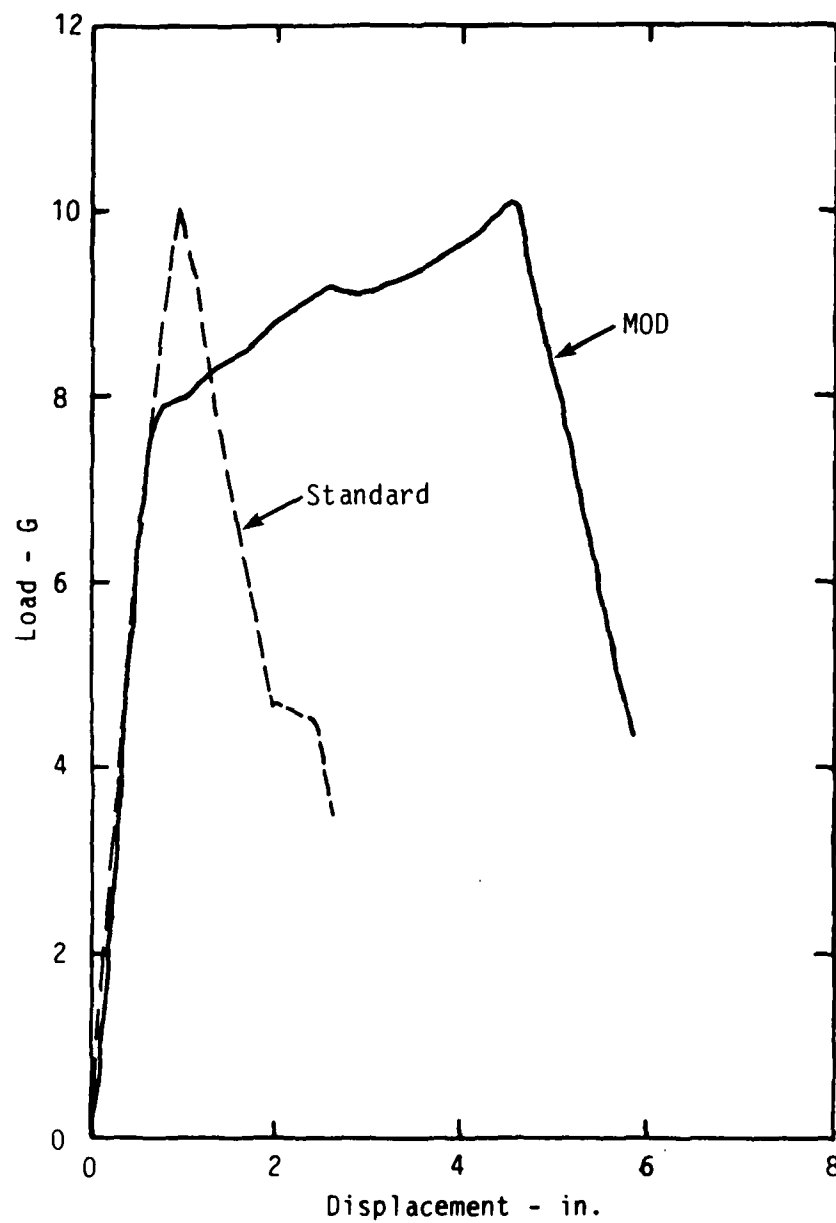
In order to compare the performance of the modified seat versus the standard seat, the average displacement of both seats was plotted against the applied static test load (figure 110). As the figure indicates, both seats deflected about 1 in. before reaching the ultimate load. The standard seat then failed, but the energy absorbers on the modified seat stroked, displacing the seat another 3.8 in. until failure occurred. The window-side energy absorber stroked 3.5 in., and the aisle-side energy absorber stroked 2.9 in.

Figure 110. Load versus forward displacement of
standard and UOP MOD I seats.

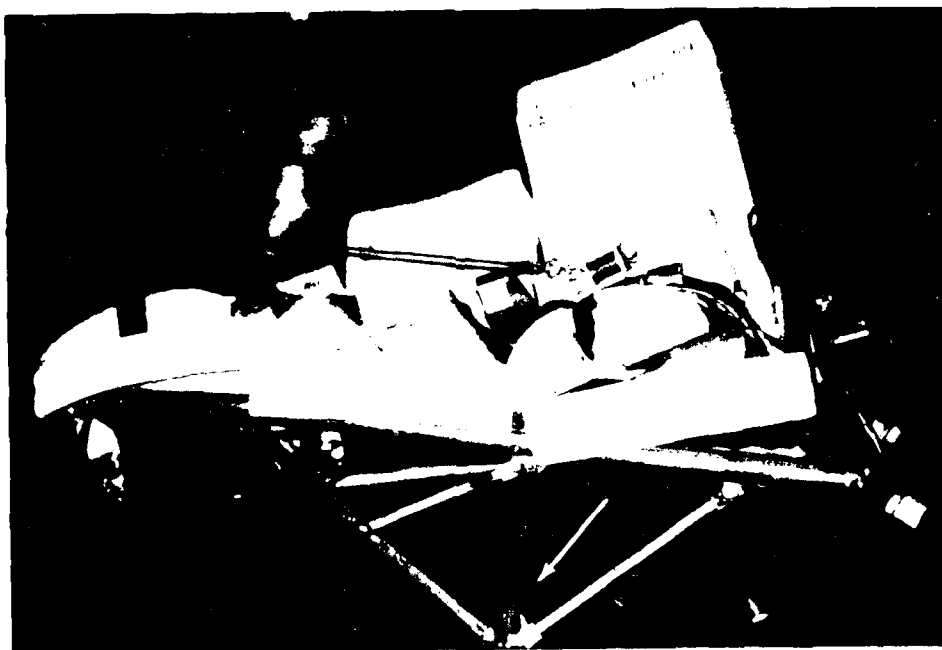
Figure 126.   Posttest top view of front window-side leg and failed
track fitting of UOP MOD II seat (Lateral Test).

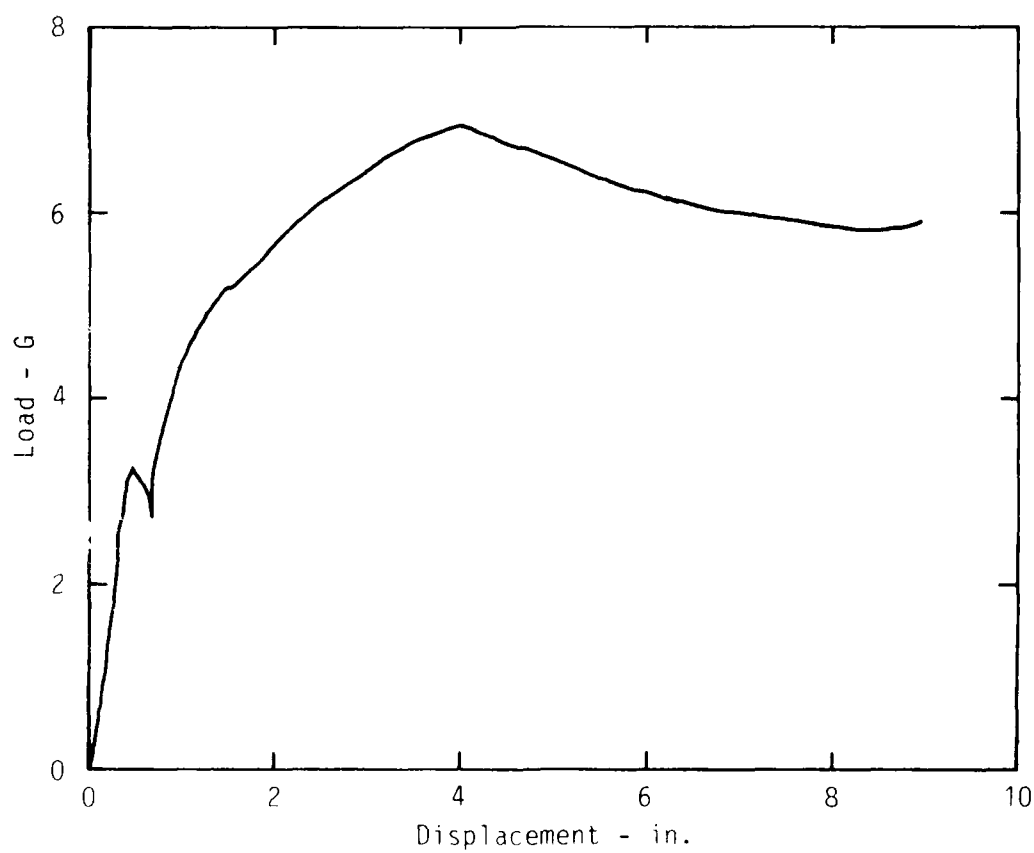
Figure 152.   Load versus lateral displacement of Weberlite MOD seat.

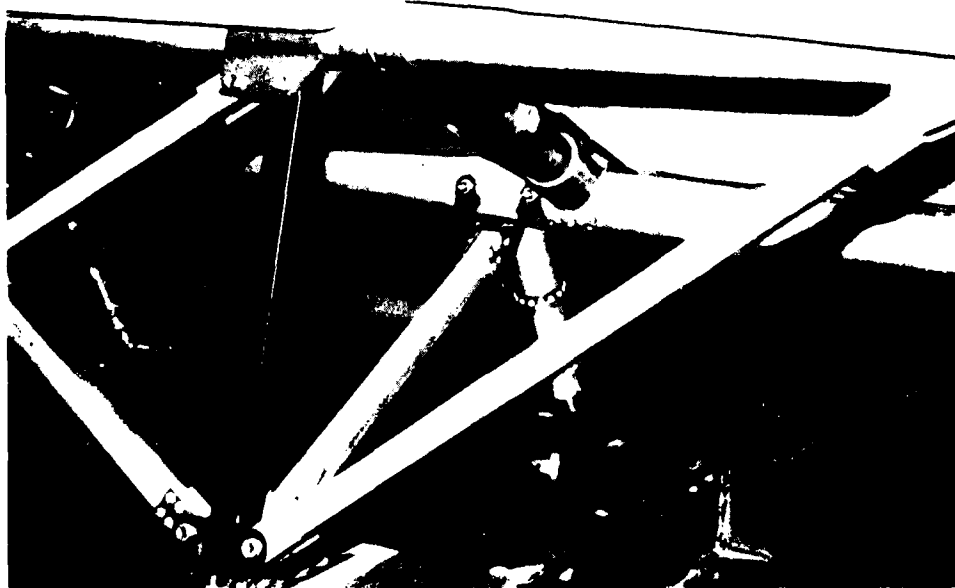
Figure 168. Posttest damage to front tube bracket of Weber
aft-facing MOD seat (Forward Static Test).

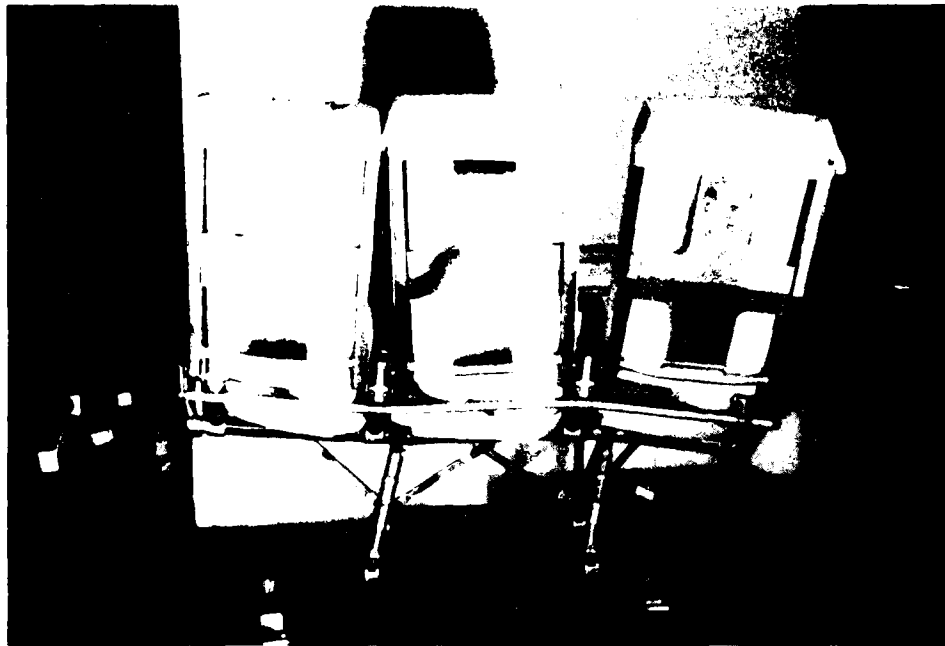
Figure 169. Posttest Weber aft-facing MOD seat (Lateral Test).

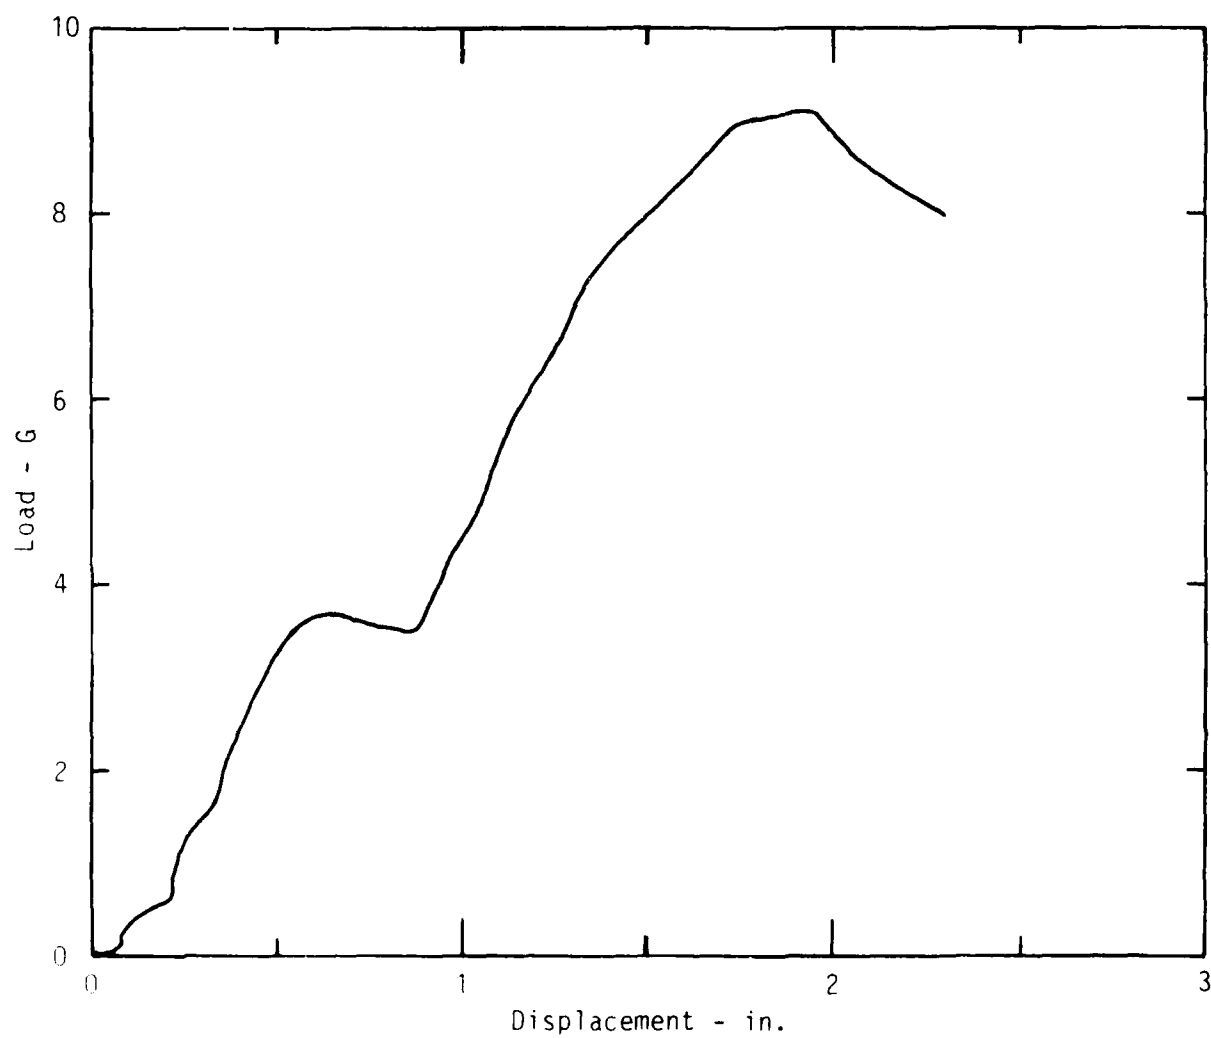
RESULTS OF LATERAL STATIC TEST. A lateral test was performed on the seat, as
is illustrated in figure 169. The first failure occurred at 3.7 G, when the
bolt connecting the rear window-side leg to the rear tube fitting pulled through
the leg, as is indicated by arrow 1 in figure 170. Since ultimate failure of
the complete structure had not occurred, the test was continued until, at 9.1 G,
the bolt connecting the rear tube aisle-side fitting to the diagonal pulled
through the diagonal, as is indicated by arrow 2. The loading curve during
the test is shown in figure 171. A further description of the seat's perfor-
mance is in reference 48.

Figure 171. Load versus lateral displacement of Weber aft-facing MOD seat.

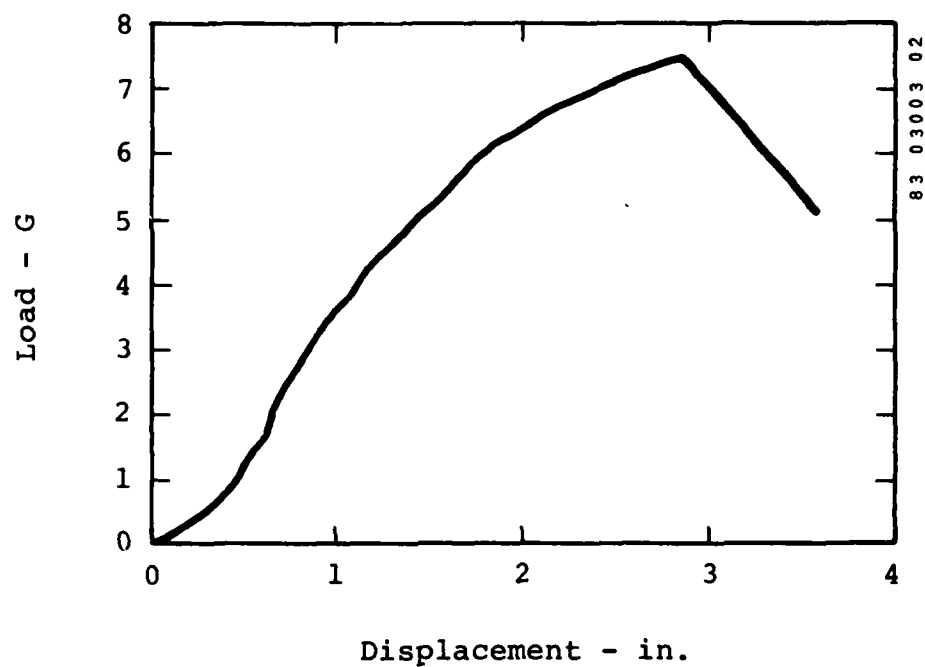
At a load of 7.5 G, the seat failed at the pivot bolt attachment on the left-side rail bracket. The 1/8-in.-thick bracket failed in shear tearout at the pivot arm bolt and bushing (figure 182). This failure left no rigid attachment for the left side of the seat pan, and the test was stopped. A loading curve of the left seat pan is in figure 183. Further details of this test are described in reference 49.

Figure 183. Load versus vertical displacement of Trans-Aero
flight attendant seat left seat pan.

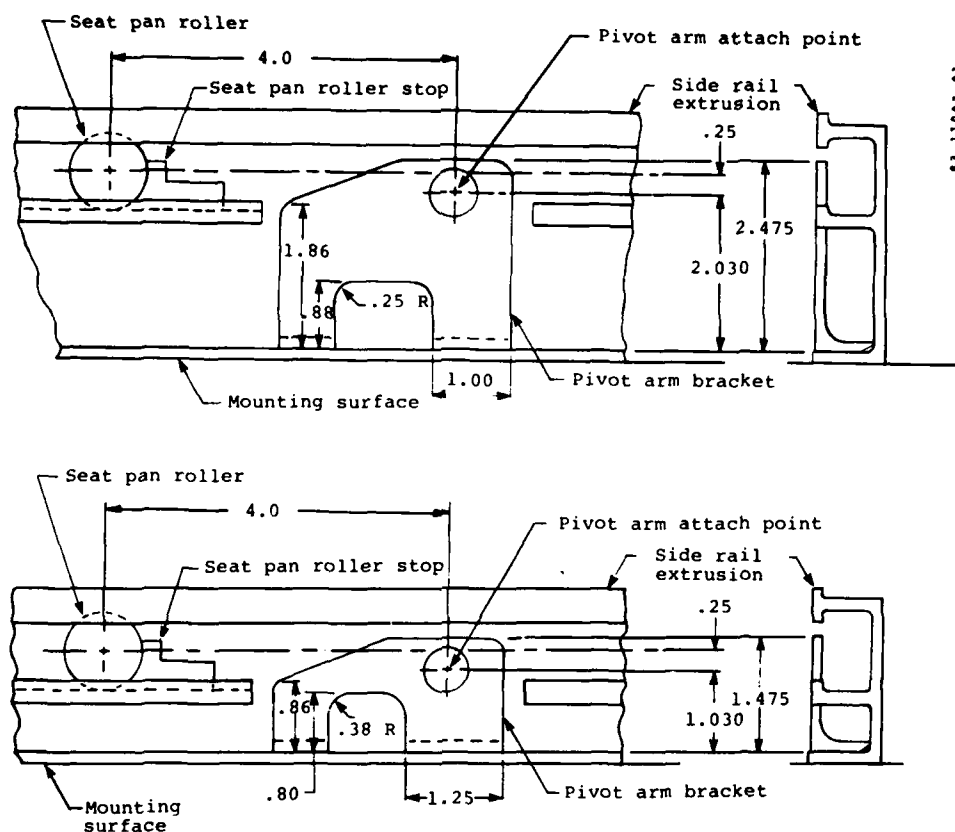
The 2-in. side rail has the same location of the seat pan roller track and the same location of the pivot arm attachment to the pivot arm bracket relative to a flat wall baseline. This bracket is the only other part to differ between the two seats. Dimensional differences of the brackets and side rails are noted in figure 184.

Figure 184. Dimensions of Trans-Aero Model 90835-6 flight attendant seat pivot arm bracket and side rail versus Model 90835-4 right-side pivot arm bracket and side rail.

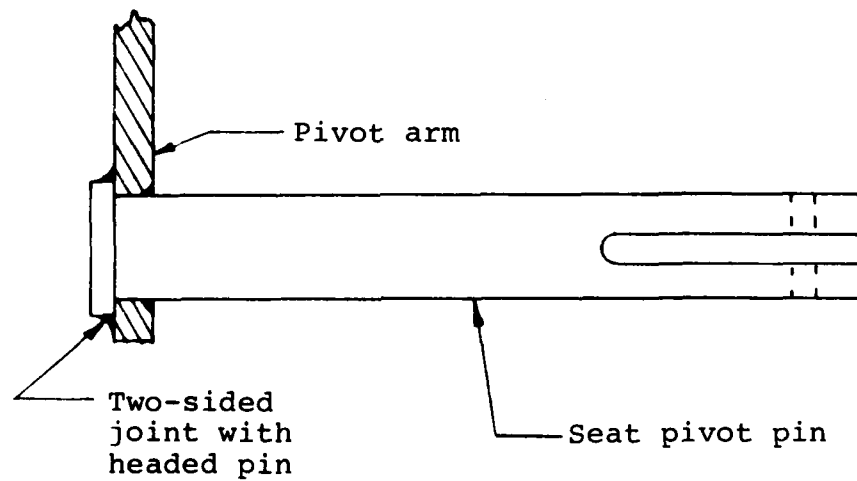
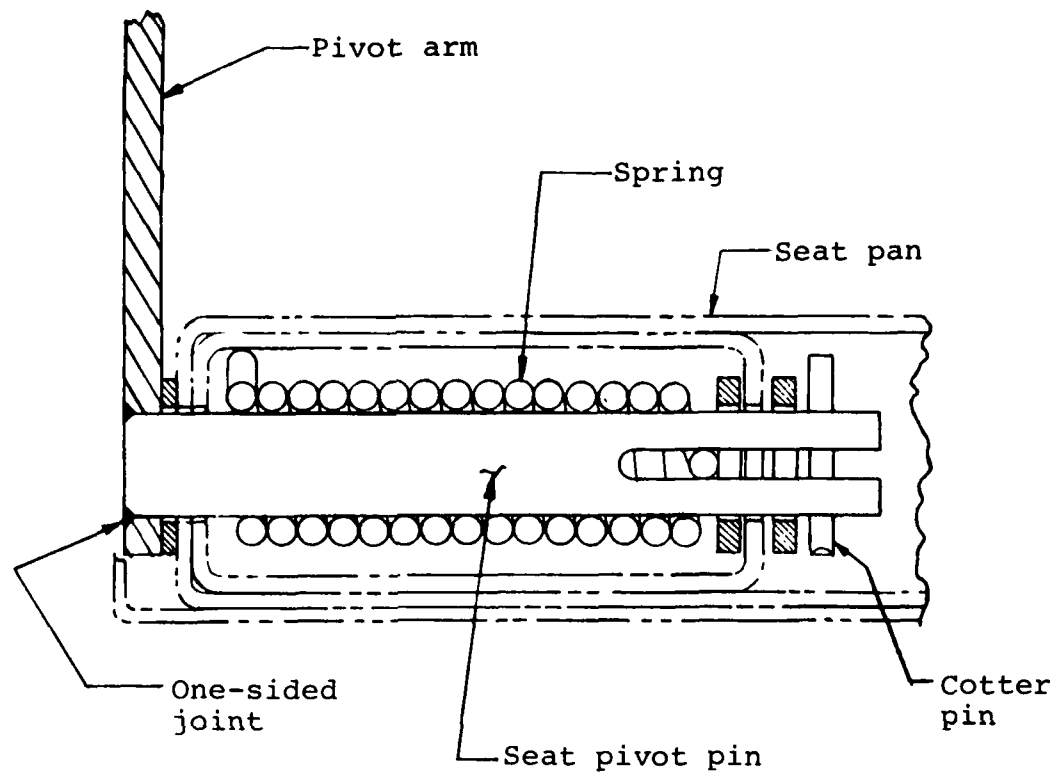
Figure 186. Comparison of modified and standard
pivot arm assembly joints.

Pivot Arm Assembly. To withstand the moments imposed by a 10-G downward load, the pivot arm assembly was strengthened at the arm-to-seat pivot pin joint. The pin picks up two attachment points to the seat pan spar, and by its rigid connection to the pivot arm, allows the seat pan to rotate to its storage position. The standard seat utilized a single-sided weld or silver-solder joint where the pin fit into a hole through the pivot arm. The increased moments required a stronger joint, which is illustrated in figure 186. A headed pivot pin was inserted into the pivot arm and welded on both sides. The modified pin and weld added .77 oz per assembly to the seat weight. The two parts are shown in figure 187.

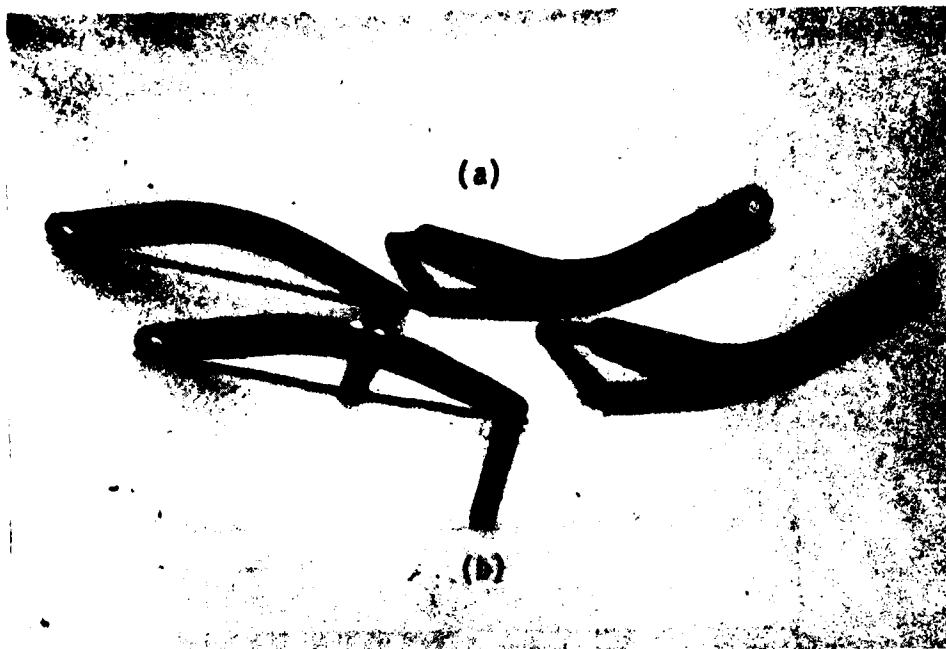
Figure 187.   Comparison of modified (a) and standard (b)
              pivot arm assemblies.

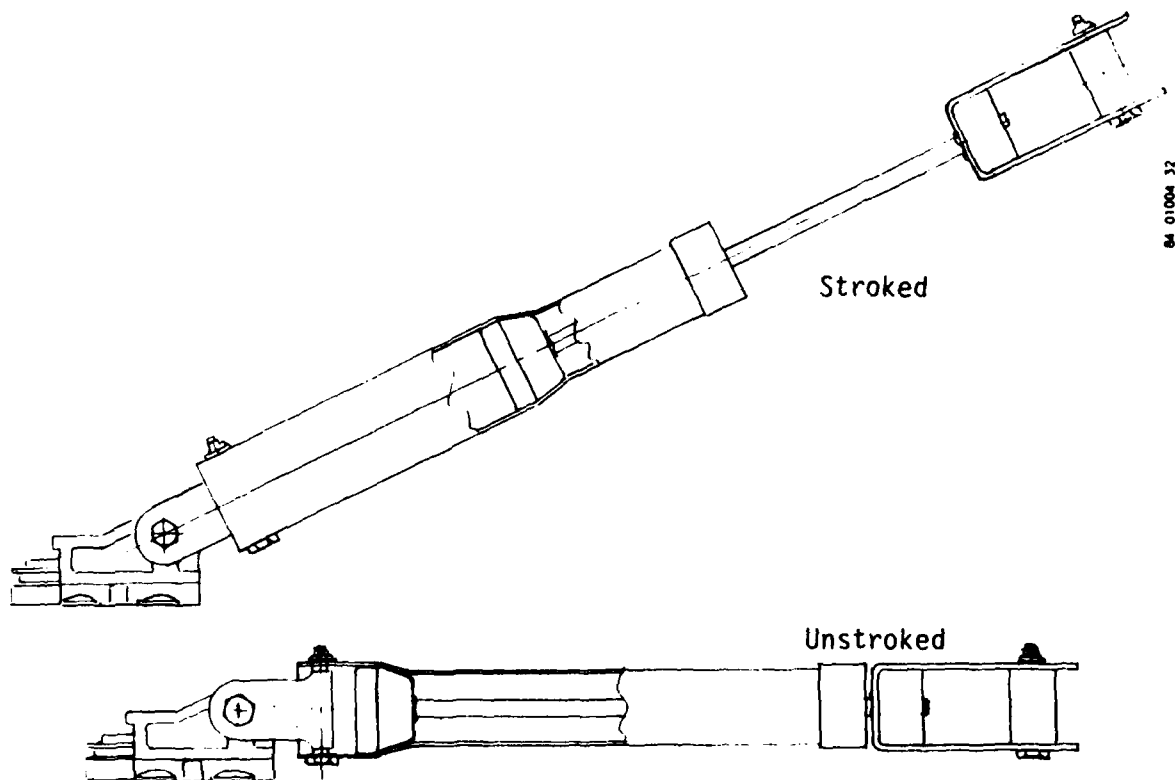
Figure 196. Secondary restraint system energy absorber.
