DOT/FAA/CT-84/10

Seat Experiments for the Full-Scale Transport Aircraft Controlled Impact Demonstration

March 1985
Final Report

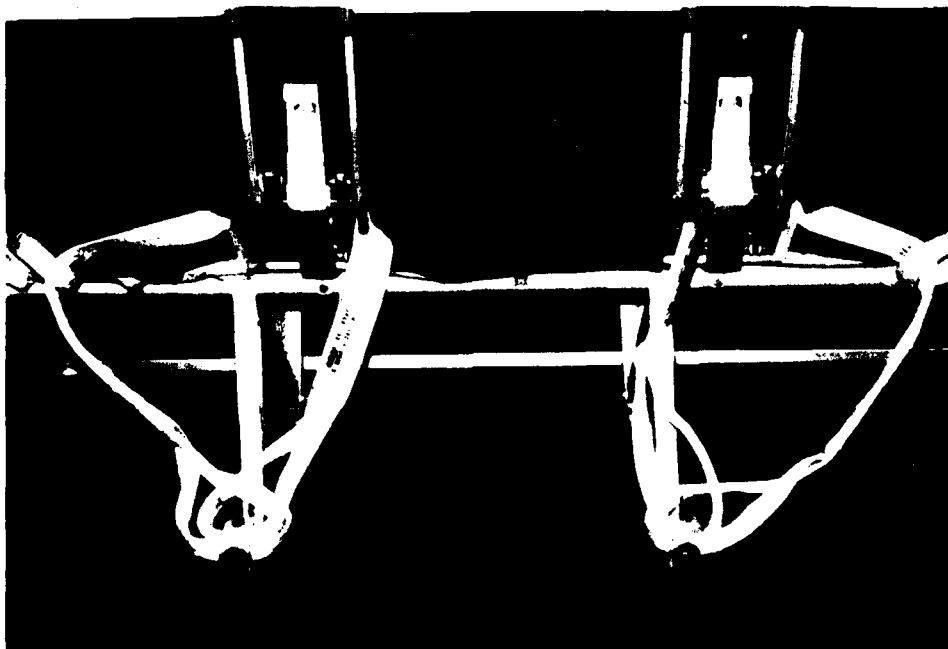
The components of the secondary restraint system consist of polyester slings and expanding-tube energy absorbers. The slings were cinched about the waist of the dummies, and connected to the energy absorbers, which were in turn connected to floor track fittings. The attachment to the dummies is illustrated in figure 195. The energy absorbers were designed to stroke at a load of 6000 lb for a distance of 6 in. One energy absorber in the unstroked and stroked position is illustrated in figure 196. This system uses two energy absorbers per seat, and would therefore decelerate a typical experimental seat at 20 G were the seat to fail. The secondary restraint system is installed with 6 in of slack, so that it will not interfere with the energy-absorbing function of the seat. The system is tied to the dummies, because this appeared to be the most reliable means of restraining the seat should it fail. The installation shown in figure 195 is typical of the restraint system used on the various seat configuration.

Figure 195. Secondary restraint system - side and rear views.

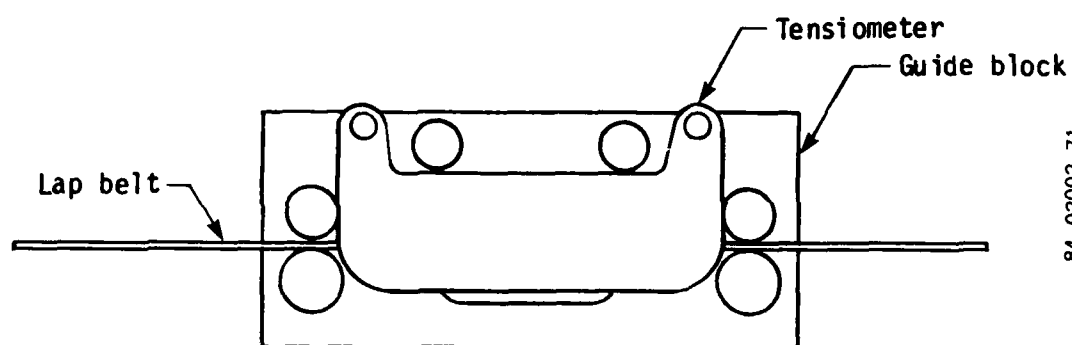
applied to the base of the device as tension is applied to the belt on which it is installed. In the intended application, the thigh and/or pelvis of the dummy will apply a load to the base of the tensiometer. Therefore, guide blocks (figure 194) were installed to suspend the tensiometers on the belts and prevent them from experiencing loads other than tension.

Figure 194. Installation and sketch of lap belt tensiometer guide block.

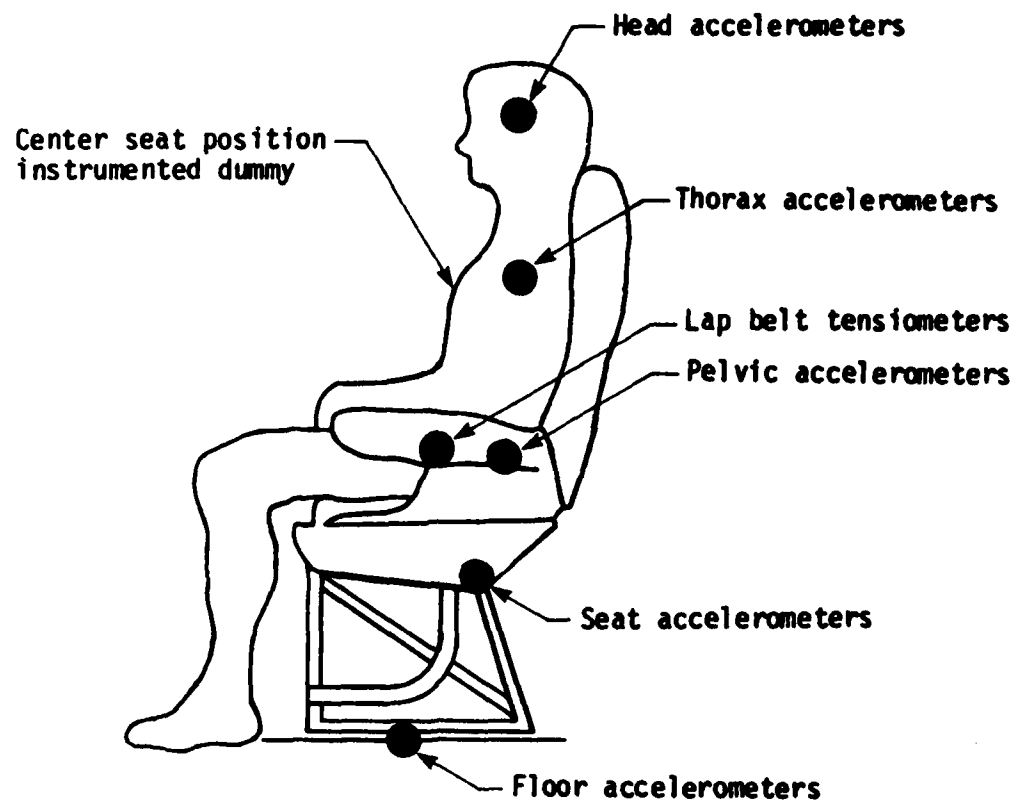
The experimental seats and dummies are instrumented with accelerometers and lap belt tensiometers. The accelerometers are Endevco Model 7264-200 and the tensiometers are LeBow Model 3419. To obtain various data requirements with limited data channels, the instruments are distributed unequally. The location of instruments in the most completely instrumented seats is shown in figure 193.

Figure 193. Typical complete instrumentation setup for test aircraft seats.
