INSTALLATION RESTORATION PROGRAM
PHASE II - CONFIRMATION/QUANTIFICATION

STAGE 1

WILLIAMS AIR FORCE BASE,
CHANDLER, ARIZONA

JANUARY 1986

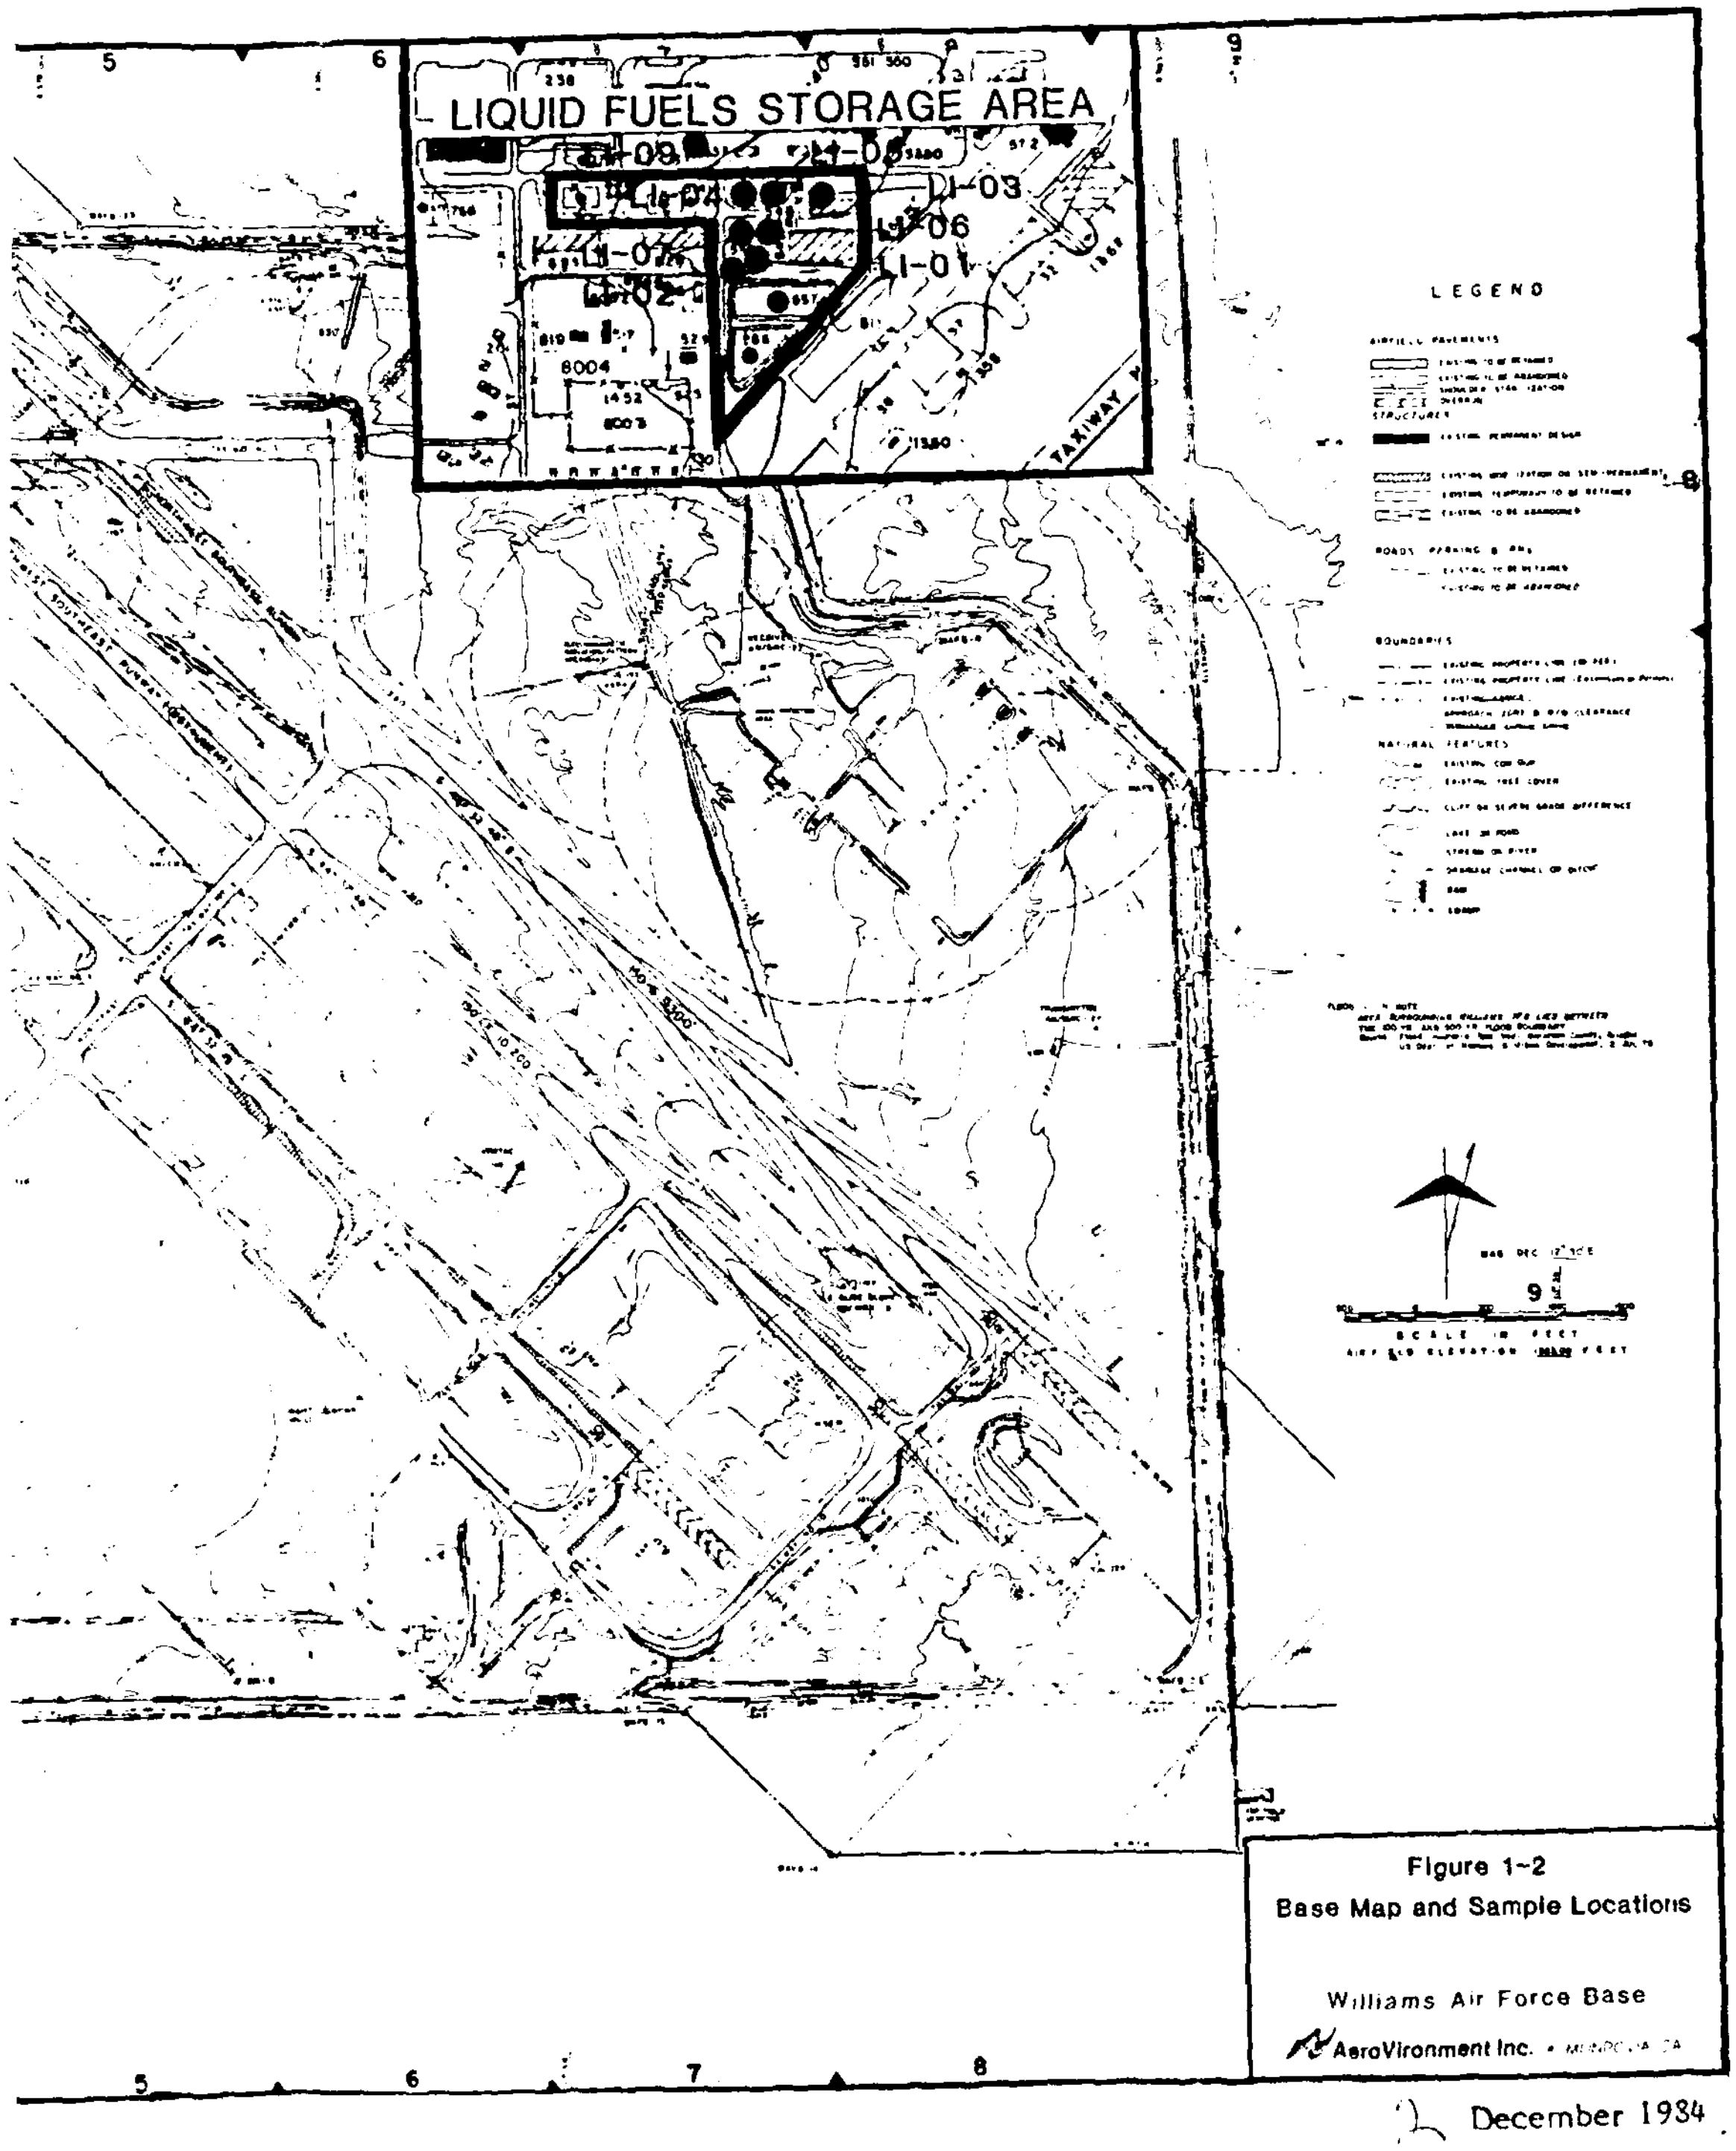
Figure 1-2
Base Map and Sample Locations

More specifically, AV was tasked to collect soil samples from various depths around identified sites, to analyze those samples and to conduct a geophysical survey at a burial site on the base. In the Phase I IRP study, six priority sites were identified at Williams AFB (see Figures I-1 and I-2). These sites were all thought to be potentially contaminated with hazardous substances, due to past practices in handling or disposing of hazardous material. These sites, in the order of their priority, are

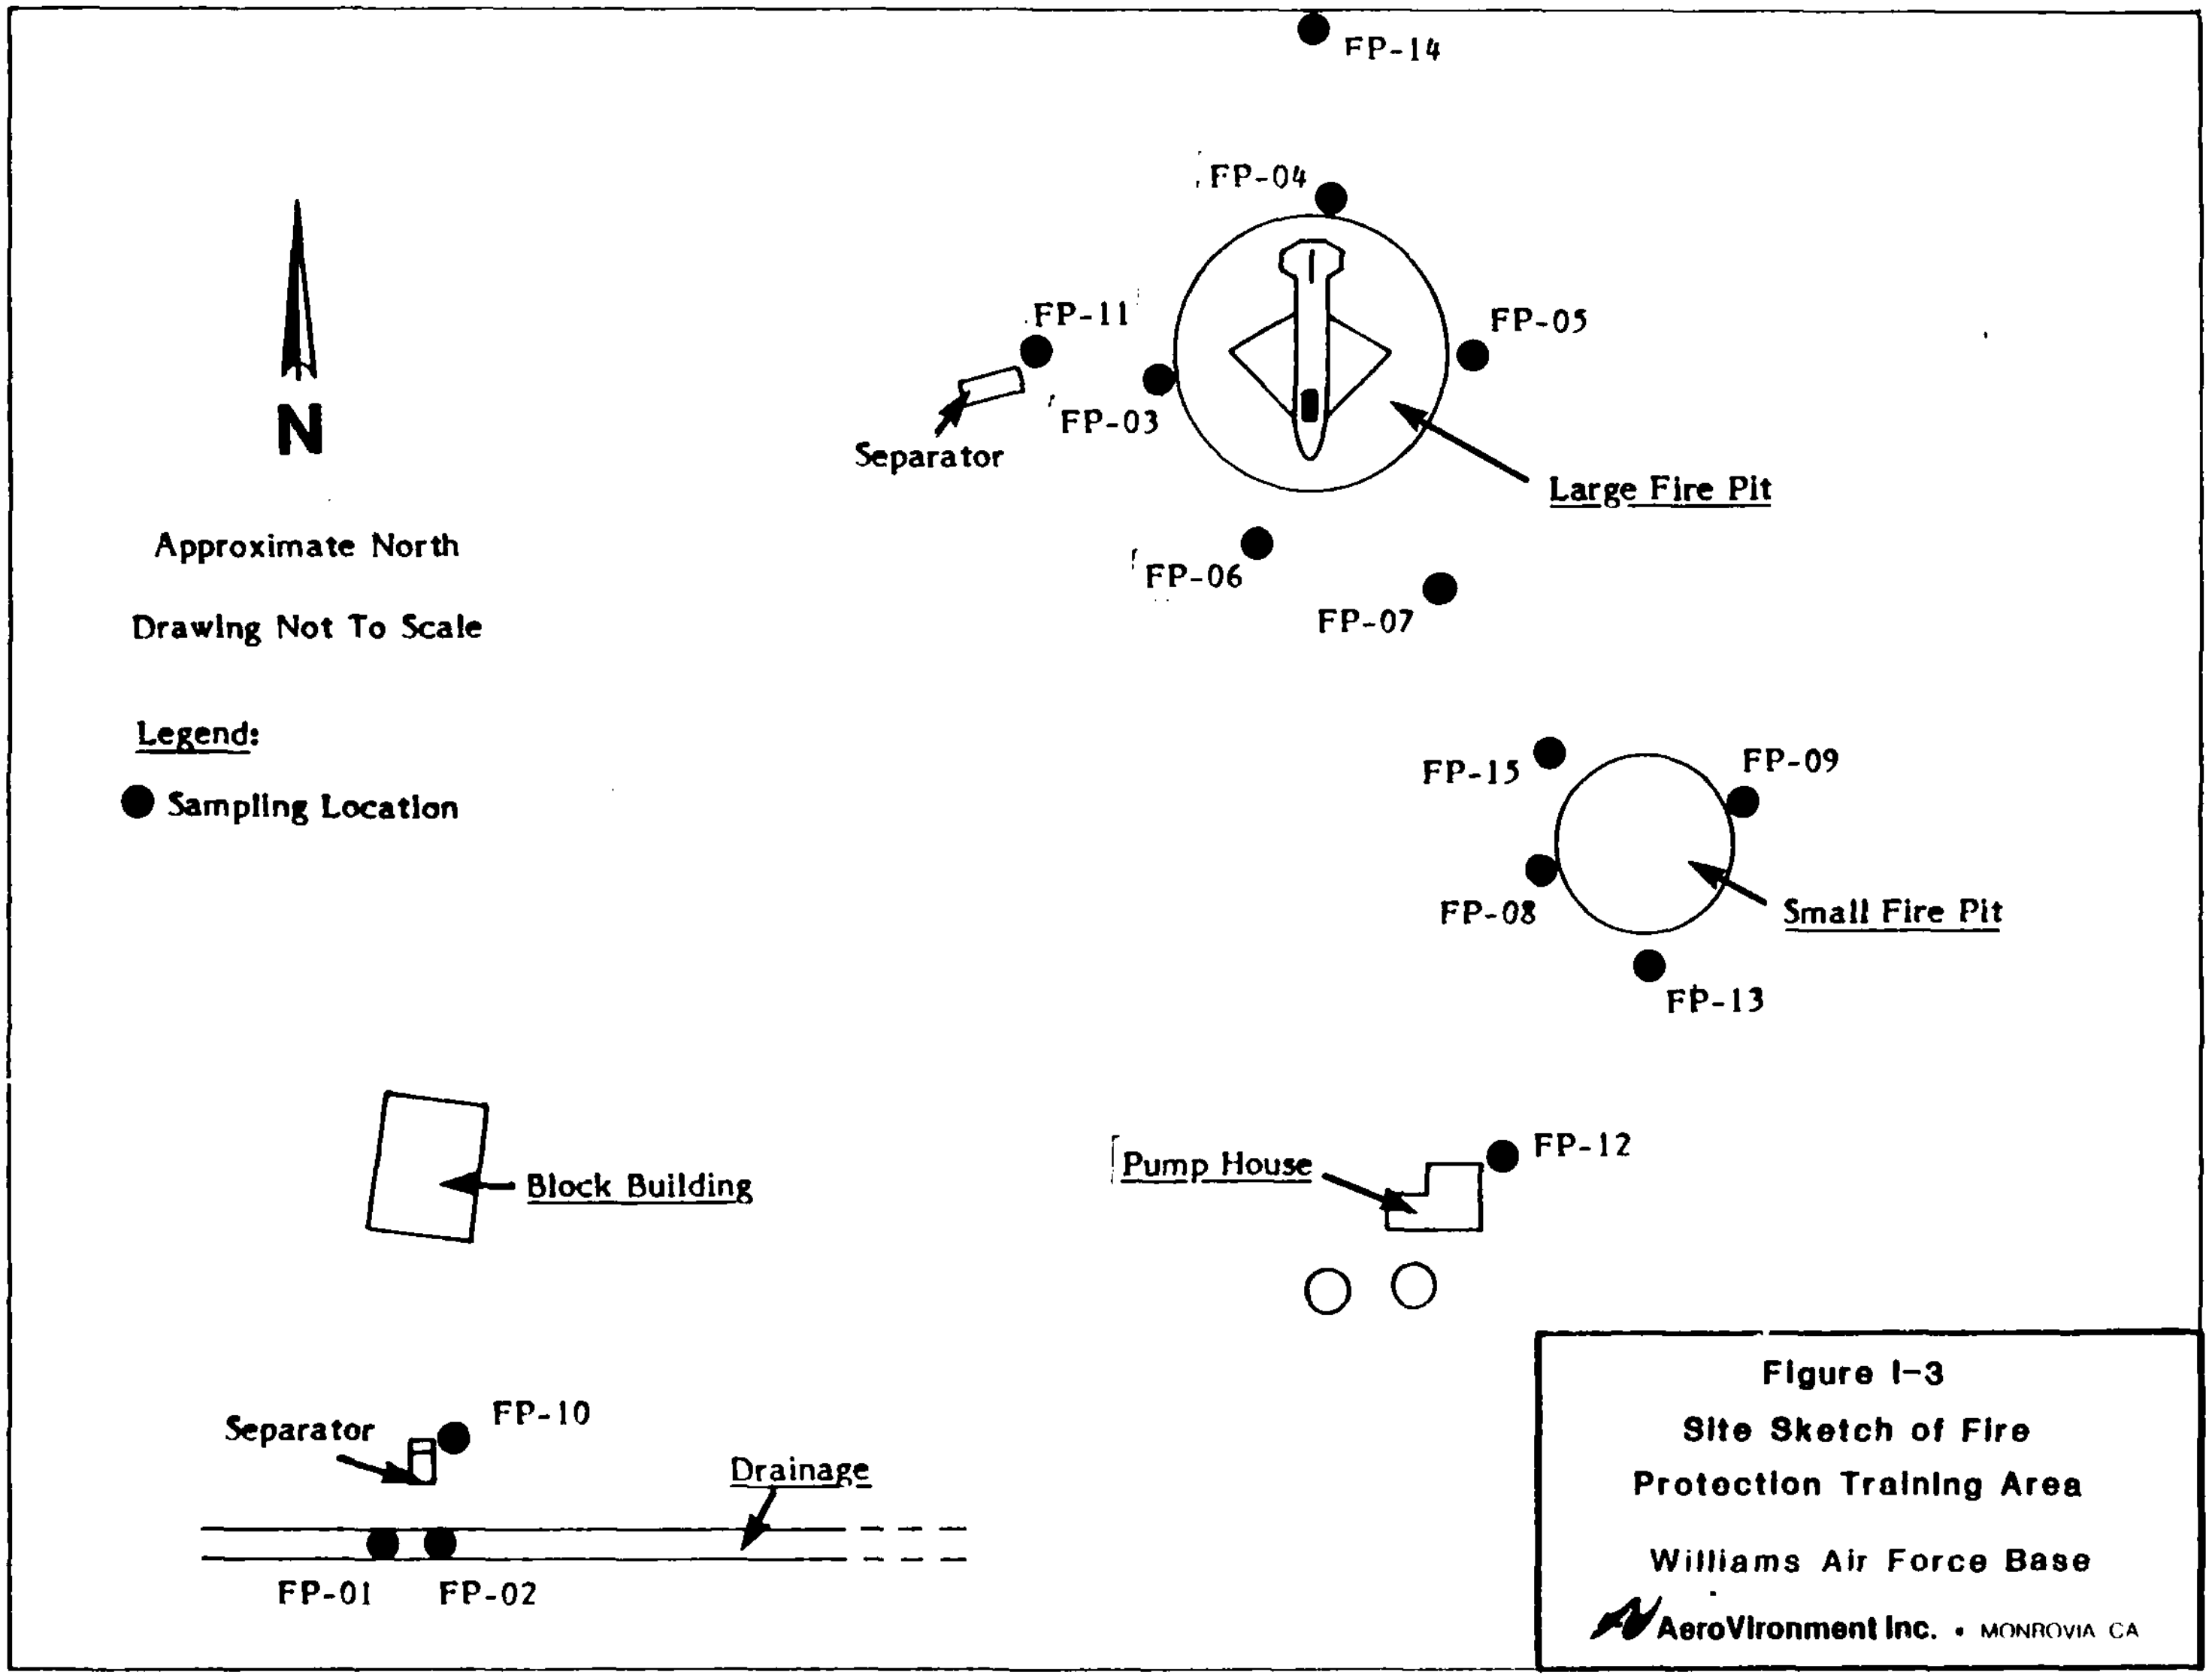
Figure I-3
Site Sketch of Fire
Protection Training Area

This fire protection training area has served the base from 1948 to the present. Prior to 1948, the area was used as a parking apron. From 1948 until the late 1960's, this site was an unlined burn pit used to burn large quantities of the combustible liquid waste generated at Williams AFB (see Figure I-3). The fires were then extinguished as part of fire training.

Not all the flammable materials were burned, and remaining combustibles and water were left to infiltrate or evaporate. These wastes included waste fuels, oils, lubricants, cleaning solvents and some paint stripper. Although water was applied to the soil before each burn and may have minimized the total impact of the waste application (by hydrophobic repulsion), the total volume that may have percolated into the ground over the years is reported by the Air Force to be substantial. Current operations, starting in 1983, use a concrete liner under the burn pits, but overflow from the pits is still allowed to percolate into the ground. Overflow occurs because there is no drain mechanism in the burn pit. Water is applied as part of the fire fighting process (water based foam) and fills the liner. The remaining unburned hydrocarbons float on top of the water and either flow over the liner lip or are blown over by wind action (if water level is very close to the lip).

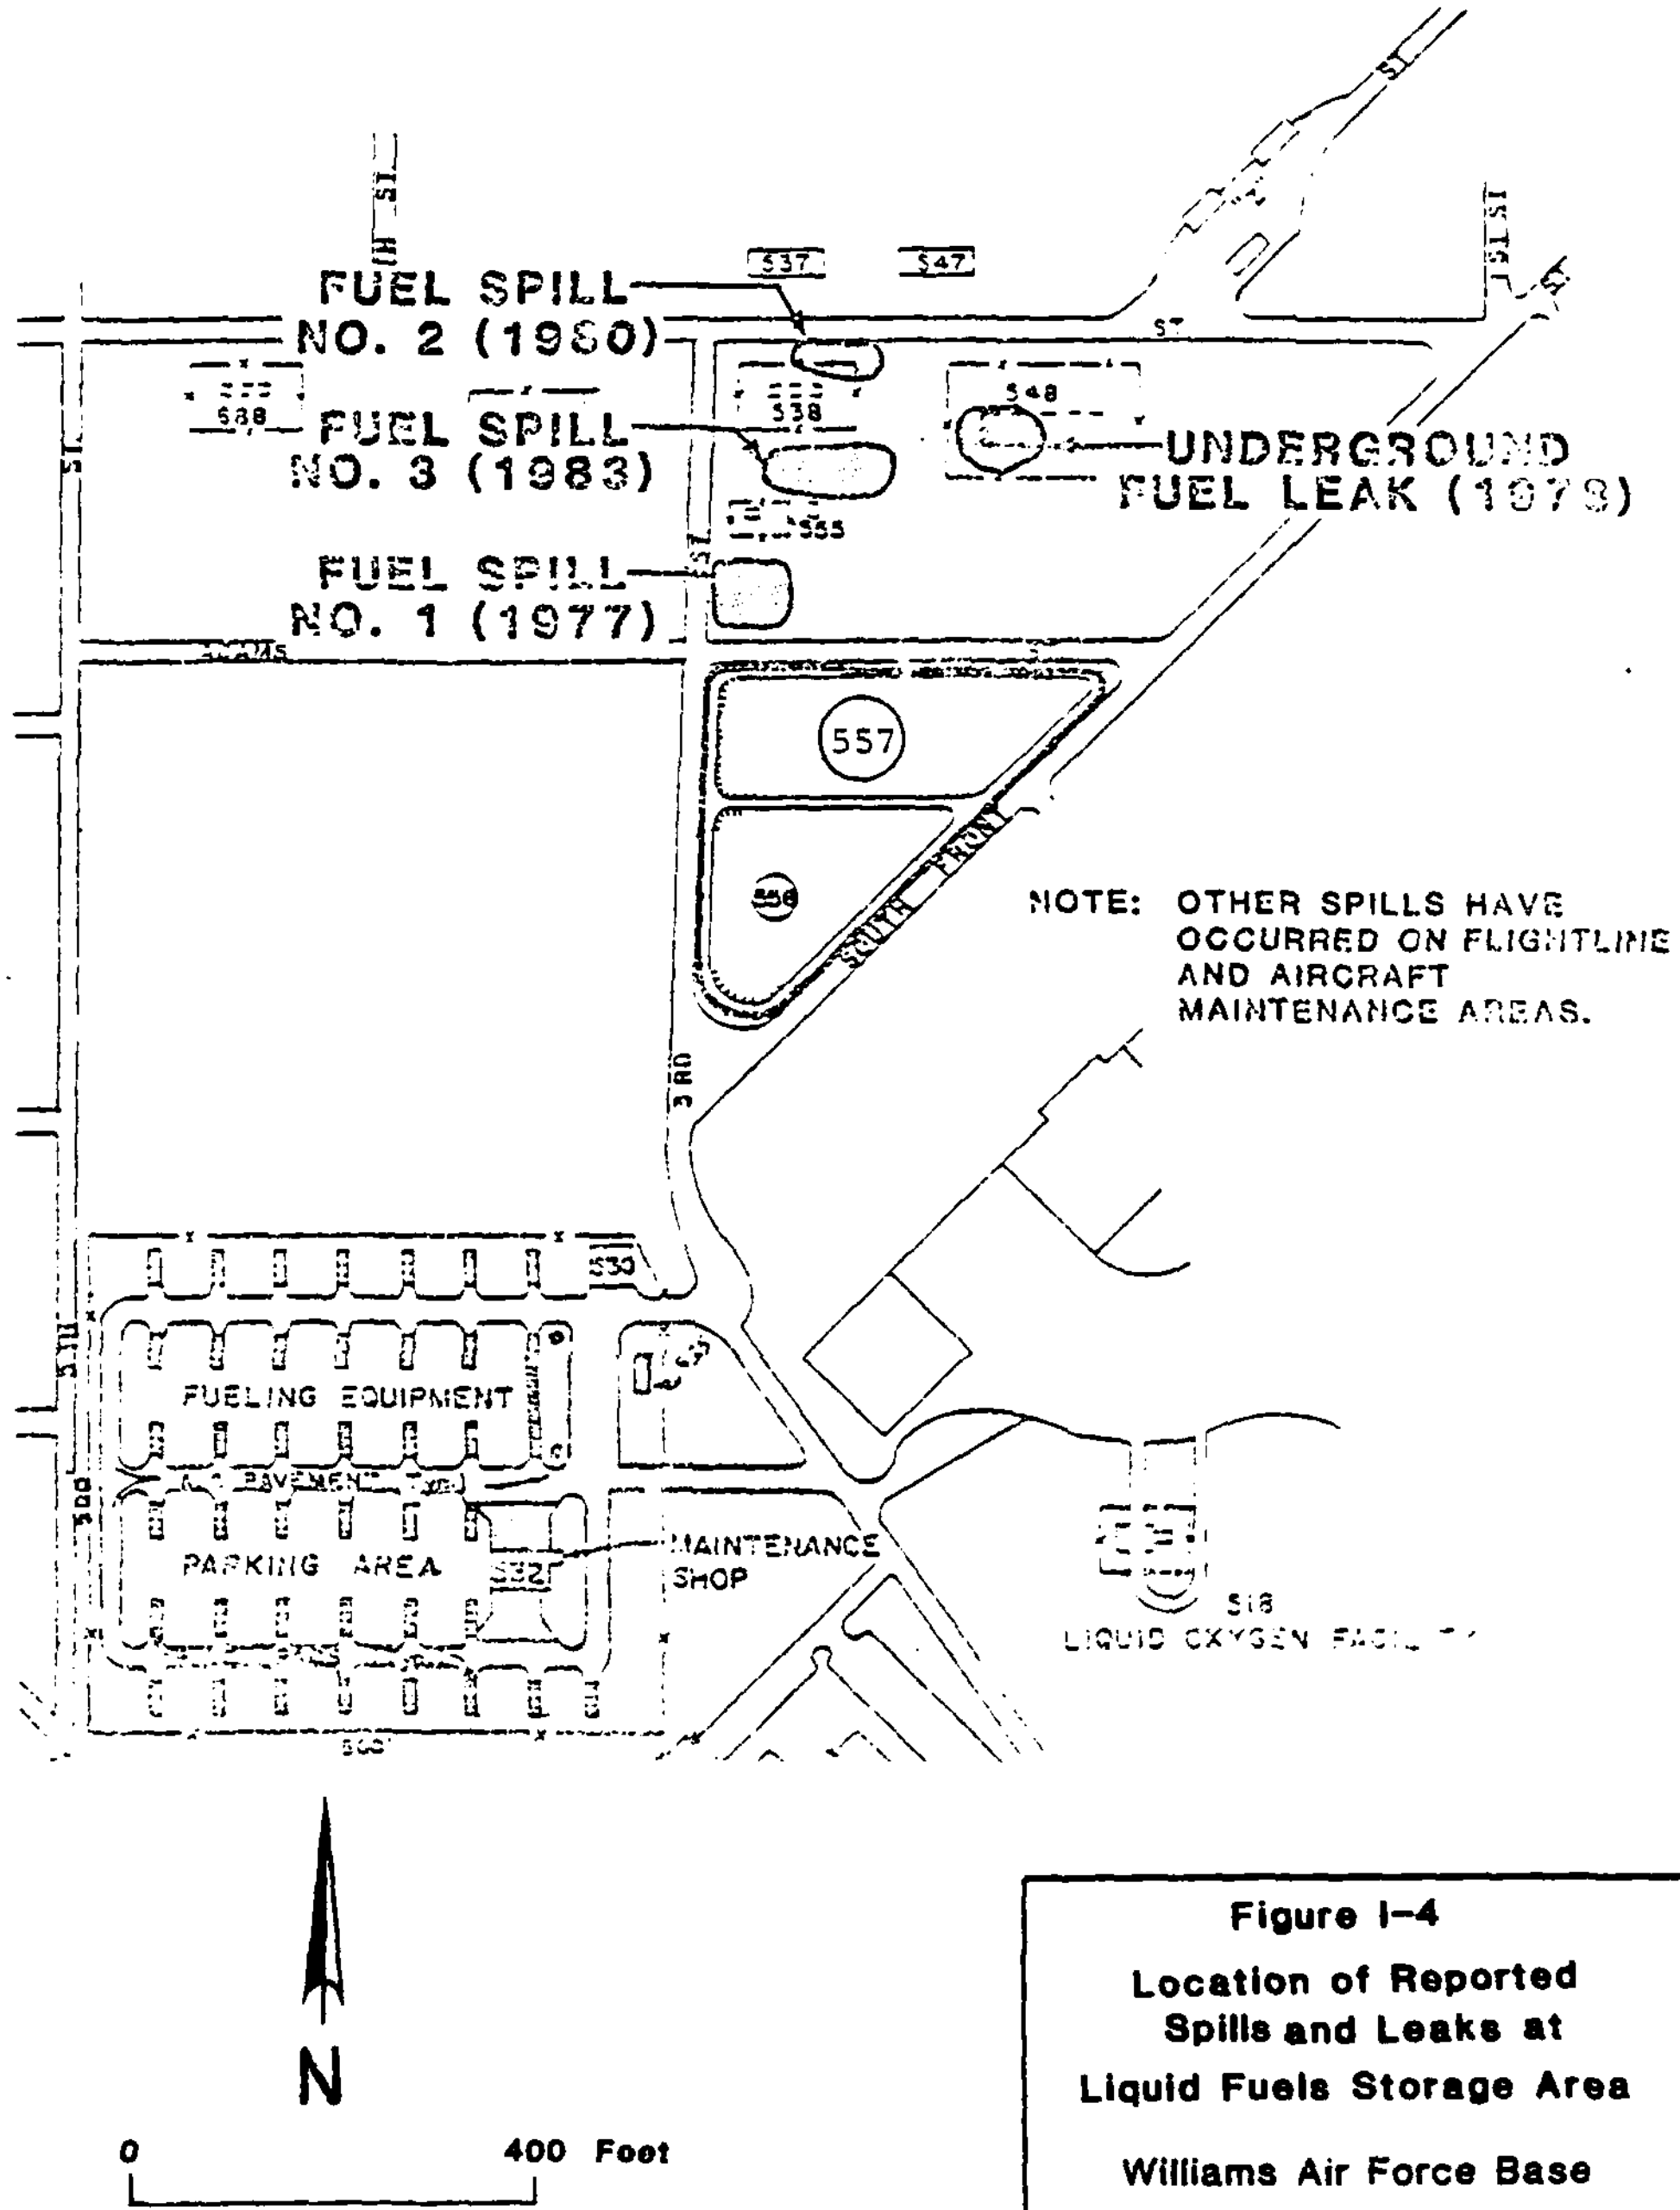
Location of Reported Spills and Leaks at Liquid Fuels Storage Area

The Phase I report identified three spills and one leak at the LFSA. These are shown on Figure I-4. Air Force personnel contacted during Phase II work confirmed the leak and two of the spills reported. No record has been found on the third spill. An old piping system, including subsurface tanks, was sealed and abandoned in 1960. It is not known if this system was drained prior to decommissioning.

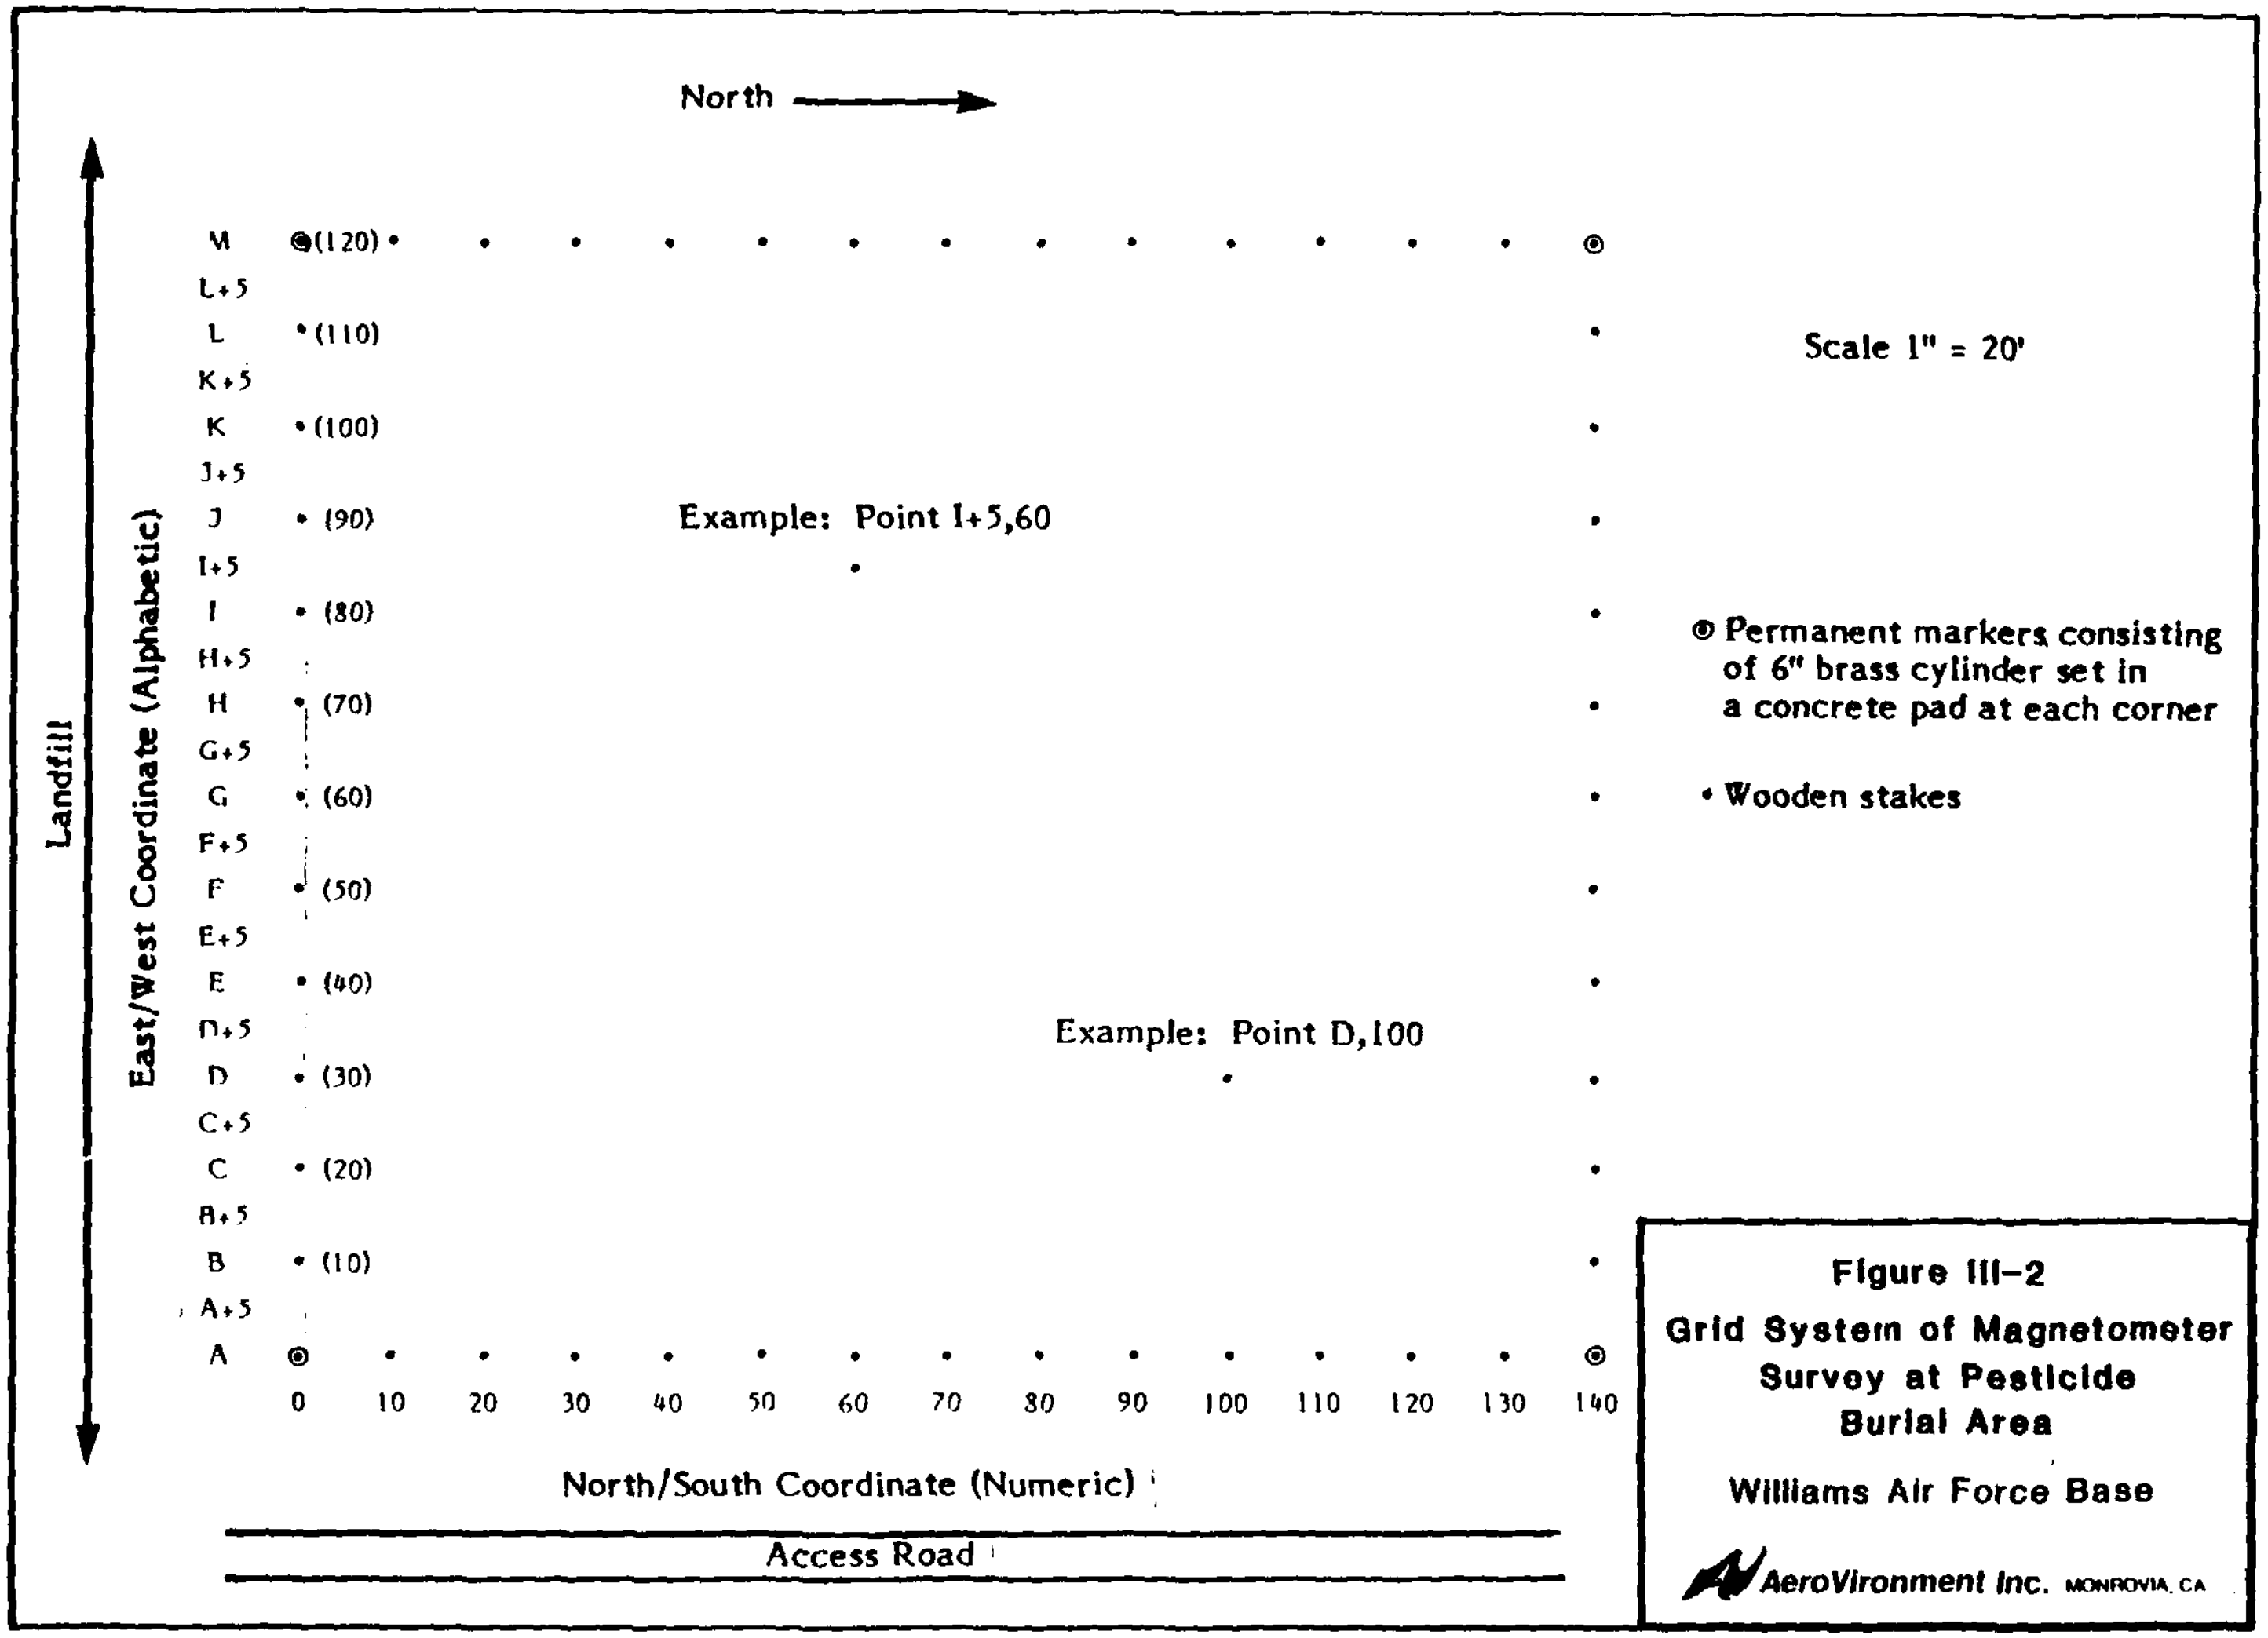
Figure III-2
Grid System of Magnetometer Survey at Pesticide Burial Area

The limits of the pesticide burial site are unknown. The best guess is that the site is bounded by the metal warning signs placed in the area. The magnetometer crew set up a 120-foot-by-140-foot grid system which extended approximately 30 feet past the signs to the north, south, and east, and over 50 feet to the west. The grid system is shown in Figure III-2. No equipment, other than the magnetometer, was used for this study. All vehicles were kept out of the area to avoid metallic interference.

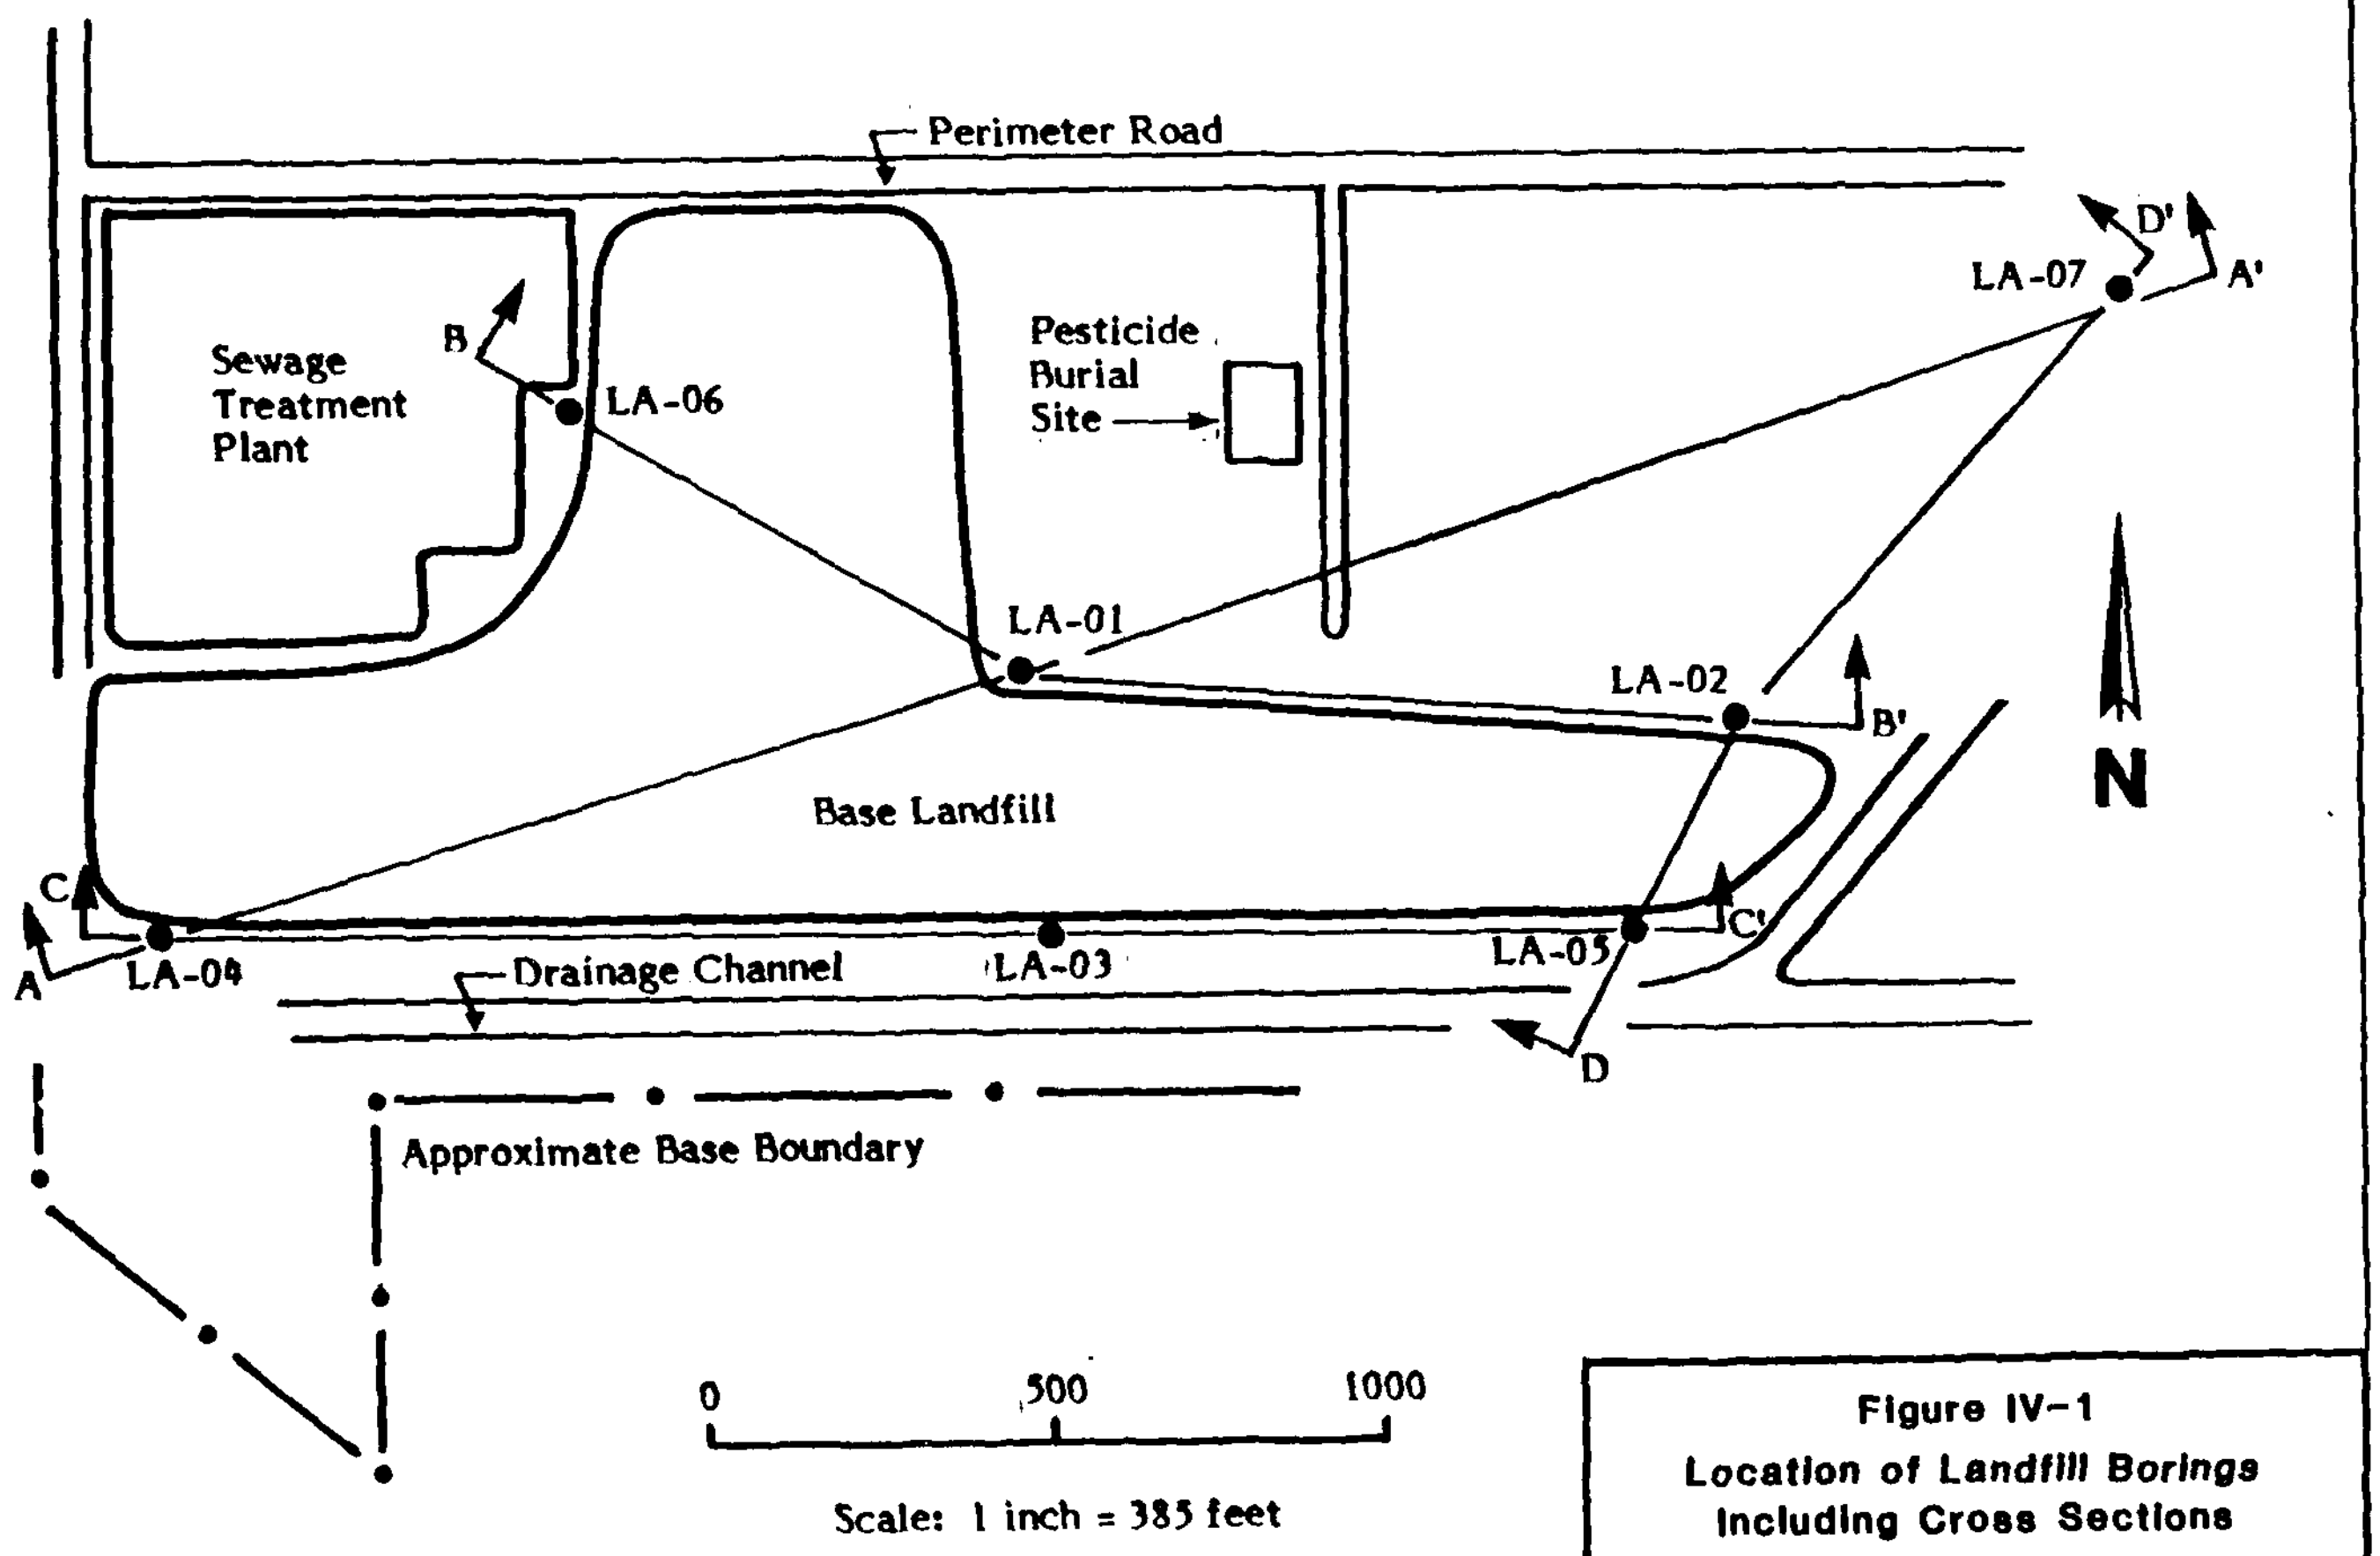
Figure IV-1
Location of Landfill Borings Including Cross Sections

Our best information on the geology below the soil zone on base was obtained during our drilling at the landfill. Four of these borings were extended down to approximately 80 feet (see Figures IV-1 through IV-5). These borings showed three distinct, essentially flat, planar units in a "layer cake" configuration. This "layer cake" configuration is typical of the central areas of alluvial basins (Ariz. Bureau of Mines, Bull. 180). The upper unit consisted of very fine to medium sands and silt down to 35-40 ft. The fine sands and silts of the surficial soil associations (Mohall and Gilman) were very similar to this upper unit. However, the unit had less clay and was generally coarser grained than either of
