INSTALLATION RESTORATION PROGRAM
PHASE II - CONFIRMATION/QUANTIFICATION

STAGE 1

WILLIAMS AIR FORCE BASE,
CHANDLER, ARIZONA

JANUARY 1986

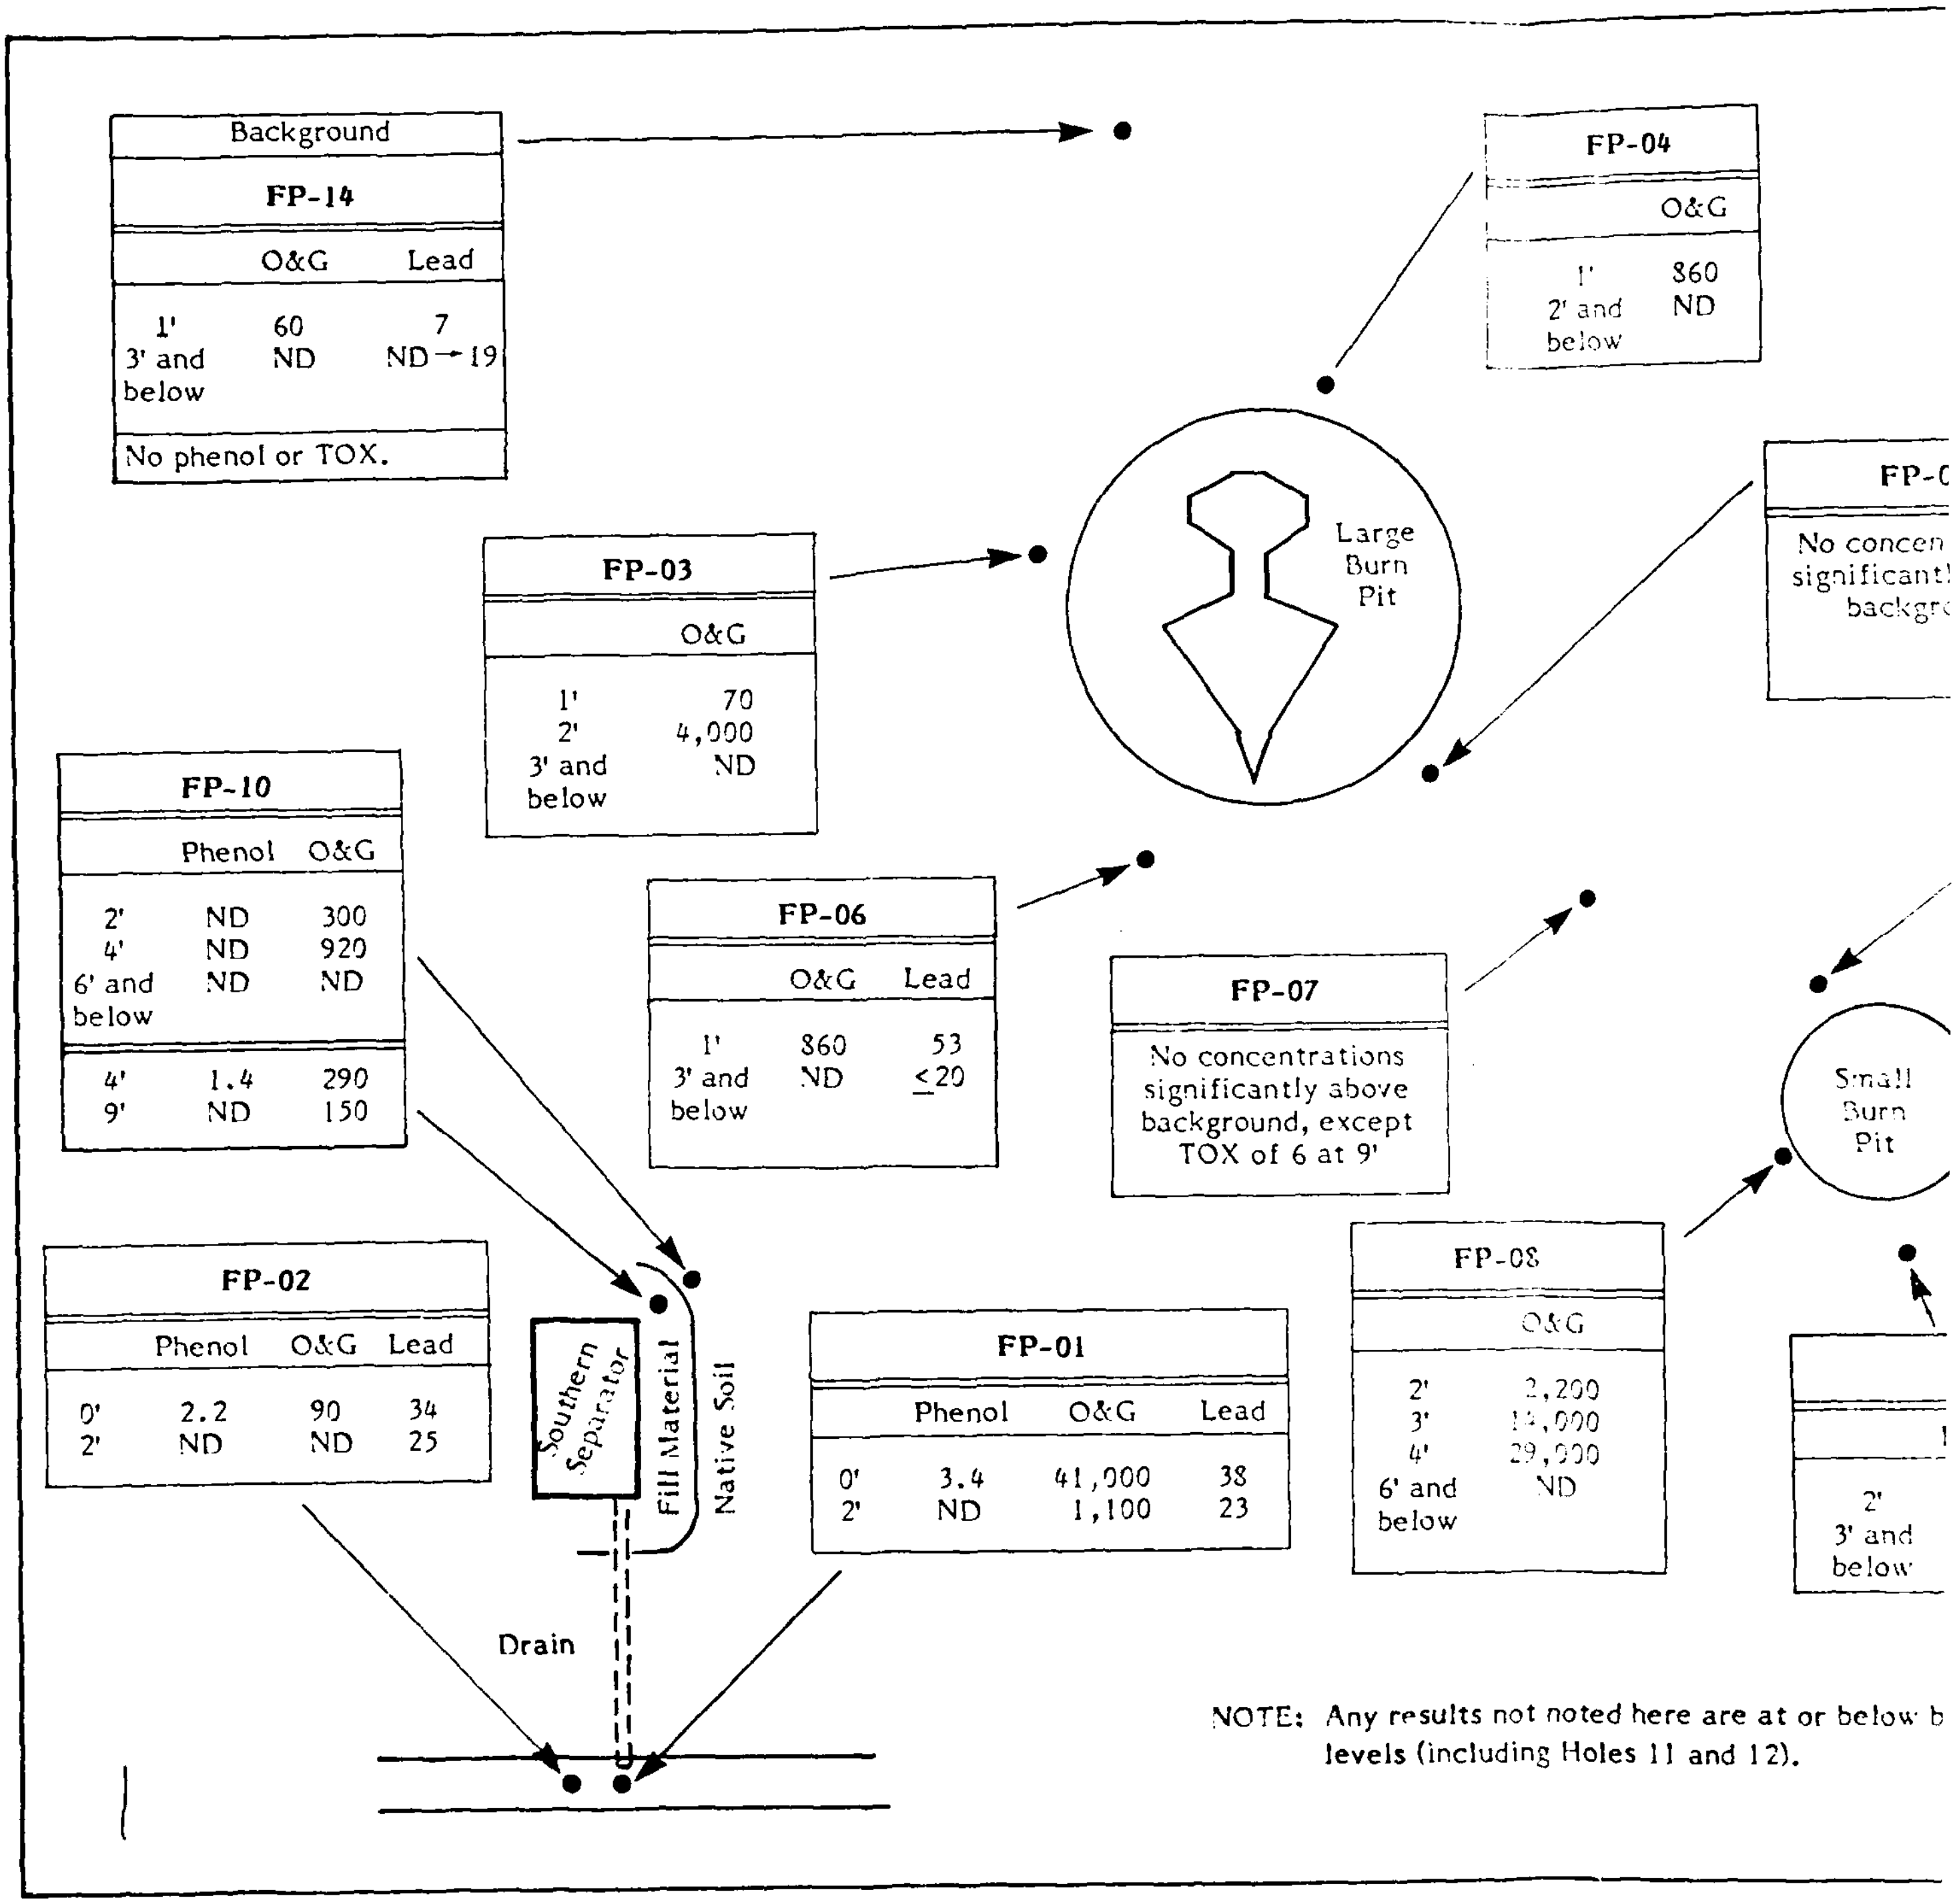
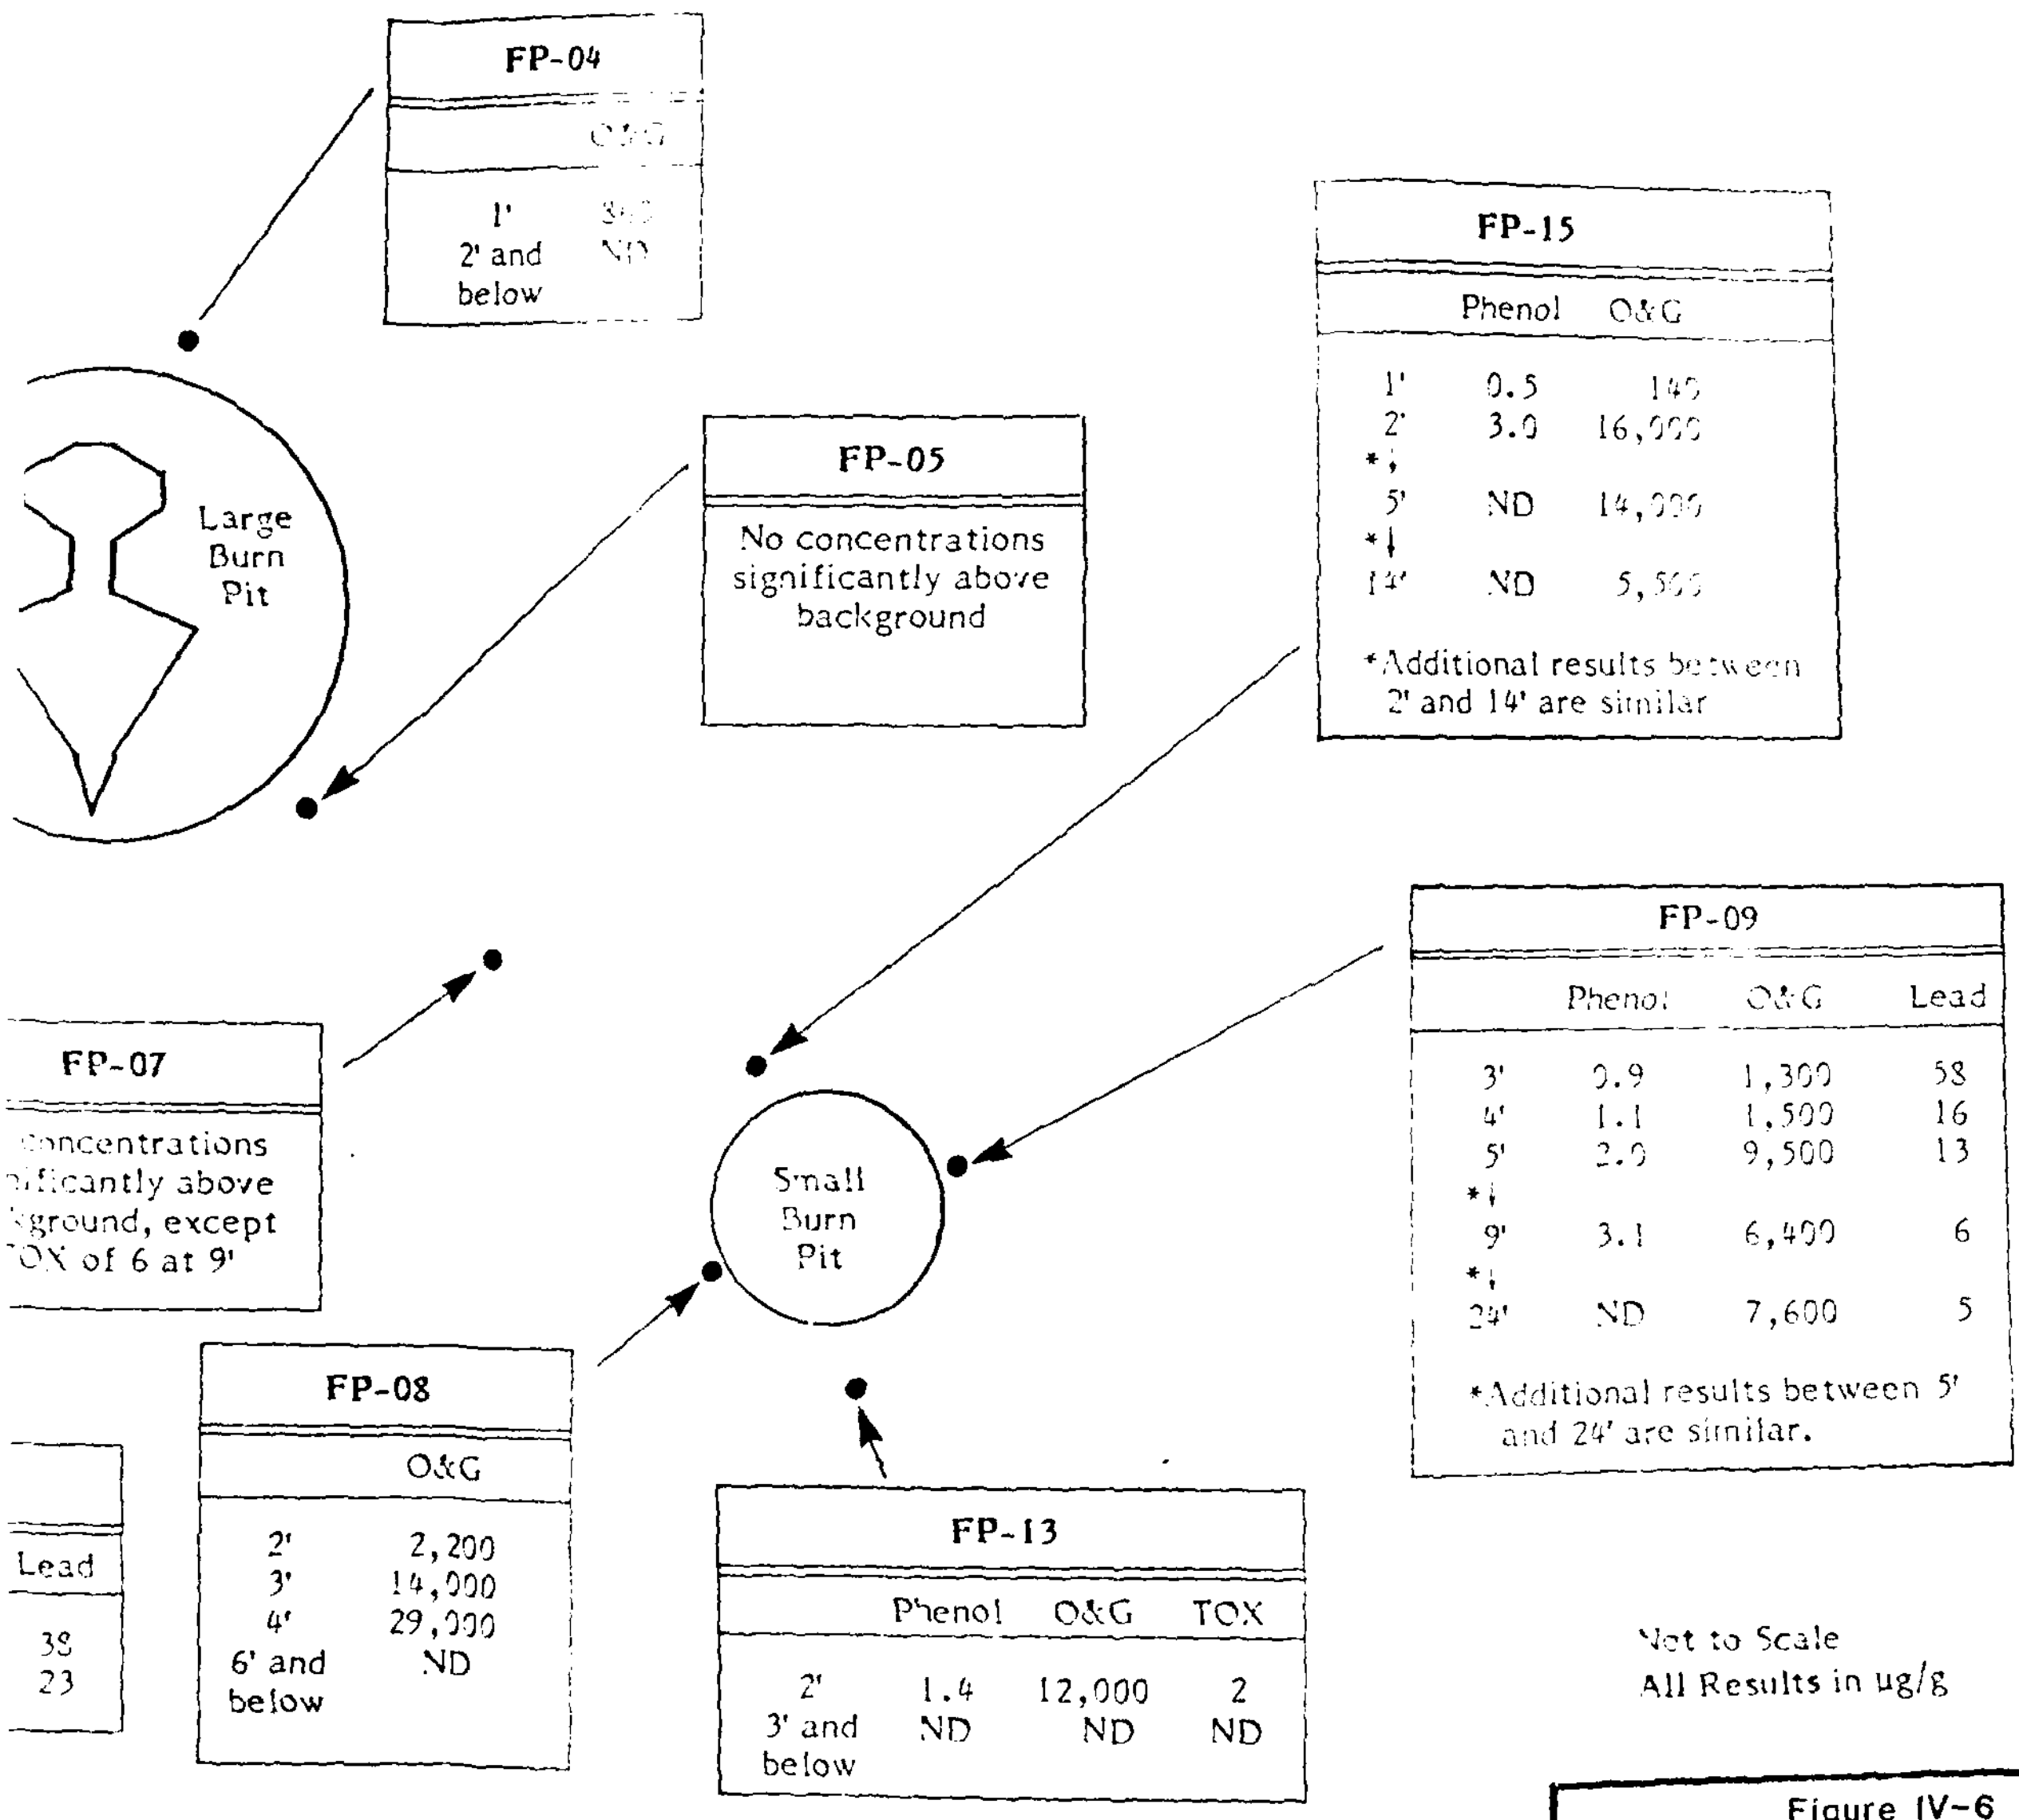
Samples at the FPTA contained oil and grease in concentrations up to 9,500 µg/g in the soil below the small burn pit and 41,000 µg/g in the drainage channel near the separator pit. The contamination in the drainage channel is very limited. Contamination under the burn pit was confirmed, but the extent of the problem was not determined.

During our investigation at the fire protection training area, 15 test holes were drilled in areas of possible contamination around the site. Samples taken in 10 of the 15 holes showed soil contamination ranging in depth from 2 to greater than 25 feet from the surface (see Figure IV-6). We were able to establish an apparent lower limit of contaminated soil in all but two borings and the area of deep (greater than 25 feet) contamination appears to be limited, generally to the

- Fire Protection Training Area
  - Drill up to 10 borings, sampling to determine extent of contamination near the burn pits; total drilling up to 200 feet
  - Drill two deep borings to determine whether a clay layer underlies FPTA (up to 200 feet)
  - Sample soils directly above the clay layer, if found (four samples)
  - Analyze soil samples for oil and grease, up to 84 samples
  - Analyze the most badly contaminated samples for priority pollutants, up to five samples
  - Revise FPTA area to reduce additional application of contaminants
  - Remove contaminated soil from the drainage channel south of the separator pit (approximately 5 cubic yards)

2) Additional drilling and soil sampling around the fire pits -- This activity would fully define the extent of contamination in three dimensions so the magnitude of soil contamination under the two fire pits could be fully understood.

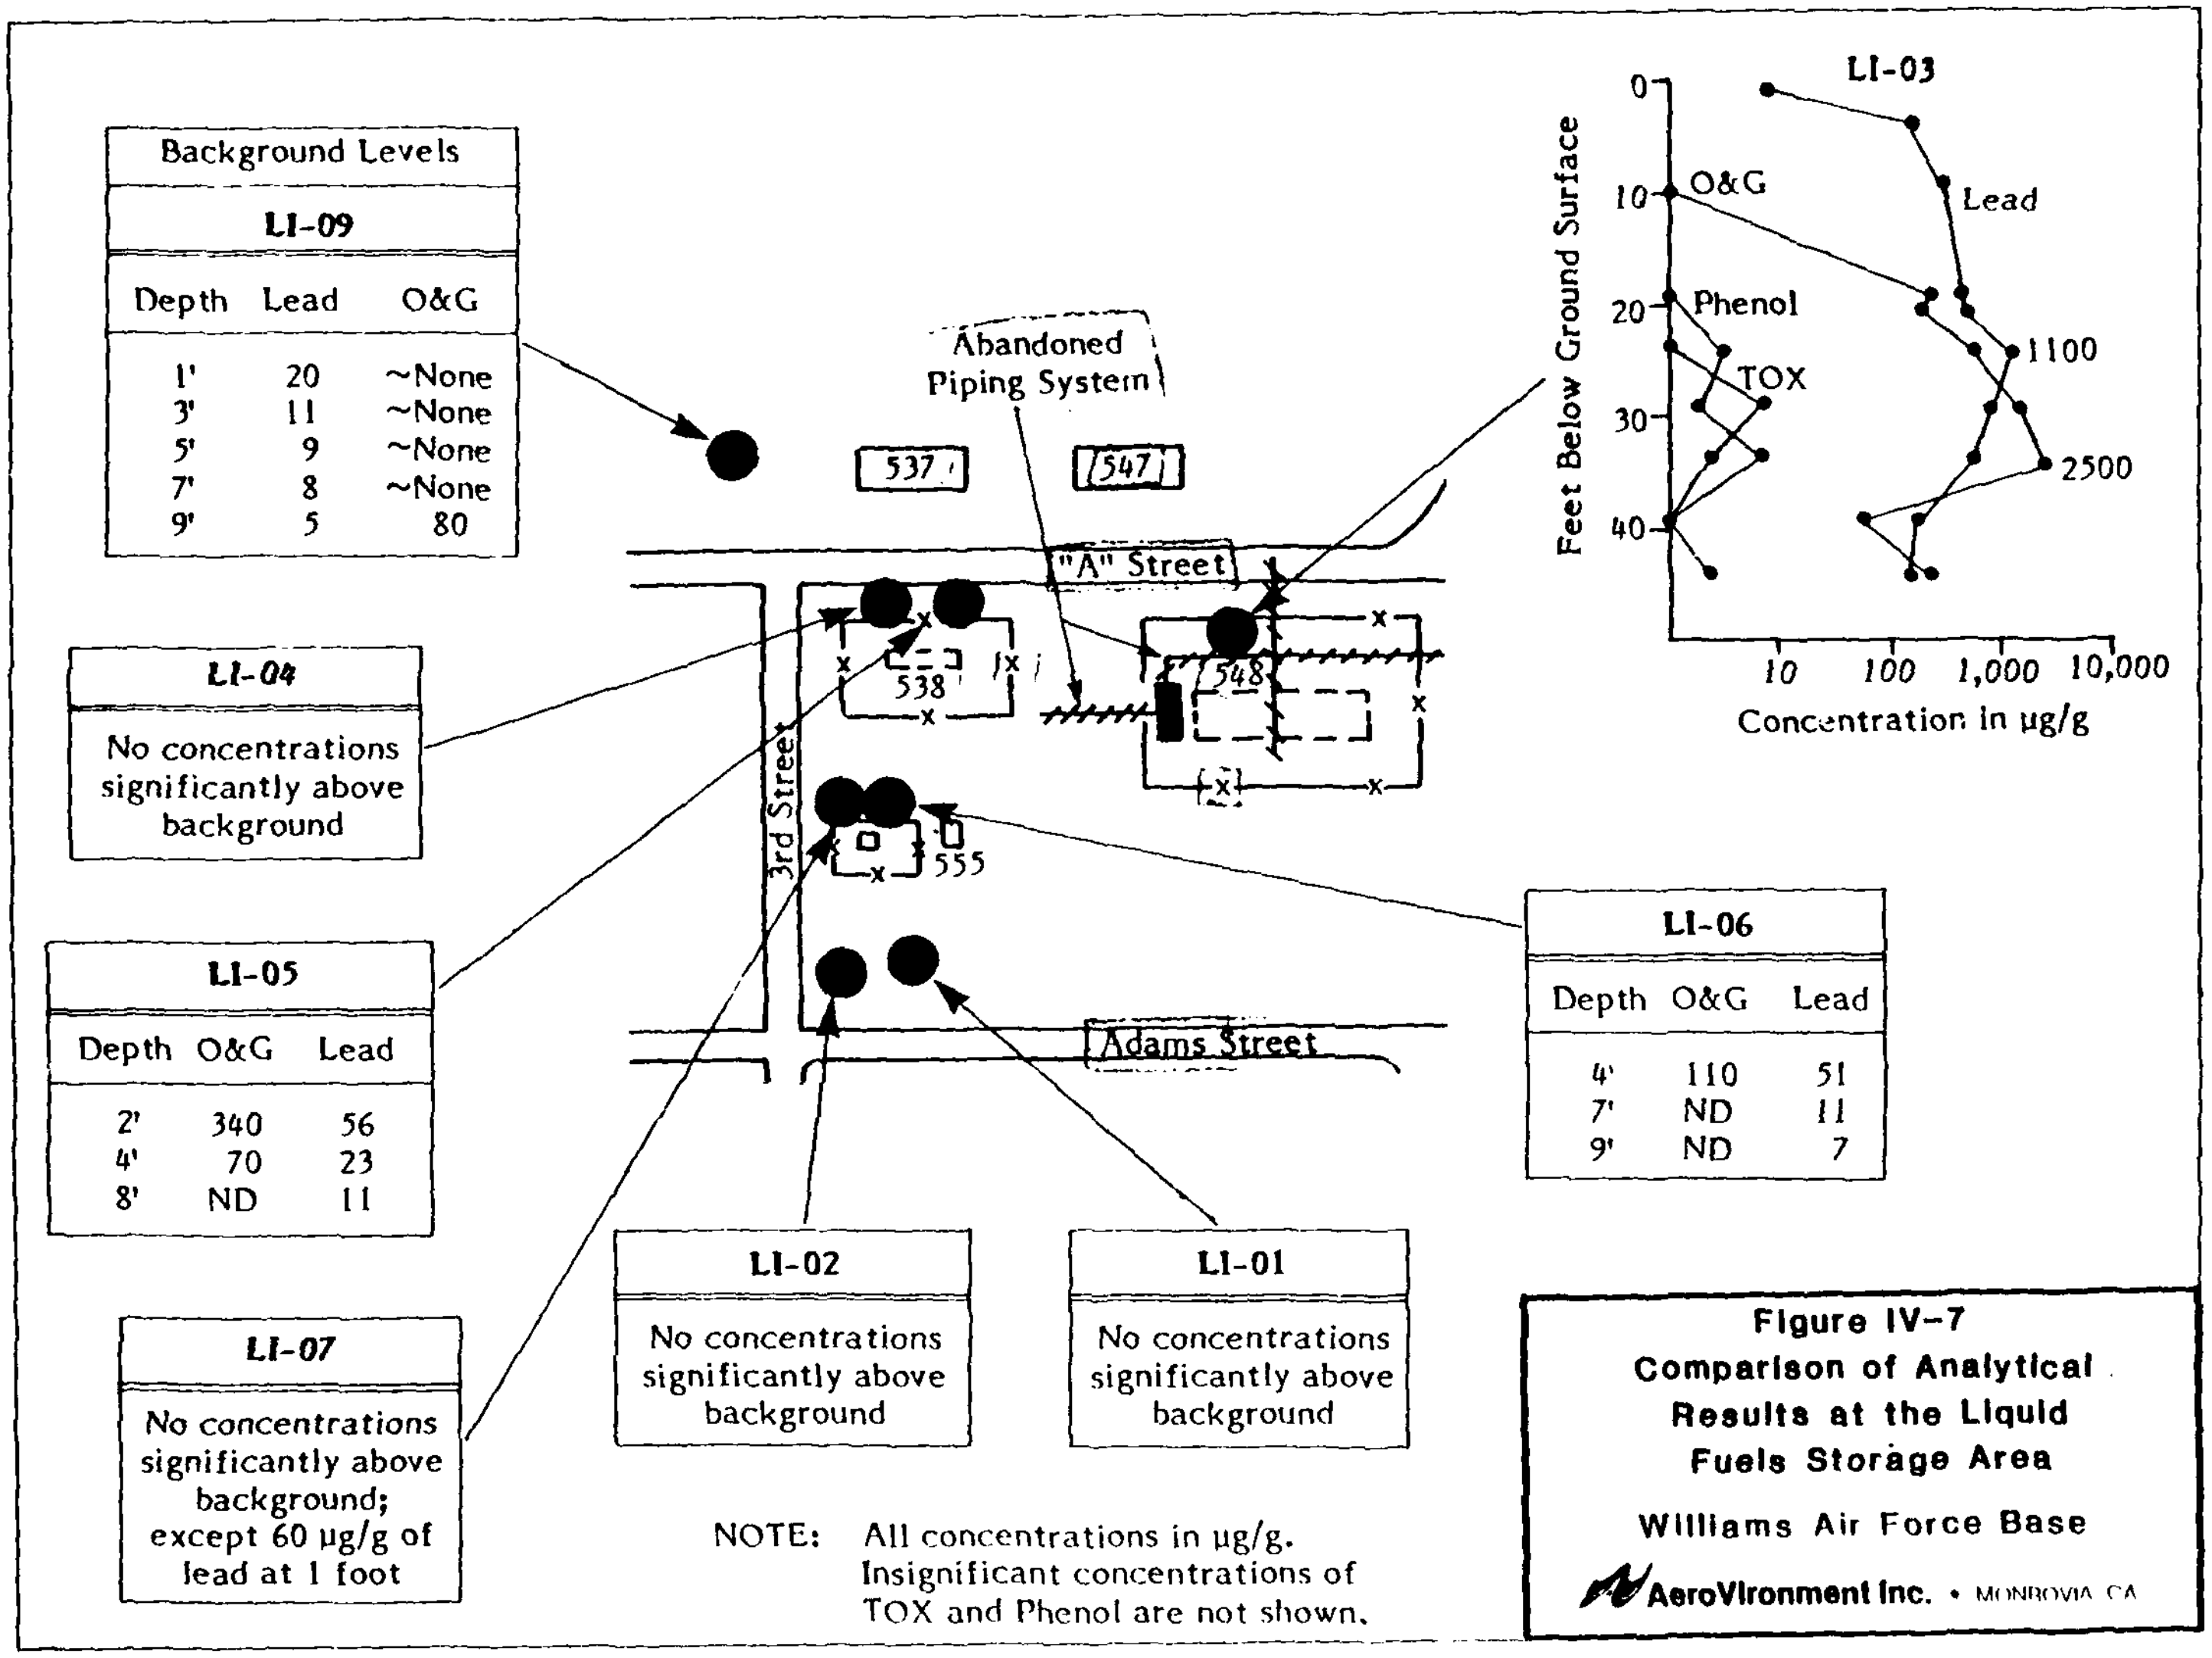
Contamination discovered at the LFSA in this study was localized and for the most part shallow. We drilled eight test holes, and twice found contaminated soils down to about four feet in areas of known surface spills. This level of contamination is not considered to be a serious problem since it is very shallow and localized (see Figure IV-7). The reported concentration of 80 µg/g oil and grease in the bottom background sample (LI-09-05) is considered to be suspect. There is no way to explain the test result.

Most contamination at the liquid fuels storage area was found in surface soils at historic fuel spill locations. Levels up to 340 µg/g of oil and grease and 60 µg/g of lead were found in the top four feet of soil. No evidence was found of downward migration of contamination from spills.

- Liquid Fuels Storage Area
  - Drill up to 15 borings, sampling to determine the extent of contamination along the old AVGAS system; total drilling up to 750 feet
  - Drill two deep borings to determine whether a clay layer underlies LFSA (up to 200 feet)
  - Sample soils directly above the clay layer, if found (four samples)
  - Analyze soil samples for oil and grease and lead, up to 154 samples
  - Analyze the most badly contaminated samples for priority pollutants, up to five samples
  - Place vapor monitoring wells under the contamination zone, if appropriate

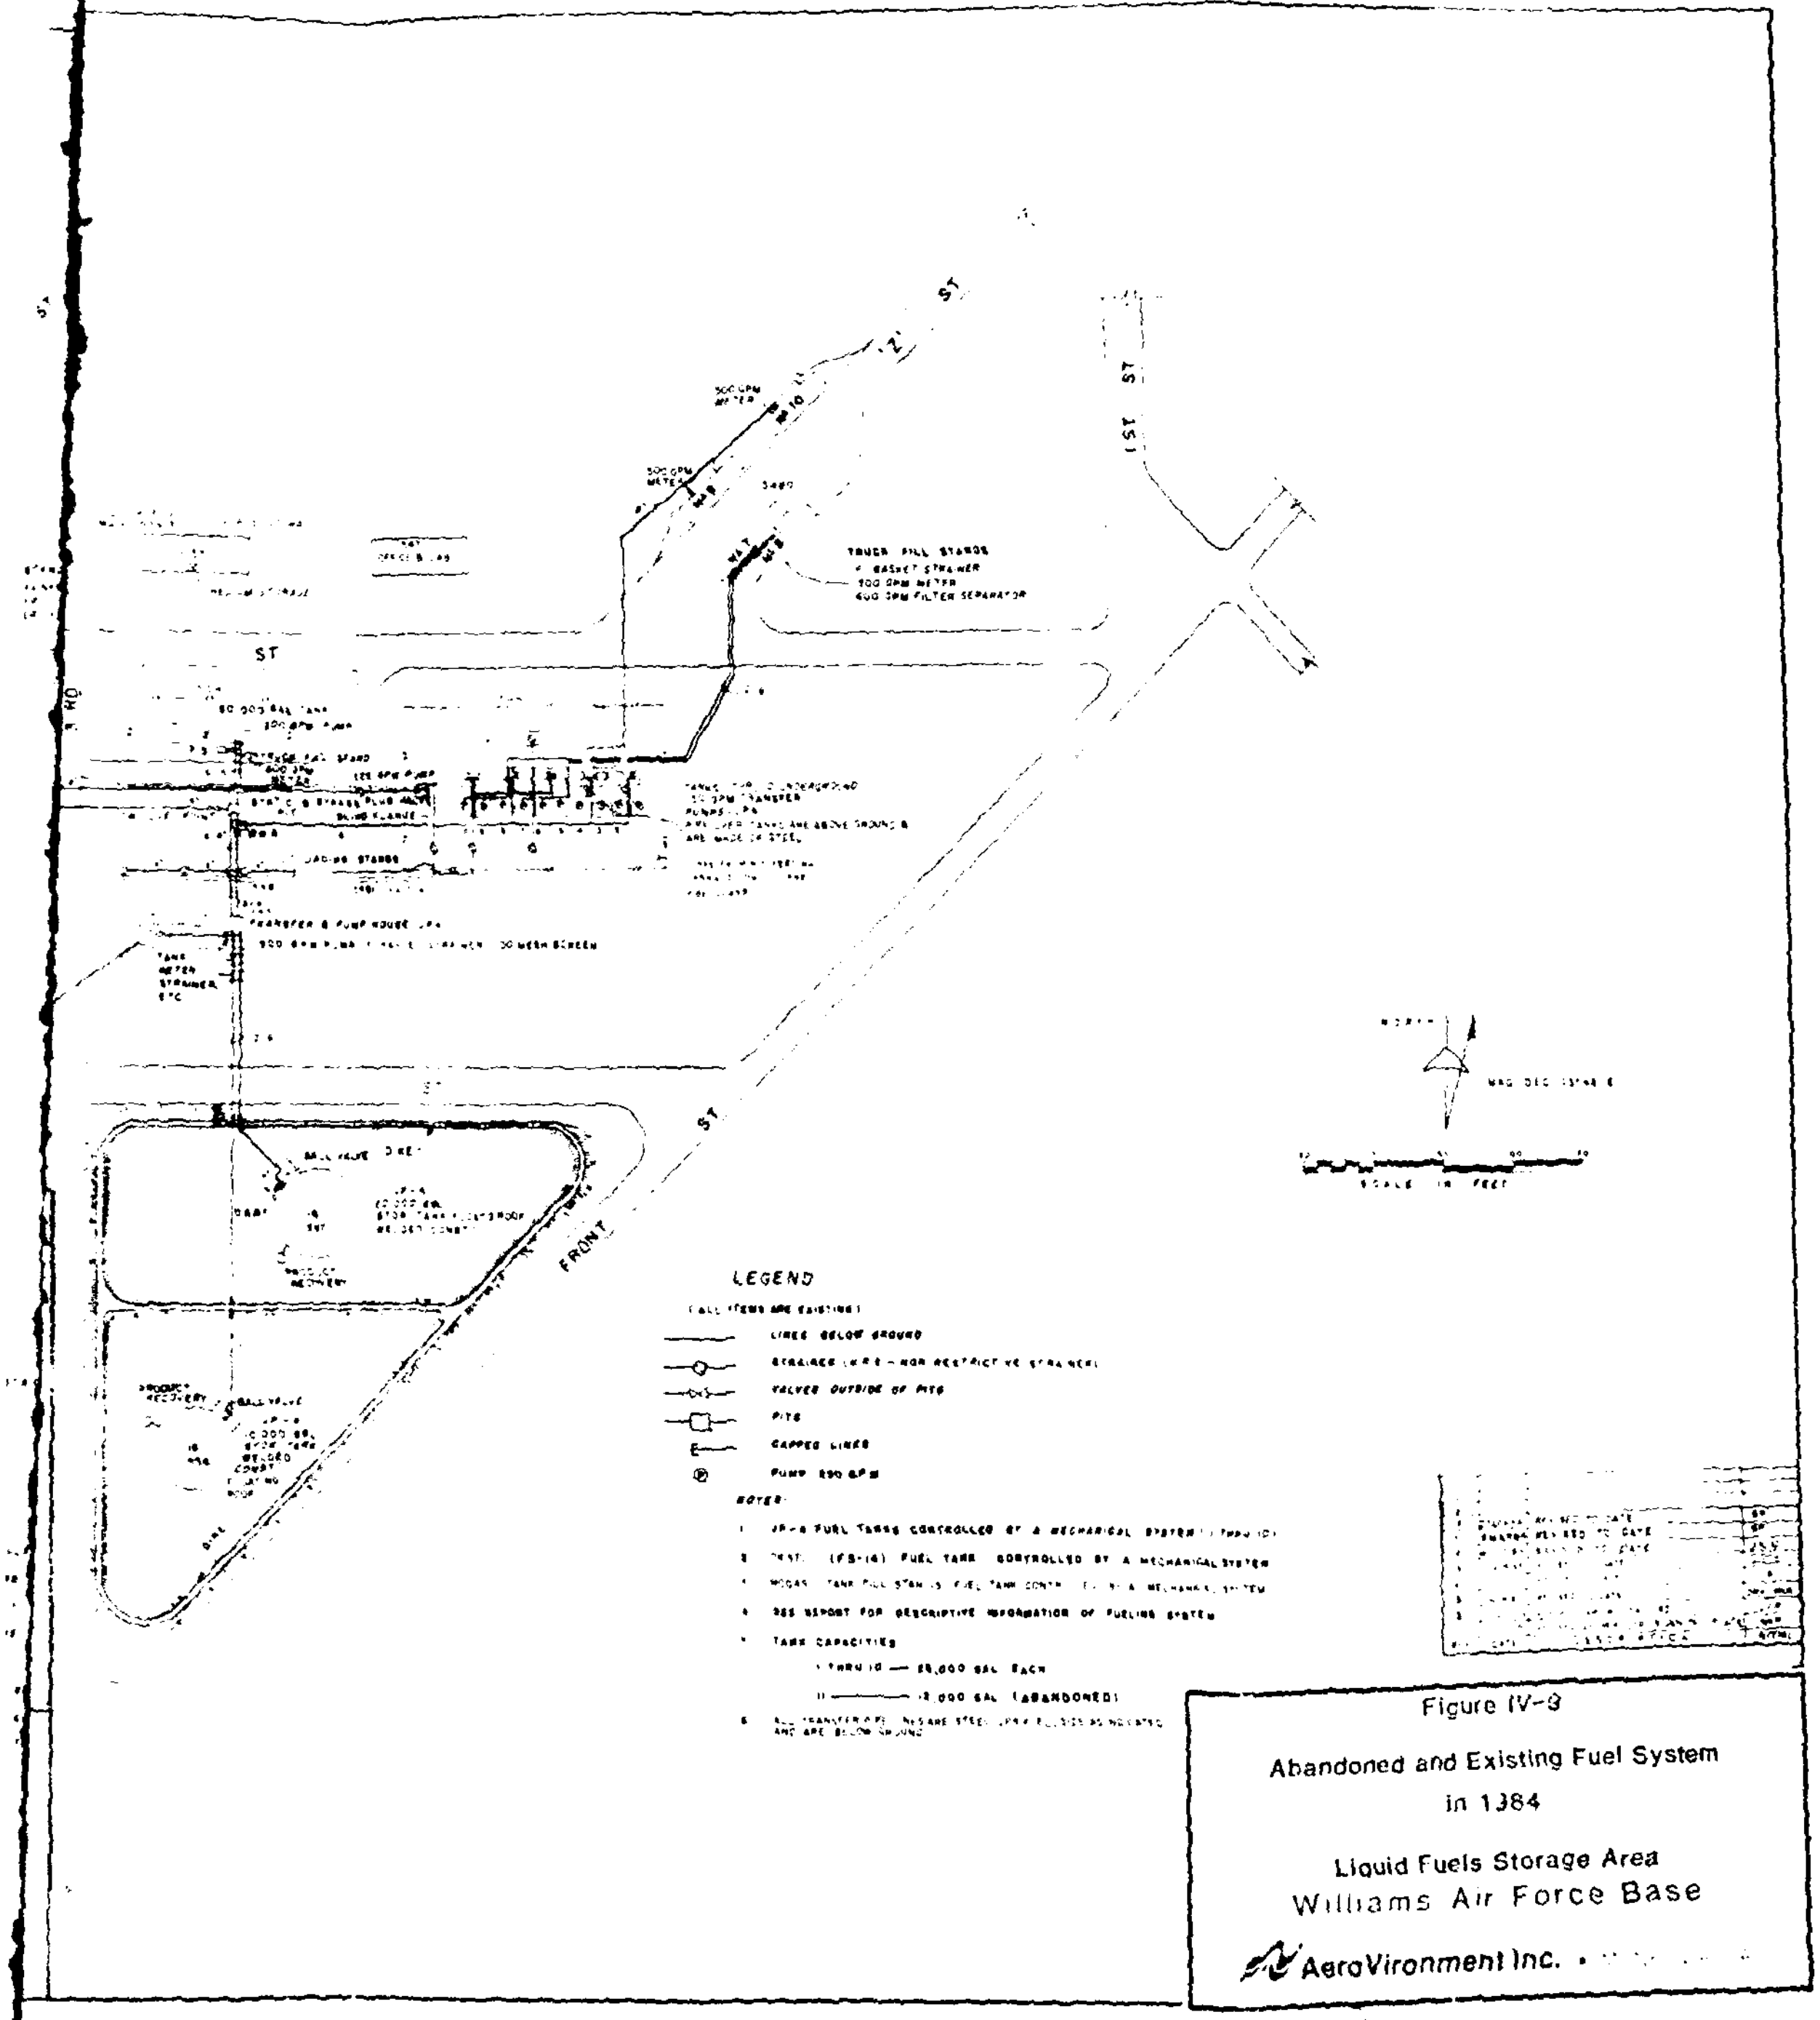
Figure IV-8

The major problem at the LFSA was encountered during the test boring placed inside the fenced compound at the underground fuel storage tanks (Building 548). We extended boring LI-03 down to 45 feet and were unable to find the lower extent of contaminated soil at that location. Laboratory analyses of the soil showed very high lead concentrations (in addition to phenol and oil and grease), indicating that the soil was contaminated by leaded AVGAS instead of nonleaded JP-4 that is currently being used at the facility. The best records available at this time indicate that AVGAS has not been used since 1960 or 1961. About the same time, an old fuel delivery system and one of the underground storage tanks (Tank 11) were abandoned (Figures IV-8 and IV-9). By using plans for modifications of the fuel delivery system, we have determined that approximately 3,600 feet of four- and six-inch pipe, as well as the tank, were cut and abandoned in place. Air

During the investigation of the LFSA, AeroVironment identified a potential problem which had not previously been addressed at this site. While drilling to assess the effects of a JP-4 leak at facility 548, we found high levels of oil and grease and lead. Phenol and TOX were found at levels above background, but are not considered significantly elevated. The high levels of lead (up to 1,000 µg/g) indicated that AVGAS, not JP-4, was probably the source of contamination. Later in the field program, USAF fuels management personnel found a map showing an AVGAS fuel delivery system which was abandoned in 1961. AV's boring LI-03 had been drilled within five feet of piping in that system. Soil samples taken from LI-03 were found to have oil and grease concentrations up to 2,500 µg/g and phenol and TOX up to about 8 µg/g. Laboratory results indicate that the bottom of the contamination zone is probably just below the bottom of the boring, which was terminated at 45 feet. This is suspected because the concentrations of contaminants at 45 feet are substantially below the peak concentrations found at 25-35 feet. However, there is no way to confirm this suspicion during this stage.

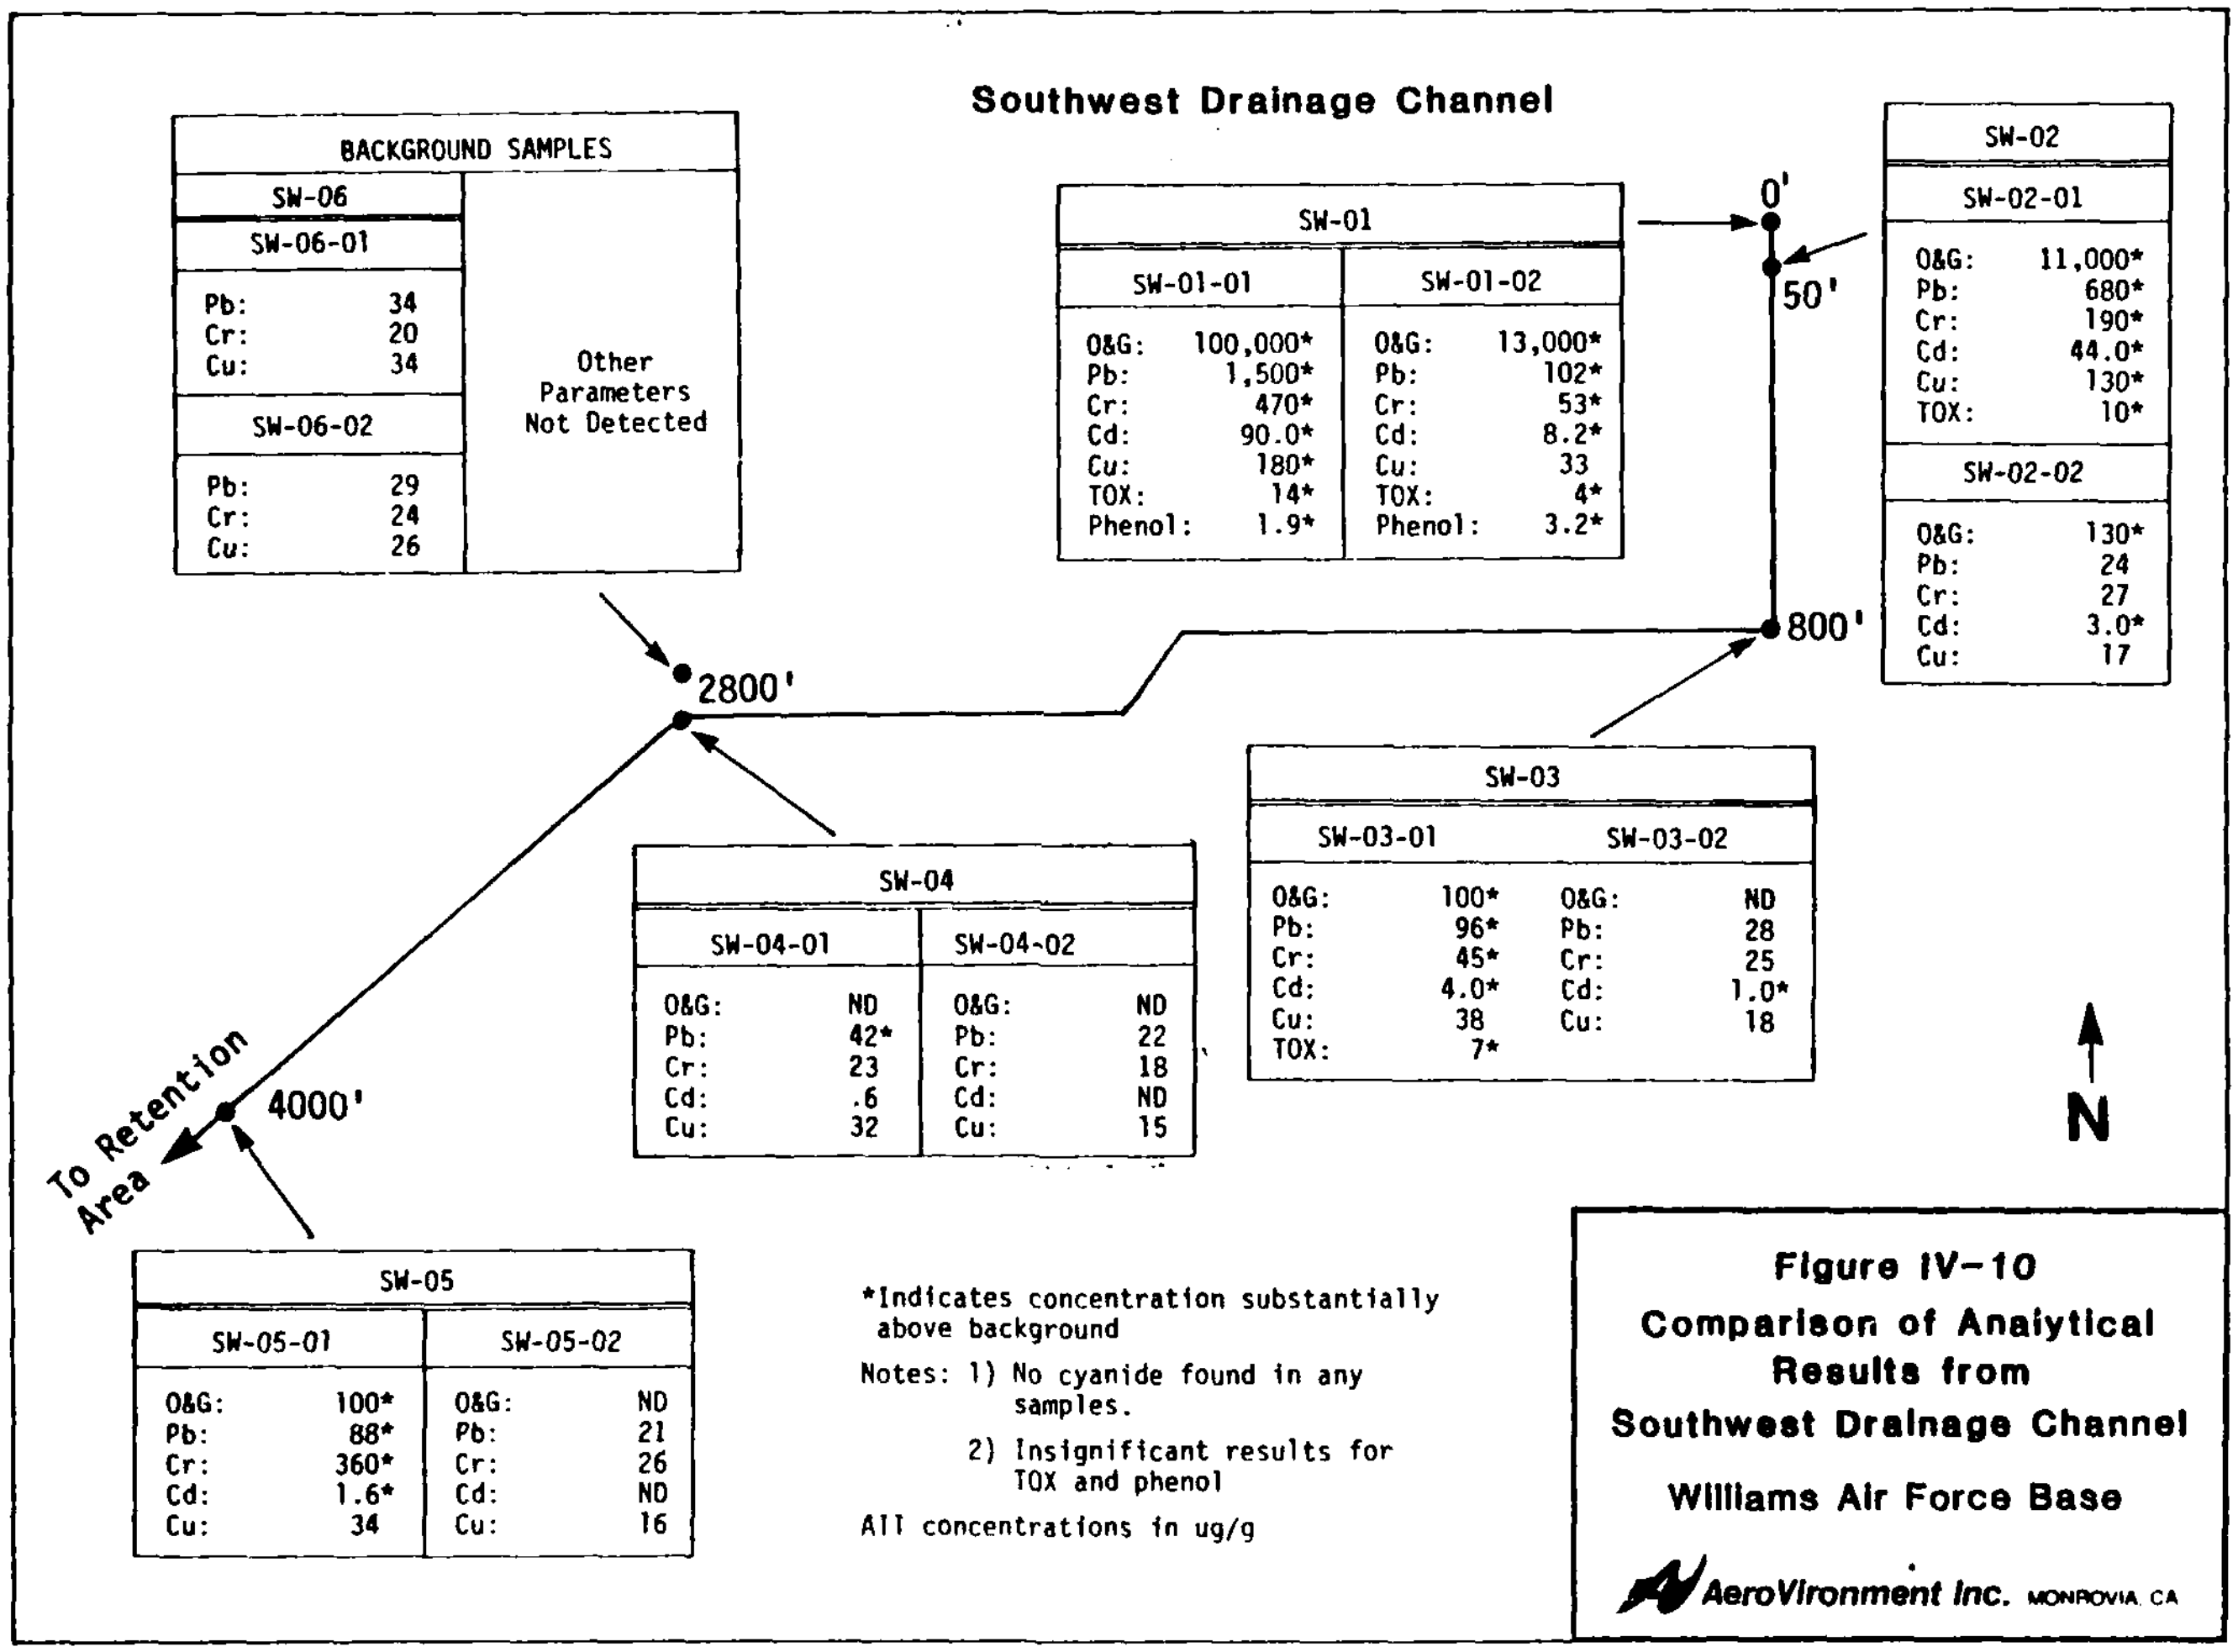
The southwest drainage has two distinct zones of contamination (see Figure IV-10). The first, and most contaminated, is located from the pipe outfall to approximately 50 feet down channel. The soil in this area is extremely contaminated, but the volume of highly contaminated soil is small, about 12 yd^3.

The second reach of channel, 50 feet to about 850 feet from the outlet pipe, has slight to moderate contamination. This area is much larger, but the depth of contaminated soil decreases along the channel, so the estimated volume of contaminated soil in this area is only 90 yd^3. The remainder of the channel appears to be free of significant soil contamination. Due to the very small volume of highly contaminated soil, degradation of the perched groundwater from this site is considered unlikely.

BACKGROUND SAMPLES		
SW-06		
SW-06-01		Other Parameters Not Detected
Pb:	34	
Cr:	20	
Cu:	34	
SW-06-02		
Pb:	29	
Cr:	24	
Cu:	26

SW-01			
SW-01-01		SW-01-02	
O&G:	100,000*	O&G:	13,000*
Pb:	1,500*	Pb:	102*
Cr:	470*	Cr:	53*
Cd:	90.0*	Cd:	8.2*
Cu:	180*	Cu:	33
TOX:	14*	TOX:	4*
Phenol:	1.9*	Phenol:	3.2*

o Southwest Drainage System - Immediately excavate and remove soils, to a depth of two feet, from the upper 50 feet of the channel (approximately 12 cubic yards); handle as hazardous waste - Excavate surface soil from the remainder of the channel and place it in hardfill or landfill areas; refill channel with clean soil
o Landfill - No further action
o Pesticide Burial Area - Excavate the ten identified magnetic anomalies (buried metals) and determine whether any are pesticide drums or cans - Dispose of excavated material in an appropriate manner - If needed, drill up to ten borings (200 feet total) and collect up to 40 samples to assess the impact from any pesticide leakage
o Northwest Drainage System - No further action
