INSTALLATION RESTORATION PROGRAM
PHASE II - CONFIRMATION/QUANTIFICATION

STAGE 1

WILLIAMS AIR FORCE BASE,
CHANDLER, ARIZONA

JANUARY 1986

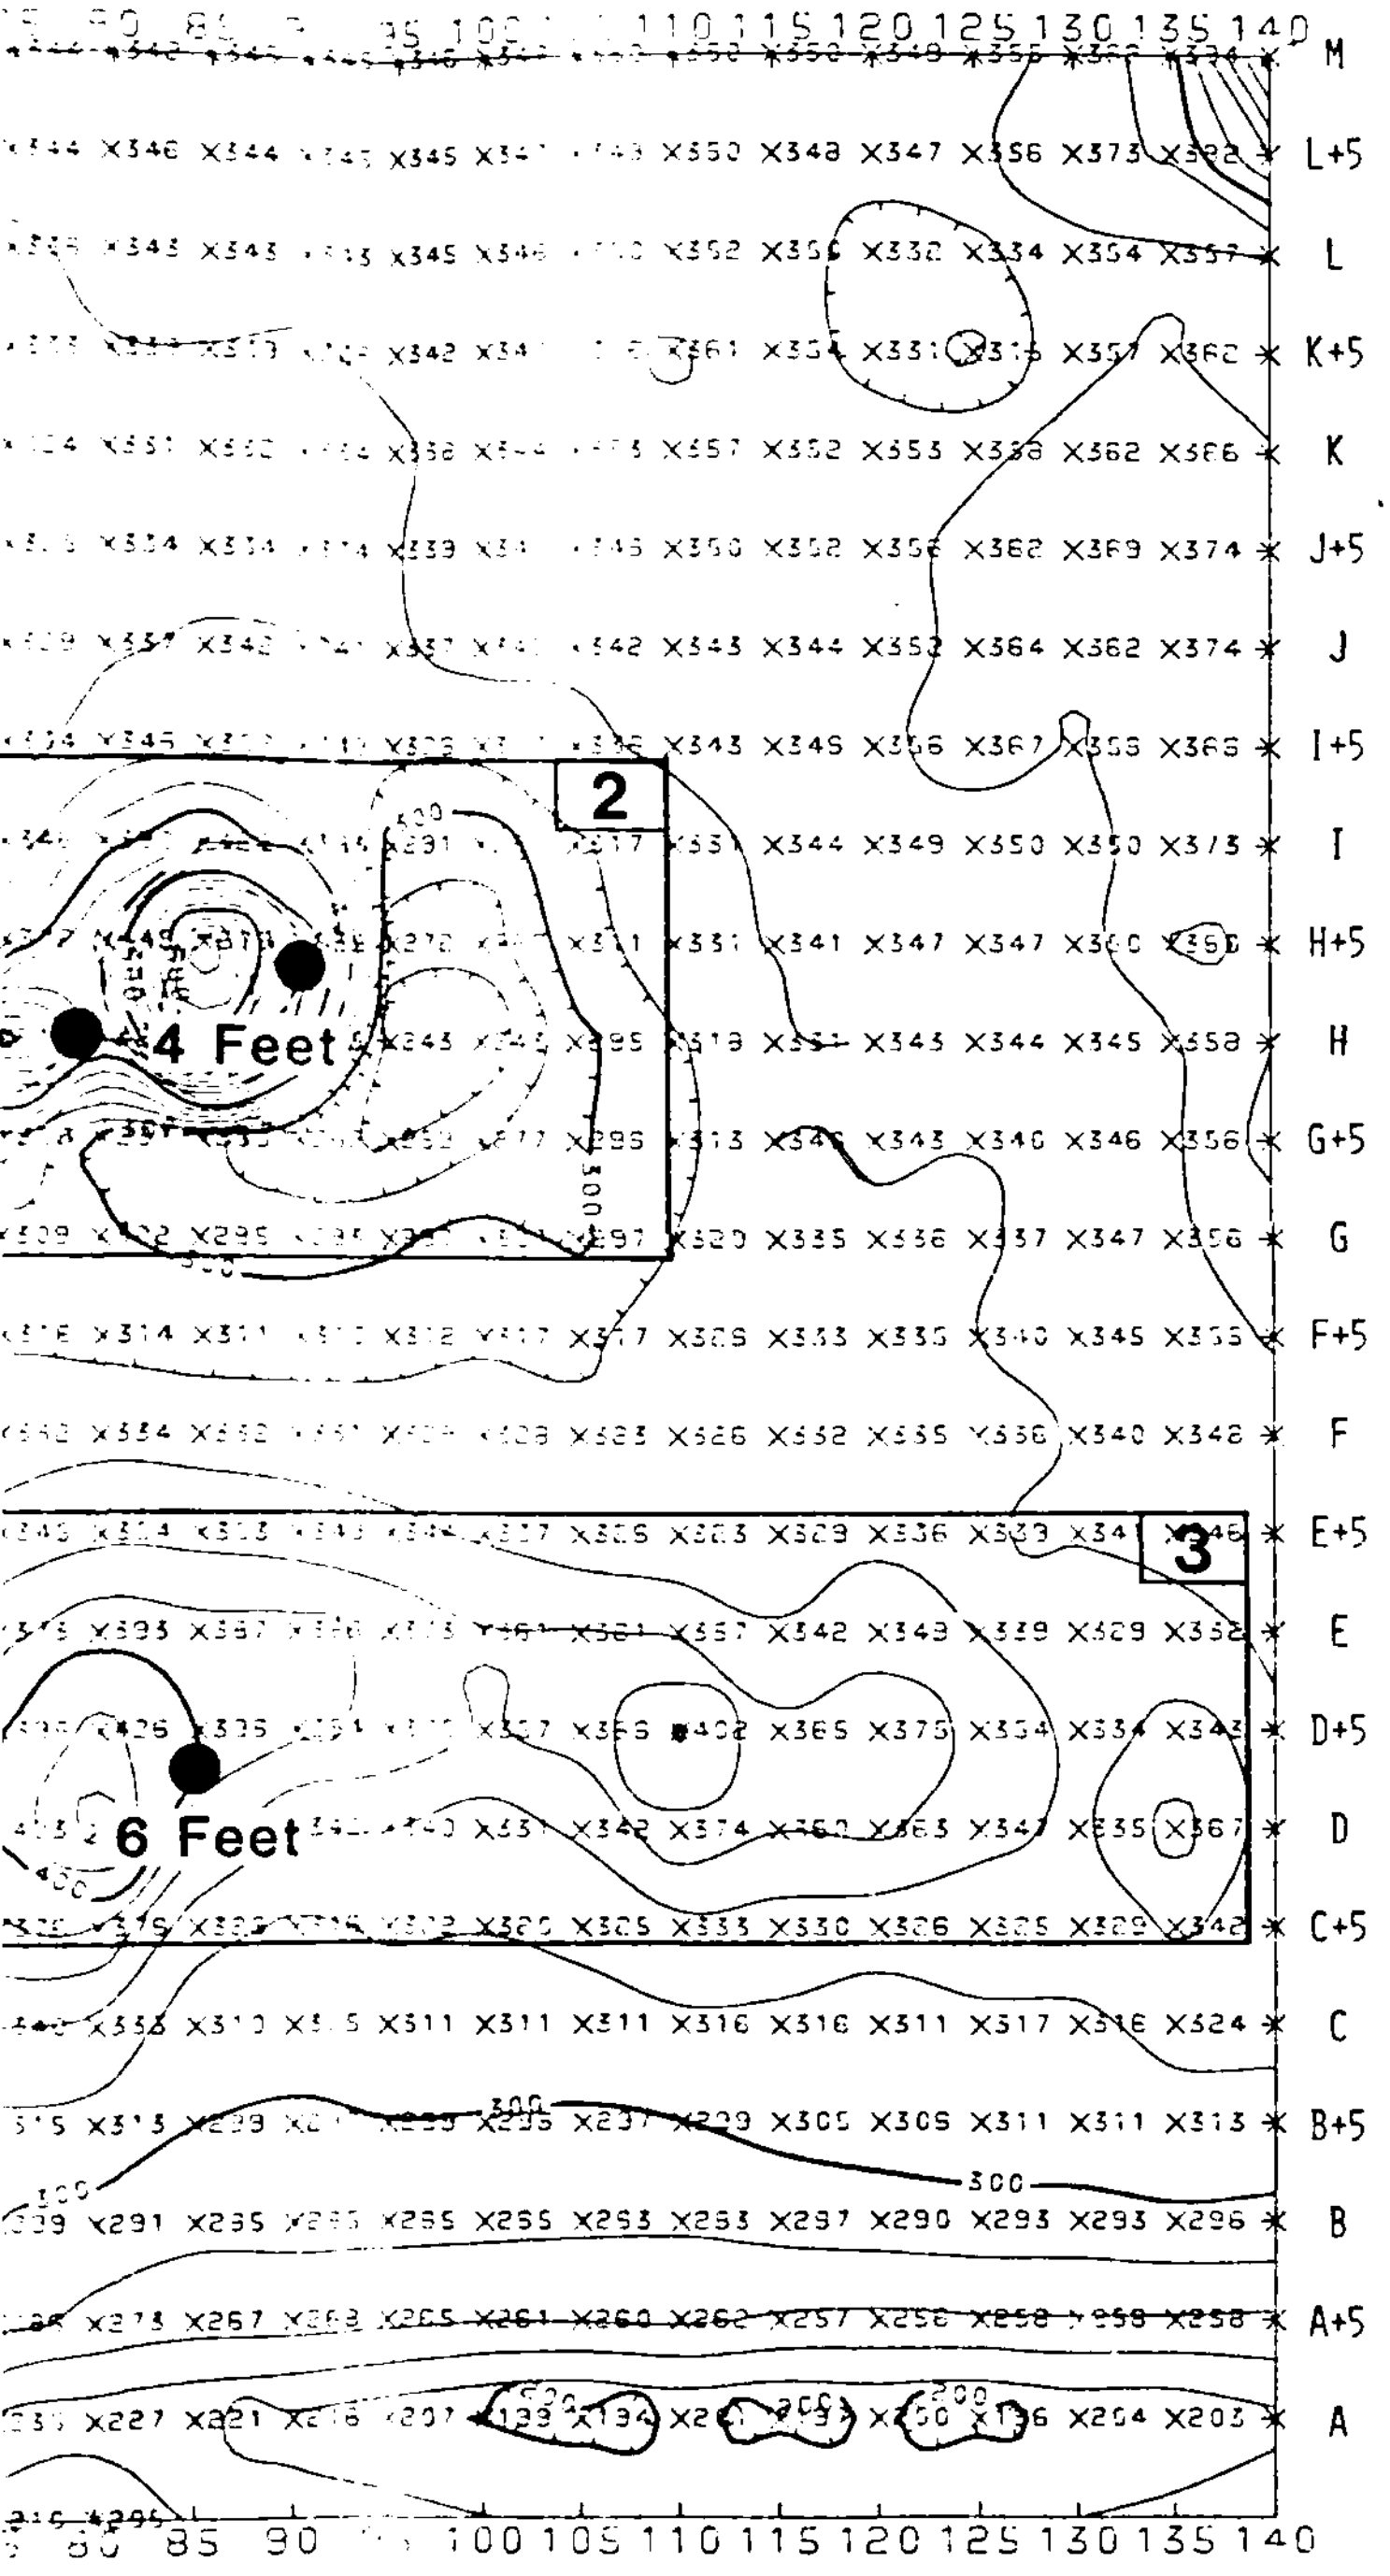
Figure IV-12

Three anomalies are present in Region 2 and are centered at (H5,85), (H,75), and (H,60). The centers of the bodies causing these anomalies are grouped close together and have similar depths. It is possible that two or all three of these anomalies are part of one large burial site. The (H+5,85) anomaly has a very large amplitude and may consist of multiple 55-gallon drums.

Magnetic highs dominate Region 3. It is possible that a number of small canisters are buried within this region, causing the high background values and eliminating the expected magnetic lows. The highest amplitude anomaly in this region is centered at (D+5,25) and may consist of several 55-gallon drums. The anomaly centered at (D+5,50) is the anomaly closest to a reported burial site, estimated at (E,70), where rusty containers were encountered four feet beneath the
