INSTALLATION RESTORATION PROGRAM

Records Search

Idaho Air National Guard
Boise Air Terminal (Gowen Field)
Boise, Idaho

Hazardous Materials Technical Center
February 1985

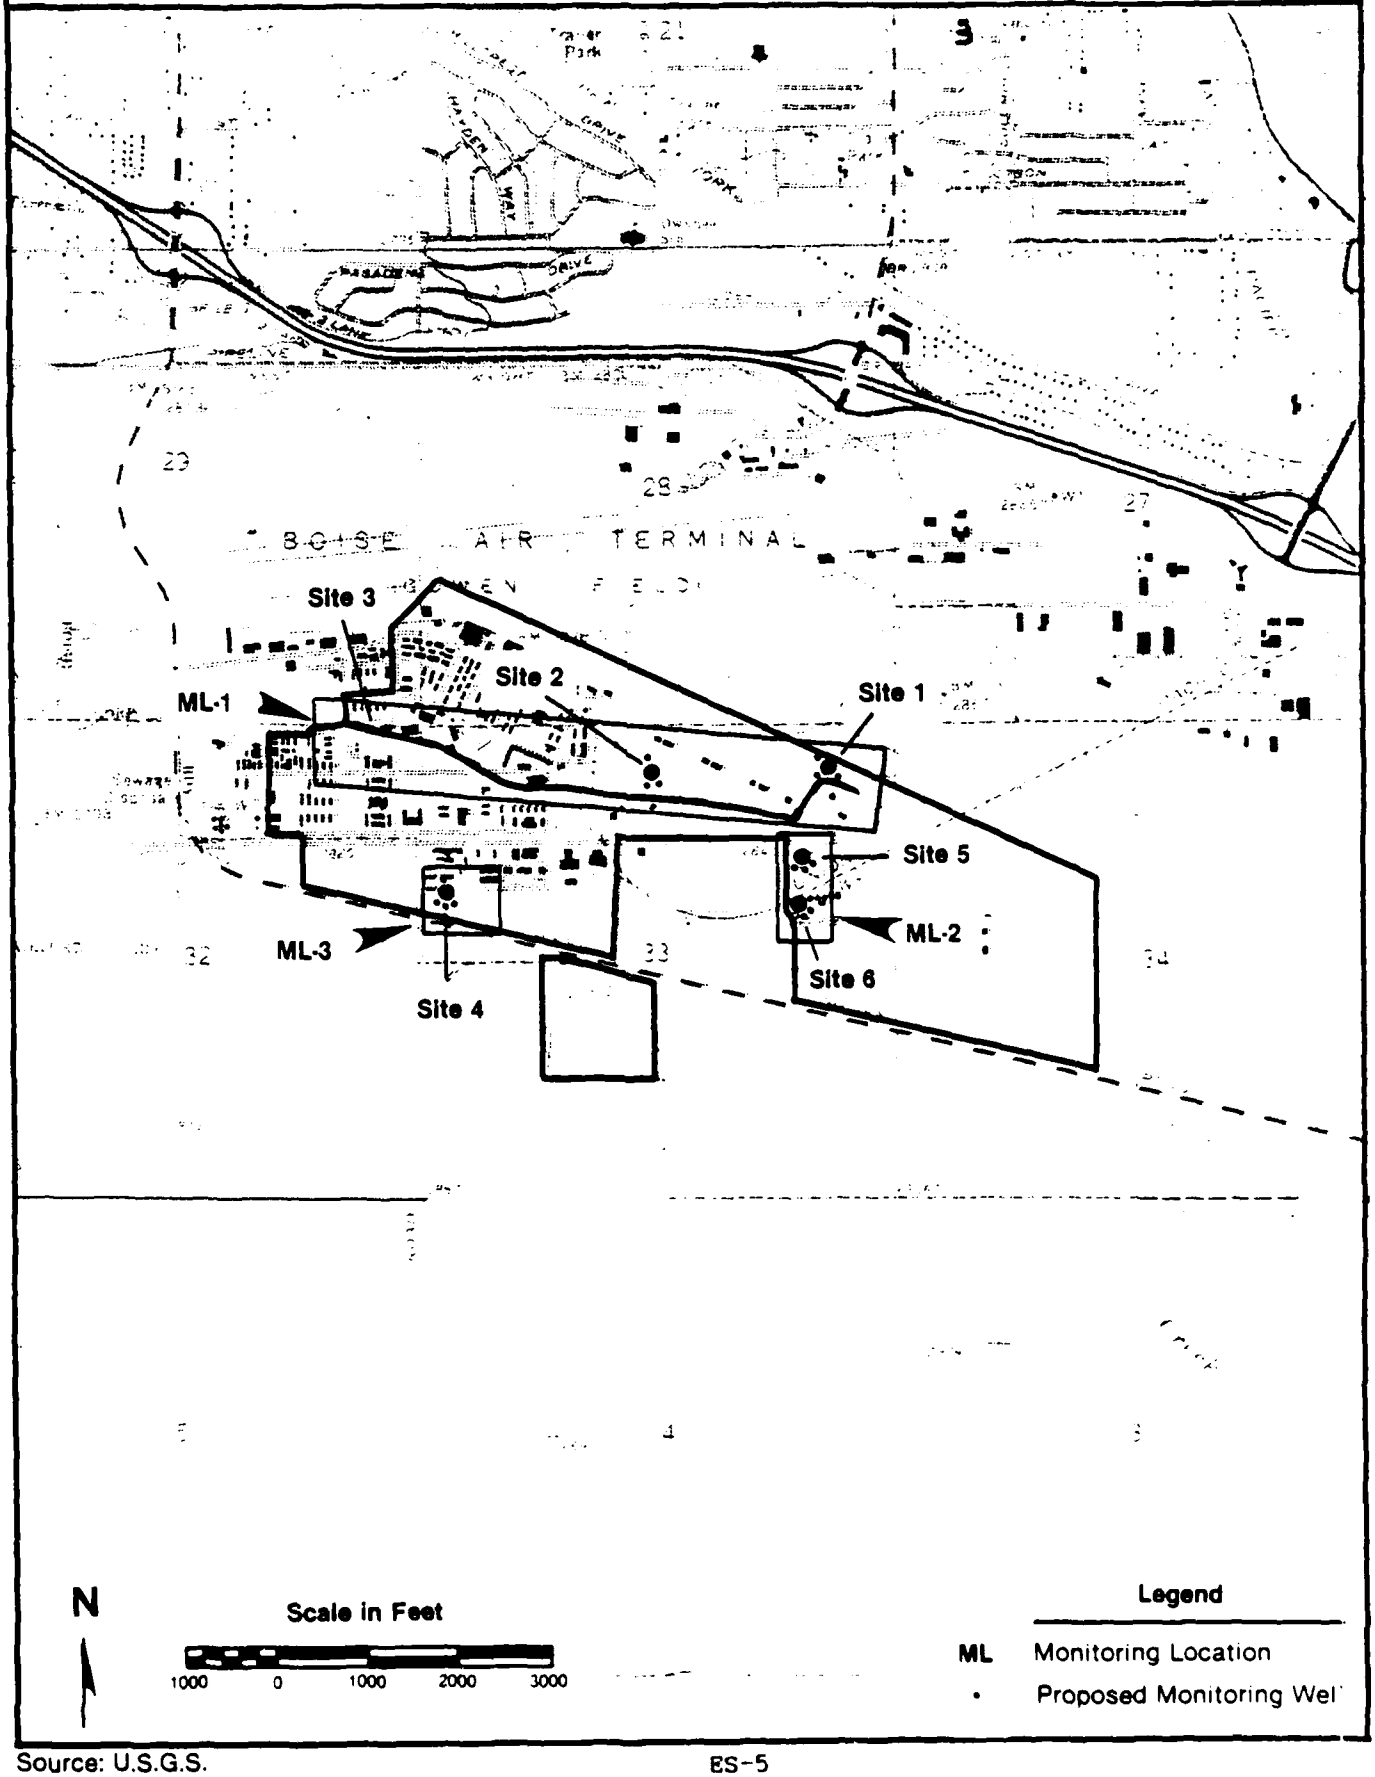
Figure ES-1.
Locations of the Proposed Areas at Gowen Field to be Investigated During Phase II of the IR Program.

All of the rated sites are recommended for monitoring. These sites have been grouped into monitoring areas on the basis of their proximity to each other. Figure ES-1 illustrates the three general areas at Gowen Field that are recommended for monitoring, and the locations of the spill/disposal sites within these areas. Two of the proposed monitoring areas encompass more than one spill/disposal site due to the close proximity of the sites. The first monitoring area encompasses the current and former Fire Department

training areas and the central drainage ditch (Sites No. 1, 2, and 3). The second monitoring area encompasses the former fence post preserving operation and the tar pit (Sites No. 5 and 6). The third monitoring area encompasses the oil patch in the drain field (Site No. 4). Table ES-1 summarizes the monitoring locations within which all of the above spill/disposal sites are located.

The potential for contaminant migration at Gowen Field is high; therefore, it is recommended that Phase II monitoring be conducted. This monitoring should consist of analysis of soil and groundwater samples for selected organic and inorganic parameters. The primary purposes for monitoring each of the proposed locations are to:

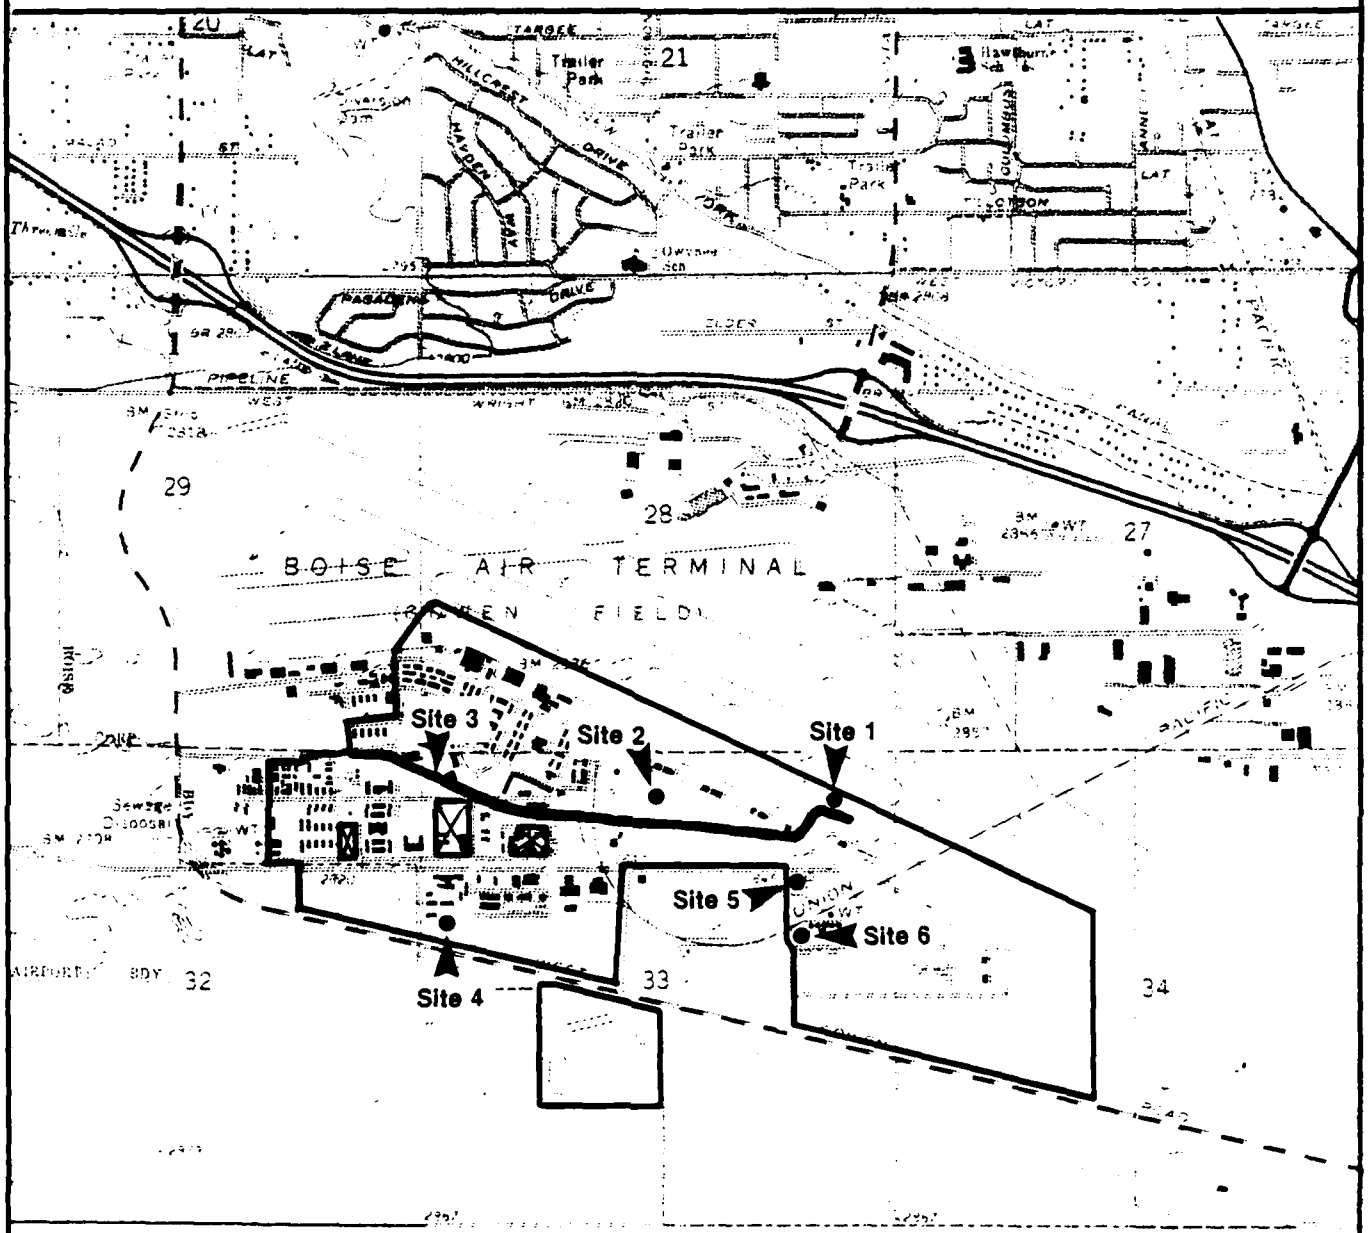
Figure 10.
Location of the Rated Waste Disposal and Spill Site at Gowen Field.

This site is identified as Site No. 1 in Figure 10 and is located between Taxiway K and the central drainage ditch approximately 200 feet northeast of Building NG 1515. The receptors, waste characteristics, pathways, and waste management subscores for this site are 52, 100, 67, and 0.95, respectively. The waste characteristics subscore received the maximum value because of the large amount of high-hazard material known to have been disposed of at the pit. Another significant factor related to the scoring of this site is its close proximity to two on-site wells of the Boise Water Corporation, both of which are used for drinking water. The pathways subscore is influenced by the proximity of the site to the drainage ditch and the potential for occasional flooding of the site.

Today, the firefighting training pit measures in excess of 100 feet in diameter and is surrounded by a sand-gravel dike. Evidence of soil discoloration and odor beyond the pit was only observed around the inlets to the waste holding tanks and the adjacent waste pumping station. No vegetative stress or visible hydrocarbon contamination was evident in the adjacent portion of the central drainage ditch.

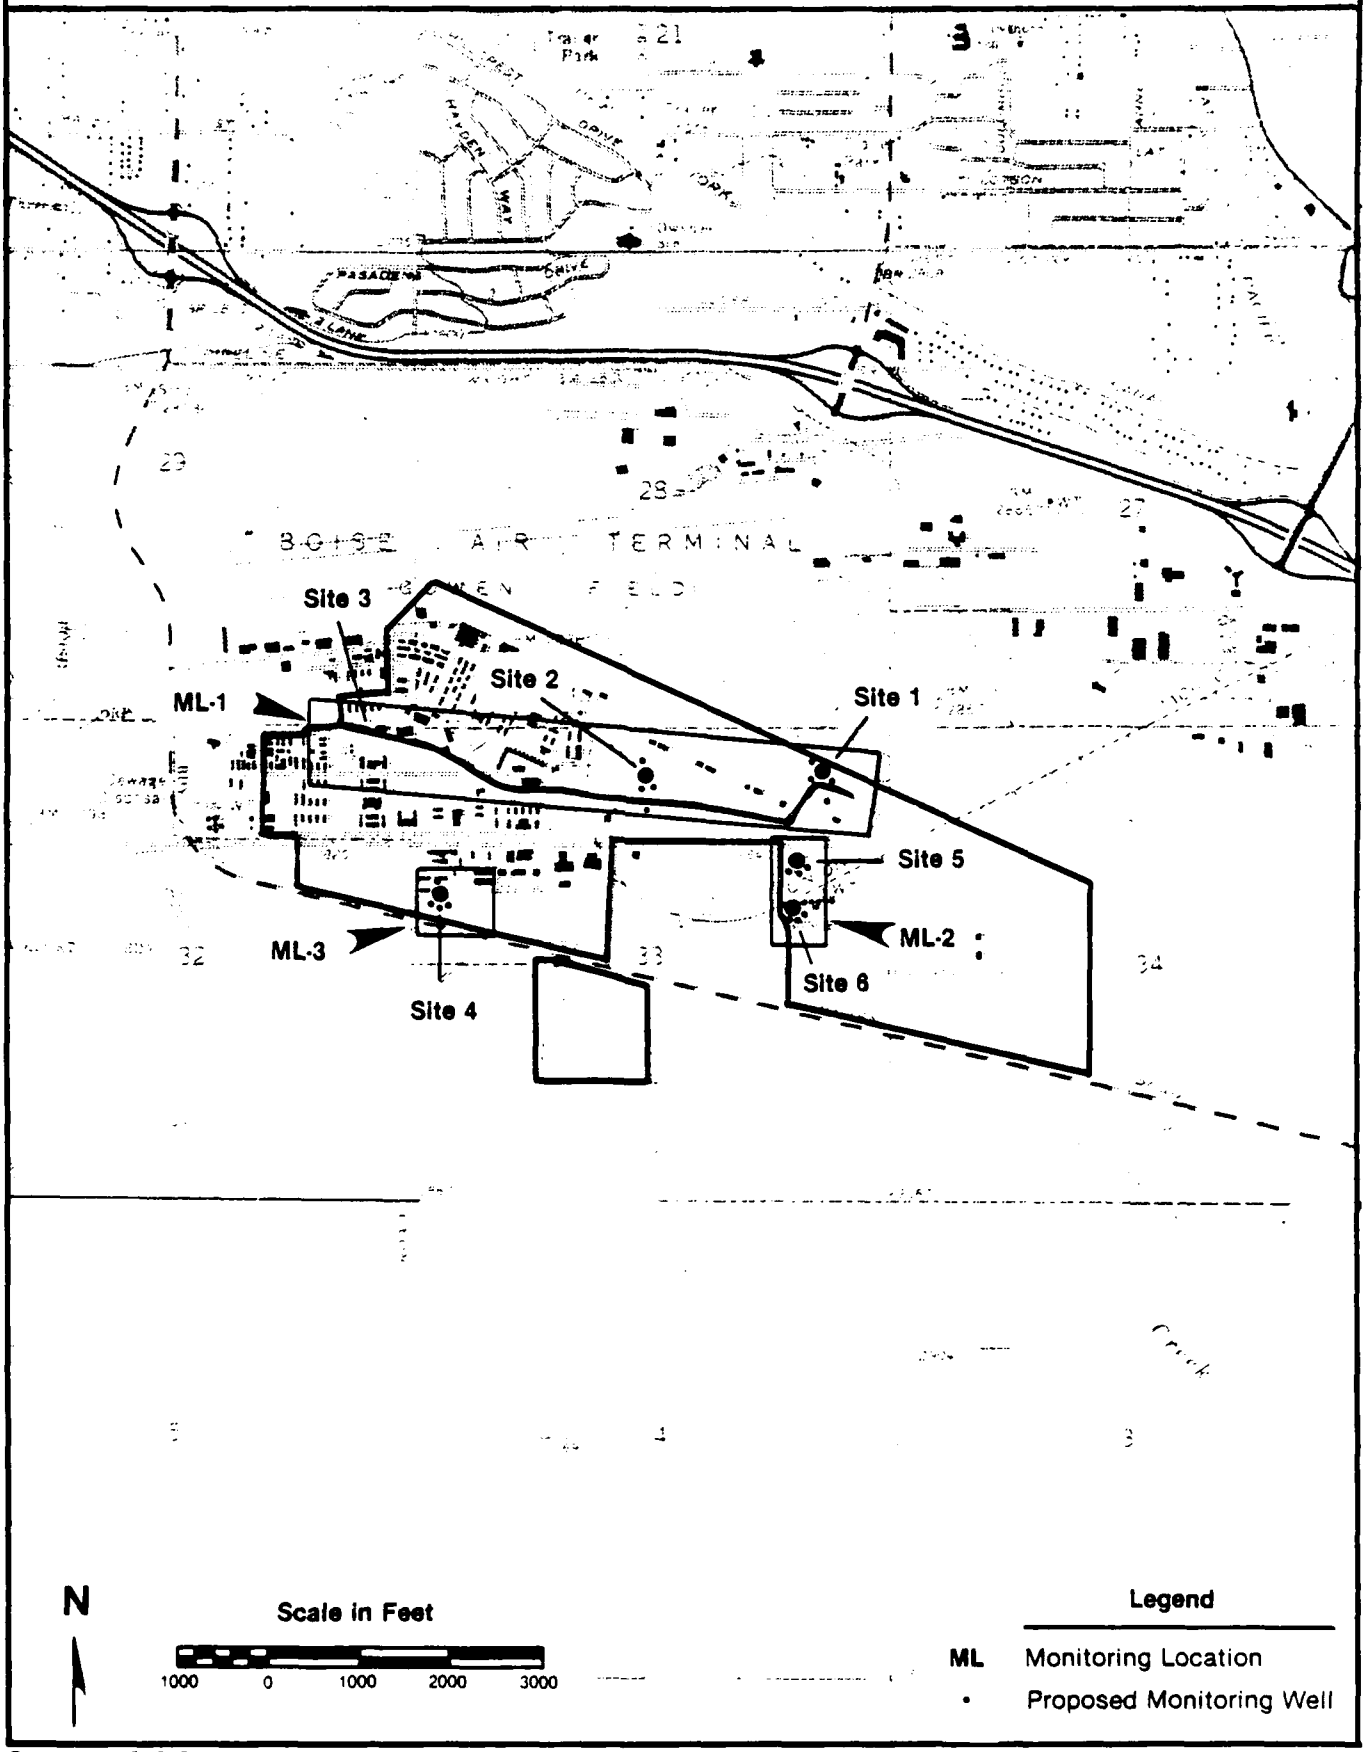
Figure 11.
Locations of the Proposed Areas at Gowen Field to be Investigated During Phase II of the IR Program.

Table 7 summarizes the monitoring locations within which all of the above spill/disposal sites are located.
