INSTALLATION RESTORATION PROGRAM
PHASE II—CONFIRMATION/QUANTIFICATION

STAGE 1

Final Report

AIR FORCE PLANT 6, COBB COUNTY, GA.

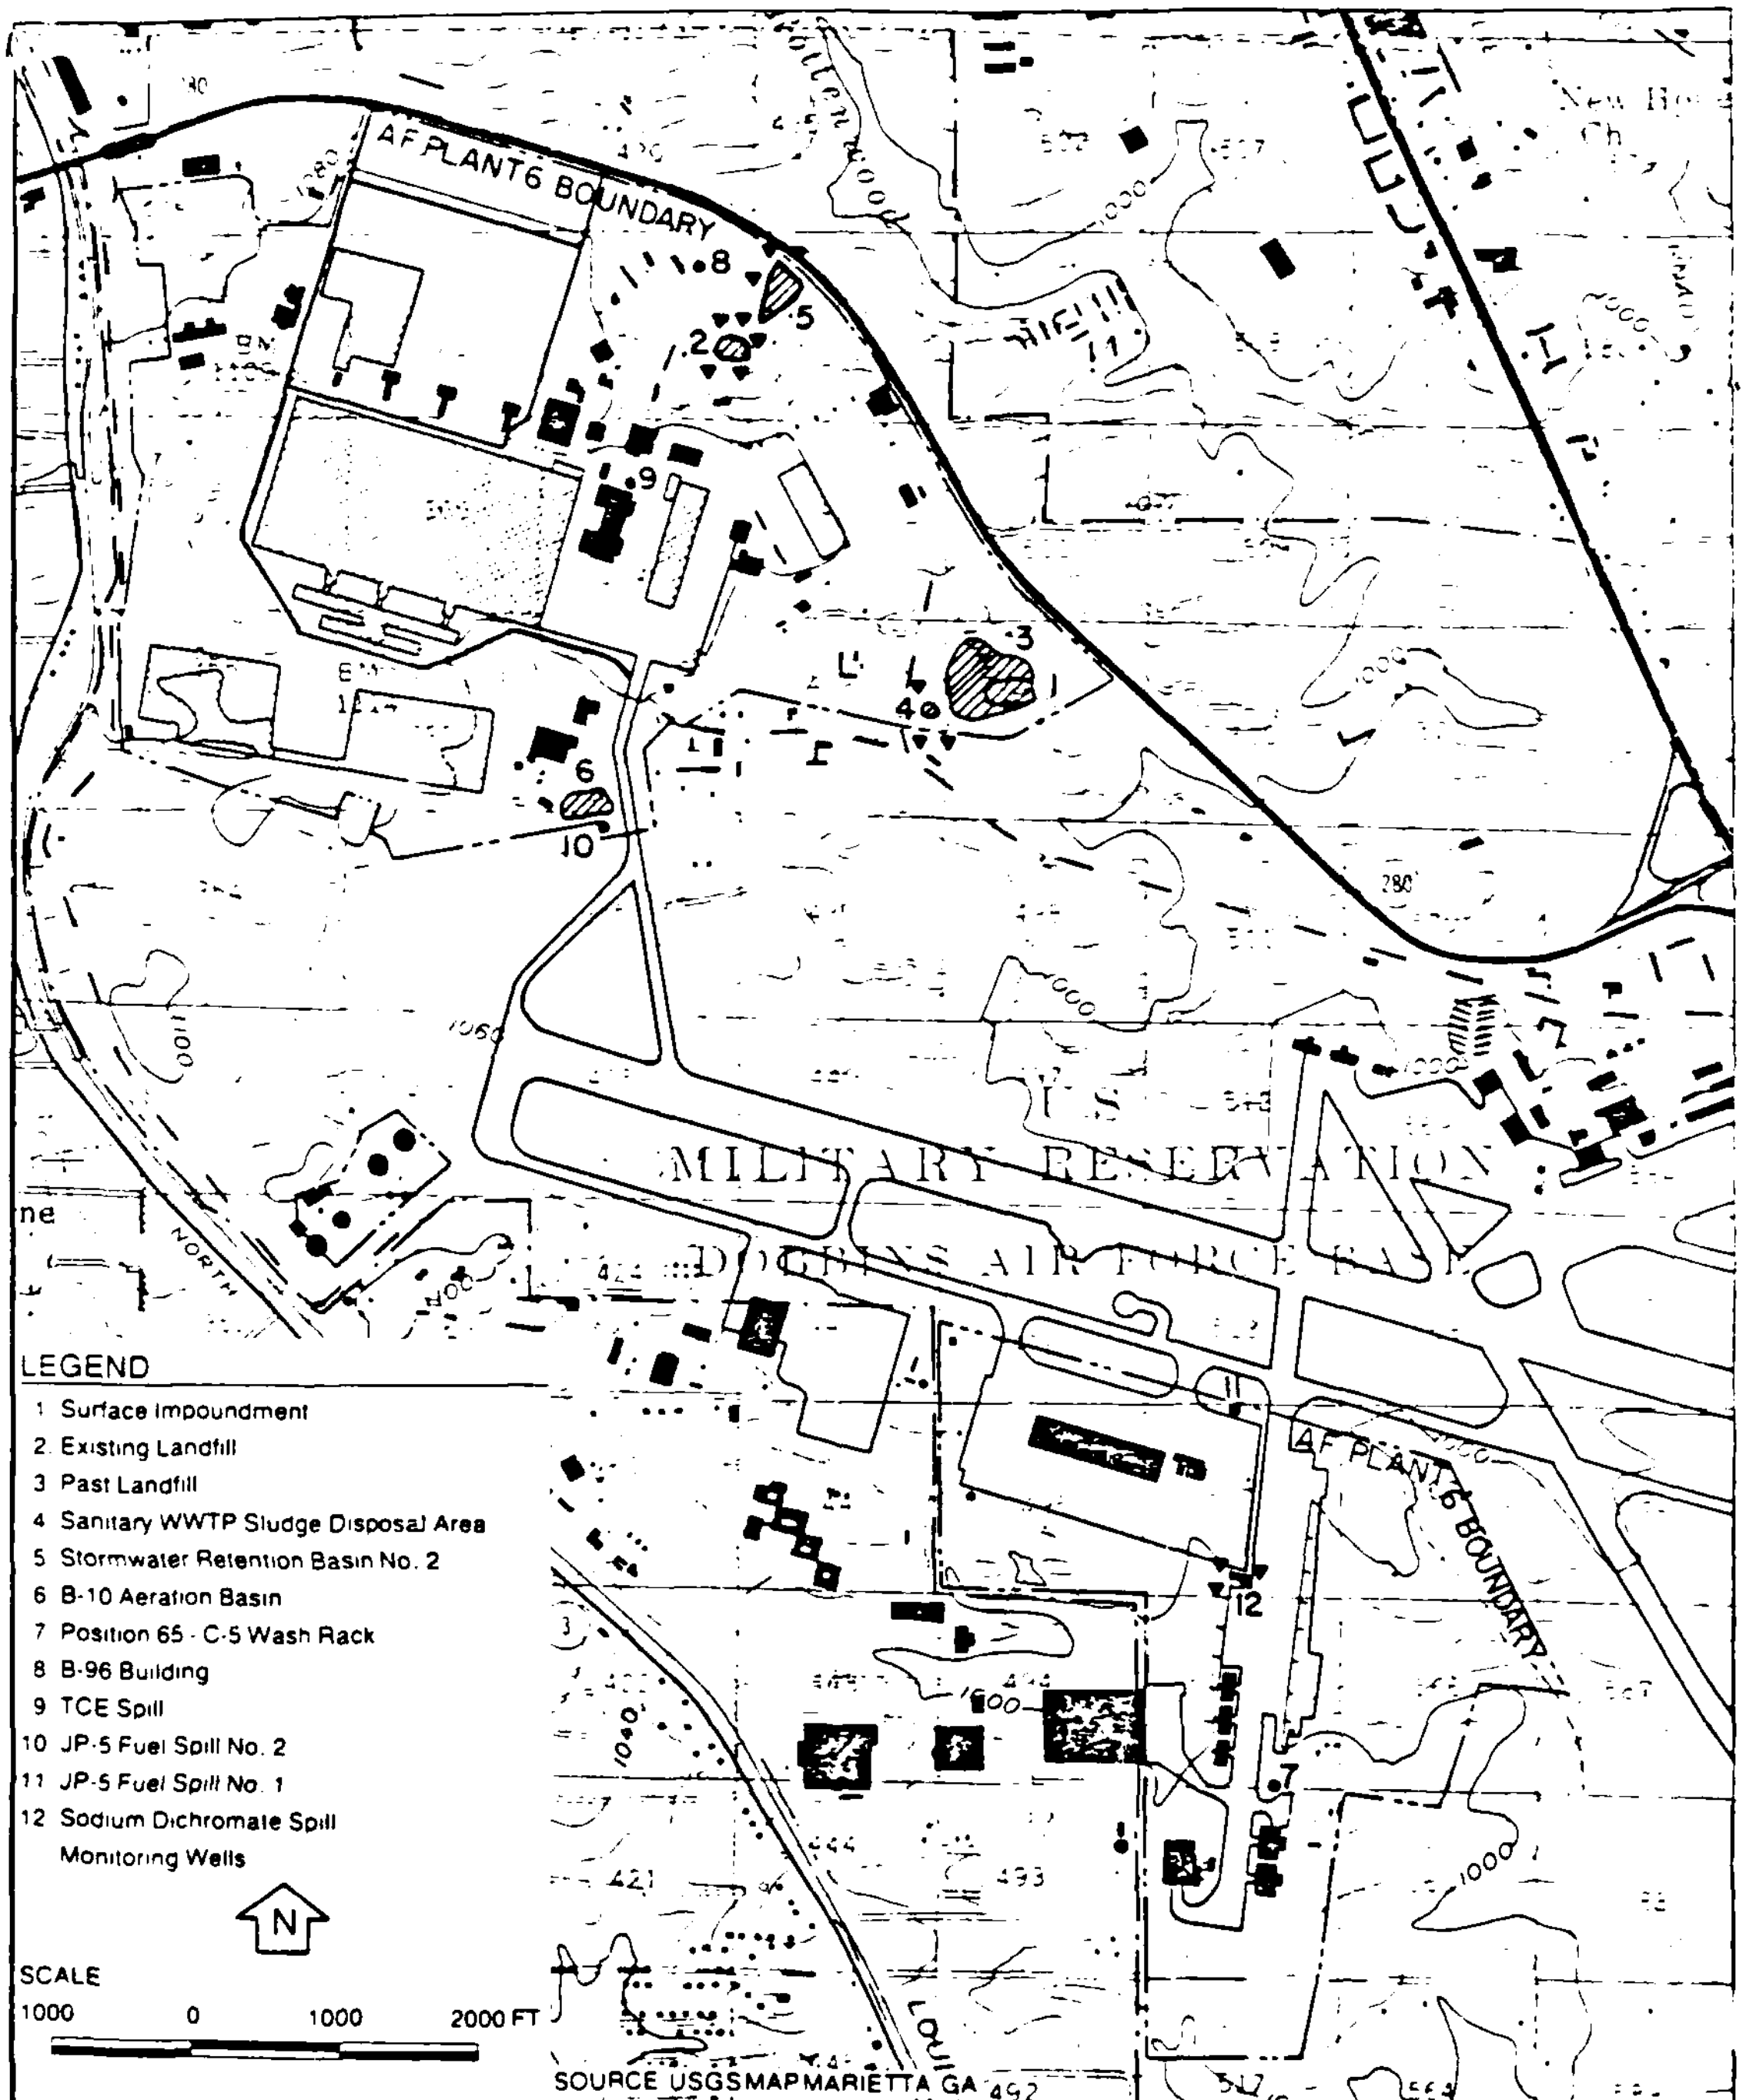
TheChesterEngineers			SHEET NO.	LOCKHEED-GEORGIA COMPANY AIR FORCE PLANT 6
DWN.BY:	SCALE:	DATE	DWG. NO.	
CHK'D.BY:	APPR.BY:		FIGURE 1	INSTALLATION RESTORATION PROGRAM TENATIVE WELL LOCATIONS

1. Industrial Waste Sludge Disposal Basin
2. Existing Landfill
3. Oil Landfill
4. Sanitary WWTP Sludge Disposal Area
5. Stormwater Retention Basin No. 2
6. B-10 Aeration Basin
7. Position 65 - C-5 Wash Rack Ponds
8. B-96 Slosh Test Building
9. Trichloroethylene Spill
10. JP-5 Fuel Spill No. 2
11. JP-5 Fuel Spill No. 1
12. Sodium Dichromate Spill

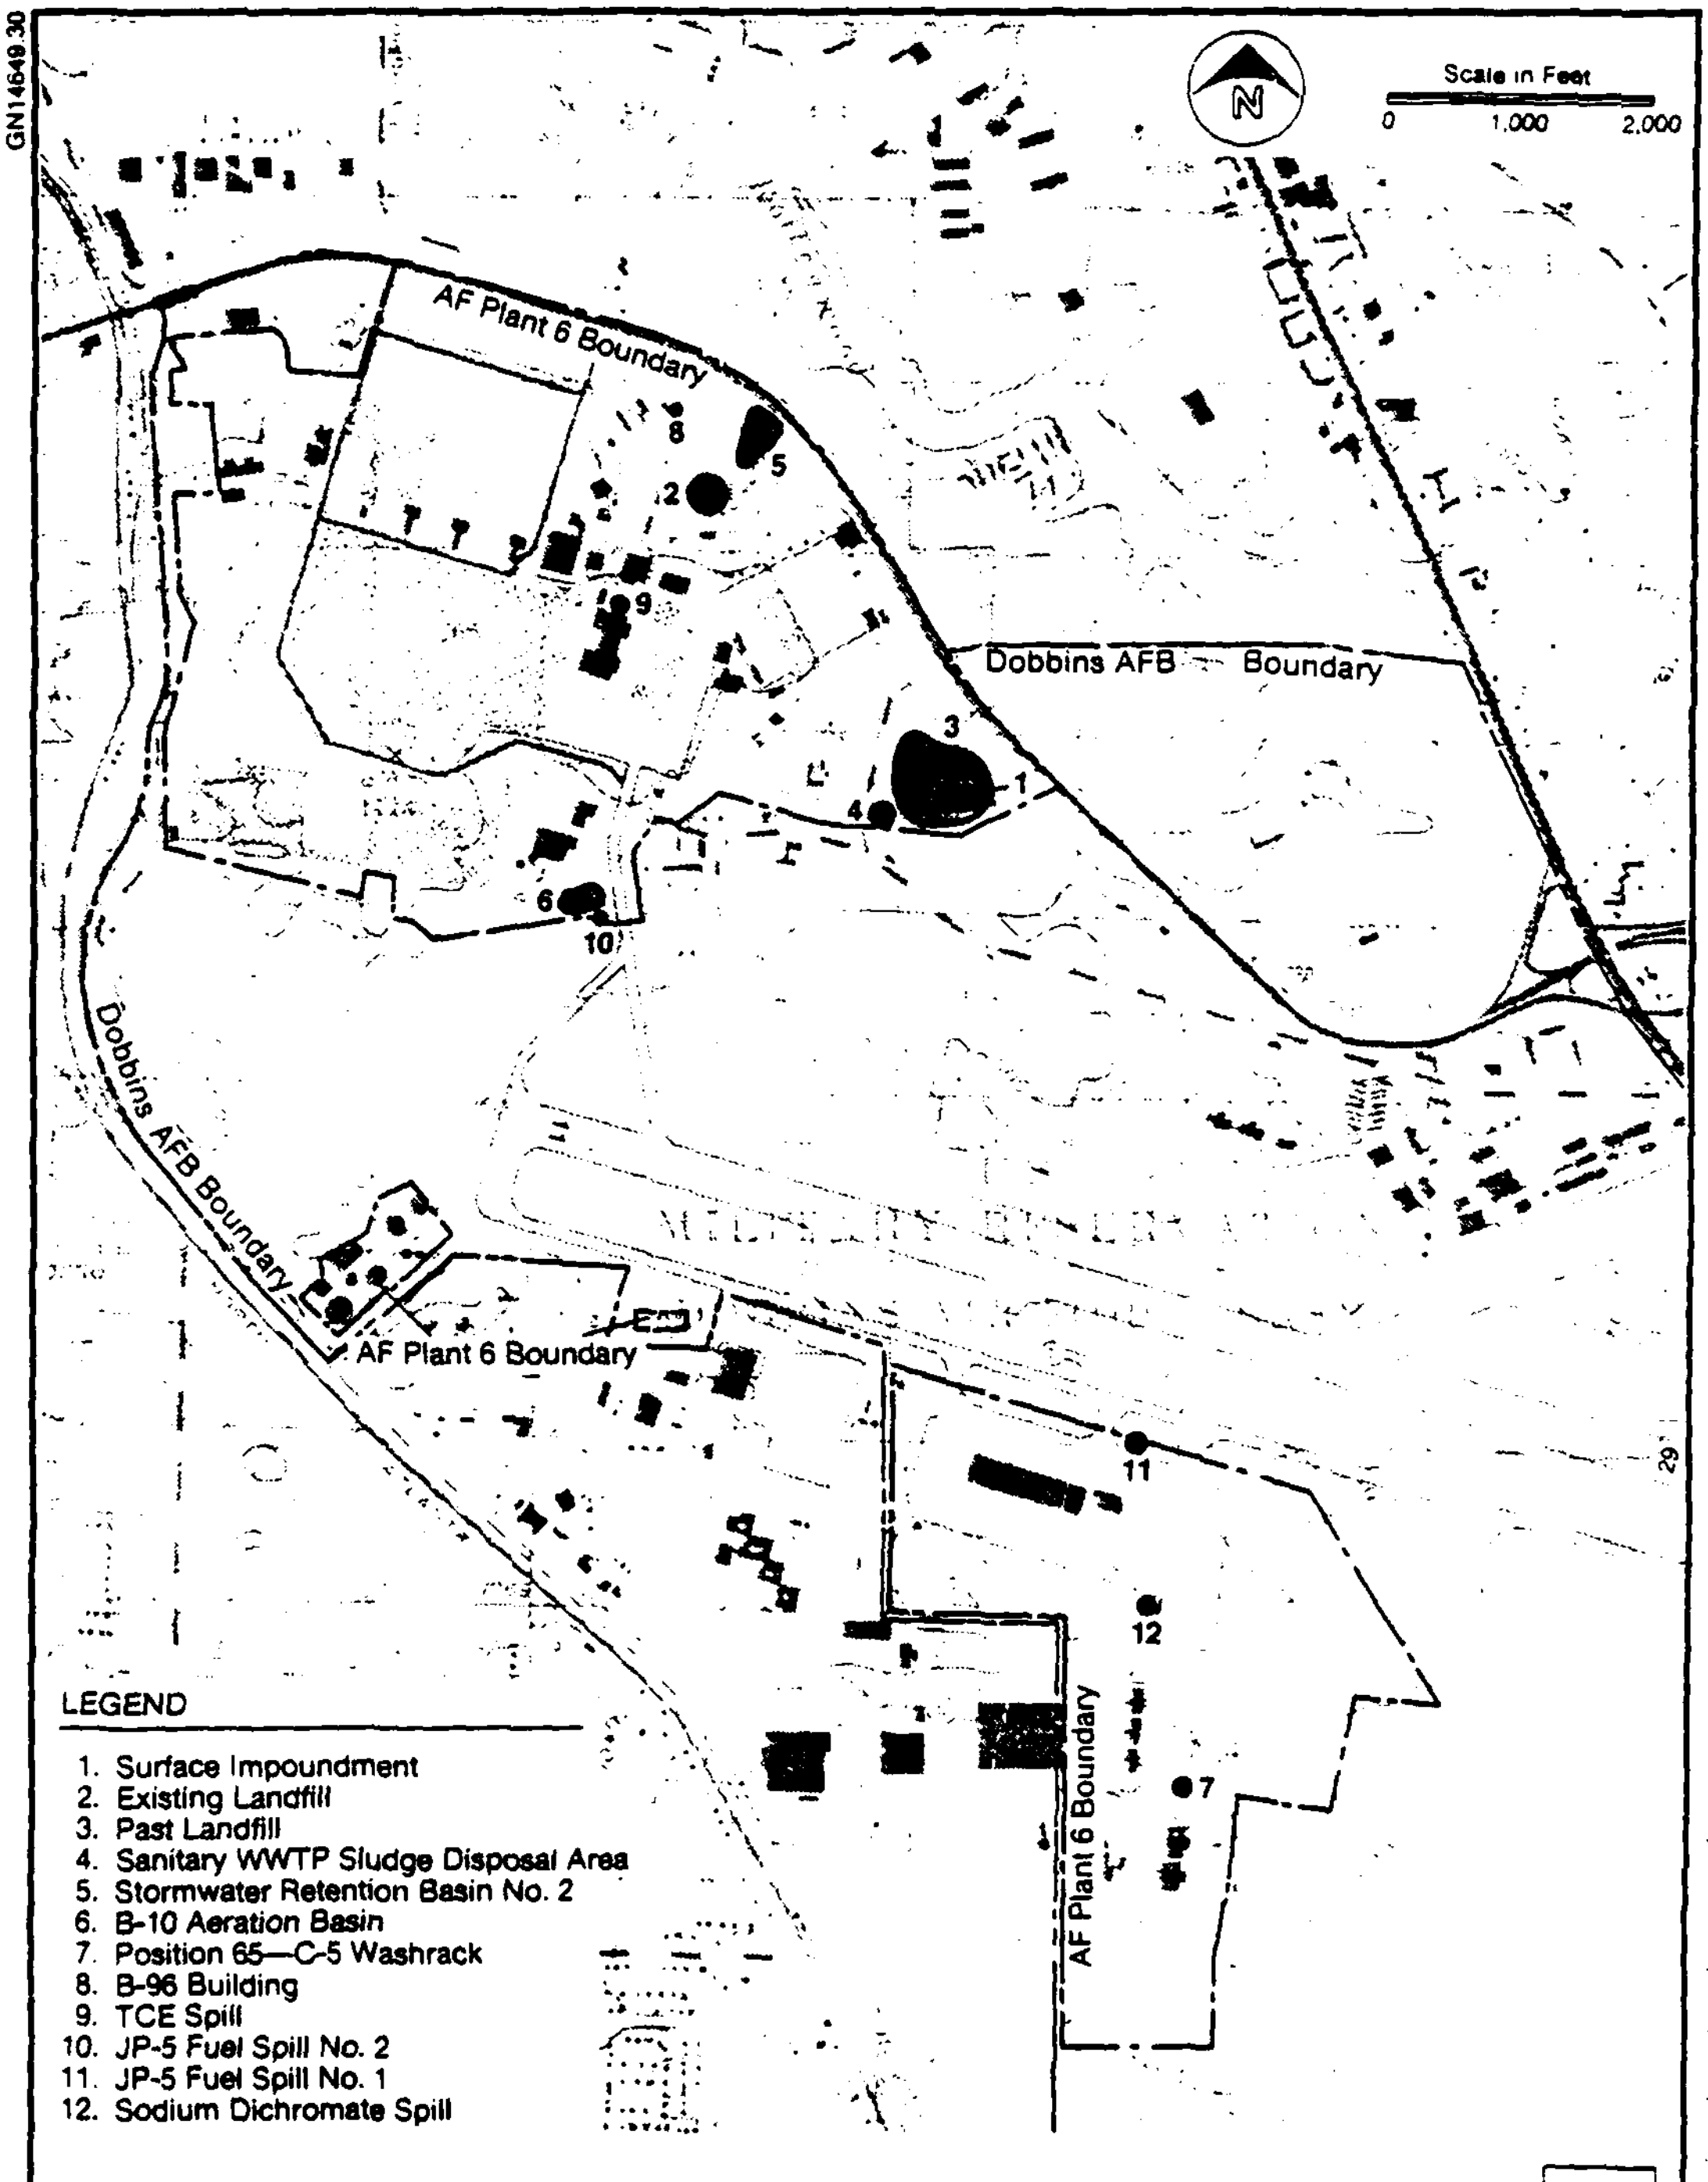
FIGURE 1.
Location Map of Identified Disposal and Spill Sites at AF Plant 6.

3. Interviews with installation employees resulted in the identification of 12 past disposal or spill sites at AF Plant 6 and the approximate dates that these sites were active (see Figure 1 for site locations).

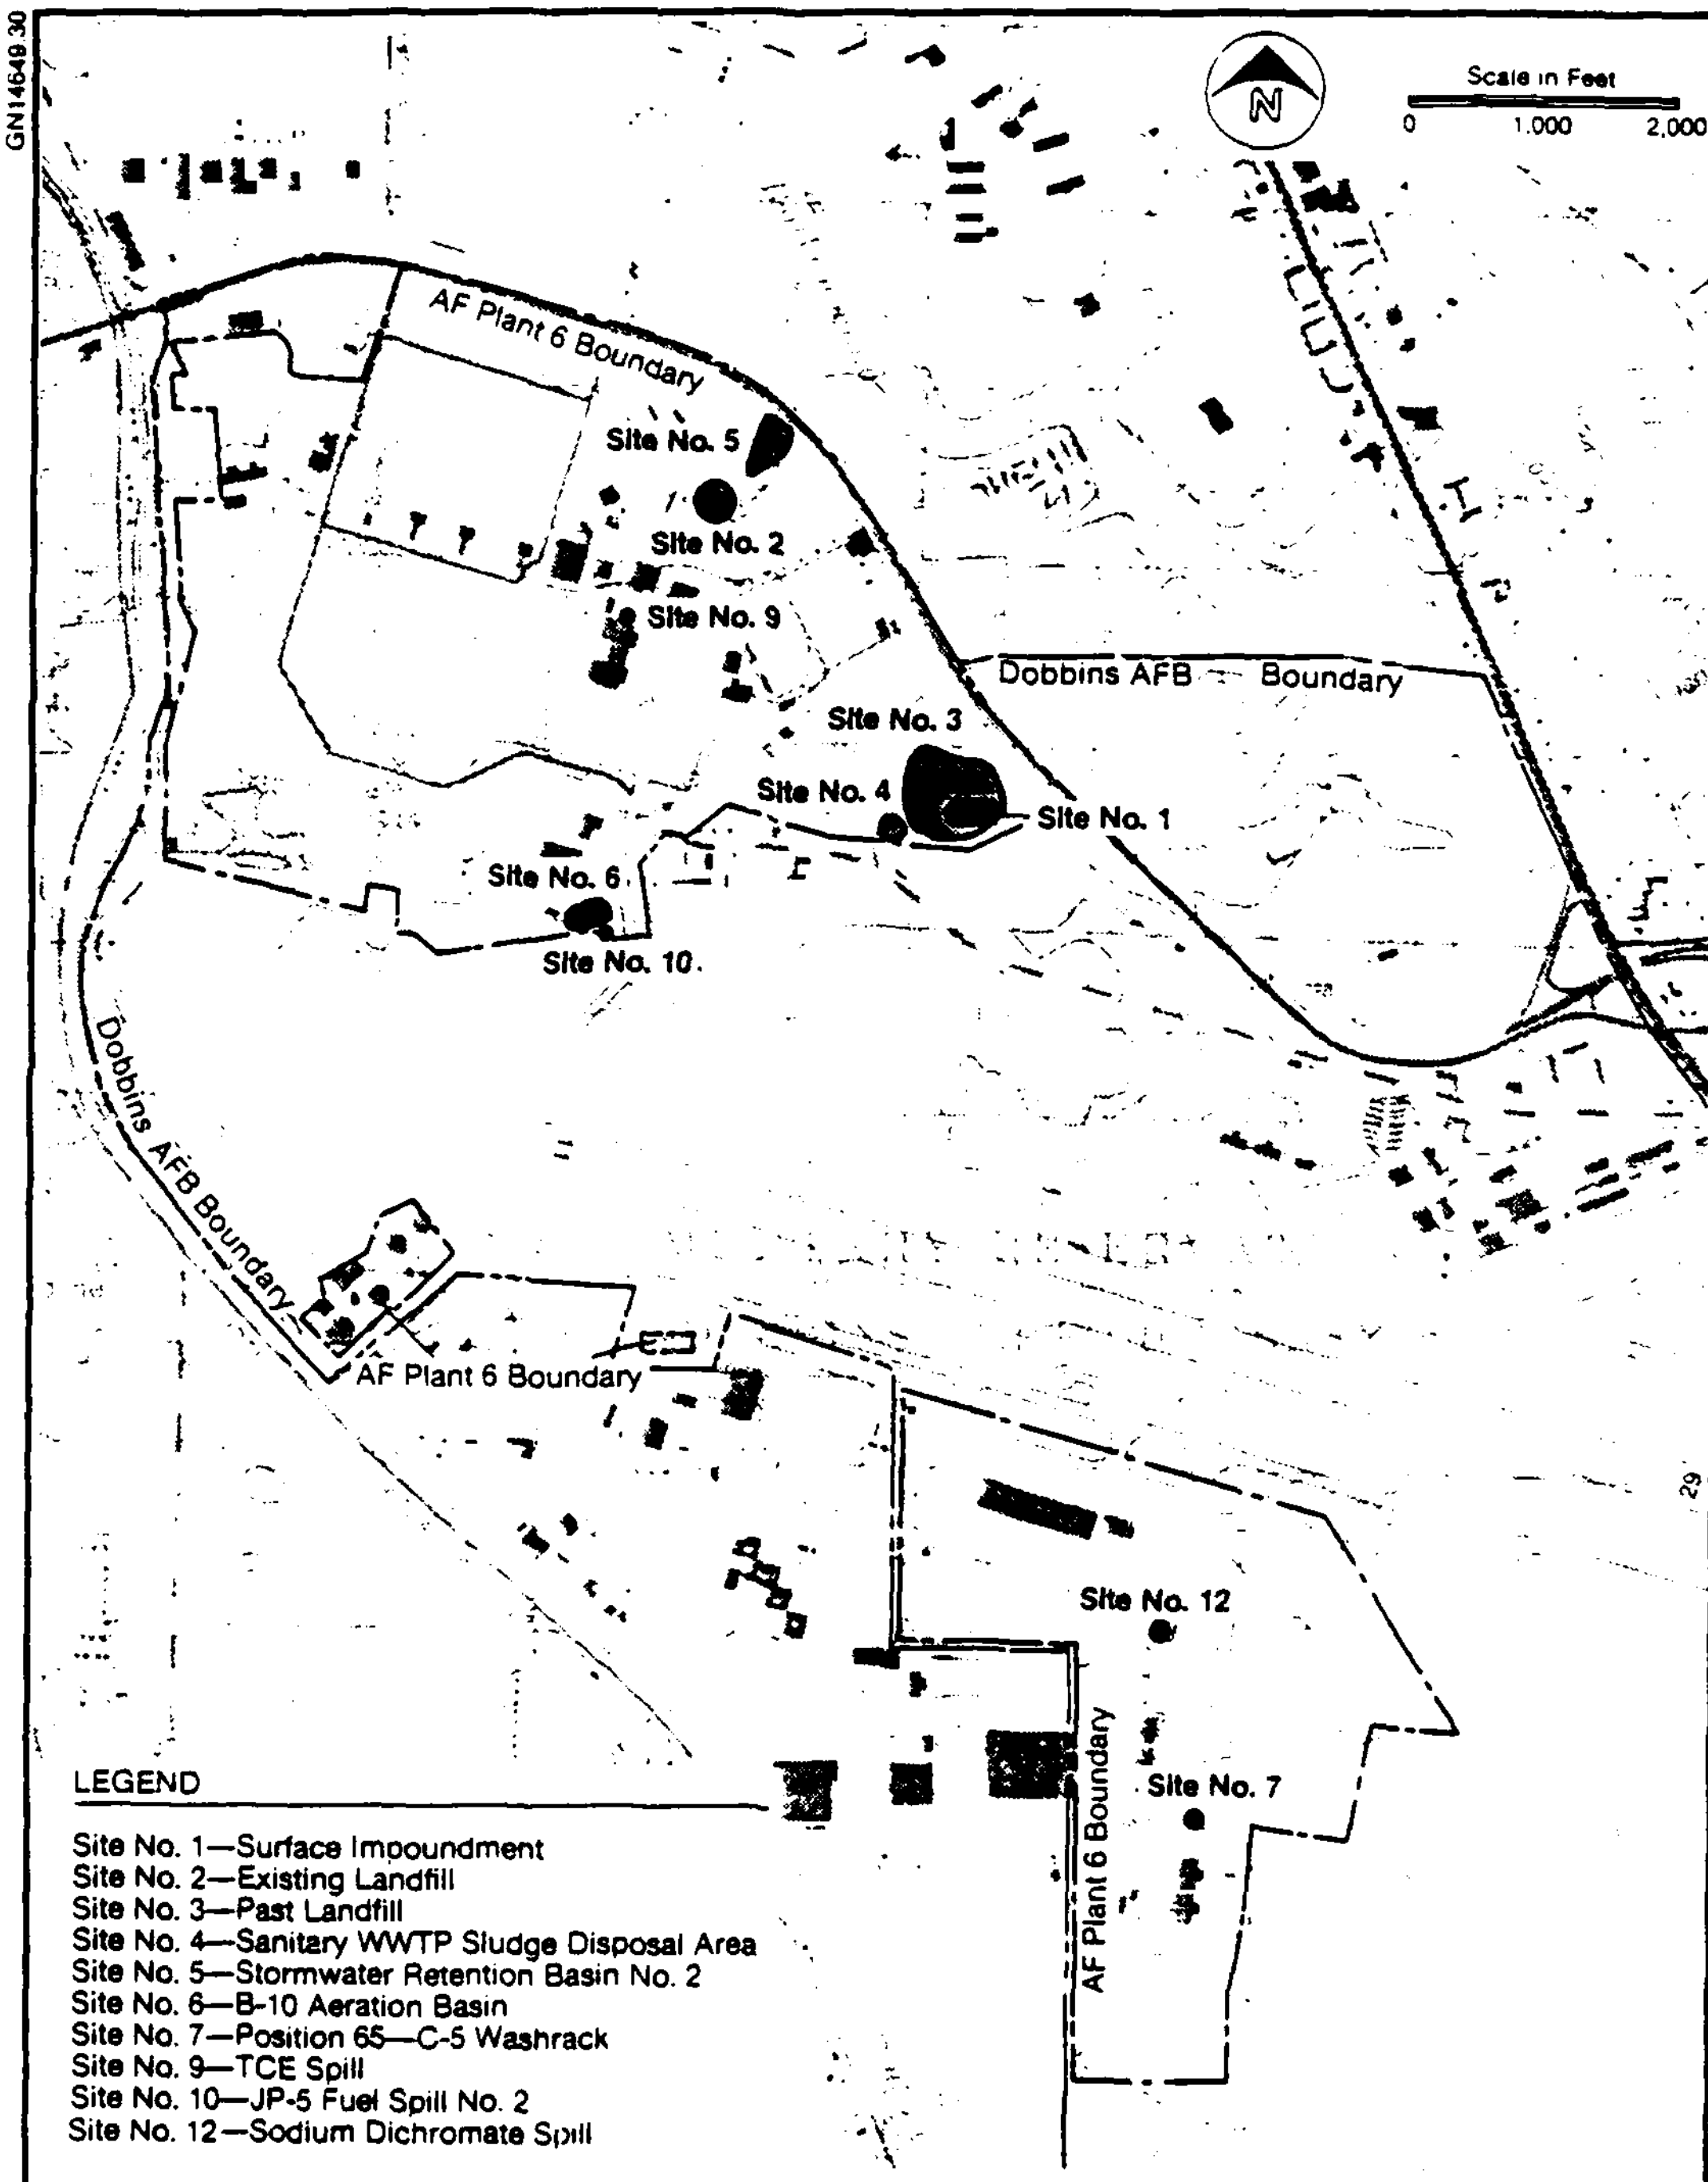
FIGURE 2.
Location Map of Sites Recommended for Phase II Monitoring.

covered by these recommendations. Figure 2 shows the locations of the sites being recommended for Phase II monitoring.

a. Discontinuing the use of the two ponds at Site No. 7, Position 65--the C-5 Washrack. The contaminated water should be pumped to the IWTP for treatment and the ponds should be properly closed. The piping system should be reworked to pump washwater from the washrack directly to the IWTP.

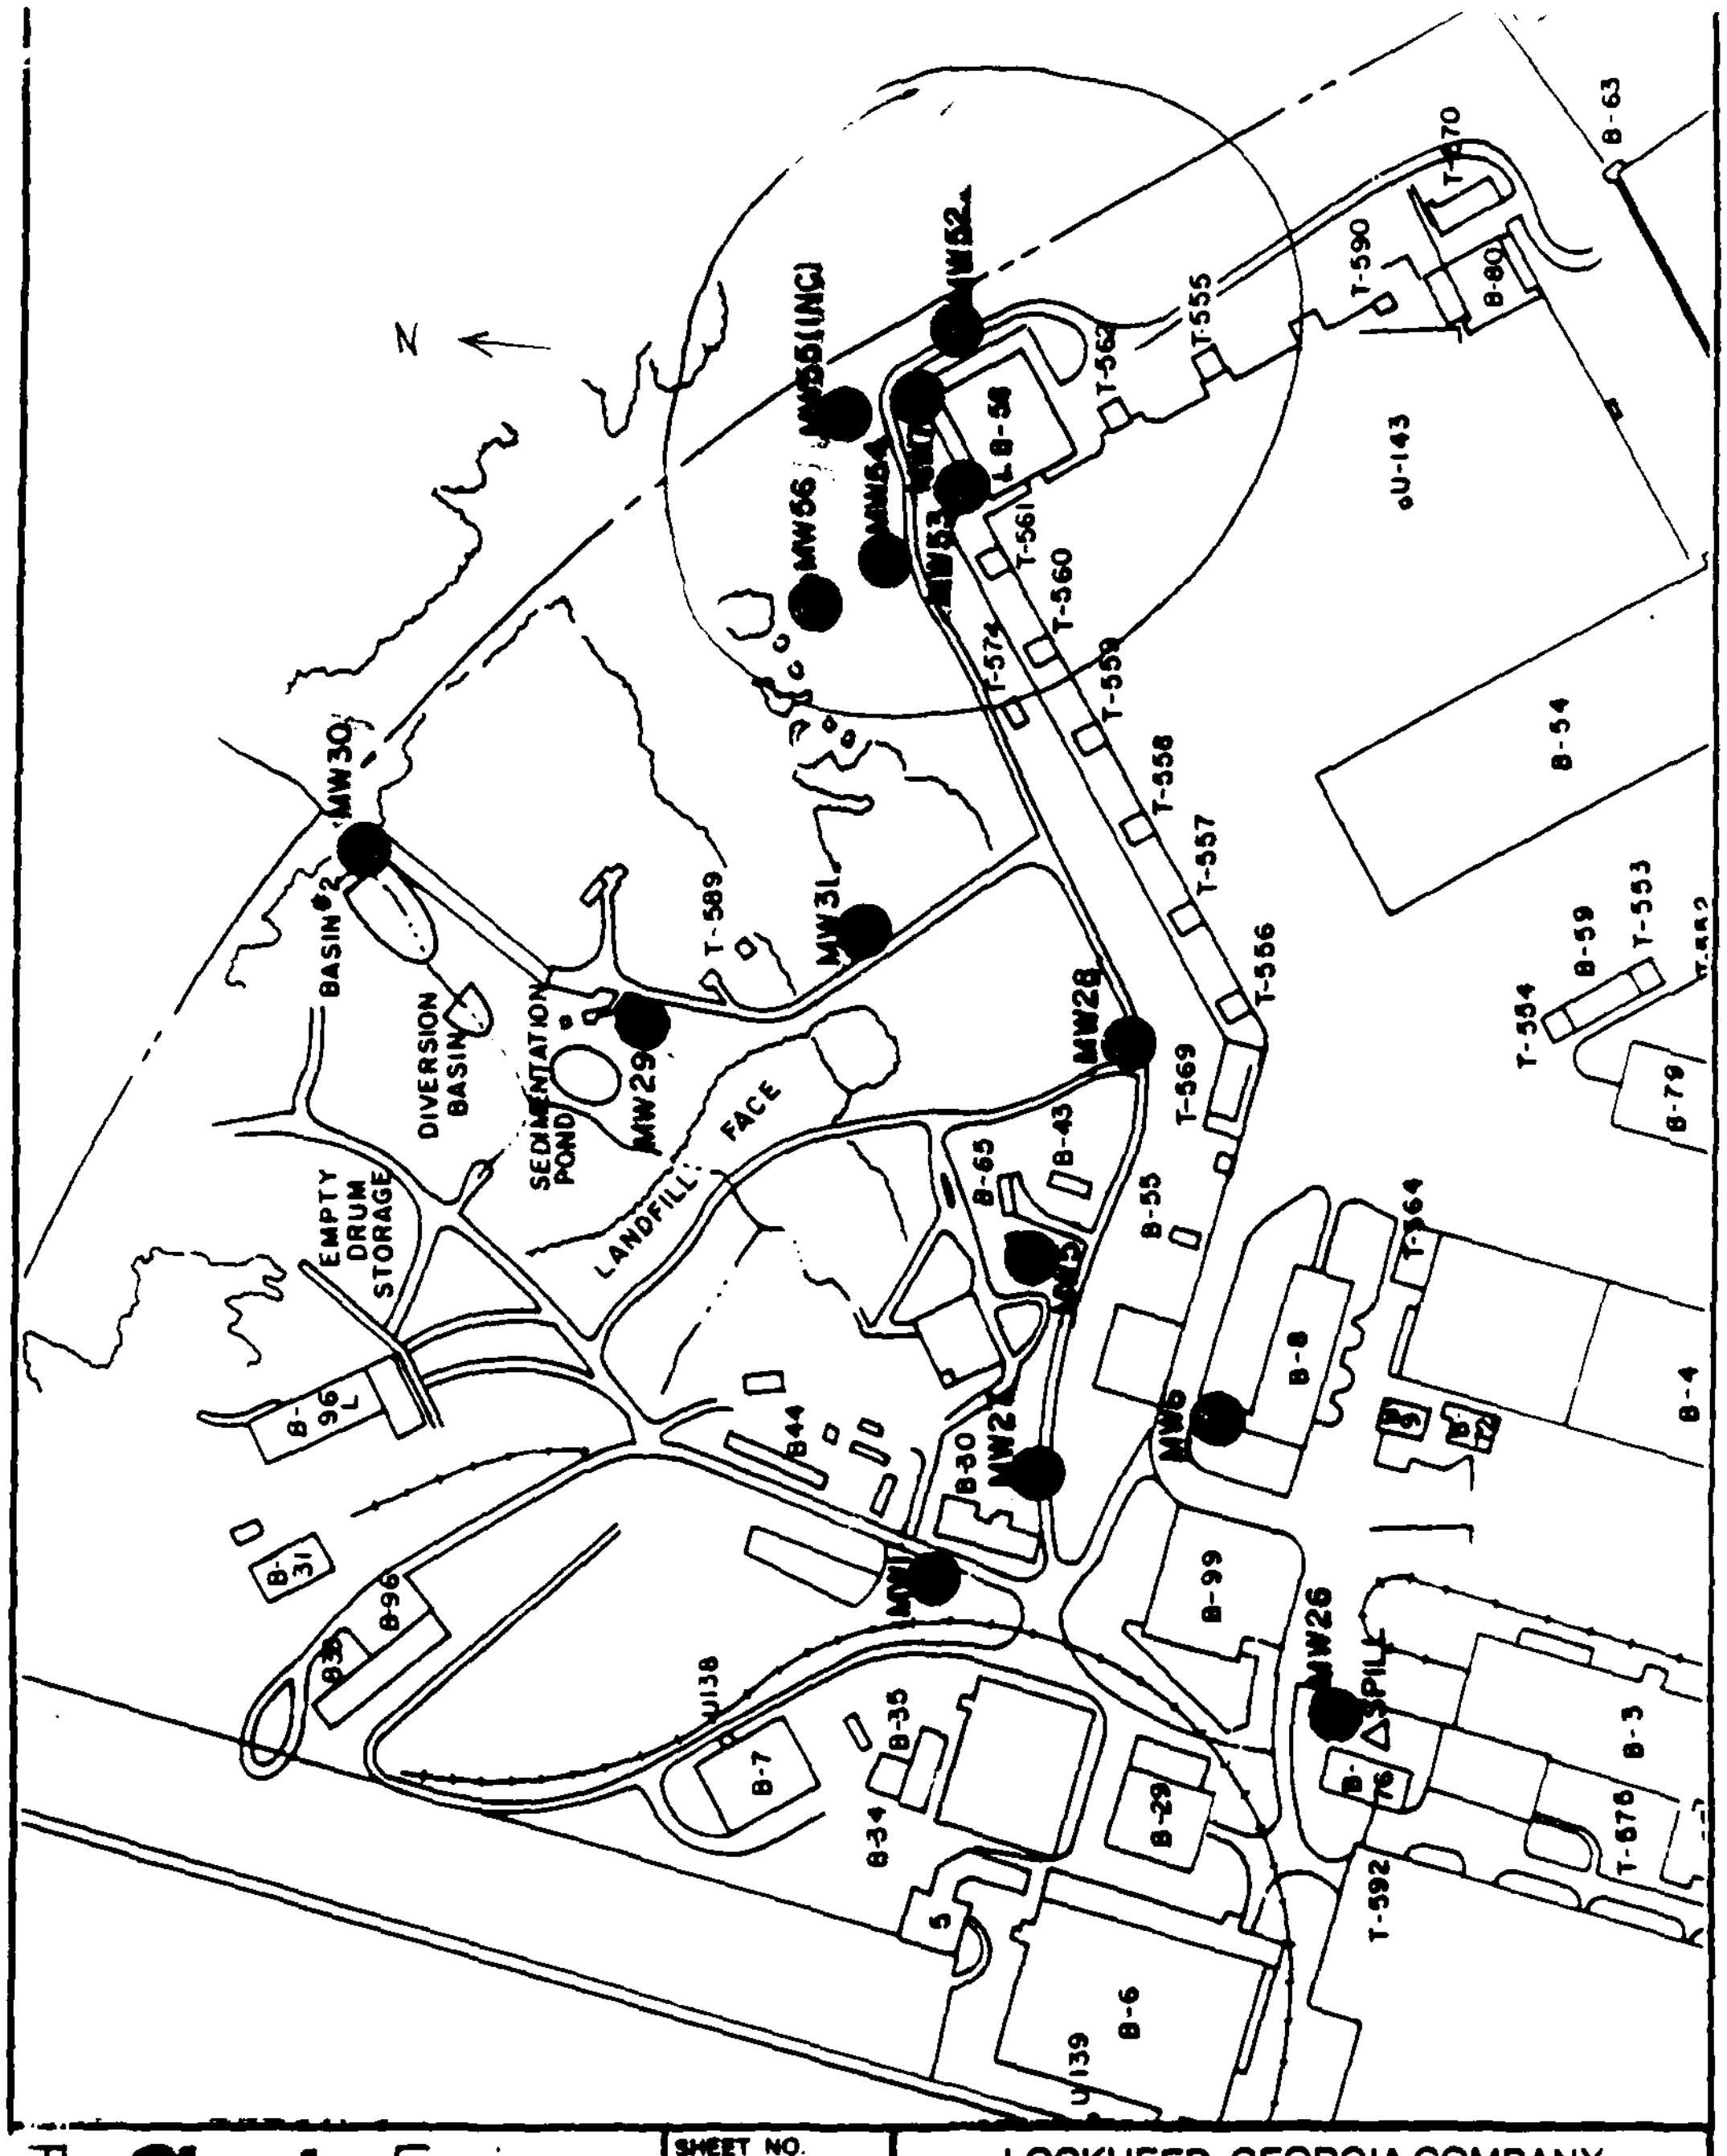
DWN.BY:	SCALE:	DATE	SHEET NO.	LOCKHEED-GEORGIA COMPANY
CHK'D.BY:	APPR.BY:		DWG. NO. FIGURE III-1	AIR FORCE PLANT 6 LOCATION OF B-58 WING TEST FACILITY

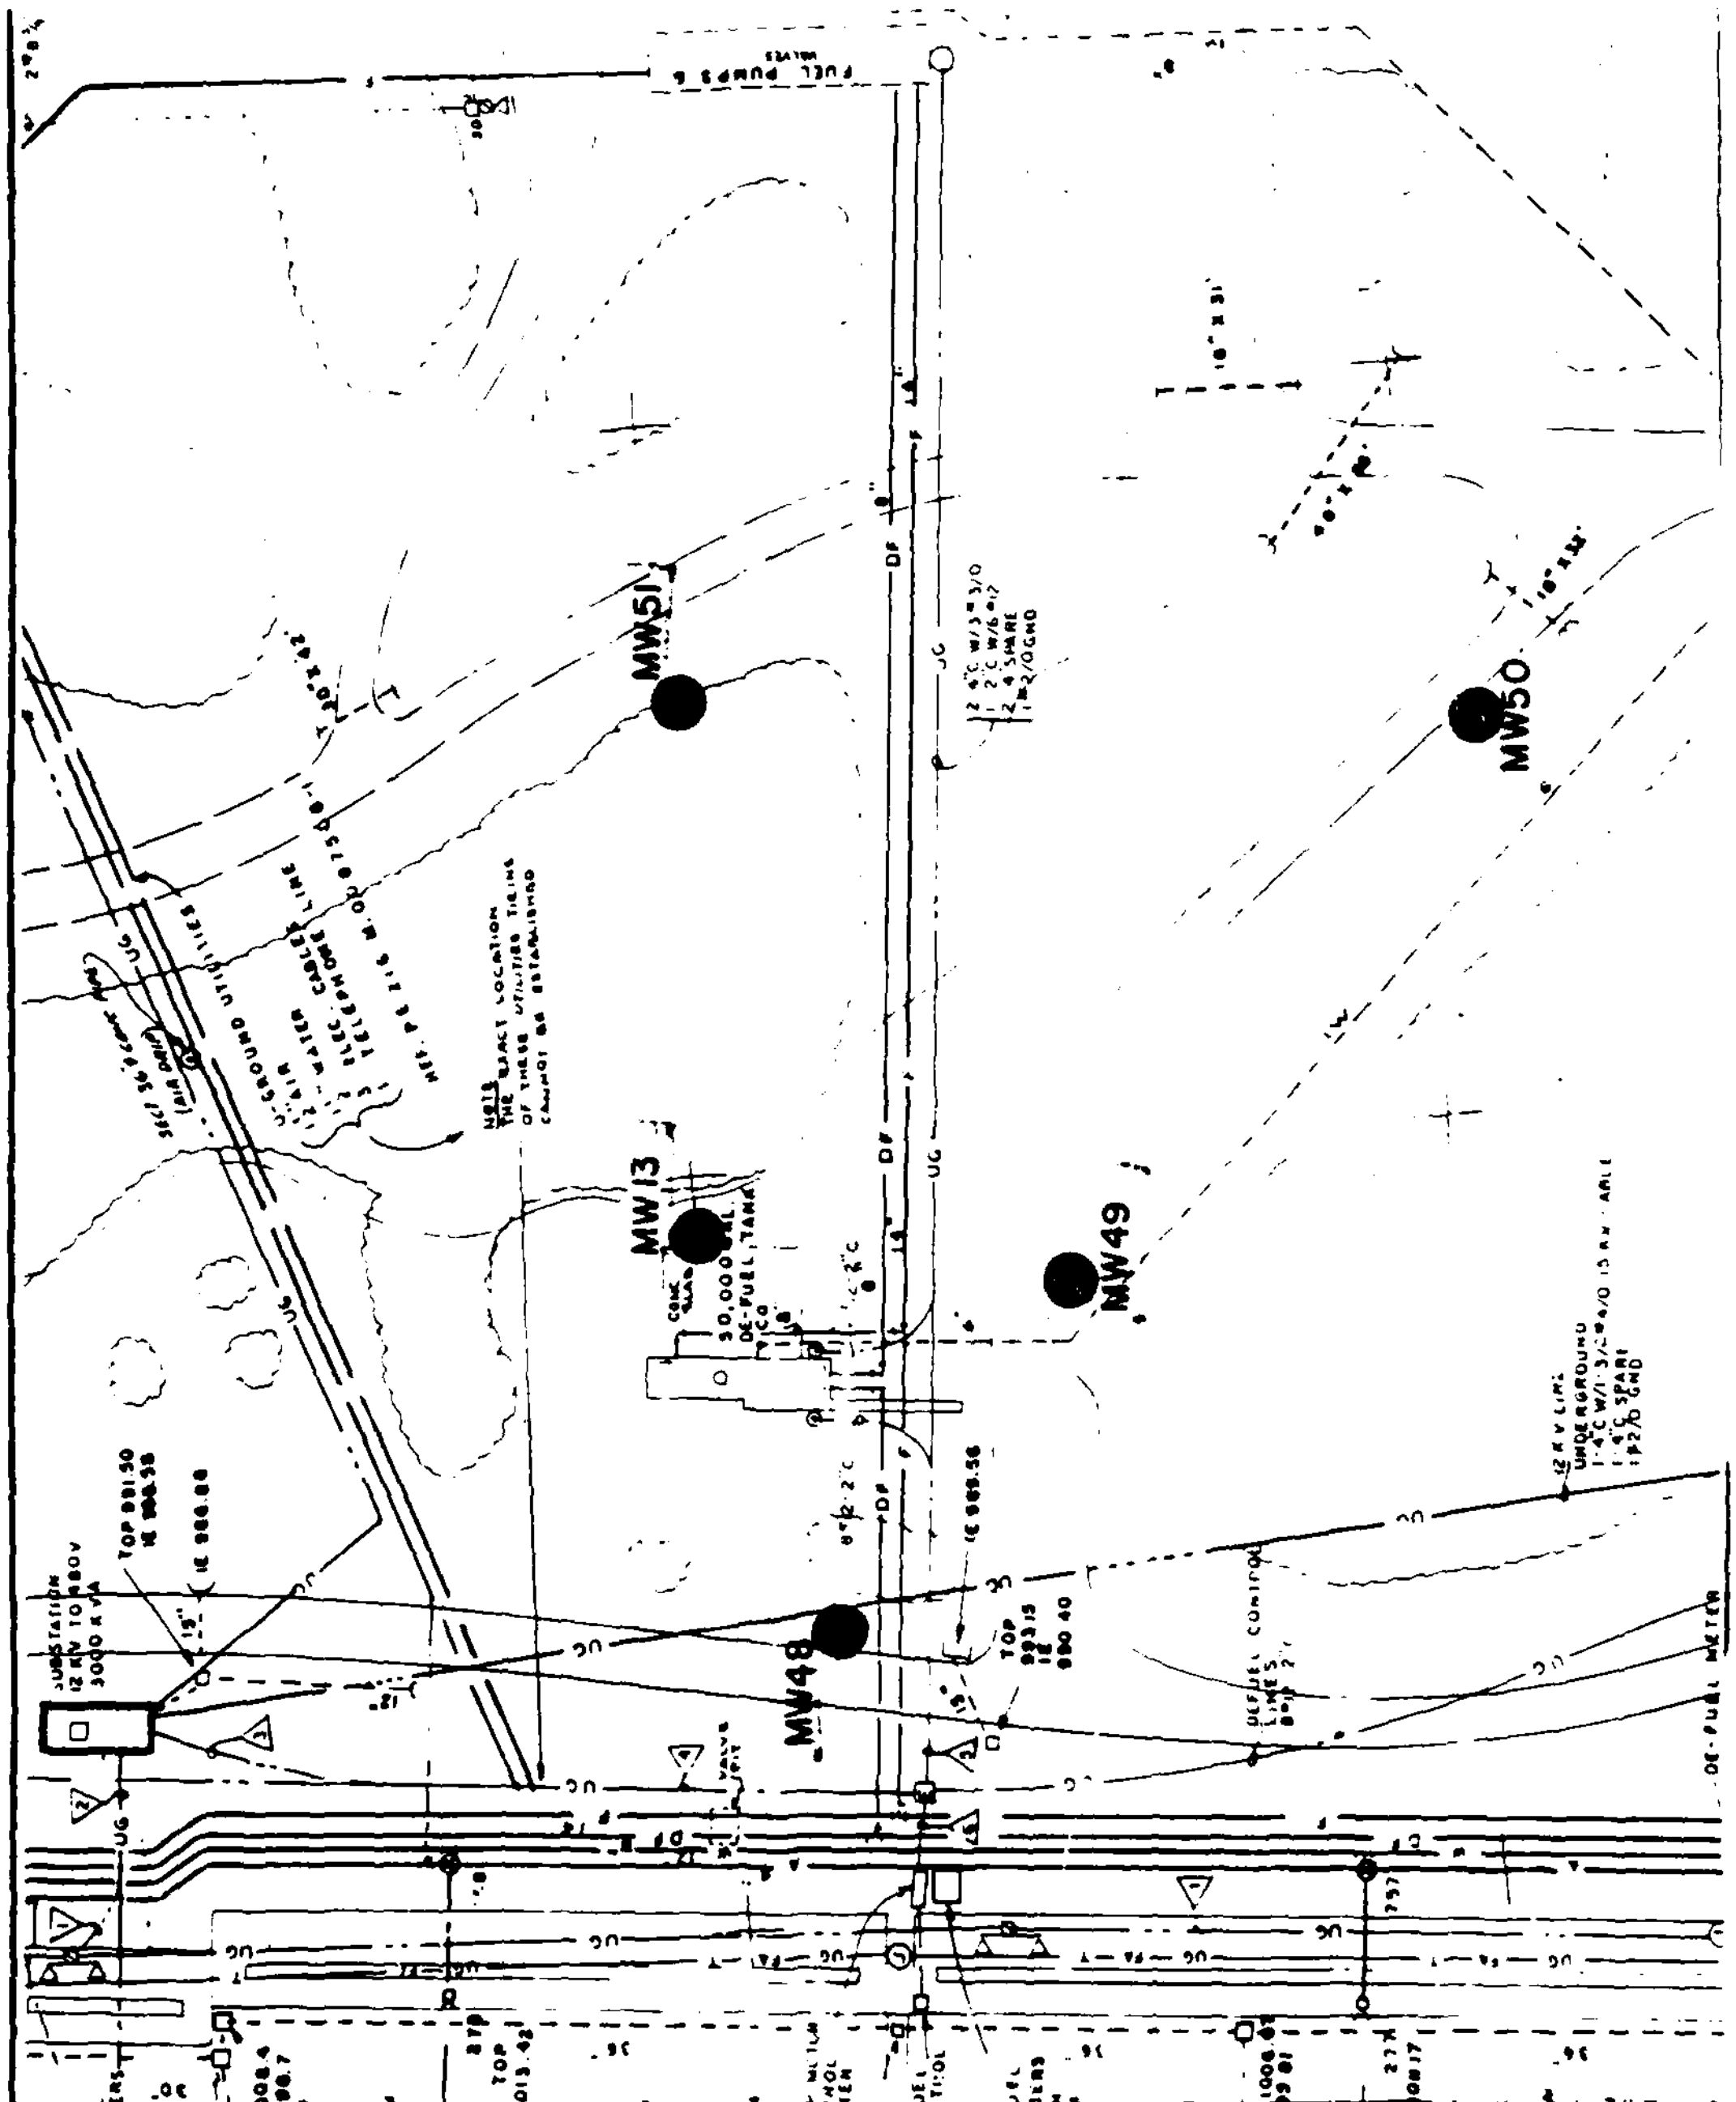
The Chester Engineers			SHEET NO	LOCKHEED-GEORGIA COMPANY AIR FORCE PLANT 6
DWN.BY:	SCALE:	DATE	DWG. NO.	POSITION 58 DEFUELING TANK MONITORING WELL LOCATIONS
CHK'D.BY:	APPR.BY:		FIGURE V-1

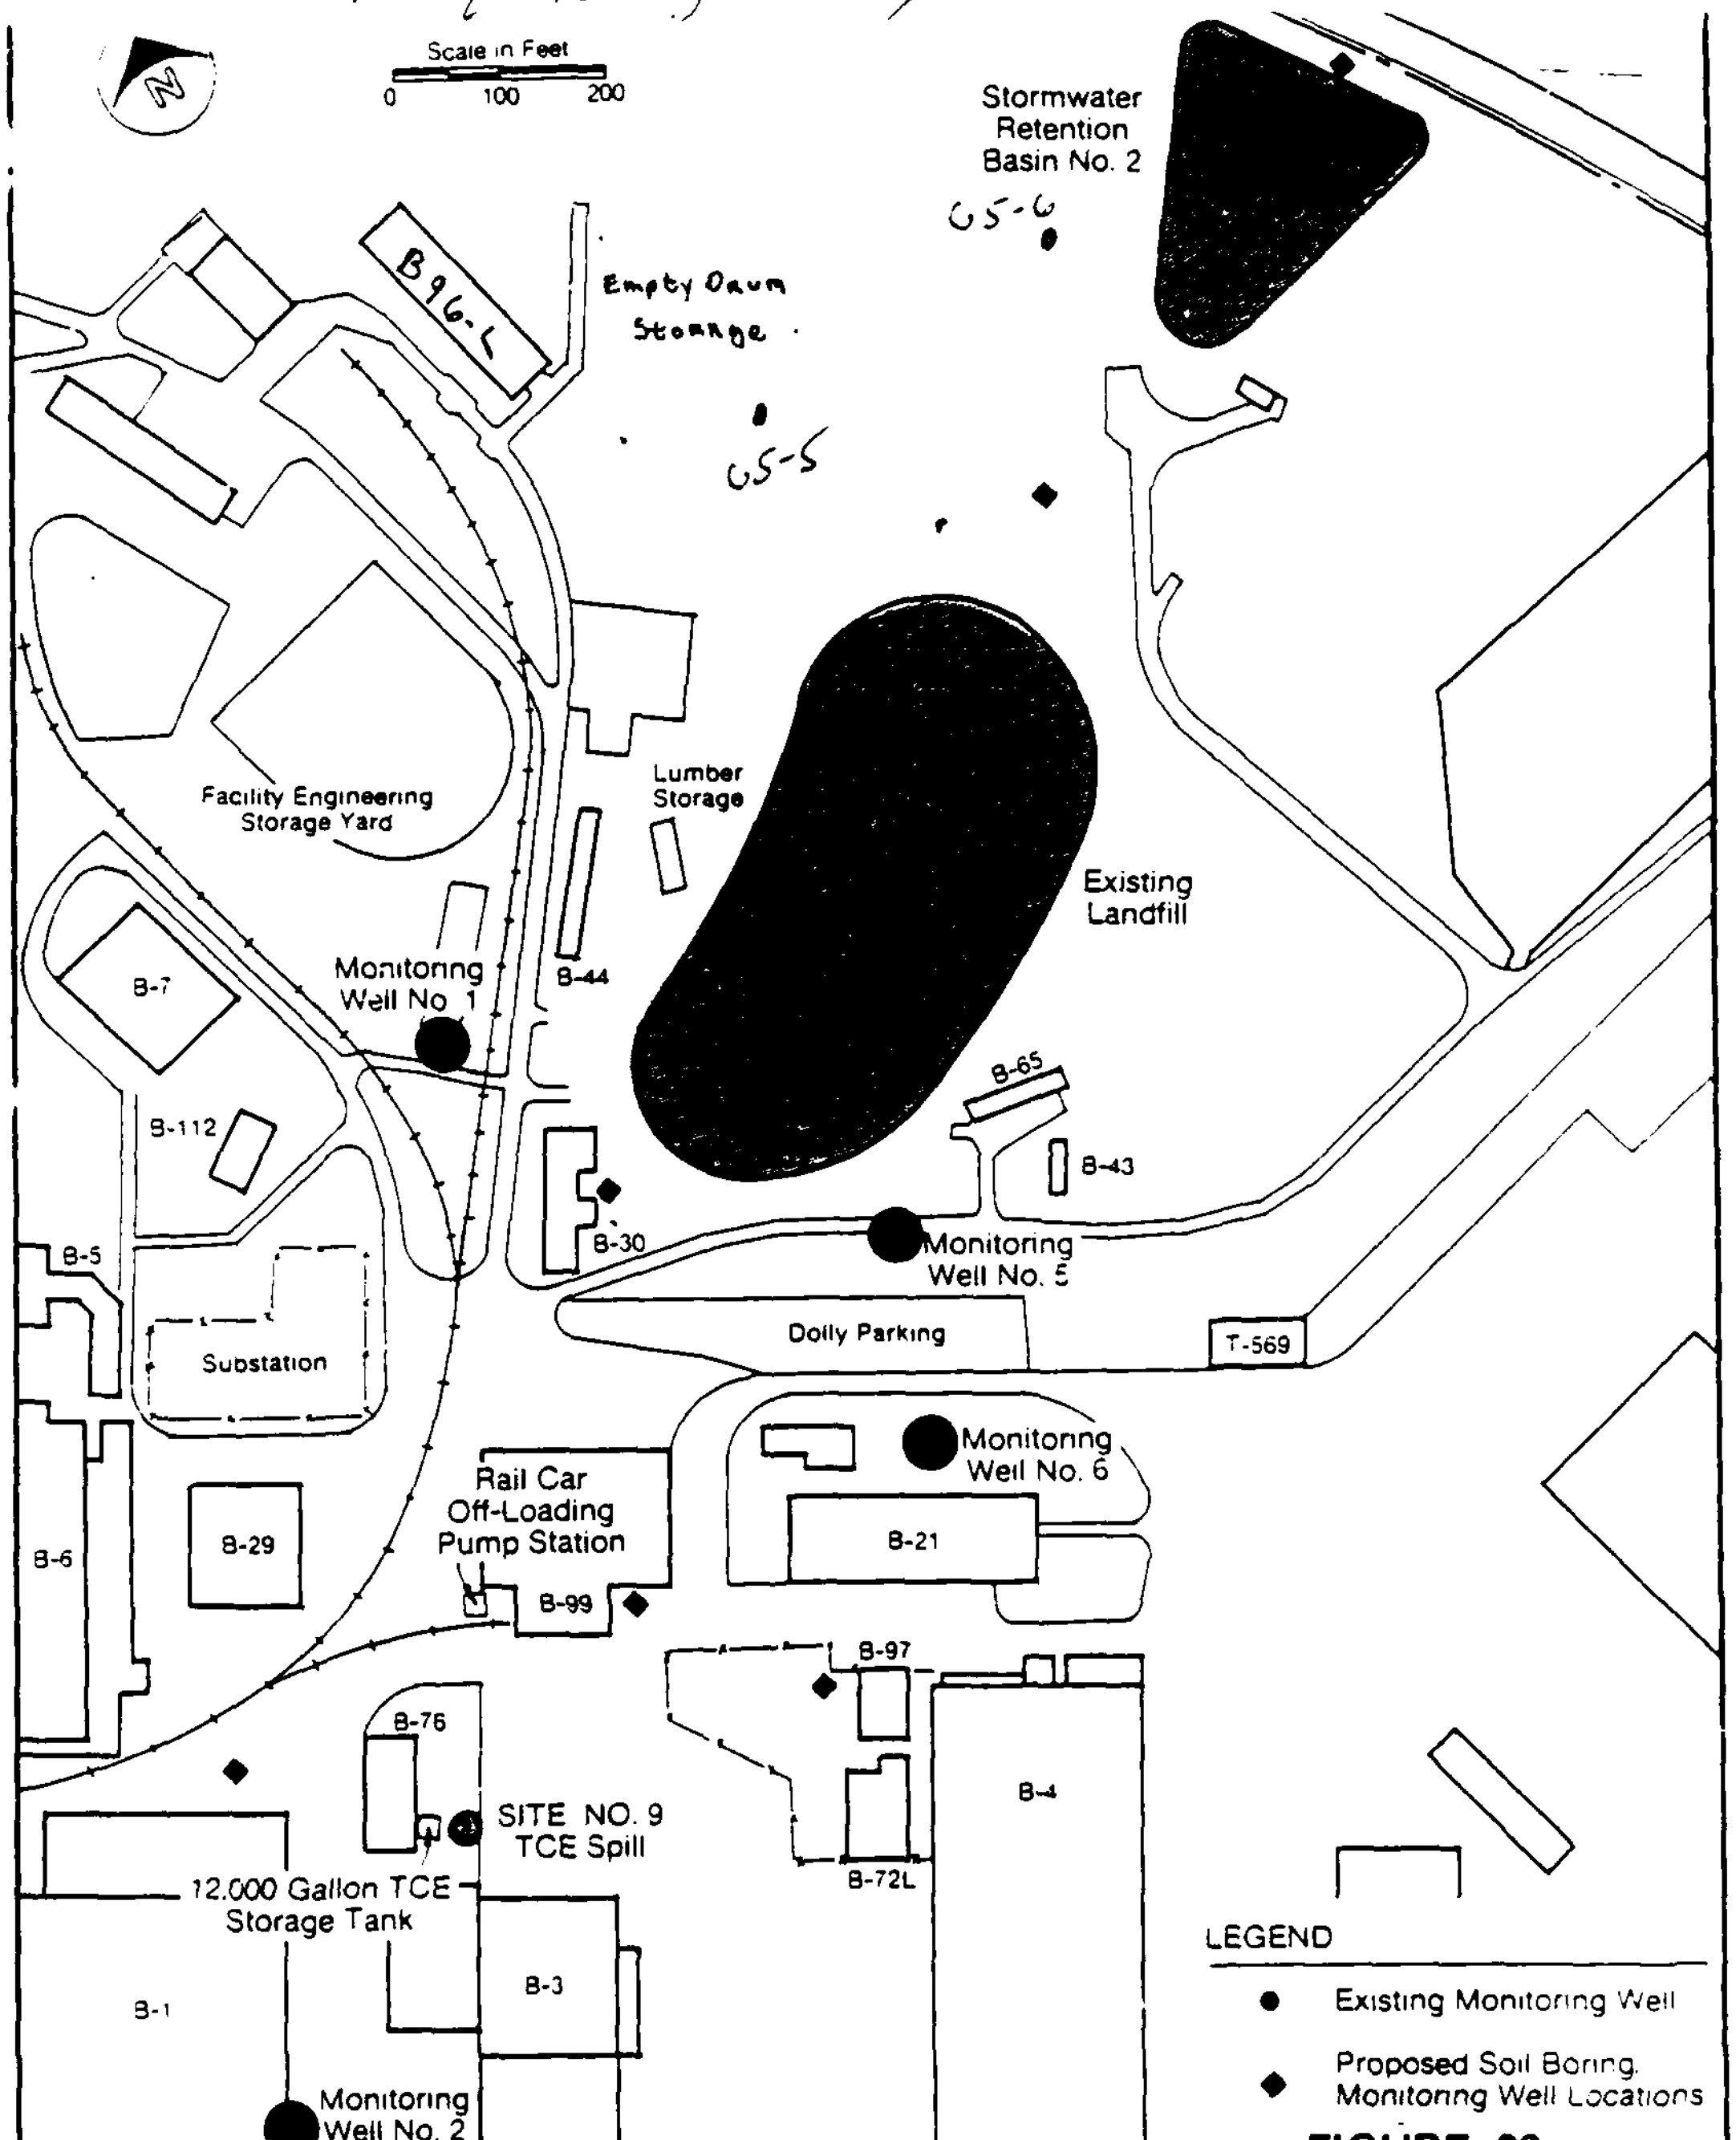
FIGURE 20.
Recommended Monitoring Well and Preliminary Sampling Locations for Site No. 2—the Existing Landfill; Site No. 5 GS-385 Stormwater Retention Basin No. 2; and, Site No. 9—the TEC Spill.

The IRP [redacted] The two upgradient locations shown in the work plan might be located within the fill material. Operations in the area obscure the actual upgradient extent of landfill material. Two somewhat further upgradient wells are already present, i.e., MW-5 and MW-27. Both of these wells have organic contamination. Upgradient conditions from the landfill are therefore reasonably defined within the shallow aquifer. The one downgradient well installed by Chester is not sufficient to firmly identify downgradient conditions.

As part of Chester's study of the TCE spill one shallow well (MW-29) was placed in a downgradient position from the active landfill. Conductivity is at background levels. Some organic contamination is present but the impact of the landfill is obscured by the many other possible organic contaminant sources identified by Chester as being present in upgradient areas. Chester has recommended that the entire Stormwater Basin No. 2 watershed be considered a single integrated study unit.
