INSTALLATION RESTORATION PROGRAM
PHASE II—CONFIRMATION/QUANTIFICATION

STAGE 1

Final Report

AIR FORCE PLANT 6, COBB COUNTY, GA.

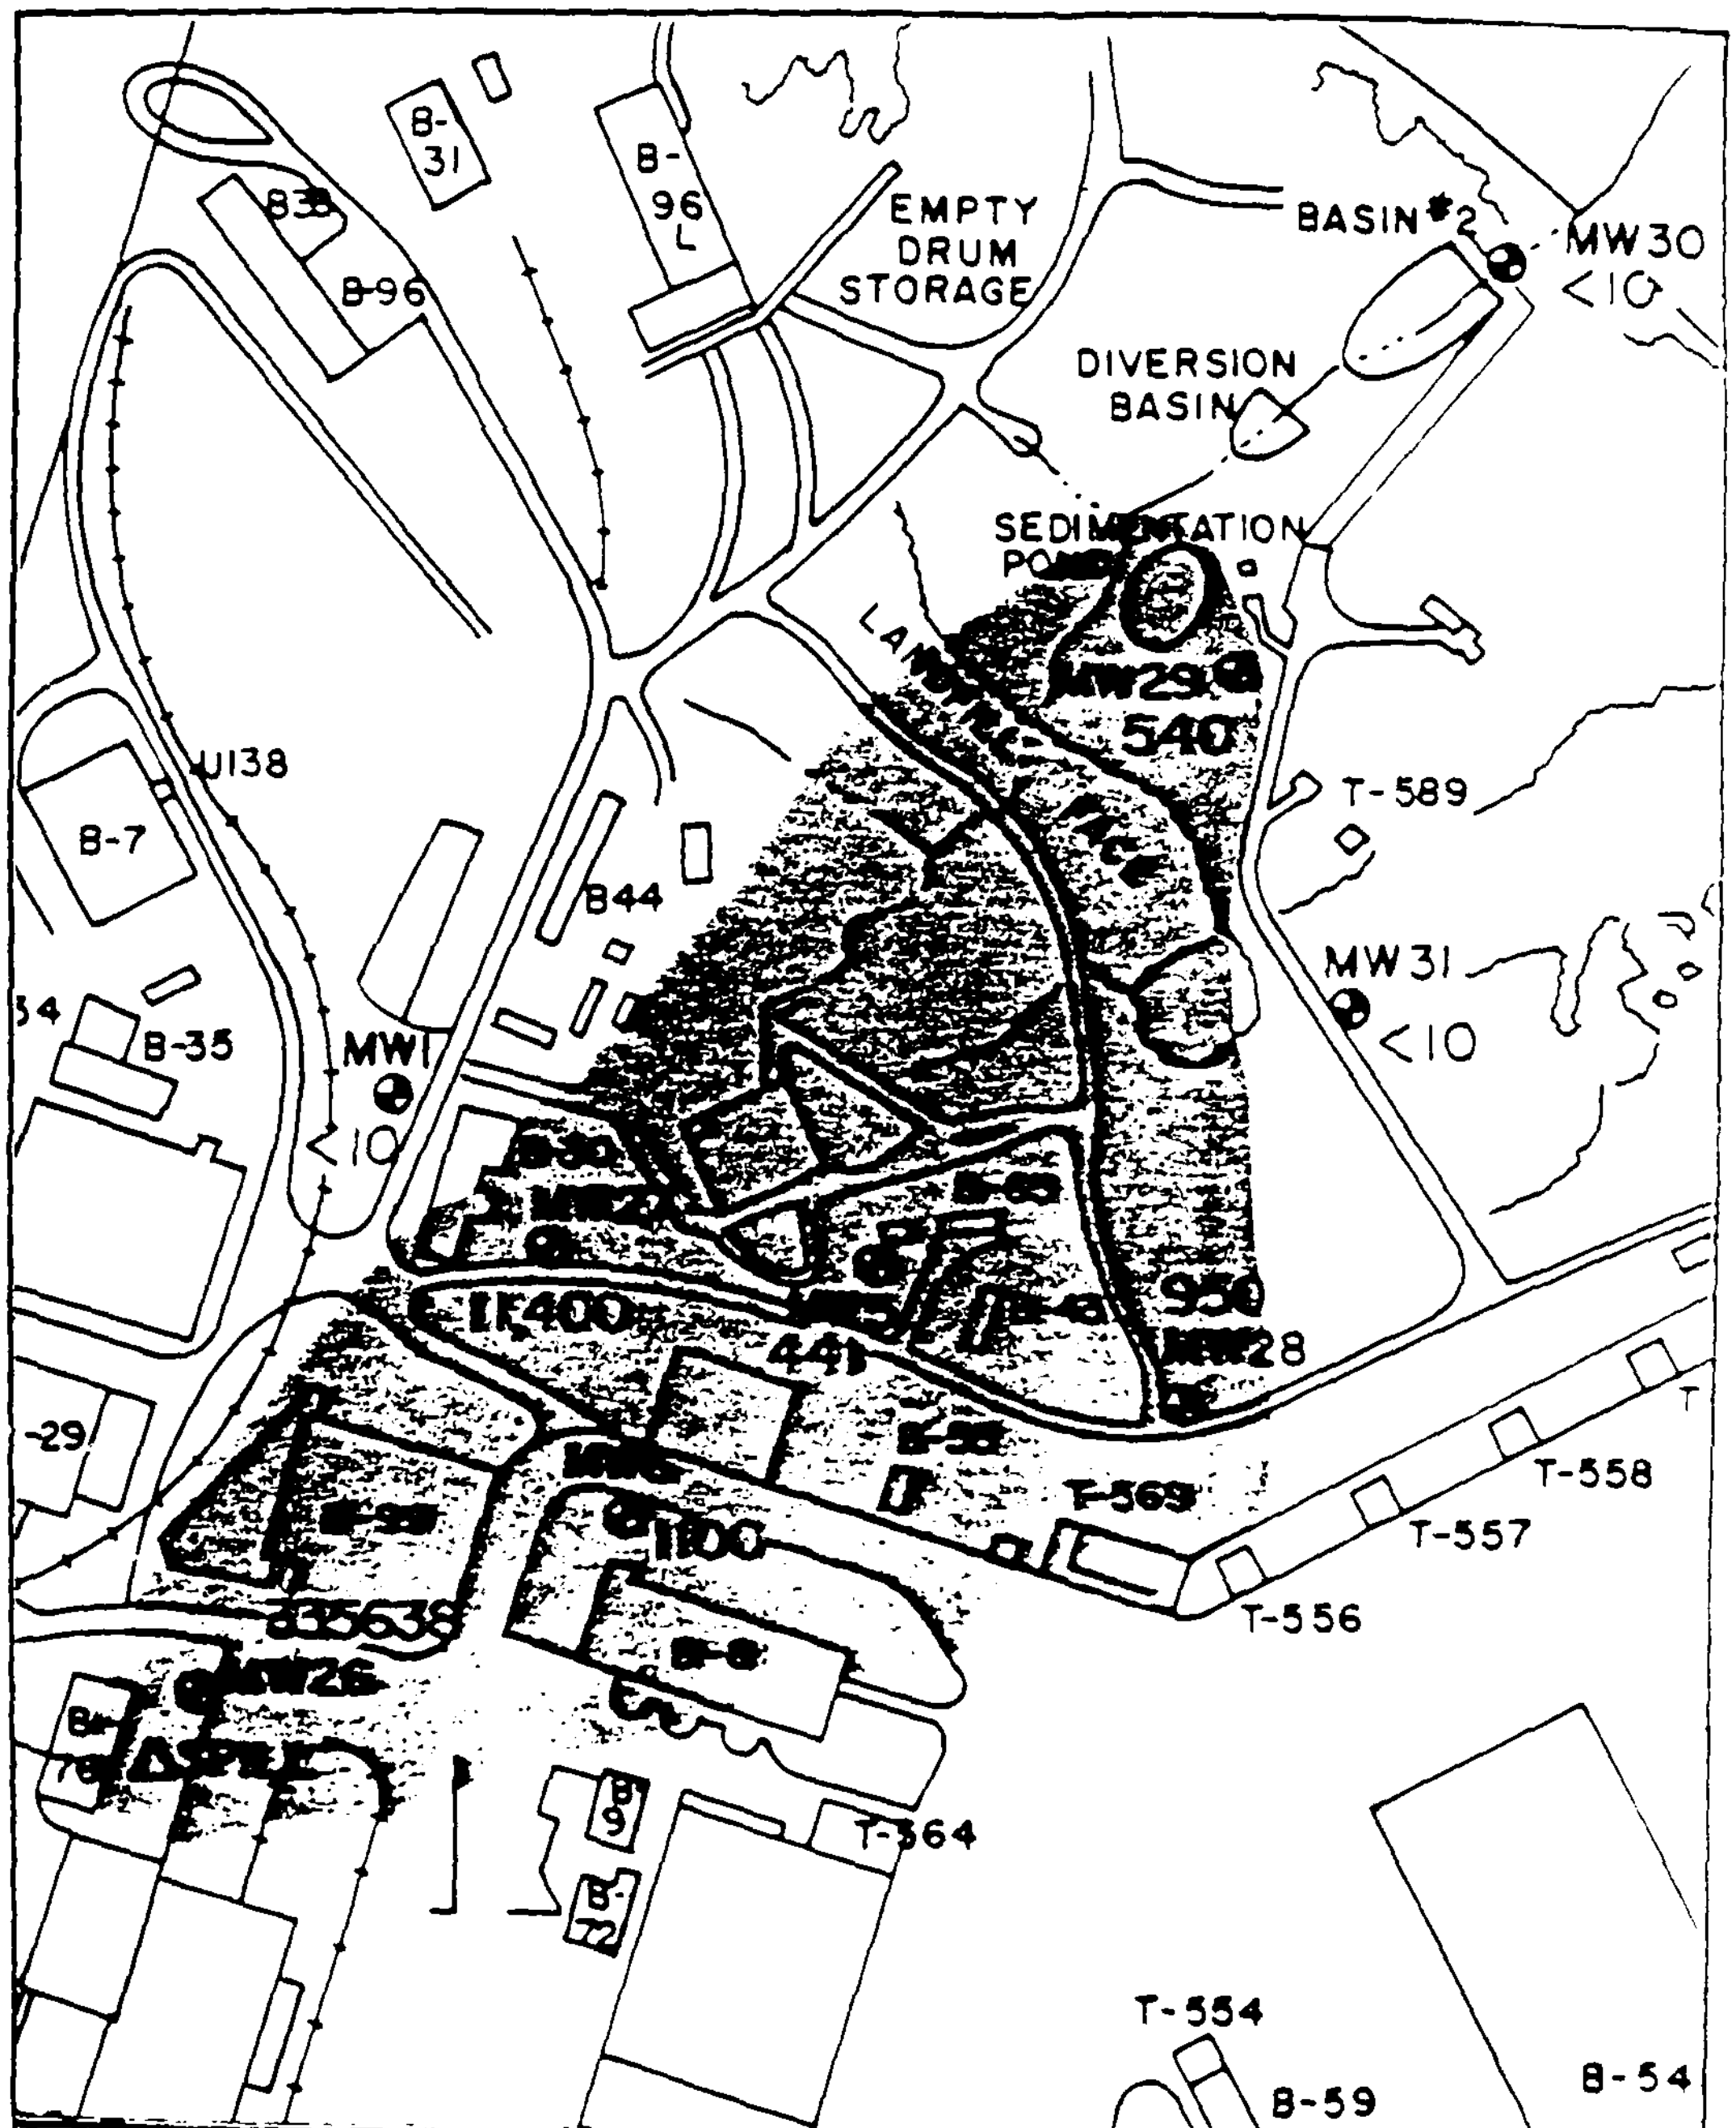
DWN. BY:	SCALE:	DATE	SHEET NO.	LOCKHEED-GEORGIA COMPANY
CHK'D BY	APPR BY		DWG. NO.	AIR FORCE PLANT 6
			FIGURE IV-9	TCE SPILL AREA TRICHLOROETHYLENE ug/L

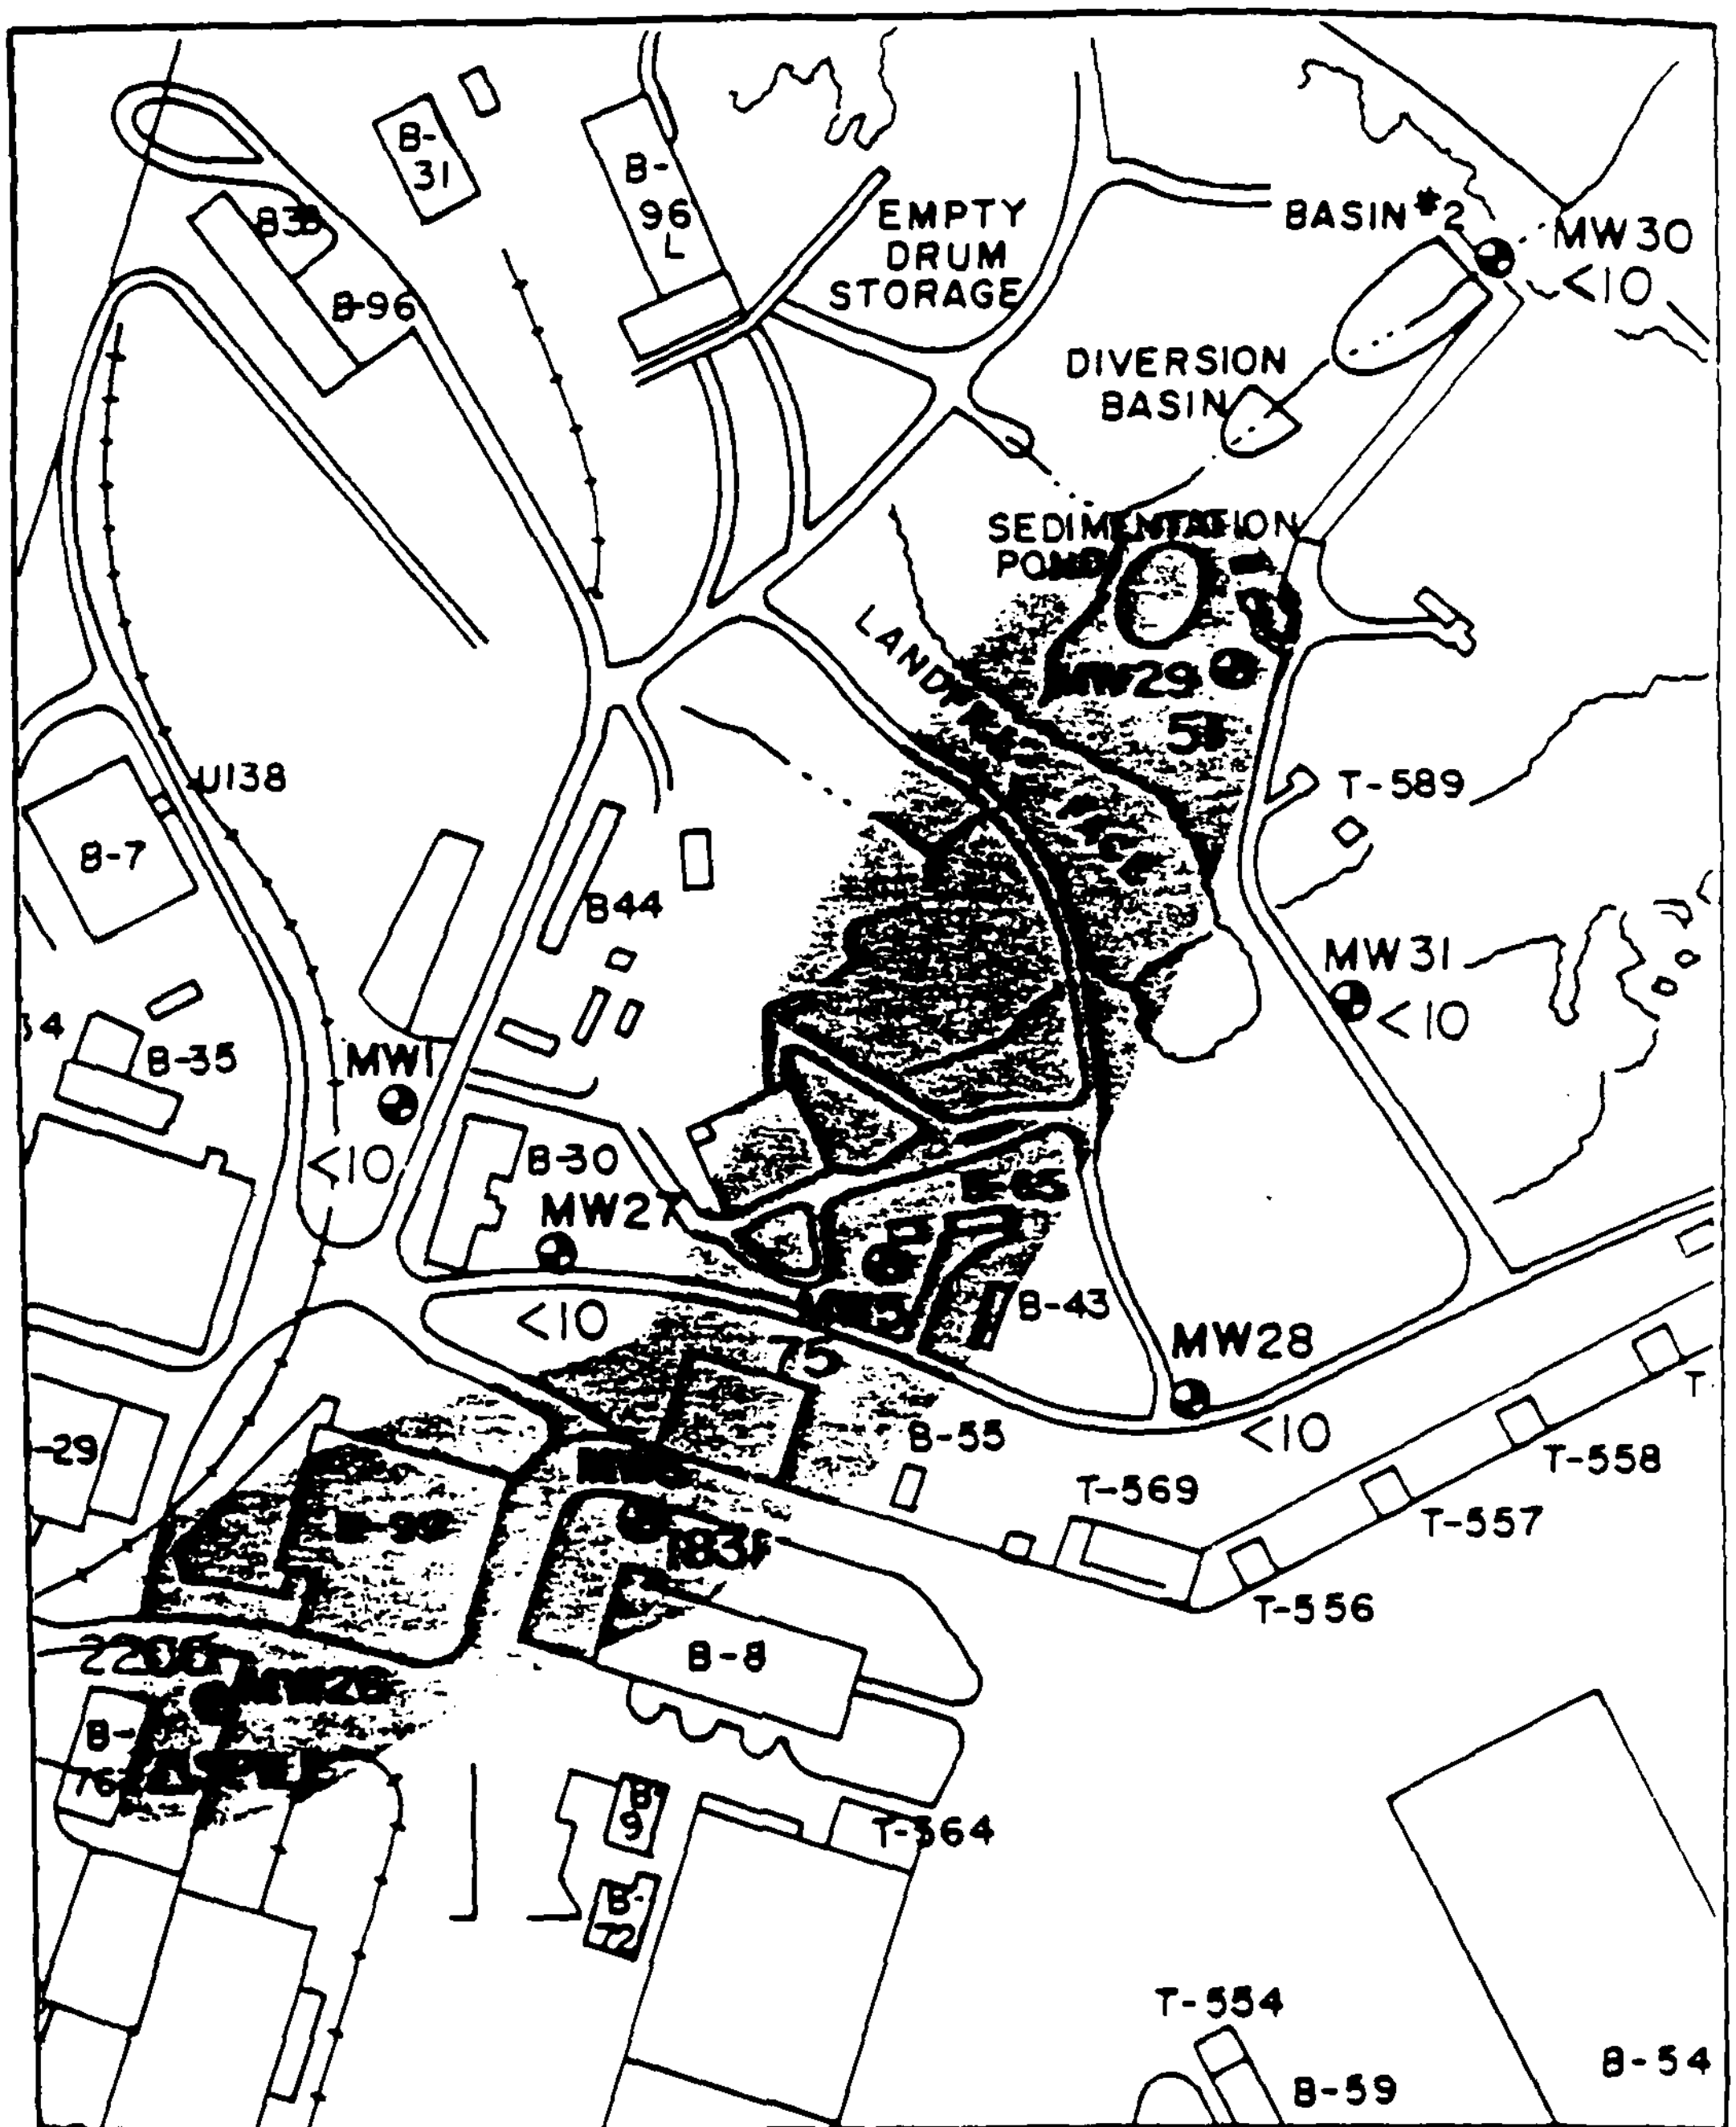
The Chester Engineers	SHEET NO.	LOCKHEED-GEORGIA COMPANY
DWN.BY / SCALE / DATE	DWG. NO. Q-390	AIR FORCE PLANT 6
CHK'D BY / APPR.BY	FIGURE IV-10	TCE SPILL AREA 1,2-DICHLOROETHANE ug/L
