INSTALLATION RESTORATION PROGRAM
PHASE II - CONFIRMATION/QUANTIFICATION

STAGE 1

FINAL REPORT FOR

BEALE AIR FORCE BASE,
MARYSVILLE, CALIFORNIA

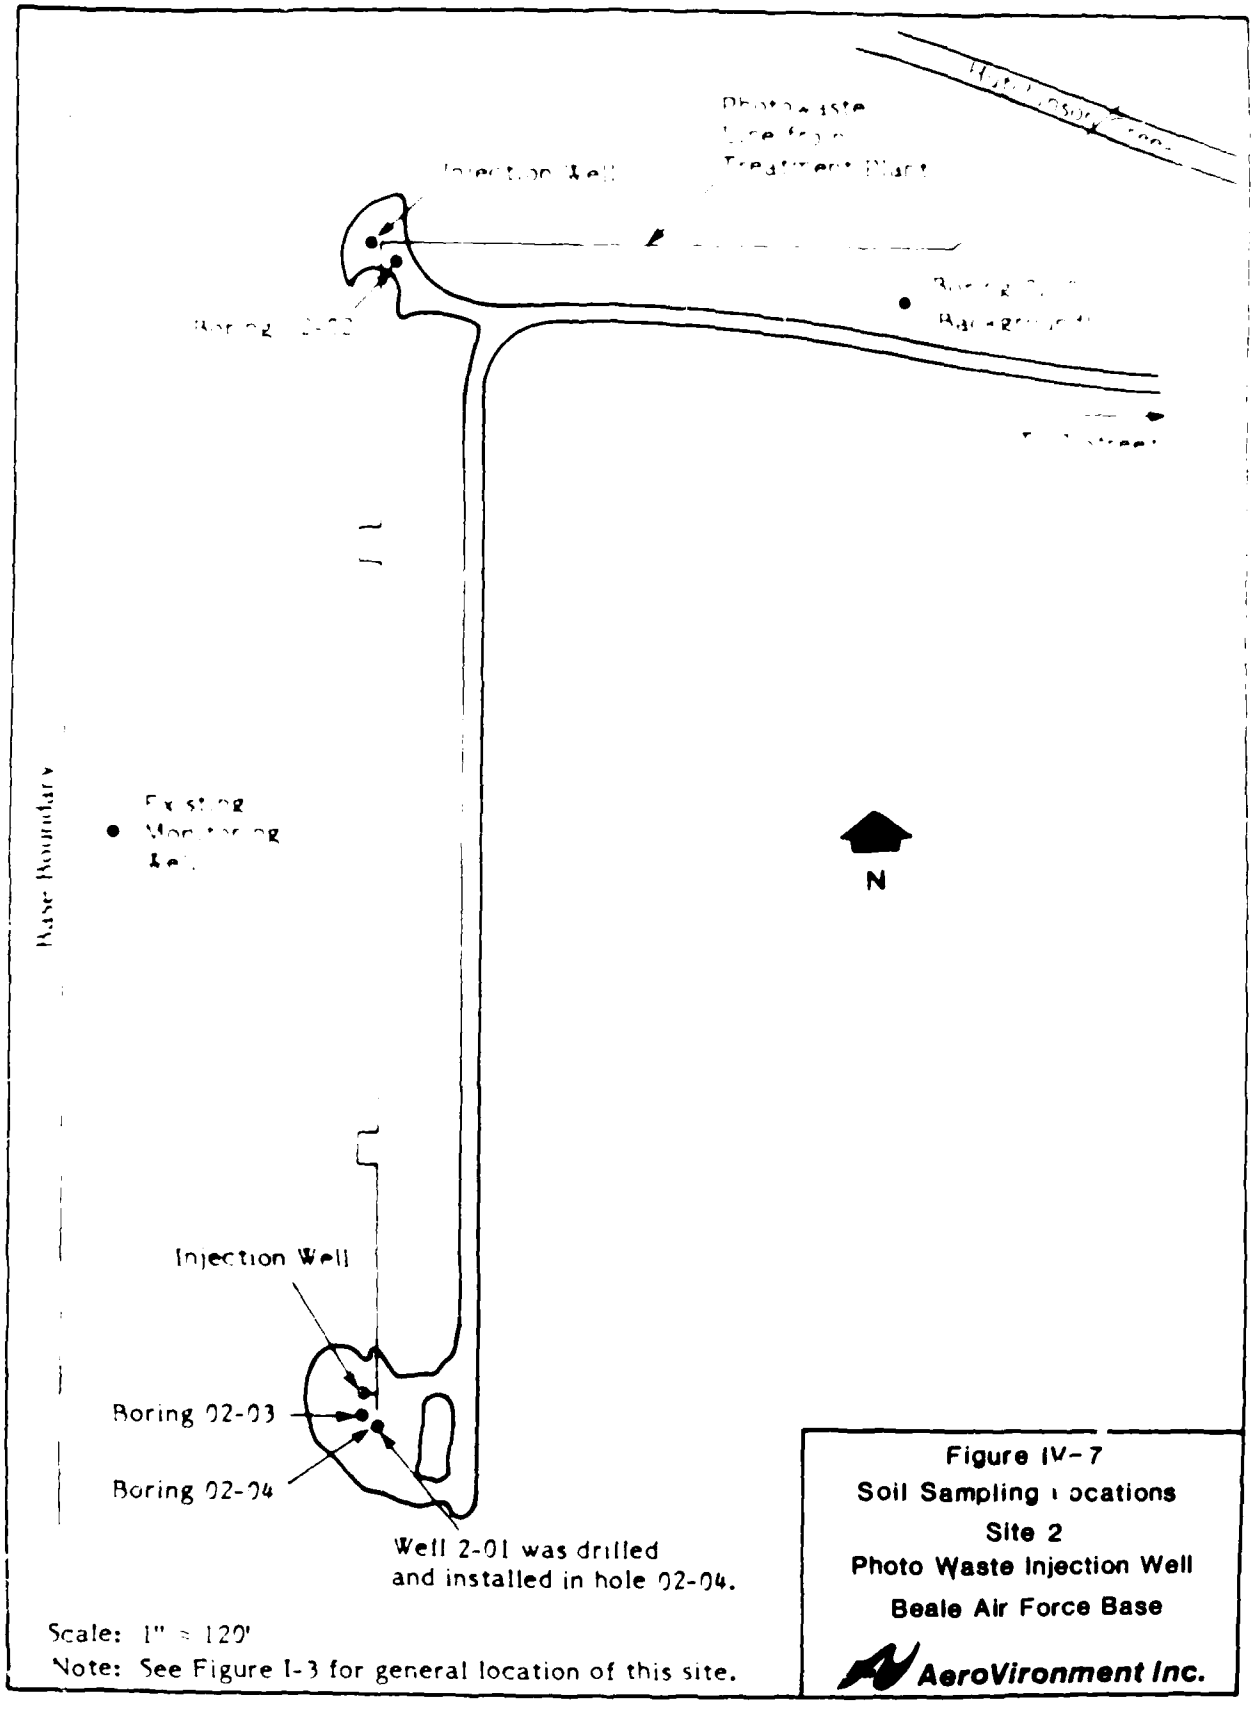
Figure IV-7
Soil Sampling Locations
Site 2
Photo Waste Injection Well
Beale Air Force Base

The soil sampling program at Site 2, the photo wastewater injection wells, included four soil borings, each sampled at 1.5-foot, 6.5-foot, 11.5-foot and 16.5-foot depths (see Figure IV-7). Boring 02-01, the background boring or control boring, was located along the access road leading into the site and approximately 100 feet from the photo waste line and the injection wellheads. Boring 02-02 was located near the north injection well. Boring 02-03 was located approximately 10 feet south of the blow-down valve at the end of the pipeline. Boring 02-04 was located approximately five feet southeast of the southern injection wellhead at Site 2. The borings were sited to define the presence and extent of contamination that may have been caused by the practice of periodically purging the waste lines and backflushing the injection well filters. Samples from the 1.5-foot and 11.5-foot depths were analyzed for volatile organics, O&G, and base/neutrals and acid extractables (BNA). Table IV-- gives the results.

Contamination in the form of elevated O&G and pentachlorophenol (PCP) was found in Boring 02-04 at a depth of 16.5 feet, but no evidence of contamination was found in any of the shallower samples. Pentachlorophenol was added to the photo wastewater as a bactericide until February 1986. Since Boring 02-04 was the only hole at Site 2 from which a 16.5-foot sample was

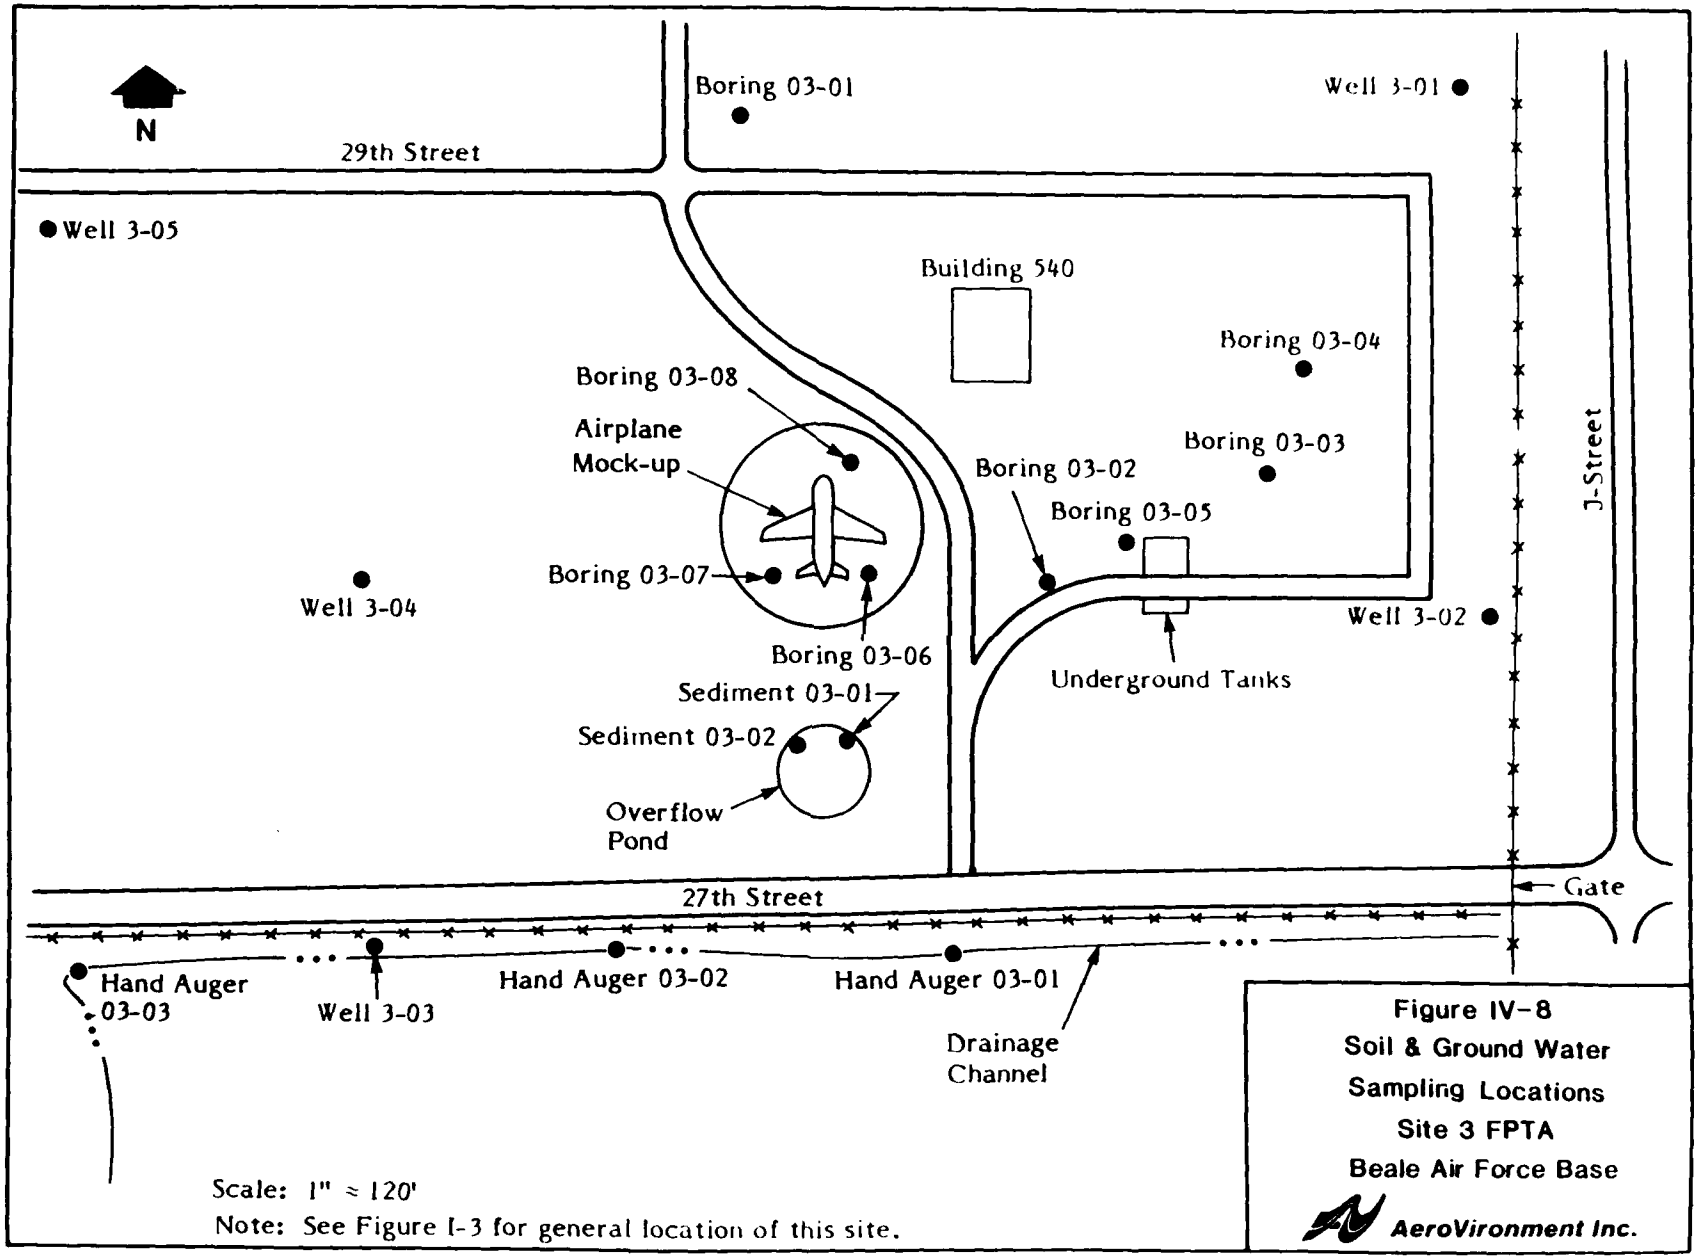
Figure IV-8
Soil & Ground Water
Sampling Locations
Site 3 FPTA
Beale Air Force Base

Other soil sampling at Site 3 included six hand-auger samples from three locations along the 27th Street drainage ditch, which receives runoff from the entire FPTA area, and two surface sediment samples from the runoff pond located south of FPTA No. 2. Table IV-5 shows the soil sampling results for this site.

Soil Boring 03-02 was located approximately 50 feet west of the underground storage tanks. Oil and grease (O&G) and petroleum hydrocarbon (Pet HC) levels were above background in the 1.5-foot sample from this boring. The original hole was terminated at 4 feet due to an obstruction and moved 6 feet to the west. Strong hydrocarbon odors were noticed while drilling the original hole, but were not observed for the second boring, which showed no evidence of contamination to a final depth of 11.5 feet. Because the original hole was located closer to the underground tanks than the second hole, the decision was made to drill a third hole, Boring 03-05, close to the tanks to check suspected leakage.

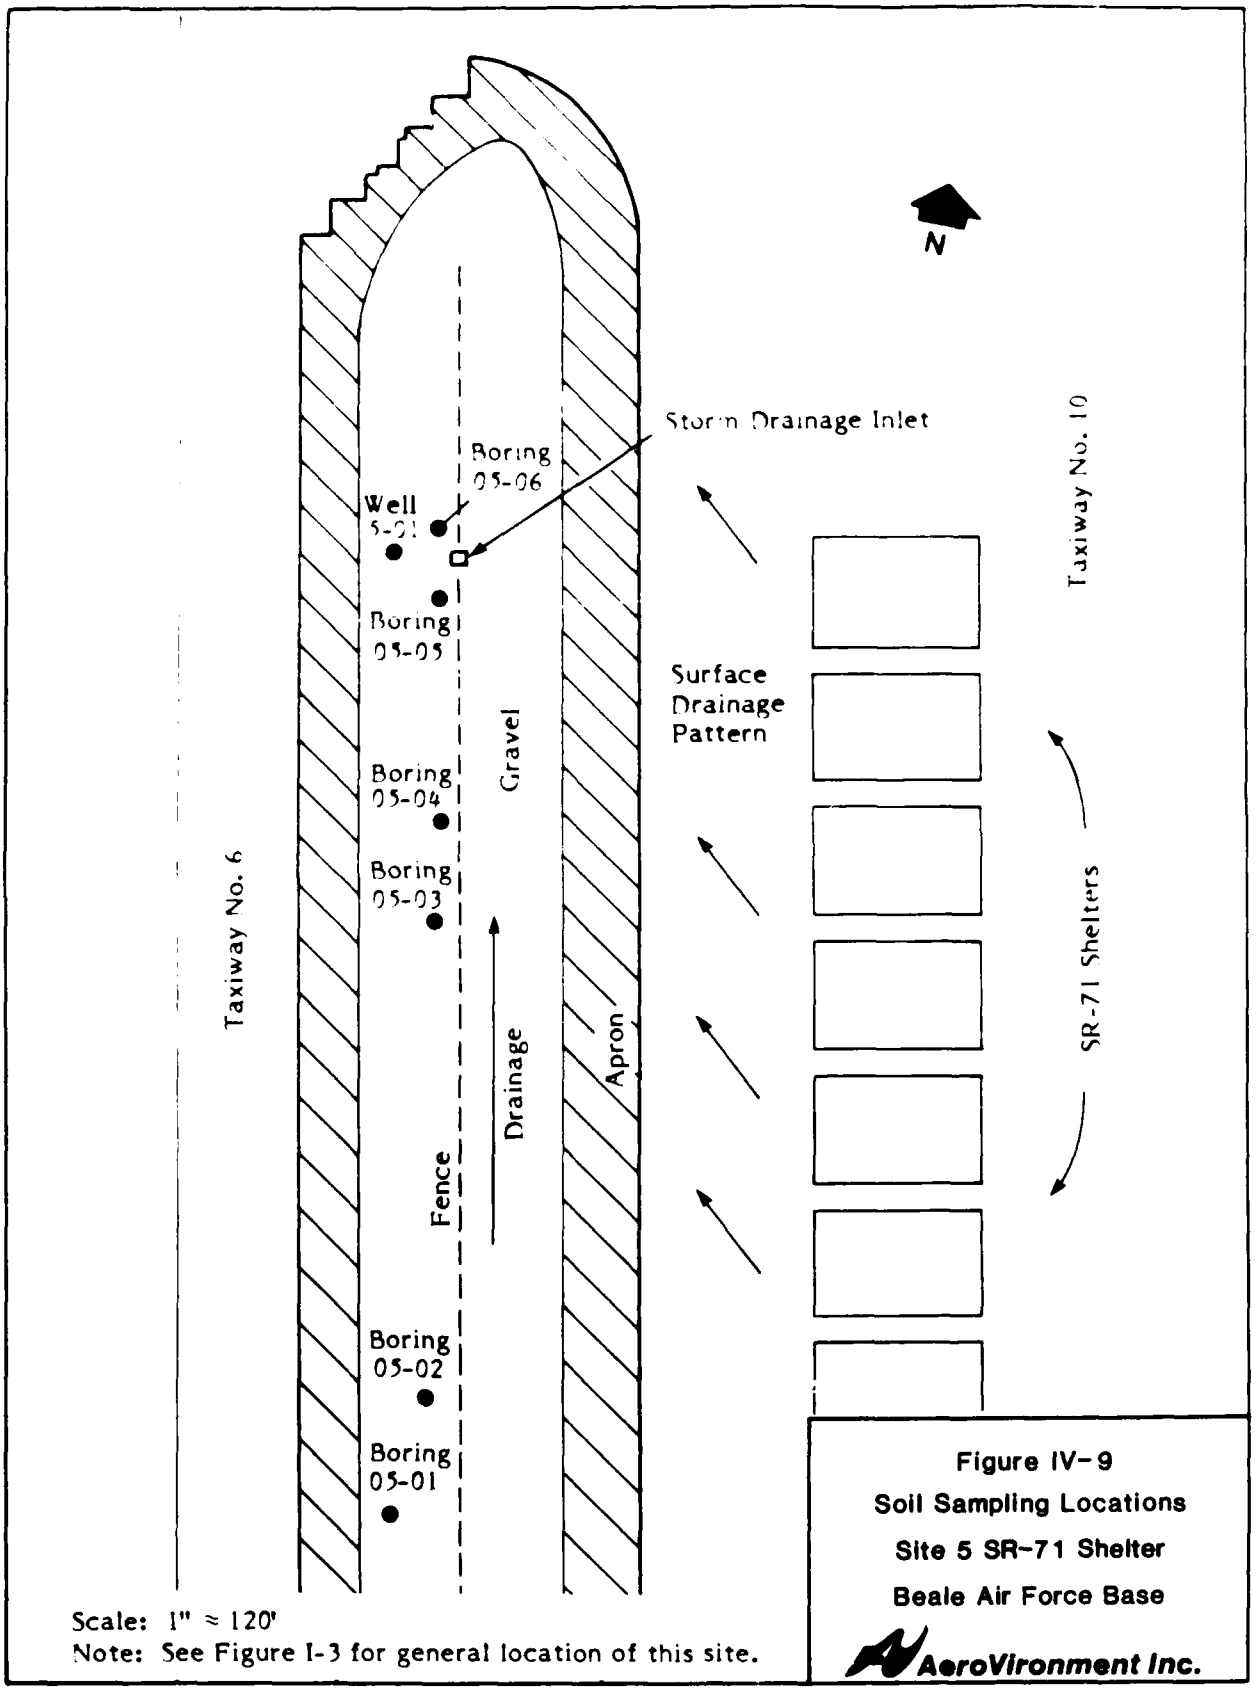
Figure IV-9
Soil Sampling Locations
Site 5 SR-71 Shelter
Beale Air Force Base

Analytical results from Borings 05-01, 02 and 03 showed no evidence of contamination. However, high organic vapor readings were taken in the field at Boring 05-03. Also, a blind field duplicate of the 16.5-foot sample from Boring 05-03 had an O&G value of 400 µg/g, while the original sample was reported below the method detection limit for O&G (100 µg/g). While this difference is not considered significant (400 µg/g is less than five times the detection limit, which is considered the level of quantification), it may indicate slight hydrocarbon contamination, taking into account the high organic vapor reading.

Borings 05-04 and 05-05 had slightly elevated O&G levels. Samples from 6.5 and 11.5 feet at Boring 05-06 were contaminated with volatile aromatics, primarily benzene, with O&G up to 4000 µg/g at 6.5 feet. However, due

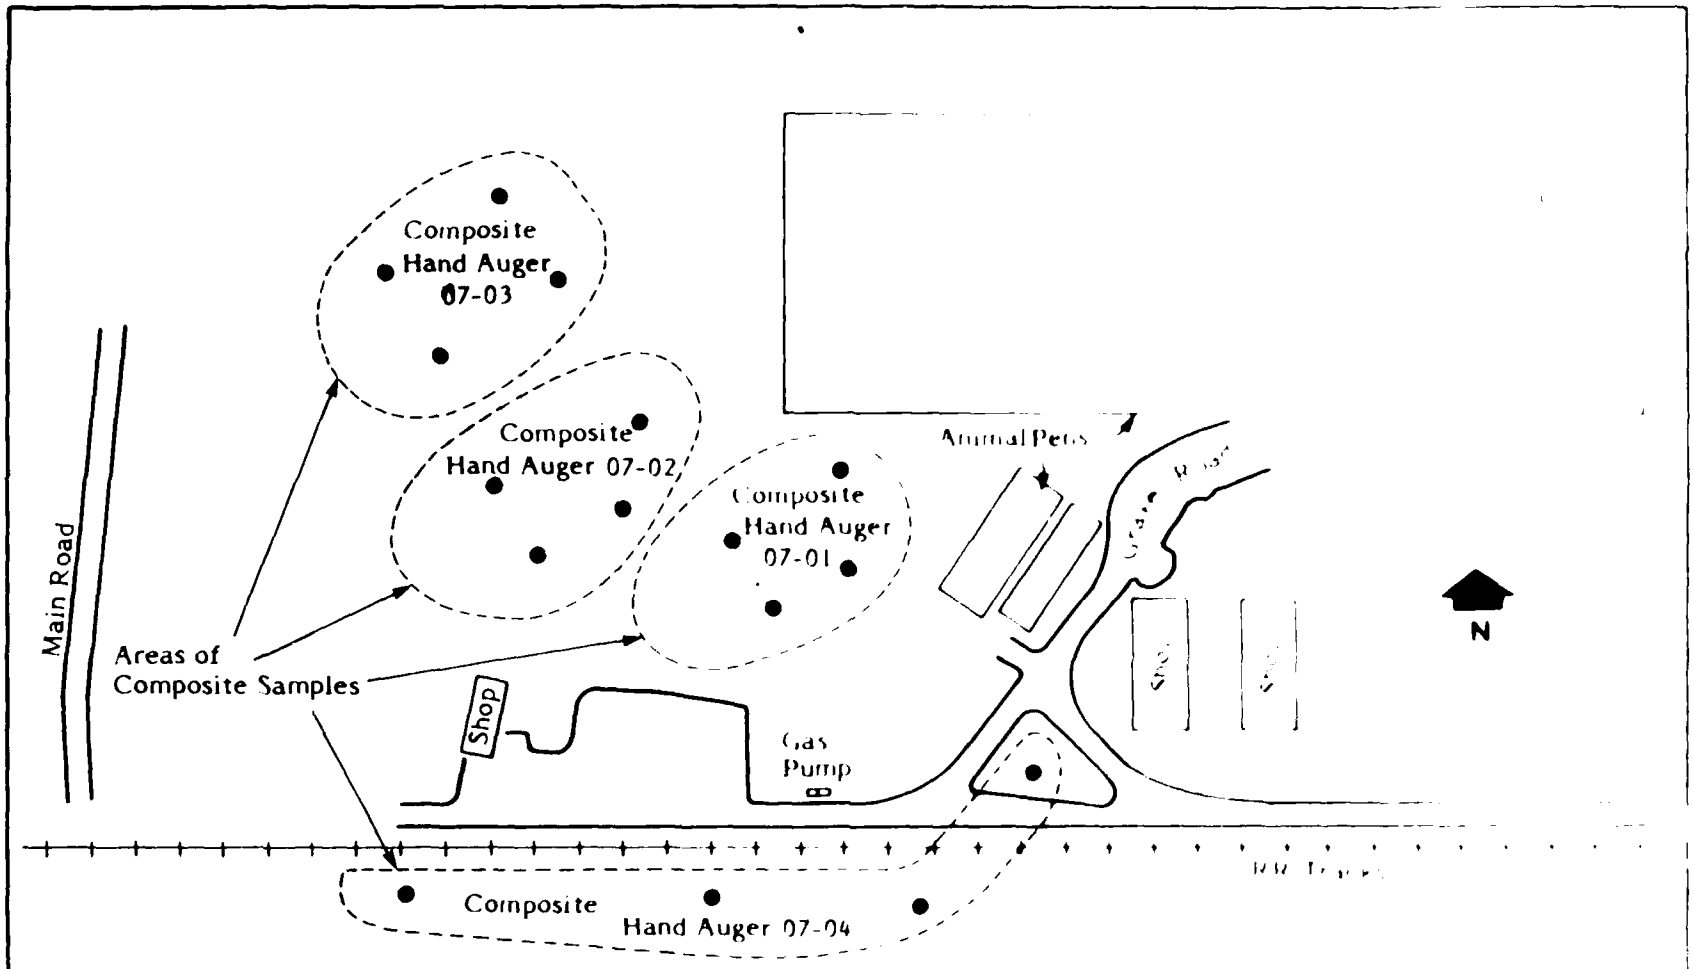
Figure IV-10
Soil Sampling Locations
Site 7 Biological Production
Beale Air Force Base

Surface soil at Site 7, the Biological Production Site, was sampled to identify potential contamination from the past burial of incinerator residue. The sampling was conducted in a loose grid pattern that included a large area adjacent to the gun club north of the railroad tracks and an area just south of the tracks (see Figure IV-10). Sixteen samples were collected from a depth of 0 to .5 feet. At the laboratory, four groups of four samples (related by vicinity) were composited and analyzed for VOCs and heavy metals. Table IV-7 shows the soil sampling results for Site 7.

The composite sample from an area south of the pheasant pens and north of the railroad tracks contained 12 µg/g silver, which is slightly elevated above background (approximately 4 µg/g) though not significantly so. Previous analyses of the residue indicate the level of silver present in the residue to be about 2 ppm (µg/g) (Engineering Science, 1984). No other contaminants were found above background levels.

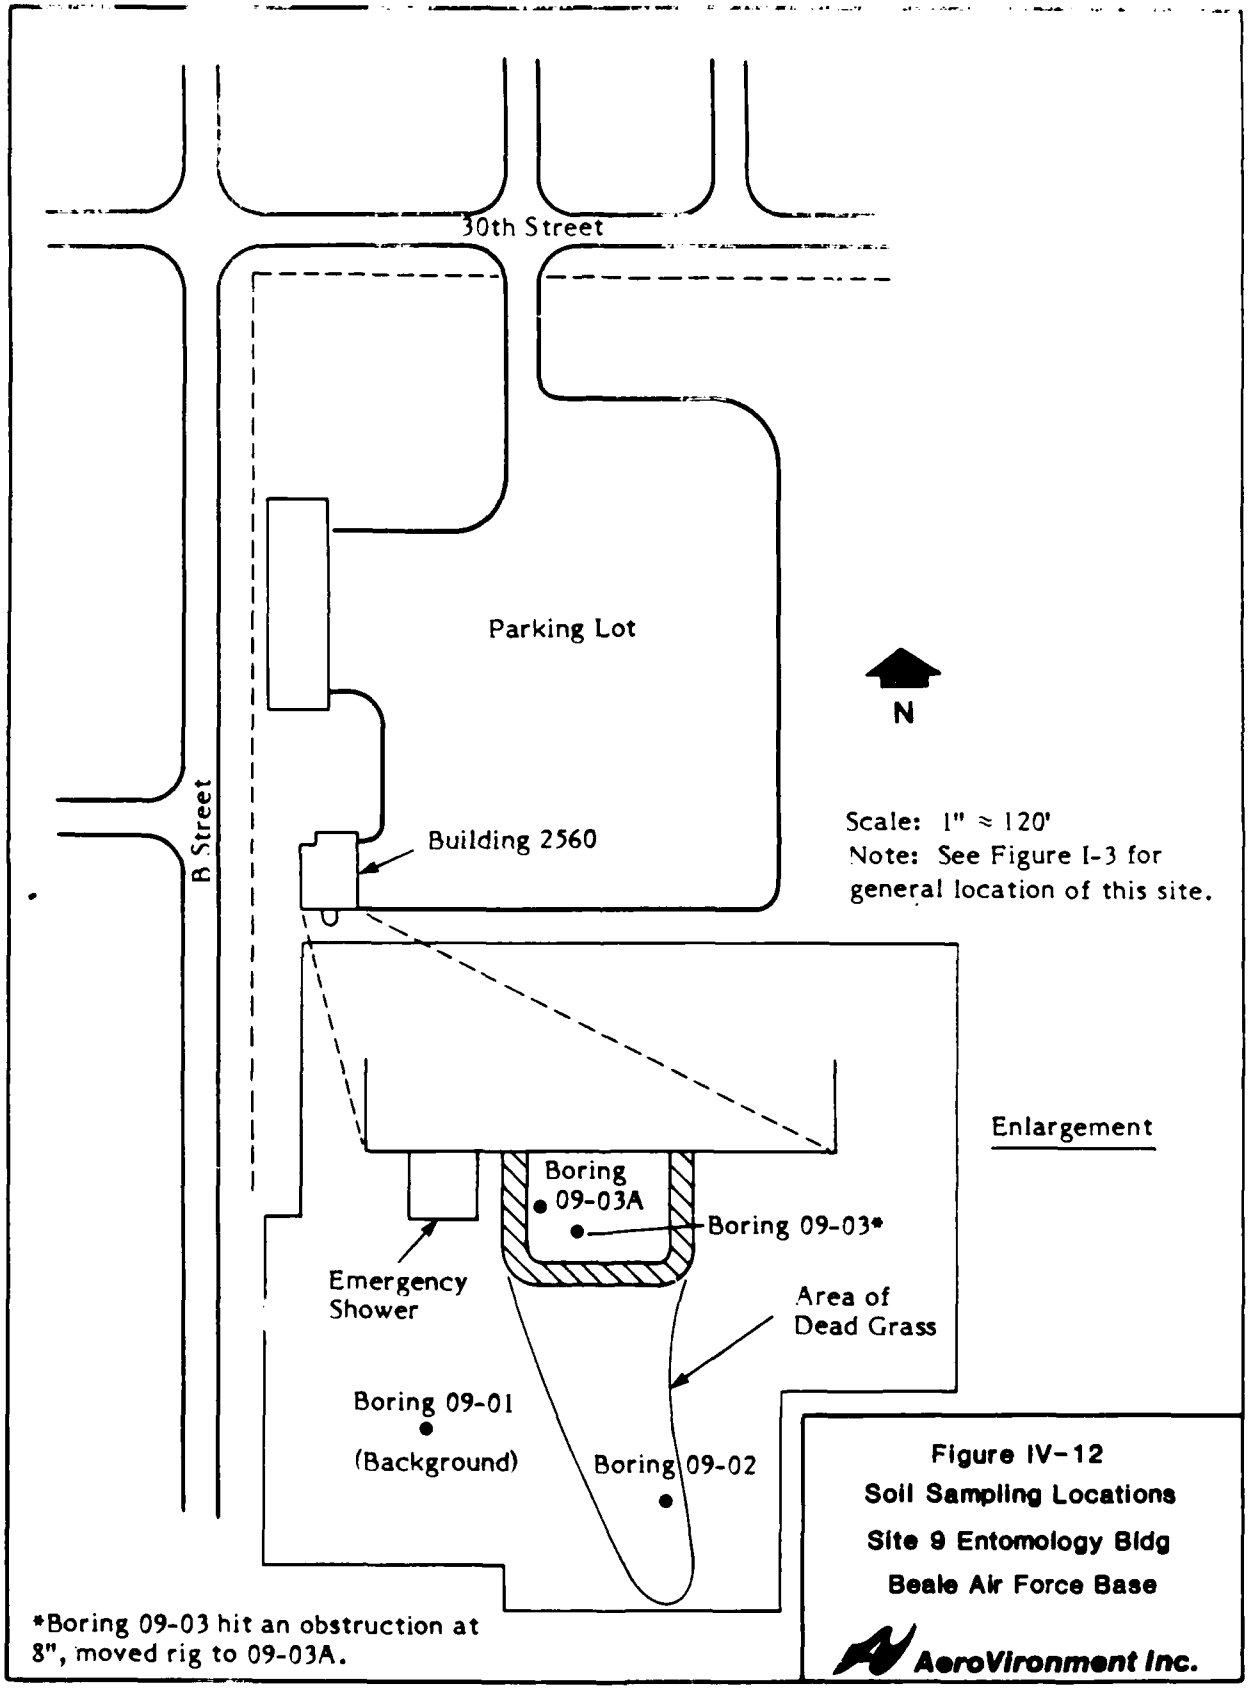
Figure IV-12
Soil Sampling Locations
Site 9 Entomology Bldg
Beale Air Force Base

Table IV-9 presents the analytical results from Site 9. The samples collected from Boring 09-03 in the mixing basin contained low levels of Chlordane. It was detected at 0.9 µg/g in the 1.5-foot sample, which is at the level of quantification (LOQ) for the analyte and is therefore considered significant (LOQ is considered to be five to ten times the method detection limit, which is 0.08 µg/g for Chlordane). The concentration dropped to 0.1 µg/g in the 6.5-foot sample from that boring. The DOHS TTLC value for Chlordane is 2.5 µg/g. No other evidence of contamination was found at Site 9.

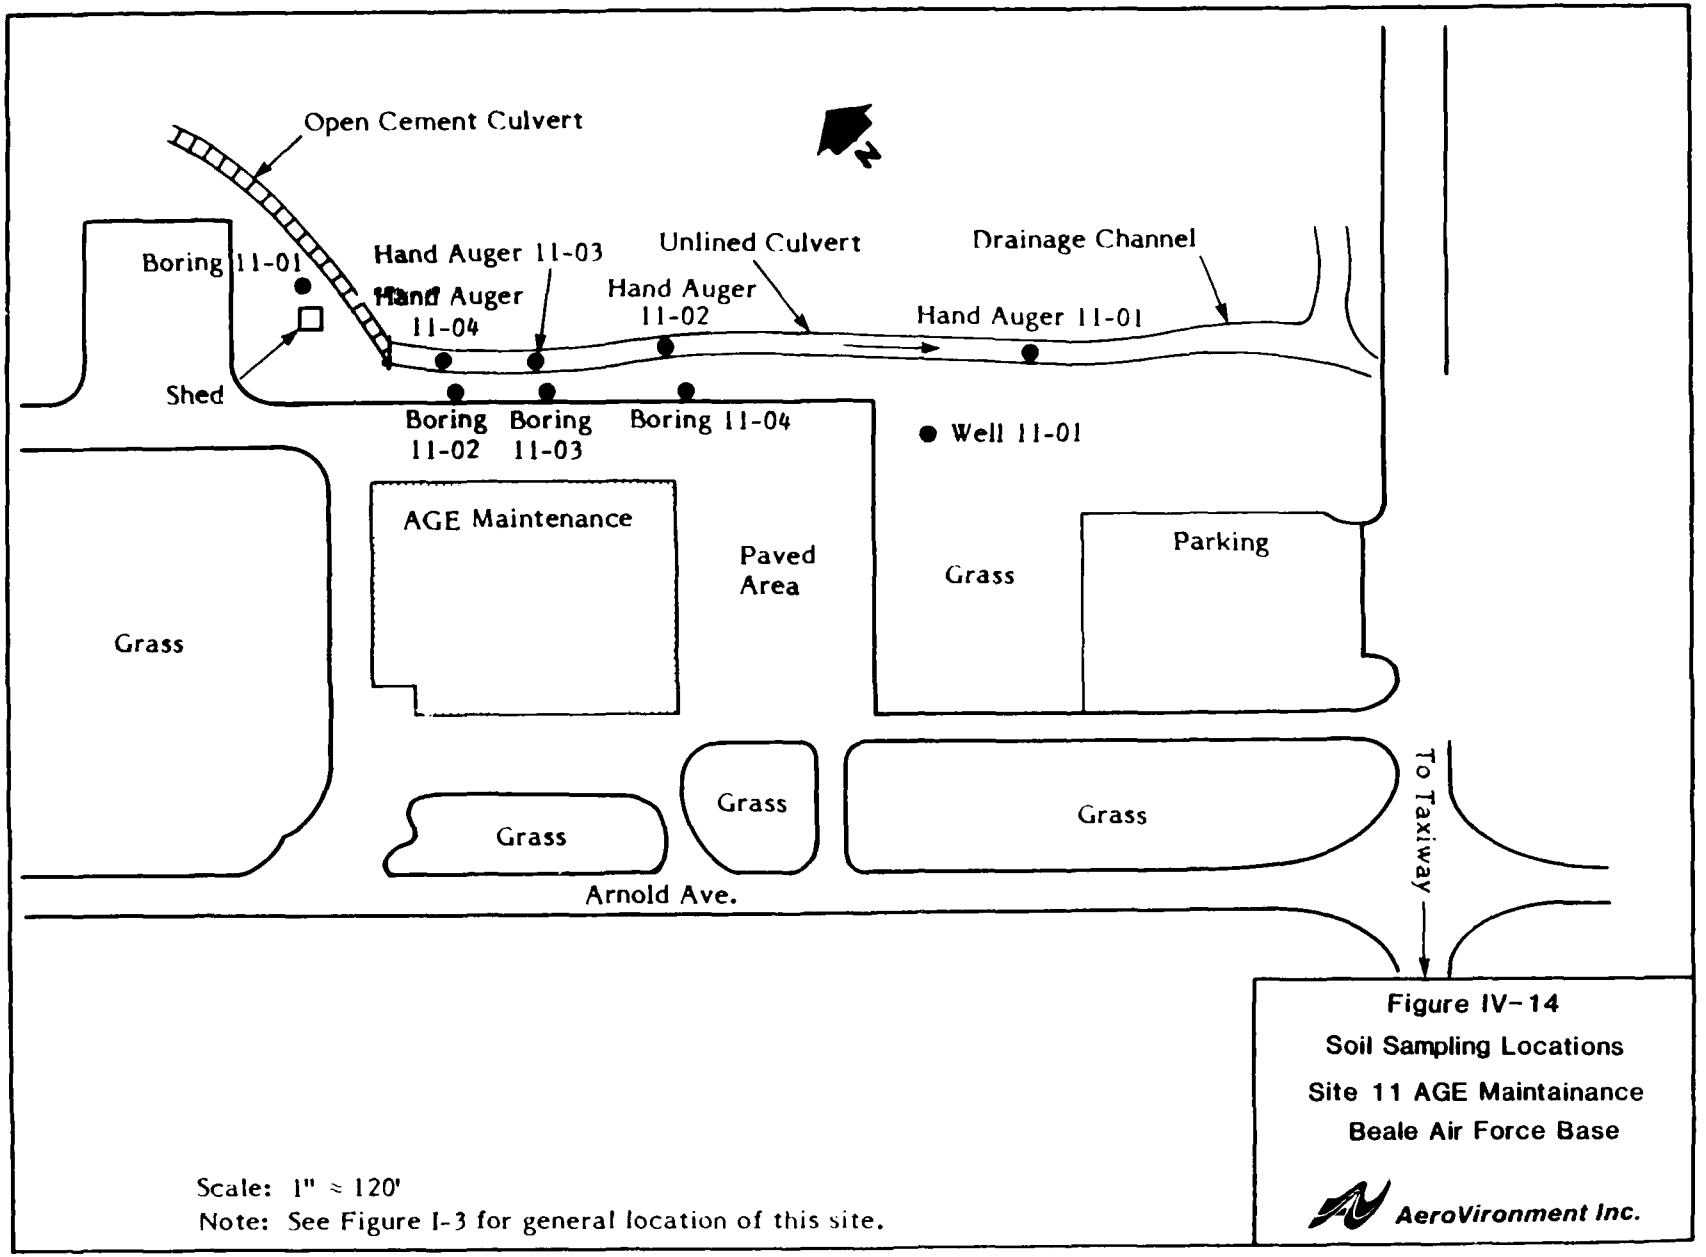
Figure IV-14
Soil Sampling Locations
Site 11 AGE Maintainance
Beale Air Force Base

Table IV-11 shows the analytical results. Hydrocarbon contamination was identified at the surface (1.5 feet) in Borings 11-02, 03 and 04. O&G values at 1.5 feet ranged from 1500 to 7000 µg/g and showed a decreasing trend from Boring 11-02 to Boring 11-04 (north to south). Elevated levels of volatile aromatics characteristic of gasoline were detected in the 1.5-foot sample from Boring 4, which had the highest organic vapor reading of the three borings.

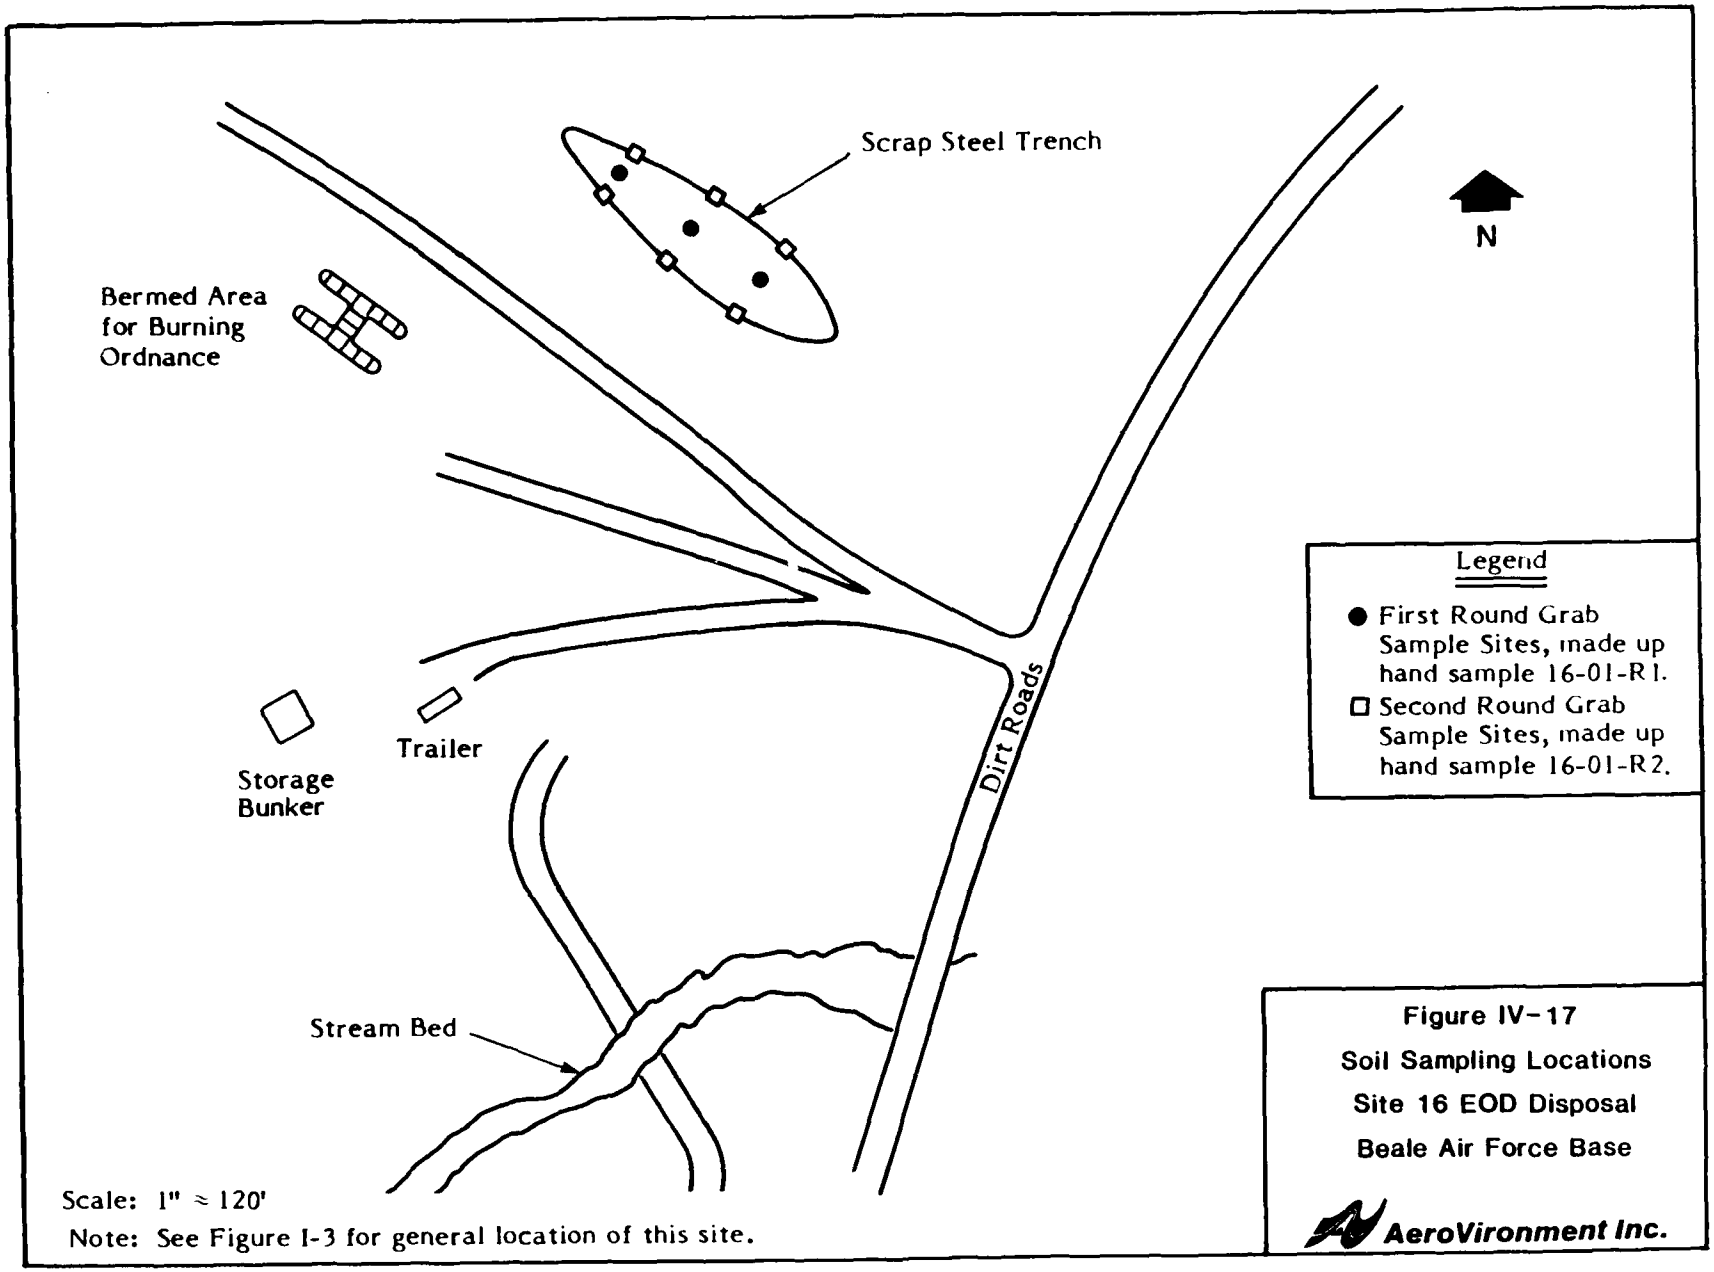
The trench soil was found to be contaminated with chromium, barium and lead. Lead was found at 14,000 µg/g (1.4% by weight), which greatly exceeds the TTLC of 1000 µg/g. (Background levels at other sites are about 10 µg/g.) An unidentified yellow powder was observed in the trench at the time of sampling and may have contributed to the high concentration of metals. No evidence of explosive residues was found. Because of the high metal concentrations, the trench was resampled five months later, at which time it contained several feet of water. During the second sampling, surface soil samples were taken around the perimeter of the trench at the waterline and approximately six inches beneath the water surface. Three samples were again composited in the laboratory for metals analysis. Concentrations of metals in a composite of these samples were lower than in the original sample, but chromium and lead were still present at significant levels. The metals appear to be in an insoluble form, based on the results of an EP Toxicity Test performed on the second round sample. The EP Toxicity Test showed lead at only 0.26 ppm weight per volume in the leachate.

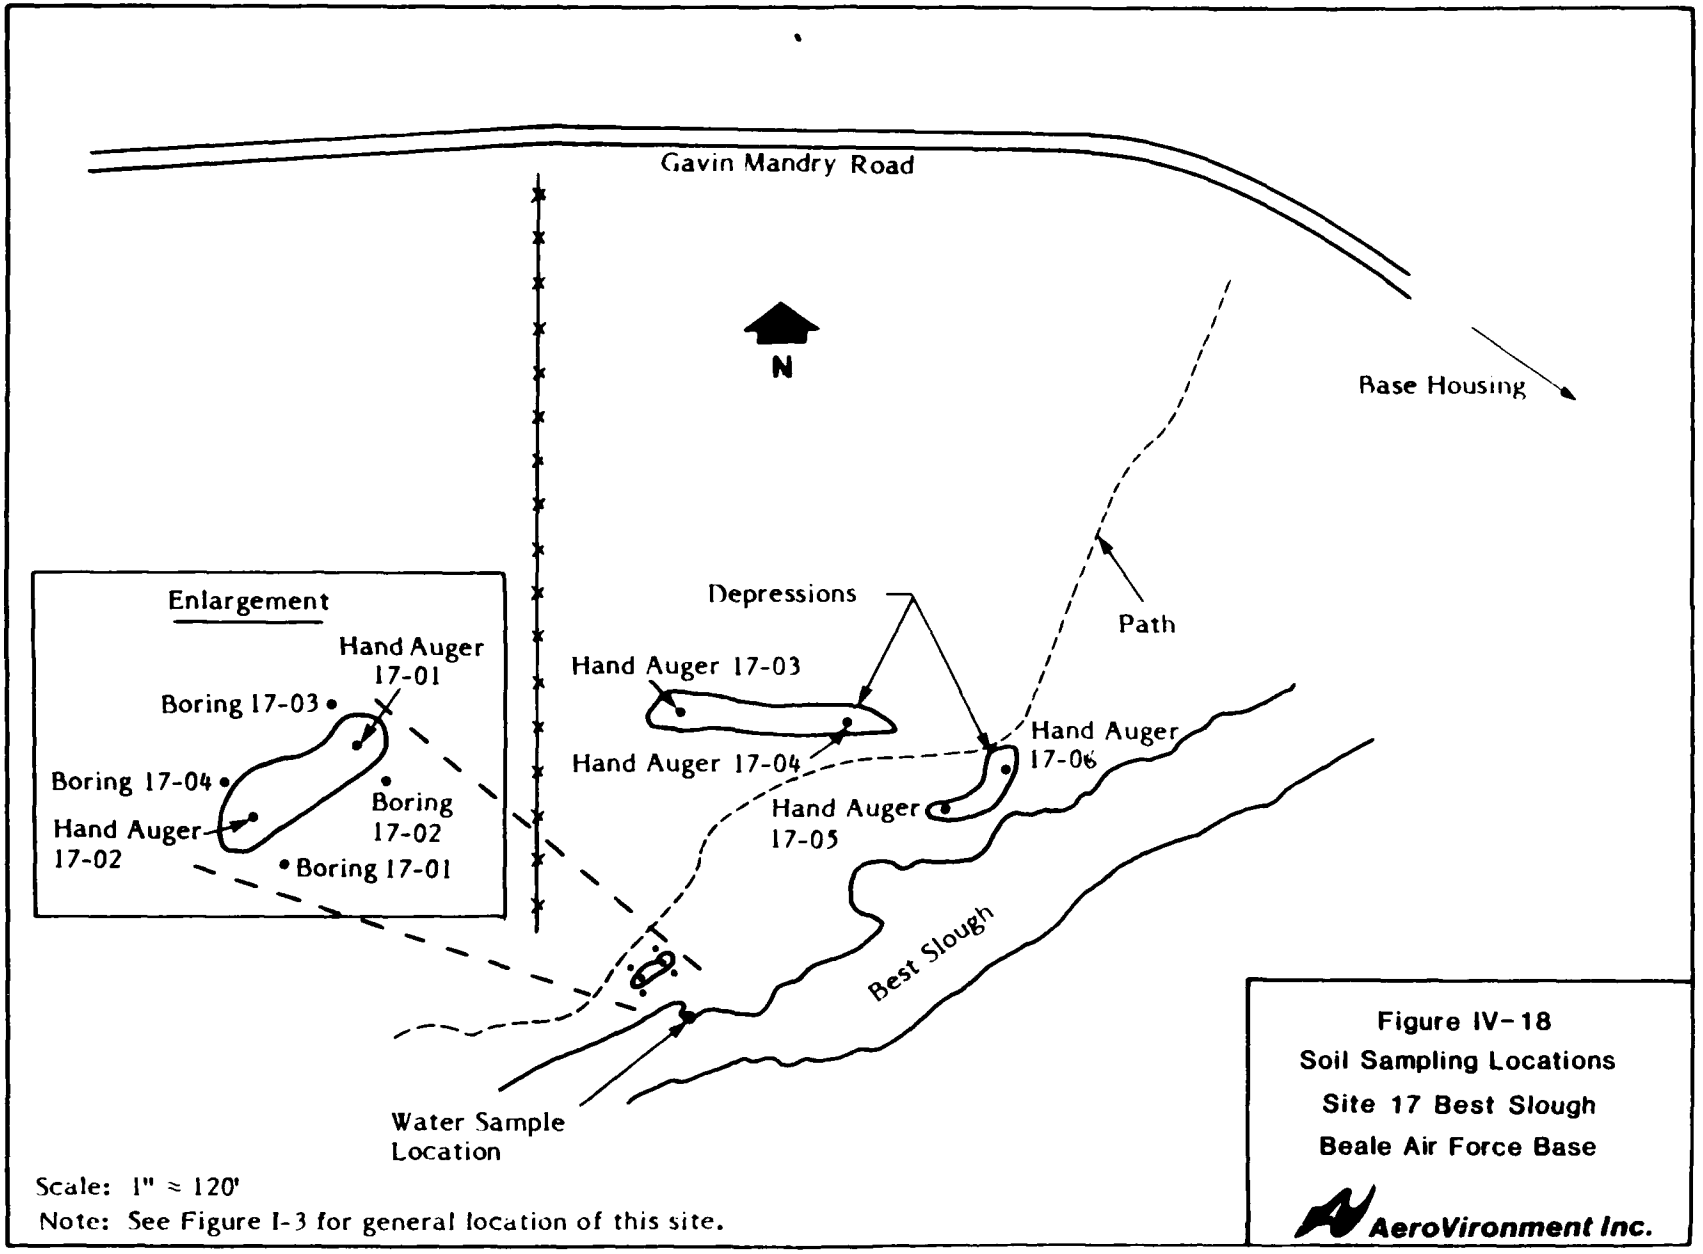
At Site 17, Best Slough, four soil borings were sited around the perimeter of a small trench containing rusting 55-gallon drums, one boring was located 220 feet west of the trench, and the background boring was located along the fence at the northwest edge of the site (see Figure IV-18). Samples were collected at 5-foot and 15-foot depths and analyzed for O&G, VOCs, total phenolics and pesticides/herbicides. Two surface hand-auger samples were also collected from each of three trenches at the site and analyzed for the same parameters. Table IV-15 shows the laboratory results for these samples. No detectable concentrations of any of the analytes were found.

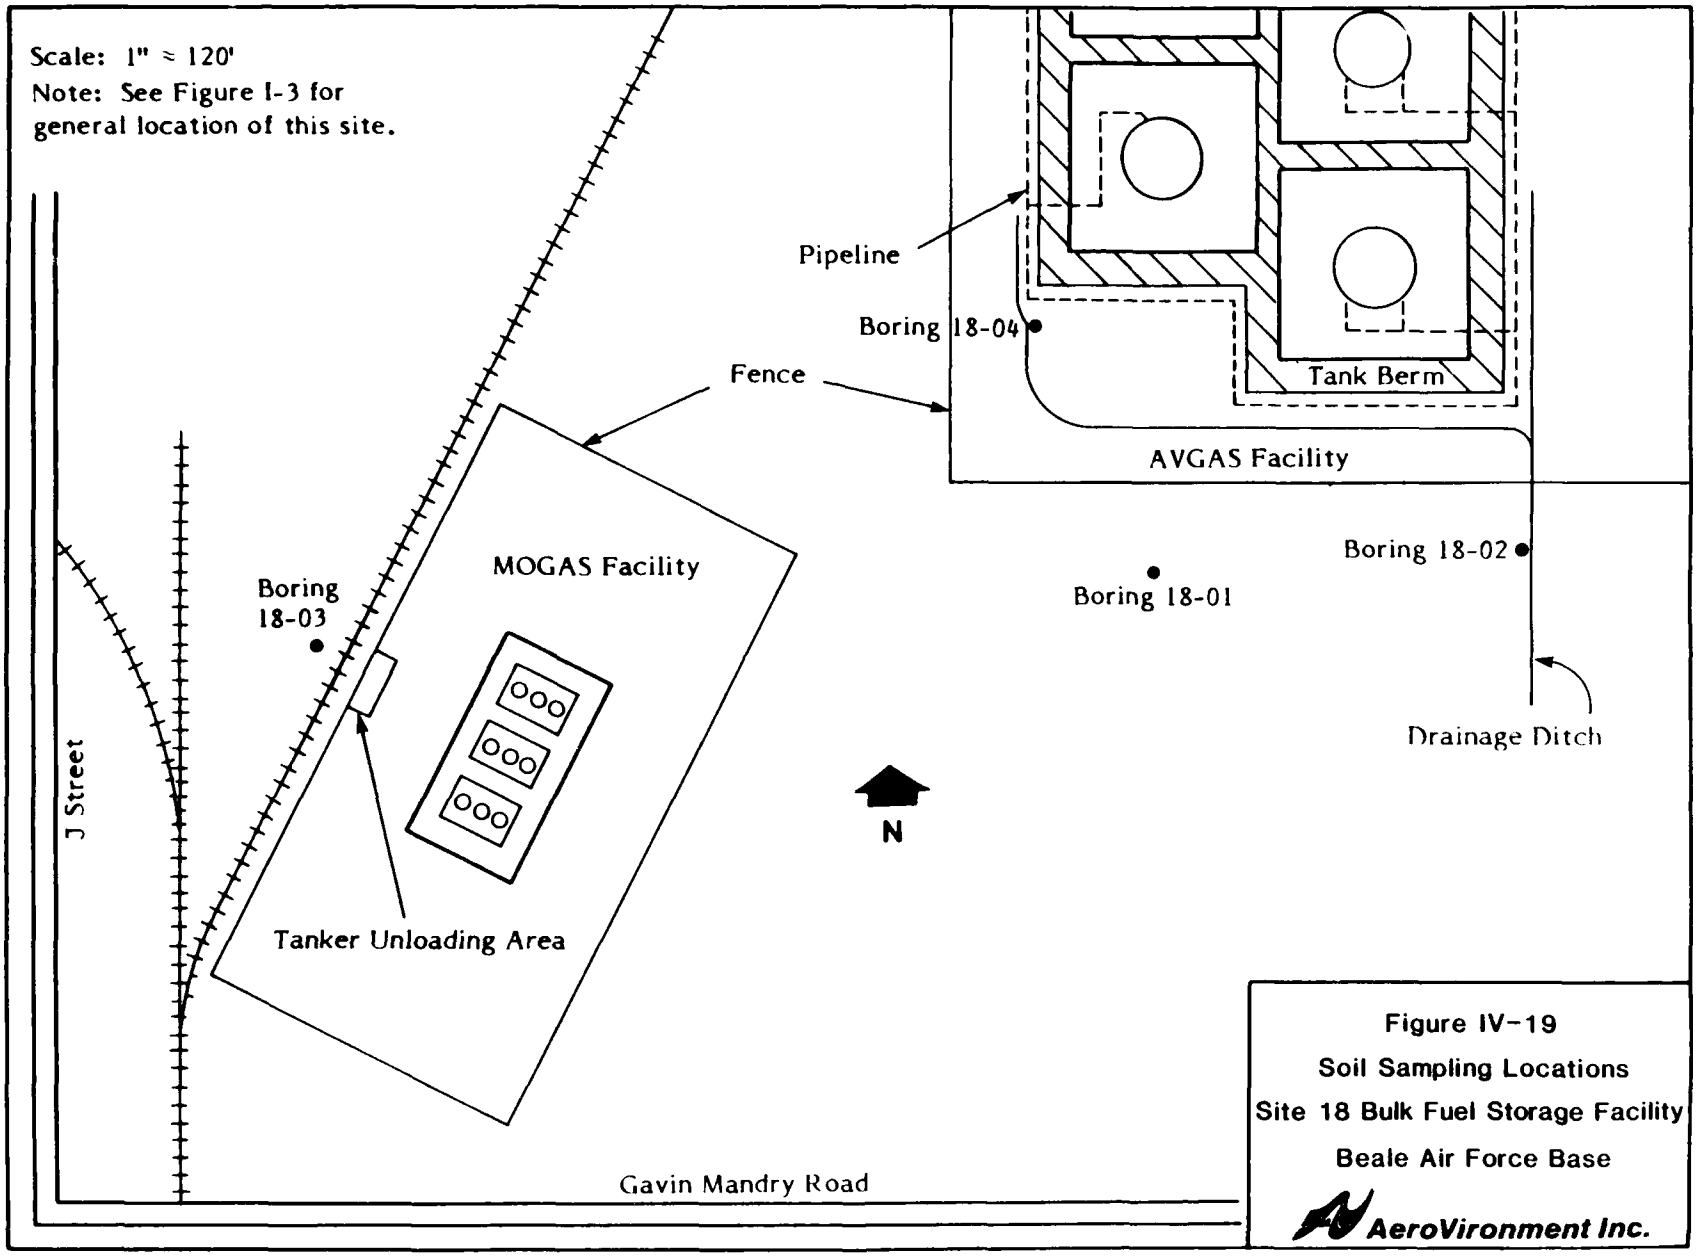
Figure IV-19
Soil Sampling Locations
Site 18 Bulk Fuel Storage Facility
Beale Air Force Base

Table IV-16 shows the analytical results from Site 18. Most of the samples from Borings 18-01, 02 and 03 had levels of O&G and petroleum hydrocarbons (400/300 µg/g) slightly above background concentrations. These values are not considered significant for the following reasons: (1) Most of the O&G values in the laboratory analysis batch were reported as 400 µg/g, indicating a potential analytical background problem. (2) Samples from the background boring were reported to have 400 µg/g O&G at the surface and at 16.5 feet, which was unexpected. (3) No visible evidence of contamination was observed in the field.
