INSTALLATION RESTORATION PROGRAM
PHASE II - CONFIRMATION/QUANTIFICATION

STAGE 1

FINAL REPORT FOR

BEALE AIR FORCE BASE,
MARYSVILLE, CALIFORNIA

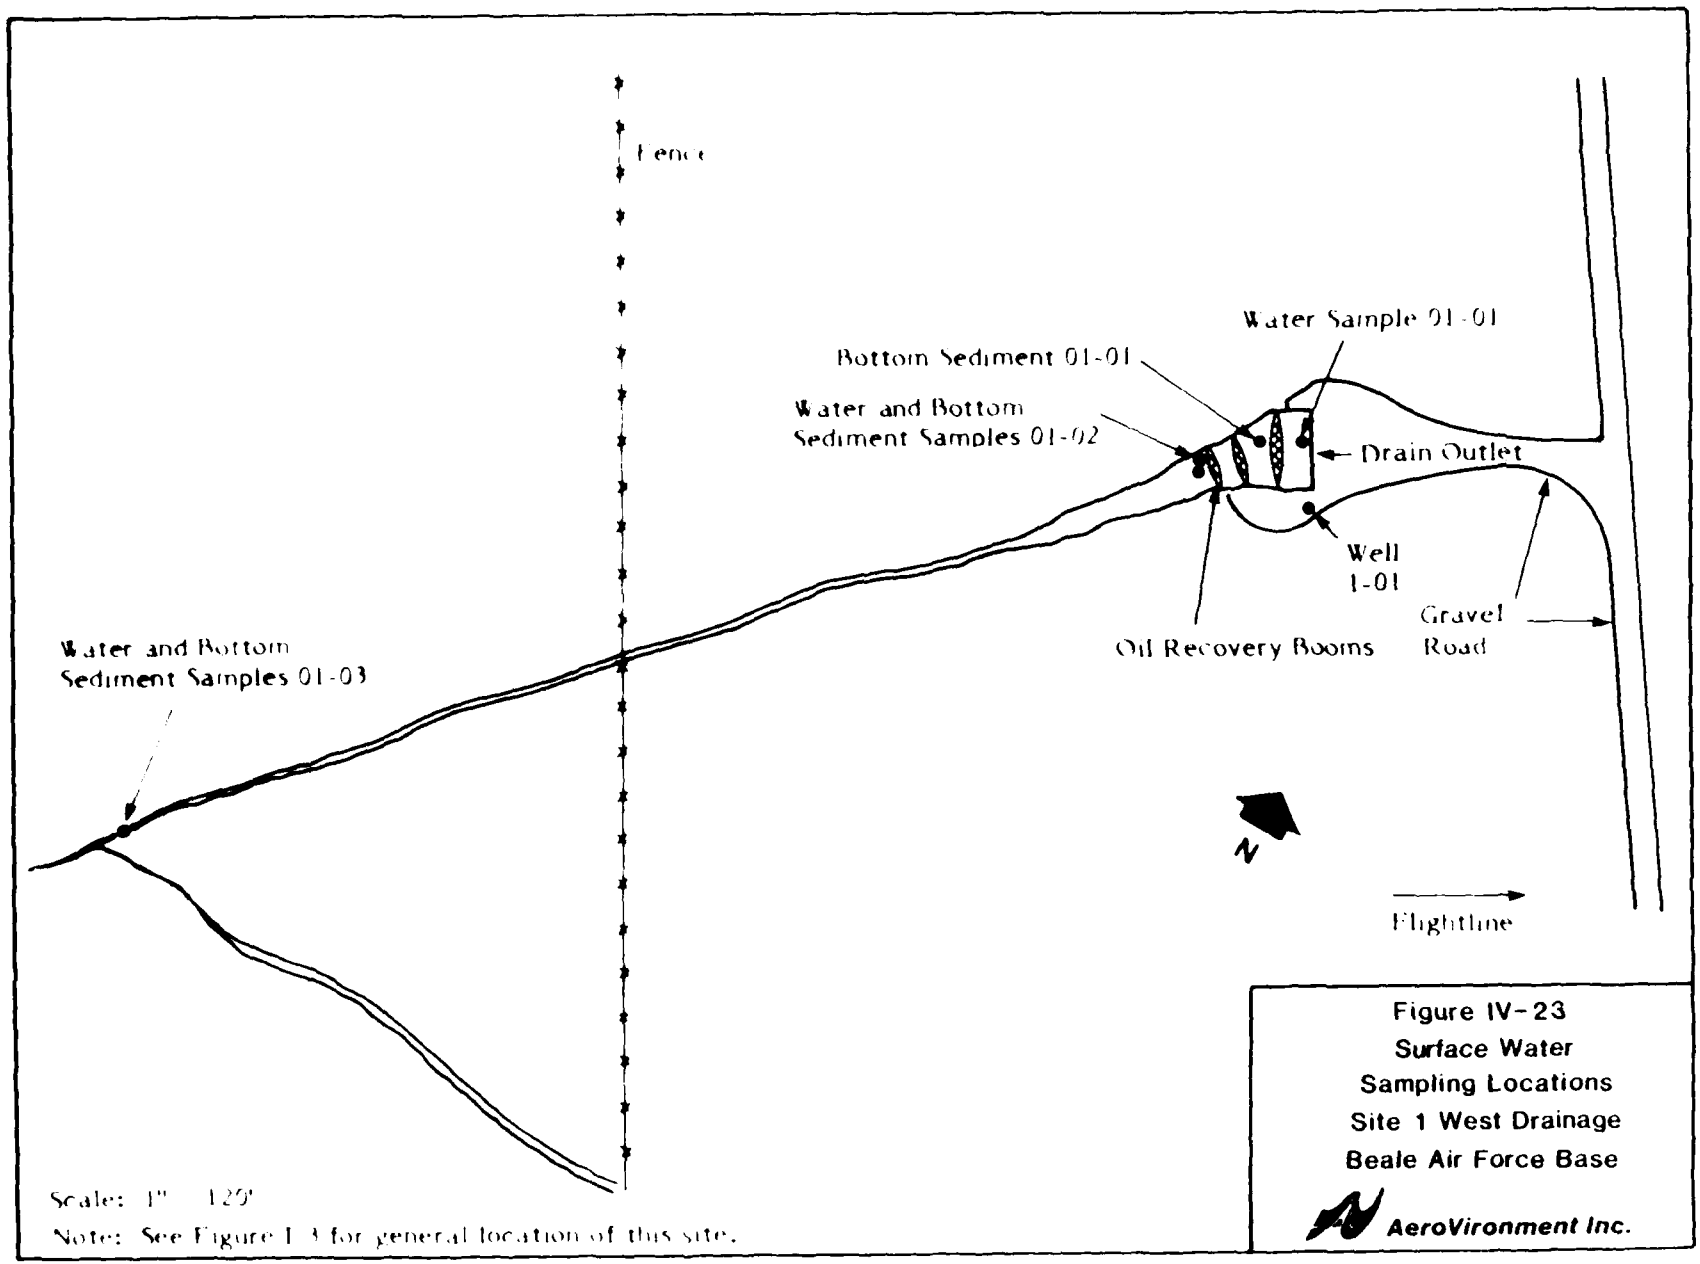
Figure IV-23
Surface Water
Sampling Locations
Site 1 West Drainage
Beale Air Force Base

Bottom sediment samples were collected at each surface water sampling location at depths of 0-0.5 feet, with the exception of Sampling Location No. 3, where surface sediment was sampled. VOC results indicated significant hydrocarbon contamination in the bottom sediments; the highest level was

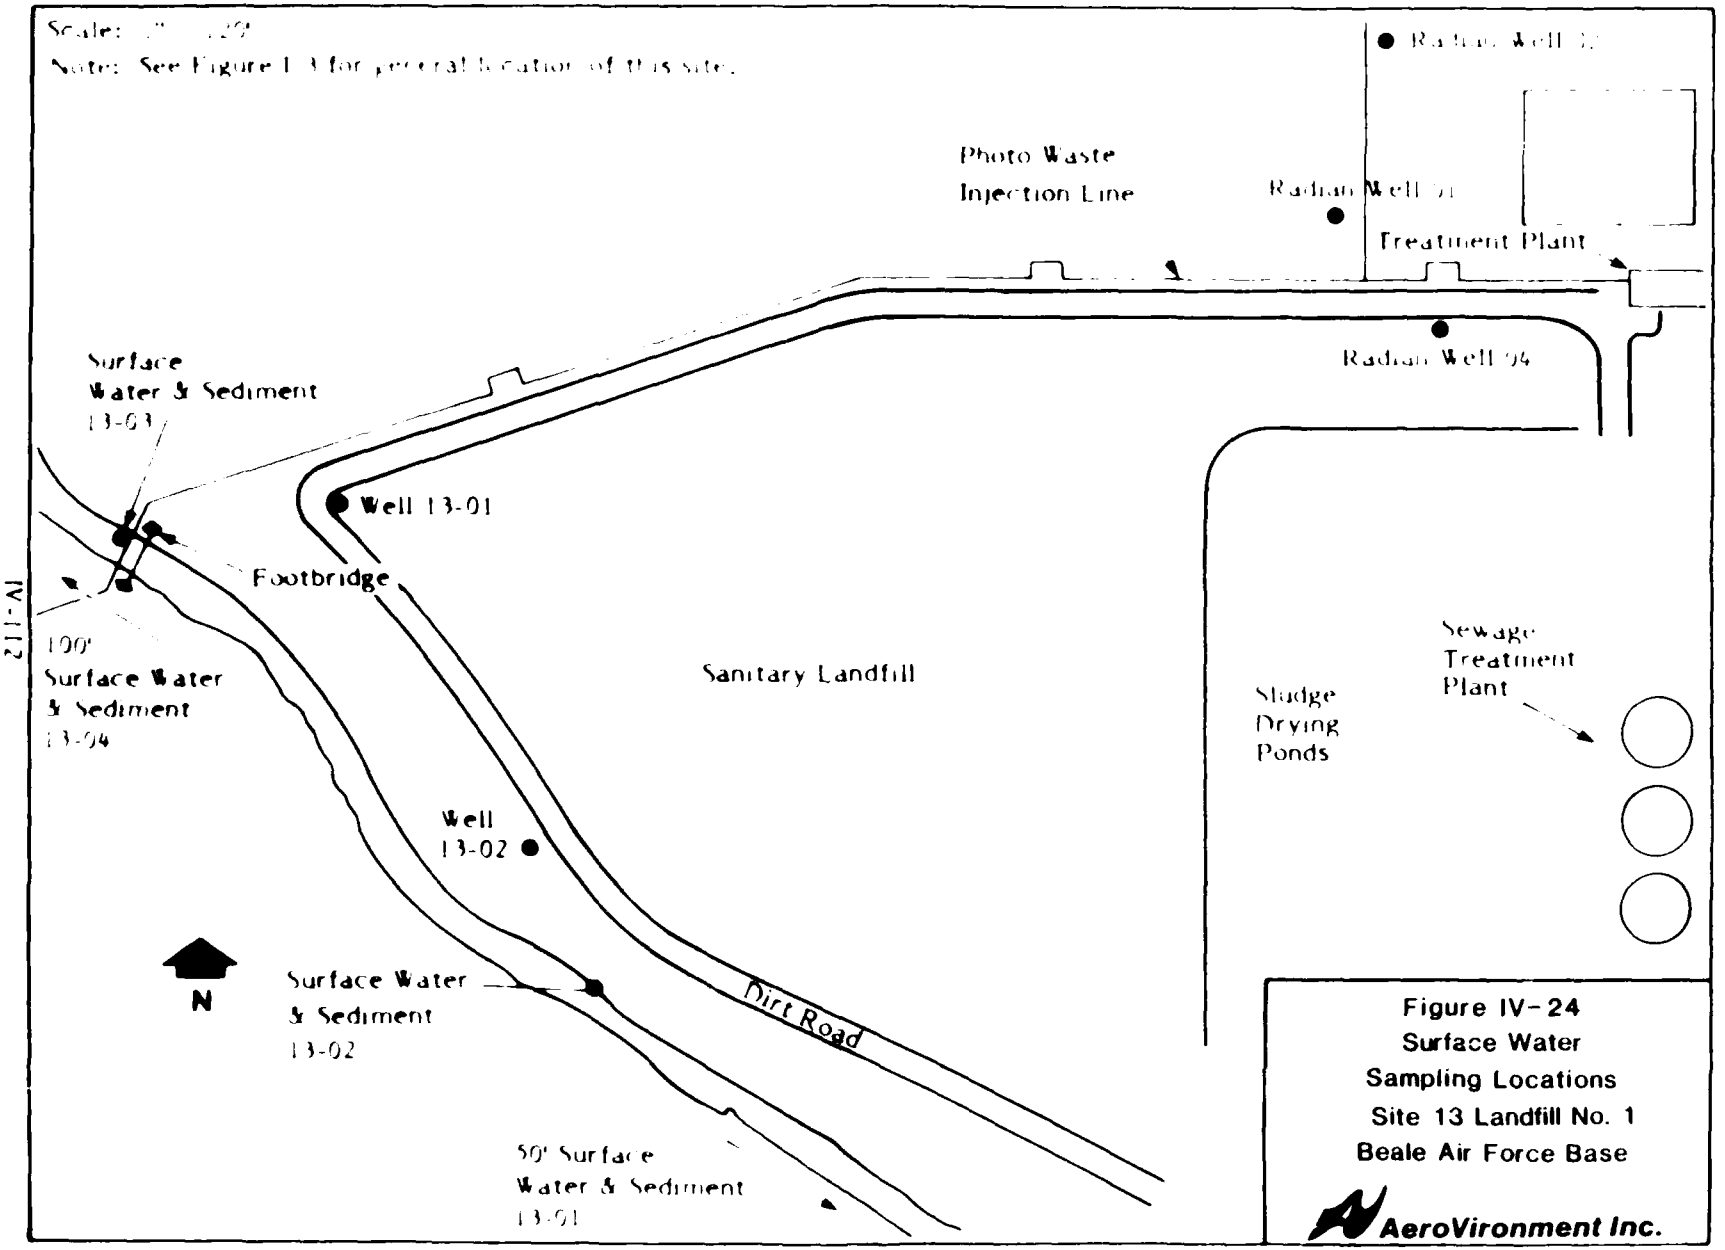
Figure IV-24
Surface Water
Sampling Locations
Site 13 Landfill No. 1
Beale Air Force Base

Low levels of the organochlorine pesticides gamma-BHC (Lindane) and Aldrin and the chlorophenoxy herbicide 2,4-dichlorophenoxyacetic acid (2,4-D) were detected in the water samples. Lindane was found at levels above the LOQ in all but one sample from both sampling rounds and is therefore considered to be significant (0.04-0.11 ug/l). No action level is specified for Lindane. Aldrin was detected in all of the second round samples at concentrations near the method detection limit and well below the LOQ. The action level for Aldrin, which is 0.05 ug/l, was equaled or exceeded for each sample collected during the second round. No Aldrin was detected during the first round. The nonreproducibility between sampling rounds does not necessarily indicate sampling or analytical error, given the dynamic nature of surface water systems as opposed to groundwater. Aldrin and Lindane are relatively persistent and stable in the environment, though the probability that these compounds originate at Landfill I is remote, since the upstream sample was reported to contain both, and there is no significant increasing trend in the downstream samples. 2,4-D, a common herbicide, was detected in three samples at levels of 0.07 and 0.08 ug/l (below the LOQ). Although no action level is specified for 2,4-D, the primary drinking water standard is 100 ug/l. The levels of 2,4-D found are not considered to be significant evidence of contamination.

Volatile organic (VOC) samples collected from Site 13 during the first sampling round in November 1985 were not analyzed by EPA Method 602 within the specified holding time due to a laboratory instrument malfunction. VOC was resampled in January 1986 to provide a valid data set. No significant levels of VOCs were found in Site 13 surface water samples.

All bottom sediment samples were below background for the parameters analyzed. No further significant evidence of surface water contamination was found at Site 13.

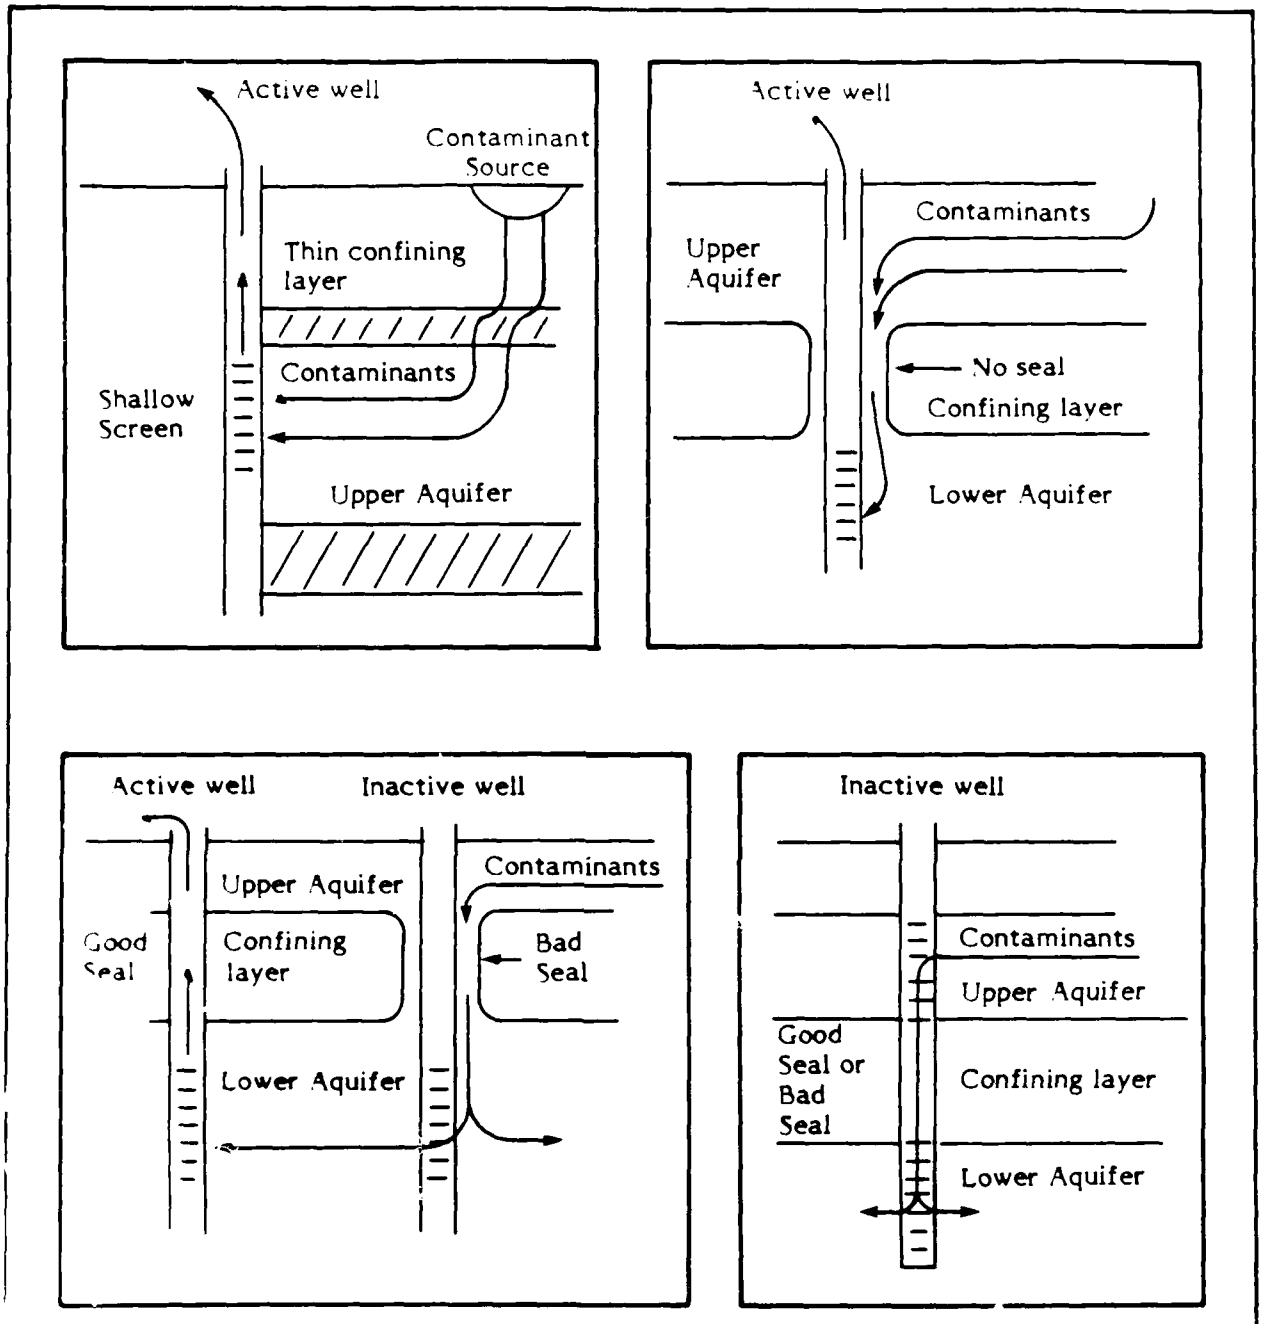
Figure IV-25

A number of pathways are possible for upper strata contamination to enter the production zone. The primary pathways are shown in Figure IV-25. The first is infiltration and leakage from the upper strata into the production zone through the confining layer. The source of the leakage is at an up gradient location. This is especially critical where the overlying strata are permeable due to gravel near the surface. A contributing factor to this pathway of pollutant travel into production wells is the placement of well screening in relatively shallow, permeable zones. In some of the production wells, perforation begins as shallow as 93 feet. This upper permeable zone would be the first stratum to be contaminated, and wells which tap these shallower zones in areas where contamination exists are likely to become contaminated.

A second contamination pathway is the vertical movement of pollutants from a contaminated shallow aquifer, down the annular space of a well, into lower aquifers. This is a common source of pollution in old wells and is related to past well construction practices where no seal or an inadequate seal was provided between the surface zones and the deeper zones from which water is drawn into the well. This situation can cause problems in two ways. If the well is active, the contaminants will be drawn down through the well's gravel pack and be

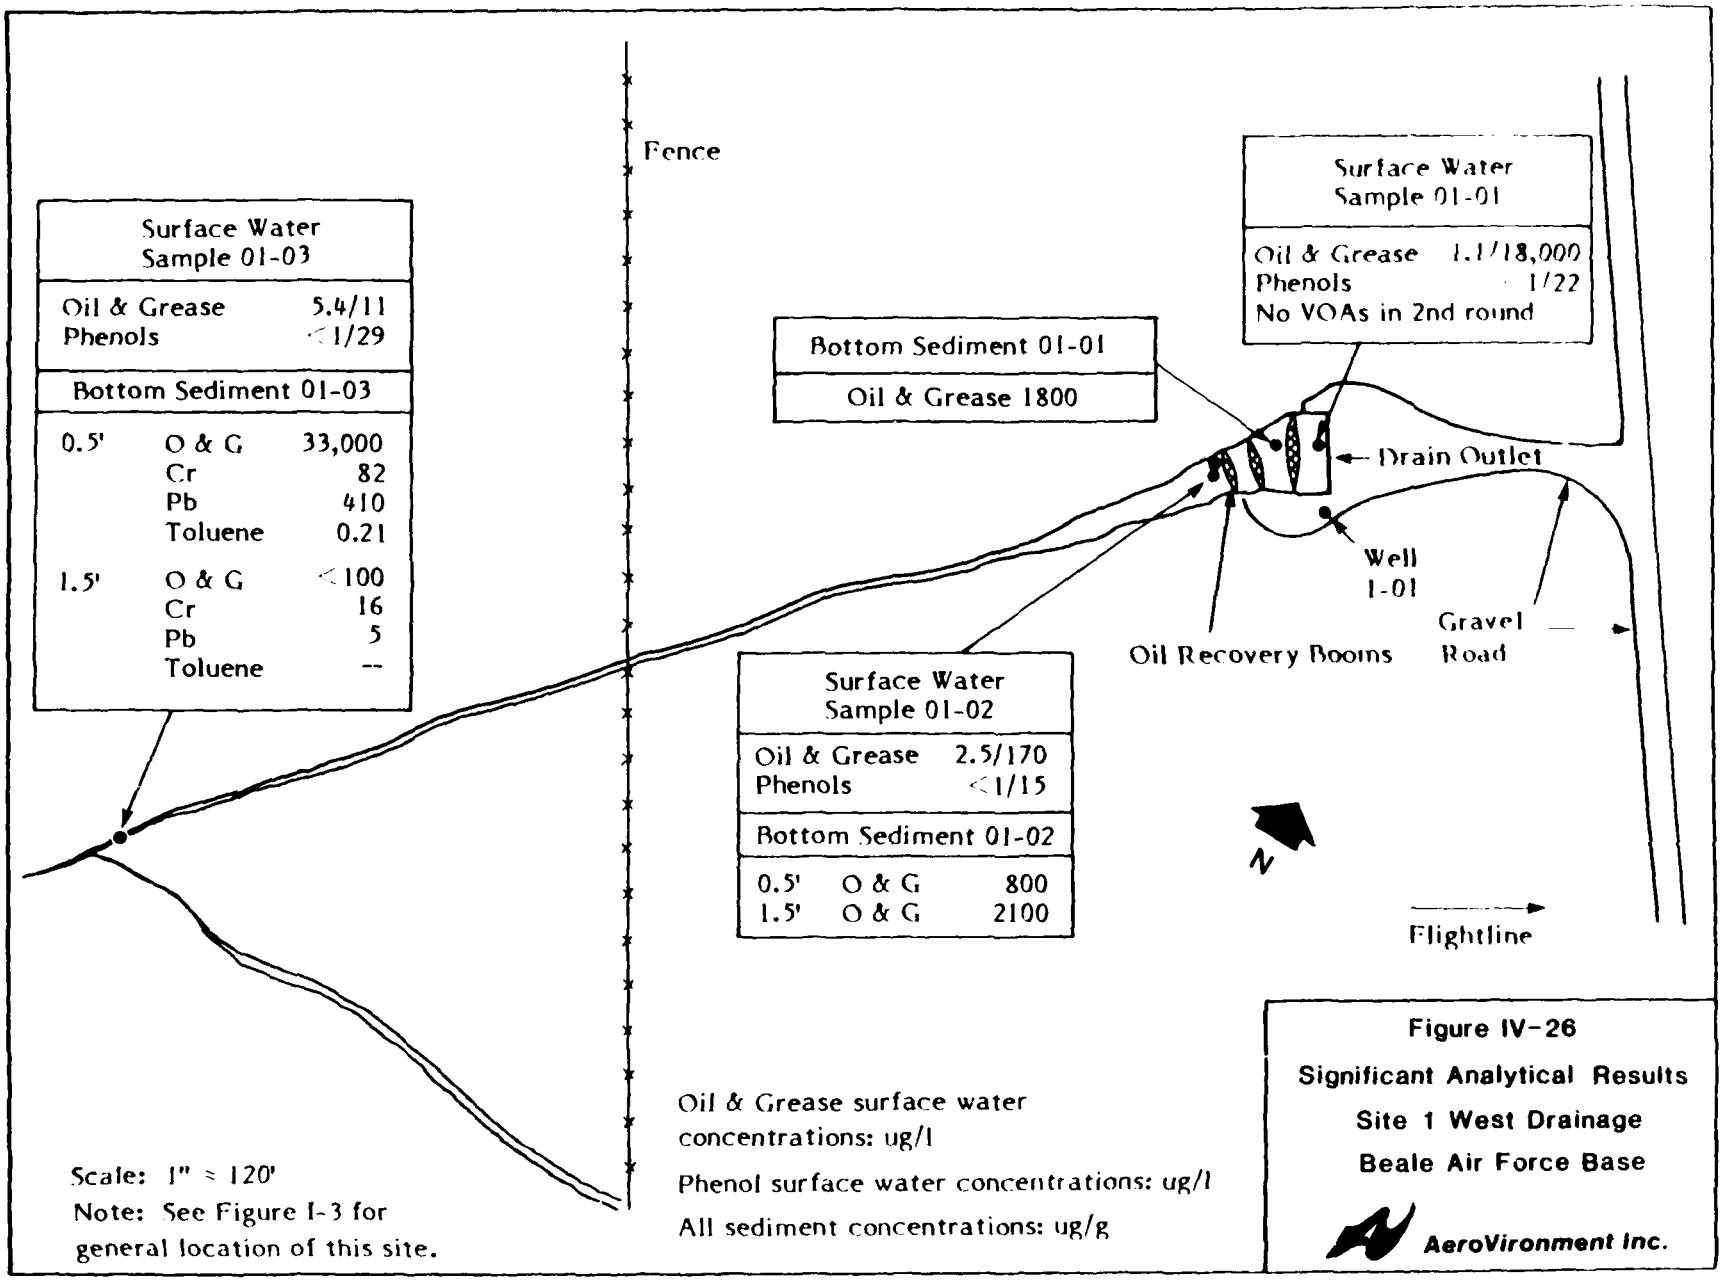
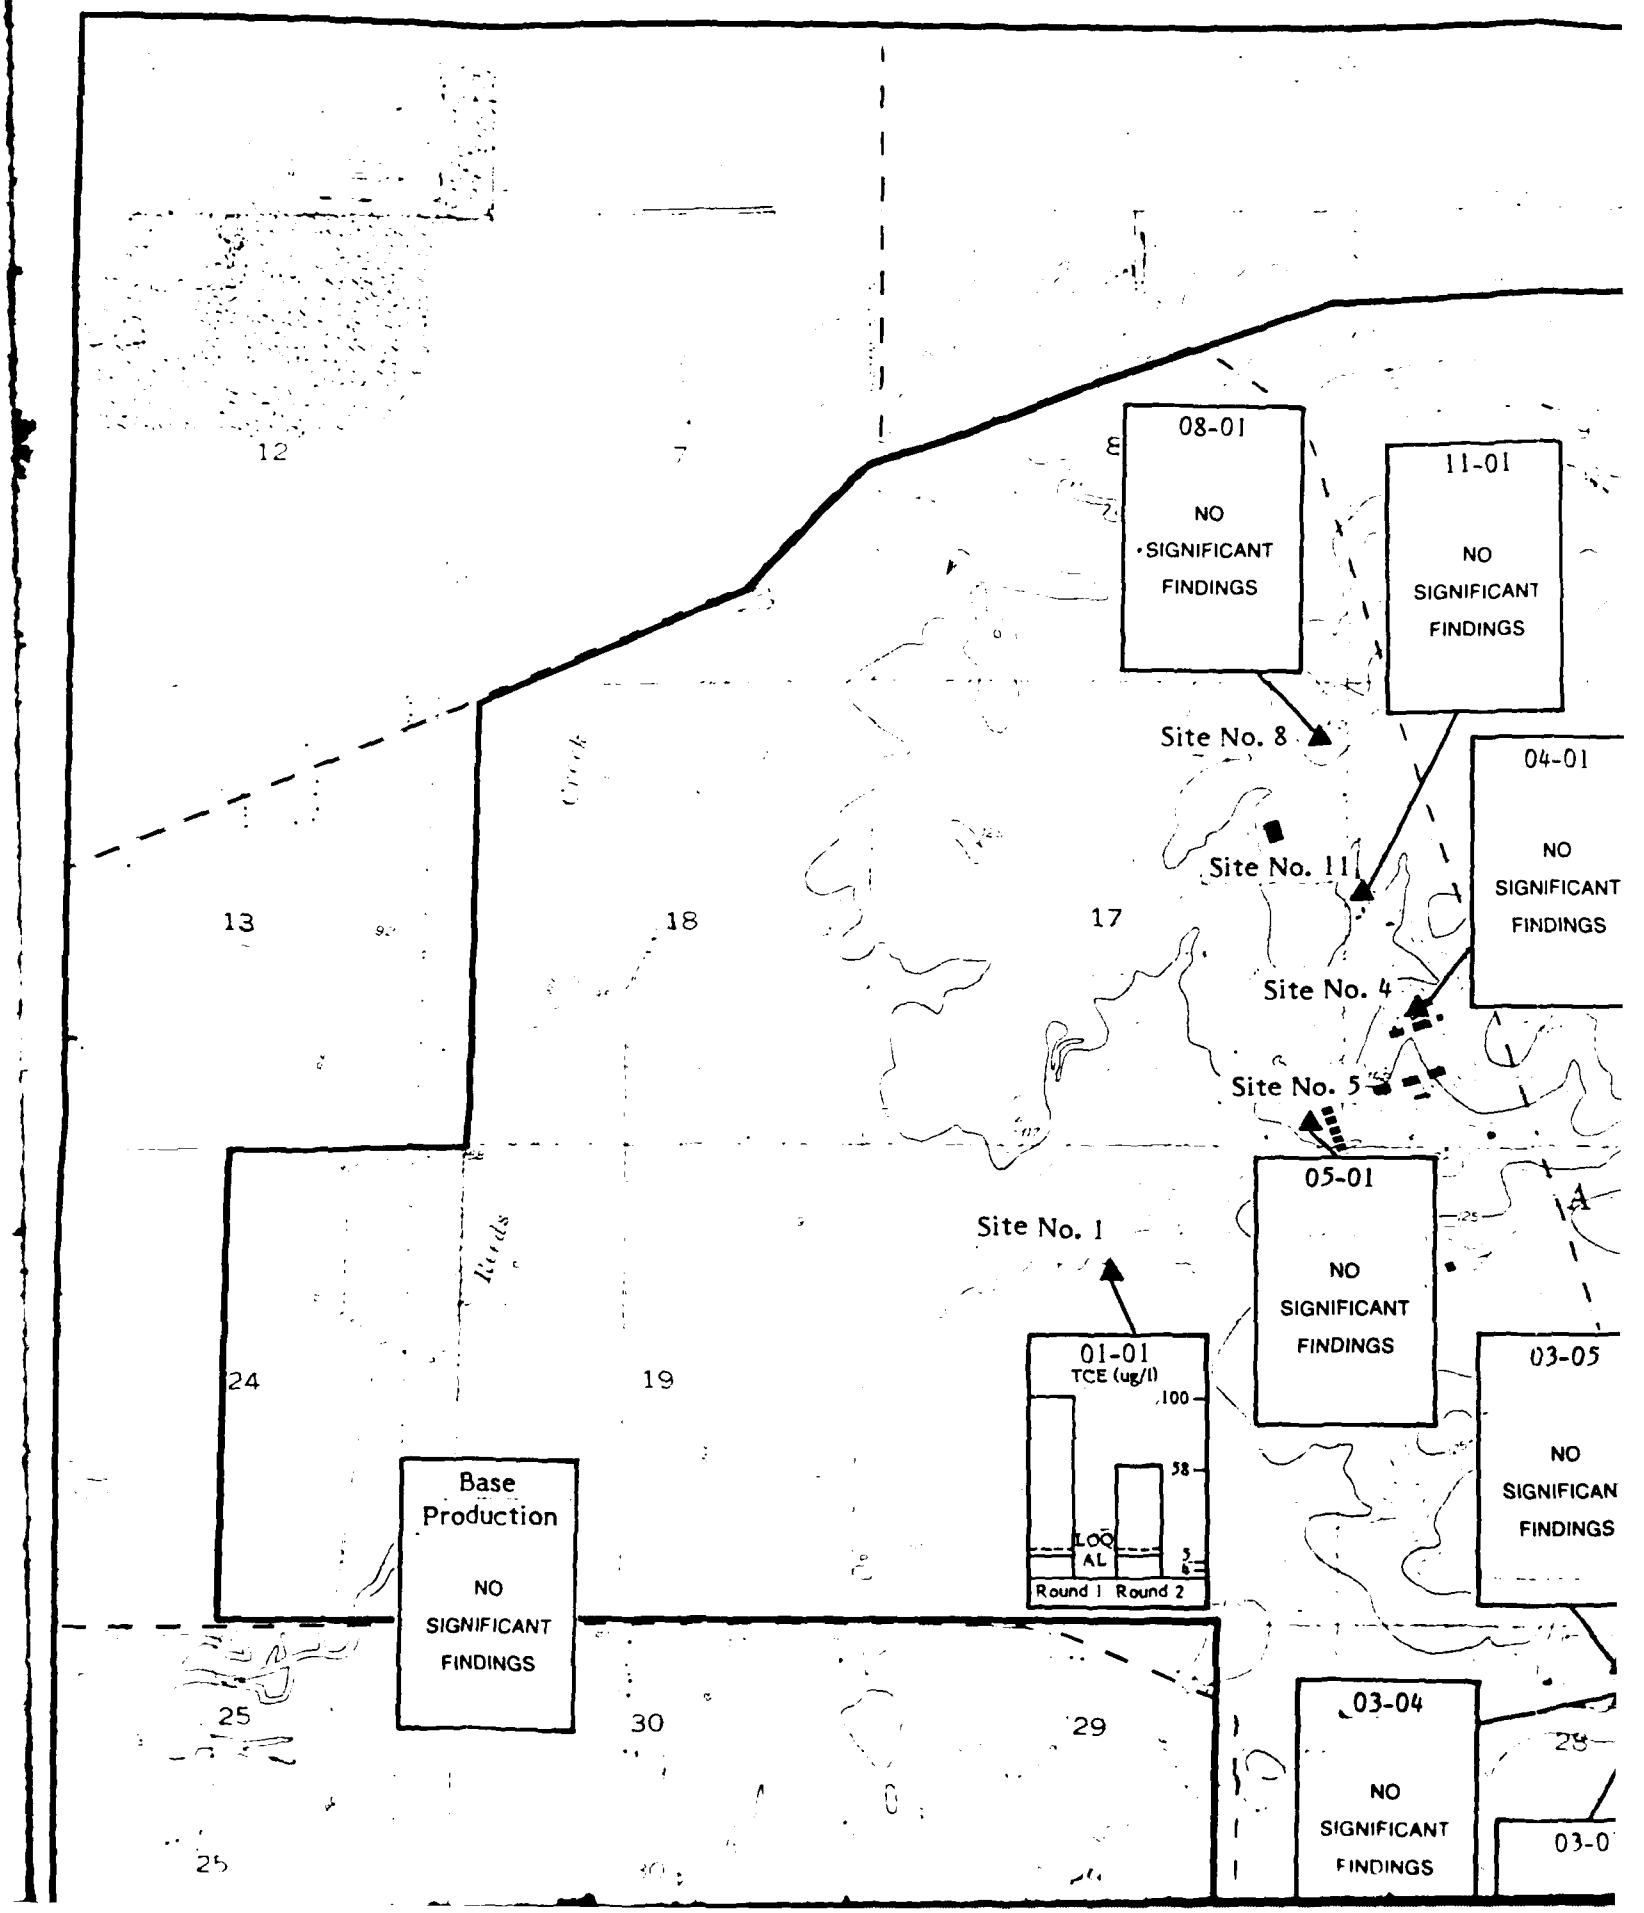
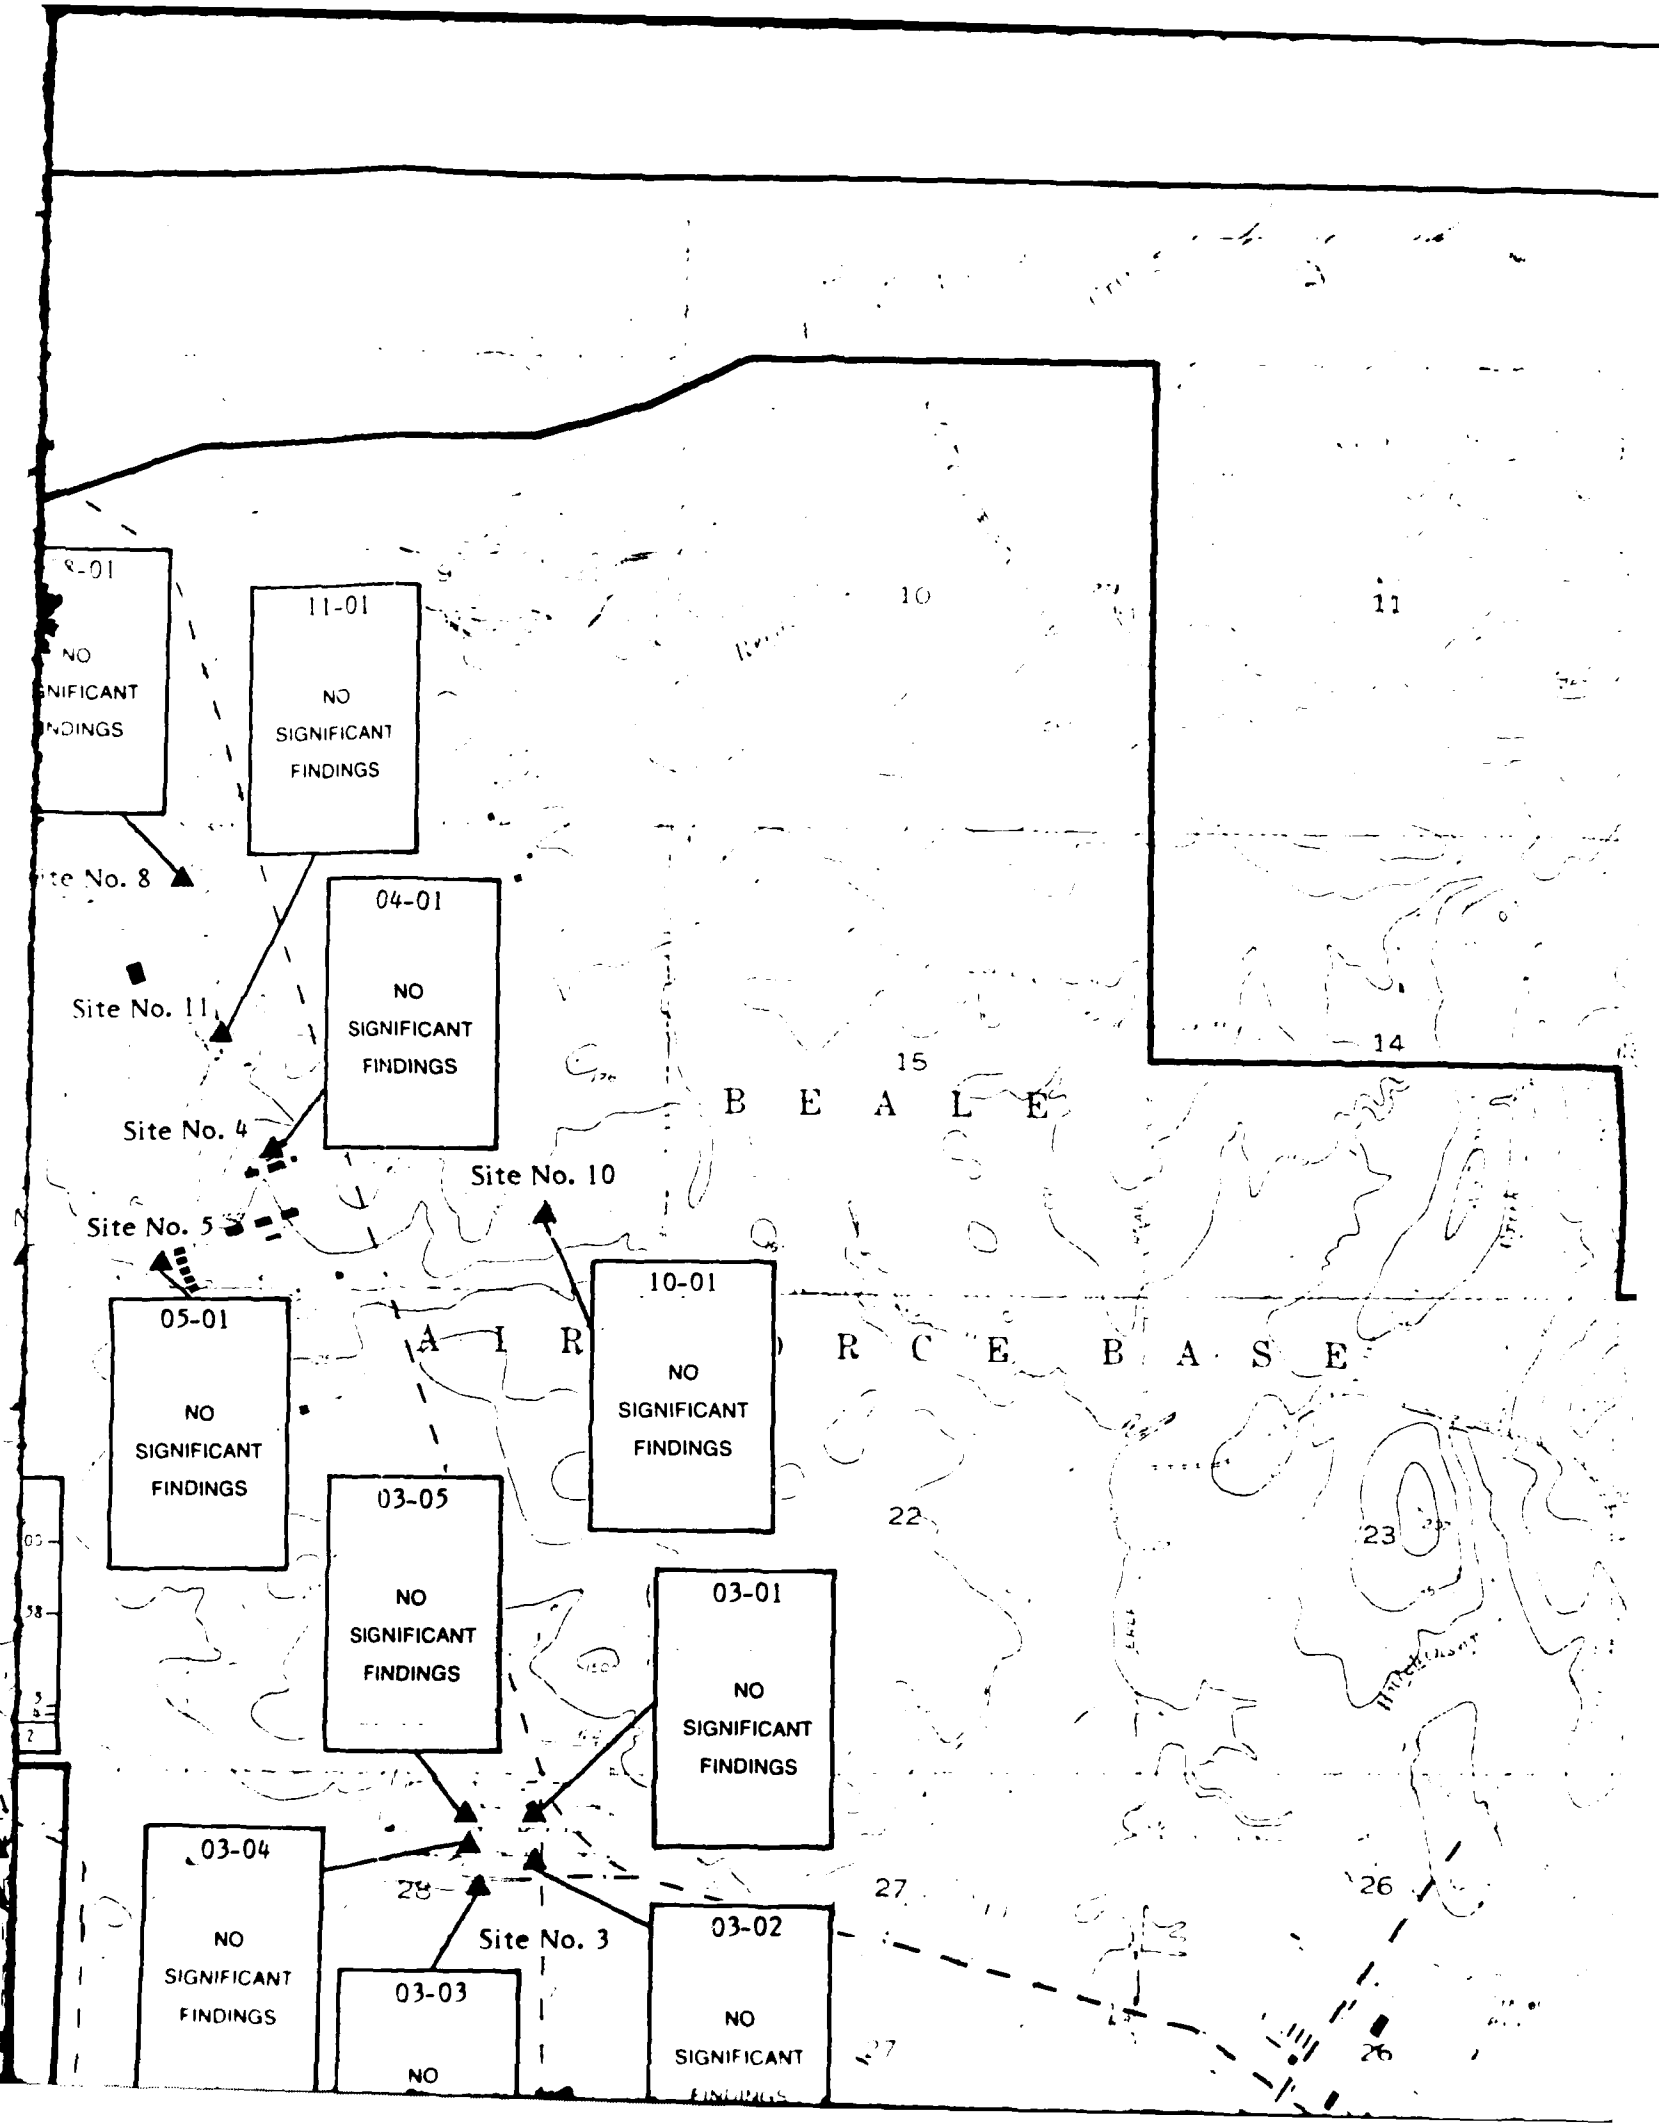
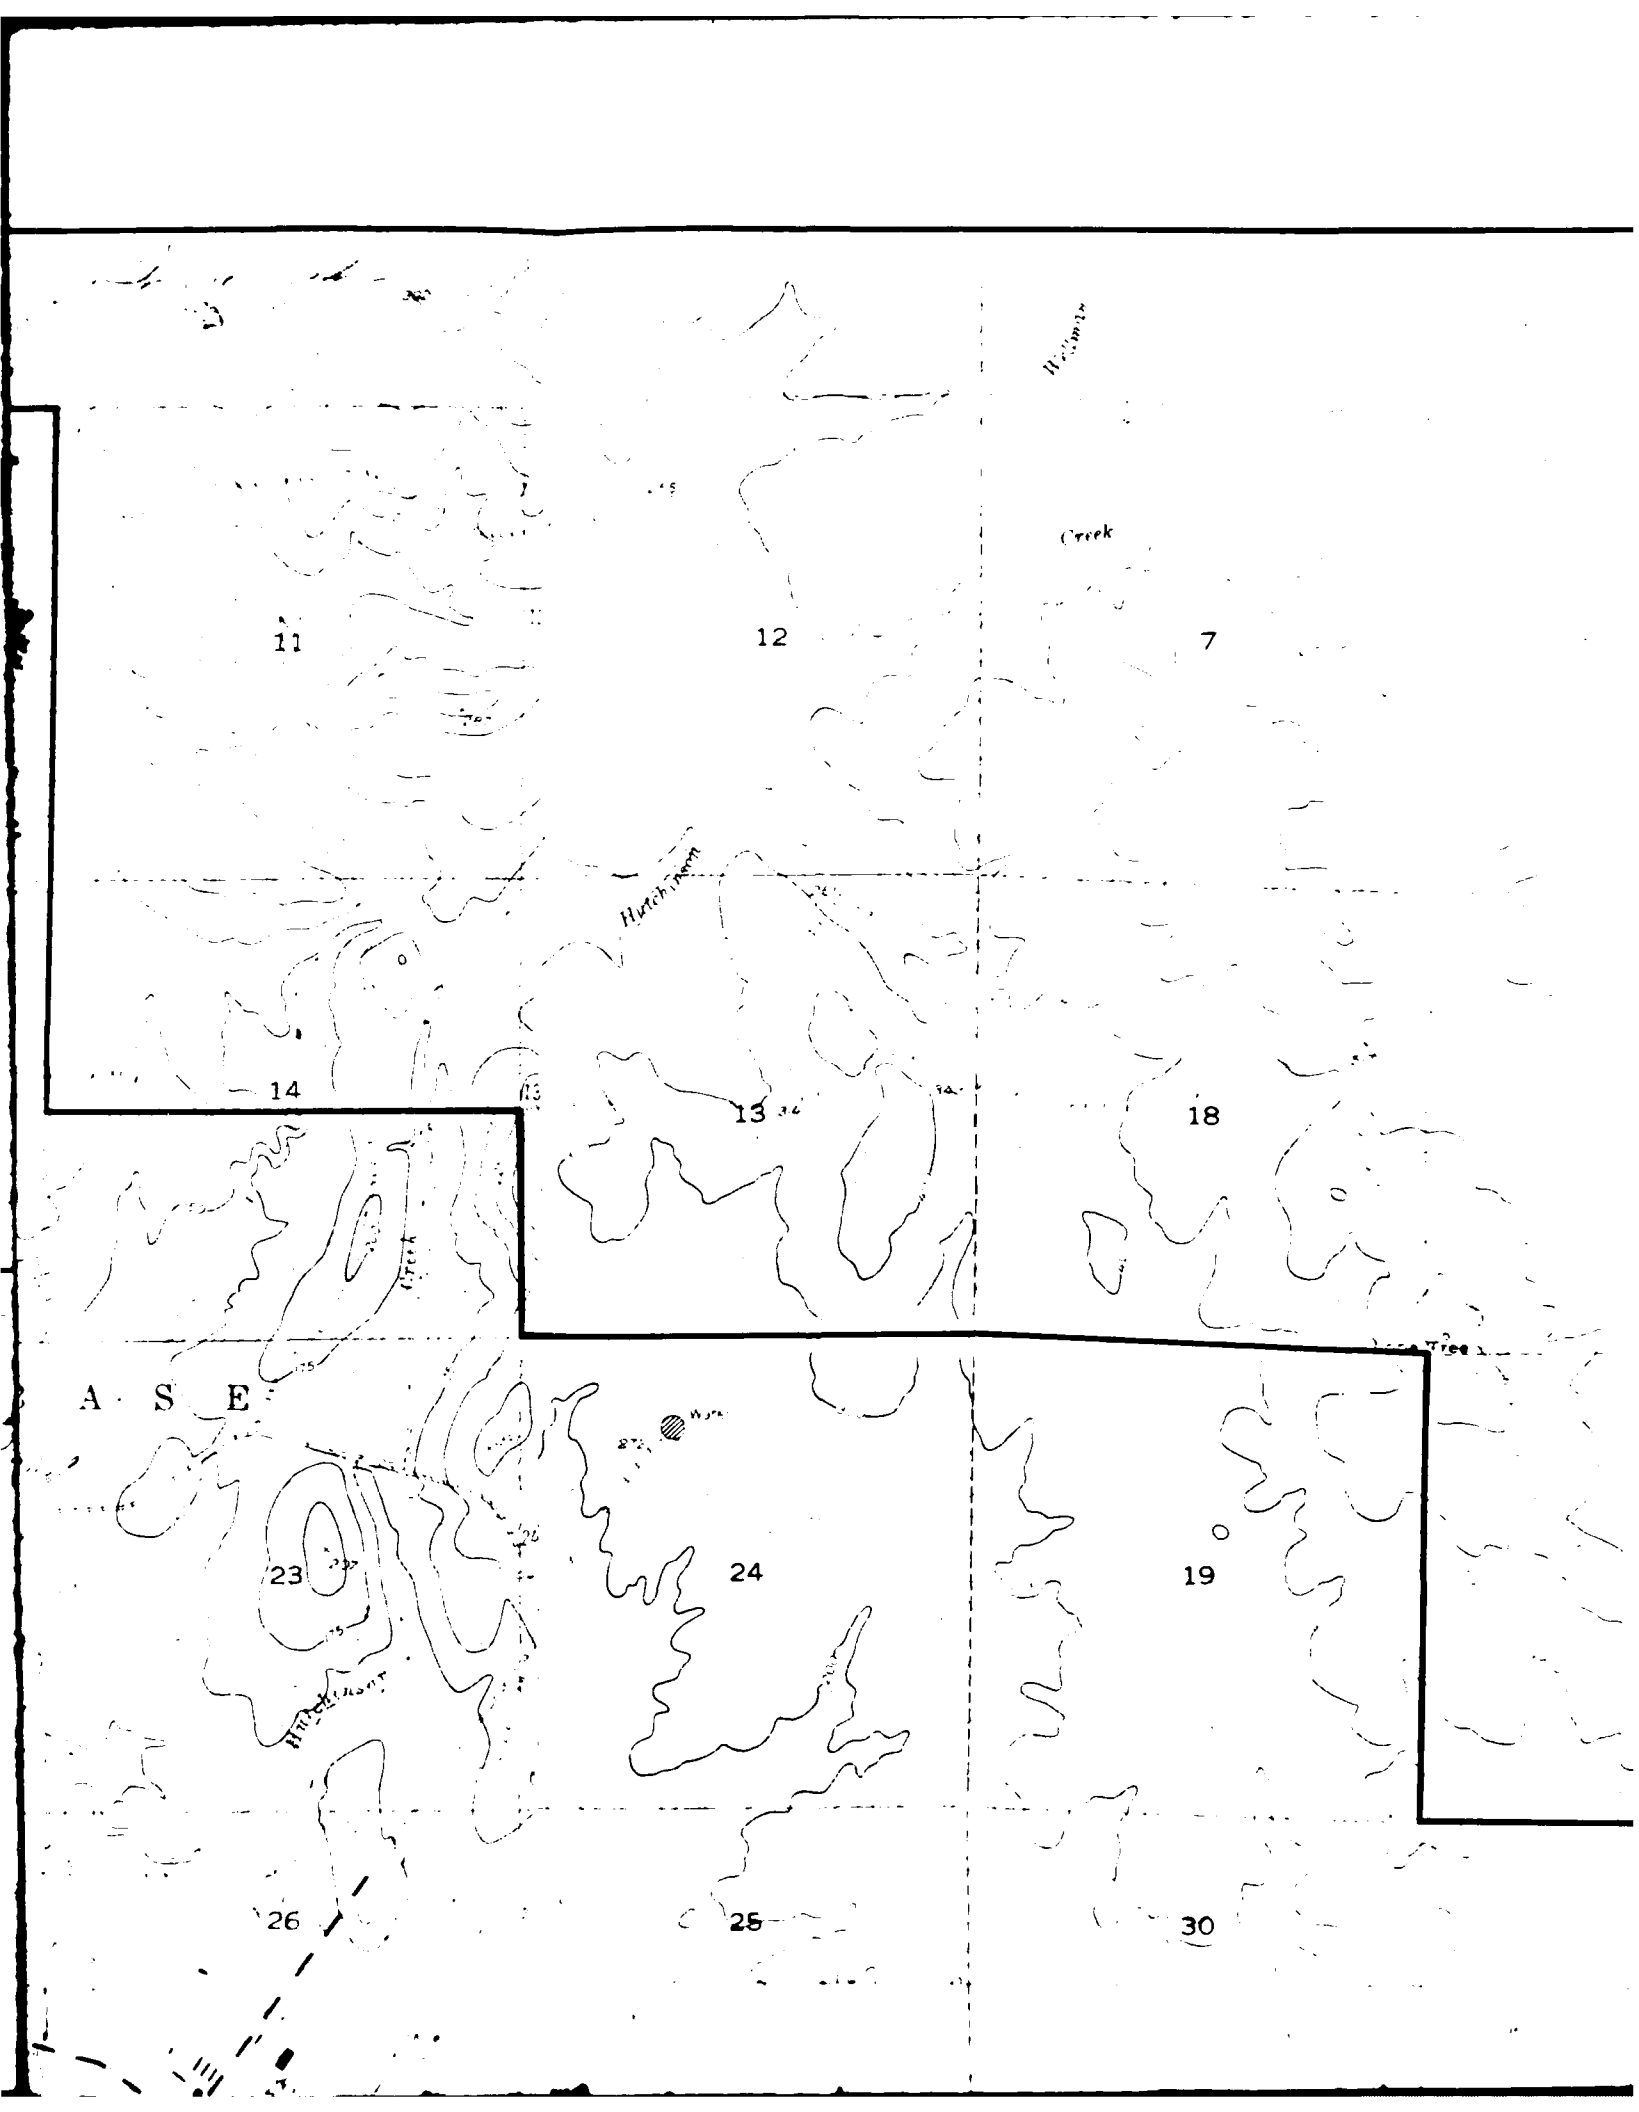
Figure IV-26
Significant Analytical Results
Site 1 West Drainage
Beale Air Force Base

Surface water samples collected along the ditch bank at the West Drainage site contained oil and grease (probably jet fuel). In the second sampling round, the water at the head of the ditch contained almost 2% (20,000 µg/g) hydrocarbon. Downstream sediment samples were also high in fuel components -- up to 3% (30,000 µg/g) by weight. There was very little flow from this drainage system either time the water was sampled so downstream impacts could not be assessed. Samples from Hutchinson Creek, near Landfill No. 1, contained the pesticide aldrin; however, the aldrin was also found in upstream (background) samples, suggesting that the source is not Landfill No. 1.

Site		Recommendation
1	West Drainage	- Install three groundwater monitoring wells, two between Site 1 and the base production wells and a third at the base boundary, downgradient from the site. - Sample the 4 wells (1 existing and 3 proposed) and test for VOCs (EPA 601/602) and oil & grease (EPA 413.2) - Sample surface water and stream bottom sediments at 8 downstream locations. . Analyze surface water for VOCs (EPA 601/602), lead (EPA 239.2), and oil & grease (EPA 413.2). . Analyze bottom sediment for VOCs (EPA 8010/8020 + 5030), lead (EPA 239.2 + 3050), and oil & grease (EPA 3550/413.2) - Identify sources of organic material which flow into west ditch and implement a plan to eliminate the flow of contaminants to this site.
2	Injection Well No. 2	- Drill 3 soil borings to 30 feet near the inactive injection wells. Analyze for Phenols (EPA 8040 +3550), 8 Metals (Series 200 + EPA 3050) and oil & grease (EPA 413.2 + 3550). - Continue monitoring the 5 wells on site (1 at injection wells and 4 at sludge disposal area) and analyze for Phenols (EPA 604), Benzene (EPA 602) and 8 Metals (Series 200).

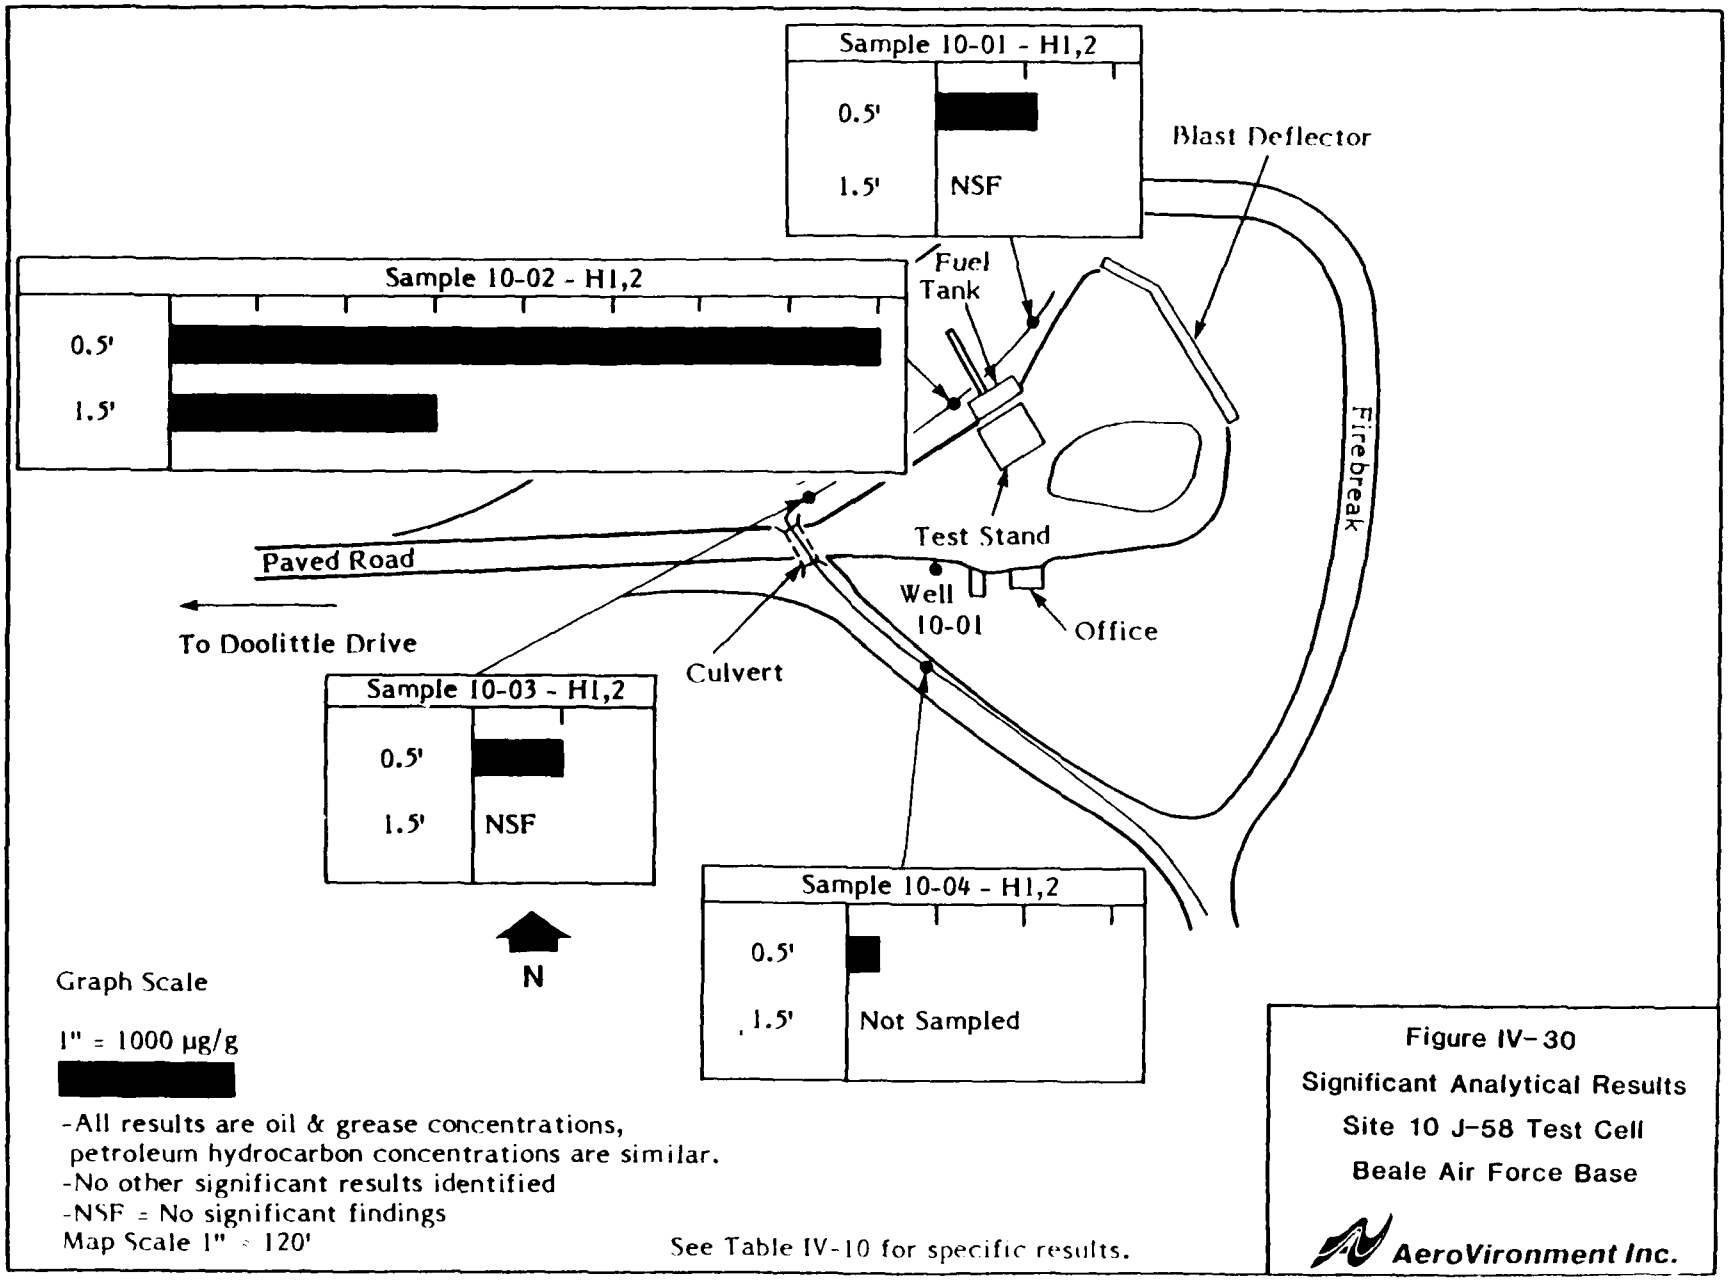
Figure IV-30
Significant Analytical Results
Site 10 J-58 Test Cell
Beale Air Force Base

O&G and petroleum hydrocarbon contamination was found in the surface samples from all the hand borings (see Figure IV-30). However, at the 1.5-foot depth only one boring still showed elevated oil and grease concentrations (1600 µg/g). The sample (10-02-H2) that had deeper contamination also had the highest concentrations in the surface sample. It is located near a small undiked, above-ground fuel tank located between the test stand and the channel. Also, most washdown from the test stand probably enters the channel near Hand Auger Location 10-02, judging by soil staining at the site. The main fuel tanks for the J-58 Test Cell have double containment to eliminate any leakage.

The J-58 test cell shows evidence of some environmental degradation resulting from fuel spilling and equipment washdown. Soil contamination is localized and probably shallow, as would be expected from an operation such as this. There is no evidence of groundwater contamination. The risk from this site is considered minimal.
