INSTALLATION RESTORATION PROGRAM
PHASE II - CONFIRMATION/QUANTIFICATION

STAGE 1

FINAL REPORT FOR

BEALE AIR FORCE BASE,
MARYSVILLE, CALIFORNIA

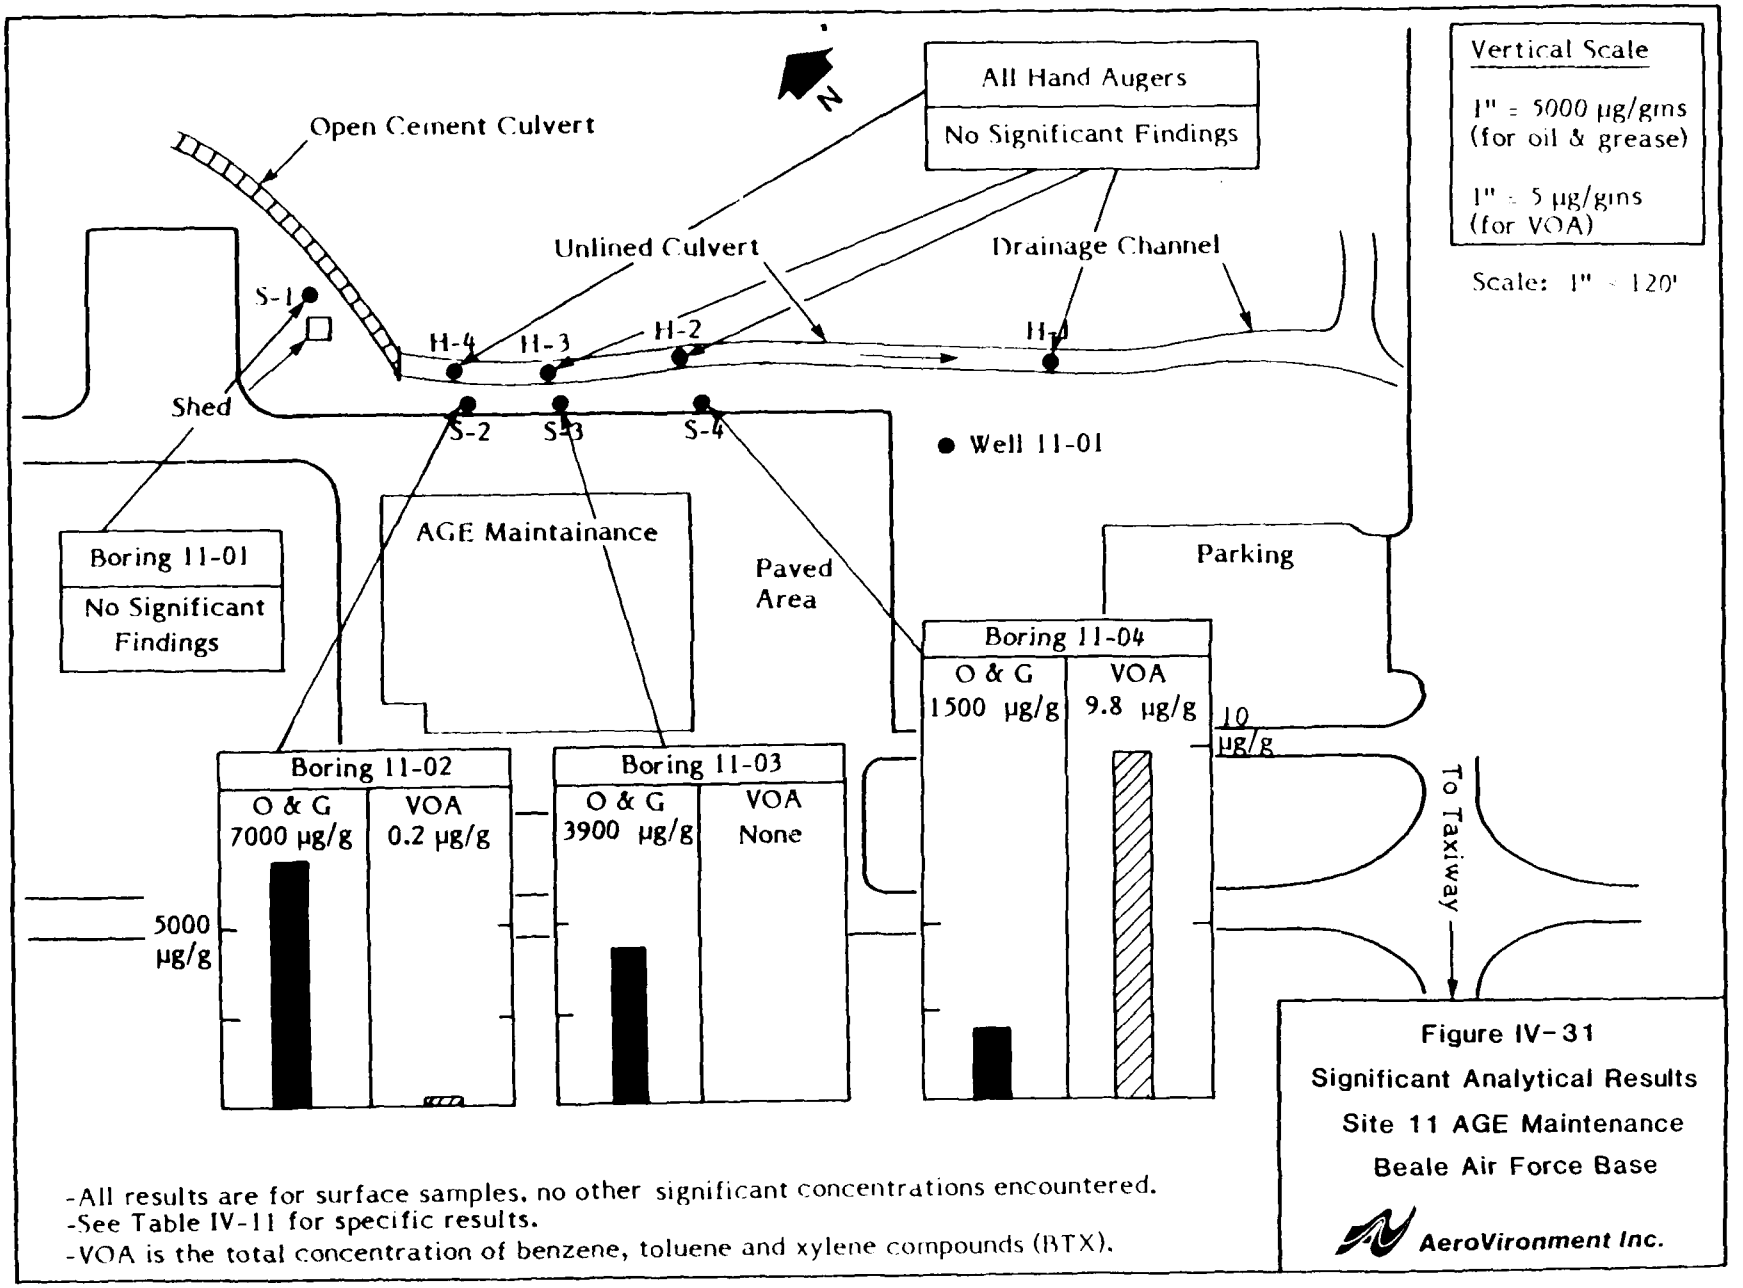
All the soil borings near the edge of the pavement showed high levels of oil and grease, up to 7000 µg/g, in the 1.5-foot samples but were clean in 6.5-feet samples (see Figure IV-31). This is probably the result of very hard soil and relatively small quantities of material being discharged. No evidence of contaminants was found in the drainage ditch samples and the groundwater samples showed no indication of degradation. The highest concentrations of oil and grease contamination were found in Borings 11-02 and 11-03. The surface sample from Boring 11-04 also showed evidence of benzene, toluene and xylene, common constituents of the fuel used by AGE. The hydrocarbon concentrations at Borings 11-02, 11-03 and 11-04 correlate with the visual evidence of staining and the apparent flow patterns in the area.

Only localized surface hydrocarbon contamination was found at this site. The migration of contaminants, either laterally or vertically, is minimal. Due to the work practices at the maintenance shop, large-scale soil or water pollution is not expected; however, runoff of fuel and oil products will continue unless procedures change to preclude it. No groundwater contamination is evident. The environmental threat from this site is considered minimal.

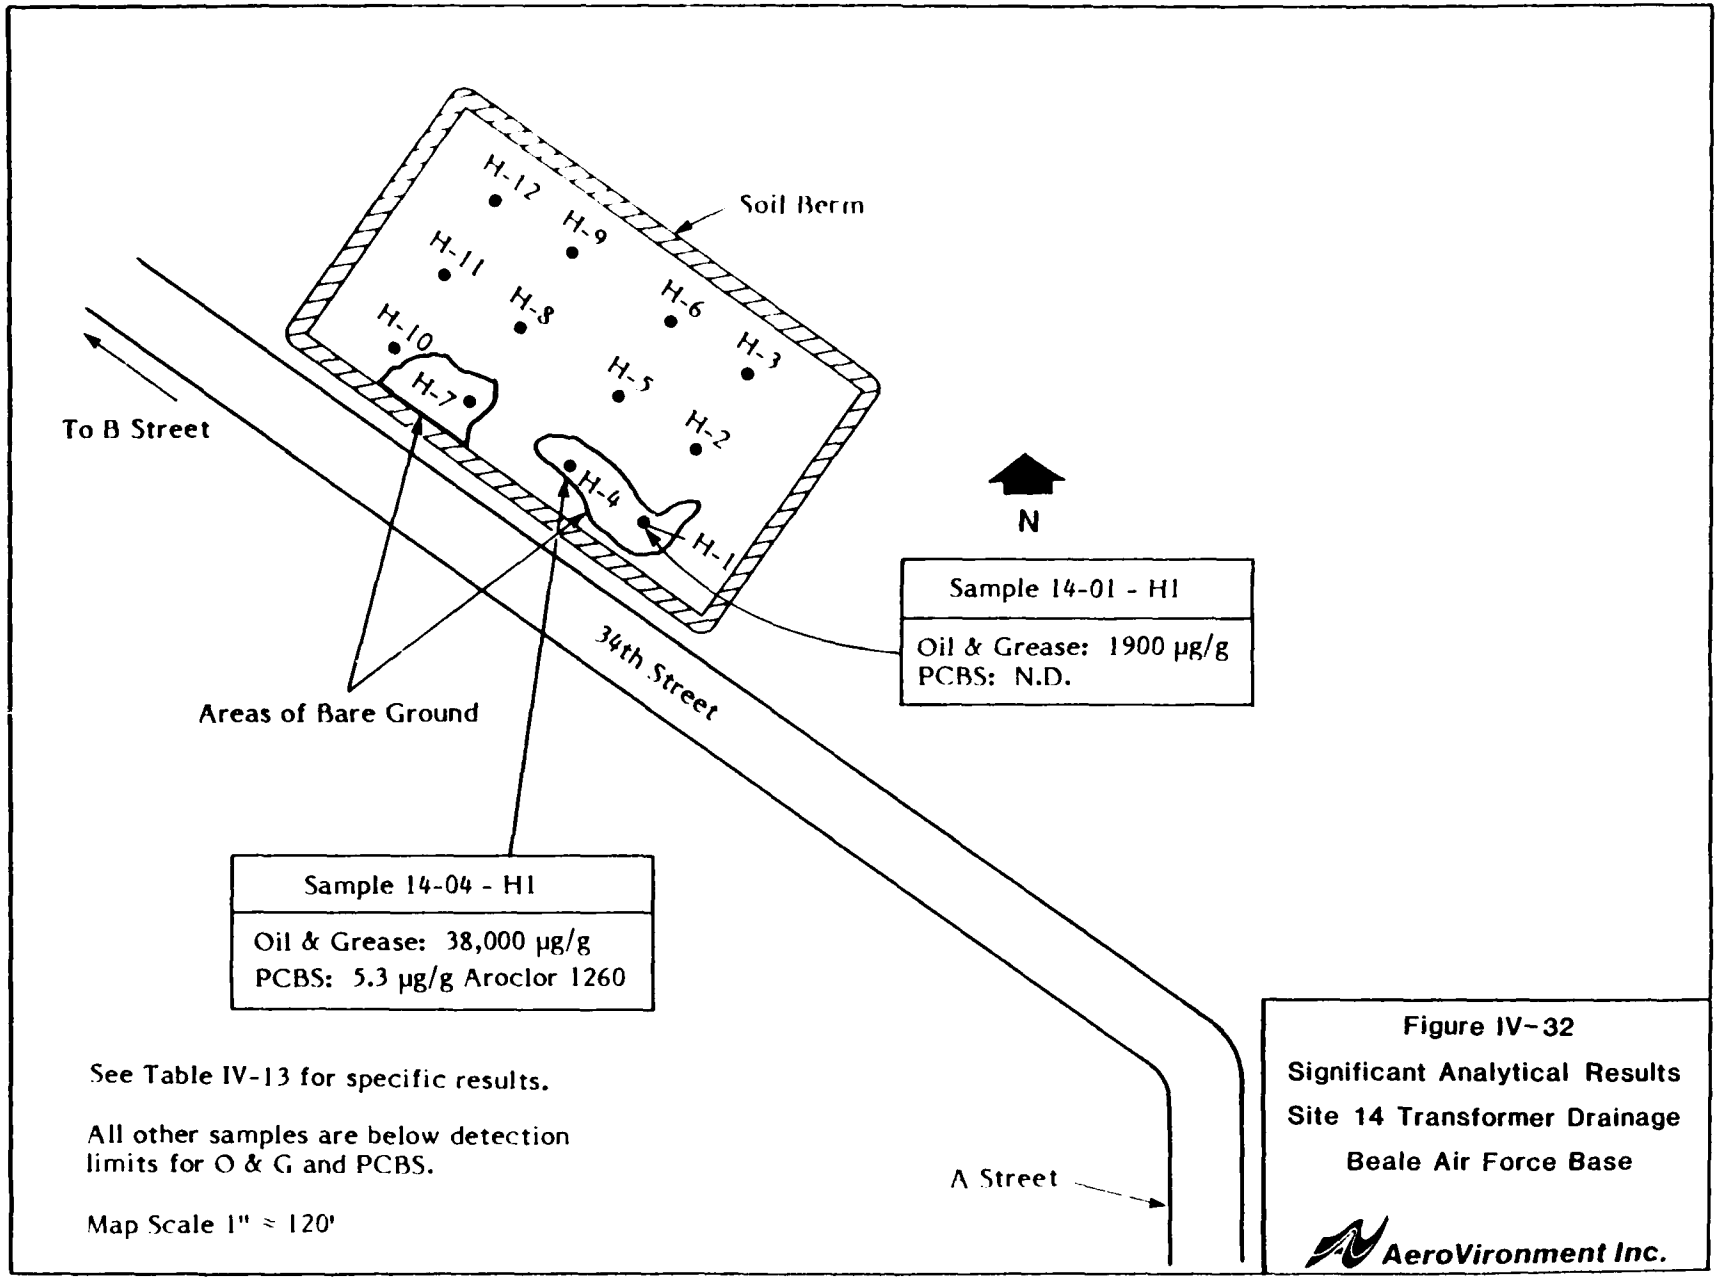
Figure IV-32
Significant Analytical Results
Site 14 Transformer Drainage
Beale Air Force Base

In addition, localized deposits of nonfuel compounds were detected in soil samples at four locations. PCBs and oil and grease were found at levels of 5.3 and 38,000 µg/g (ppm), respectively, in the surface soil at one portion of the Transformer Drainage Area. Chlordane was found at a concentration 0.9 µg/g in the surface soil below the mixing basin at the current Entomology Shop (Building 2560). The concentrations of chlordane found at these two sites is below the state of California Total Threshold Limit Concentrations. The bottom of the disposal trench at the EOD contains levels of lead (14,000 µg/g) high enough to classify the soil as hazardous waste according to California Title 22 standards. Finally, potential pentachlorophenol soil contamination was identified at Injection Well No. 2, but other nearby samples showed no evidence of pentachlorophenol.
