RADC-TR-89-203
In-House Report
October 1989

A COMPARATIVE STUDY OF THREE COMMERCIAL INDIUM PHOSPHIDE SUBSTRATES

Kenneth P. Quinlan

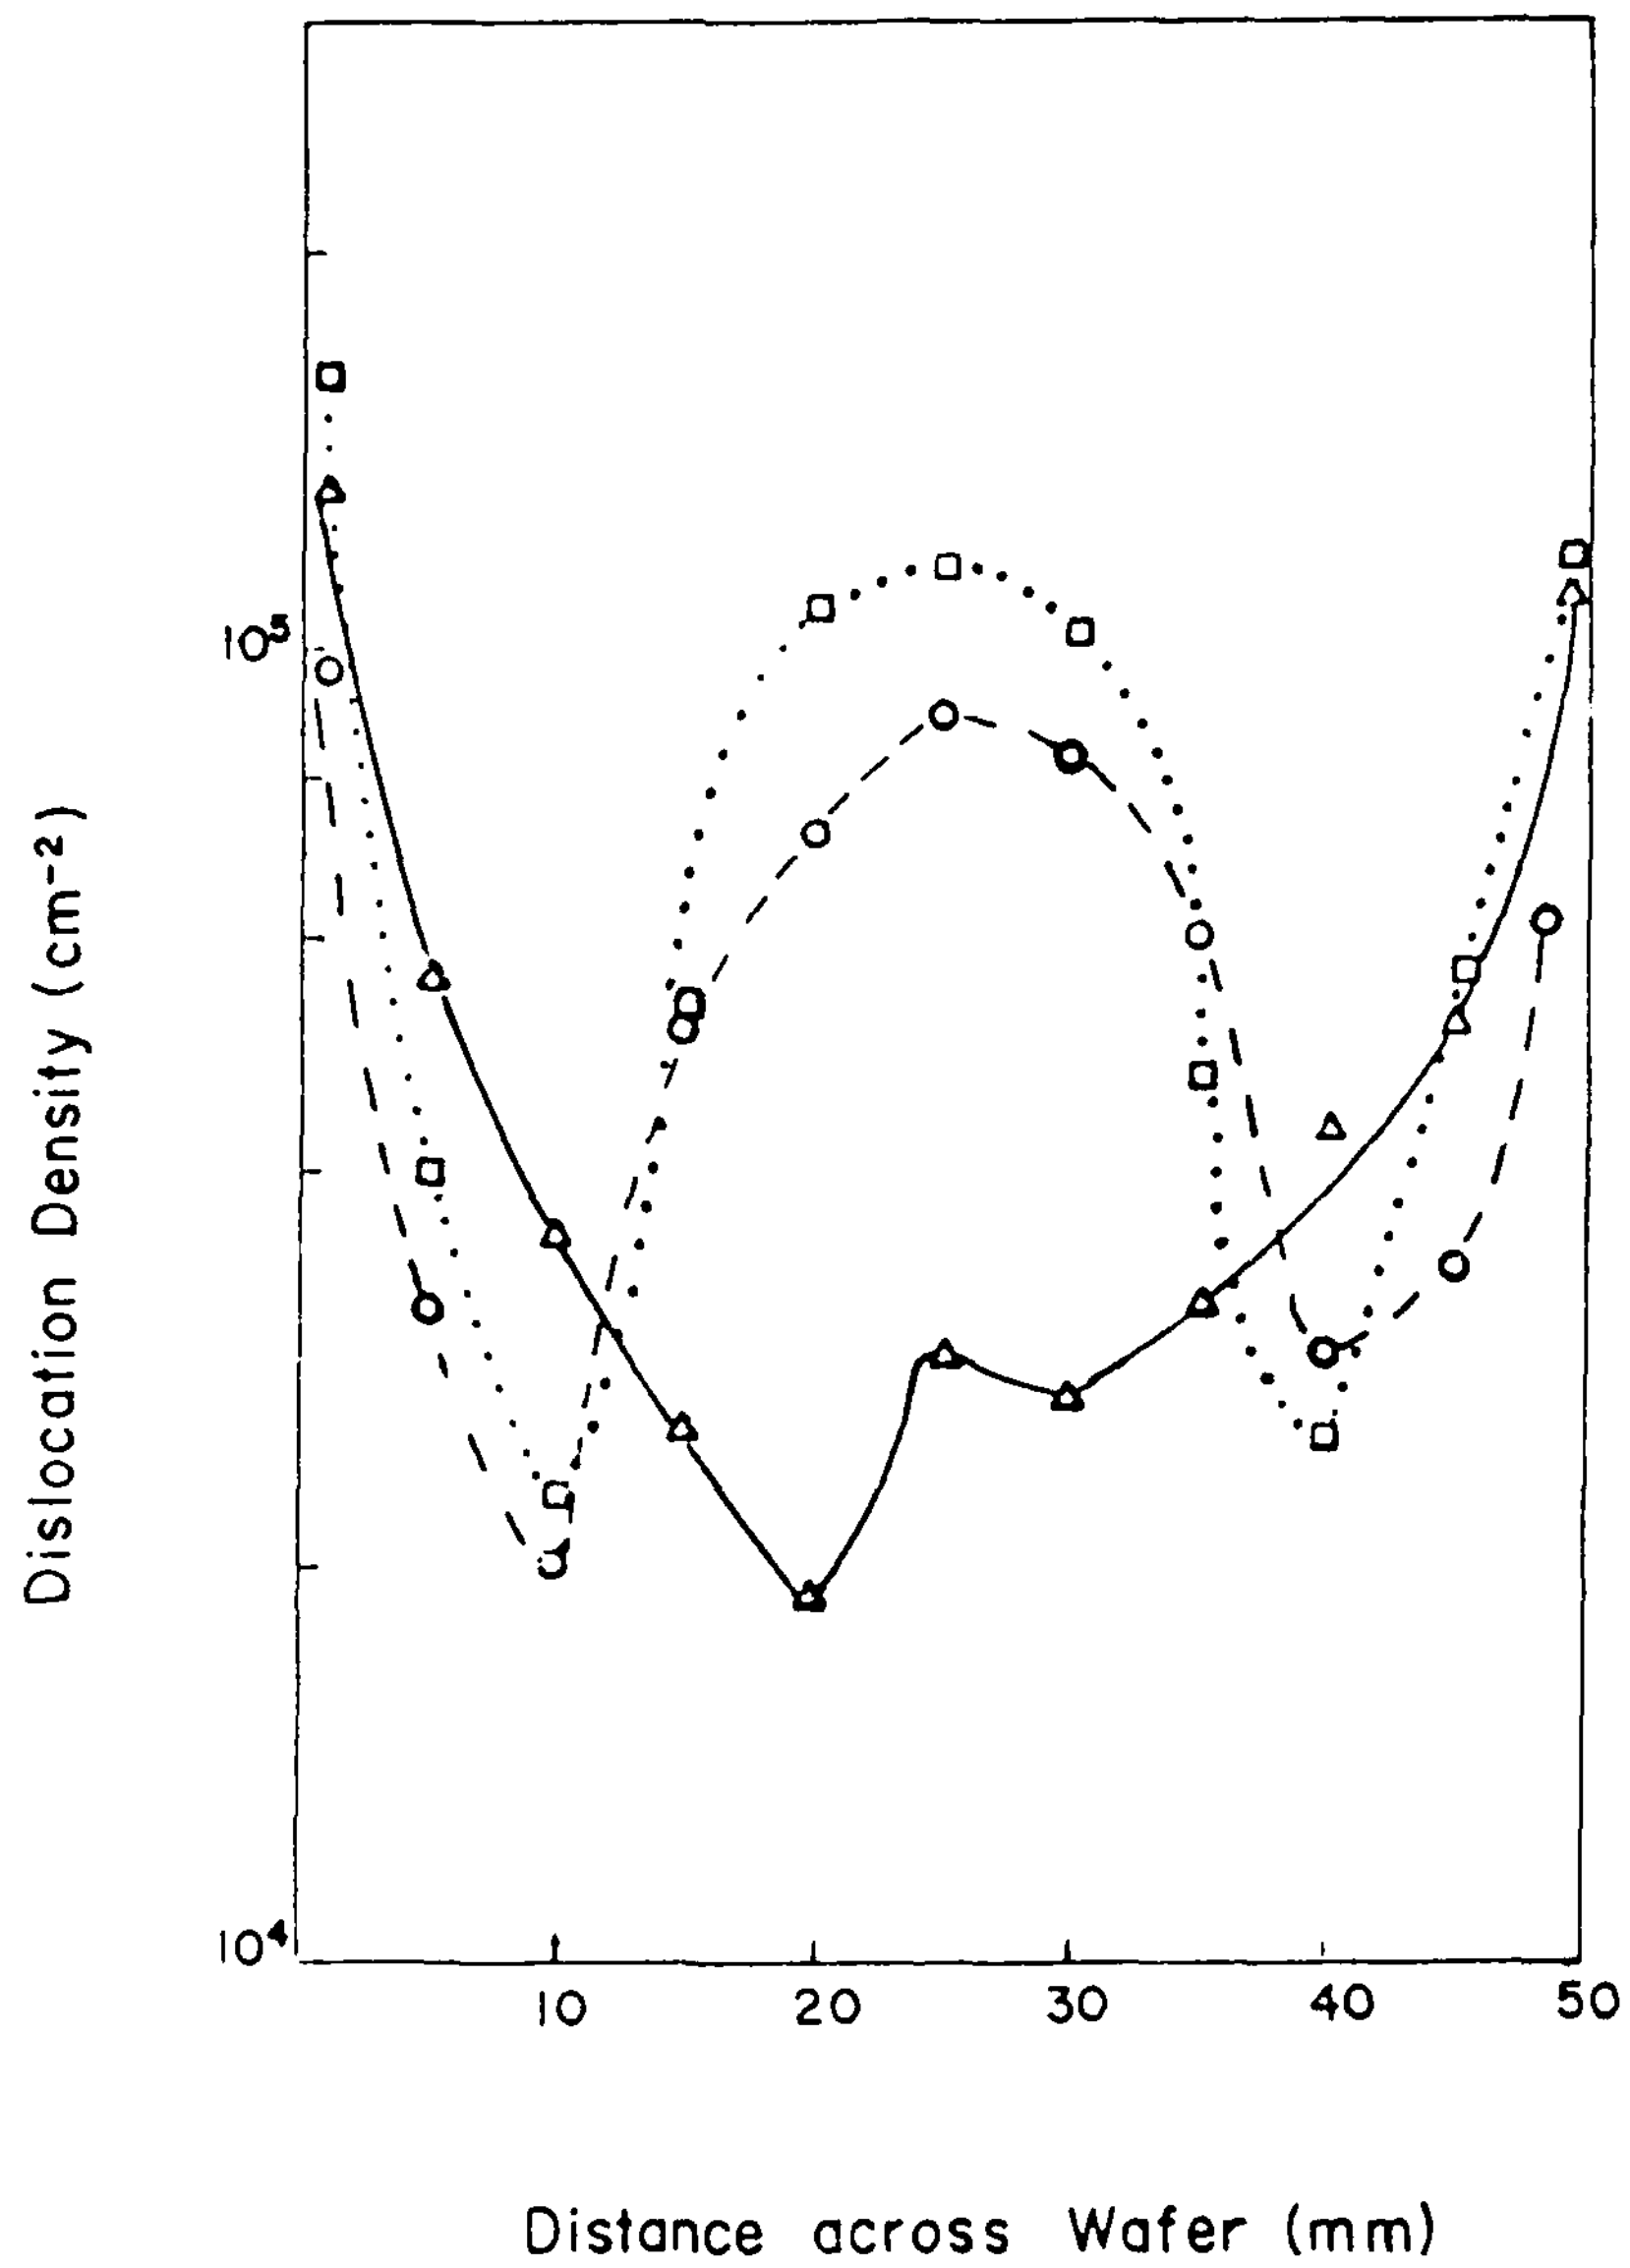
The dislocation densities across the three commercial wafers are shown graphically in Figure 1. The dislocations originate from a slip on the {111} planes in the <110> directions. The dislocation pits were either conical or of the shallow flat bottomed type. The etched features of the pits have been classified by Brown et al.[10,11] The ICI Americas and Sumitomo substrates gave the typical "W" shaped curves as predicted from the analysis of Jordan et al.[12] for dislocation generation in GaAs. The CrystaComm wafers exhibit a simple "U" shaped dislocation curve. Different wafers of the CrystaComm and Sumitomo substrates exhibited similar results. The difference in the shape of the curves (Figure 1) is most probably due to the fact that the wafers were obtained from different areas of the boule. Chen et al.[13] obtained similar curves for GaAs. The front-end slices exhibited simple "U" shaped dislocation density curves. The "W" shape of the dislocation density curves became more apparent as the tail-end of the boule was approached. The average dislocation densities found for the CrystaComm, ICI Americas and Sumitomo wafers were 4×10^4, 7×10^4 and $5 \times 10^4/cm^2$, respectively. The CrystaComm and ICI Americas results are slightly higher than those reported (see Table 1) by the manufacturer. The dislocation density determined for the Sumitomo wafers agrees with the reported value. These slight differences between the determined dislocation densities and those reported may also be caused by the comparison being made between wafers from different areas of the boule. These dislocation studies show that the wafers from the three commercial sources exhibited no great deviation from each other.

Figure 1. Dislocation Densities Across Diameters of Wafers in the <011> Direction for Three Commercial Substrates: Δ-Δ, CrystaComm; 0-0, Sumitomo Electric; and □-□, ICI Americas.

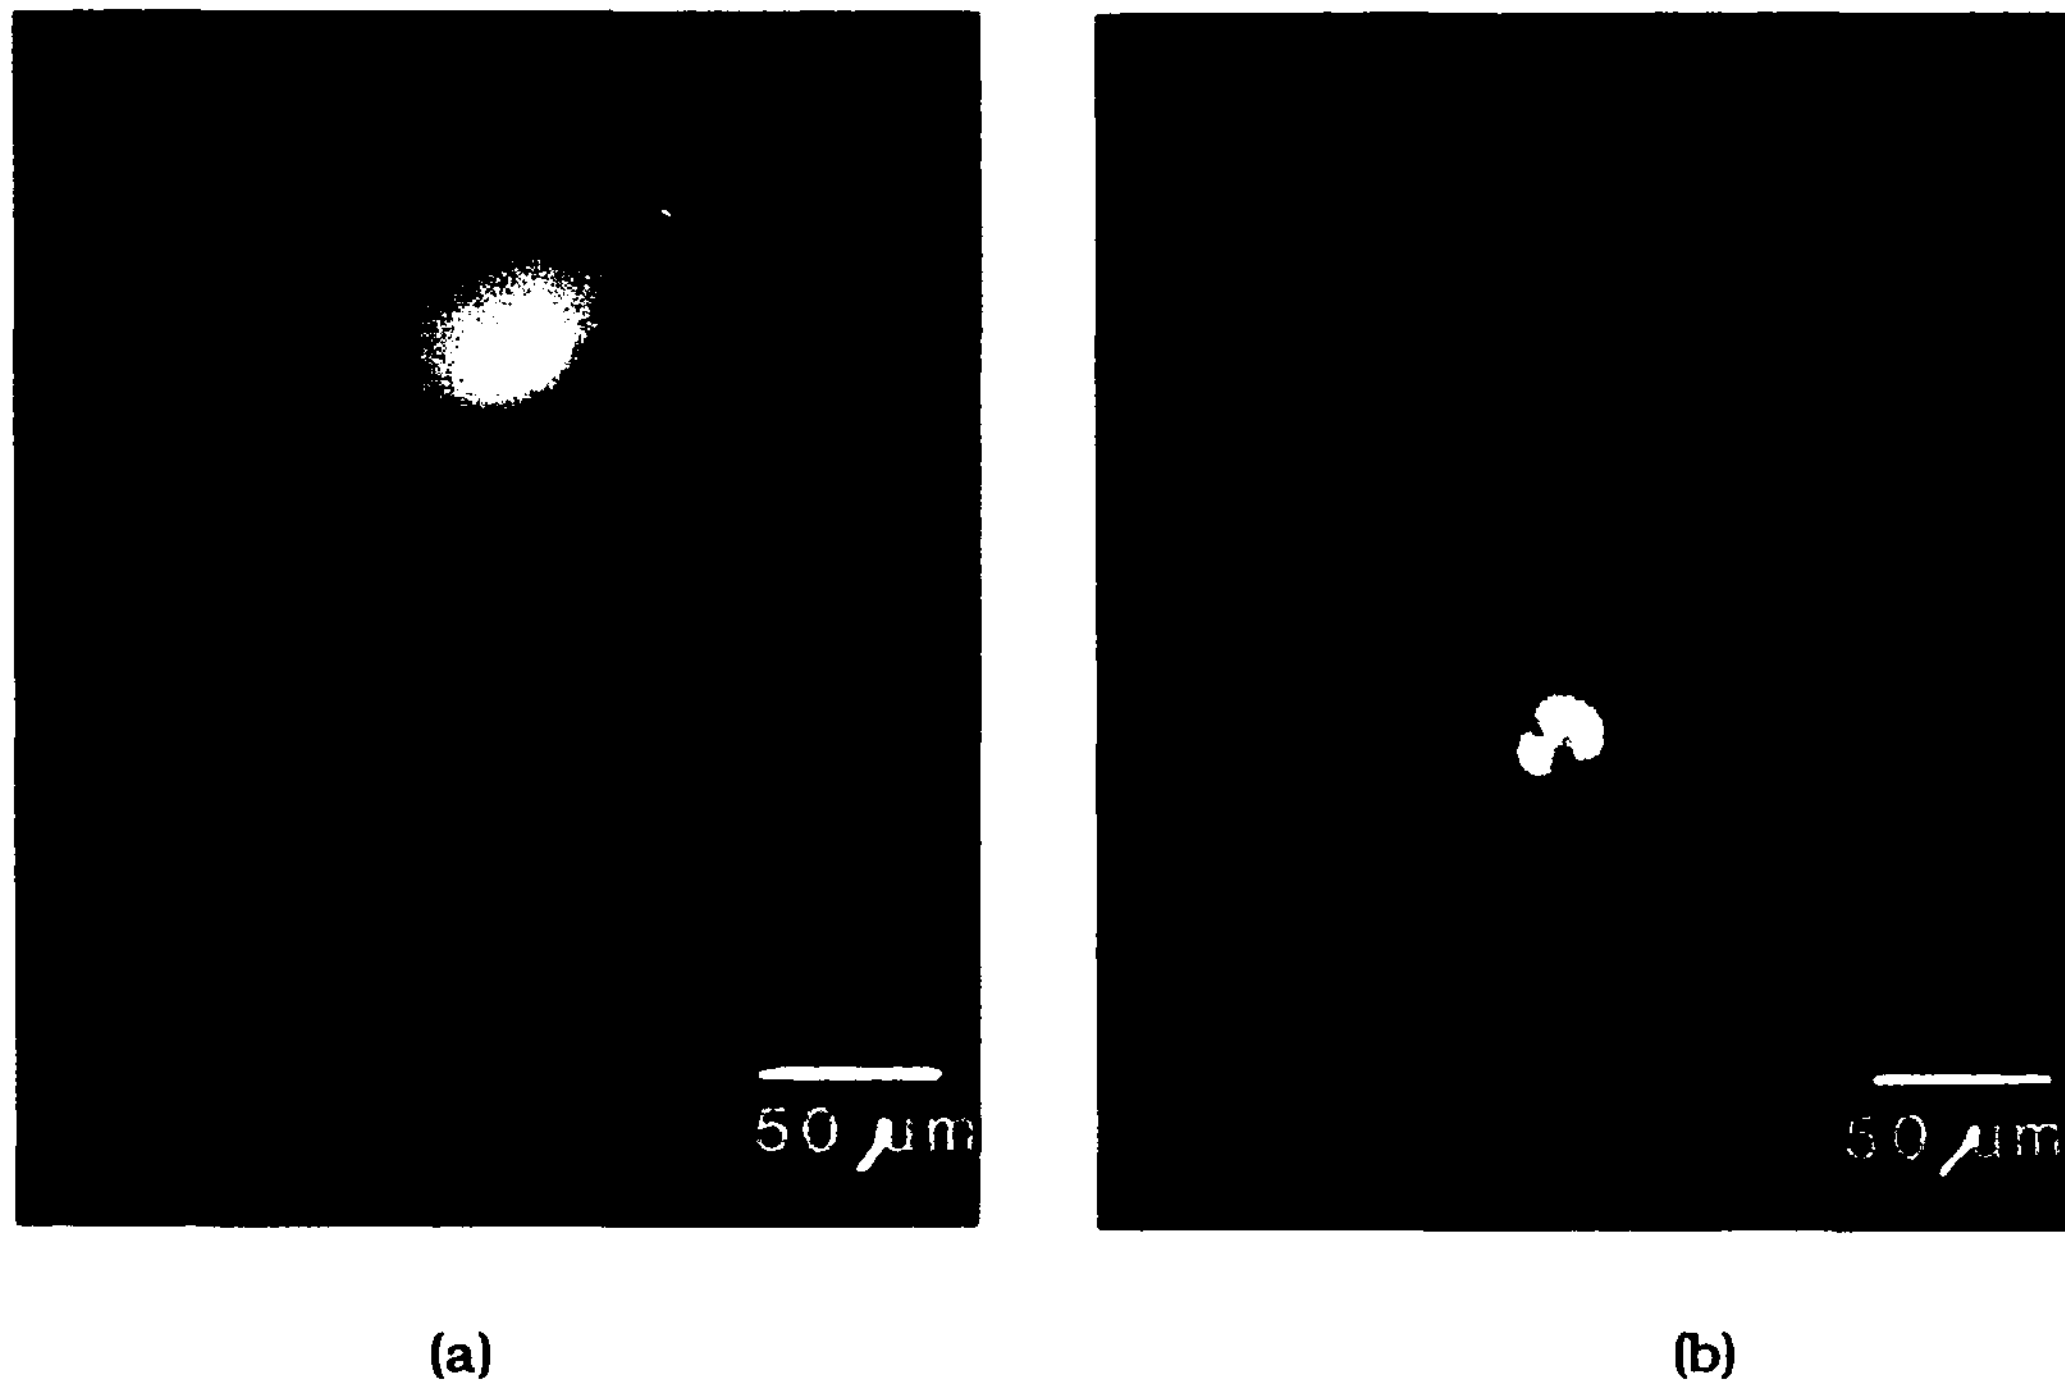
Etching of the three substrates with the standard etch procedure revealed an unspecified type defect. Examples of these unspecified defects are depicted in the photomicrographs of Figure 4. These defects were observed on all the substrates in the complete range of

Figure 4. Unspecified Defects on InP Substrate Surfaces. a) Photomicrograph of CrystaComm InP substrate after 2 etchings for 2 minutes each with the standard etch procedure using 3 vol % bromine in methanol; b) Photomicrograph of Sumitomo InP substrate etched for 2 minutes with standard etch procedure using 1.5 vol % bromine in methanol.

bromine-methanol concentrations studied (0.3 to 10 vol %). The sizes of the defects ranged from 8 to 70 µm. These defects were present after 80 µm of the substrates were etched and probably exist throughout the wafers. A study showed that the same defects persisted for at least 30 µm into the wafer. Figure 5 depicts a typical defect after 50 µm of the substrate has been removed and the same defect with the removal of an additional 30 µm. A study with

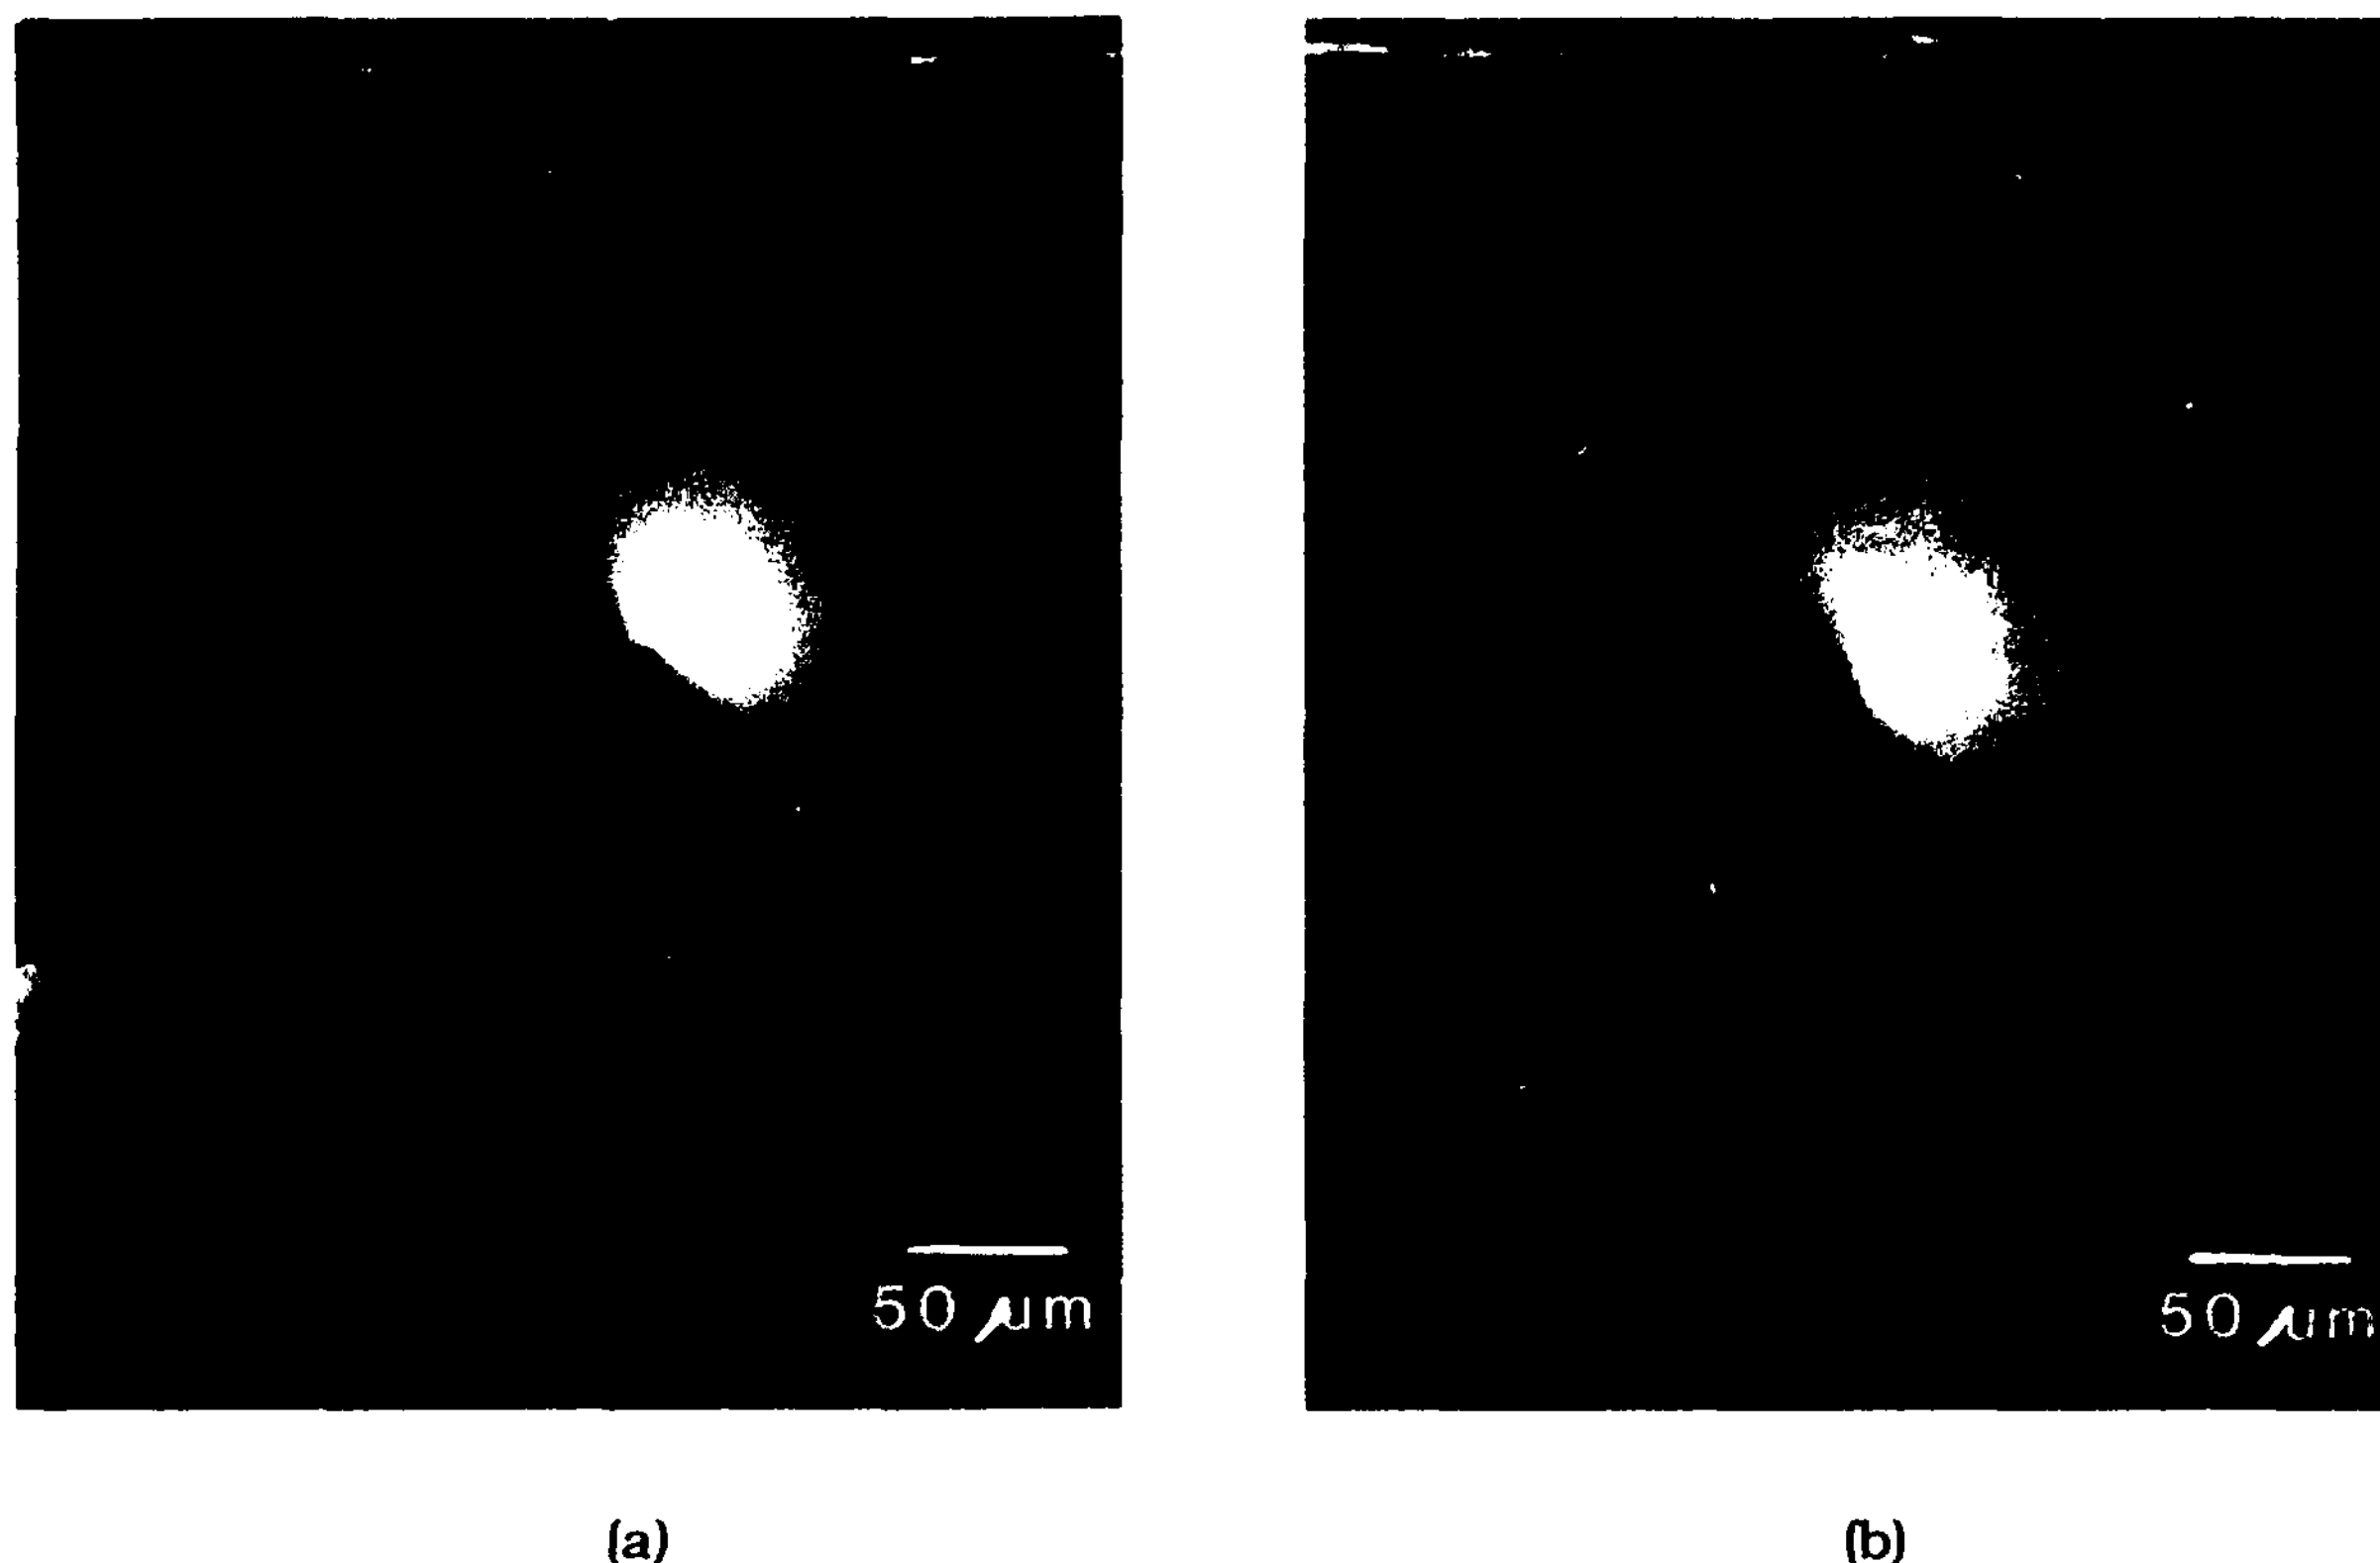
Figure 5. Tenacity of Unspecified Defects in InP Substrates. a) Photomicrograph of CrystaComm InP substrate etched for 2 minutes with standard etch procedure using 10 vol % bromine in methanol; b) Photomicrograph of substrate in Figure 5a etched for an additional 2 minutes with standard etch procedure using 10 vol % bromine in methanol.

Huber's etch indicated that these defects are not associated with dislocations. These results are shown in Figure 6 where the defects are shown before and after treatment with Huber's etch. The origin of these defects may be a precipitate, inclusion, or areas with non-stoichiometric composition. Other Sumitomo substrates with an orientation of (100) $\pm$ 0.5° exhibited the same defects.

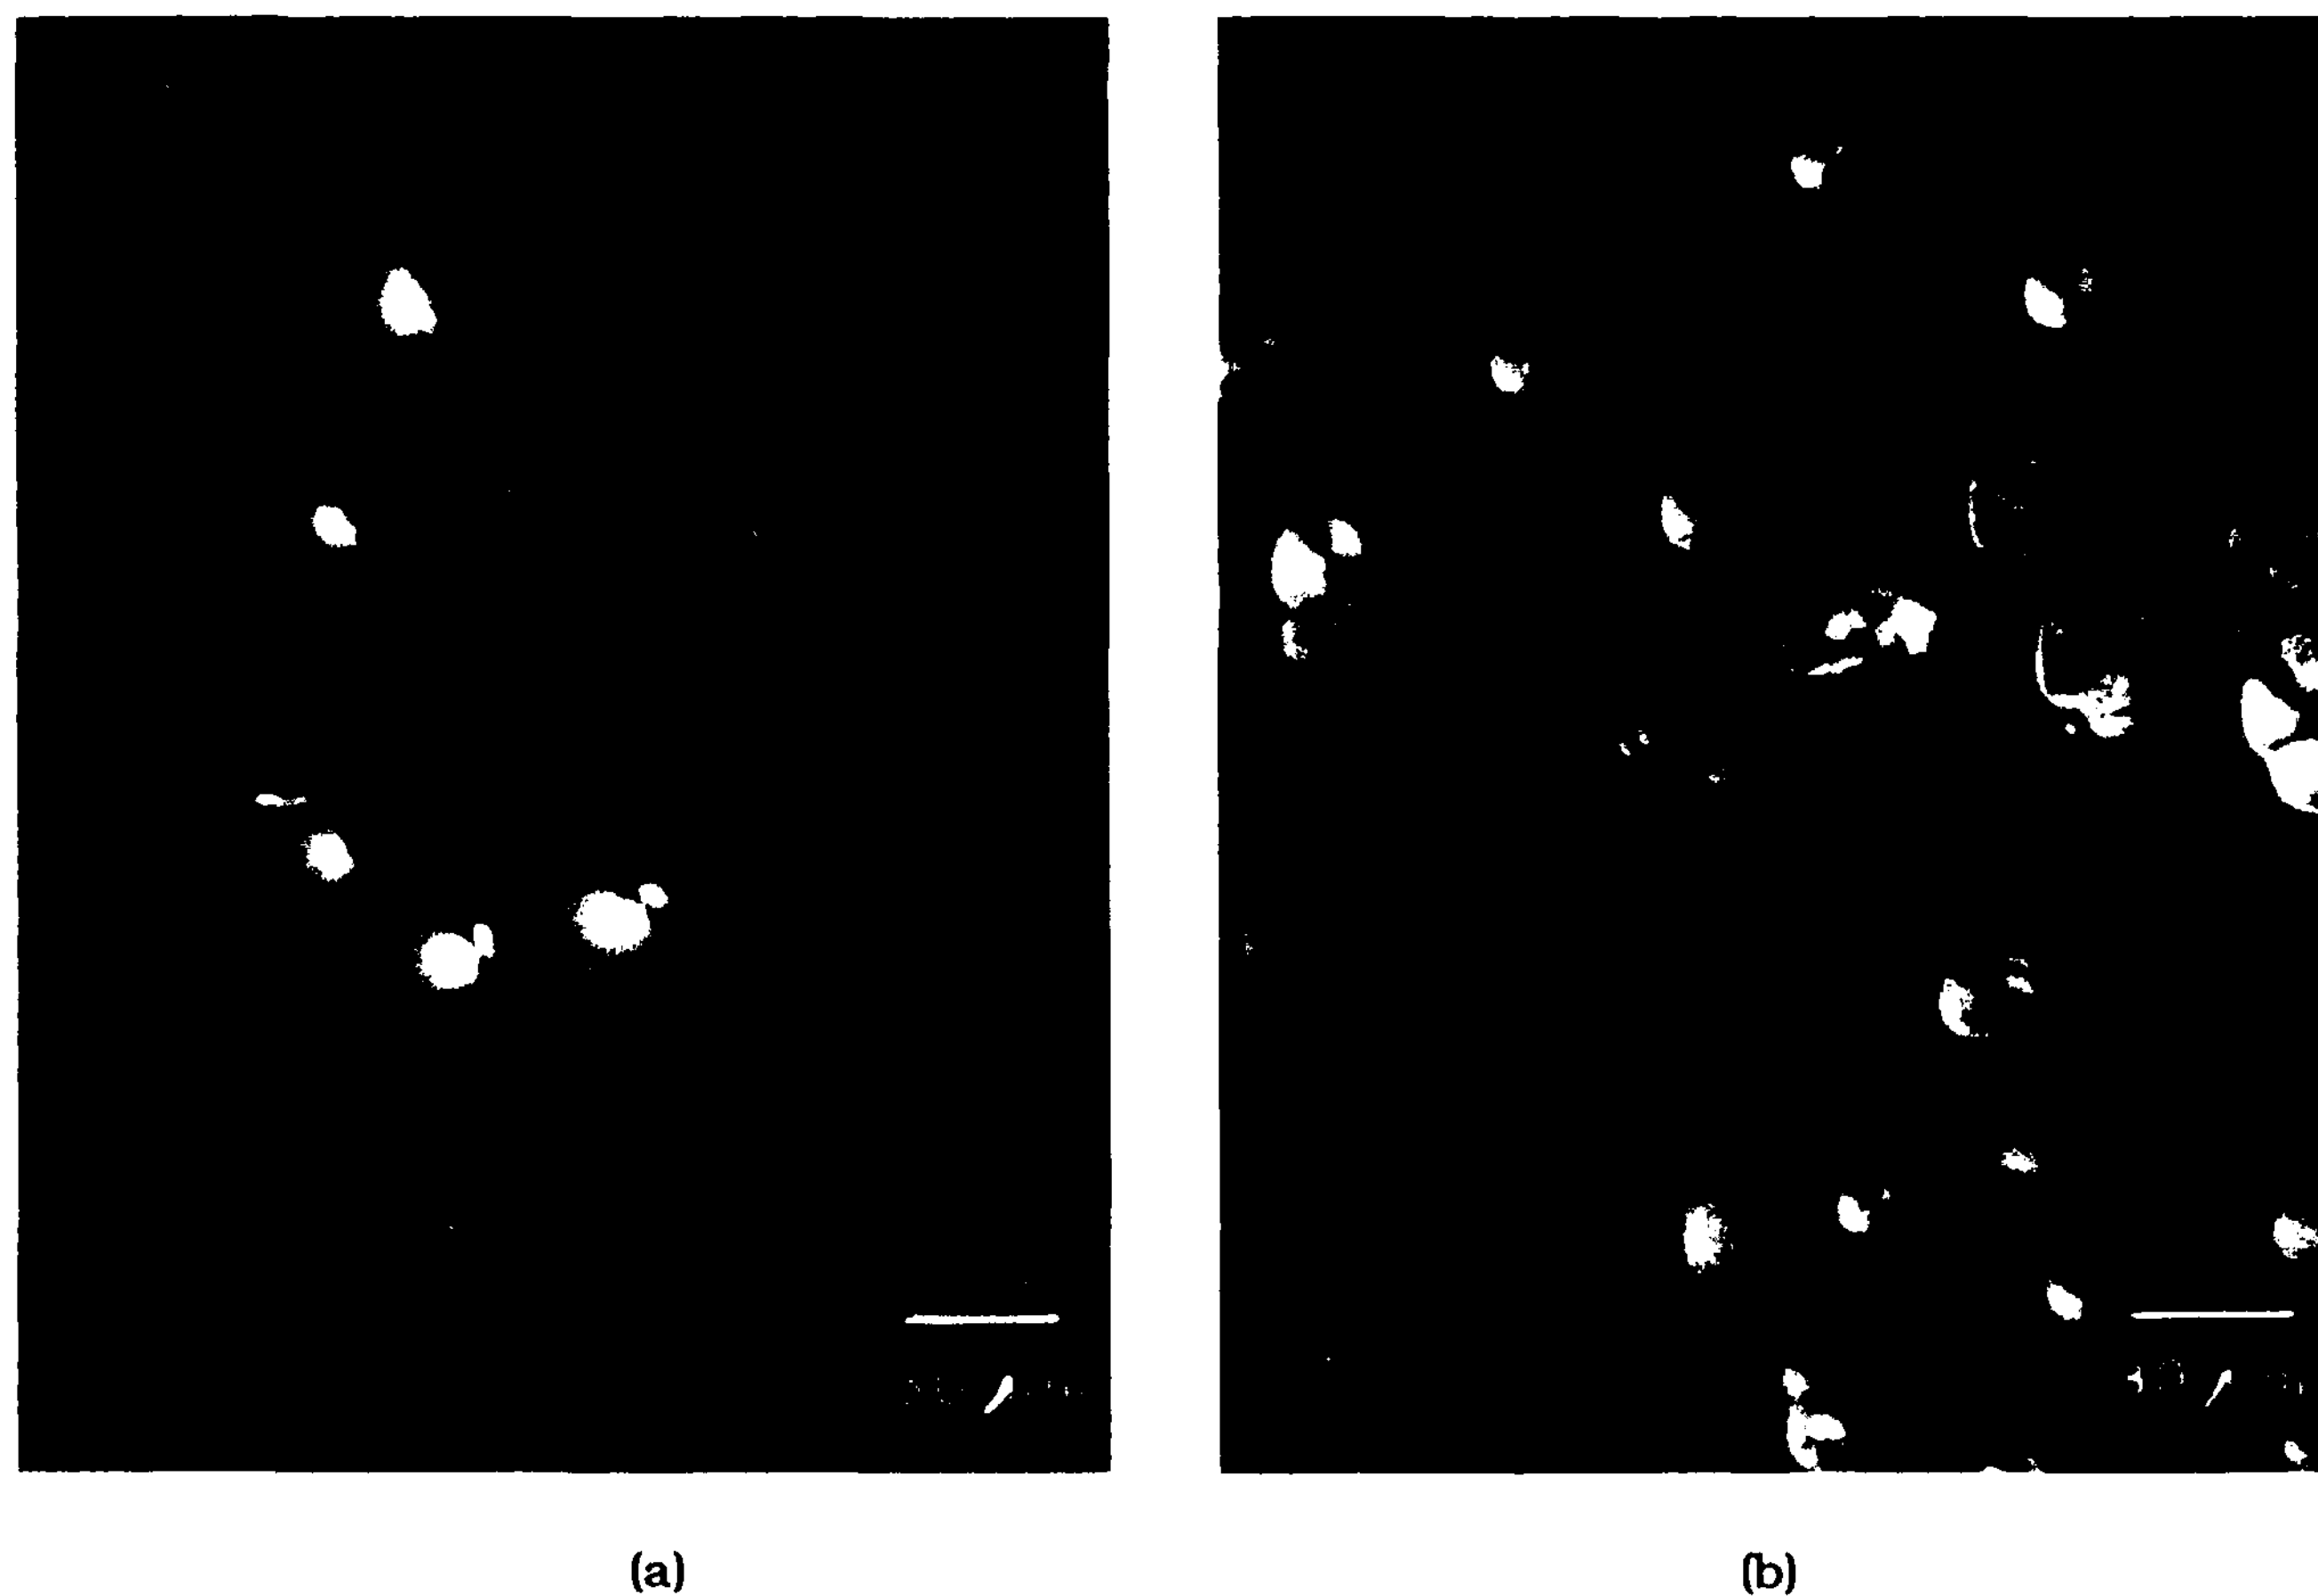
Figure 6. Effect of Huber's Etch on Unspecified Defects. a) Photomicrograph of CrystaComm InP substrate etched for 2 minutes with standard etch procedure using 3 vol % bromine in methanol; b) Photomicrograph of substrate in 6a after etching with Huber's etch (2 volumes H_3PO_4/1 volume HBr) for 2 minutes.

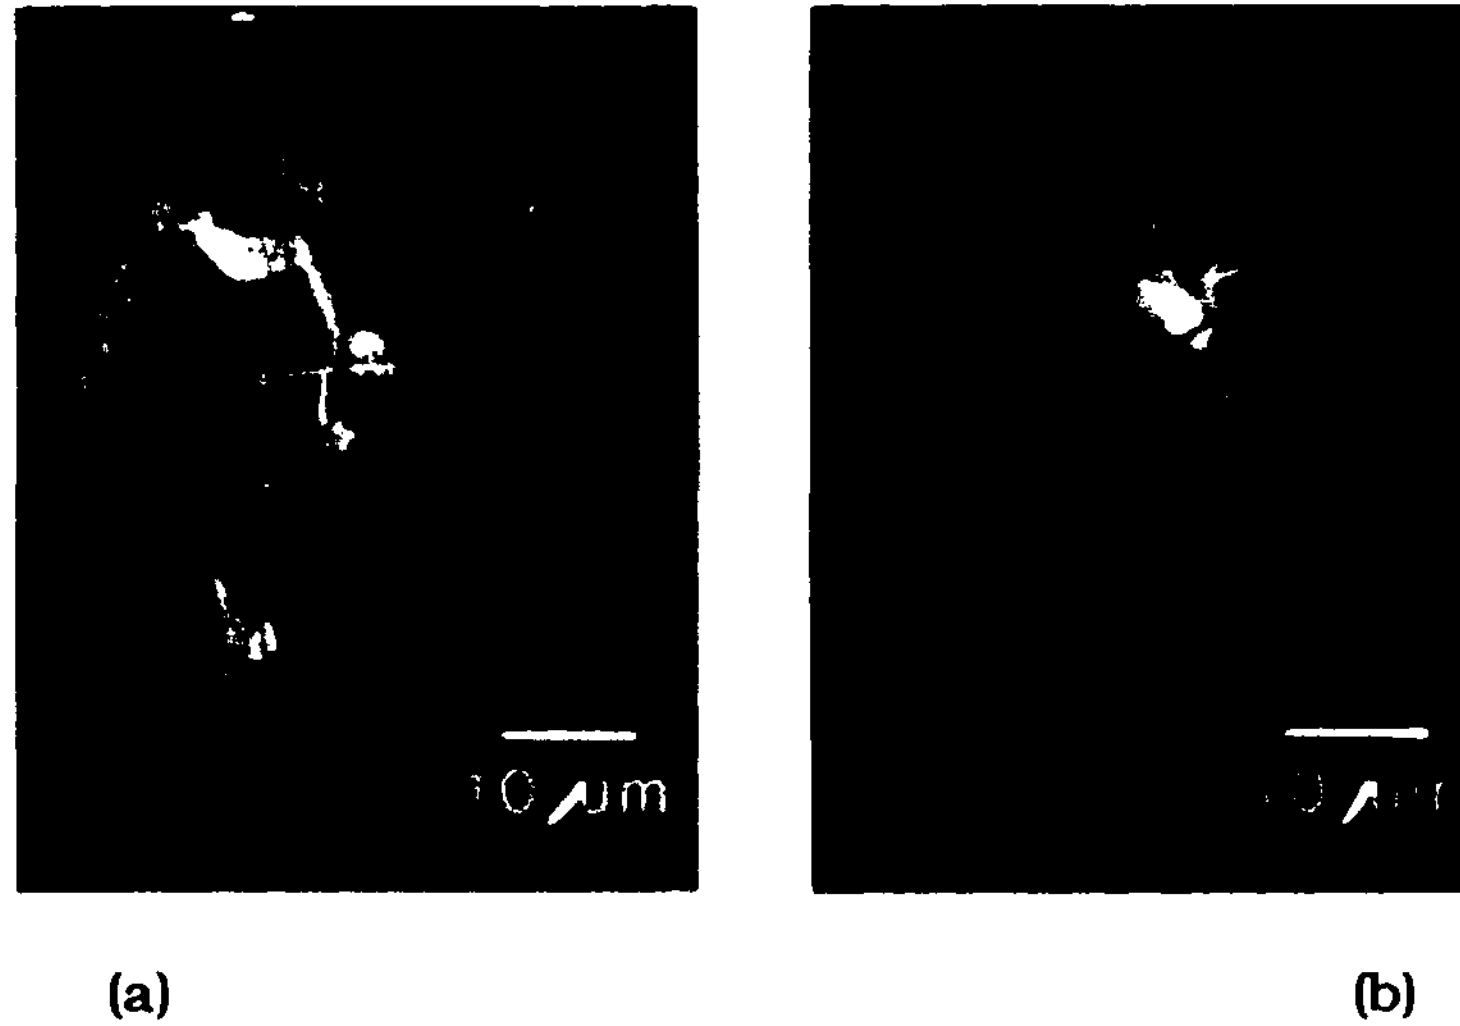
Small numbers of other defects were randomly observed on all the substrates after the standard etch procedure with the Br_2-methanol solutions. These defects displayed various features, for example, ridges, swirls, defects looking like broken blisters, and furrows. These broken-blister type defects are shown in Figure 7. No one substrate exhibited any more or less of these imperfections.

Figure 7. Examples of Broken Blister-Type Defects on InP Substrates. a) Photomicrograph of CrystaComm InP substrate etched for 2 minutes with standard etch procedure using 3 vol % bromine in methanol; b) Photomicrograph of Sumitomo InP substrate etched for 2 minutes with standard etch procedure using 3 vol % bromine in methanol.

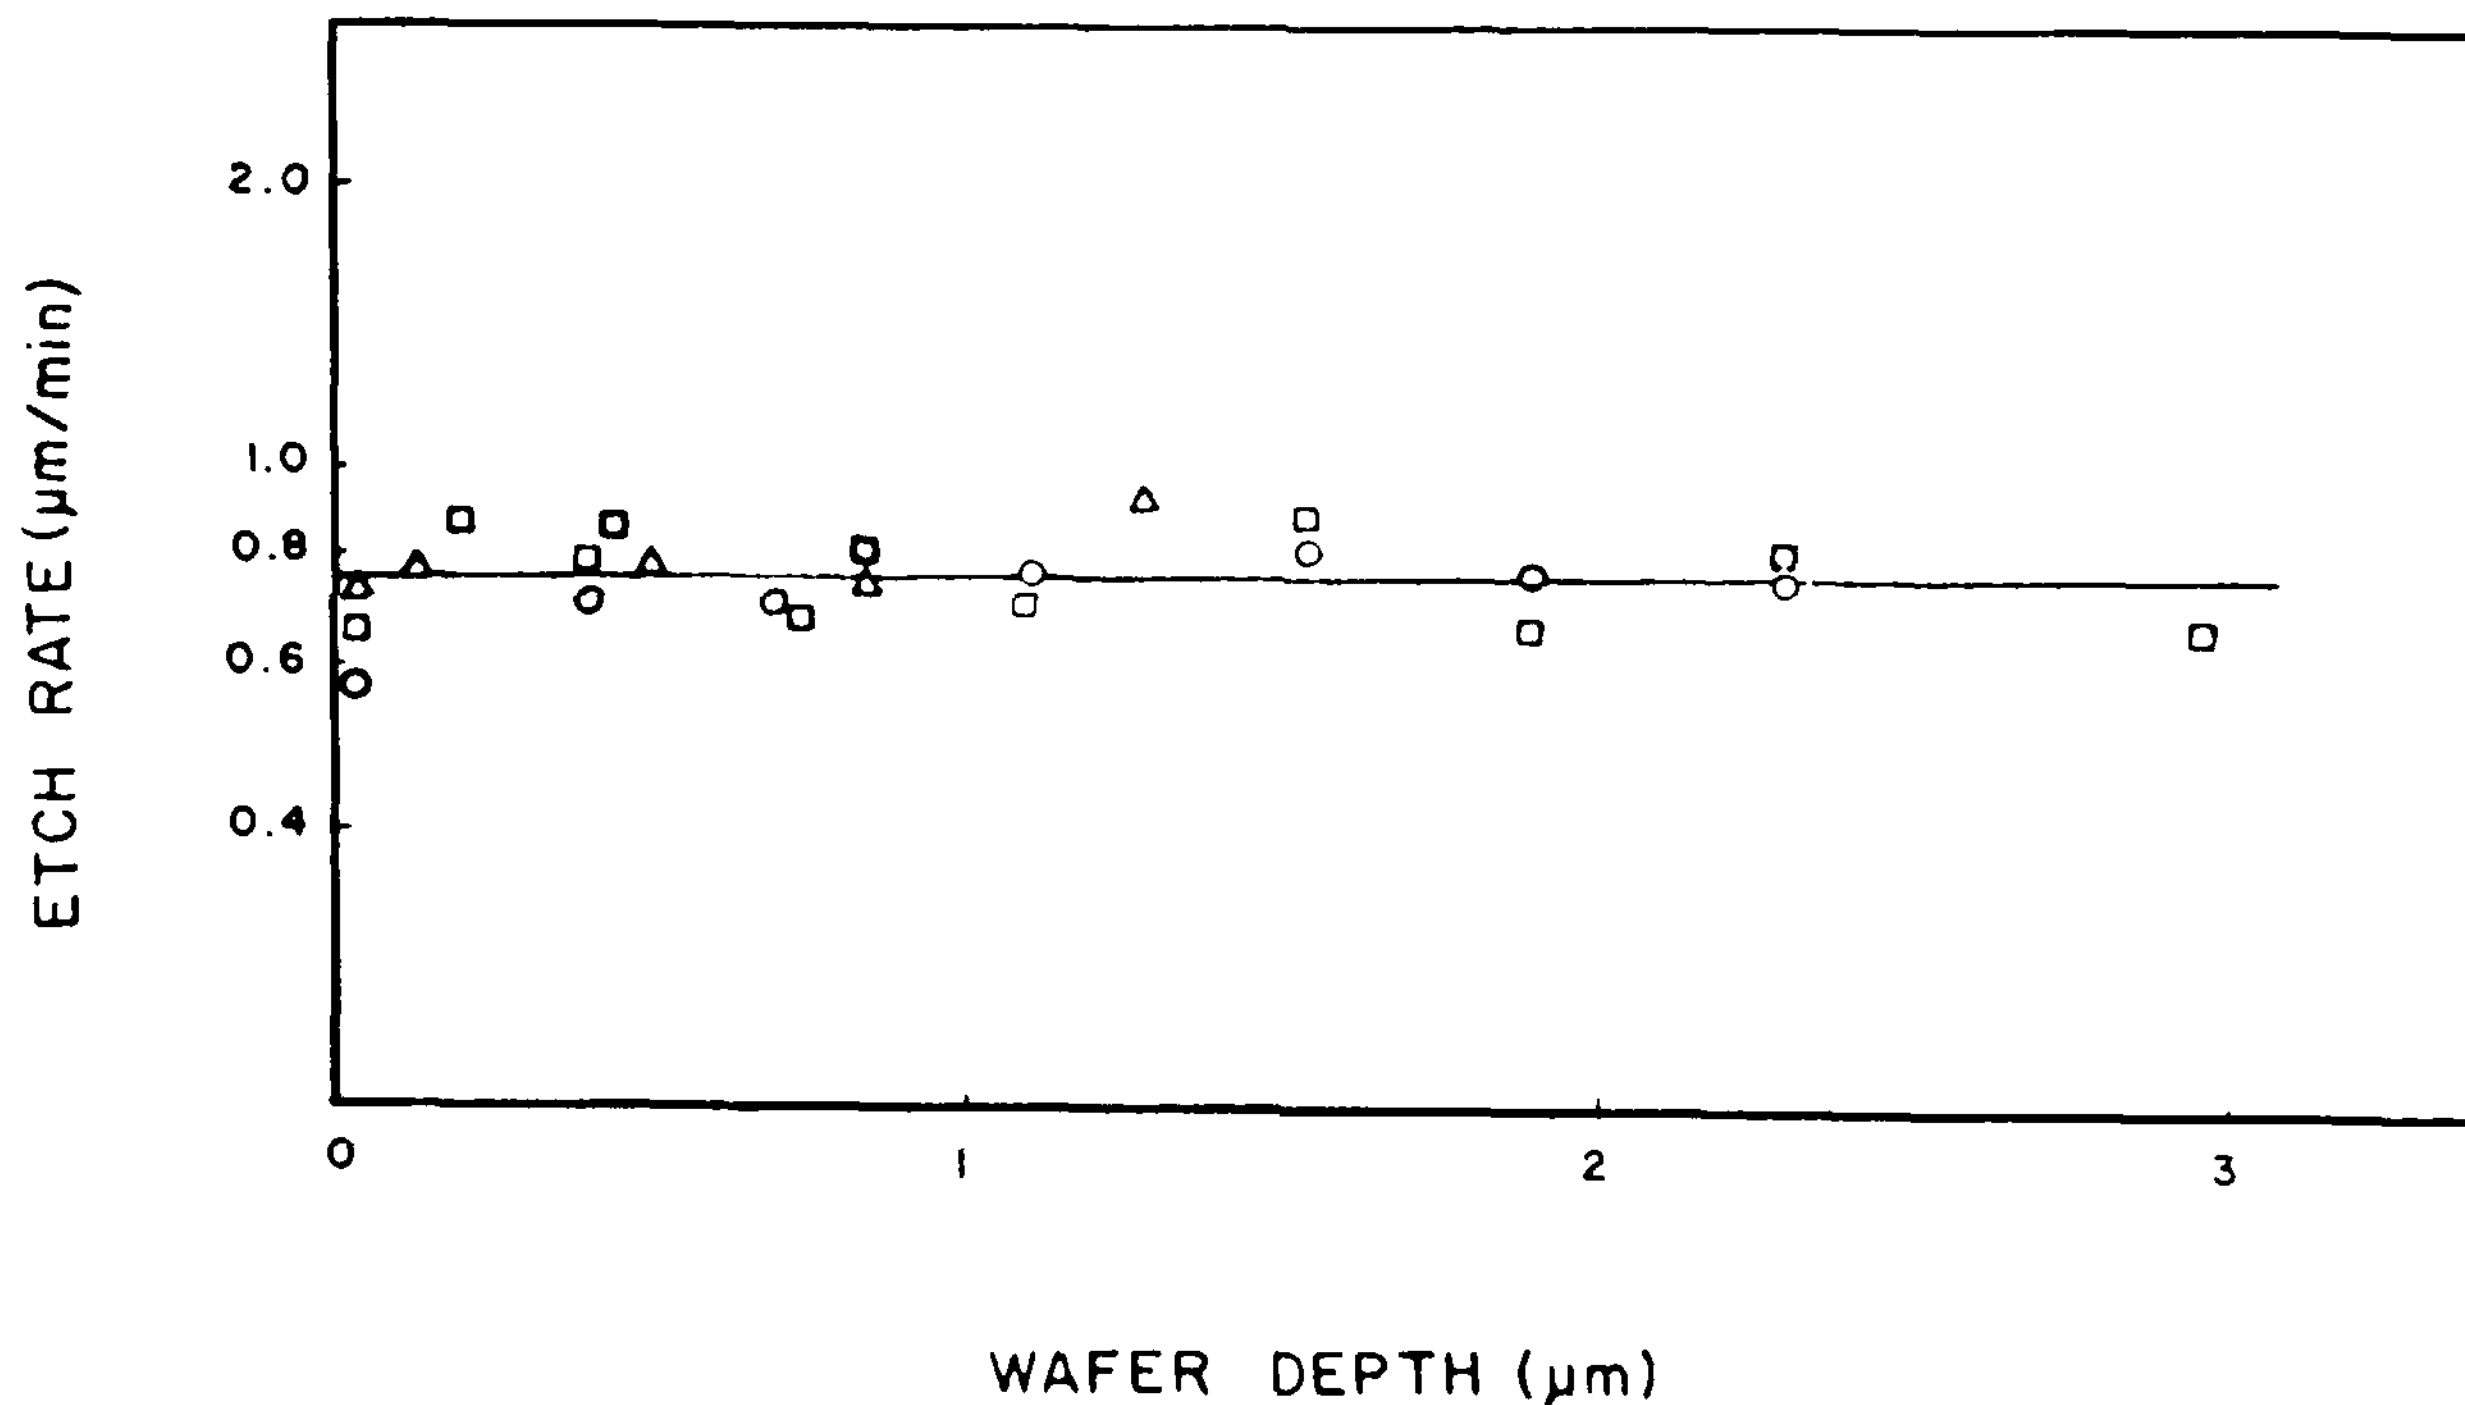
The small amount of subsurface damage on the wafers was verified from the results of the study of etch rates as a function of wafer depth. Tuck et al.[8,9] have shown that the depth of subsurface damage can be determined from plots of etch rates vs wafer depth. These investigators demonstrated that the etch rates of InP wafers containing damage was lower with bromine-methanol etching than the steady-state etch rate. Figure 9 depicts the etch rates determined for the three commercial substrates with 0.1 vol % bromine in methanol at various wafer depths. The plot shows that the etch rates determined at the different wafer depths were relatively constant (0.76 μm/min.) indicating that there was insufficient damage on the wafers to affect the etch rate. Tuck et al.[8] reported the depth of subsurface damage on a (100) surface of a InP wafer as 8 μm.

Figure 9. Etch Rates of Three Commercial Indium Phosphide Substrate Wafers as a Function of Wafer Depth. Etchant: 0.1 vol % bromine in methanol. Temperature: 25.0 ± 0.1°C. O-O, ICI Americas; □-□, CrystaComm; Δ-Δ, Sumitomo.
