Landfill Impact Evaluation

USAR Center Complex and Training Area
Milwaukee, Wisconsin

U.S. Army Corps of Engineers
Omaha District

April 1985

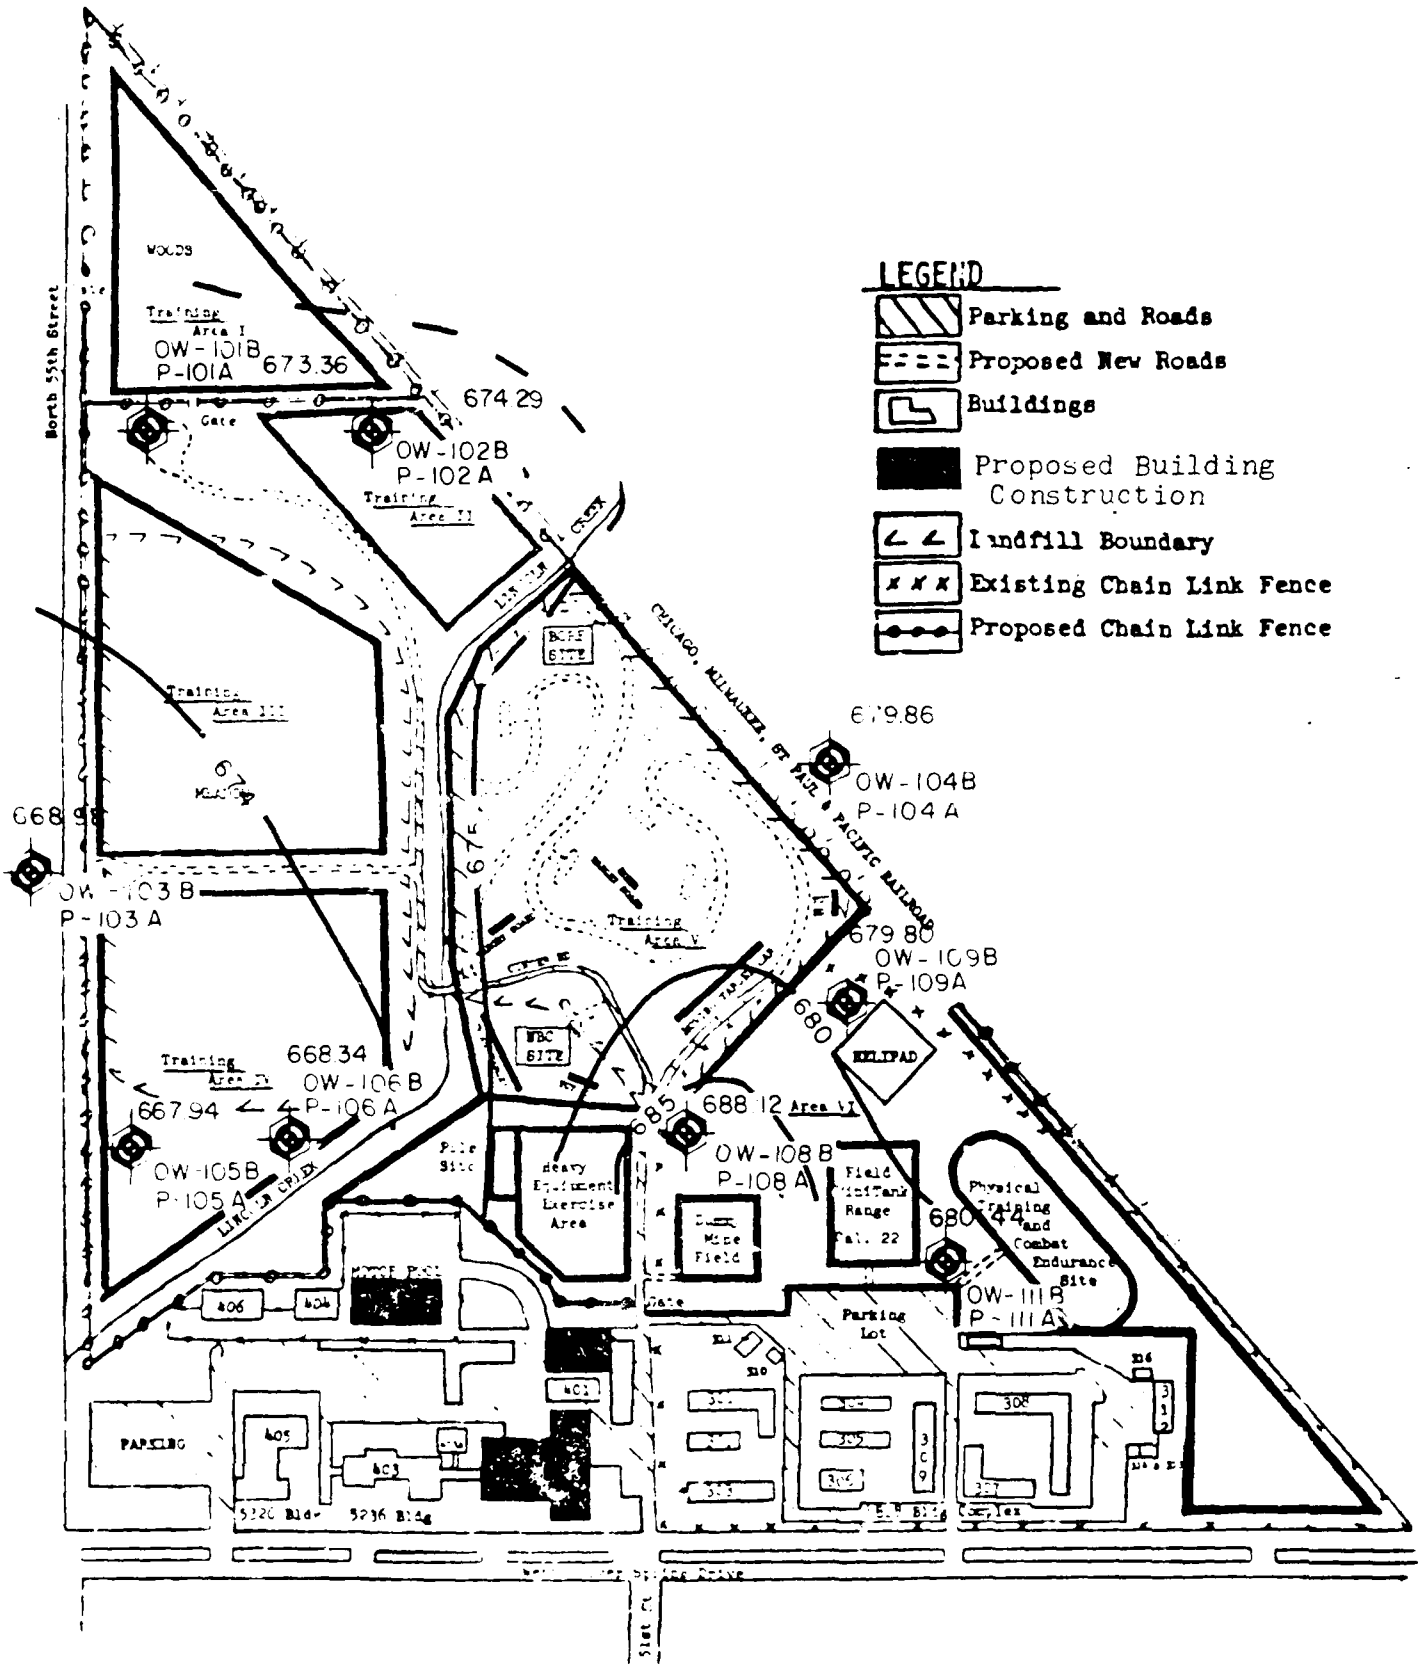
FIGURE 2

Figure 2 shows a water table contour map that was constructed from water elevations taken on February 13, 1985. This groundwater contour map indicates that there is a water table high located in the south central portion of the site. Flow from this area moves laterally and downward towards the east, west, and north. It is expected that away from the mound the predominant local direction of groundwater flow is towards the west. Wells along the eastern portion of the site (104, 108, and 111) show downward vertical gradients indicating groundwater recharge occurring in these areas. Wells along the western portion of the site including 101, 102, 103, 105, and 106 show either very little vertical gradients or upward gradients. Since the vertical gradients become upward along the western portion of the site, groundwater recharge which occurred on the eastern portion of the site would not be expected to move deep into the groundwater flow system.
