FINAL
INFORMATIONAL FIELD REPORT
WATER WELL ABANDONMENT
Delivery Order 5007

Prepared for
McClellan Air Force Base
Sacramento, California

January 1992

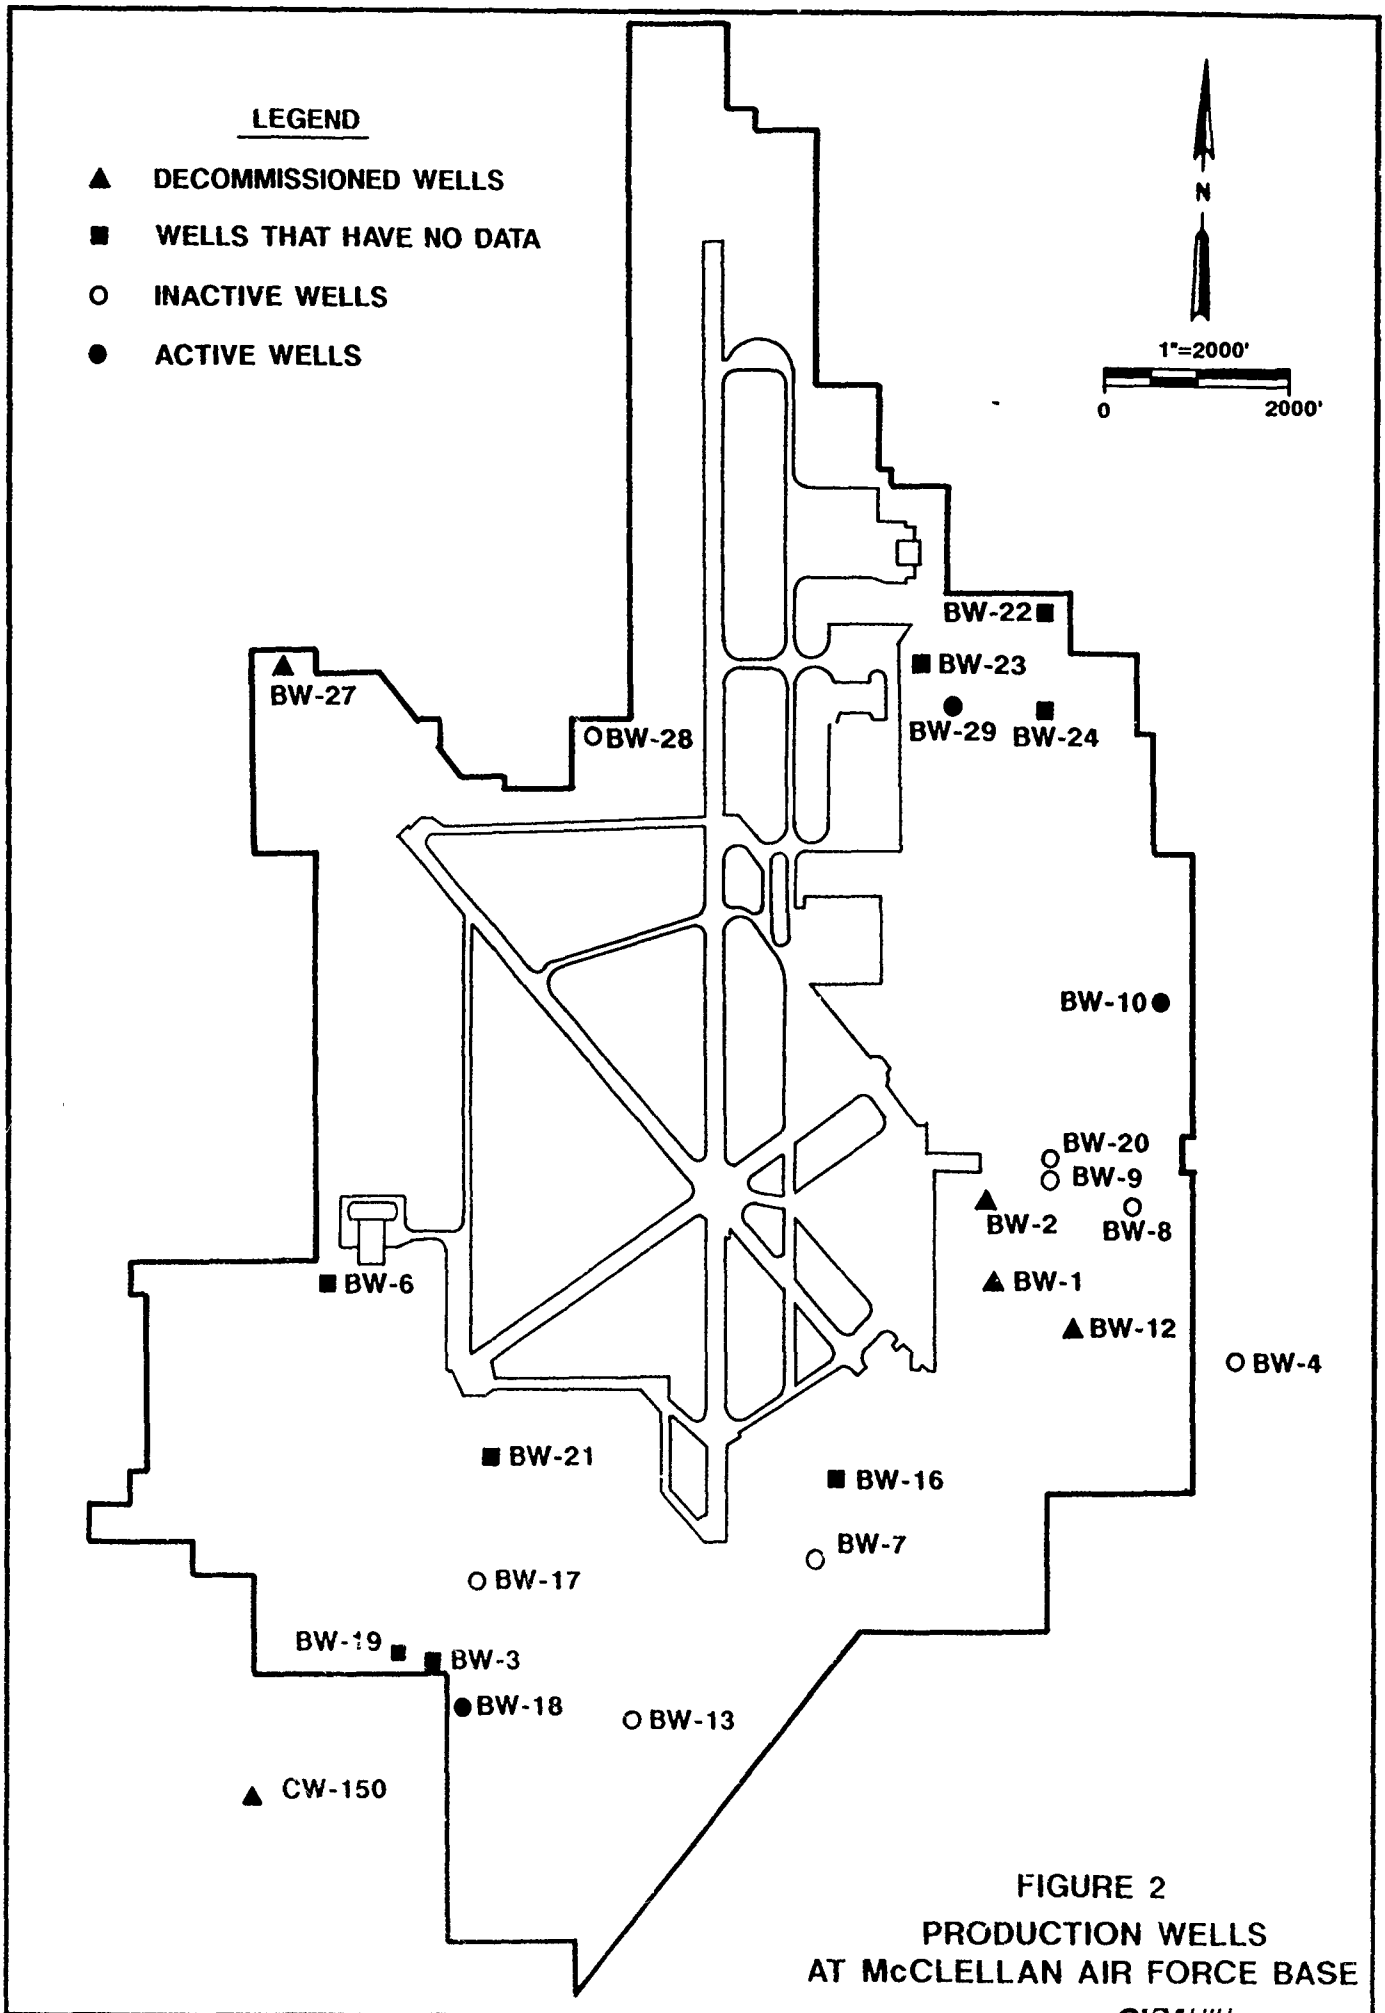
FIGURE 2
PRODUCTION WELLS
AT McCLELLAN AIR FORCE BASE

Originally, eight inactive water supply wells were targeted for decommissioning. However, four of these wells (Base Wells 3, 6, 16, and 19) were eliminated from consideration because they could not be located. Later, City Well 150 (CW-150), on Astoria Street near the southwestern base boundary, was added to the list for decommissioning. The general locations of the five wells abandoned during the course of this project are shown in Figure 2.

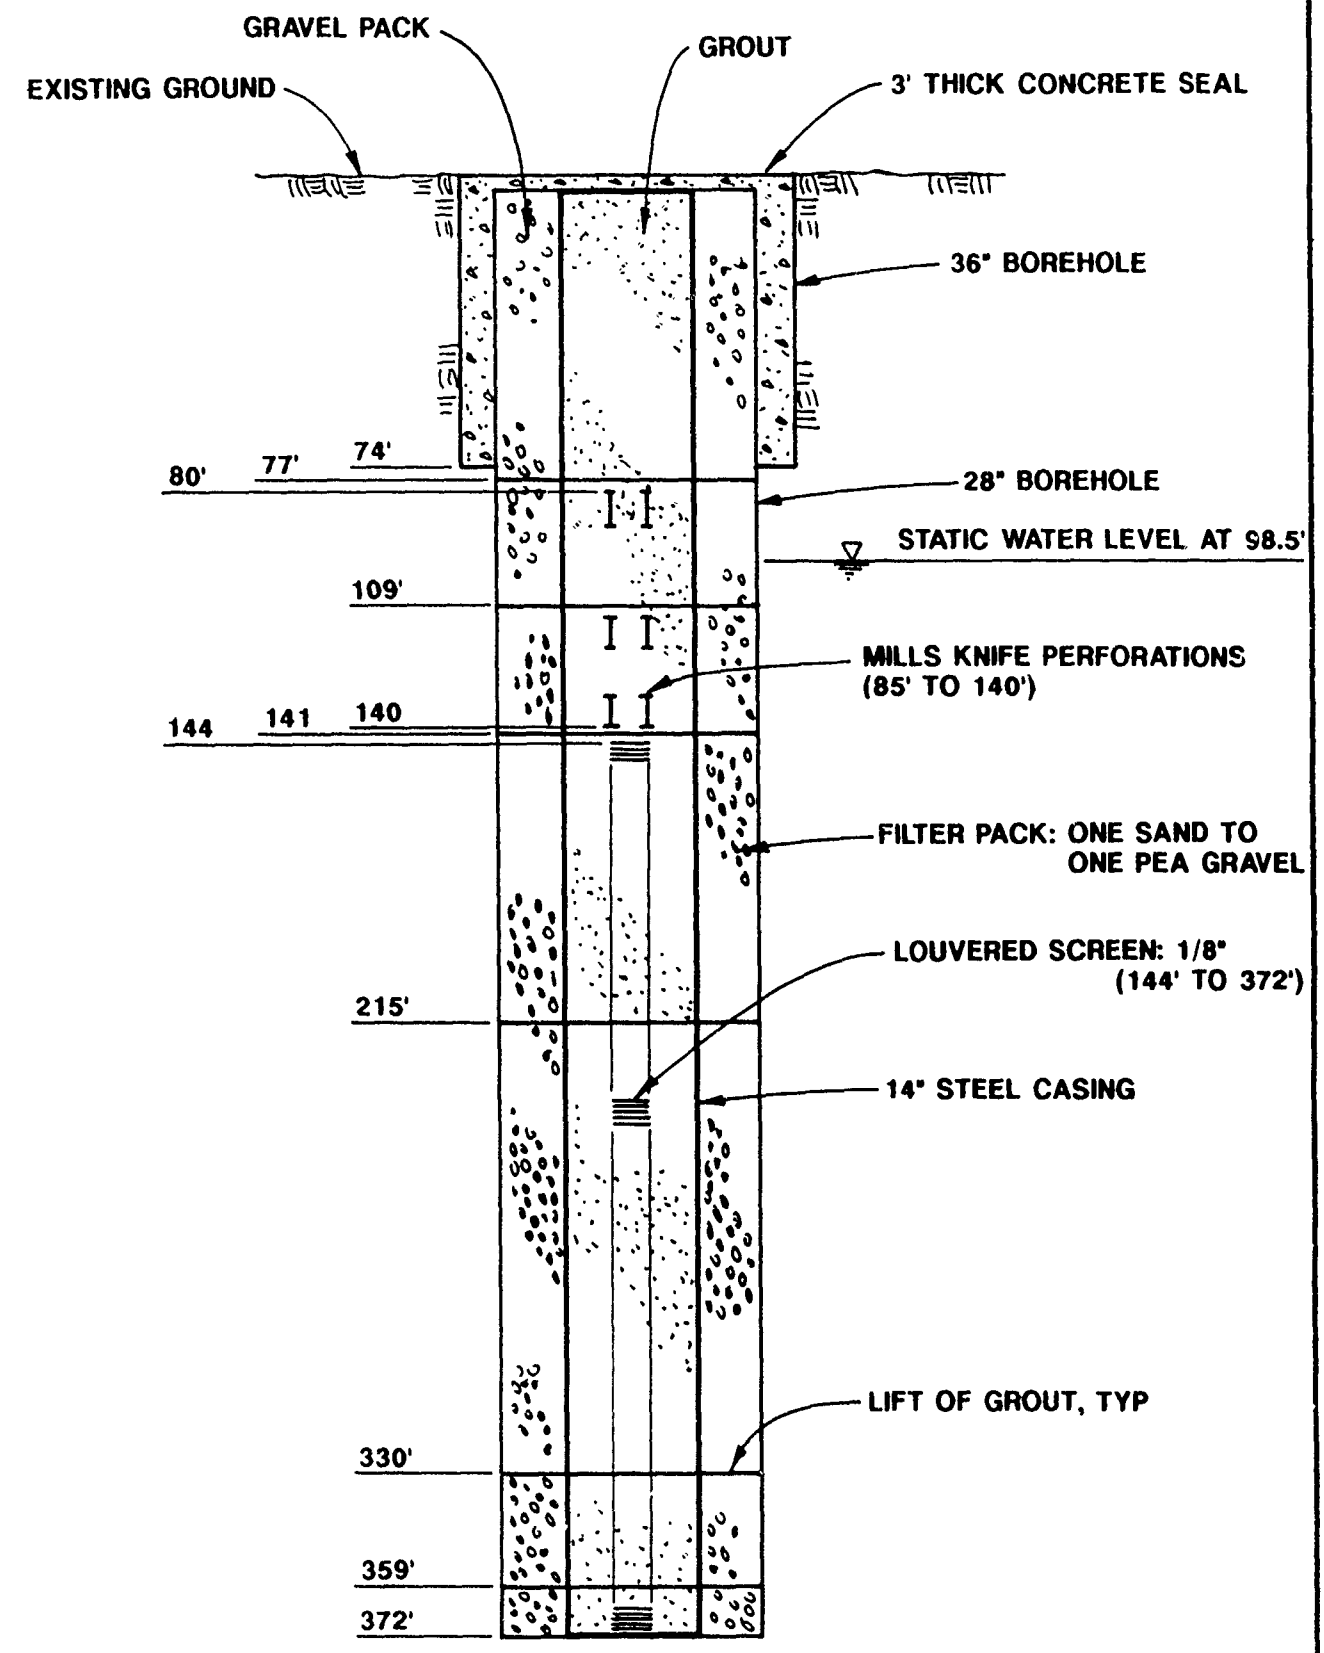
FIGURE 4

CW-150, the first well to be decommissioned, was abandoned between April 1 and April 8, 1991. Table 1 provides a summary of CW-150 cementing operations. This well was operated by the City of Sacramento. It is located near the southwest base boundary, as shown in Figures 2 and 3. A representation of cementing operations in CW-150 is shown in Figure 4.

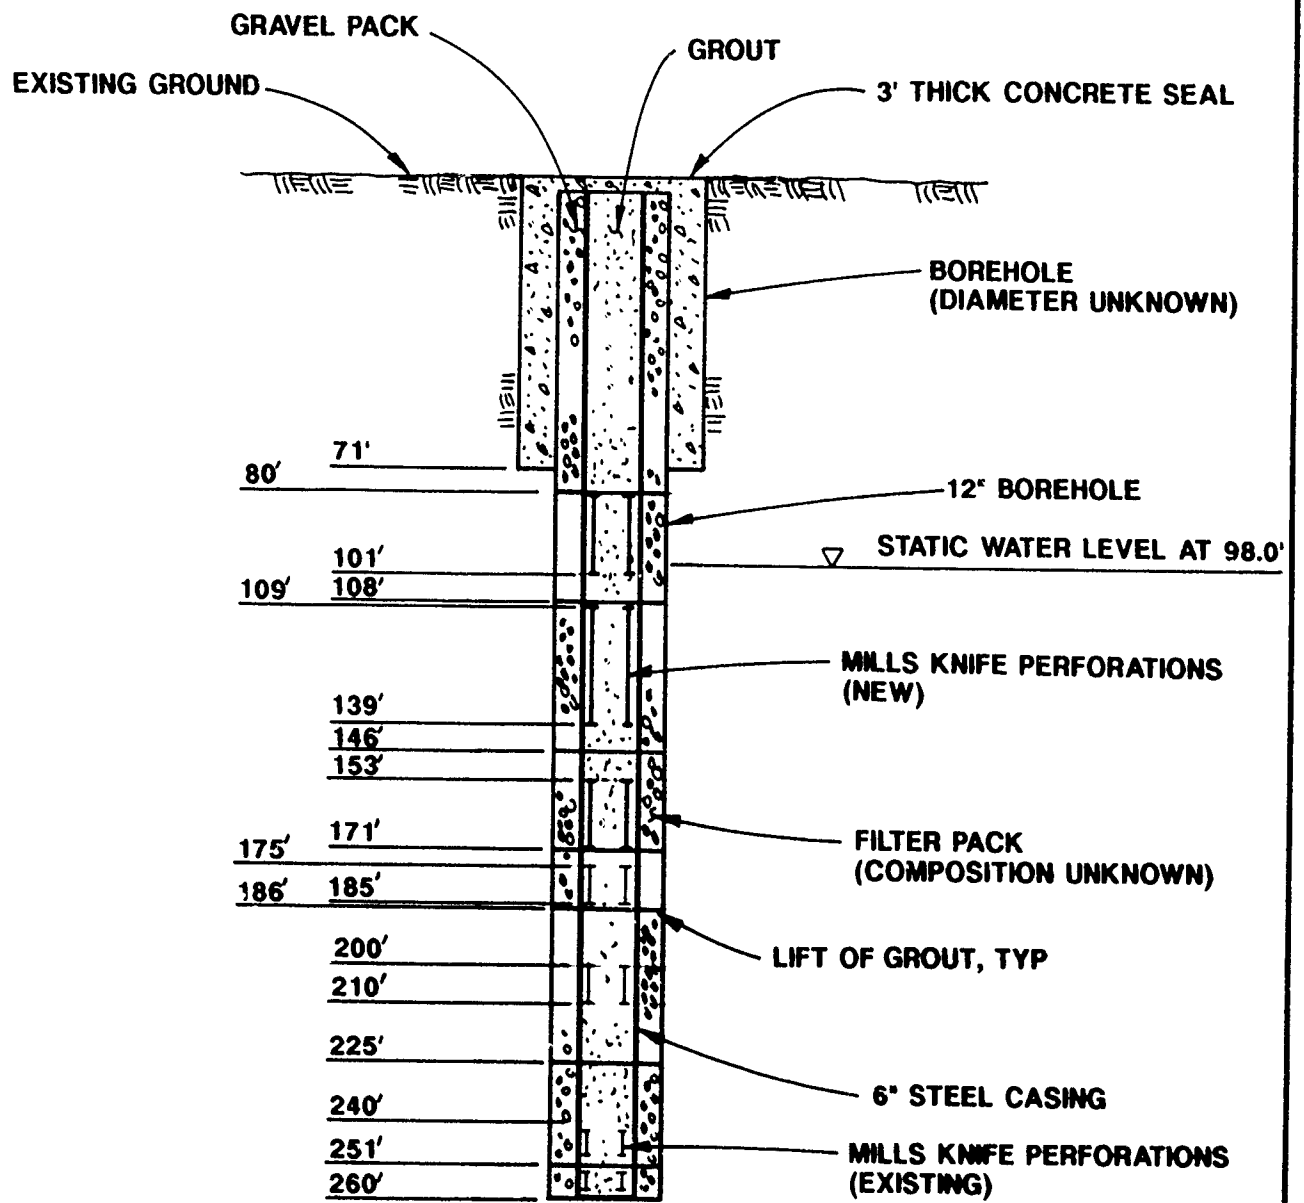
FIGURE 6
CEMENTING OPERATIONS AT BASE WELL NO. 27
McCLELLAN AIR FORCE BASE

The downhole squeeze approach to well abandonment was refined at BW-27. As at CW-150, tremmie pipe was lowered in the well for the first lift to a position about 10 feet above the bottom, or a depth of about 250 feet. The minimum amount of cement that Halliburton could mix and pump at one time was about three barrels, or 16.8 cubic feet. The grout formulation used throughout the abandonment of BW-27 was Pozmix, with 2 percent bentonite gel and 3 percent calcium chloride. First, about three barrels of water was pumped through the tremmie pipe to establish circulation, after which 16.8 cubic feet of Pozmix was pumped down the well. The pipe was pulled up about 60 feet and approximately 15 barrels of water pumped through the mixer, pump, and pipe to flush and clean the system of cement. Next, the tremmie pipe was withdrawn from the well and fitted with a cup packer. The cup packer was lowered in the hole but became very difficult to push at a depth of about 175 feet. Because the cup packer might have been pushing cement, it was decided to set the cup packer at a depth of 200 feet and pump water to apply pressure. About 60 psi was achieved and 2.5 barrels of water had been pumped when all pressure was lost. After the pump was turned off, water continued to drain from the mixing tank under the force of the head of water in the pipe. This indicated that a permeable zone was taking all the water that could be applied. To avoid cementing the cup packer in the hole, it was removed from the well. Water was pumped into the well at about 400 gpm to apply a head. Setup was judged in the same manner as CW-150. When the sample was set, the tremmie pipe was run down the hole to tag the top of the cement. The top was found at a depth of 251 feet, indicating a large amount of cement was lost to a permeable zone:

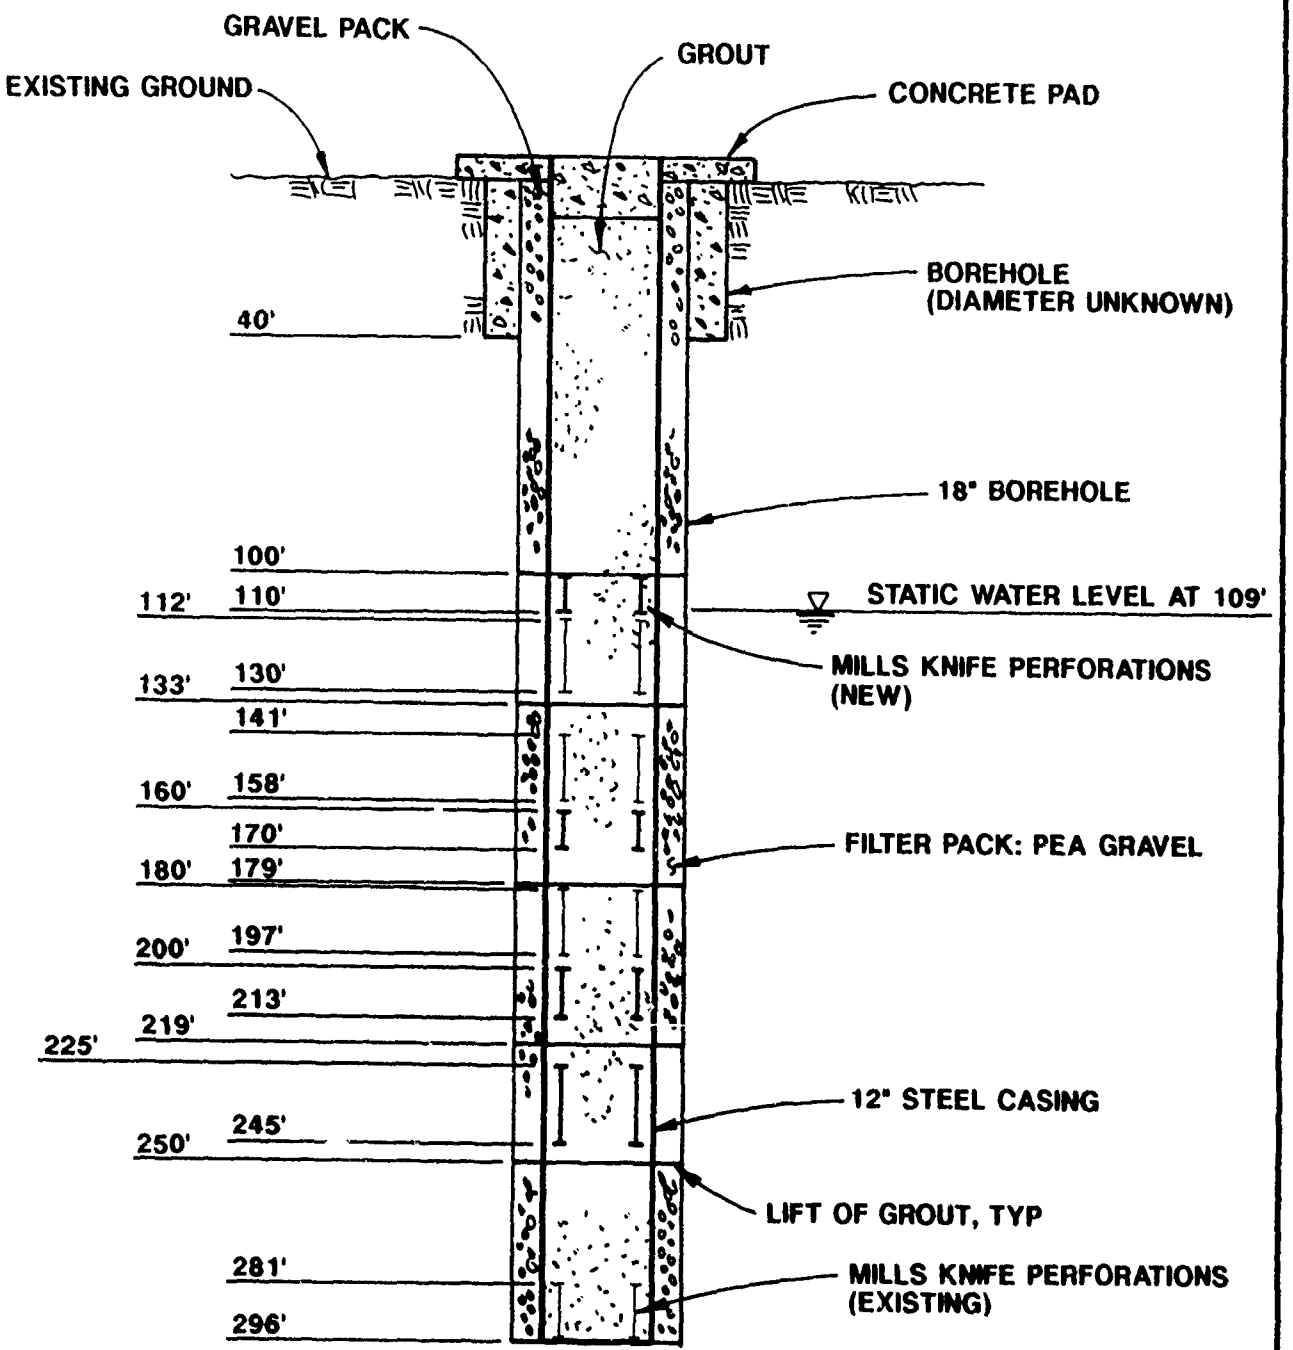
FIGURE 8

The cementing approach developed at BW-27 was employed with success at BW-2, with the exception of the first lift. Existing perforations lay at depths of 281 to 296 feet, 180 to 197 feet, 141 to 158 feet, and 100 to 110 feet. On the first lift, the cup packer was set at a depth of 260 feet. As a first step, about five barrels of water were pumped down the hole to establish circulation. By circulating water in the hole with the cup packer set, the operator was able to determine whether the perforations were open and ready to be cemented. Also, by monitoring the pressure gauge, it was possible to estimate the relative permeability of the adjacent formation. For example, if positive pressure was required to pump the water, then the formation might be relatively low in permeability and consist of silt or clay. On the first lift in BW-2, no pressure was developed when water was circulated. In fact, after the pump was turned off,

However, when the top of cement was tagged, both the tremmie pipe and weighted line were unable to move past a depth of 250 feet. It was unlikely that cement had set at that height because the cup packer had been set at 260 feet. Even if all the cement pumped (28.3 cubic feet) had remained in the casing, it would have filled only about 36 feet of casing, bringing the top of the cement it up to the 260-foot depth. The cause of the obstruction at 250 feet is unknown.

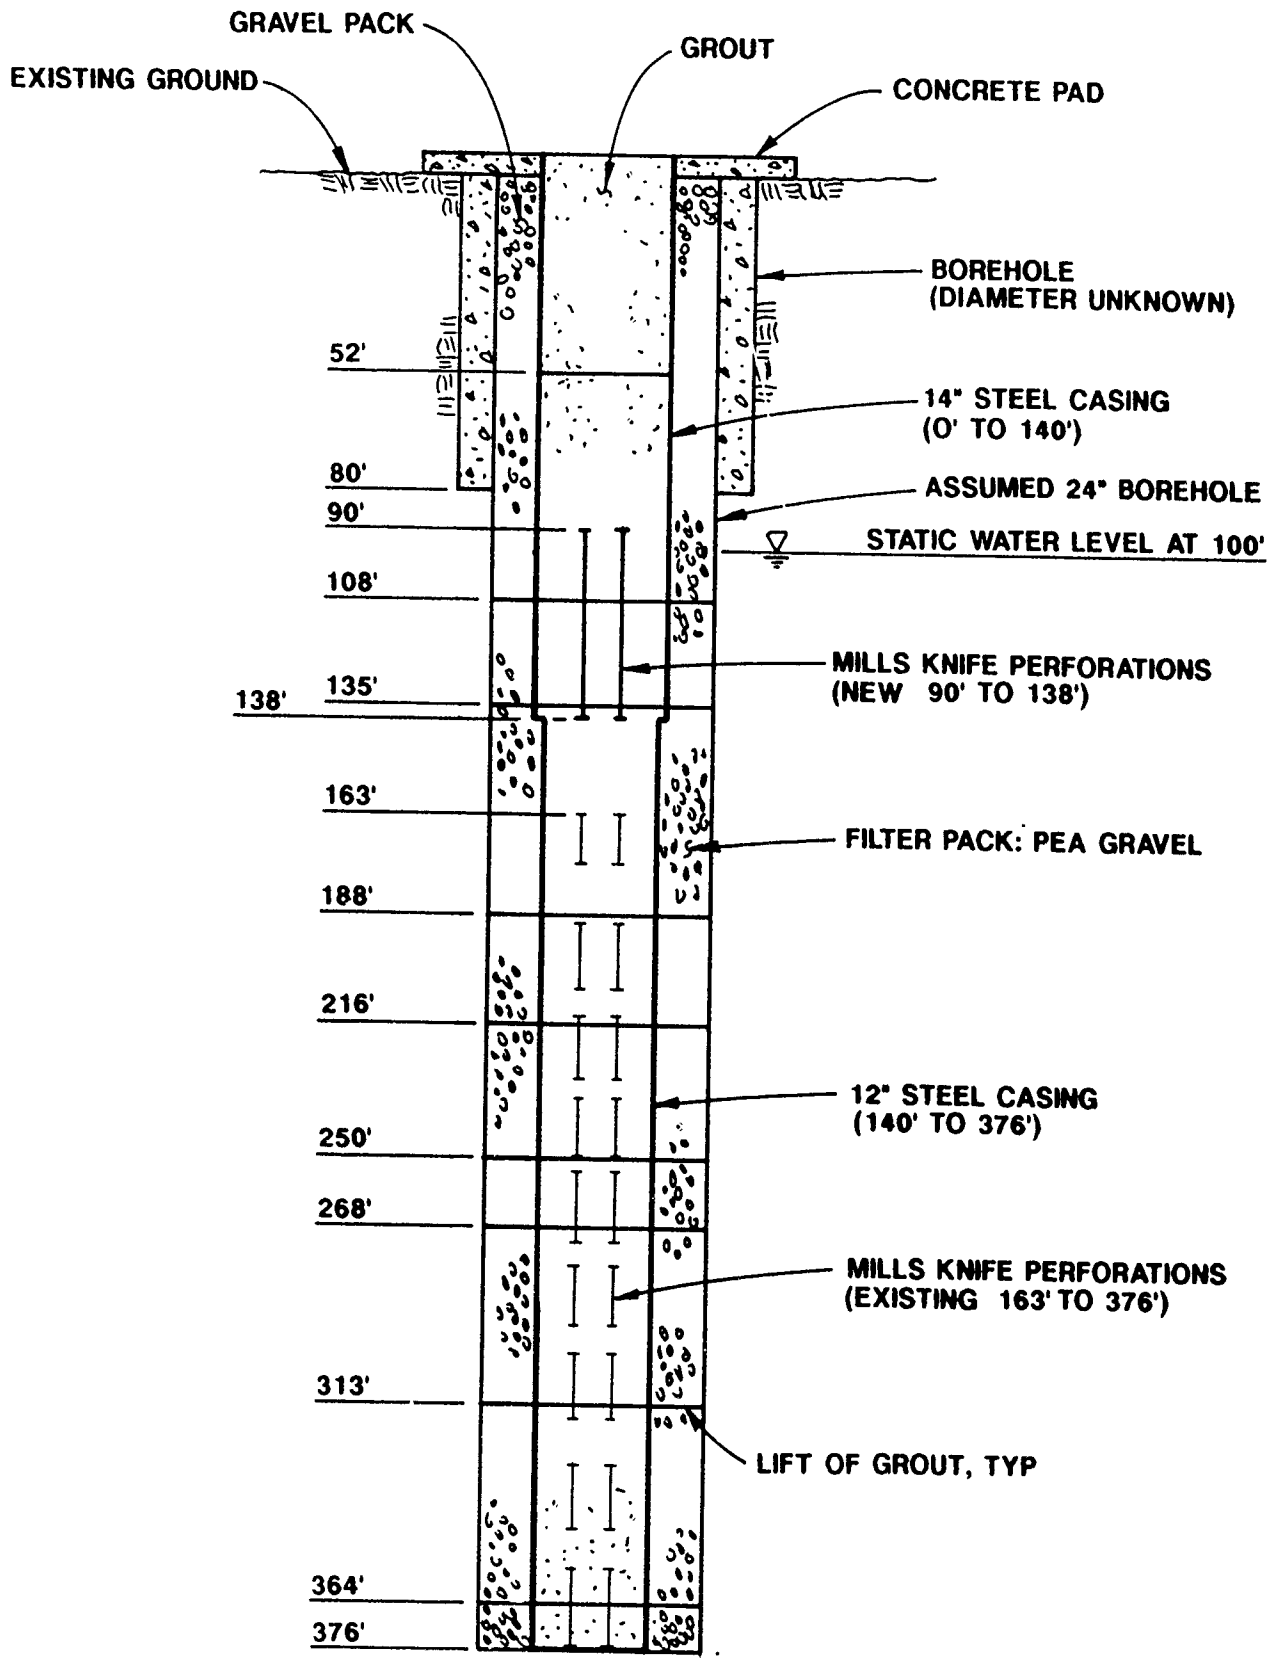
FIGURE 10
CEMENTING OPERATIONS AT BASE WELL NO. 12
McCLELLAN AIR FORCE BASE

The television survey conducted in BW-12 revealed that the casing was in an advanced state of deterioration, with holes, cracks, and splits extending throughout the length of the well. This fact, together with the fact that the well was already perforated through most of its depth, dictated that the packer method of abandonment could not be used. After consultation with Halliburton, it was decided to use Matrix Cement, which has the ability to flow into small pore spaces without additional pressure. This capability was enhanced by the addition of CFR-3.

The successful abandonment of BW-12 served to refine the technique to be used in decommissioning wells that are perforated for great intervals, or contain weak or damaged casing. In these situations, use of a cup packer is not appropriate. However, a low-viscosity cement such as standard fine cement with a dispersant additive similar to CFR-3 was found to seal the well adequately. The well should be abandoned in stages, with water pumped into the well to supply additional driving force.

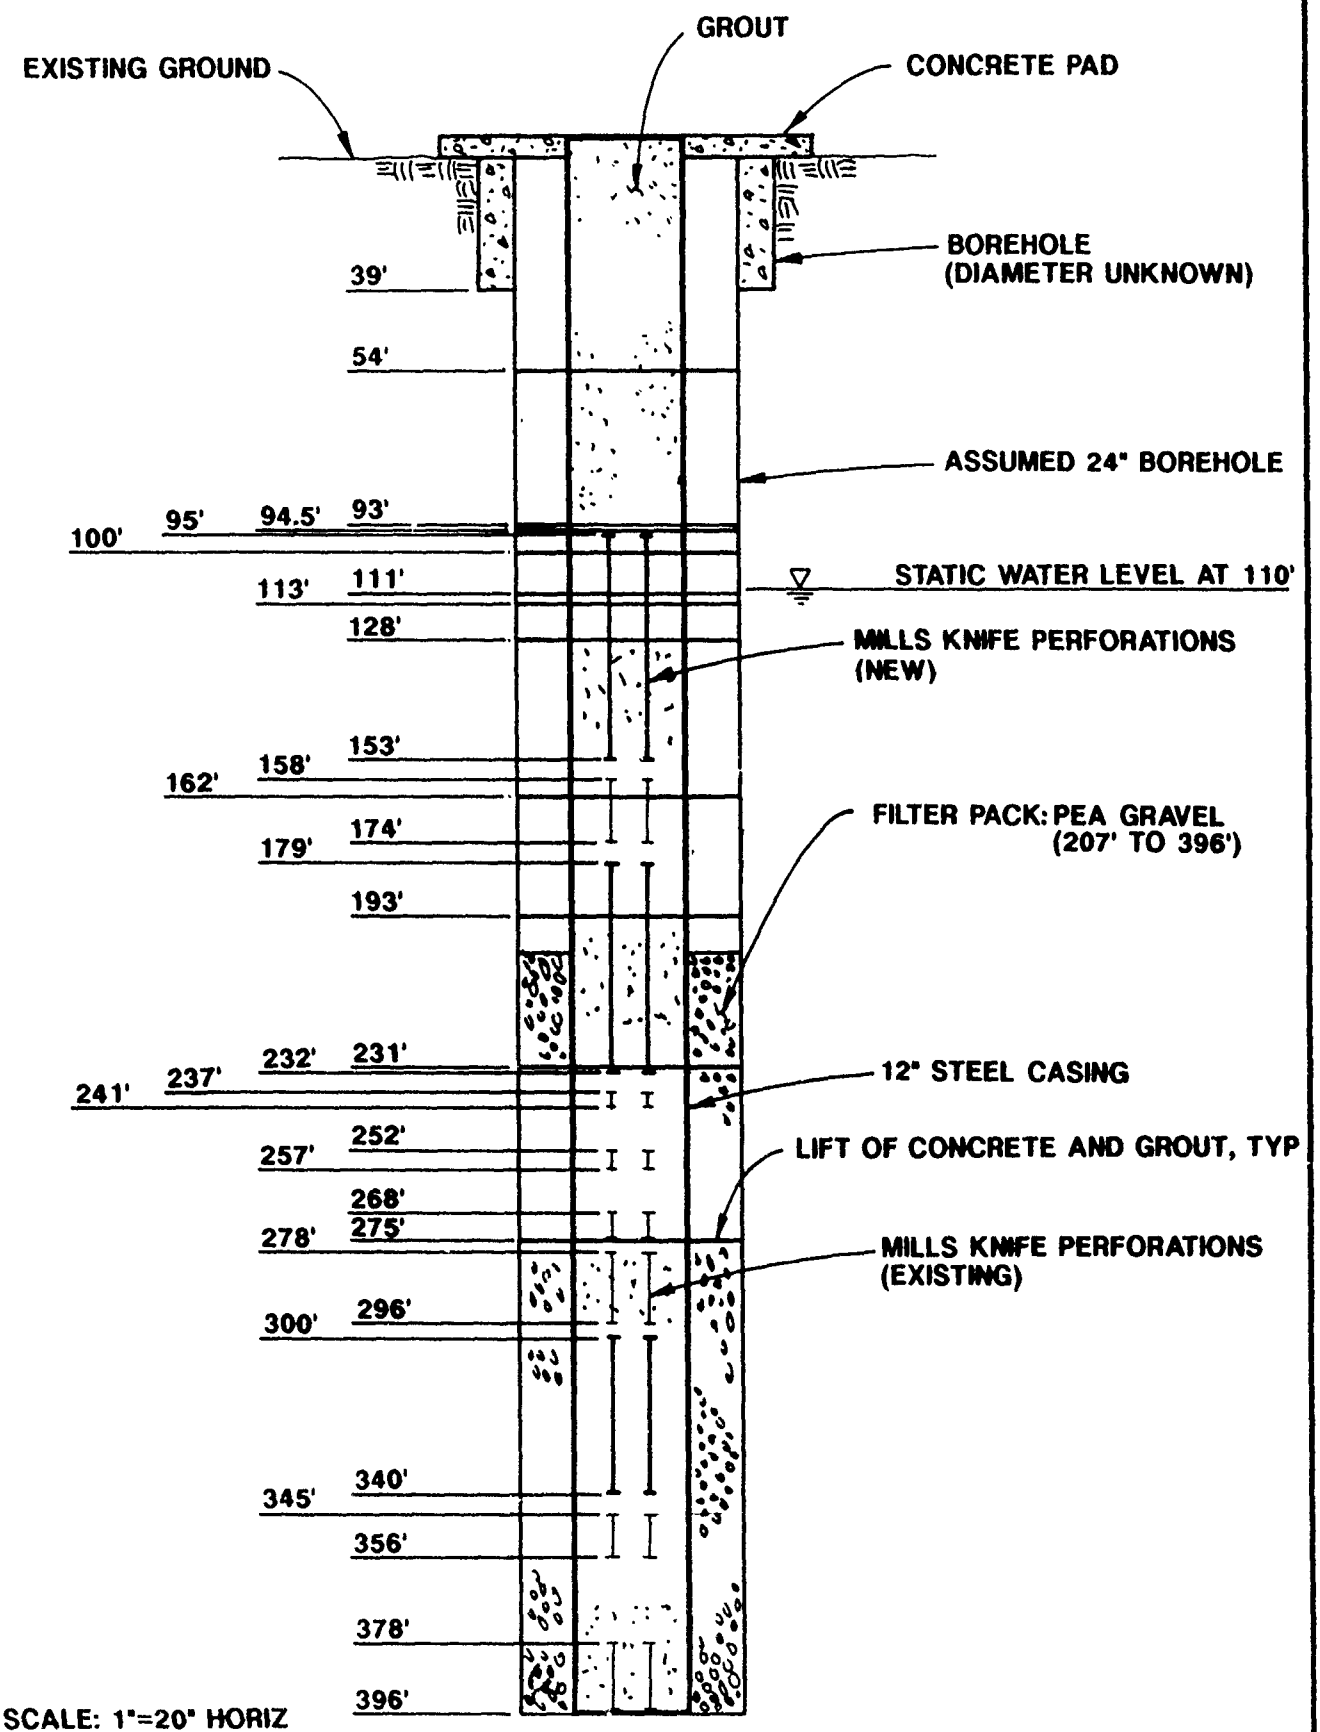
CEMENTING OPERATIONS AT BASE WELL NO. 1

Airlifting continued until the packer was freed on June 28, 1991. A television survey revealed holes and cracks in the casing from 164 to 192 feet and the top of additional sediment at 215 feet. Airlifting continued until July 10, when the bottom of the well was cleared of sediment. In all, two bins were filled about two-thirds full with material removed from the well. Nearly all of the material removed appeared to be pea gravel from the gravel pack, although some material may have been derived from a permeable zone near the water table. A small volume of fine-grained material was removed from BW-1, mainly derived from existing sediment at the bottom of the well. At the conclusion of airlifting, the top of the gravel was at 207 feet in the annulus around the casing, as tagged through the gravel feed tube.

It was decided to remove the sediment and cup packer from BW-1 using an airlift procedure. Following this operation, BW-1 would continue to be abandoned as was BW-12 using standard fine cement. This work began on June 19, 1991.

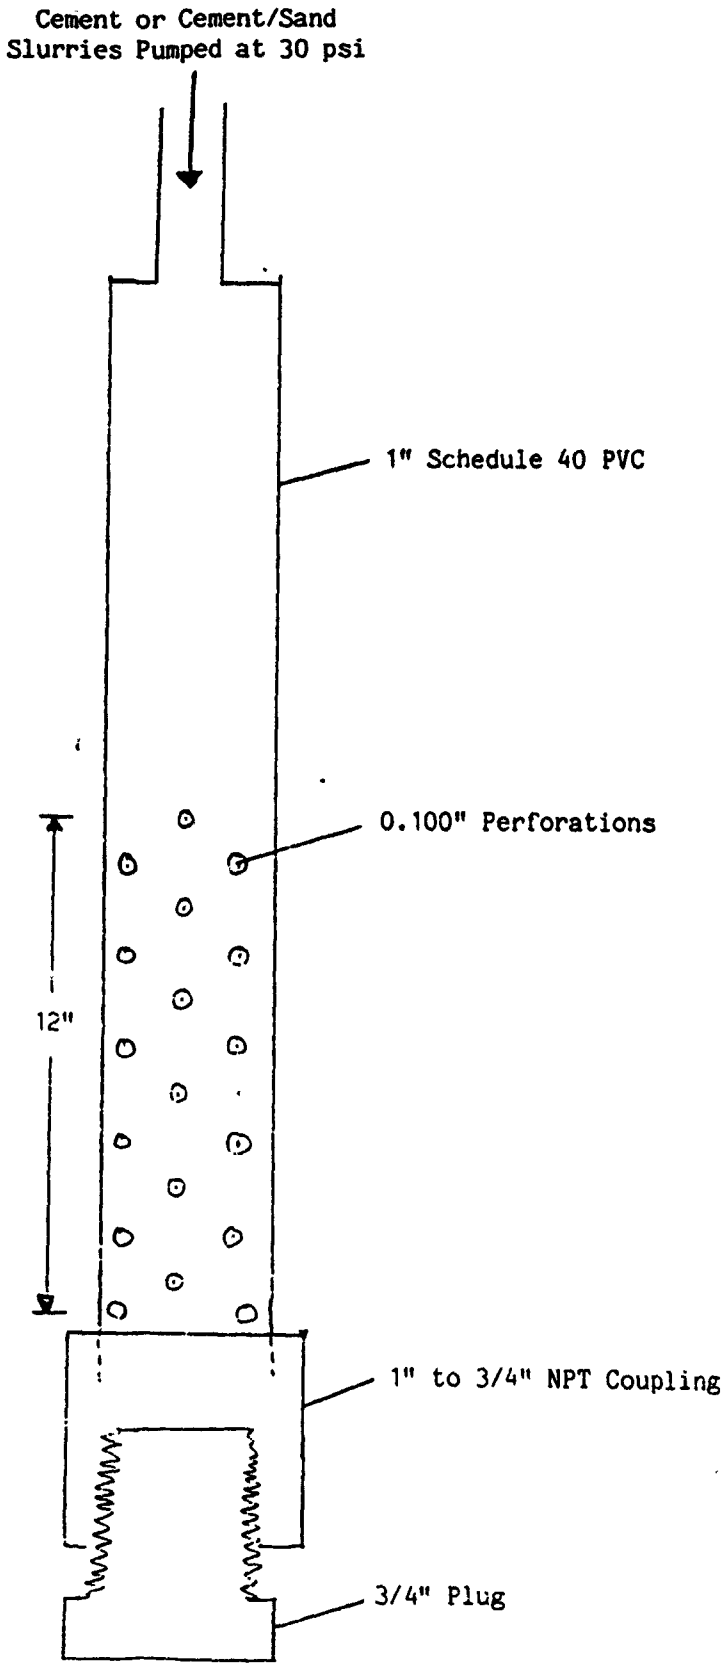
Figure 2. Perforation Flow Test

The apparatus used for the perforation flow tests is shown in Figure 2. The perforation size of one-tenth of an inch (0.100") was chosen to model the slots used in the actual wells which are 0.100 inches. The results are given in Table 3. The only slurries which failed were the sand/cement slurries. A plot of sieve opening versus cumulative weight retained for the sands used in the sand/cement slurry explains why these slurries failed (Figure 3). The D_{50}, or the diameter which 50% of the sand is retained on a sieve, was 0.0325" for the Logan sand and 0.025" for the Hollister sand. The D_{50}'s of both sands falls into the optimum plugging size range for an opening of 0.100". Optimum plugging has been shown to occur when the particle size diameter is approximately 1/4 to 1/3 the opening diameter (see References 1-3). For a 0.100" opening, the optimum plugging diameter range of 0.025" to 0.033" would be calculated. Unfortunately, this range is almost exactly the D_{50} value for both the Logan and Hollister sand.

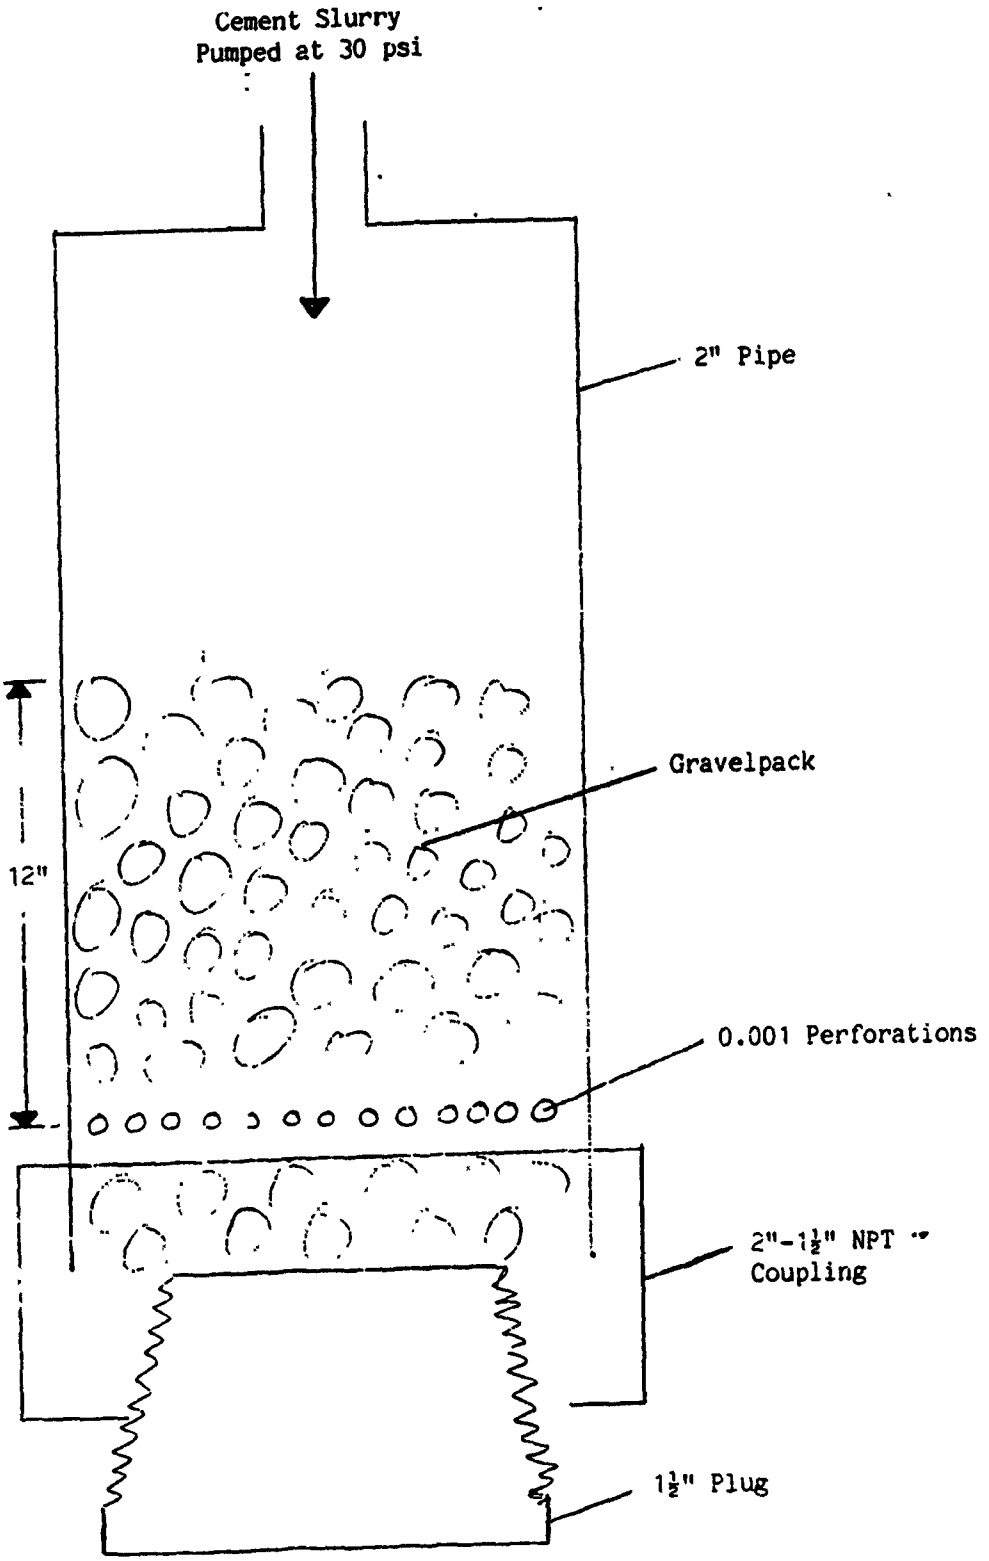
Figure 4. Gravelpack Flow Test

The gravelpack flow tests were performed on the apparatus shown in Figure 4. The results are listed in Table 3. Every slurry which passed the perforation test (Slurries 2, 3 and 4) also passed the gravelpack tests. Again, Slurries 2, 3 and 4 passed the gravelpack tests.

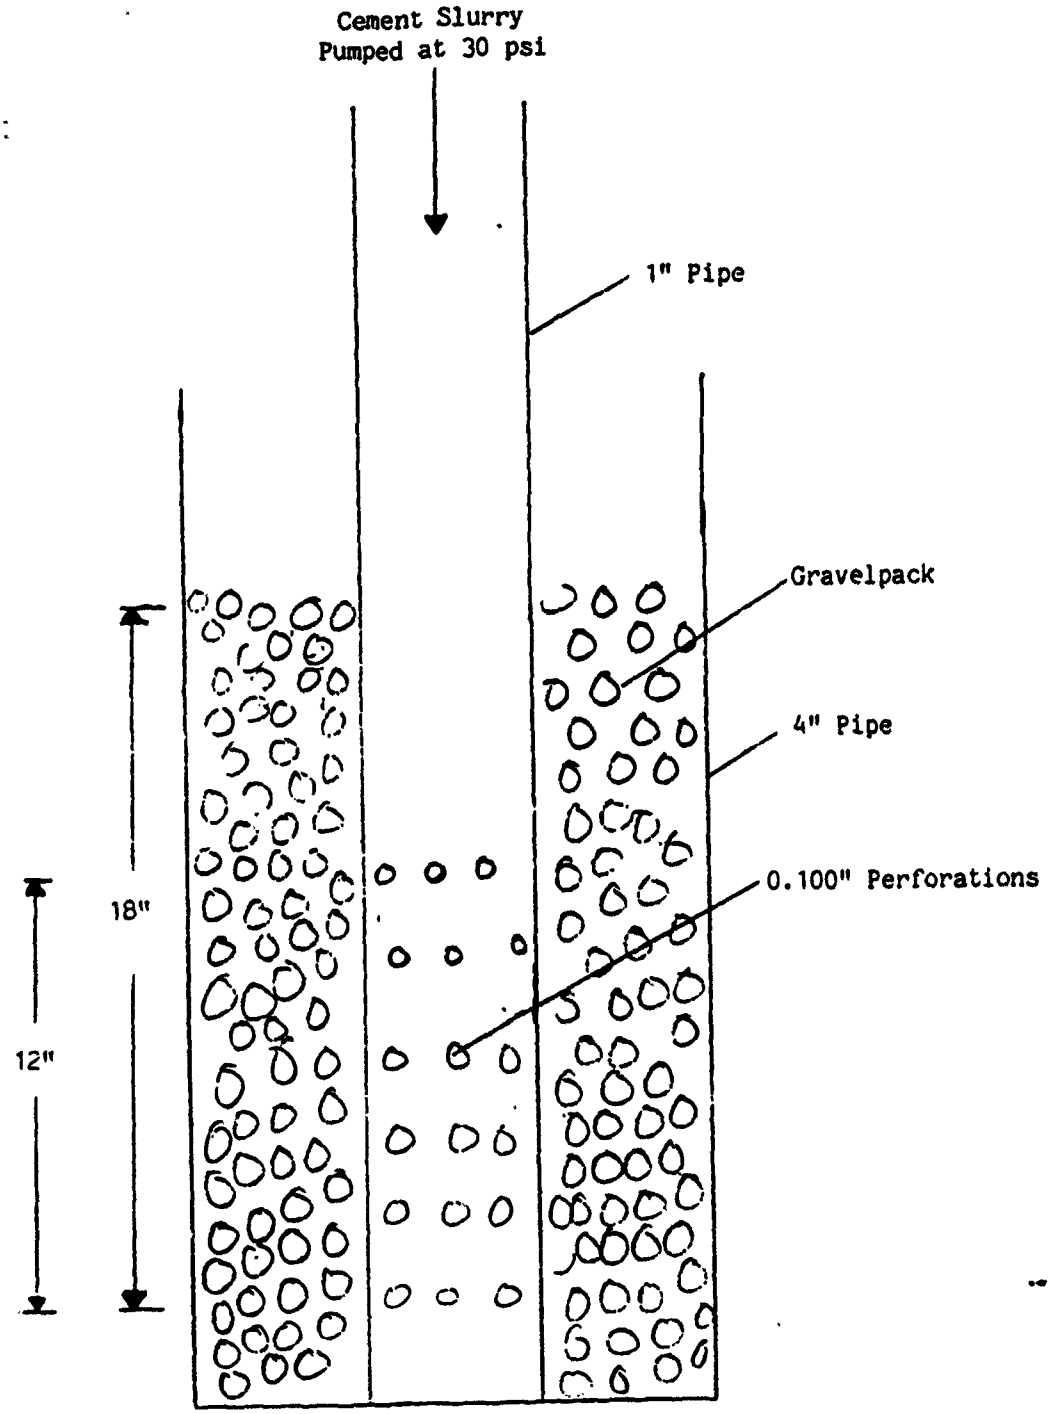
Figure 5. Perforation - Gravelpack Flow Tests

The perforation/gravelpack tests were performed with the apparatus shown in Figure 5. The results are listed in Table 3. Slurries 2, 3 and 4 passed the test both with and without a 25% w/w contamination of formation sand in the gravelpack. The only parameter which changed was the pressure required to push the slurry through the gravelpack. As expected, the slurry with the lowest viscosity, Slurry 4, was the easiest to push through the perforation and gravelpack.
