INVESTIGATION OF TENSION-COMPRESSION FATIGUE
BEHAVIOR OF A CROSS-PLY METAL MATRIX
COMPOSITE AT ROOM AND ELEVATED TEMPERATURES

THESIS

Elizabeth A. Boyum
Captain, USAF

December 1993

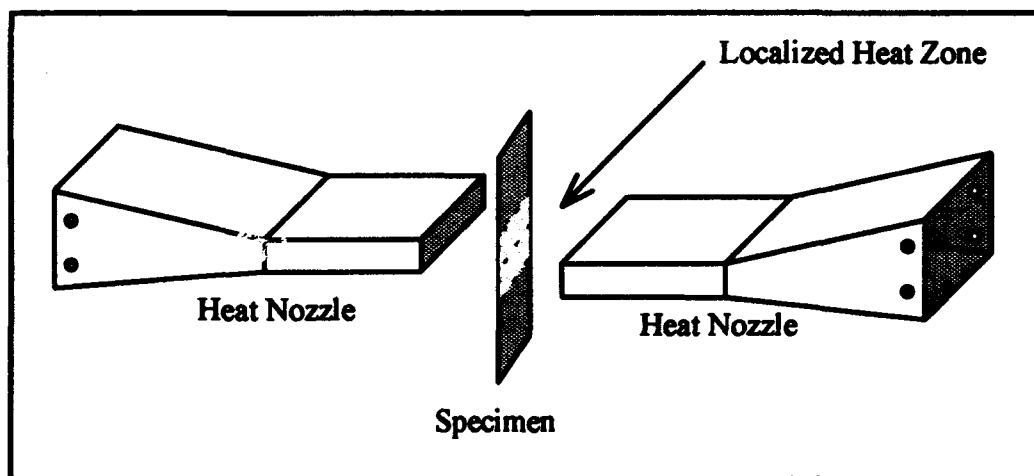
Figure 3. Localized Heat Zone on Specimen

The inability of the heat nozzles to heat the entire specimen caused a thermal gradient on the specimen which caused failure outside the region of interest. Thus, the next logical step was to heat the entire specimen, in which the thermal gradient would be eliminated, and the specimen failure would then characterize that of the elevated temperature. However, the equipment needed for this type of a test was not available. Thus, a less localized heat zone was needed which would heat as much of the specimen as possible. To accommodate the full vertical length of the heat lamps which would provide this extended heat zone, the test stand grips had to be further apart. This required a much longer specimen, which would surely buckle under the compressive loads.

To avoid premature specimen failure due to both the matrix cracking caused by the temperature gradient and the buckling caused by the required increased gage length, a new specimen geometry and buckling guide were developed. A dogbone specimen geometry was designed with the expectation that a reduced area in the heated gage length would induce the failure to occur there. Since it was not known how much stronger the material was at elevated temperature, a drastic area reduction was desired to ensure heat zone failure. The heat lamps were then used without nozzles, increasing the heat zone area, which further increased the possibility for failure in the gage section. Thus, the dogbone design was selected with a 58 percent width reduction in the center gage length. This design involved tradeoffs between maximum width reduction and maximum radius of curvature at the shoulder of the dogbone, since small shoulder radii could cause failure due to the localized high shear stress (53:1). A unique buckling guide was also designed for specific use in fatigue loading with the dogbone specimens. Use of the dogbone specimens in conjunction with the buckling guide was successful, resulting in consistent heat zone failures. Additionally, the buckling guide was used at room temperature to validate the fact that buckling did not occur during the TC RT tests which were performed without a buckling guide. The fatigue lives for these tests with and without the buckling

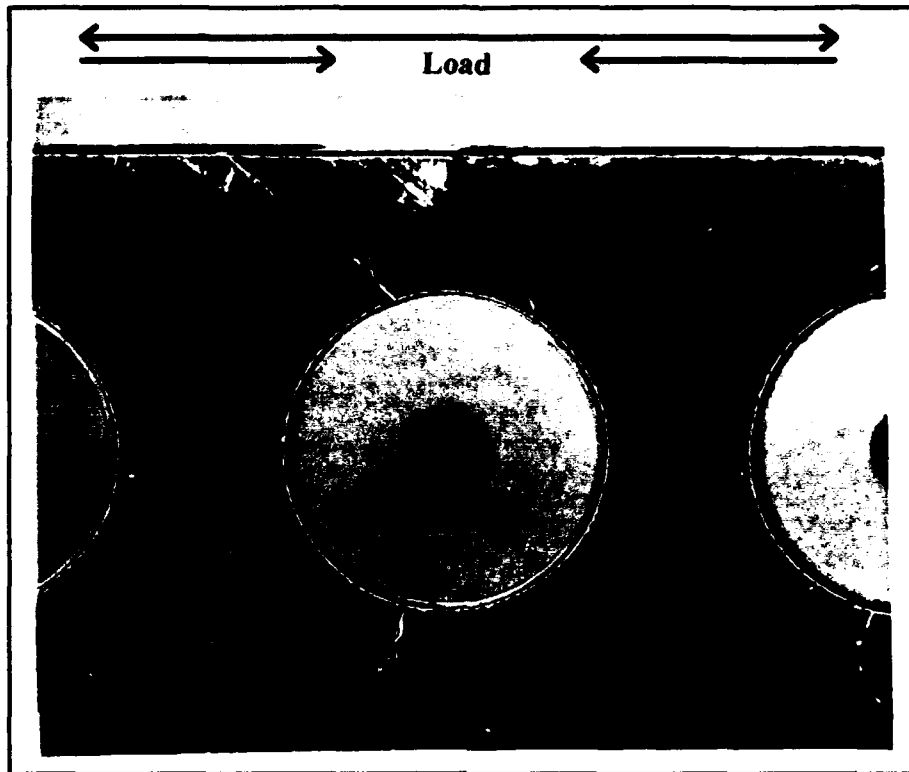
Figure 30. 600 TC RT: Debonded Fibers, RZCs, and Slip Bands (300x)

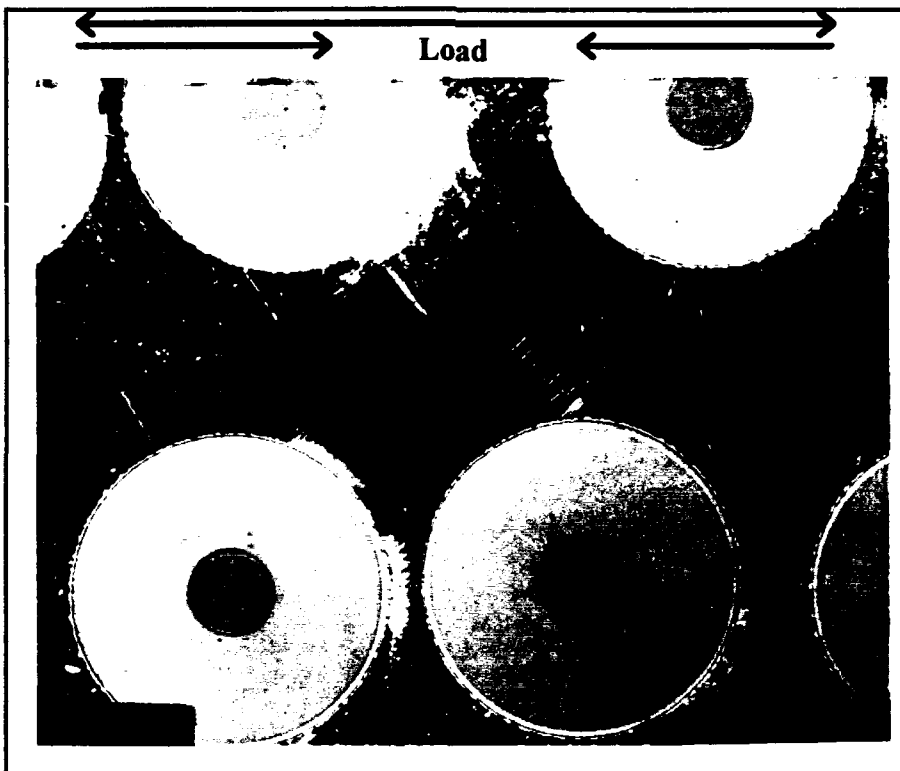
Figure 32. 600 TC RT: Matrix Plasticity Due to Compressive Load (300x)

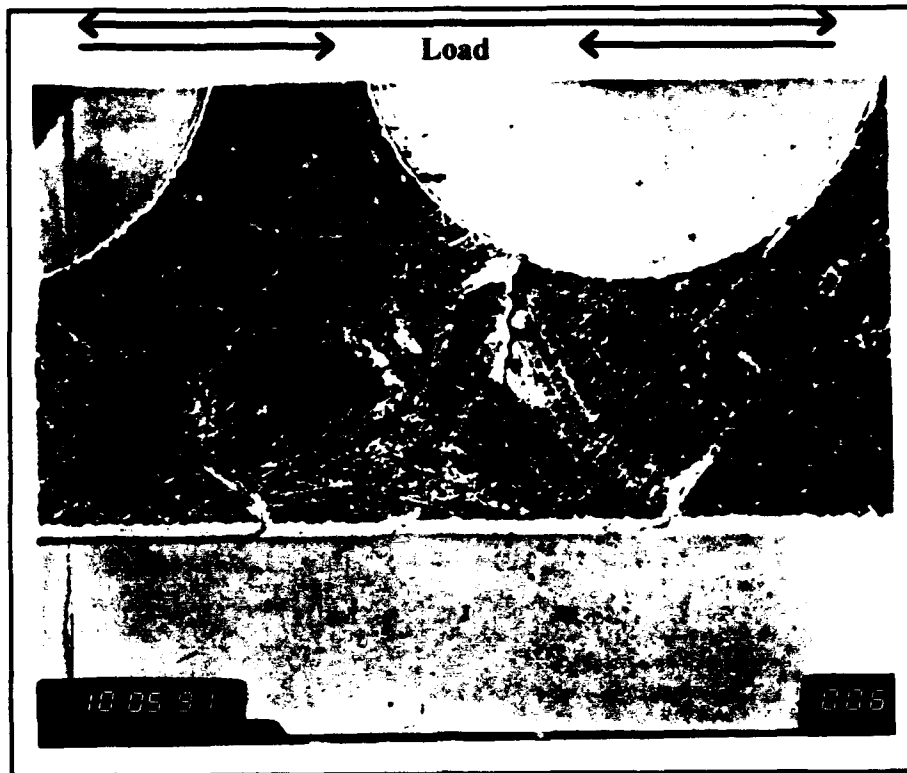
Figure 34. 445 TC RT: RZCs in Both 0° and 90° Fibers Initiate Matrix Cracks (500x)

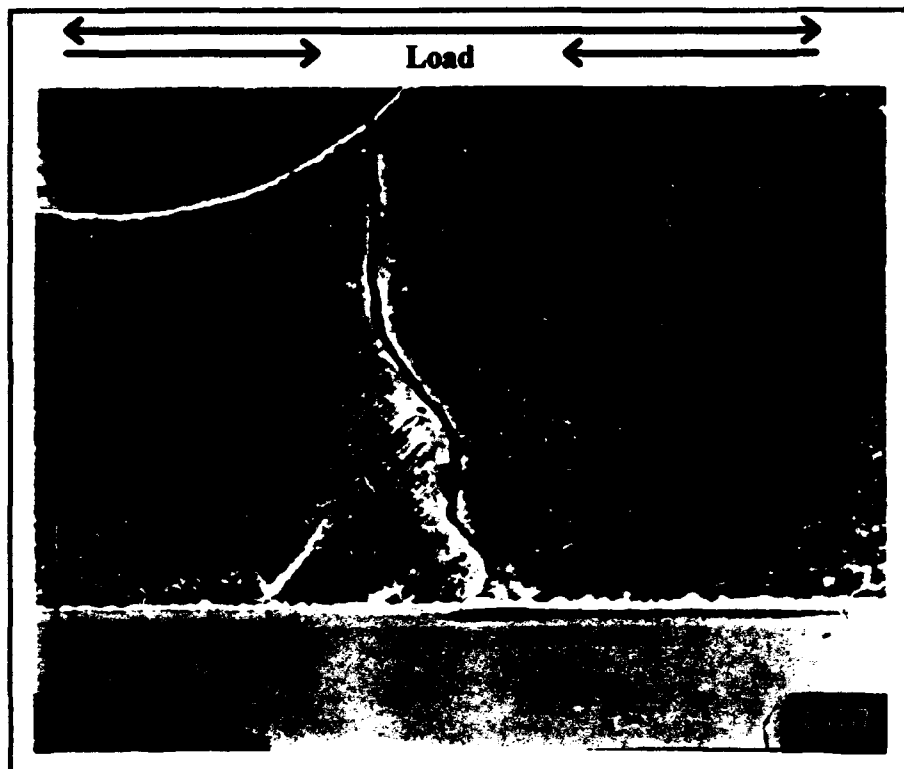
The etched specimen sections revealed additional matrix crack induced damage which was not seen in the Regime 1 test. Matrix cracks were found to cause debonding in 0° fibers before they physically hit the fiber (Fig 36). This is due to the extremely high tensile stress ahead of the crack tip and the shear stress parallel to the fibers, which is caused by matrix plasticity ahead of the crack. This was also observed by Majumdar and Lerch in their unidirectional fatigue tests (30). Also shown in this picture is matrix plasticity in the form of slip bands formed by the mode 1 type fatigue crack (see *Fundamentals of Micromechanic Evaluation* section).

Figure 36. 445 TC RT: 0° Debond Caused by Incoming Matrix Crack (750x)

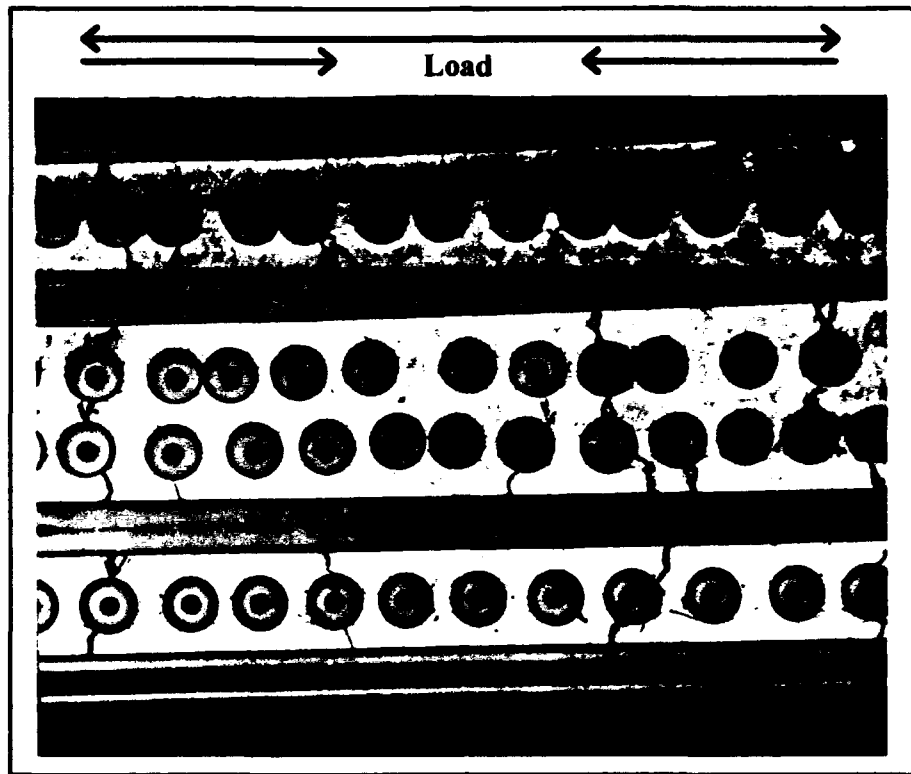
Figure 39. 175 TC RT: Specimen Edge After Failure (50x)

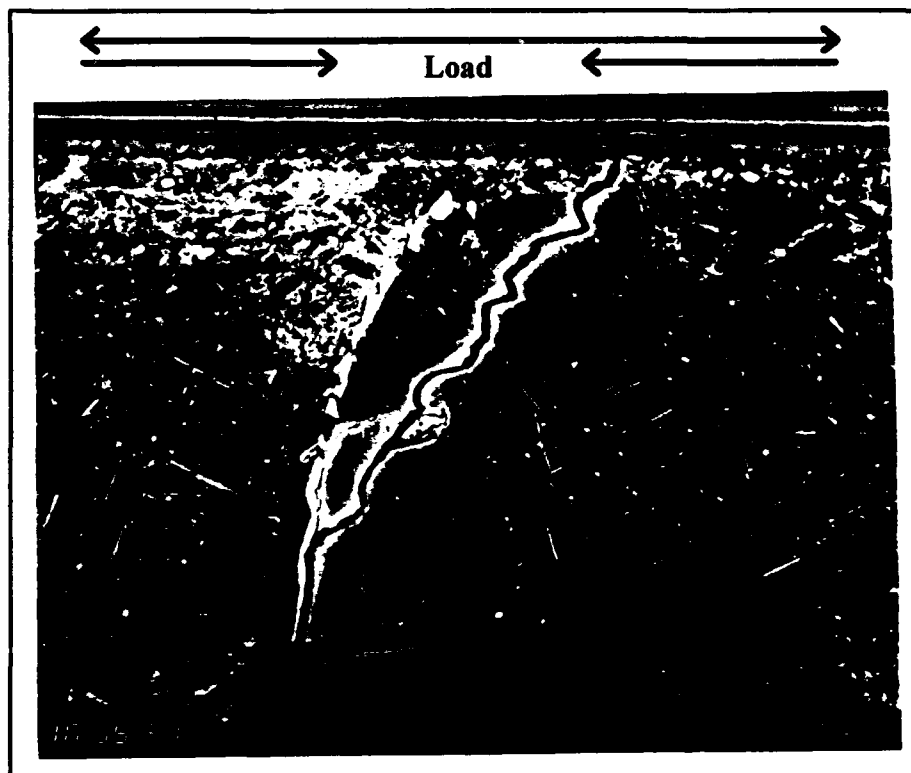
Figure 40. 175 TC RT: Slip Bands Emanating From a Matrix Crack (752x)

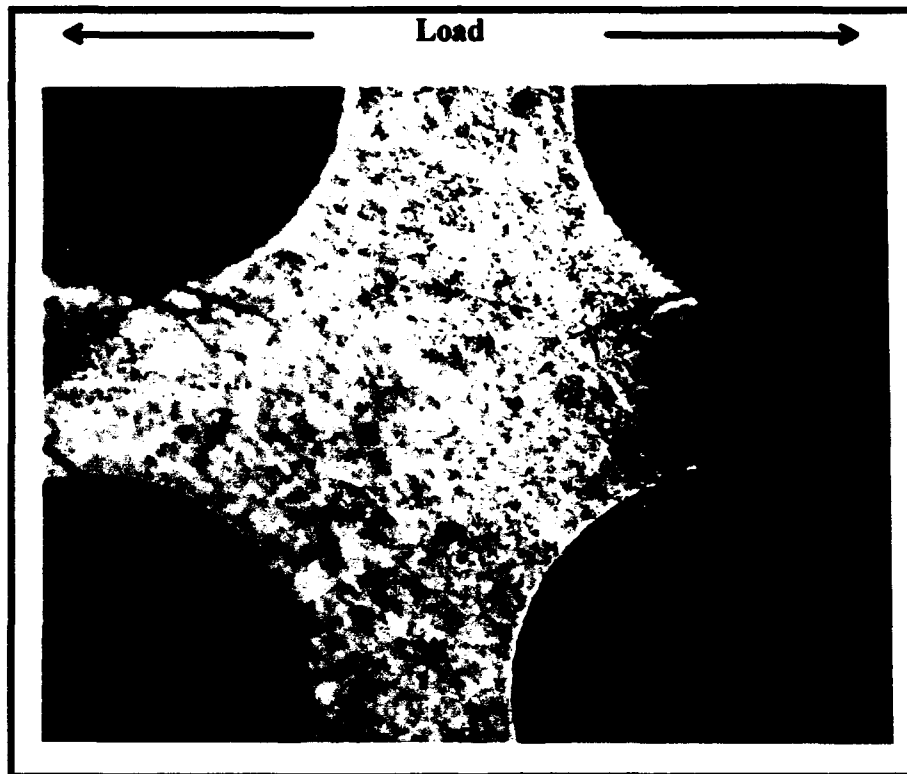
Figure 51. 600 TT RT: 90° RZCs On Fracture Edge (400x)

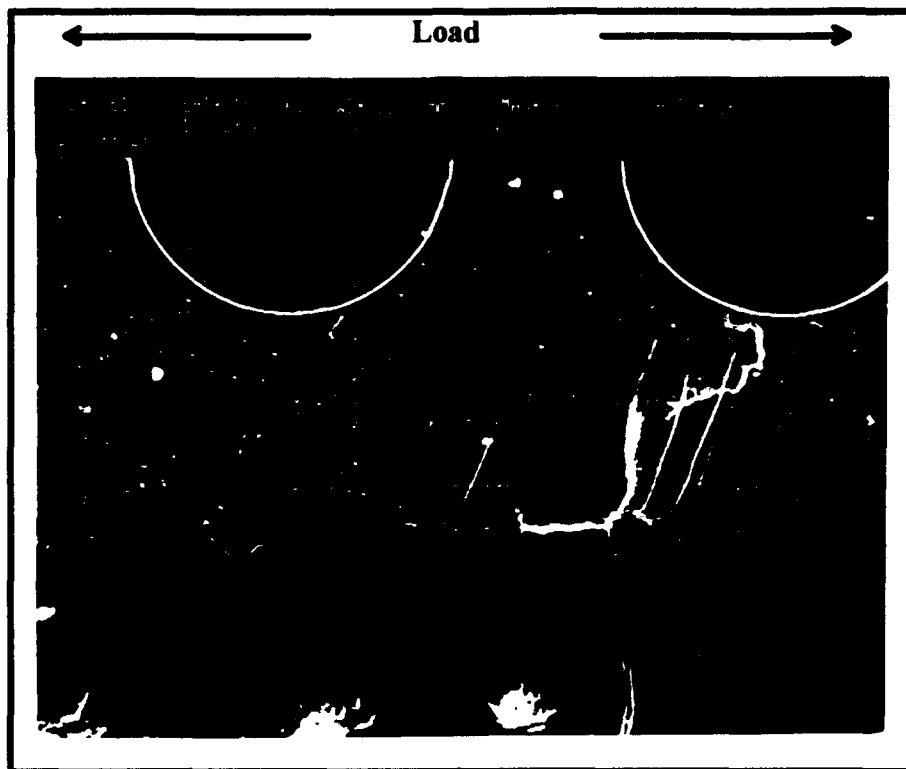
Figure 53. 600 TT RT: Slip Band Formation Near a Broken 0° Fiber (300x)

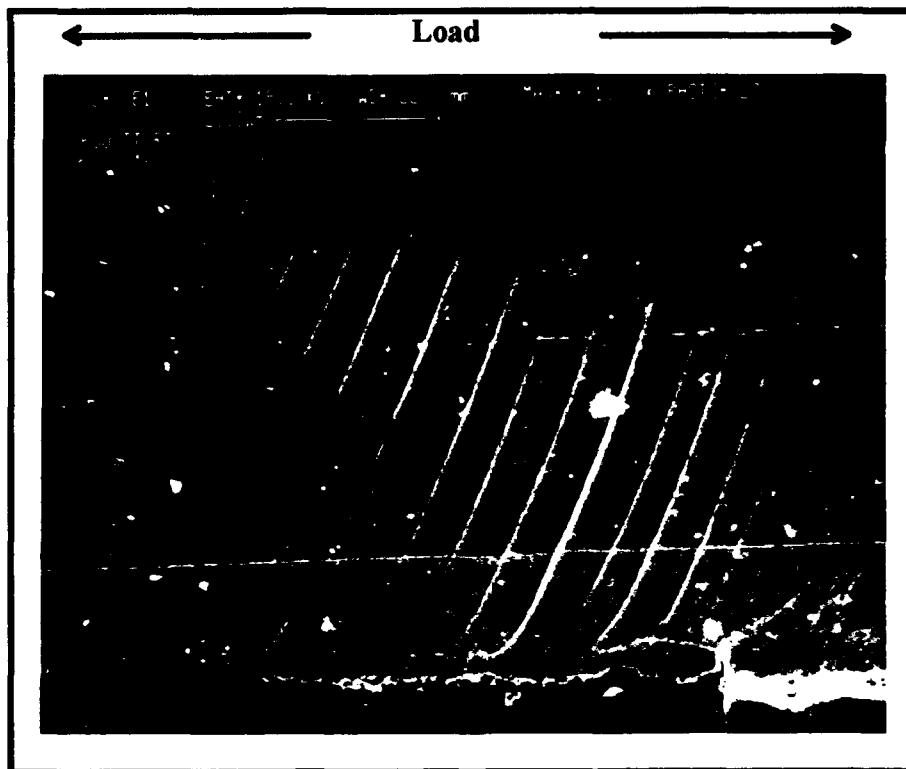
Figure 54. 600 TT RT: Close-up of Slip Bands (1000x)

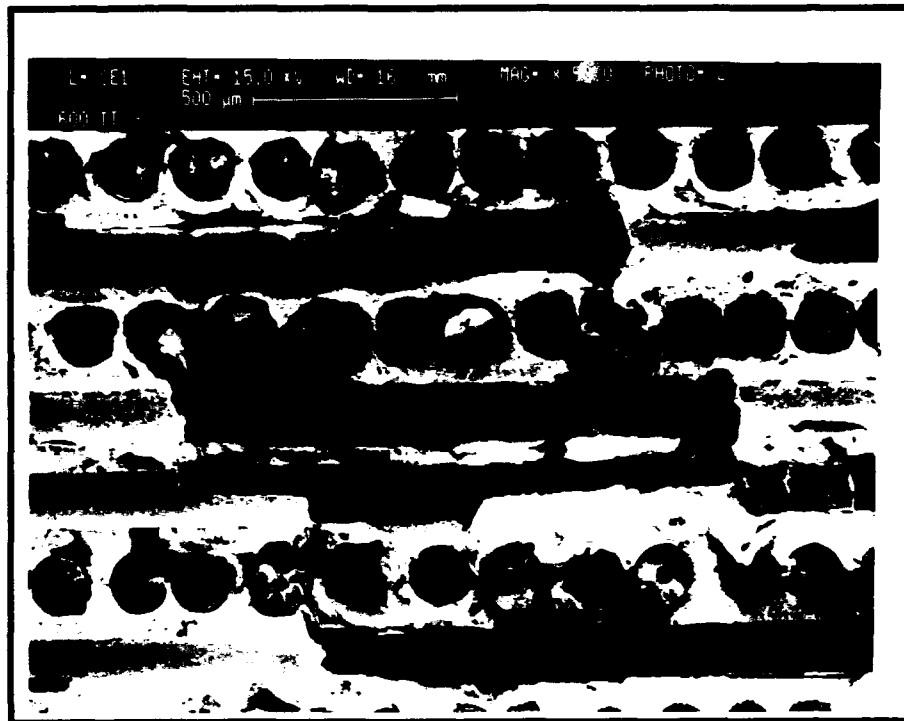
Figure 56. 600 TT RT: Fracture Surface (50x)

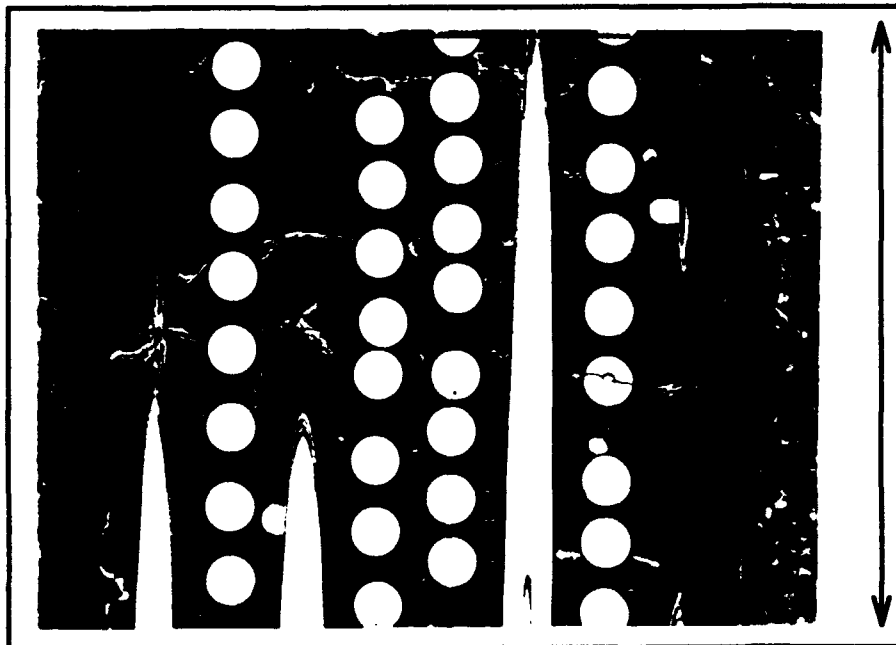
Figure 60. 300 TT RT: Matrix Crack Over Entire Specimen Thickness (50x)

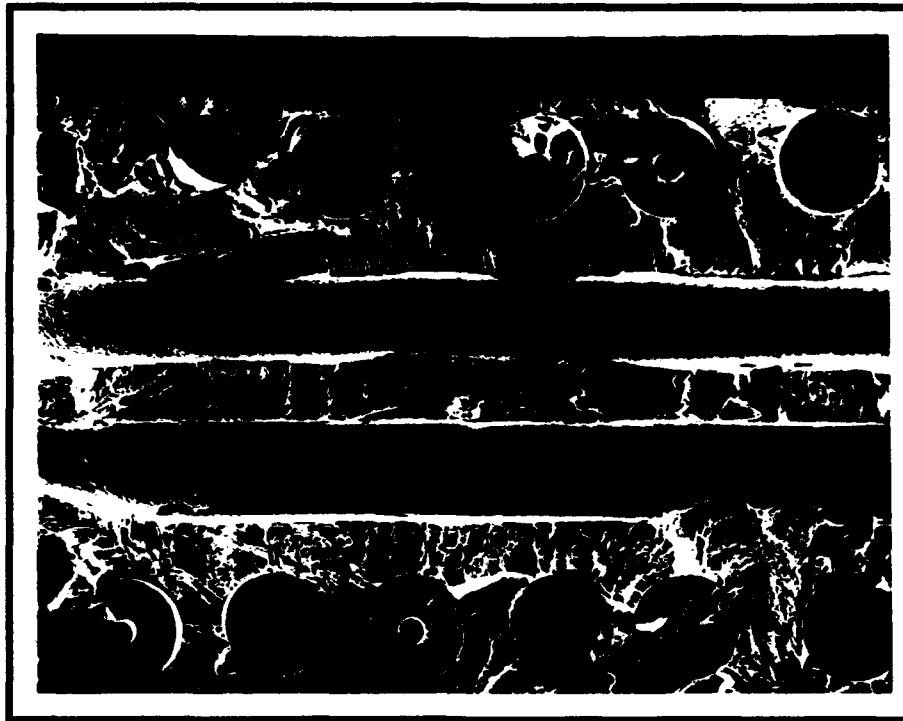
Fractography also indicated matrix dominated failures for both tests. The fractures occurred along single 90° plies, with very little fiber pullout, no matrix necking, and no ductile void coalescence (Fig. 61). High magnification of the matrix regions revealed a combination of fatigue striations and highly crystallographic and faceted surfaces (Figs. 62 and 63). This fracture morphology is very similar to that found in the 175 MPa tension-compression (Regime 2) specimen.

Figure 61. 300 TT RT: Planar, Brittle Cleavage Type Fracture Surface (100x)

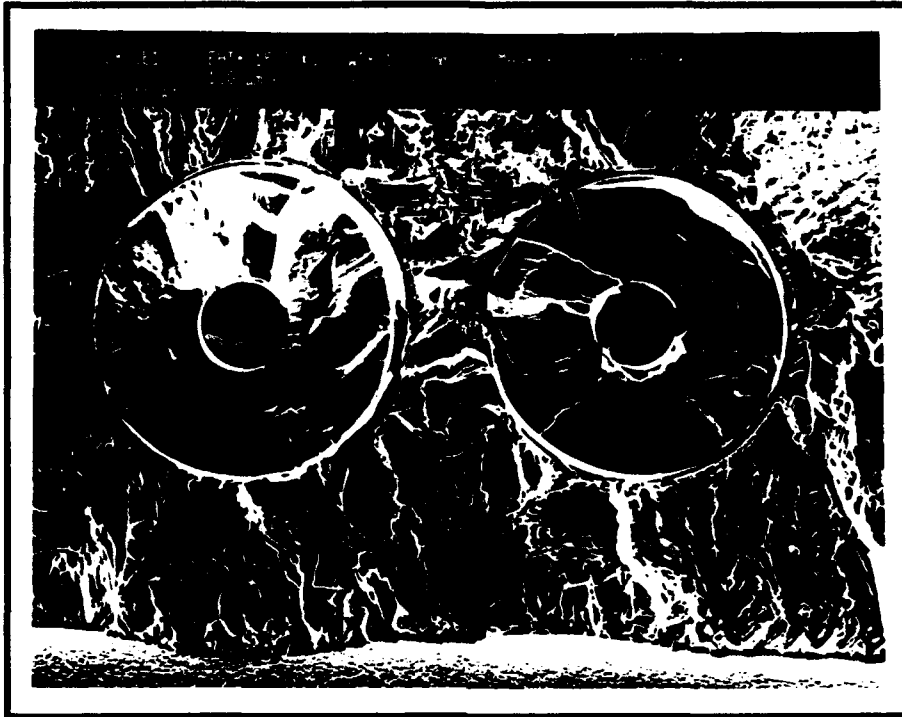
Figure 62. 300 TT RT: Crystallographic and Faceted Matrix Surface (300x)

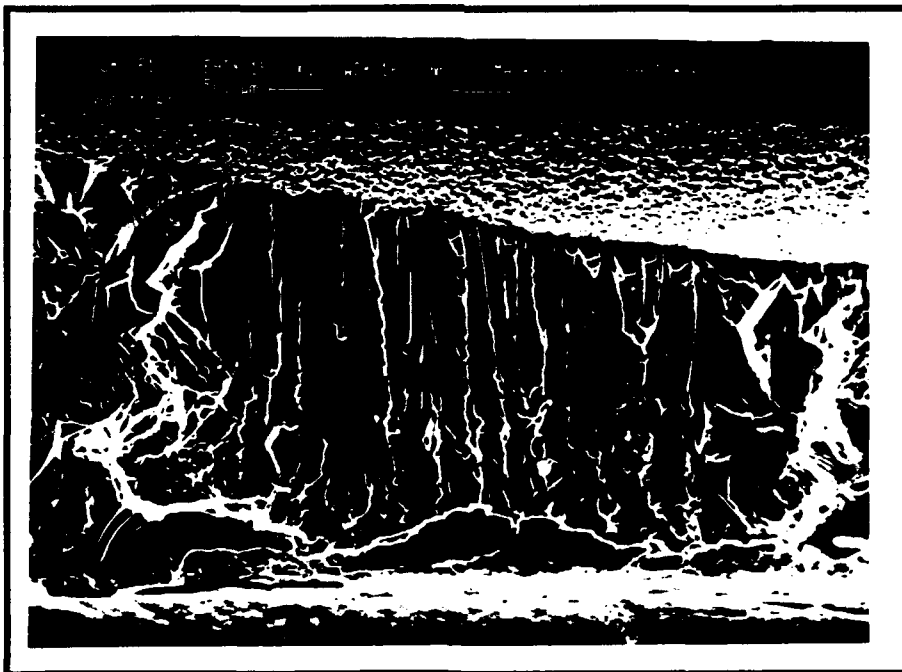
Figure 63. 300 TT RT: Fatigue Striations in Matrix Between Two 90° Fibers (650x)

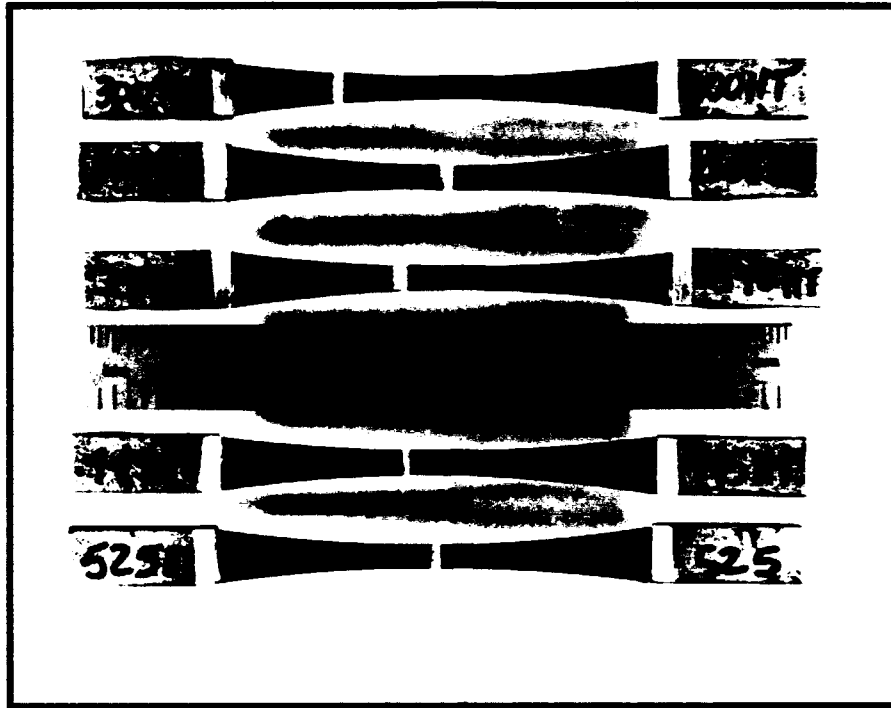
With the exception of the first 300 MPa test, each of the above specimens failed in the center of the gauge length, or heat zone (Fig. 65). As mentioned previously, the

Figure 65. TC HT: Failed Dogbone Specimens

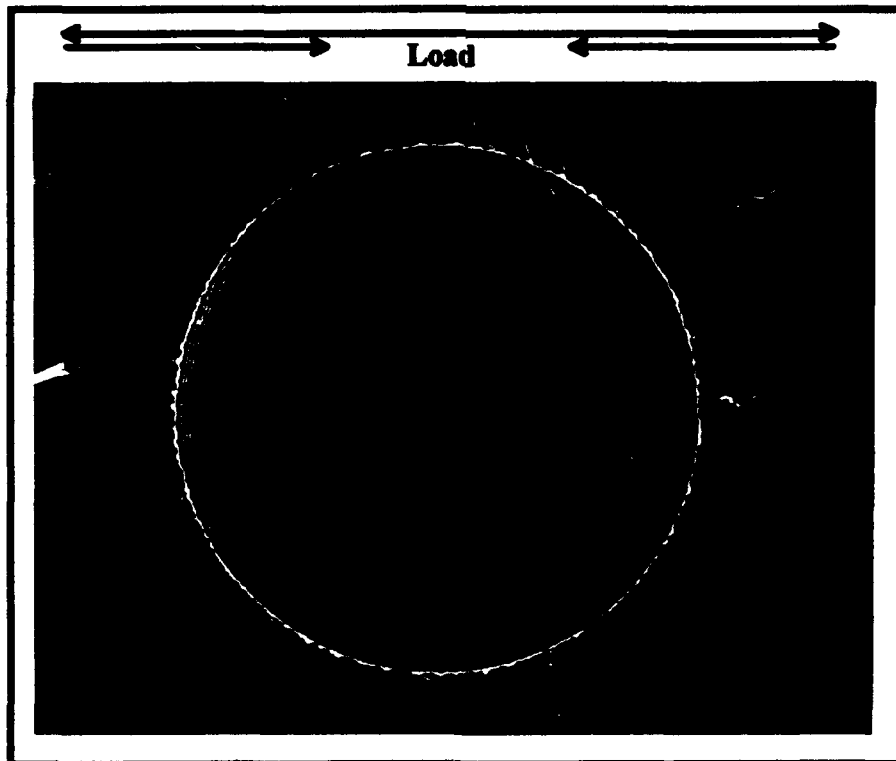
Figure 71. 525 TC HT: Extensive Debond and Radial Fiber Crack (500x)

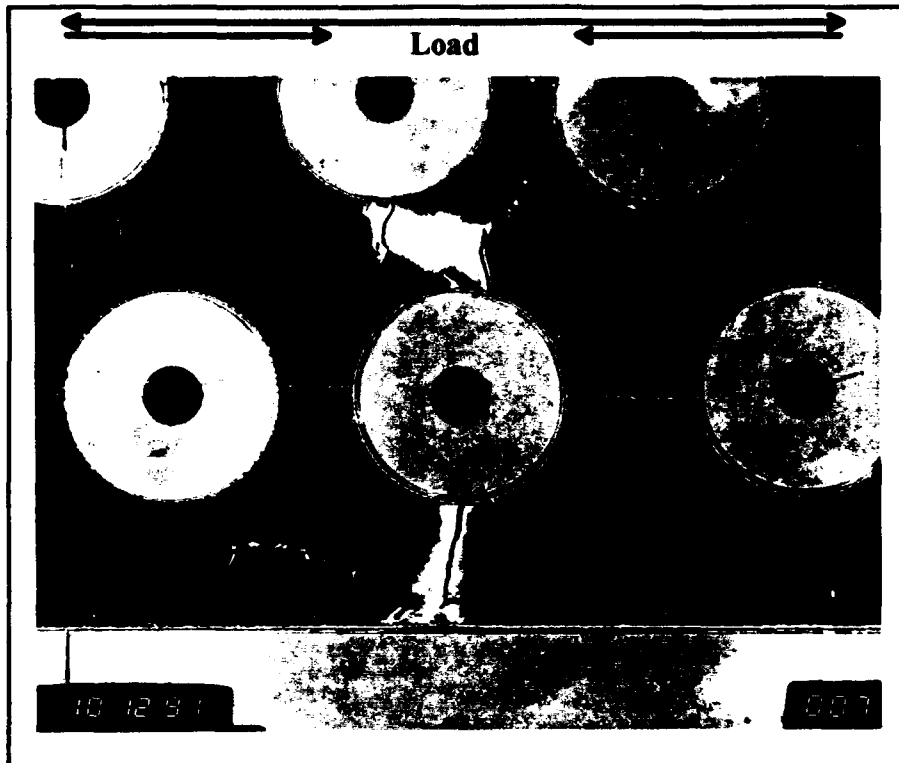
Figure 72. 525 TC HT: Matrix Cracking and Plasticity, Debonded 0° Fiber (200x)

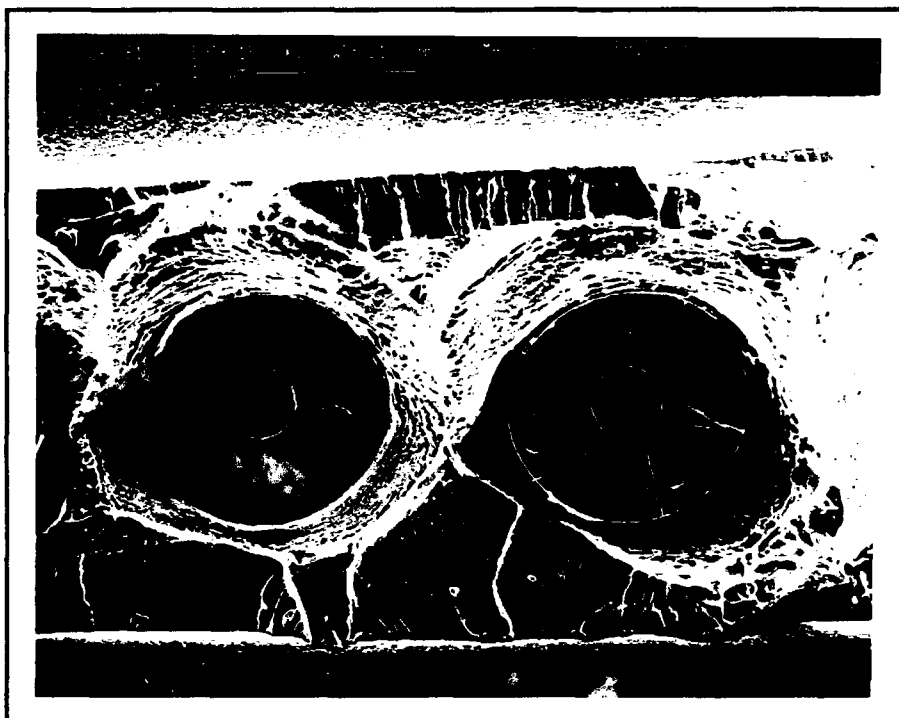
Examination of the fracture surface revealed that fiber fracture occurred before matrix failure, or dominant matrix cracking. This can be seen in Fig. 73, where the matrix is covered with ductile void coalescence. Thus, it is concluded that this highest stress test failed predominantly due to fiber failure, although matrix plasticity and matrix cracking were definitely contributing factors.

Figure 73. 525 TC HT: Matrix Necking and Ductile Void Coalescence (250x)

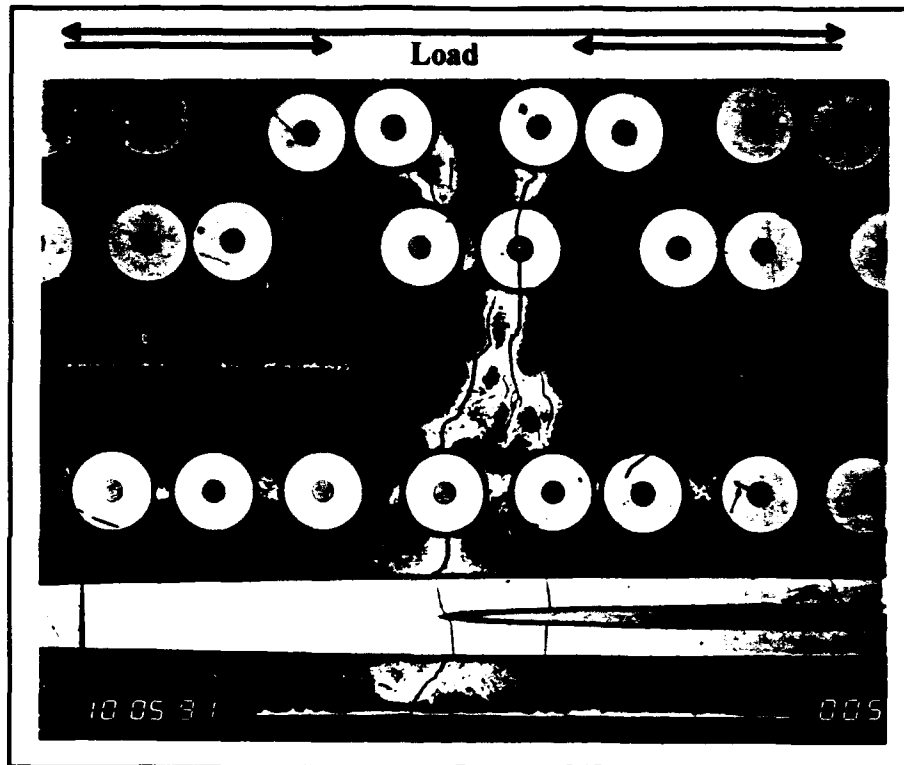
Figure 74. 445 TC HT: Diffused Plasticity, Matrix Cracking, Fiber Breaks (80x)

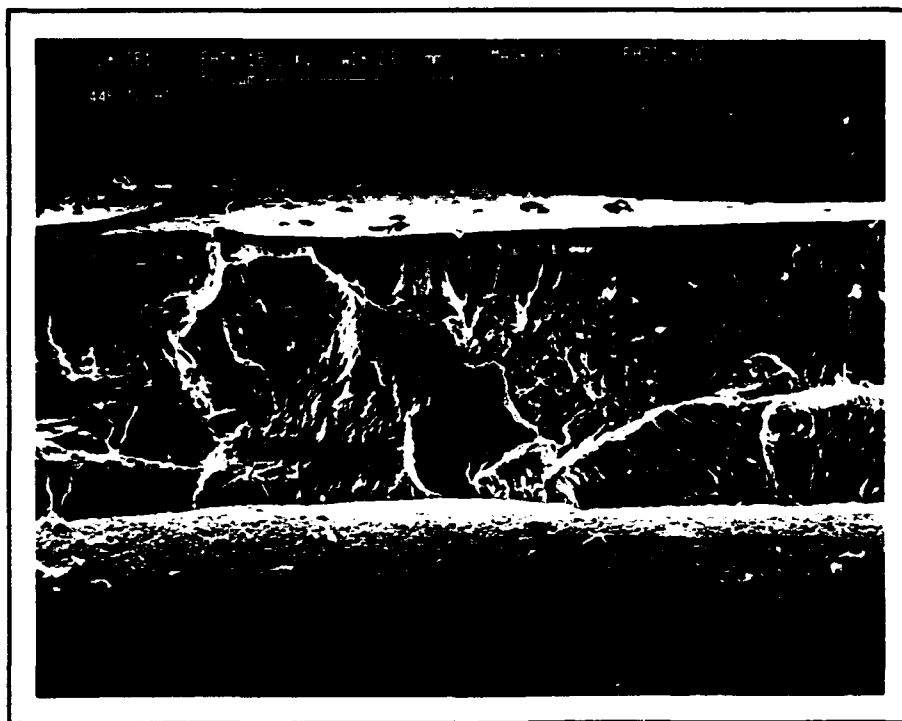
The fracture surface indicated both fiber breaking and matrix cracking, since a combination of cleavage and ductile void coalescence areas existed. The cleavage type fracture surface was predominant, indicating that although the matrix cracks were few, final fracture occurred along the plane of one of these matrix cracks. Further supporting this is the fact that fatigue striations existed on the surface, appearing to emanate from the 90° fibers (Fig. 76).

Figure 76. 445 TC HT: Striations on Fracture Surface Between 90° Fibers (500x)

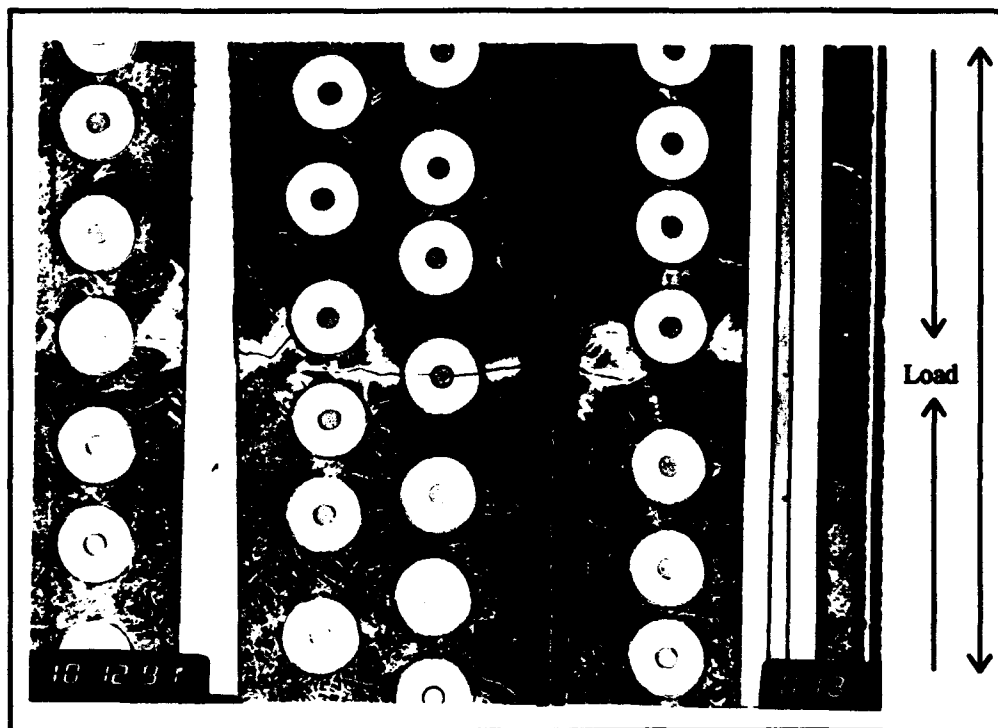
Figure 77. 370 TC HT: Crack Bridging, Radial Fiber Crack, Localized Plasticity (75x)

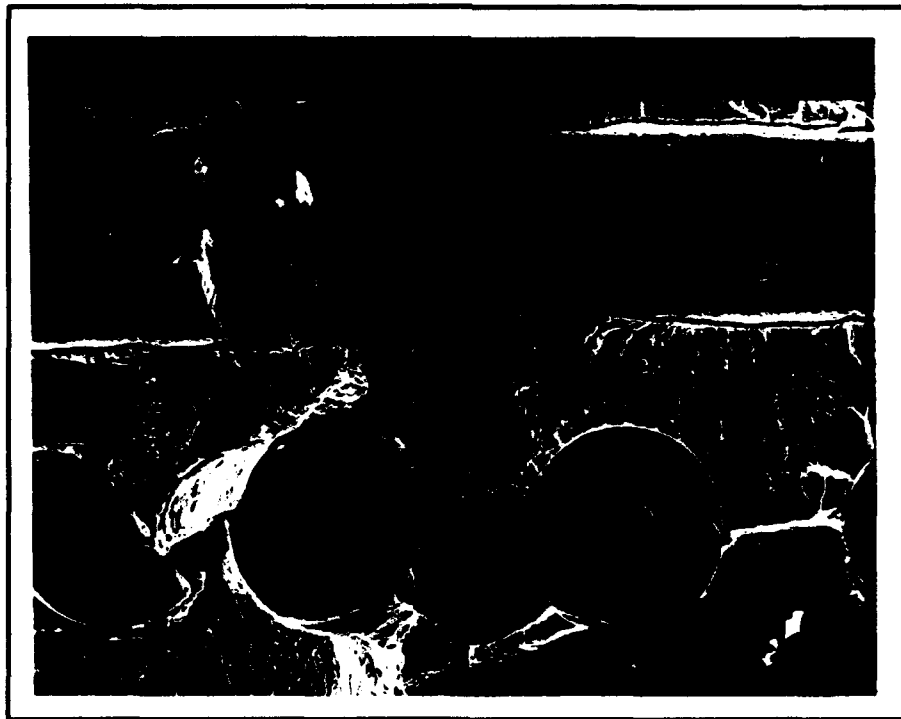
Figure 78. 300 TC HT: Fracture Surface (200x)

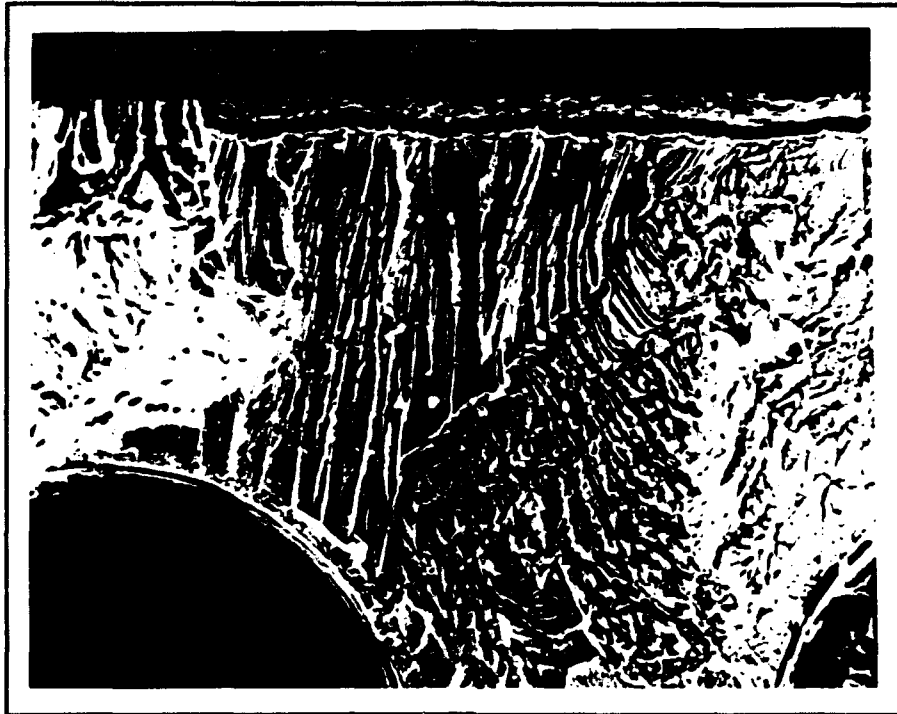
Figure 79. 300 TC HT: Fatigue Striations (662x)

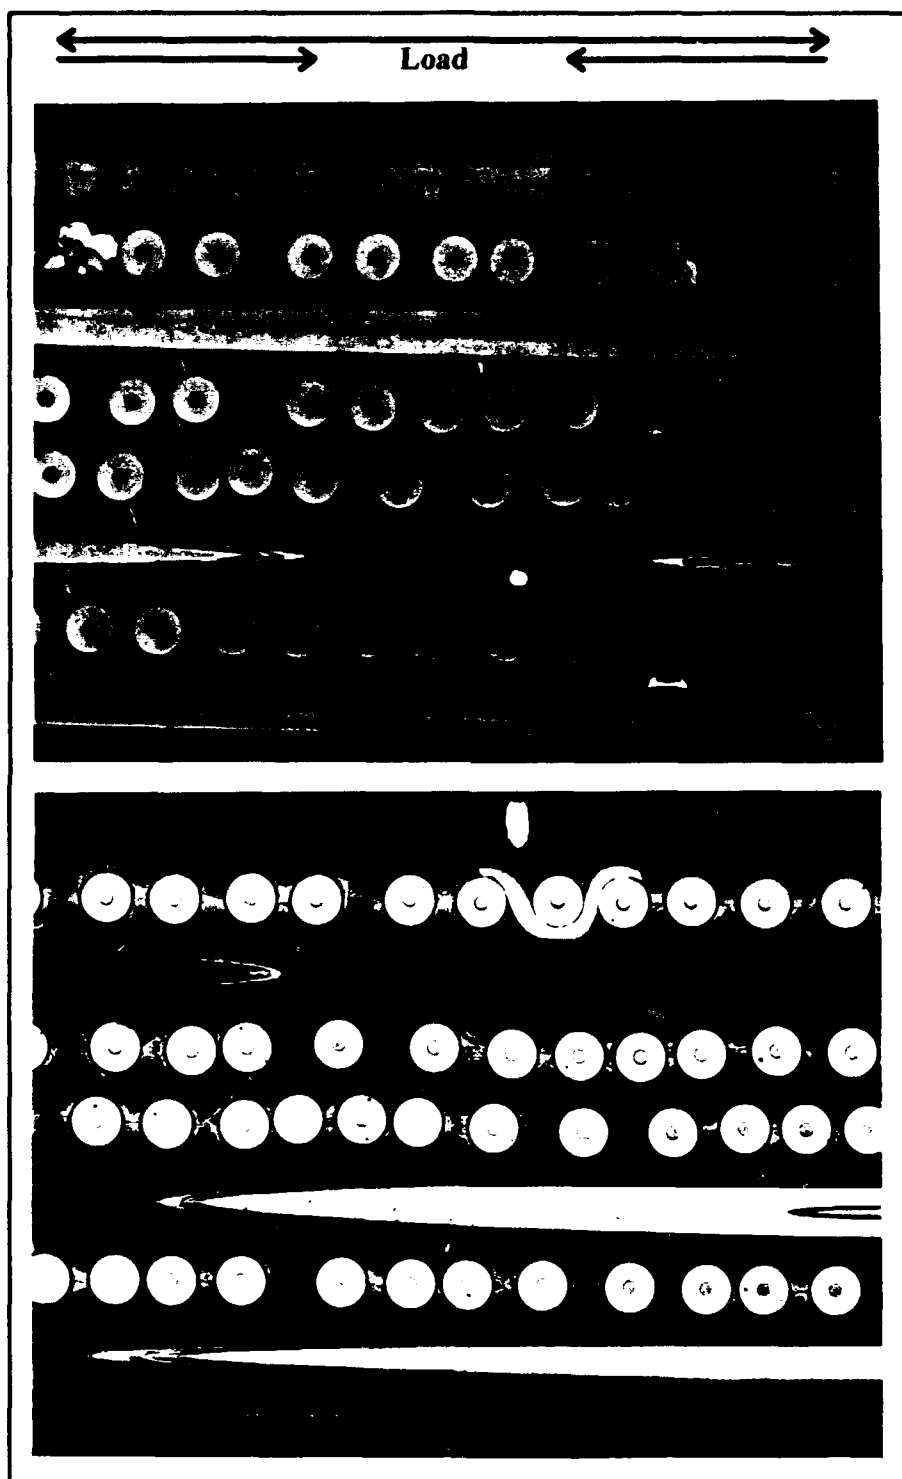
Figure 93. Matrix Cracking, 300 TC RT(top) and 300 TC HT (bottom)
