Acrylic Plastic Spherical Pressure Hull for Continental Shelf Depths

J. D. Stachiw

Technical Report 1606

March 1993

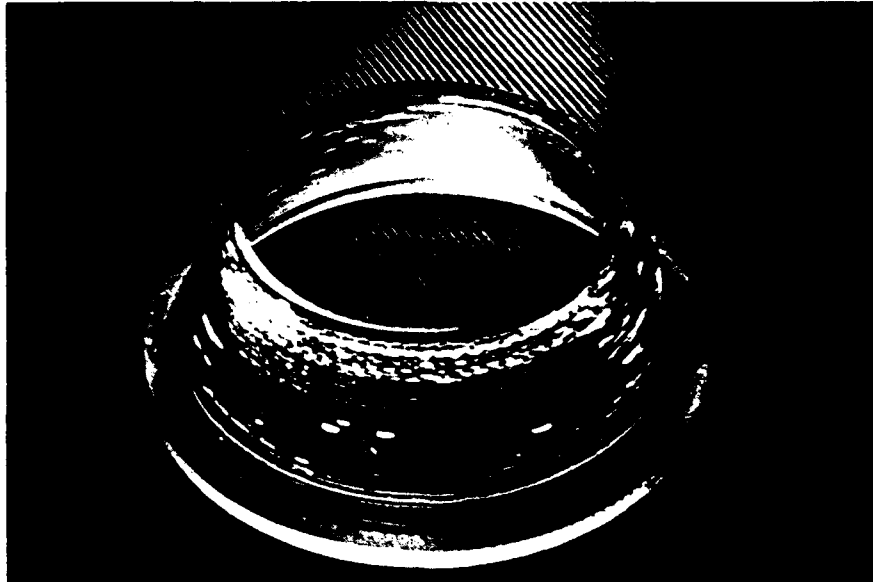
Figure 48. Cast epoxy bearing gasket from Model CC after 435 pressure cycles.

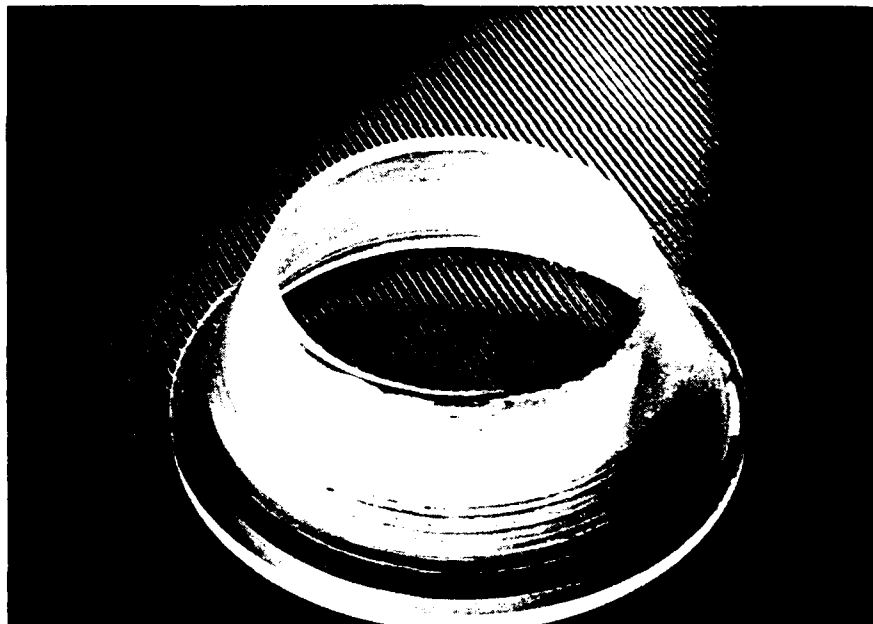
Figure 49. Cast polycarbonate bearing gasket from Model CC after 435 pressure cycles.

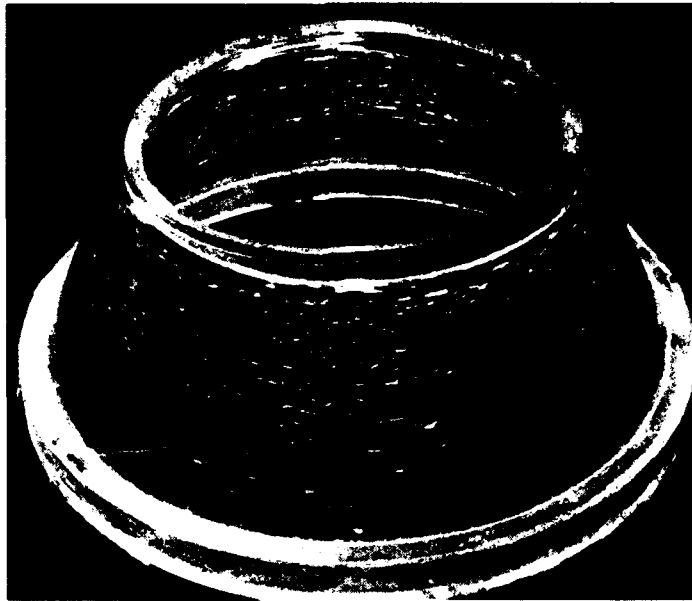
Figure 58. Penetration E in Model CC after removal of cast polyurethane gasket upon completion of 435 pressure cycles.

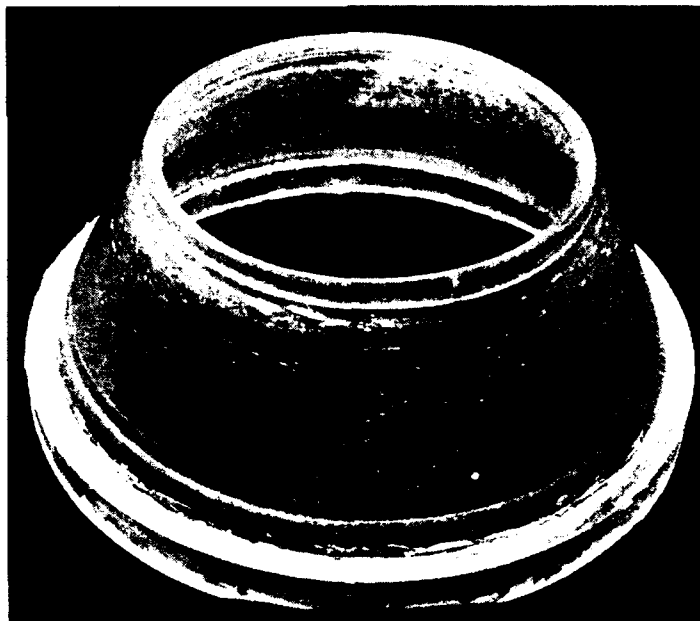
Permanent deformation was observed only on the plastic bearing gaskets fabricated from cast polyurethane (Composition Calthane #9 and #10). The polyurethane gasket (Calthane #10), which was in Model CC from the very beginning of the cycling program and was subjected to 1,000 cycles, extruded 0.3 inch past the edge of the penetration into the interior of the acrylic sphere (figure 59). The polyurethane gasket (Calthane #9), which was placed in service only after the 435th cycles as a replacement for the badly cracked epoxy gasket and was subjected to only 565 pressure cycles, extruded only 0.15 inch past the opening in the sphere (figure 60).

Cracks were observed in bearing gaskets fabricated from polycarbonate (figure 61), acrylic (figure 62) and polyurethane (figures 59 and 60). Since all gaskets, except Nylon and polyurethane Calthane #10, were placed in service during the inspection of Models BB and CC after the 435th cycles, all were subjected to only 565 pressure cycles. Observation here confirmed the finding made during the inspection after the 435th cycle; polycarbonate exhibits more extensive and deeper cracks than acrylic or polyurethane after only 500 pressure cycles. The shear cracks in the polyurethane Calthane #10 gasket after *1,000 pressure cycles* were less severe than those in the polycarbonate, epoxy, or acrylic gaskets after only *565* or *435 cycles.*

Figure 60. Cast Polyurethane bearing gasket from
penetration B in Model CC after total of 565 pressure cycles
(installed at 435th and removed at 1,000th cycle).

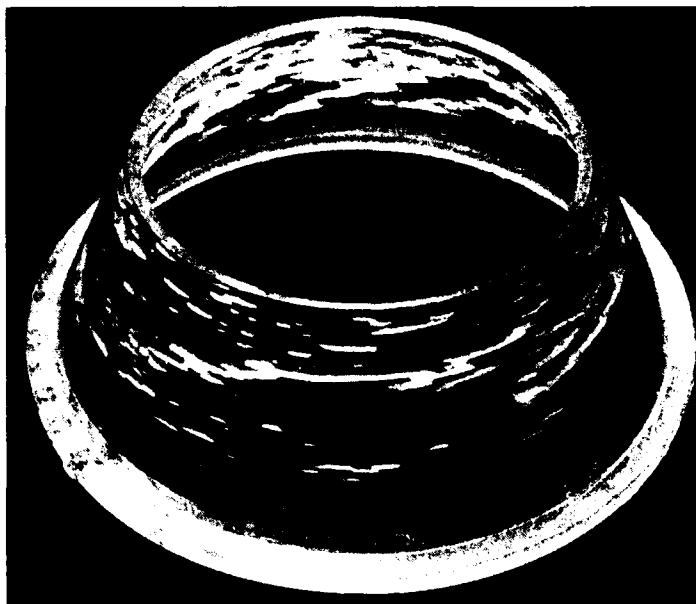
Figure 61. Cast polycarbonate bearing gasket from penetration
D in Model CC after a total of 565 pressure cycles (installed at
435th and removed at 1,000th cycle).

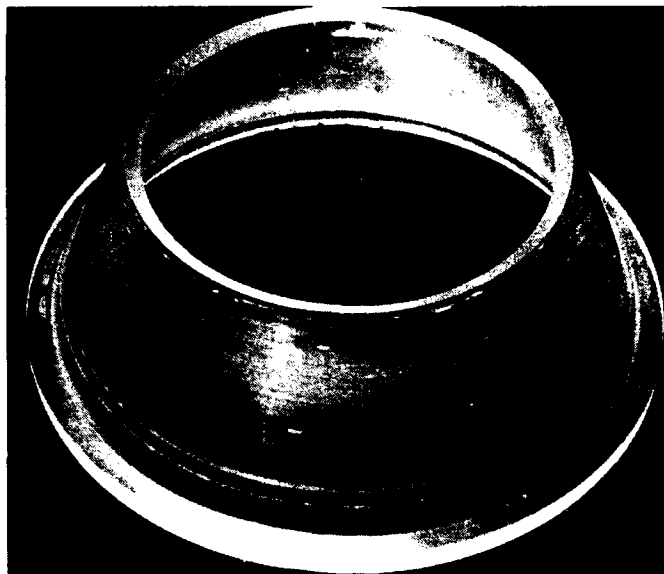
Figure 62. Cast acrylic bearing gasket from penetration C in
Model CC after a total of 565 pressure cycles (installed at
435th and removed at 1,000th cycle).

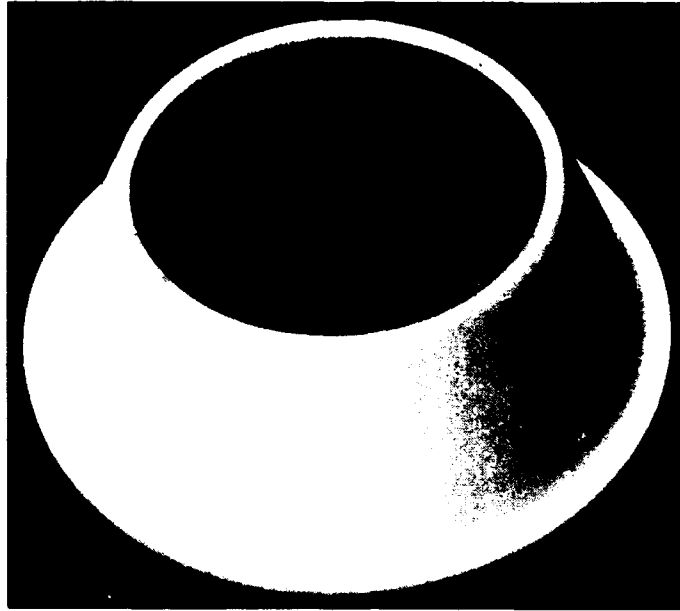
No cracks were found in the Nylon bearing gaskets from Model BB exposed to 565 pressure cycles (figure 63) and Model CC exposed to 1,000 pressure cycles (figure 64). Because of their excellent condition, Nylon bearing gaskets can be placed back into service after the 1,000 pressure cycle inspection.

Figure 63. <u>Cast nylon</u> bearing gasket from penetration A in Model CC after a total of 1,000 pressure cycles.

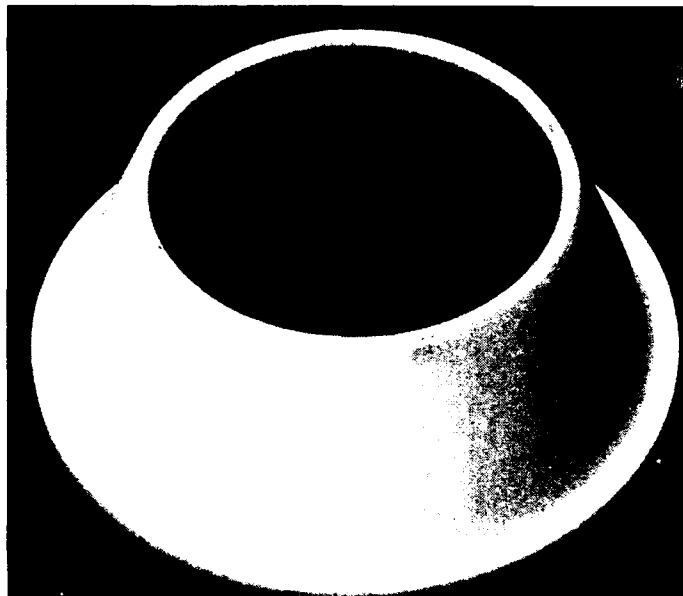
Figure 64. <u>Cast nylon</u> bearing gasket from penetration in Model BB after a total of 565 pressure cycles (installed at 435th and removed at 1,000th cycle).

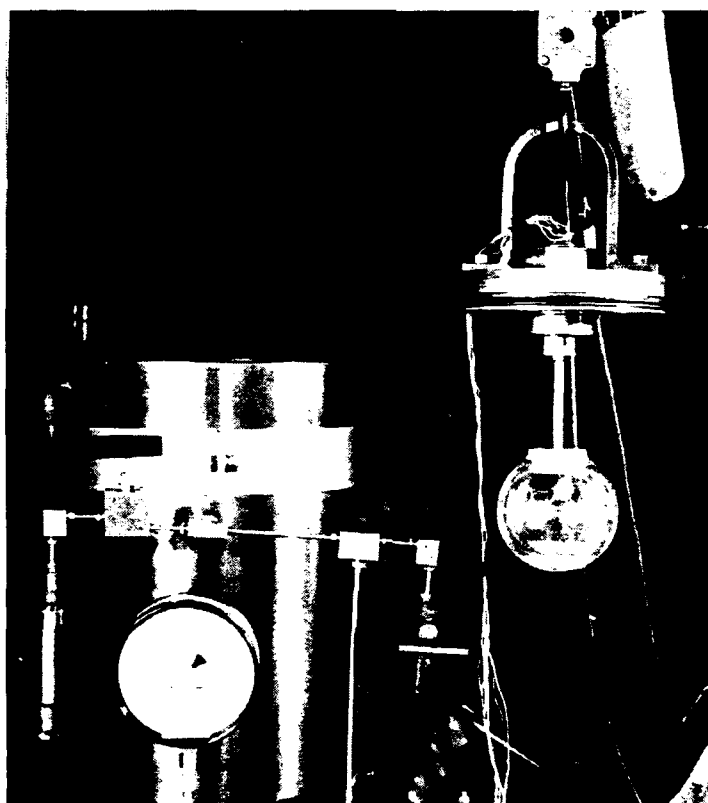
Figure 74. Test arrangement for long-term pressure testing of Models 6A and 6B.

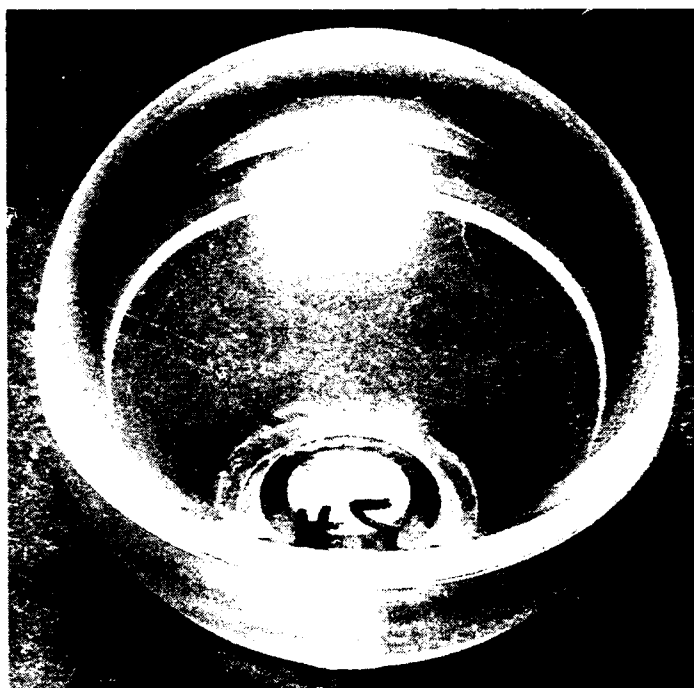
Figure 76. Model 2 after 1,000 pressure cycles to 3,560 psi at 75° F. Models 3,4,5,6,7, and 8 also did not show any cracking.

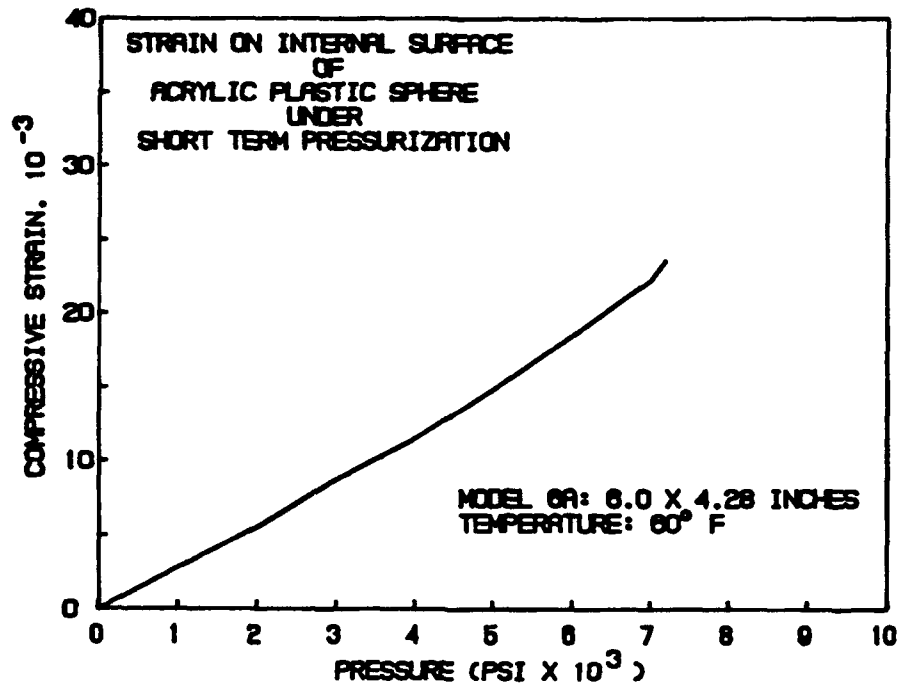
Model 6A did not fail during sustained pressurization of 312 hour's duration at pressures that varied from 7,200 to 7,500 psi and at ambient temperatures that varied between 55°F to 65°F. The compressive strains measured by strain gages on the interior surface of the sphere during the test show (figures 77 through 84 and tables 14 through 17) that the creep rate on the interior surface of the sphere decreased from -515×10^{-6}/minute at the beginning of sustained pressurization to -33×10^{-6}/minute after 1 hour, -6.75×10^{-6}/minute after 10 hours, -0.77×10^{-6}/minute after 100 hours, and -0.01×10^{-6}/minute after 300 hours (figures 79 and 80).

Figure 77. Strain on the interior surface of Model 6A during short-term pressurization to 7,200 psi.

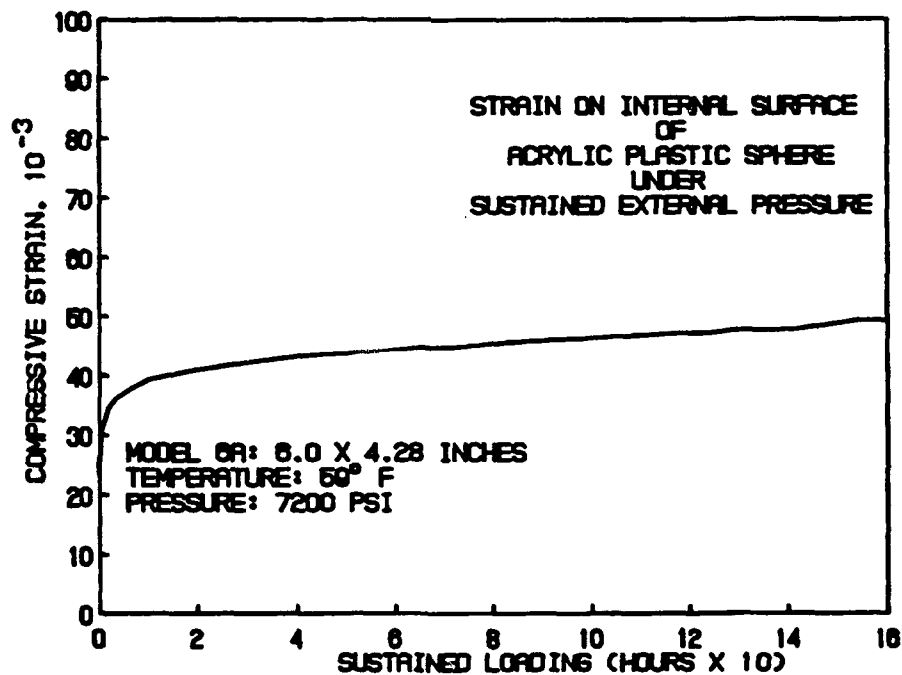
Figure 78. Strain on the interior surface of Model 6A during sustained pressure loading at 7,200 psi.

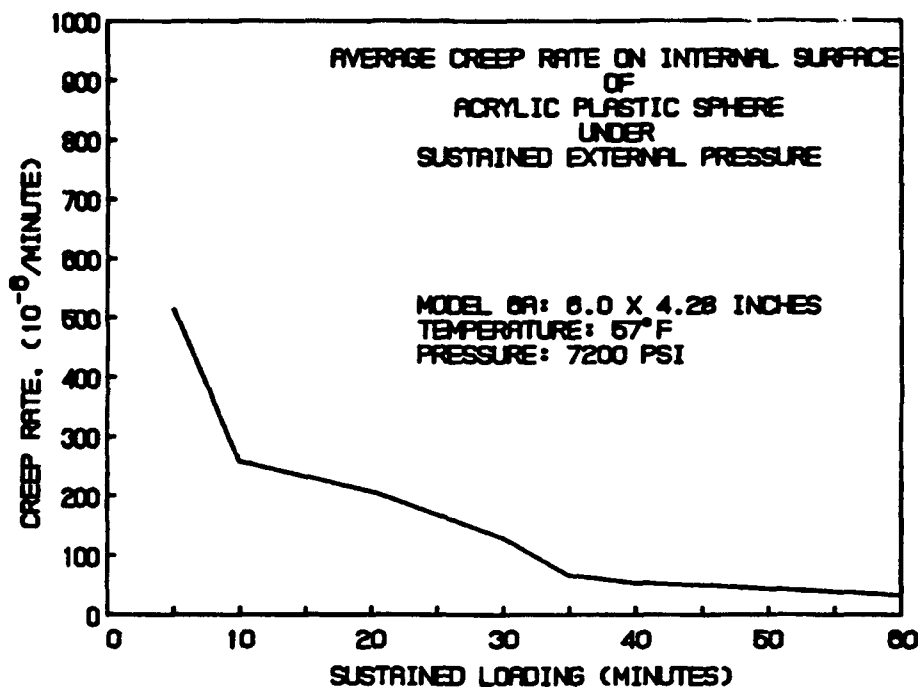
Figure 79. Creep rate on the interior surface of Model 6A during sustained pressure loading at 7,200 psi; 0 to 1 hour's duration interval.

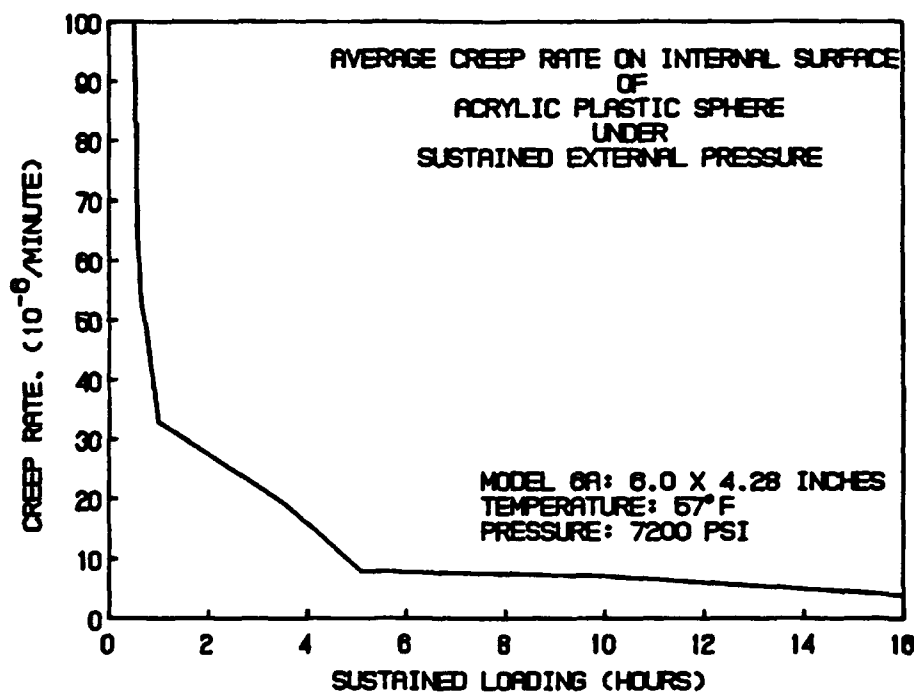
Figure 80. Creep rate on the interior surface of Model 6A during pressure sustained loading at 7,200 psi; 0 to 16 hour's duration interval.

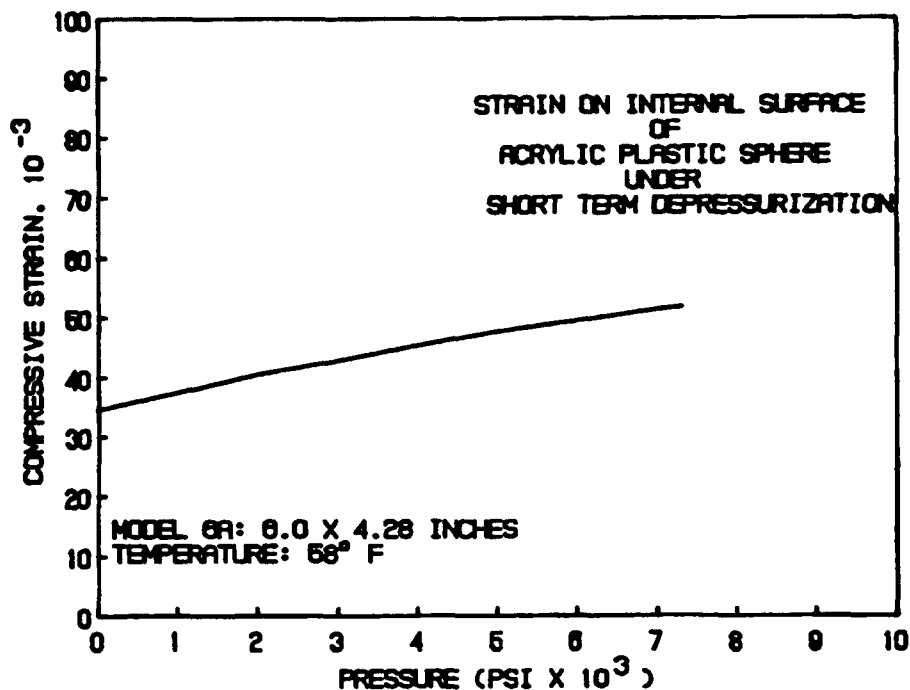
Figure 81. Strain on the interior surface of Model 6A during depressurization after 312 hours of sustained pressure loading to 7,200 psi.

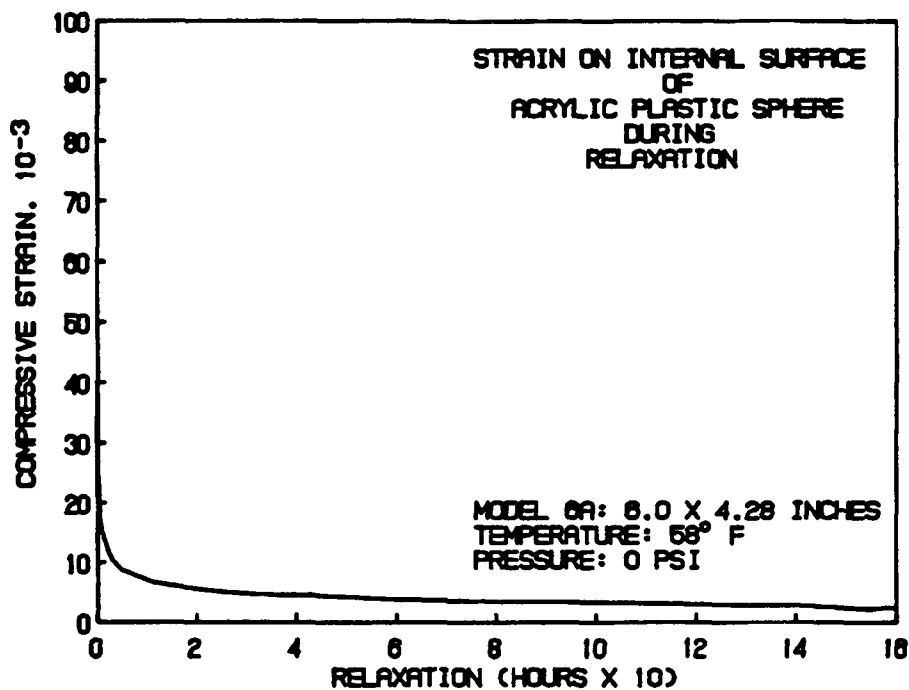
Figure 82. Strain on the interior surface of Model 6A during relaxation after 312 hours of sustained pressure loading at 7,200 psi.

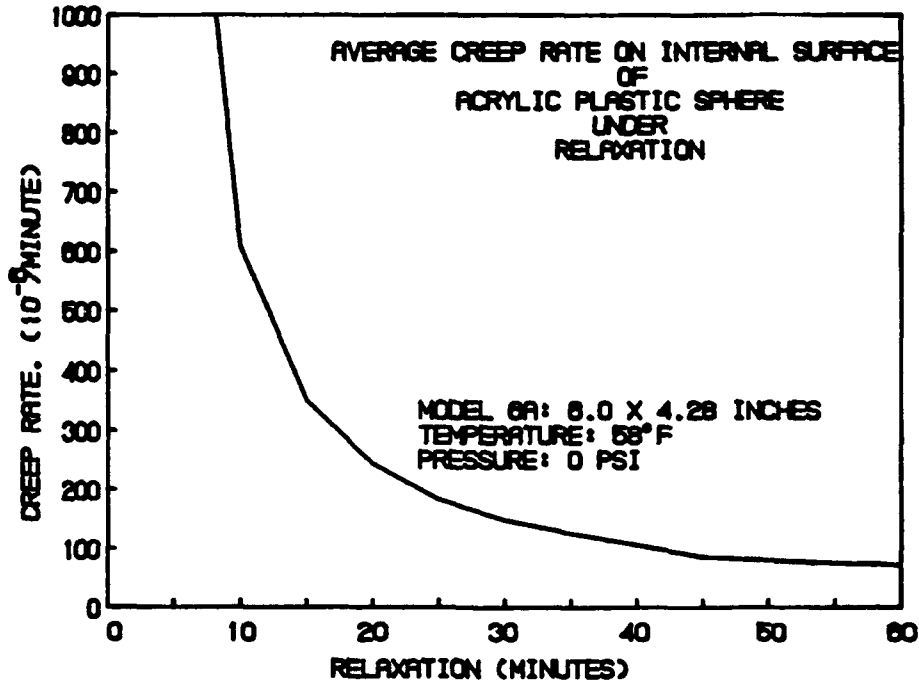
Figure 83. Creep rate on the interior surface of Model 6A during relaxation after 312 hours of sustained pressure loading at 7,200 psi; 0 to 1 hour's duration interval.

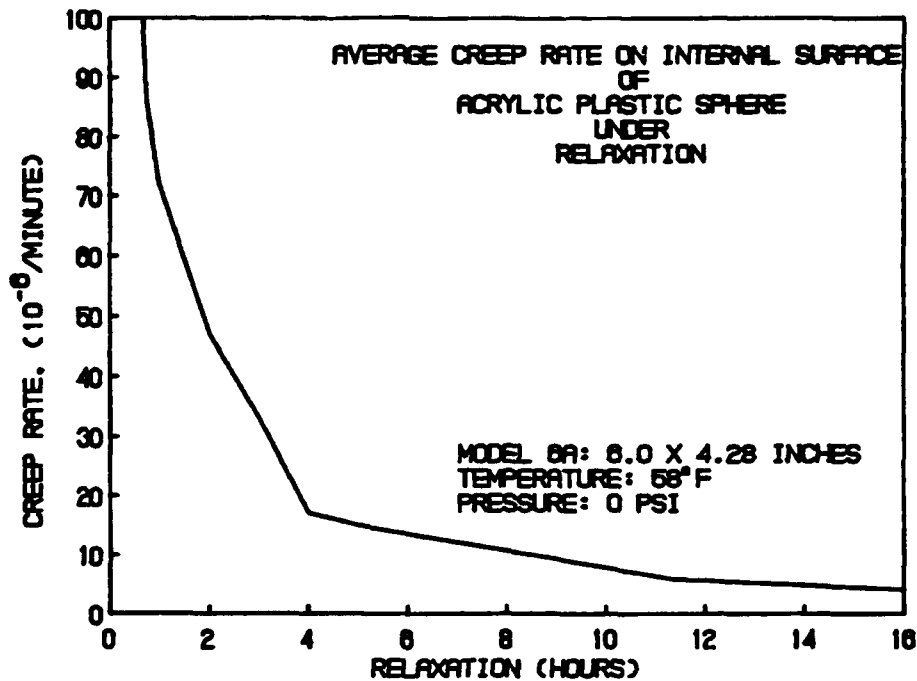
Figure 84. Creep rate on the interior surface of Model 6A during relaxation after 312 hours of sustained pressure loading at 7,200 psi; 0 to 16 hour's duration interval.

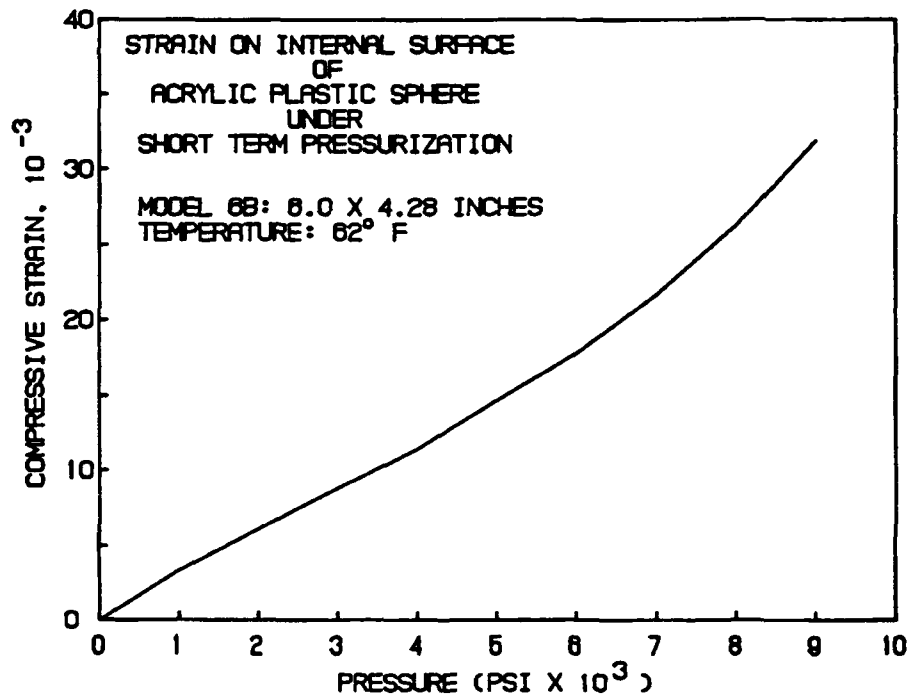
Model 6B did not fail during sustained pressurization of 144 hour's duration at pressures that varied from 8,800 to 9,300 psi and at ambient temperatures that varied from 55°F to 65°F. The compressive strain measured on the interior surface of the sphere (figures 86 through 93 and tables 18 through 21) increased with duration of loading significantly faster than during sustained pressurization of Model 6A to 7,200 psi. Its magnitude was $-31,897 \times 10^{-6}$ at the beginning of sustained pressurization, $-48,000 \times 10^{-6}$ after 1 hour, $-63,163 \times 10^{-6}$ after 10 hours, and $-82,900 \times 10^{-6}$ after

Figure 86. Strain on the interior surface of Model 6B during short-term pressurization to 9,000.

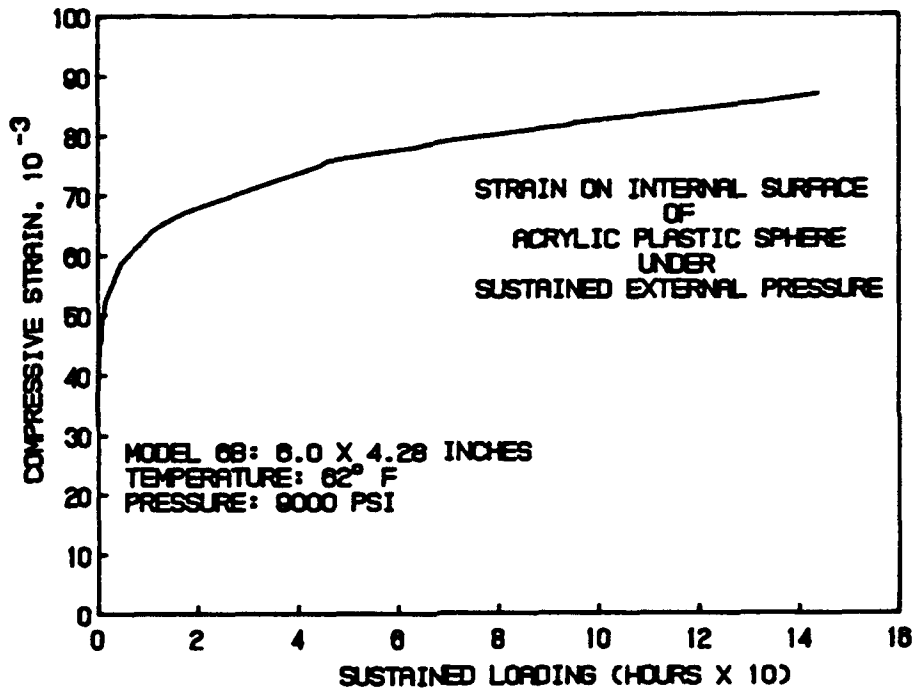
Figure 87. Strain on the interior surface of Model 6B during sustained pressure loading to 9,000 psi.

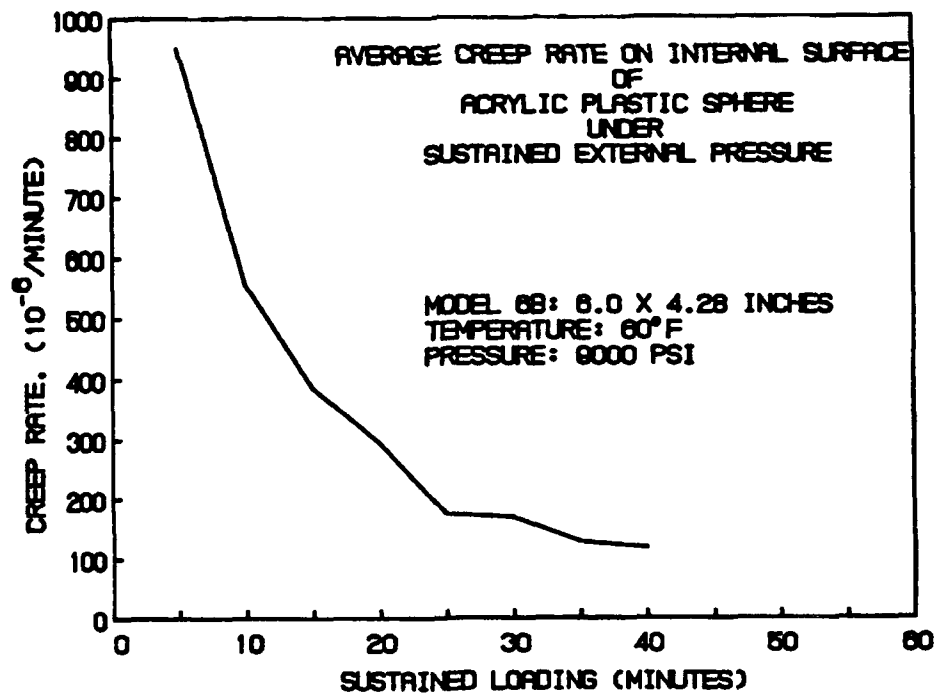
Figure 88. Creep rate on the interior surface of Model 6B during sustained pressure loading at 9,000 psi; 0 to 1 hour's duration interval.

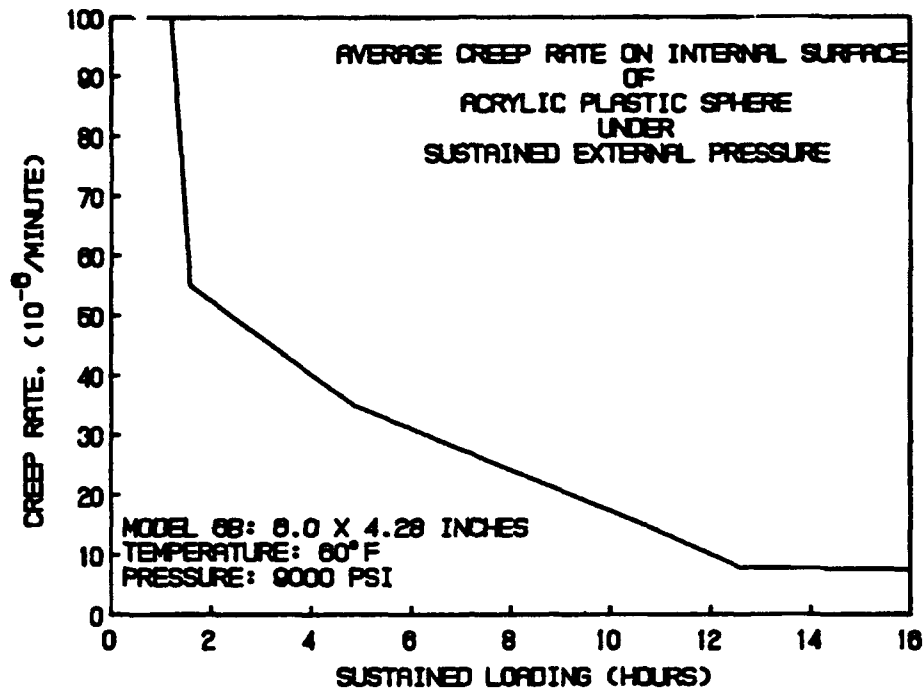
Figure 89. Creep rate on the interior surface of Model 6B during sustained pressure loading to 9,000 psi; 0 to 14 hour's duration interval.

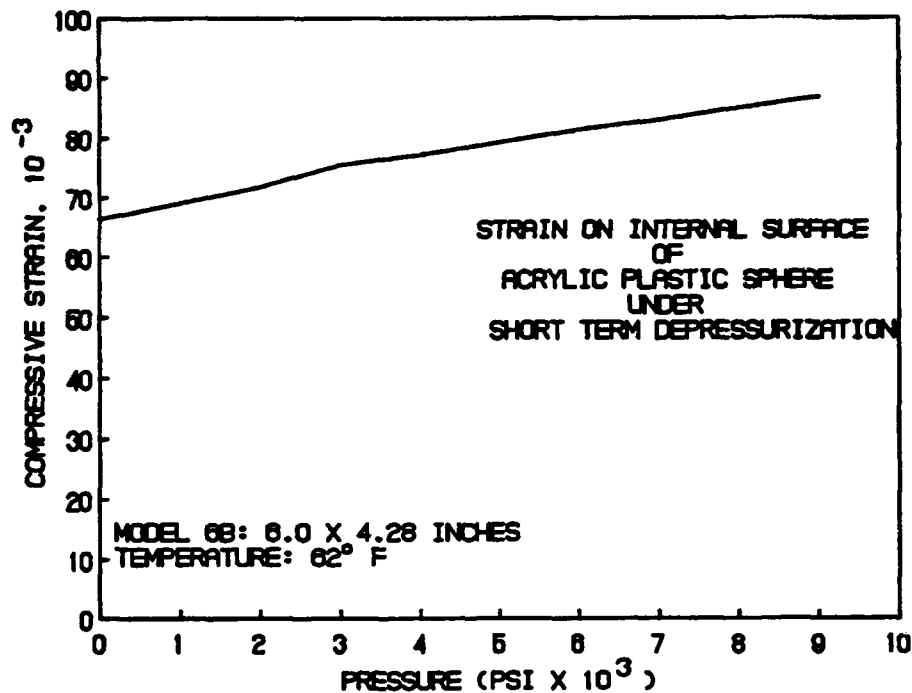
Figure 90. Strain on interior surface of Model 6B during depressurization after 144 hours of sustained pressure loading at 9,000 psi.

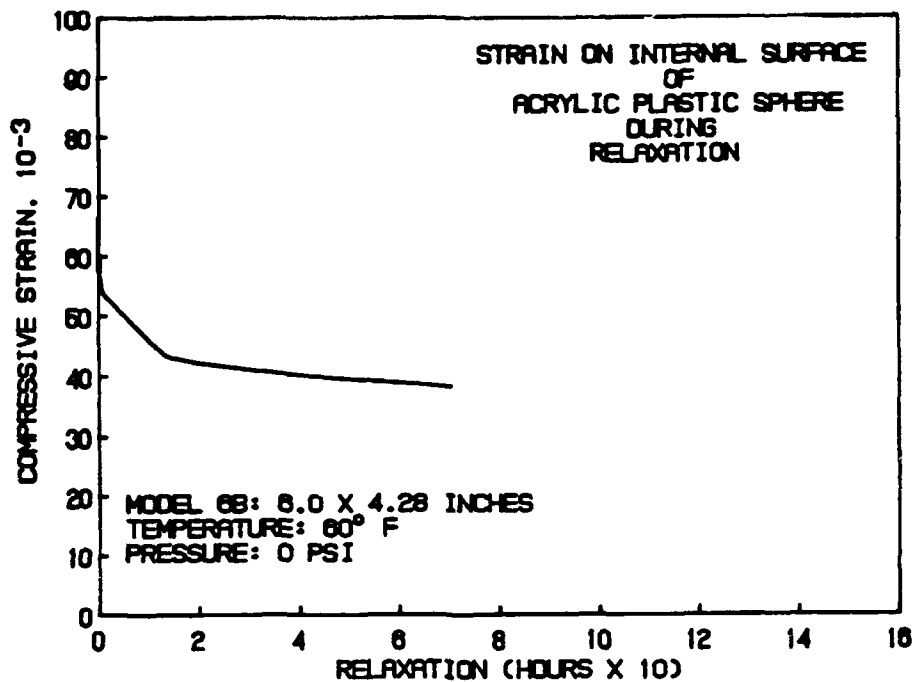
Figure 91. Strain on interior surface of Model 6B during relaxation after 144 hours of sustained pressure loading at 9,000 psi.

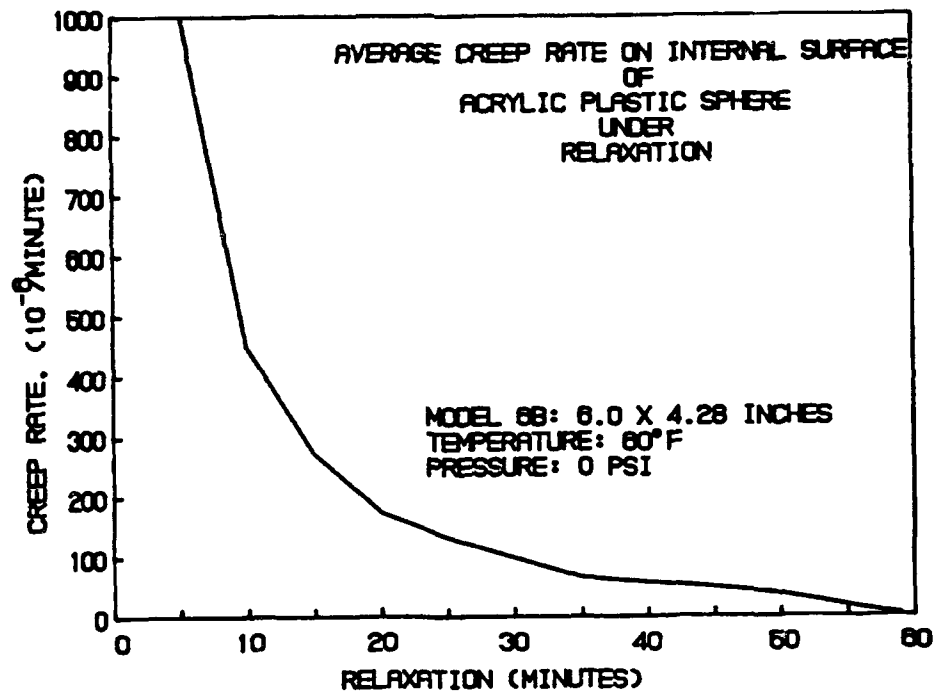
Figure 92. Creep rate on the interior surface of Model 6B during relaxation after 144 hours of sustained pressure loading at 9,000 psi; 0 to 1 hour's duration interval.

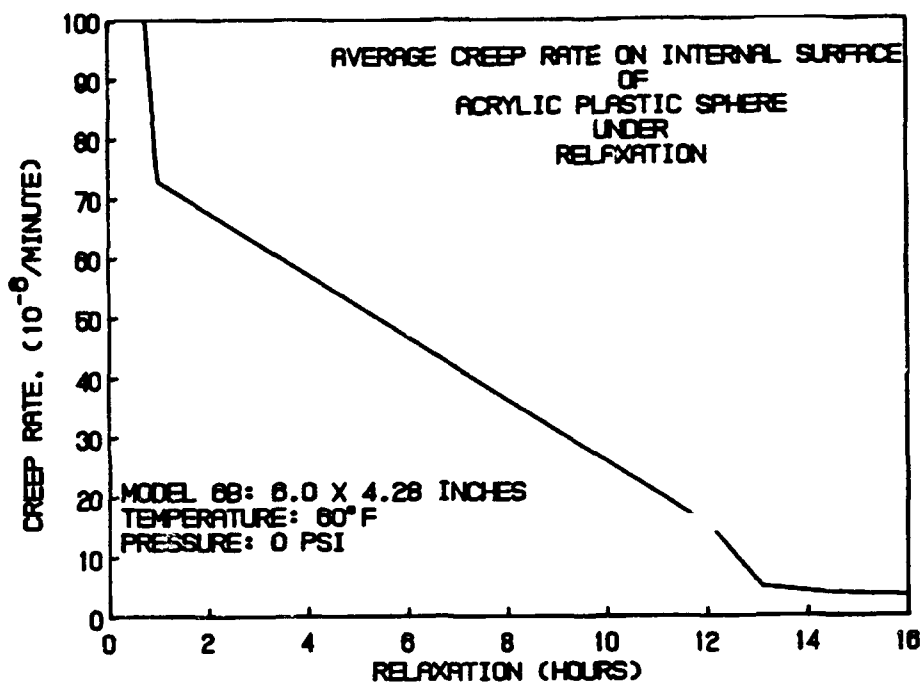
Figure 93. Creep rate on the interior surface of Model 6B during relaxation after 144 hours of sustained pressure loading at 9,000 psi; 0 to 16 hour's duration interval.

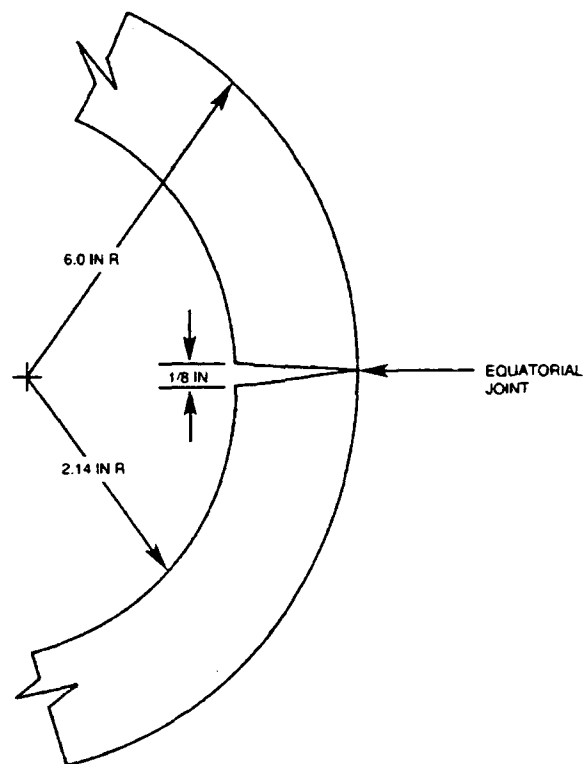
Figure 96. Cross section of delaminated bond in
equatorial joint on Model 6B.

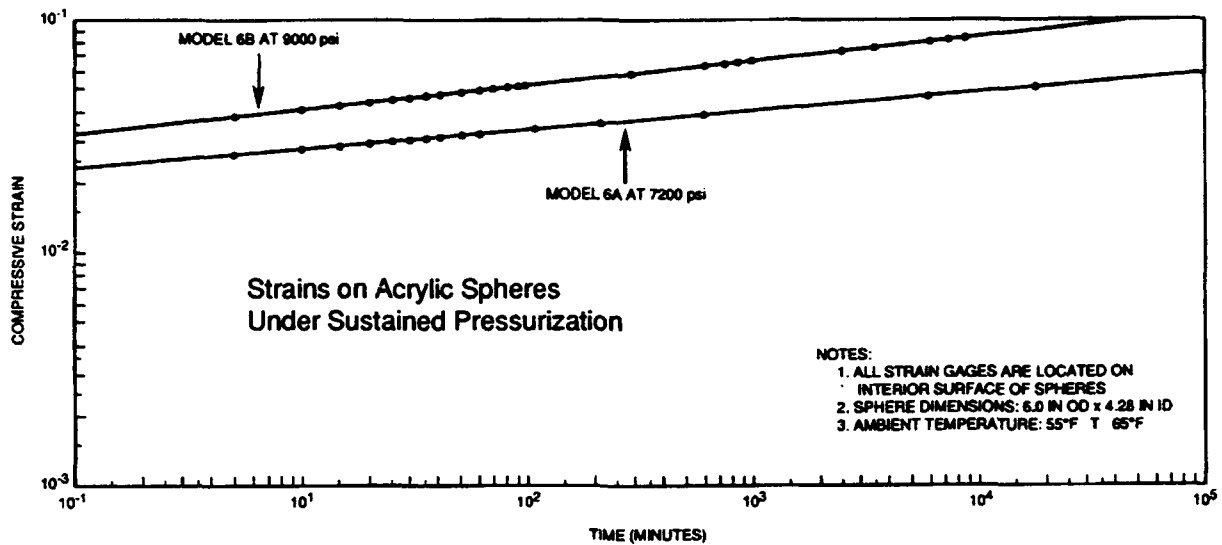
6. When the strains generated by sustained pressure loading are plotted on log-log coordinates, a straight line can be drawn through the data points (figure 97). This plot is a useful tool for extrapolating time-dependent strains beyond experimentally generated short-term strain data. Thus, to predict strains on an acrylic sphere for any duration of sustained loading at any pressure, one needs

7. Acrylic Models 6A and 6B with $t/D_i = 0.2$ will never cease to creep when subjected to external pressure loading $\geq 7,200$ psi at 60°F (figure 97). This is not the case when subjected to sustained pressure loading at design pressure of 3,560 psi.

Figure 97. Summary of strain data generated by Models 6A and 6B during sustained pressure loading to 7,200 psi and 9,000 psi respectively.
