Wear Particle Analysis Results for Variably Loaded Single Reduction Helical Gearboxes

Terri A. Merdes, Derek C. Lang, James D. Kozlowski, and Karen Meister
Applied Research Laboratory
The Pennsylvania State University
P.O. Box 30
State College, PA 16804-0030
(814) 863-5843

1998

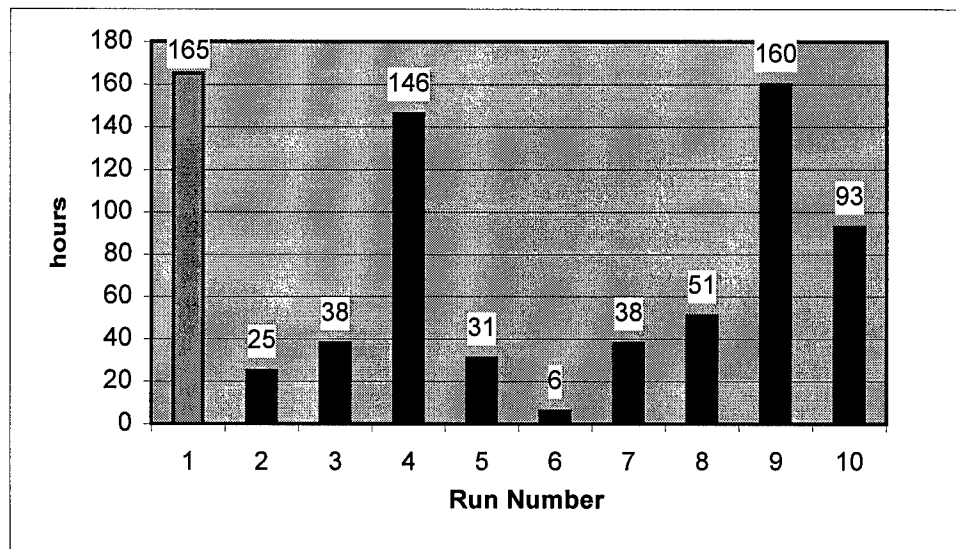
Figure 2. Loaded Gearbox Run Time

The mean (μ) and sample standard deviations (s) in hours on load for runs 2-6 (3X output torque load) and runs 7-10 (2X output torque load) were (μ = 49.2, s = 55.4) and (μ = 85.5, s = 54.9), respectively. Note that lower output torque loading (runs 7-10 above in Fig. 2) results in longer time-to-failure on average. This agrees with intuition. However, the variance in run times is relatively high and approximately equal for both load conditions. It is a coincidence that the third run of each set (#4 vs. #9) has the longest

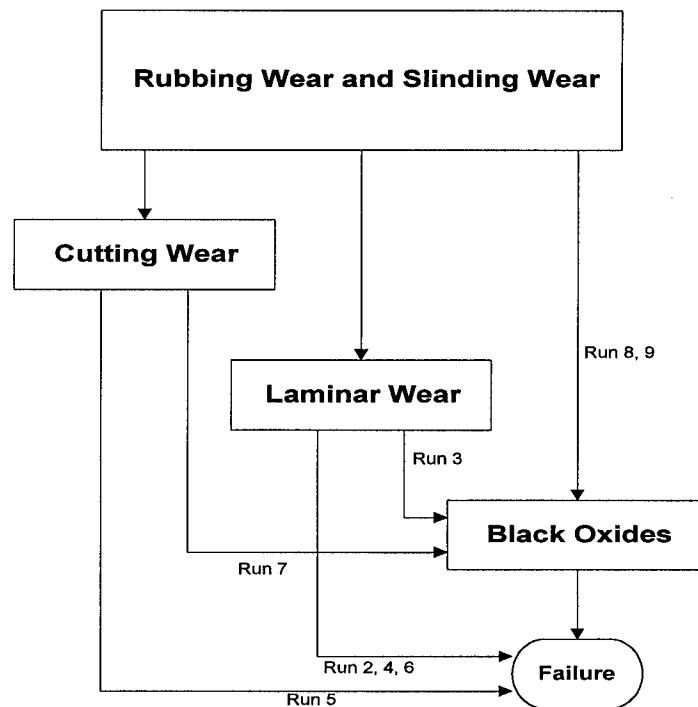
Figure 3. Paths to Failure

Figure 3 (next page) includes run number labels along each path segment. In every case of 2X loading black oxides (indicator for insufficient lubrication) appears in the lubricant prior to breakdown.

All but one case of 3X loading indicators from laminar wear are present; on the other hand only one of these cases showed black oxide observed in the oil sample. While eight samples are hardly enough for valid statistics, these observations suggest that correlating changes in ferrographic content of lubricating oil with operating parameters (e.g. loading level) will facilitate in-line degradation analysis. (As of this writing, oil analysis results for Run #10 have not been finished.) This illustrates the approach on which we are embarking to develop a real-time condition monitoring capability.

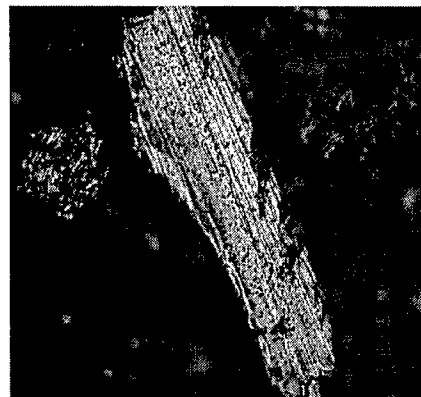
Figure 4. Cutting Wear

Each of the various paths to failure passed through at least one of three observable alarm conditions (our term for conditions indicating a high risk of imminent failure): cutting wear, laminar wear, or deficient lubrication. Cutting wear, which arises from misalignment or the presence of solid contaminants in the lubricant, is indicated by swarf-like particles 2-5 mm wide and over 100 mm long [2]. Laminar wear results from rolling contact failure of bearing and gears and is indicated by non-striated platelets of various sizes. Deficient lubrication results from poor design or excessive loading or speeding, and is indicated by the presence of black oxide in the lubricating oil.

Examples of cutting and sliding wear are exhibited in Figures 4 and 5 below, [5].
