TECHNICAL REPORT ARCCB-TR-98019

SHOT-BY-SHOT EROSION MODELING OF RETIRED 120-MM M256 GUN TUBE #1988

OCTOBER 1998

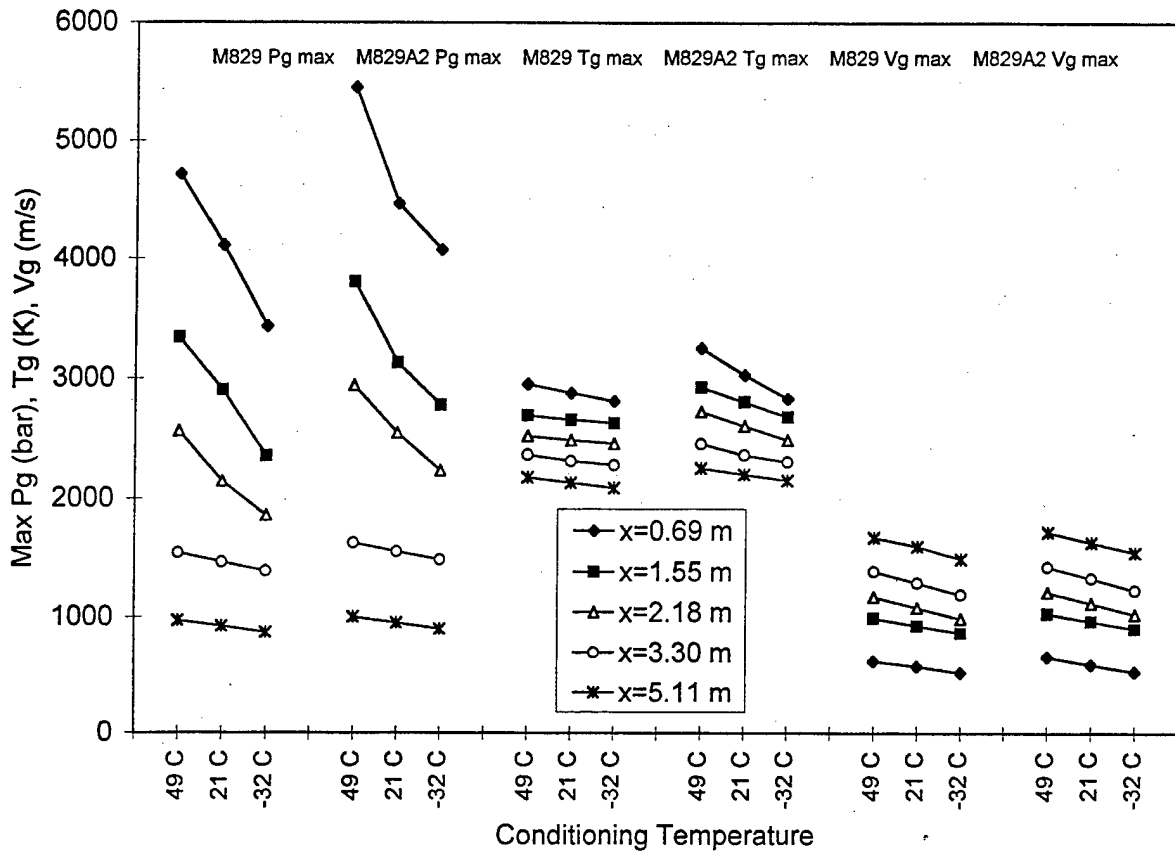
Figure 1. M829 and M829A2 calibrated interior ballistic analysis for maximum values of gas pressure, gas temperature, and gas velocity.

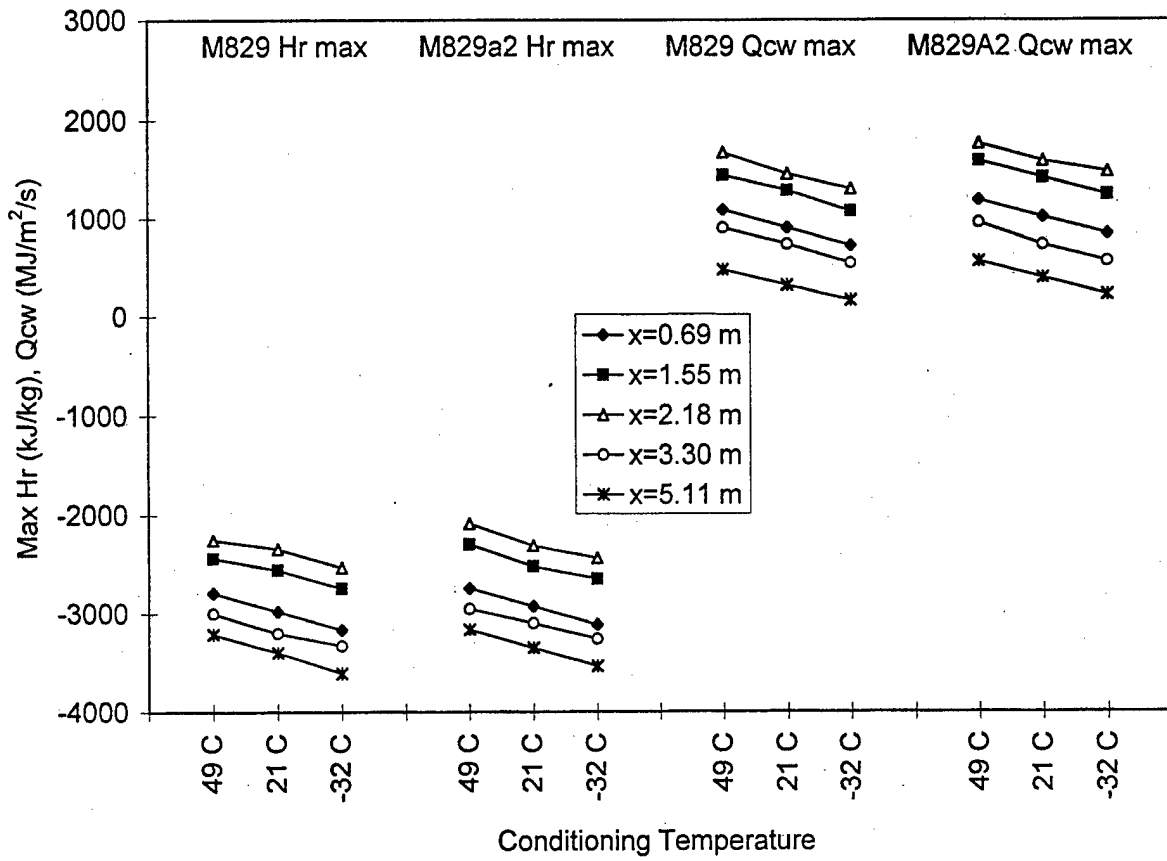
Figure 2 summarizes the M829 and M829A2 MABL analysis for maximum values of recovery enthalpy (H_r) and cold wall heat flux (Q_{cw}) as a function of the selected axial positions and round-conditioning temperatures. Maximum values were also used instead of time-dependent data to simplify the appearance of this figure. Experimental thermal repacking depth away from cracks, thermal transformation depth away from cracks, and thermocouple data were used to calibrate this improved boundary layer analysis. The figure illustrates that H_r and Q_{cw} values increase with increasing axial position for the 0.6 to 1.2 meter from RFT region; both values peak in the 1.2 to 2.4 meter range; then both values decrease with increasing axial position to the muzzle. Note that the heat transfer pattern in Figure 2 significantly differs from the core flow pattern in Figure 1 and cannot be solely explained on the basis of simple heat transmission (film) coefficient effects (ref 5). We theorize that this difference can be explained by an improved boundary layer analysis, including significant combustion case gas cooling effects and these significant turbulent gas mixing/heating effects.

Figure 2. M829 and M829A2 calibrated MABL analysis for maximum values of recovery enthalpy and cold wall heat flux.

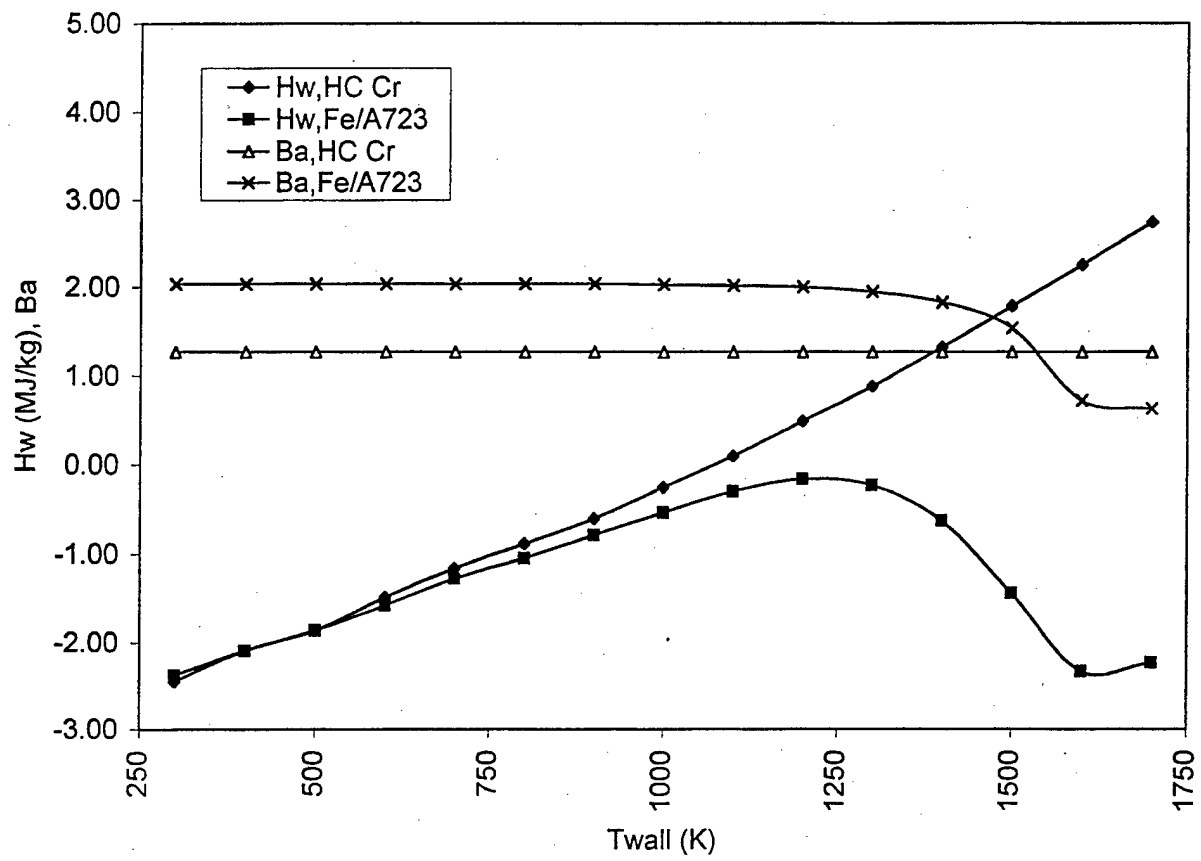
Figure 3 summarizes the M829 and M829A2 CCET thermochemical analysis of reacting wall enthalpy (H_w) and ablation potential (B_a) (ref 3) for tube #1988 as a function of wall temperatures (T_{wall}) for high contraction (HC) chromium plate/A723 gun steel wall materials. Experimental kinetic rate function data and subsurface metallographic data were used to calibrate the thermochemical analysis and transform the chemical equilibrium analysis into a partial chemical kinetic analysis. The respective HC chromium maximum T_{wall}'s are about 1600°K and 1650°K for the M829 and M829A2 rounds. These are below its passivating oxidation temperature at about 2000°K and well below its melting point at about 2130°K, which explains its inertness. The respective A723/iron maximum T_{wall}'s are about 1375°K and 1400°K for the same M829 and M829A2 rounds. These are well above its rapid expansive flaking oxidation temperature at about 1055°K, explaining its reactivity. In addition, they are below its iron oxide melting point at about 1640°K and well below its A723/iron melting point at about 1810°K.

Figure 3. M829 and M829A2 calibrated CCET thermochemical
analysis of reacting wall enthalpy and ablation potential.

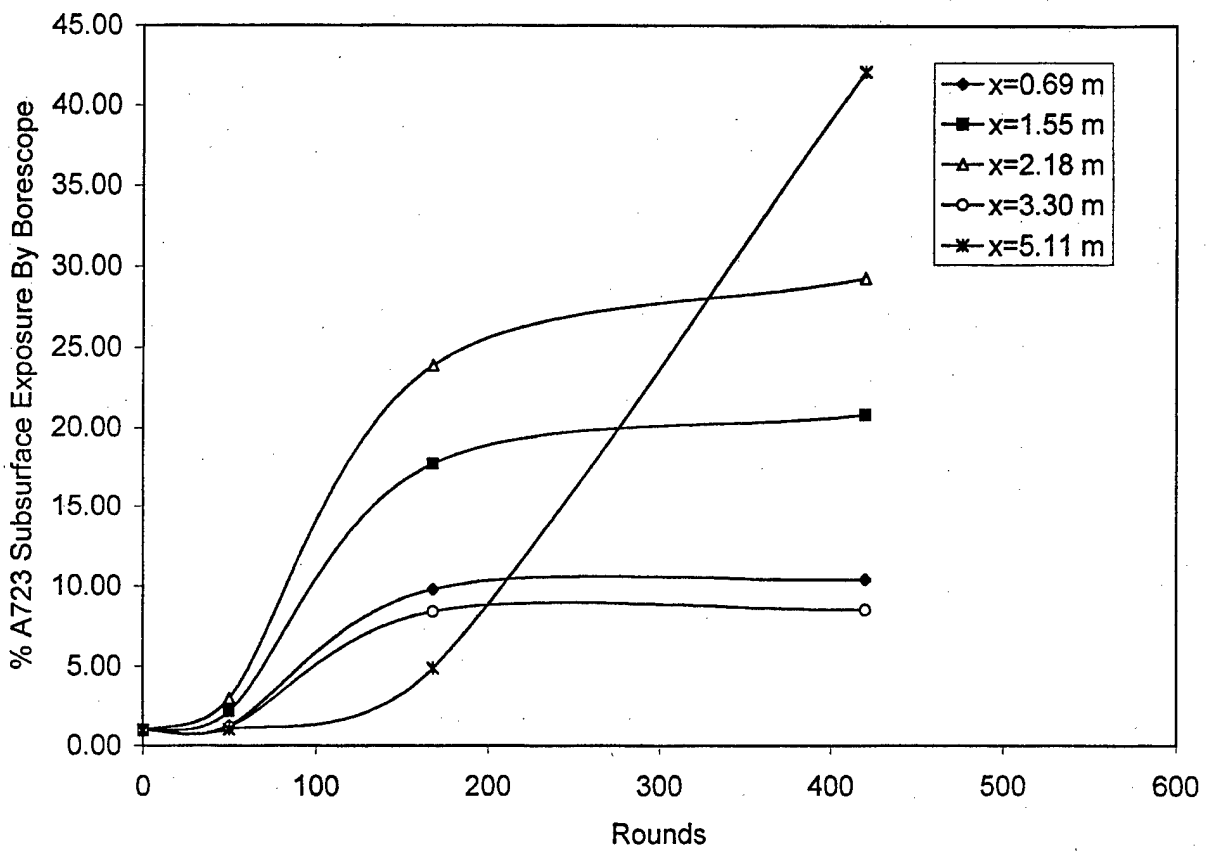
Figure 4 summarizes the M829 and M829A2 borescope data analysis of A723 subsurface exposure through HC chromium plate cracks as a function of rounds fired for selected axial positions. The experimental borescope data was used to calibrate the erosion analysis. This data was collected on a cleaned M256 tube that had about half M829A2 and half M829 rounds. These M829A2 and M829 rounds consisted of a nearly equal distribution of hot, ambient, and cold temperature conditioning. Data collection involved the use of a magnifying borescope with a calibrated scale to measure the number and average area of each HC chromium platelet within a designated total area as a function of axial position for a given round count.

For the selected axial positions in Figure 4, from 50 to 125 rounds, the A723 subsurface exposure rose rapidly due to HC chromium thermal repacking, nonmetallic out-gassing, and possibly compression resulting in its shrinkage and heat checking. After about 125 rounds, the above mechanism diminished and A723 subsurface exposure rose more slowly because only the HC chromium platelet spalling mechanism remained. At the 5.11 meter from RFT near-muzzle position, the A723 subsurface exposure rose very rapidly from about 125 rounds until its out-of-service round count due to HC chromium platelet spalling by a different purely mechanical mechanism. This tube was taken out-of-service due to dispersion at about seventy percent of its estimated erosion life possibly because of the typical severe muzzle wear.

Figure 4. M256 tube #1988 borescope data analysis of
A723 subsurface exposure through HC chromium plate cracks.

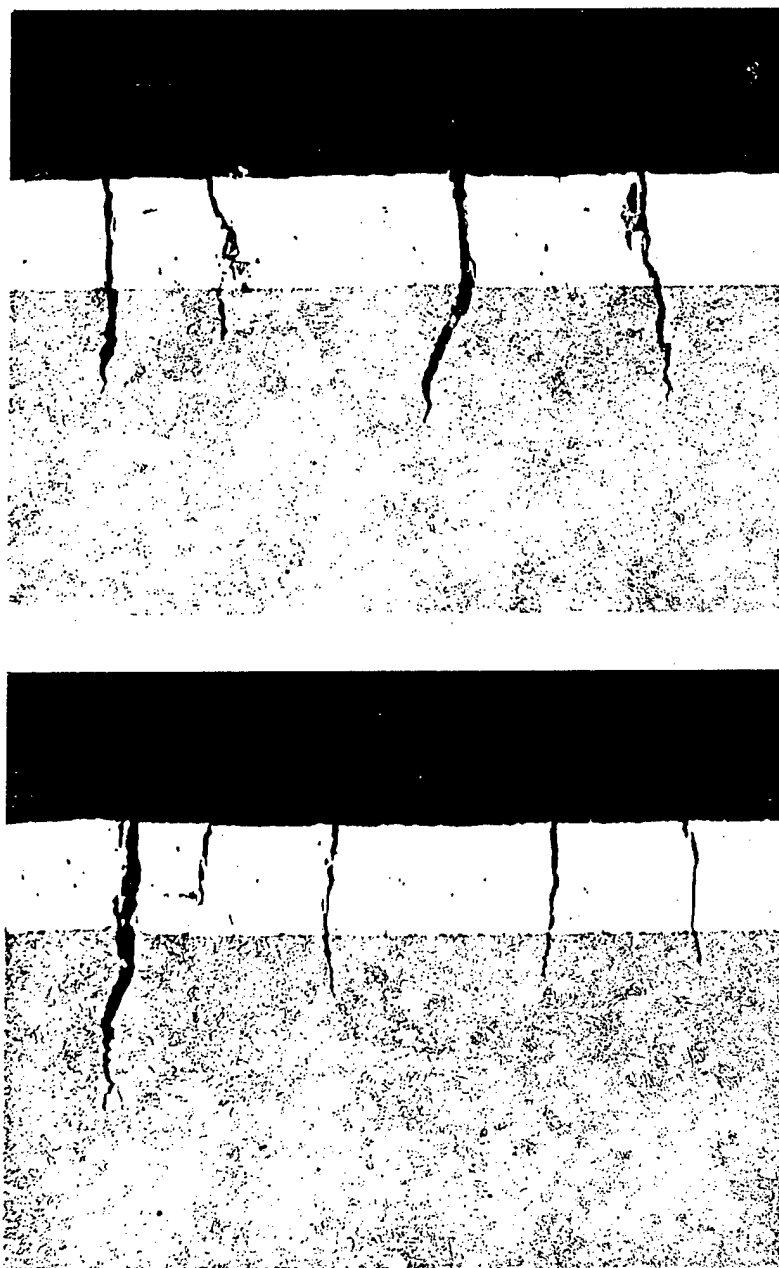
Figure 5 presents two typical 100x metallographs of M256 tube #1988 with about half M829A2 and half M829 rounds at 0.69 meter from RFT. This represents the 0.6 to 1.2 meter region, and was used to calibrate the erosion analysis. The 0.6 to 1.2 meter region has the highest gas pressure of any bore region (Figure 1), which explains the deep crack depths due to severe dilation. Although this 0.6 to 1.2 meter region has the highest gas temperature of any bore region (Figure 1), heat transfer to the wall is significantly diminished due to combustion case gas cooling effects (Figure 2). These observations explain the heat checking and crack spacing as well as the near absence of interface degradation and chromium platelet spalling.

Figure 5. Tube #1988 metallographs at 0.69 meter
representing 0.6 to 1.2 meter region (100x).

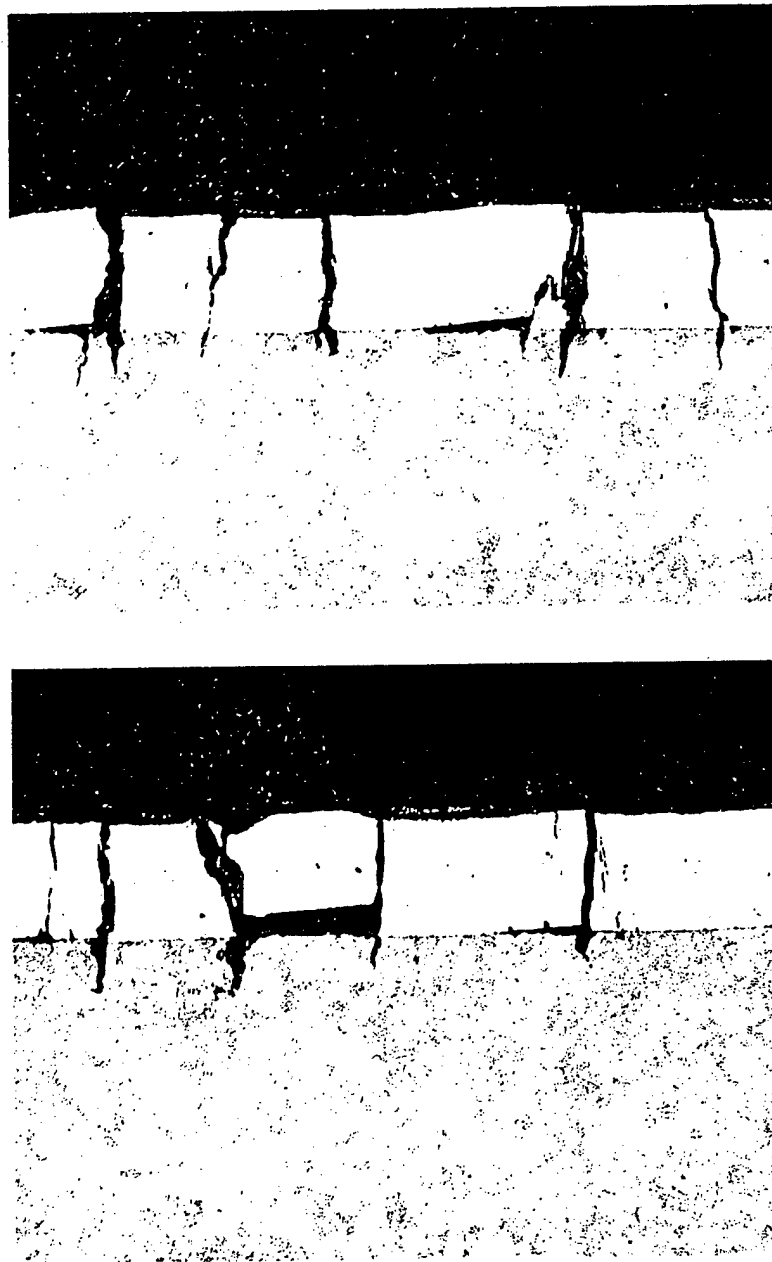
Figure 6 presents two typical 100x metallographs of M256 tube #1988 with about half M829A2 and half M829 rounds at 1.55 meters from RFT. This represents the 1.2 to 2.4 meter region and was also used to calibrate the erosion analysis. The 1.2 to 2.4 meter region has a lower gas pressure than the 0.6 to 1.2 meter region (Figure 1), which explains the moderate crack depths due to moderate dilation. Although this 1.2 to 2.4 meter region has a lower gas temperature than the 0.6 to 1.2 meter bore region (Figure 1), heat transfer to the wall is significantly higher due to turbulent gas mixing (Figure 2). These observations explain the heat checking and crack spacing as well as the prevalent interface degradation and chromium platelet spalling. We theorize that the main gun erosion mechanism consists of inert chromium plate cracking, shrinkage, and heat checking, followed by subsequent interfacial degradation of the subsurface gun steel substrate at the chromium crack bases, subsequent chromium platelet spalling, and subsequent bare gun steel gas wash. The gun steel at the chromium/gun steel interface is more susceptible to interface degradation than either of its components separately due to its higher energy state and reactivity. In addition, interface degradation is enhanced by expansive flaking of iron oxide.

As chromium platelets detach from the substrate and rise above attached chromium platelets, they are more susceptible to mechanical removal by the projectile. In addition, the 1.2 to 2.4 meter region has a wavy chromium surface appearance in cross-section due to partially detached chromium platelets. Rarely do radial heat-checking cracks link-up to spall a chromium platelet with attached gun steel. Although there appears to be evidence of heat-checking cracks extending into the wall well beyond the heat-affected zone due to environmental-assisted cracking, great scrutiny has produced no measurable evidence of chromium platelet spalling due to cracking in the plane of the chromium plate/gun steel interface.

Figure 6. Tube #1988 metallographs at 1.5 meters
representing 1.2 to 2.4 meter region (100x).

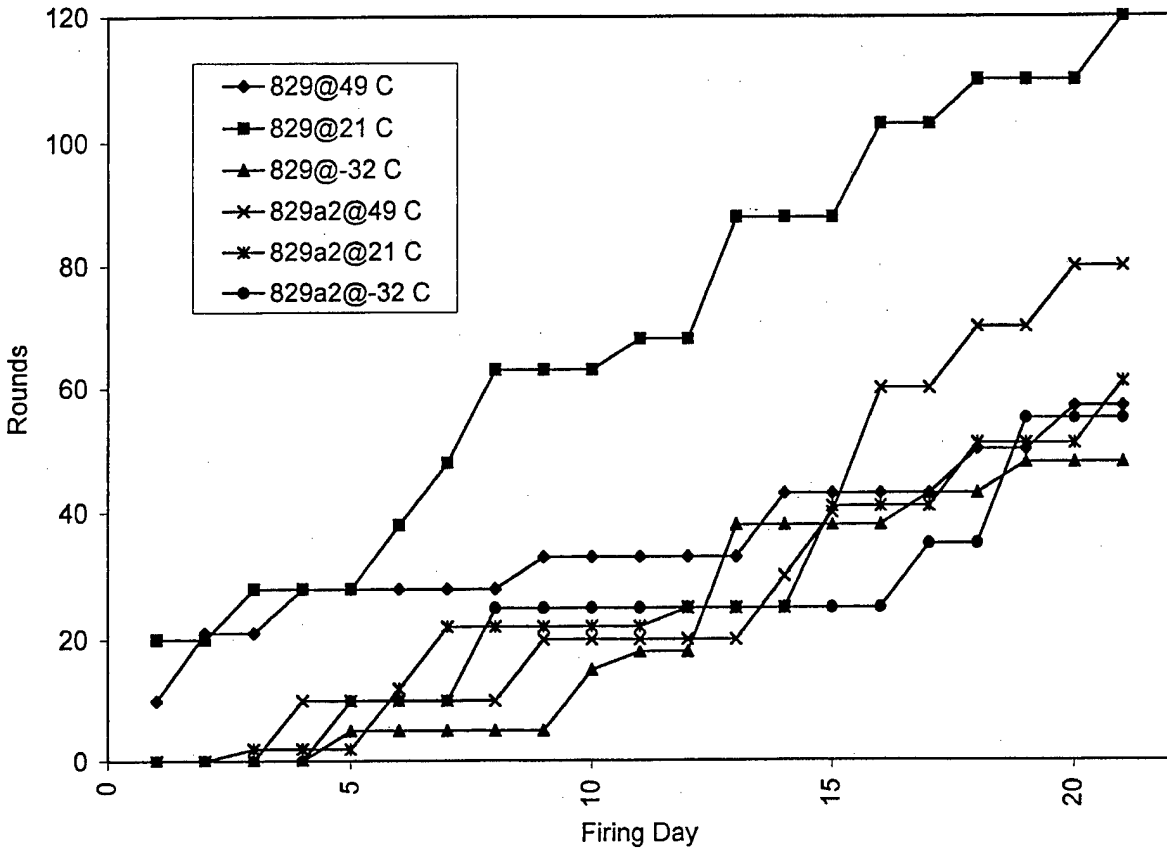
Figure 7 summarizes the M256 tube #1988's distribution of M829 and M829A2 round types and hot/ambient/cold round-conditioning temperatures, which are the same as those in Figure 1.

Figure 7. Tube #1988's distribution of M829 and M829A2 rounds
(424 total) and their hot/ambient/cold round-conditioning temperatures.

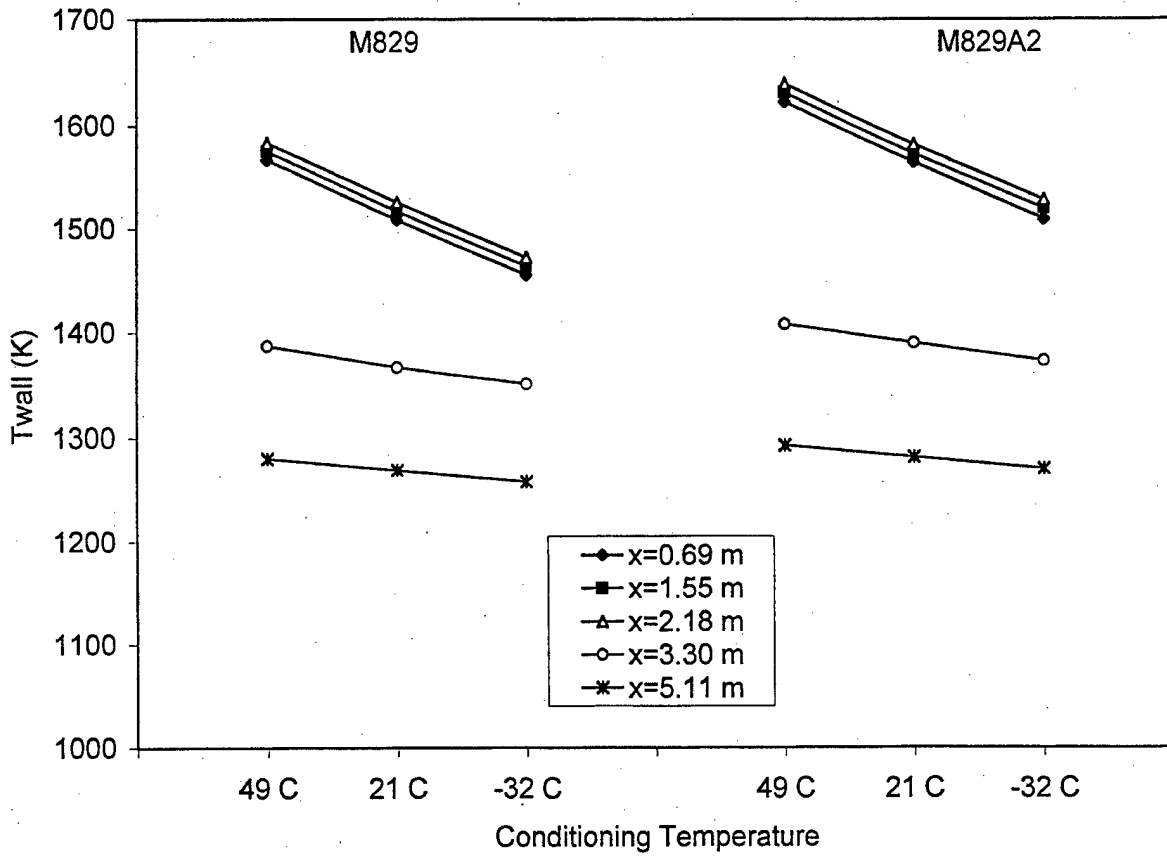
Figure 8 shows the subject tube's MACE wall temperature profile analysis for HC chromium maximum surface temperature (T_{wall}) as a function of round-conditioning temperatures for selected axial positions and round types. The respective HC chromium maximum T_{wall}'s are about 1600°K and 1650°K for the M829 and M829A2 rounds. These are below its passivating oxidation temperature at about 2000°K and well below its melting point at about 2130°K, thus explaining its inertness.

Figures 8 and 9 show that wall temperature profiles follow the positional order of the heat transfer pattern from Figure 2. In these two figures, maximum values were used instead of time-dependent data to simplify their appearance. Also, experimental thermal repacking depth away from cracks, thermal transformation depth away from cracks, and thermocouple data were used to calibrate calculated wall temperature profiles.

Figure 8. M256 tube #1988 calibrated MACE wall temperature profile analysis for HC chromium maximum surface temperature.

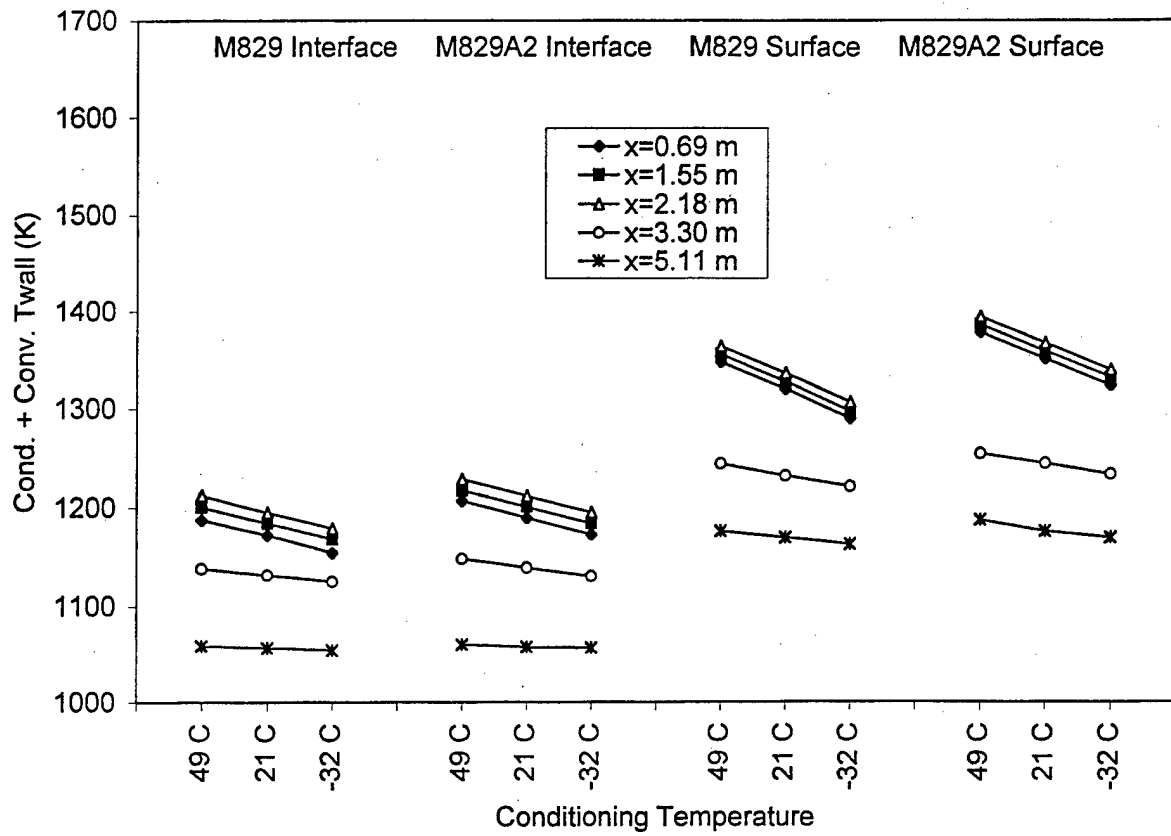
Figure 9 shows the tube's MACE wall temperature profile analysis for A723 maximum interface and surface wall temperatures (T_{wall}) as a function of round-conditioning temperatures for selected axial positions and round types. The A723 maximum interface T_{wall} values are a combination of convection and conduction at the crack walls. The respective A723/iron maximum interface T_{wall}'s are about 1225°K and 1250°K for the M829 and M829A2 rounds. These are above its rapid expansive flaking oxidation temperature at about 1055°K, explaining its reactivity. In addition, they are below its iron oxide melting point at about 1640°K and well below its A723/iron melting point at about 1810°K. Diffusion, reactions, transformations, and gas wash thermochemically degrade interfacial A723 at HC chromium plate heat-checked crack bases. The respective A723/iron maximum surface T_{wall}'s are about 1375°K and 1400°K for the M829 and M829A2 rounds. These are well above its rapid expansive flaking oxidation temperature at about 1055°K, explaining its reactivity. In addition, they are below its iron oxide melting point at about 1640°K and well below its A723/iron melting point at about 1810°K. Diffusion, reactions, transformations, and gas wash thermochemically degrade fully exposed surface A723 after HC chromium plate spalling.

Figure 9. M256 tube #1988 calibrated MACE wall temperature profile analysis for A723 maximum interface and surface wall temperatures.

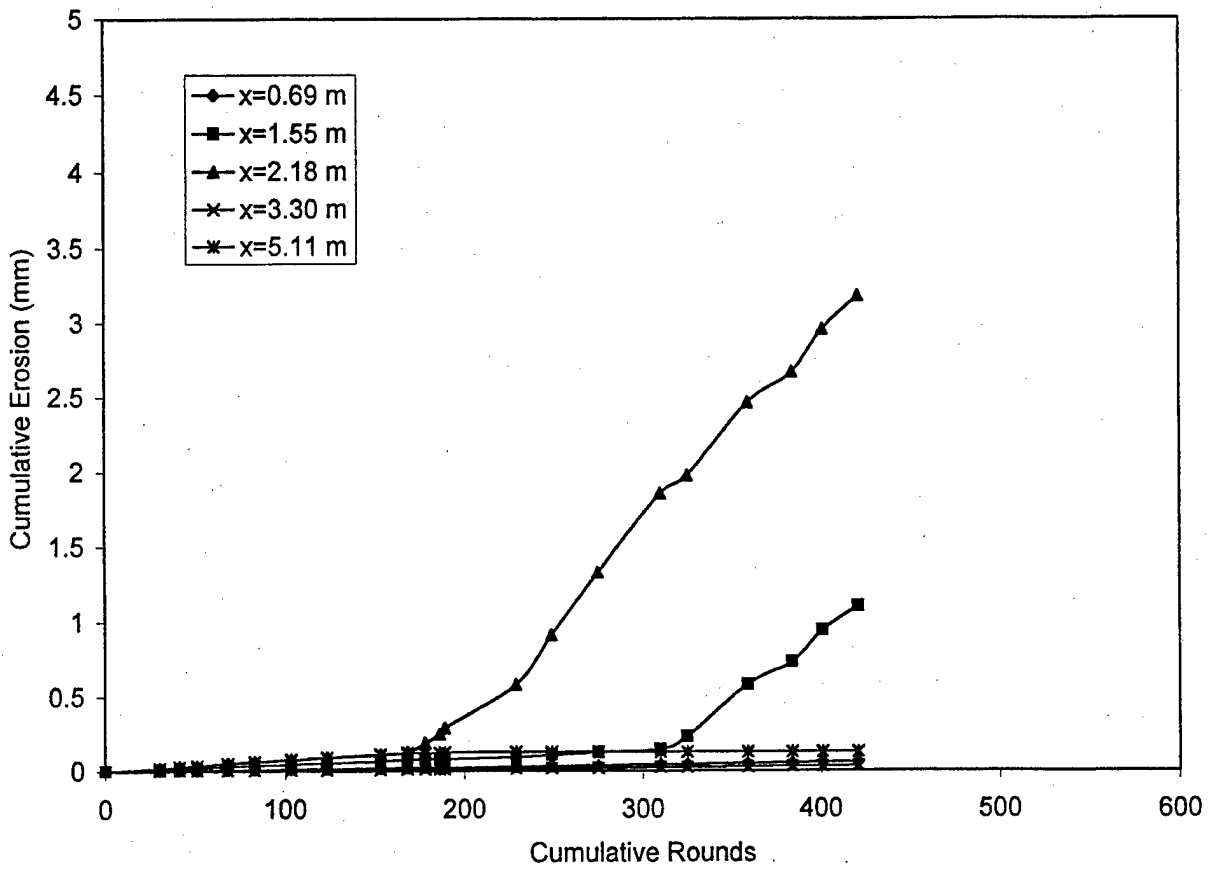
Figure 10 summarizes the MACE cumulative erosion analysis for tube #1988 as a function of cumulative rounds for selected axial positions. Tube #1988 was taken out-of service for excessive dispersion at 424 rounds, which is about seventy percent of its estimated erosion life. This figure shows the 2.18 meter from RFT axial position to be the most eroded position. It takes about 170 rounds for chromium platelet spalling onset/gun steel gas wash onset to occur, and it takes 424 rounds to achieve about 3 mm of cumulative erosion. This is typical erosion damage for this gun system when taken out-of-service by dispersion. If this gun tube had remained in service, it should have lasted an estimated 550 to 600 rounds before being condemned by erosion at 5-mm depth.

In Figure 10 cumulative wall erosion profiles also follow the positional order of the heat transfer pattern from Figure 2. Erosion life is lowest at 2.18 meters, higher at 1.55 meters, still higher at 0.69 meter, higher yet at 3.30 meters, and highest at 5.11 meters from RFT. Additionally, the figure shows that interface life follows this same pattern with the exception of the 5.11 meter position, which is believed to be by a different mechanism.

Figure 10. Summary of MACE cumulative erosion analysis for M256 tube #1988 as a function of cumulative rounds for selected axial positions.
