Acquisition Directorate

Report No. CG-D-10-11

CSSC Fish Barrier Simulated Rescuer Touch Point Results, Operating Guidance, and Recommendations for Rescuer Safety – Final Report

September 2011

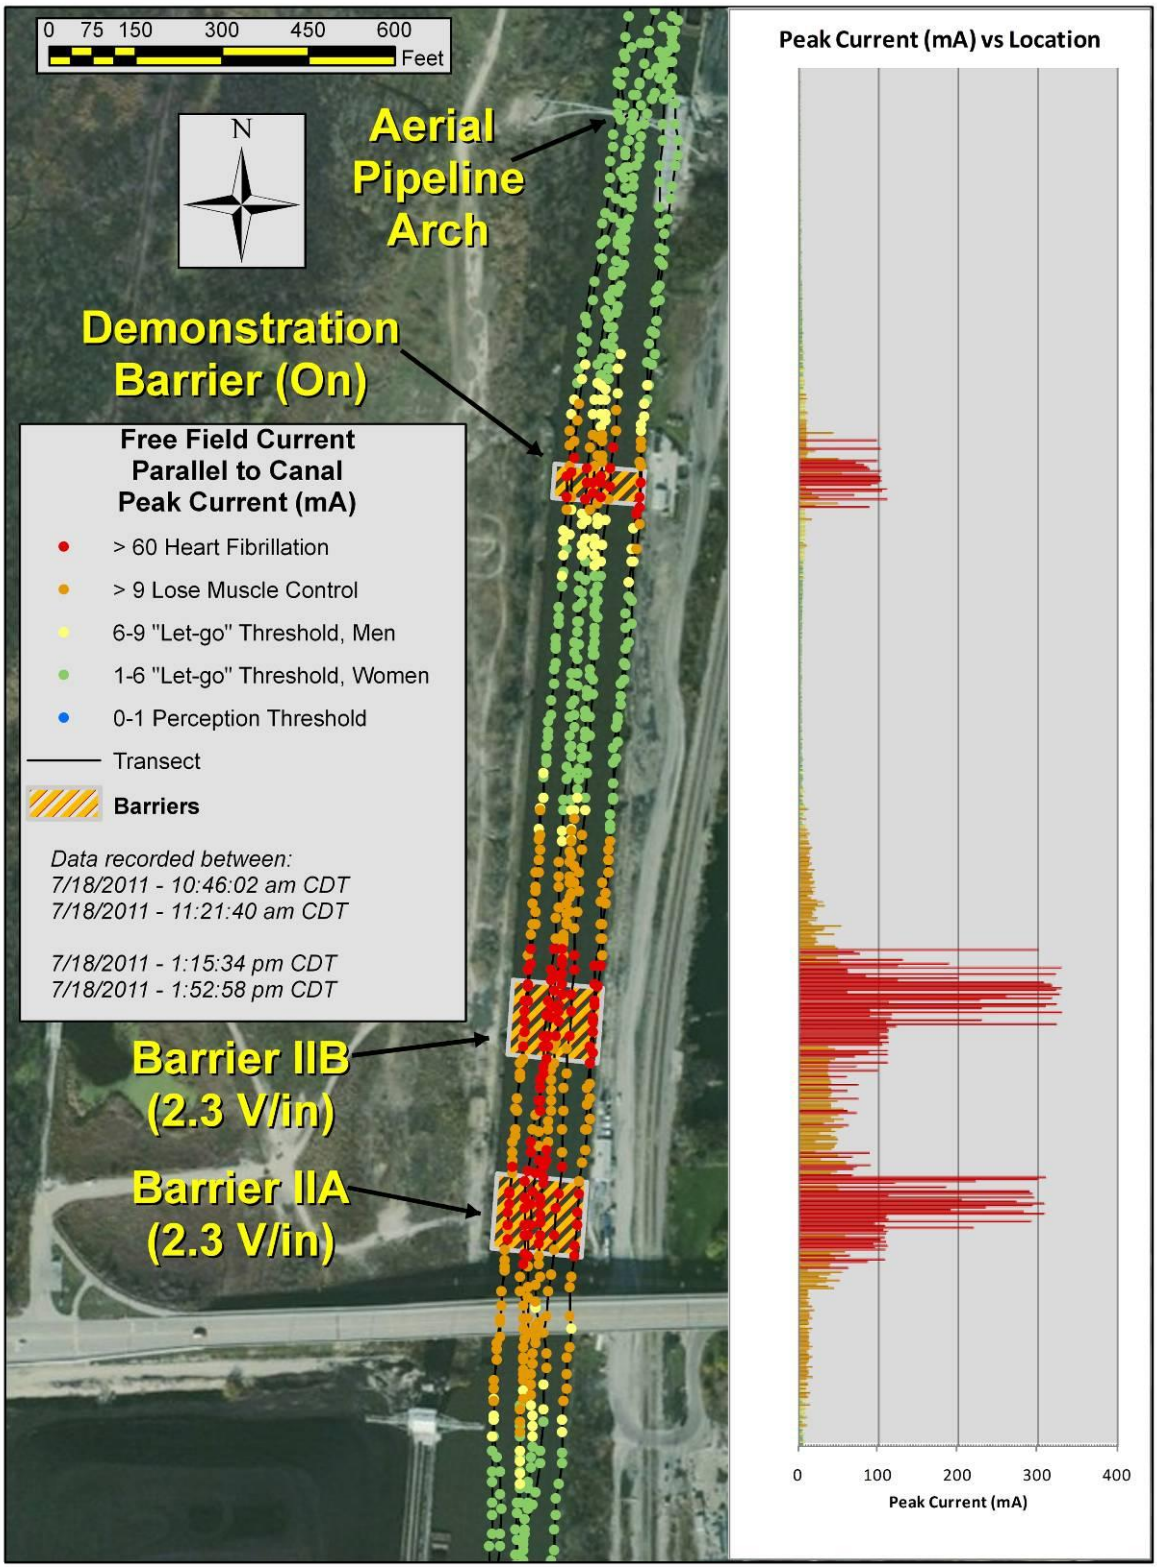
Figure 15. Peak free-field electrical current (mA) between horizontal electrodes, 72" apart, oriented parallel to vessel track, 2.3 volts/inch.

We observed significant electrical currents in this test condition, with barriers operating at both 2.0 and 2.3 volts/inch. Maximum currents measured occurred horizontally along the direction parallel to the canal axis, with peak levels of 330 milliampere (mA) observed for Barrier IIB operating at 2.3 volts/inch (see Table 5). Using 72" spacing, this current was equivalent to the nominal barrier setting of 2.3 volts/inch. Figure 15 shows the peak free-field electrical current between horizontal electrodes, 72" apart, oriented parallel to vessel track. Maximum levels from Barrier IIA in this same operating condition (2.3 volts/inch)

resulted in a worst-case peak current of 310 mA, equivalent to approximately 2.2 volts/inch. Measured levels for Barrier IIB were consistently higher than the same condition for Barrier IIA, although worst-case levels generally agreed to within approximately 8 percent. Results are scaled proportionally with barrier operational voltage in this orientation.

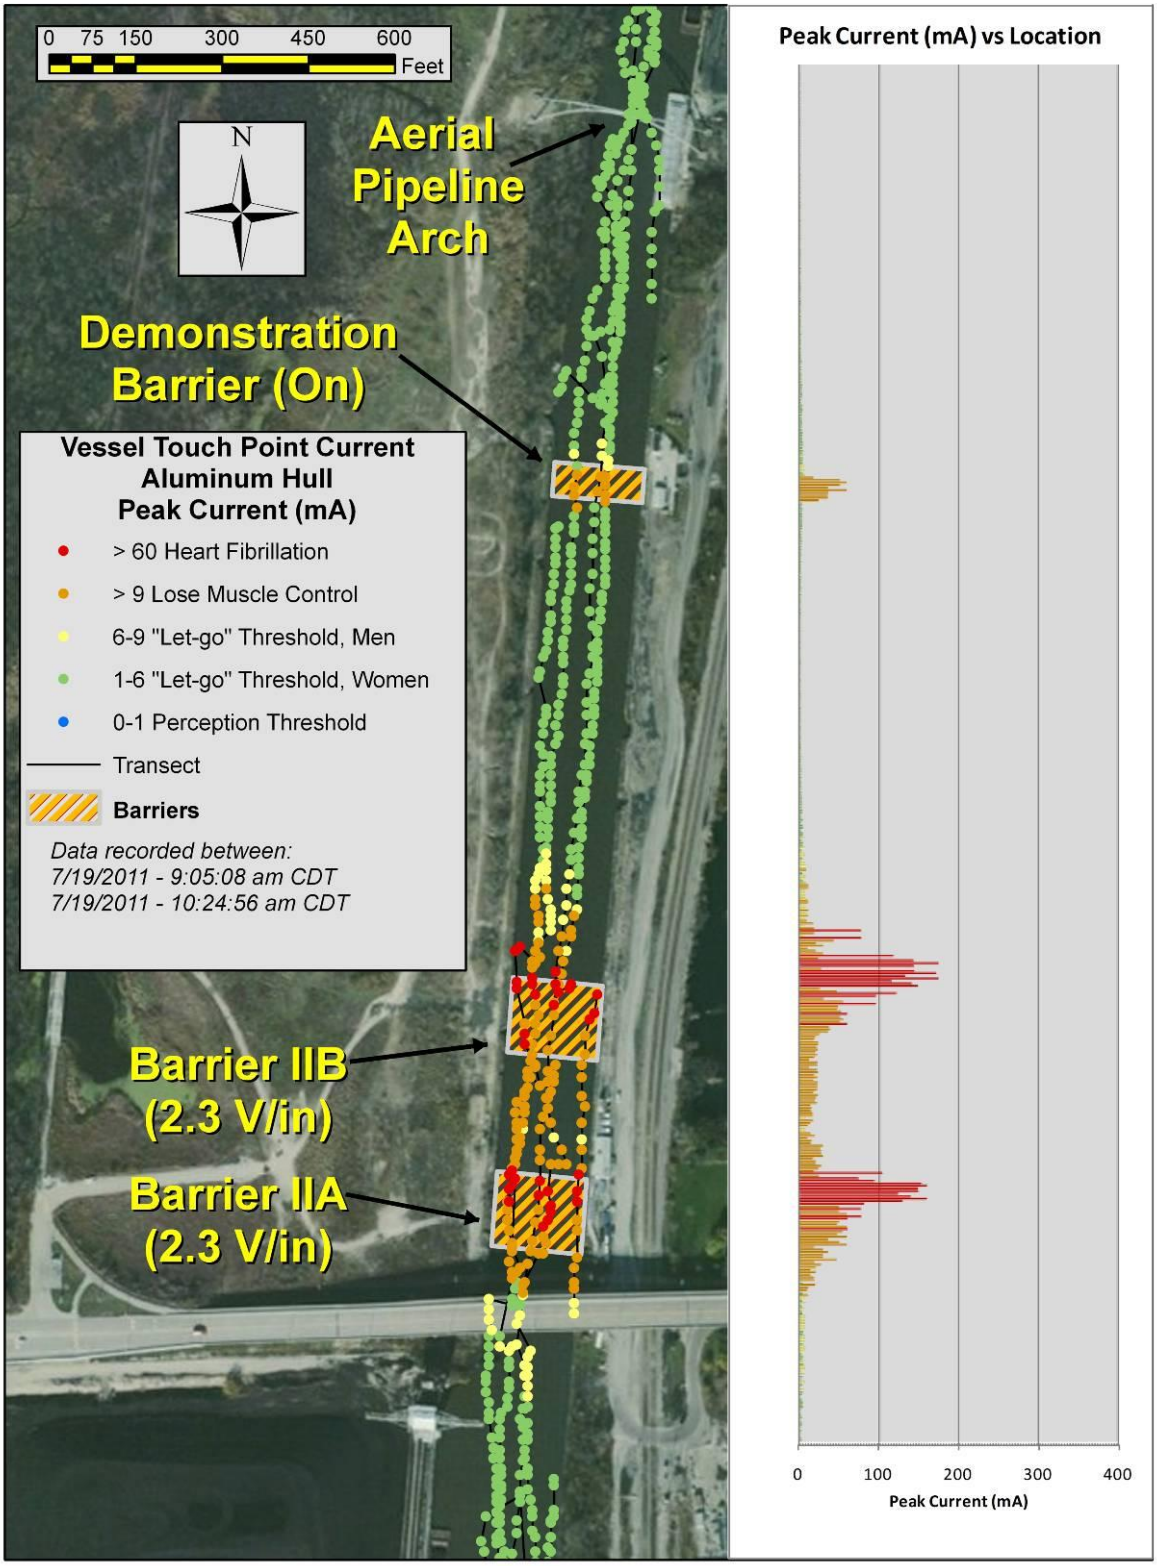
Figure 17. Peak rescue vessel electrical current (mA), aluminum hull, 2.3 volts/inch.

As in Test Condition 1, we observed significant electrical currents in this test condition. The maximum current measured in this condition was 191 mA (see Table 6). Figure 17 shows the peak current flowing from a PIW in direct contact with the metallic hull of a rescue vessel with Barriers IIA and IIB operating at 2.3 volts/inch. This test condition demonstrated that significant electrical currents can flow via a "victim" in the water through a "rescuer" electrically connected with a well-grounded metallic object (a vessel). Furthermore, this test showed that the PIW should not directly touch the hand of a rescuer on an aluminum vessel, or the vessel hull. For this test, we executed several transects through the center of the canal and along both sides. Figure 18 shows results with an aluminum hull when operating the barriers at 2.0 volts/inch.

Worst-case peak currents measured with the aluminum test vessel in July 2011 were 191 mA, with typical peak levels ranging from 131 mA to 175 mA for various barrier settings and electrode configurations (see Table 6). Measured current values from November 2010 were substantially higher (nearly 1 ampere (amp)) than measured in July 2011, most likely due to the test vessel configuration. In November 2010, an aluminum-hulled test vessel with a painted hull was used for the test, and the actual electrical current path was not surveyed which was well beyond the scope of the test. Therefore, the separation distance from the test electrode and the hull was not known, but could have been several times further apart than with the new, unpainted hulled vessel. Regardless, in both cases with the aluminum-hulled test vessel, the measured electrical currents were well above the onset level for fibrillation.

3. Simulated human skin from a PIW in direct contact with the rescue vessel metallic hull is more hazardous than having no contact at all with the rescue vessel. Rescue methods need to isolate the PIW from metallic objects.

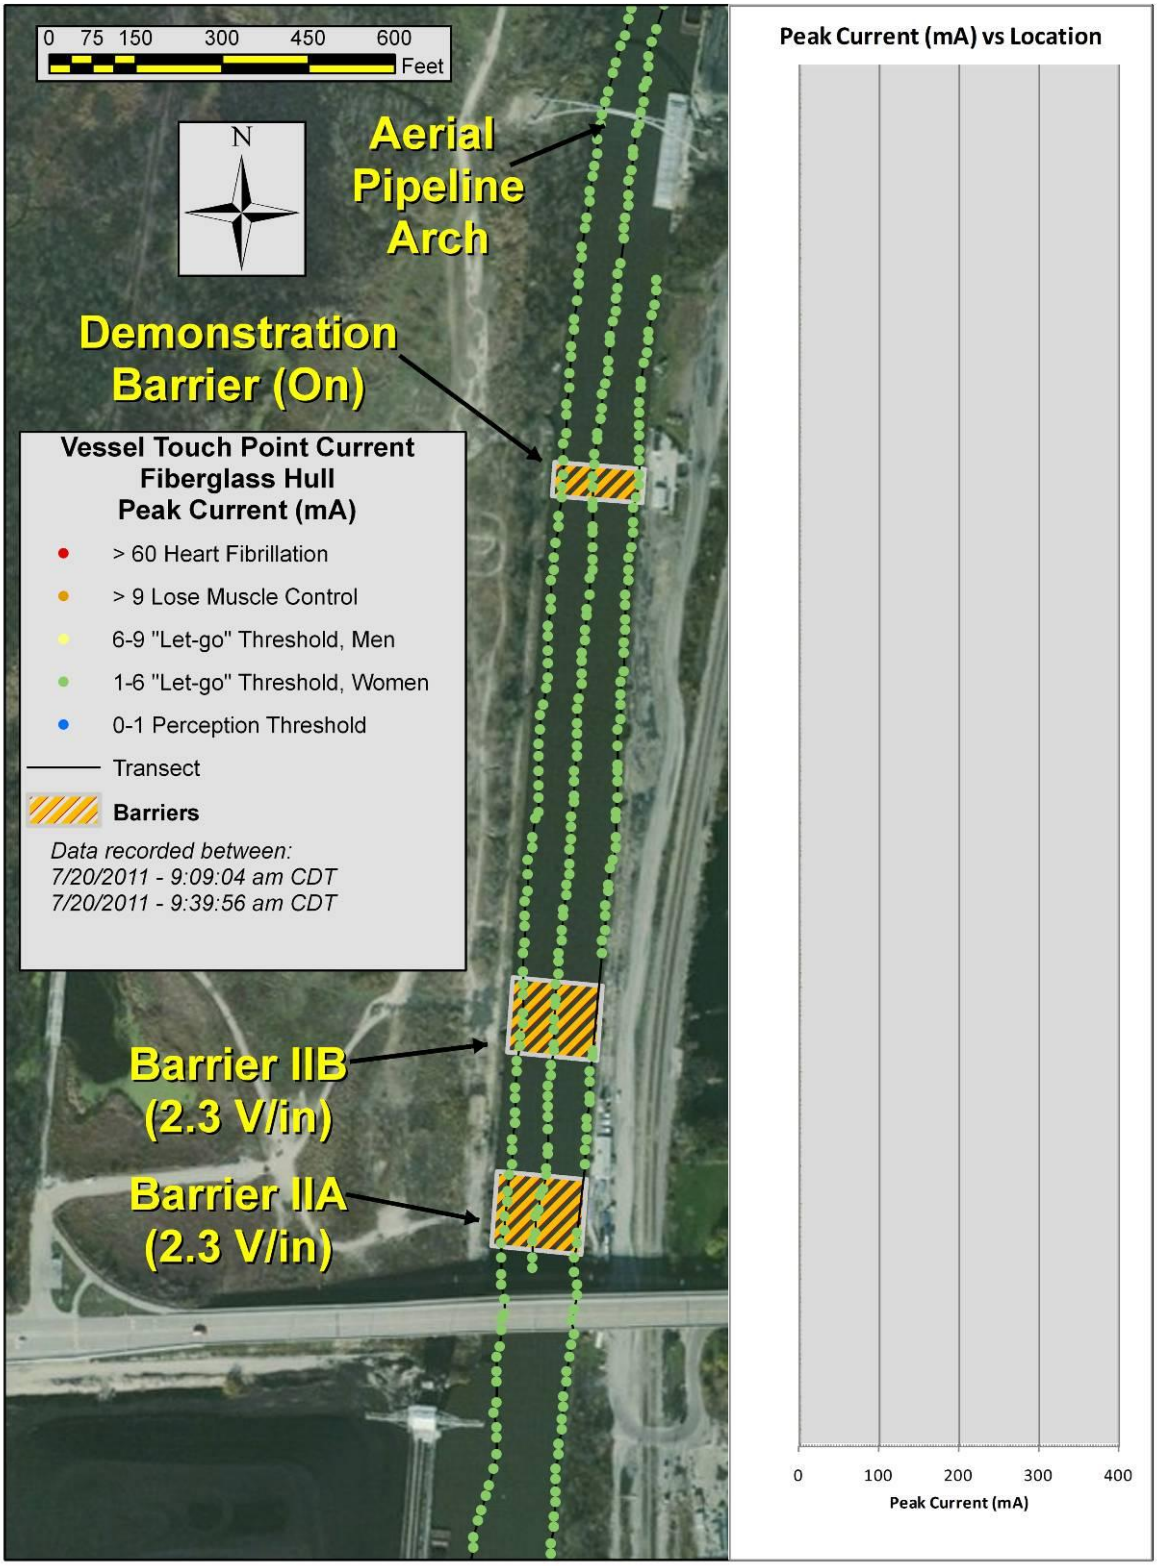
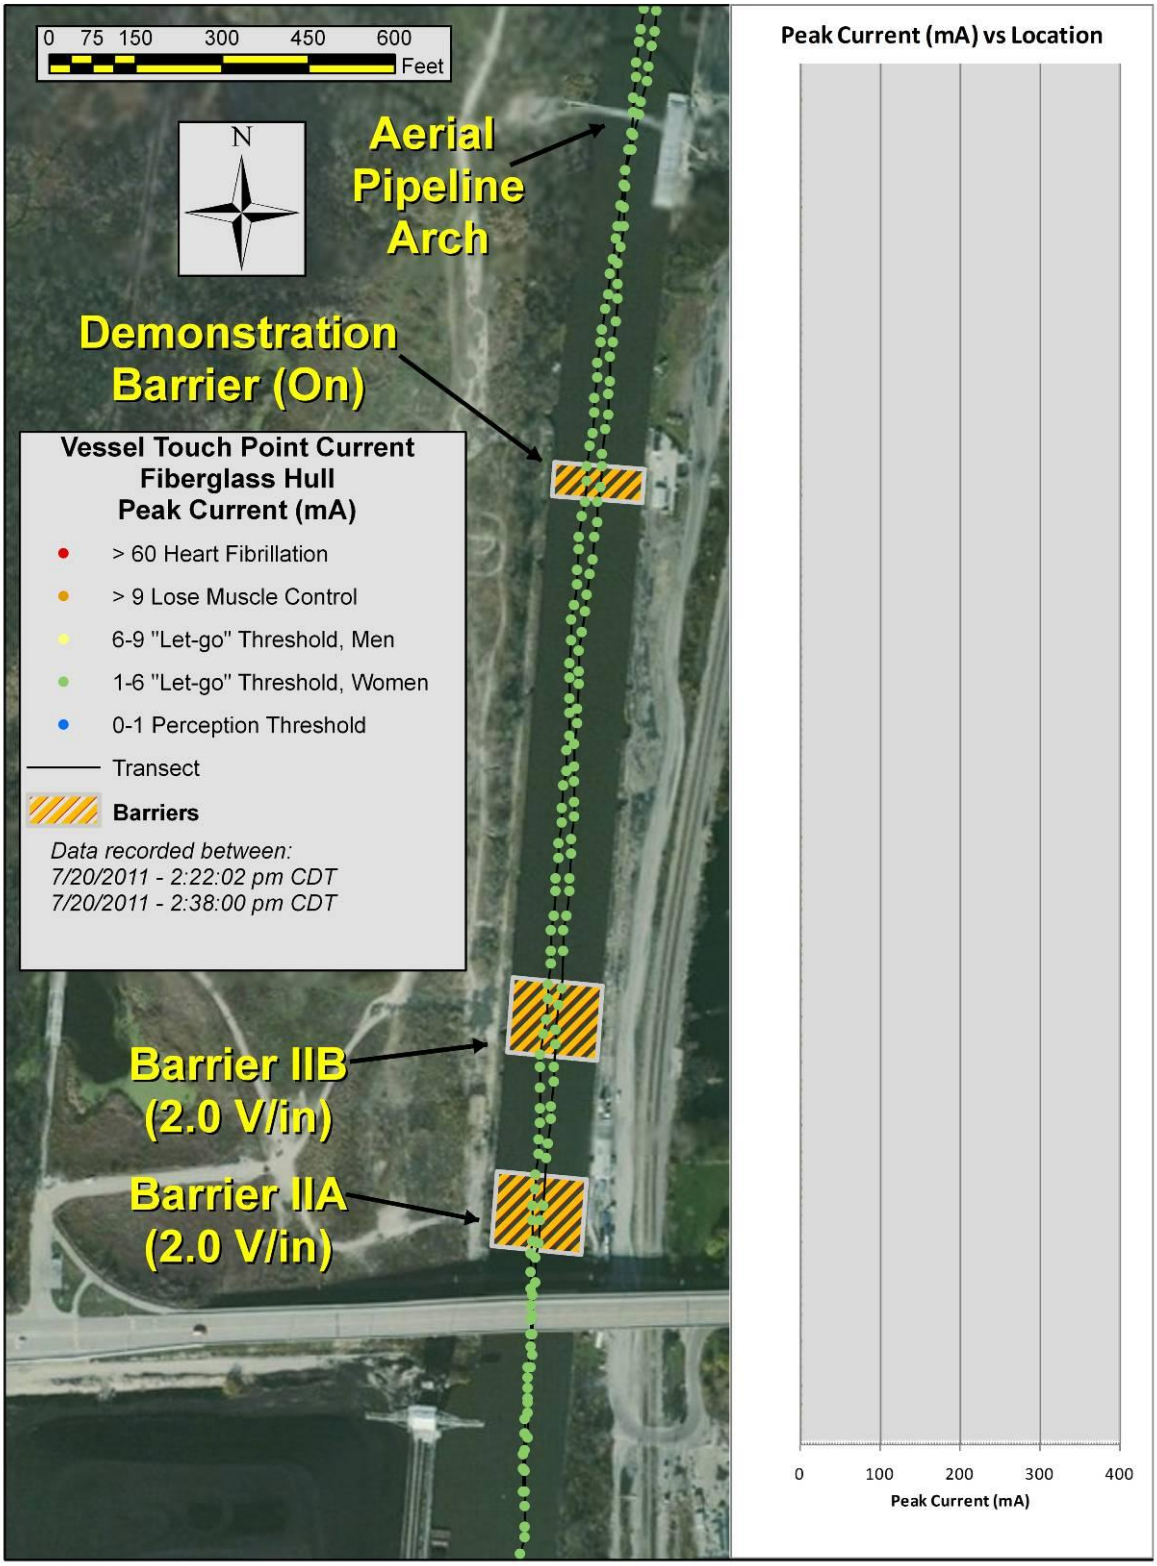
A separate test was conducted with the fiberglass-hulled test vessel to assess the risk of touch-point currents with a rescuer in electrical contact with any metallic section of the hull immersed in the canal. For this test we connected the ground electrode to the outboard motor mount located on the transom. The mount was aluminum, most of which was submerged for the test. Worst-case measured currents in this configuration were 131 mA and 159 mA from Barriers IIA and IIB, respectively, operating 2.0 volts/inch (Figure 21). This condition was not evaluated at 2.3 volts/inch. This result shows that even in a fiberglass vessel, rescuers need to be attentive to avoid creating a low resistance electrical path through their bodies, either by touching the motor or motor mounts, railings, ladders, or other components that may have electrical contact with the canal water. Although not evaluated, there is also the potential for bilge water in a fiberglass rescue vessel to become a conductive path, if the rescuer were in contact with the water. This condition should be avoided.

Figure 19. Peak rescue vessel electrical current (mA), fiberglass hull, 2.3 volts/inch.

Figure 20. Peak rescue vessel electrical current (mA), fiberglass hull, 2.0 volts/inch.

5. A fiberglass-hulled rescue vessel provides excellent isolation from shock hazard when in the barrier zone. However, it is possible to introduce a shock hazard by making contact with wetted metallic items onboard a fiberglass-hulled vessel, such as the motor, motor mount, swim ladder, or other portion of the vessel or hull that has direct contact with the canal water.

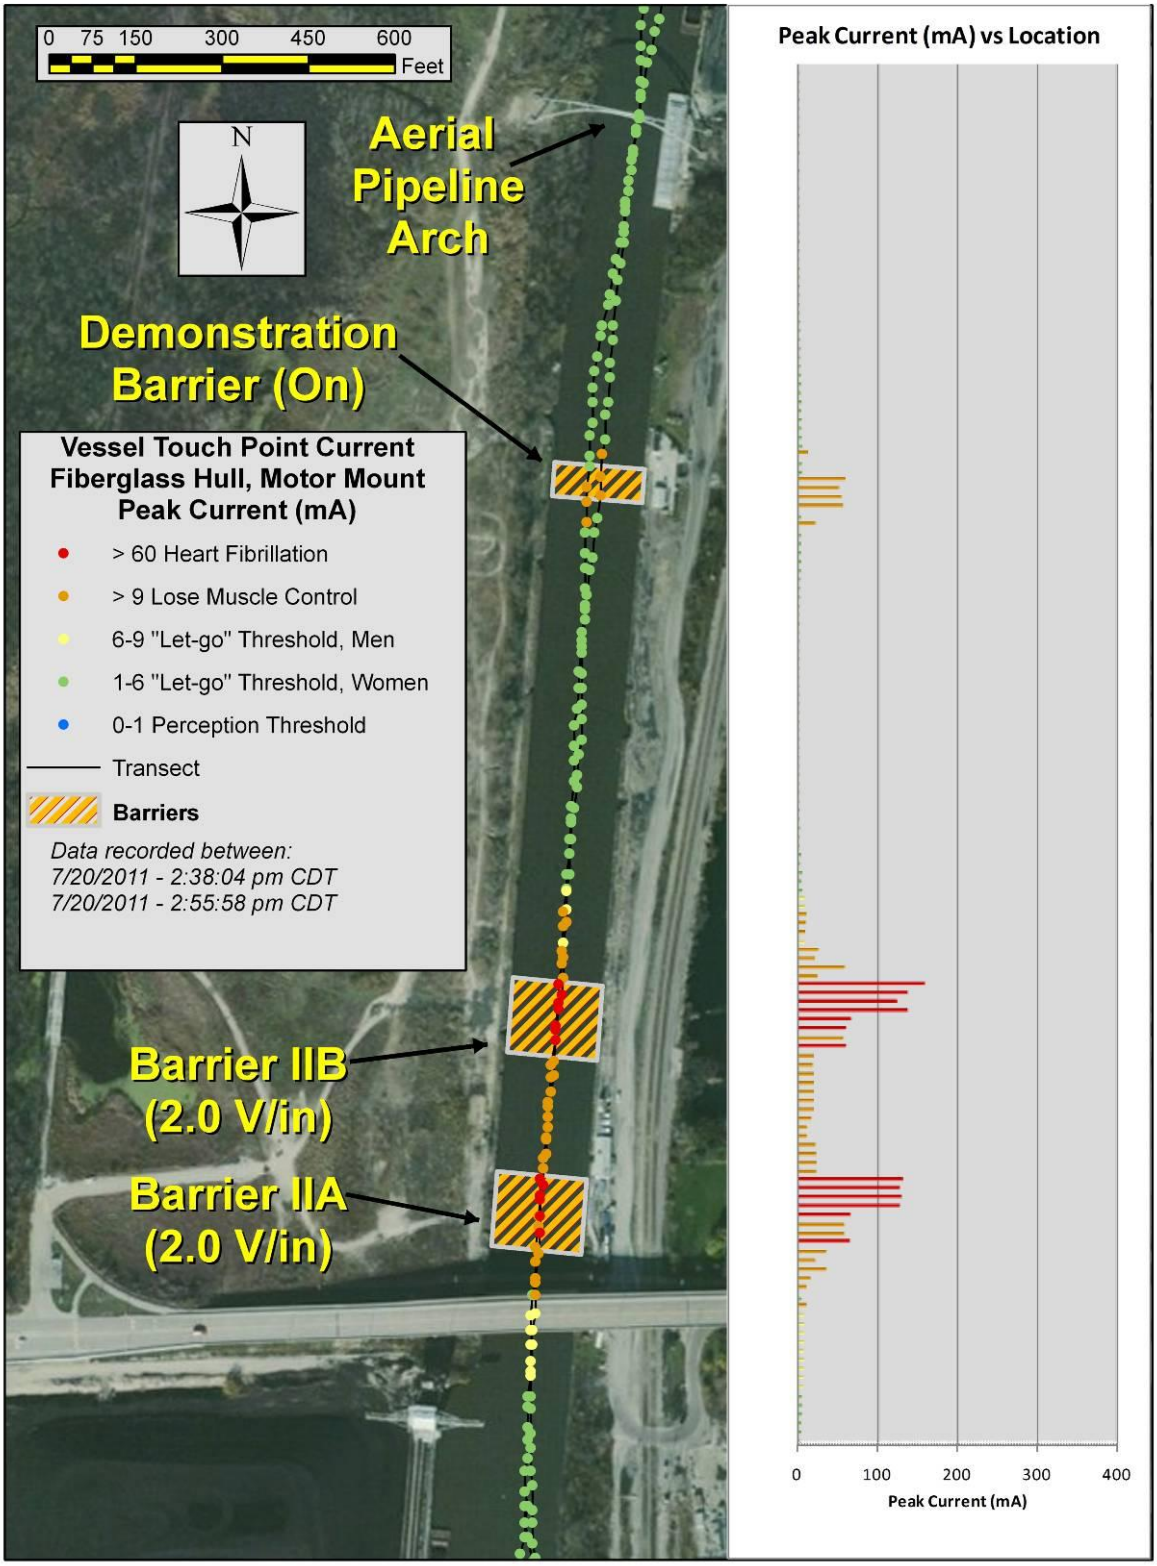
Figure 21. Peak rescue vessel electrical current (mA), fiberglass hull, metal motor mount, 2.0 volts/inch.

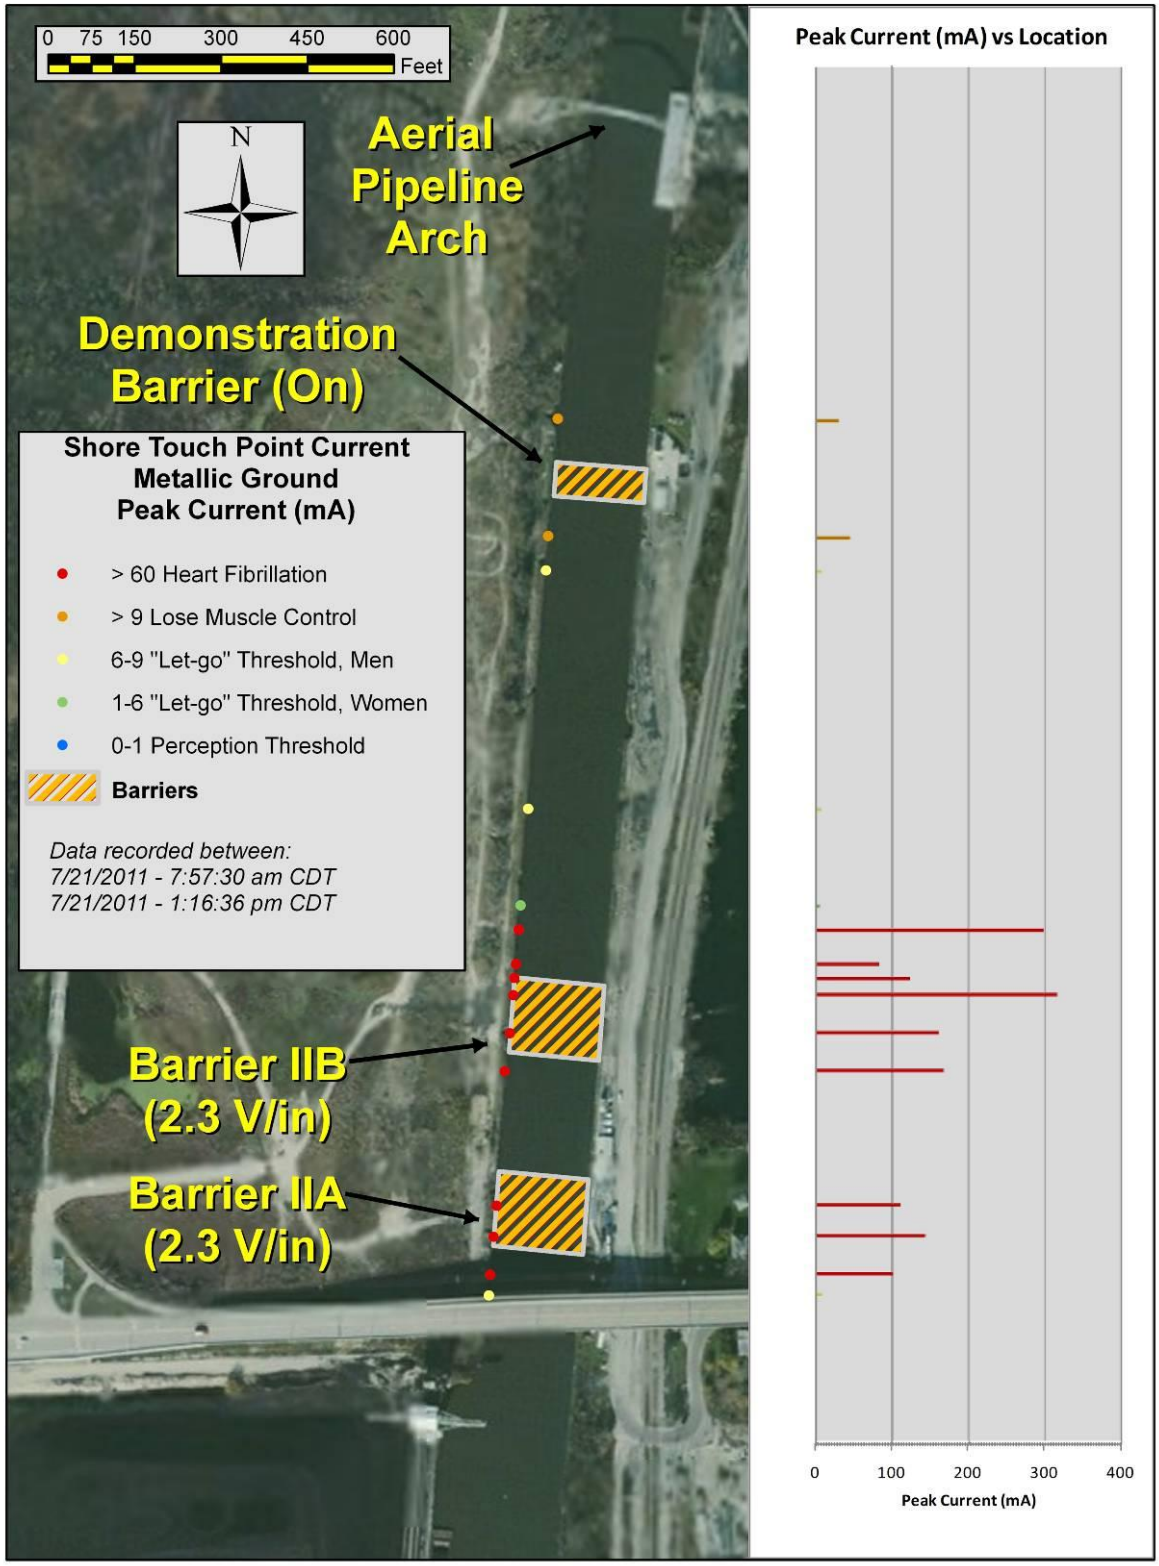
Results for this test condition were strongly dependent on the resistance between the ground electrode and the earth, and the location of each test. Tests using a metallic object of opportunity (e.g., sign post or grounded fence post) resulted in the highest levels measured (316 mA on an embedded steel fence post), as might be expected, thus creating a higher risk of shock hazard than simple earth grounds (e.g., earth, rocks, or vegetation). However, grounded positions without an embedded metallic object at some locations were nonetheless sufficient to cause loss of muscle control, since worst-case peak current exceeded 20 mA. Maximum levels of 49 mA were observed for earth ground tests using the aluminum plate electrode apparatus. Measurement noise levels were approximately 1.5 mA (peak) throughout this test condition. In a general sense, highest levels were also measured adjacent to the operating barriers, although as previously described, areas south of Barrier IIB exhibited high levels even when Barrier IIA was turned off.

Touch-point current with the canal bank showed that the magnitude of electrical current hazard strongly related to the electrical resistance to the grounding point. We note that observed conditions during the July 2011 data collection period were relatively dry (mid-summer), and earth conductivity may change throughout the year due to amounts and recency of precipitation.

Figure 23. Results for shore touch-point current, "metallic ground", all barriers operating.

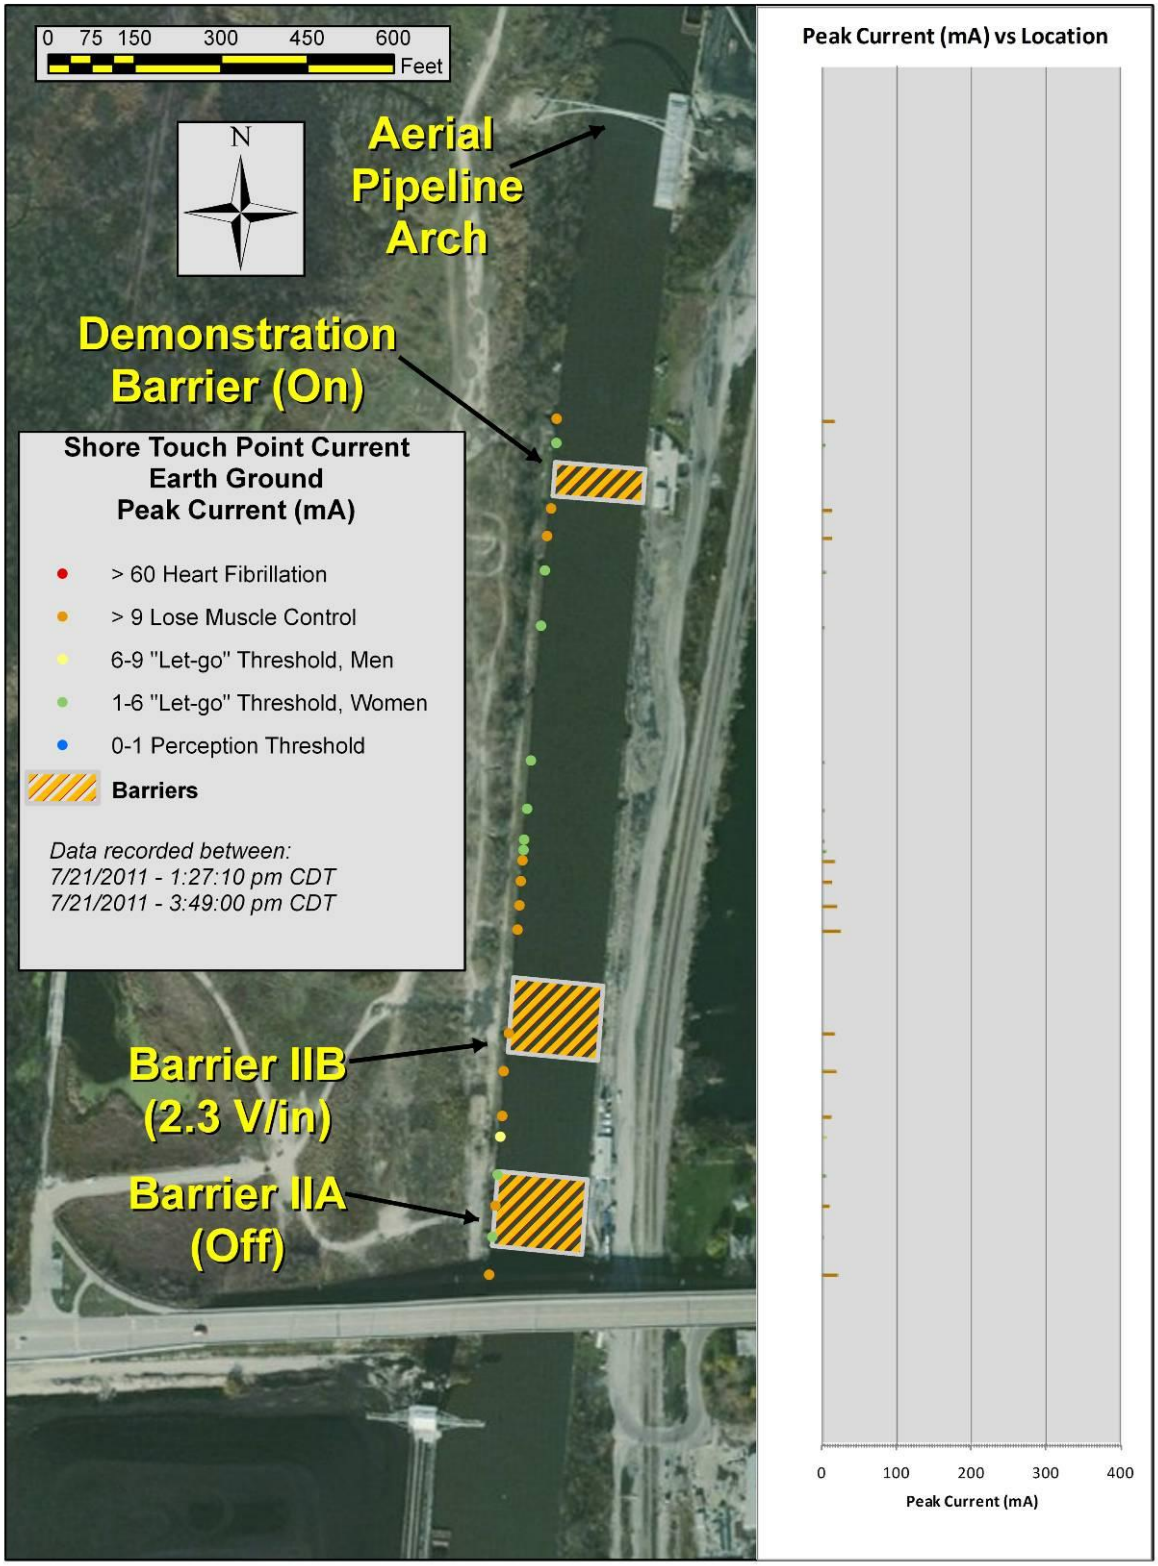
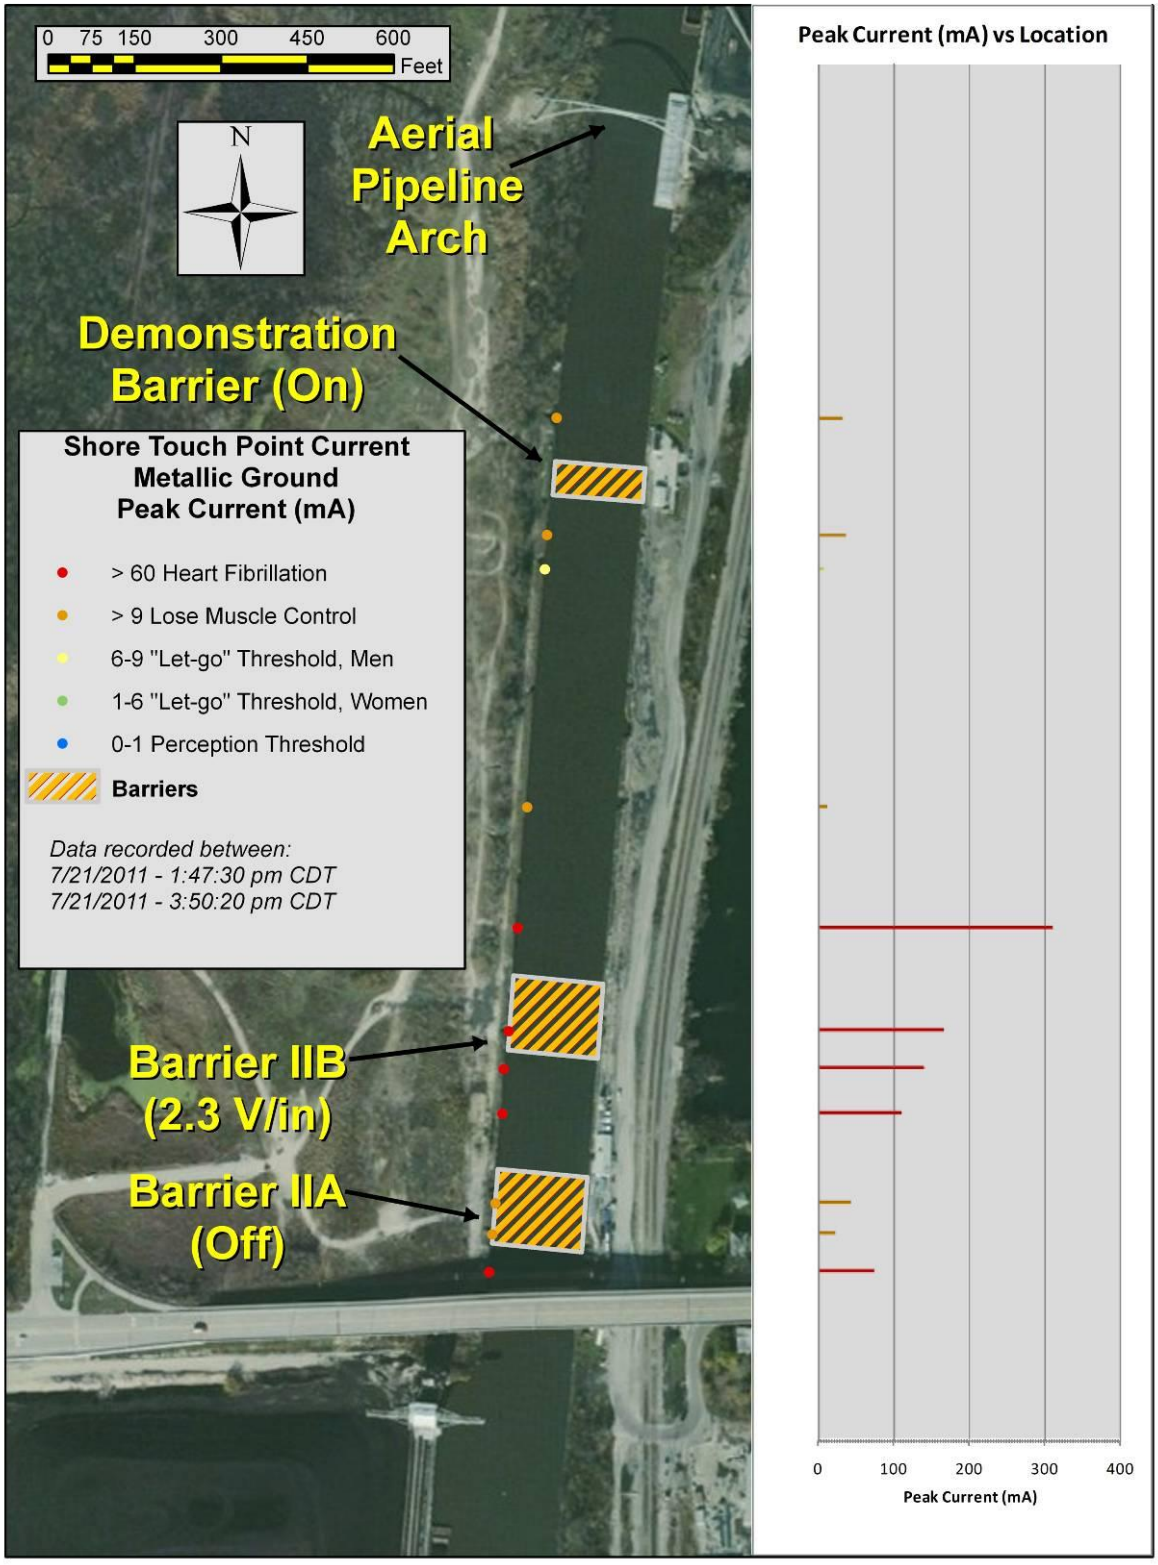
A second pass along the canal was made with just the demonstration barrier and Barrier IIB operating at 2.3 volts/inch. Results for earth ground conditions are shown in Figure 24, and Figure 25 shows results for metallic ground conditions at locations of opportunity. Positions measured and worst-case peak current for each position for this test condition is provided in

Table C-2. In general, measured peak-currents at positions south of location 1X (41.641633, -88.060617) were substantially lower when Barrier IIA was not operating compared to when all barriers were operating. However, even with Barrier IIA off, measured touch-point currents south of location 1X were sufficient to cause fibrillation and loss of muscle control. This result demonstrates that areas south of the primary barriers are not generally suitable for a shore-point rescue. Measurements acquired north of location 1X were dominated by operation of Barrier IIB and the demonstration barrier, thus measured results in these locations for the second pass were similar to those measured during the first pass. Some differences in measured values were noted from the first to second passes at the same positions, due to the imprecise manner in which the ground electrodes were established at each position.

Figure 24. Results for shore touch-point current, "earth ground", Barrier IIA "off".

Figure 25. Results for shore touch-point current, "metallic ground", Barrier IIA "off".
