Demonstration of Corrosion-Resistant Coatings for Air-Conditioning Coils and Fins

Final Report on Project F10-AR01

Alfred D. Beitelman and Susan A Drozdz   June 2015

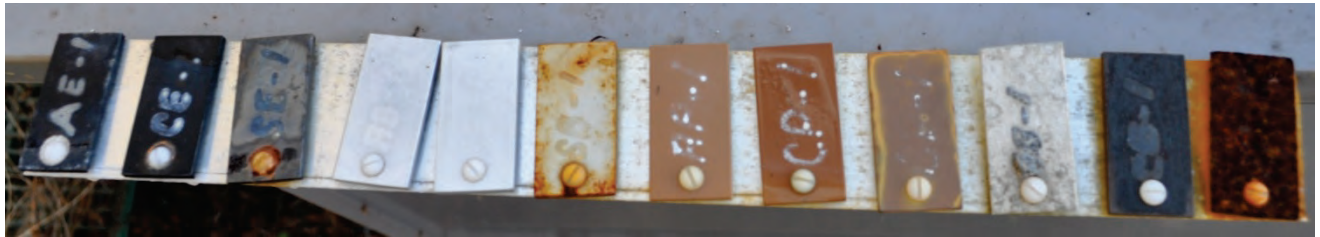
• The phenolic coating and Coating B failed to protect the steel substrates at both of the on-site locations.
• Rust and blistering were most prominent on the edges of each coupon.
• Blistering on the aluminum and copper coupons was substantially less.
• The phenolic coating adhered better to the aluminum and copper coupons than did Coating B and Coating A.
• The uncoated coupons showed severe signs of corrosion on 100% of the material within 12 months of exposure.
• The bare aluminum coupon on Rack 2 began to crack and separate into layers from exfoliation corrosion, causing the coupon to break away from the nylon fastener (Figure 7).
• The uncoated aluminum surface of the condenser exterior showed significant corrosion after 24 months of exposure (Figure 8).

Figure 6. Rack-1 coupons after 24 months of on-site field exposure.

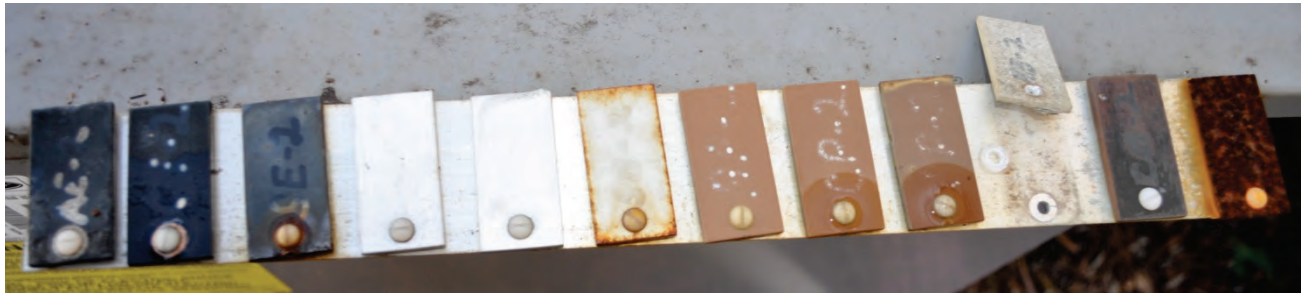
Figure 7. Rack-2 coupons after 24 months of on-site field exposure.

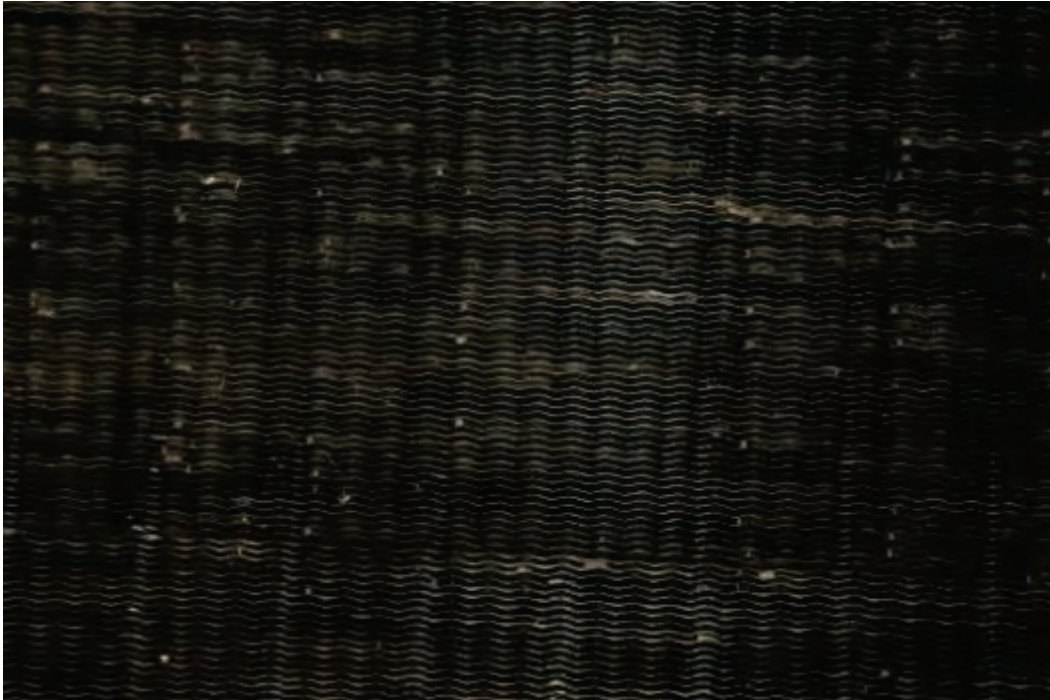
- The condenser fins coated with Coating B and Coating E showed no visible signs of corrosion or coating failures after 24 months of exposure (Figure 9 and Figure 10).

Figure 9. HVAC condenser fins with Coating E after on-site exposure for 24 months.

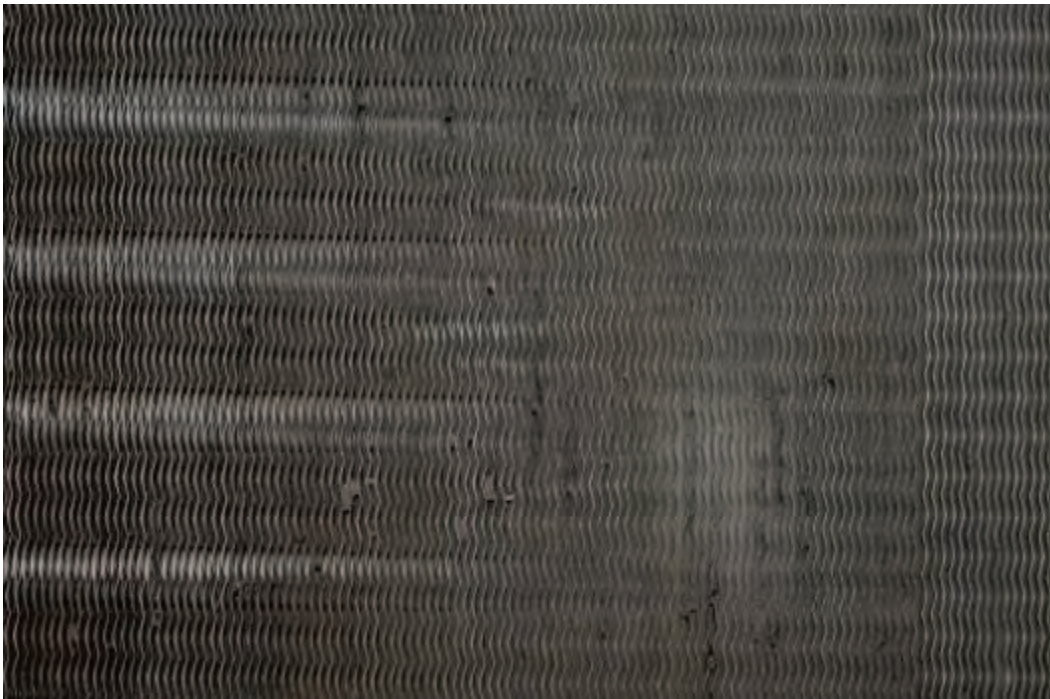
Figure 10. HVAC condenser fins with Coating B after on-site exposure for 24 months.

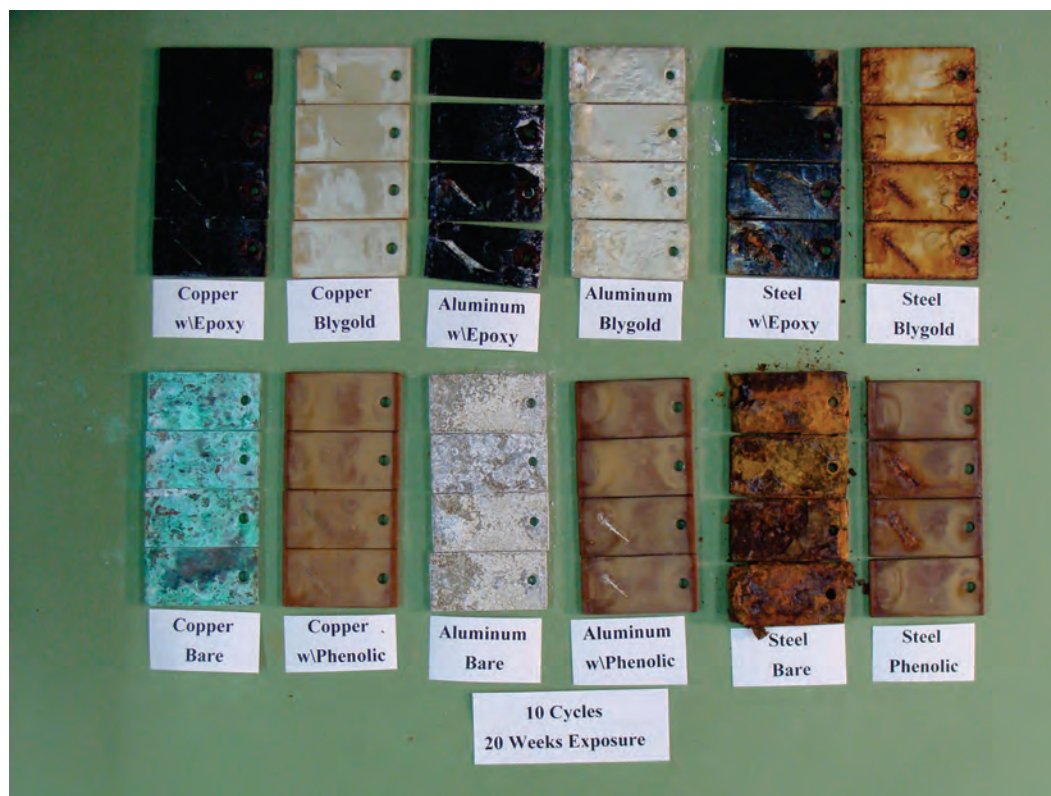
Review of accelerated-weathering data in Table 4 shows the copper substrate to be the superior substrate. Uncoated, it quickly developed a green copper oxide patina that progressively grew thicker, eventually flaking off the surface at 32-weeks. Coupons that were scored developed a minor amount of oxides in the score, but the oxide development seemed to seal the score from further corrosion. Clearly, copper is the superior substrate, but the exposure did not indicate any difference in the performance of the various coatings applied to it because all coatings performed similarly well on the copper substrate.

Figure 11. Accelerated-weathering coupons after 20 weeks of exposure.

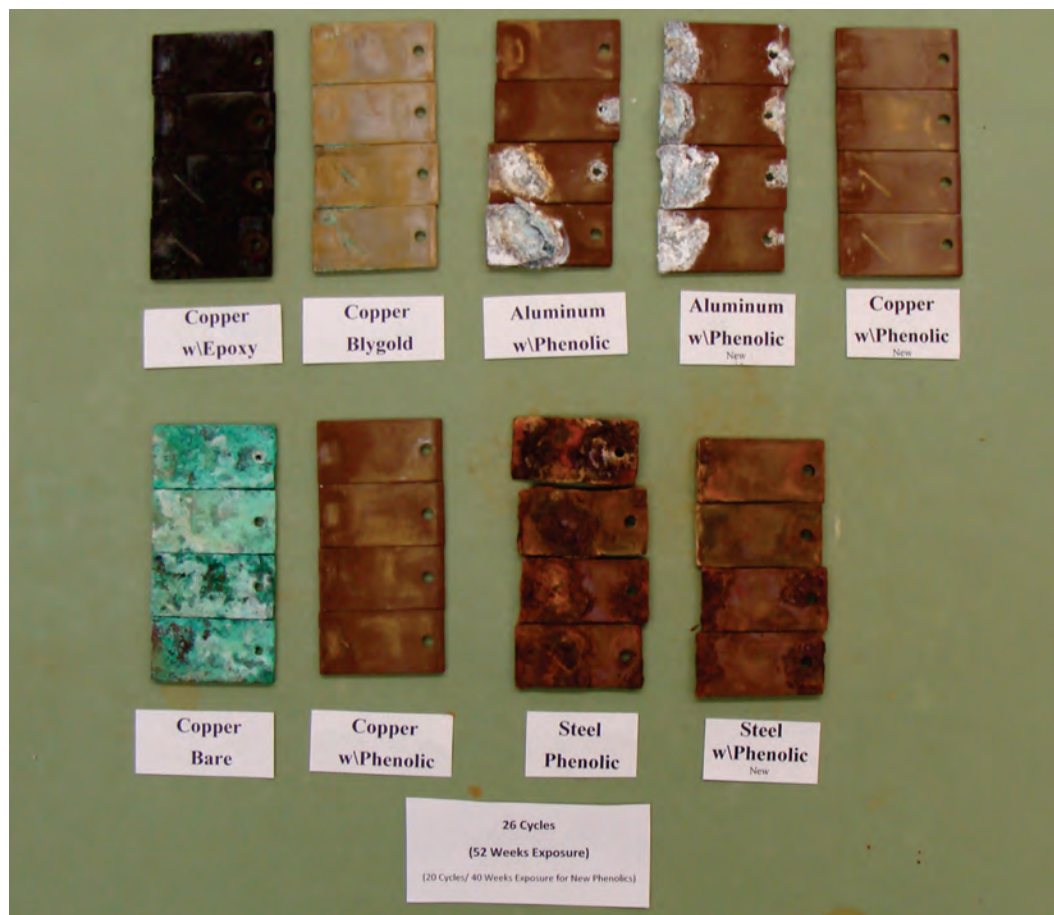
Figure 12. Accelerated-weathering coupons remaining
at conclusion of test after 52 weeks of exposure.

Based on the accelerated weathering data, it is recommended that condensers in corrosive environments be manufactured with copper coils and fins that are coated. The data does not identify any coating as being superior on copper, so it is suggested the manufacturer's standard coating system be accepted.

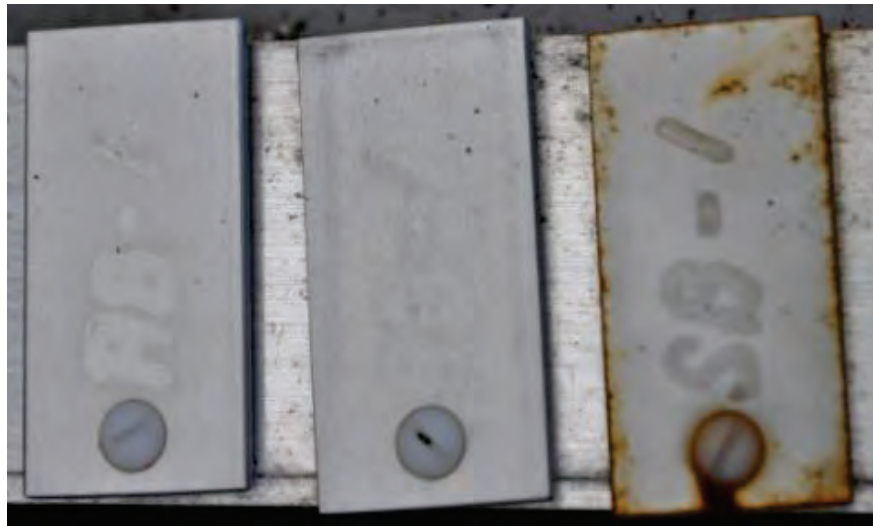
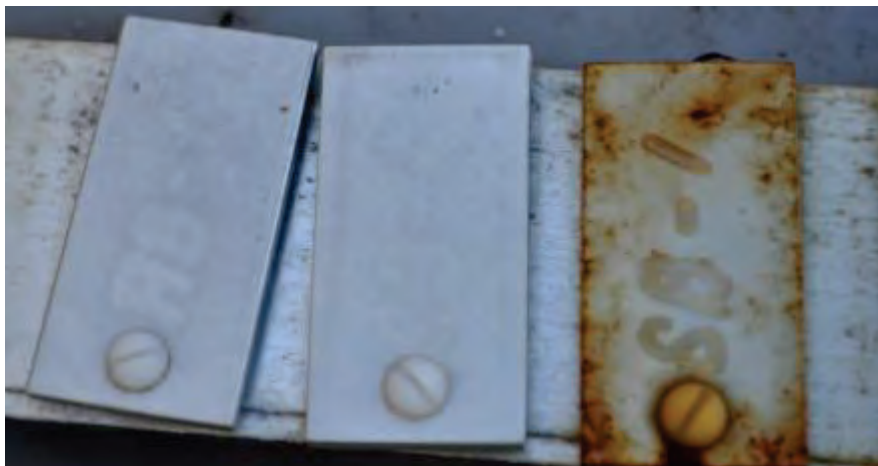
Figure A4. Rack 1, Coating B coupons at time zero.

Figure A5. Rack 1, Coating B coupons at 12 months.

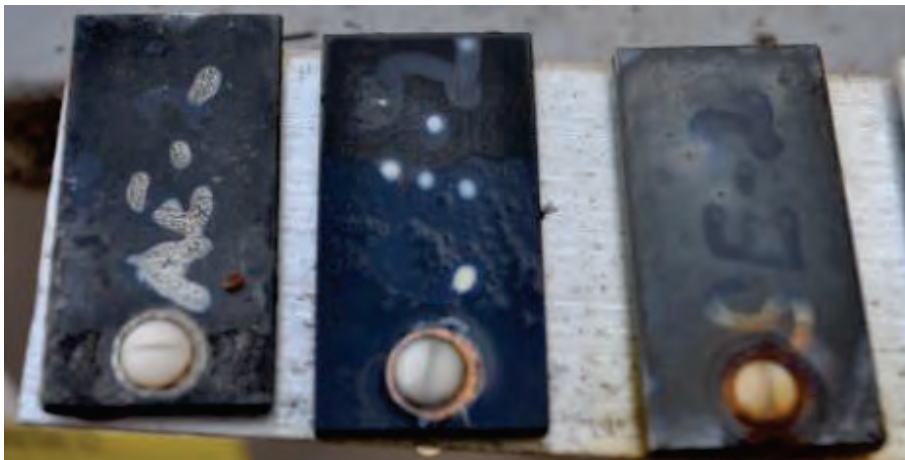
Figure A12. Rack 1, bare coupons at 24 months.

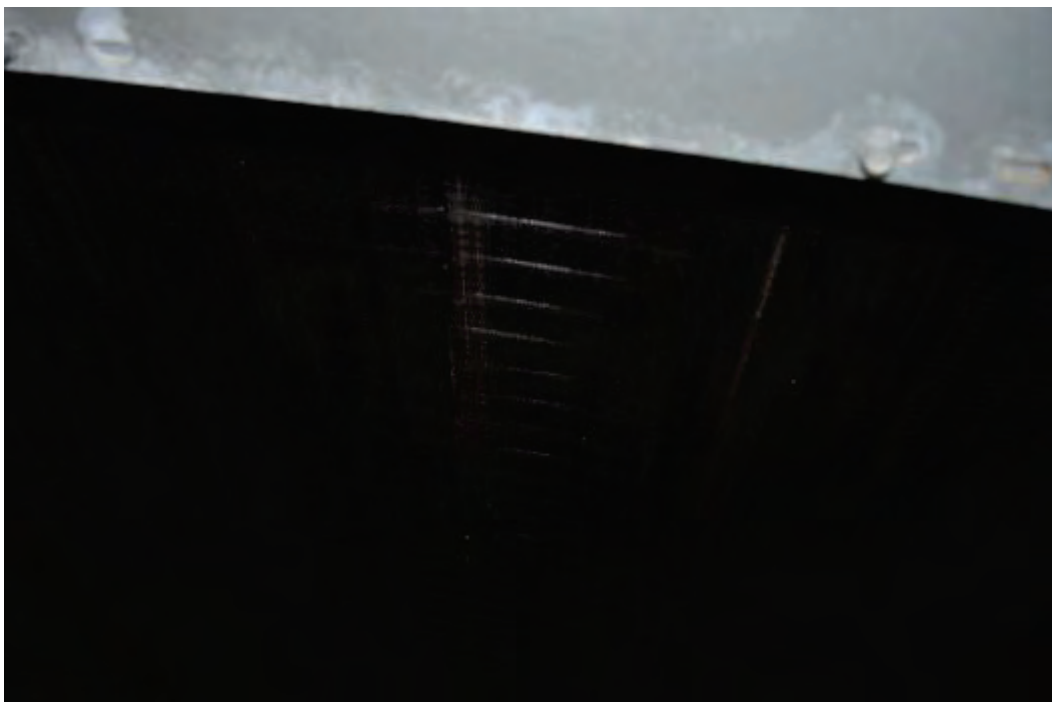
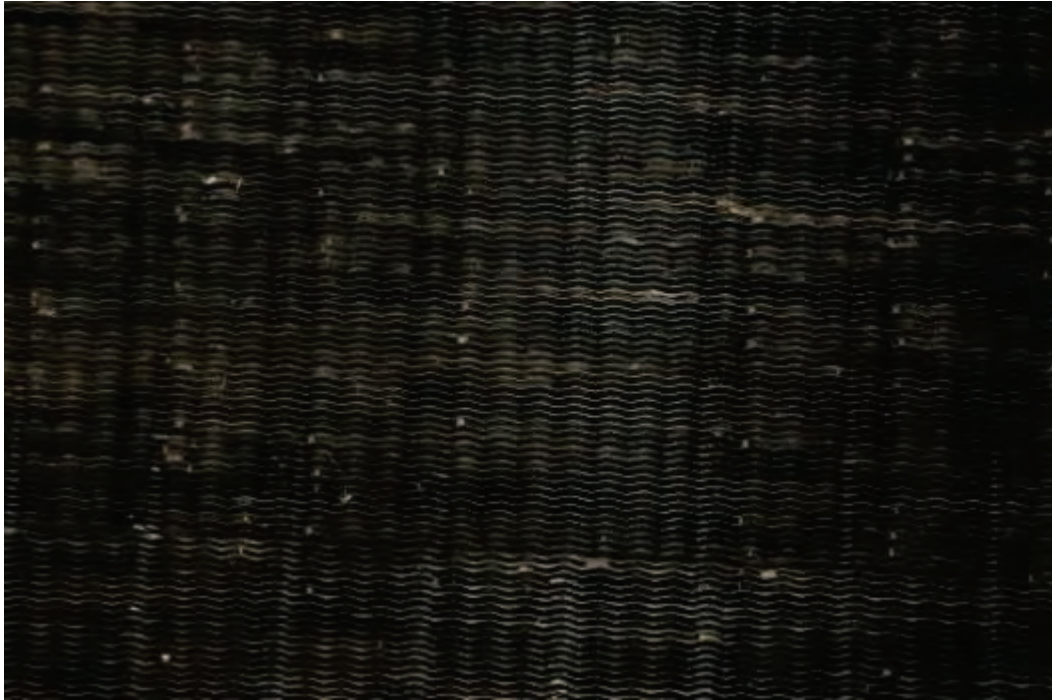
Figure A26. Coating E condenser fins at time zero.

Figure A27. Coating E condenser fins at 12 months.

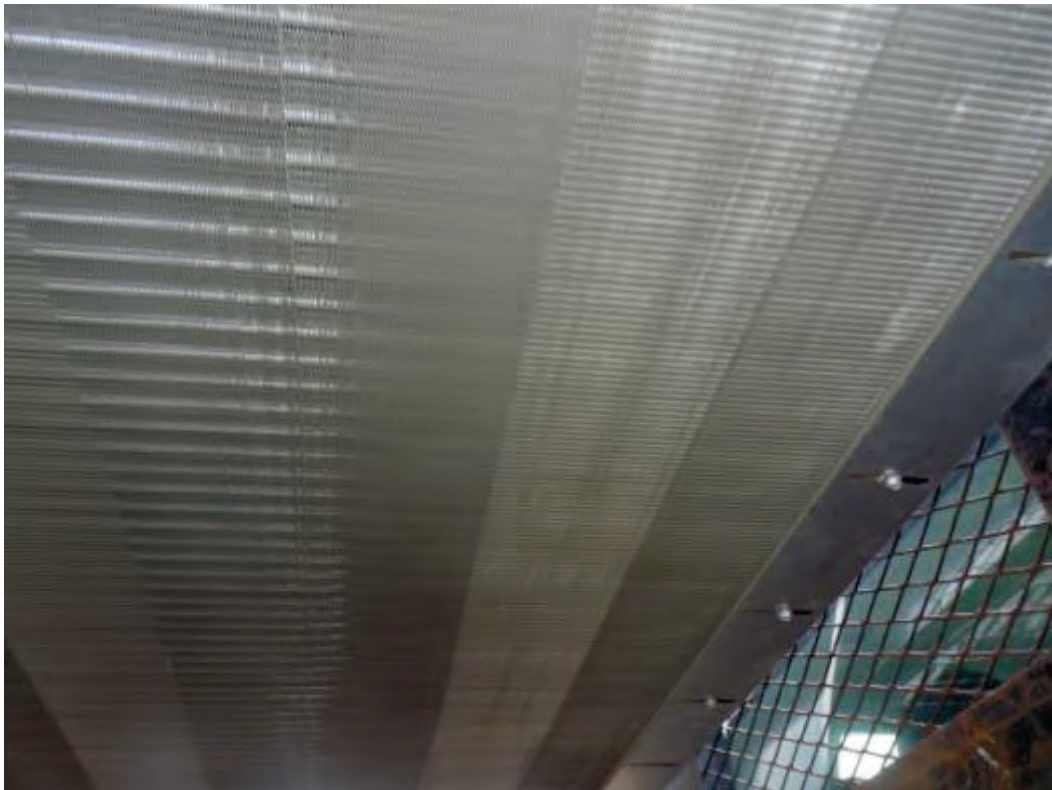
Figure A29. Coating B condenser fins at time zero.

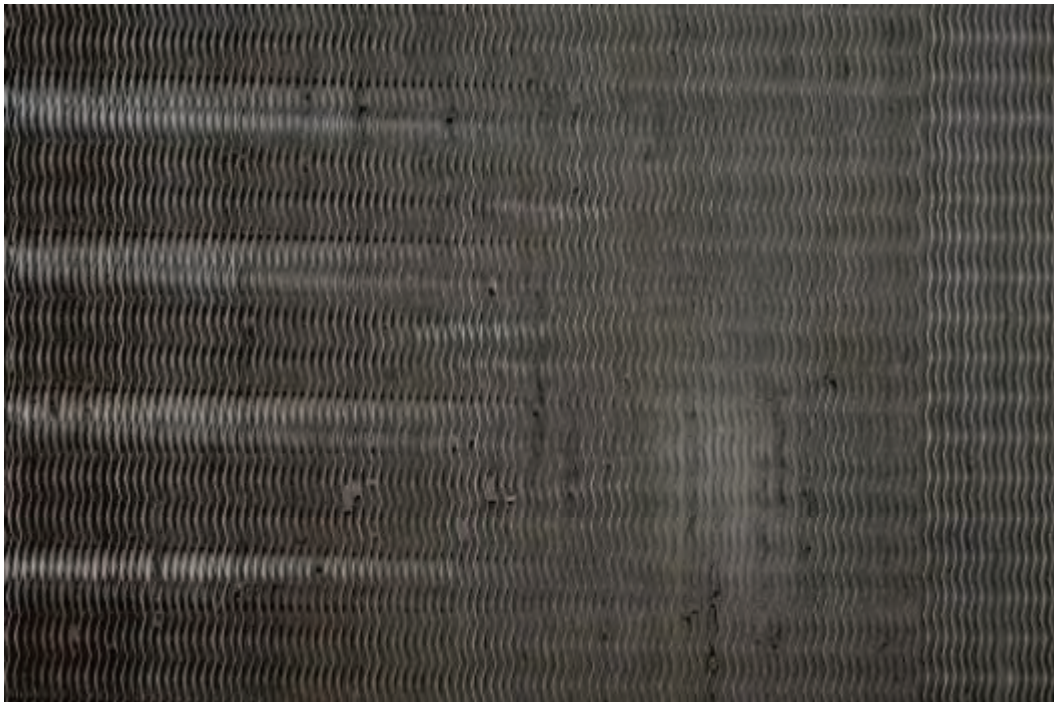
Figure A30. Coating B condenser fins at 12 months.
