TITLE: Detection and Severity Assessment of Faults in Gear Boxes from Stress Wave Capture and Analysis

TITLE: New Frontiers in Integrated Diagnostics and Prognostics. Proceedings of the 55th Meeting of the Society for Machinery Failure Prevention Technology. Virginia Beach, Virginia, April 2 - 5, 2001

DETECTION AND SEVERITY ASSESSMENT OF FAULTS IN GEAR BOXES FROM STRESS WAVE CAPTURE AND ANALYSIS

James C. Robinson
Computational Systems, Inc.

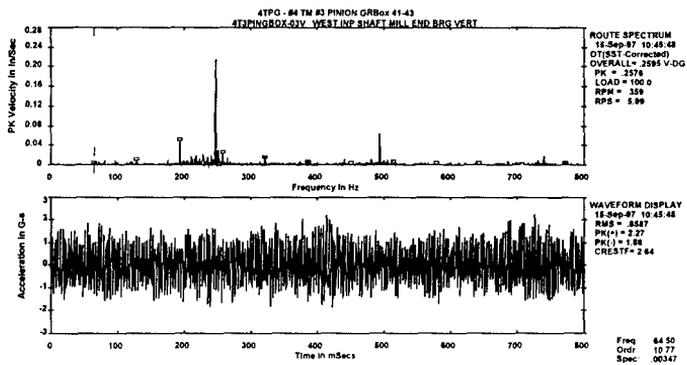
The normal vibration spectra and acceleration time waveform for data acquired on September 15 1997 are presented in Figure 1. There is some indication of a possible outer race problem but not conclusive.

Figure 1. Vibration velocity spectra and acceleration time waveform on pinion stand gearbox on September 15, 1997.

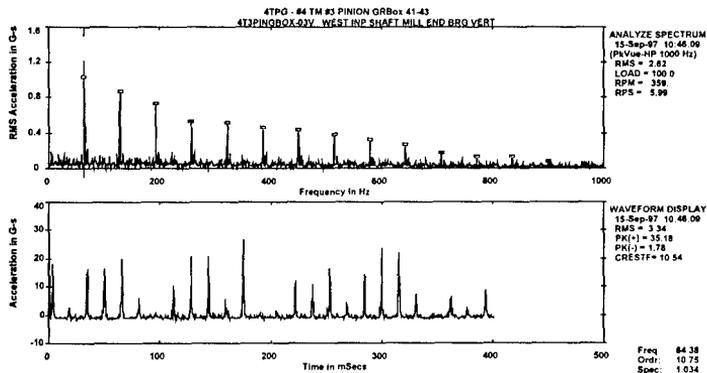
It was obvious from the PeakVue data there was an outer race defect on the inlet shaft. The peak g readings were 18 g's (the normal vibration readings were showing 1.5 g's with no indication of a problem). The peak g readings in PeakVue continued to trend up (got to 38 g's in mid Sept. 1997) and then started a downward trend (14 g's in early October). The bearing was then replaced the peak g-levels on the replacement bearing was less than 1-g.

The data from the PeakVue methodology acquired on the same date are presented in a Figure 2. The peak absolute g-levels are up to 38 g's with a recurring rate consistent with the outer race defect frequency. The bearing was replaced in early October 1997. A picture of the defective bearing is presented in Figure 3. The defects in the outer race are apparent.

Figure 2. PeakVue spectra and time waveform on Pinion stand gearbox (same as Fig. 1.)

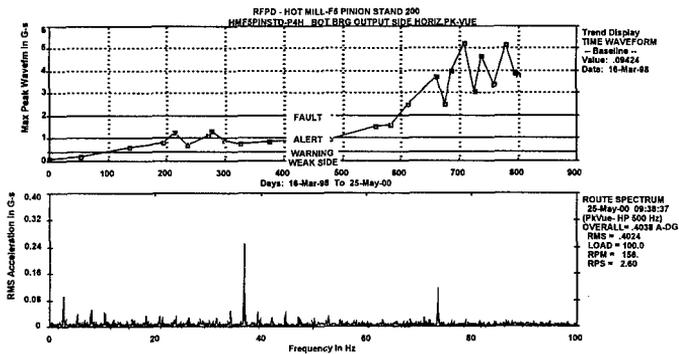
The PeakVue peak g-level trend parameter for the lower output shaft and PeakVue spectra for last collection date of May 28, 2000 are presented in Figure 4. The alert and fault levels are set at recommended levels for this speed machine and type fault. From the spectra, the fault is an inner race fault which is side banded (amplitude modulated) at running speed which is indicative of fault going in and out of load zone at running speed. From Figure 4, it is obvious that the fault exceeded the "fault" level about 7 months prior to replacement, in July 2000.

Figure 4. Maximum peak g-level (from PeakVue) trend from March 16, 1998 to May 25, 2000 and PeakVue spectra from May 25, 2000.

Based on the trend values in PeakVue, a work order was release in June 2000 to replace the bearing. The bearing was replaced in July 2000. A picture of the defective bearing is presented in Figure 6. The failure was clearly advanced and could have induced catastrophic failure easily by e.g., metal "chunks" interfacing with the gear teeth meshing.

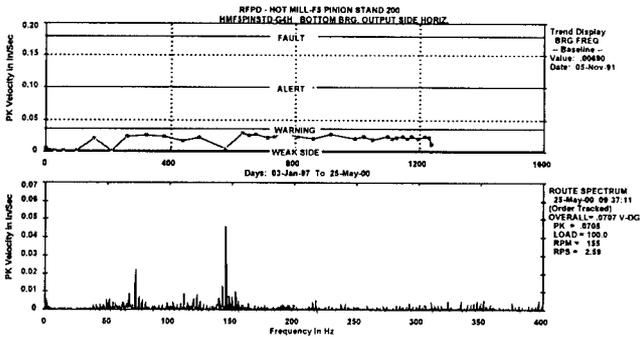
The trend value for bearing fault over the same time interval for the normal vibration monitoring are presented in Figure 5. Here there are no indications of a bearing fault.

Figure 5. Normal vibration bearing fault trend and spectra for latest measurement over same time period as in Fig. 4.

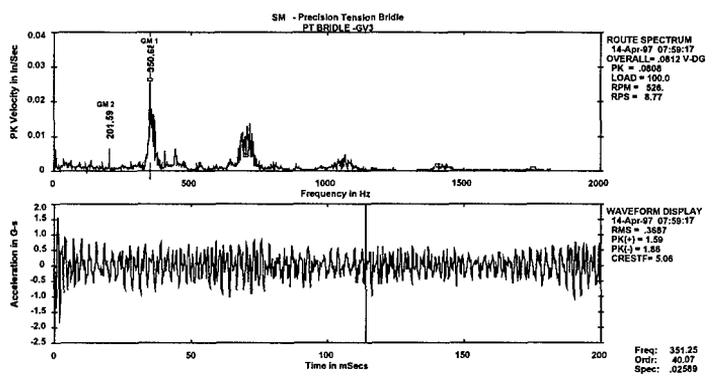
The only accessible point for acquiring data was over the input shaft. The normal velocity vibration spectra and acceleration time waveform acquired on April 14, 1997 are presented in Figure 7. The speed reduction (input) gear mesh, 351 Hz, is dominant in the spectral data in Figure 7 and showing significant side banding (especially at 2 × GM). This pattern is indicative of gear wear and perhaps some misalignments. The P-P acceleration data in time waveform was less than 4 g's and not considered significant. This possible gear wear misalignment had been flagged with an action item to initiate a visual inspection at next opportunity.

From the spectral presented in Figure 7, one would be suspicious that the defective gear would be in the GM 1 set since nothing unusual is present relative to the GM 2 set. There was an additional PeakVue spectra taken with a bandwidth of 5000 Hz. In this PeakVue spectra set, the GM 2 activity was present and the GM 1 absent. This leads to the conclusion that the gears with the cracked teeth were most probably in the GM 2 set.

Figure 7. Velocity spectra and acceleration time wave form from the precision tension bridle gearbox.

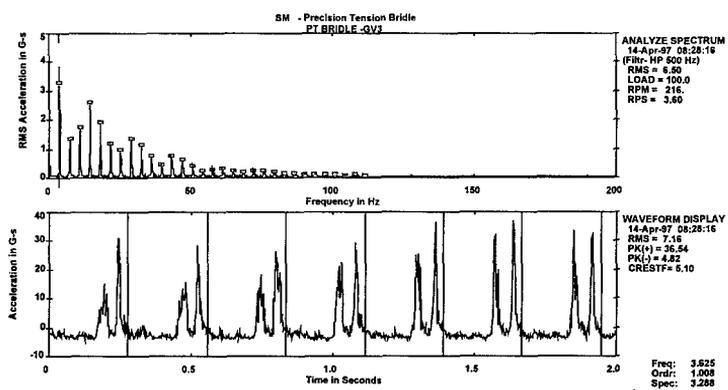
It was decided to apply the PeakVue methodology on April 14, 1997. The PeakVue spectral and waveform data are presented in Figure 8. The only activity in the spectral data is the output shaft turning speed with many harmonics. The time waveform has two impacting regions per turn of the output shaft. The impacting levels exceed 40 g's. This signature indicates a gear with significant cracked teeth (at root) in two regions. One of the output shafts has the bull gear with 158 teeth and the pinion gear with 90 teeth driving

the second output shaft. The bandwidth in Figure 8 is not sufficient to encompass either gear mesh; therefore we cannot identify from this data set which gear set has the defective gear.[*]

Figure 8. PeakVue spectra and time waveform from the precision tension bridle gearbox.

Following the acquisition of the PeakVue data, the gearbox was shortly shutdown and inspected. One of the gears in the GM 2 set was found to have two visible cracks.

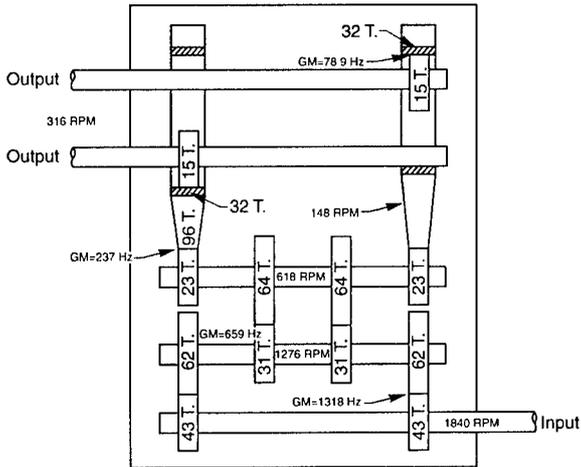
Figure 9. Plan view of the extruder gearbox.

The monitoring of the gearbox using normal vibration and PeakVue methodologies identified worn gear sets, probable gear misalignment, defective bearings, and excessive driver (DC Motor) speed variations. The signatures identifying the driver speed variation are presented below.

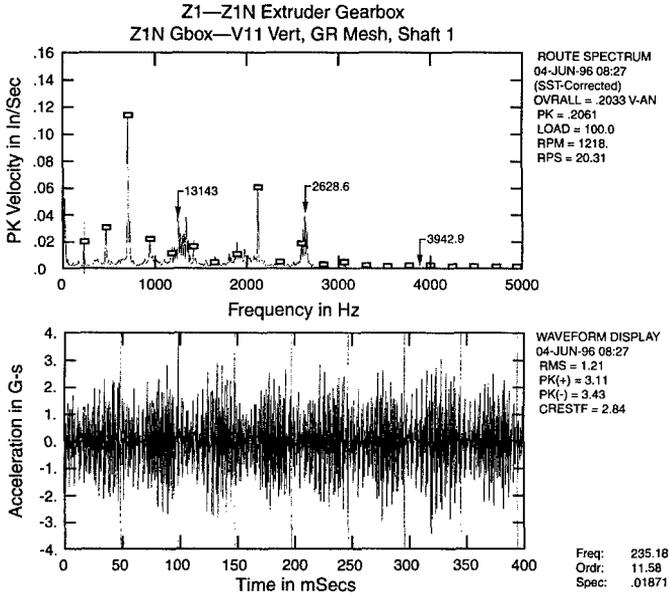
The velocity spectra and acceleration time waveform for an input shaft speed of approximately 1825 RPM are presented in Figure 10. The dominant activity is the gear mesh for the 23T/96T set and the 43T/62T set. There are many harmonics of the 23T/96T set with the third being the largest (indicating looseness). The 43T/62T have reasonable shaft speed side banding at 2 × GM, which suggests some misalignment.

Figure 10. Velocity spectra and acceleration time waveform from extruder gearbox on June 4, 1996.

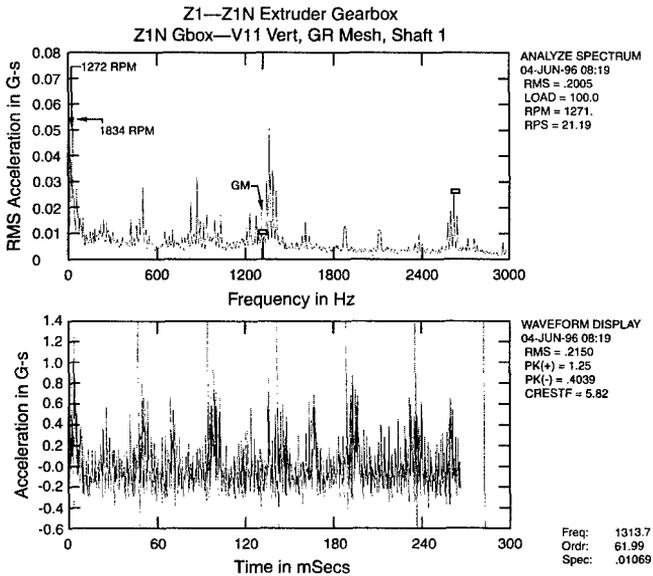
The PeakVue spectra and time waveform for inlet shaft speed of 1833 RPM are presented in Figure 11. There are activity at (1) the inlet shaft speed of 21.2 Hz (2) the first intermediate shaft speed at 31 Hz, and (3) the 43T/62T GM frequency and 2 times the 43T/62T GM frequency. The 2 times 43T/62T GM frequency is side banded with the shaft speed on which the bull gear is mounted. The impacting at 2 times gear mesh is indicative of significant back lashing which could be introduced with torsional resonance or (more probable) significant inlet shaft speed fluctuation.

Figure 11. PeakVue spectra and time waveform form extruder gearbox on June 4, 1996.

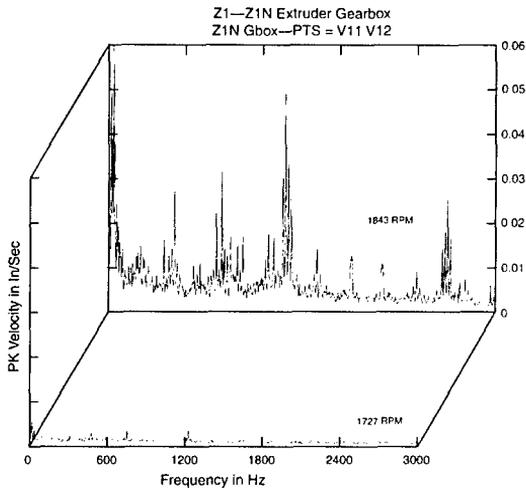
Figure 12. PeakVue spectra on extruder gearbox before DC motor speed adjustment (1843 RPM) and PeakVue spectra on extruder gearbox after DC motor speed adjustment (1727 RPM).

Spectra data on the inboard of the DC motor showed excessive* activity of 0.2 ips-peak at the SCR frequency (360 Hz) with amplitude variation (side banding) at the motor shaft frequency (inlet shaft to gearbox) and first intermediate shaft of the gearbox. The speed controller was adjusted and measurements on the gearbox repeated. The velocity spectra did not change, i.e., the 23T/96T set still showed signs of looseness and the 43T/62T set still showed probable misalignment. There were significant differences in the PeakVue spectra as shown in Figure 12. The spectra captured after adjustment of the speed controller (1727 RPM) shows no indication of impacting.

*Vibration exceeding 0.1 ips-peak at the SCR firing frequency on inboard of a DC Motor generally imply a problem in the controller circuit.

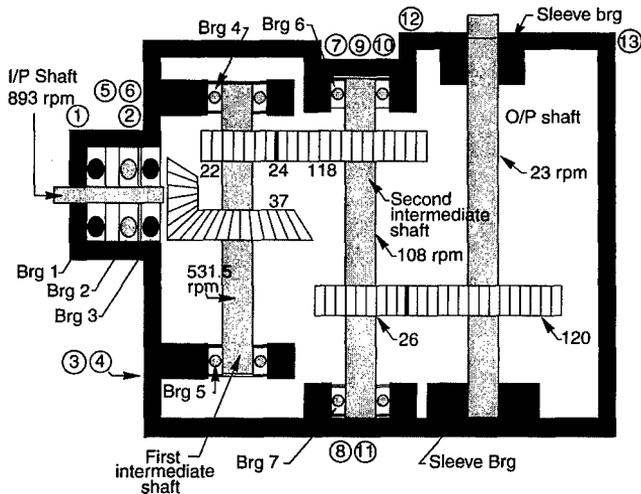
Figure 13. Plan view of crusher gearbox.

3.4 Crusher Gearbox: This gear box, driven by a 8-pole 2000 HP motor, drives a rock crusher at a mining facility. A plan view of the gearbox is presented in Figure 13. The gearbox is nominally 17' × 12' × 7' in size. Normal vibration and PeakVue data was acquired on a scheduled basis on the motor and, as much as possible, at each bearing with the gearbox. The input shaft speed was in the proximity of 894 RPM. The first intermediate shaft was turning at 531.5 RPM or 8.86 Hz.

The first intermediate shaft has a beveled bull gear with 37 T and a pinion gear with 22 T (see Figure 13). The first postulate was that the 24 T pinion gear had some fault at every 6[th] tooth since the total number of teeth (24) was divisible by 4. The bothersome fact with this postulate was the g levels of the impacts were greater at measurement point 3 than at measurement point 5 (the 24 T pinion was closer to measurement point 5). The impacts were clearly occurring at four equal intervals per rev of the first intermediate shaft and hence the 37 T bull gear was not considered to be the source where the impacting had occurred (37 not divisible by four).

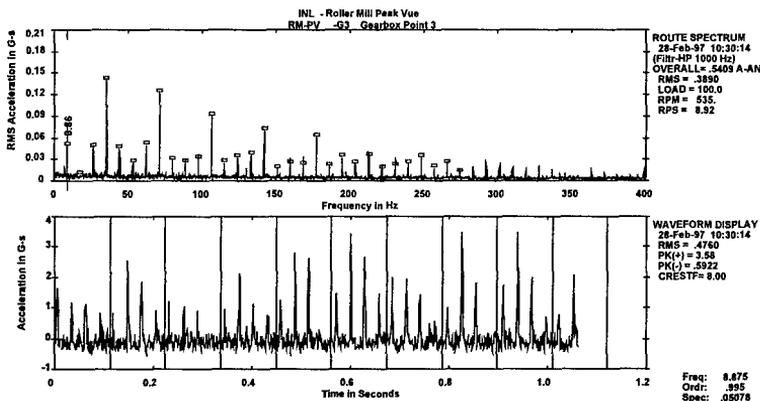
The PeakVue spectra and time waveform data taken at measurement point 3 (see Figure 13) are presented in Figure 14. The dominant activity in the PeakVue spectra are the intermediate shaft turning speed (8.86 Hz) and many harmonics with the 4th, 8th, 12th etc. being dominant. In the PeakVue time waveform, Figure 14, there are four distinct impacts per turn of the first intermediate shaft (the vertical lines are spaced at time increments corresponding to the first intermediate shaft turning speed).

Figure 14. PeakVue spectra and time waveform taken on crusher gearbox at point 3.

The gearbox was disassembled and inspected. The 24 T pinion showed no indication of a problem. The impacting was occurring between the 37 T bull gear and the first intermediate shaft. An approximate 2 in. band of fretting was completely around the intermediate shaft at the top of the beveled bull gear.

The postulate then was the impacting was being introduced by a reasonable sharp (high Q) torsional resonance of the input shaft. Strain gauges were installed near the gearbox on the inlet shaft and torsional vibrations data acquired. The torsional resonance spectra showed dominant activity at 35.3 Hz, which is 4 times the intermediate shaft speed.
