REPORT NO. DPS TW-414/2

PERFORMANCE OF CONFINED-COLUMN TYPE APPLIQUE ARMOR UNDER COMBAT ATTACK (U)

Second Report on Ordnance Project No. TW-414

DECEMBER 1959

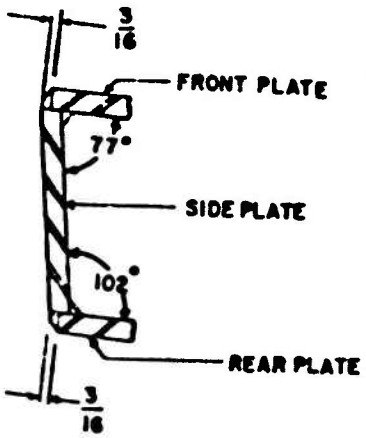
Figure 5: Cross Section of Applique Section Fabricated with Structural Type Weld Joint.

Excessive weld cracking was observed on the applique sections fabricated with both the structural and full-penetration type weld joints. After a number of rounds had been fired into a section or an adjacent section, the front plate opened enough for the asphalt-filled cells to fall out (Figures 13 and 14).

b. An interlock type of weld joint be used to attach the front and rear plates on the applique sections, since this type of welded construction provides an irregular path for weld fracture and should help to limit joint failure.

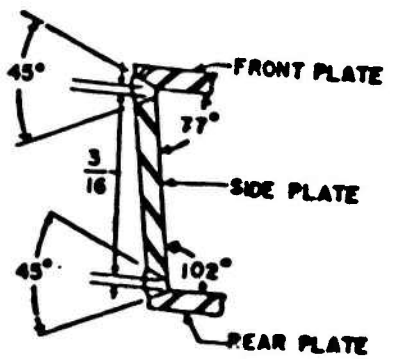
Figure 6: Cross Section of Applique Section Fabricated with a Full-Penetration Weld Joint.

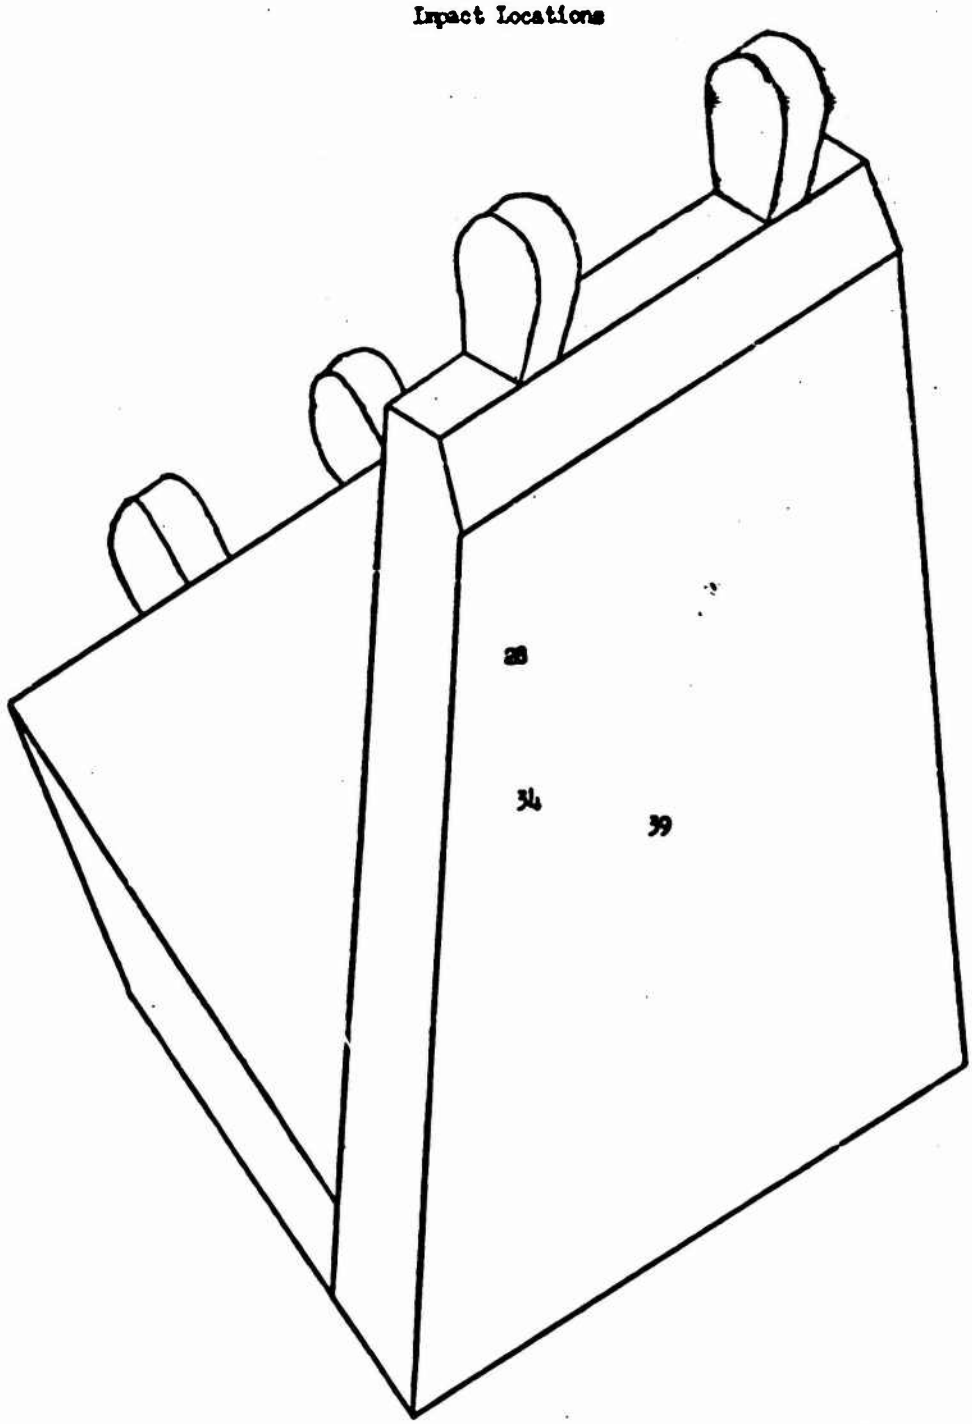
Upper panel, left section, full penetration type weld joint, square tubing showing location of hits by round number

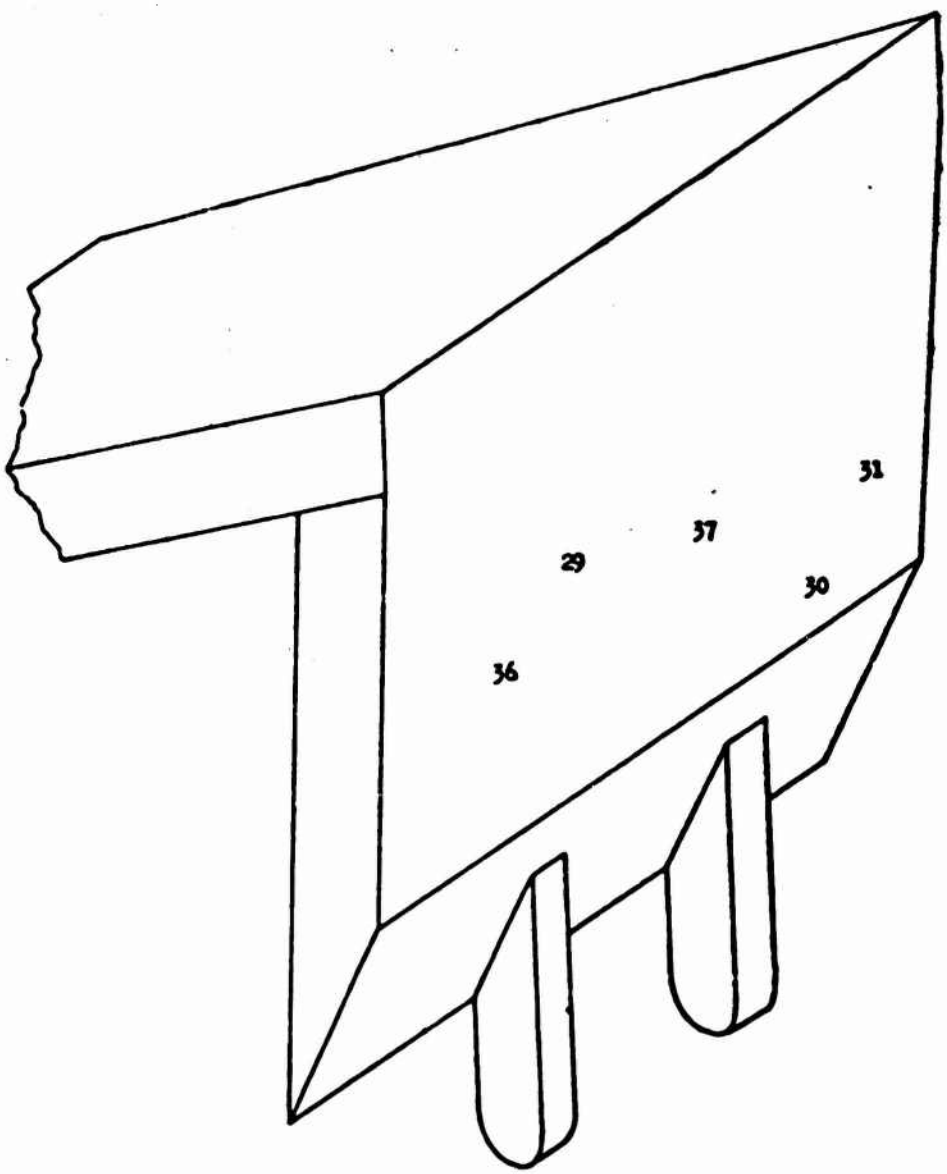
Lower panel, left section, full penetration type weld joint, square tubing showing location of hits by round number

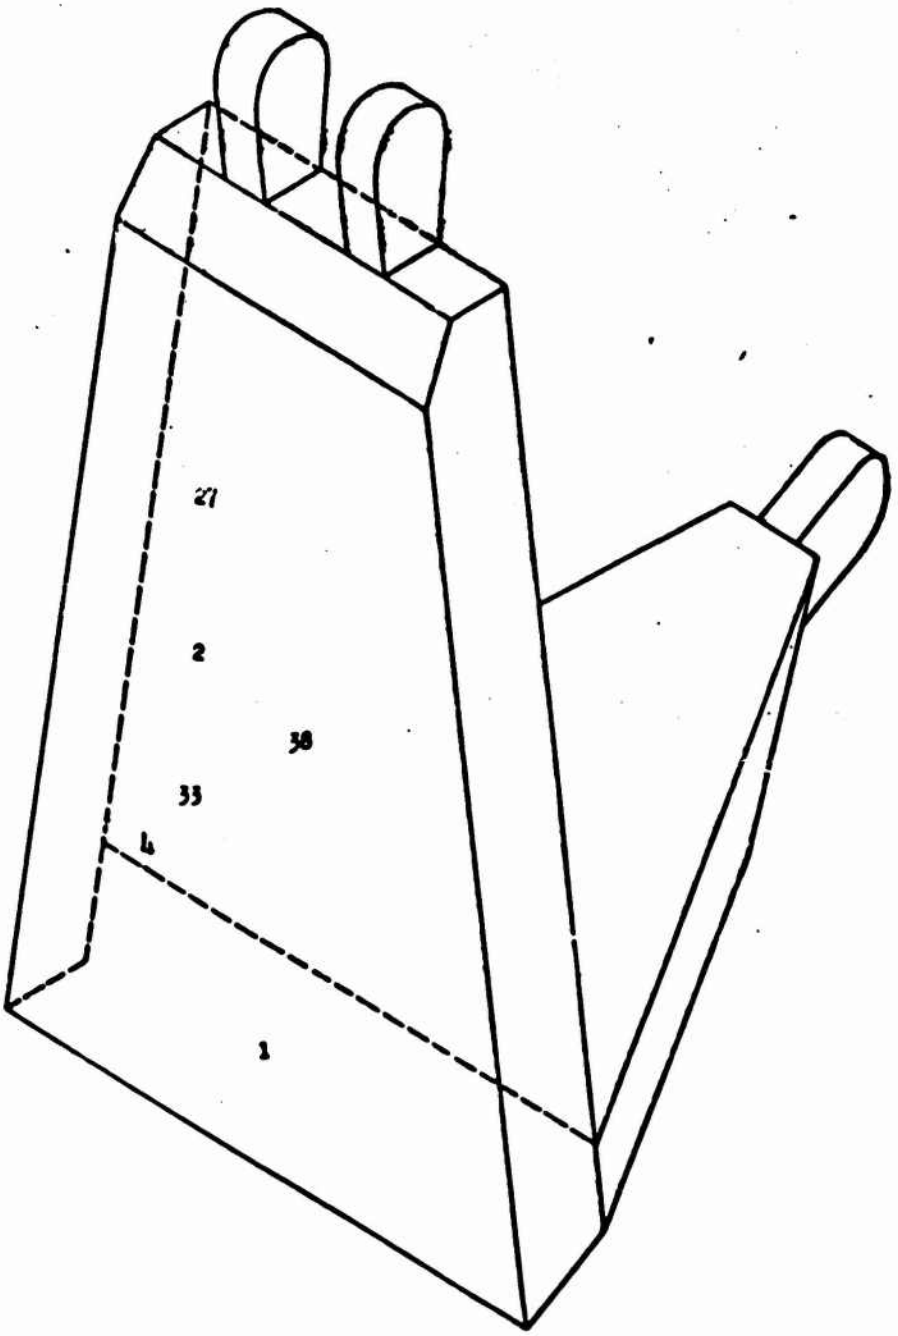
Upper panel, center section, structural type weld joint, hexagonal tubing showing location of hits by round number

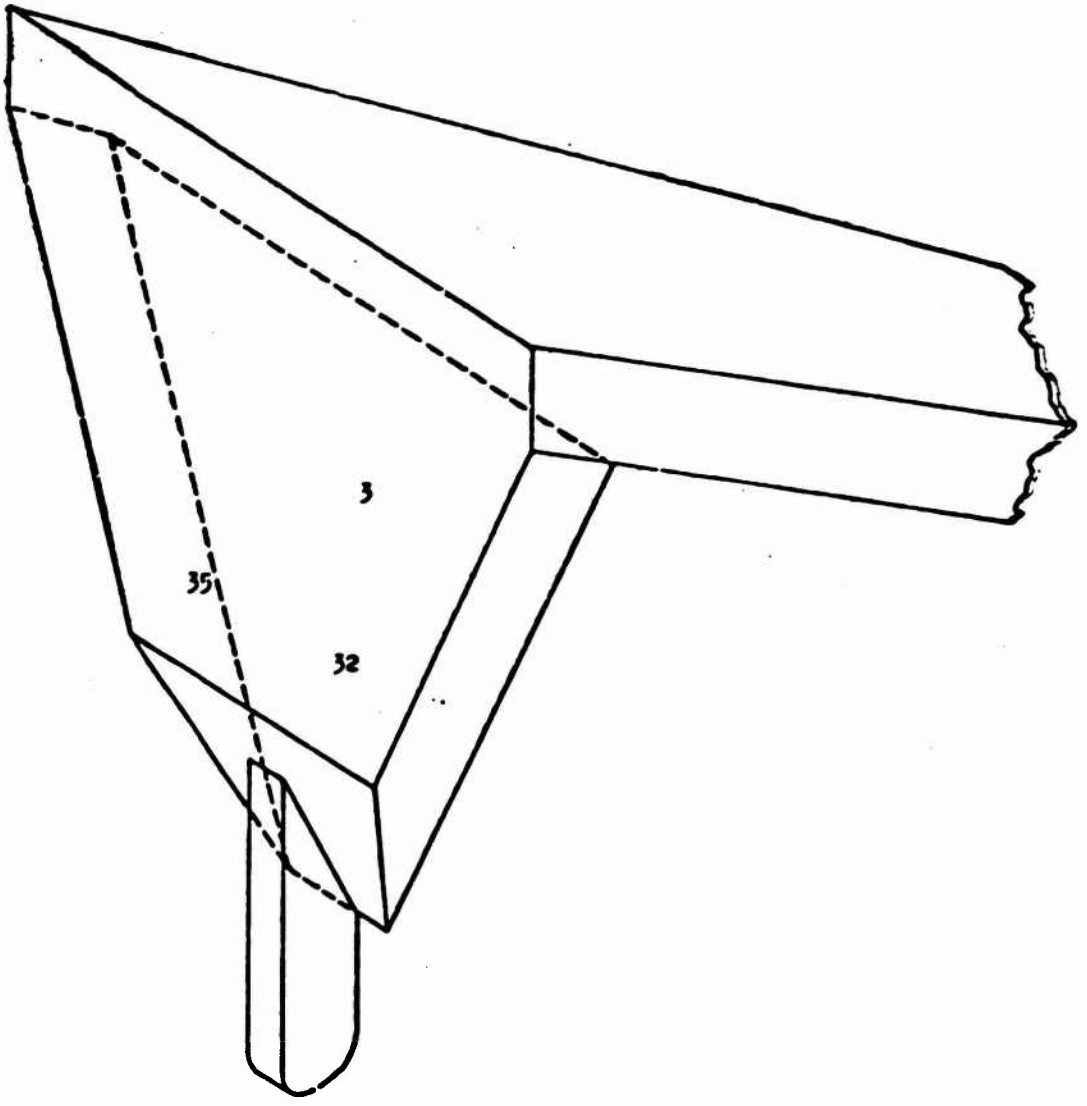
Lower panel, center section, structural type weld joint, hexagonal tubing showing location of hits by round number

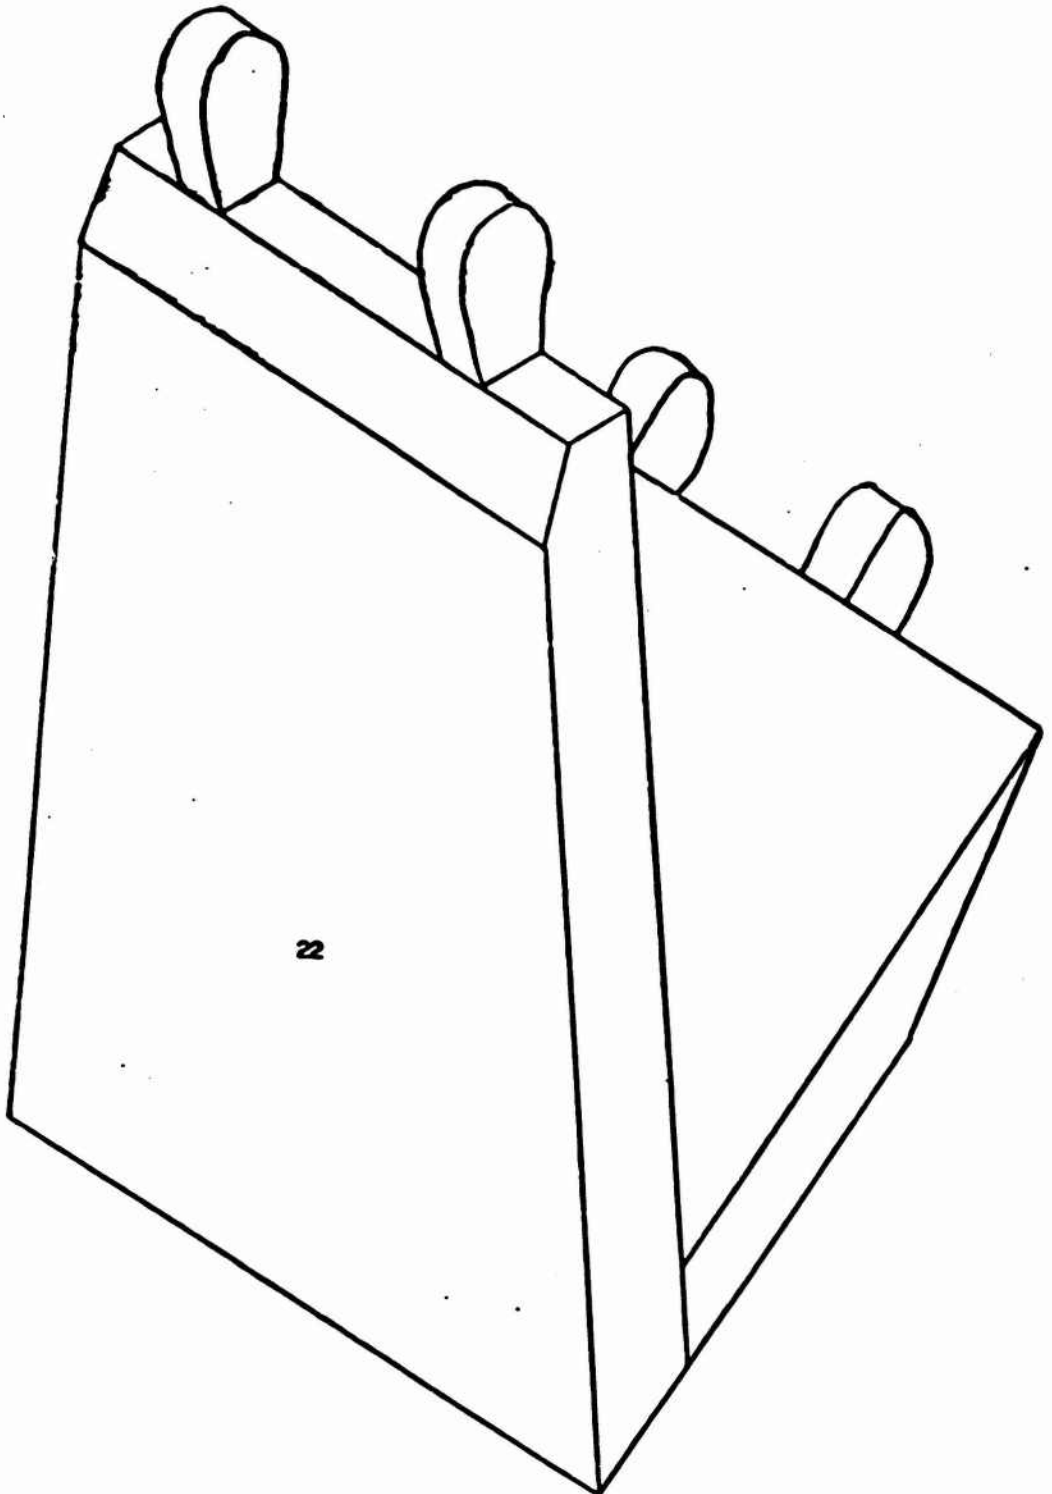
Upper panel, right section, structural type weld joint, square tubing showing location of hits by round number B-6

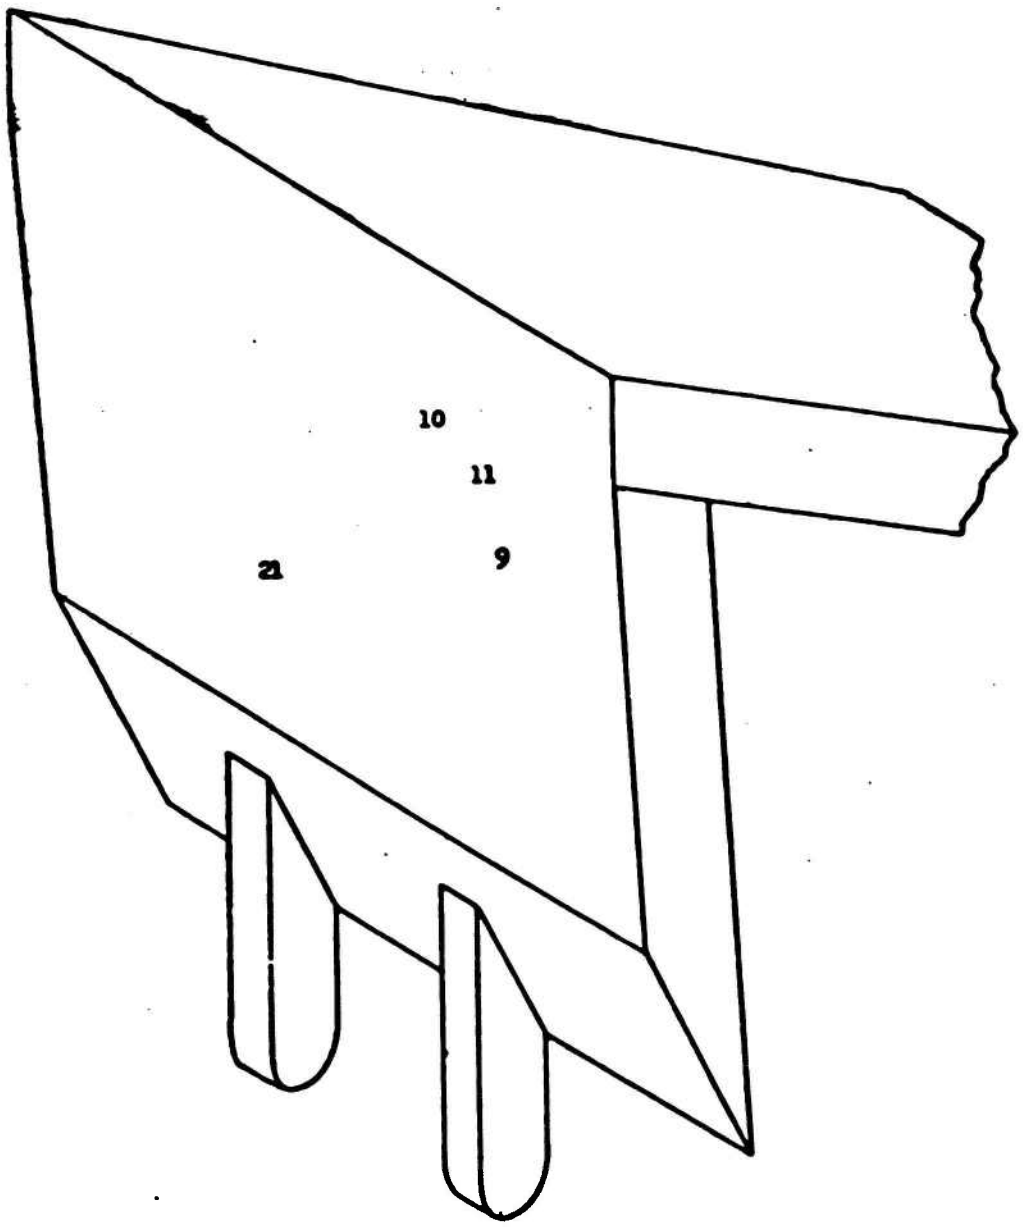
Lower panel, right section, structural type weld joint, square tubing showing location of hits by round number

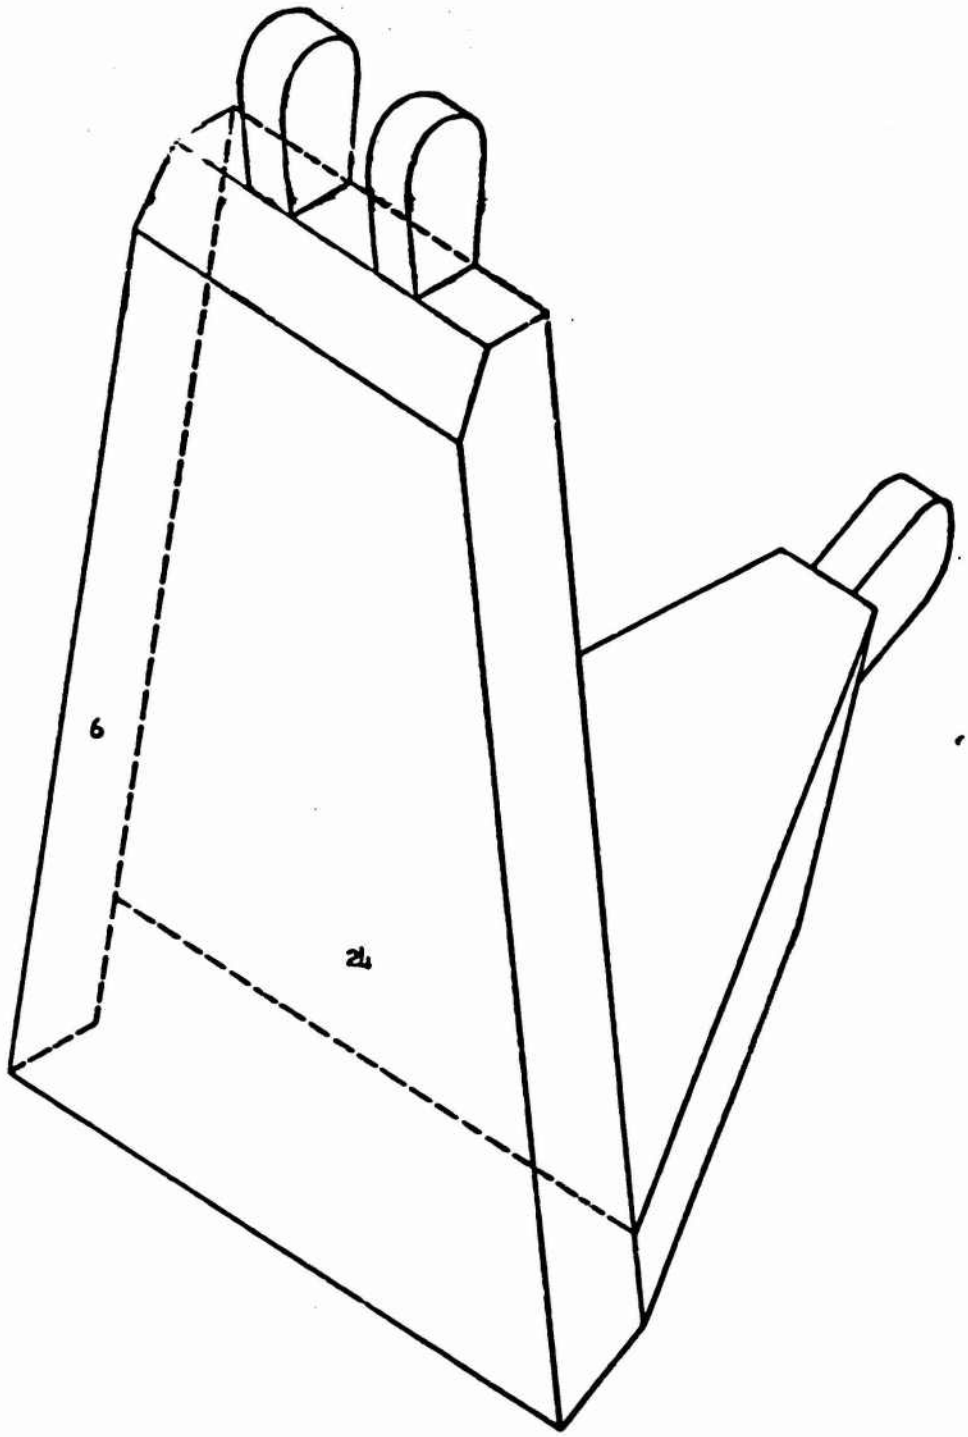
Upper panel, center section, full penetration type weld joint, square tubing showing location of hits by round number

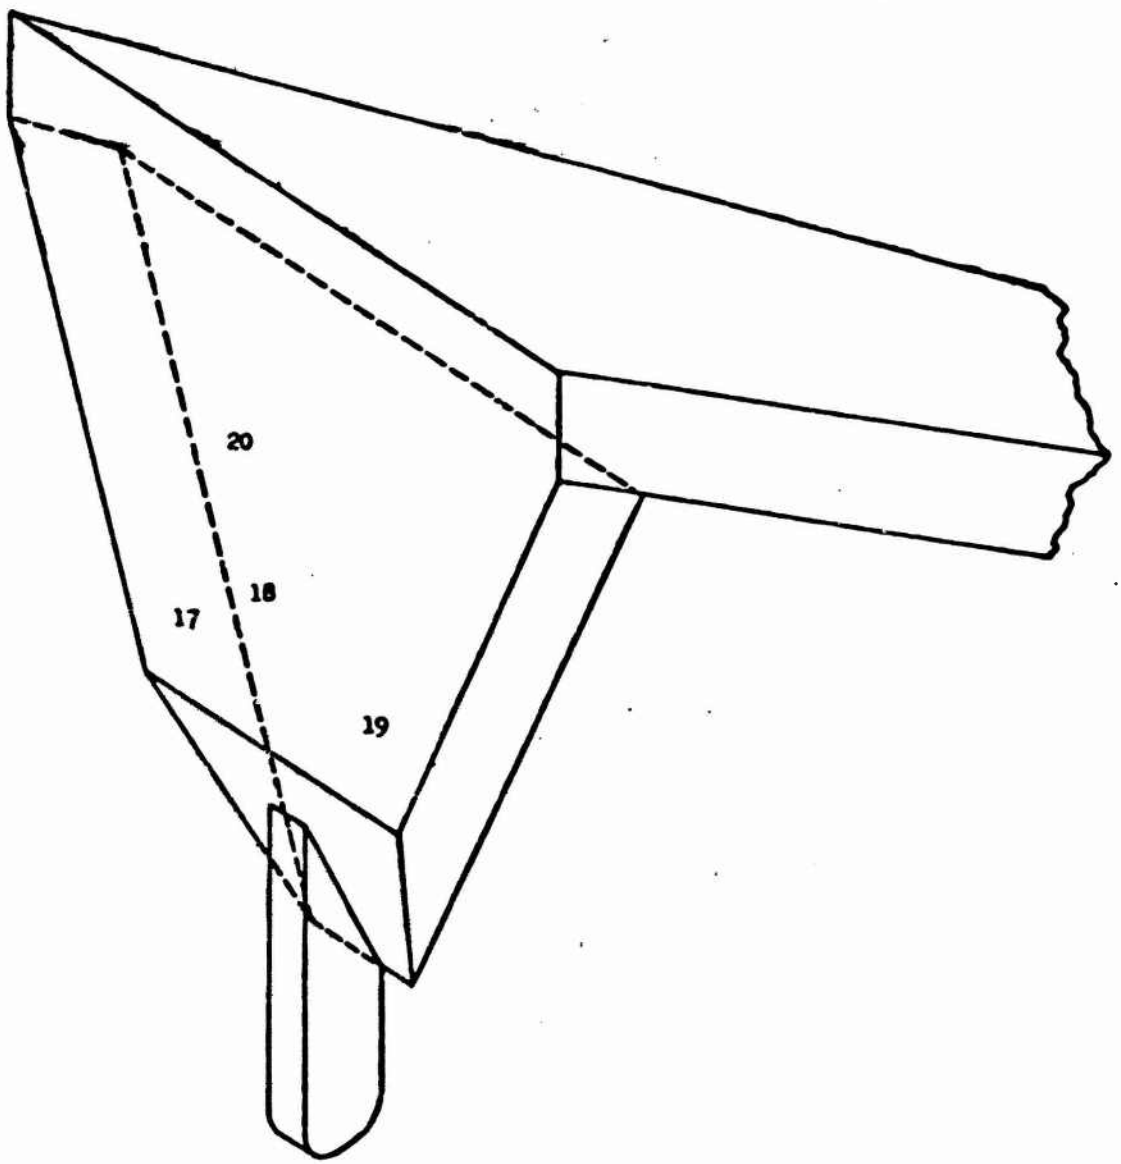
Lower panel, center section, full penetration type weld joint, square tubing showing location of hi's by round number

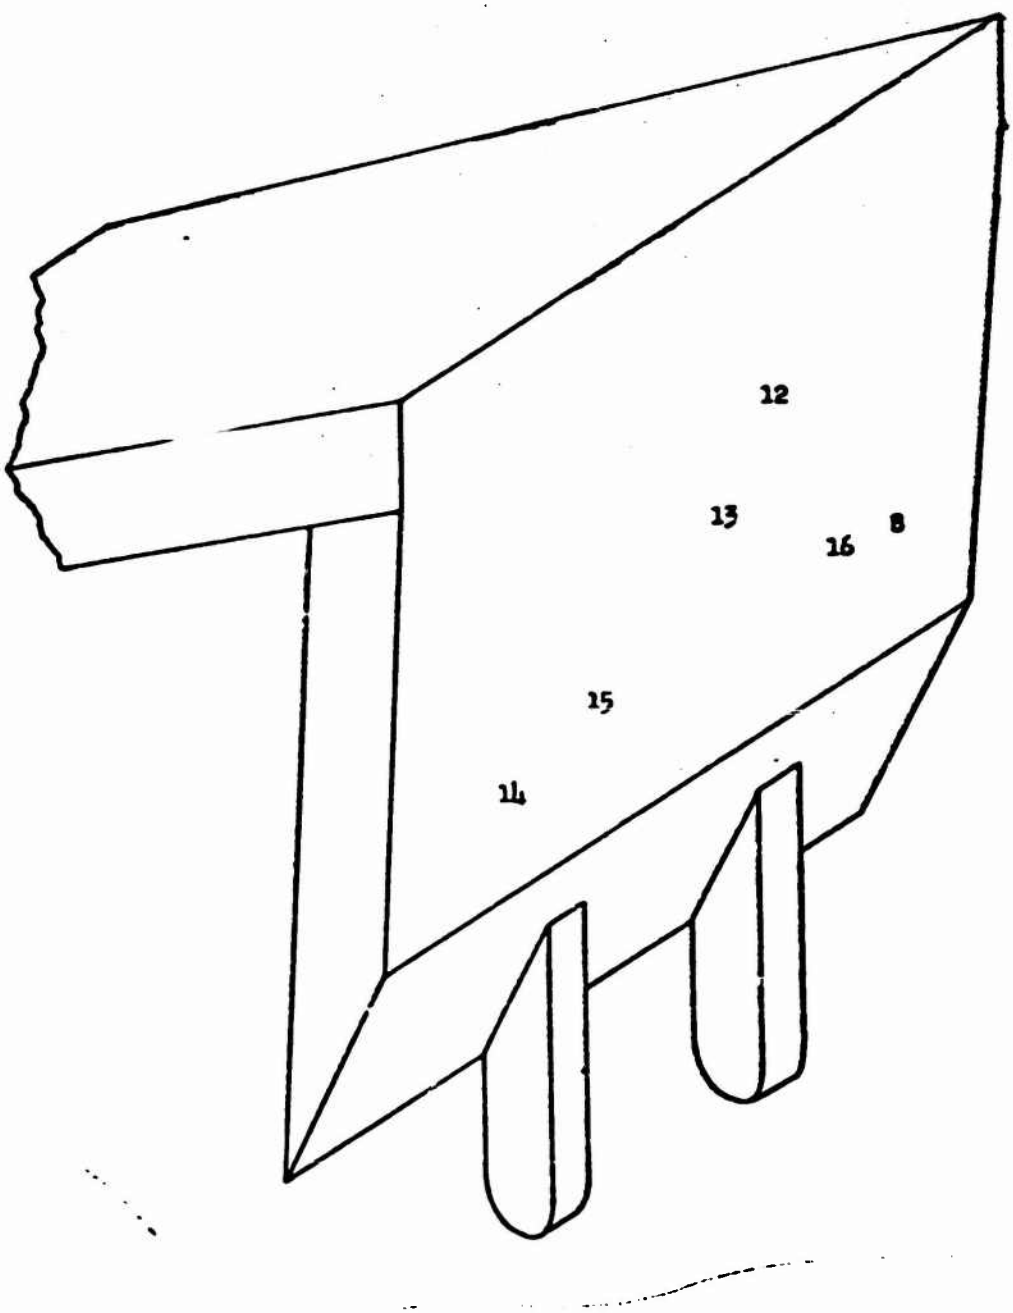
Lower panel, left section, structural type weld joint, hexagonal tubing showing location of hits by round number

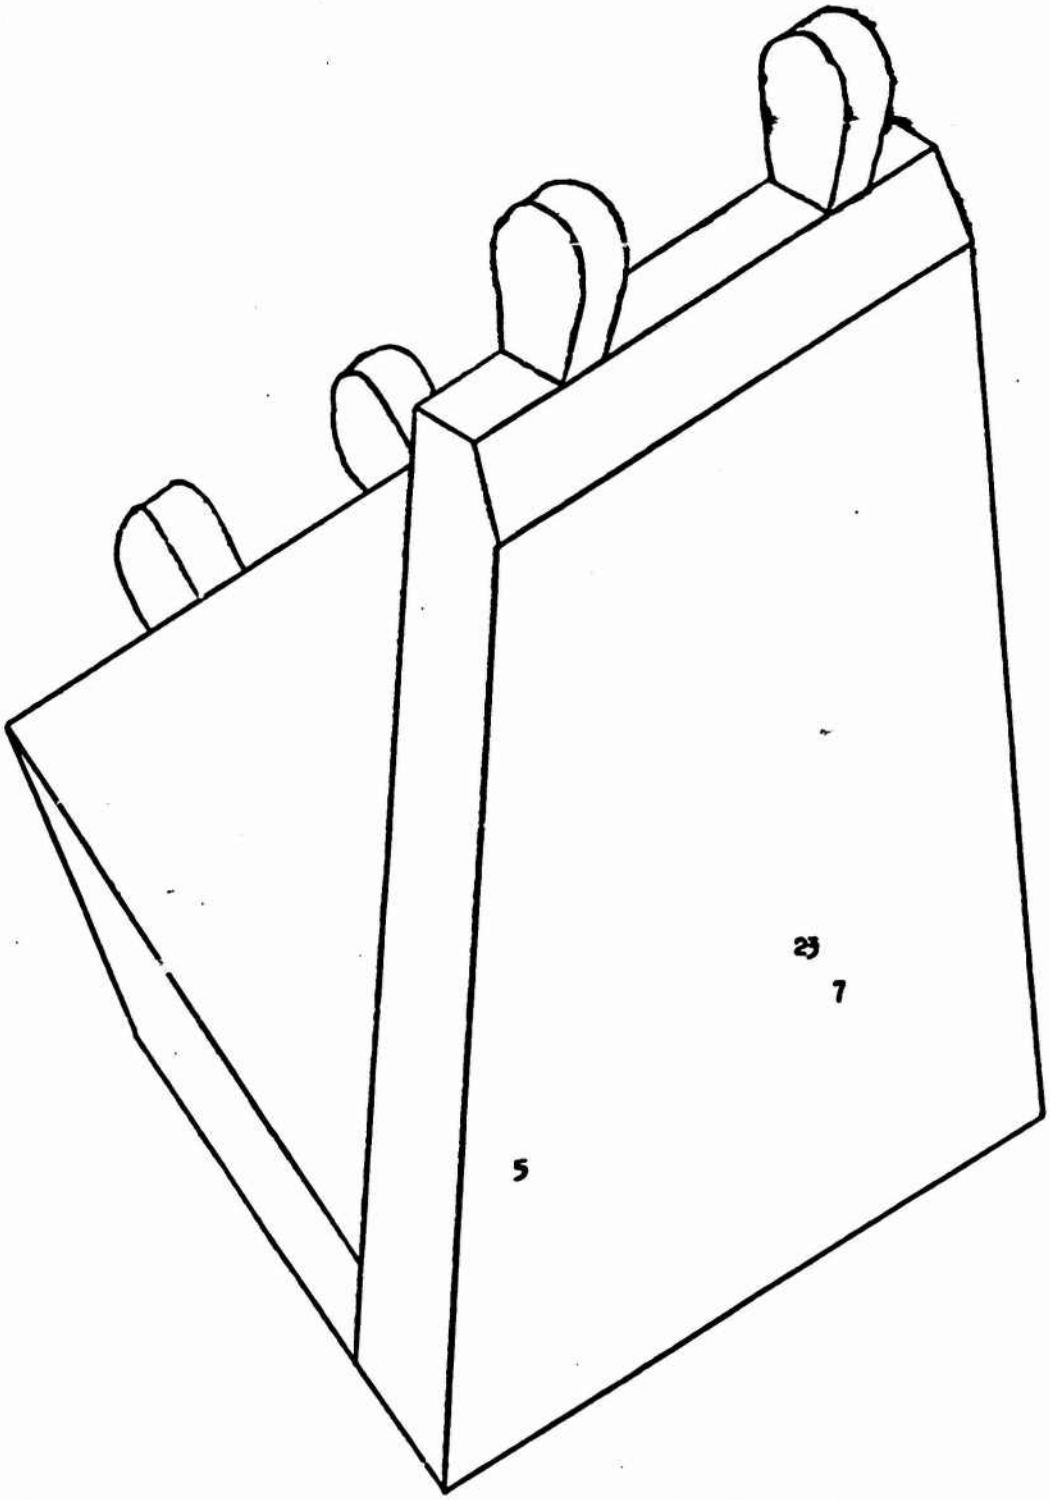
Upper panel, left section, structural type weld joint, hexagonal tubing showing location of hits by round number
