TECHNICAL REPORT
TR-NAVFAC-EXWC-EV-1706
DECEMBER 2016

Final Report : Innovative Acoustic Sensor Technologies for Leak Detection in Challenging Pipe Types

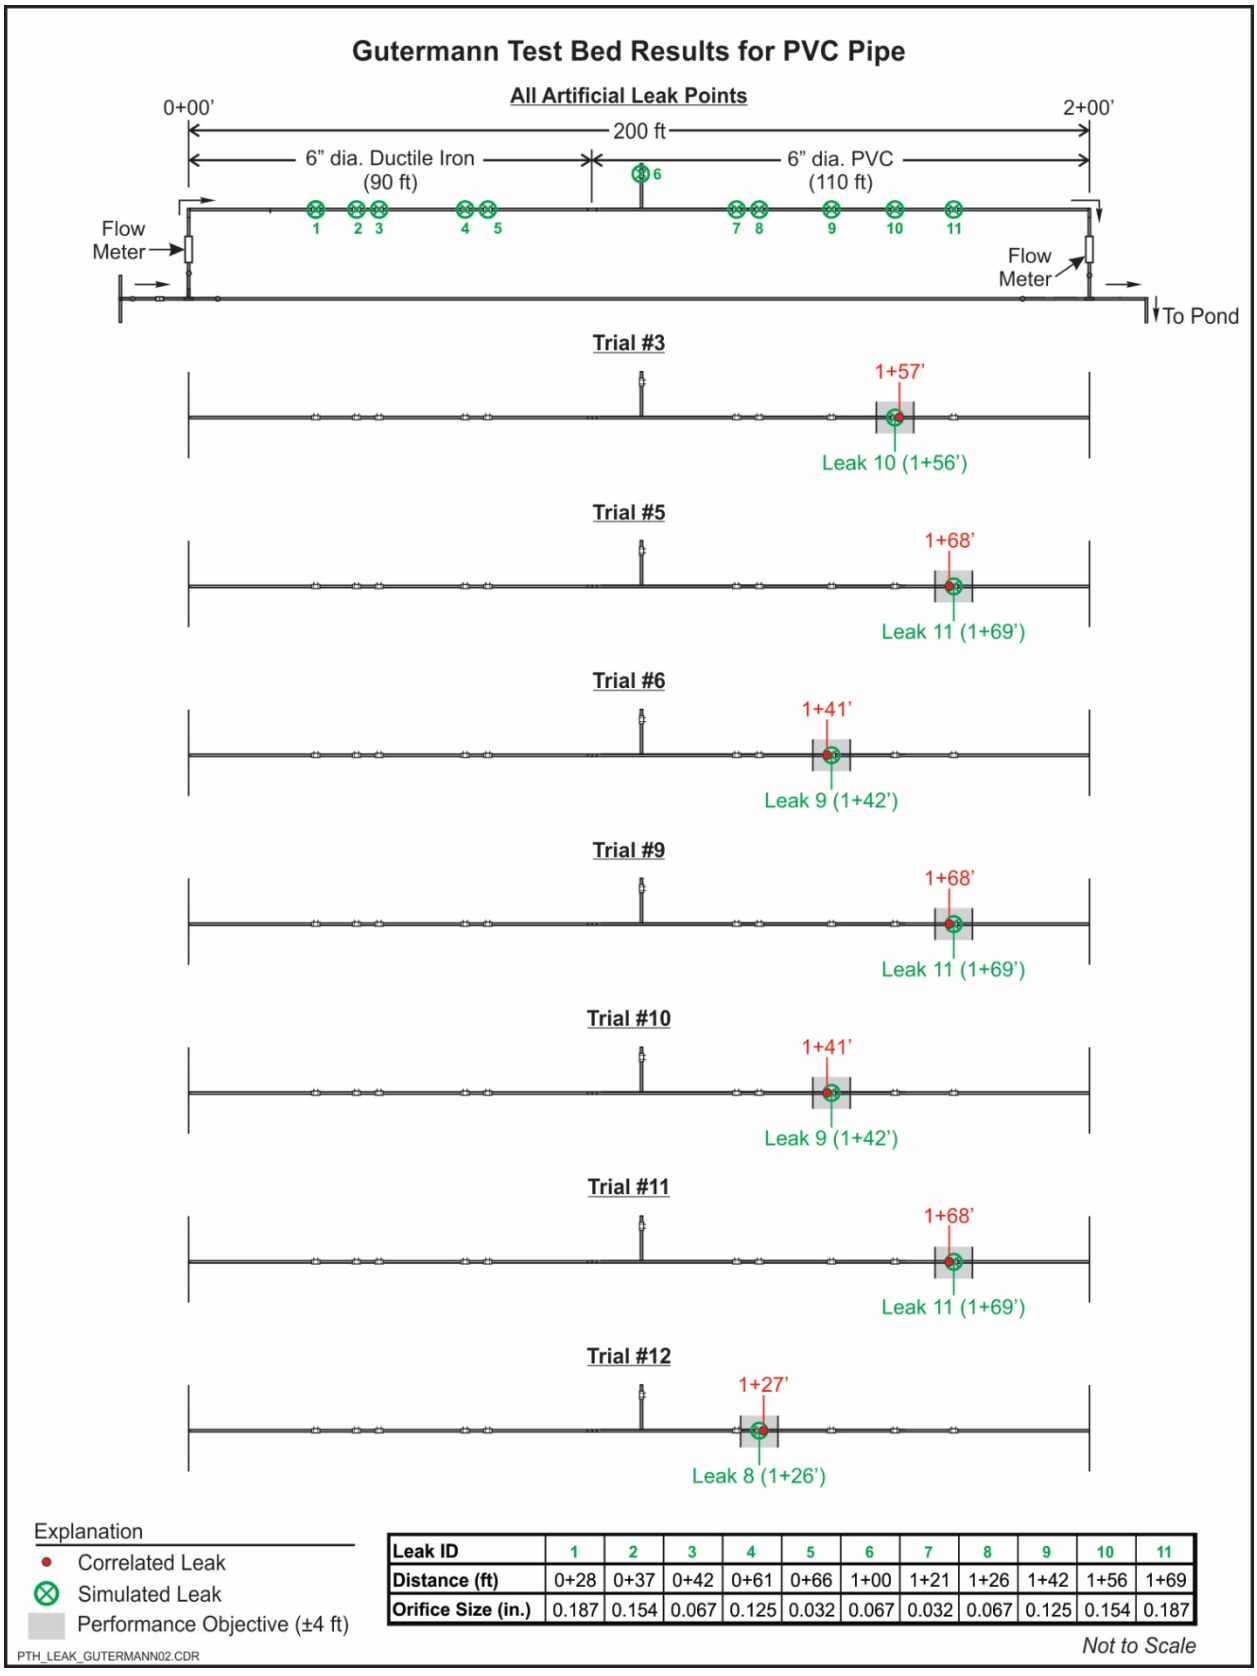
Figure 6-1. ZoneScan Alpha Test Bed Leak Location Results for PVC Pipe

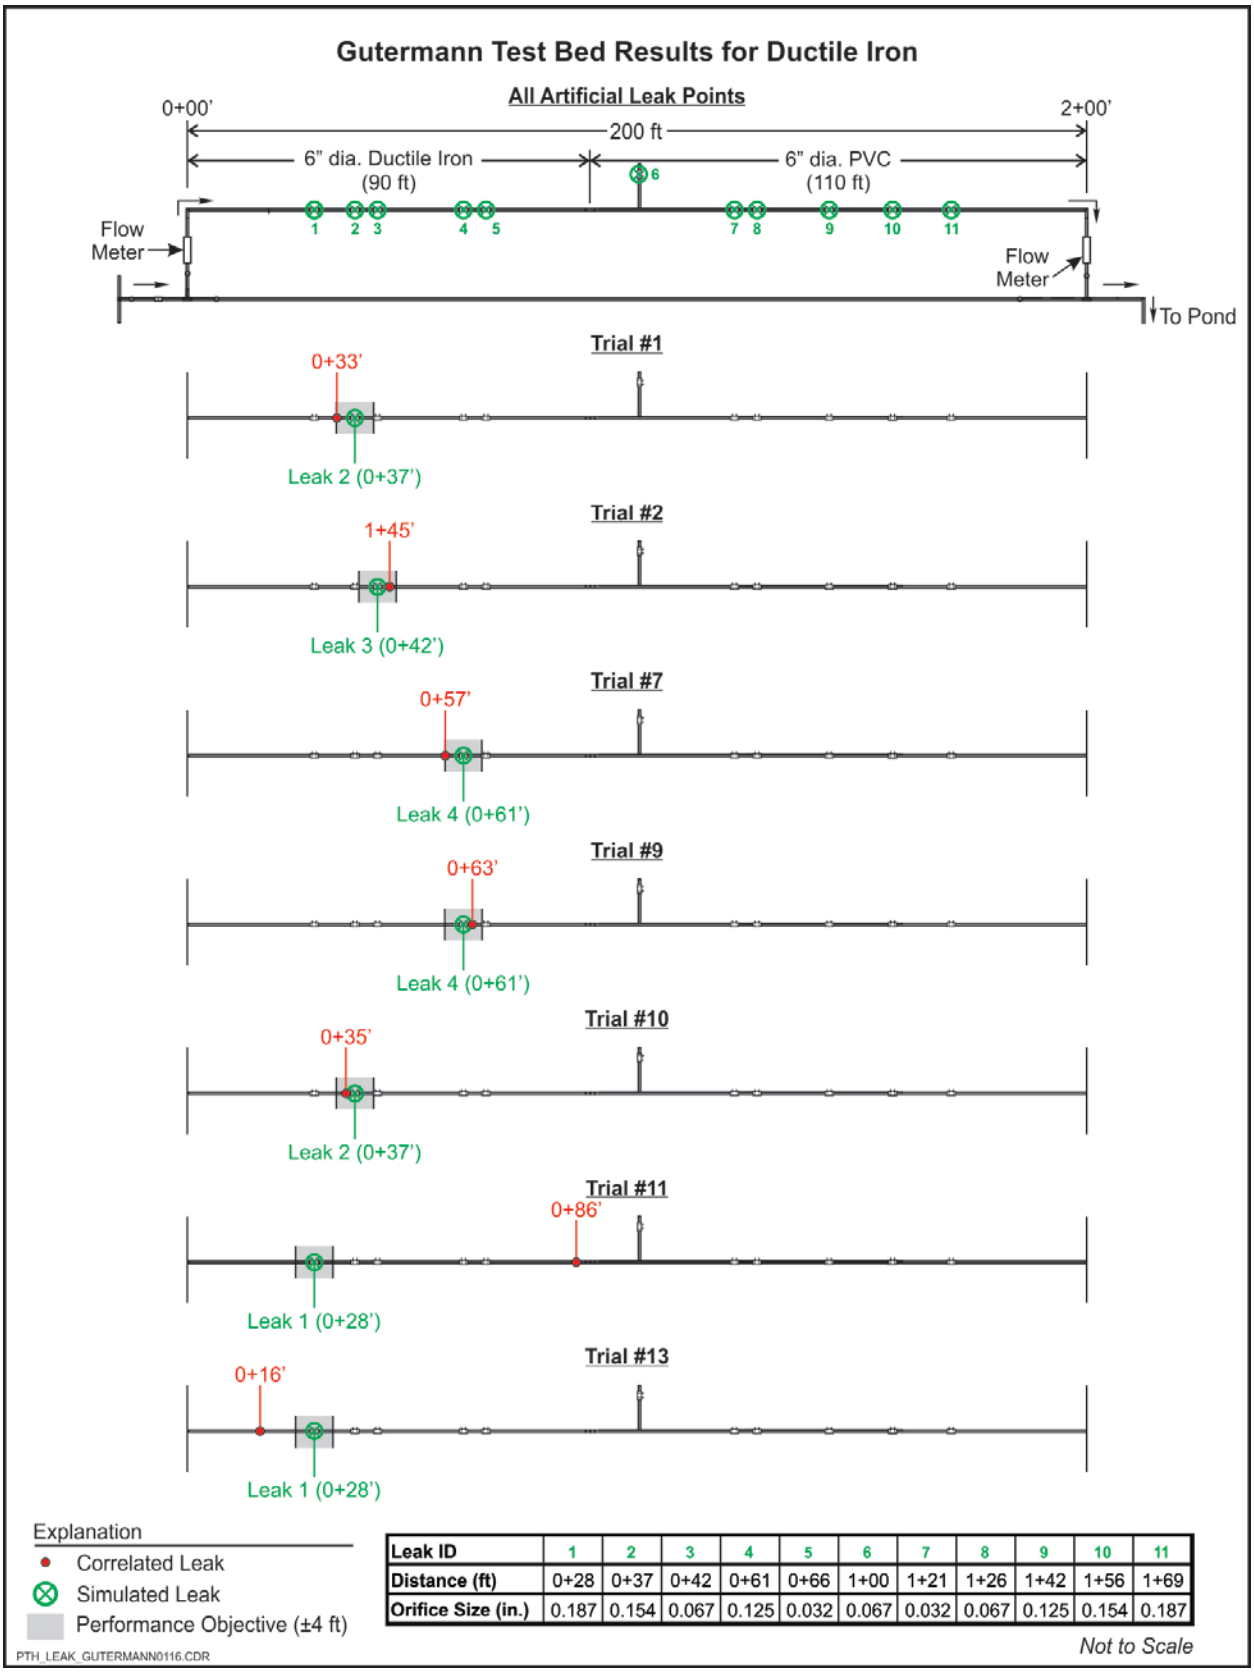
Figure 6-2. ZoneScan Alpha Test Bed Leak Location Results for DI Pipe

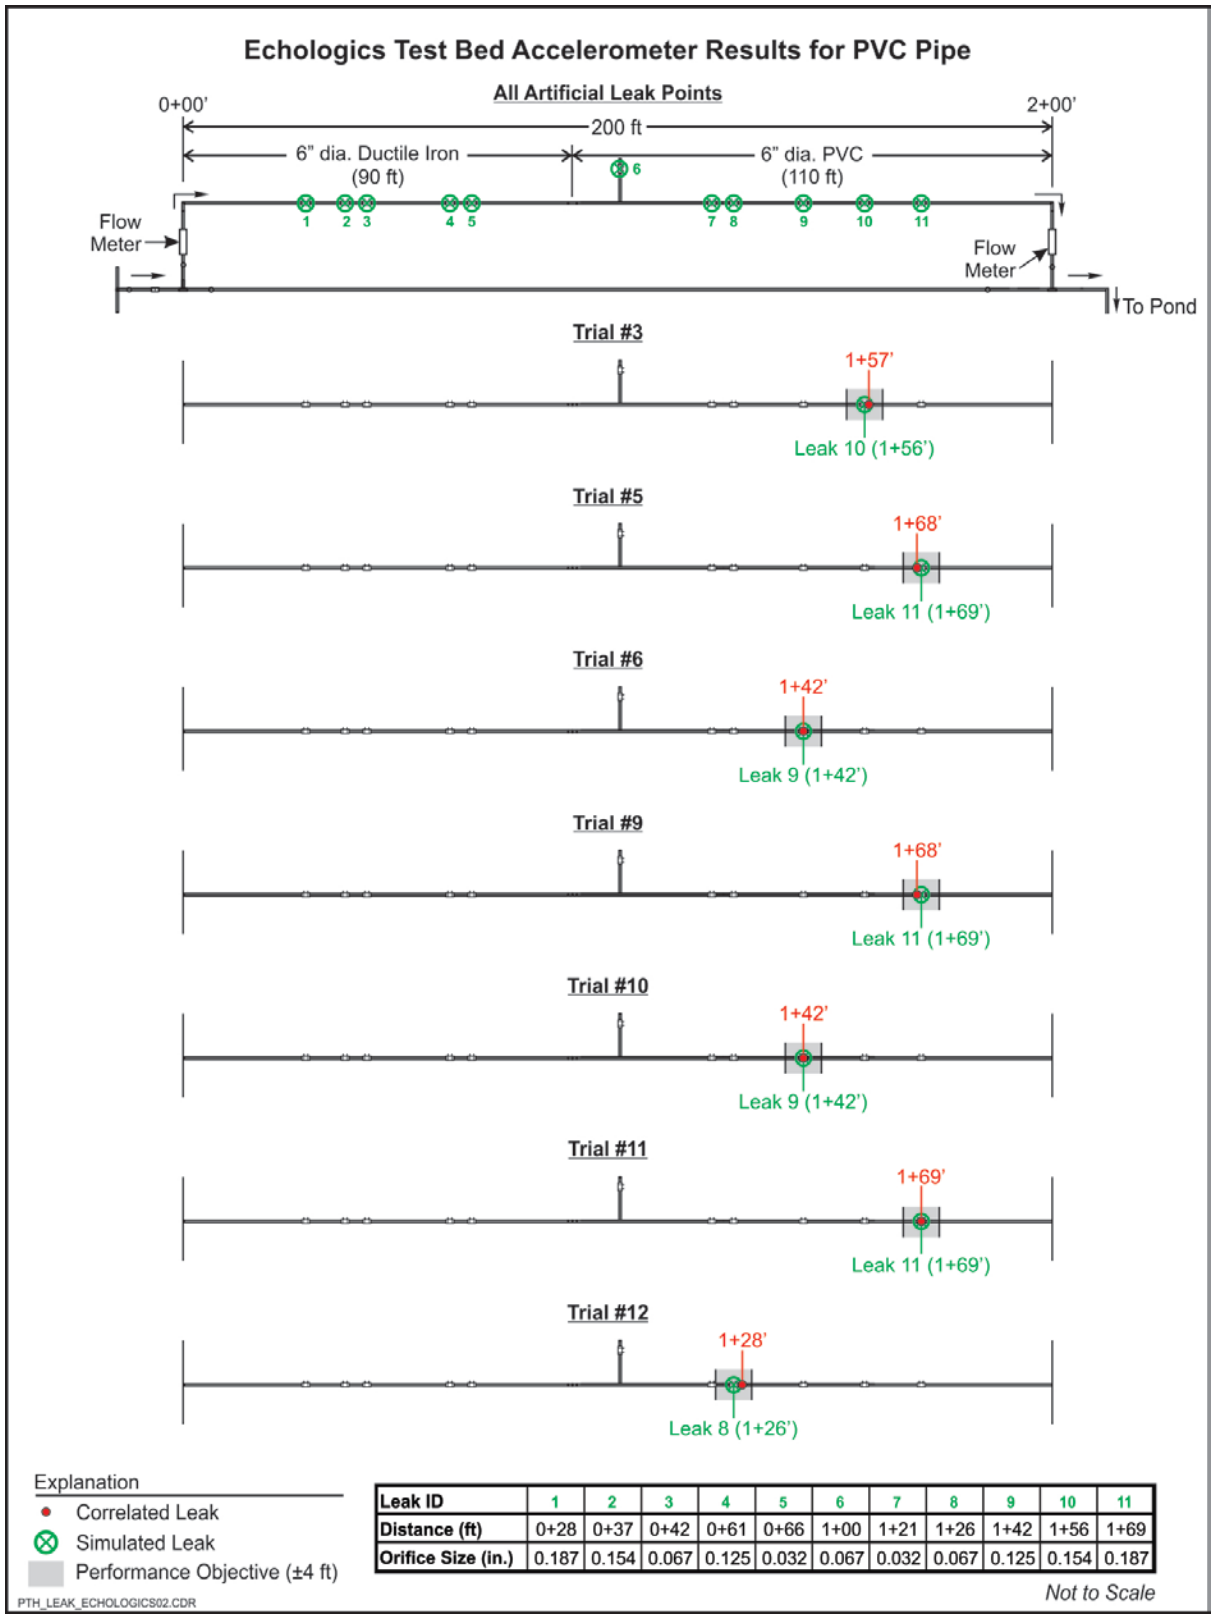
Figure 6-6. LeakFinderRT Simulated Leak Testing Results on PVC Pipe Using Accelerometer

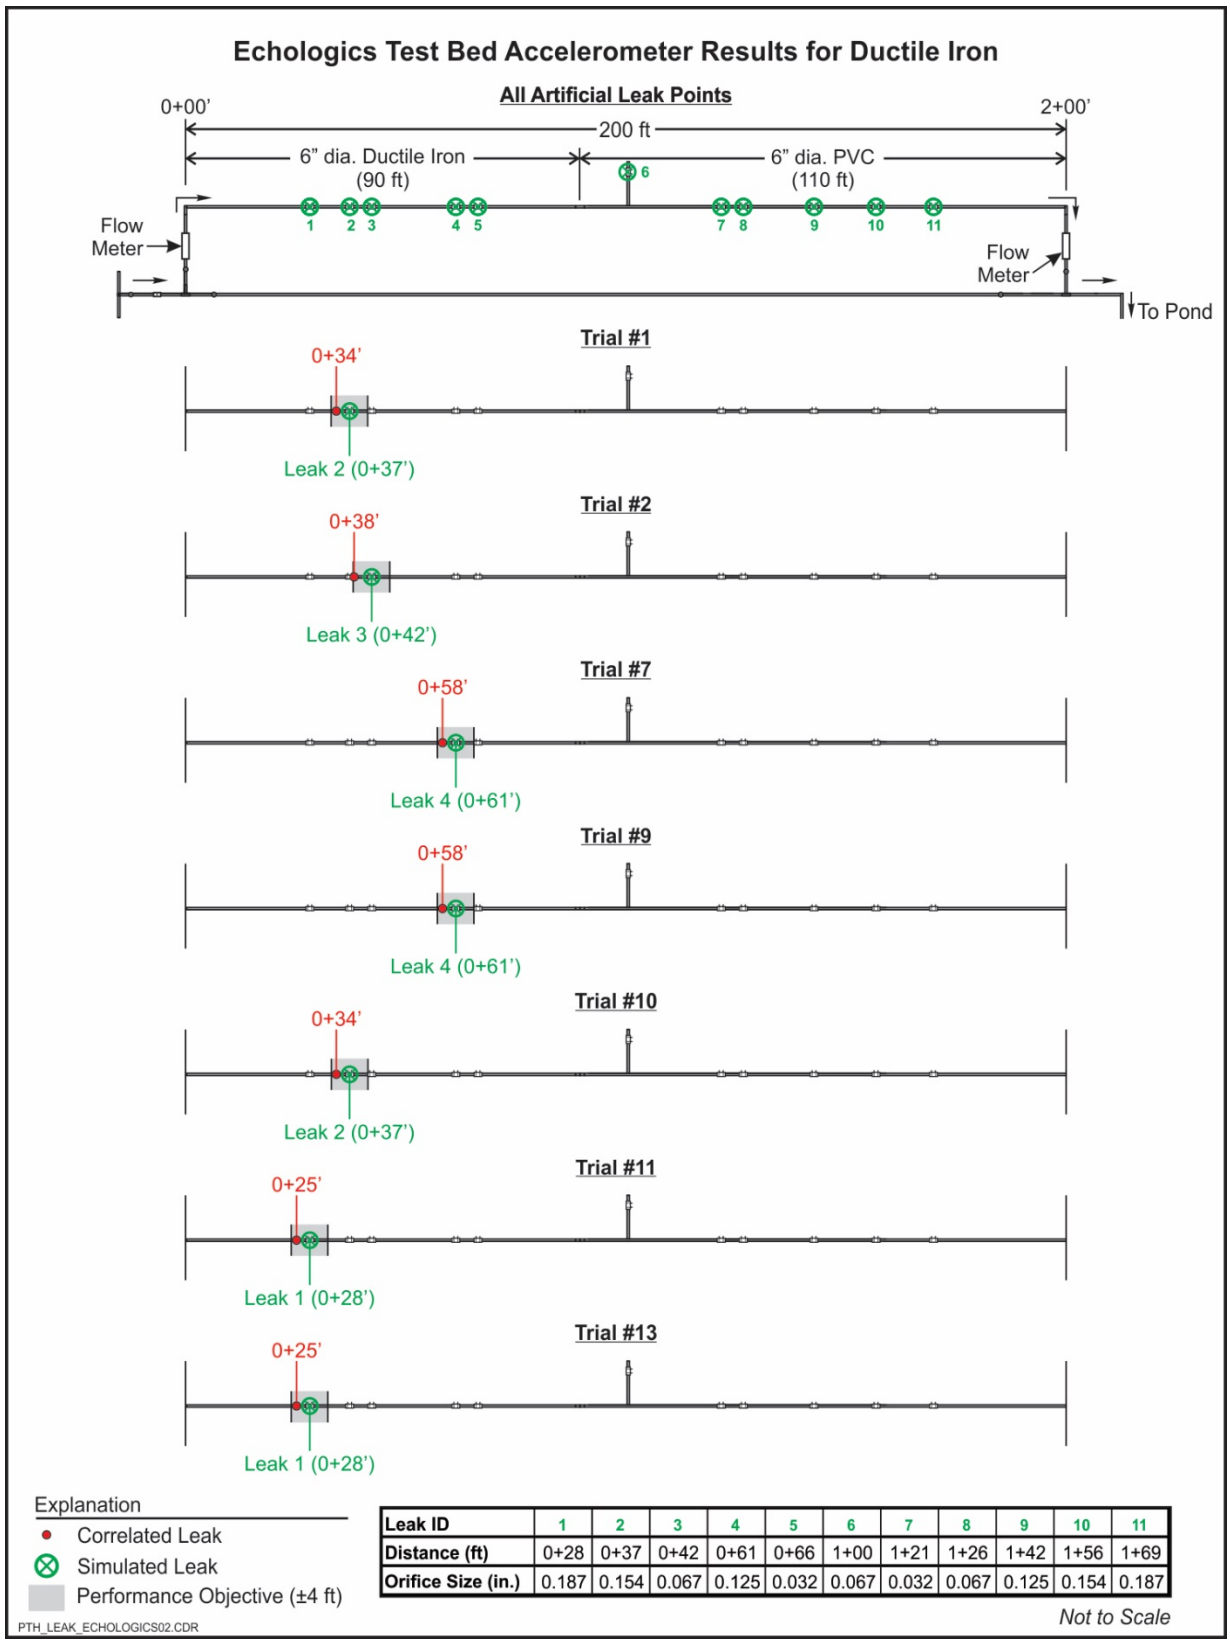
Figure 6-7. LeakFinderRT Simulated Leak Testing Results on DI Pipe Using Accelerometer

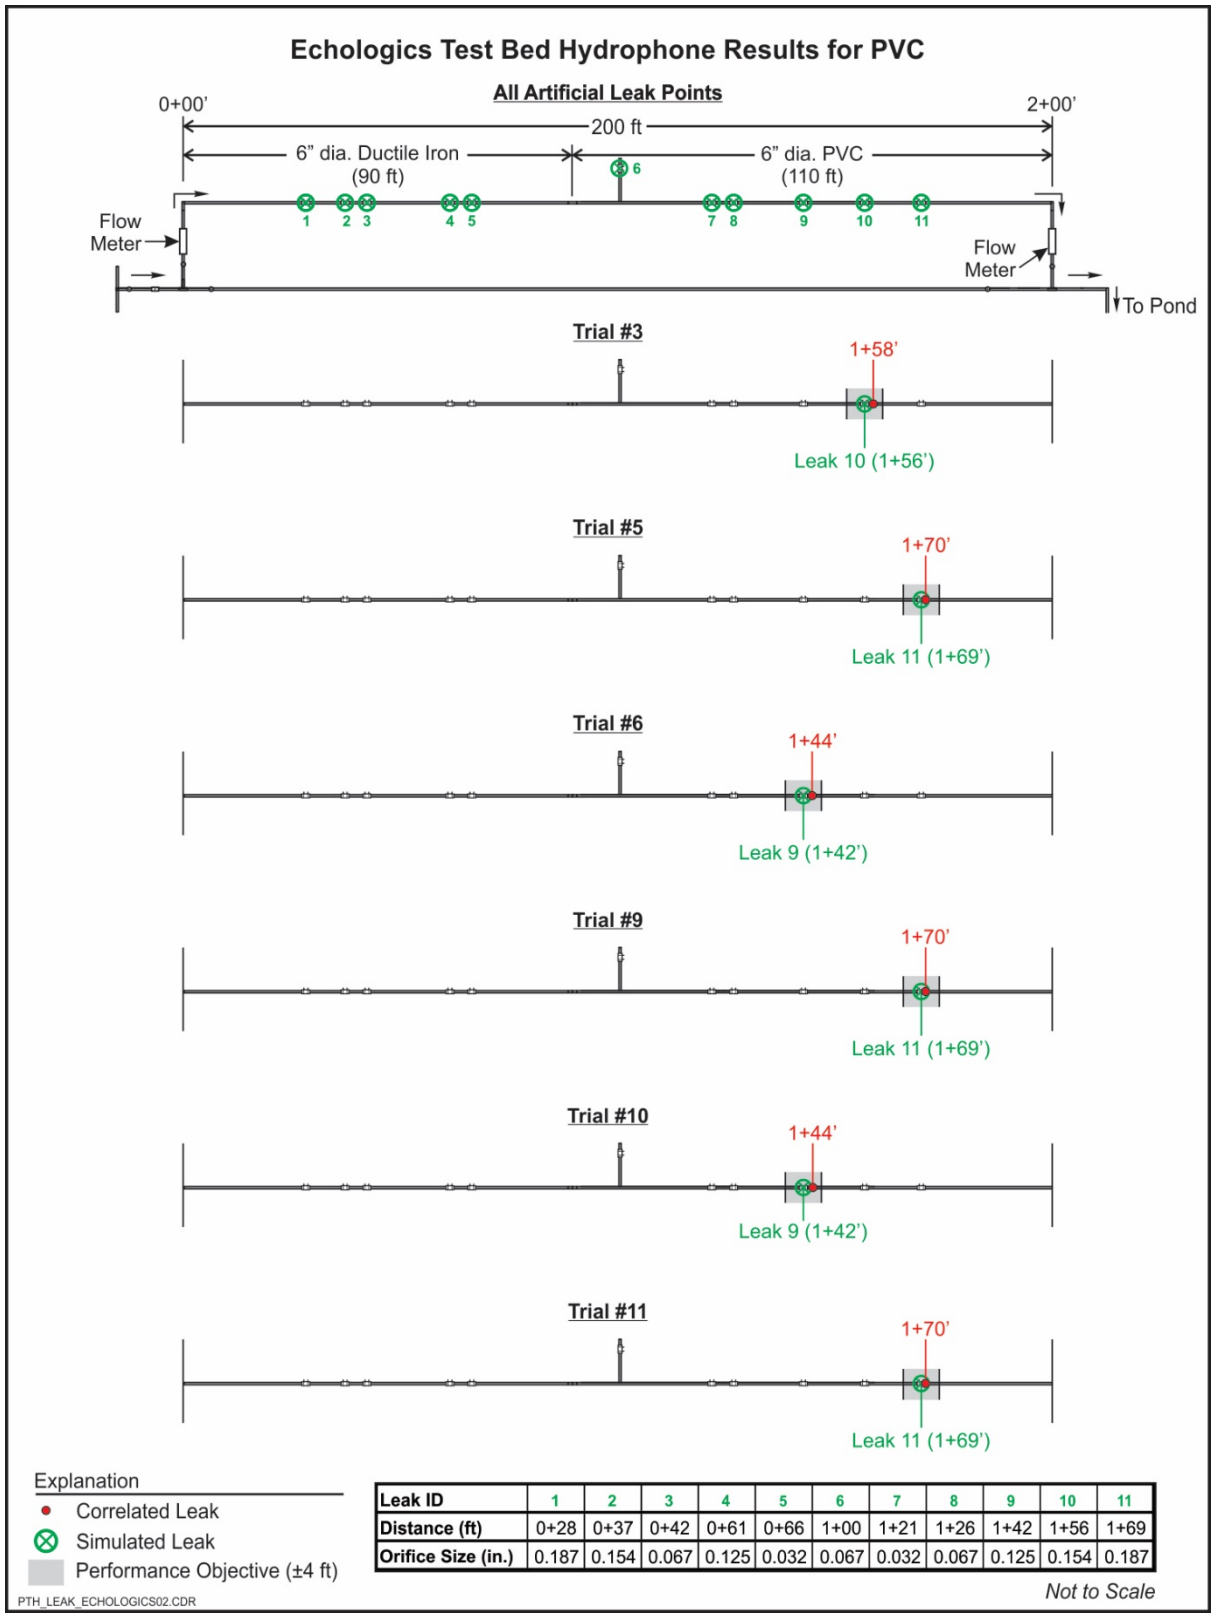
Figure 6-8. LeakFinderRT Simulated Leak Testing Results on PVC Pipe Using Hydrophone

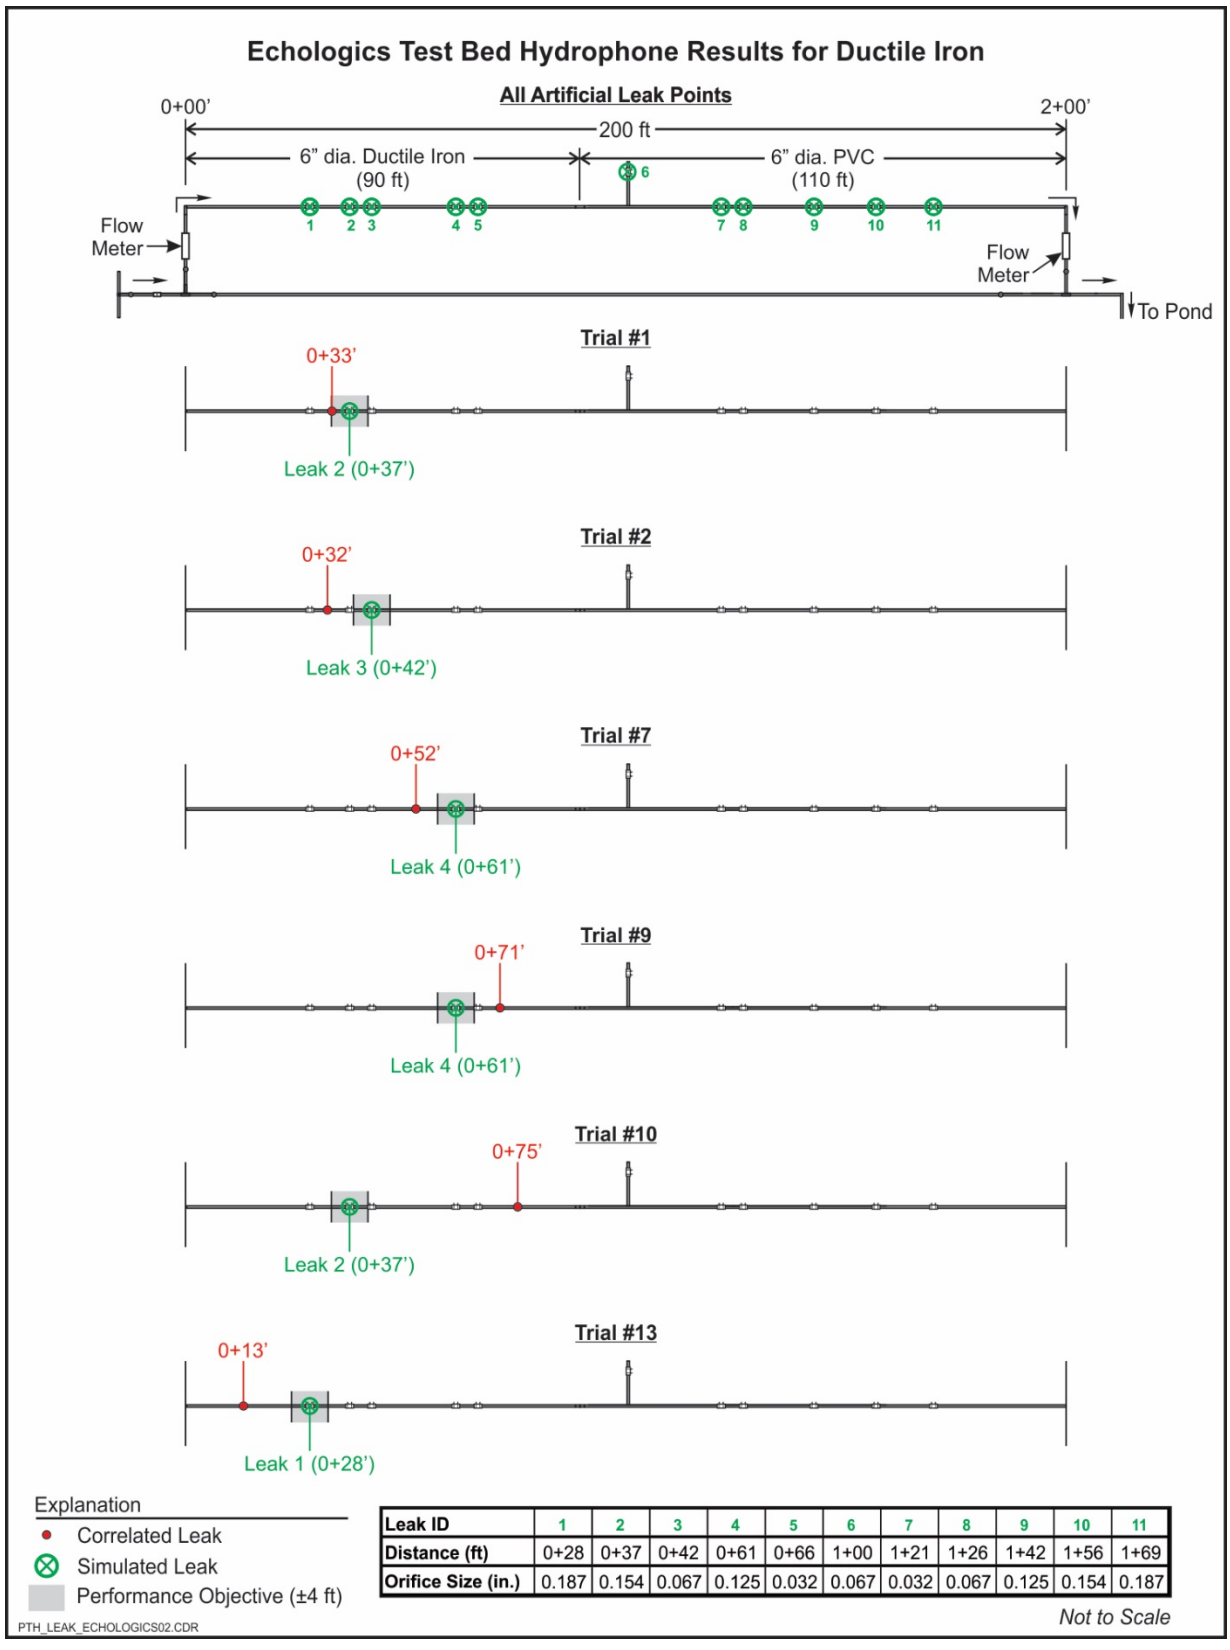
Figure 6-9. LeakFinderRT Test Bed Results on DI Pipe Using Hydrophone

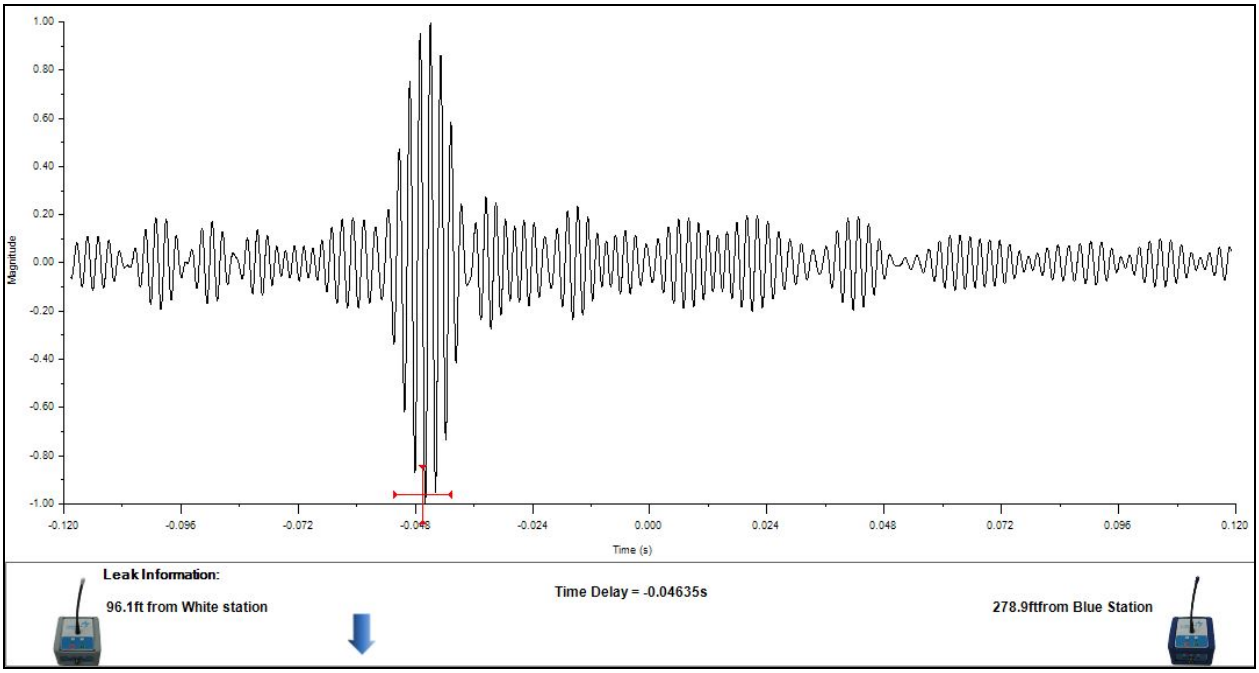
Figure 6-12. LeakFinderRT Correlation Results for the Large Leak Identified at ERDC

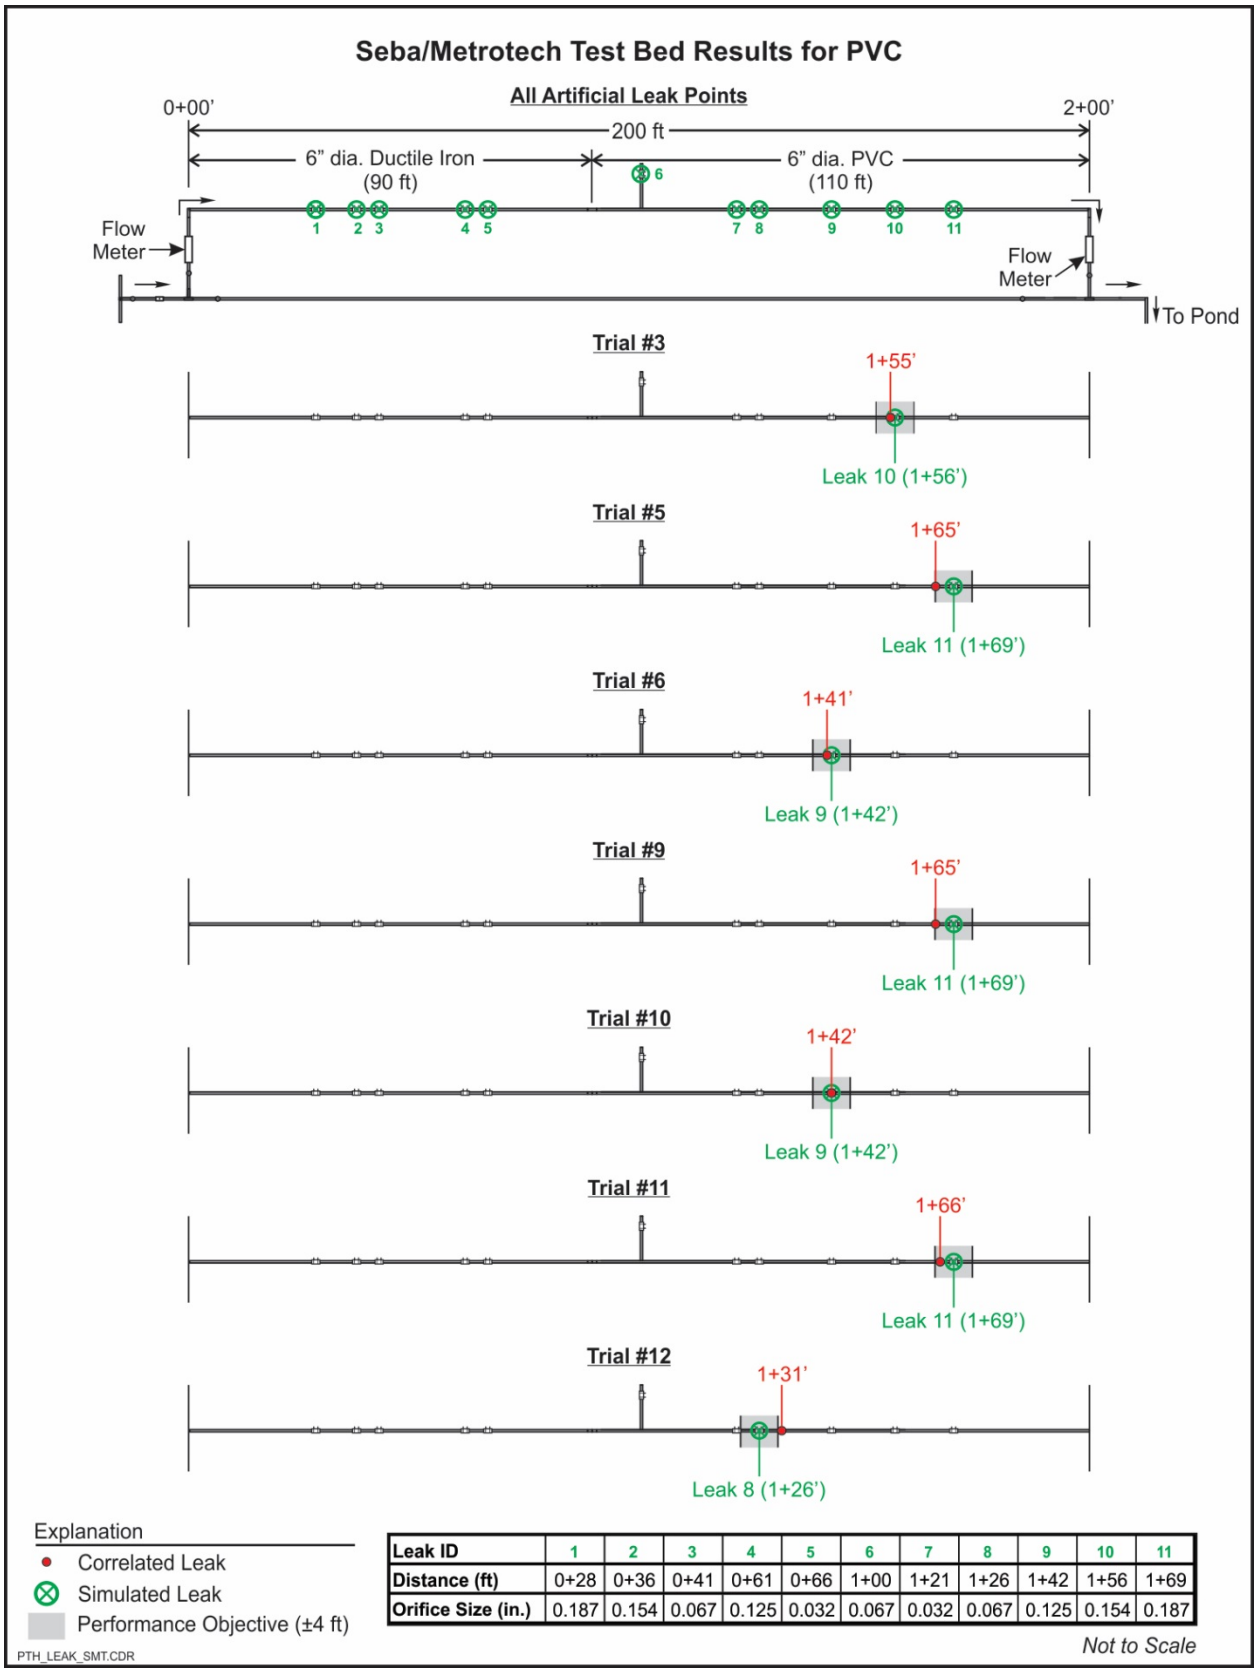
Figure 6-14. Correlux System Simulated Leak Testing Results on PVC Pipe

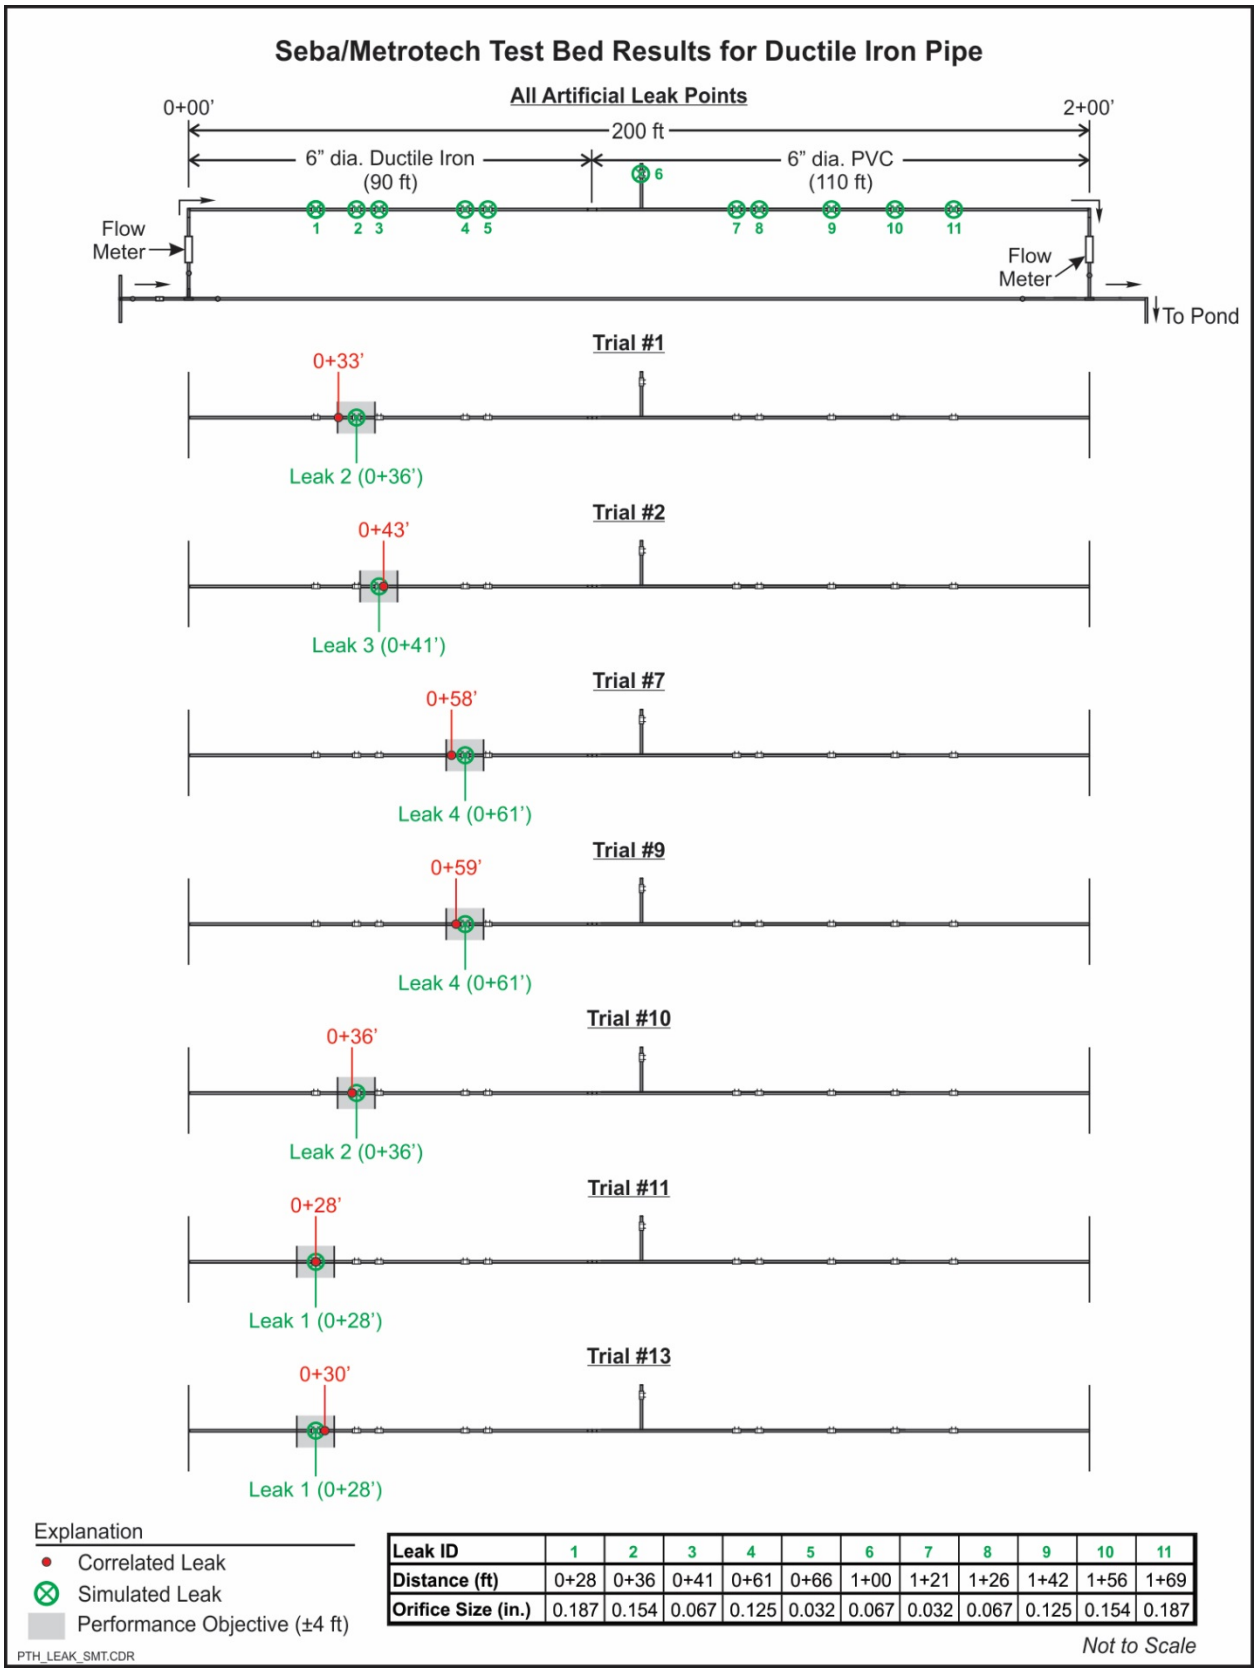
Figure 6-15. Correlux System Simulated Leak Testing Results on DI Pipe
