USAAEFA PROJECT NO. 75-04

MODIFIED HELICOPTER ICING SPRAY SYSTEM EVALUATION

FINAL REPORT

MARCH 1977

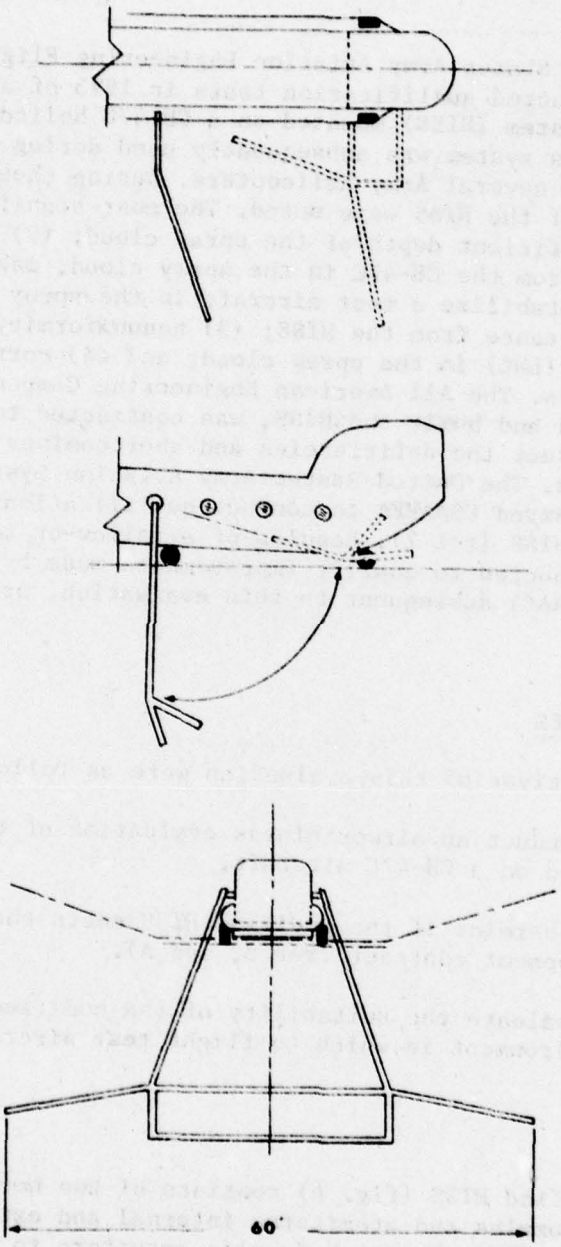
Figure A. Dual Boom Configuration.

3. The modified HISS (fig. A) consists of two horizontal booms with spray nozzles and atomizers, internal and external supporting structure for these booms, hydraulic actuators to extend and retract the external apparatus, an 1800-gallon unpressurized

water tank, and operator control equipment. In the extended position the upper and lower horizontal booms are 20 and 25 feet below the aircraft, respectively. The upper horizontal boom and vertical extensions are made of steel. The lower horizontal boom and vertical extensions are made of aluminum. The booms and part of the supporting structure are jettisonable in an emergency. The water can also be jettisoned.

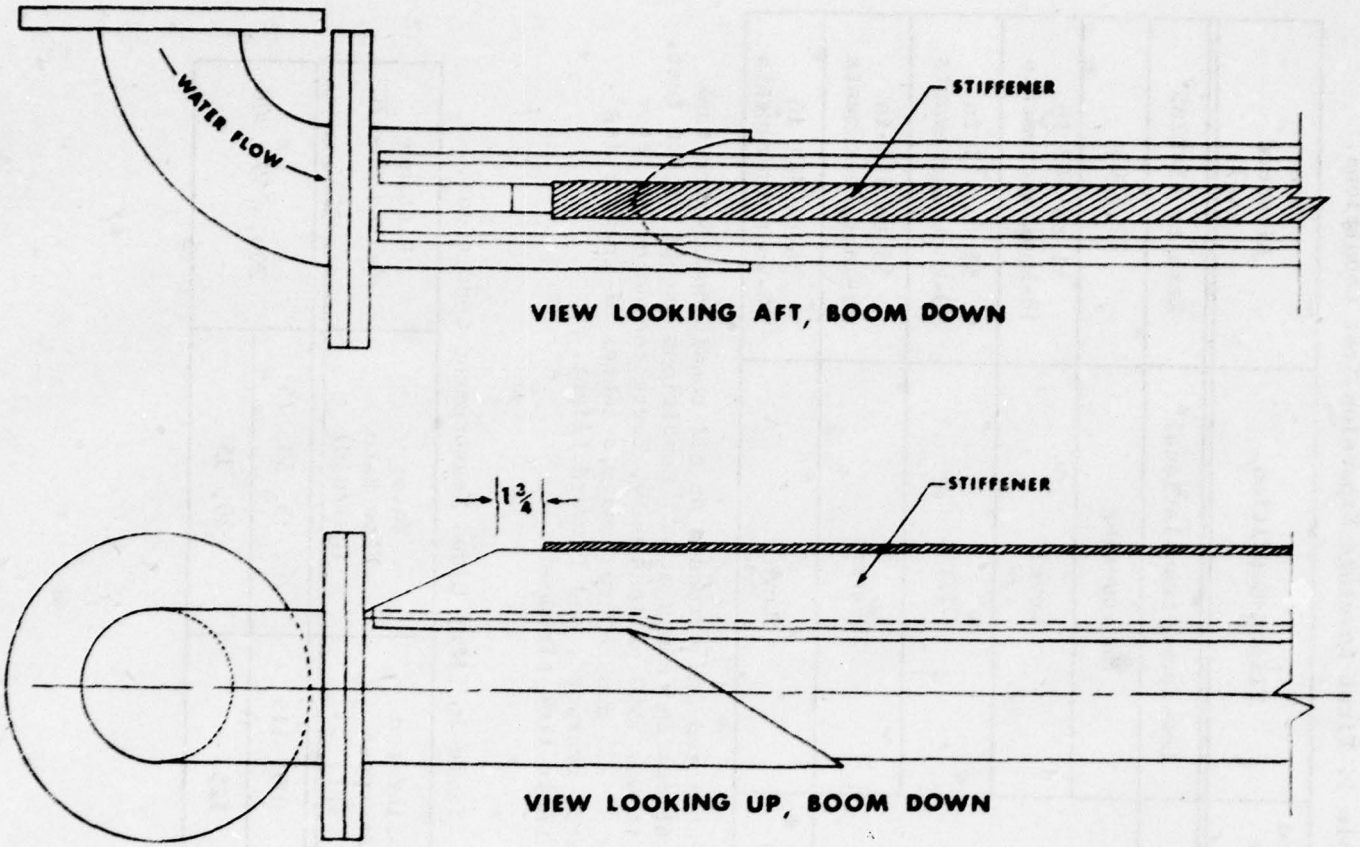
Figure C. Stiffener Configuration.

15. Addition of the stiffener changed the shape of the lower horizontal boom and created an apparently aerodynamically induced vertical oscillation at a frequency of 6 Hz in the lower boom in the extended position. This oscillation was encountered in an airspeed range of 90 to 110 knots calibrated airspeed (KCAS). This oscillation was uncomfortable to the crew and caused boom stresses near the endurance limit. Tape was added to the lower boom and stiffener to change the aerodynamic shape (fig. E). The oscillations were not observed after addition of the tape. This tape (MIL-SPEC-PPP-T-0060C or equivalent) should be a part of the standard HISS configuration until a more permanent modification is tested.

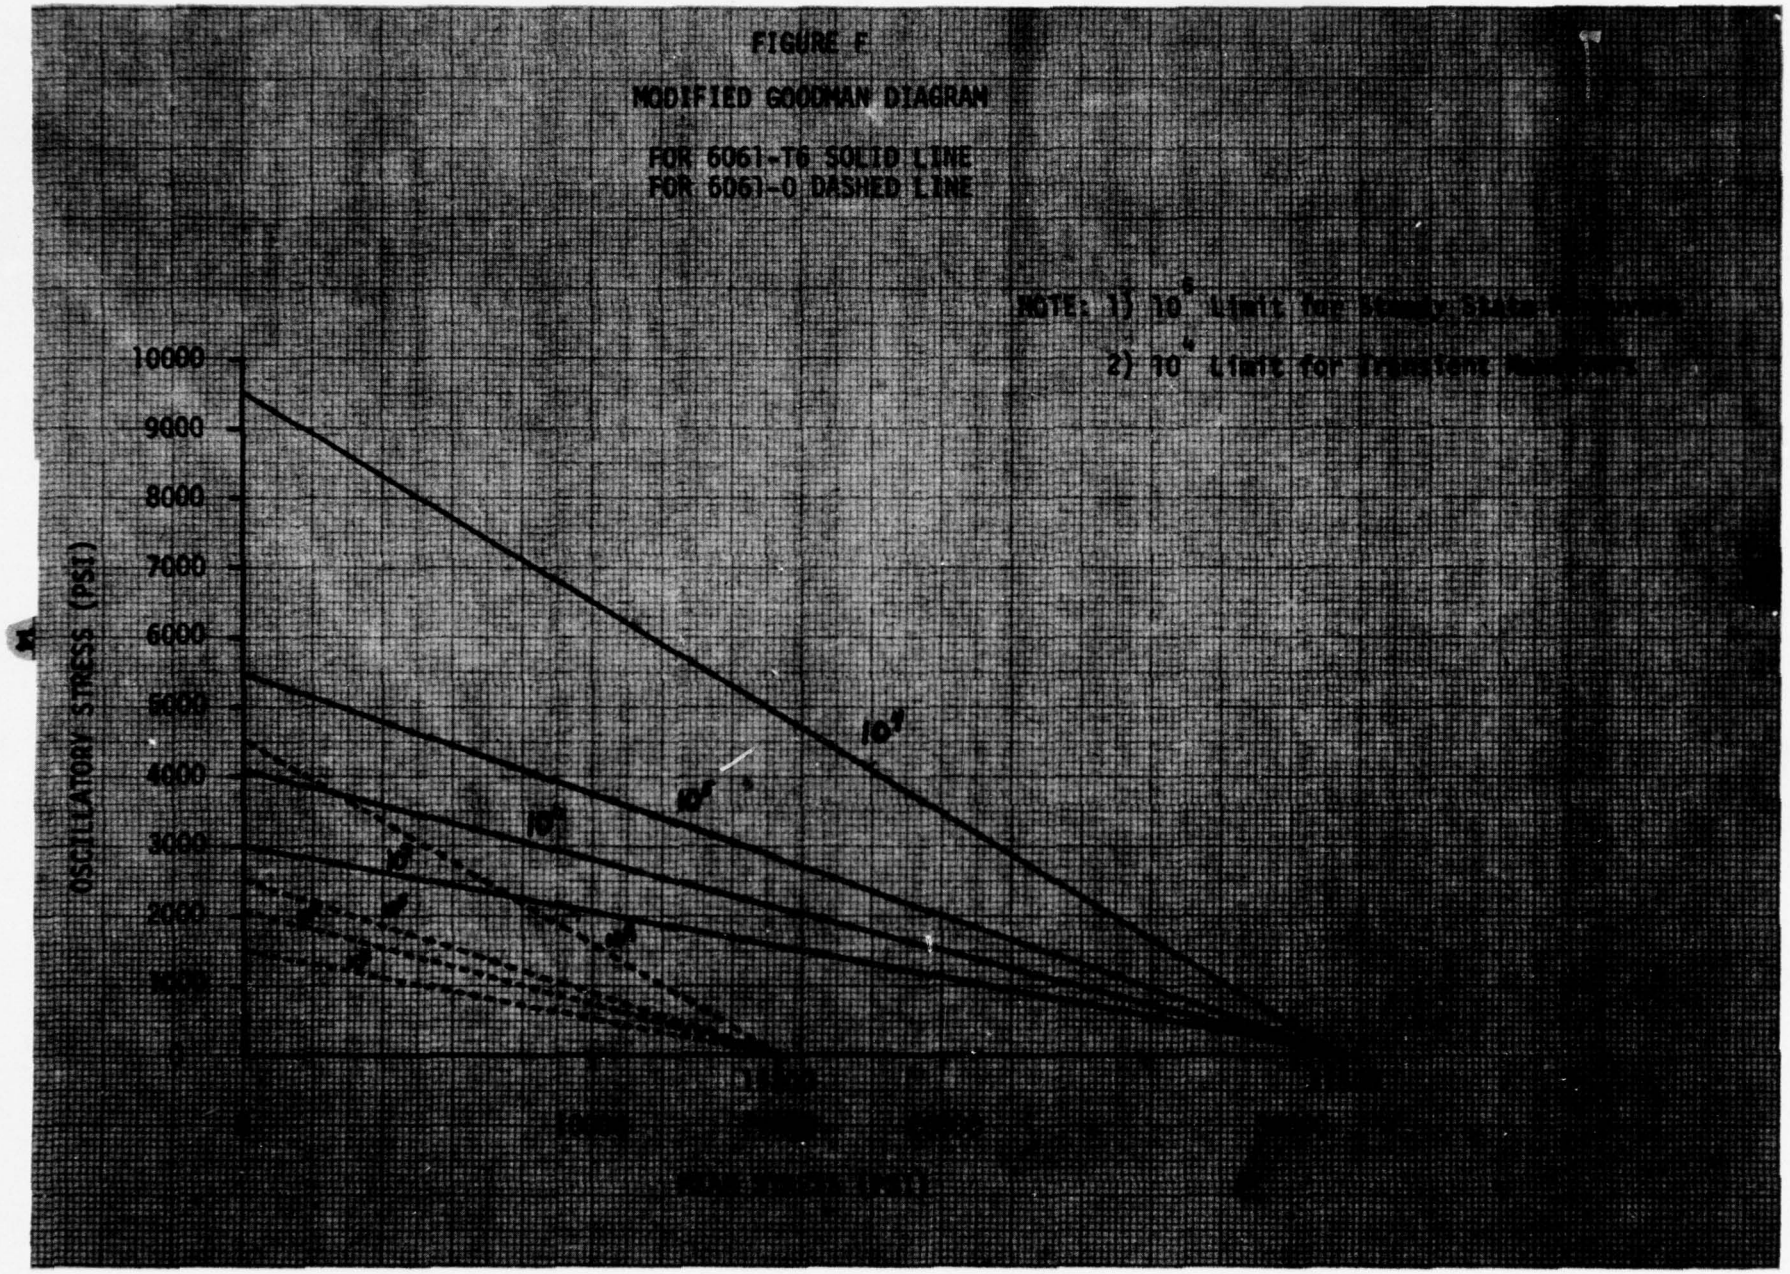
MODIFIED GOODMAN DIAGRAM

18. The lower horizontal spray boom, vertical tubes, and 90-degree elbows were made of heat-treated aluminum alloy. After fabrication, the welded areas were not heat-treated, and therefore, material strength near welds was less than the strength of heat-treated alloy. Allowable stresses for the two types of material are shown in figure F. After completion of the low-speed translational flights during the first envelope expansion tests (5.9 hours of flight), fatigue failures were found near welds on both the vertical tubes (app D). Subsequently, AAE built new, stronger vertical tubes and heat-treated the tubes and 90-degree elbows after welding. The horizontal boom was left in the "as welded" condition. The new tubes were used for the remainder of the tests and no failures were encountered.

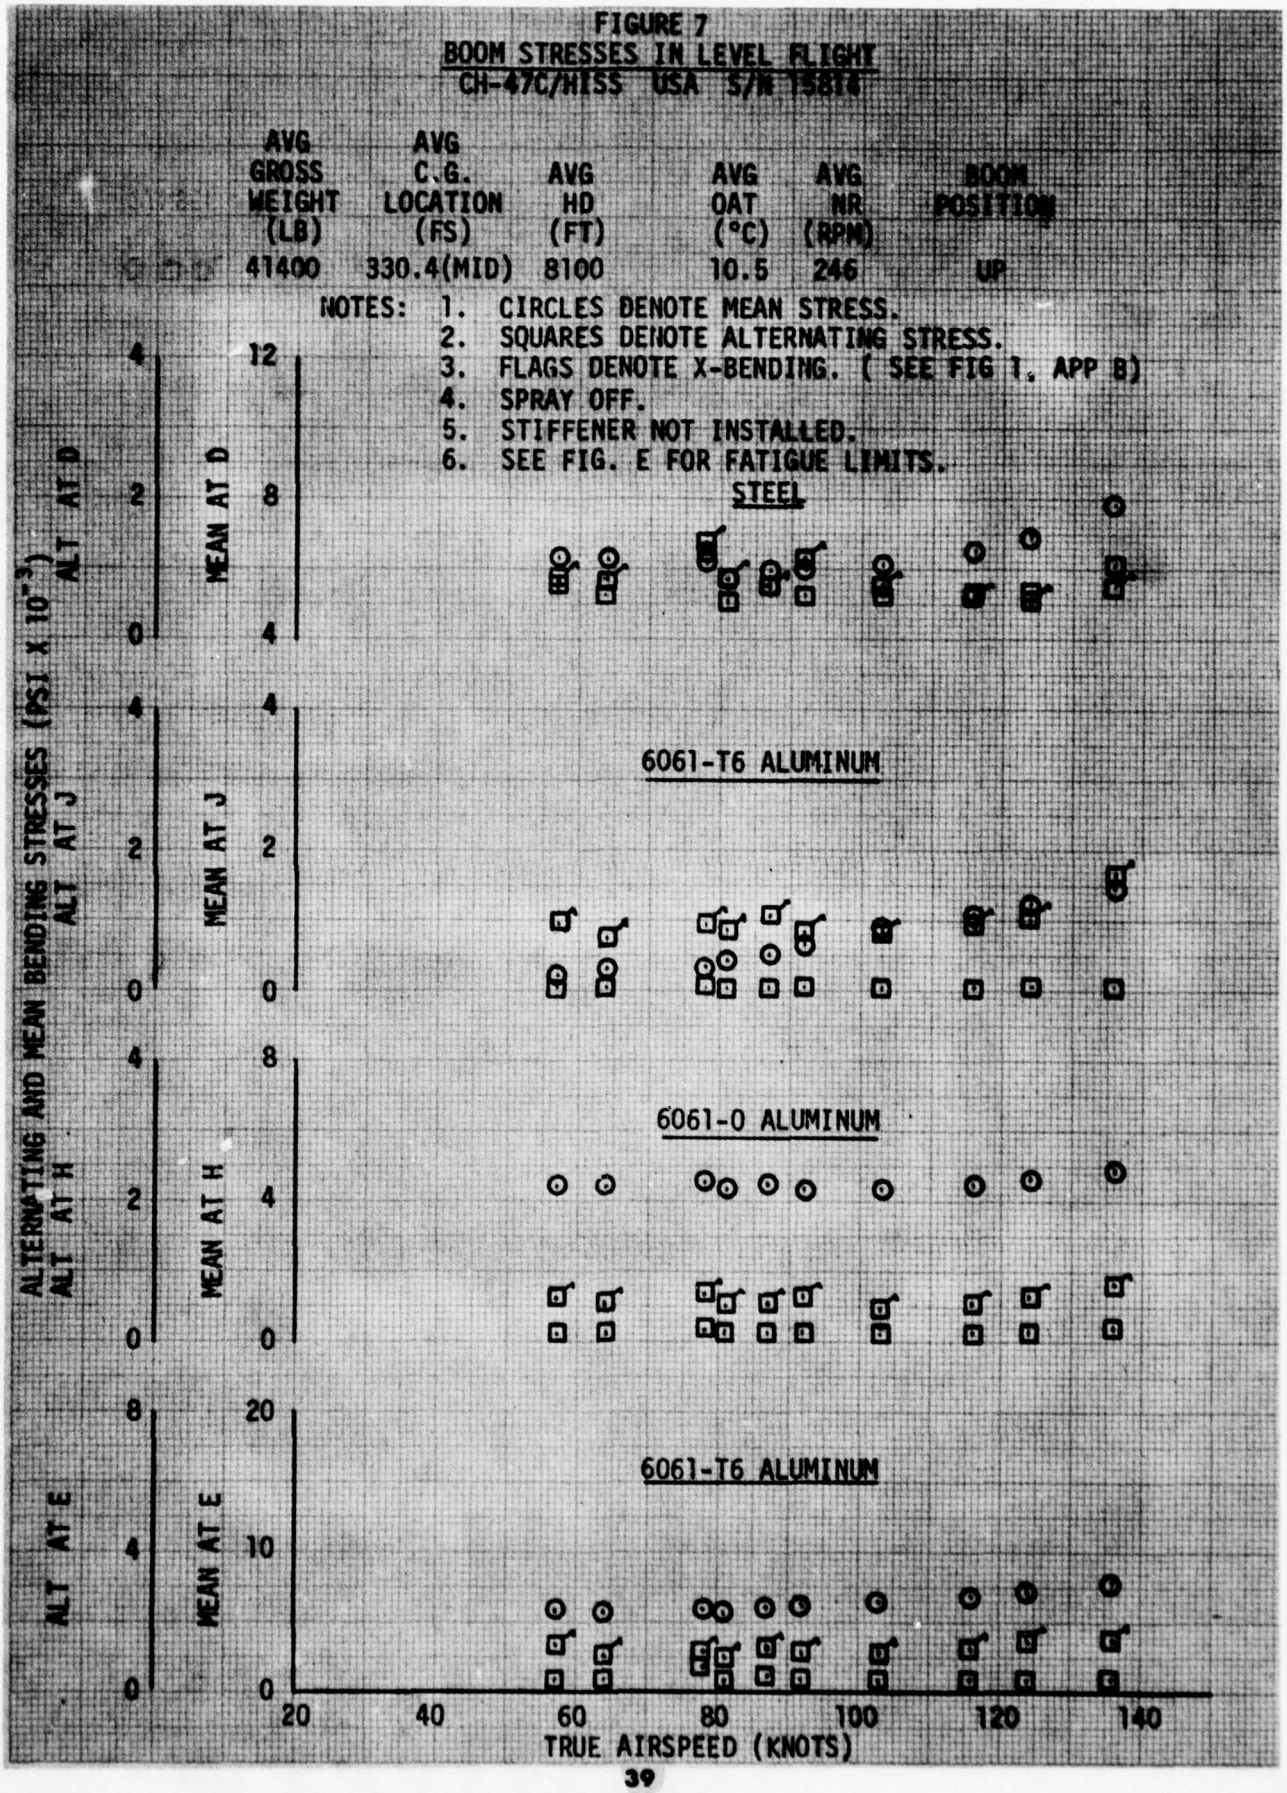
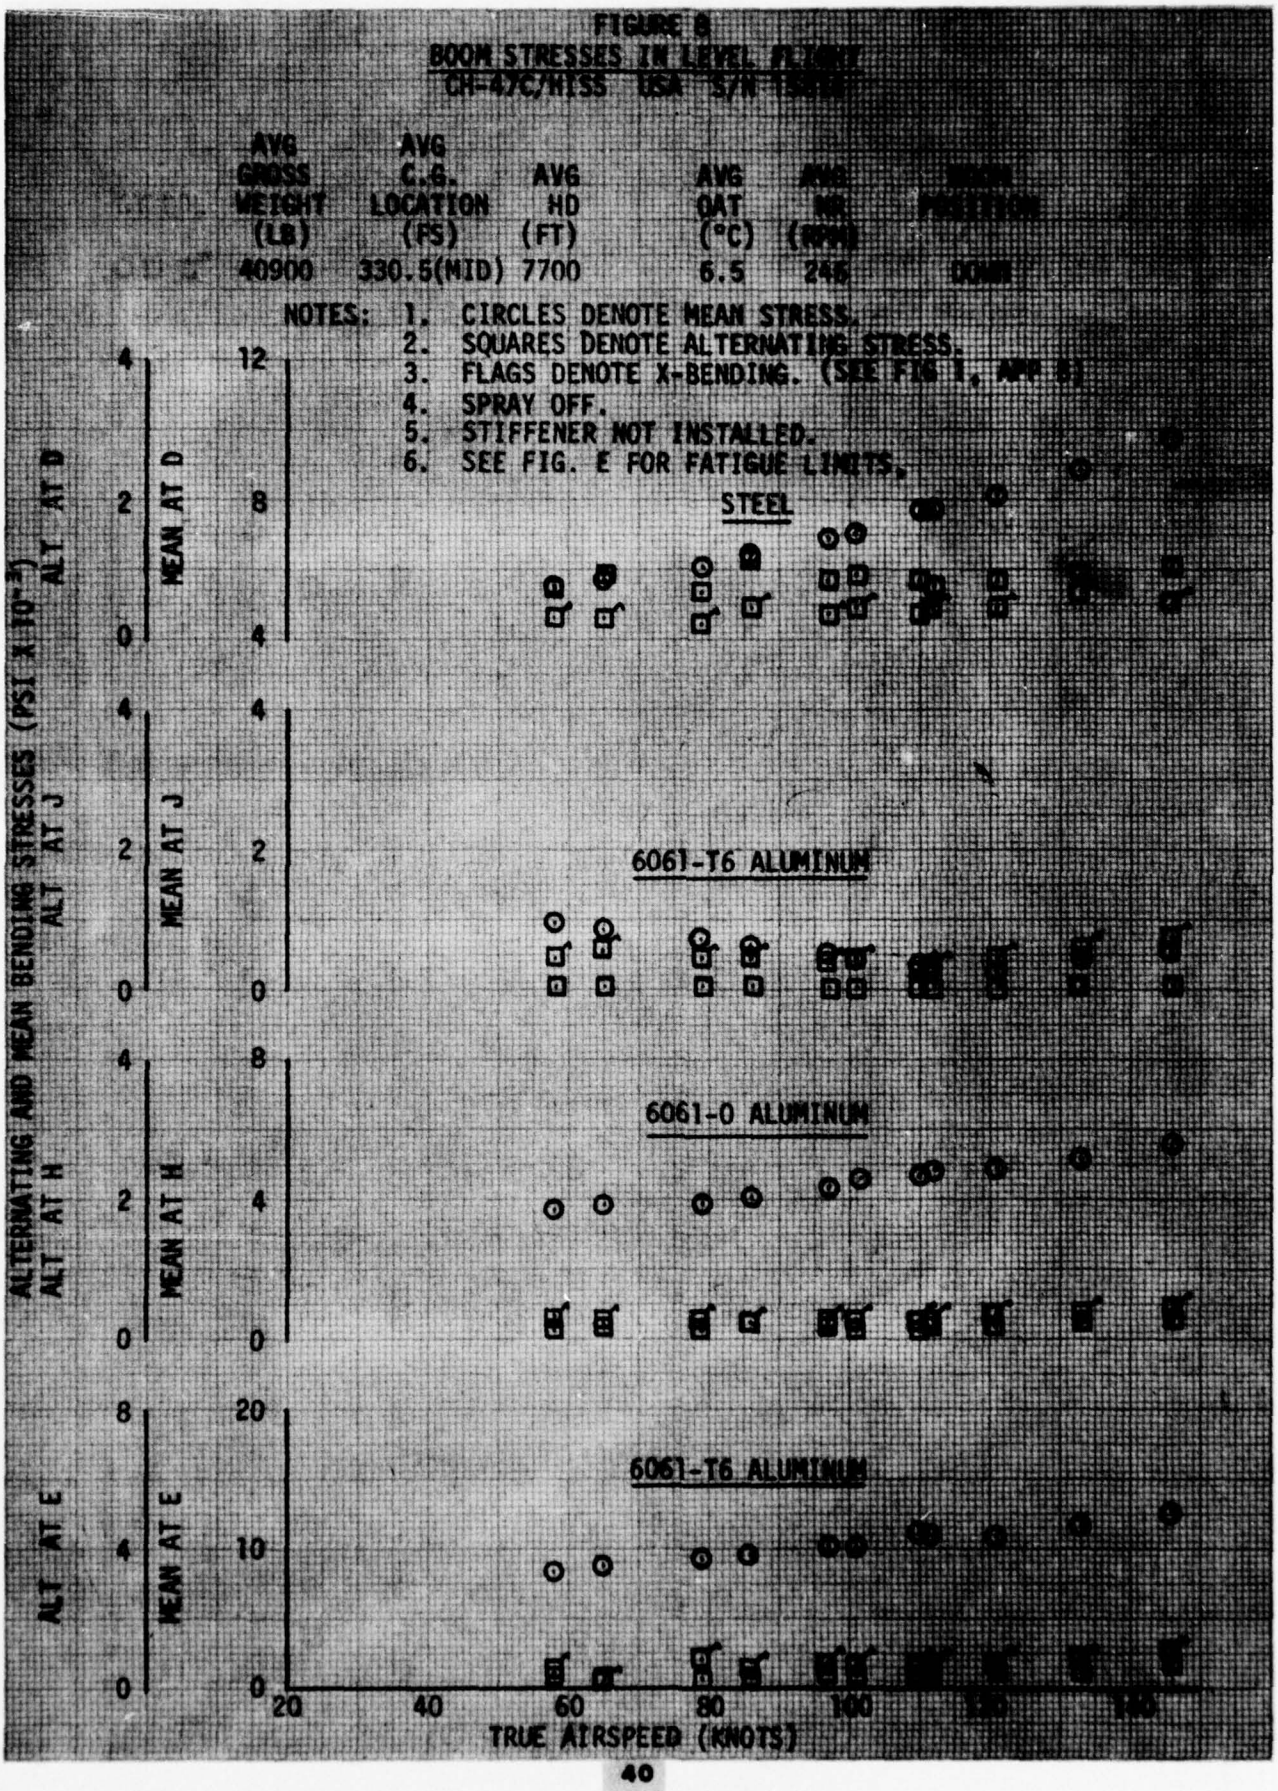
FIGURE 8
BOOM STRESSES IN LEVEL FLIGHT
CH-47C/HISS USA S/N 15[illegible]

(fig. 8, app C). Alternating stresses in the aluminum sections were larger with spray ON than with spray OFF. Figures 8 and 9 illustrate the higher loads with spray ON. The stresses at location E reached the endurance limit specified in the safety-of-flight release at 138 KTAS during the envelope expansion tests with spray ON. However, during the cloud measurement flights, significantly higher alternating stresses were randomly encountered (mean stresses were unchanged). These higher alternating stresses could not be correlated to changes in gross weight, density altitude, rotor speed, water remaining in the tank, or water flow rate. Without the stiffener installed, the CH-47C/HISS would be restricted to 110 KTAS for all flight conditions.

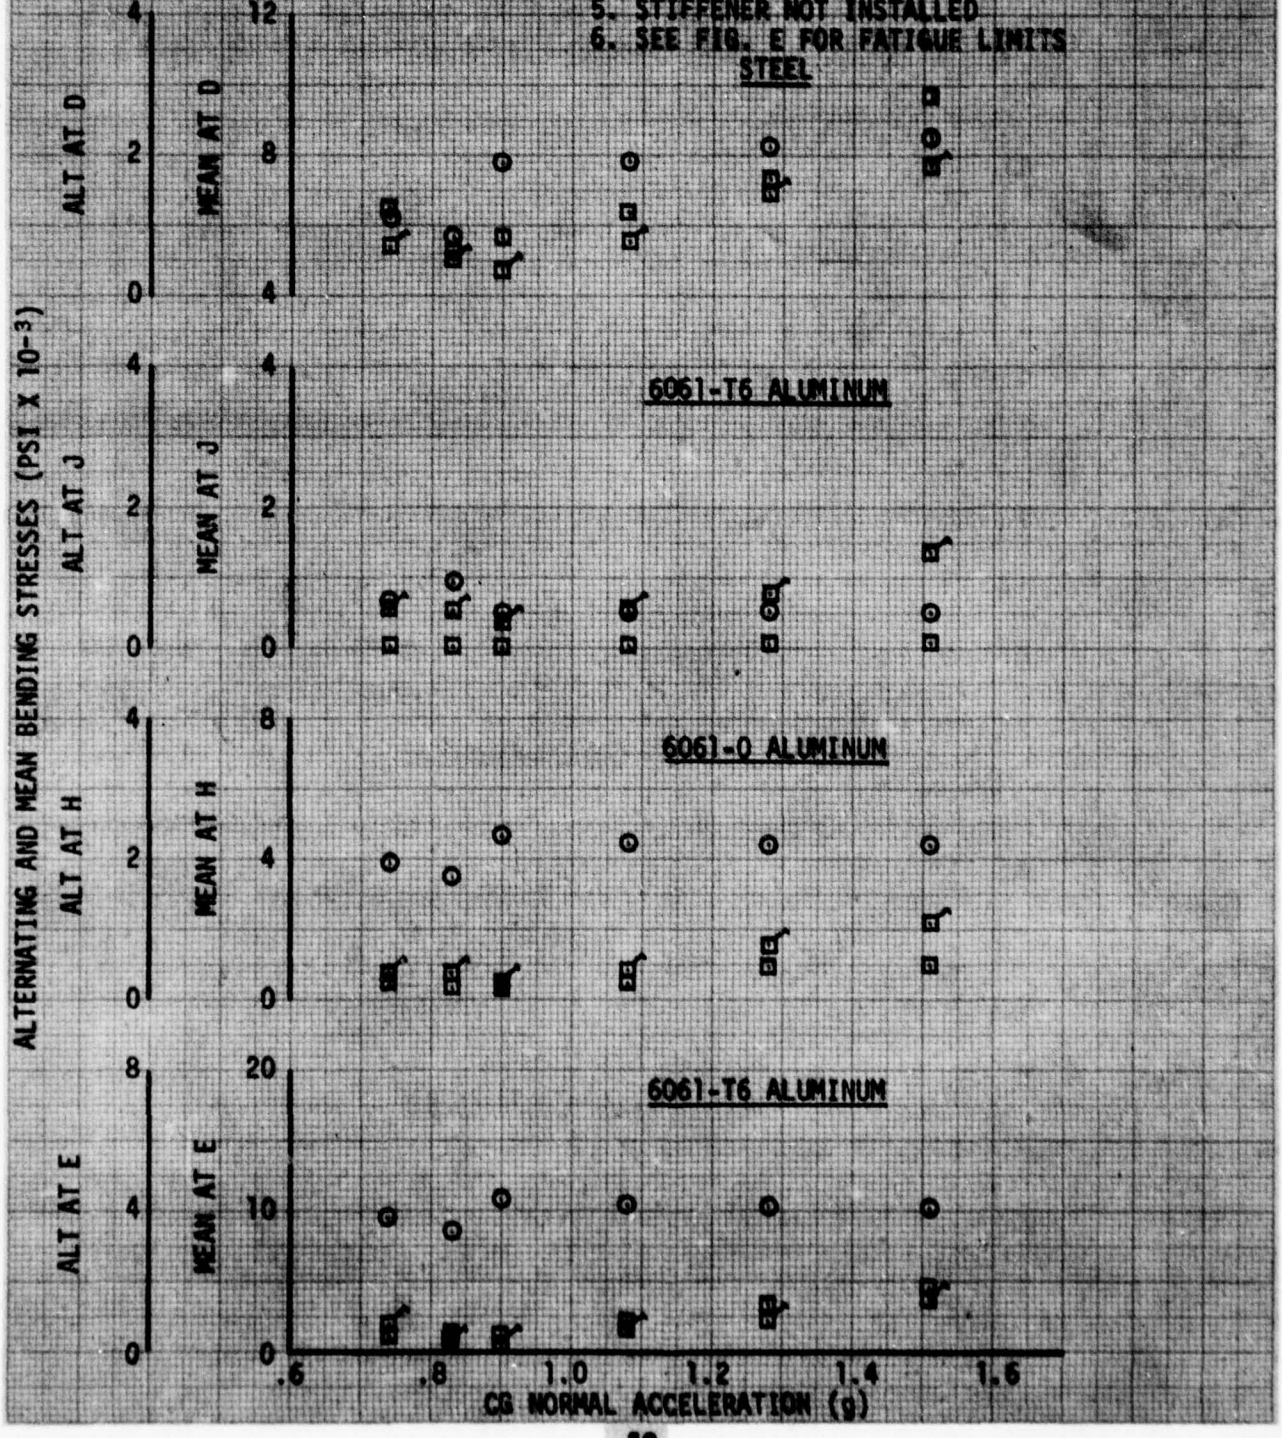
FIGURE 19
BOOM STRESSES IN LEVEL FLIGHT
CH-47C/HISS USA S/N 15814

20. With the stiffener attached, two conditions produced oscillatory stresses in the aluminum sections in excess of the endurance limit. At a rotor speed of 235 rpm, the stresses were above endurance limit at all flight conditions with the boom retracted or extended (figs. 19 and 20, app C). At 245 rpm, the stresses were excessive with the boom UP at airspeeds greater than 30 KTAS in any direction (figs. 21 and 22). Stresses at all other conditions (*ie*, boom DOWN, 245 rpm, greater than 30 KTAS) were acceptable. Excessive oscillatory stresses at 235 rpm at all flight conditions and at 245 rpm with the boom retracted at greater than 30 KTAS constitute a shortcoming. All flights should be conducted at 245 rpm. During flight with the boom retracted, airspeed in any direction should be limited to 30 KTAS.

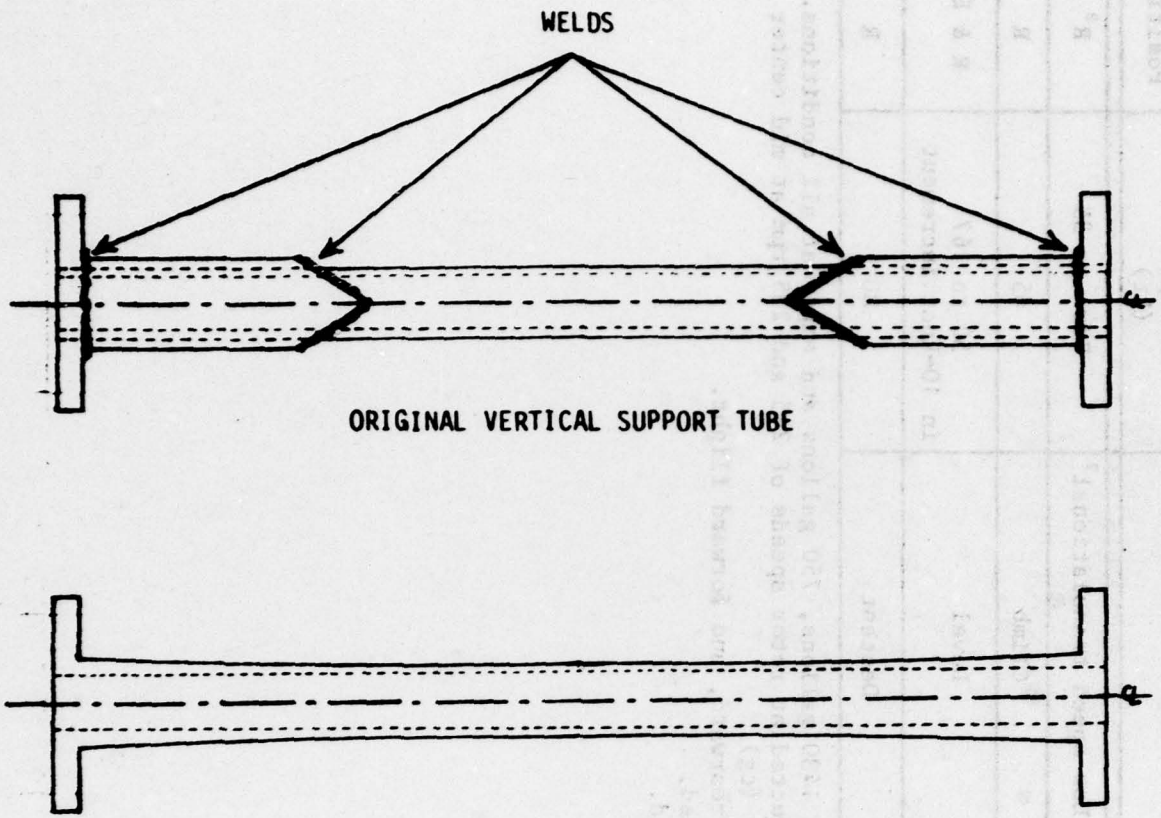
Figure 2. Vertical Support Tubes.

Cracks in weld between upper attaching flange and right-hand tube were discovered during routine inspection following 4th flight. Removal and inspection of left-hand tube revealed similar cracks. Cause appears to be insufficient fusing of weld material and tube. Investigation is continuing. Tubes have been removed and will be replaced.

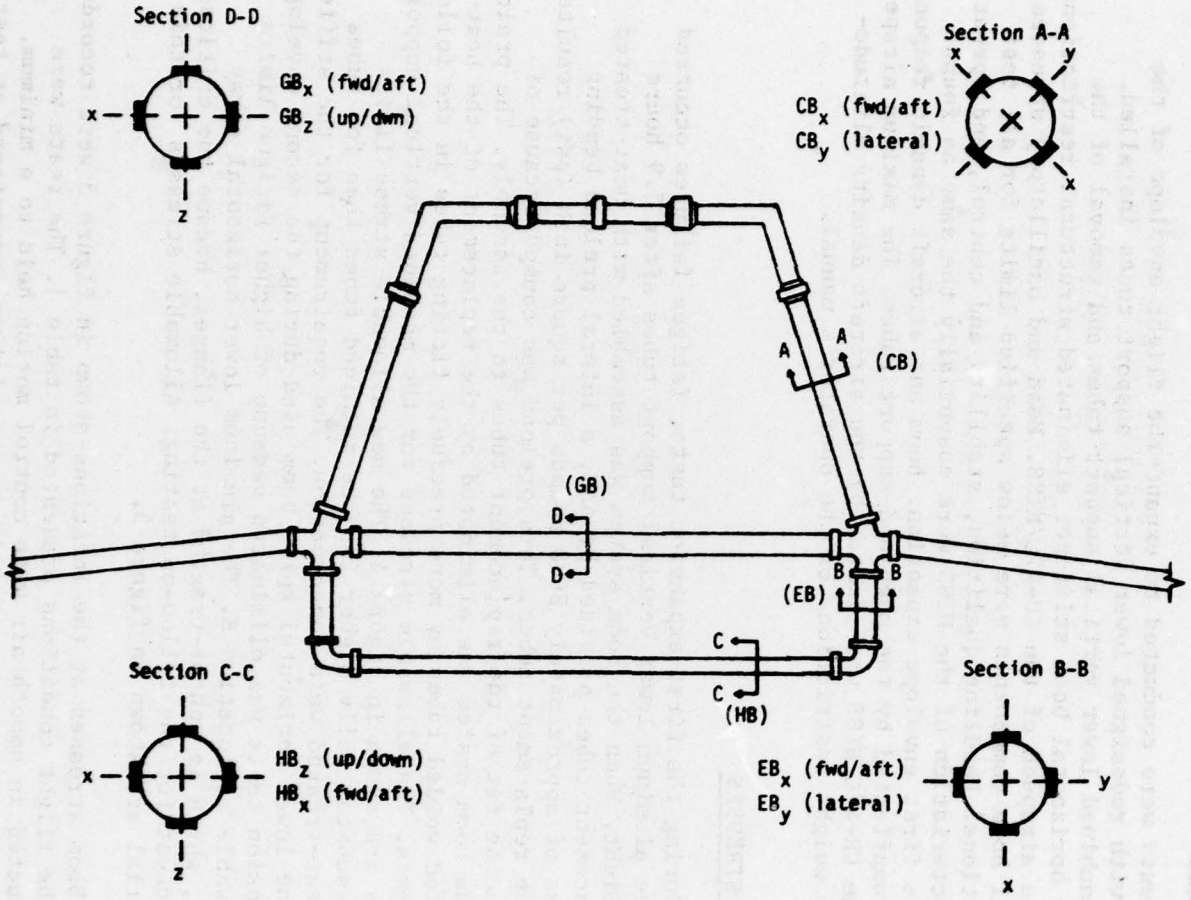
Figure 3. Spray Boom Strain Gauge Locations.

12. Boom stresses at the locations shown in figure 3 were recorded at the flight conditions presented in table 1. The tests were conducted in smooth air with control motion held to a minimum. Thus, the stresses presented are the minimum encountered at test conditions. The data are presented as mean bending stress (vector sum of the bending in two axes) and alternating stress (one-half peak-to-peak stress in each axis). Data are presented in figures 6 through 11.

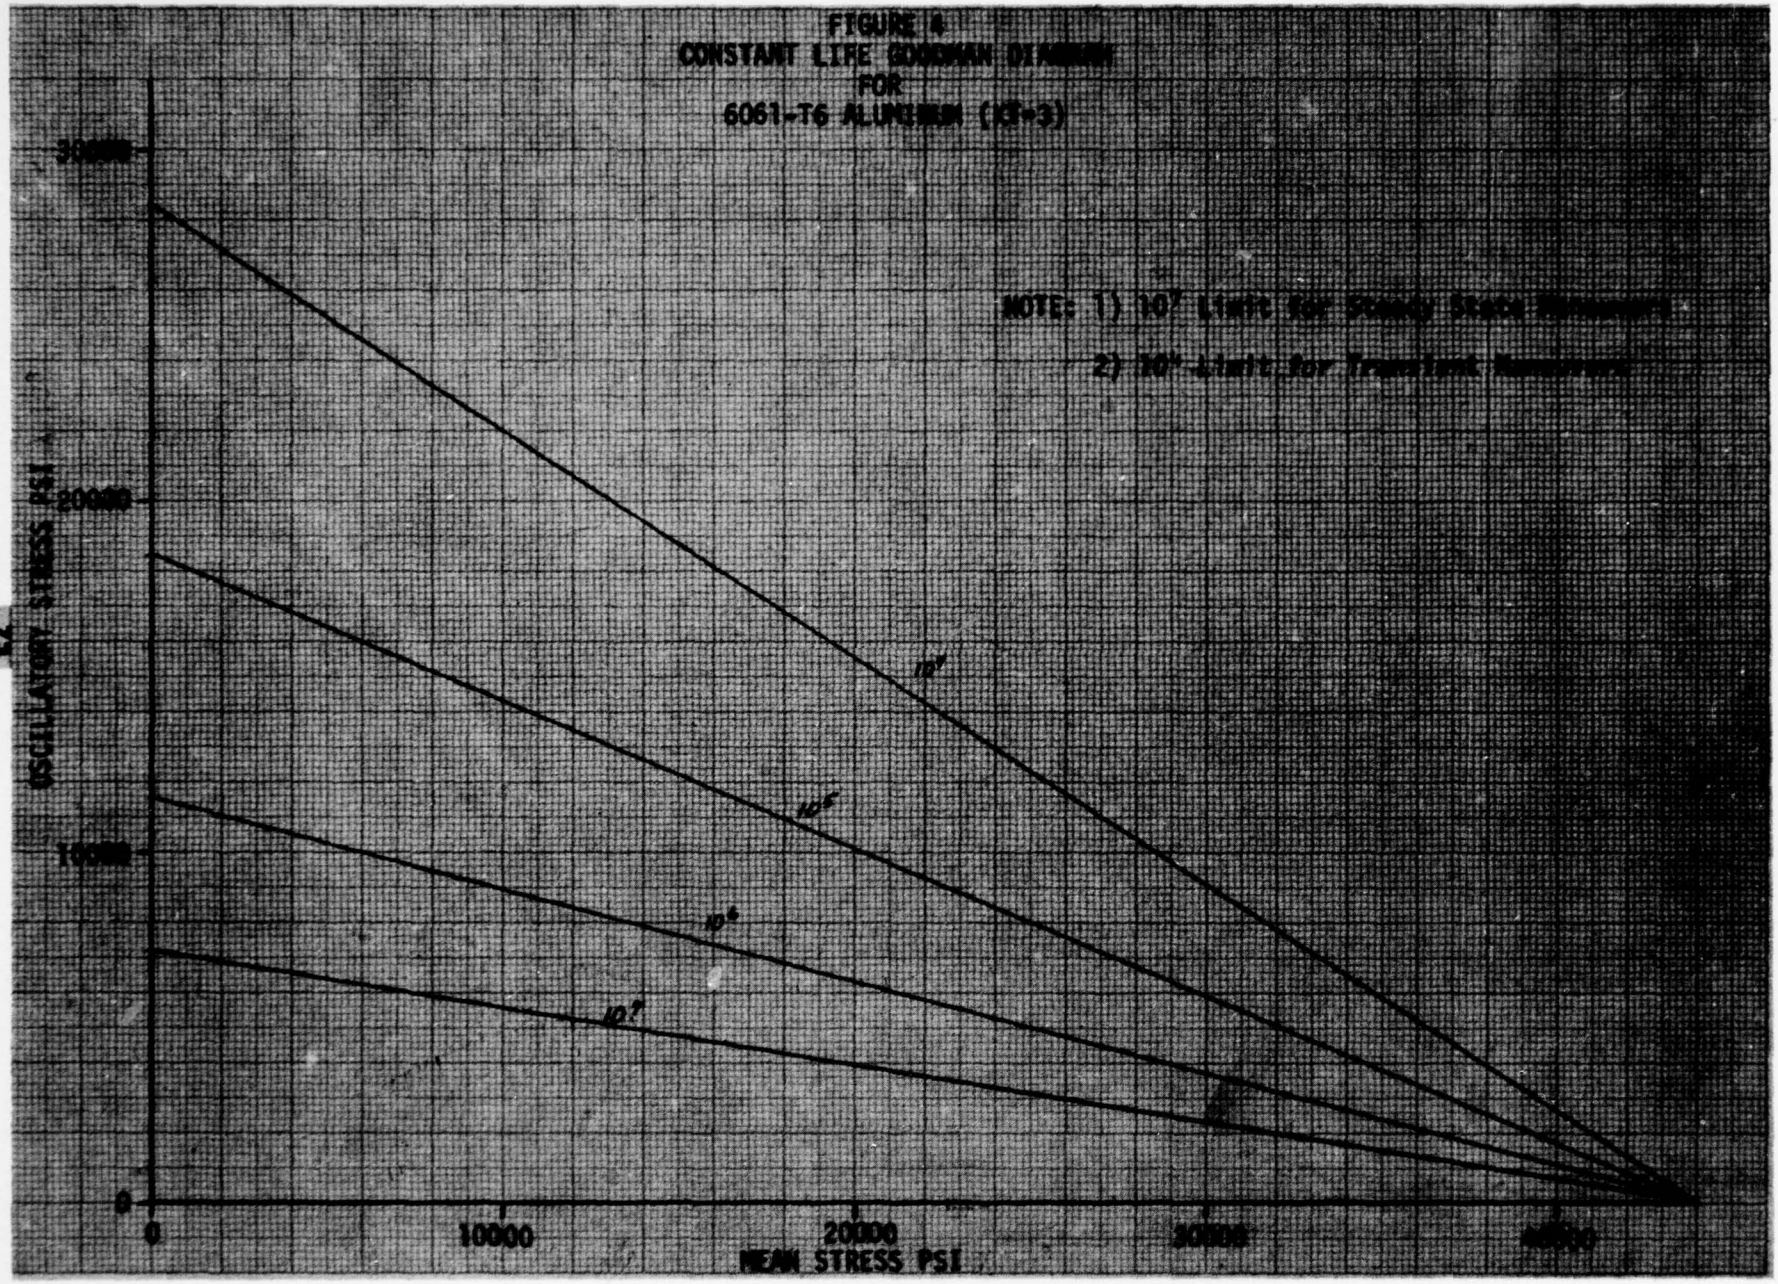
FIGURE 5
MODIFIED GOODMAN DIAGRAM

11. During the first expansion tests, fatigue failures occurred in the aluminum lower vertical support tubes after 5.9 hours of flight. When the boom system was assembled with heat-treated replacement tubes provided by AAE, a lateral preload bending stress of approximately 3600 pounds per square inch (psi) resulted in the replacement tubes. This preload was caused because of imprecise fit of the replacement tubes to the assembly. The preload in the boom system was eliminated by the replacement of the heat-treated welded tubes by more precisely fitting tubes in the follow-on tests. The allowable stresses for the machined vertical support tubes are shown in figure 4. The new allowable stress limits were substantially higher for the machined tubes than for tubes of heat-treated weld construction. The requirement for the stiffener on the lower horizontal spray boom used during the second envelope expansion tests was eliminated because of higher fatigue limits allowable at location E. The aluminum lower horizontal spray boom, which is unheat-treated at the flanges, became the critical component for the follow-on testing. Allowable stresses for this material are shown in figure 5.
