AN/TPS-59(XN-1) EDM
RADAR SET, MARINE LIGHTWEIGHT TACTICAL 3D
ENGINEERING DEVELOPMENT MODEL .

PRE-SERVICE ACCEPTANCE TEST REPORT.

VOLUME I.

(11) 29 Apr 1977

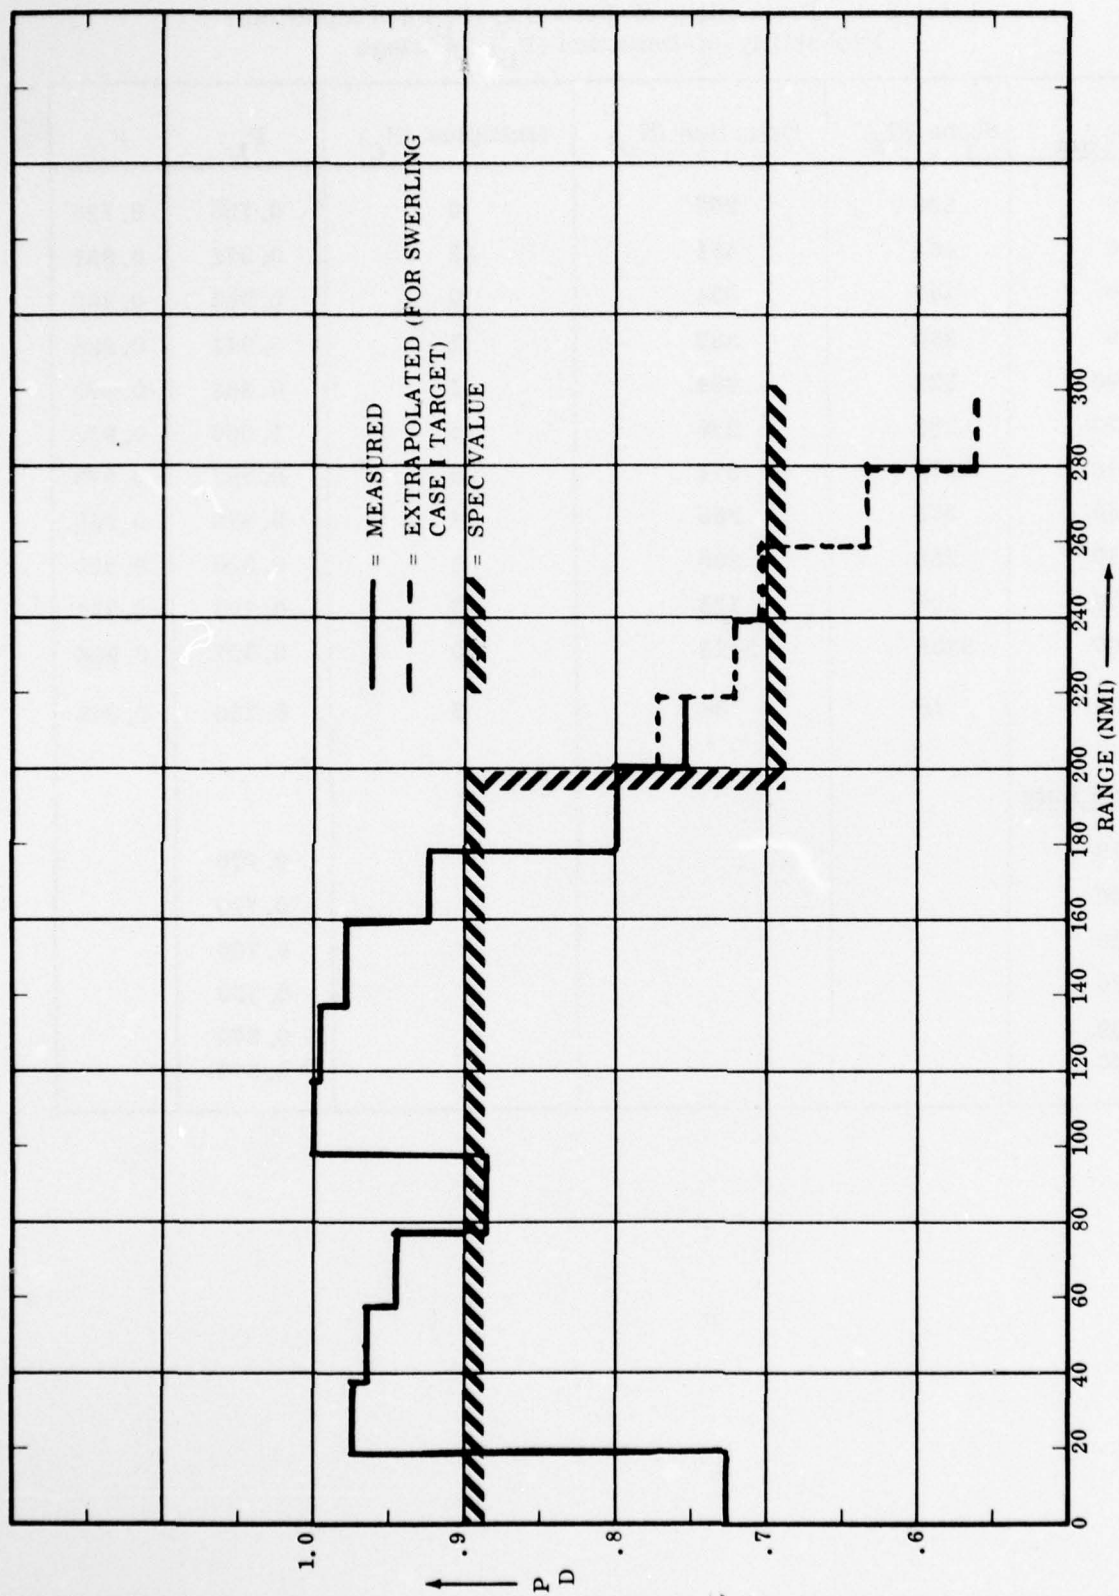
Figure 2-1. Probability of Detection vs Range

Comparison of the flight data with an analytical prediction which assumes a $0.7m^2$ steady (i.e., nonfluctuating) target, indicates that the radar is 2 dB low in sensitivity relative to its condition as determined in our April sensitivity evaluation (presented to NRL on 21 April 1976). The conclusion of a lack of sensitivity is hard to accept in face of the exhaustiveness of the April evaluation. An alternative explanation is that the target is not steady, but actually fluctuates. For example, the signal-to-noise ratio required to achieve a 90% detection probability on a $0.7m^2$ (Swerling Case I) fluctuating target is 8.0 dB greater than that required against a $0.7m^2$ steady reflector.

One argument supporting the notion that the target cross section fluctuates stems from a comparison between the performance achieved at 80 to 100 nmi and 180 to 200 nmi. At the longer range, including the higher atmospheric absorption loss, 12.3 dB more energy is required to achieve the same signal-to-noise ratio. The long range pulse has four times the energy of the short range pulse, hence the signal-to-noise ratio achieved at 200 nmi is less by 6.3 dB.

Thus, it appears that the radar sensitivity exhibited during flight testing is very nearly that predicted as a result of the April sensitivity evaluation. There are, however, several simple changes that can be made to the transmit template which should enhance performance in the range intervals beyond 180 nmi for a Swerling Case III target as well as overcome the turn-on difficulties associated with predrivers in the 0 to 20 nmi range interval. These changes are given in the recommendations paragraph below.

2.4.1.4.   Recommendations.

Two software changes are recommended to enhance detectability and height accuracy in this region.

1)   Replace the two spoiled beams used at the upper elevations of the short range interval with three unspoiled beams.

2)   If further investigation proves feasible, eliminate simple short pulse and use short range LFM pulse from 4 to 100 nmi (for XN-1 only).

To improve the detectability in the 0 to 20 nmi range interval, the previously known turn-on difficulties associated with the row transceiver predrivers must be overcome. Since the predriver has been substantially modified in the design of the next-generation, low-cost row transceiver scheduled for future production, improving the present predriver seems to be of questionable value. A possible solution that requires additional investigation is to eliminate the simple short pulse in the transmit template and use the 102.4 μs, short-range LFM pulse for the 0 to 100 nmi region. This solution, applicable only to the XN-1 model of AN/TPS-59, may have several minor complications. One is a definite, but slight loss of range resolution between 4 and 9 nmi due to truncation of the receive pulse. The other is a possibility of a high false alarm rate. Since the short-range LFM pulse has such high energy relative to the simple pulse (256 times as much), very short range clutter returns may cause false alarms, especially when entering through the sidelobes of the upper beams which do not employ MTI. Prior investigations of this change using the spoiled beams were not encouraging. Another investigation should be made after the spoiled beams have been eliminated. The unspoiled beams have lower sidelobes, to the extent that few clutter returns should be detectable and these should be eliminated by subsequent signal processing. If the investigation indicates improvement in short range performance, then this solution should be adopted for the AN/TPS-59(XN-1) to overcome the predriver turn-on difficulties.

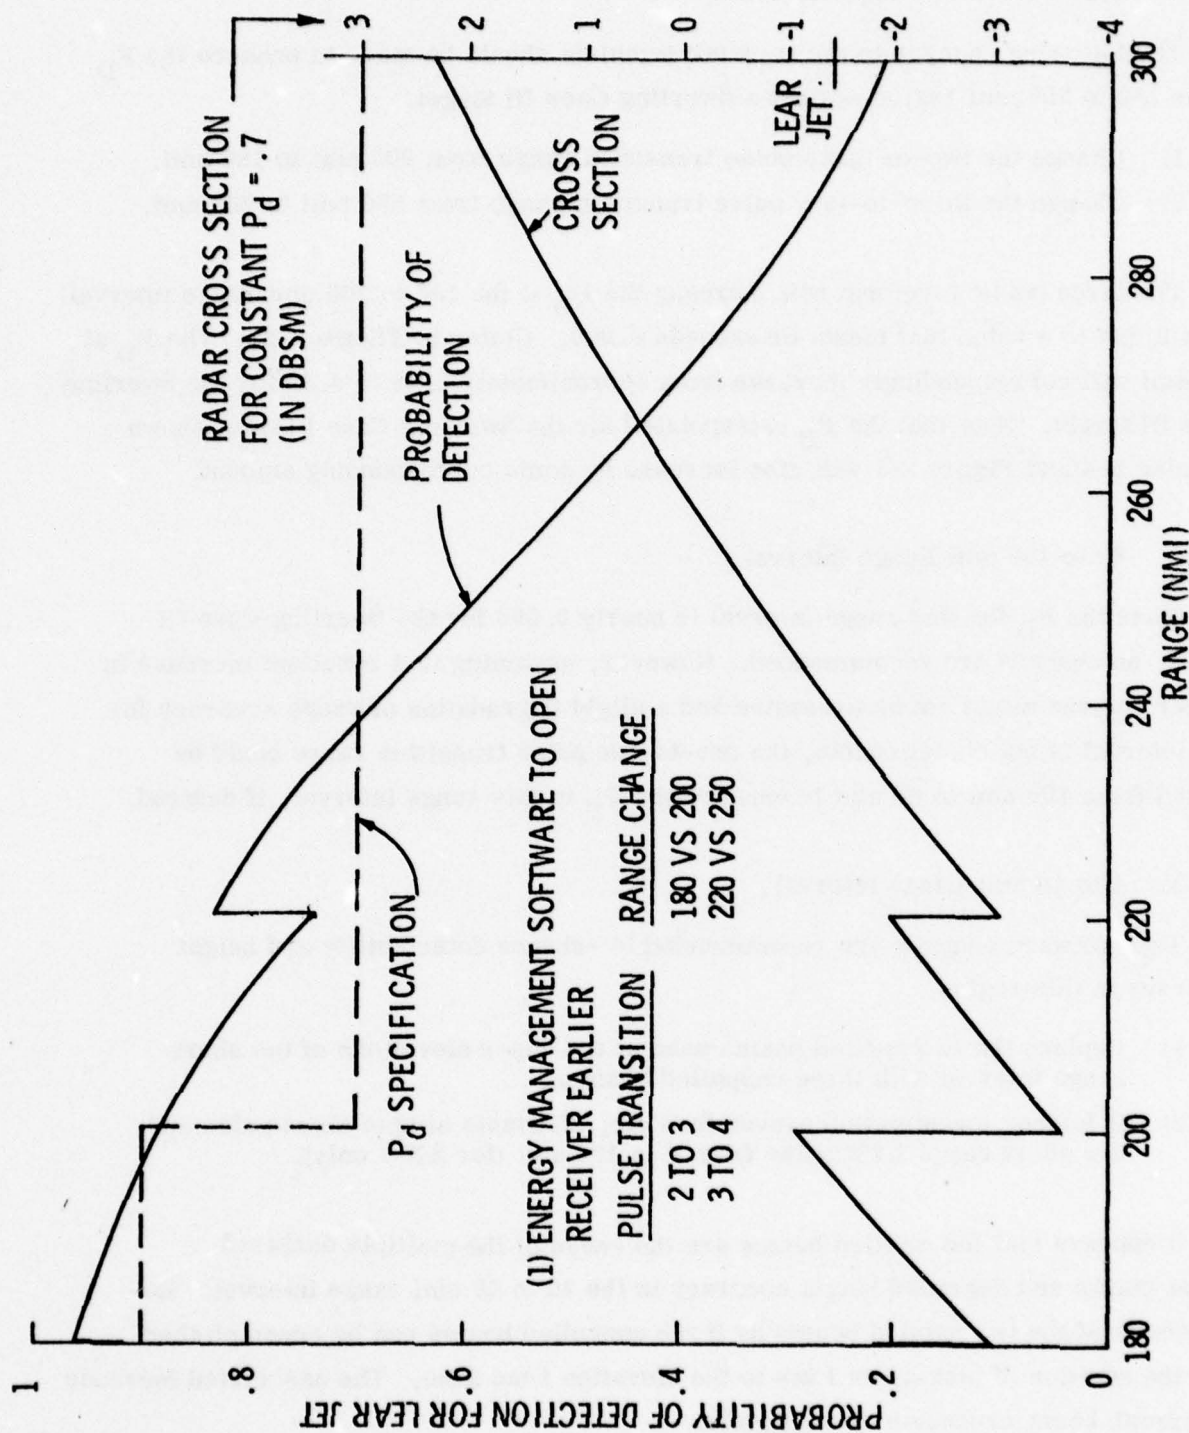
Figure 2-2. Detection Extrapolations for High Altitude Targets

Note that improvements of the P_D for the 180 to 200 nmi range interval will cause a corresponding increase in the extrapolated P_D (based on Swerling Case I target) for the 200 to 300 nmi region. The resulting increases should cause the average P_D to meet or exceed the overall specification P_D requirement of 0.700 for the 200 to 300 nmi region.

It appears that the spoiled beams are the cause of the multiple declared target marks and degraded height accuracy in the 20 to 40 nmi range interval. Replacement of the two spoiled beams by three unspoiled beams can be accomplished with the addition of just under 1 ms to the elevation scan time. The associated increase in azimuth beam crossover is negligible.

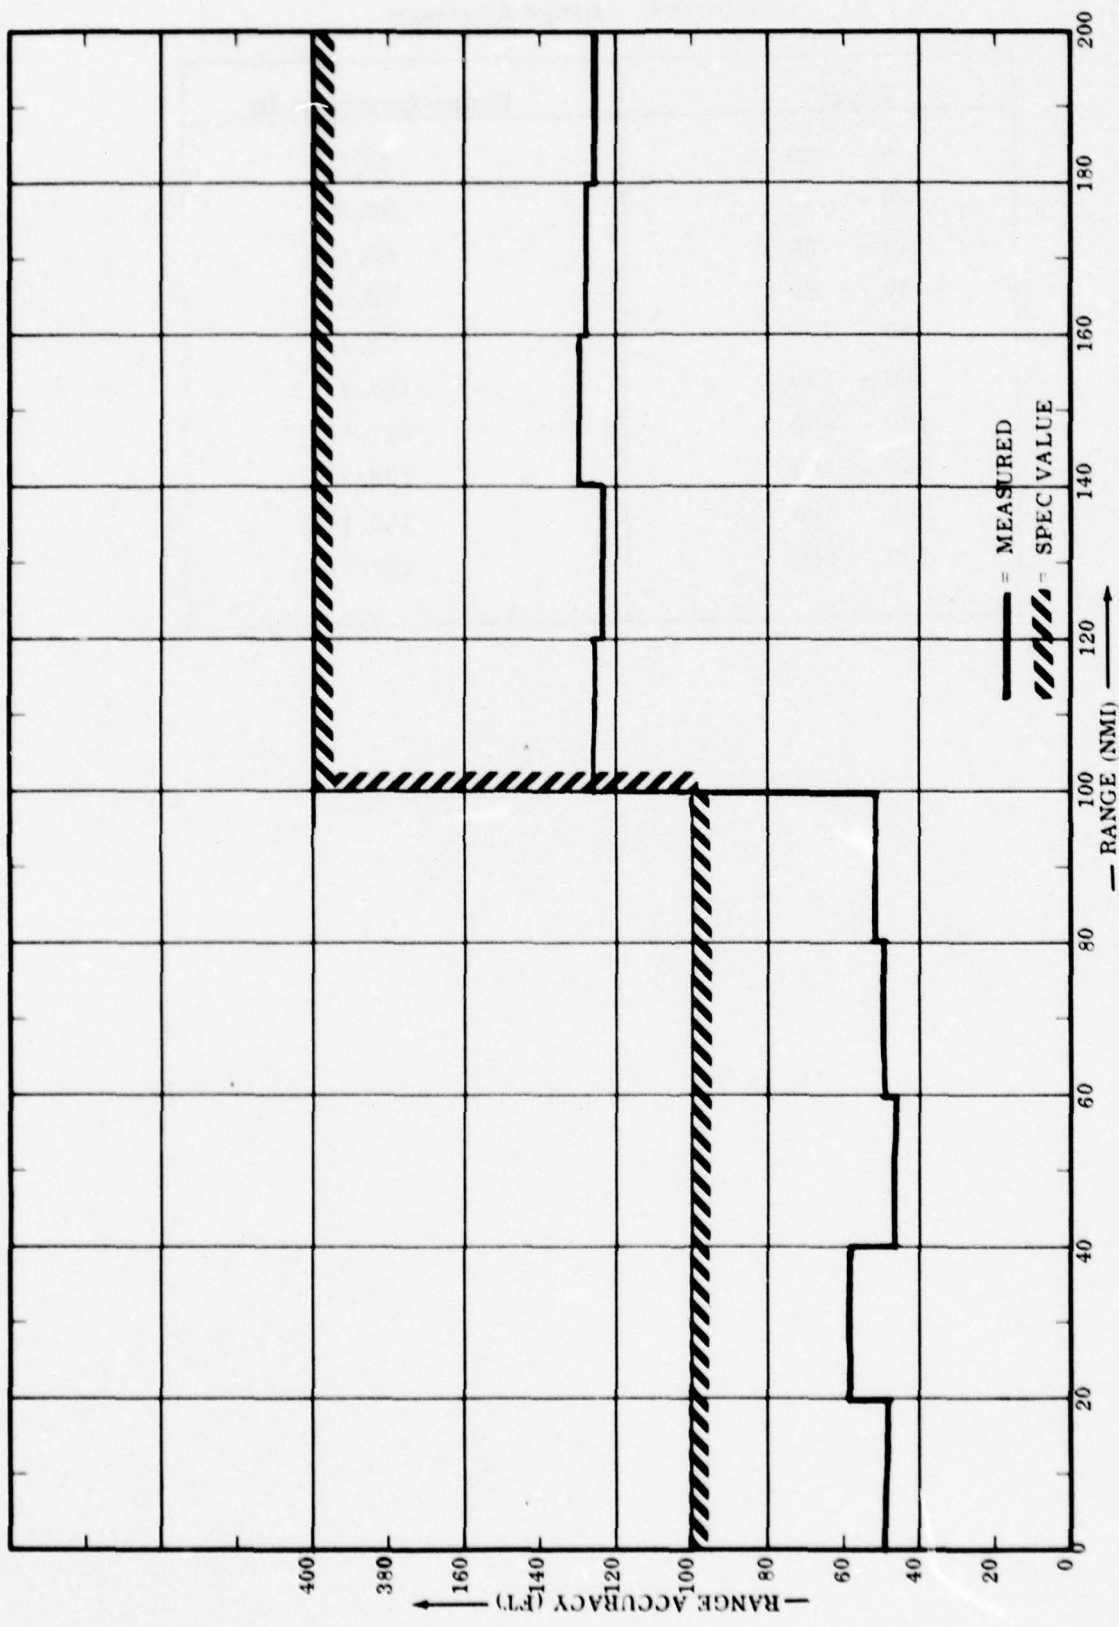
Figure 2-4. Range Accuracy vs Range

The summary of range accuracy (error) versus range is given in Table 2-8. and is shown graphically in Figure 2-4.

Assuming that the rms range error of the AN/FPS-16 is negligible, the most stringent case, than the inequalities given in paragraph 2.6.1.1 reduce to a range accuracy requirement of 100 ft from 0 to 100 nmi and 400 ft beyond 100 nmi for the AN/TPS-59(XN-1). Examination of Table 2-8 or Figure 2-4 shows that the AN/TPS-59(XN-1) is nearly twice as accurate as required from 0 to 100 nmi and over three times as accurate as required beyond 100 nmi.

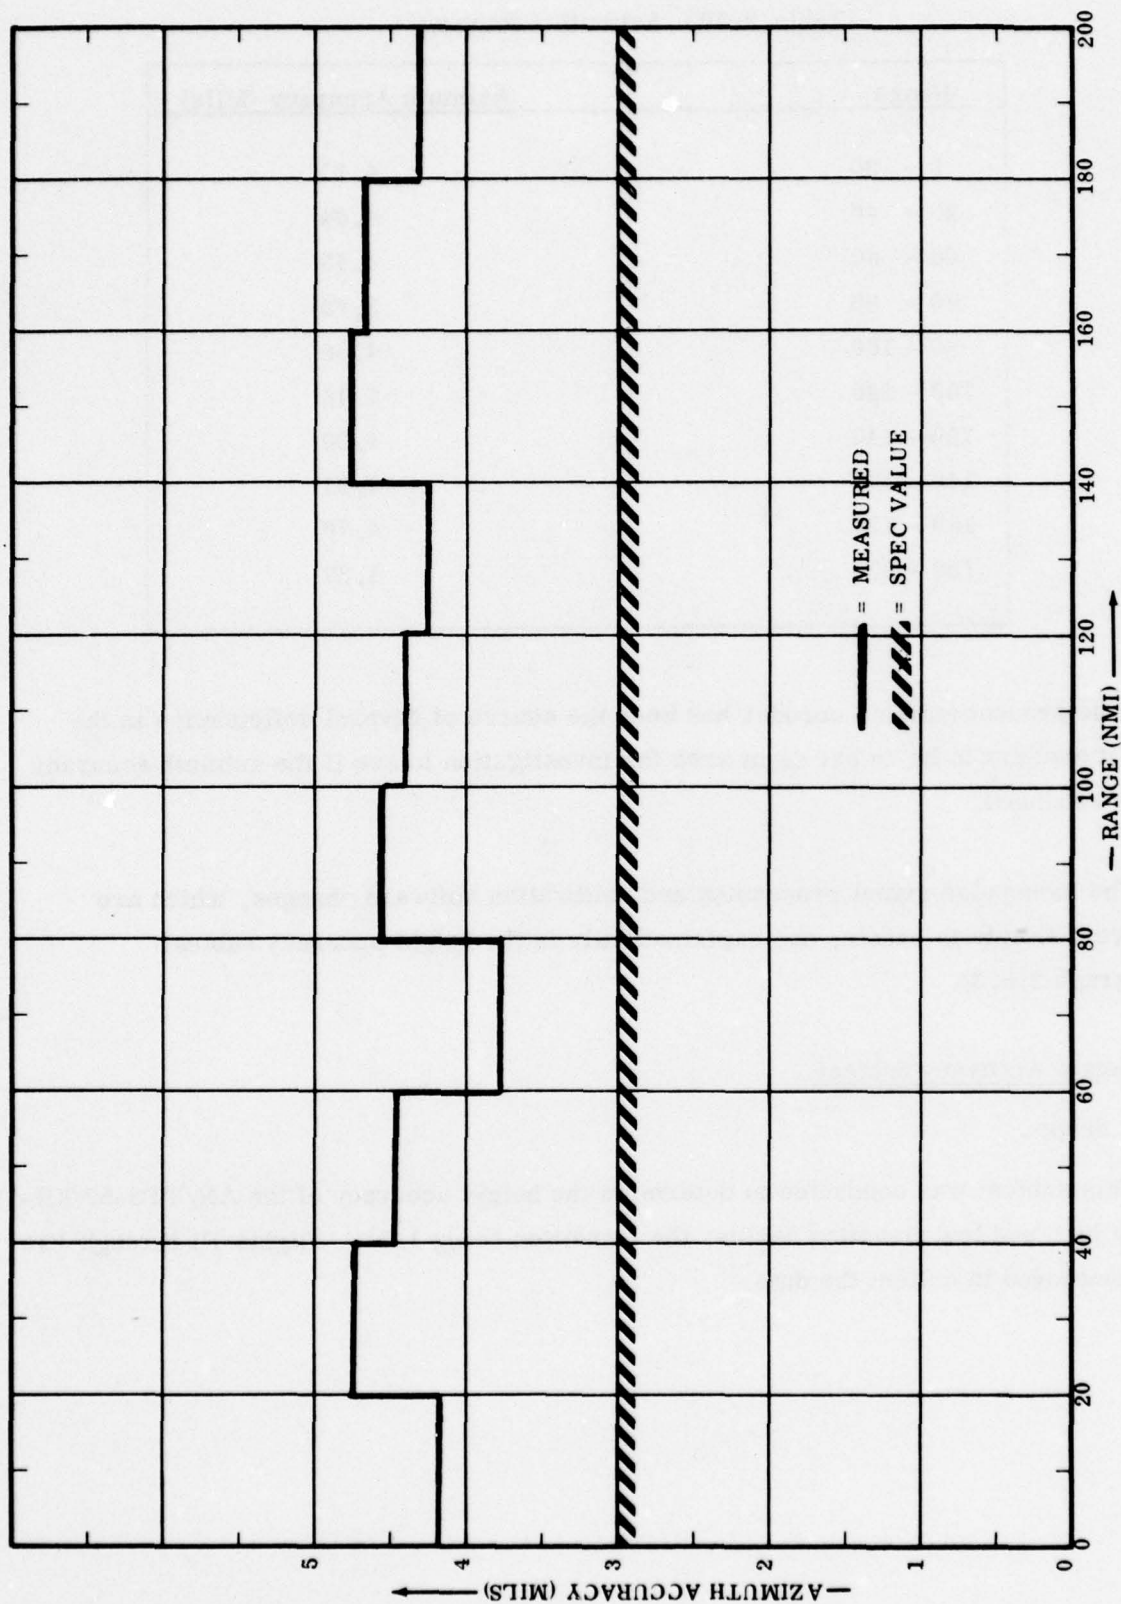
Figure 2-5. Azimuth Accuracy vs Range

An azimuth accuracy of 4.41 mr averaged over a 0 to 200 nmi range, was obtained on the test aircraft on ten flight paths at altitudes that varied from 200 to 40,000 feet. The measured accuracy is degraded from the specified value of 3 mr by 47%. The azimuth accuracy is relatively constant with range and recommended software modifications to improve the accuracy are included in this report.

Two changes are recommended to enhance the azimuth accuracy of the AN/TPS-59(XN-1).

Since the present azimuth encoder has been the source of several deficiencies in the past, it appears to be an excellent area for investigation to see if the azimuth accuracy can be enhanced.

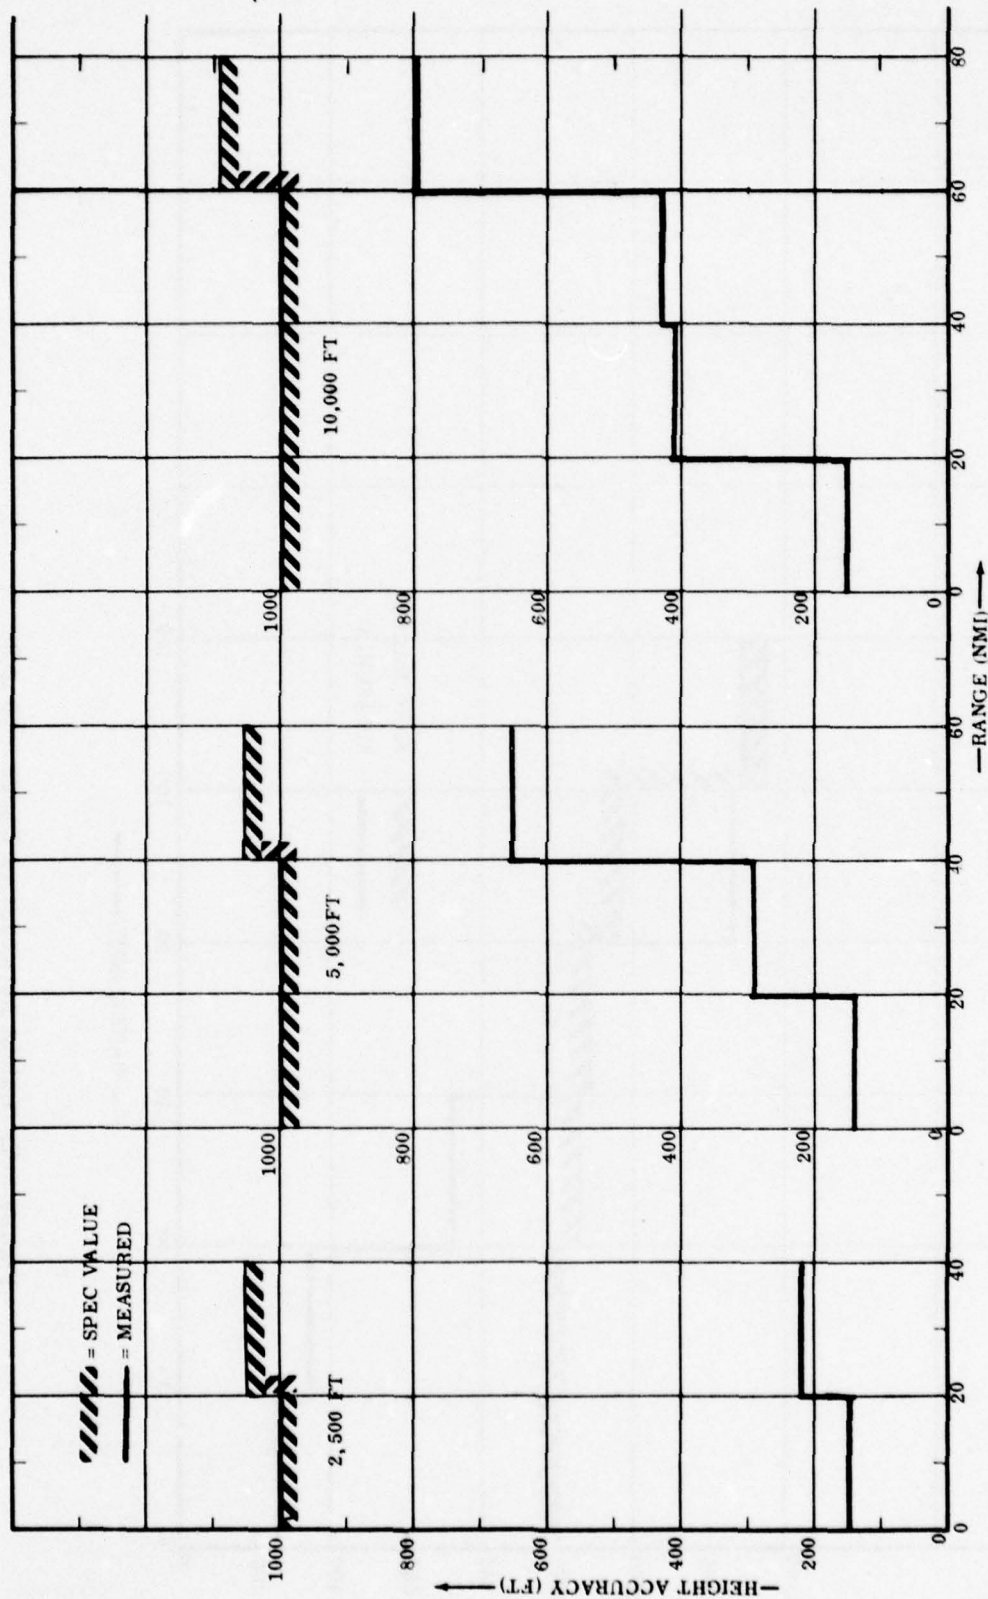
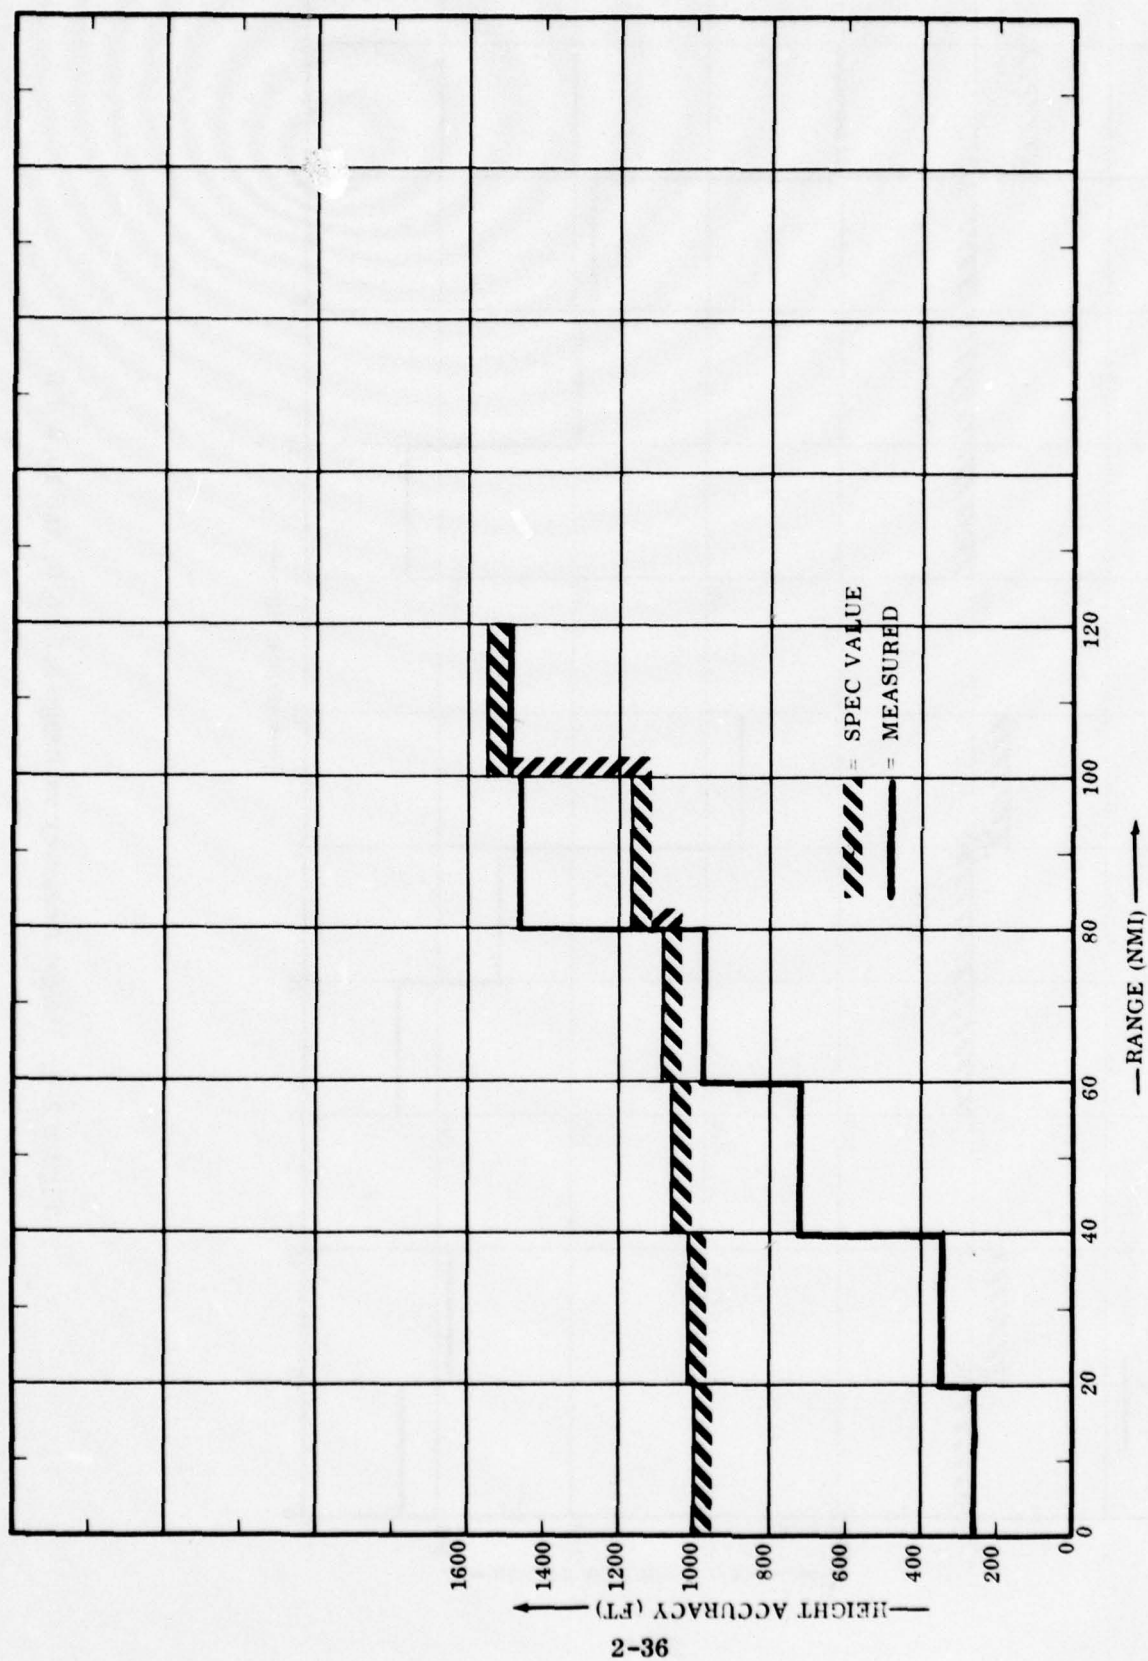
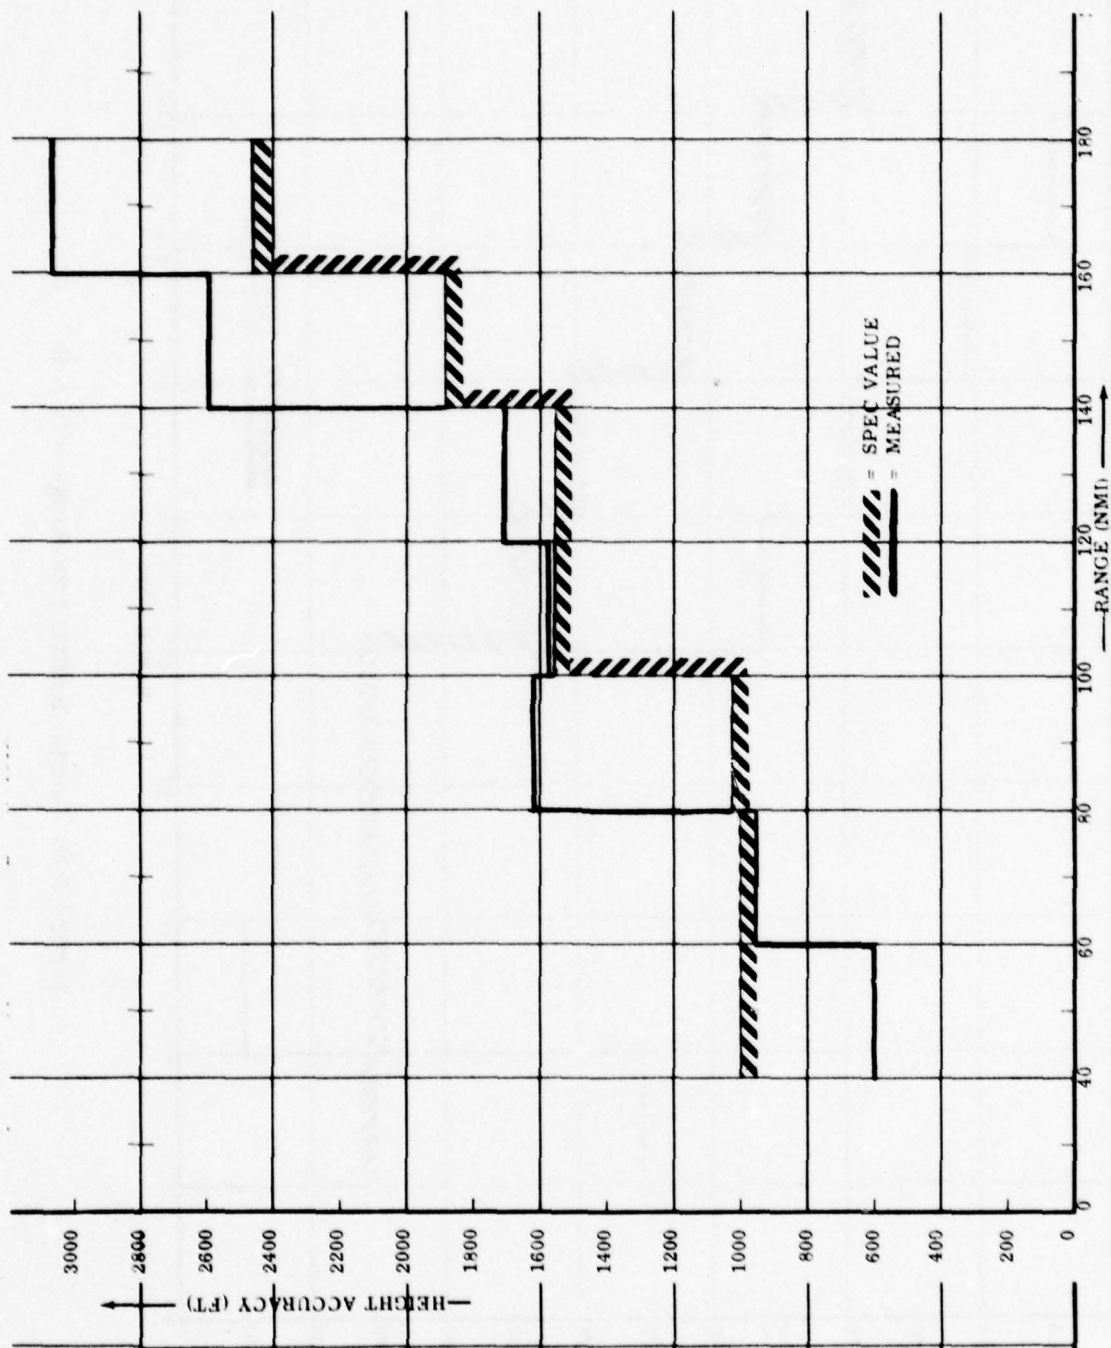
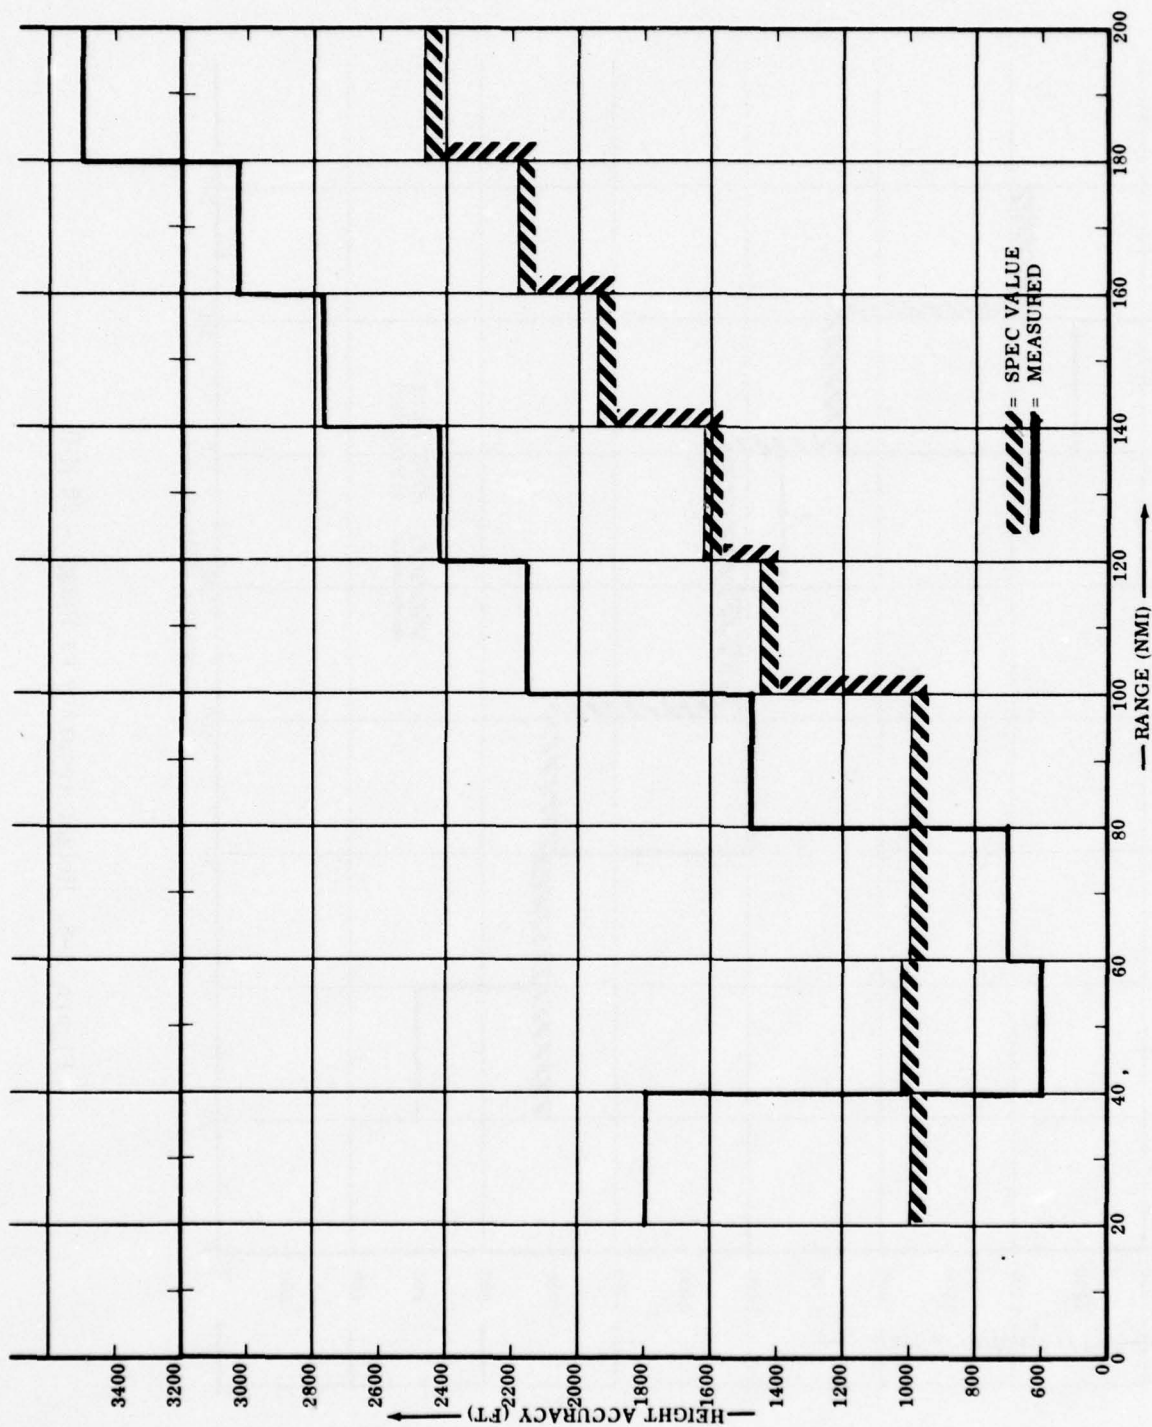
The accuracy was better than the specified 1000 feet for all ranges and altitudes out to 80 nmi except for the 40,000 feet altitude in the 20 to 40 nmi range interval. Spoiled beams in this region degraded the height accuracy.

Beyond 80 nmi, the height accuracy is degraded by about 60% from the specified accuracy except for the 20,000 to 30,000 feet altitudes in the 100 to 120 nmi range interval where the specified accuracy was met. Post flight data indicated that a 1.5 mr elevation bias existed at the time of the flights. Removal of this bias would improve the height accuracy to the point where it is only degraded about 35% from the specified accuracy.

Examination of Table 2-13 or Figures 2-6 through 2-9 shows that the AN/TPS-59(XN-1) is more accurate than required for all ranges and altitudes out to 80 nmi except for the 40,000 ft altitude in the 20-40 nmi range interval. As discussed in the aircraft detectability subtest, the multiple DTM's that appear to be caused by the spoiled elevation beams in the 40 K ft/20-40 nmi region are also affecting the height accuracy. Beyond 80 nmi, the AN/TPS-59(XN-1) height accuracy was degraded about 60% from the required height accuracy except for the 20,000 and 30,000 ft altitudes in the 100 to 120 nmi range interval where it meets the accuracy requirement.

The gradual increase in degradation of the height accuracy with increasing range is low enough to suggest that it is not related to system sensitivity; i.e., increasing the signal-to-noise ratio will not substantially affect height accuracy.

To enhance height accuracy at 40,000 ft in this range interval, it is recommended that the two spoiled beams used at the upper elevation be replaced with three unspolied beams as discussed in the aircraft detectability subtest.

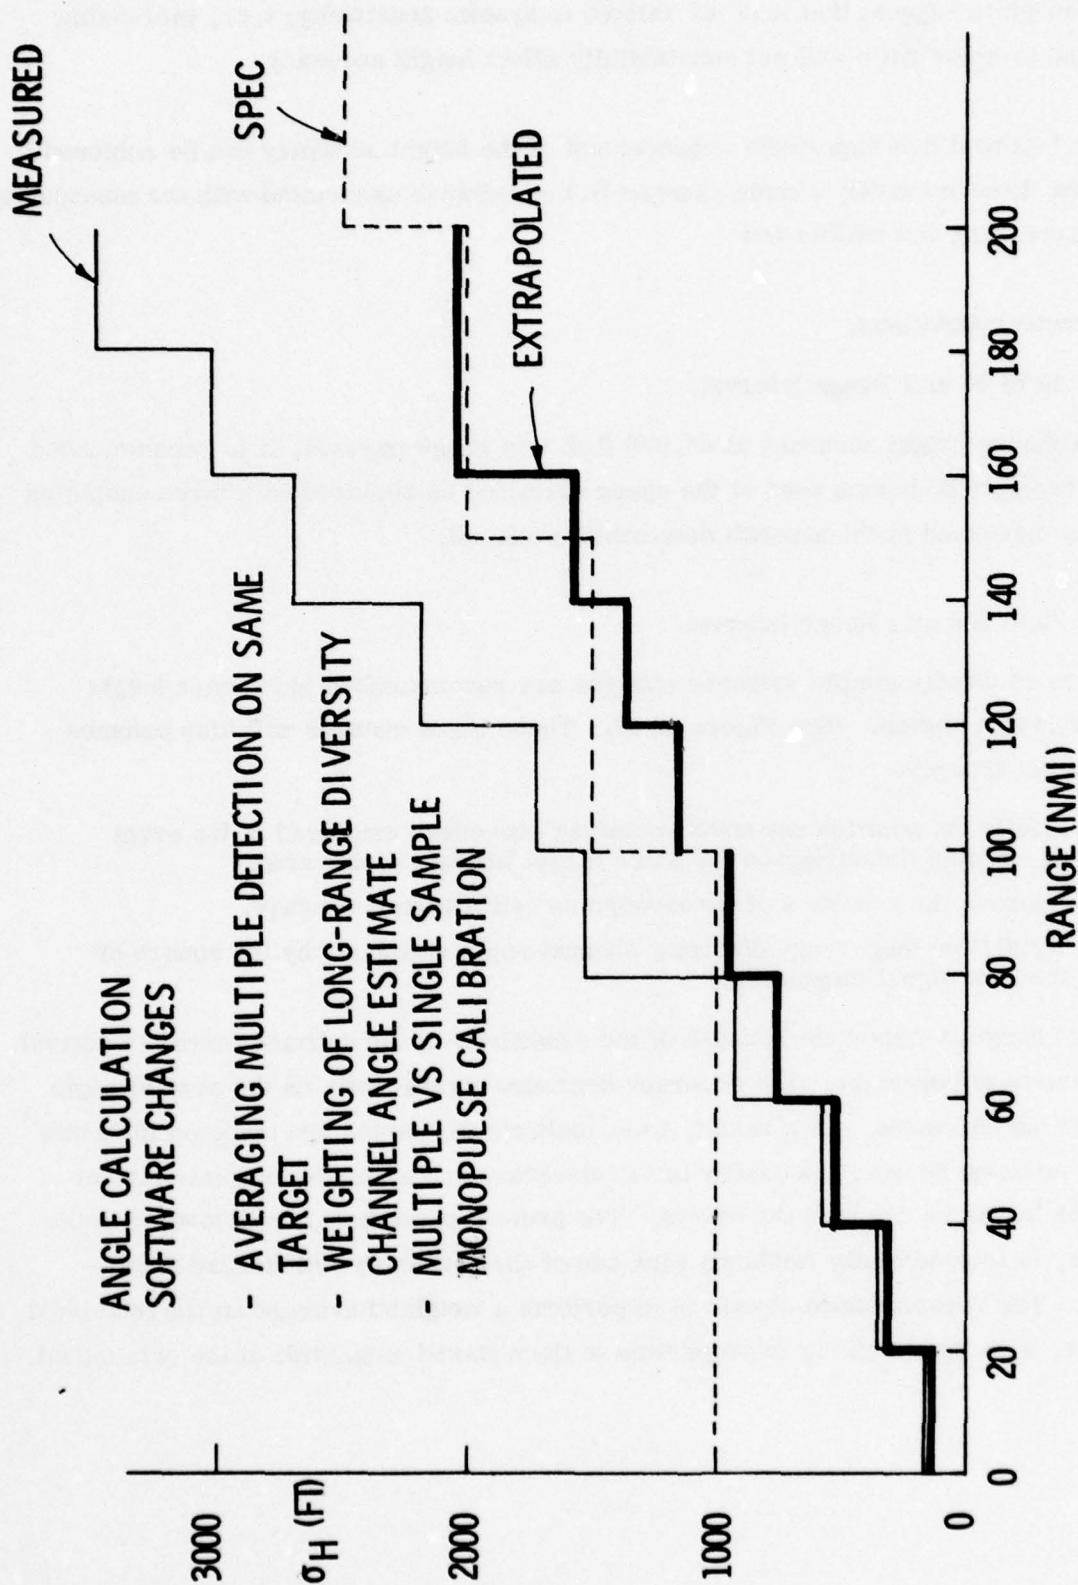
Figure 2-10. Height Accuracy Extrapolation

The first change is important because of the sensitivity of the estimate error to arrival angle relative to boresight. The accuracy degrades significantly as the arrival angle moves off the boresight. As a result, when multiple detections are made on the same target in adjacent beams, the quality of the elevation (and azimuth) estimate may be very much better on one than the others. The present procedure, implemented in the computer, is to essentially randomly pick one of the estimates and discard the remainder. The recommended change is to perform a weighted average on the individual estimates, with the weighting in proportion to the squared magnitude of the sum signal.

Three relatively simple software changes are recommended to enhance height accuracy in this region. (See Figure 2-10.) These three changes will also enhance the azimuth accuracy.

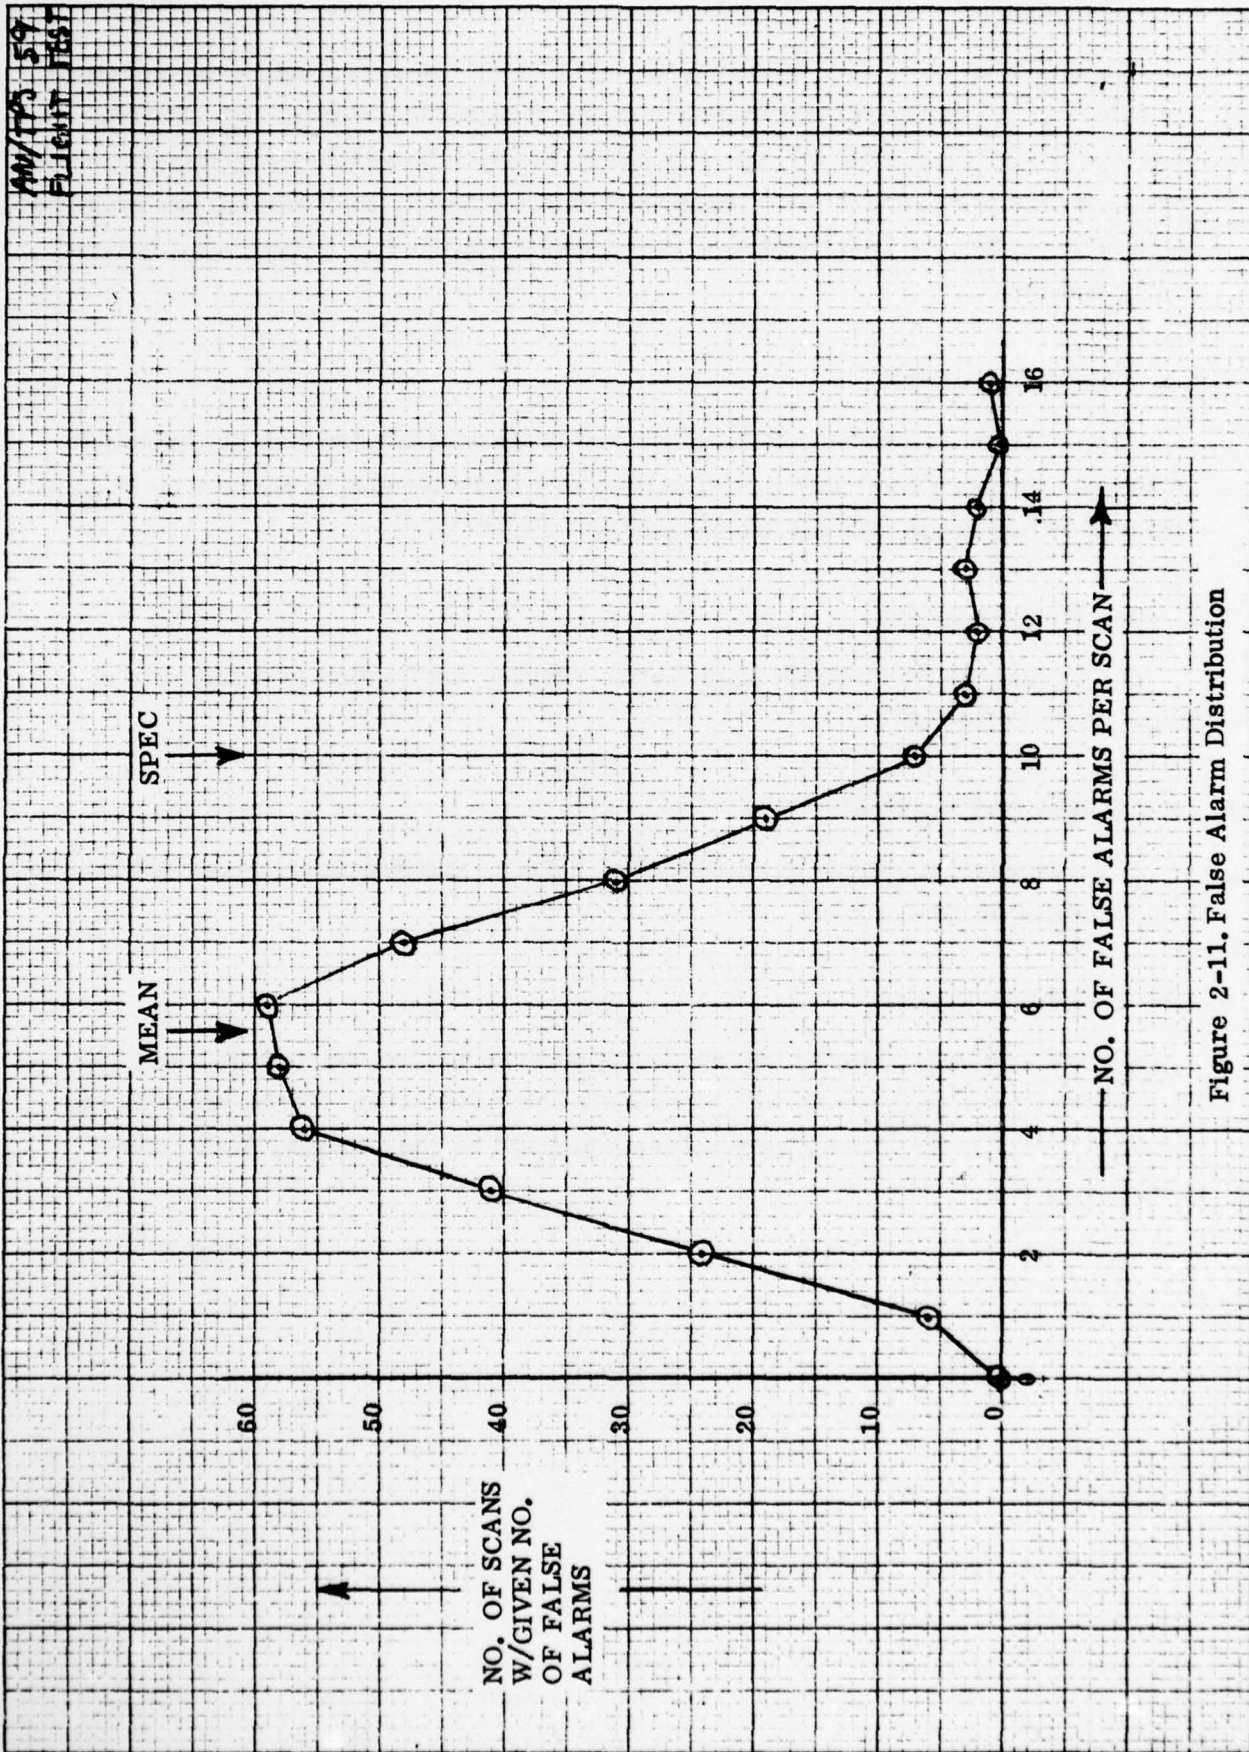
Figure 2-11. False Alarm Distribution

False alarm data were collected for 360 scans out to a range of 300 nmi after conclusion of flights F12 and F13.   Actual targets or returns that correlate over two scans or more were eliminated.   The remaining returns, representing false alarms as a result of clutter or noise, are shown in Table 2-15.   The distribution of false alarms is shown in Figure 2-11.

The changes recommended and discussed in the aircraft detectability subtest to overcome the pre-driver turn on difficulties are recommended to enhance the P_{DC} in the 0 to 20 nmi range interval for the AN/TPS-59(XN-1).

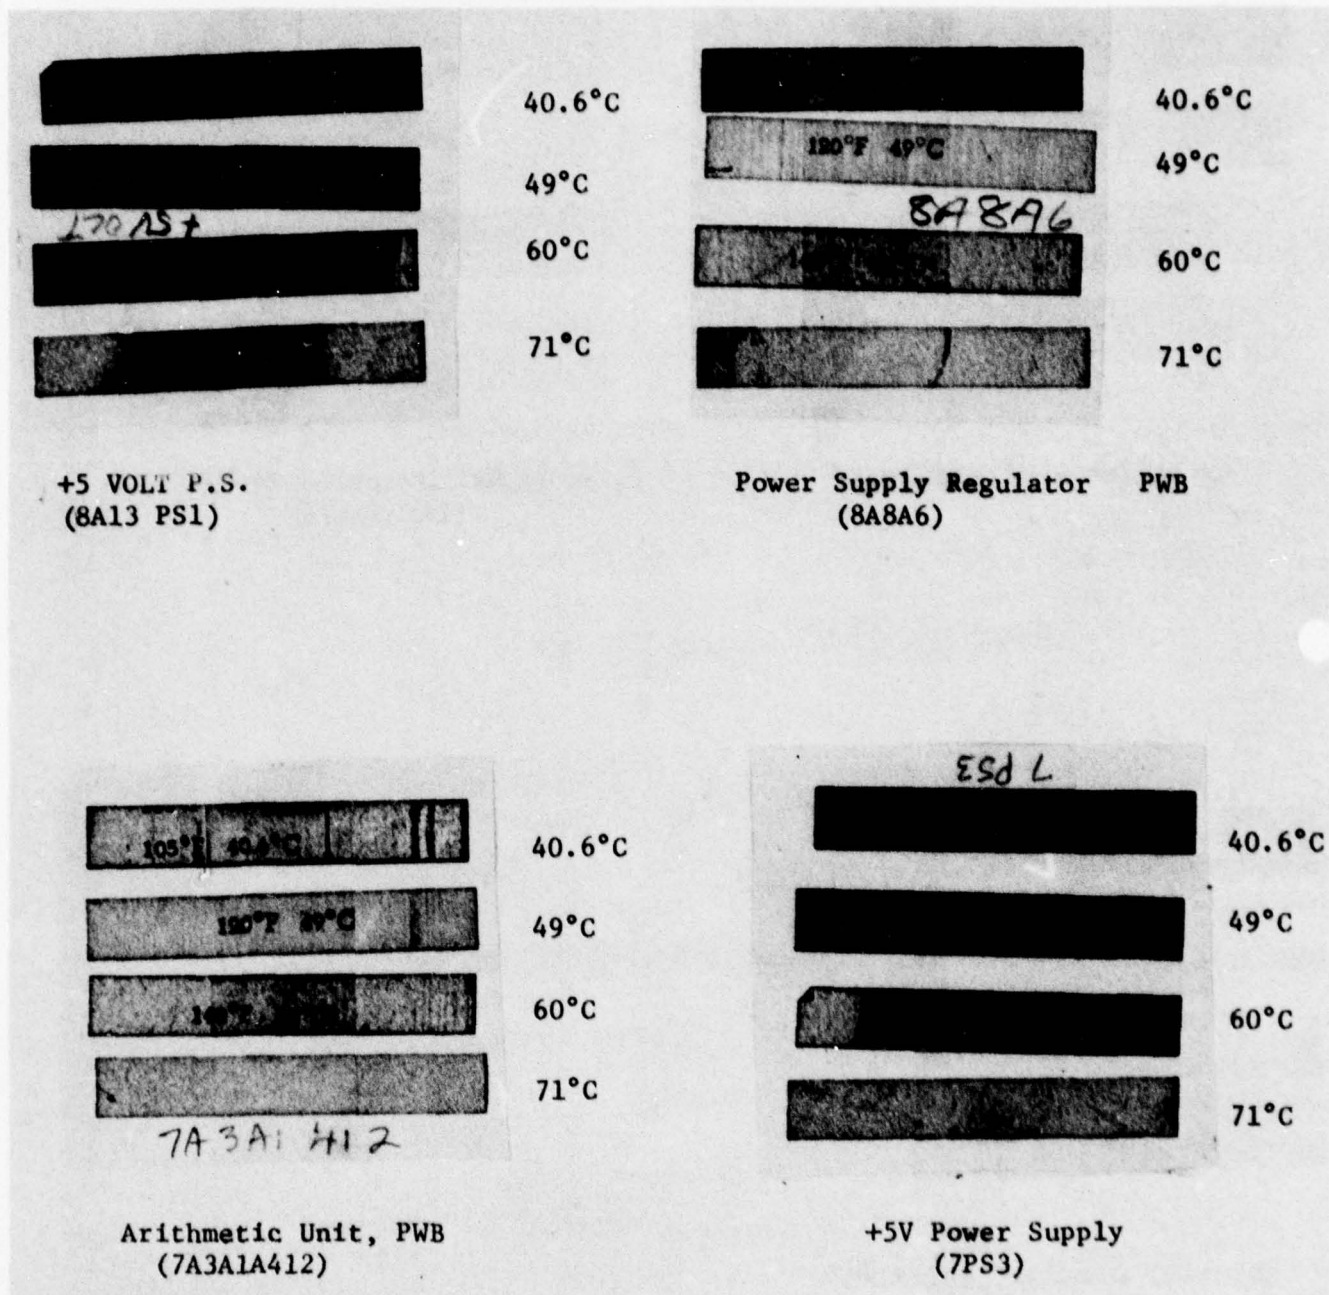
Figure 7-2. Shelter Temperature Sensor Readings (Sheet 1 of 2)

Temperature indicators were mounted on specific components and assemblies. The location and the temperatures are as shown below and in Figure 7-2. The only apparent over temperature problem was as indicated on the console power supply.

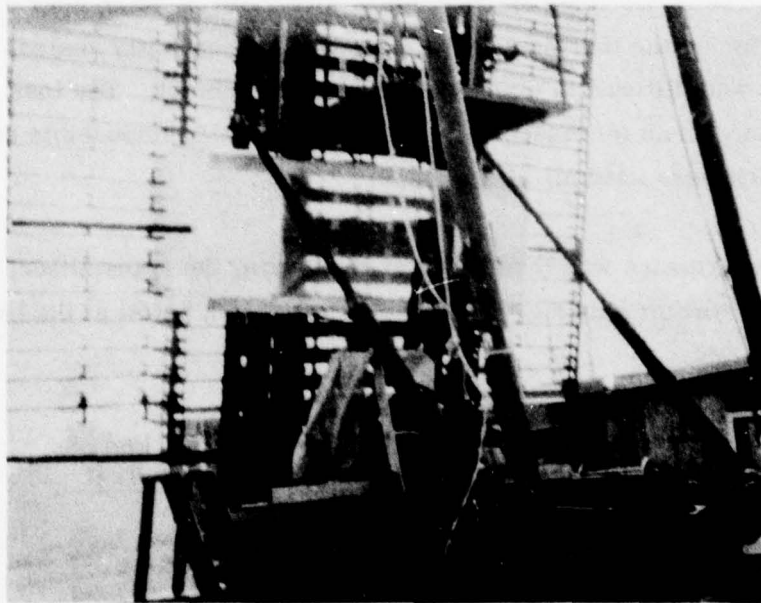
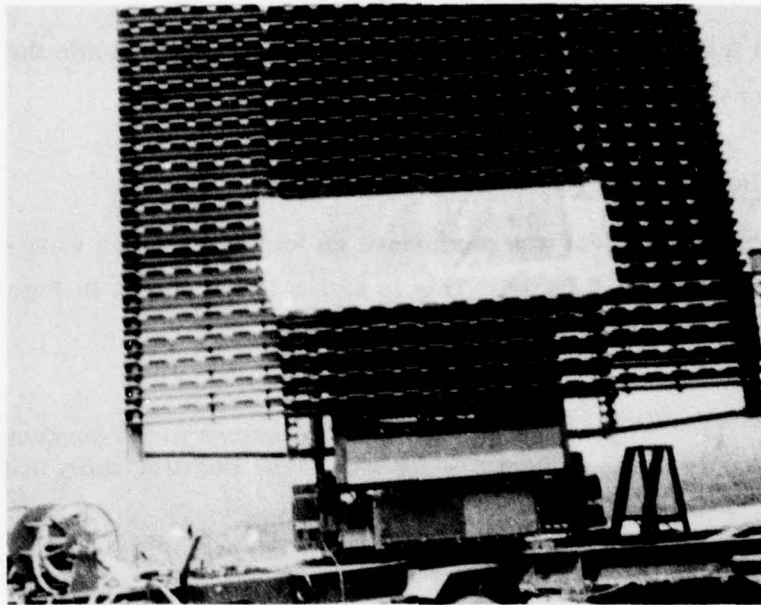
Figure 7-3.   Four Row Temperature Enclosure

The array temperature test was performed on four rows which were enclosed with plastic and insulating materials. This is shown in the photos in Figure 7-3. The location of the thermocouples were:
