AN/TPS-59(XN-1) EDM
RADAR SET, MARINE LIGHTWEIGHT TACTICAL 3D
ENGINEERING DEVELOPMENT MODEL .

PRE-SERVICE ACCEPTANCE TEST REPORT.

VOLUME I.

(11) 29 Apr 1977

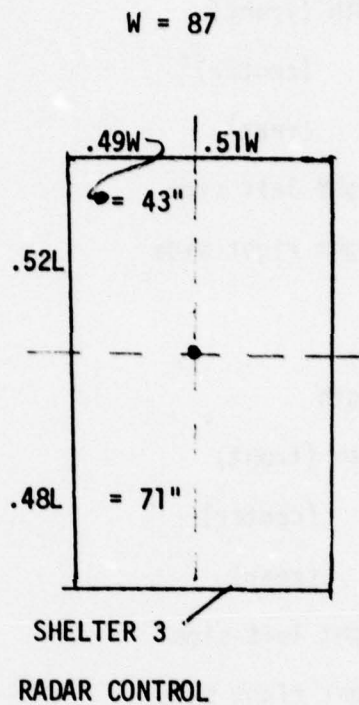
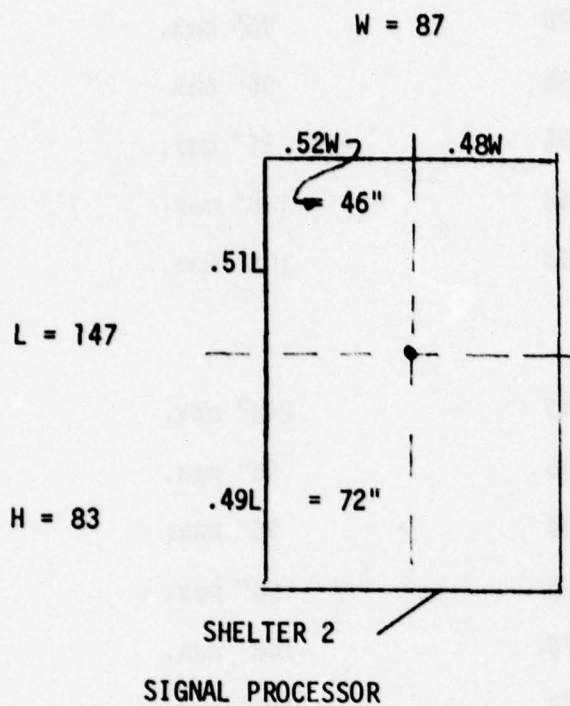
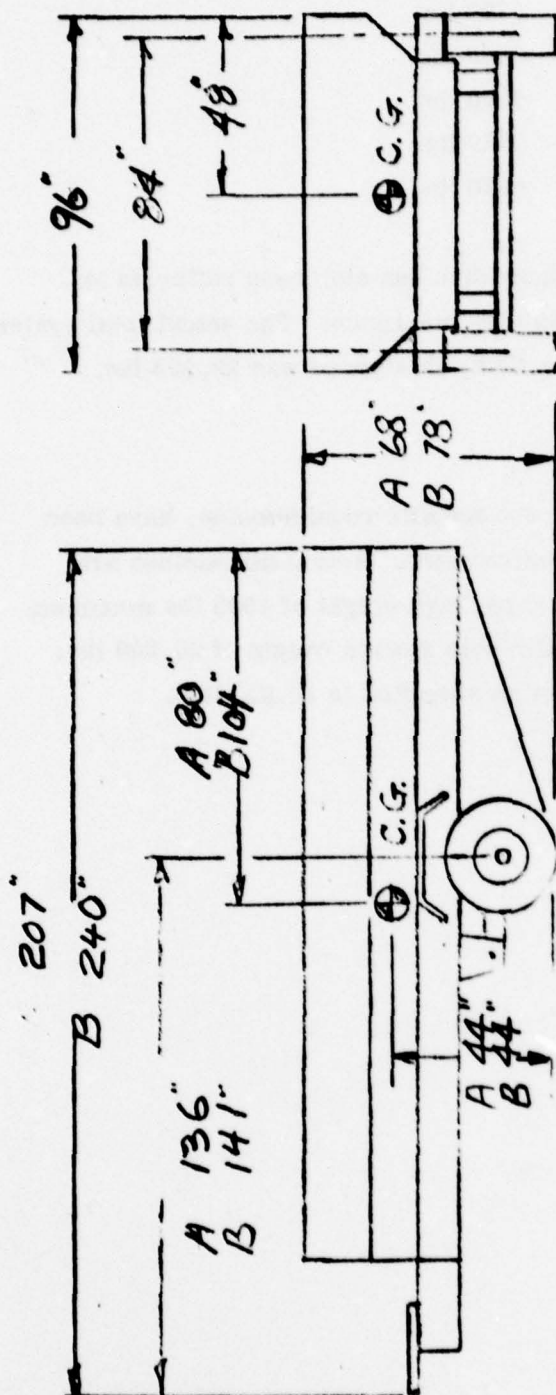
Figure 10-5.   AN/TPS-59 Shelter CG's and Dimensions

The dimensional measurements, although not specific requirements, have been demonstrated satisfactorily in the transport environment. Actual dimensions are shown in Figures 10-5 and 10-6. The transport package weight of 5000 lbs maximum was exceeded on all packages along with the allowable system weight of 20,000 lbs; therefore, the equipment does not meet weights as specified in ELEX-R50.

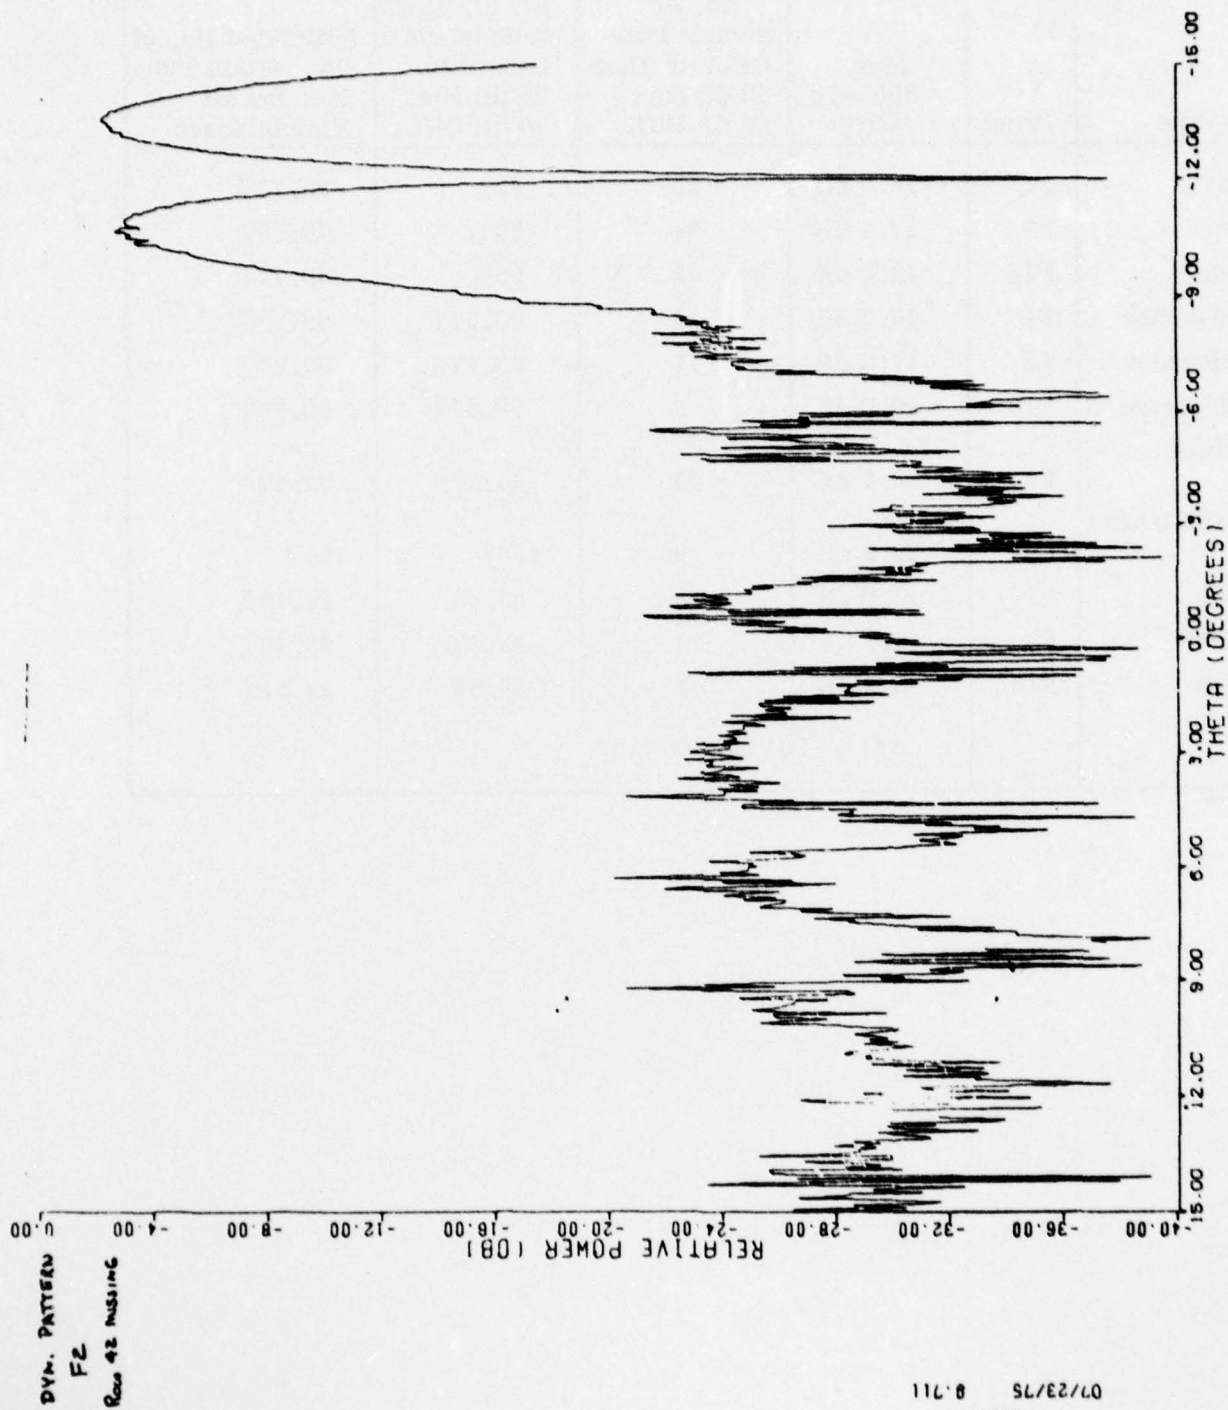
Figure 12-5. Calculated Elevation Dynamic Sum Pattern

The calculated dynamic patterns were generated assuming a 4-bit phase shifter and 0.05 degree elevation scan steps. Only row 42 was missing (zero amplitude) for this calculation. These dynamic pattern calculations (Figures 12-5 and 12-6) compare closely to the measured patterns Number 43 and 44 in Figure 12-1.

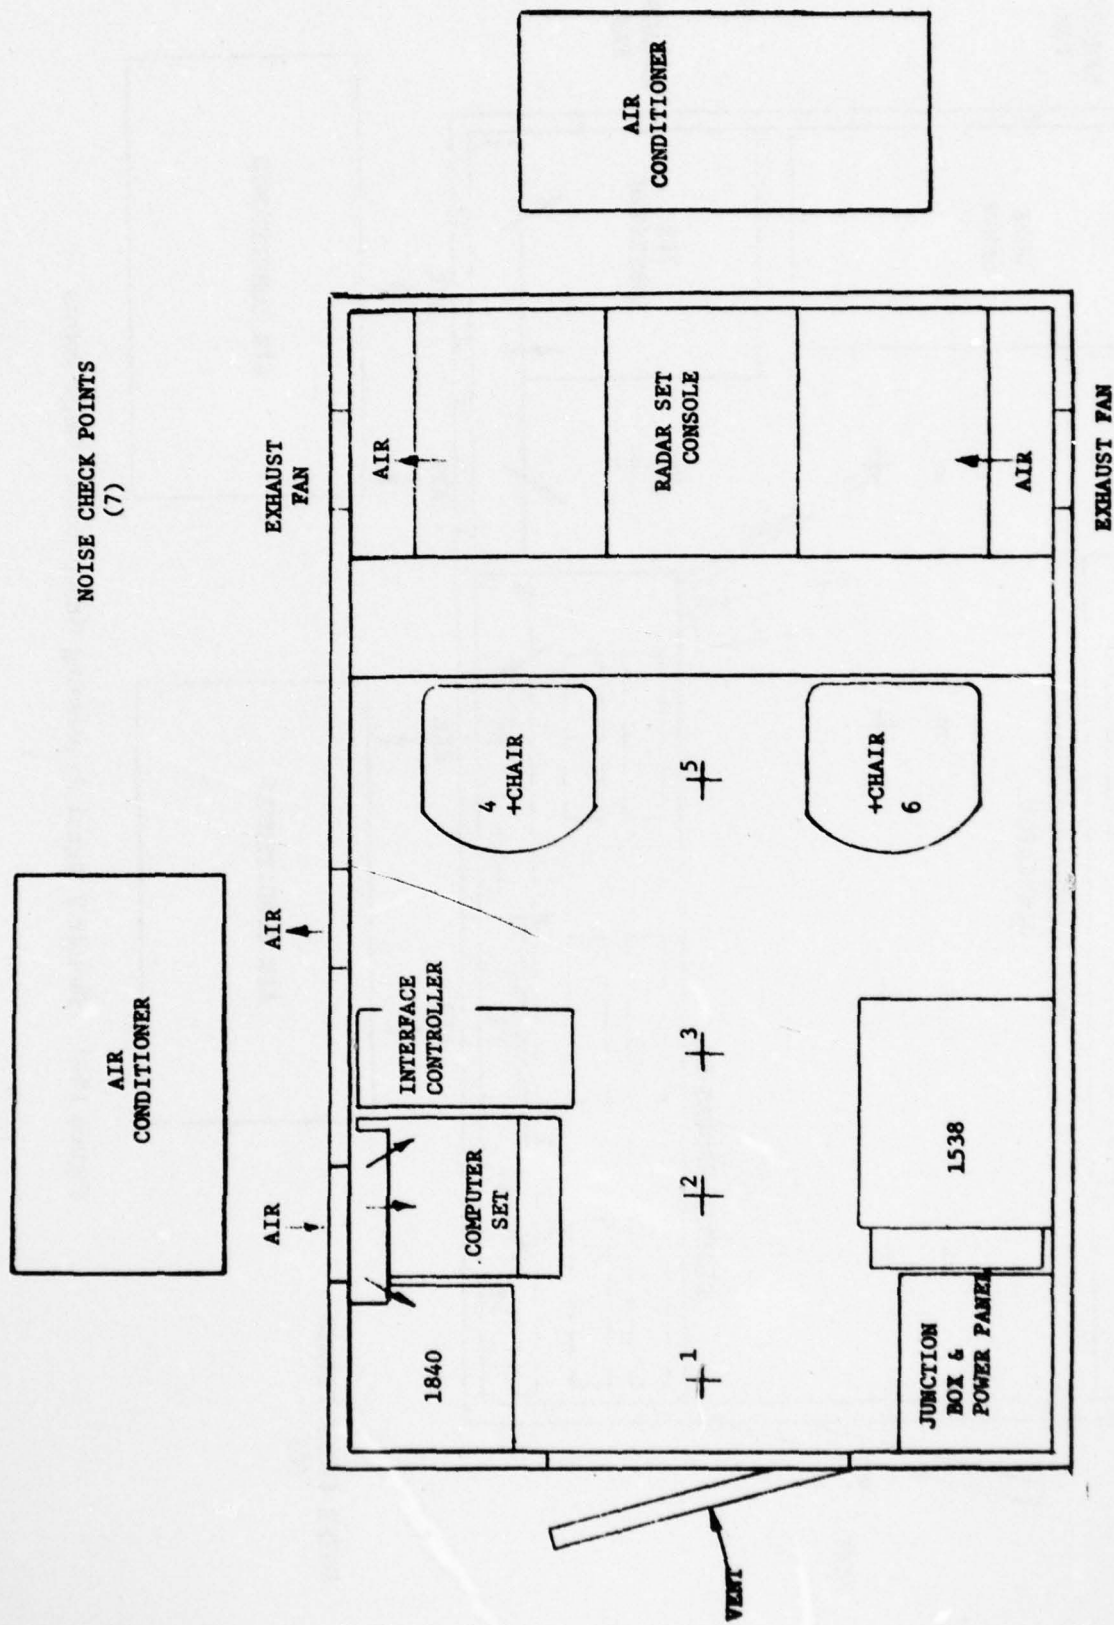
Figure 13-1. Shelter 1 Radar Control Group Noise Check Points

Table 13-1 presents the data measured at the points shown in Figures 13-1 through 13-3. The measurements indicated a background noise level in the shelters, with all equipment off, of 36 dBA. The diesel generators added 16 to 18 dB of noise. The fans increased the noise ratio by another 26 to 28 dB. However, the noise level in the shelters never exceeded the 90 dBA maximum allowable level for continuous exposure. Comparisons of noise levels in the shelter, with the air conditioners and diesels running, with and without the system operating, showed an average increase in noise level of 13 to 15 dB due to the operation of the system.

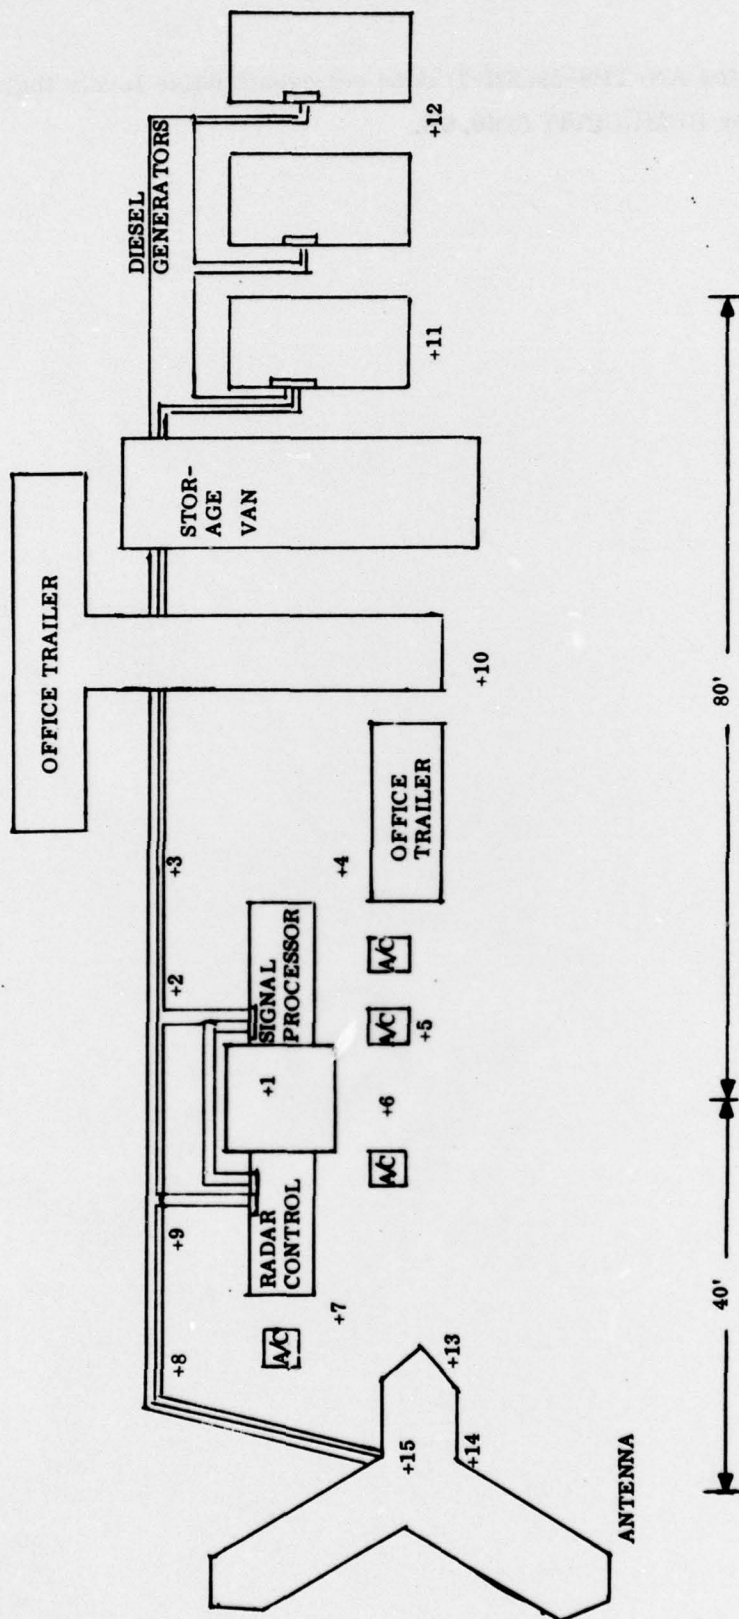
Figure 13-3.   Radar External Noise Check Points

Measurements made external to the shelters showed very little increase in noise due to system operation. The only exception was the noise increase on the array due to array fans (5 to 9 dB). The 90 dBA noise level was exceeded at the diesel generators (measurement positions 11 and 12 of figure 4.12-3). This condition was known prior to the actual measurements, in that acoustically protective headphones were issued to those maintenance personnel that worked on the generators.
