AD-A082 160 COAST GUARD RESEARCH AND DEVELOPMENT CENTER GROTON CT F/G 13/12
CHIEF PETTY OFFICER (CPO) BERTHING COMPARTMENT BURNOUT TESTS.(U)
MAR 80 C D WOLVERTON
UNCLASSIFIED CGR/DC-16/79 USCG-D-78-79 NL

(CPO) BERTHING COMPARTMENT BURNOUT TESTS

8. Performing Organization Report No.
(14) CG R&DC-16/79

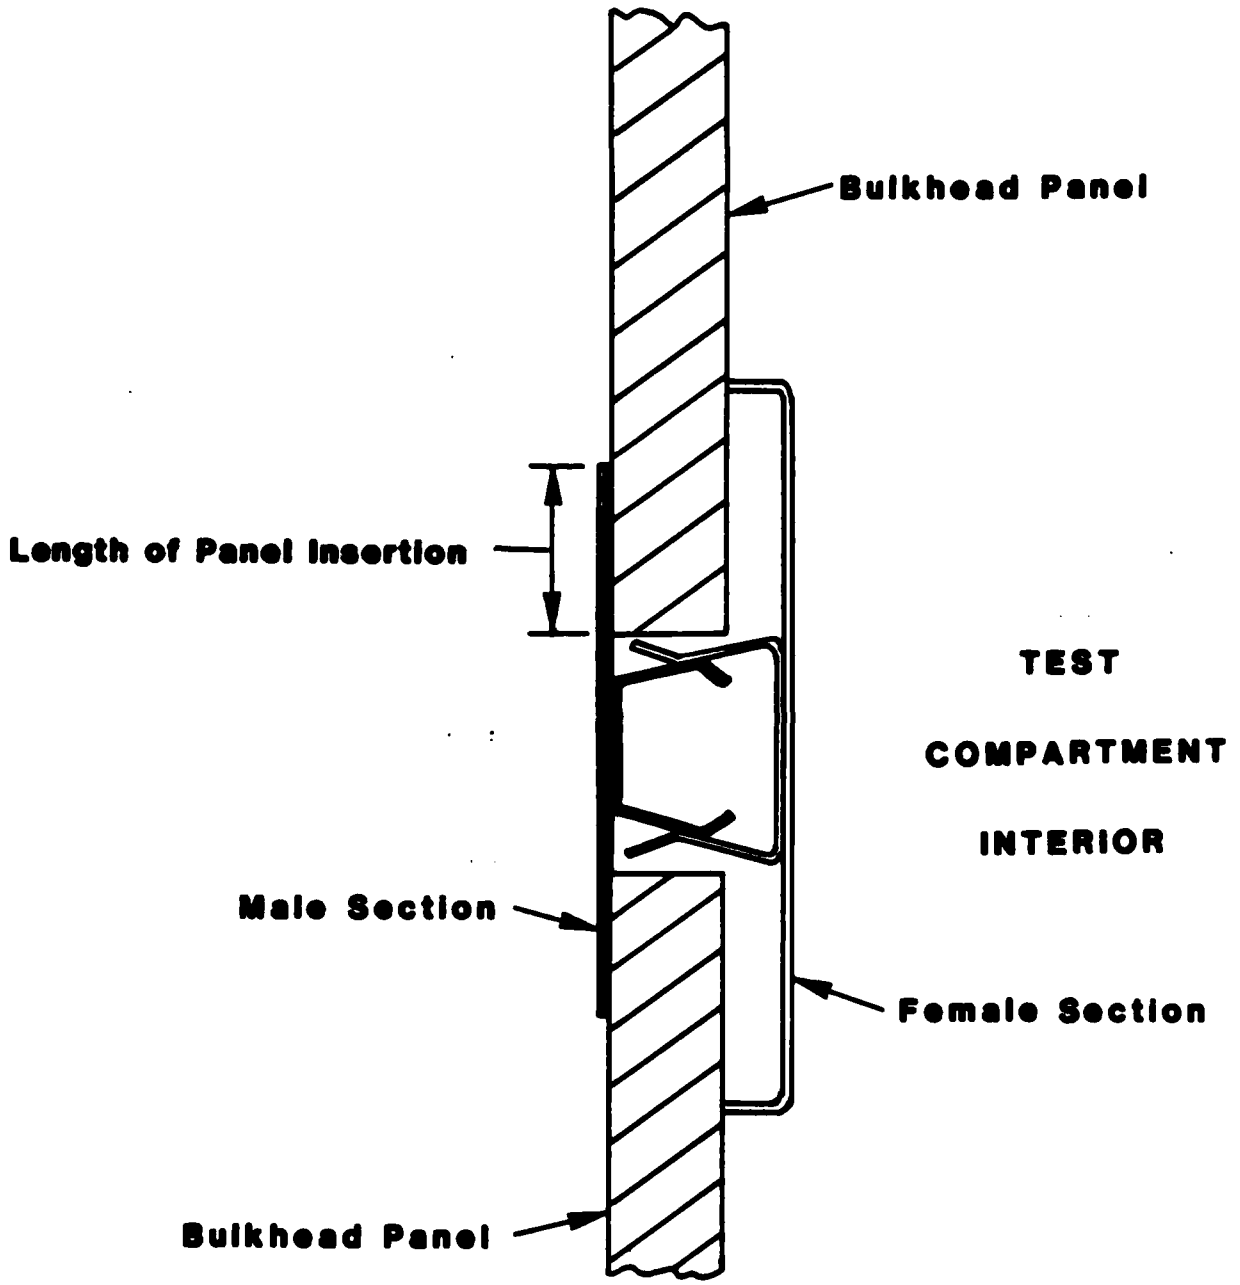
FIGURE 2

Where breaches occurred in the bulkheads, it appeared that the usual cause was insufficient engagement of the panel in its joiner system. The type of H-post (see Figure 2) used in test compartment construction allows for insertion of the bulkhead panels about 7/8-inch into the space between the parallel flanges of the post, but in some cases the panels were

gripped by as little as 1/8-inch. Once the panels are in place this inadequate engagement cannot easily be detected. During the fires, distortion of the panels and warpage of the joiner system allowed some panels to separate from their posts. Usually the length of this separation along the post extended no more than a foot or so.

As was demonstrated in these tests, a set of bulkhead panels may be highly resistant to fire, but if their joiner system is improperly designed or installed, they will not provide a satisfactory fire barrier. It is therefore important to consider the panels and joiner hardware as a complete system, and to take whatever steps are necessary to insure that proper installation is accomplished. Close spacing of Z-bar fasteners and secure attachment of the fixed H-post members are means of achieving this. Due to the configuration of the H-posts, it is difficult to detect improper panel engagement by visual inspection once installation is complete. One way of checking for proper engagement would be to measure the width of each panel that is exposed between the flanges of adjacent H-posts. In any case, a minimum panel insertion of 3/4-inch should be insured.

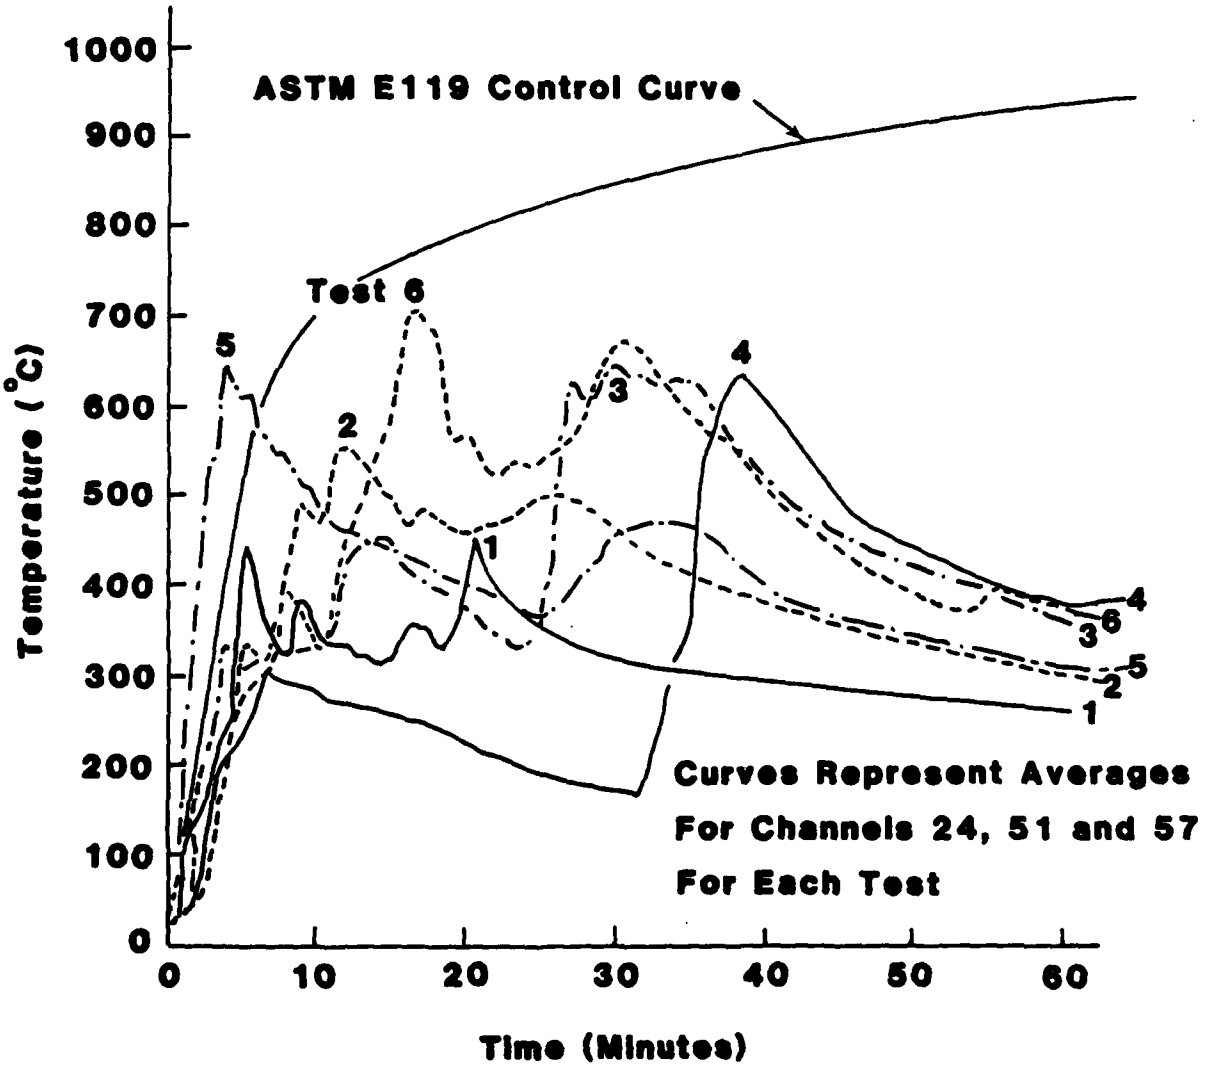
FIGURE 18

Upper gas temperatures provide the most useful means for comparing severity of the six test fires. Figure 18 shows the average of the temperatures measured by channels 24, 51, and 57. All three were 78 inches above the deck and locations relative to the test compartment furniture were as indicated in Figure 7. For comparison, Figure 18 includes the temperature-time curve used to control ASTM E119 tests. Another measure of the fire severity is shown in Figure 19, where the cumulative areas beneath the curves of Figure 18 have been plotted against time.

AVERAGE UPPER GAS TEMPERATURES
