AFWAL-TR-81-2094

A RETIREMENT-FOR-CAUSE SUTDY OF AN ENGINE TURBINE DISK

November 1981

Aero Propulsion Laboratory
Air Force Wright Aeronautical Laboratories

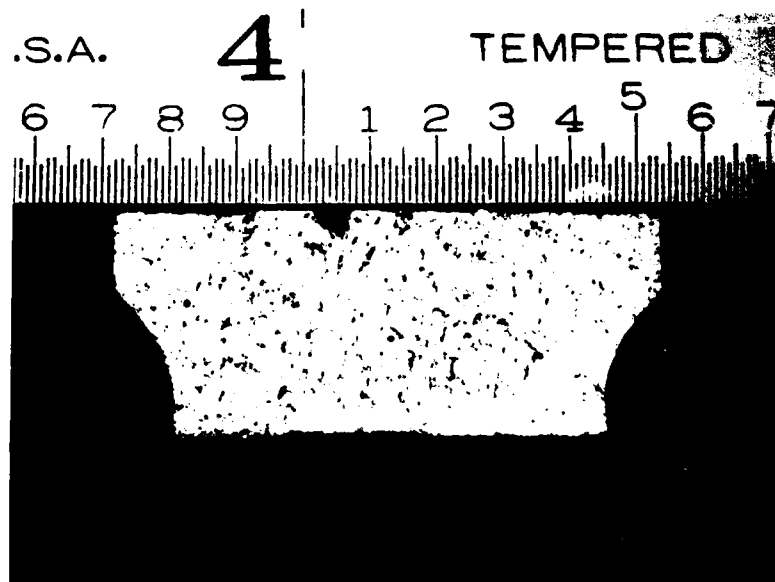
Figure 11
Bolt Hole Crack Geometry

Figure 11 shows the TF33 disk cross-section with the assumed elliptical starting crack superimposed. It should be noted that the Bowie correction factor used in the analysis was for an imbedded crack in a bolt hole exposed to a biaxial stress field. In addition, this expression was modified slightly to account for the fact that the radial component of the biaxial field was lesser in magnitude than the tangential stress. Some conservatism was also applied by assuming that the elliptical crack transitioned to a through-the-thickness crack when the surface length of the crack, 2c, exceeded 75% of the actual disk bolt pad thickness. This assumption appears reasonable considering the geometry of the disk in which the crack front is propagating. The aspect ratio for the crack (crack depth ÷ crack length) was arrived at by breaking open scrap TF33 disks which exhibited cracks in the bolt hole region as shown in Figure 12. Although the characteristic of the cracks in the bolt holes varied with multiple initiation sites, and appeared to propagate at a changing aspect ratio, a value of .35 was determined to best represent the average aspect ratio and was used in the analysis. Disk failure would occur when the crack depth, a, reached a critical crack depth value, a_c, which was calculated using the fracture toughness value, K_{IC}, in equation (2). These values are 0.335 inches and 110,000 psi√in., respectively.

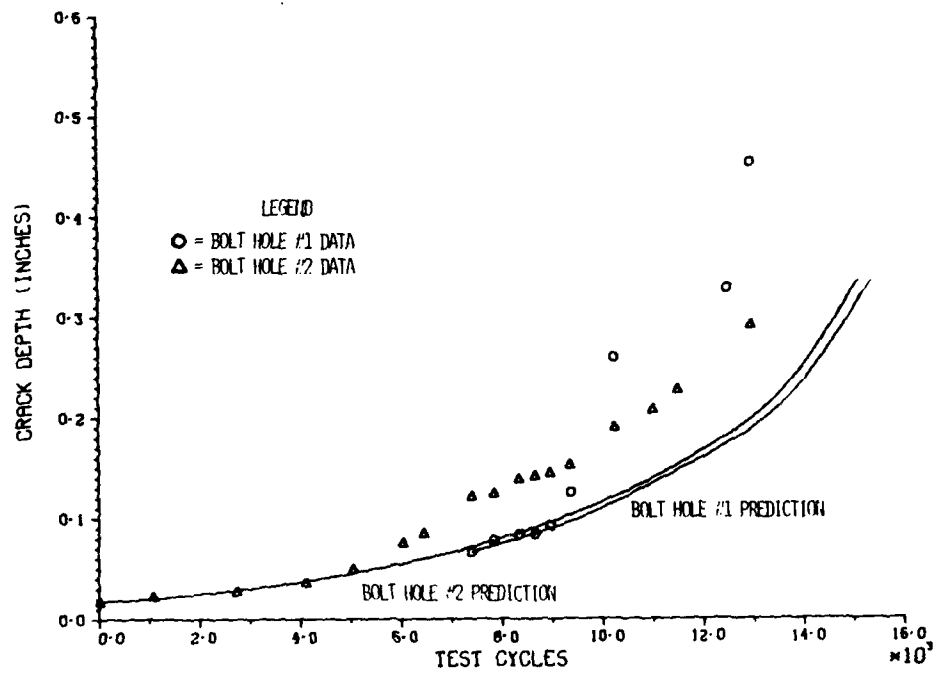
Figure 12

For the spin pit verification, a high time TF33 third stage turbine disk which had been retired from service with an unknown history was used. The particular disk, however, had been cycled beyond the "initiation" point and contained a measured service-induced crack of 0.052 inches surface length. At an aspect ratio of .35, this surface length was the starting size used in the fracture mechanics analysis and resulted in a predicted critical crack depth of .335 inches at a propagation cycle count of 15,090 cycles with a growth rate as shown in Figure 13.

Typical Bolt Hole Starting Crack
