ROYAL AIRCRAFT ESTABLISHMENT

# THE QUANTITATIVE ANALYSIS OF FATIGUE CRACKING UNDER PROGRAMMED LOADING

Technical Report 80073

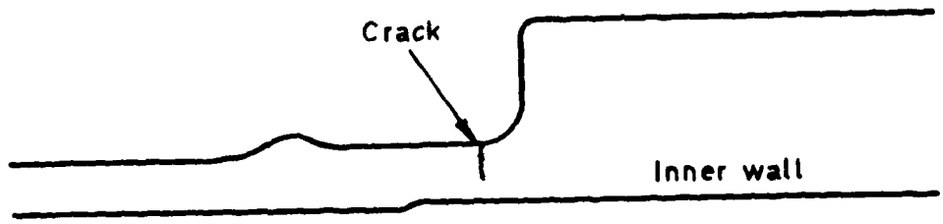
The undercarriage main fitting failed prematurely during testing, that is after approximately one tenth of its designed fatigue life had been achieved. Failure occurred by the growth of a transverse fatigue crack at a change in section in the undercarriage cylinder wall. The crack penetrated the cylinder wall, jumped forward abruptly for several millimetres, stabilized and, after a further small period of stable fatigue crack growth, catastrophic failure occurred (Figs 1 and 2). The undercarriage had been loaded servo-hydraulically to represent the vertical, drag and side loads experienced in service. The combination of these different types of loadings produced a duty cycle of fluctuating tension stresses representing the stresses set up during one aircraft flight, *ie* taxying, engine run-up, take-off and landing and finally braking.

Fig 1 A longitudinal section of the undercarriage wall in the region of the fatigue crack x1

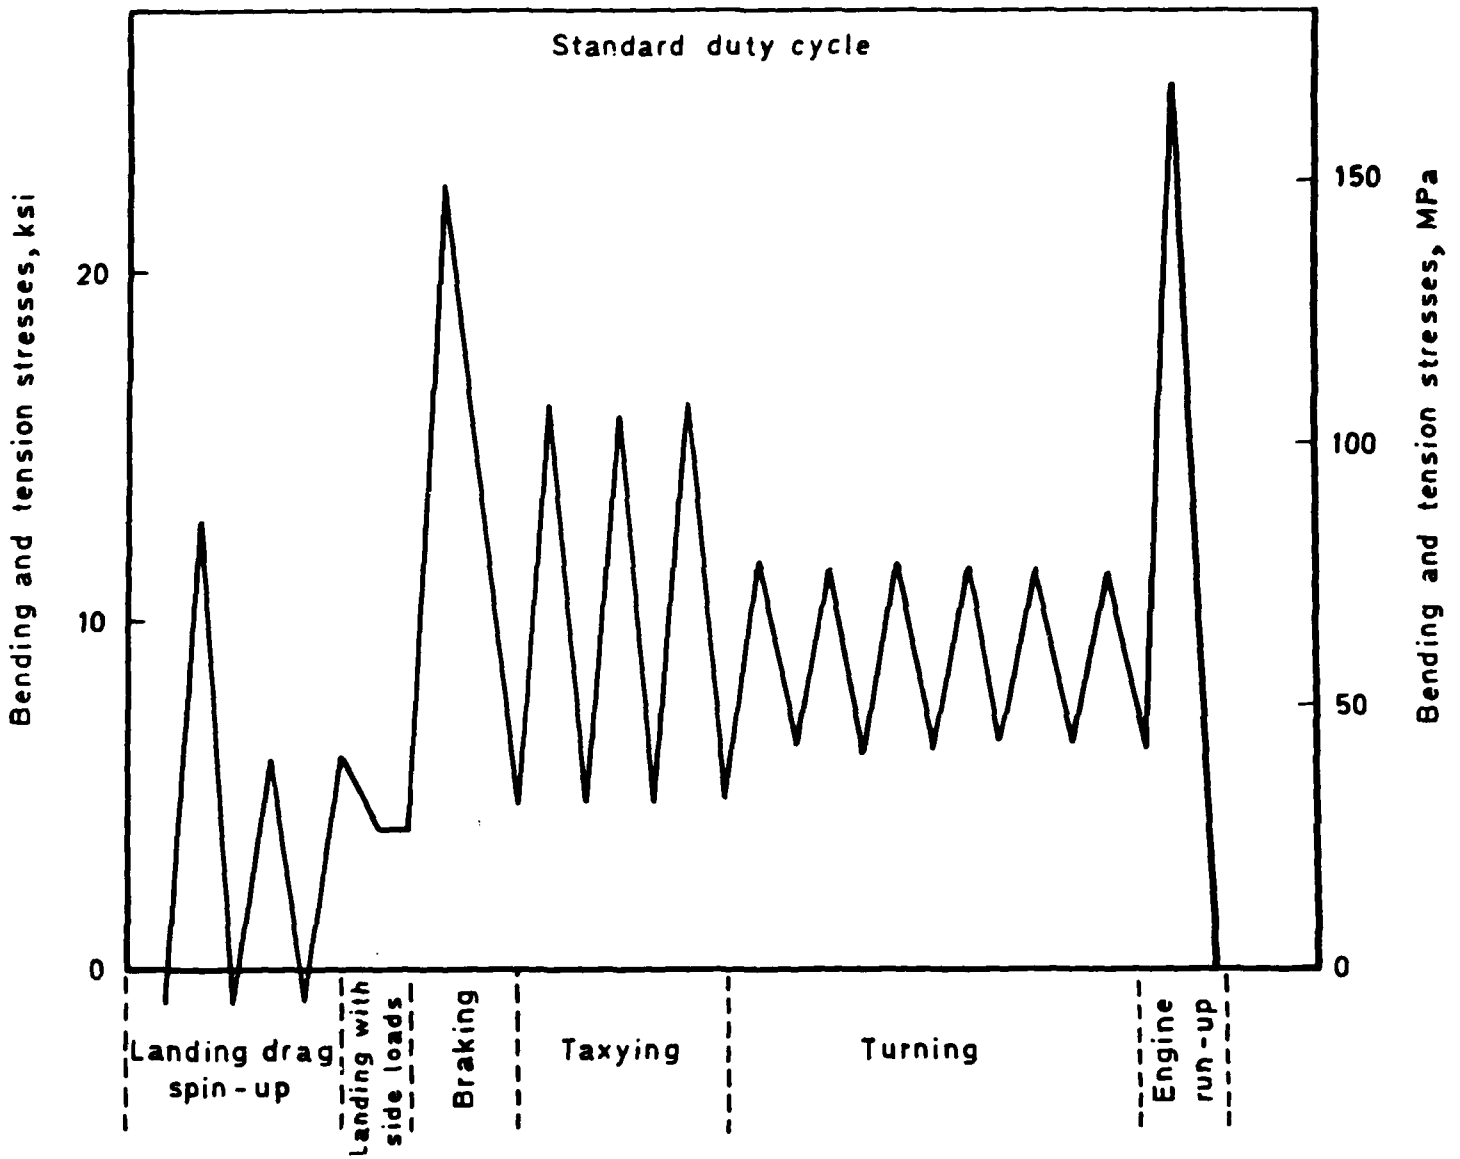
**Fig 3** The standard duty cycle of loadings. Stress maxima and minima for the severe duty cycle were approximately 11% higher

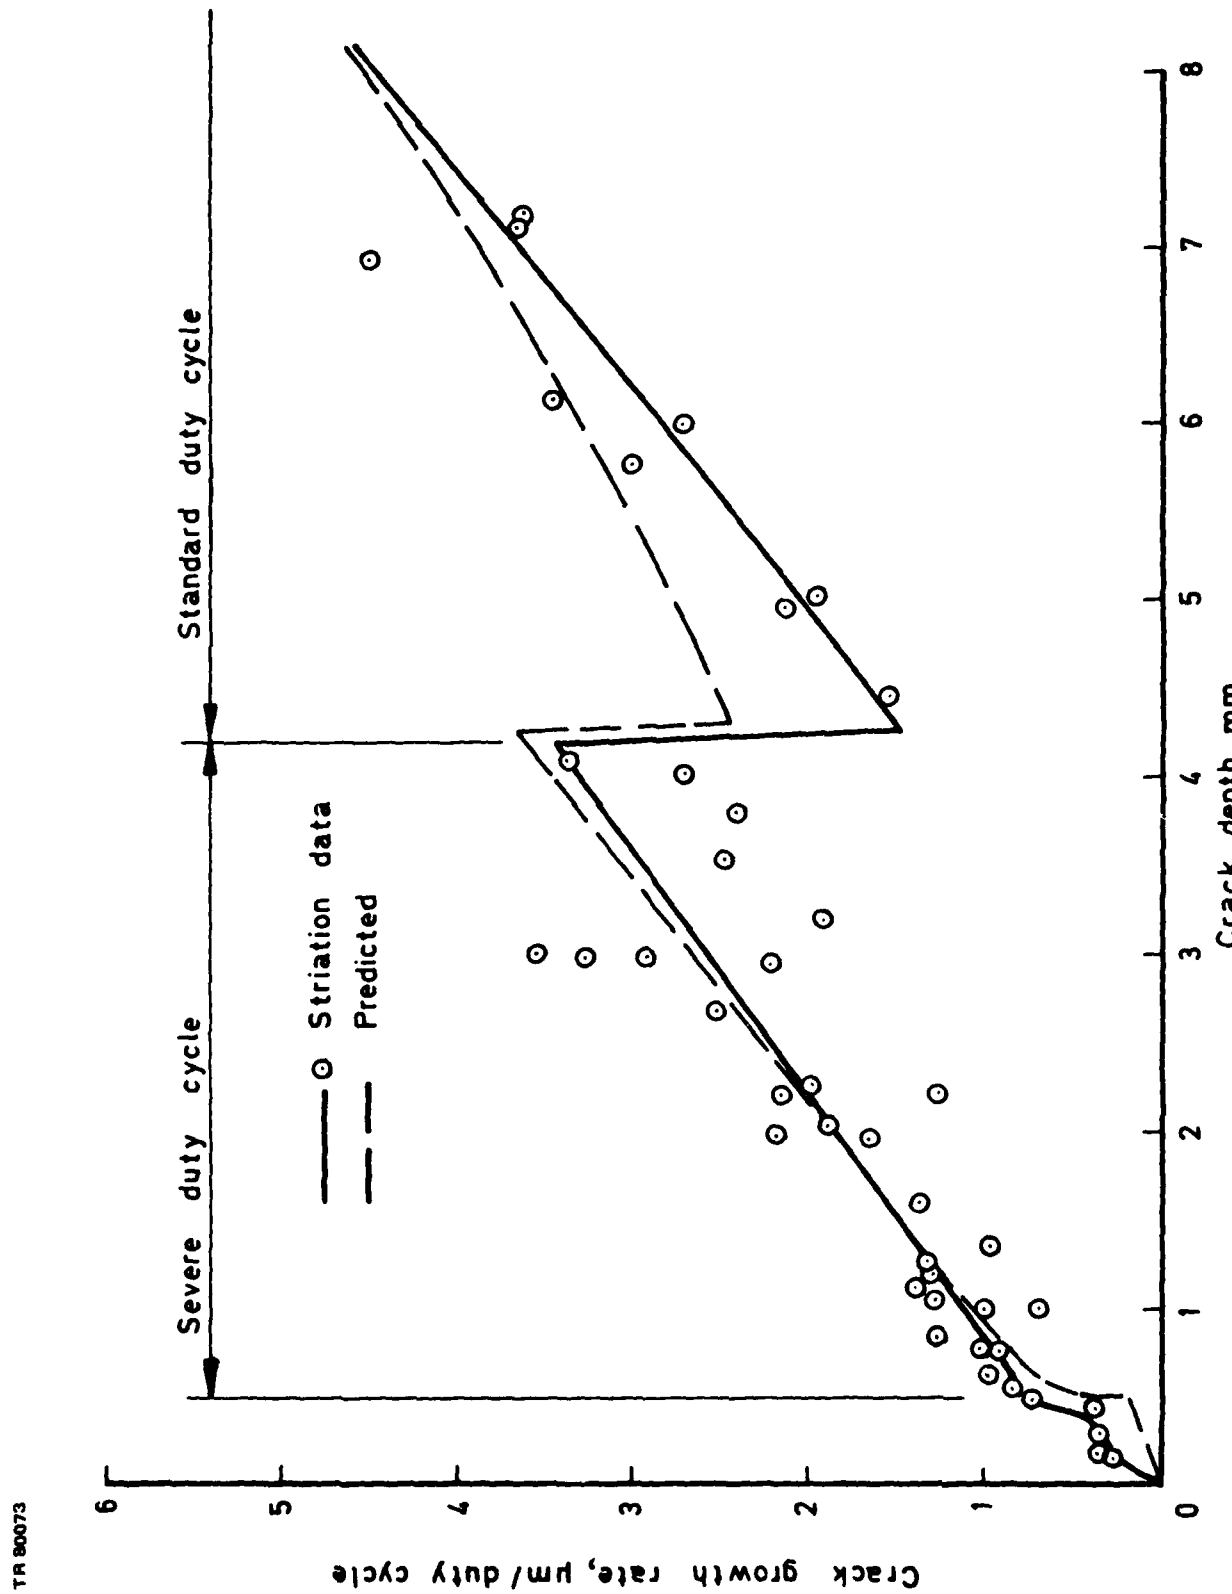
Generally, the predicted growth rates matched the striation spacings very well, the predicted rates lying within the striation scatter band. However, a closer examination revealed a significant over-prediction in rate immediately after the change from severe duty cycles to standard duty cycles (Fig 8). The effect was found to persist far in excess of 1000 duty cycles until the striation spacing had increased to the predicted level at 8 mm crack depth. The deceleration in actual growth rate below that predicted was taken as evidence for a load interaction effect that persisted over a considerable distance. It should be noted that at high growth rates (> 3 μm/cycle) it was anticipated that the striation spacing would underestimate actual growth rates because of a significant contribution from crack jumping[8]. A further discrepancy was observed at very short crack depths, where the predicted rate significantly underestimated the growth rate. The most likely cause for this underestimation was thought to have been a low prediction of the value of Z at short crack depths. That is, whilst the effects of the combinations of several small cracks growing from separate origins were hard to predict, it would seem that the value of $k_{t_e}$ was increased at the surface by the coarse machine marks. Consequently, values of Z were

Fig 8 Predicted and measured crack growth rates

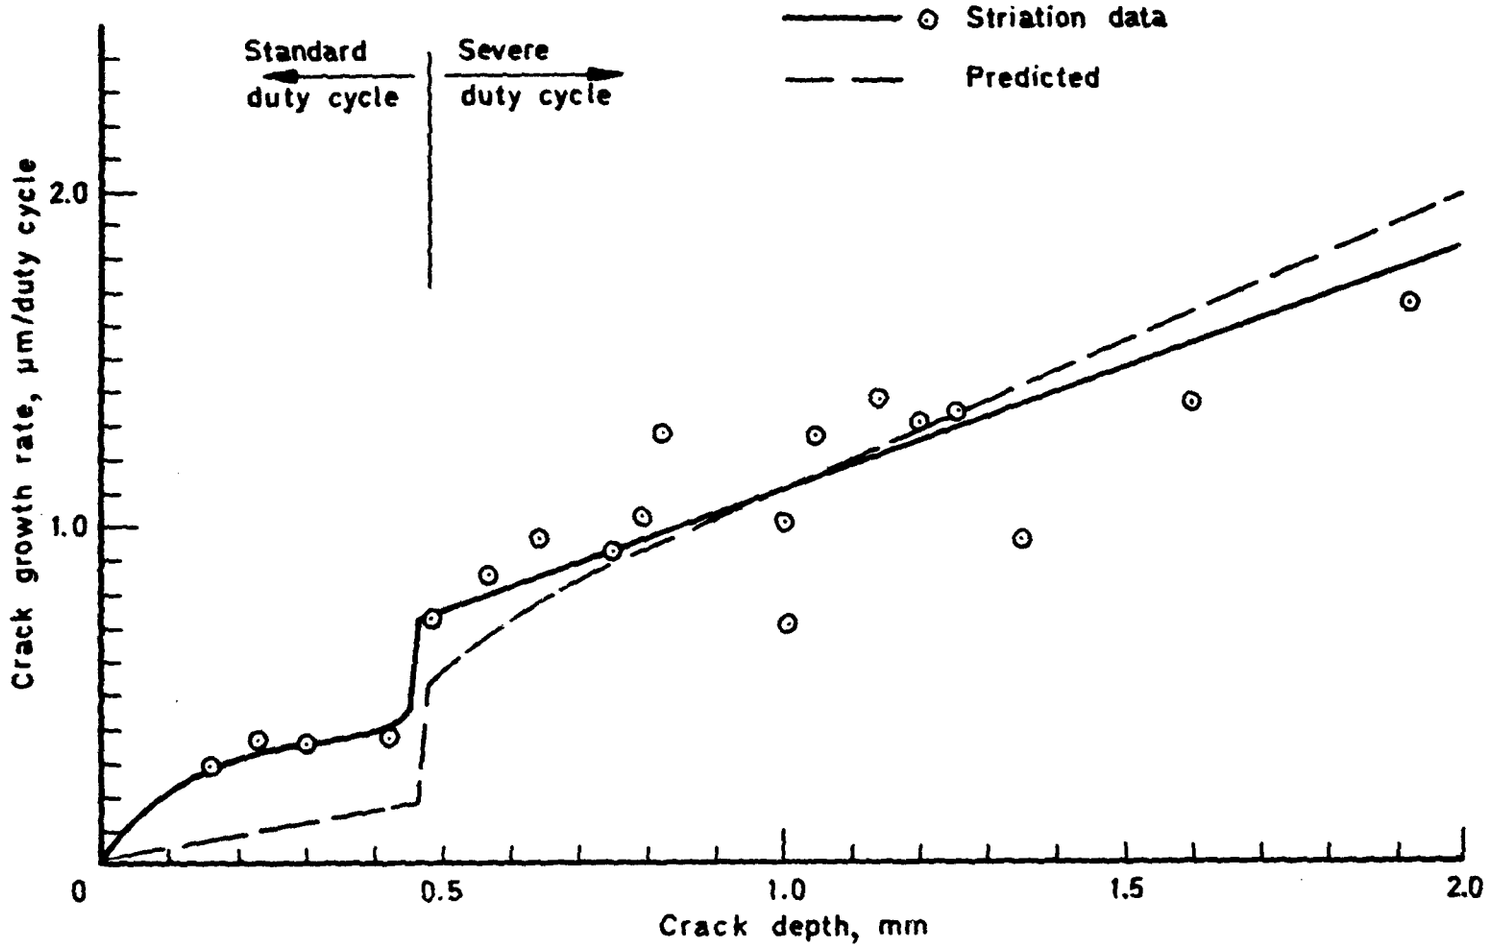
Fig 9 Predicted and measured fatigue crack growth rates at short crack depths

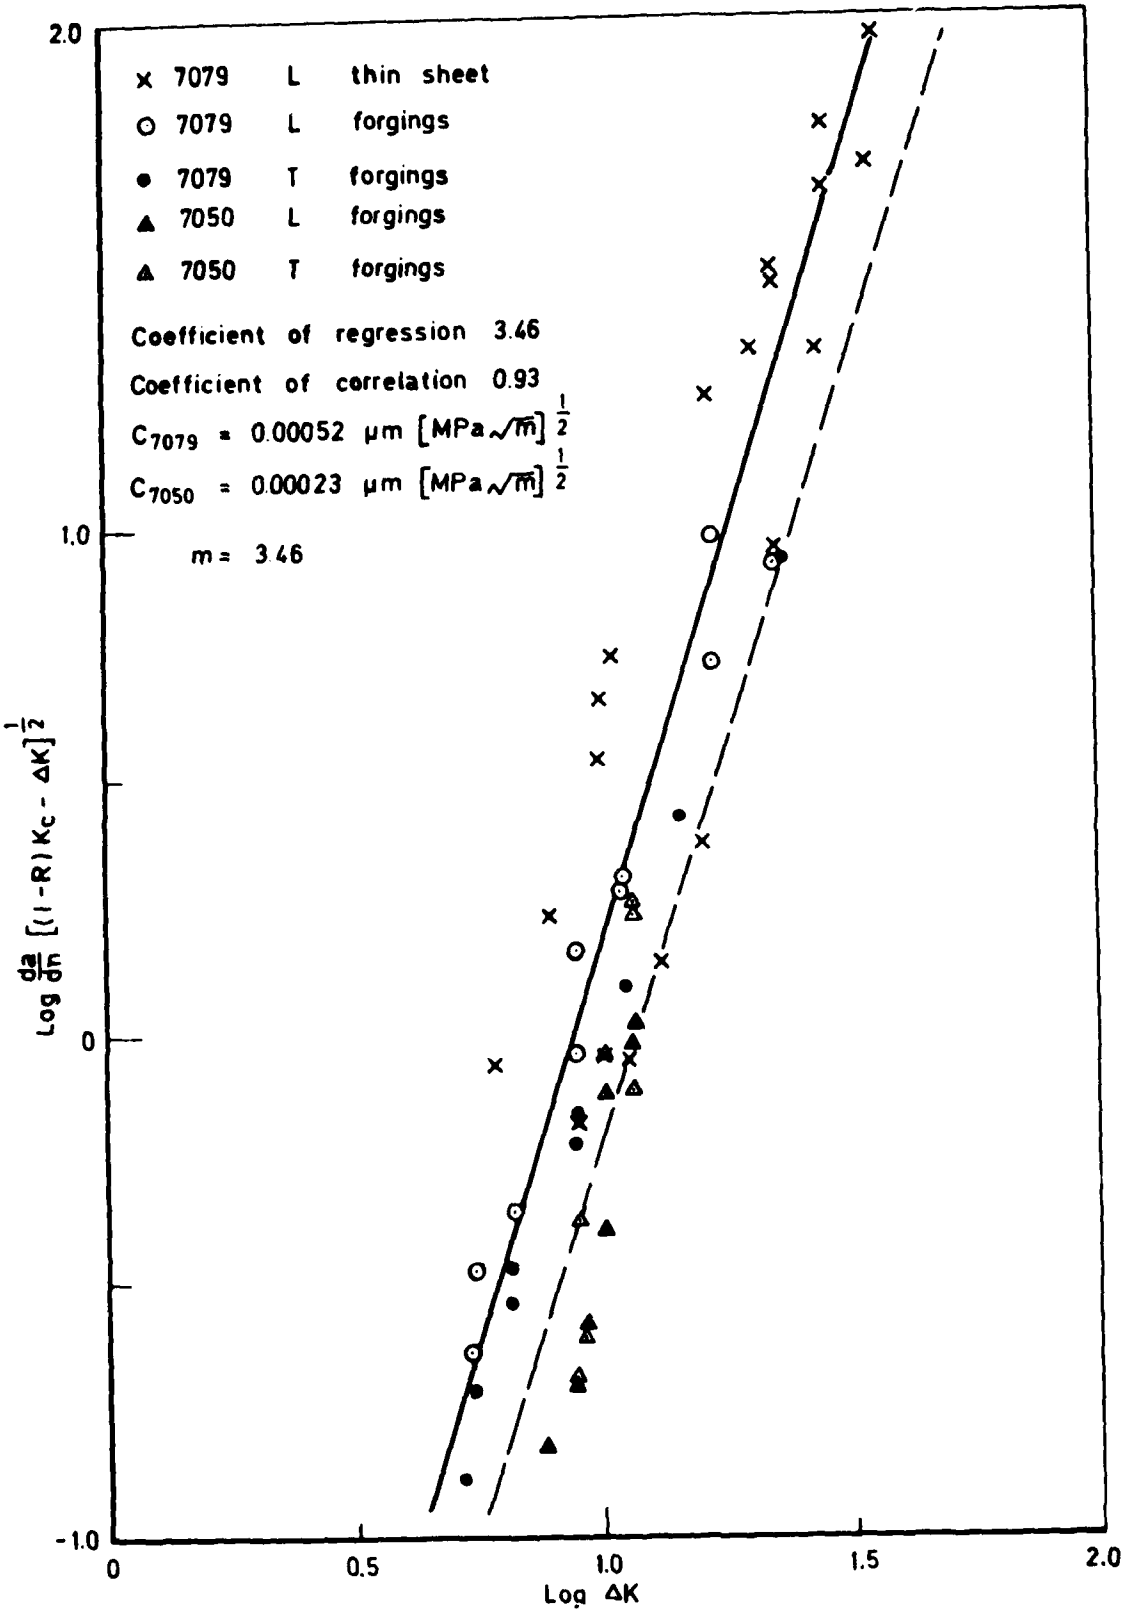
as either the severe duty cycle or the standard duty cycle. A comparison of the predicted total growth rate (Fig 12) with the laboratory data (Fig 10) revealed that the effective stress cycle was approximately 1.2 times the magnitude of the large engine run-up cycle with same zero value of R . The engine run-up stress cycle had a range of 191 MPa for the severe case and 173 MPa for the standard duty case and the effective stress cycles were therefore 229 MPa and 208 MPa respectively. Stress-life data for these effective stresses were obtained by combining data for 7050-T73651 plate and 7050-T736 die forgings for a $k_t$ of 3 (Fig 15). Lives of 8000 severe duty cycles and 10200 standard duty cycles were predicted by the plate data for the two effective stress cycles. The limited data indicated that forged material might have had a slightly longer life. The actual fatigue life was a combination of 1.21 times the predicted standard life plus 0.21 times the predicted severe life; a small underprediction in fatigue life of the order of the scatter in the laboratory data. Data for a $k_t$ of 3 was used in the prediction but the quality of the surface finish of the laboratory test pieces was unknown.

Fig 10 Log $\frac{da}{dn}$ $[(1-R)K_c - \Delta K]^{\frac{1}{2}}$ versus log ΔK for 7079 and 7050

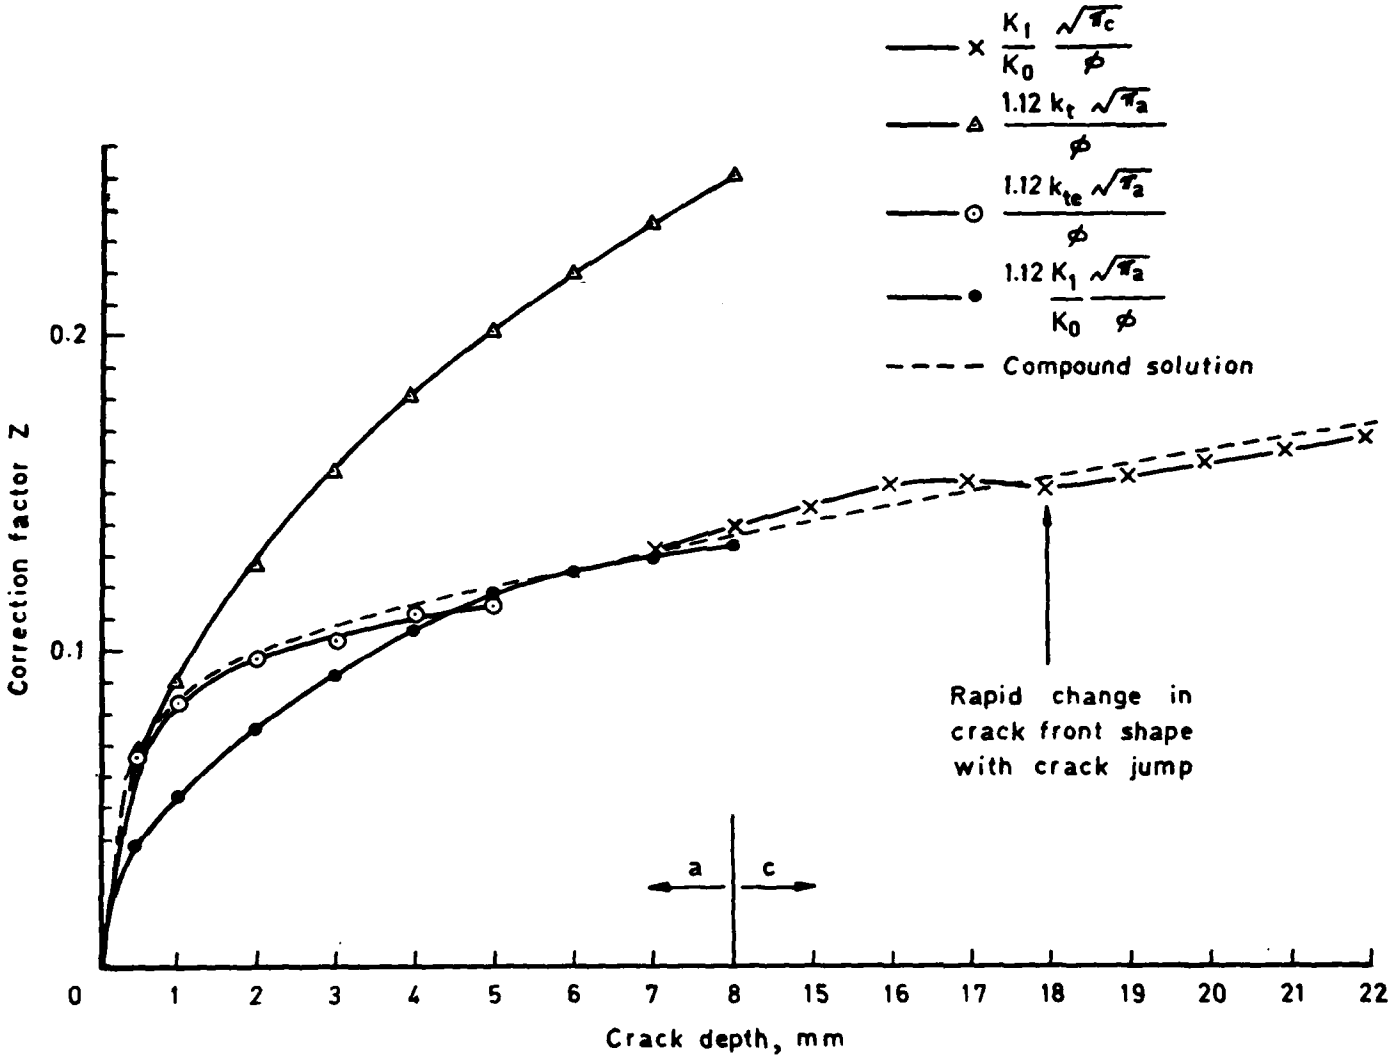
The selected solutions for Z were plotted as a function of crack depth (Fig 11) using a value of $\phi$ determined from the apparent crack front shape. The crack was assumed to be semi-elliptical at short depths with a c:a ratio of 2:1 ($\phi = 1.2$) and with penetration of the cylinder wall to increase in curvature to semi-circular at final failure ($\phi = 1.57$). An abrupt increase in curvature had occurred at 18 mm depth where the crack had jumped. A smooth curve, representing the best estimate for Z compounded from the selected solution, was drawn and used for the growth rate predictions (Fig 11). Combining equations (1) and (2):-

**Fig 11** Predicted values for the correction factor Z for the various solutions and the compounded solution used for growth rate predictions

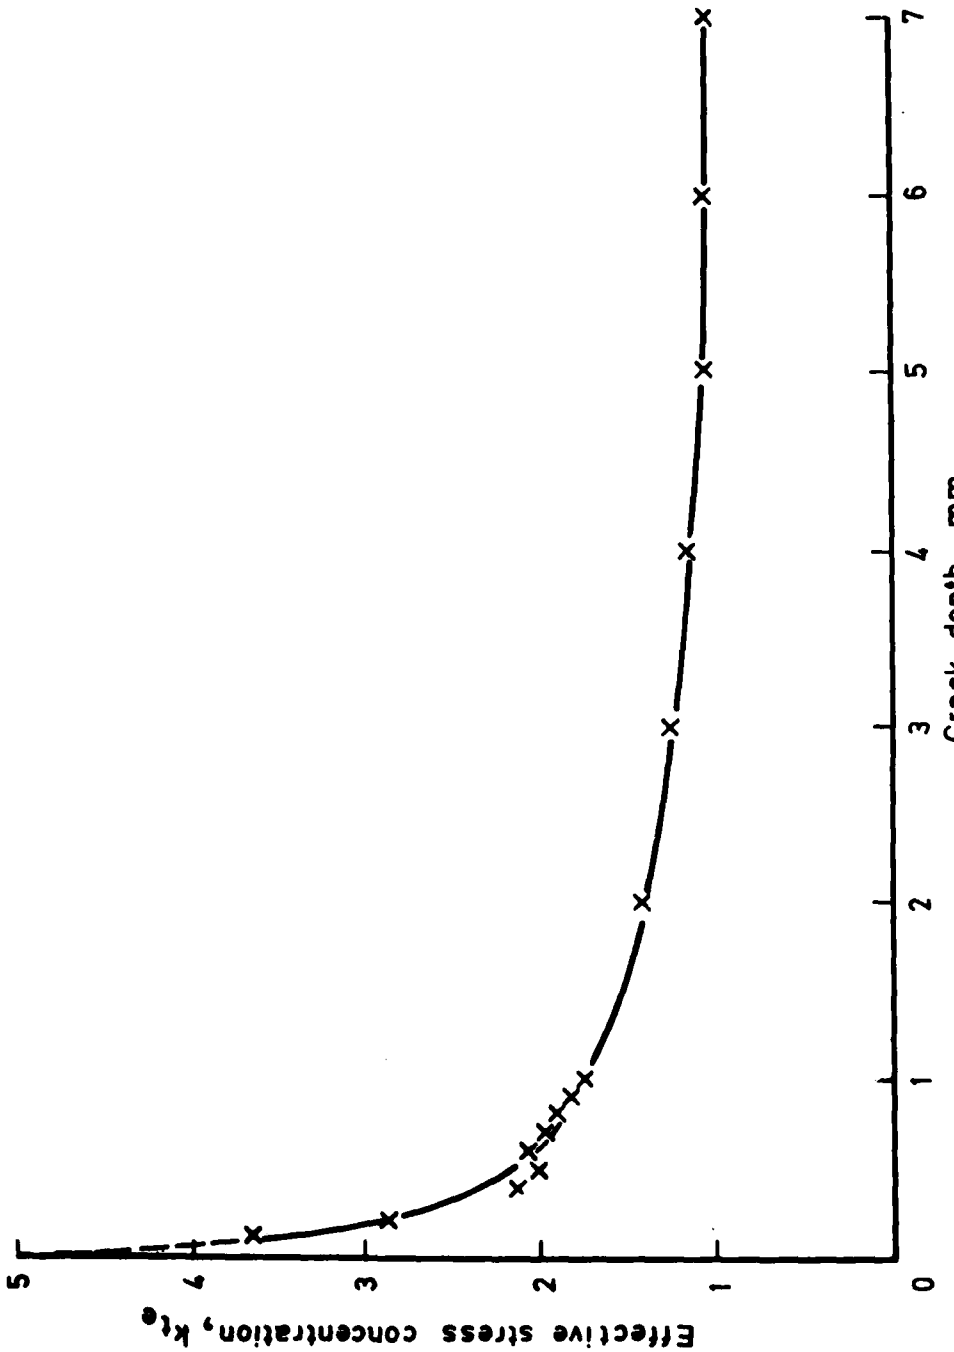
calculated to give a perfect fit to the striation data and values of $k_{te}$ were recalculated from the new values for Z . It was found (Fig 13) that the striation data for short cracks suggested that the surface $k_{te}$ may have been as high as five but that its effects diminished very quickly as the crack grew. This appeared to indicate that the surface $k_{te}$ was the product of a nominal $k_t$ of 1.7 for the surface curvature and locally a value of approximately three for the deep machine marks. The deleterious effects of the coarse machining were thus very severe.

Fig 13 The apparent or effective stress concentration predicted by the striation spacings

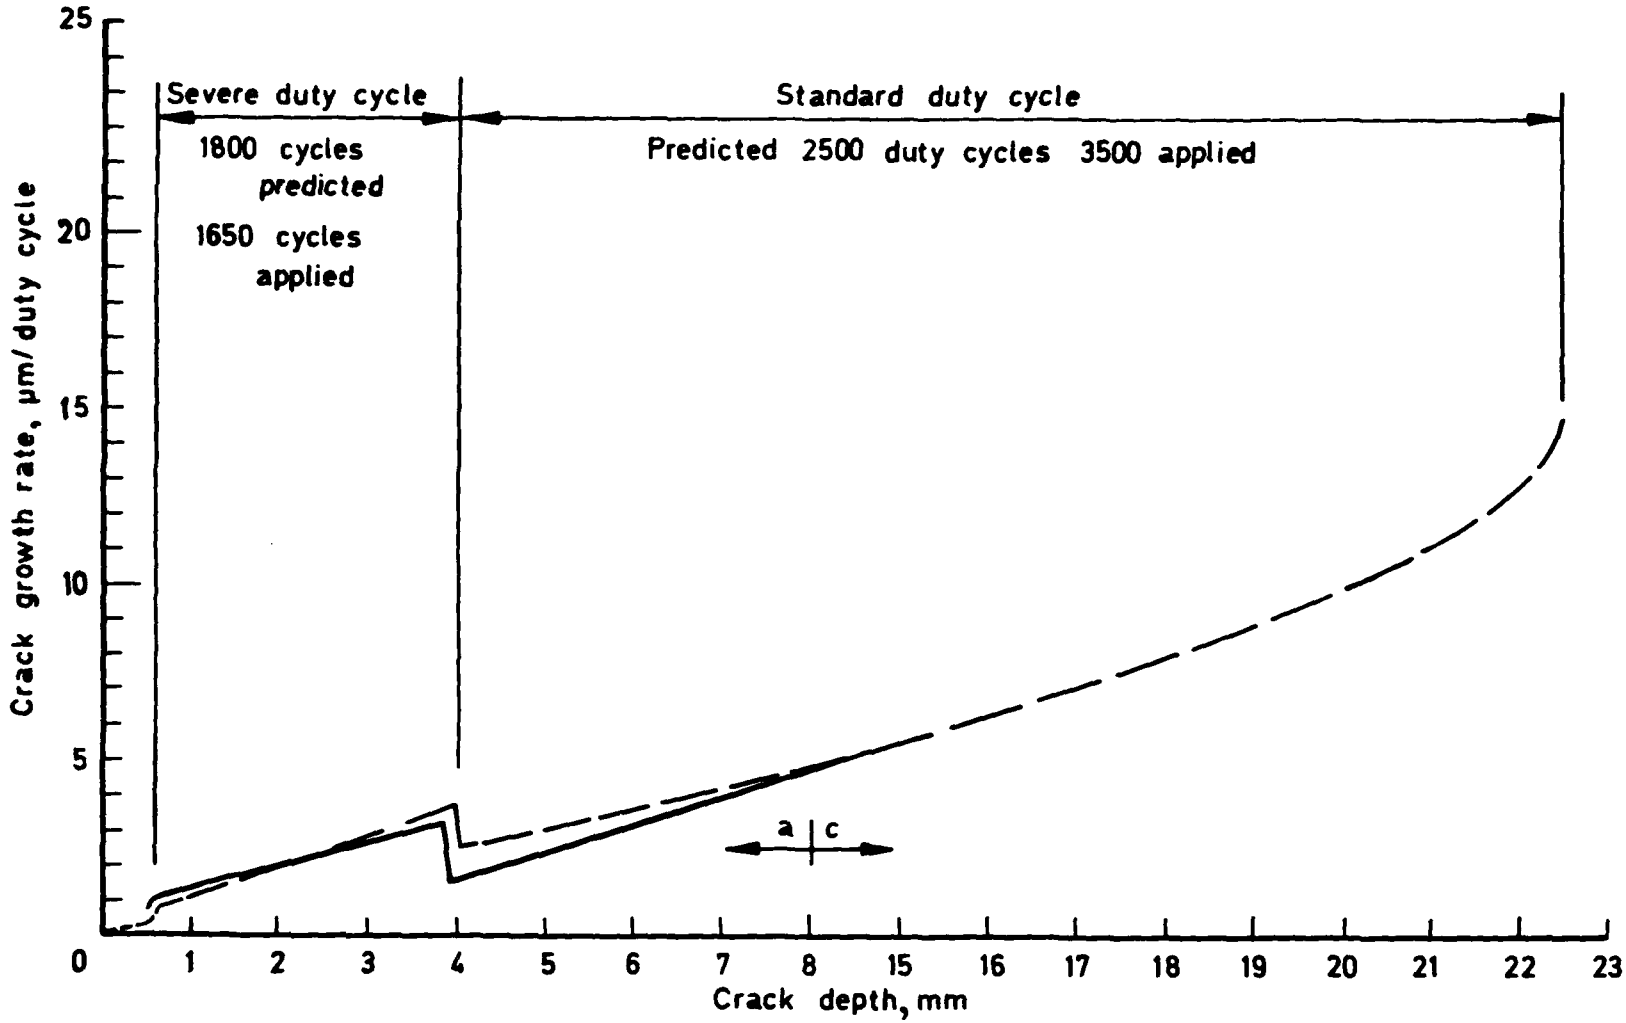
Fig 14 Fatigue crack growth rates from initiation to catastrophic failure. The crack penetrated the cylinder wall at a depth of 8 mm

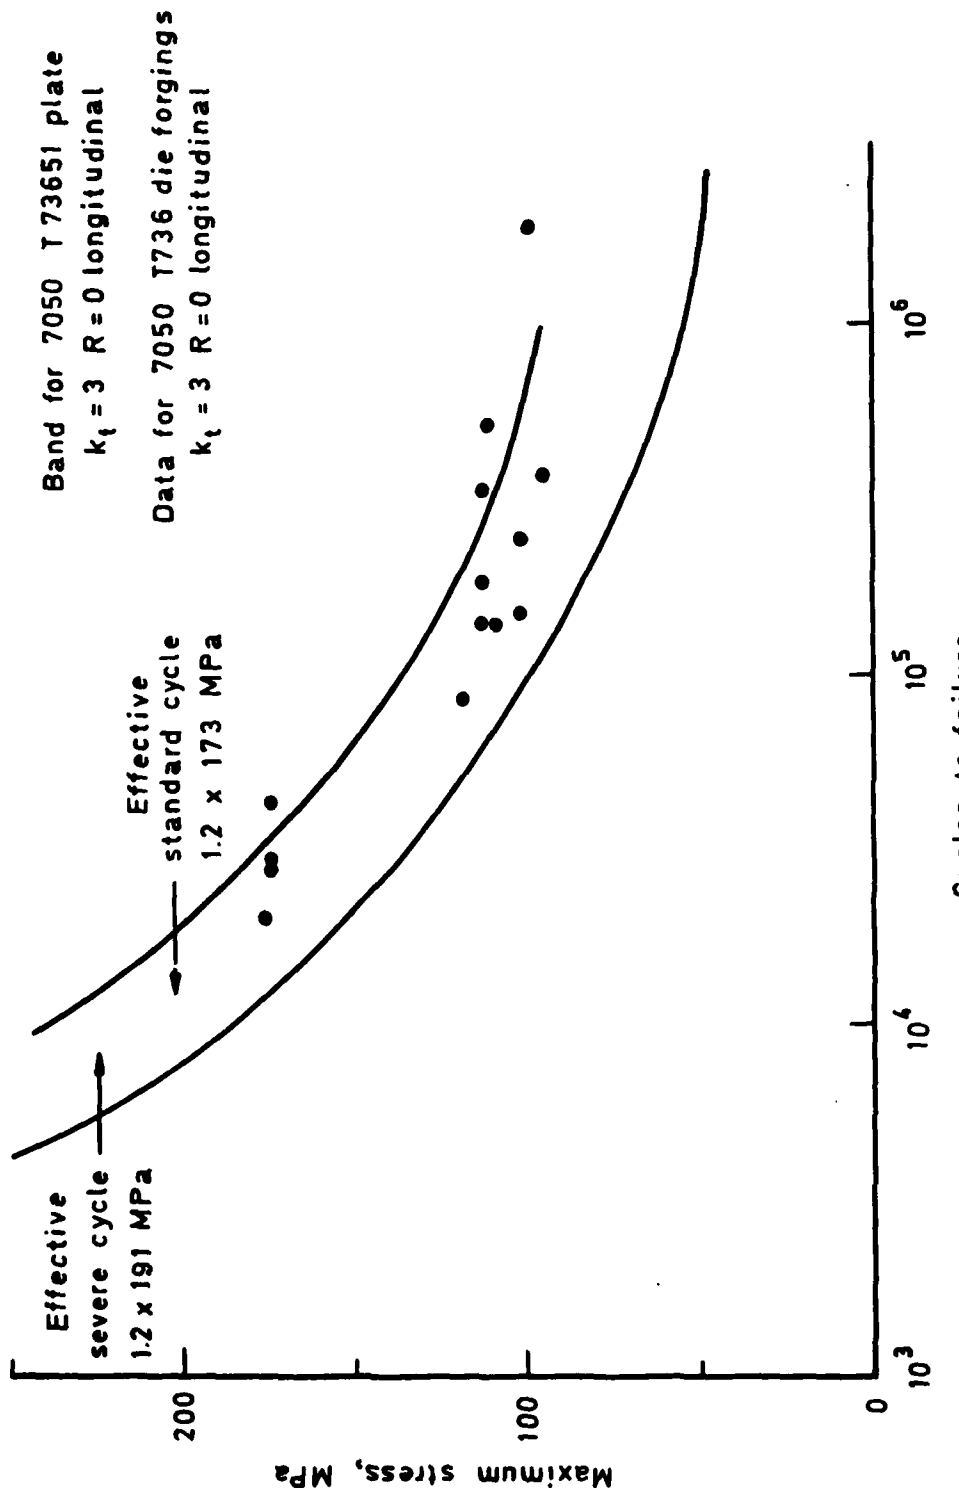
Fig 15 Axial stress fatigue data for 7050 alloy plate and die forgings, showing the levels of effective stress for the severe and standard duty cycles
